Asset #06732(Routine)

U.S. 62 - Wash. Co over Illinois River

Location: 1mi. E. Prairie Grove

Team Lead: Eric West, Inspection Date: 02/08/2022

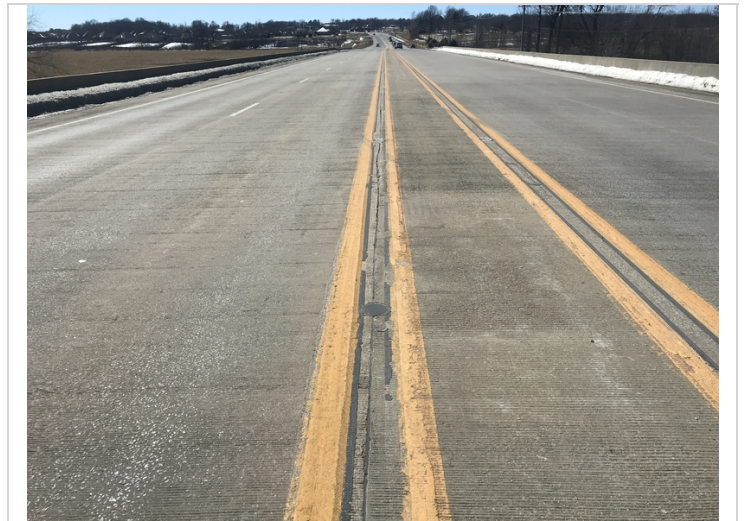
Typical driving surface of the deck.

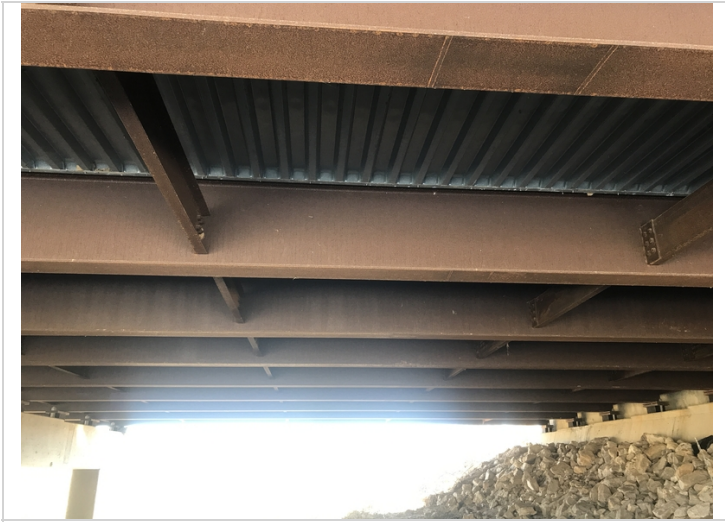
Span #1 typical undersurface of the deck.

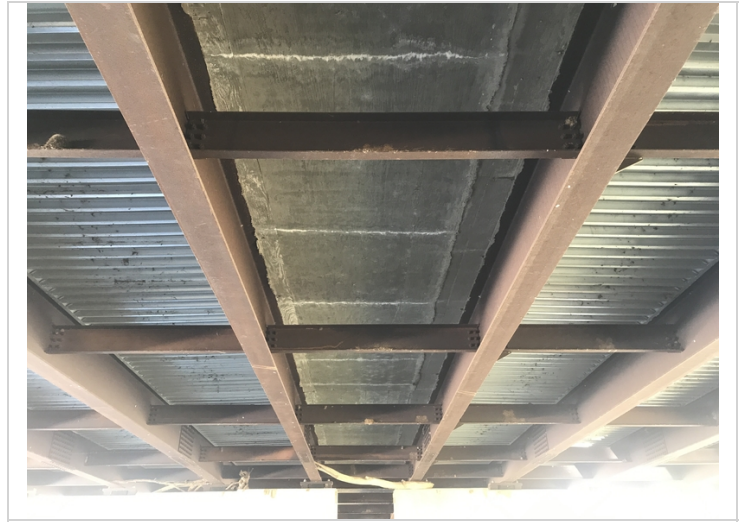
(12) -Sealable deck cracking in all spans with areas of map cracking, transverse cracking, longitudinal cracking and random cracking visible -Full length longitudinal cracks appear to be over the top flanges of the beams. -Transverse cracks visible in the undersurface at centerline bay where SIP forms were not used and in the deck overhangs have light efflorescence.							
107	Steel Open Girder/Beam	LF	3830	3830	0	0	0
515	Steel Protective Coating	SF	25280	6358	18922	0	0
3430	Oxide Film Degradation Color/Texture Adherence(Steel Protective Coatings)	LF	25280	6358	18922	0	0

Typical transverse cracking with efflorescence buildup along the centerline.

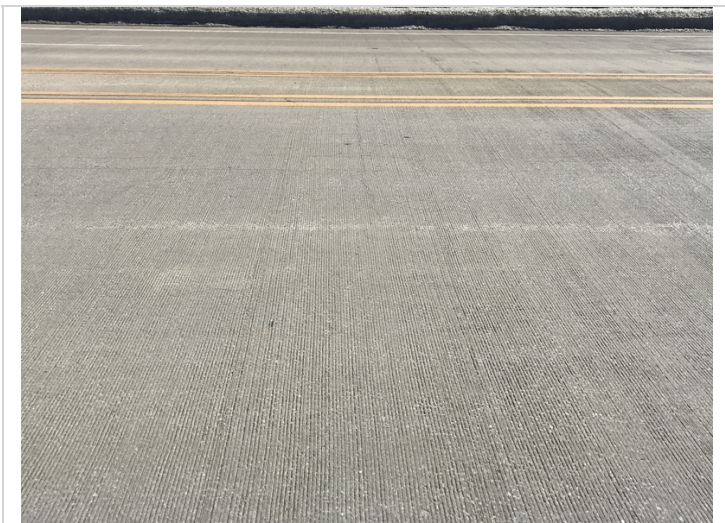
Sealable deck cracking.

Deck -  
The deck has sealable cracks in all spans.

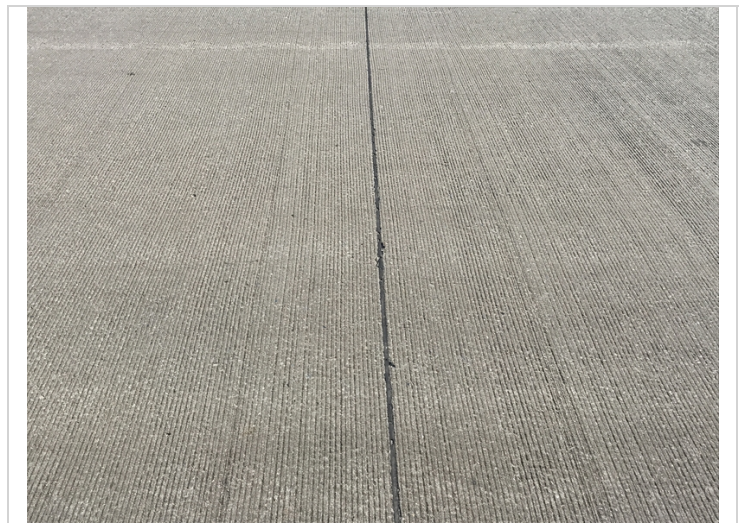
Deteriorating saw joint sealant.

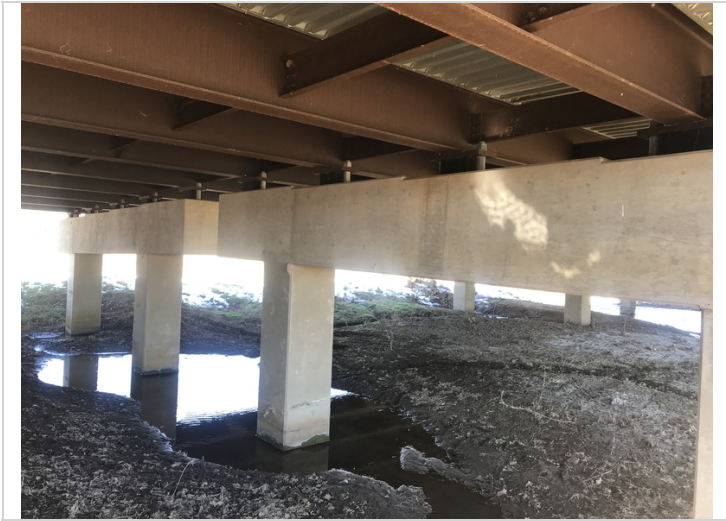
Bent #2 typical.

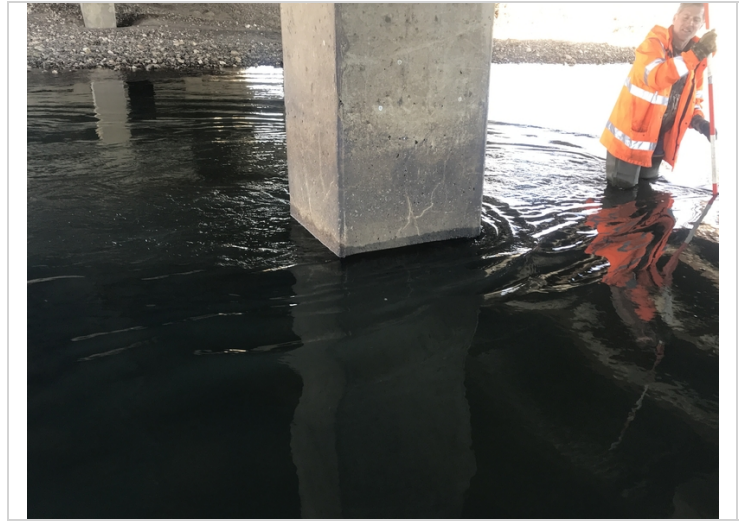
(205) -Several columns in the channel have light abrasion. -Bent #3, column #1 has an area of honeycombing at base. -Bent #4, column #2 has vertical cracking in lower portion of column on two sides.							
215	Reinforced Concrete Abutment	LF	142	45	91	6	0
1120	Efflorescence/Rust Staining	LF	8	0	5	3	0
1130	Cracking (RC and Other)	LF	89	0	86	3	0

Bent #4 column #2 cracking with efflorescence buildup.

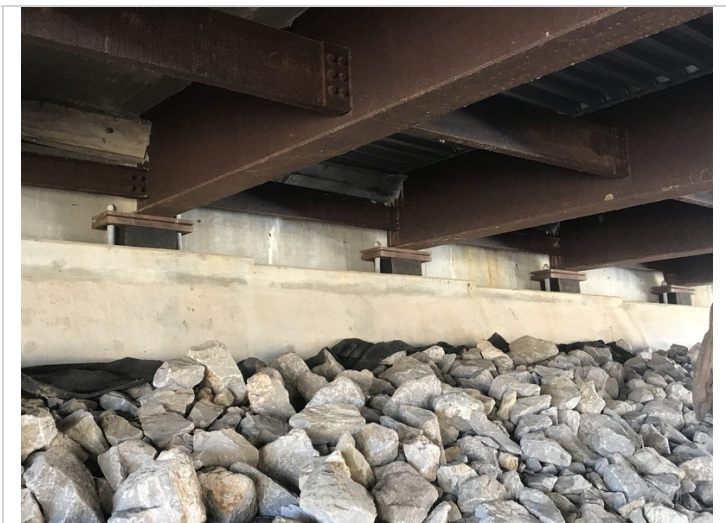
(215) -There is map, transverse and longitudinal cracking in the top of the back walls visible from the driving surface of the deck. -Exposed snap ties from the construction process in the face of the back walls in both abutments. -Vertical cracks with light efflorescence in the back walls visible from the undersurface. -Abutment #1 backwall has horizontal cracking in the right half of backwall located mid-way up the wall behind the end diaphragm.							
220	Reinforced Concrete Pile Cap/Footing	LF	162	162	0	0	0

Abutment #1 cracking with efflorescence buildup in the backwall.

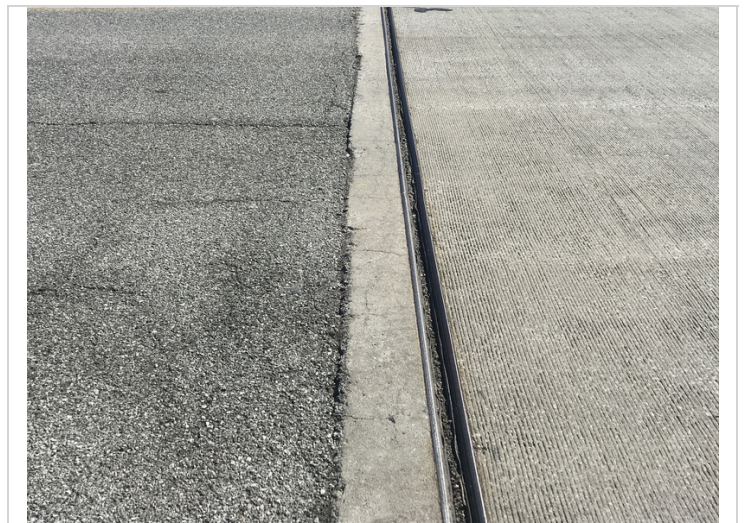
Abutment #2 top of the backwall cracking.

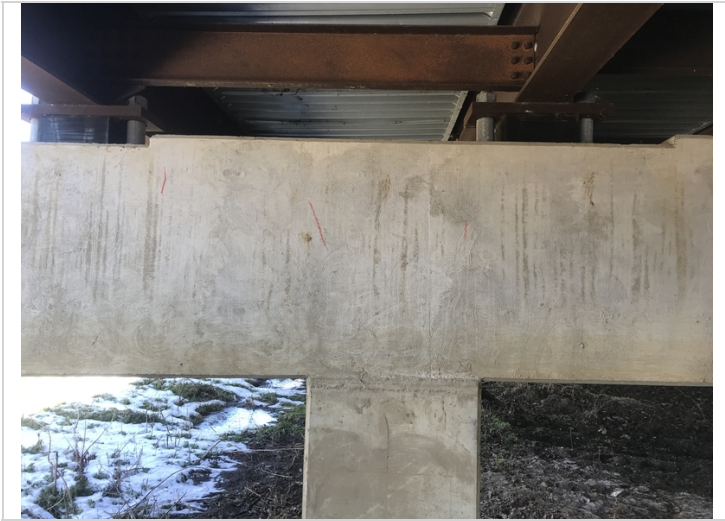
(234) -Isolated areas of shallow honeycombing from the construction process. -Bent caps have a few short duration hairline cracks at the step downs and other random locations. -Bent caps have drift accumulation in some locations indicating water elevation during high water event. (1130-234) Bent caps have a few short duration hairline cracks at the step downs and other random locations.							
300	Strip Seal Expansion Joint	LF	145	0	61	84	0

Bent #6 Lt cap cracking over column #1.

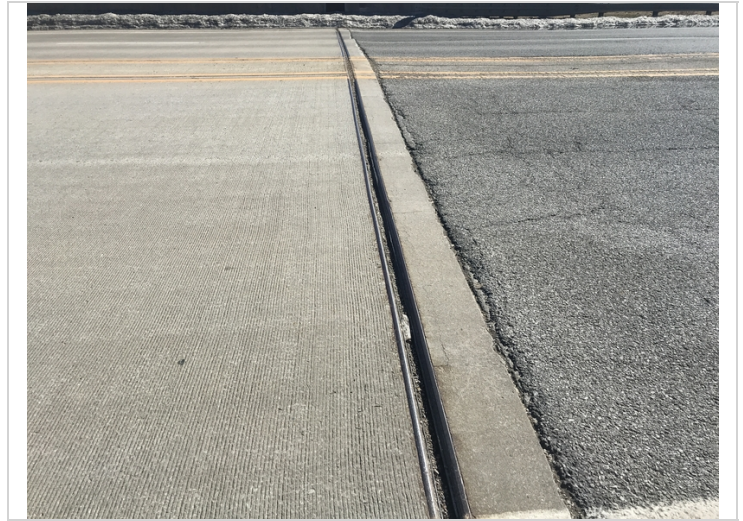
Abutment #1 debris impact in the expansion joint.

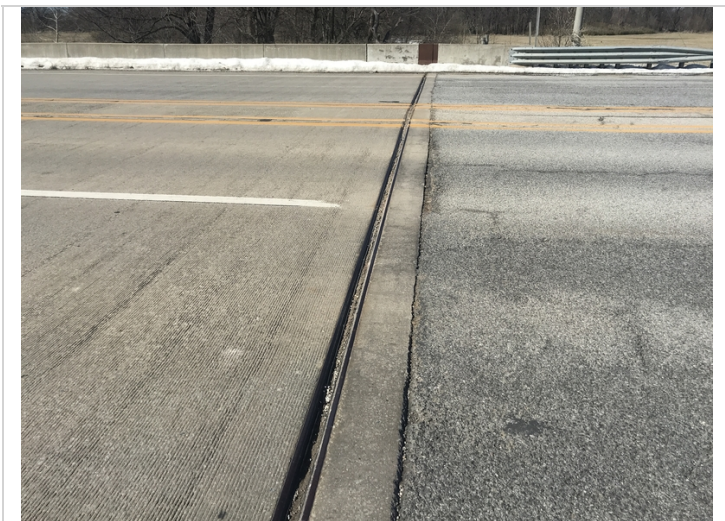
Abutment #2 joint seal debris impact.

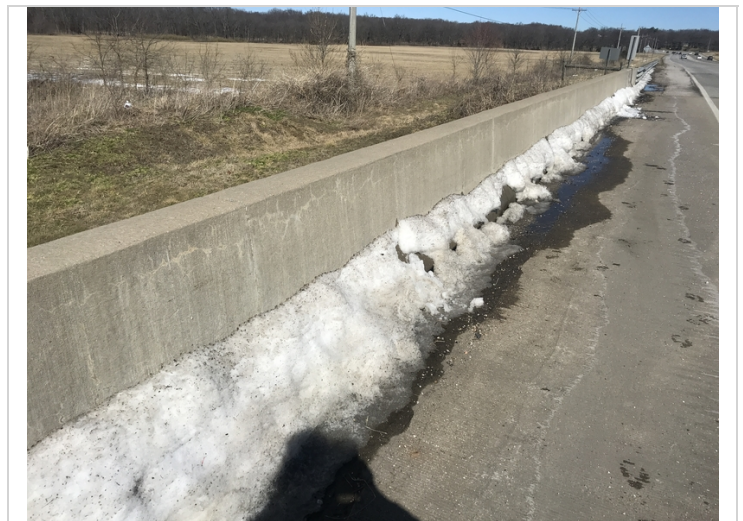
Typical cracking in the parapet walls.

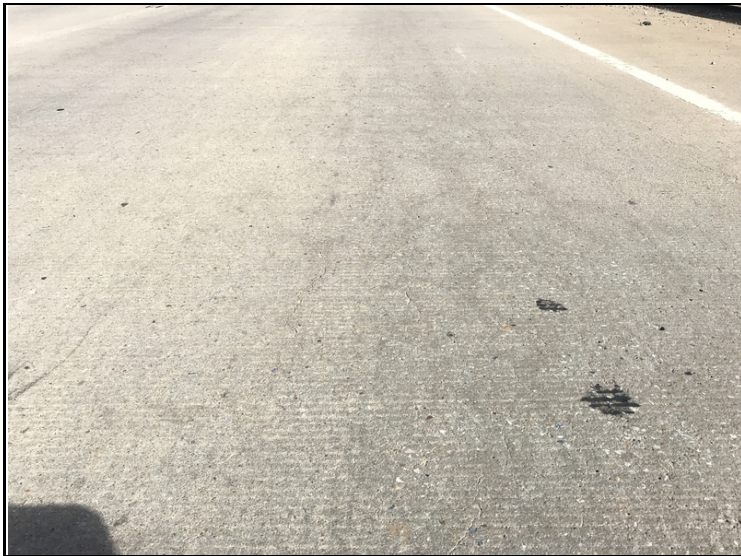
Map cracking.

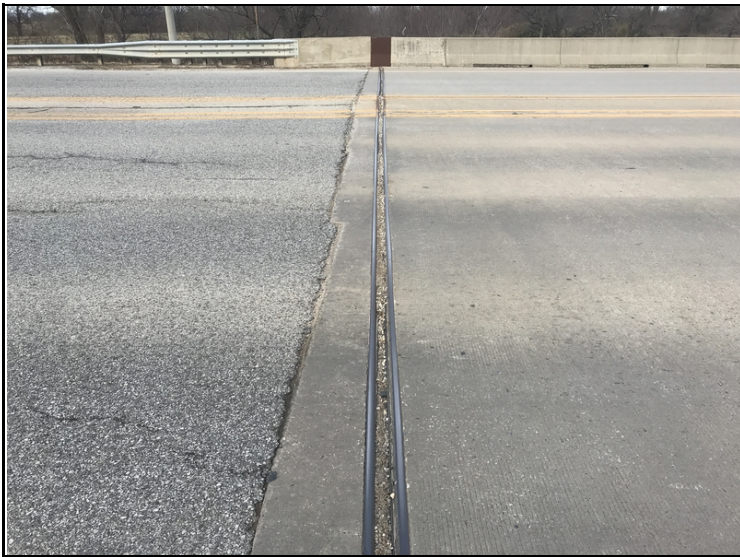
Expansion joint assemblies -  
Expansion joint assemblies have heavy dirt and debris accumulation.

Abutment 1 expansion joint assembly has heavy dirt and debris accumulation.

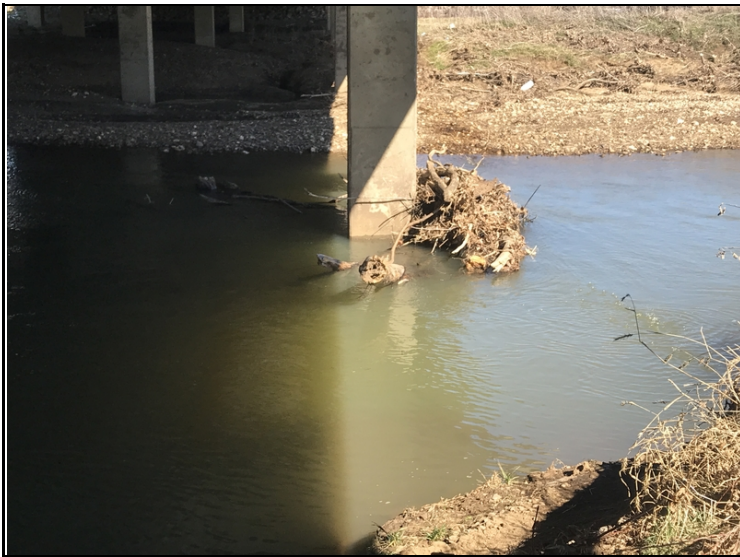
02/03/2020 - RSM & SPC: Underwater Type II inspection: Wading probing and visual observation revealed that the channel has moderate drift accumulation at bents #3 and #4 causing localized scour at base of columns. All footings have cover at this inspection.

Channel-  
Drift accumulation at Bent # 4.

Bent #4 drift accumulation.
