Asset #01648(Routine)

US Highway 64 over Pond Creek - Frank. Co.

Location: 1.00 Mi. West OF ALTUS

Team Lead: Eric West, Inspection Date: 05/26/2022

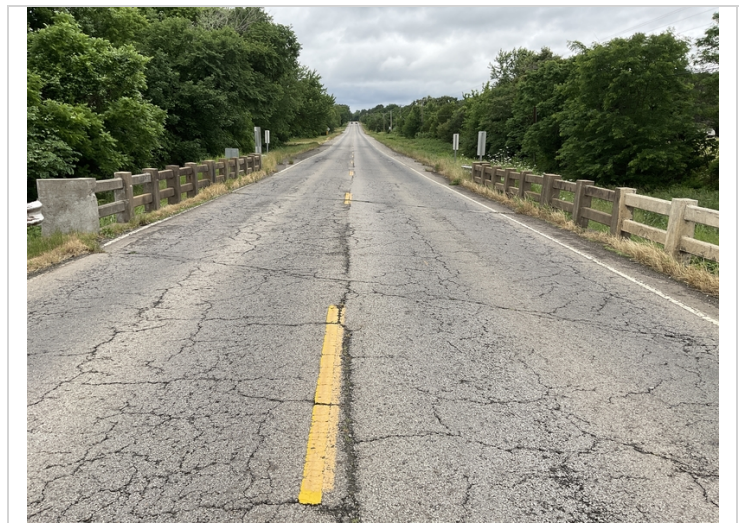
Typical driving surface of the deck.

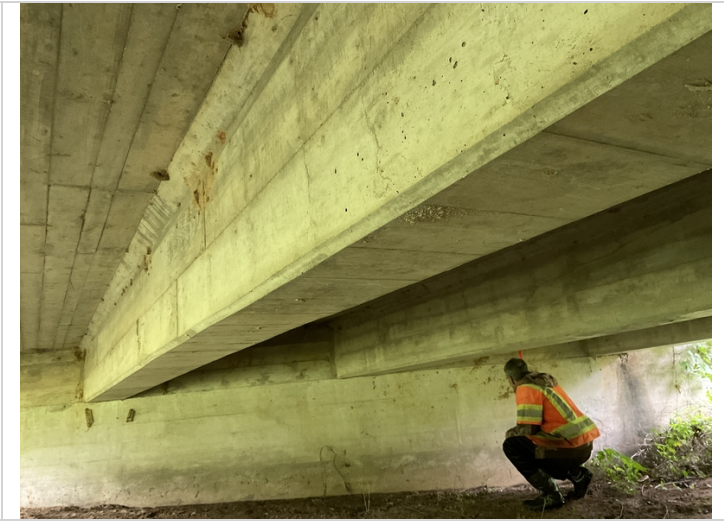
Span #2 typical undersurface of the deck.

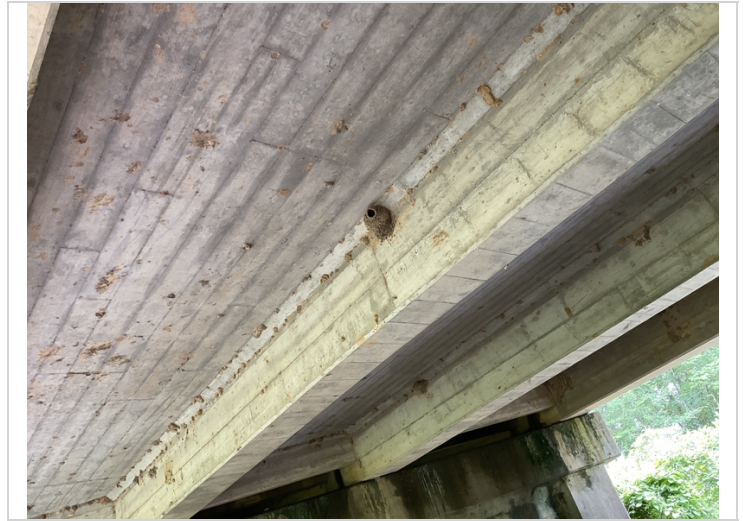
Span #2 typical undersurface of the deck.

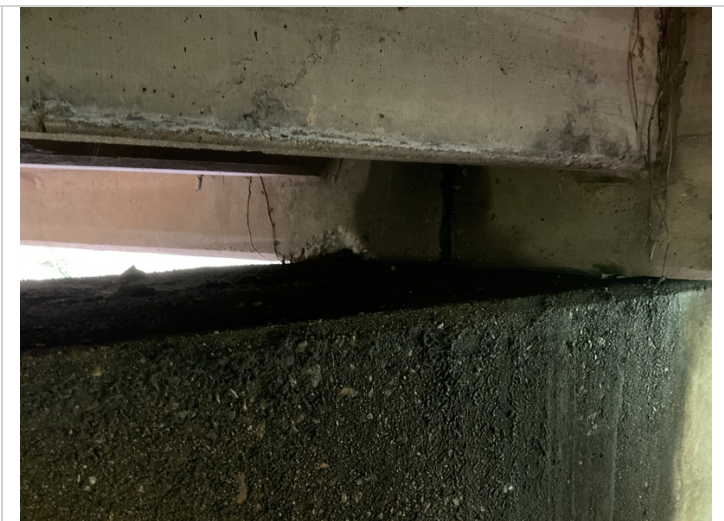
Span #2 girder #4 at Bent #2 spalling.

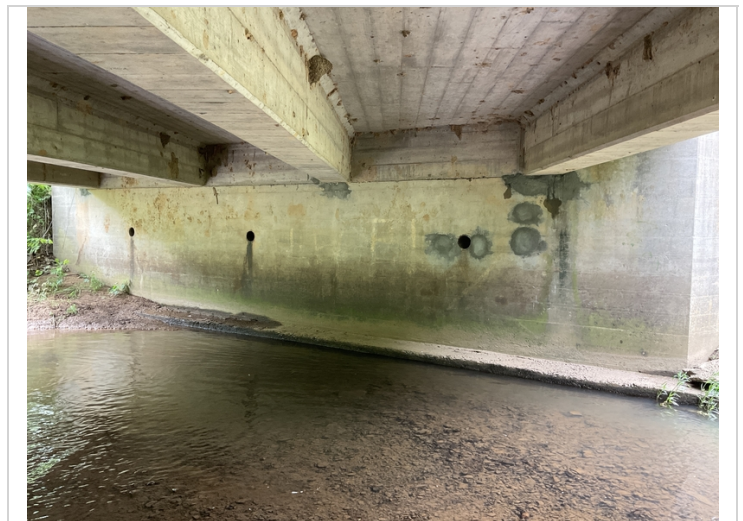
Abutment #2 grouted repairs to the spalling in the abutment stem.

05/26/2022 - EJW - Maintenance forces have made grouted repairs.

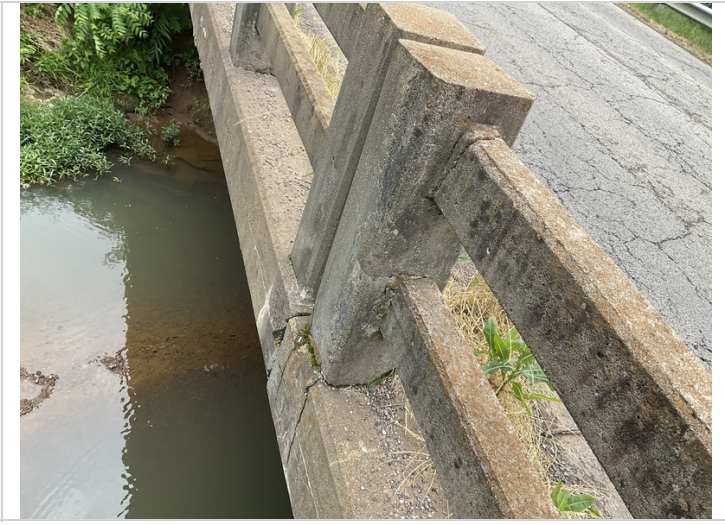
Span #1, Bent #2 Lt fractured rail and post.

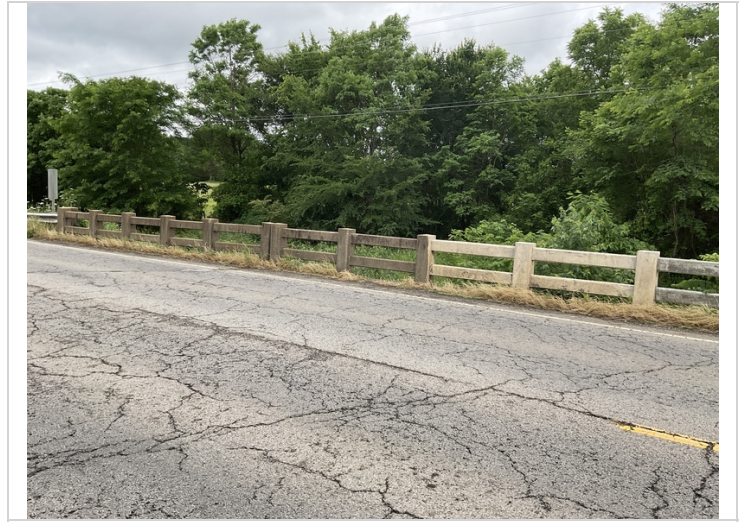
Typical bridge rail.

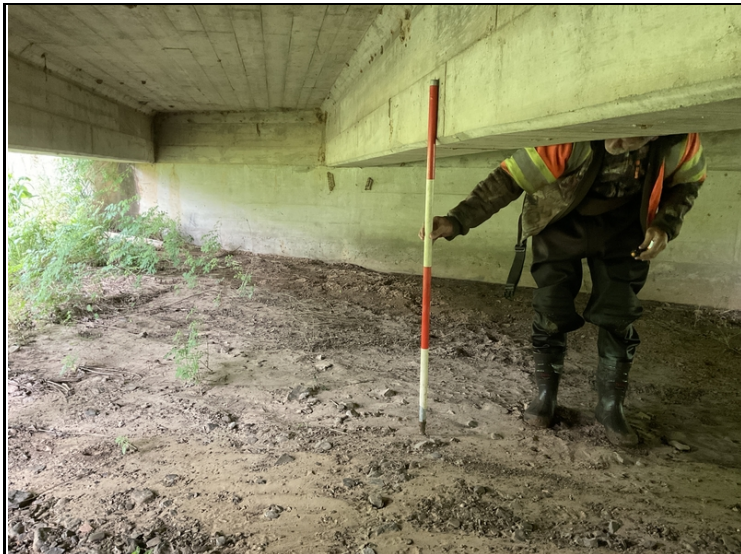
Span #2 channel restricted by stream bed material accumulation.

Will schedule streambed accumulation when equipment and manpower comes available

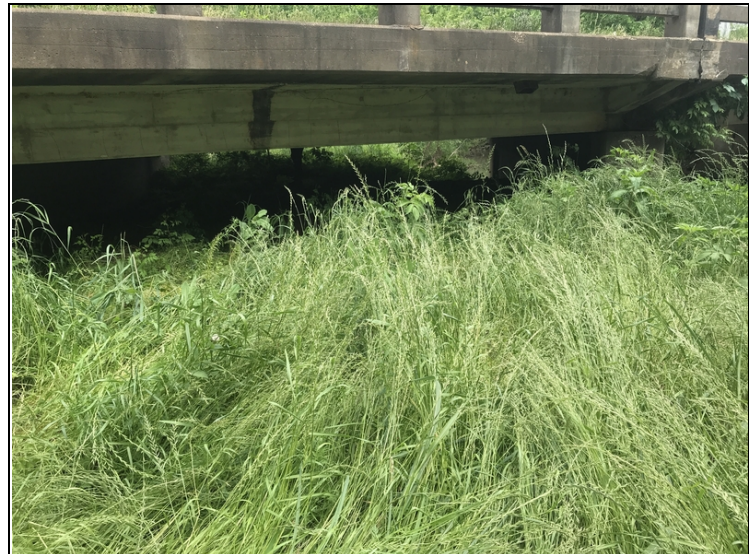
Channel has streambed accumulation under Span # 1 reducing the channel freeboard to less than 4' at this inspection.

Cut trees in the channel - 1/13/2019

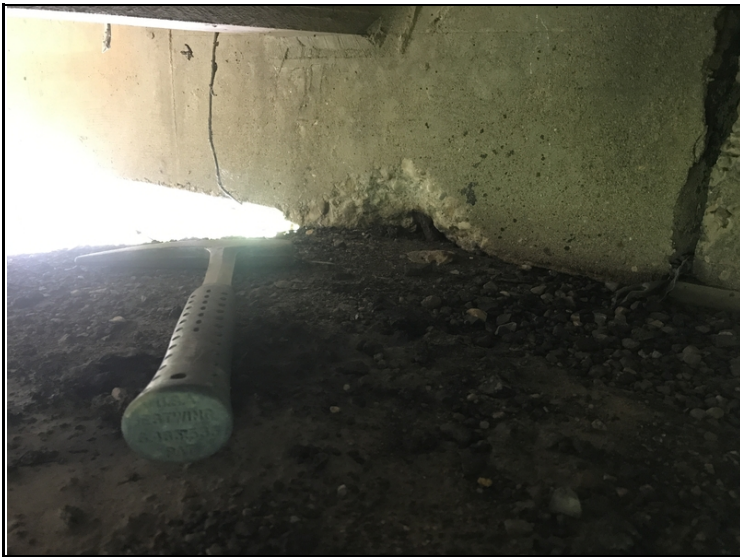
Superstructure -
There are spalls in the ends of Girders # 3 & 4 at Bent # 2.

There are spalls in the ends of Girders # 3 & 4 at
Bent # 2.

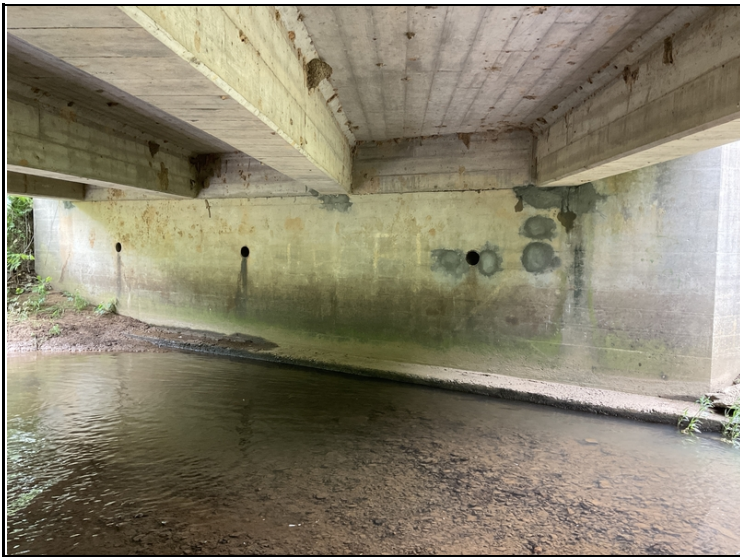
Abutment #2 typical.

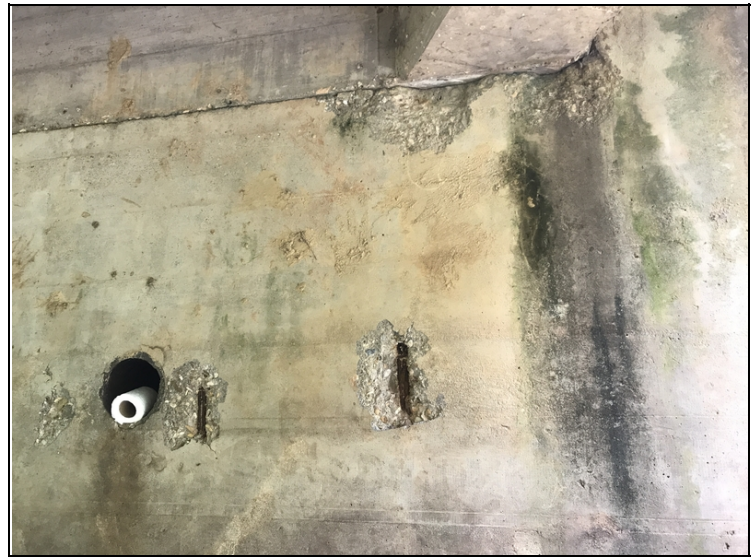
Substructure -
Abutment # 2 stem wall has two 10" spalls with exposed reinforcing steel on the right side.

Abutment # 2 stem wall has two 10" spalls with exposed reinforcing steel on the right side.
