Asset #05180(Routine)

US Highway 64 over Gar Creek - Frank. Co.

Location: 0.30 MI E JCT SH 219

Team Lead: Eric West, Inspection Date: 05/25/2022

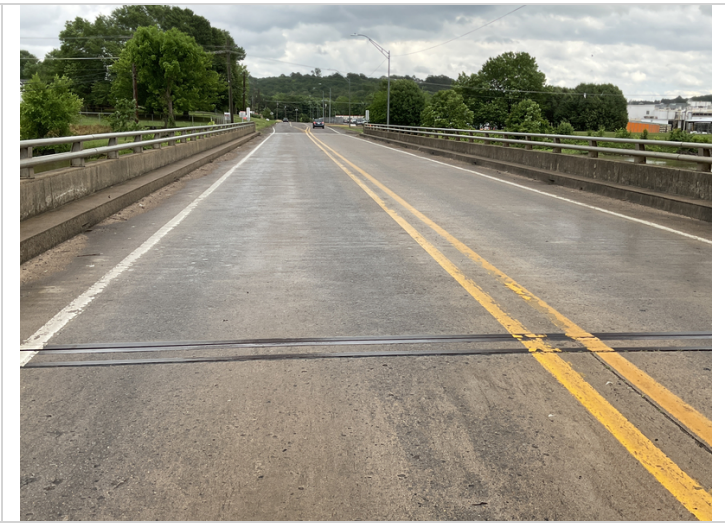
Typical driving surface of the deck.

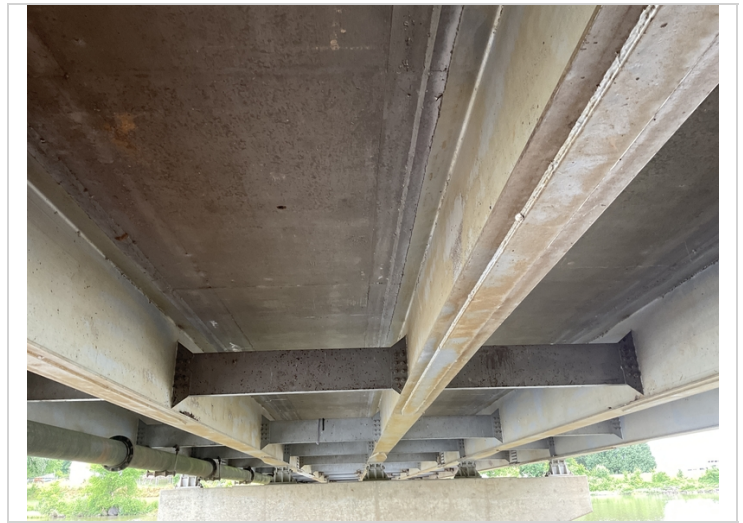
Span #1 typical undersurface of the deck.

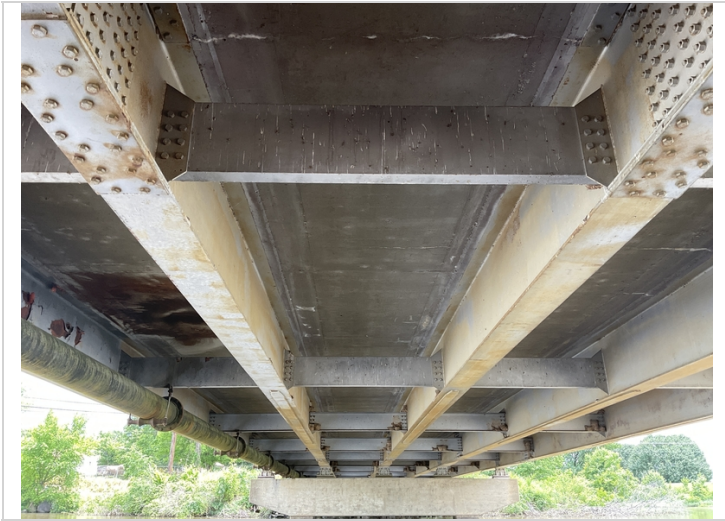
Span #2 typical undersurface of the deck.

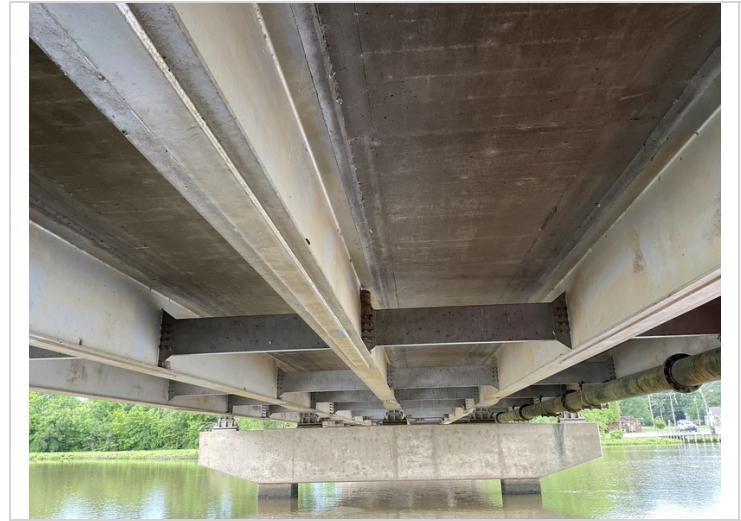
Span #3 typical undersurface of the deck.

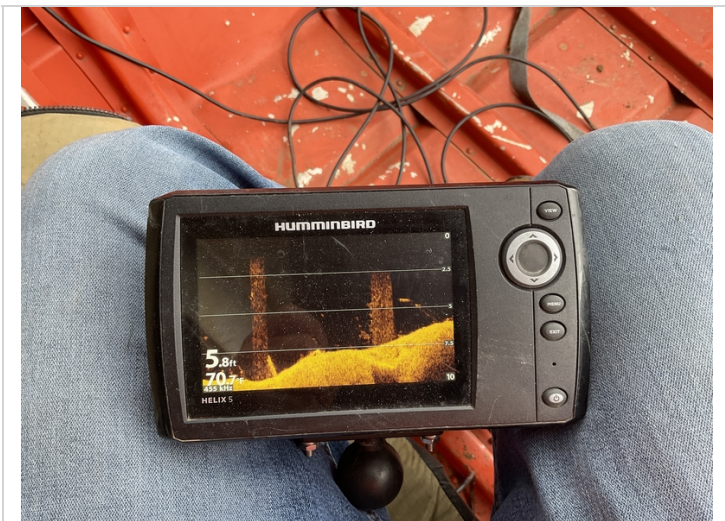
04/07/2020 - RSM & SPC: Probing from a boat revealed that all footing have cover at this inspection. No apparent scour problems at this inspection.

Bent #2 no apparent scour problems.

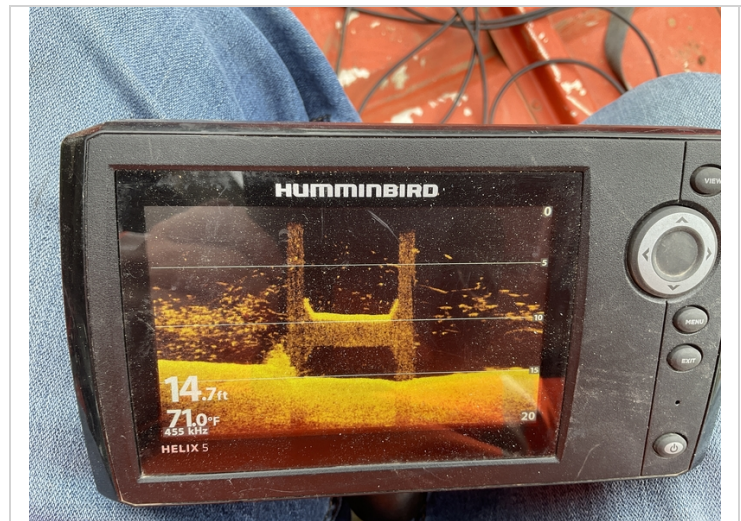
Bent #3 no apparent scour problems.

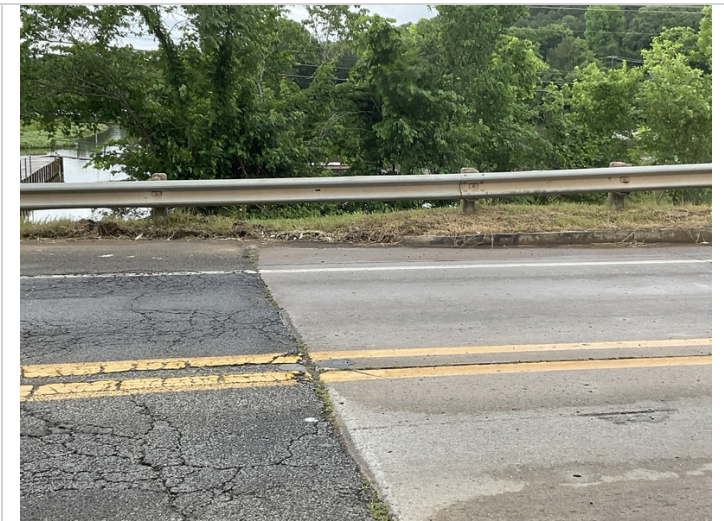
Approach drains filled with dirt.

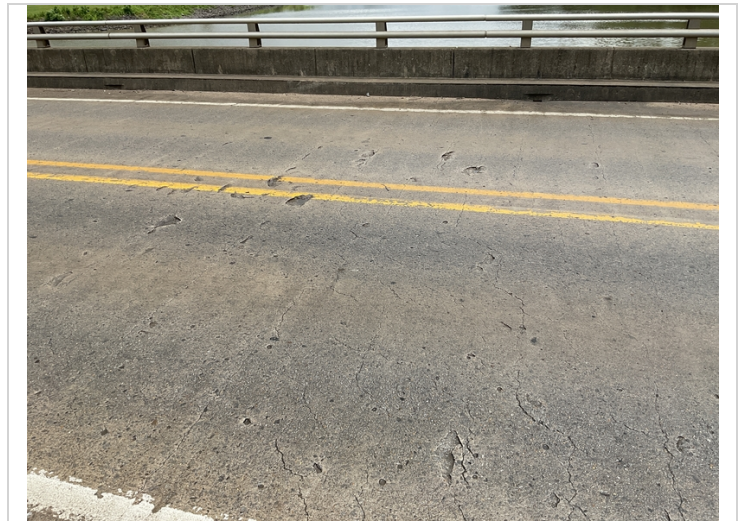
Span #2 concrete cracking and delaminating areas.

There are delaminated areas and spalls with a few isolated areas with exposed reinforcing steel visible on the driving surface of the deck adjacent to the sealable deck cracks. The left and right gutters have delaminated areas in random locations.

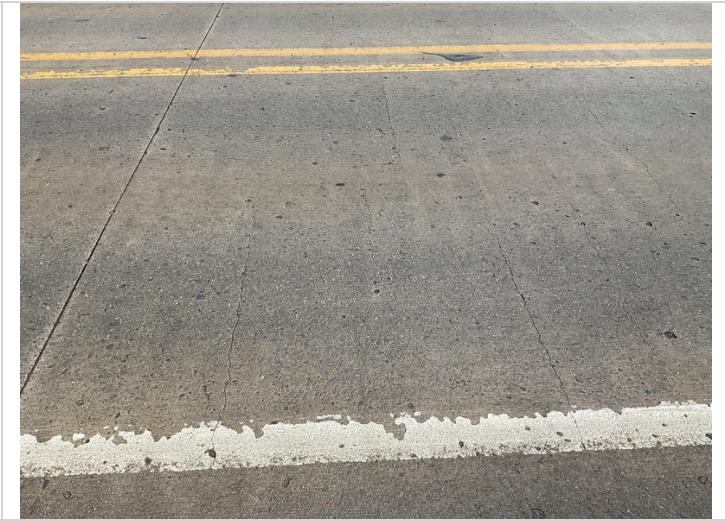
Sealable deck cracking.

The bridge deck has areas of sealable moderate width longitudinal, transverse, and map cracking.

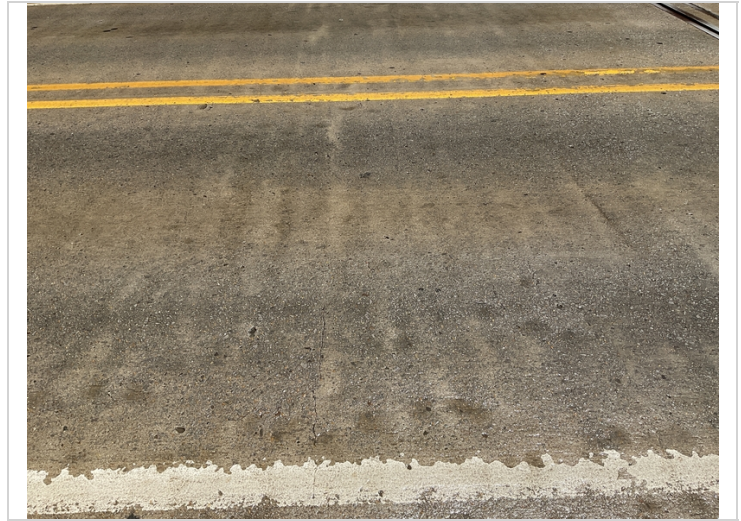
Sealable deck cracks.

The sealable transverse cracks are approximately 1' to 2' centers.

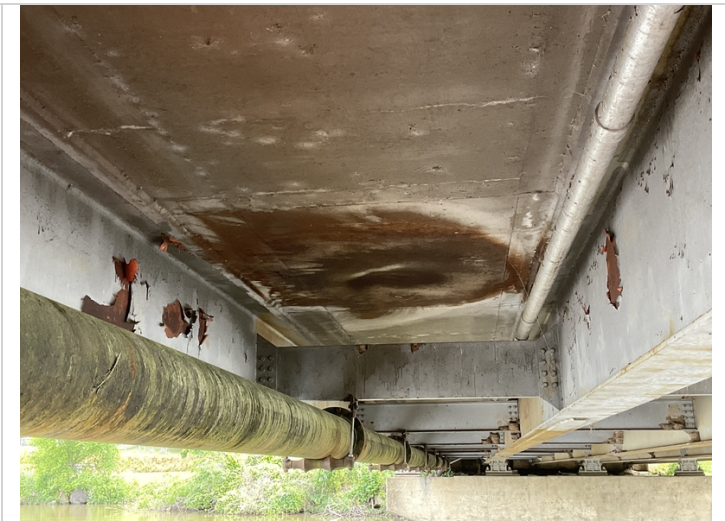
Span #2 bay #1 concrete discoloration.

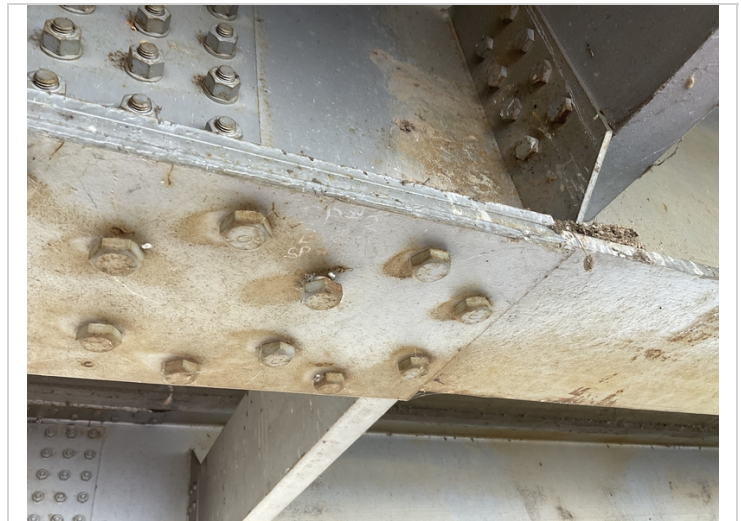
Span #2 beam #4 splice #2 loose bolt.

Superstructure -
The bottom flange in Span # 2, Beam # 4, Splice # 2 has a loose nut in the bottom splice plate connection.

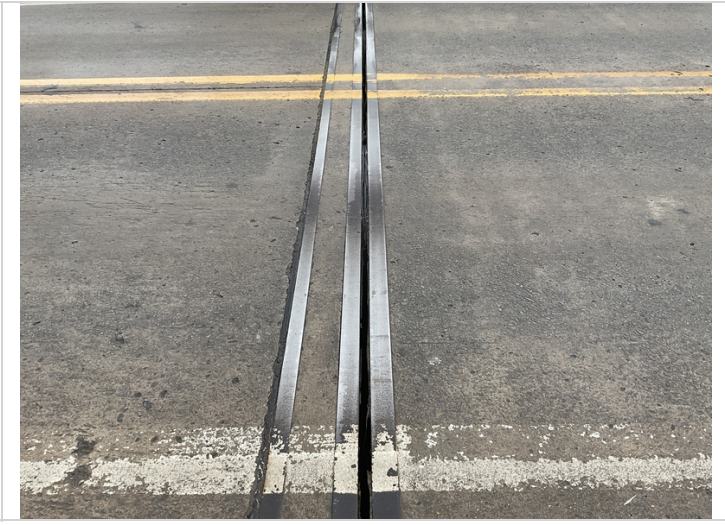
Abutment #2 missing joint seal.

The compression joints seals at the East and West abutments are no longer in place.

The missing joint seals are allowing water, dirt, and debris to leak onto the bridge seats and accumulate against the steel superstructure.

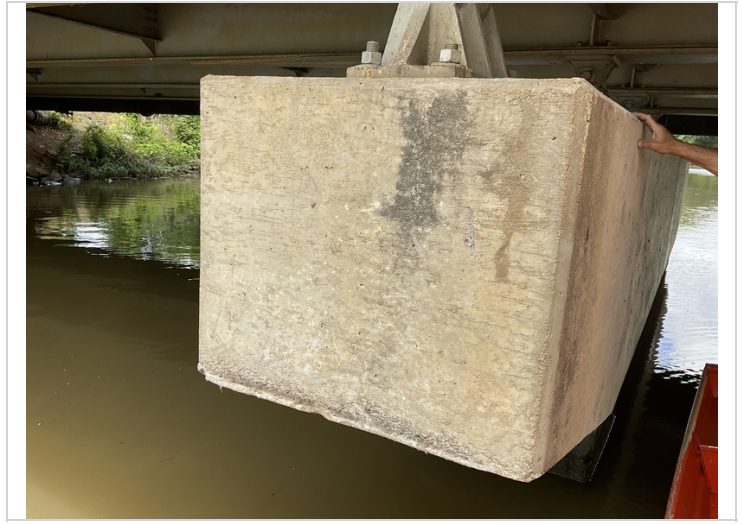
(234) -Bent #2 Rt end of the cap has a 6" vertical delamination.							
302	Compression Joint Seal	LF	67	0	0	0	67
2330	Seal Damage	LF	67	0	0	0	67
(302) -The expansion joints at the abutments are open. Compression joint seals are missing from structure.							
311	Movable Bearing	EA	15	5	0	10	0
1000	Corrosion	EA	10	0	0	10	0
515	Steel Protective Coating	SF	45	15	0	8	22
3440	Effectiveness (Steel Protective Coatings)	EA	30	0	0	8	22

Bent #2 Rt end of the cap delamination.

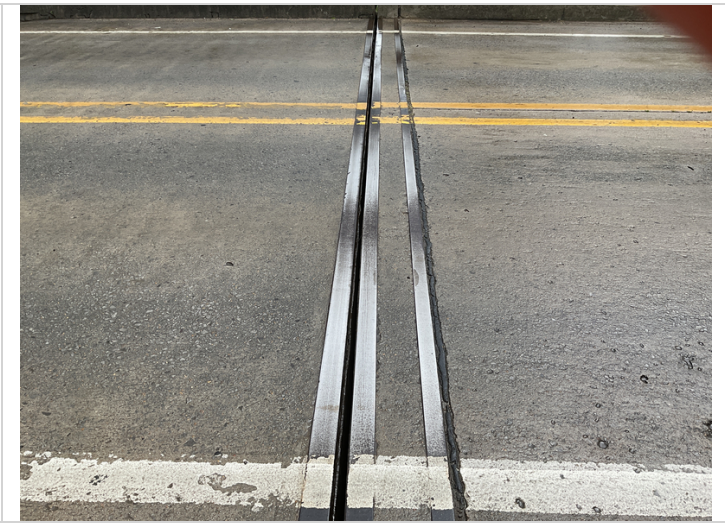
Abutment #1 joint seal missing.

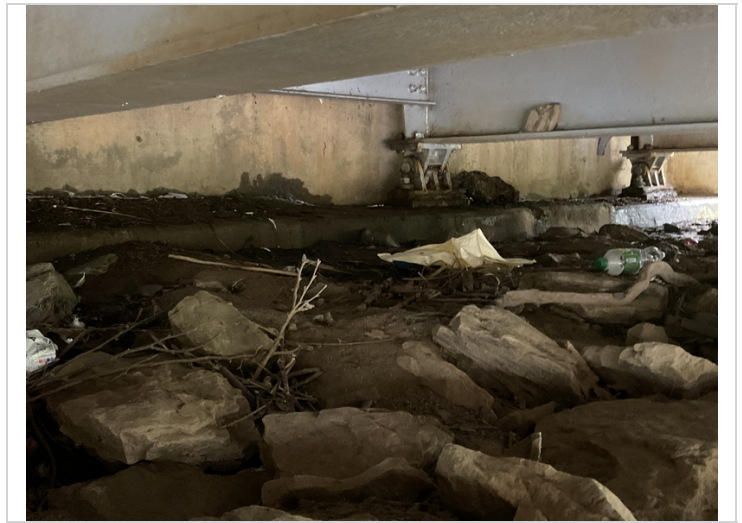
(311) -Bearings at abutments have active corrosion with pack rust between the rockers and masonry plates. The abutments have dirt and debris that has accumulated on the bearings. -The expansion bearings at Bent # 3 have no apparent noteworthy deficiencies at this inspection.							
313	Fixed Bearing	EA	5	4	1	0	0
1000	Corrosion	EA	1	0	1	0	0
515	Steel Protective Coating	SF	15	10	5	0	0
3440	Effectiveness (Steel Protective Coatings)	EA	5	0	5	0	0

Abutment #2 bearings with active corrosion and pack rust.

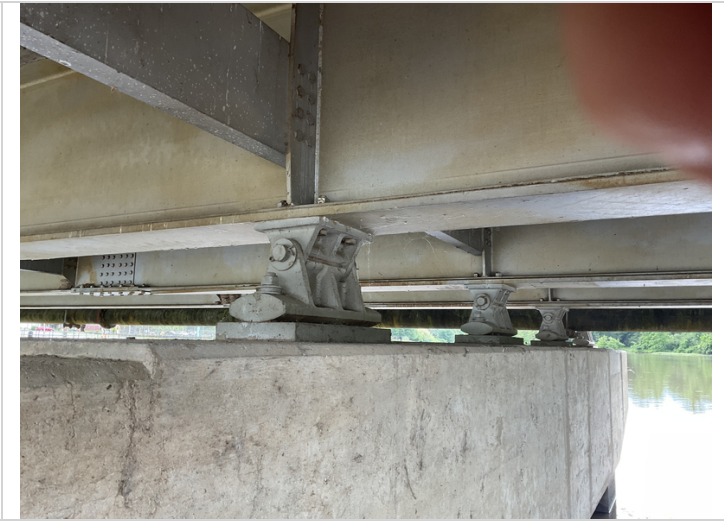
Bent #3 typical bearings.

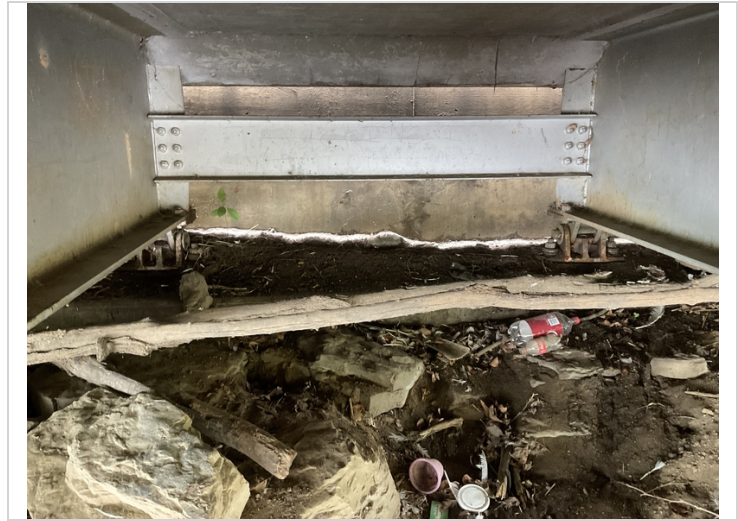
Abutment #1 debris accumulation.

Bearing area of the East and West abutments -
The bridge seats at the East and West abutments have dirt and debris that has accumulated against the steel superstructure.

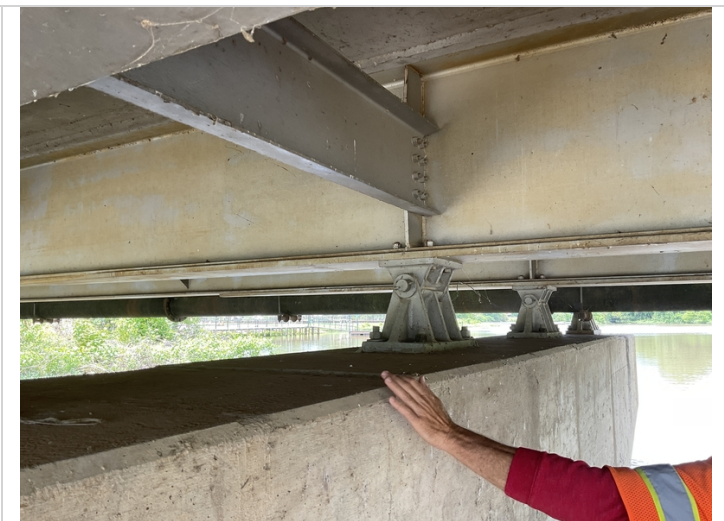
(313) -The fixed bearings at Bent # 2 appear to be functioning as intended with no apparent noteworthy deficiencies at this inspection.							
321	Reinforced Concrete Approach Slab	SF	1820	1532	288	0	0
1080	Delamination/Spall/Patched Area	SF	2	0	2	0	0
1130	Cracking (RC and Other)	SF	6	0	6	0	0
1190	Abrasion/Wear (PSC/RC)	SF	280	0	280	0	0

Bent #2 typical bearings

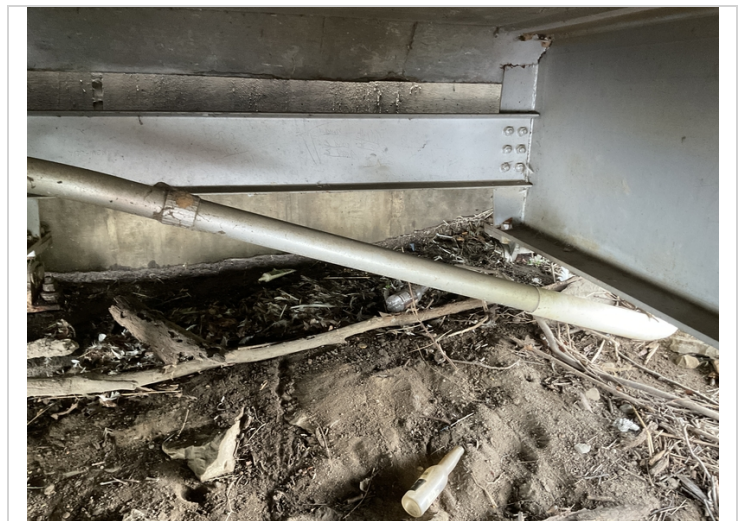
Abutment #1 Bearing #1 debris accumulation.

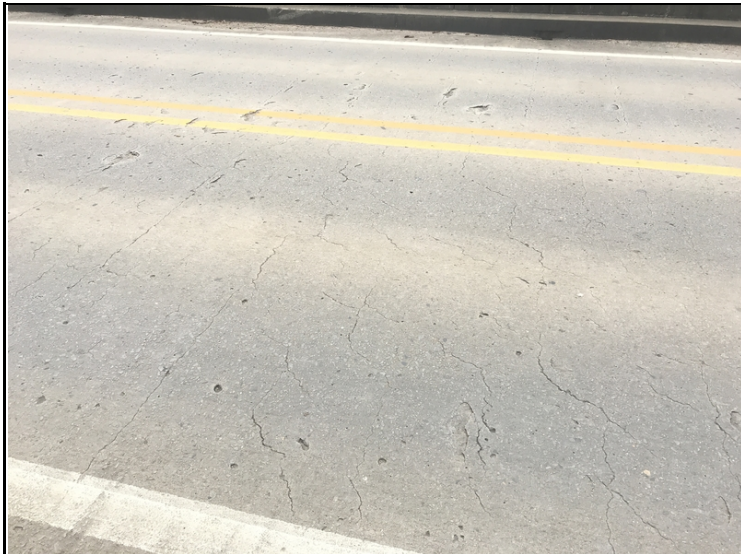
Span 2-Wide cracking with areas of spalling.

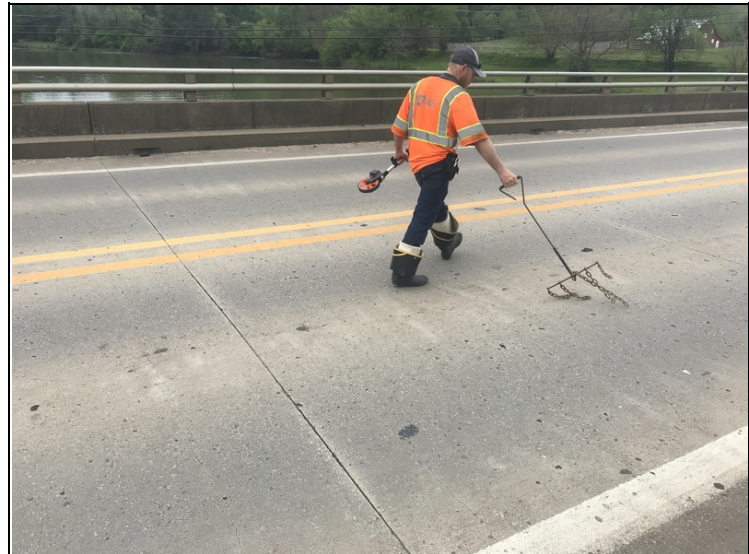
Sounding the deck.

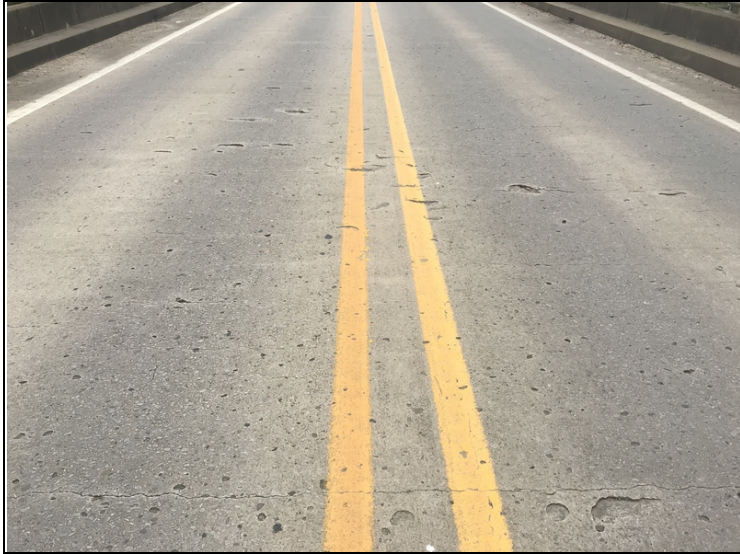
Span 2-Spalling / delaminated areas.

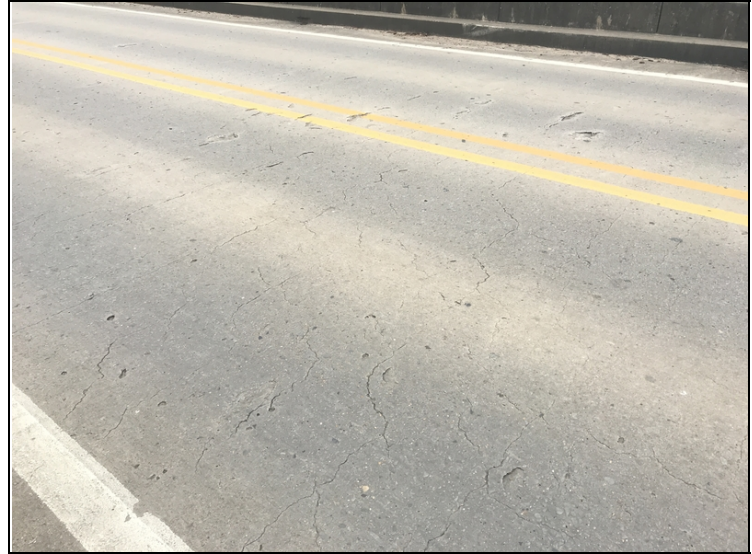
Span 2-Wide cracking.

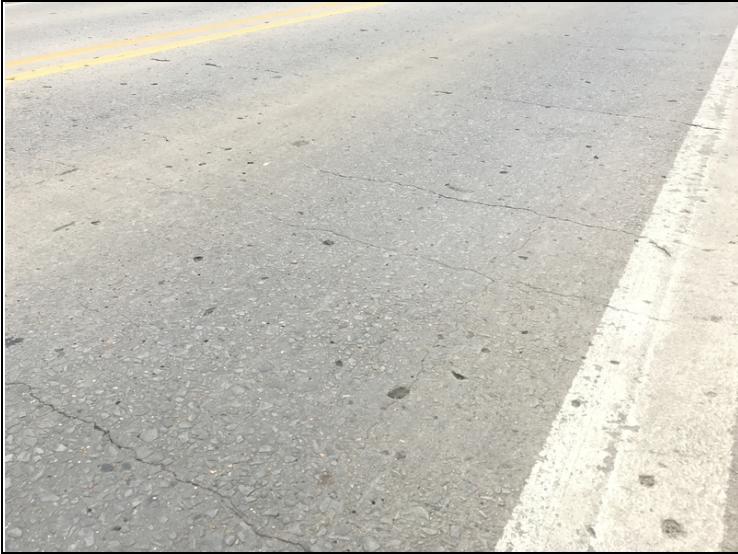
Transverse deck cracking.

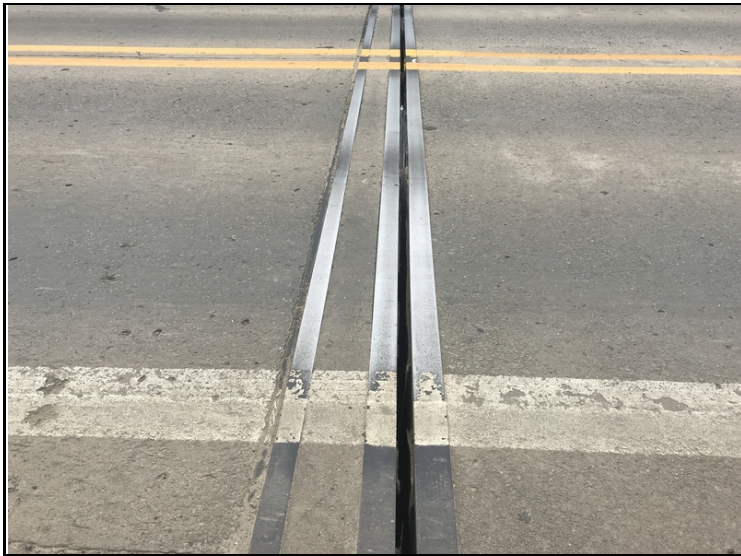
Abutment # 2 joint seal missing.

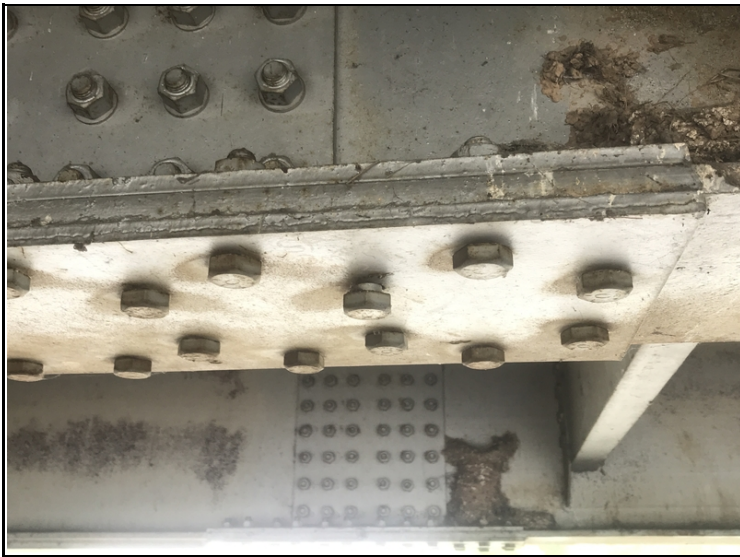
Span 2, beam 4 at splice connection 2-Loose bolts
in bottom flange splice.

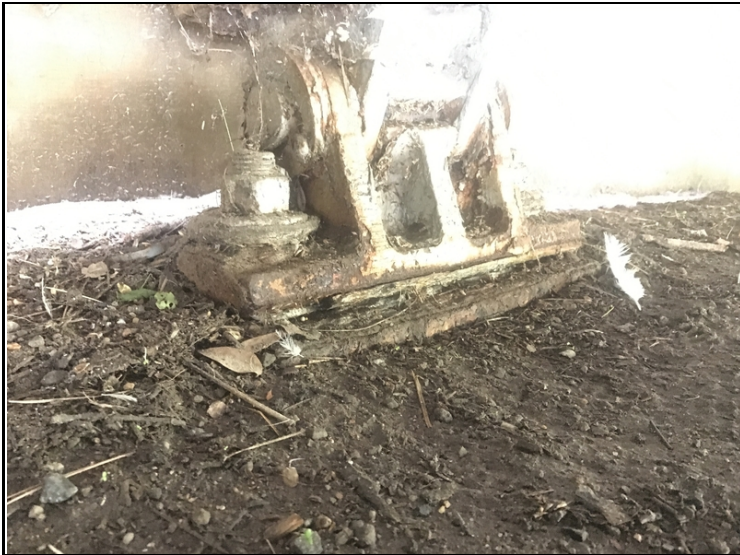
The movable bearings at the abutments have a failing paint system with active corrosion and pack rust between the rockers and masonry plates.

Bearing 3 over abutment 2-Corrosion with pack rust between rocker and masonry plate.

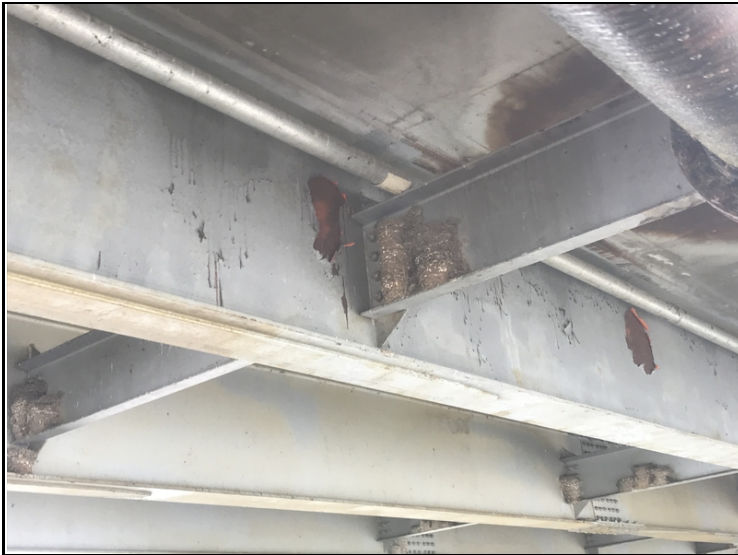
The superstructure paint system is failing with areas of flaking paint with rust showing through in several locations. The exterior beams are the worst case.

Span 2, beam 2-Flaking paint.

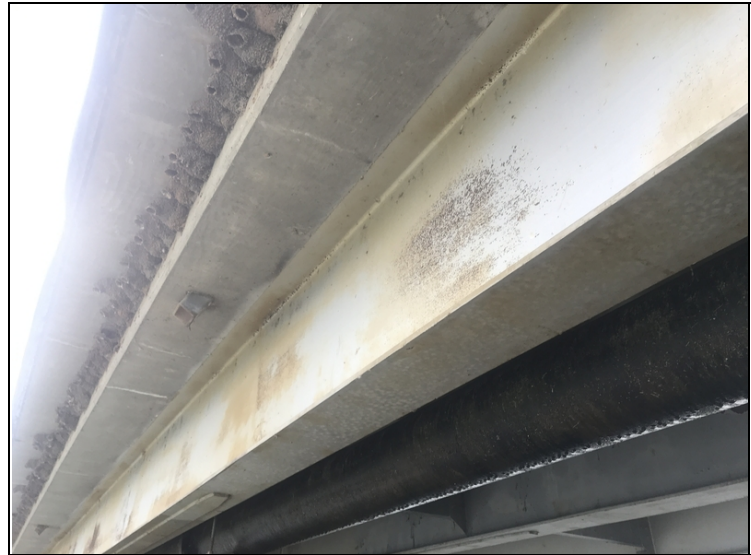
Paint system failing.

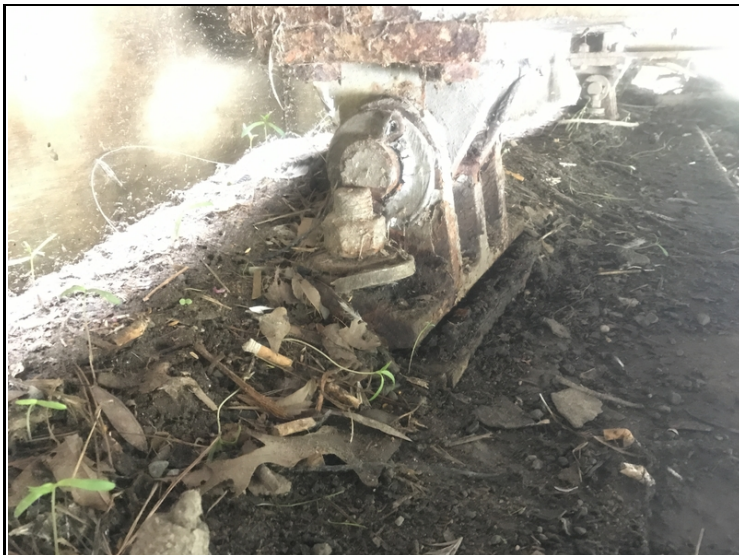
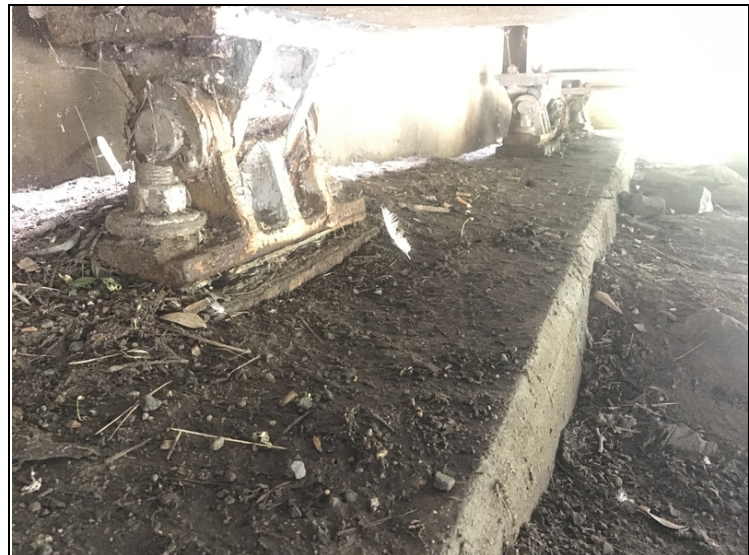
The bridge seats at the East and West abutments have dirt and debris that has accumulated against the steel superstructure.
