Asset #A1415(Routine)

US Highway 64 over Town Branch-Franklin Co.

Location: 0.5 MI EAST JCT SH 23

Team Lead: Eric West, Inspection Date: 05/16/2022

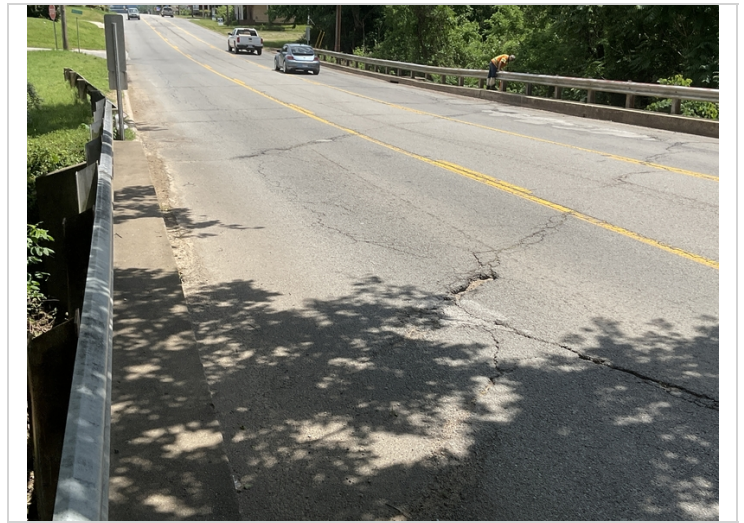
Typical driving surface of deck.

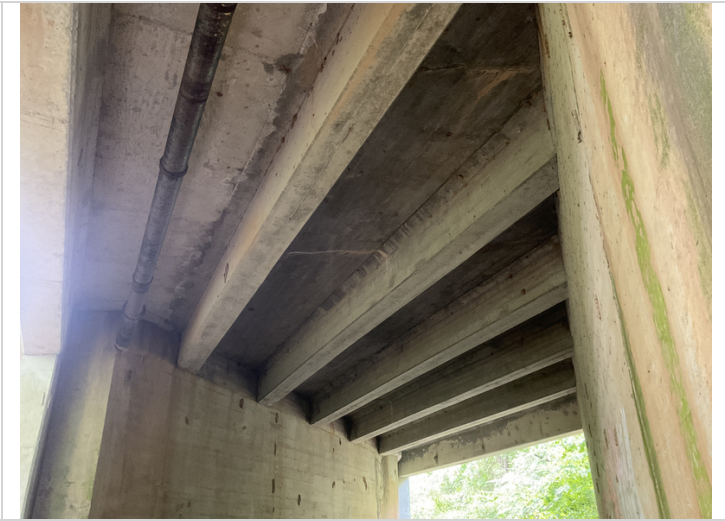
Typical undersurface of the deck.

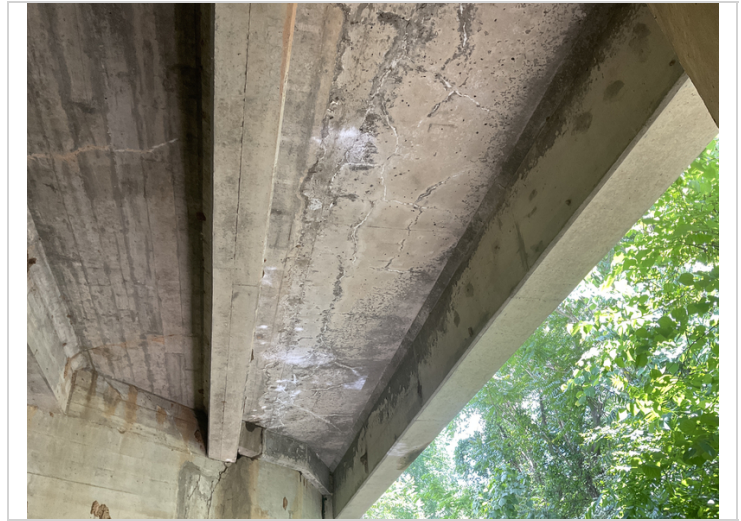
Bay #6 map cracking with efflorescence buildup.

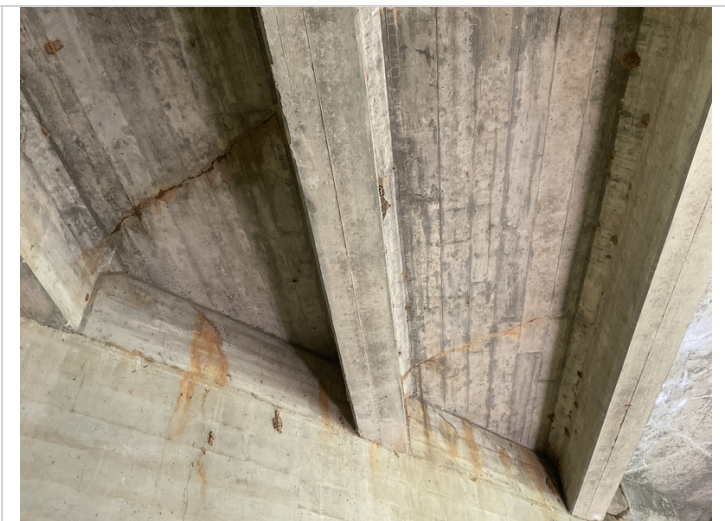
Transverse cracking with rust stains.

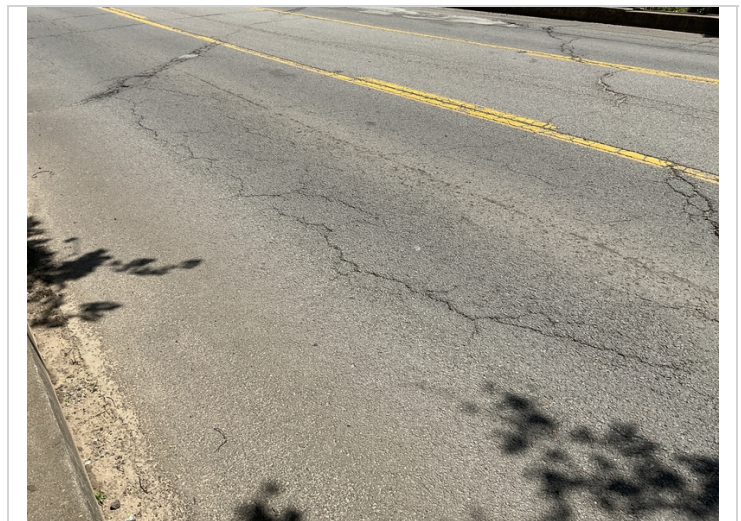
Typical cracking on the wearing surface.

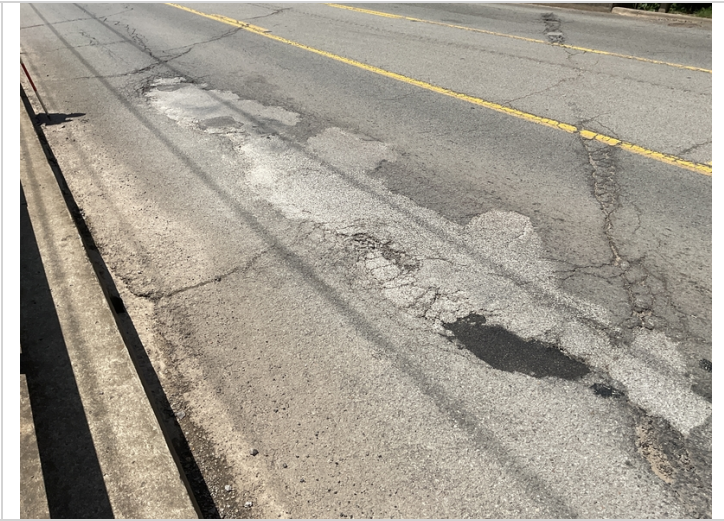
Asphalt wearing surface patched areas.

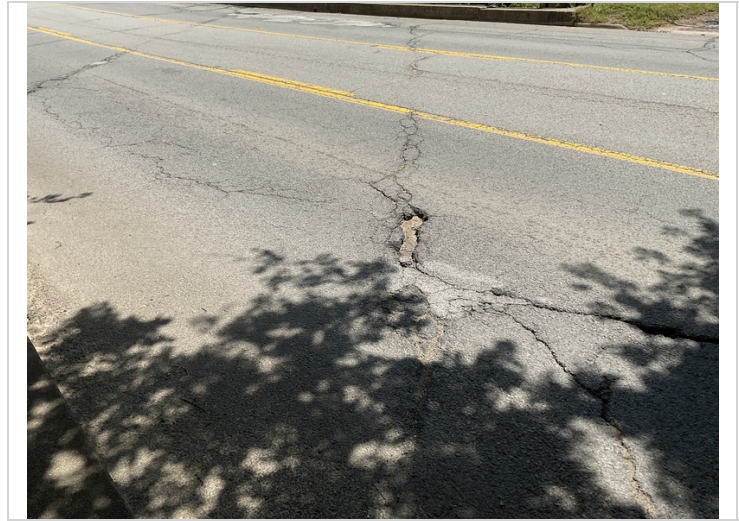
Wearing surface with potholes forming over the abutments.

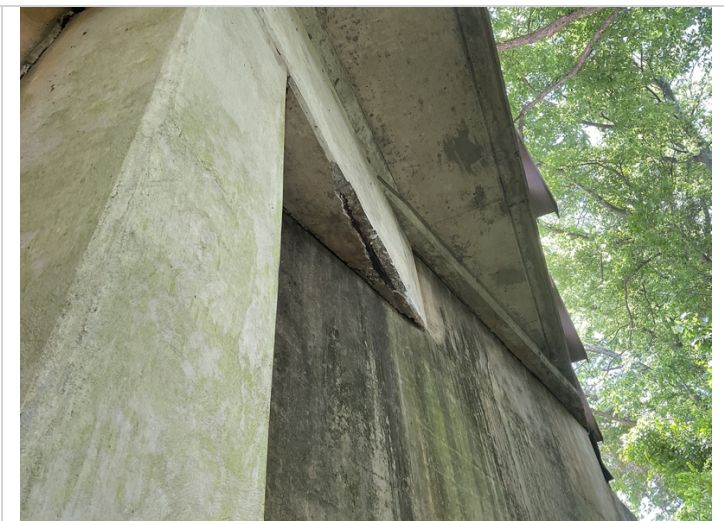
Abutment #1 girder #1 spalling with exposed reinforcing steel.

Girder # 1 adjacent to abutment # 1 has a 2' long spall with exposed primary longitudinal reinforcing steel. Exposed reinforcing steel has corrosion with flaking rust.

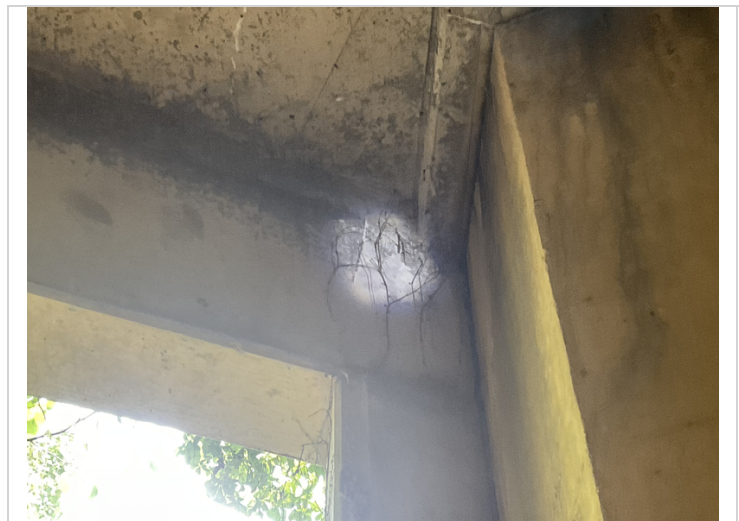
Abutment #1 Girder #7 with exposed reinforcing steel in the side of the girder.

Girder # 7 adjacent to abutment # 1 has 2 shallow 8" spalls with exposed secondary reinforcing steel. Exposed reinforcing steel has no apparent section loss at this inspection.

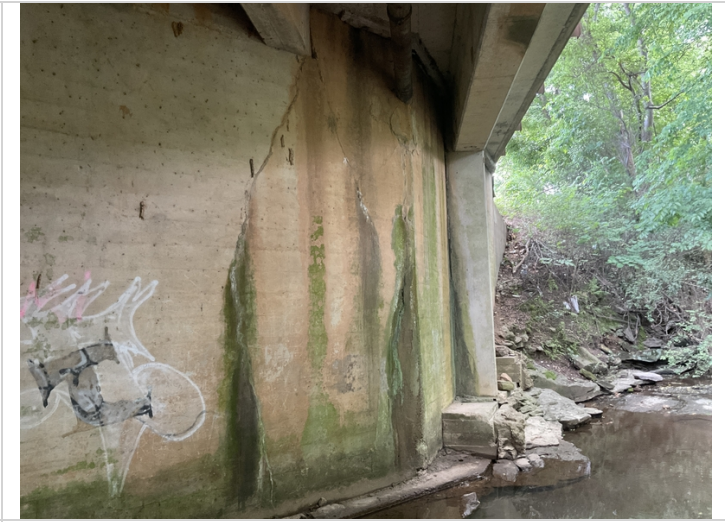
Abutment #1 Lt cracking at the wing wall juncture.

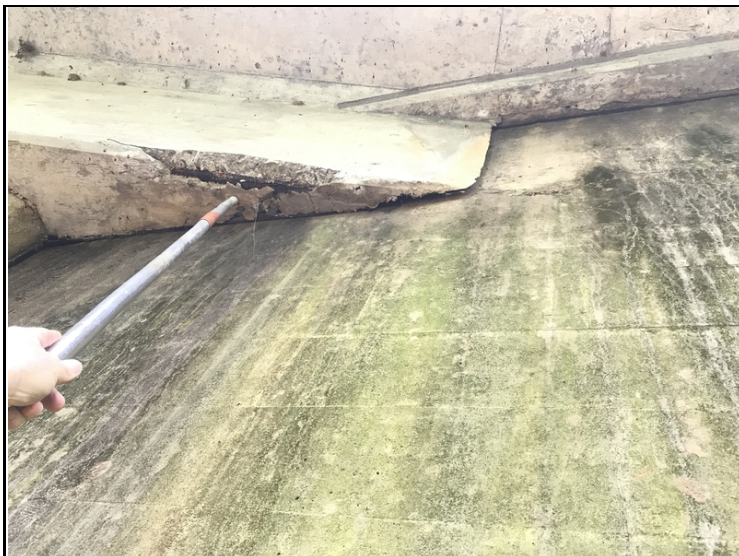
Girder # 1 has a 2' long spall with exposed primary longitudinal reinforcing steel over abutment # 1.

There are 2 shallow 8" spalls with exposed secondary reinforcing steel in Girder # 7 adjacent to abutment # 1. Exposed reinforcing steel has no apparent section loss at this inspection.

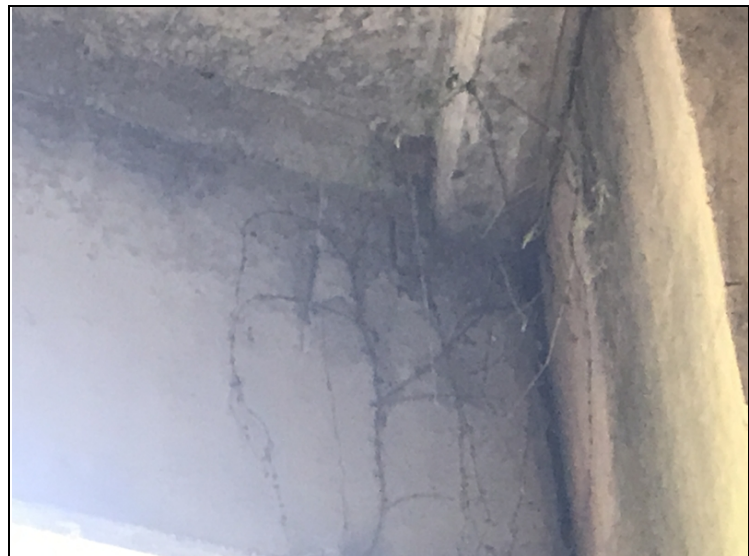
Girder # 1 has a 2' long spall with exposed primary longitudinal reinforcing steel over abutment # 1.

There are 2 shallow 8" spalls with exposed secondary reinforcing steel in Girder # 7 adjacent to abutment # 1. Exposed reinforcing steel has no apparent section loss at this inspection.

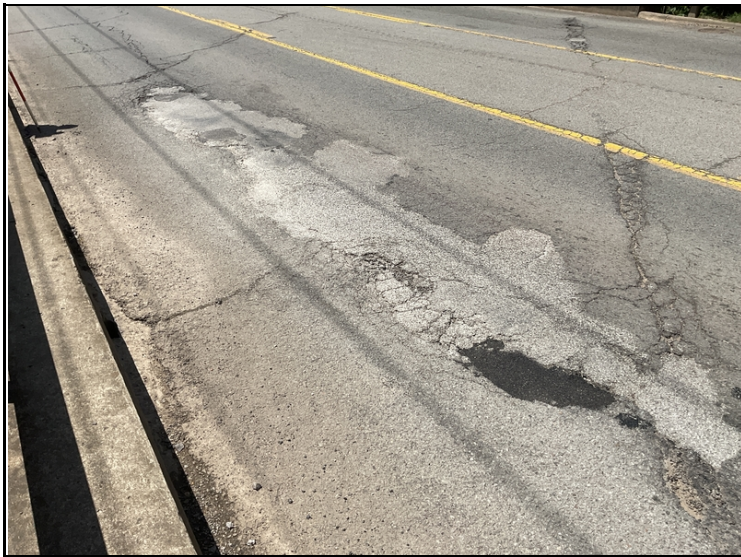
Asphalt wearing surface patched areas.

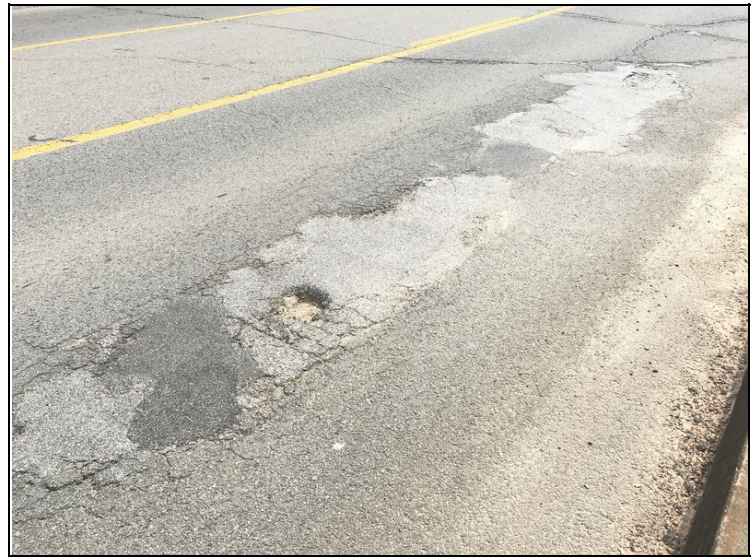
Driving surface -
The asphalt patches in the right lane are failing in locations with potholes forming.

The asphalt patches in the right lane are failing in locations with potholes forming.

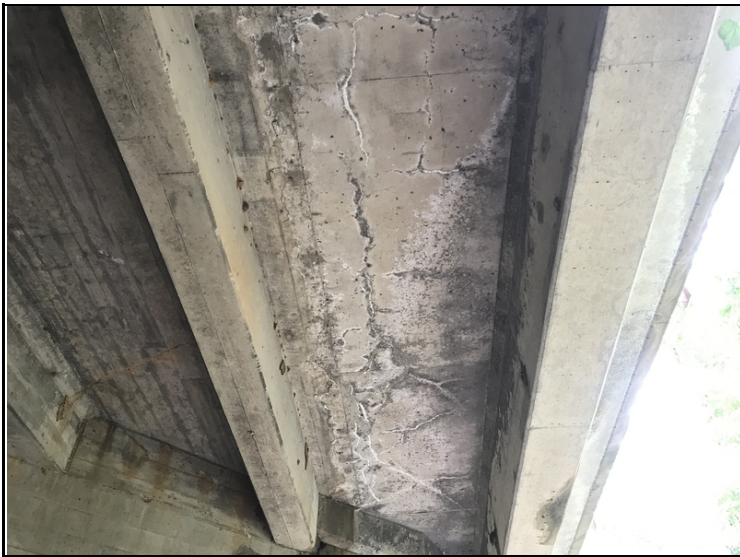
Deck undersurface -
The undersurface of the deck has mapcracking with efflorescence in bay # 6.

Mapcracking with efflorescence in undersurface of
deck in bay # 6.

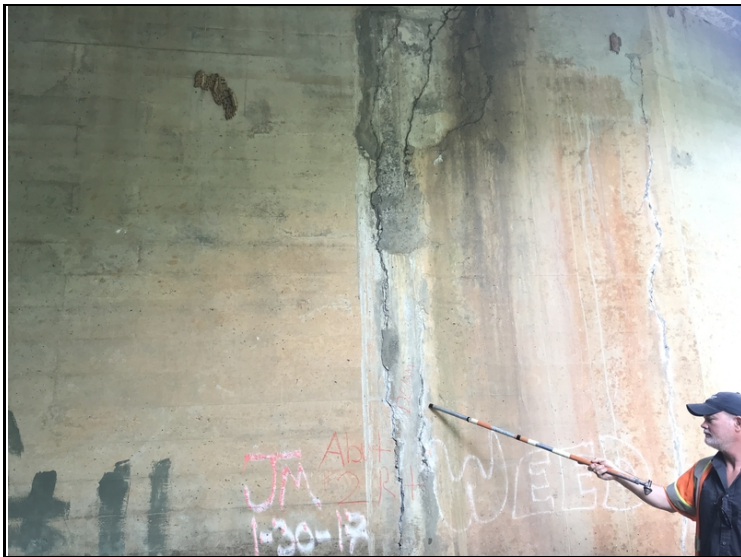
The grouted repairs to the vertical crack in the right side of abutment # 2 stem wall under girder # 6 are delaminated. The upper portion of the stem wall in the same area has mapcracking with delaminated areas.

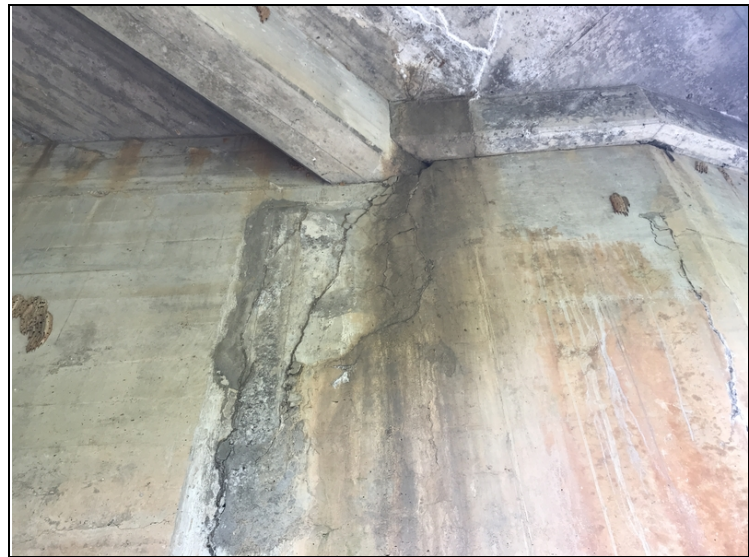
The grouted repairs to the vertical crack in the right side of abutment # 2 stem wall under girder # 6 are delaminated. The upper portion of the stem wall in the same area has mapcracking with delaminated areas.
