Asset #A1647 (Routine, Underwater type 2)
US Highway 64 over Hicks Creek-Franklin Co.

Location: 7.06 MI W JOHNSON CO LI

Team Lead: Eric West, Inspection Date: 06/09/2022

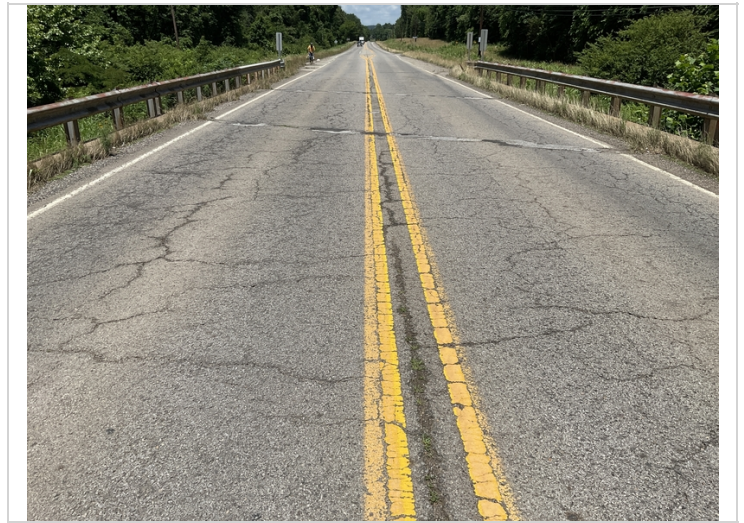
(510-16) -Map cracking typical on the driving surface and asphalt breaking apart over the expansion joints.

Typical driving surface of the deck.

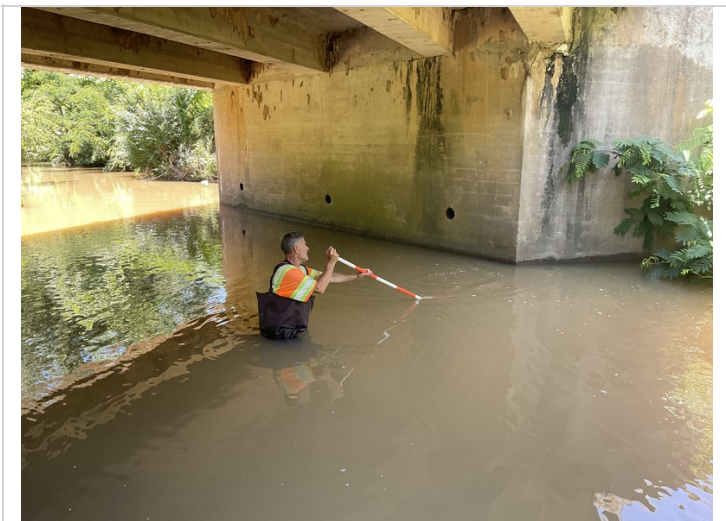
Type 2 Underwater Inspection - Wading and probing in approximately 5' deep water conditions adjacent to Bent # 1 indicate that the top of the footing is exposed with no apparent scour problems at this inspection. The channel appears to be solid rock adjacent to the Bent # 1 footing. All other footings have cover at this inspection.

Underwater Type II Inspection.

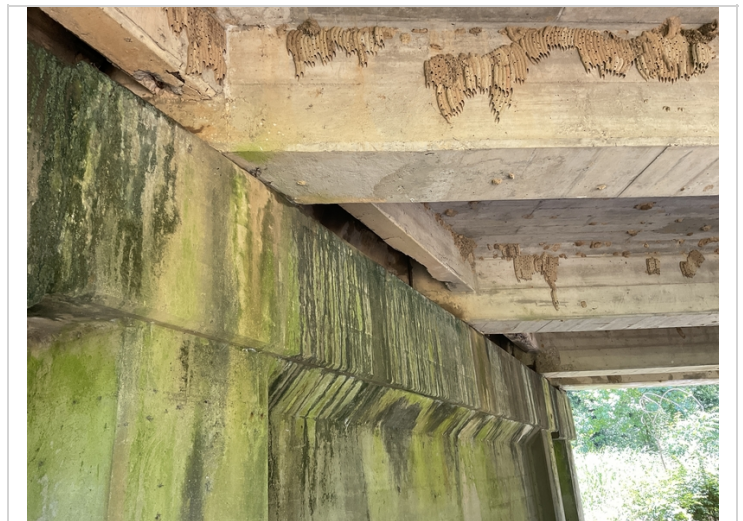
-Span # 1 bay # 1, 2 & 3 Bent # 2 have spalling with exposed reinforcing steel in the expansion dam.
 -Span # 2 bay # 2 & 3 Bent # 3 have spalling with exposed reinforcing steel in the expansion dam.
 -Span # 3 bay # 3 & 4 Bent # 3 have spalling with exposed reinforcing steel in the expansion dam.

Span #1 Bent #2 spalling with exposed reinforcing steel.

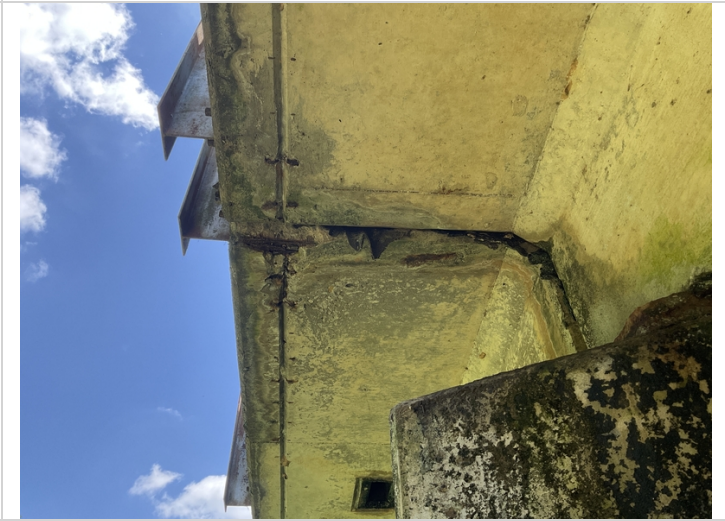
Span #2 Lt spalling with exposed reinforcing steel

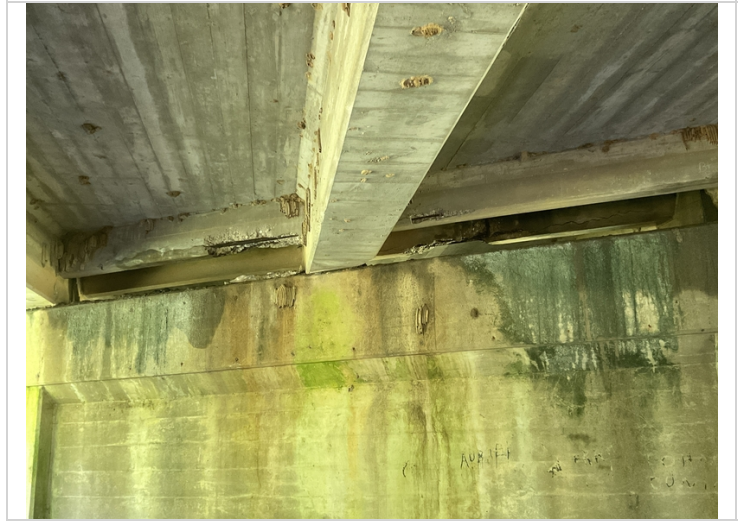
Span #2 bay # 2 & 3 spalling with exposed reinforcing steel in the expansion dam.

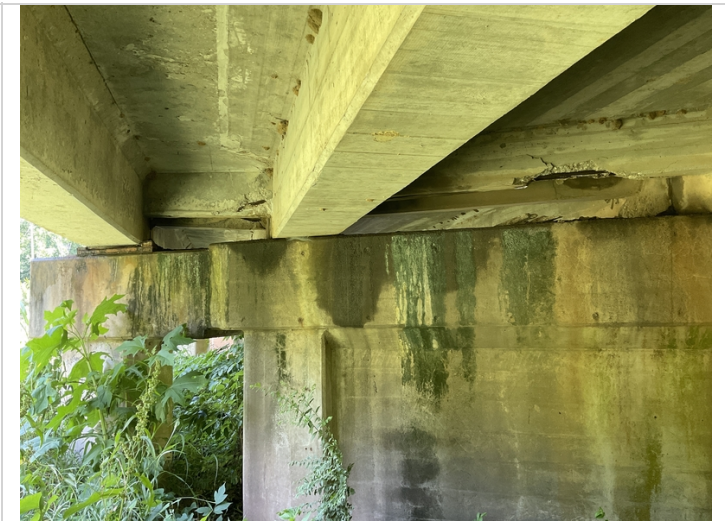
Span #3 bay # 3 & 4 spalling with exposed reinforcing steel in the expansion dam.

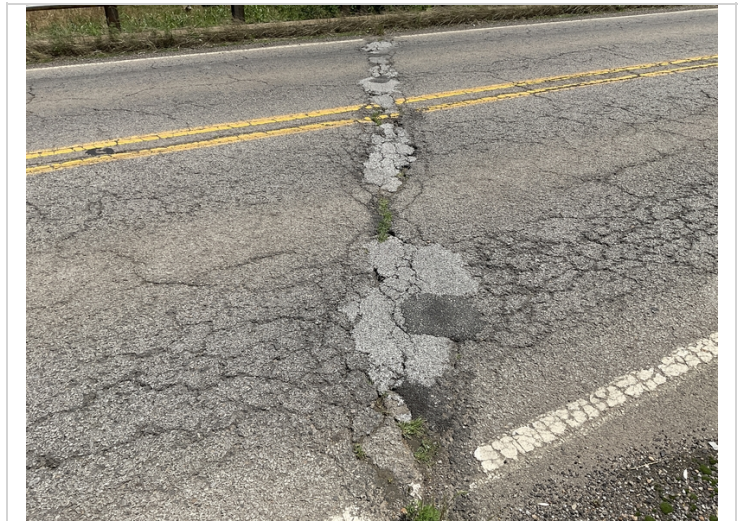
(16) Asphalt driving surface of the deck:
 -Map cracking in the asphalt is typical in all spans.
 -The asphalt driving surface is breaking apart over the intermediate expansion joints with numerous patches.
 -There is vegetation growing in the gutters restricting the deck drains.

Bent #2 asphalt deterioration over the deck joint.

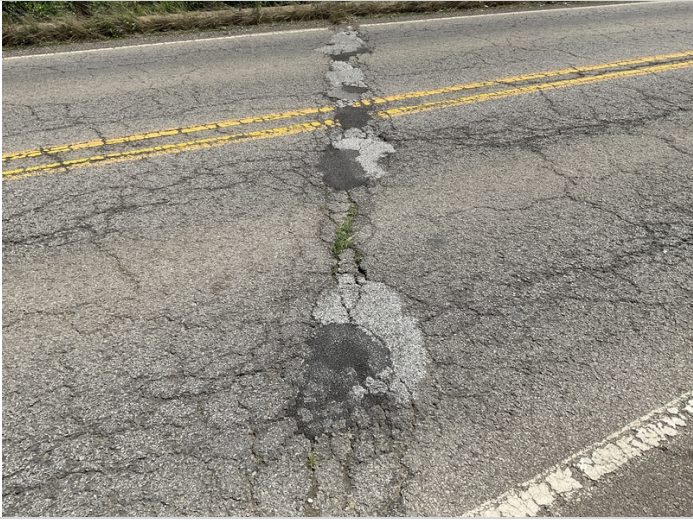
Bent #3 asphalt deterioration over the deck joint.

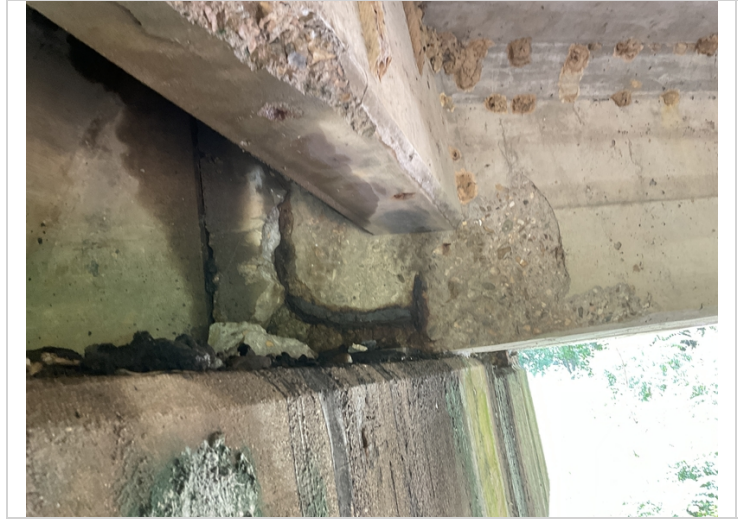
-There are several patched areas that have been grouted over in the past.
 -The exterior girders have light scale.
 -Girder # 5 of spans # 2 and # 3 appears to make contact over bent # 3.
 -Span # 1 Girders # 3 & 4 Bent #2 have spalling with exposed reinforcing steel.
 -Span # 2 Girders # 2, 3 & 4 Bent # 3 have spalling with exposed reinforcing steel.
 -Span # 2 Girders # 2, 3 & 4 Bent # 2 have spalling with exposed reinforcing steel.

Span #1 Girder #4 Bent #2 spalling with exposed reinforcing steel.

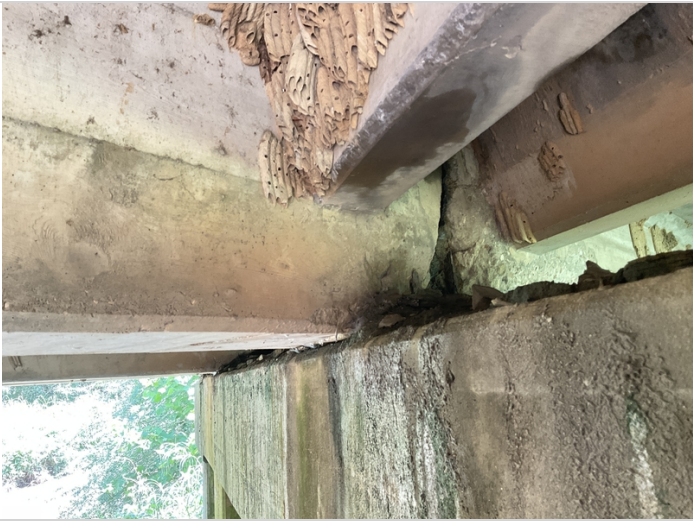
Span #1 Girder #3 Bent #2 spalling with exposed reinforcing steel.

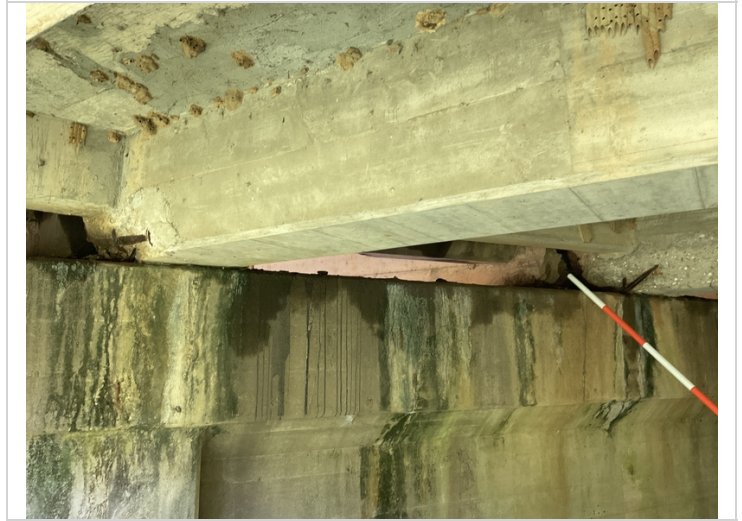
Bent # 2 Span # 2 Girder # 3 & 4 spalling with exposed reinforcing steel.

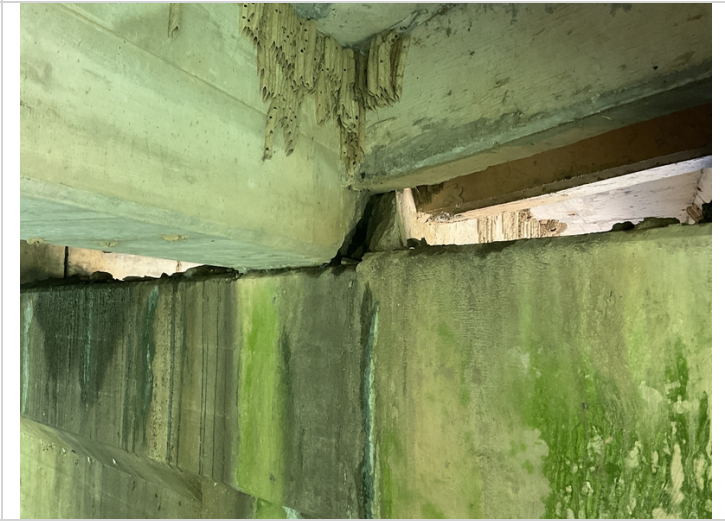
Bent #2 Span #2 Girder #2 spalling with exposed reinforcing steel.

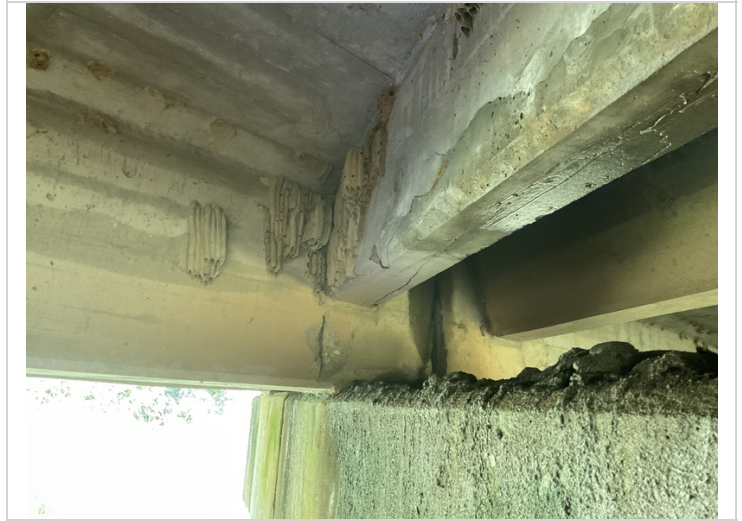
The ends of the original girders have large delaminated areas and spalls with exposed reinforcing steel at Bents # 2 & 3 where the expansion joints leak water on to the ends of the girders.

The exposed longitudinal primary reinforcing steel and secondary steel bands have active corrosion with up to approximately 1/8" section loss.

Bent # 3 Girder #2 spalling with exposed reinforcing steel.

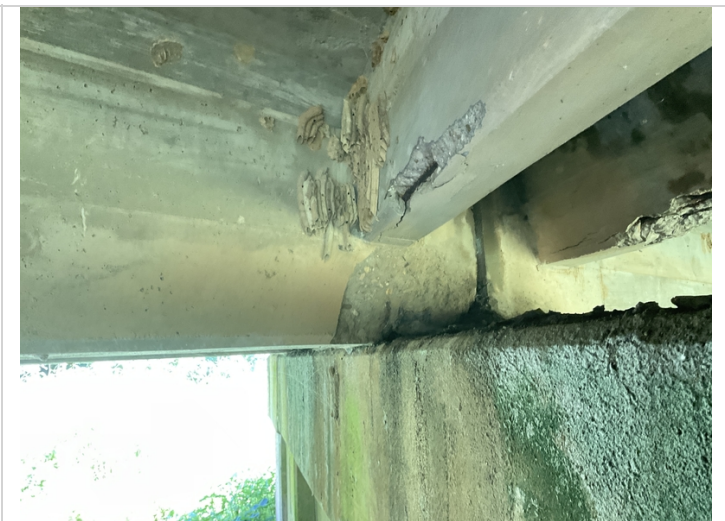
Bent #3 Girder #3 spalling with exposed reinforcing steel.

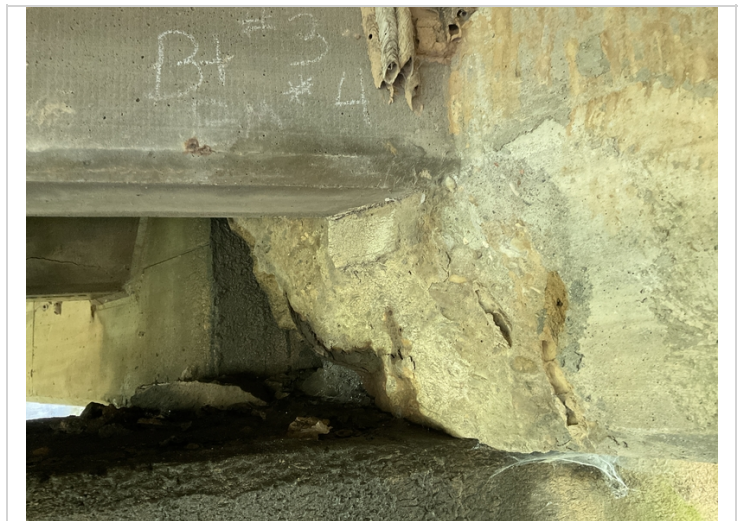
Bent #3 girder #4 spalling with exposed reinforcing steel.

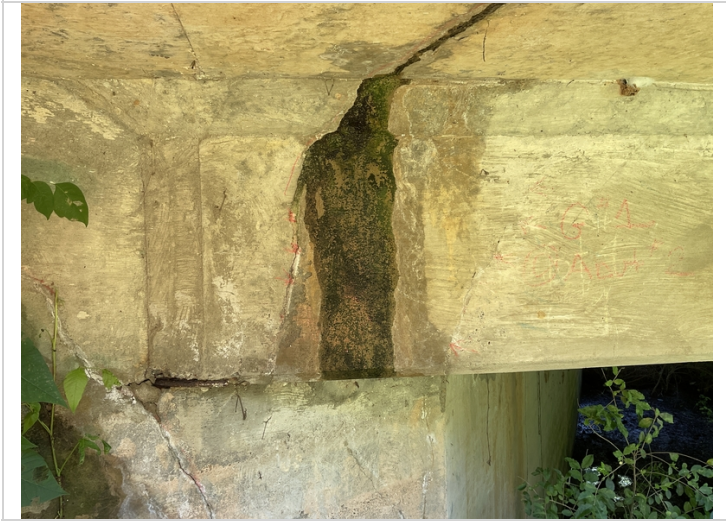
There is a hairline shear type crack on the exterior surface of Girder # 1 (East crack Measures 0.01" and West crack measures 0.002") adjacent to Bent # 4 and at Girder # 5 (Measures 0.005") adjacent to Bent # 4 that have no apparent changes since last inspection.

Span #3 Girder #1 Abutment #2 shear type cracks in the girder.

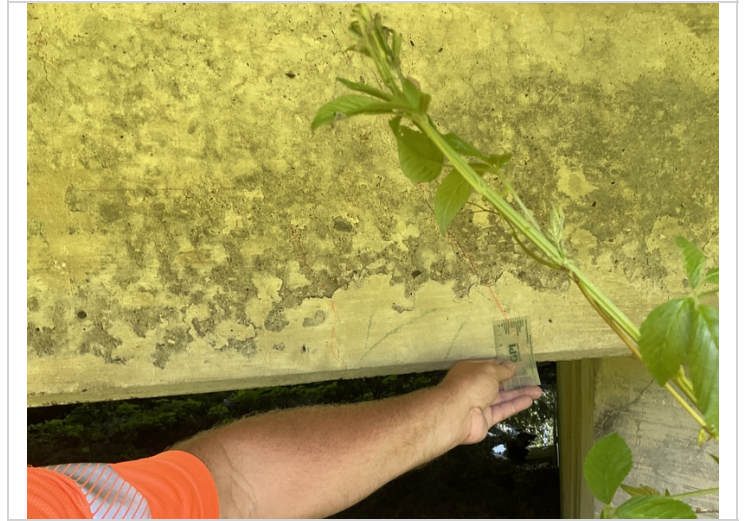
Span #3 Girder #5 exterior shear type crack.

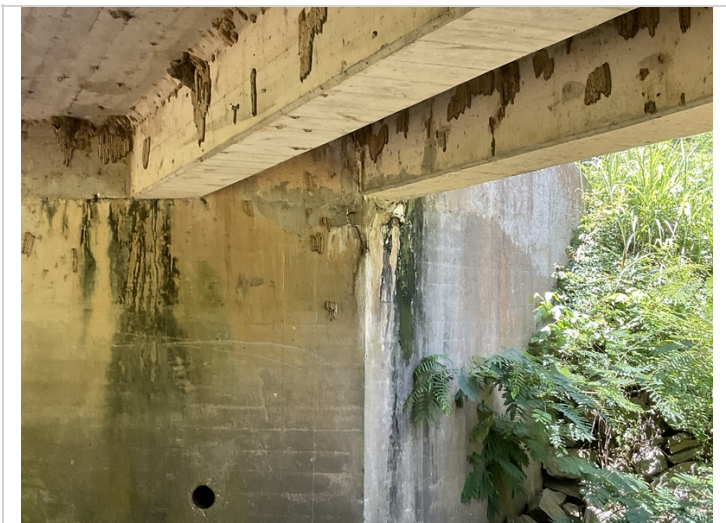
Abutment #1 Lt failing patch under girder #1.

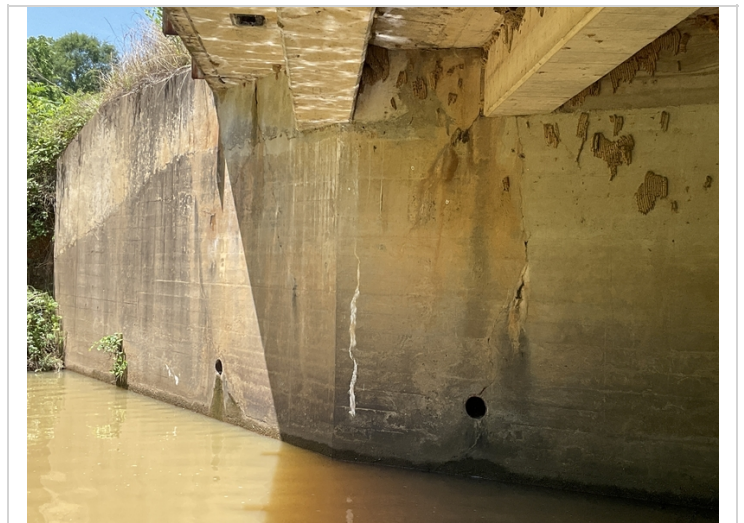
| ELEMENTS | DESCRIPTION | UNITS | TOTAL | CS1 | CS2 | CS3 | CS4 |
|--|---|---|---|---|---|---|---|
| (215) -Abutments have full height vertical cracks at variable spacing with light efflorescence in the stem walls with diagonal cracks in the exterior edges adjacent to the wing wall junctures. -There is one 3" spall with exposed reinforcing steel in each abutment. -Abutment # 1 Lt has a failing concrete patch under girder #1. -Abutment # 1 has vertical and diagonal cracking in the stem wall and Rt wing wall efflorescence and staining. -Abutment # 2 stem wall has light abrasion along the base. -Abutment # 2 has a diagonal crack that propagates diagonally from under girder # 1 up the wing wall and transversely through the deck overhang. The crack is approximately 1/16" wide in undersurface of deck overhang and approximately 1/8" wide in vertical face of curb. -Abutment #2 has a 3" spall with exposed reinforcing steel under Girder #4. Exposed steel has active corrosion with section loss and appears to be cast into the girder as well as the abutment. | | | | | | | |

Abutment #1 Rt vertical and diagonal cracks with efflorescence buildup.

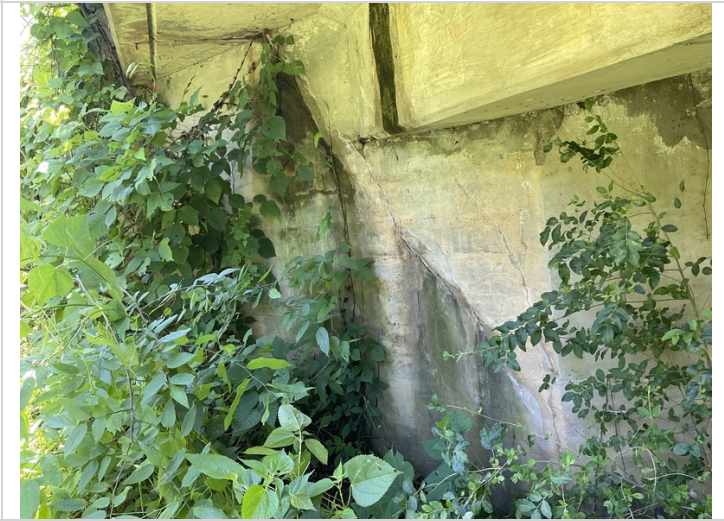
Abutment #2 Lt diagonal cracking in the wing wall.

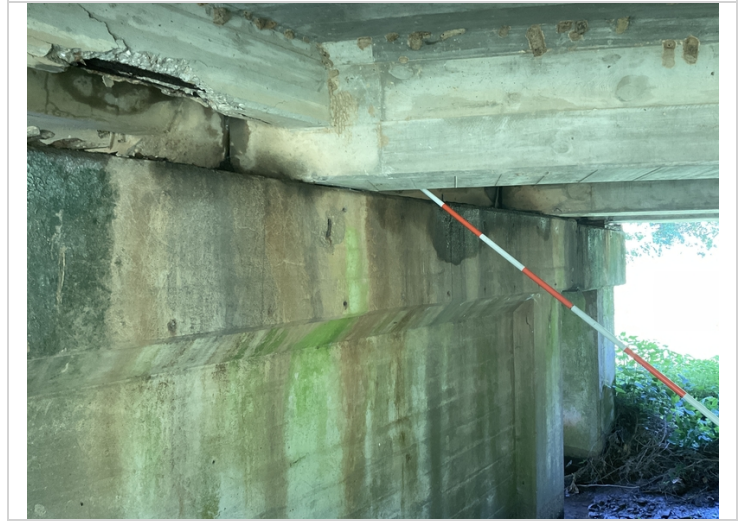
| ELEMENTS | DESCRIPTION | UNITS | TOTAL | CS1 | CS2 | CS3 | CS4 |
|--|---|---|---|---|---|---|---|
| (234) -Water stains on the substructure indicate that the deck joints leak. -Bent caps have 2" areas of concrete spalling with exposed # 9 wire / snap ties. -Bent # 2 Rt aheadface has a 8" spall with exposed reinforcing steel under girder # 4. | | | | | | | |

Bent #3 aheadface spalling with exposed reinforcing steel.

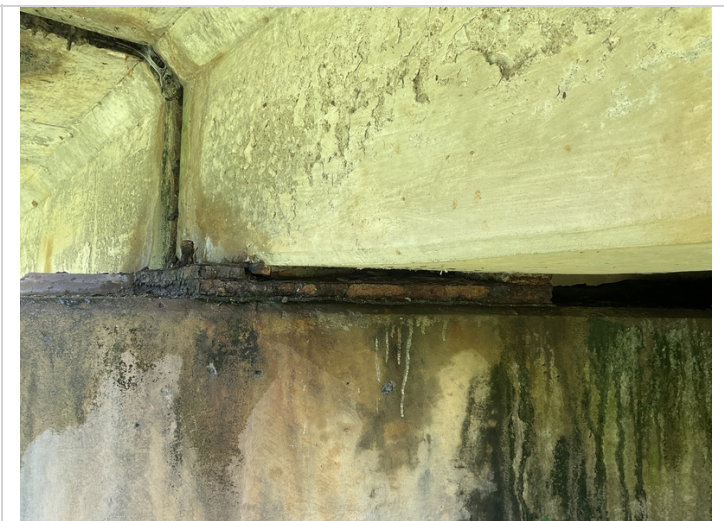
| ELEMENTS | DESCRIPTION | UNITS | TOTAL | CS1 | CS2 | CS3 | CS4 |
|--|---|---|---|---|---|---|---|
| (311) -Bearings have active corrosion with flaking rust / section loss. | | | | | | | |

Bent #3 Span #3 Girder #5 bearing with active corrosion and pack rust.

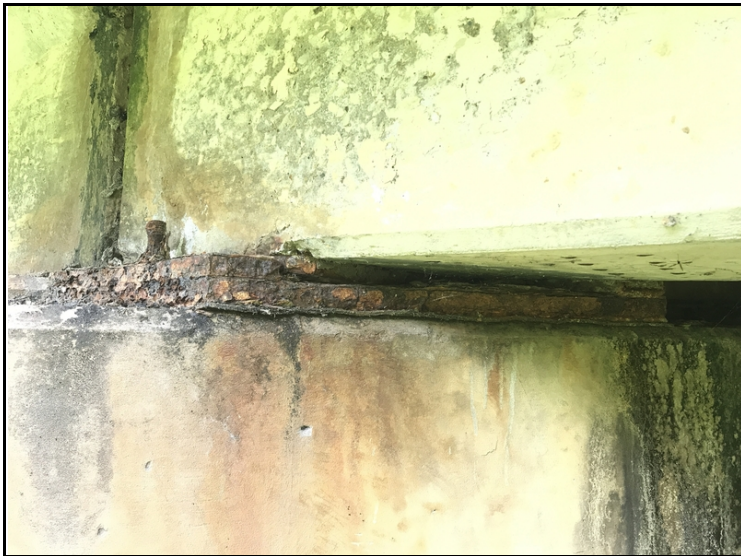
Expansion bearings -
Expansion bearings have active corrosion and flaking rust.

Expansion bearings have active corrosion and
flaking rust.

Date Reported: 06/17/2019
Priority: D- Routine
Type of Work: Repair (General)
Status: Monitor
Component: Element

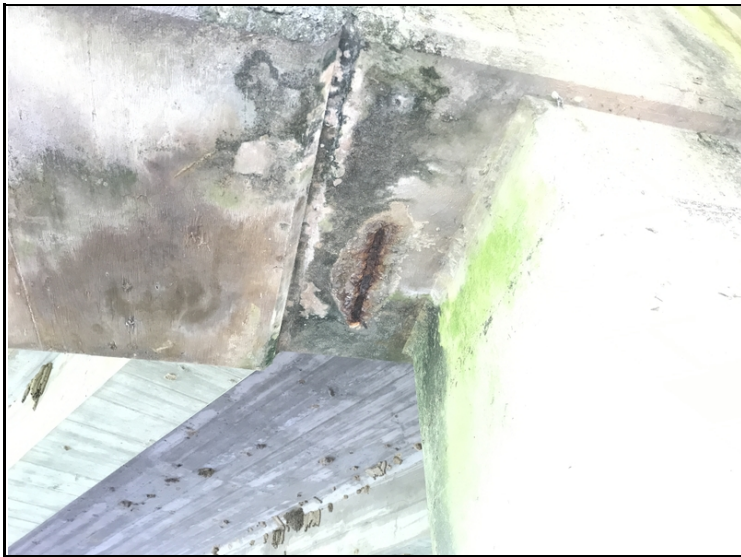
Substructure -
The substructure caps have areas of shallow spalling with exposed reinforcing steel.

The substructure caps have areas of shallow spalling with exposed reinforcing steel.

Date Reported: 04/02/2015
Priority: D- Routine
Type of Work: Repair (General)
Status: Monitor
Component: Element

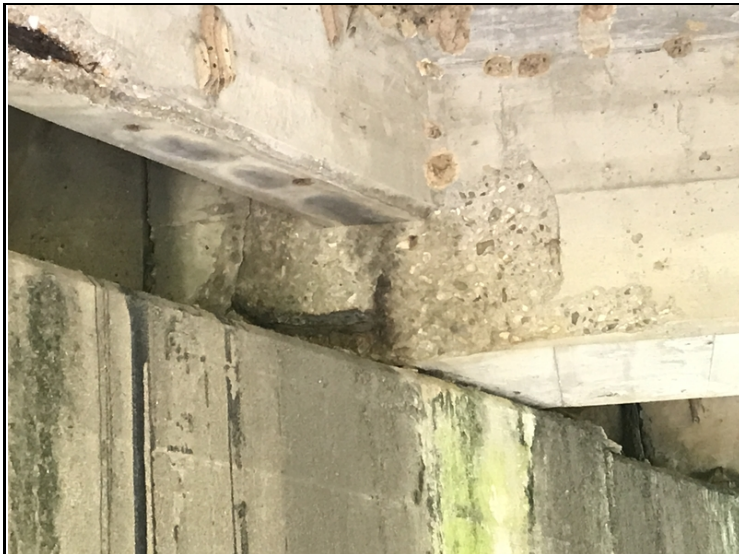
Concrete girders have vertical hairline Flexure cracks on approx. 12" centers. The exterior girders have light scale. The ends of the original girders have large delaminated areas and spalls with exposed reinforcing steel at Bents # 2 & 3 where the expansion joints leak water on to the ends of the girders. The exposed longitudinal primary reinforcing steel and secondary steel bands have active corrosion with up to 1/8" section loss. Girders # 1 and # 5 of span # 3 have shear type cracks adjacent to abutment # 2. No apparent changes since last inspection.

Span 1, girder 4-Spalling with exposed primary reinforcing steel over bent 2.

Date Reported: 04/02/2015
Priority: C - Important
Type of Work: Repair (General)
Status: Monitor
Component: Element

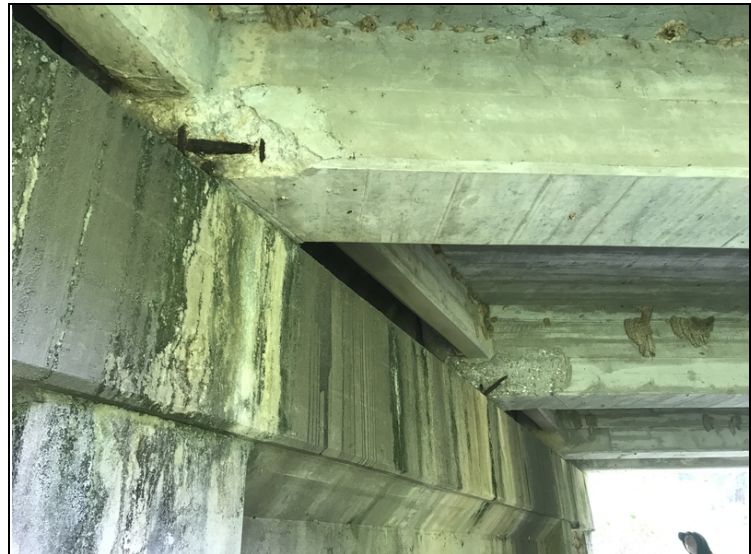
Span 2, girders 3 and 4-Spalling with exposed reinforcing steel.

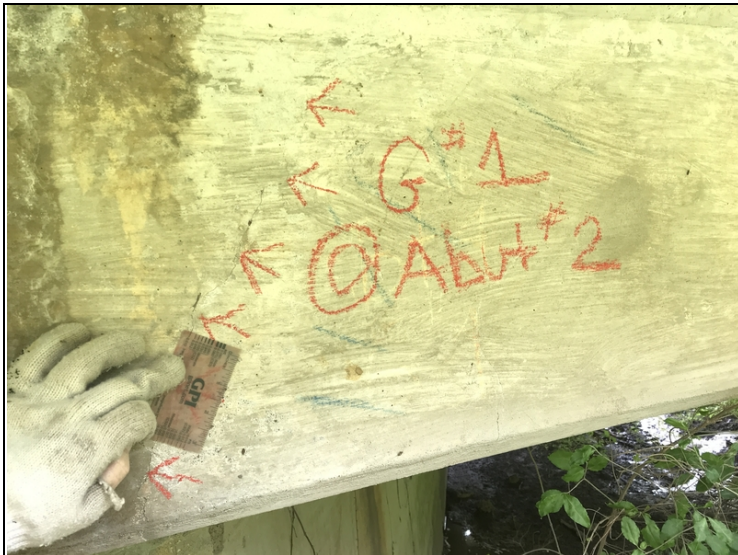
Span 3, girder 1 at abutment 2-Hairline shear type crack.

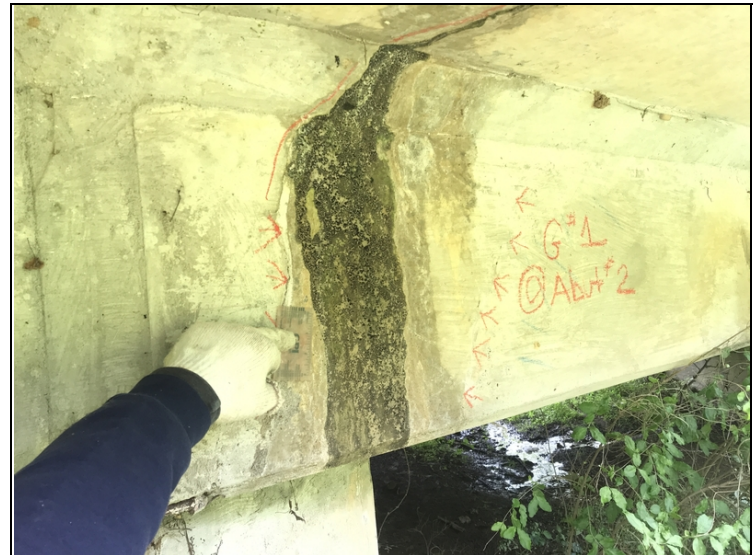
Span 3, girder 1 at abutment 2-Hairline shear type crack.

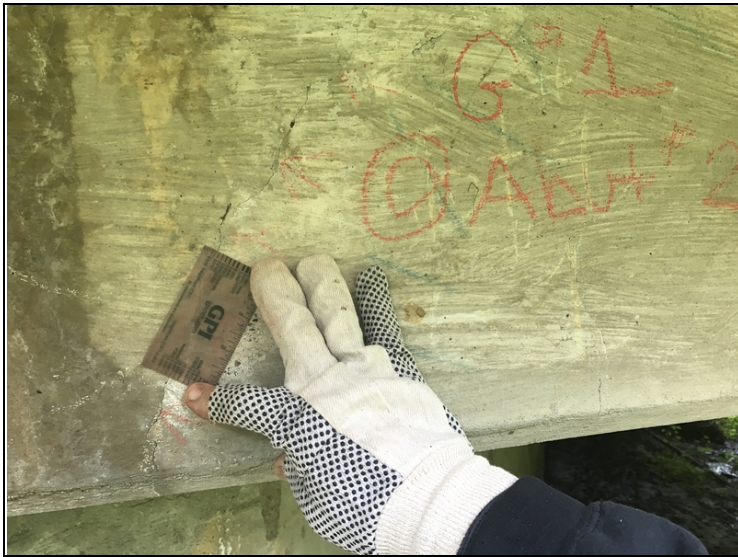
Girder 1 at abutment 2-Shear type crack.

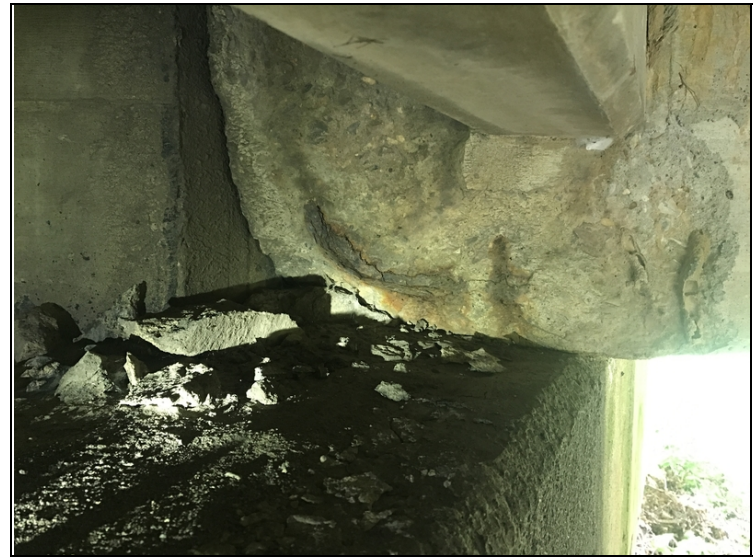
Span 2, girder 4 at bent 3-Spall with exposed reinforcing steel.

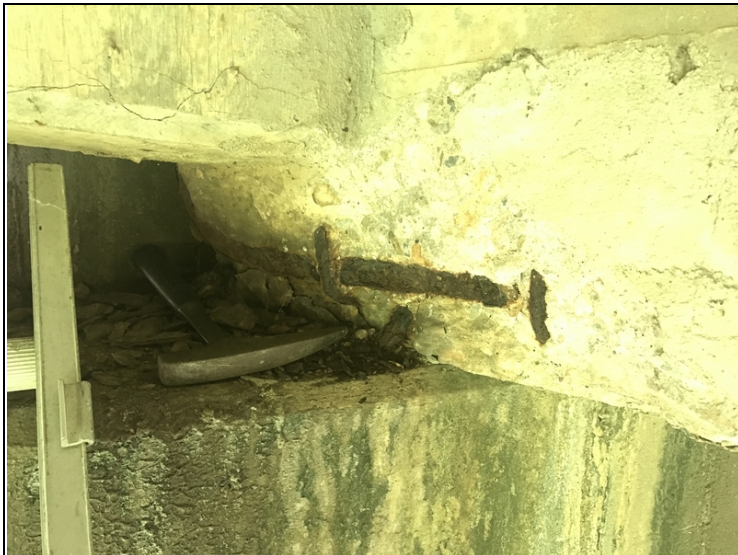
Span 2, girder 4 at bent 2-Spall with exposed reinforcing steel.

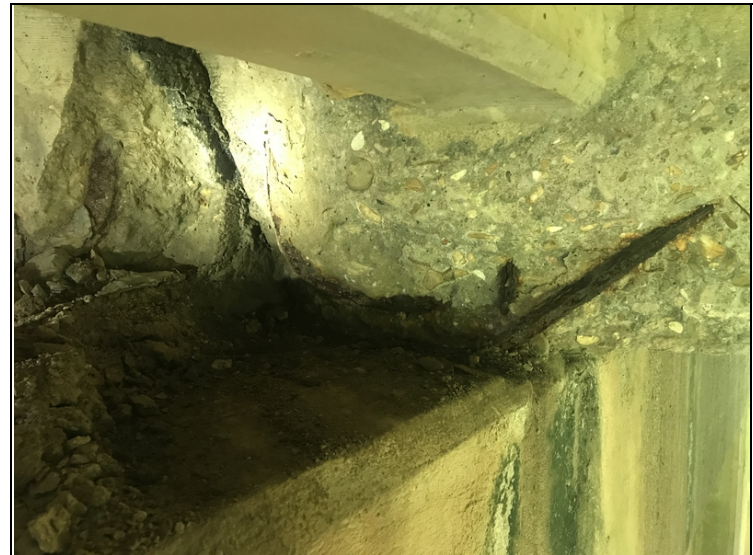
Spalling with exposed reinforcing steel to end of girder # 3 of spans 1 and 2 over bent 2.

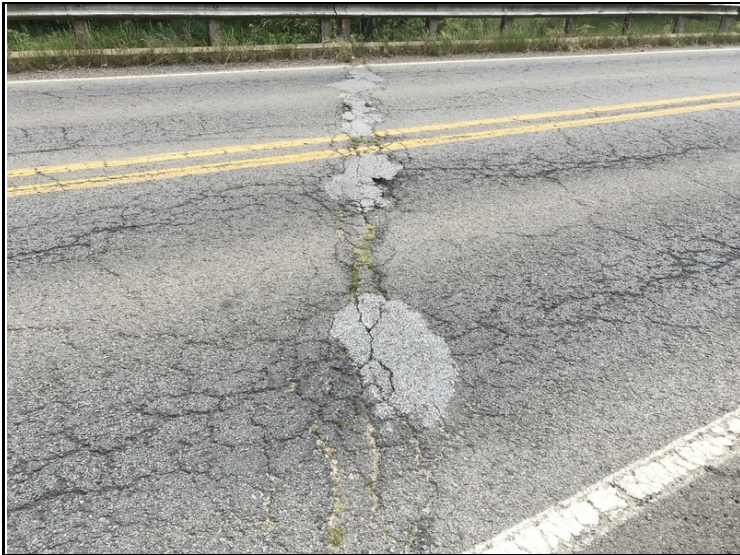
The asphalt is breaking apart over the expansion joints with potholes forming in the driving surface. Vegetation in the gutters restrict the drain openings.

Bent 3-Asphalt breaking apart.

Date Reported: 04/23/2014
Priority: D- Routine
Type of Work: Repair (General)
Status: Monitor
Component: Element

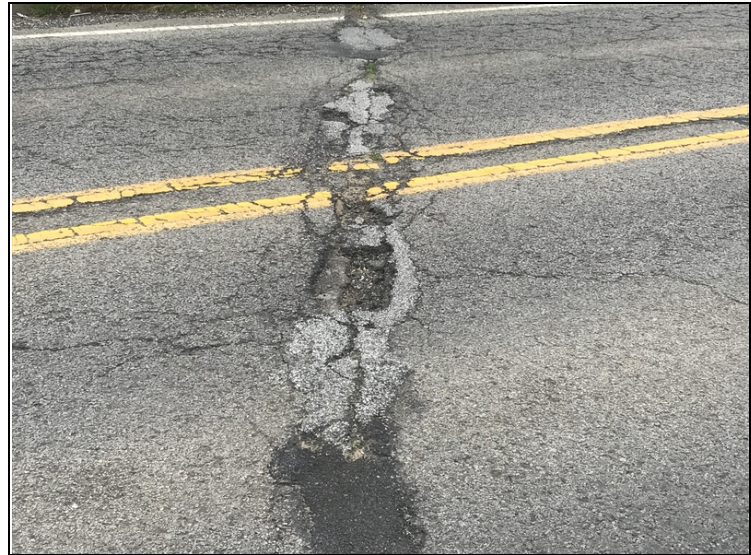
Potholes in asphalt over intermediate bents.

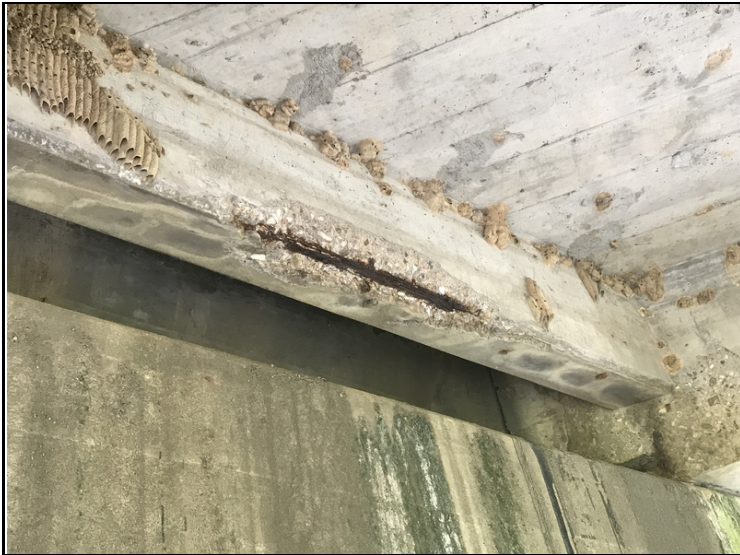
Expansion joint dams / diaphragms -
Expansion joint dams / diaphragms have spalls with exposed reinforcing steel that is visible from the undersurface of the deck.

Expansion joint dams / diaphragms have spalls
with exposed reinforcing steel that is visible from
the undersurface of the deck.

Date Reported: 05/01/2018
Priority: D- Routine
Type of Work: Repair (General)
Status: Monitor
Component: Miscellaneous

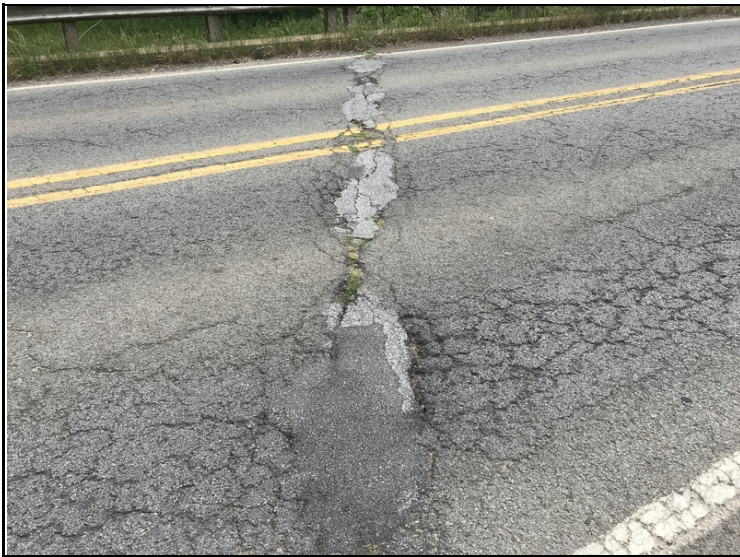
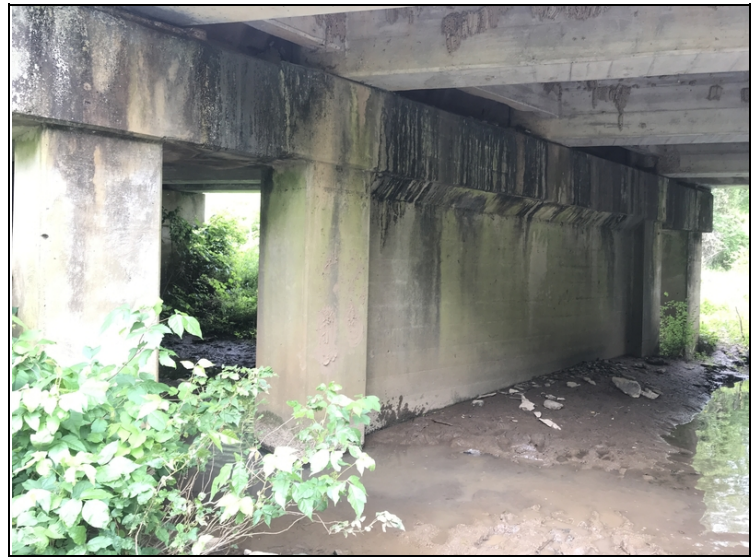
Expansion Joints -
Expansion joints leak water on the substructure and on the ends of the concrete deck girders.

Expansion joints leak water on the substructure and on the ends of the concrete deck girders.

Date Reported: 05/01/2018
Priority: D- Routine
Type of Work: Repair (General)
Status: Monitor
Component: Element

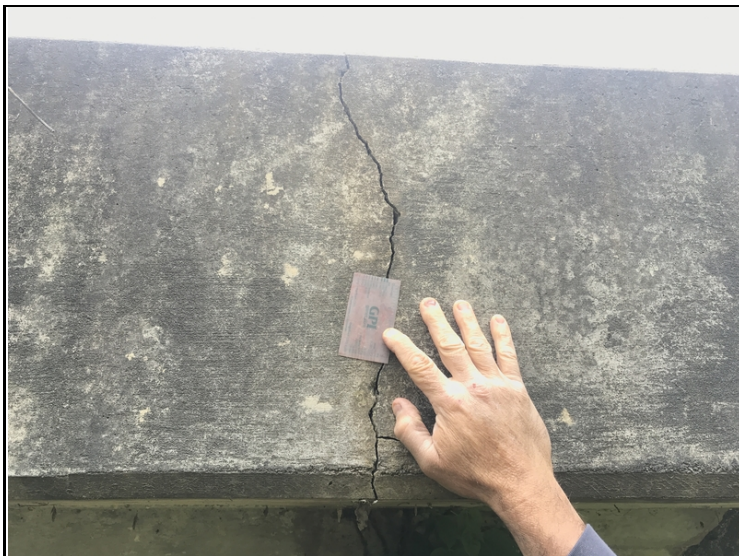
The Monolithic Northeast wing wall on the left side of abutment # 2 has a diagonal crack that propagates diagonally from under girder # 1 up the wing wall and transversely through the deck overhang. The crack is approximately 1/16" wide in undersurface of deck overhang and approximately 1/8" wide in vertical face of curb.

Date Reported: 05/13/2020
Priority: D- Routine
Type of Work: Repair (General)
Status: Monitor
Component: Substructure
