Asset #01853(Routine)

US 71 - Polk Co. over Little Hickory Creek

Team Lead: Bob McEntyre, Inspection Date: 07/02/2019

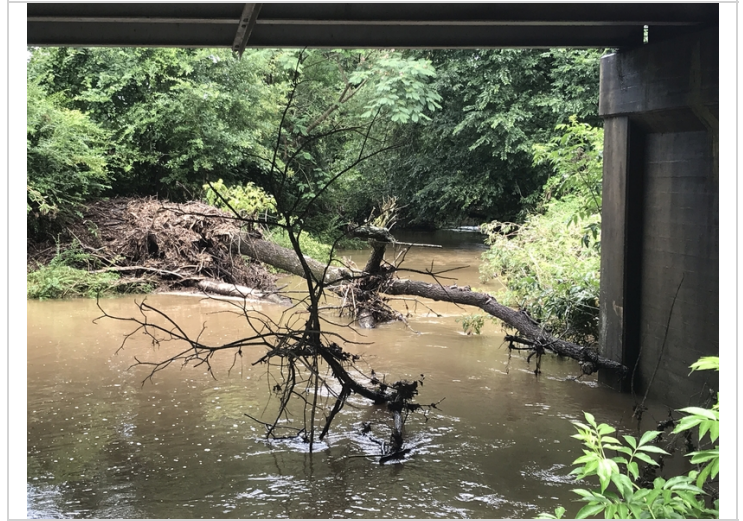
Tree across channel at the outlet end of span # 2.

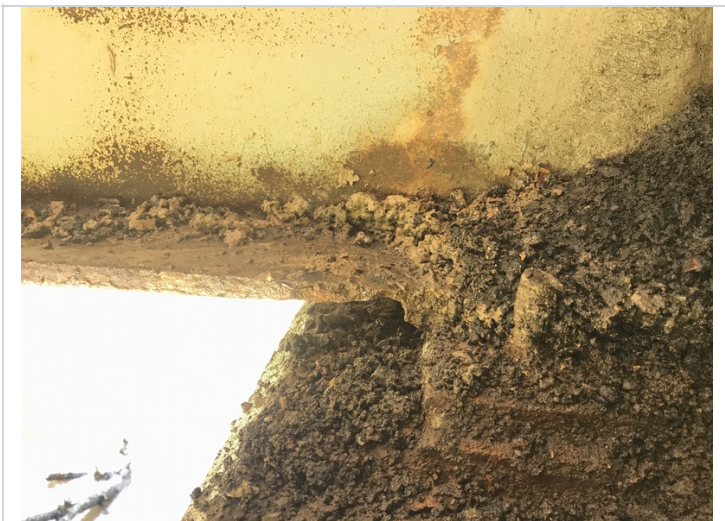
-Span # 2, beam # 3 over bent # 3 has section loss to bottom flange in an area approximately 1" long with 3/16" remaining section in the affected area.

Span # 2, beam # 3 over bent # 3 has section loss to bottom flange in an area approximately 1' long with 3/16" remaining section in the affected area.

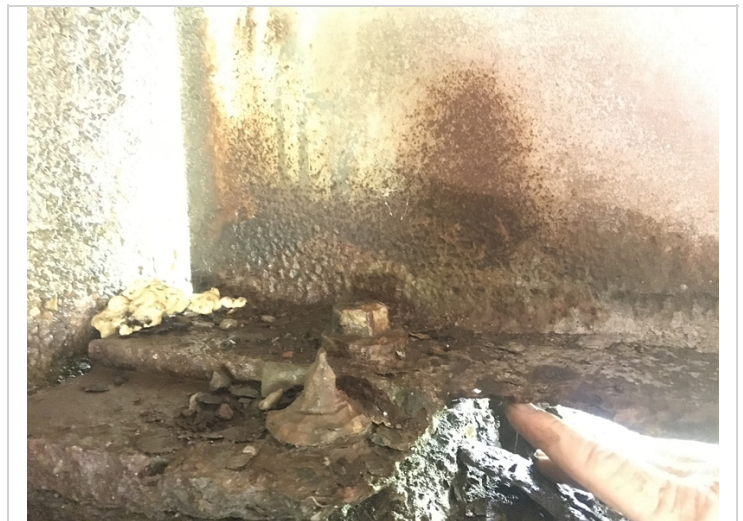
-Span # 1, beam # 1 has a 3" area of knife edged section loss to bottom flange over abutment # 1.

Span # 1, beam # 1 has a 3" area of knife edged section loss to bottom flange over abutment # 1.

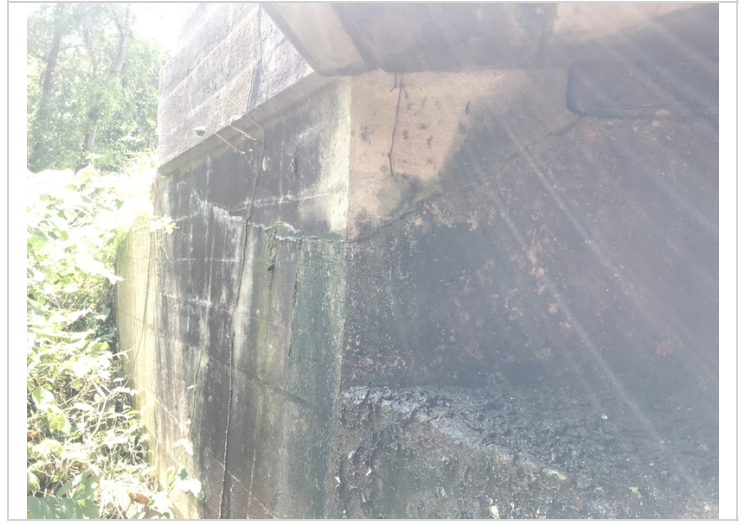
Abutment # 1, right side-Horizontal cracking.

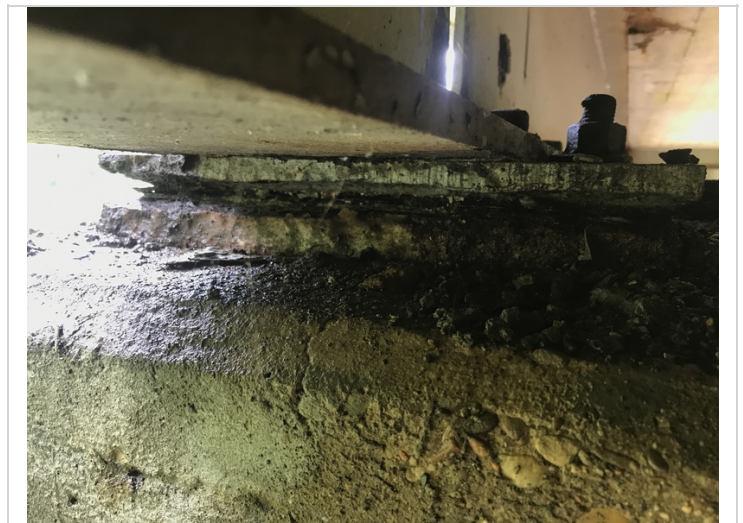
Span # 3, bearing # 5 over bent # 3-Corrosion.

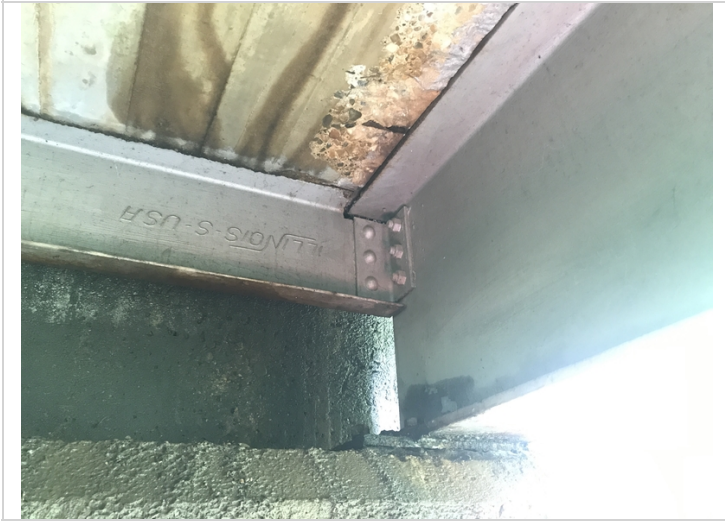
Span # 3, bay # 4 at abutment # 2-Spalling with exposed reinforcing steel in deck underside.

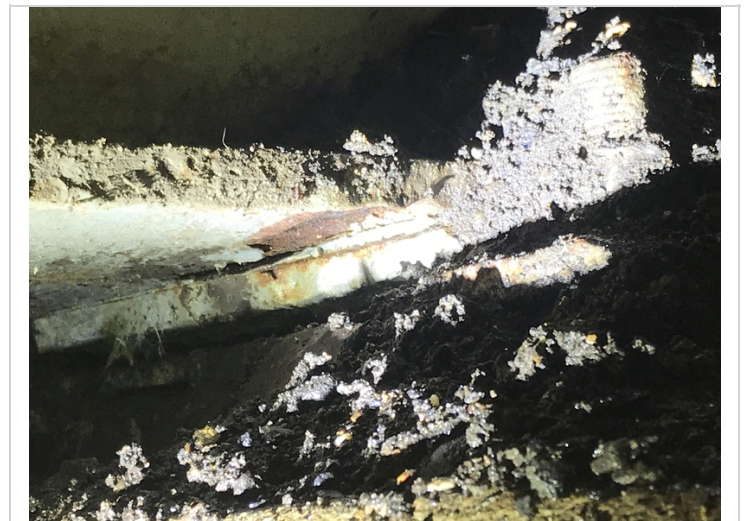
-Span # 3, beam # 4 over bent # 3 has approximately 50% section loss to bottom flange in a 1" long area.

Span # 3, beam # 4 over bent # 3 has approximately 50% section loss to bottom flange.

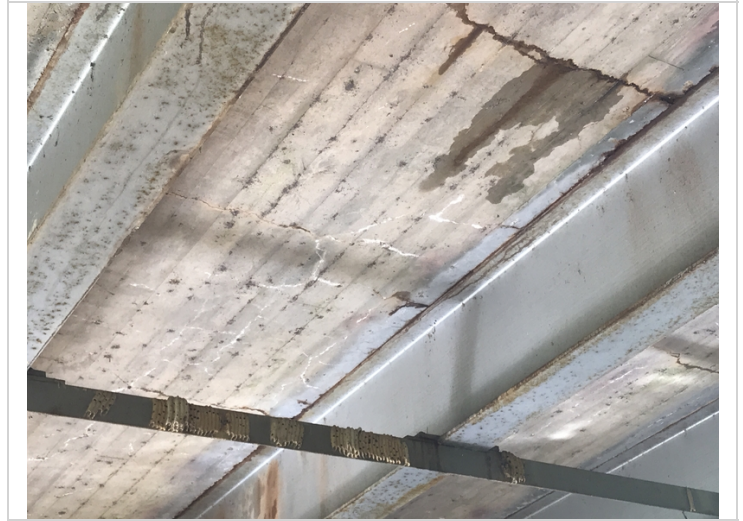
Span # 2, bay # 3-Mapcracking with efflorescence in deck underside.

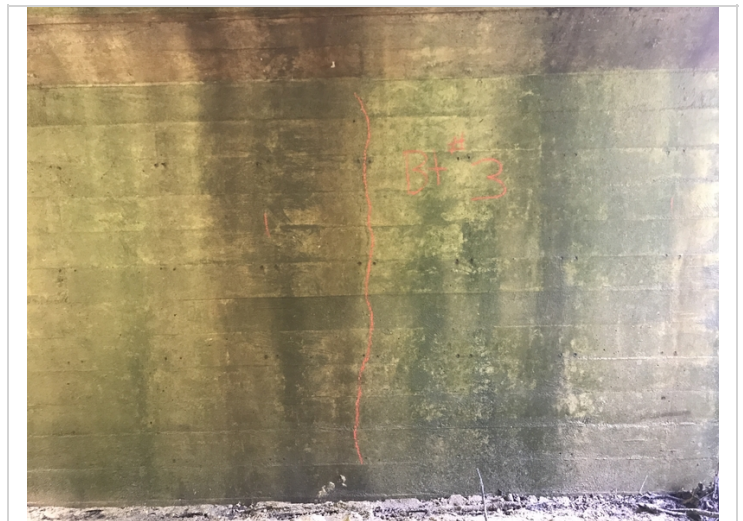
Bent # 3 web wall has a narrow vertical crack near centerline.

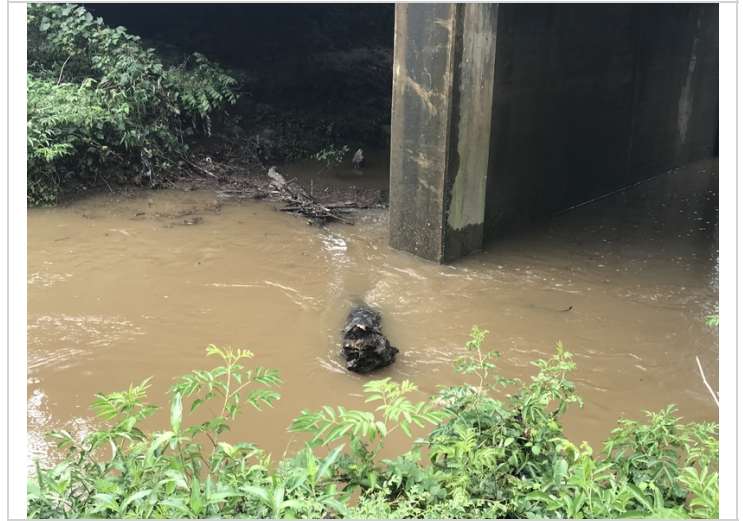
The channel has a tree wedged against bent # 2.

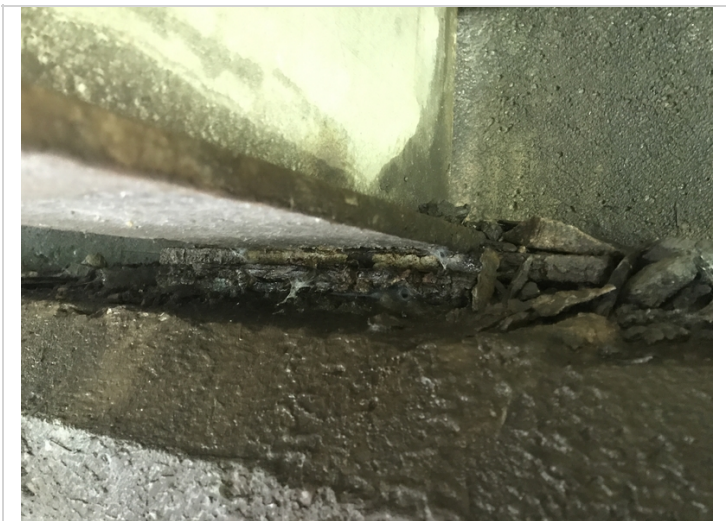
Span # 3, bearing # 4 at abutment # 2-Heavy corrosion.

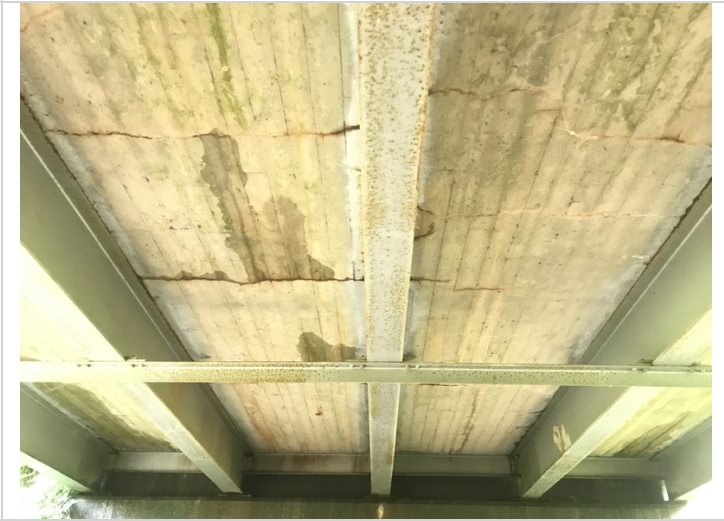
General view of span # 3 undersurface with transverse cracking and staining.

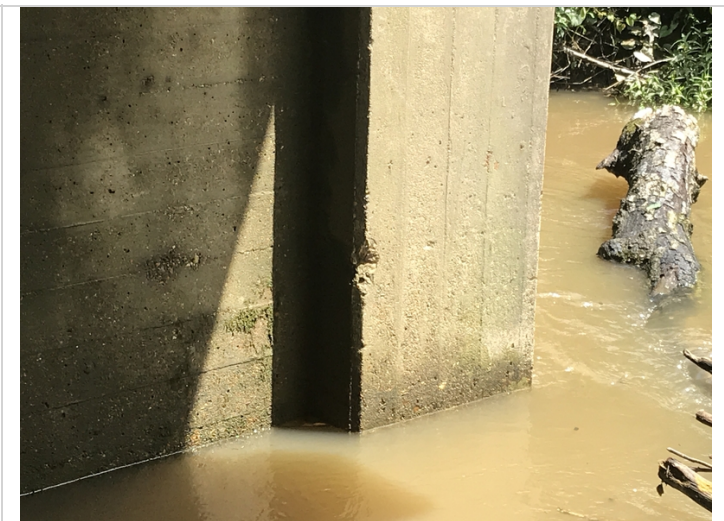
The backside of column # 2 of bent # 2 has a shallow softball sized spall with no exposed reinforcing steel near water elevation.

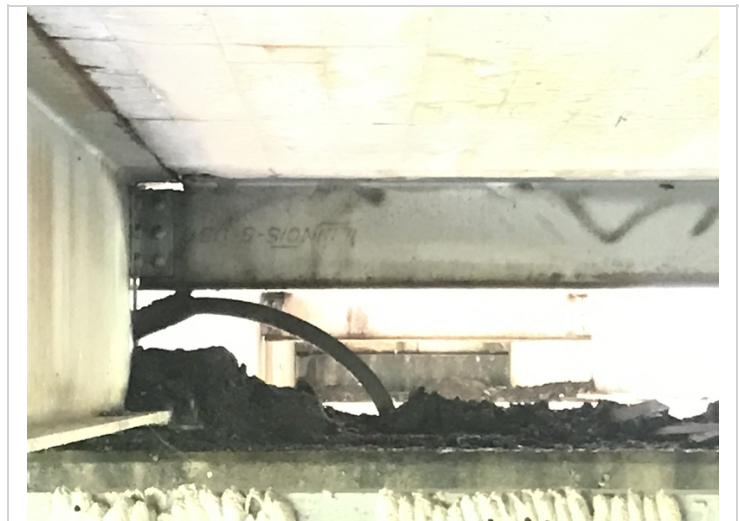
Bent # 3-Asphalt and dirt accumulation on cap.

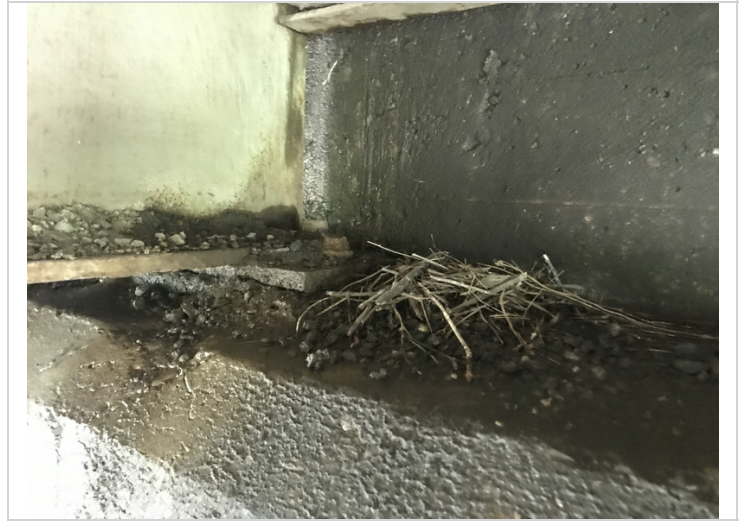
Abutment # 2-Dirt and debris accumulation.

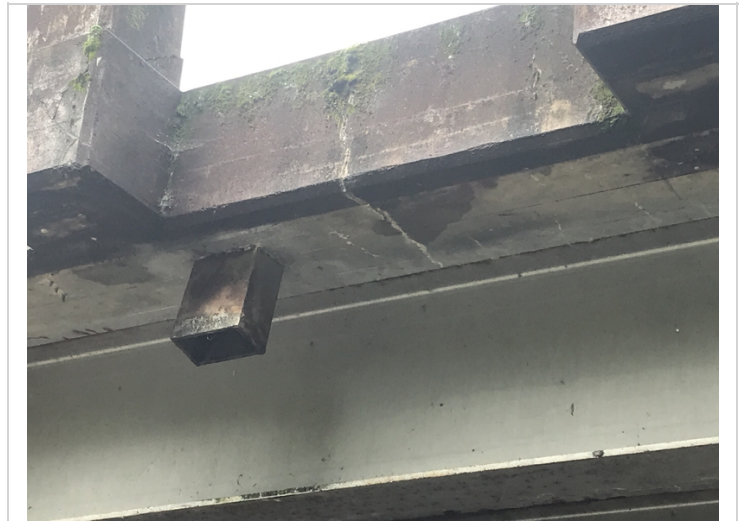
Transverse cracking with efflorescence in deck overhangs.

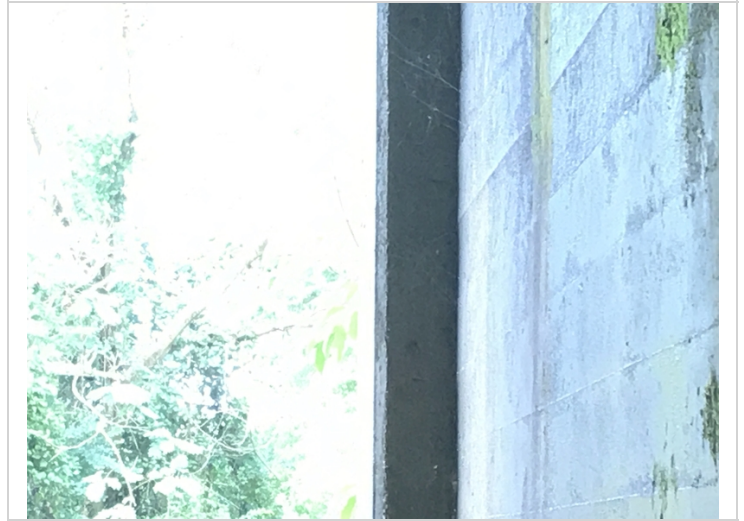
Bent # 3, column # 2 has several shallow spalls that expose reinforcing steel adjacent to the web wall.

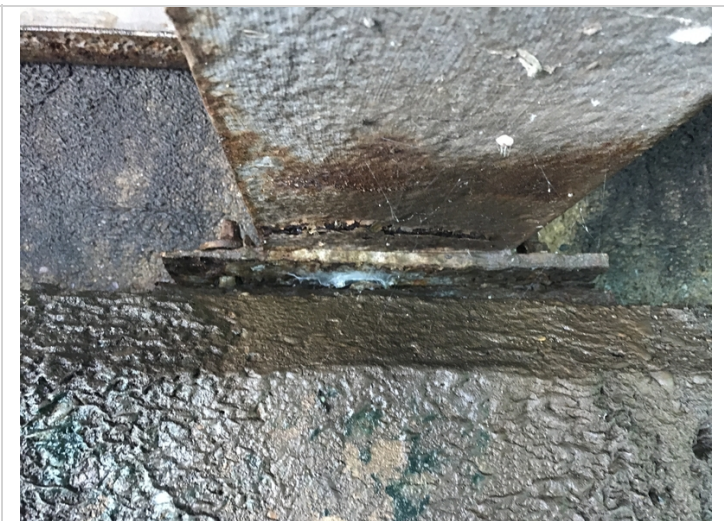
Span # 1, beam # 2 at abutment # 1-Corrosion with flaking rust.

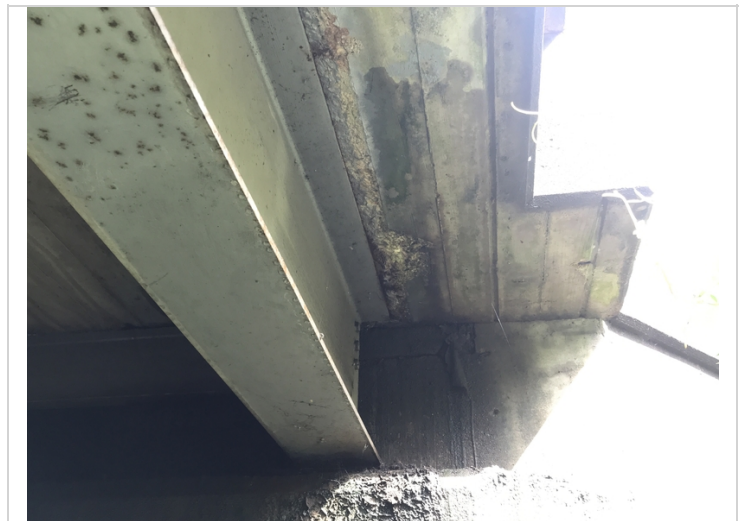
Span # 3, right side-Shallow spalling along top flange.

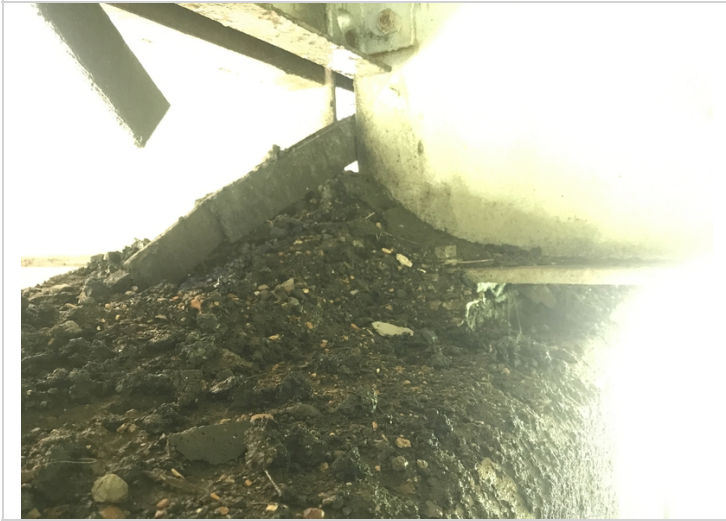
Bent # 3-Dirt and accumulation.

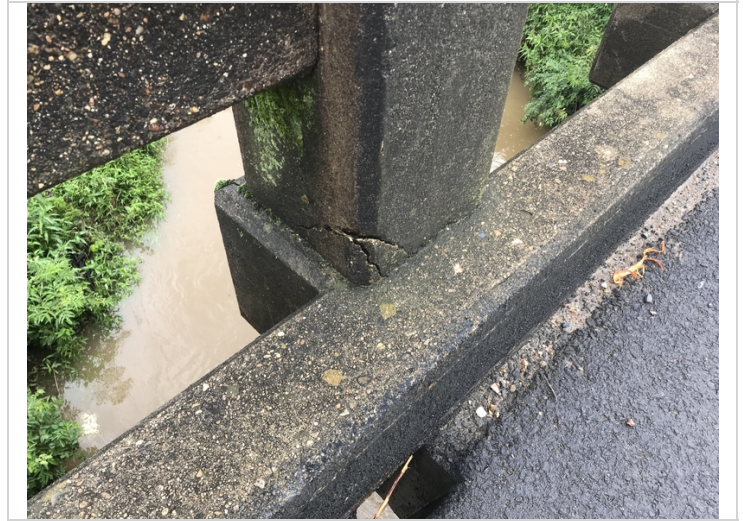
Span # 2, post #1 on right side has a softball sized spalled area at base of post.

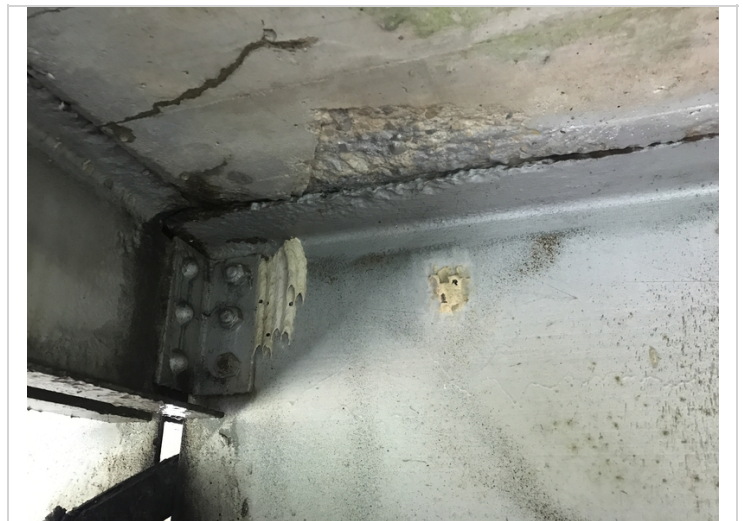
Span # 3, beam # 4-Old section loss to top flange over bent # 3.

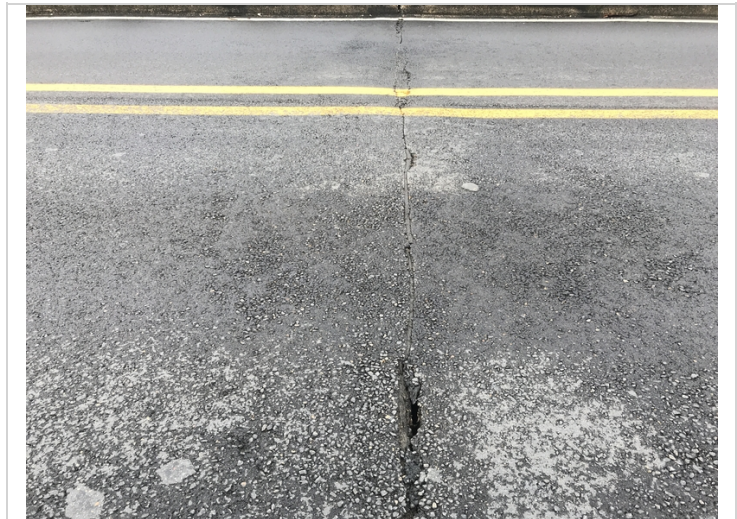
Asphalt in expansion joints.
