Asset #01918(Routine)

US 71 - Polk Co over Two Mile Creek

Location: 2.00 MI NE OF HATFIELD

Team Lead: Bob McEntyre, Inspection Date: 06/13/2019

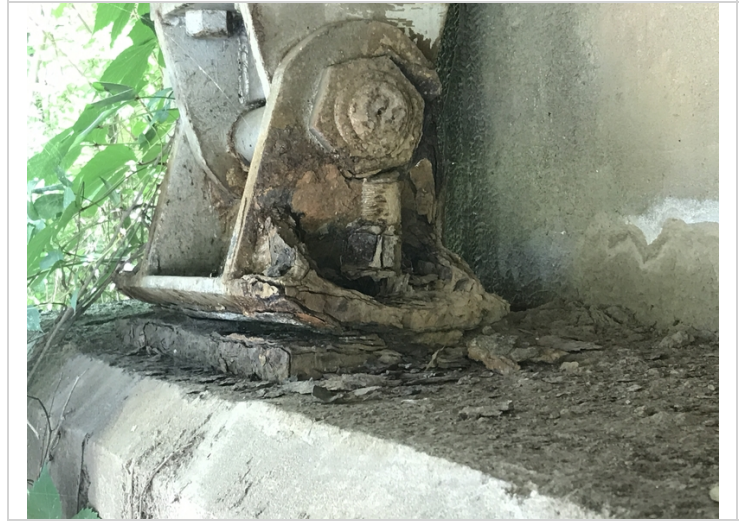
Span # 1, bearing # 3 over Abutment # 1-Corrosion with pack rust.

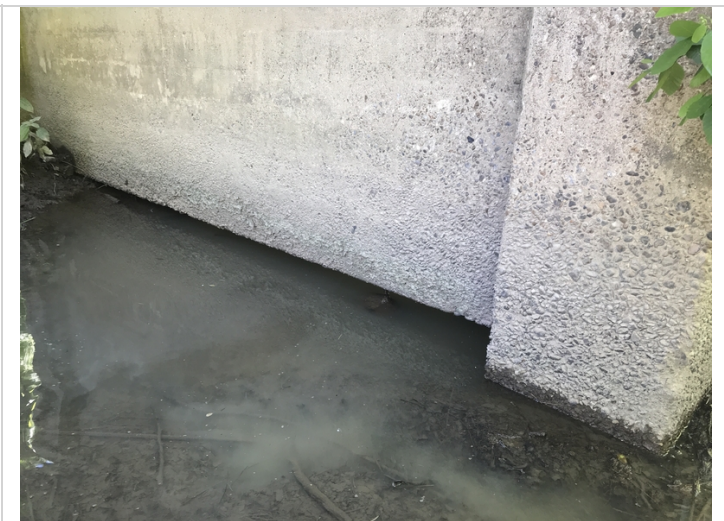
Bent # 3-Light abrasion to columns and web wall.

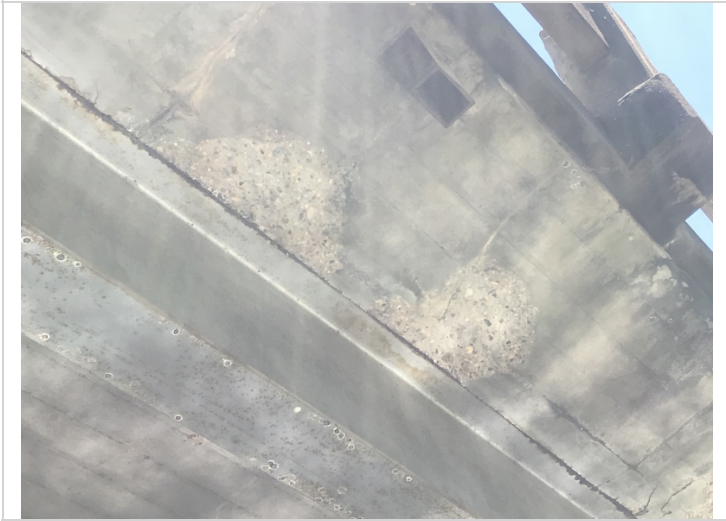
Span # 1, right side-Spalling adjacent to top flange.

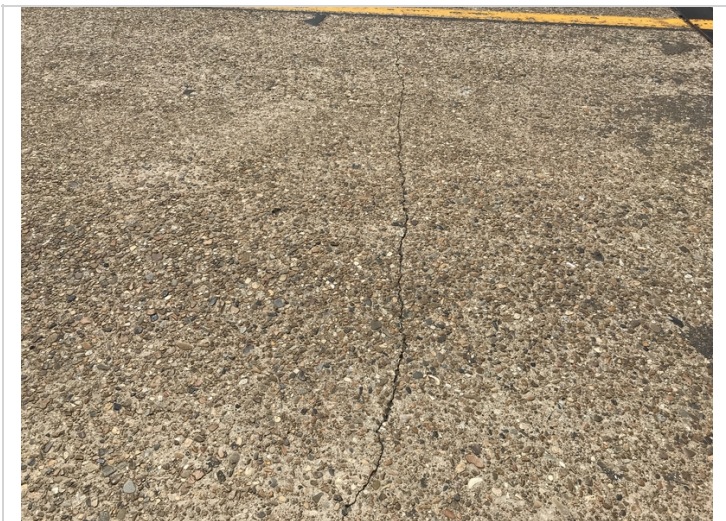
Span # 1, left lane-Moderate width transverse cracking.

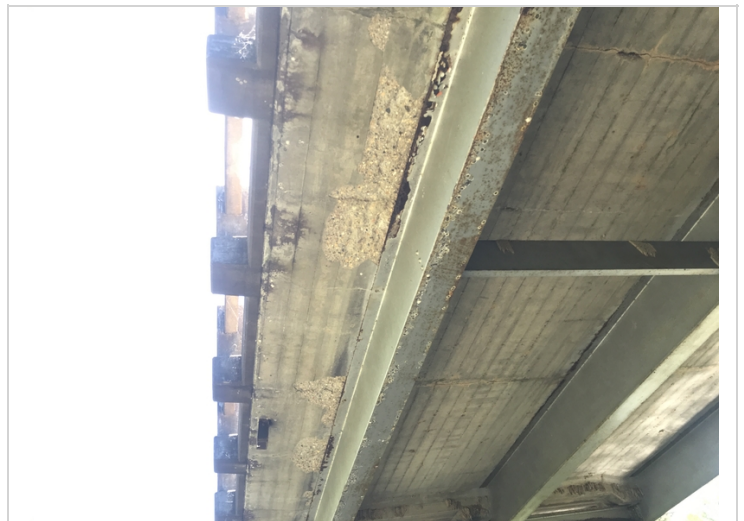
Span # 1, left side-Spalling in deck overhang adjacent to top flange.

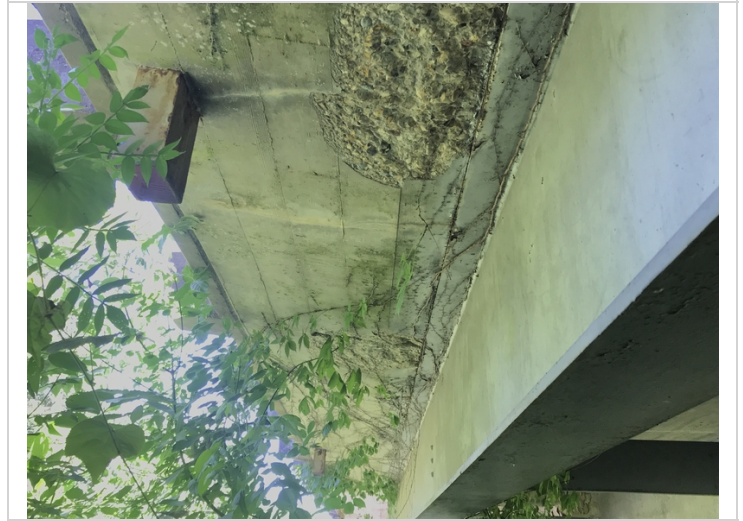
The right side of span # 3 deck overhang has large shallow spalls and delaminated areas.

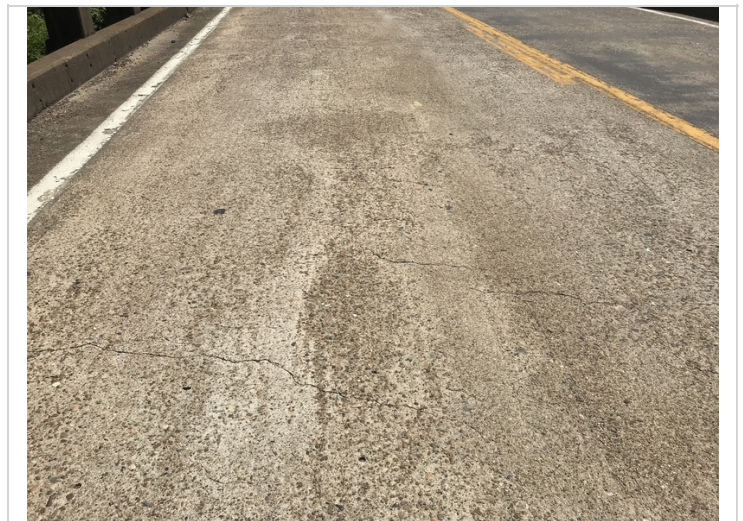
Span # 3, left lane-Moderate width transverse and random cracking.

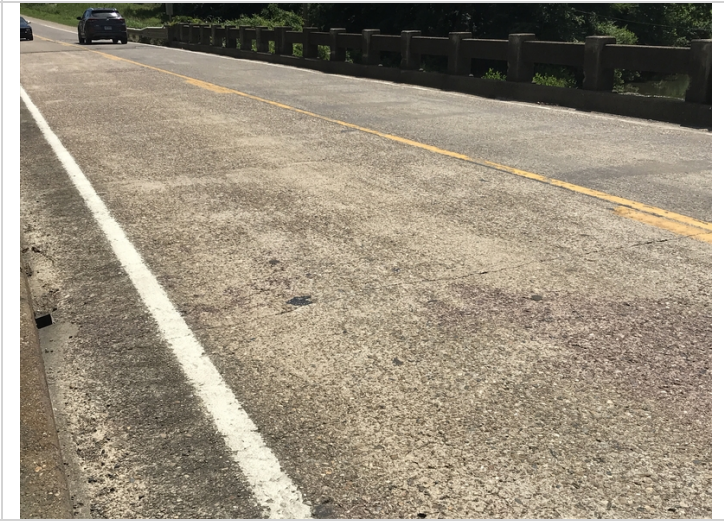
Wear to driving surface.

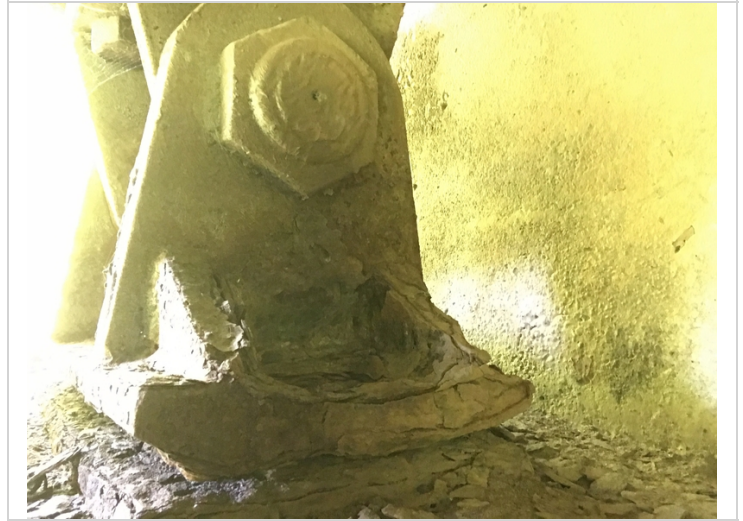
Abutment # 2, bearing # 1-Missing anchor bolt.

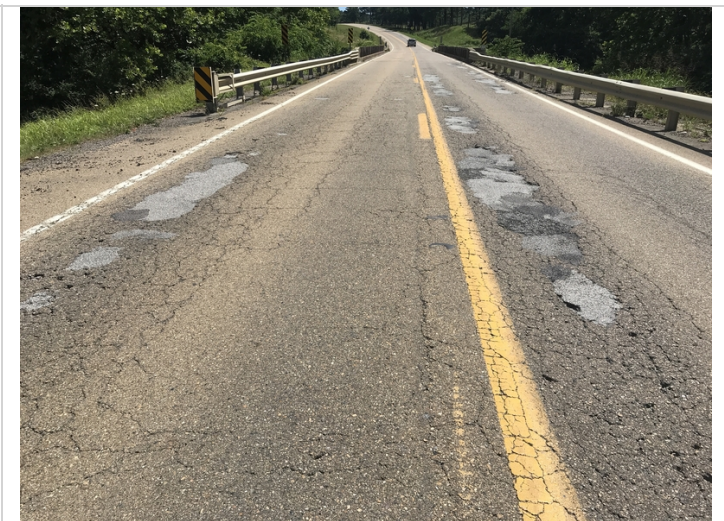
South approach roadway-Settlement in the wheel paths with potholes forming in the driving surface.

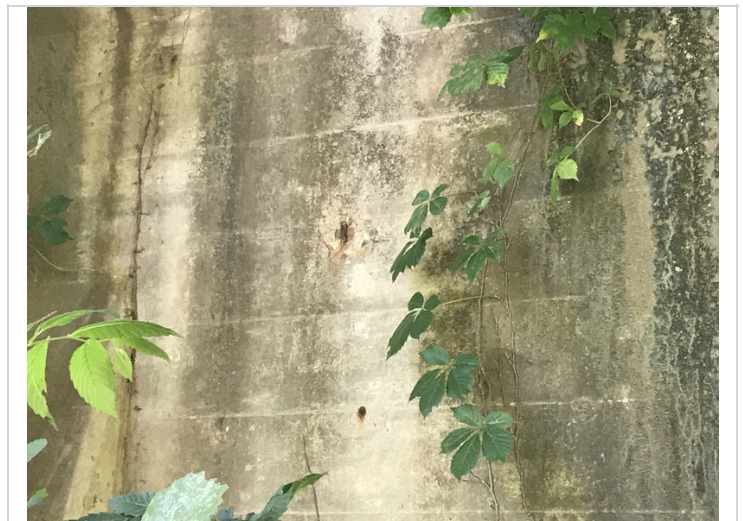
Abutment # 1 stem wall on right side-Baseball sized spall with exposed reinforcing steel.

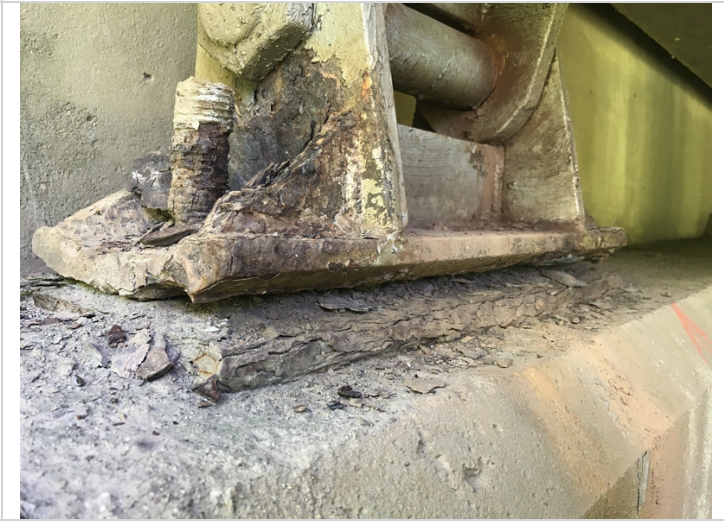
Abutment # 2, bearing # 1-Corrosion with heavy section loss.

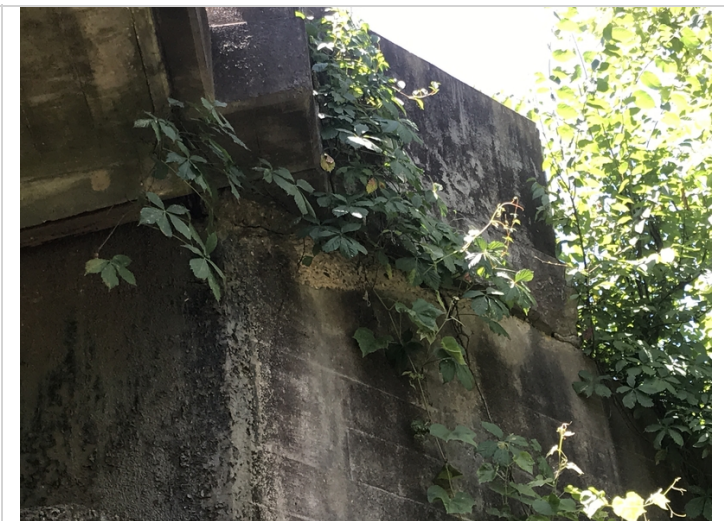
Abutment # 1-Spalling Under left end post.

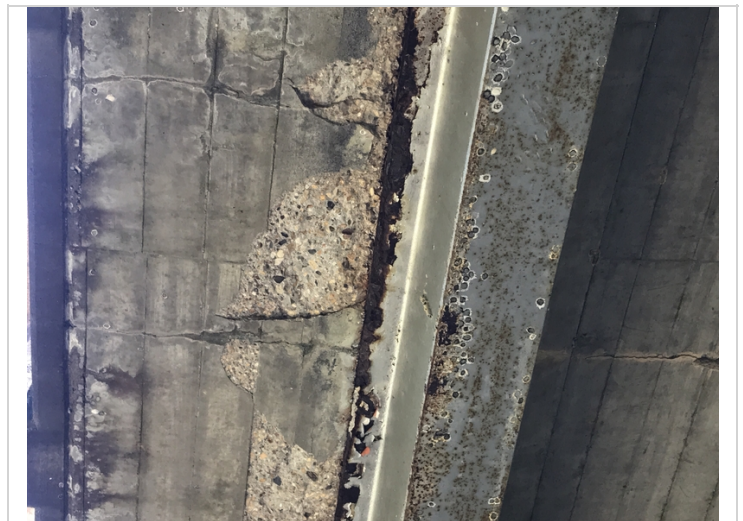
Span # 1, beam # 1-Corrosion with section loss to top flange.

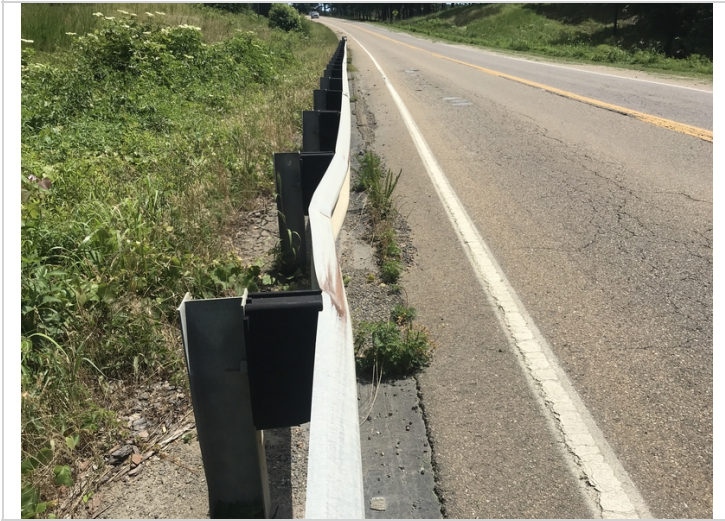
The Northwest approach railing has minor collision damage that has caused out of plane bending to the railing creating a "pocket" in the railing.

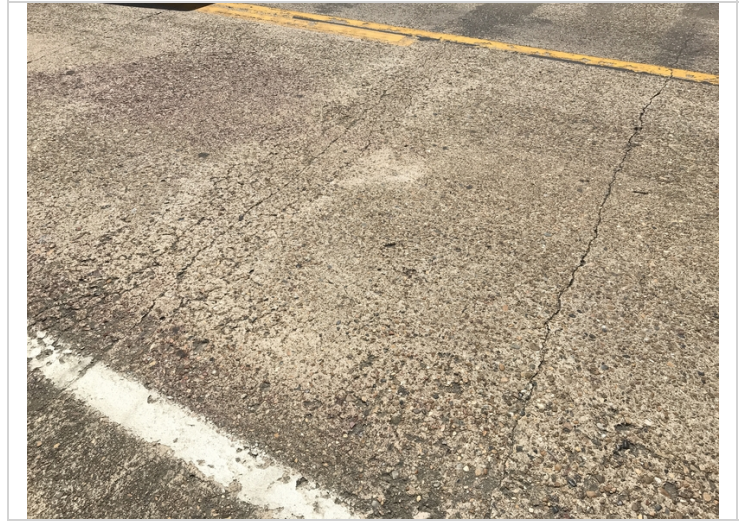
Span # 1, left lane-Transverse and mapcracking.

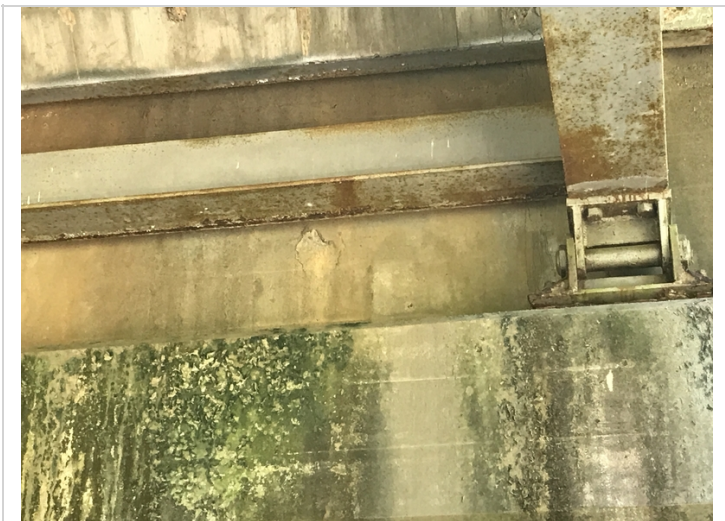
Abutment # 1 backwall-Delaminated area in bay # 1.

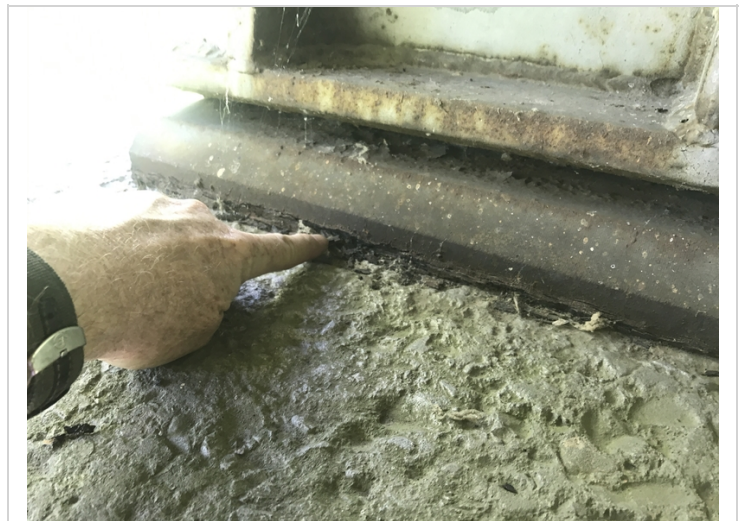
Bent # 3, bearing # 1 has corrosion with flaking rust and initial section loss to masonry plate.

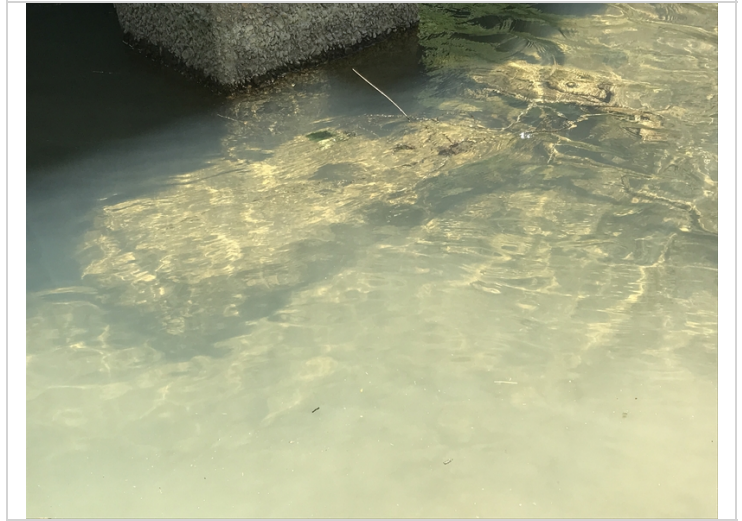
Bent # 2 exposed footing at column # 2 has spalling along edge.

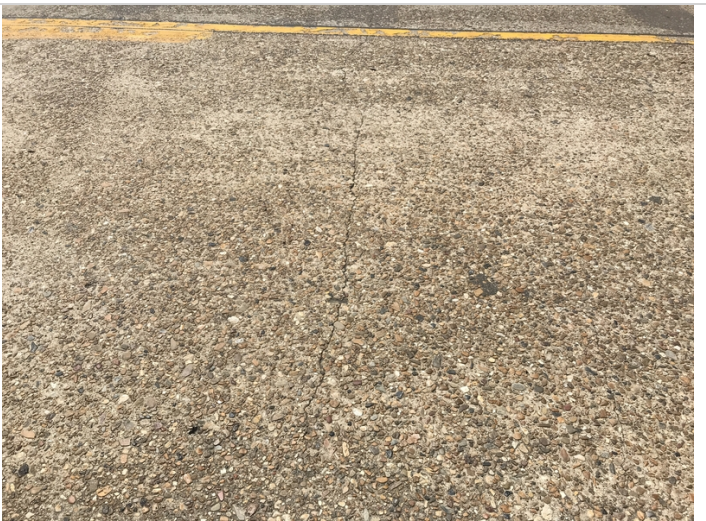
Span # 2, left lane-Transverse cracking.

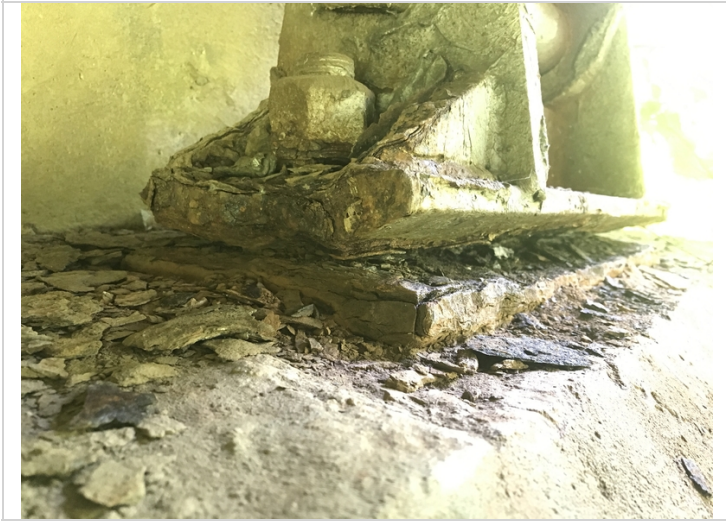
Span # 3, bearing # 3 over abutment # 2-Corrosion with heavy section loss.

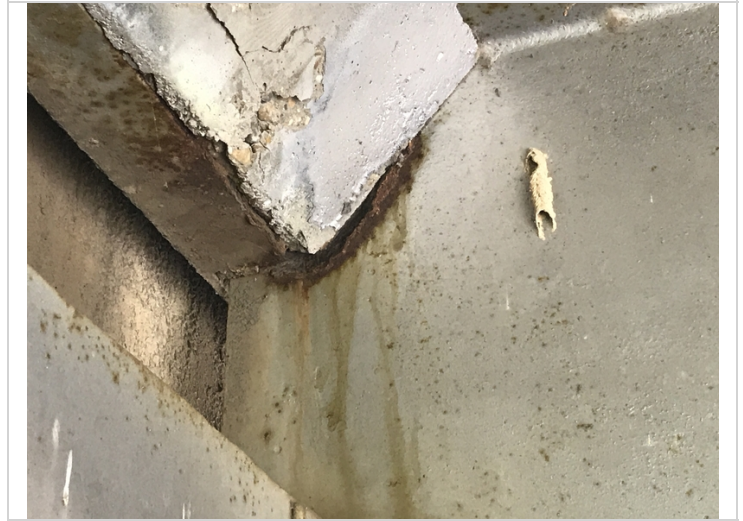
Span # 1, beam # 2 over abutment # 1 has corrosion with section loss adjacent to the expansion dam.

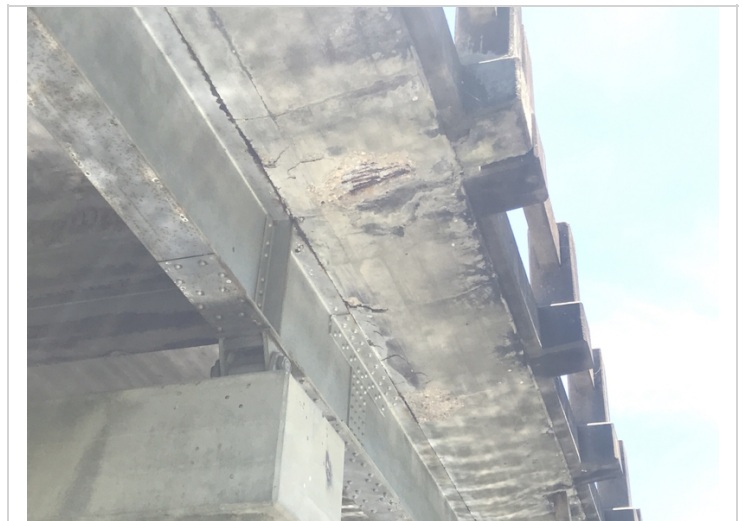
Spalling with exposed reinforcing steel in right undersurface at bent # 2.

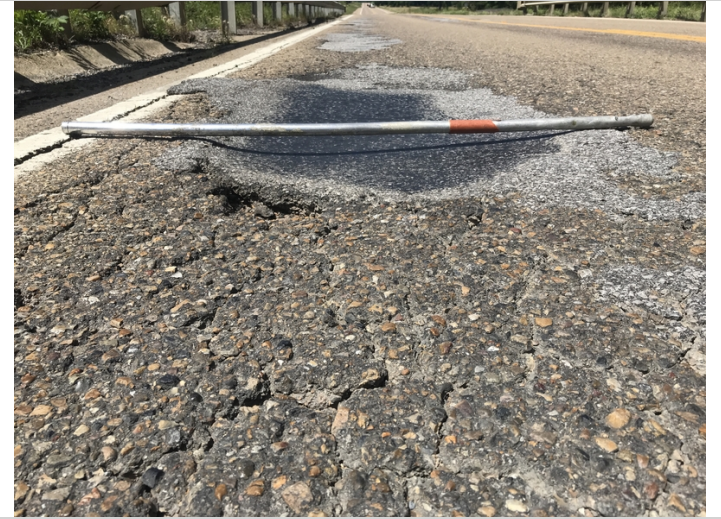
South approach roadway, right lane-Settlement with pothole in wheel path.

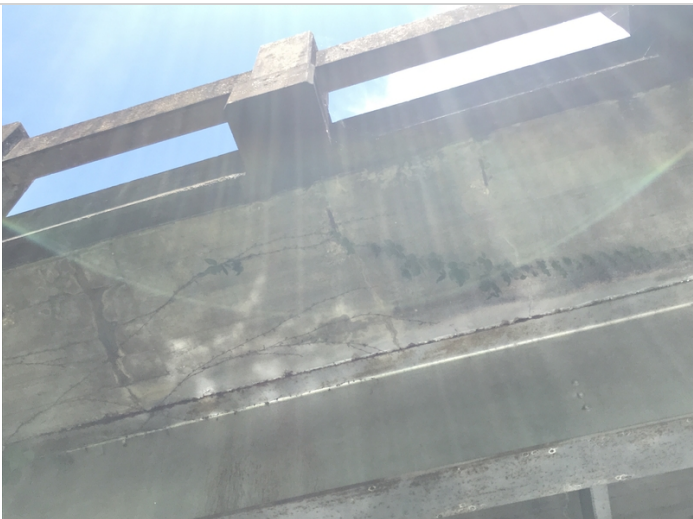
Span # 1, right side-Shallow spalling with exposed reinforcing steel.

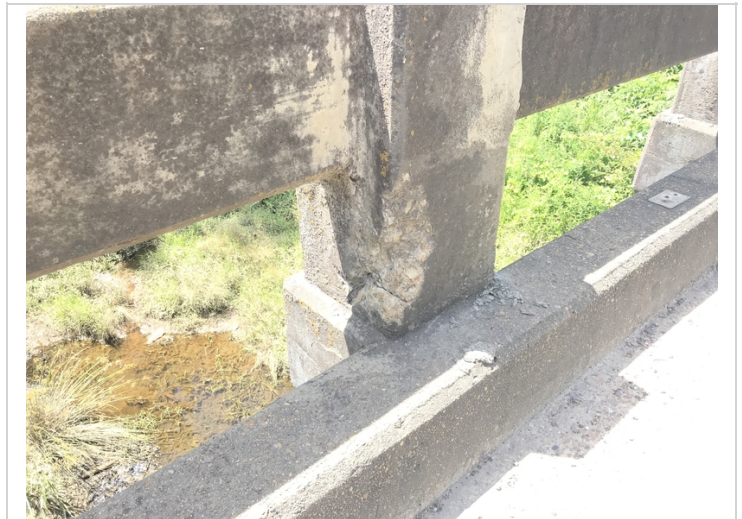
Span # 1, right bridge railing-Collision damage to post.

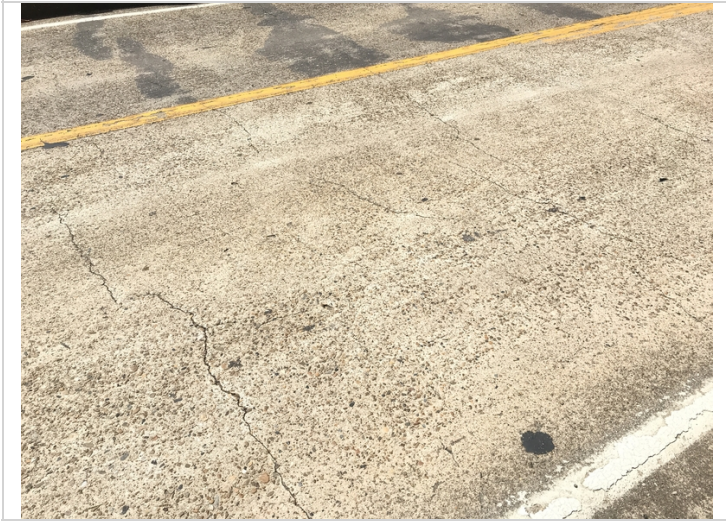
Span # 3, left lane-wide transverse cracking.

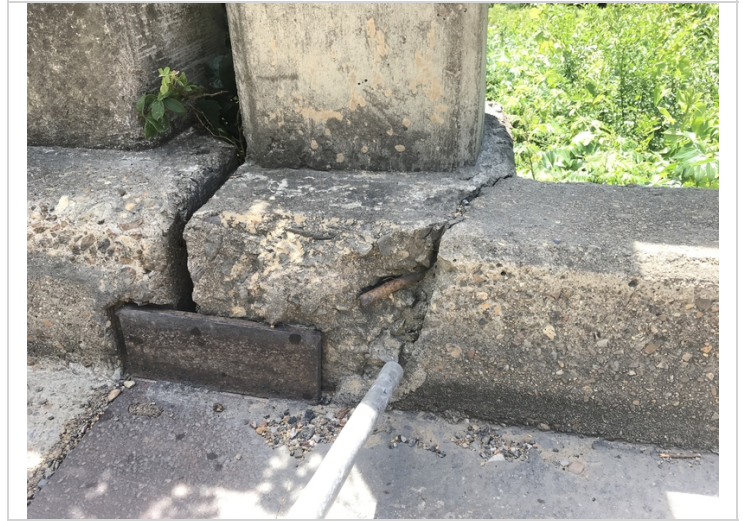
Span # 3, right side at abutment #2-Spalling with exposed reinforcing steel in curb.

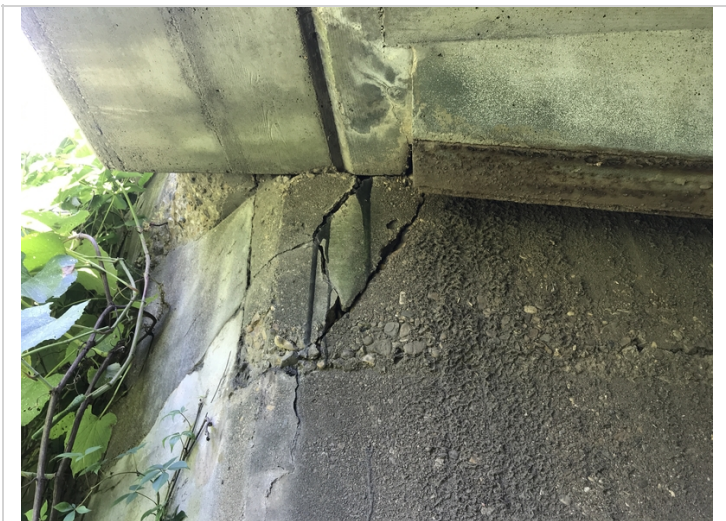
The upper portion of abutment # 2 backwall is fractured on the left and right sides at the wing wall junctures.

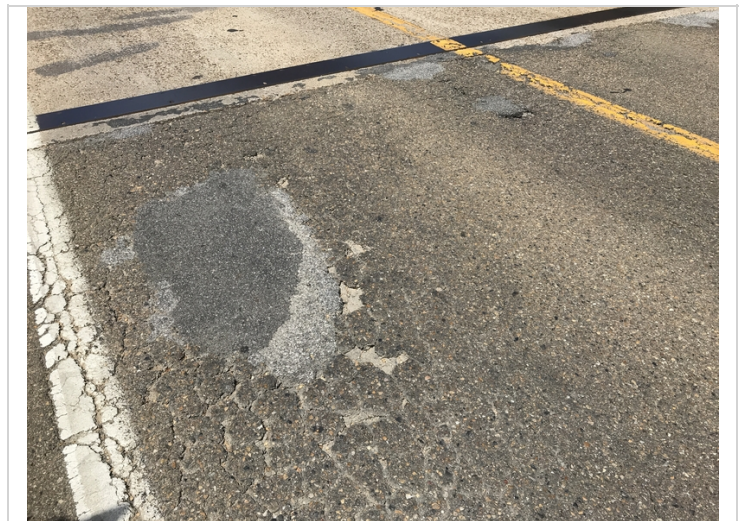
The right lane of the North approach roadway has failing asphalt repairs with potholes forming in the driving surface at the bridge end.

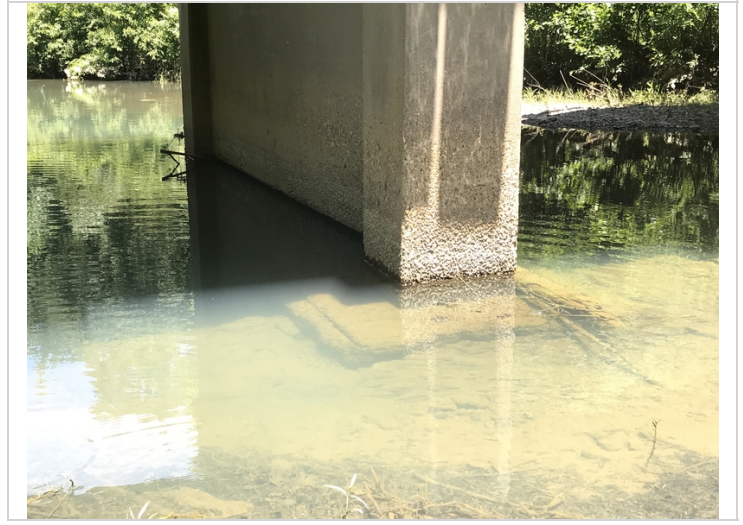
Bent # 2, column # 2 footing exposed.

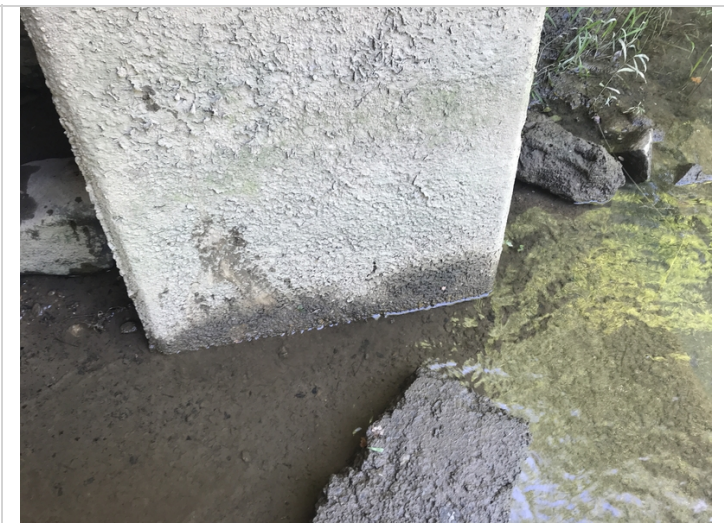
Abutment # 1, column # 1 footing-Light abrasion.

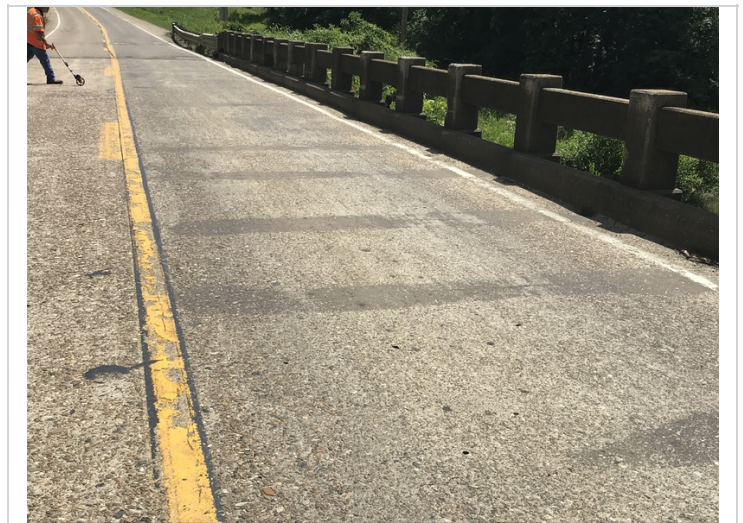
Cracks in right lane sealed.

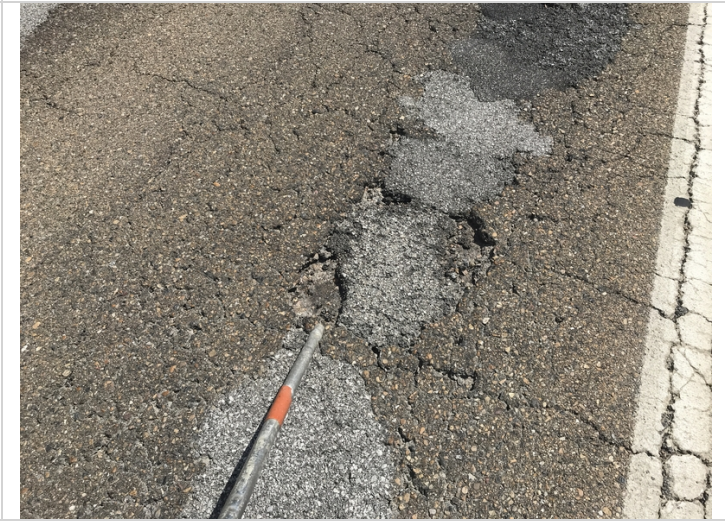
South approach roadway has settlement in the wheel paths with failing asphalt repairs and potholes in the driving surface.

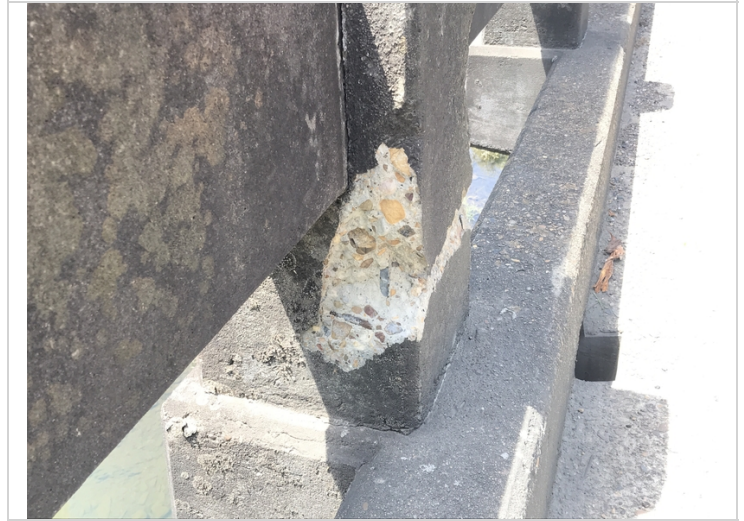
Span # 2, right bridge railing-Collision damage to post.

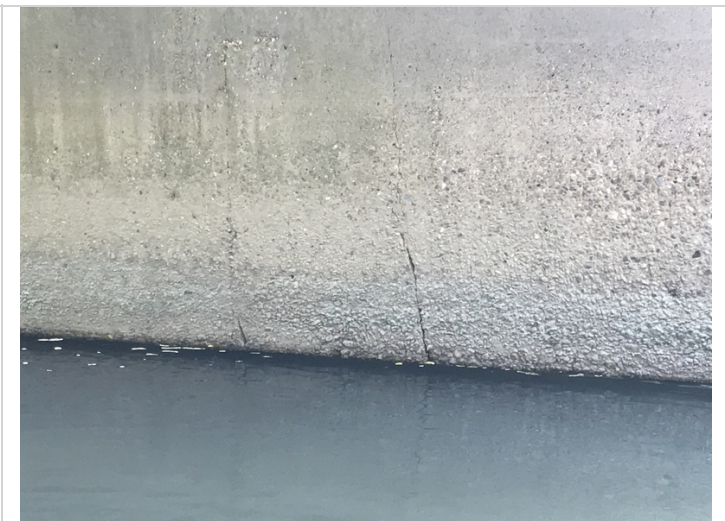
Bent # 2 web wall-Wide vertical cracking.

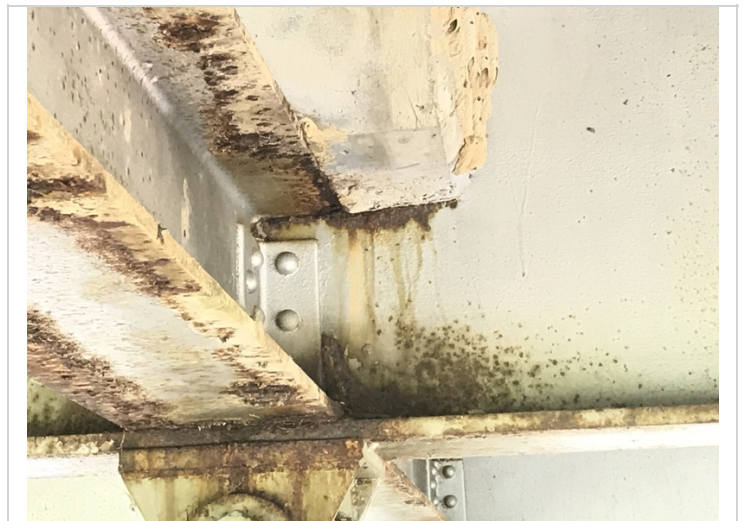
Span # 2, beam # 2 over bent # 2-Corrosion with flaking rust to web.

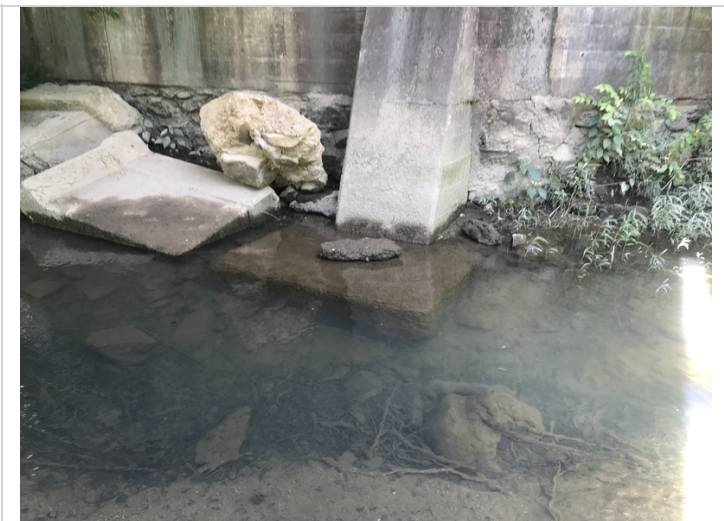
Abutment # 1, column # 1-Exposed footing.

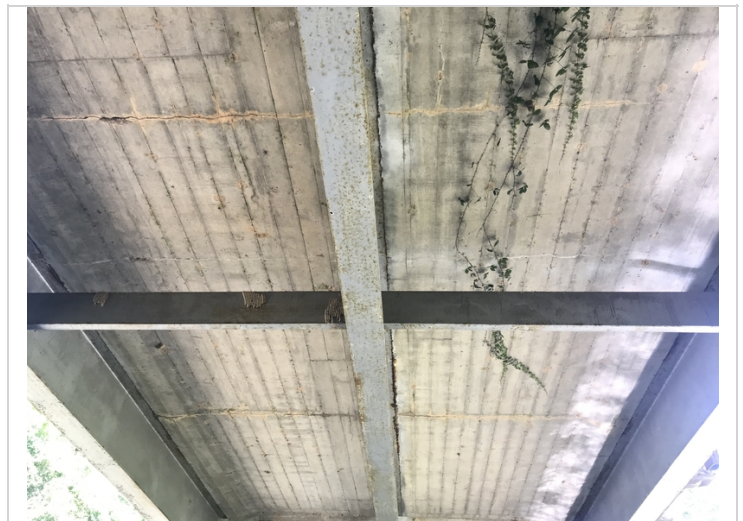
Span # 1 undersurface-Transverse cracking with leakage / staining.
