Asset #02145(Routine)

US 71 - Polk Co. over Barren Creek

Location: 1.8 MI S OF COVE

Team Lead: Eric West, Inspection Date: 08/16/2021

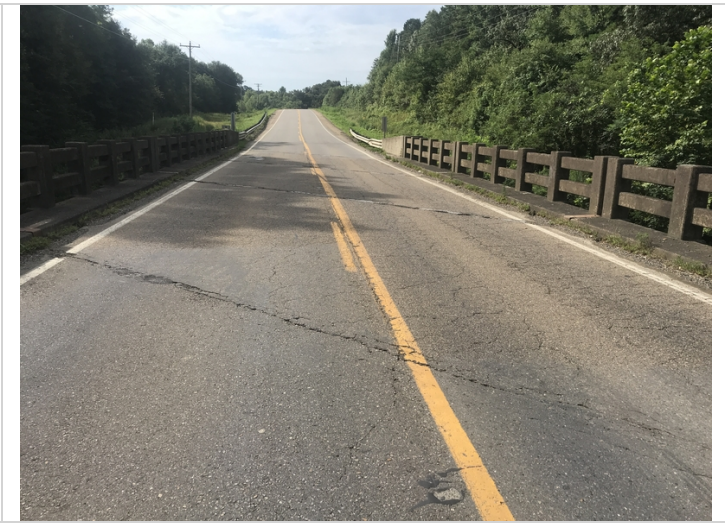
Typical driving surface of the deck.

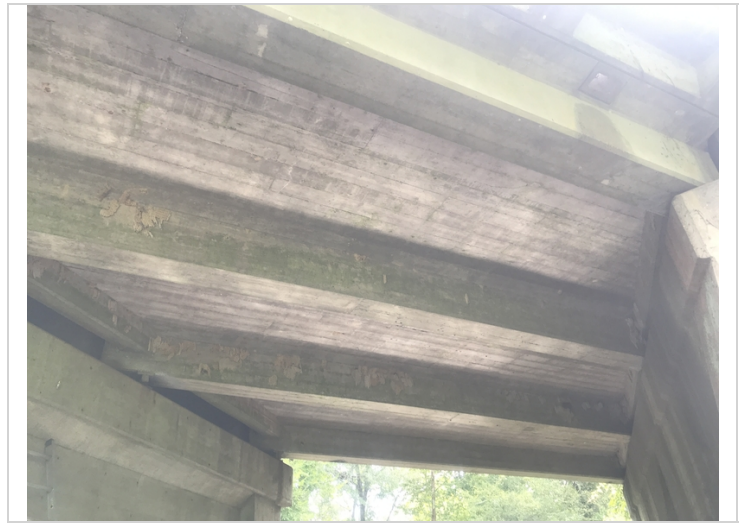
(16) Undersurface: -The undersurface of the deck in span # 1 has a transverse crack with light efflorescence in bay # 1. -Span # 1 Rt has 3 shallow spalls with exposed reinforcing steel in the drip groove. Approach roadways: -North approach roadway has a pothole in the North bound lane. (510-16) -The asphalt driving surface of the deck has map cracking and a few potholes. -The asphalt driving surface is breaking apart over the expansion joints. -Maintenance forces have made a few temporary asphalt patches on the driving surface of the deck.							
110	Reinforced Concrete Open Girder/Beam	LF	372	371	0	1	0
1090	Exposed Rebar	LF	1	0	0	1	0

Span # 1 typical undersurface of the deck.

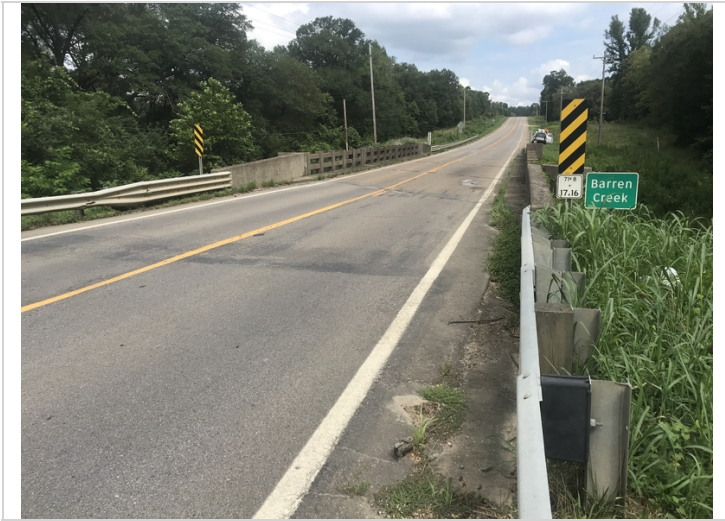
Abutment #1 with no apparent significant settlement of the approach roadway.

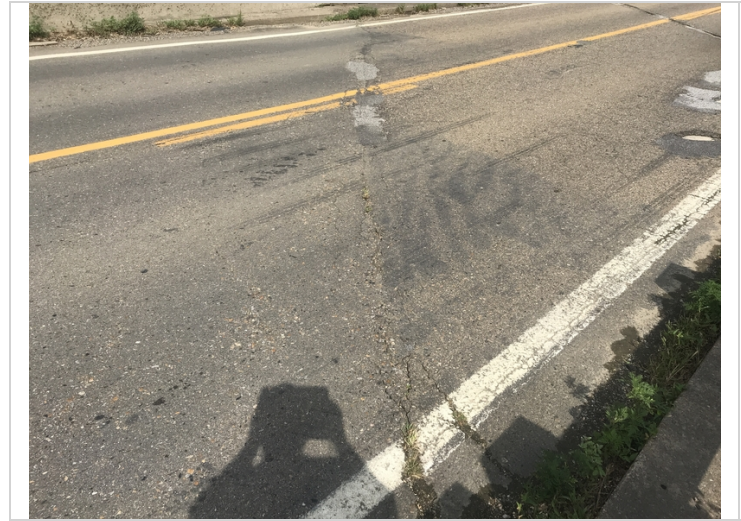
(305) -The expansion joints are primarily covered in asphalt and not visible. -The asphalt wearing surface is breaking apart over the expansion joints. -The expansion joints leak water on the substructure.							
311	Movable Bearing	EA	12	0	4	8	0
1000	Corrosion	EA	12	0	4	8	0
515	Steel Protective Coating	SF	48	6	0	11	31
3440	Effectiveness (Steel Protective Coatings)	EA	42	0	0	11	31

Abutment #1 wearing surface over the expansion joint.

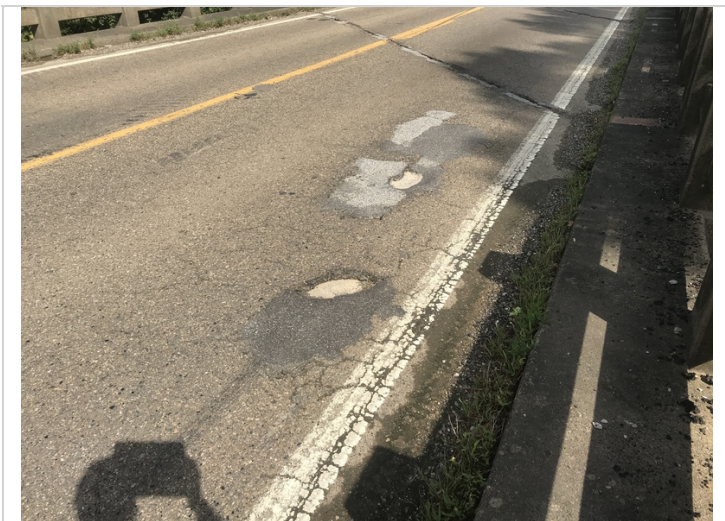
Span #1 asphalt deterioration with potholes in the northbound lane.

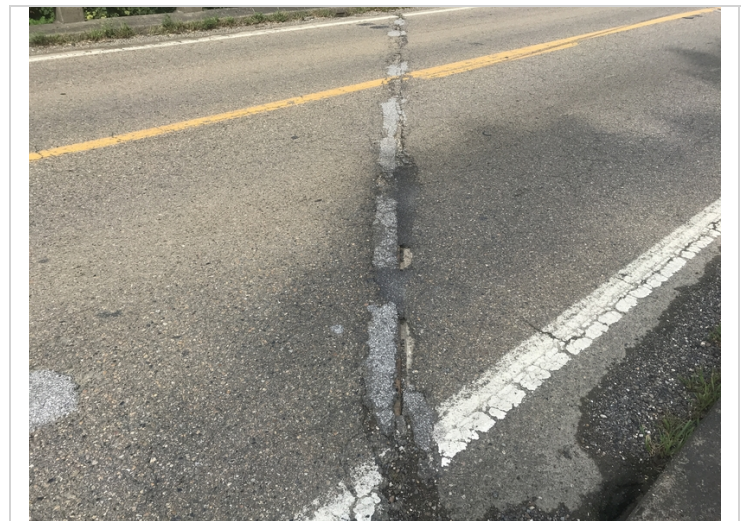
Bent #2 wearing surface over the intermediate bent.

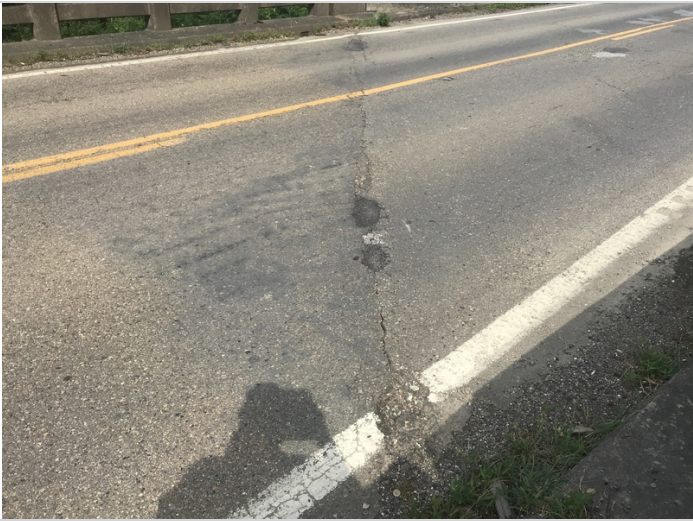
Abutment #2 wearing surface over the expansion joint.

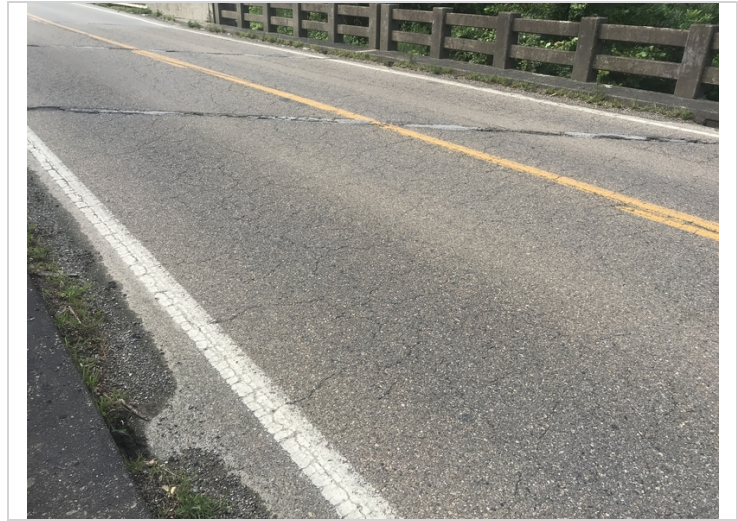
Typical driving surface cracking.

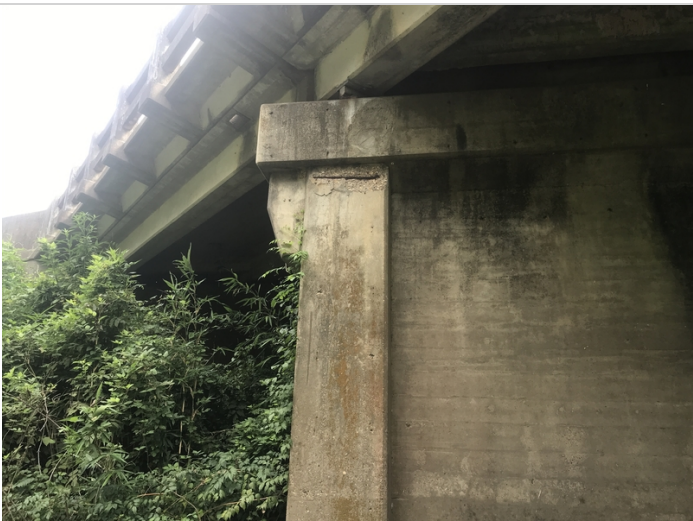
(205) -There is light scale at base of columns typical. -Bent # 3, Column # 1 has a shallow spall with exposed reinforcing steel at the cap juncture with measurable section loss. The column has a softball sized spall with exposed reinforcing steel approximately 4' from the channel floor on the downstream side. -Abutment # 2, Column # 1 has several shallow spalls that appear to be from the form work during the construction process. -Abutment # 2, column # 2 has a shallow 12" long delaminated area at the cap juncture.							
210	Reinforced Concrete Pier Wall	LF	56	0	54	2	0
1090	Exposed Rebar	LF	2	0	0	2	0
1130	Cracking (RC and Other)	LF	4	0	4	0	0
1190	Abrasion/Wear (PSC/RC)	LF	50	0	50	0	0

Span #2, Bent #3 Column #1 spalling with exposed reinforcing steel.

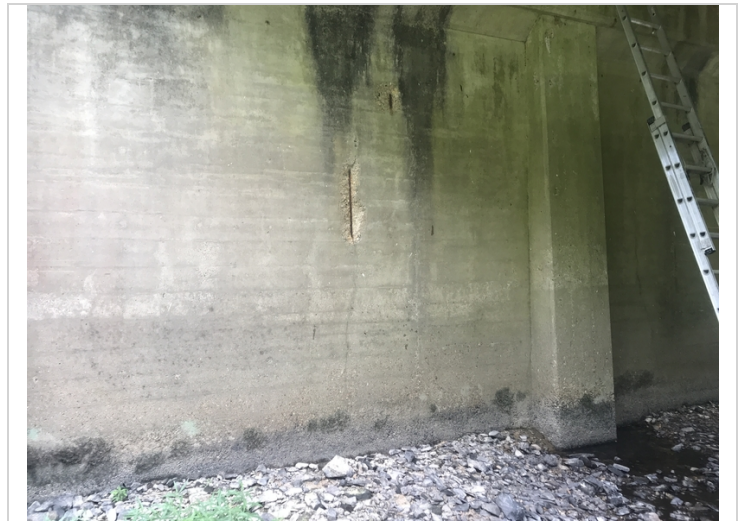
Span # 2, Bent # 3 Bay # 1 spalling with exposed reinforcing steel.

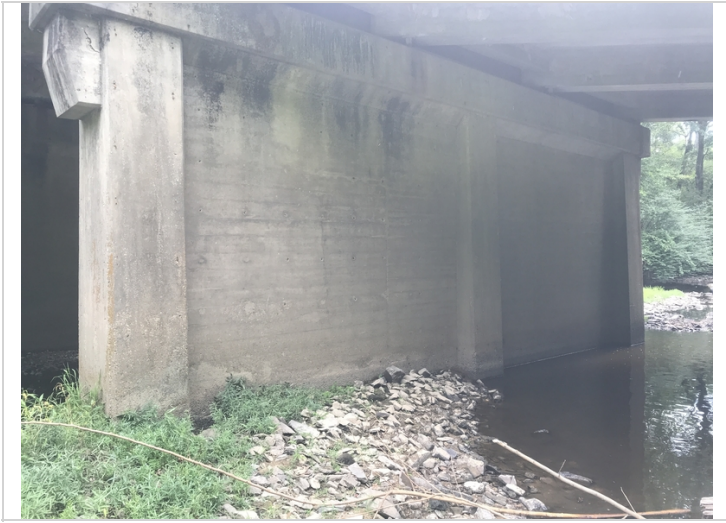
Bent #2 typical.

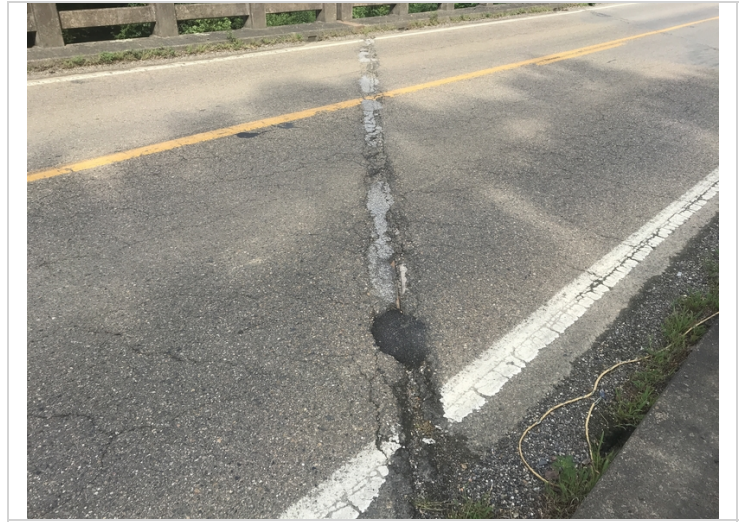
Bent #3 typical asphalt deterioration over the intermediate bents.

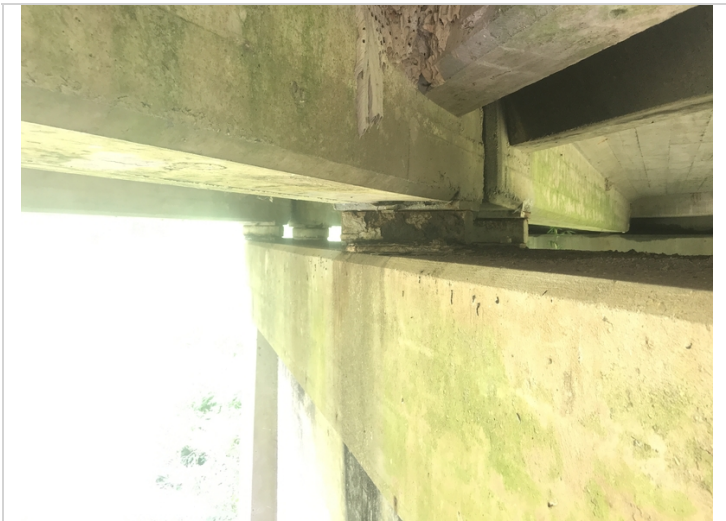
(311) -The bearings have been painted in the past. The paint system is failing with layers of flaking rust forming and numerous bearings with rust showing through the paint. -The bearings have corrosion with layers of flaking rust between sole and masonry plates in several locations.							
313	Fixed Bearing	EA	12	0	1	11	0
1000	Corrosion	EA	12	0	1	11	0
515	Steel Protective Coating	SF	48	48	0	0	0

Bent #3 bearings with active corrosion and layers of flaking rust.

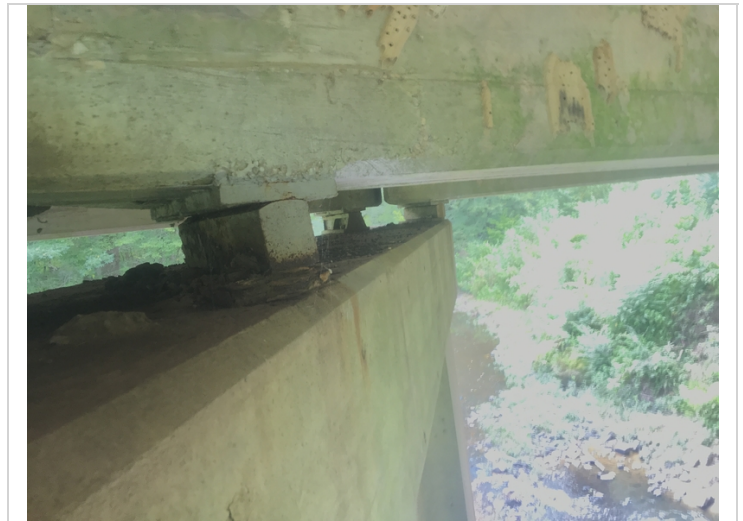
Span # 1 Bent # 2 active corrosion with layers of flaking rust between the masonry and bearings.

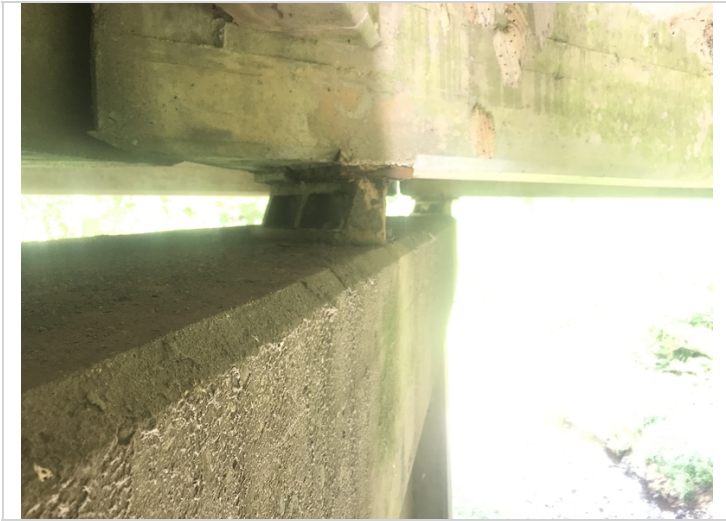
Span #2, Bent #2 bearings with active corrosion and layers of flaking rust.

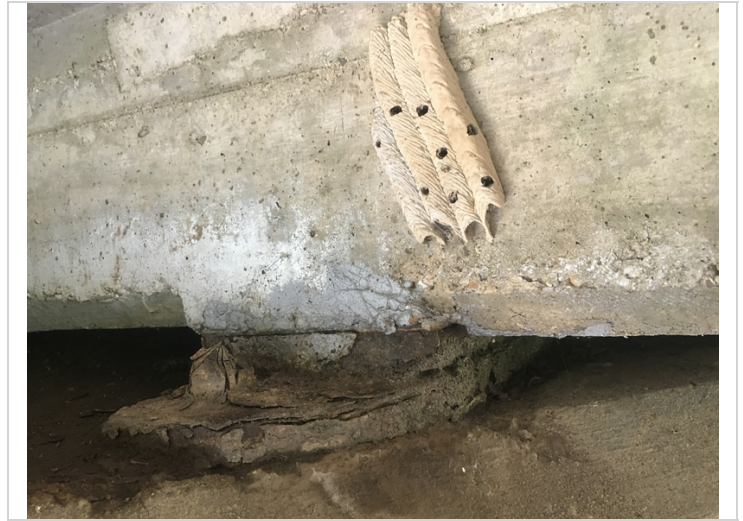
Abutment #1 bearings with active corrosion and layers of flaking rust.

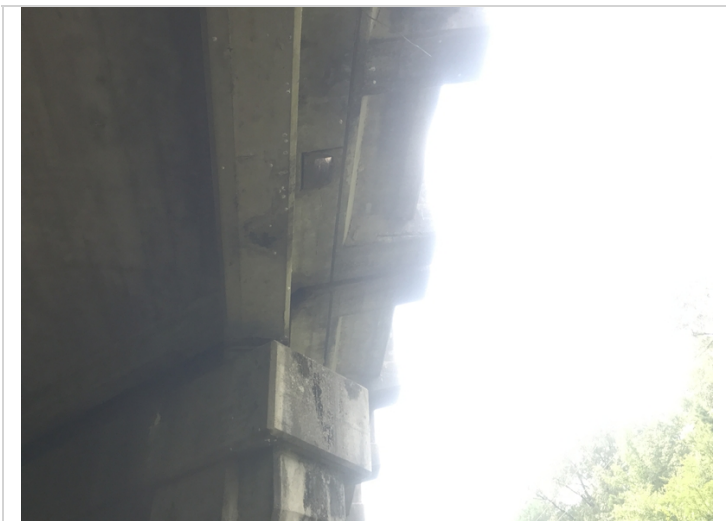
ELEMENTS	DESCRIPTION	UNITS	TOTAL	CS1	CS2	CS3	CS4
(331)	-The bridge railing has a few insignificant shallow spalls in the posts and the vertical face of the concrete curbs. -Span # 2, right post support over bent # 2 has a 12" spall with exposed reinforcing steel under the deck overhang. -Span # 2, Lt post support over Bent # 2 has a 12" spall with exposed reinforcing steel under the deck overhang.

Span # 2, Lt post support over Bent # 2 has a 12" spall with exposed reinforcing steel under the deck overhang.

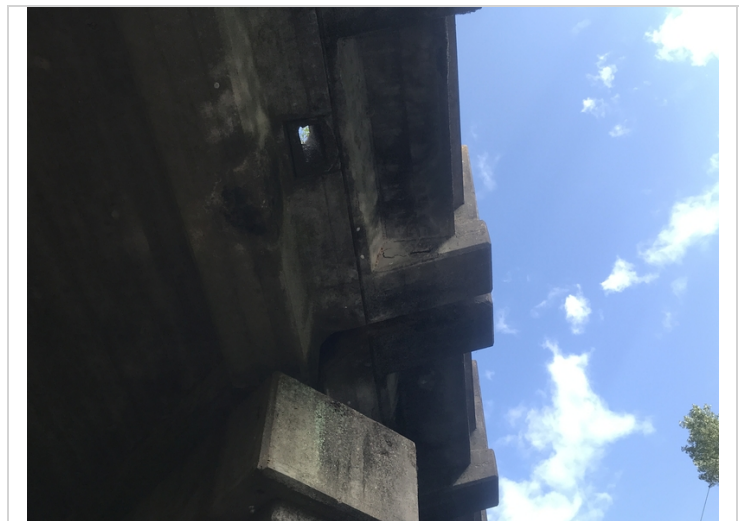
Span #1 Rt over Bent #2 spalling with exposed reinforcing steel.

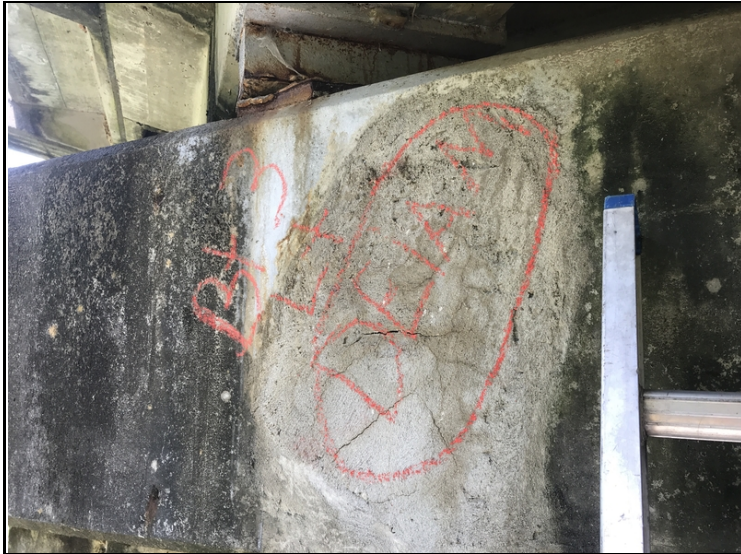
The repair to the backface of bent # 3 cap over column # 1 is cracked and delaminated.

The repair to the backface of bent # 3 cap on the left side over column # 1 is cracked and delaminated.

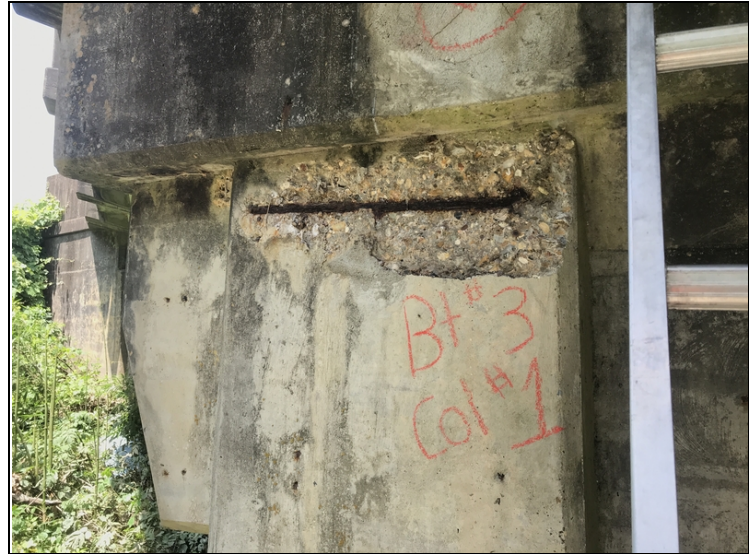
The previous repair to the top of column # 1 of bent # 3 has spalled off exposing the reinforcing steel. Exposed steel has measurable section loss. The column has a softball sized spall with exposed reinforcing steel approximately 4' from the channel floor on the downstream side.

Bent # 3, column # 1-Spalling with exposed reinforcing steel.

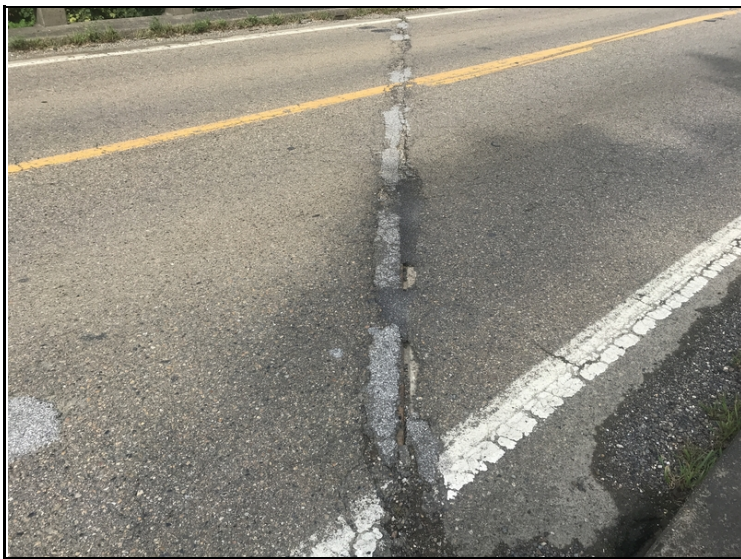
Driving Surface -
The asphalt driving surface is breaking apart over the expansion joints.

Bent #2 wearing surface over the intermediate bent.

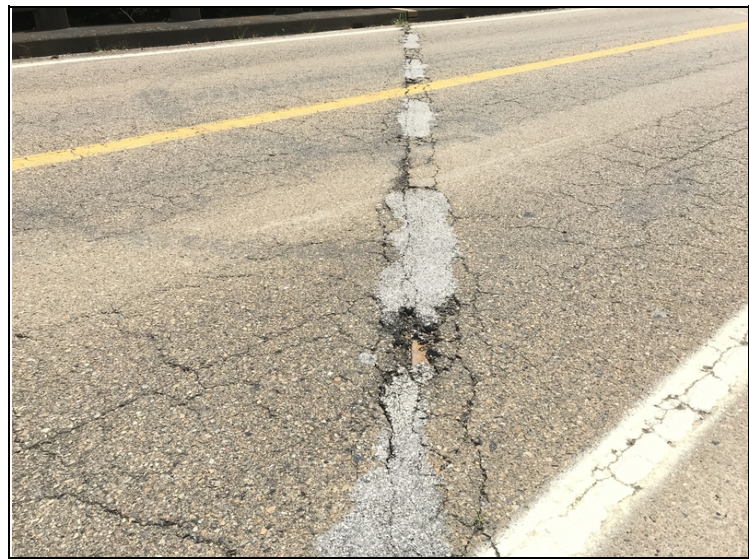
Potholes forming in driving surface over bent # 3 expansion joint.

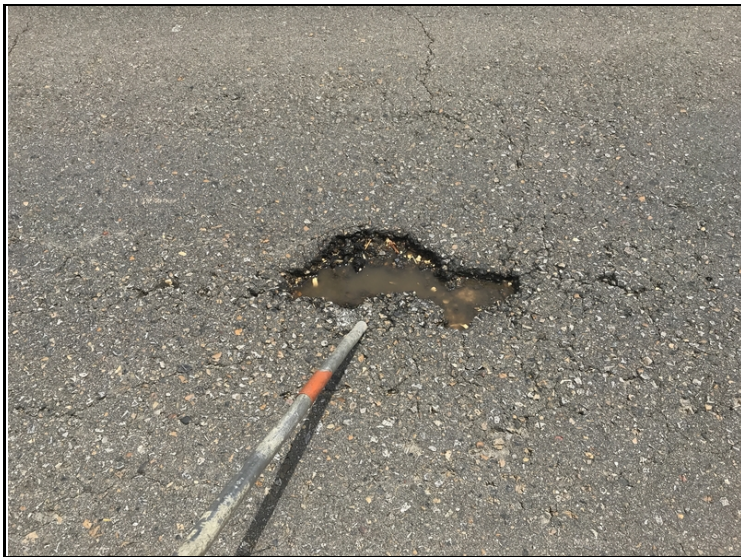
Approach Roadway -The North approach roadway has a pothole in the Northbound lane.

North approach roadway has a pothole in the Northbound lane.

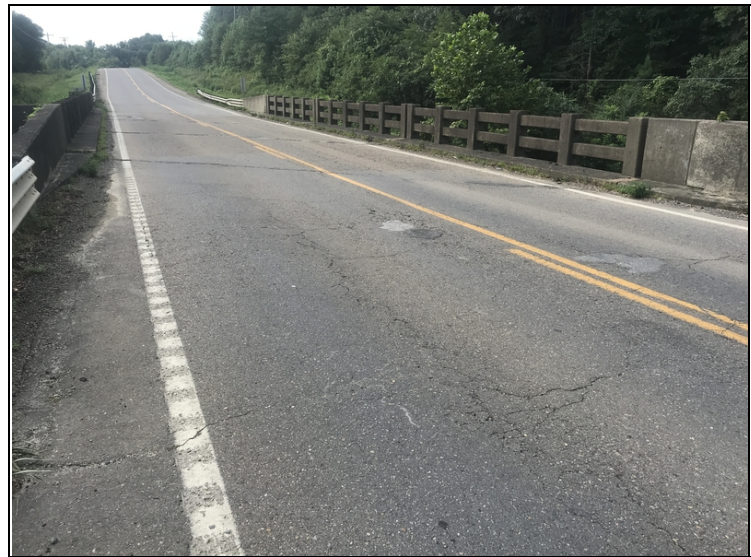
Potholes have been filled with asphalt.

08/16/2021 - EJW - Potholes have been filled with asphalt.

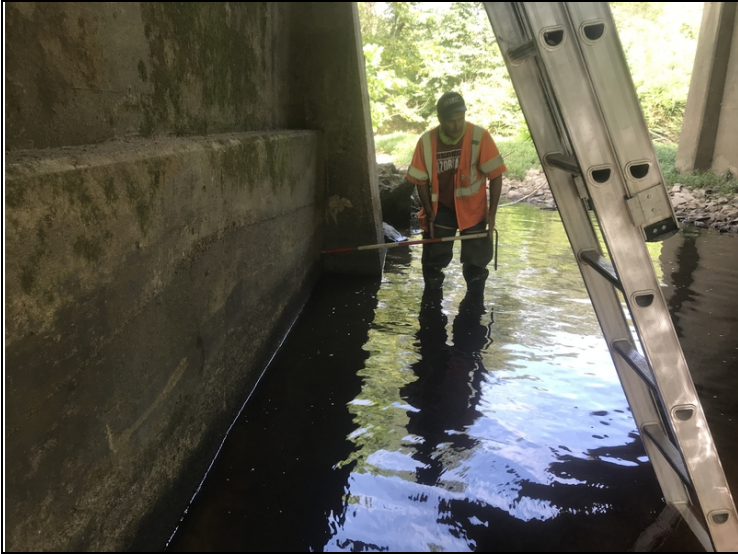
The left side of abutment # 1 has voids between Columns # 1 & 2 under the web wall and under the left wing wall.

Abutment #1 Lt undermining scale.

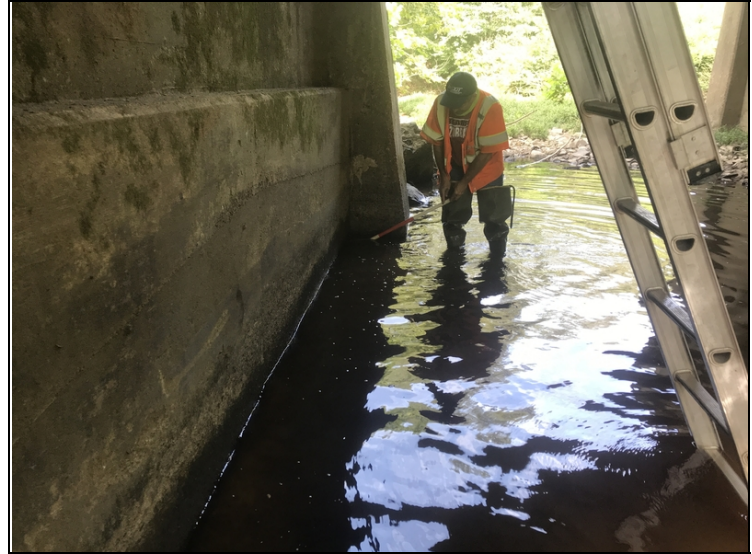
Abutment #1 Lt undermining.

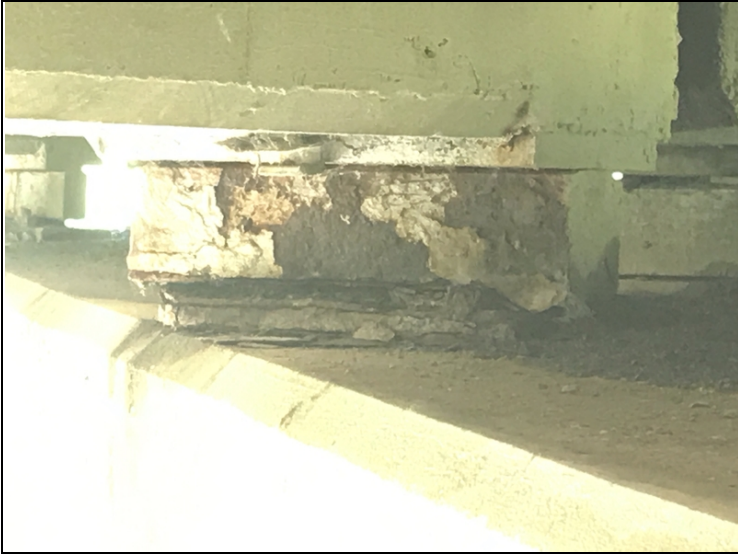
The bearings over all bents have a failing paint system with corrosion and layers of flaking rust between sole and masonry plates in several locations.

Bent # 3, bearing # 2-Corrosion with thick flaking rust.

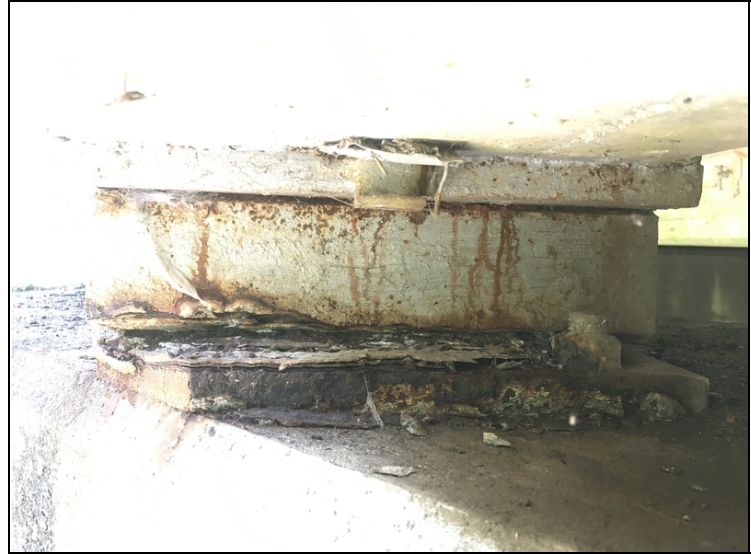
Span # 2, bearing # 1 over bent # 3-Corrosion with section loss to masonry plate.

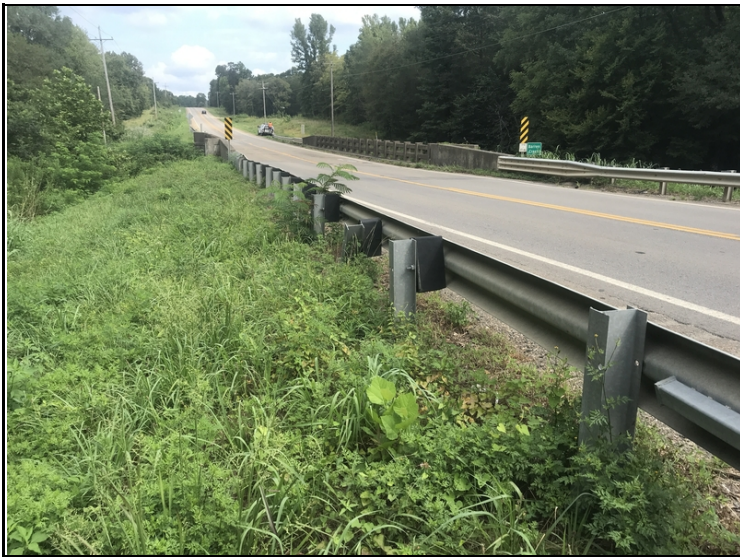
Approach Guardrail-
The Southwest approach guardrail has minor collision damage.

Southwest approach guardrail with minor collision damage that has damaged several rail posts.

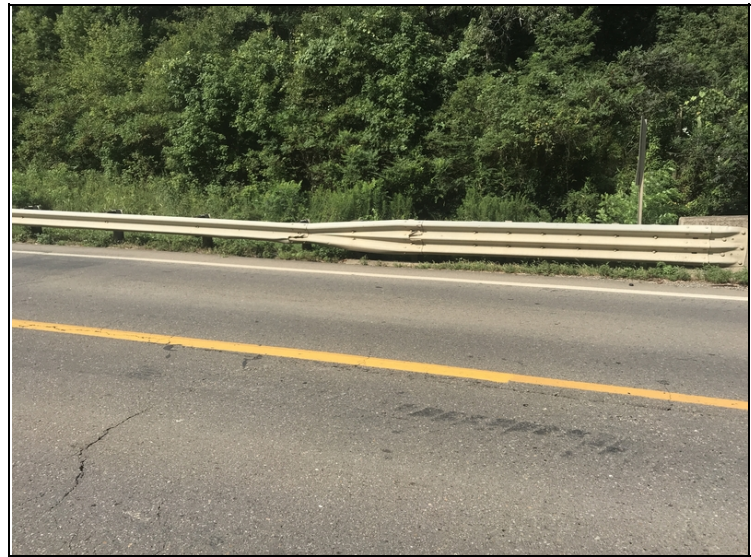
Southwest approach guardrail with minor collision damage.

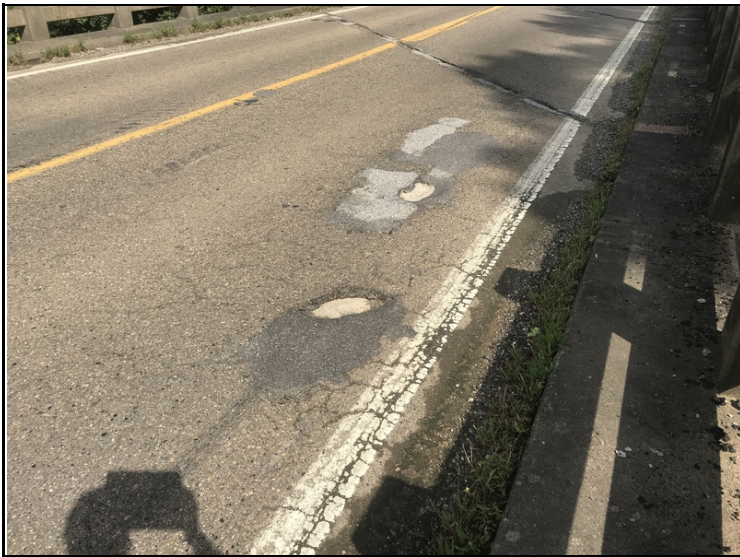
R.C. Deck-
The deck has a few potholes in the asphalt driving surface.

Span #1 asphalt deterioration with potholes in the northbound lane.
