Asset #02146(Routine)

US 71 - Polk Co. over Buffalo Creek

Location: 0.50 MI S OF Cove Ark.

Team Lead: Eric West, Inspection Date: 08/16/2021

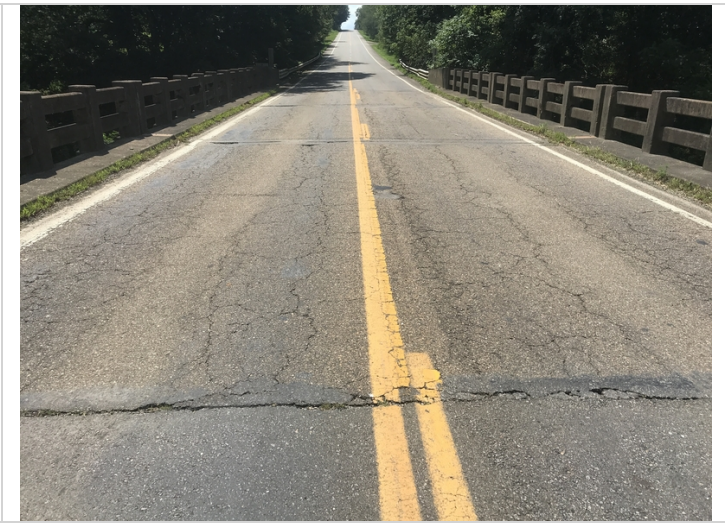
Typical driving surface of the deck.

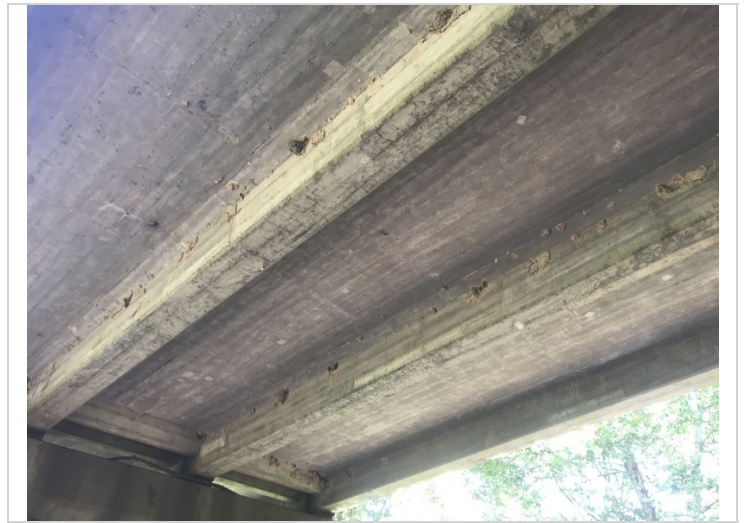
Typical undersurface of the deck.

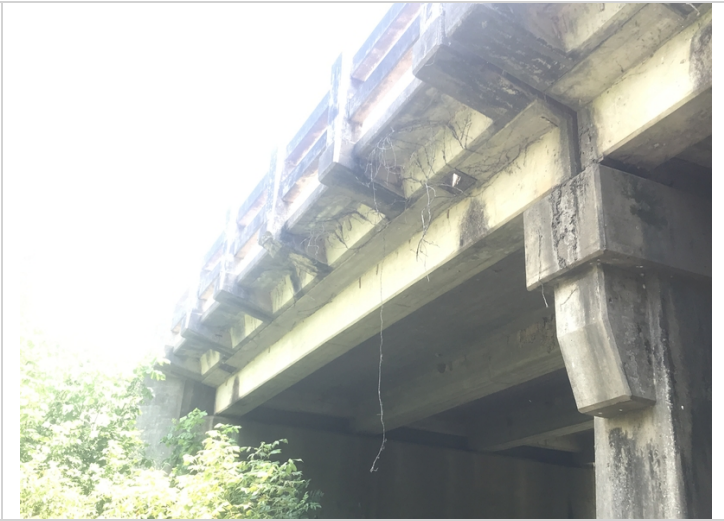
Span #3 Lt spalling with exposed reinforcing steel on the undersurface of the deck and on the rail post undersurface.

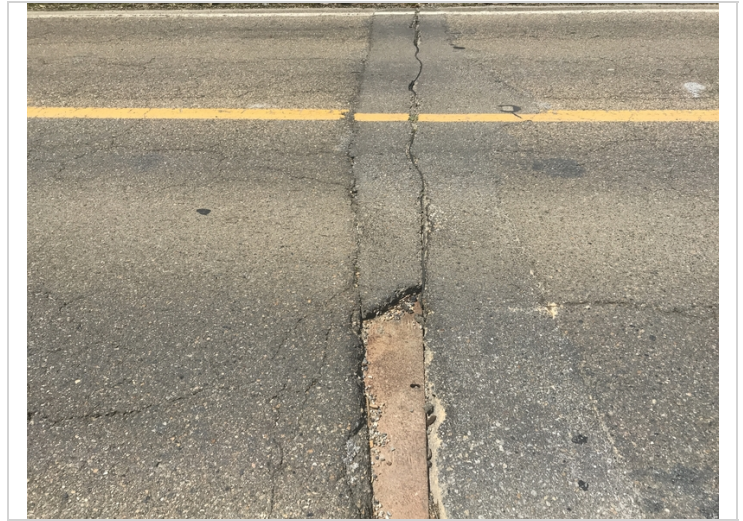
Bent #2 wearing surface over the expansion joint.

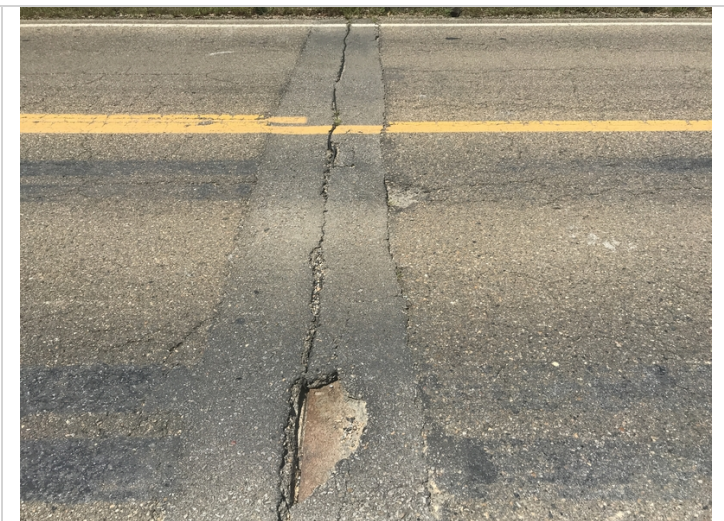
Bent #3 wearing surface over the expansion joint.

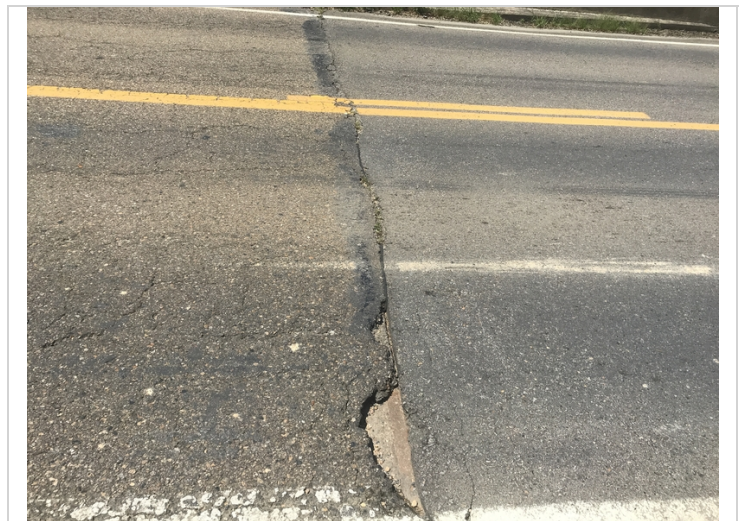
Abutment #2 wearing surface over the expansion joint.

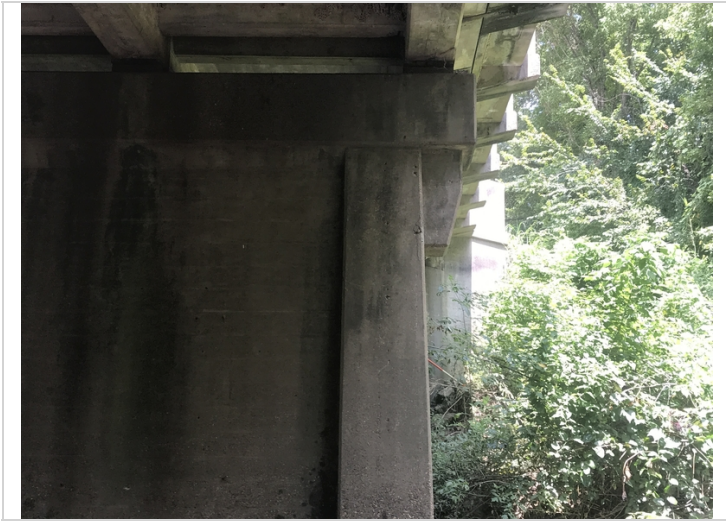
Bent #3 Column # vertical cracks in the edge of the column.

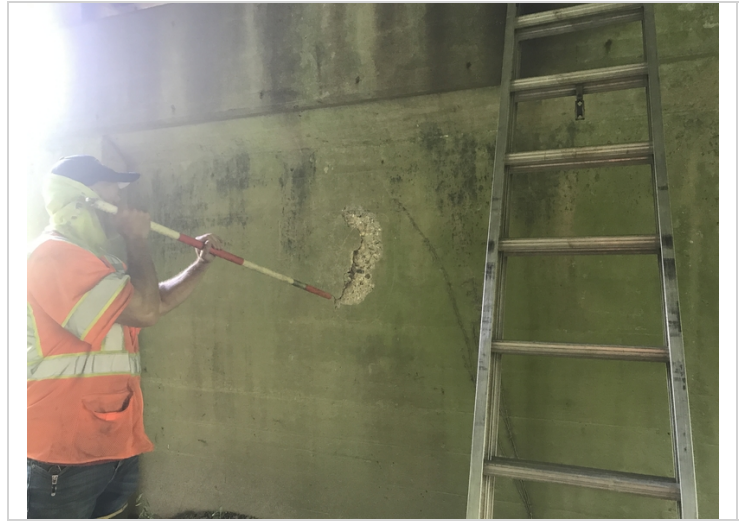
(210) -Bent #2 pier wall back face has a 16" delaminated/spall under girder #2 and a diagonal crack Rt of centerline. -Bent #3 has a vertical crack at the centerline. -The previously documented 10" spall at the base of the web wall in bent # 3 was not visible during this inspection.							
215	Reinforced Concrete Abutment	LF	112	109	1	2	0
1080	Delamination/Spall/Patched Area	LF	1	0	1	0	0
1090	Exposed Rebar	LF	2	0	0	2	0

Backface of bent #2 pier wall has a 16" delaminated/spall under girder #2.

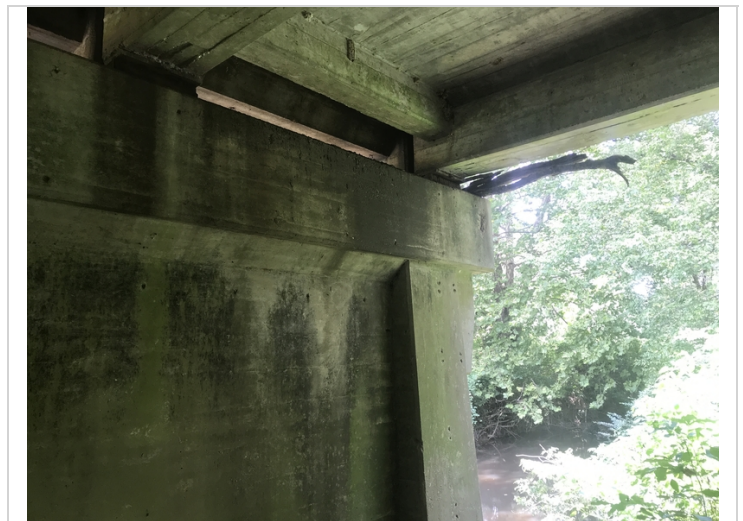
(234) -The backface of bent #2 cap has a shallow 8" spall with exposed reinforcing steel on the right side. The exposed reinforcing steel has initial section loss.							
305	Assembly Joint without Seal	LF	120	0	0	120	0
2350	Debris Impaction	LF	120	0	0	120	0

The backface of bent #2 cap has a shallow 8" spall with exposed reinforcing steel on the right side.

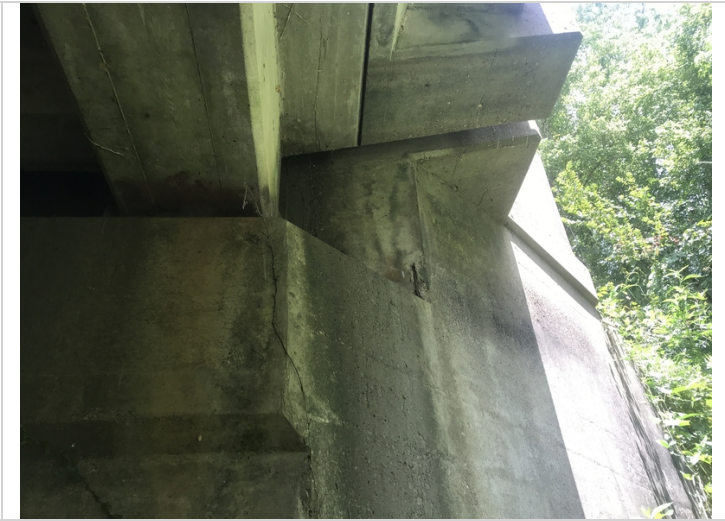
Abutment #2 Rt shallow spalling with exposed reinforcing steel at the wing wall juncture.

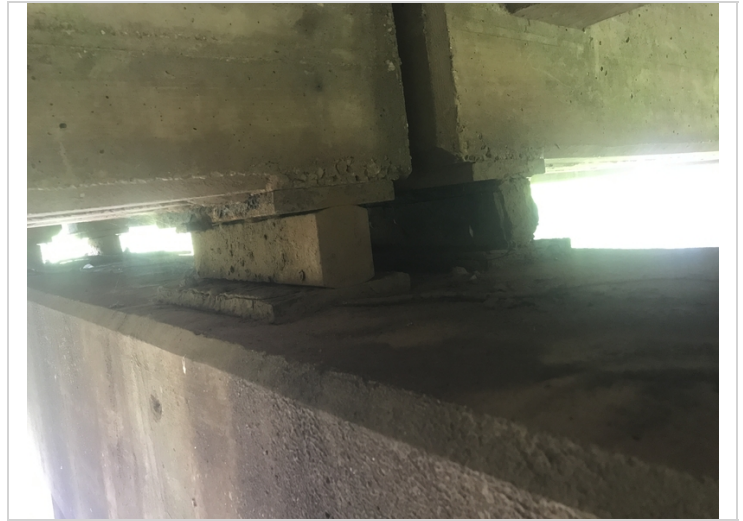
(313) -The bearings have a failing paint system with active corrosion and thick flaking rust. The bearings have pack rust between the sole and masonry plates.							
331	Reinforced Concrete Bridge Railing	LF	184	165	11	8	0
1080	Delamination/Spall/Patched Area	LF	10	0	8	2	0
1090	Exposed Rebar	LF	7	0	1	6	0
1130	Cracking (RC and Other)	LF	2	0	2	0	0

Bent # 3 bearings with active corrosion and layers of flaking rust.

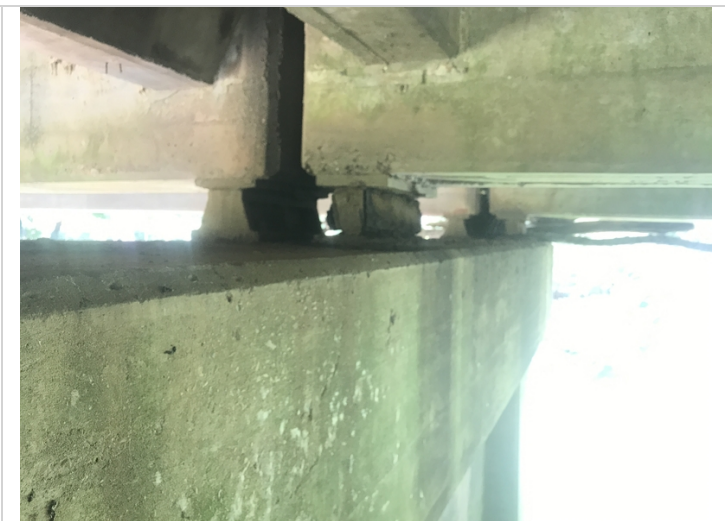
Bent #2 bearings with active corrosion and layers of flaking rust.

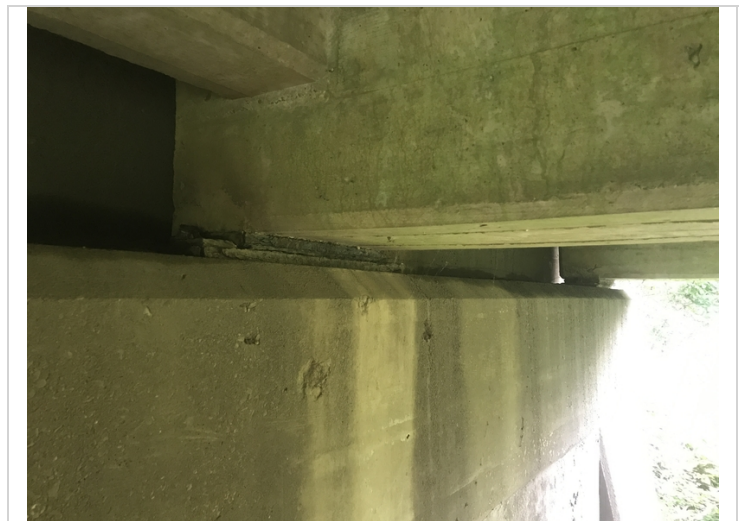
Abutment #1 bearings with active corrosion and layers of flaking rust.

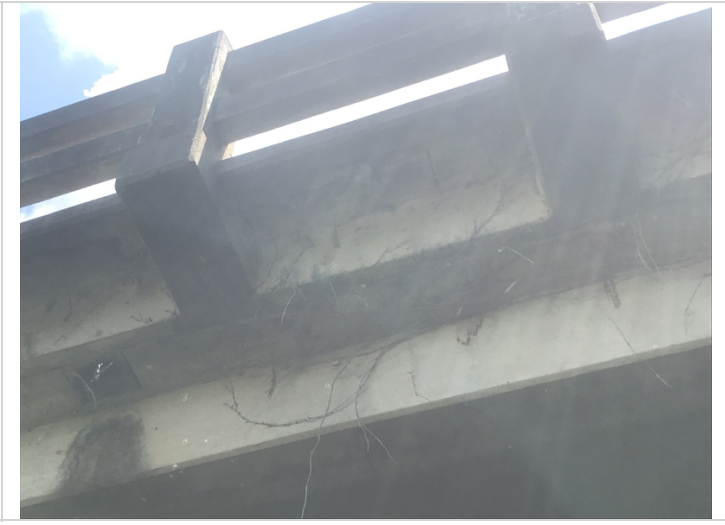
(331) -There are several shallow baseball sized spalls with no exposed reinforcing steel in the concrete bridge railing. -The undersurface of the curb portion of the railing on the right side has shallow 6" spalls with exposed reinforcing steel visible from the undersurface. The exposed reinforcing steel appears to have initial section loss at this inspection.

Span #2 Lt spalling under the concrete curb.

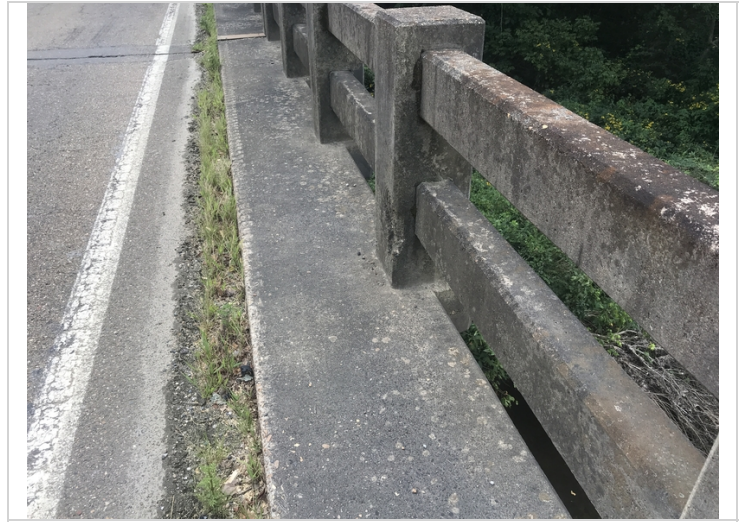
Left bridge rail with spalling.

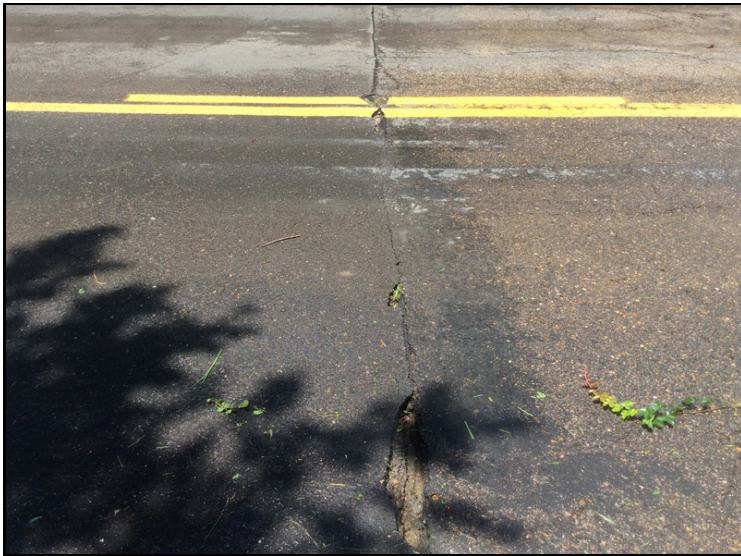
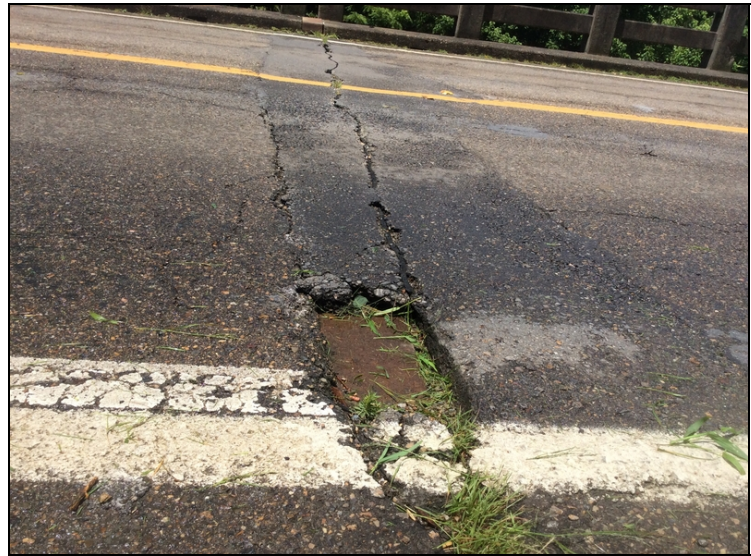
The asphalt driving surface is breaking up in a few locations over the expansion joints allowing potholes to form in the driving surface.

Pothole forming over abutment #1 expansion joint.

Bent #2 expansion joint-Pothole in asphalt driving surface.

Date Reported: 07/15/2019
Priority: C - Important
Type of Work: Repair (General)
Status: Monitor
Component: Element

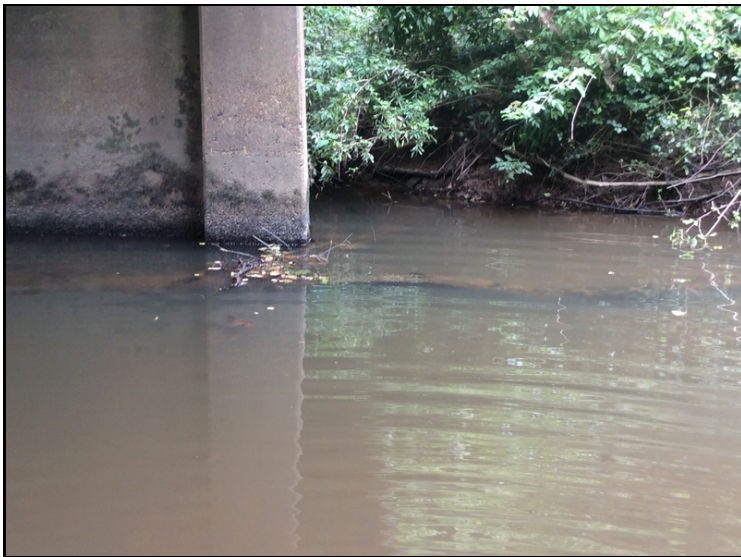
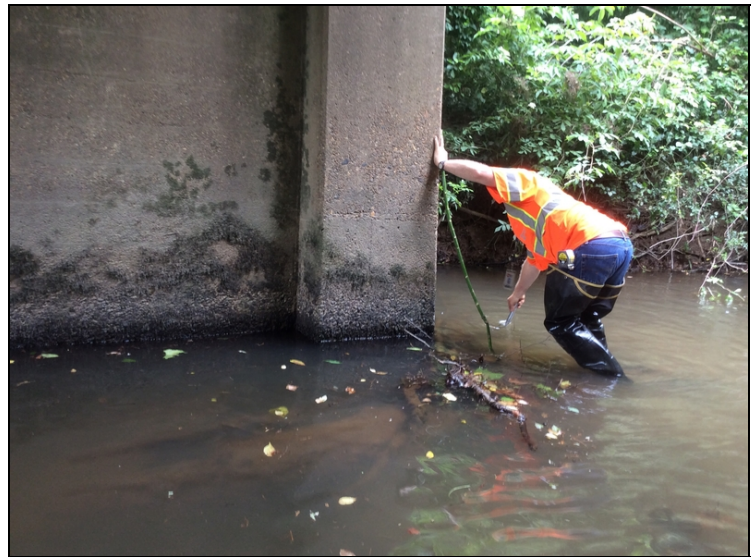
The channel has submerged drift accumulation at bent #3 causing localized scour that has partially exposed the top of the footing at column #2.

Bent #3, column #2-Drift.

Scour hole at column #2 of bent #3.

Date Reported: 07/15/2019
Priority: C - Important
Type of Work: (Inactive) (Inactive) 1 - Clean
Status: Monitor
Component: Channel

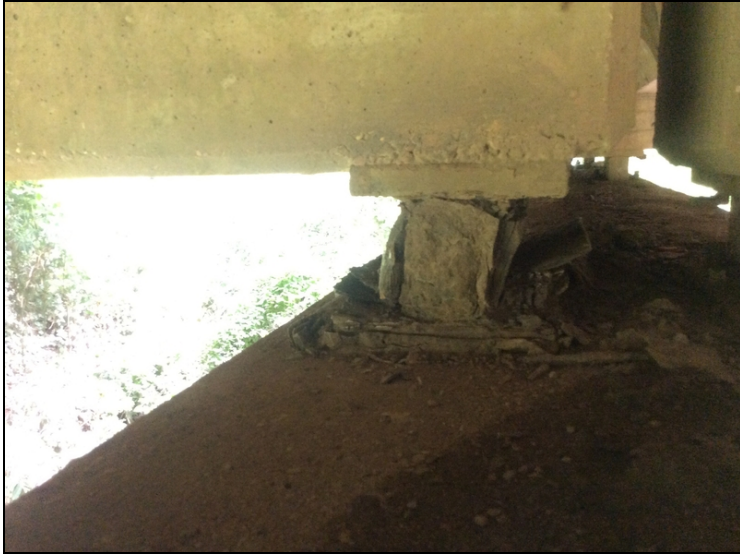
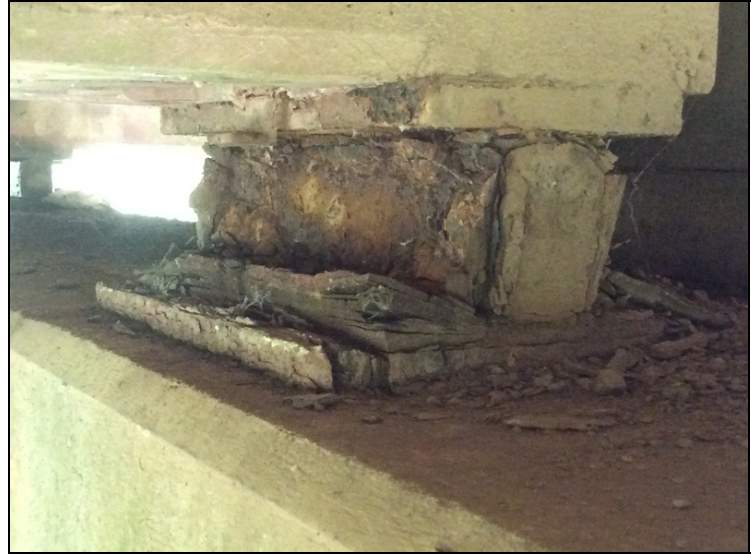
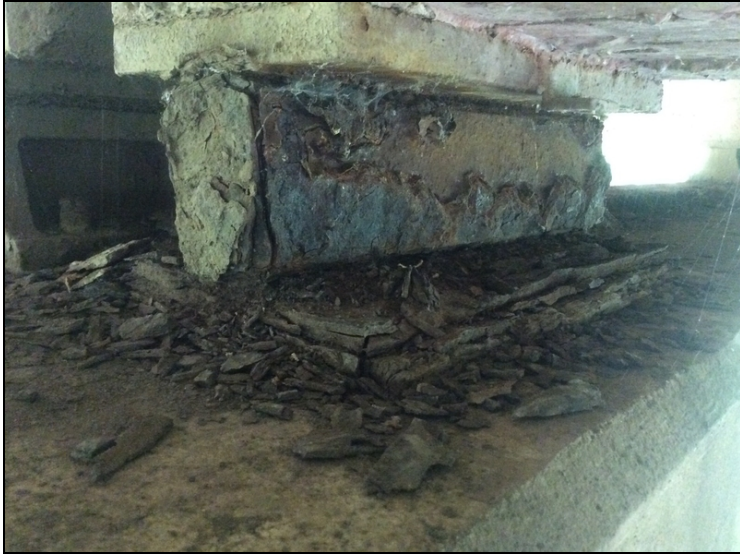
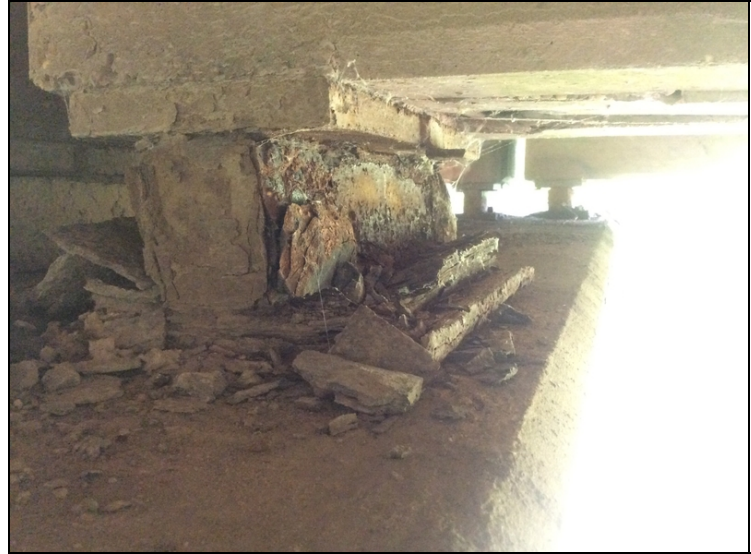
The bearings have a failed paint system with severe corrosion / section loss. Heavy pack rust between the sole plates and rockers appear to be restricting movement in several locations.

Span #3, bearing #2-Severe corrosion / section loss.

Span #3, bearing #3, over bent #3- Severe corrosion / section loss.

Span #1, bearing #2 over bent #2- Severe corrosion / section loss.

Span #3, bearing #2, over bent #3- Severe corrosion / section loss. Photo #2.

Date Reported: 07/24/2013
Priority: C - Important
Type of Work: Repair (General)
Status: Monitor
Component: Superstructure

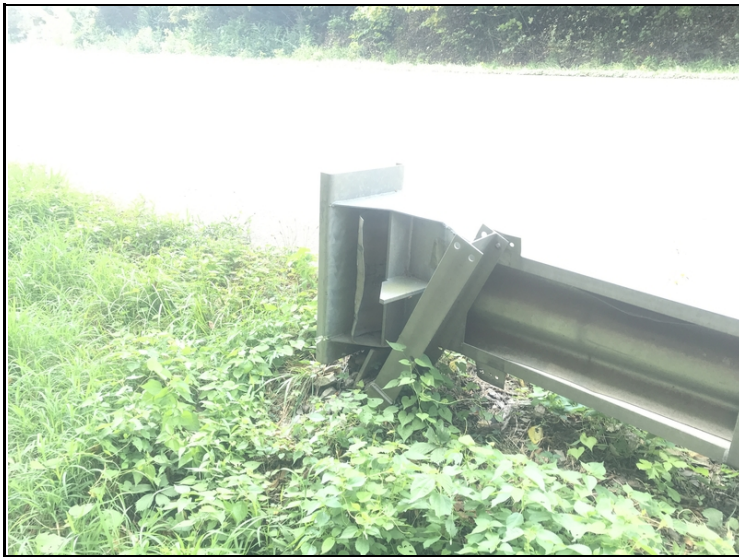
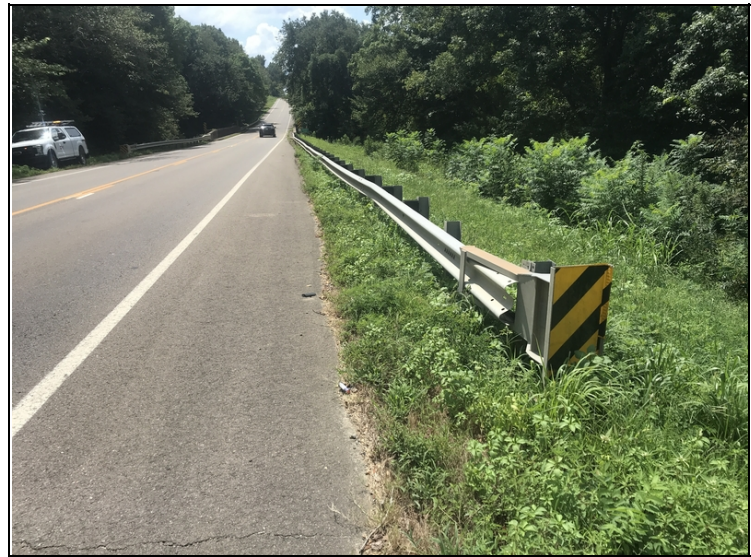
Approach Guardrail-
The Northwest and the Southeast approach guardrail has damage to the end terminals.

Southeast approach guardrail end terminal with a broke post.

Northwest approach guardrail with damage to the end terminal and the guardrail.

Date Reported: 08/17/2021
Priority: C - Important
Type of Work: Repair (General)
Status: Open
Component: Approach
