Asset #02147(Other Special Recurring)

US 71 - Polk Co over Six Mile Creek

Location: 1.5 MI S OF Hatfield

Team Lead: Jeff Jones, Inspection Date: 08/24/2022

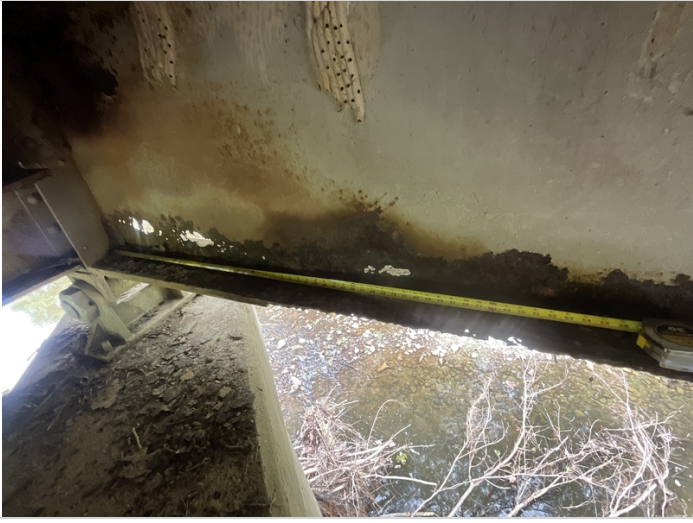
Span 4. Bent 5. Beam 5. Holes rusted through the base of web and bottom flange.

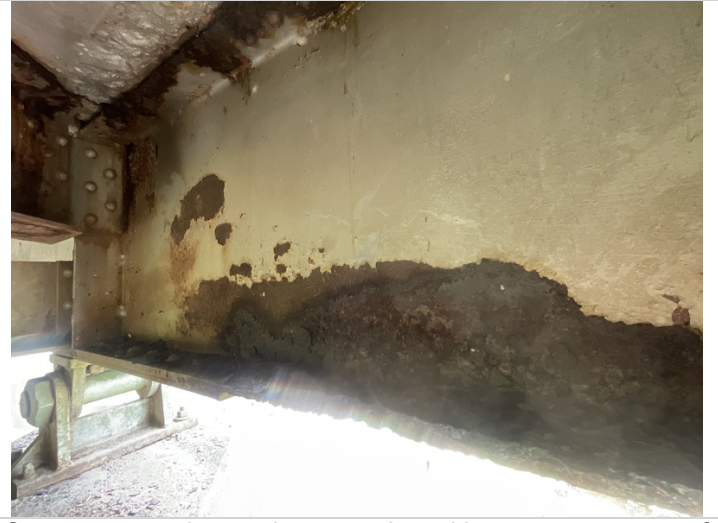
Photo of Bent 5, Span 5. Beam 1. Interior side of the beam.

Superstructure has active corrosion with numerous areas of section loss to the webs and flanges of the beams and diaphragms. Section loss ranges from initial up to numerous holes and perforations in the web and bottom flanges.

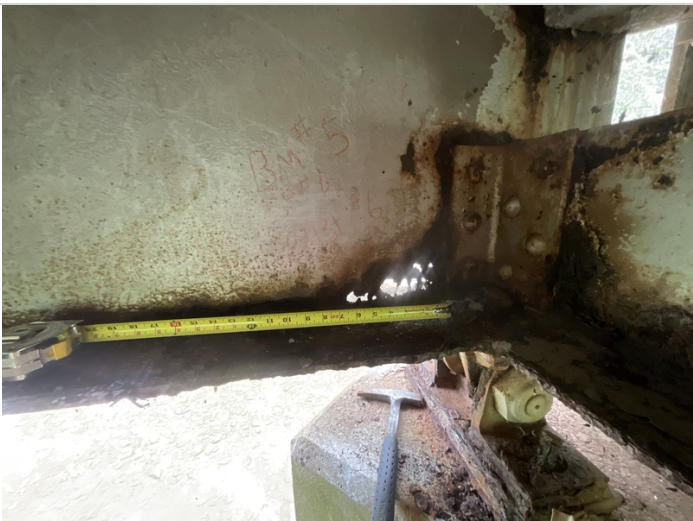
Span 6, Bent 6. Beam 5. Active corrosion with holes rusted through the base of web adjacent to the diaphragm.

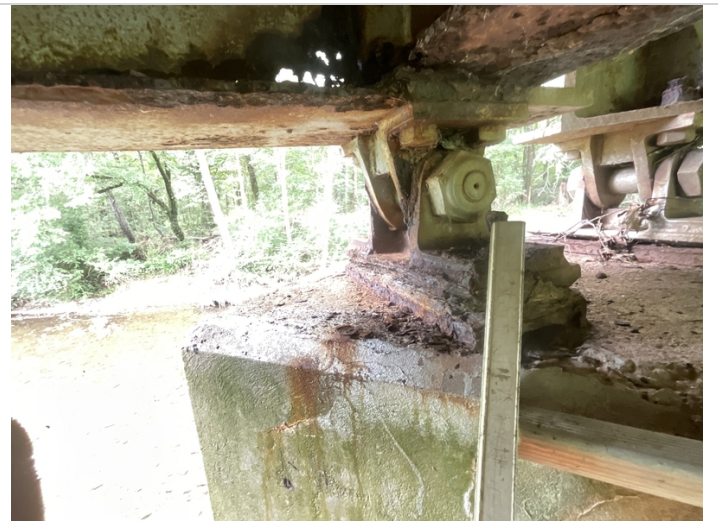
Bearing - Span 6, Bent 6. Beam 5. Active corrosion with pack rust.

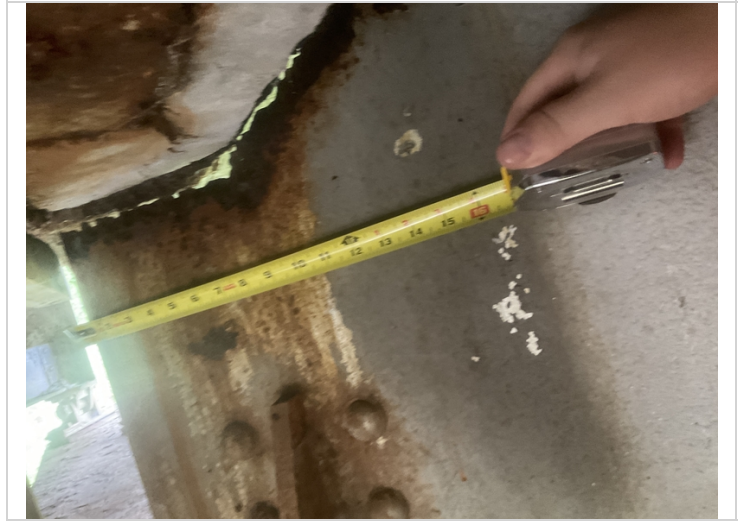
Span 6, Bent 6, Beam 2 - A 13" long X 1/2" tall area rusted through the web of the beam adjacent to the expansion dam.

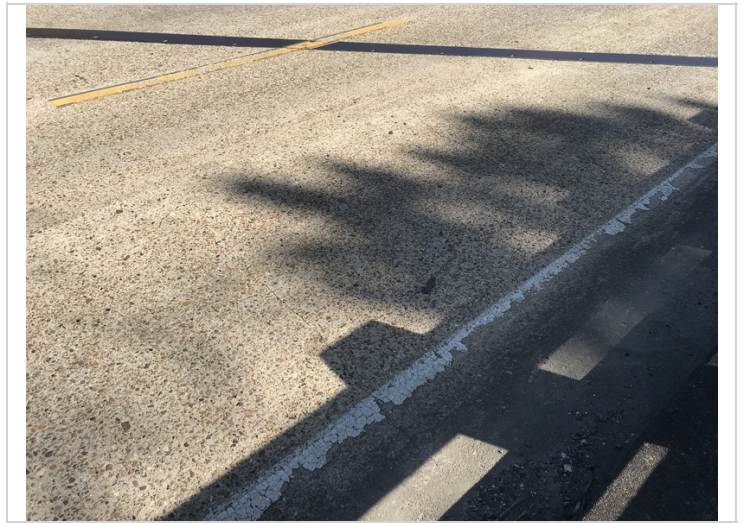
Moderate width sealable deck cracking.

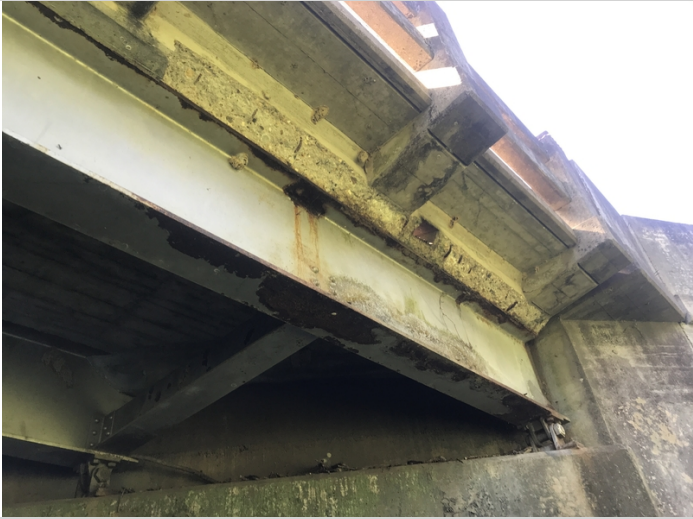
Span # 1 Lt spalling with exposed reinforcing steel on the deck undersurface in the overhang.

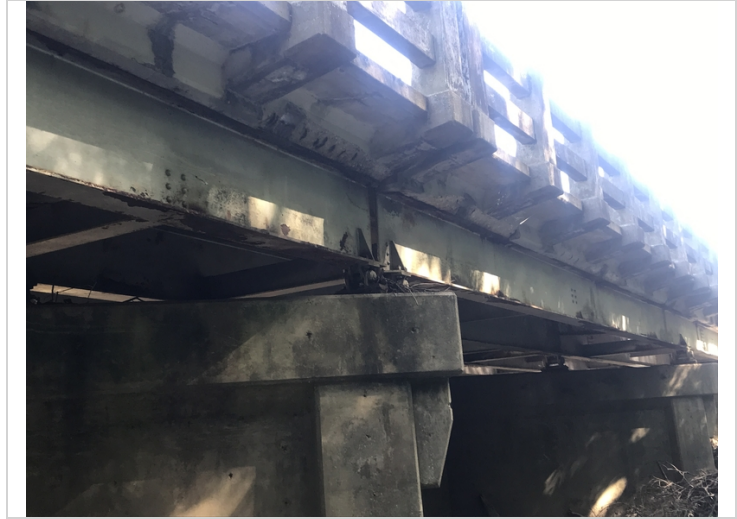
Spans # 2 & 3 Rt spalling with exposed reinforcing steel.

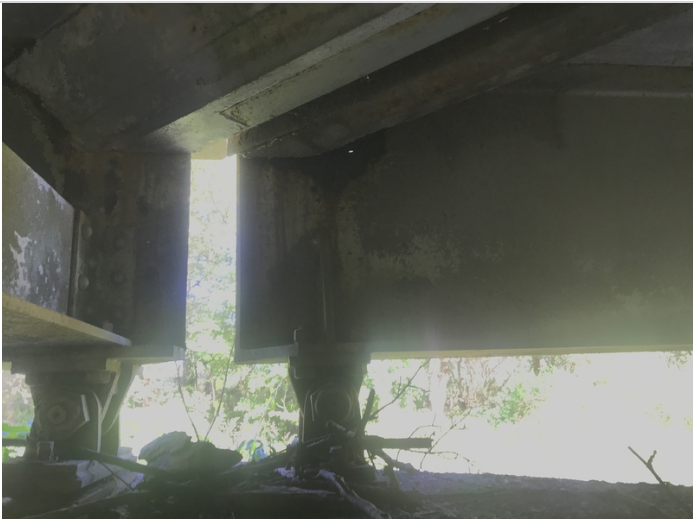
Span # 2, Bent # 2 beam # 1 with a 1/2" hole through the web.

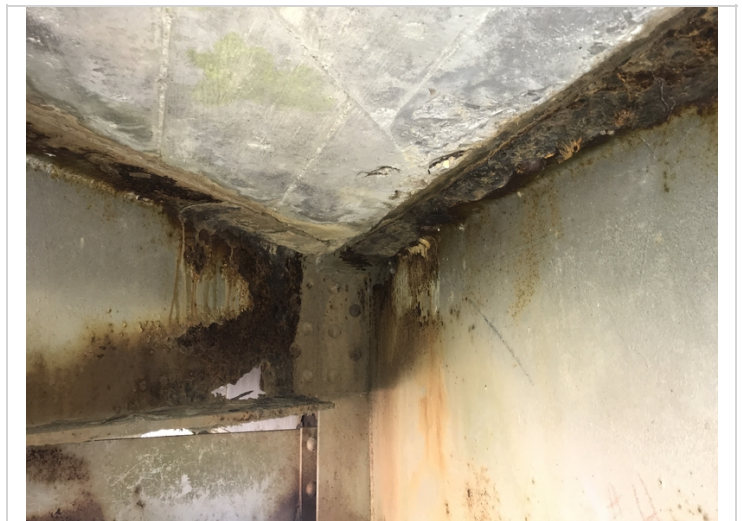
Span #3, Bent # 4 Beam #5 active corrosion with layers of flaking rust, knife edge section loss with a 3/4" reduction in flange width and a hole through the diaphragm.

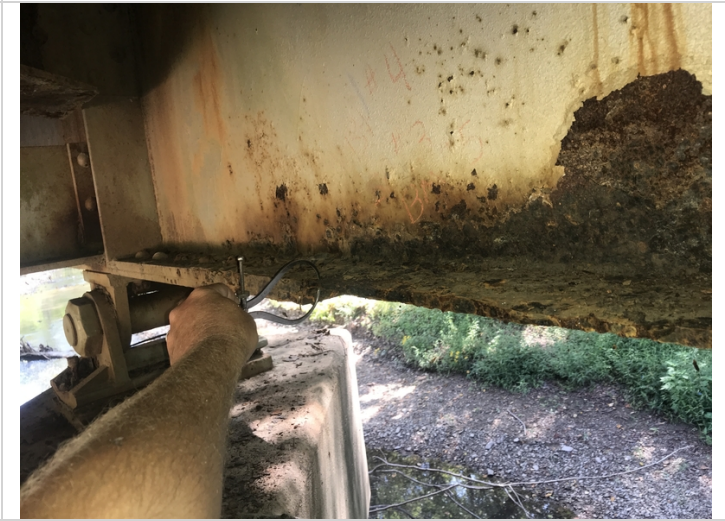
Span #3, Bent # 4 Beam #5 active corrosion with layers of flaking rust and up to 3/8" section loss adjacent to the splice plate.

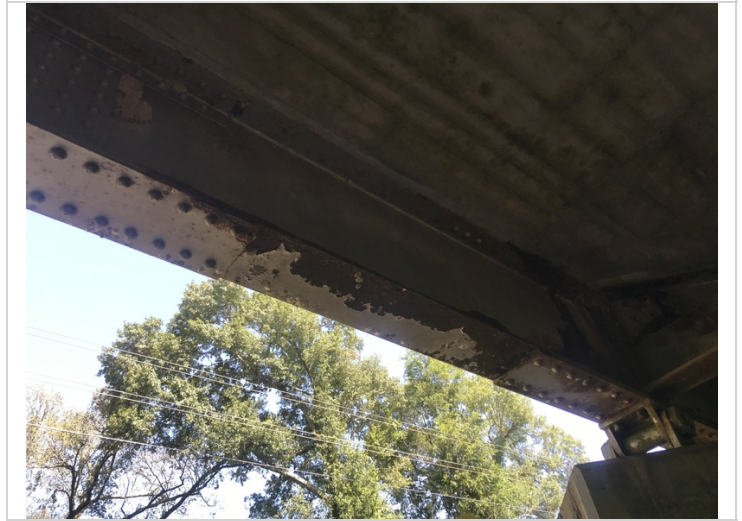
Span # 4, Beam # 1 adjacent to bent # 5 with active corrosion and up to 5/16" section loss.

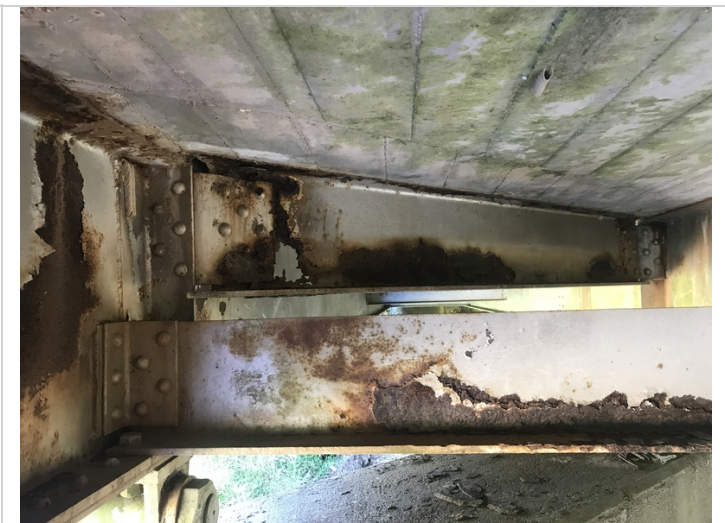
Span # 4, bay # 1 active corrosion and a hole through the web of the diaphragm adjacent to beam # 1.

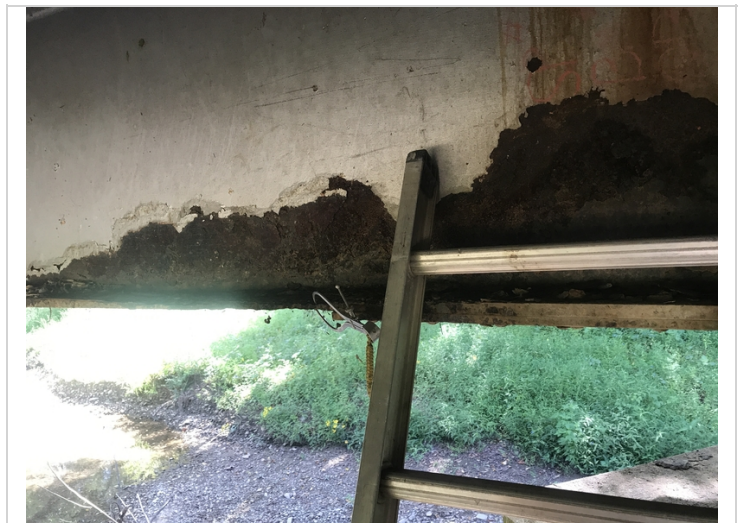
Span # 4, Bent #4 beam #5 with up to 1/2" section loss to the bottom flange.

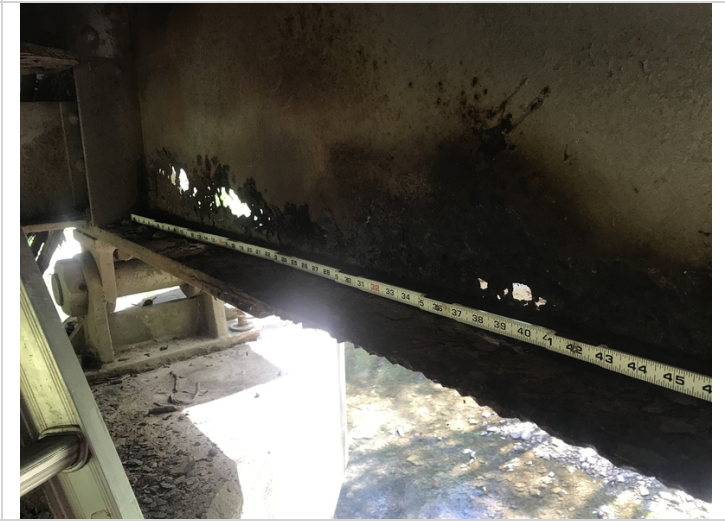
Span # 4, Bent # 5, beam #5 active corrosion with layers of flaking rust and large holes in the base of the web.

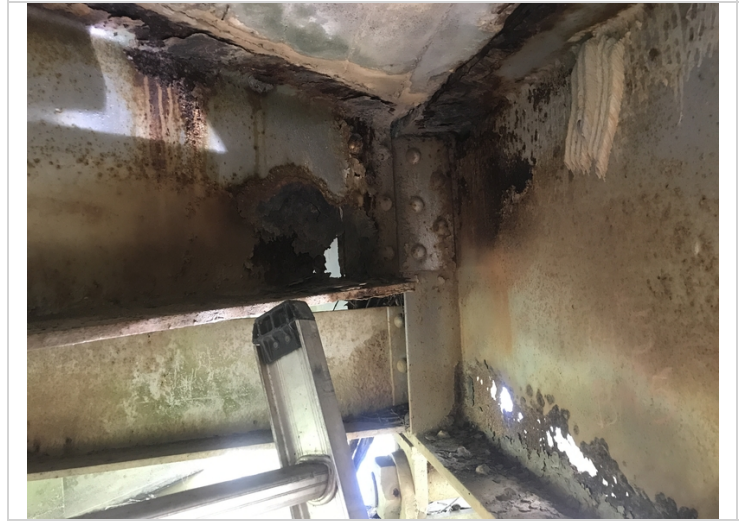
Bent # 5 bay # 4 hole in the diaphragm.

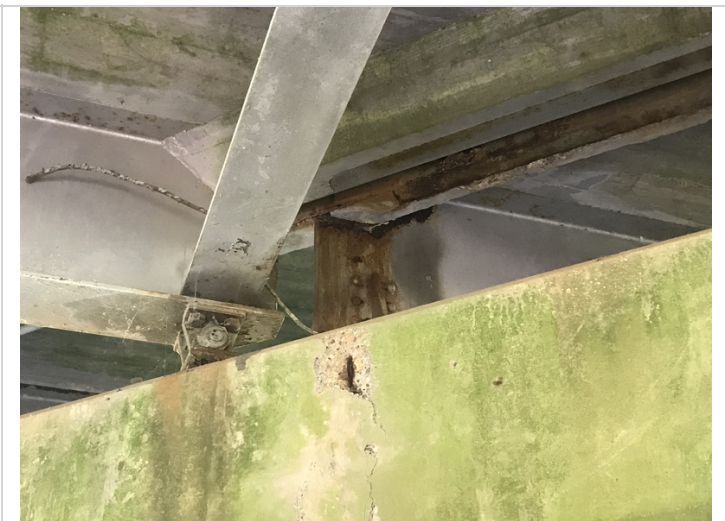
Span #6, Bent #6 beam #2 active corrosion with large hole in the web around the expansion dam.

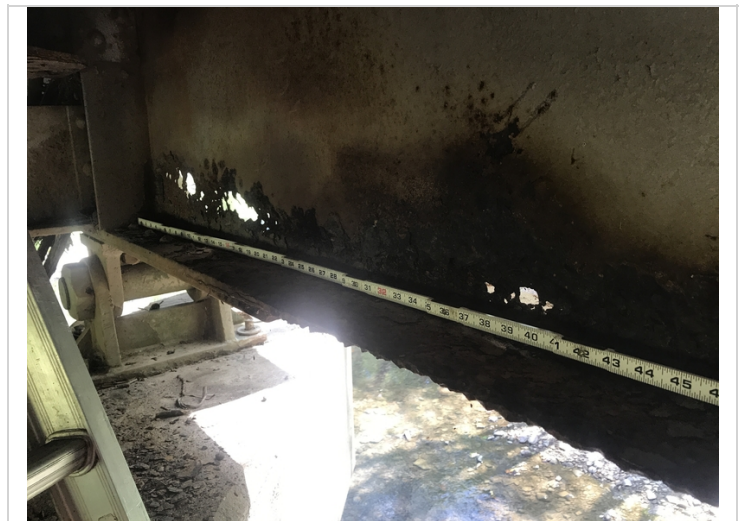
Span # 4, Bent # 5, beam #5 active corrosion with layers of flaking rust and large holes in the base of the web.

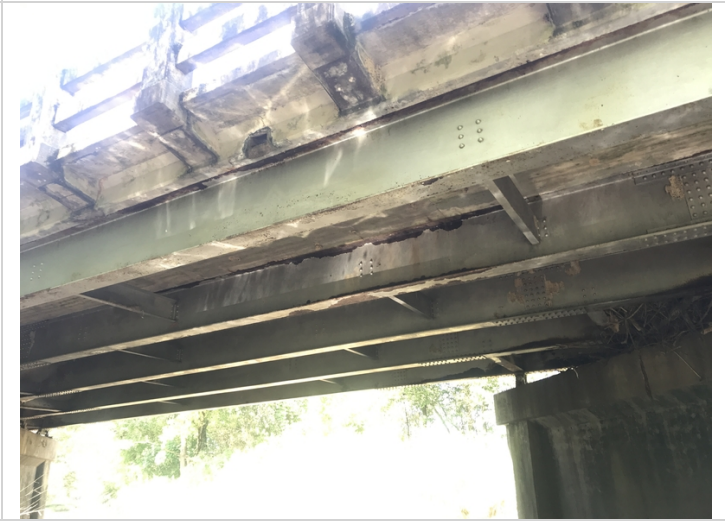
Typical failing paint system.

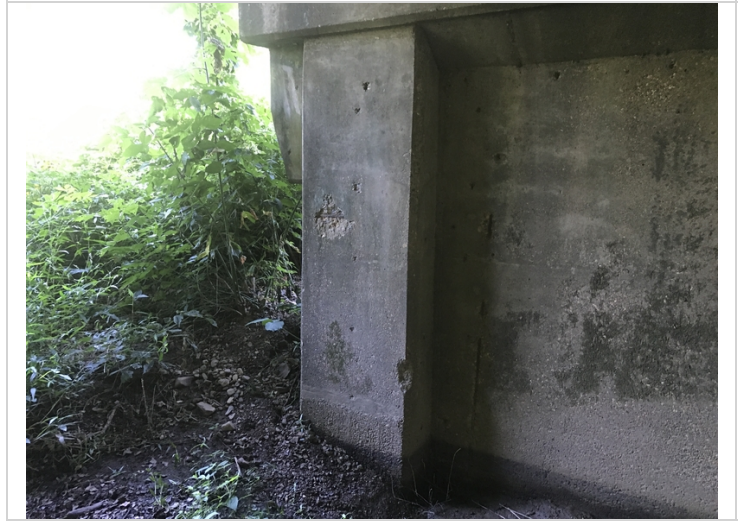
Bent # 2 Column # 1 spalling with exposed reinforcing steel.

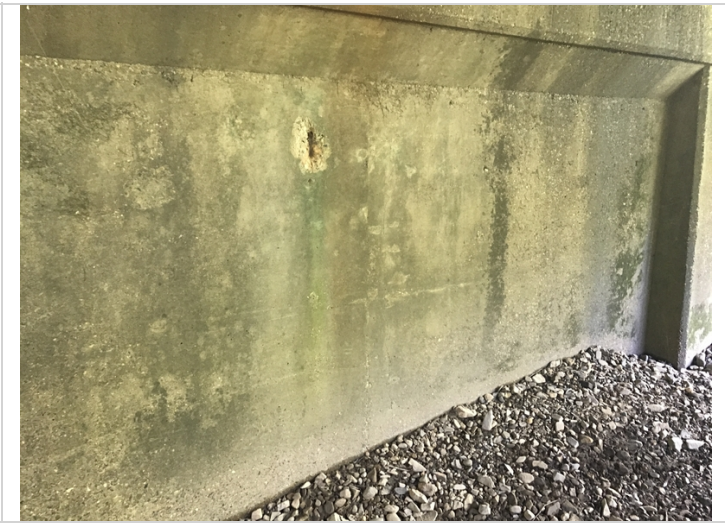
Span # 2 Bent # 2 vertical crack and spalling with exposed reinforcing steel.

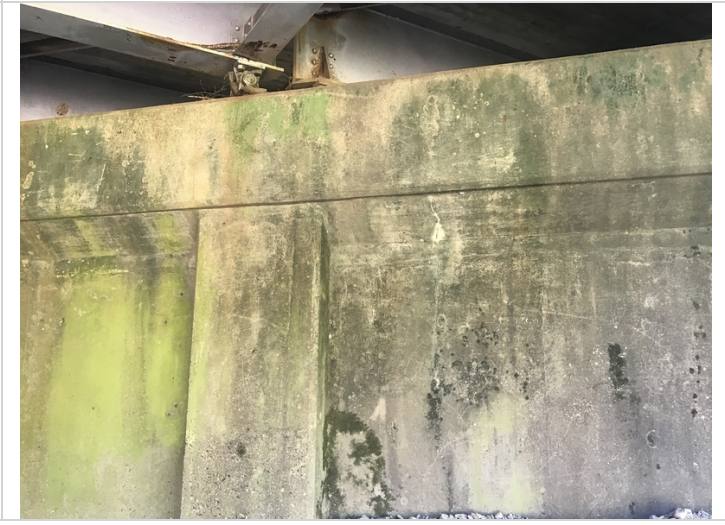
Bent # 3 cap cracking near the centerline.

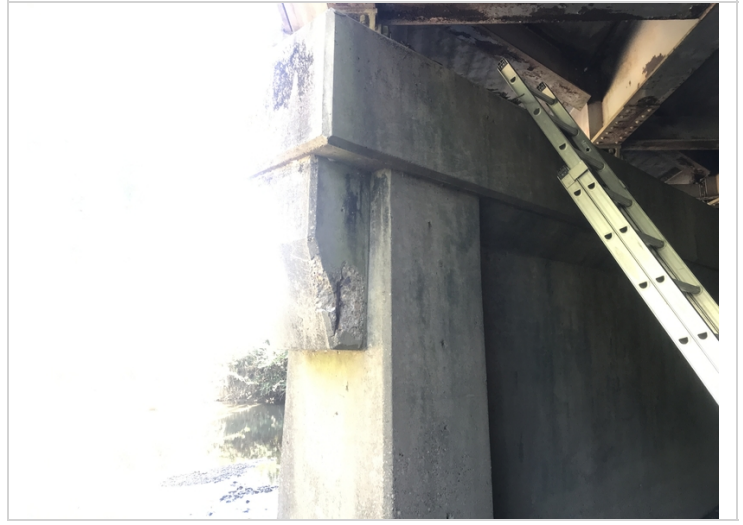
Bent # 4 cap haunch spalling with exposed reinforcing steel.

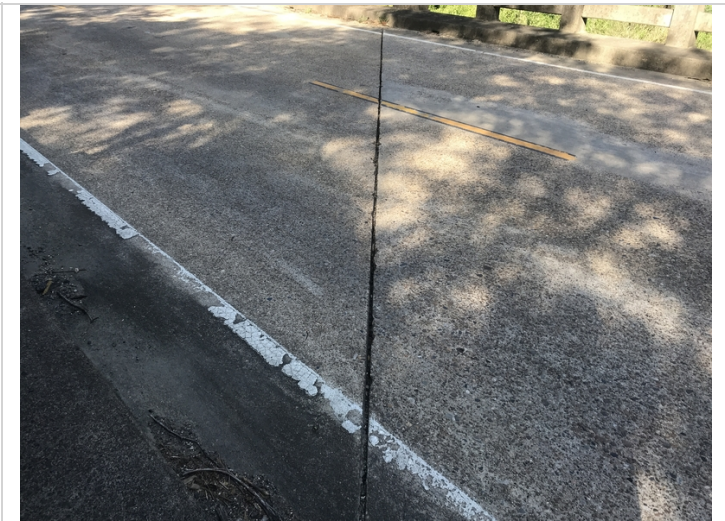
Bent # 5 missing joint sealant.

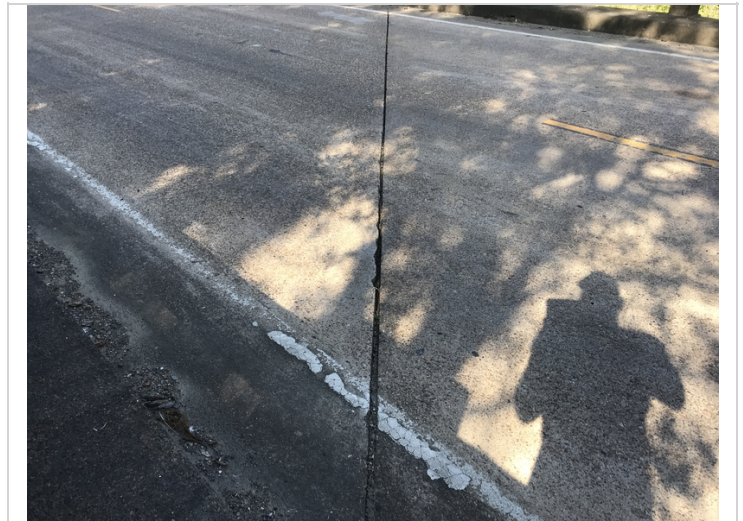
Bent # 4 missing joint sealant.

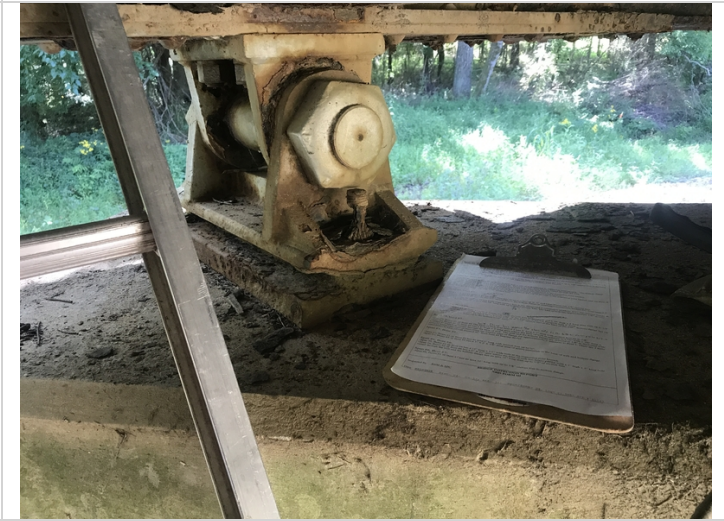
Bearings have active corrosion and layers of flaking rust.

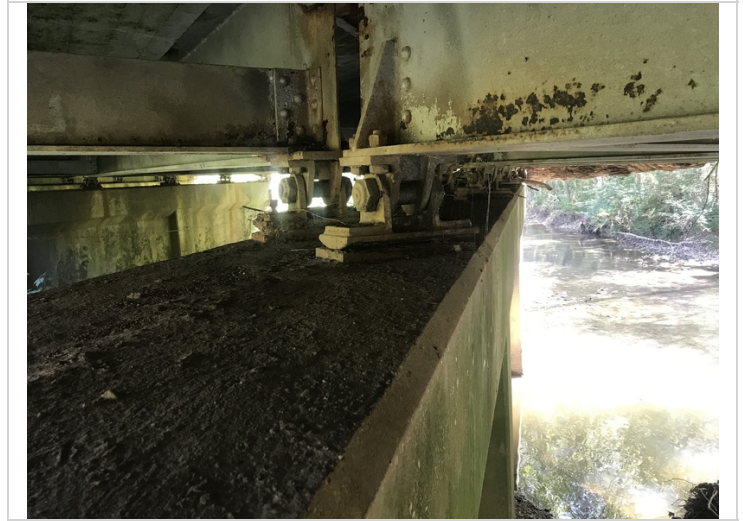
Bent # 6 with missing anchor bolts.

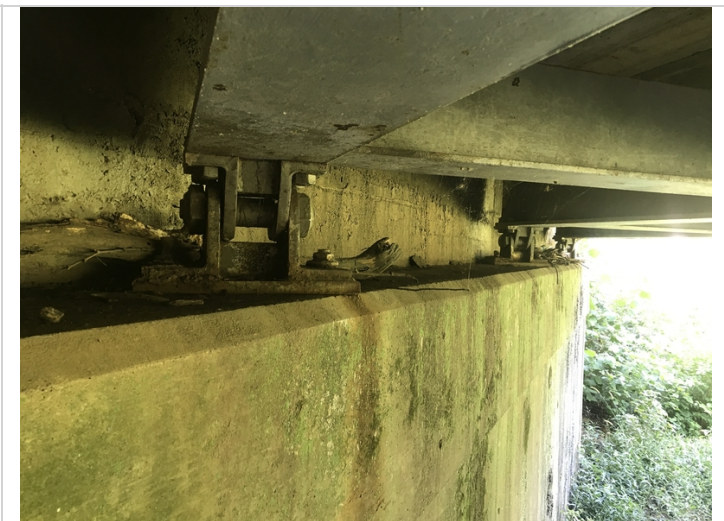
Abutment # 1 bearings with active corrosion and layers of flaking rust.

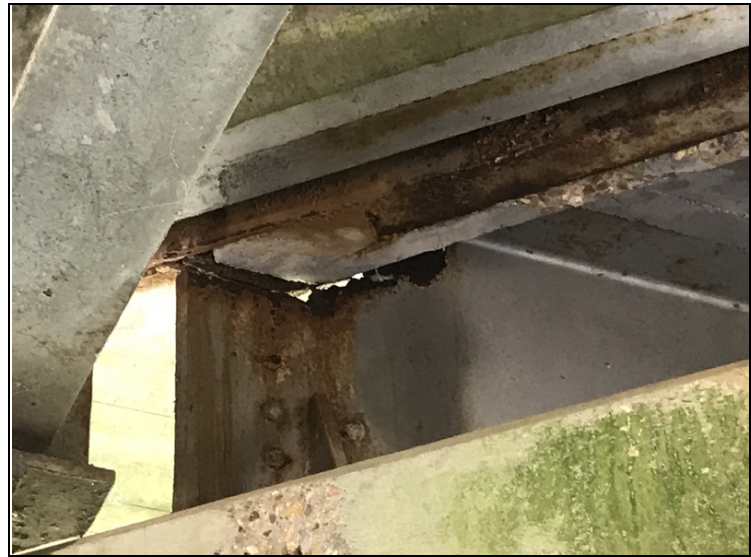
Holes rusted through upper portion of web adjacent to the deck haunch.

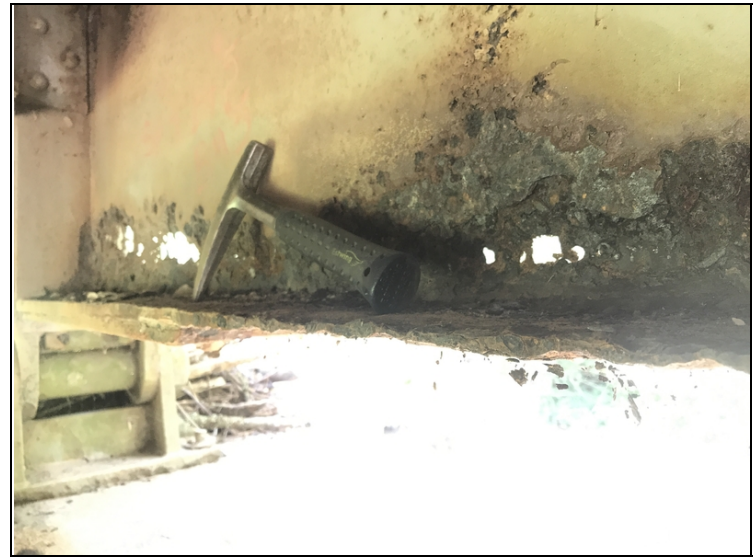
Sp #4, beam #5 at bent #5- Holes rusted through web and section loss to bottom flange.

- Span #4, Beam #5 @ Bent #5 has a 6" high x 5' long area where the base of web is paper thin with a 25" long x average 3" high hole rusted through the base of web. The web and the bottom flange is reduced to 1/8" in thickness with areas of knife edge section loss along the interior edge of flange for approximately 2' adjacent to Bent 5. There are 2 dime sized holes in base of web located 42" from bent #5 bearing device. The interior edge of the bottom flange has a 1' paper thin area with perforations located approximately 50" from the bearing.

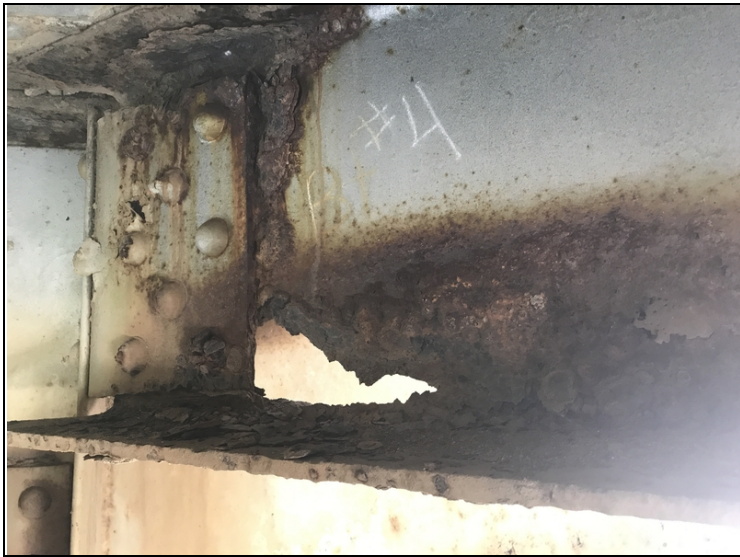
Section loss to beam web.

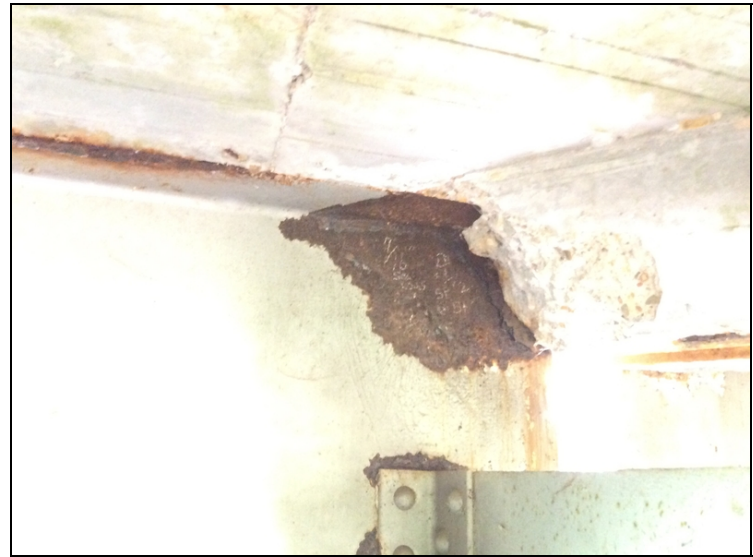
Beam 1, Span 2, Bent 3.

- Span #2, Beam #1 @ Bent #3 up to 1/2" section loss to top of web adjacent to expansion joint haunch. The bottom flange has a 12" long area with up to 7/16" section loss. There is a 2"x1" area of holes rusted through the web.

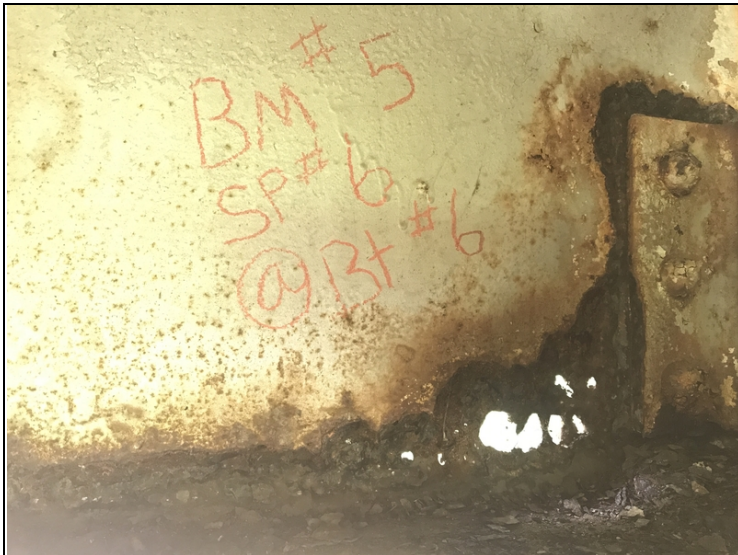
Sp #6, Beam #5 at bent #6-Hole rusted through web.

- Span #6, Beam #5 @ Bent #6 has a 6" X 21" area where the base of web has heavy pitting with a 2" high x 6" long hole rusted through the web and the bottom flange has a 16" area with up to 1/2" of section loss. The interior edge of the bottom flange is reduced to 1/4" thickness.

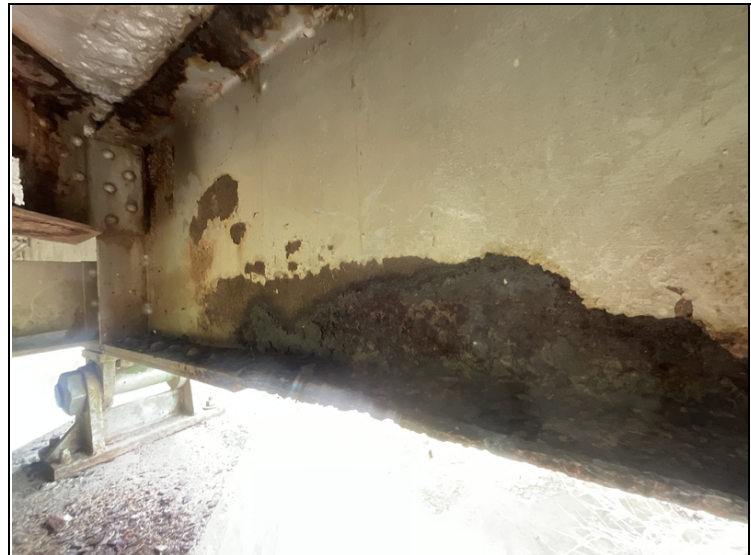
Photo of Bent 5, Span 5. Beam 1. Interior side of the beam.

Superstructure has active corrosion with numerous areas of section loss to the webs and flanges of the beams and diaphragms. Section loss ranges from initial up to numerous holes and perforations in the web and bottom flanges.

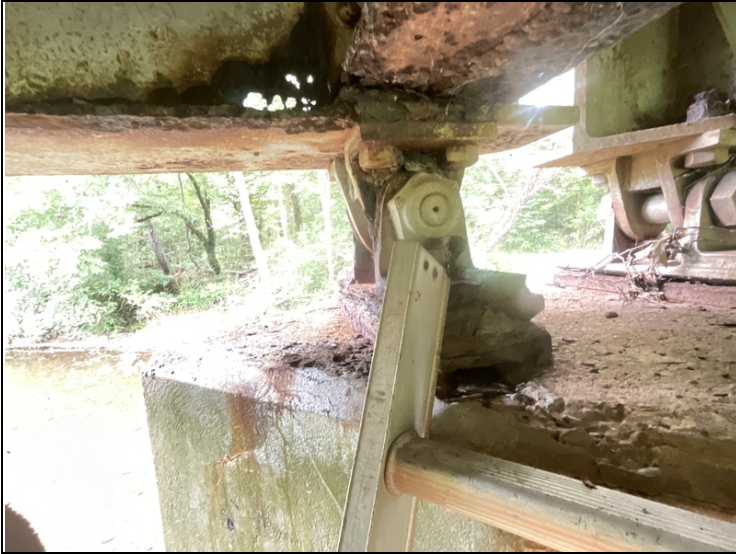
Bearing - Span 6, Bent 6. Beam 5. Active corrosion with pack rust.

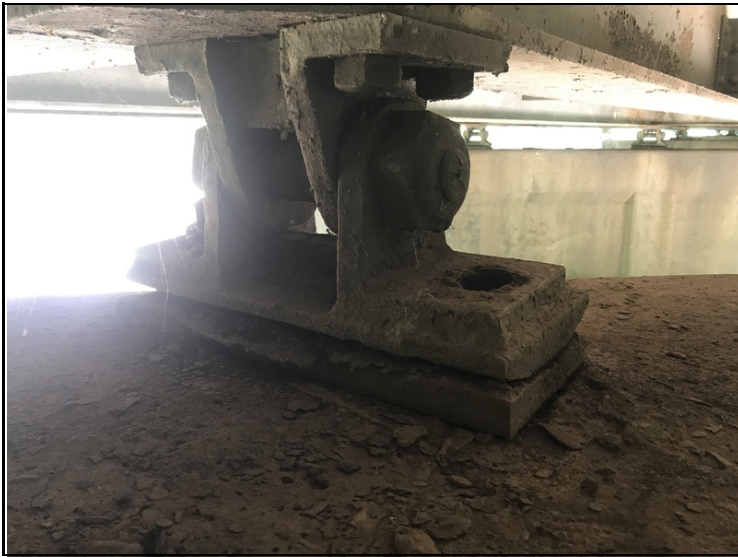
Missing anchor bolt.

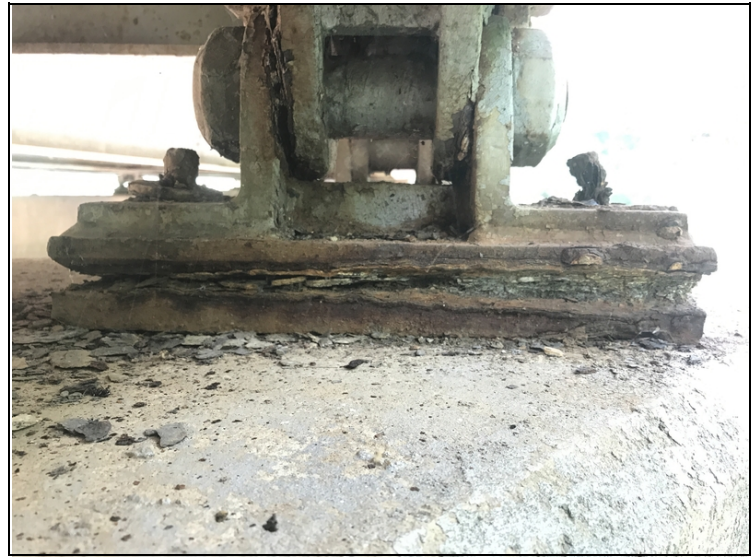
Pack rust in bearing device restricting movement.

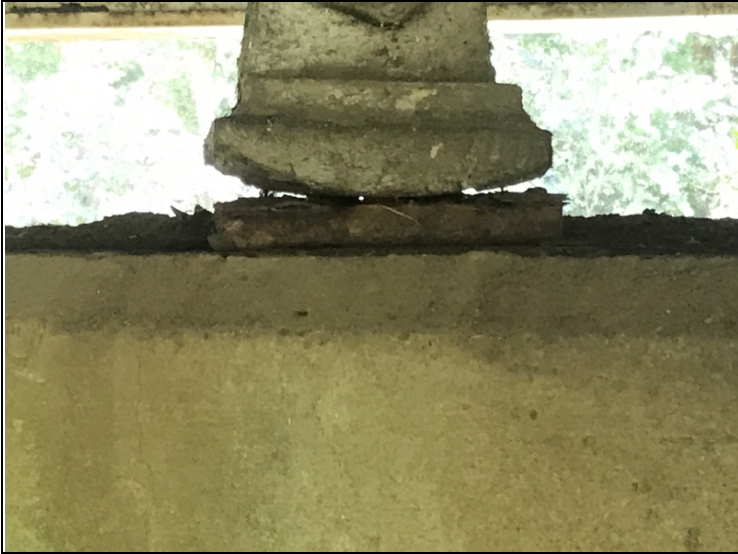
Air space in bearing.

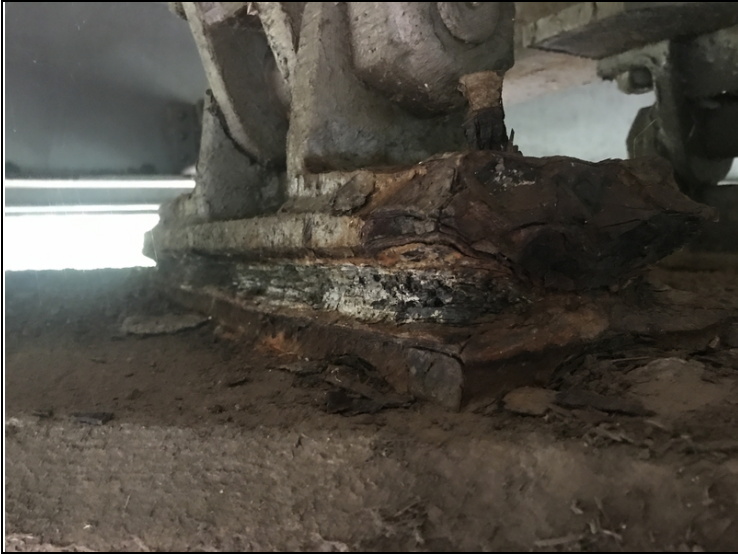
Pack rust in bearing device restricting movement.

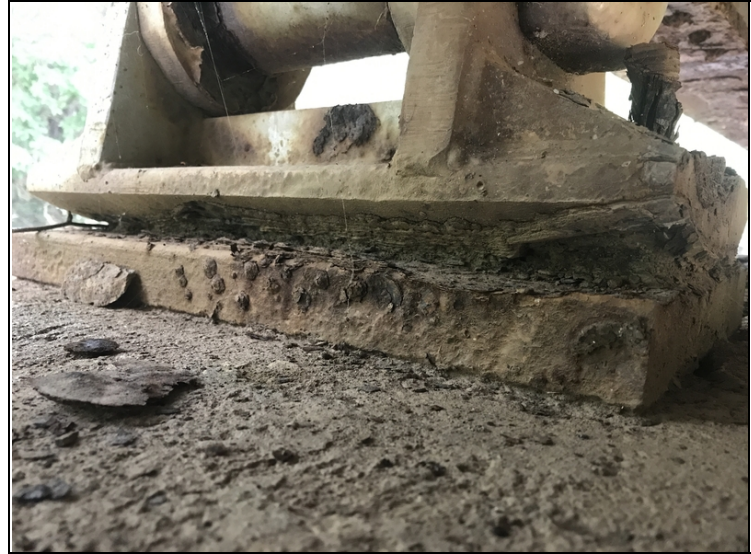
Pack rust in bearing device restricting movement.

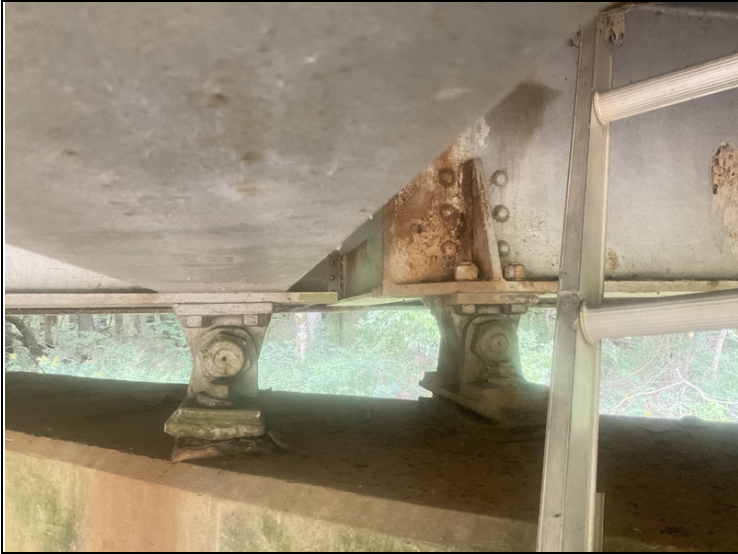
Bent 3, Beam 4 bearing corrosion.

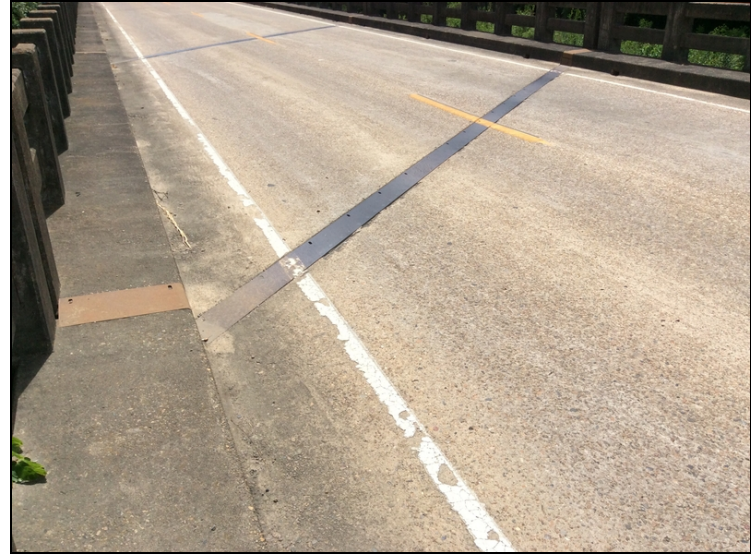
Expansion joint over Bent 7

Deck
The deck has open joints that leak water on the superstructure.

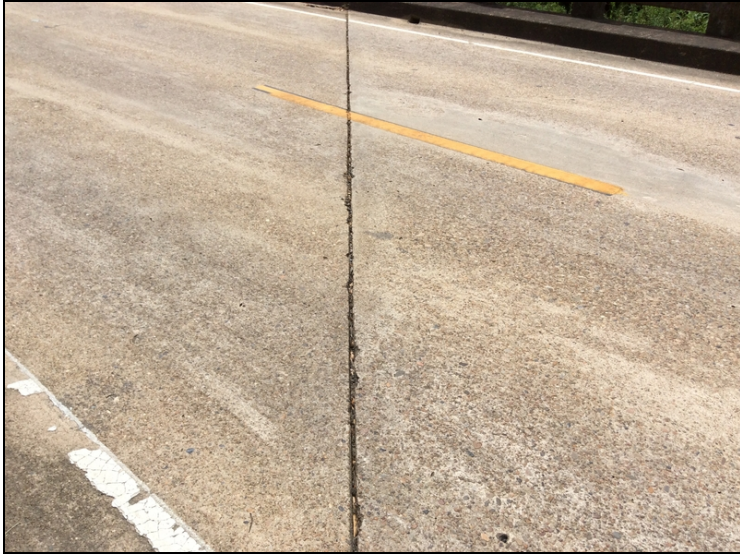
Unsealed joint.

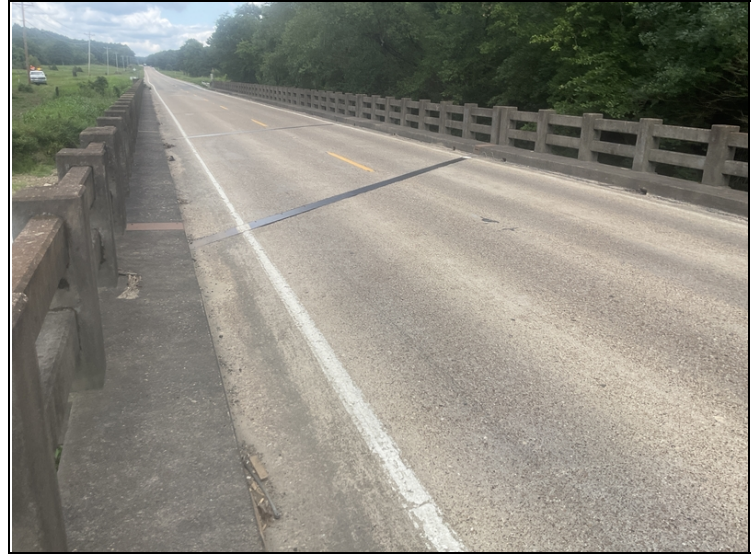
Sliding plate. Typical.

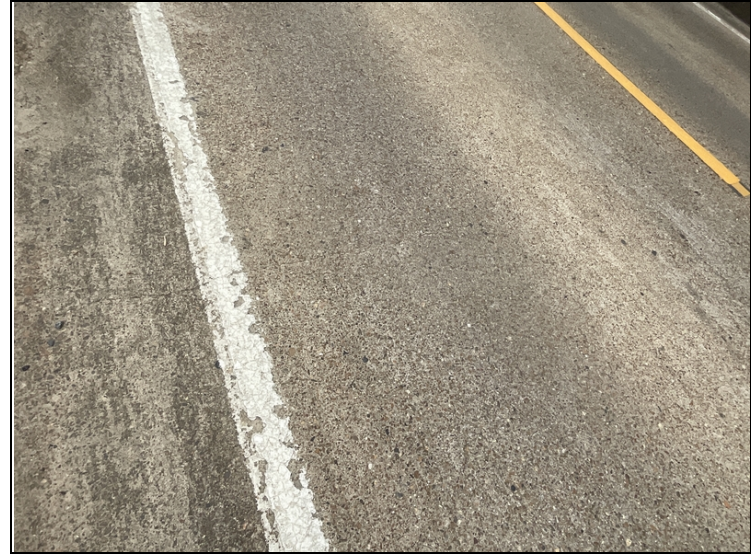
Transverse sealable cracks. Span # 4.

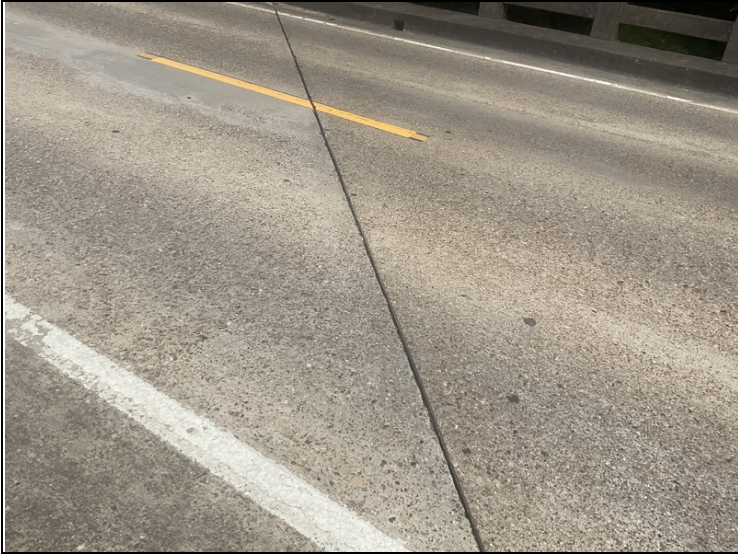
Transverse joint over Bent # 5.

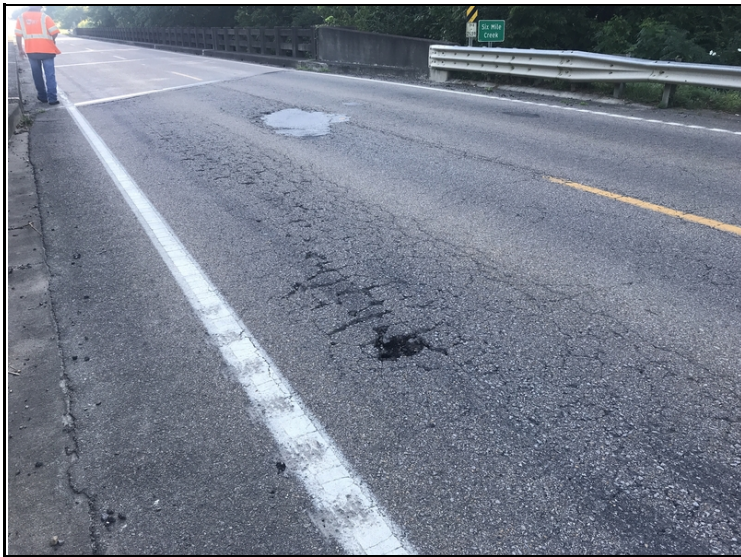
South approach roadway - Pothole forming.

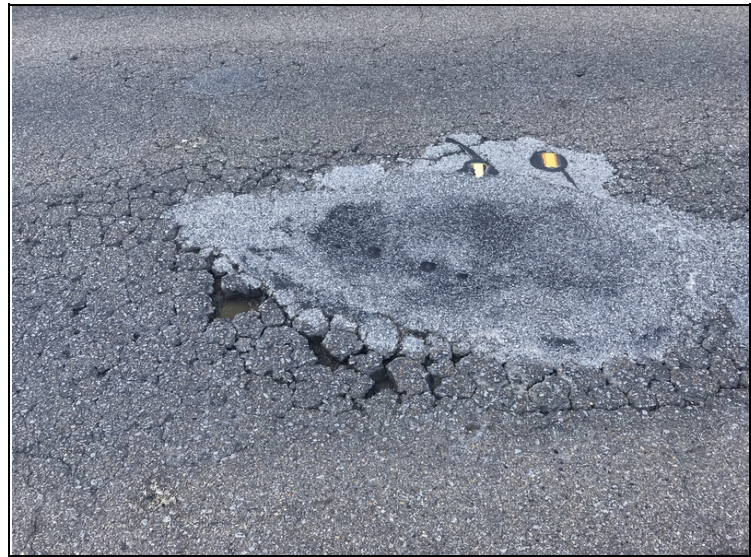
South approach roadway - Pothole forming.

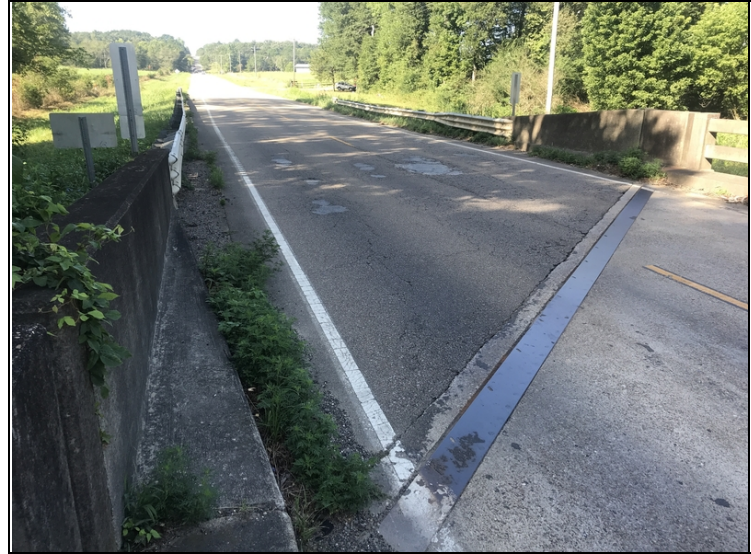
South approach roadway deterioration with potholes.

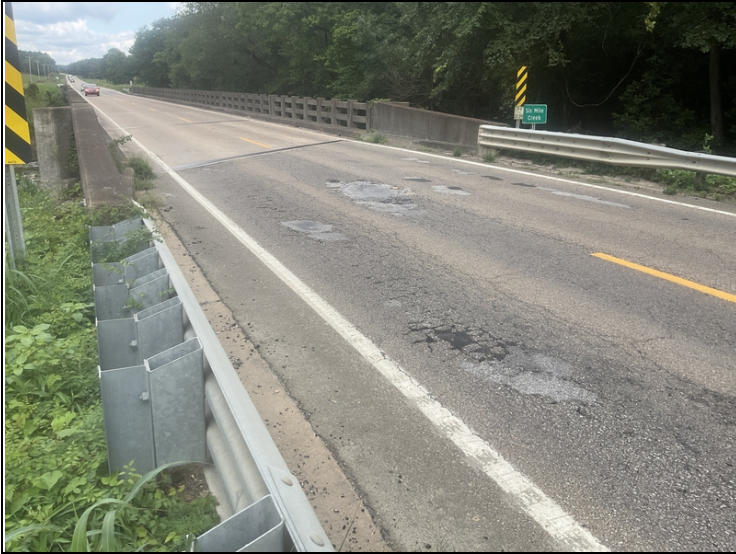
South approach roadway. Patched pot holes.

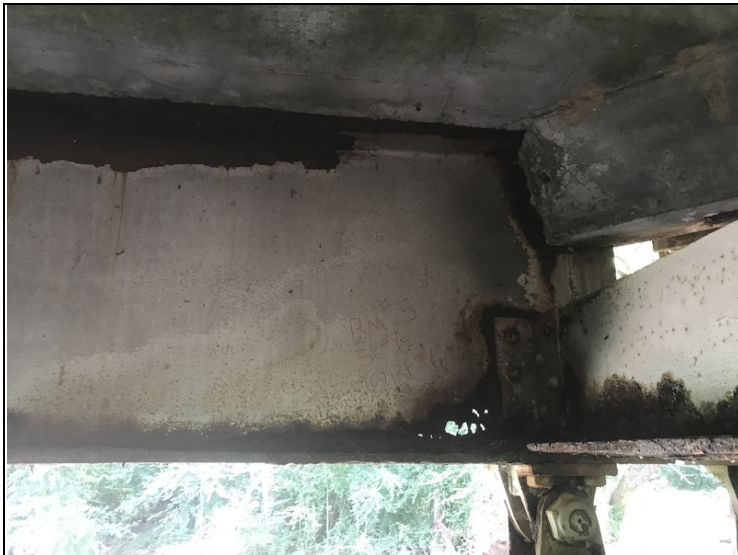
Bent #6, Span #6 Beam #5 with holes through the web. No visible cracks.

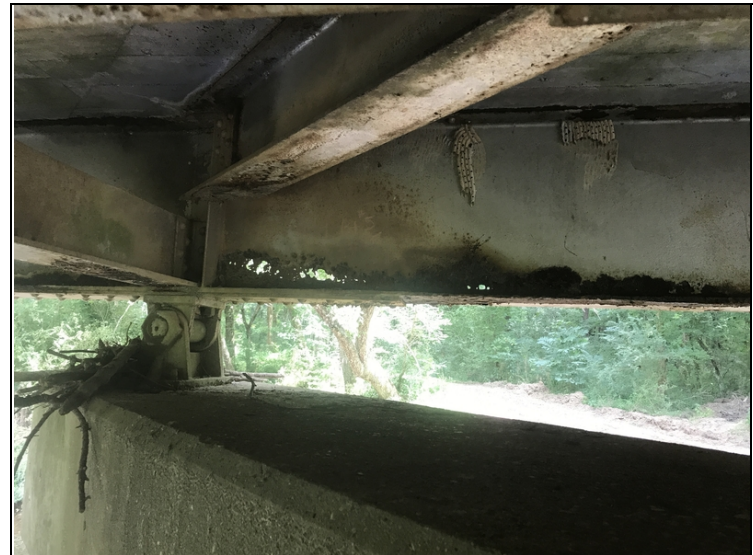
Bent #5, Span #4 Beam #5 with a 4' long section with holes in the base of the webs.

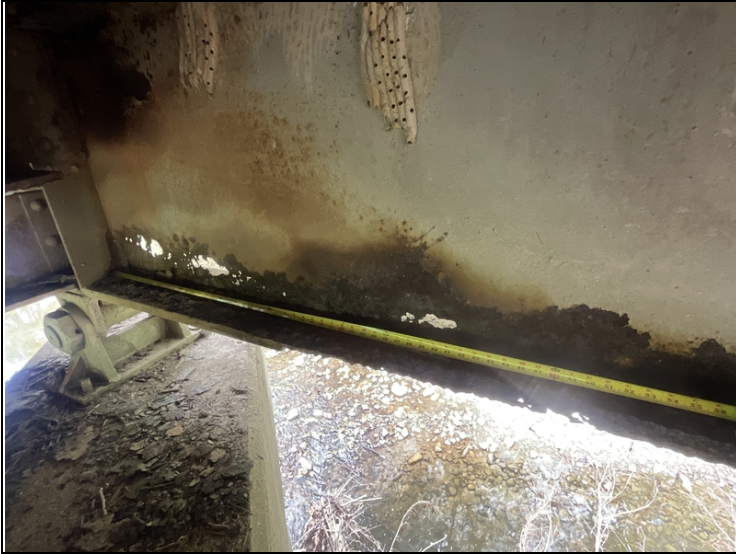
Span 4. Bent 5. Beam 5. Holes rusted through the base of web and bottom flange.

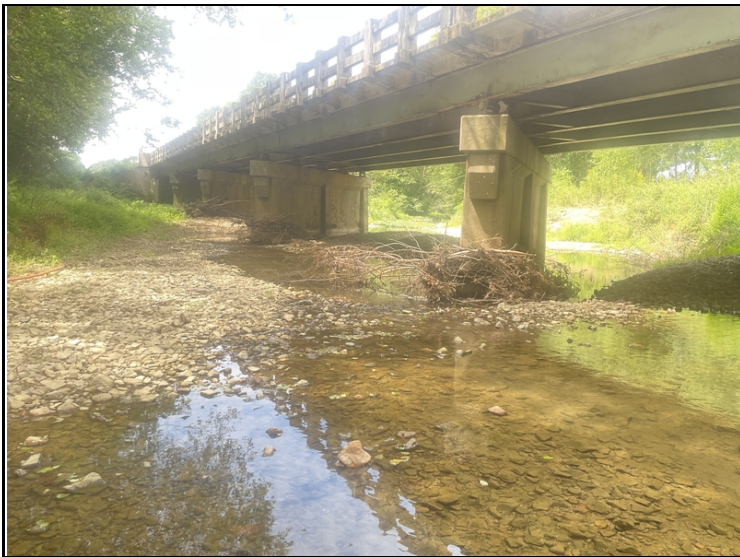
There is drift accumulation at the inlet end of structure.
