Asset #06766(Routine)

US 71-Polk Co. over Kansas City Southern RR

Location: 0.5 MI N OF WICKES

Team Lead: Jeff Jones, Inspection Date: 01/12/2022

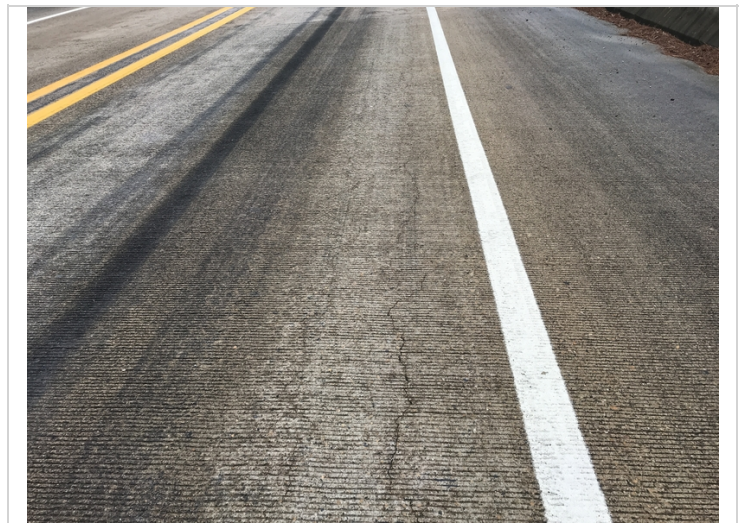
(12) -There are a few isolated sealable longitudinal cracks in the driving surface of the deck. -There is light abrasion in the wheel paths. -There are transverse cracks with light efflorescence visible from the undersurface of the overhangs of the deck that appear to correspond with the joints in the parapet walls.							
107	Steel Open Girder/Beam	LF	545	486	36	23	0
1000	Corrosion	LF	59	0	36	23	0
515	Steel Protective Coating	SF	6955	6896	0	36	23
3430	Oxide Film Degradation Color/Texture Adherence(Steel Protective Coatings)	LF	59	0	0	36	23

Sealable deck cracking.

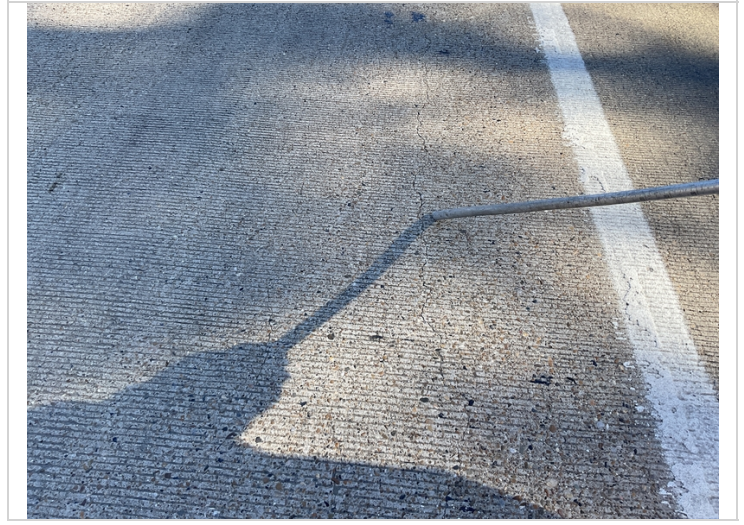
Sealable Longitudinal cracking in the deck.

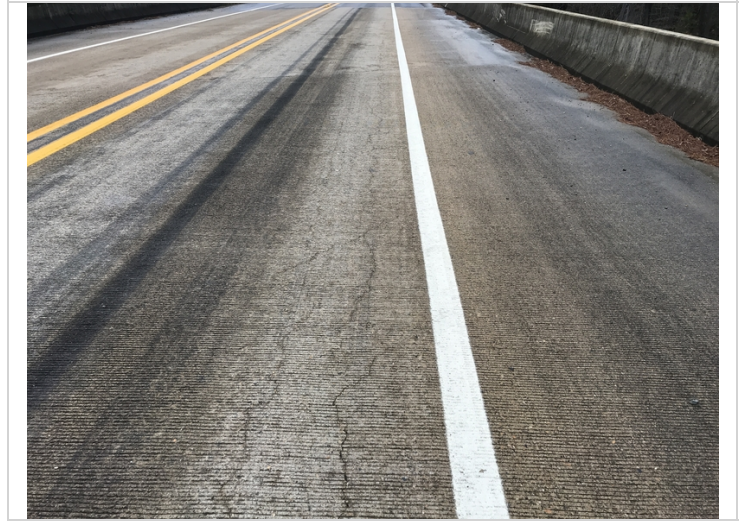
Sealable deck cracking.

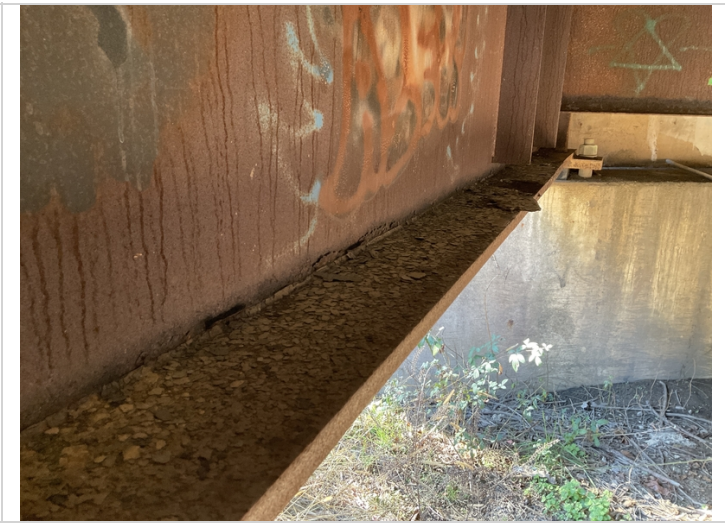
(107) -A588 weathering steel with abnormal weathering and flaking rust on Beams # 1, 2, 3, 4, and 5 at Bent # 2 due to leaking joint seal at Bent # 2.  The superstructure has active corrosion with large slabs of flaking rust on the bottom flange and base of web adjacent to the North abutment where the leaking expansion joint seal discharges onto the girders.  There is heavy pitting to the bottom flange and base of web during this inspection.							
215	Reinforced Concrete Abutment	LF	229	211	18	0	0
1120	Efflorescence/Rust Staining	LF	11	0	11	0	0
1130	Cracking (RC and Other)	LF	7	0	7	0	0

Photo of Girder # 1. Active corrosion.

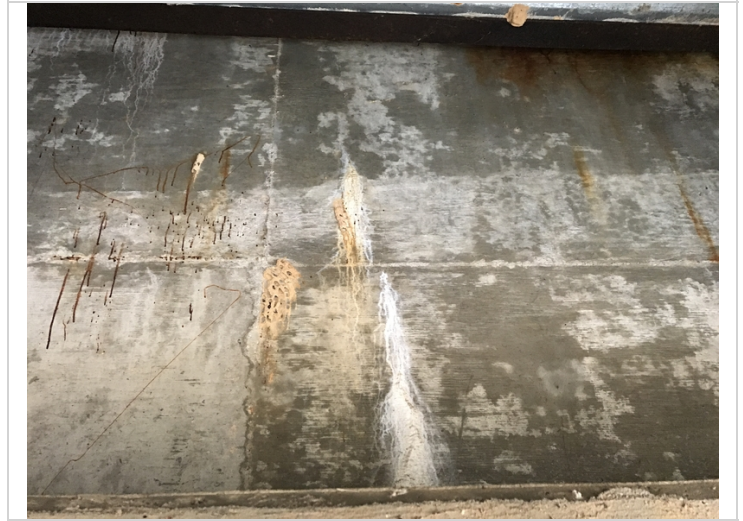
(215) -There are a few vertical hairline cracks in the stem walls and back walls of both abutments. -There are a few vertical cracks with efflorescence.							
302	Compression Joint Seal	LF	100	4	0	96	0
2310	Leakage	LF	96	0	0	96	0

Bent # 1 backwall vertical cracking with efflorescence buildup.

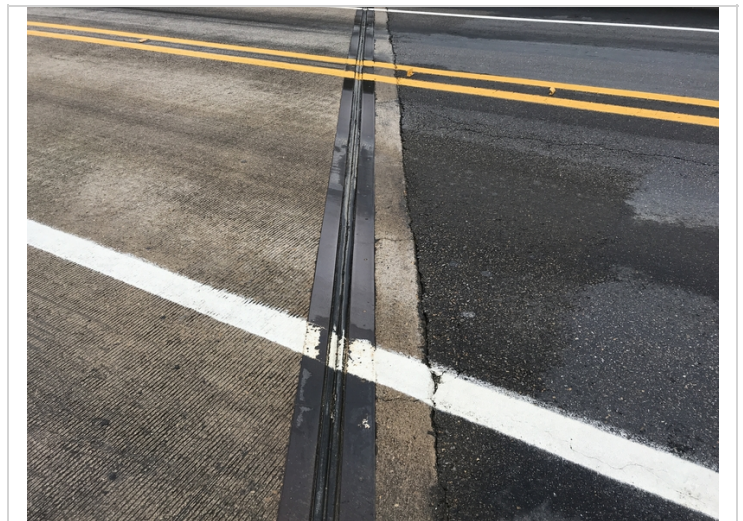
Bent 1 top of the backwall cracks.

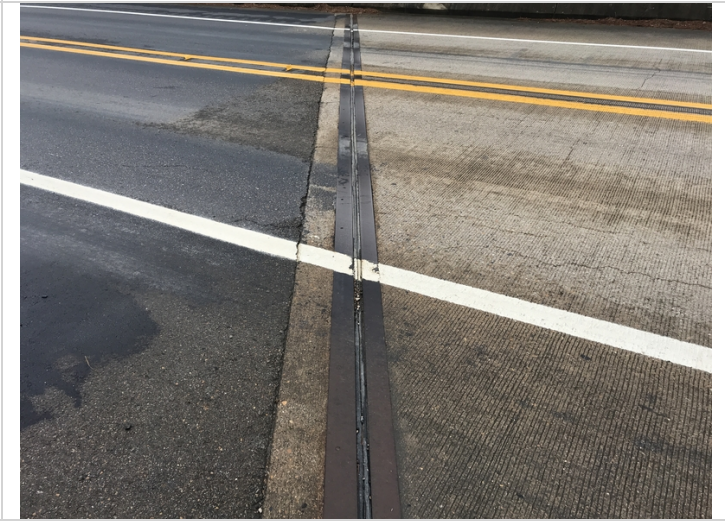
(302) -The deck joint seal at Bent # 2 has adhesion failure in areas and has dropped down approximately 1/2" in the Northbound lane during this inspection. -Stains and debris on the North abutment indicates that the deck joint seal leaks.							
310	Elastomeric Bearing	EA	10	7	3	0	0
1000	Corrosion	EA	3	0	3	0	0
515	Steel Protective Coating	SF	20	14	0	0	6
3430	Oxide Film Degradation Color/Texture Adherence(Steel Protective Coatings)	EA	6	0	0	0	6

Bent # 2 compression joint seal.

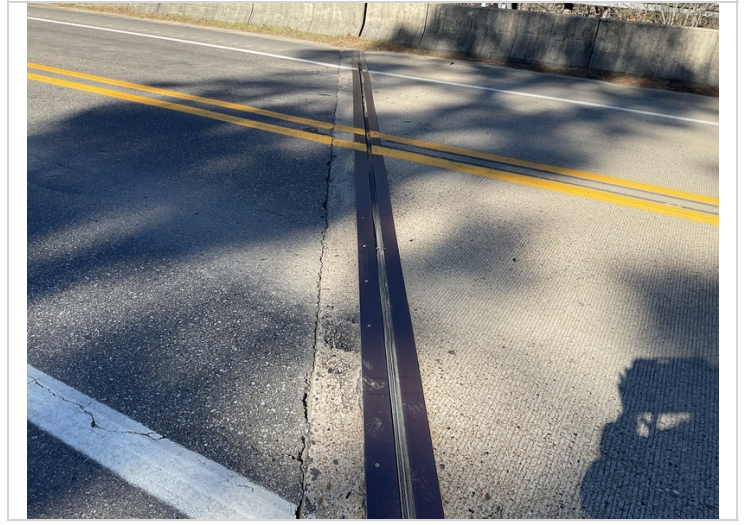
Expansion joint seal over Bent # 2.

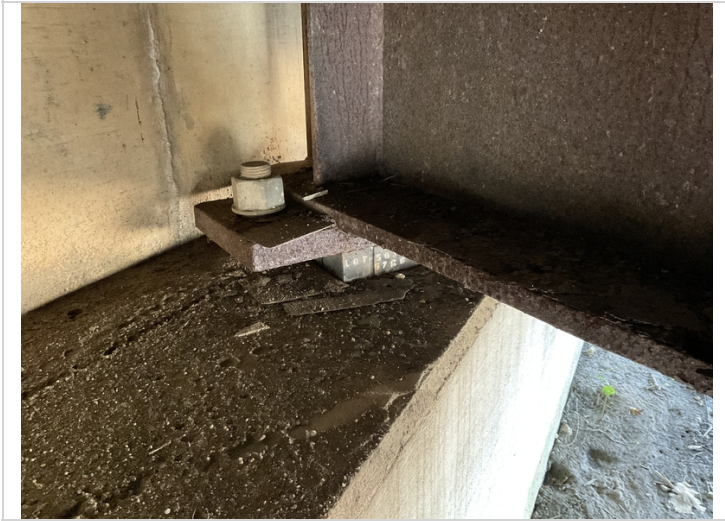
(310) -The external loading plates at Bent # 2, Beams # 2, 3, & 4 have abnormal weathering with flaking rust.							
331	Reinforced Concrete Bridge Railing	LF	218	216	2	0	0
1130	Cracking (RC and Other)	LF	2	0	2	0	0

Active corrosion with flaking rust. External loading plate of Bent # 2. Girder # 4 bearing.

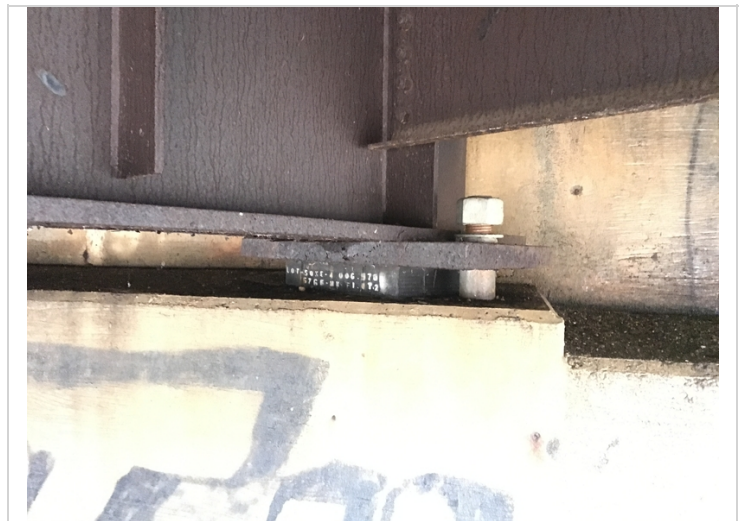
Bent 2 Bearing 4 active corrosion with layers of flaking rust.

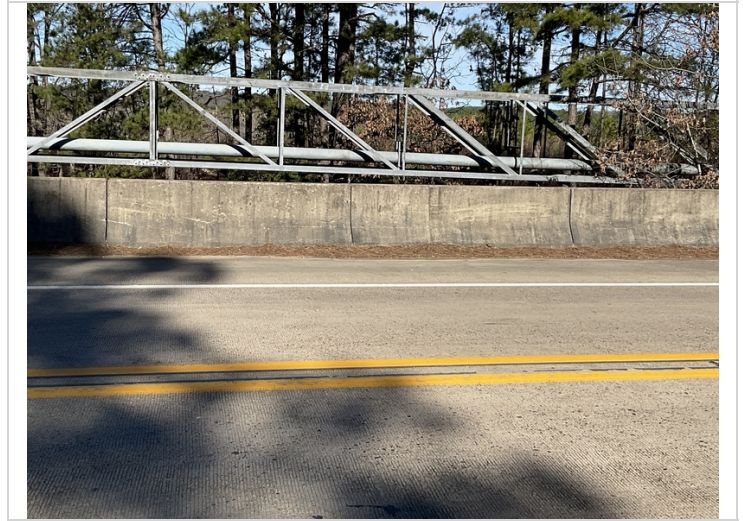
ELEMENTS	DESCRIPTION	UNITS	TOTAL	CS1	CS2	CS3	CS4
(331) -There are a few insignificant scrape marks with no apparent noteworthy deficiencies during this inspection.

Insignificant scrape marks.

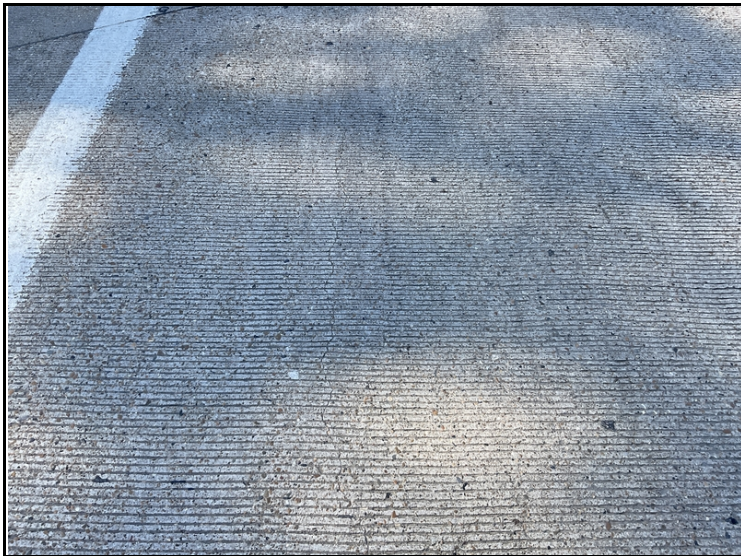
The driving surface of the deck has a few random short duration sealable cracks.

Sealable Longitudinal cracks in the wheel paths.

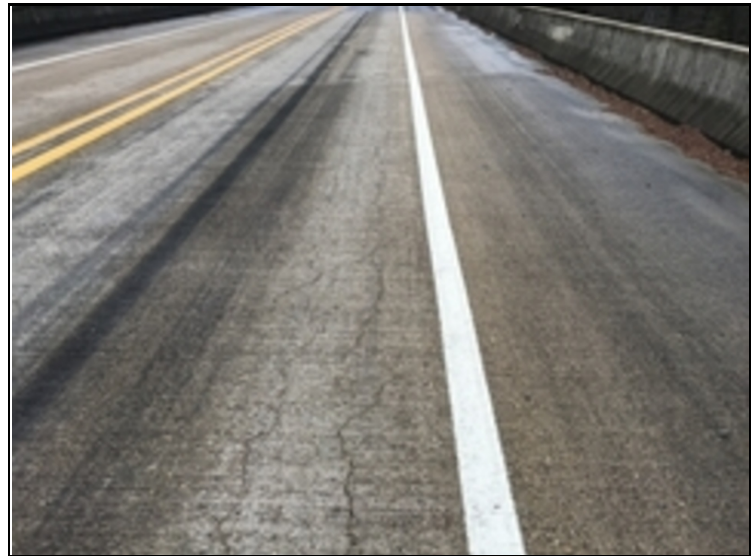
The driving surface of the deck has a few random short duration sealable cracks.

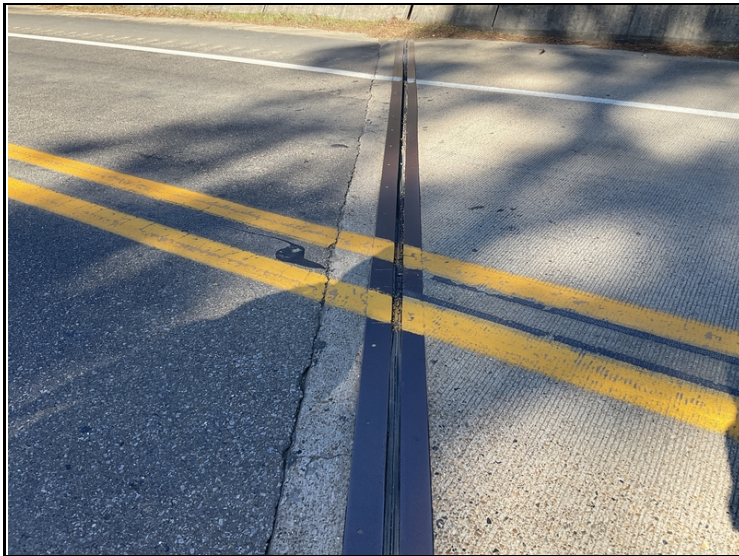
- The expansion joint seals leak.
- Compression joint seal at the North bridge end is losing its adhesion.

Expansion joint seal over Bent # 2.

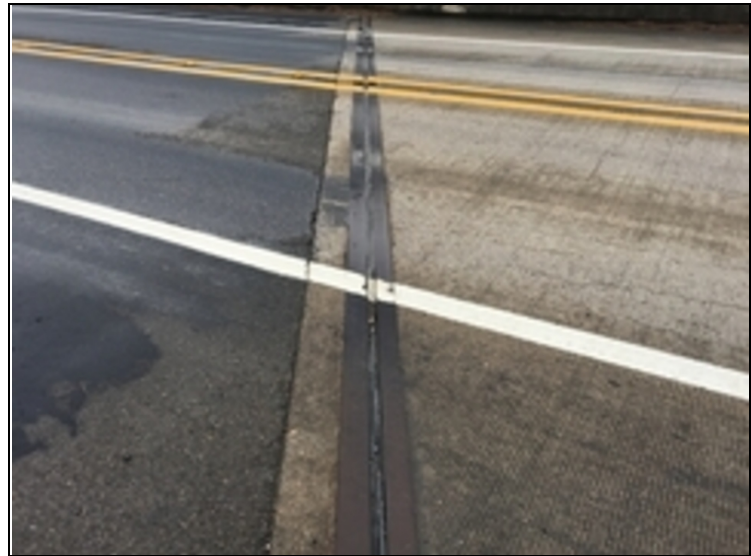
Compression joint seal at the North bridge end is losing its adhesion and is leaking through to the substructure.

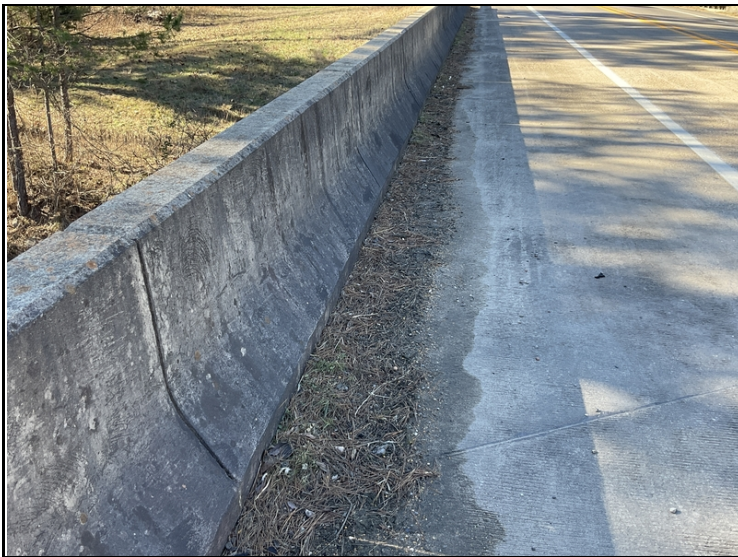
There is debris accumulation in the gutters.

Debris accumulation in the gutters.

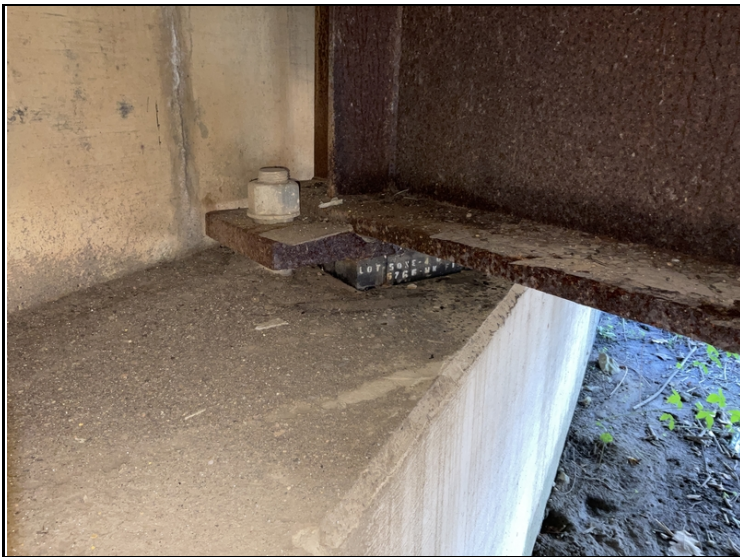
External loading plate of Bent # 2 bearings have active corrosion with flaking rust.

Active corrosion with flaking rust. External loading plate of Bent # 2. Girder # 4 bearing.

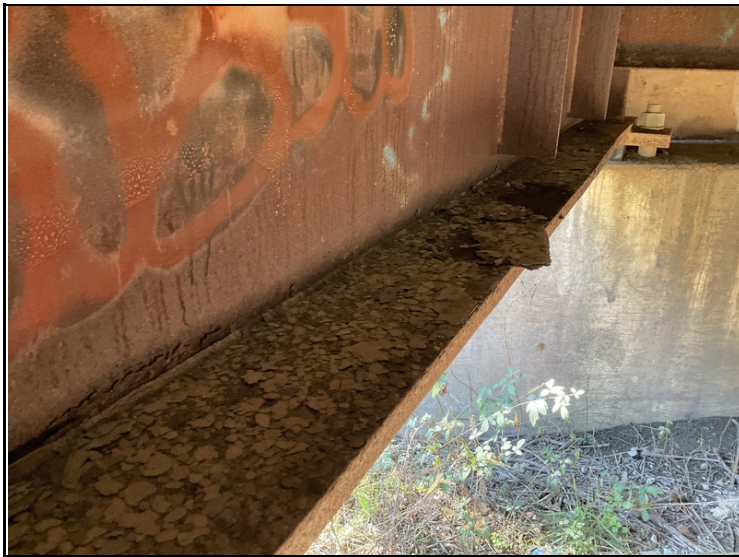
The superstructure has active corrosion with large slabs of flaking rust on the bottom flange and base of web adjacent to the North abutment where the leaking expansion joint seal discharges onto the girders.

The superstructure has active corrosion with large slabs of flaking rust on the bottom flange and base of web adjacent to the North abutment where the leaking expansion joint seal discharge onto the girders. Photo of Girder # 1.

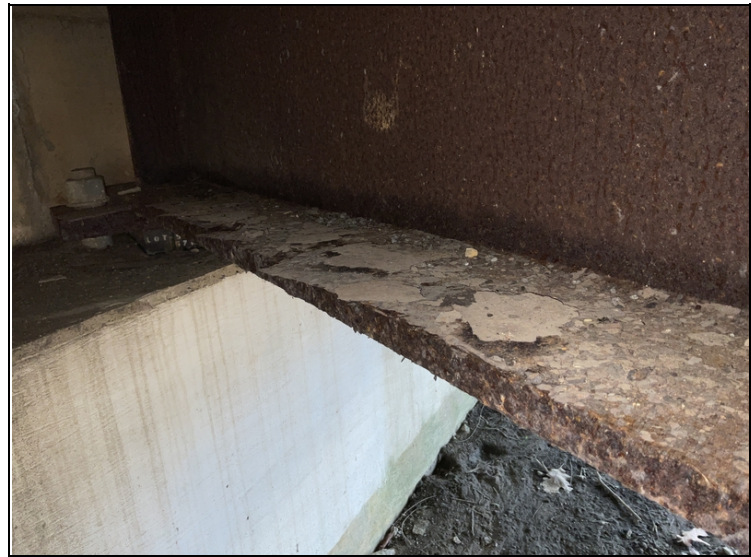
Active corrosion. Bent # 2, Girder # 4.
