Asset #A0931 (Routine)

US 71 - Polk Co over Railroad - KCS

Location: So. City Limits Hatfield

Team Lead: Eric West, Inspection Date: 06/29/2021

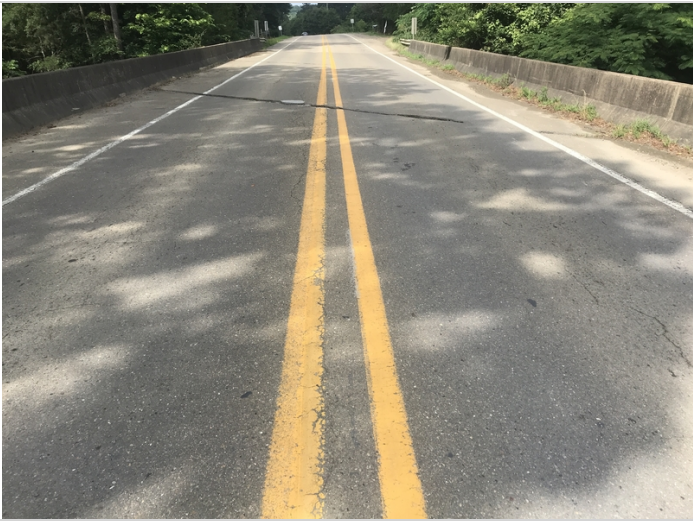
Typical driving surface of the deck.

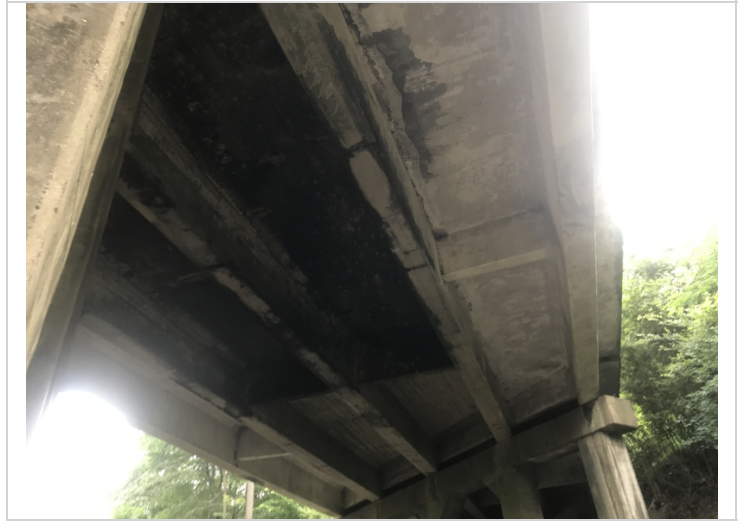
- The undersurface of the deck is delaminated in span # 1 along the right side of girder # 4 in an area approximately 12" wide for the full length of span where the structure has been widened in the past.
- The undersurface of span # 2 has longitudinal cracking and delaminated areas along the construction joints adjacent to girders # 2 and # 4 where the structure has been widened in the past.
- The undersurface has transverse cracking with rust staining at variable spacing.

Span #2 typical undersurface of the deck.

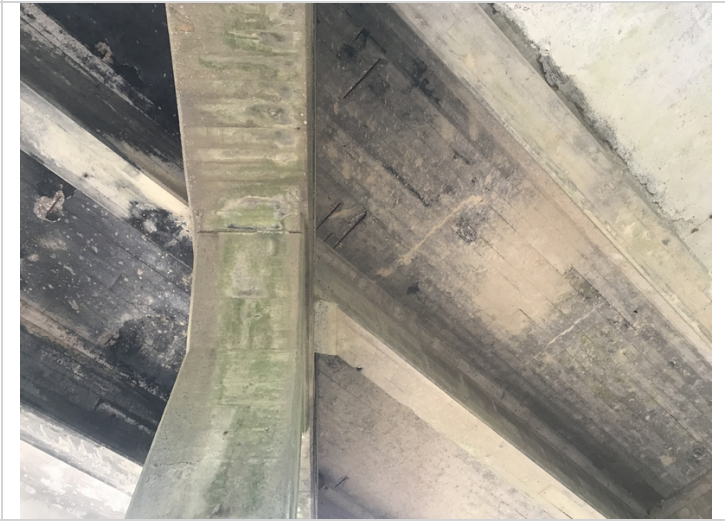
Span #3 bays # 2 & 3 spalling with exposed reinforcing steel adjacent to bent #3.

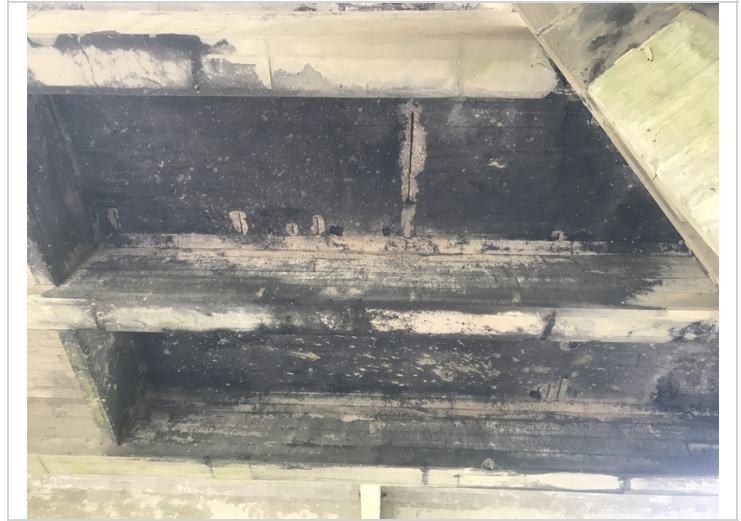
Span #2, bays # 2 & 3 spalling with exposed reinforcing steel on the undersurface of the top flange.

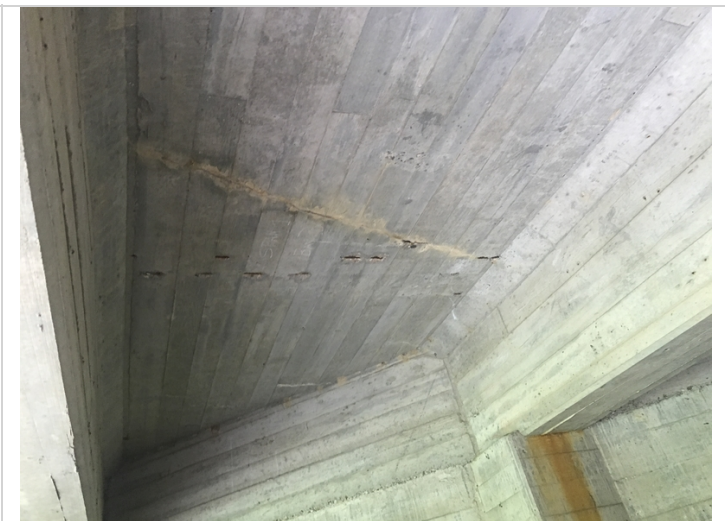
Span #1 bay #3 adjacent to abutment #1 spalling with exposed reinforcing steel.

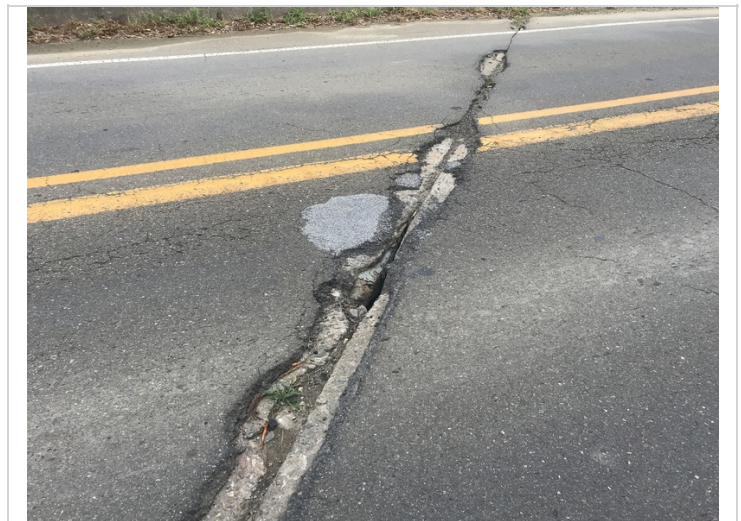
Span #2, Bent #3 with spalling adjacent to the deck joint in the top flange.

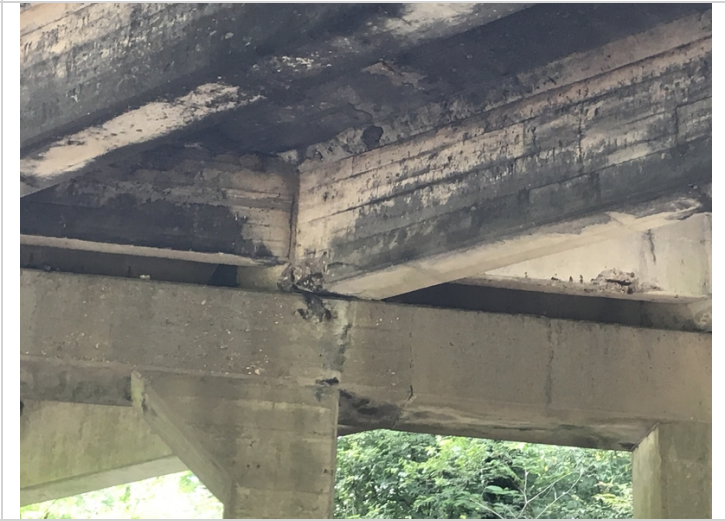
Span #2, girder # 4 spalling with exposed reinforcing steel adjacent to bent #4.

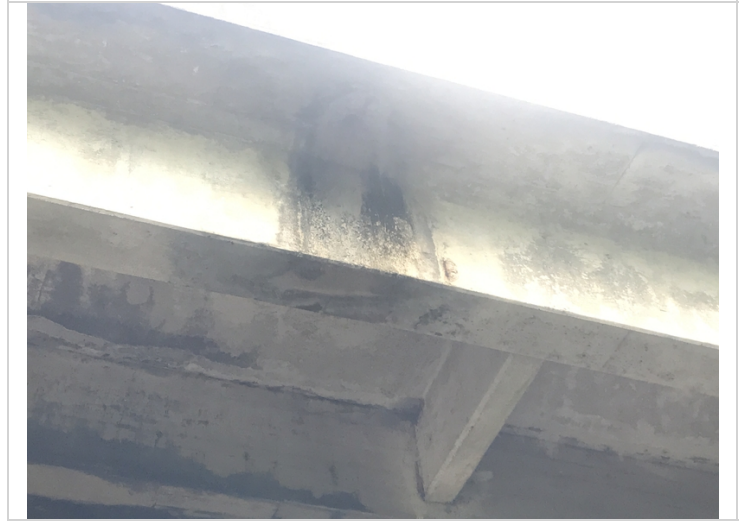
-Span # 2, Girder # 1 exterior face at midspan has 6" spall at midspan below the deck drain with exposed reinforcing steel.
-Span # 2, Girder # 2 bottom surface has shallow spalling with exposed reinforcing steel located approximately 3 feet from bent # 2 cap. The base of girder at bent # 3 has shallow spalling adjacent to bent # 2.
-Span # 2, Girder # 3 adjacent to bent # 2 cap has an area of shallow spalling with exposed reinforcing steel in the undersurface. Reinforcing steel has measurable section loss at this inspection.
-Span # 2, Girder # 4 bent #3 has a 12" spall with exposed reinforcing steel in the base of girder with an adjacent 12" delamination. Bent #2 end of the girder has a shallow 4" spall with exposed reinforcing steel.
-Span # 2, Girder # 5 bent #2 has a full height vertical spall with exposed reinforcing steel over the exterior bearing area of the girder.

Span #2 girder #1 exterior spalling with exposed reinforcing steel below the deck drain.

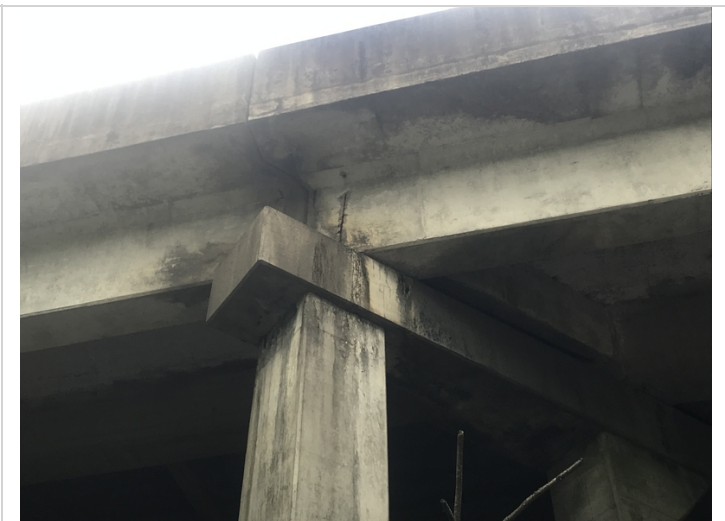
Span #2, girder #5 exterior face spalling with exposed reinforcing steel.

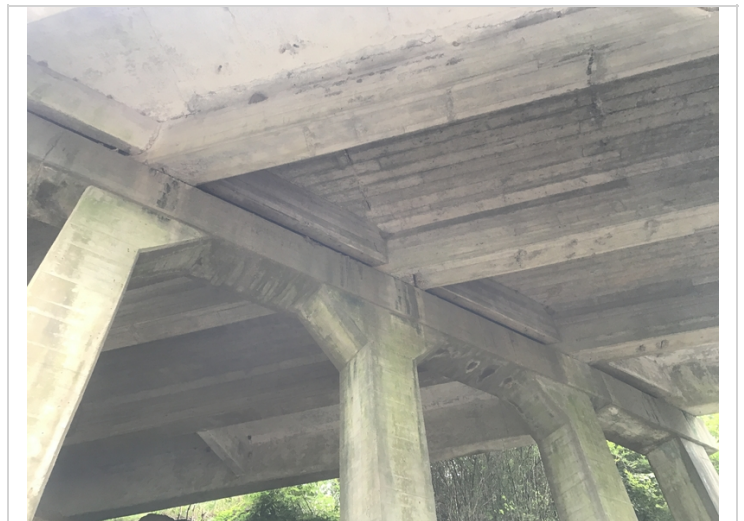
Span #2, bent #2 girders # 2, 3 & 4 has shallow spalling adjacent to bent #2.

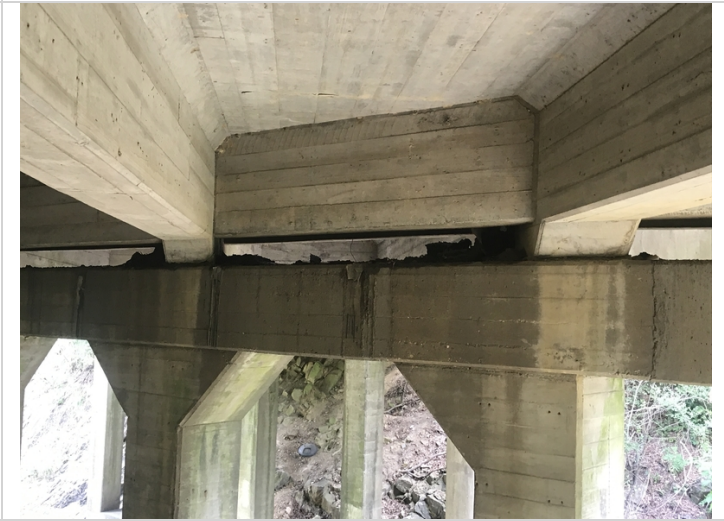
(110) -Vertical hairline flexure cracking at approximately 3 foot centers are typical in all spans near mid-span.
-Span #1 Girders # 3 & 4 haunches have cracked / delaminated areas over above masonry plates at bent # 2.

Span #1, girders # 3 & 4 cracking and delaminated areas in the bearing areas.

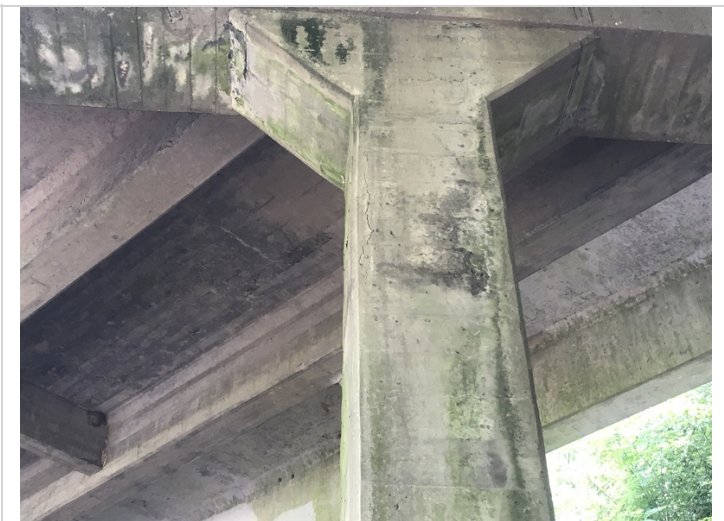
Span #2, bent #3 column #3 vertical cracking.

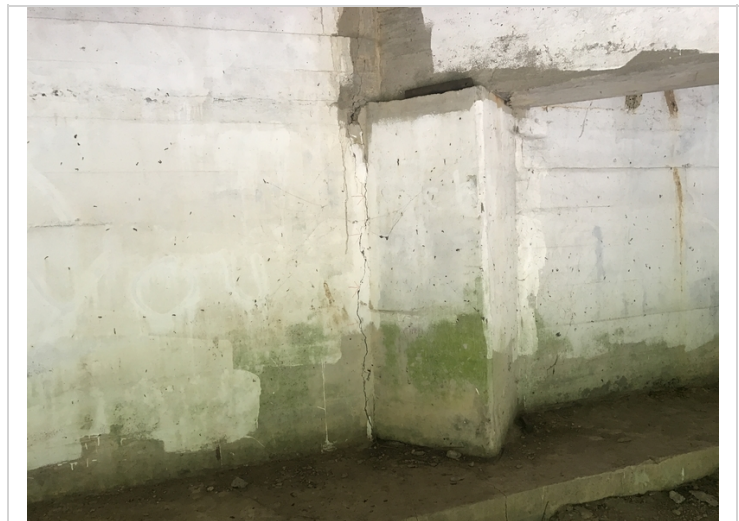
(215) -The abutments have isolated hairline vertical cracking adjacent to the bearing areas in both abutments. -Abutment # 2 stem wall has vertical cracks adjacent to the columns at girders # 2, # 3 and # 4. The cracking adjacent to girder # 3 is an 1/8" wide at the widest point and propagates transversely across the footing. The deck haunch has mapcracking in the same area.							
234	Reinforced Concrete Pier Cap	LF	140	126	12	2	0
1080	Delamination/Spall/Patched Area	LF	1	0	1	0	0
1090	Exposed Rebar	LF	2	0	0	2	0
1130	Cracking (RC and Other)	LF	11	0	11	0	0

Abutment #2 with 1/8" wide cracking adjacent to girder #3.

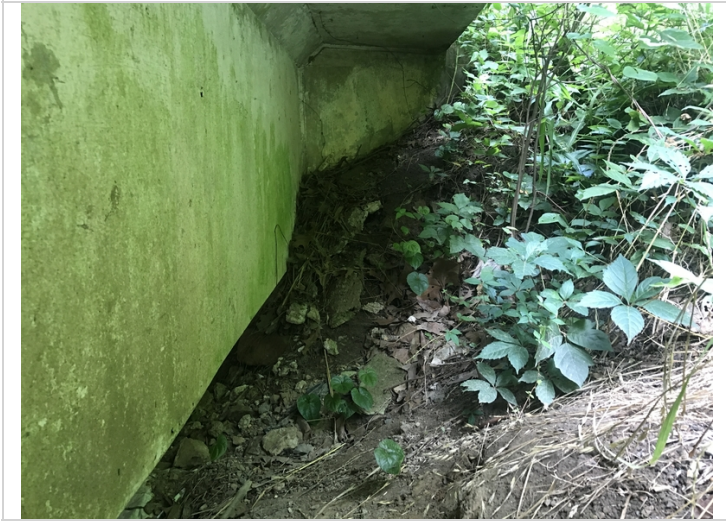
Abutment #1, beam #1 dirt accumulation.

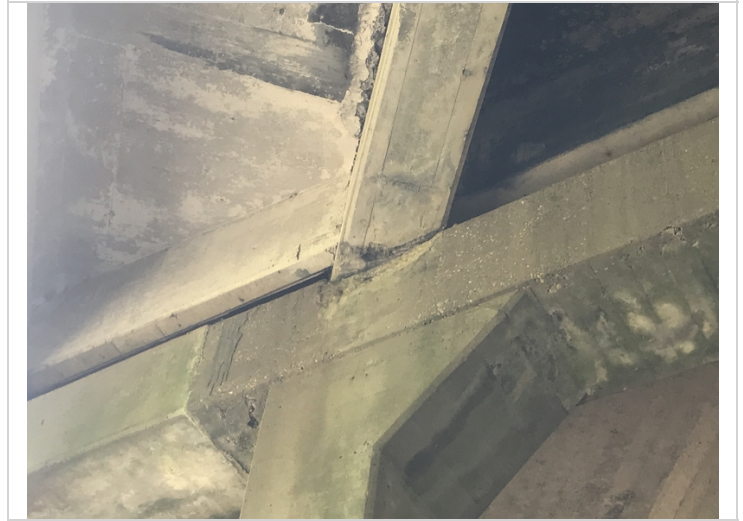
Span #2, girder #2 spalling in the bearing area of the girder.

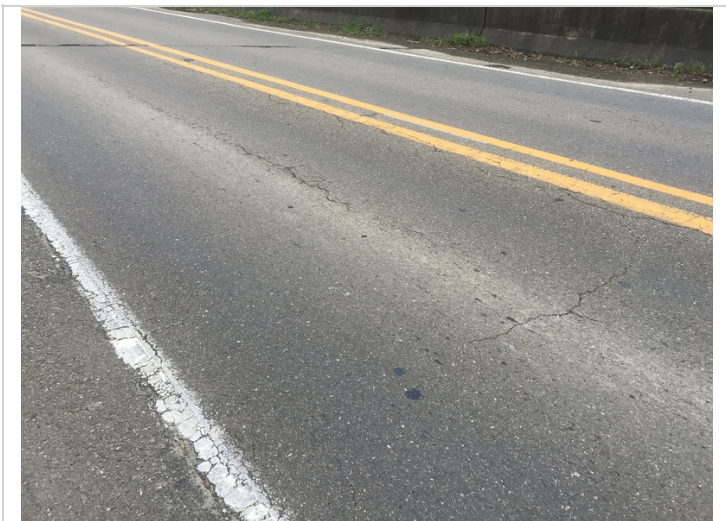
Typical cracking in the asphalt wearing surface of the deck.

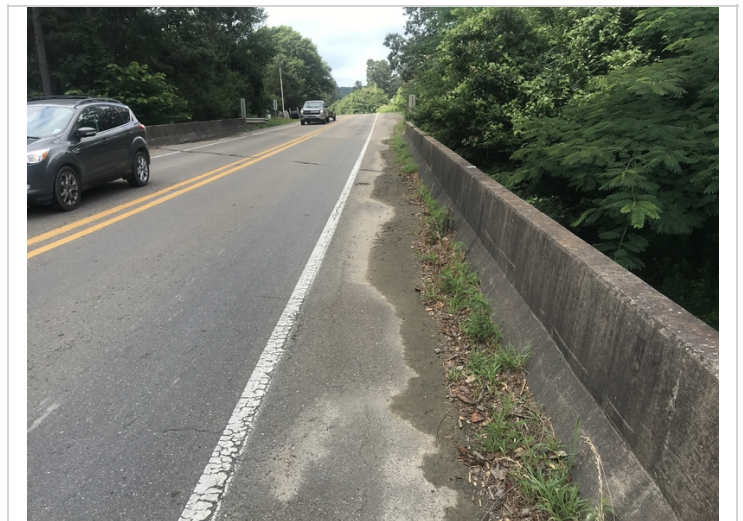
- Span #2 Lt has delaminated asphalt in the gutter with a pothole.
- isolated asphalt delamination in the gutters.

Span #2, the Lt gutter with potholes and delaminated asphalt.

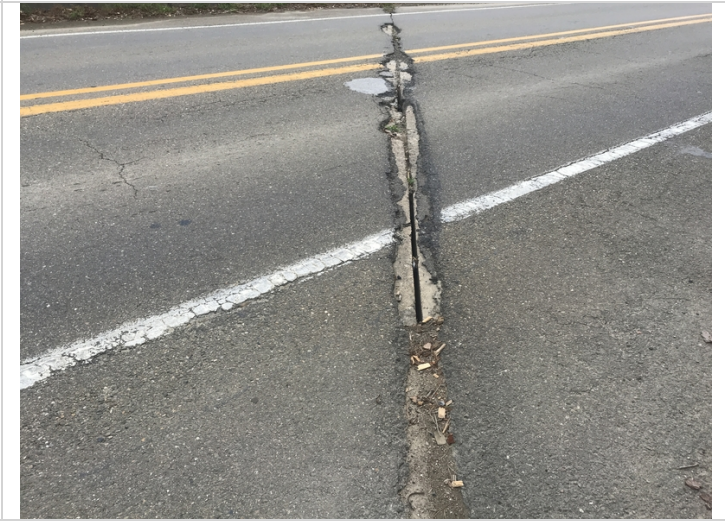
Bent #3 asphalt breaking apart over the deck joint.

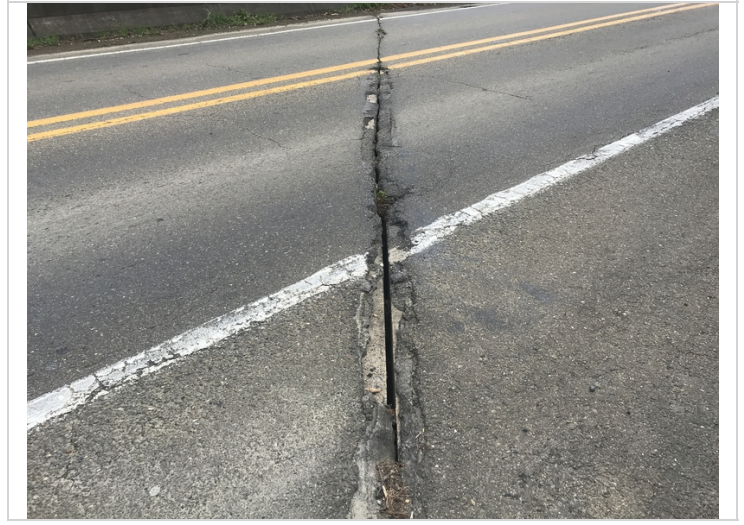
Bent #2 asphalt breaking apart over the deck joint.

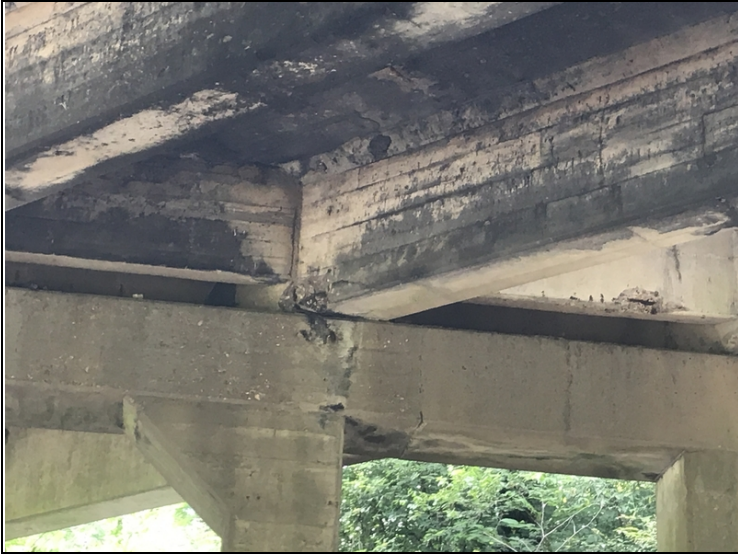
The undersurface of girders # 2 and # 3 of span # 2 has spalling with exposed reinforcing steel adjacent to bent # 2.
Span # 2, girder # 4 has a 12" spall with exposed reinforcing steel adjacent to bent # 3.
Additional girders have shallow spalls with exposed reinforcing steel.

Span #2, girder # 4 spalling with exposed reinforcing steel adjacent to bent #4.

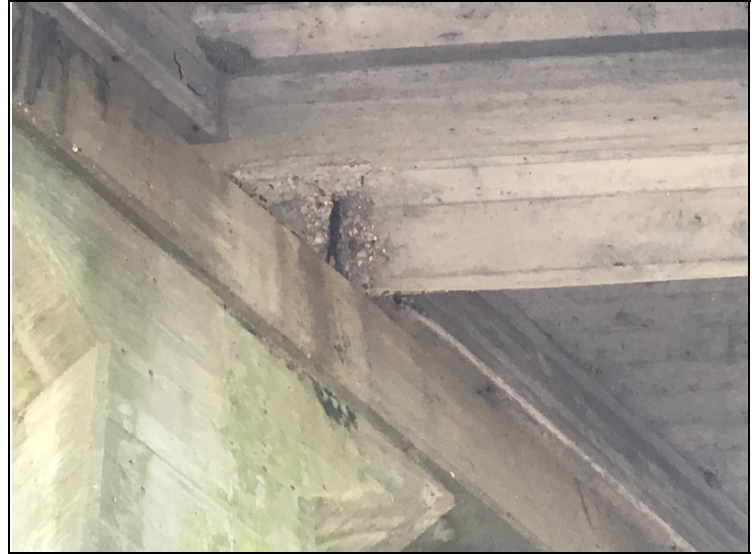
Span # 2, girder # 3 adjacent to bent # 2-Spalling with exposed reinforcing steel in undersurface.

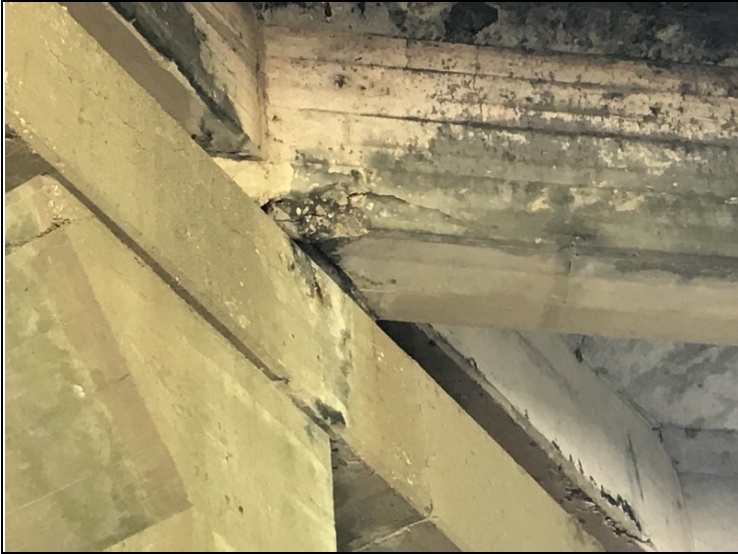
Span # 2, girder # 4 at bent # 3-Spalling with diagonal cracking.

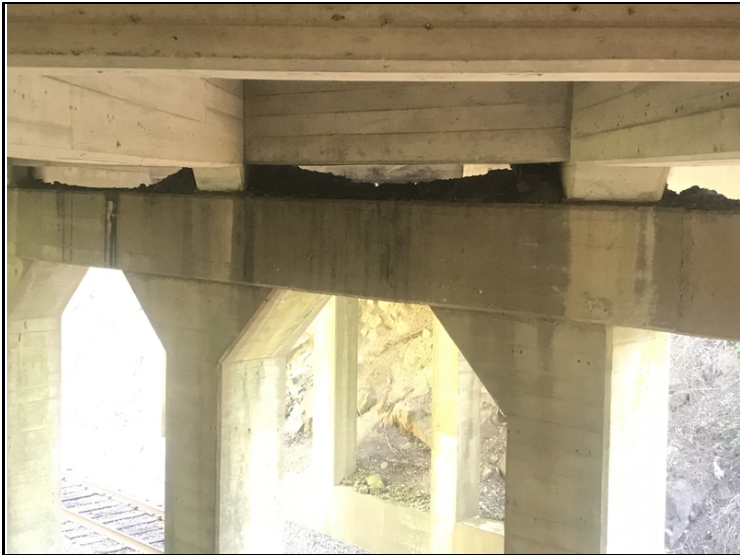
The intermediate bent caps have heavy dirt and debris accumulation where the open expansion joints allow water, dirt and debris to leak onto the substructure.

Bent # 2 cap-Dirt and debris accumulation.

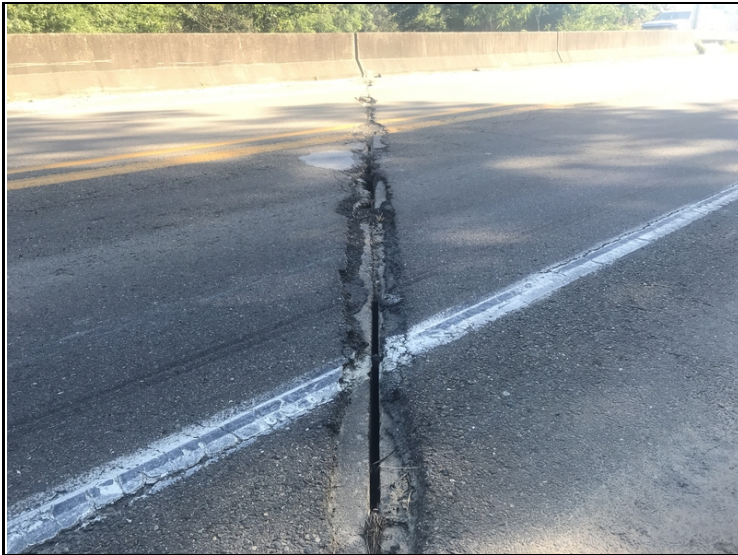
Asphalt is breaking up over the deck joints creating potholes in the driving surface. Deck joints between spans are open and leak water onto the caps.

Bent # 3 expansion joint-Asphalt breaking up over expansion joints with potholes forming in driving surface.

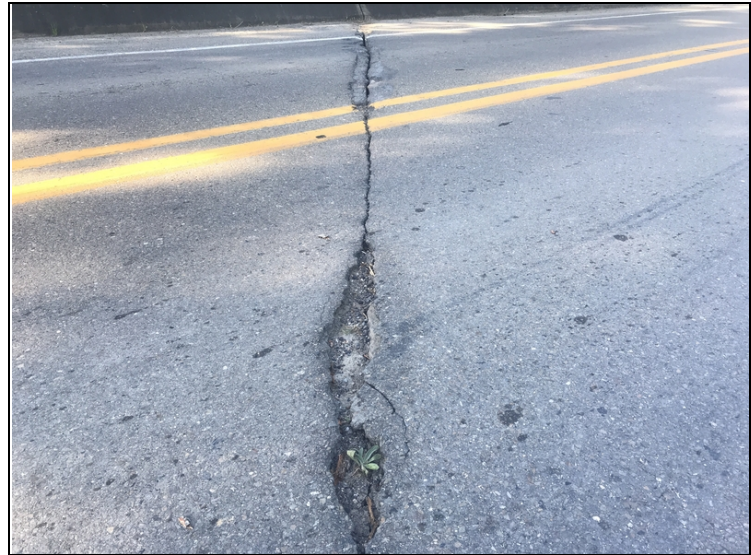
Bent # 2-Asphalt breaking up over expansion joint.

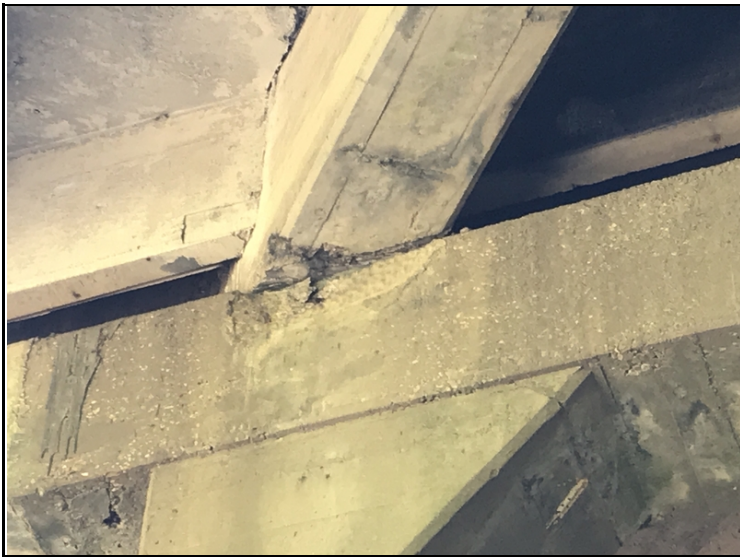
Substructure, Bent # 3 Cap -
Bent # 3 cap has spalling in the bearing area of girders # 2 and # 4.

Bent # 3 cap-Spalling with exposed reinforcing steel under girder # 2.

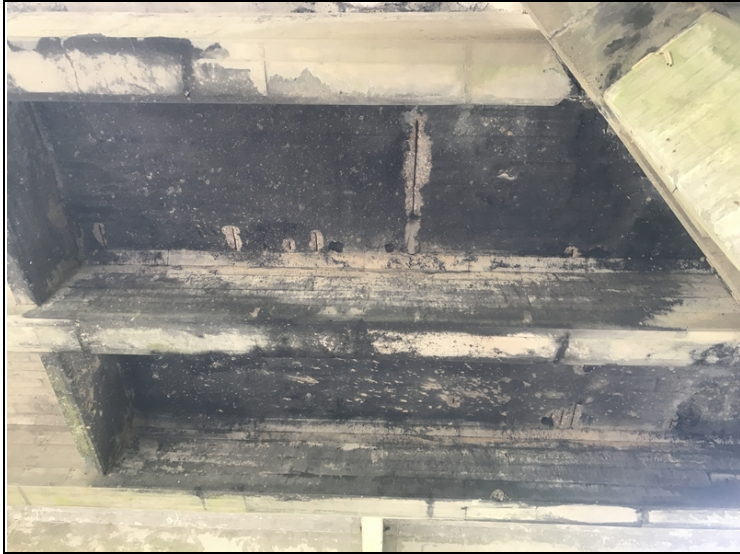
Deck -
There are shallow spalls with exposed reinforcing steel visible from the undersurface of the deck.

Span #2, bays # 2 & 3 spalling with exposed reinforcing steel on the undersurface of the top flange.

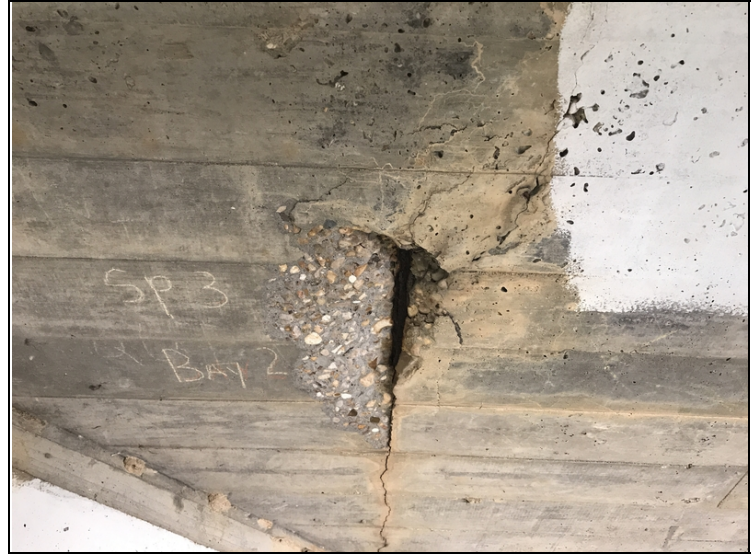
Span # 3, bay # 2-Spalling with exposed reinforcing steel in undersurface of deck at abutment # 2.

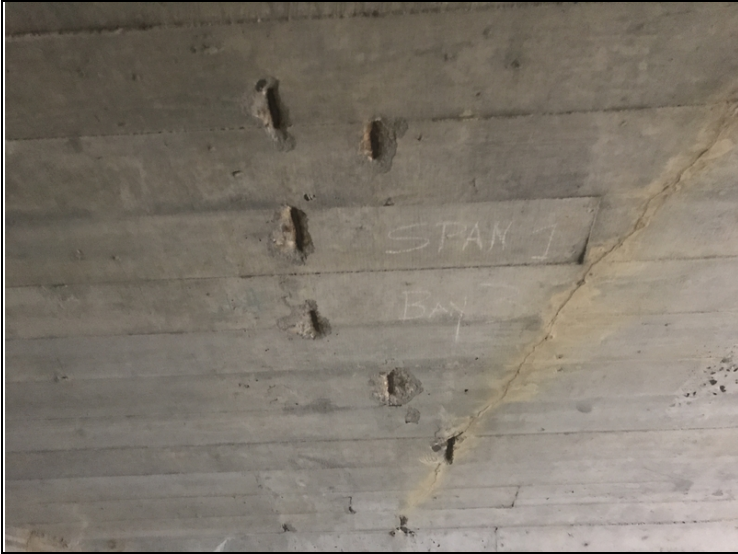
Span # 1, bay # 3-Shallow spalling with exposed reinforcing steel near abutment # 1.

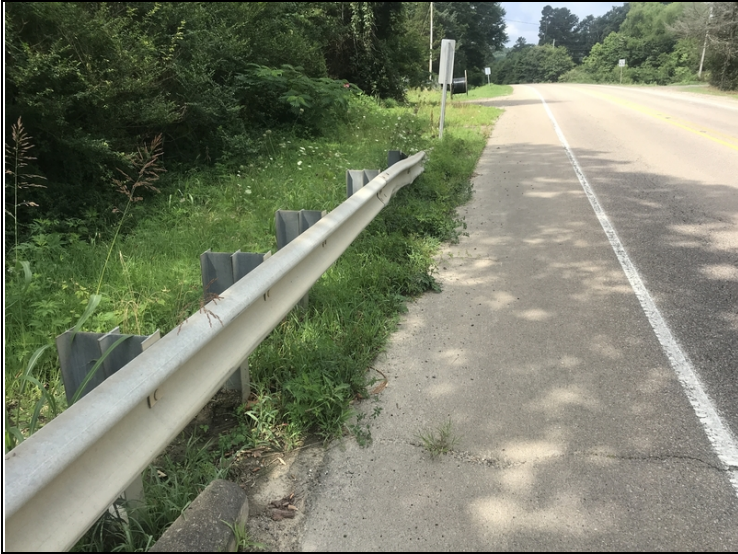
Southeast approach railing -
The Southeast approach guardrail has minor collision damage.

Approach guardrail with minor collision damage at the southeast approach.

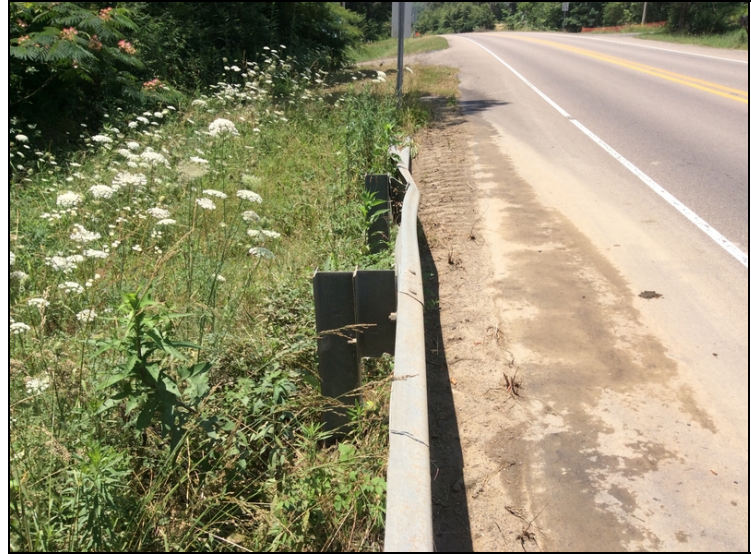
The Southeast approach guardrail has minor collision damage.

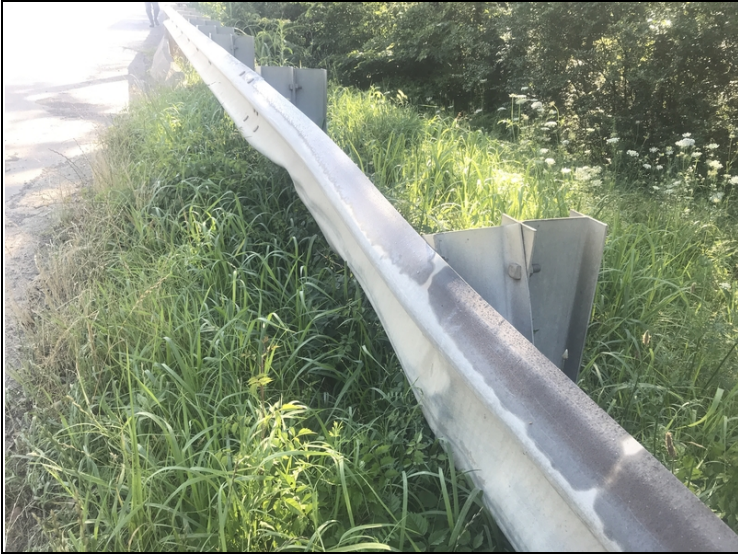
Southeast approach railing-Collision damage.

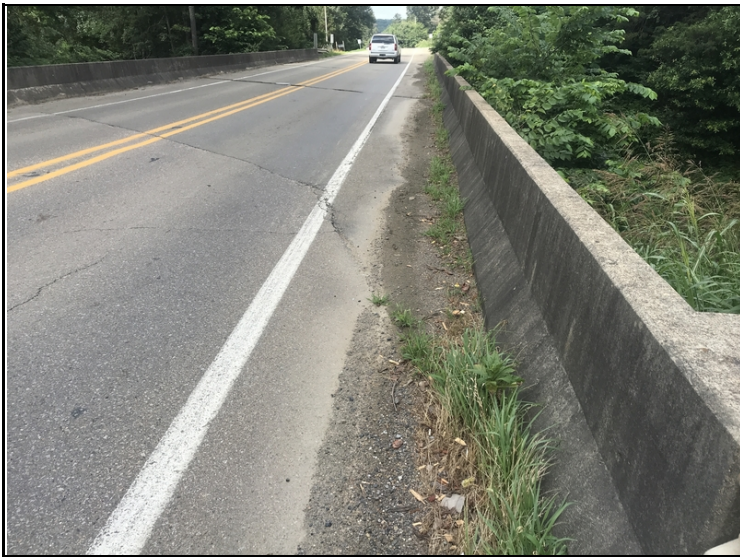
R.C. Deck-
The deck has dirt, debris and vegetation in the gutters.

Dirt and vegetation in the gutters.

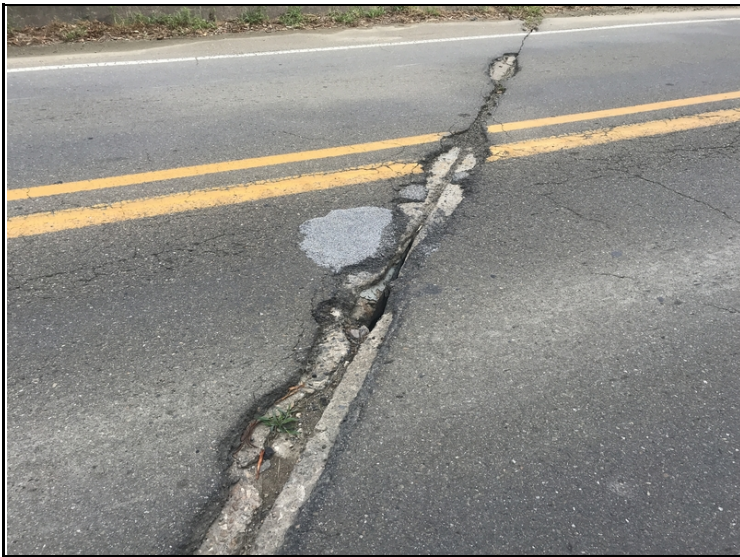
The concrete deck over the intermediate bents is cracking and spalling in the open expansion joints.

Span #2, Bent #3 with spalling adjacent to the deck joint in the top flange.

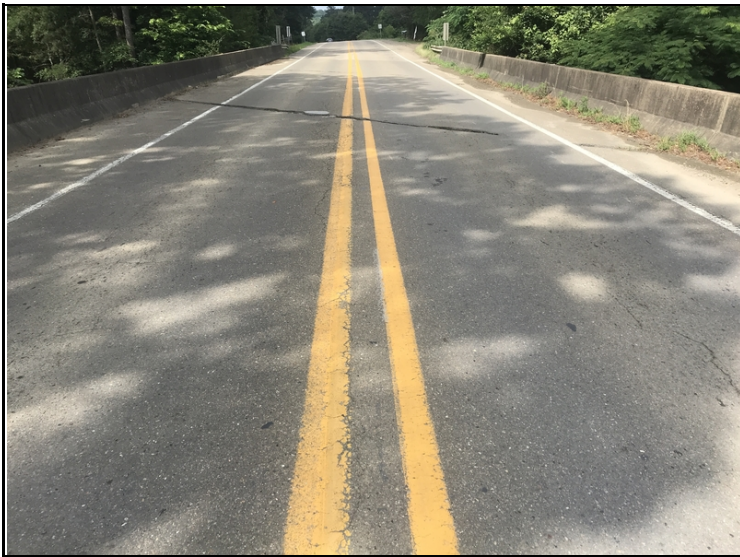
Asphalt Driving Surface-
The asphalt driving surface is delaminated in several areas along the gutters.

Typical driving surface of the deck.
