Asset #A6686(Routine)

US 412 WB Lanes over Beaver Lake

Location: 7.2 Mi E Jct 71B & 412

Team Lead: Bob McEntyre, Inspection Date: 10/28/2021

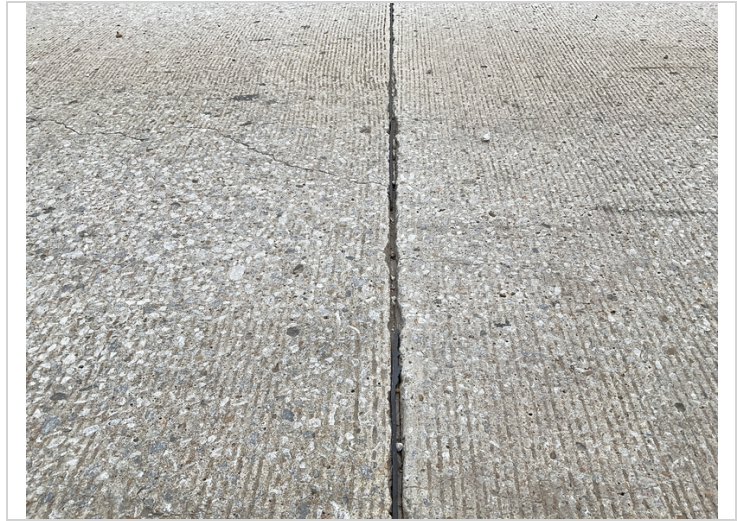
Saw joint material missing.

The saw joint sealant is deteriorated and missing in locations and appears to leak water onto the superstructure and metal stay in place forms.

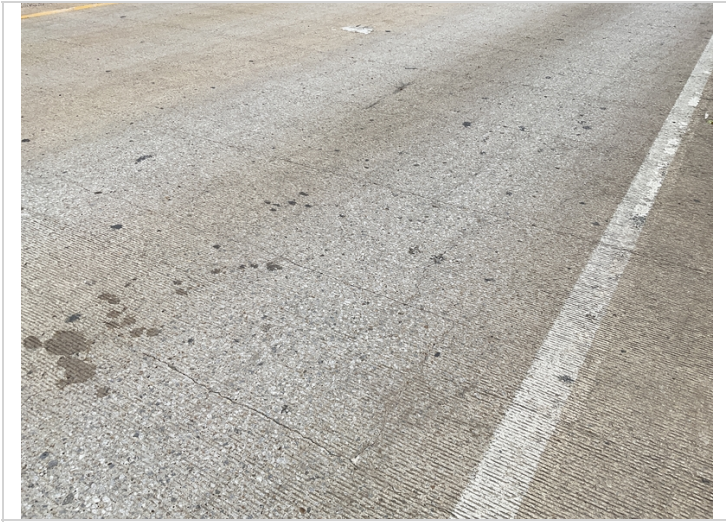
Span 4, left lane-Transverse deck cracking.

Deck -
The driving surface of the deck has sealable cracking in all spans.

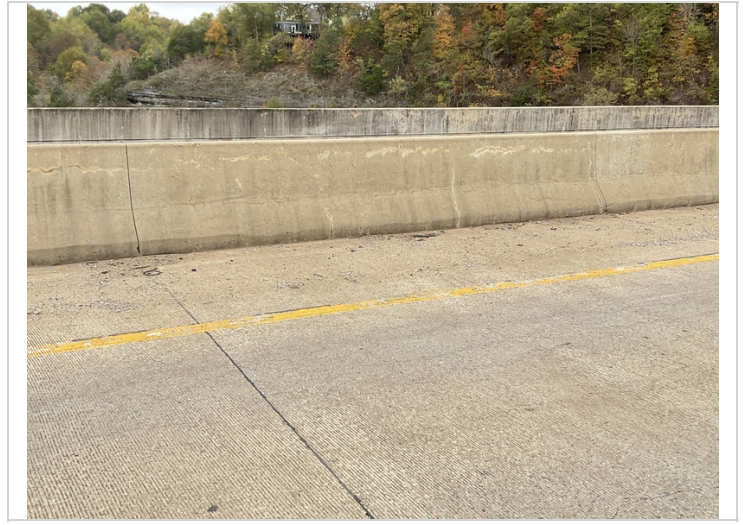
Cracking in right parapet.

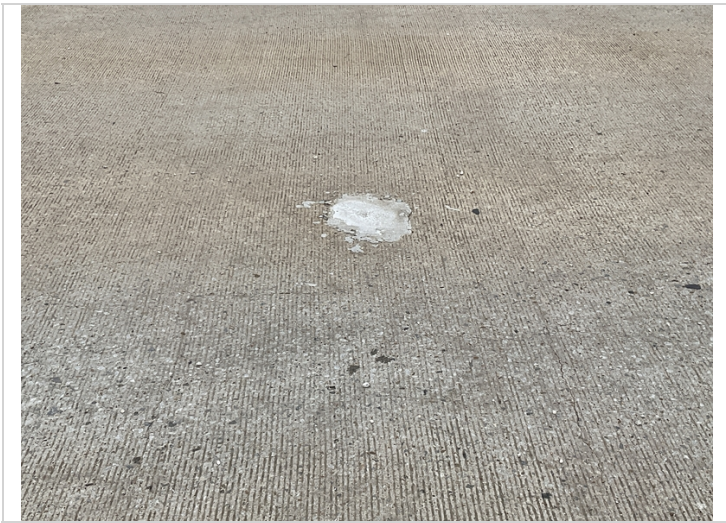
Span 3-Plowable pavement markers removed.

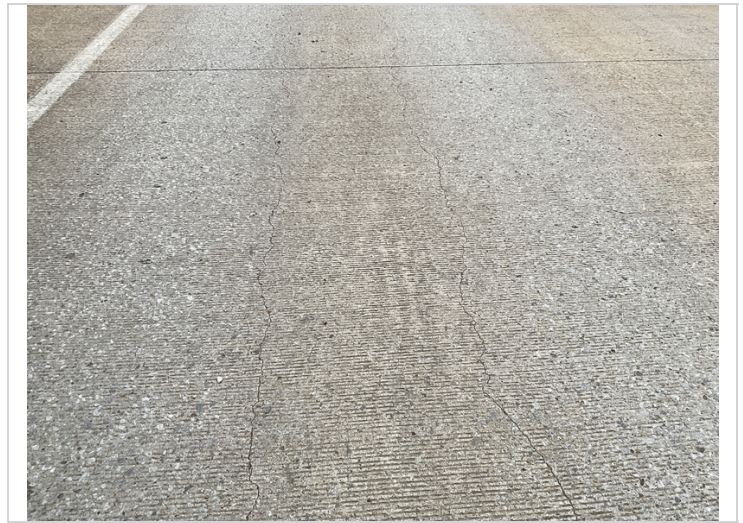
Span 2, left lane-Longitudinal cracking.

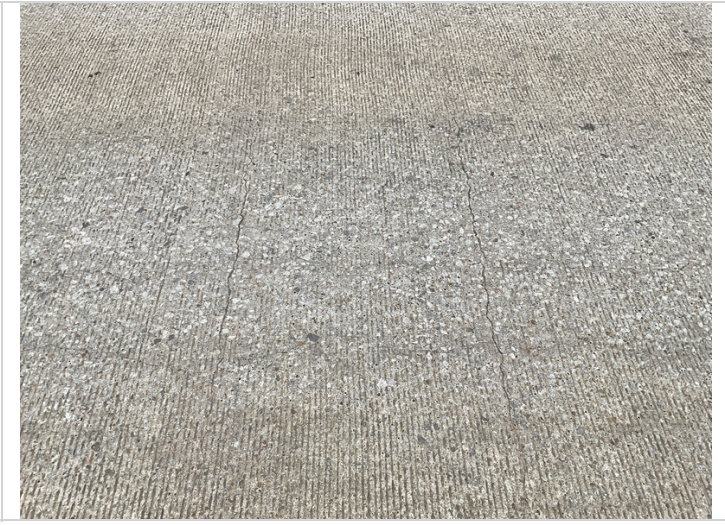
Span 2, left lane-Transverse cracking.

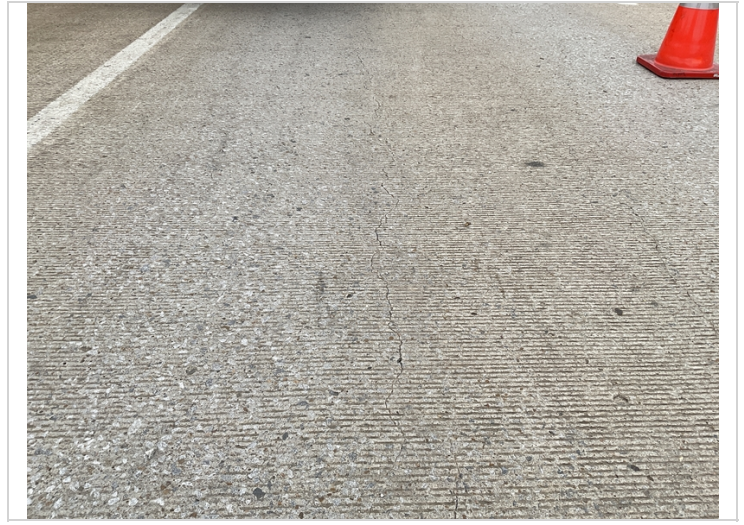
Span 1, left lane-Longitudinal cracking.

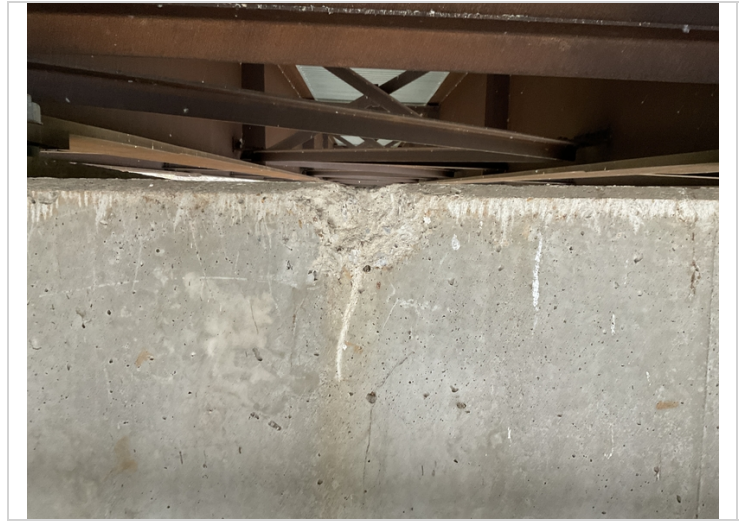
Bent 2 cap-Shallow 6" spall near centerline of cap.

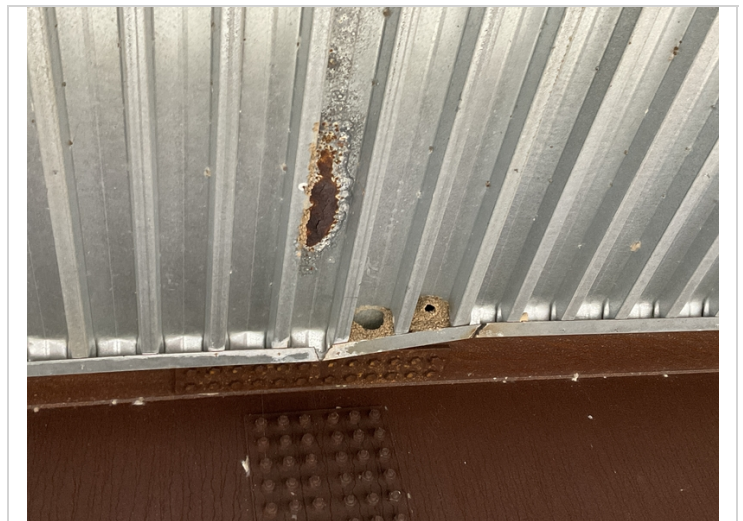
Span 2, bay 3-Corrosion in SIP forms.

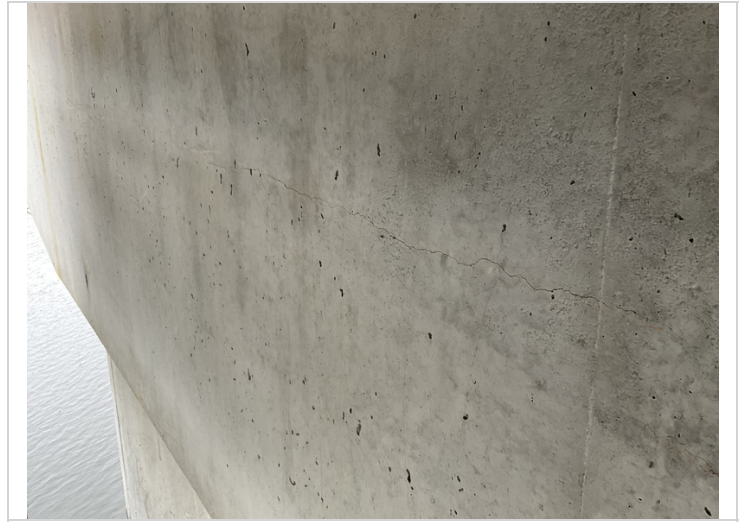
Bent 4 cap-Horizontal cracking.

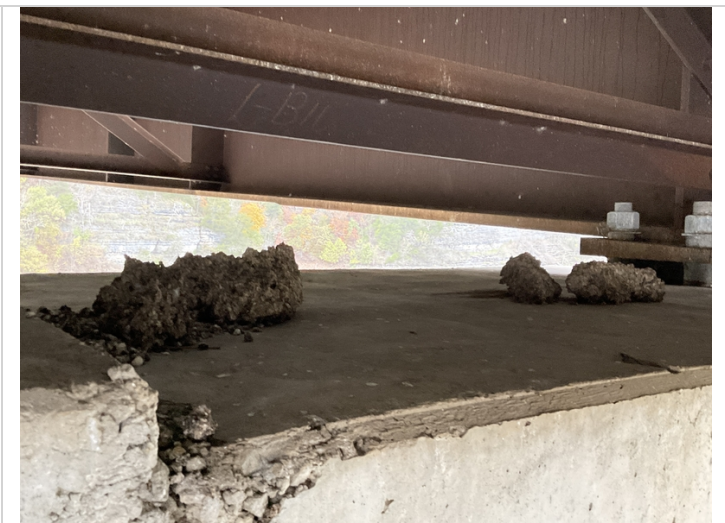
Pigeon droppings.

Bent caps -
Pigeon droppings have accumulated on the steel superstructure and bent caps. Bent # 4 is worst case.

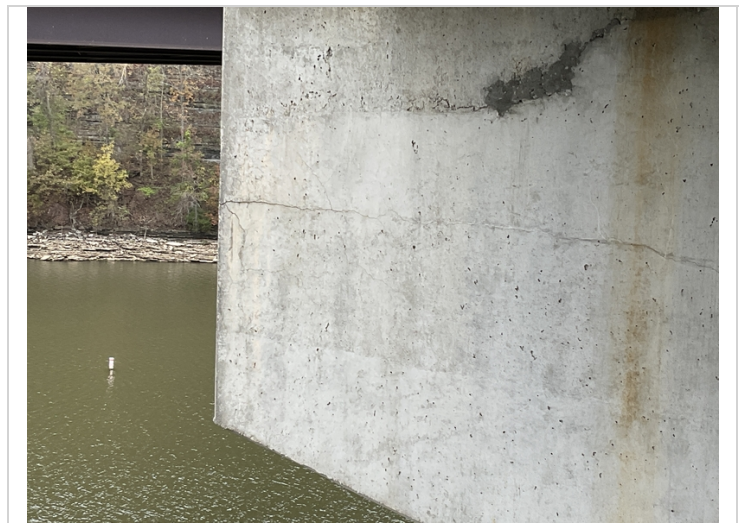
Bent 4 cap, right side-Horizontal cracking.

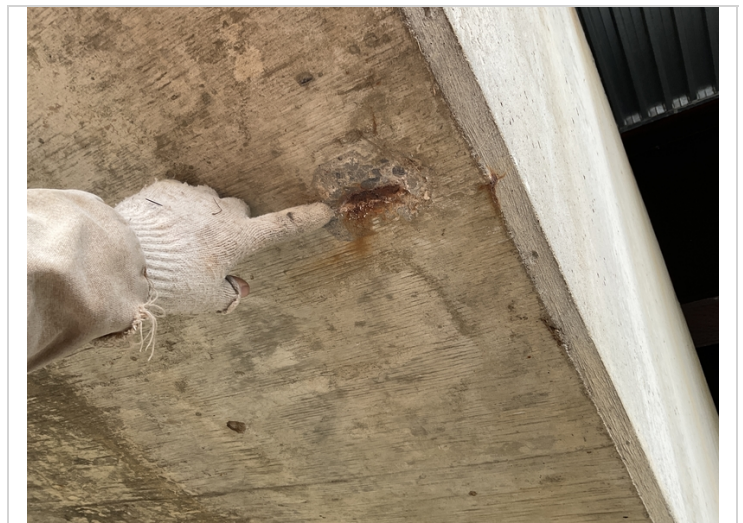
The left end of cap has a 3" spall in the undersurface with exposed reinforcing steel.

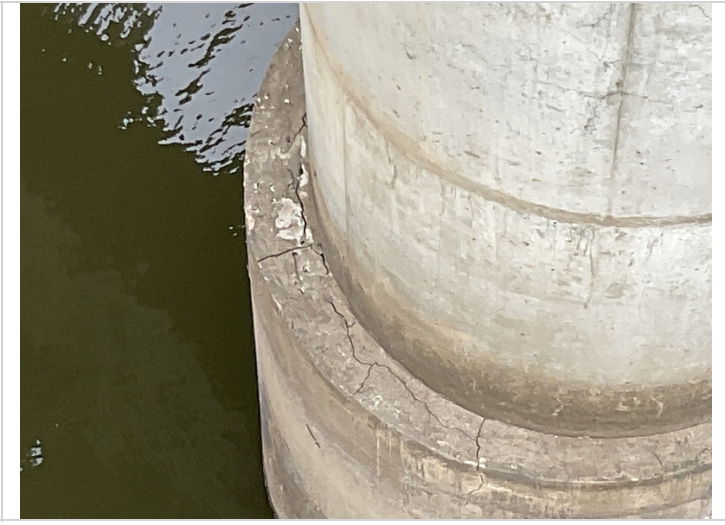
Bent # 5, column # 1-Wide cracking in top of drilled shaft.

Bent # 5 - Column # 1 has vertical cracks approximately 3/16" wide on the face and top of the drilled shaft concrete.

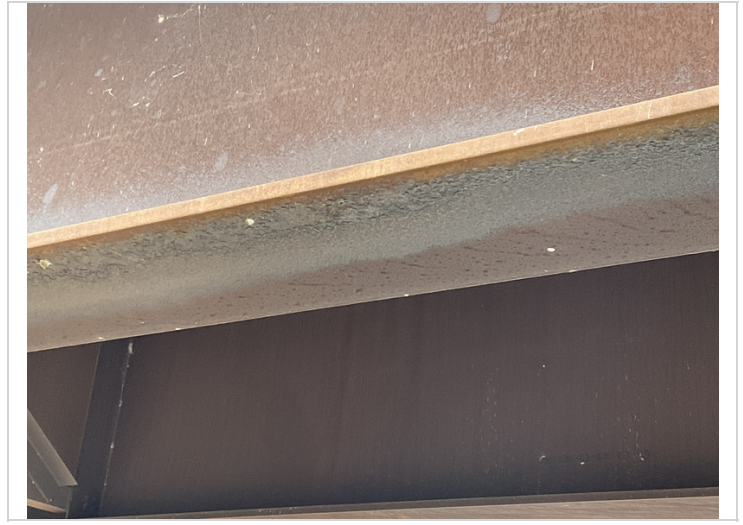
Span 5, girder 1-Abnormal weathering.

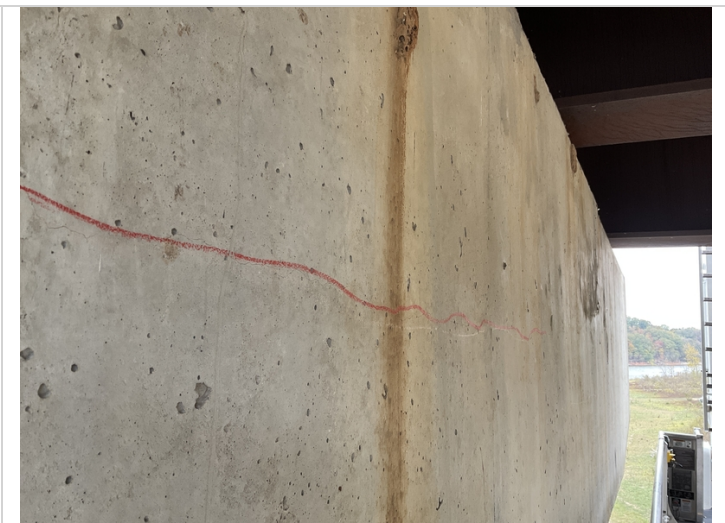
Bent 5 cap-Hairline horizontal crack.

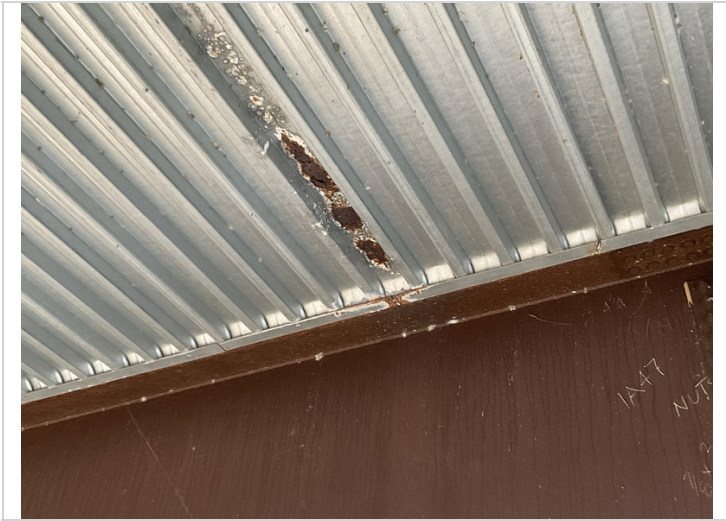
Span 5, bay 3-Corrosion to SIP forms.

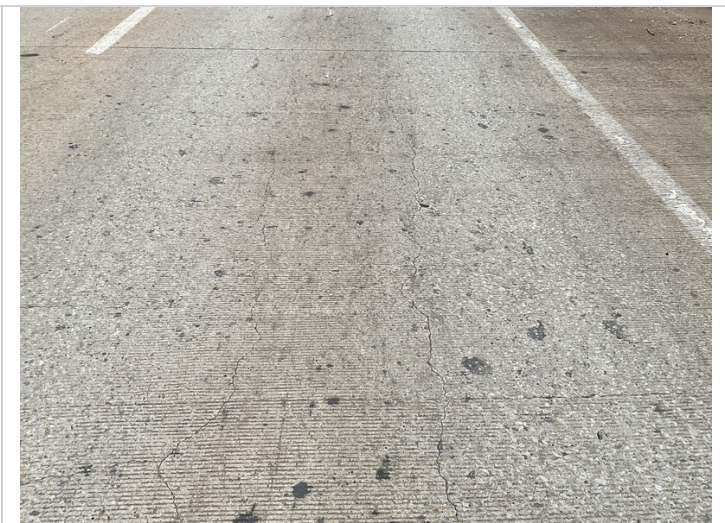
Span 5, left lane-Longitudinal cracking.

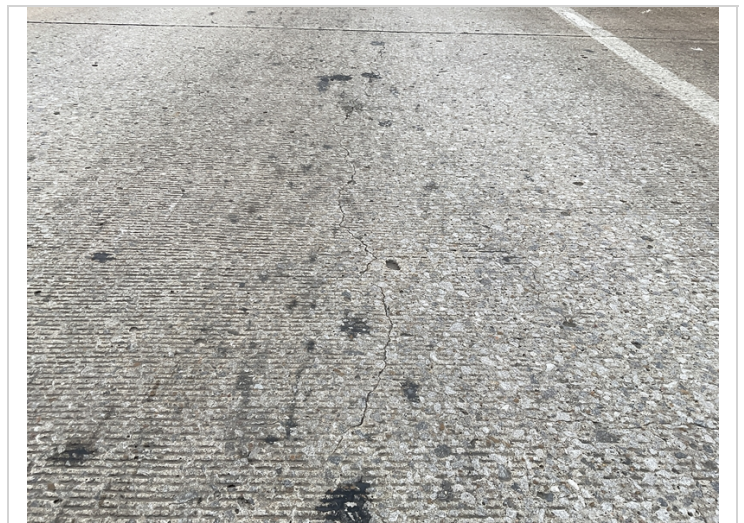
Span 5, left lane-Longitudinal cracking.

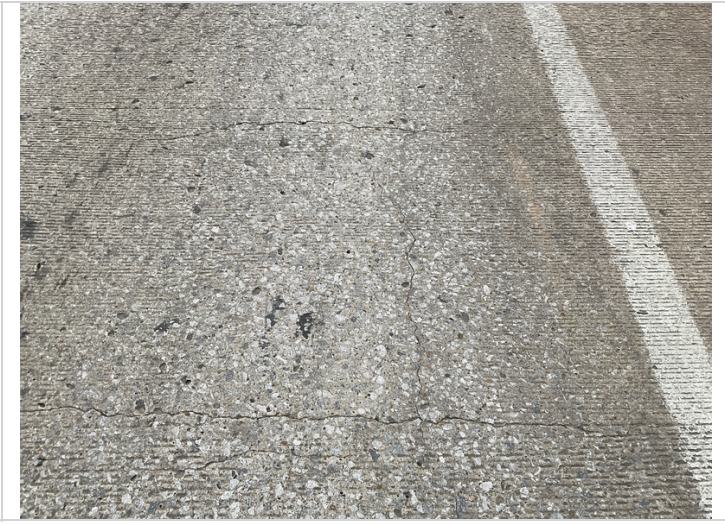
Span 5, left lane-Longitudinal and transverse cracking.

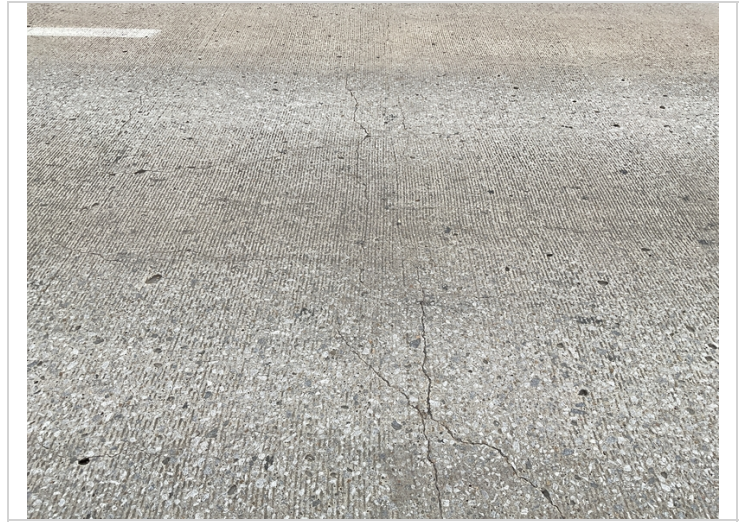
Span 5, left lane-Transverse cracking.

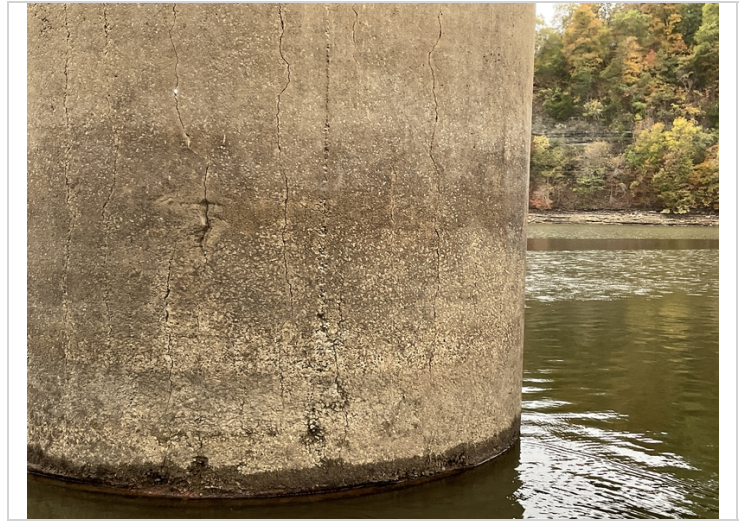
Bent 5, column 1-Vertical cracking.

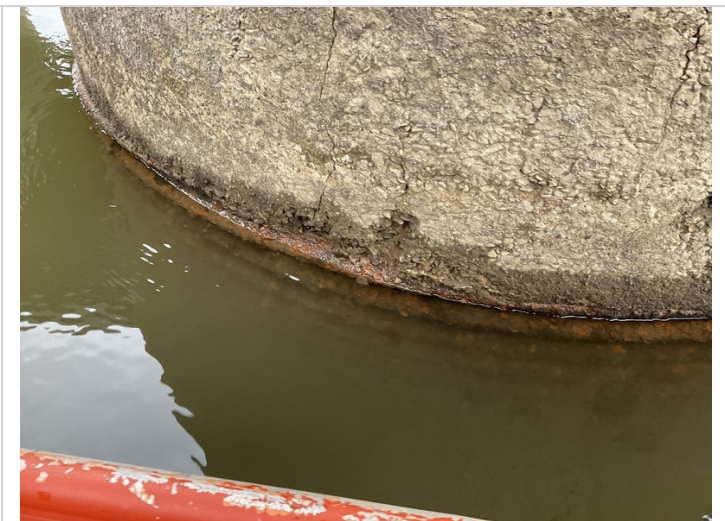
Bent 5, column 1-Concrete deterioration.

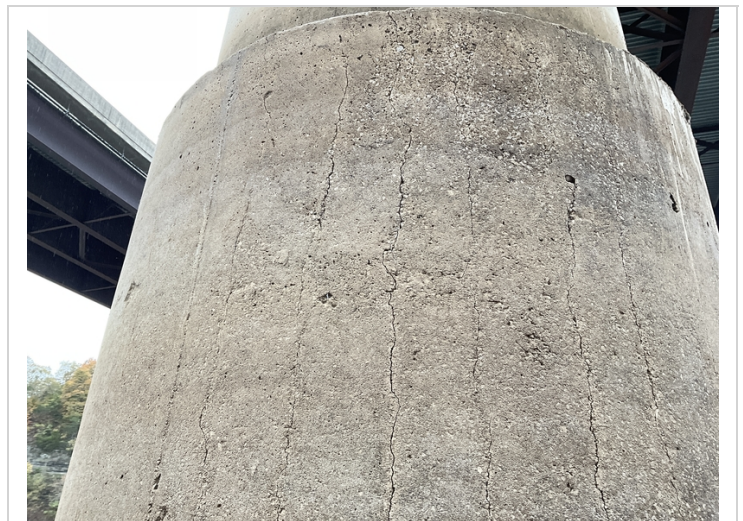
Bent 5, column 1-Vertical cracking.

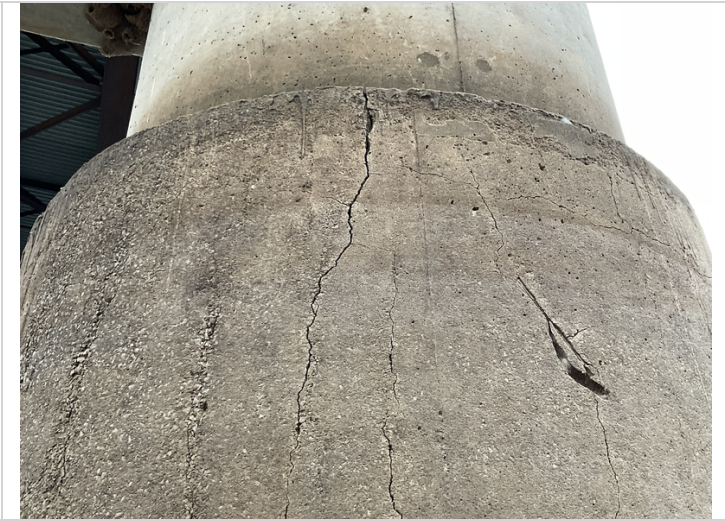
Bent # 5, column # 1-Wide vertical cracking.

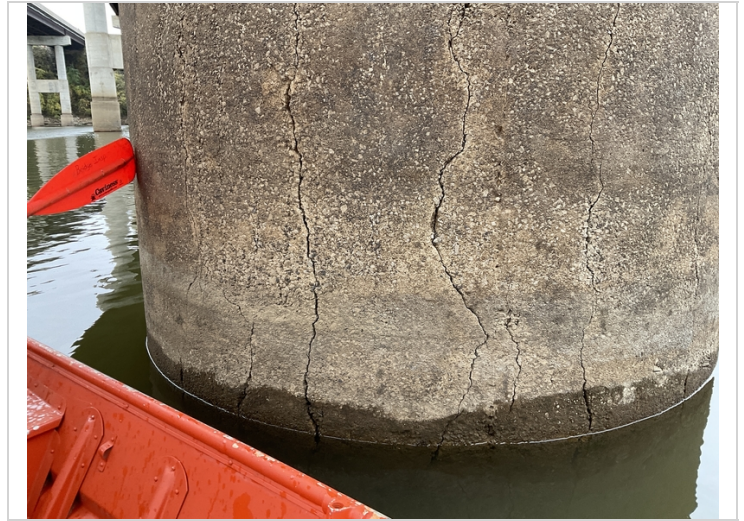
Bent # 5, column # 1-Wide vertical cracking.

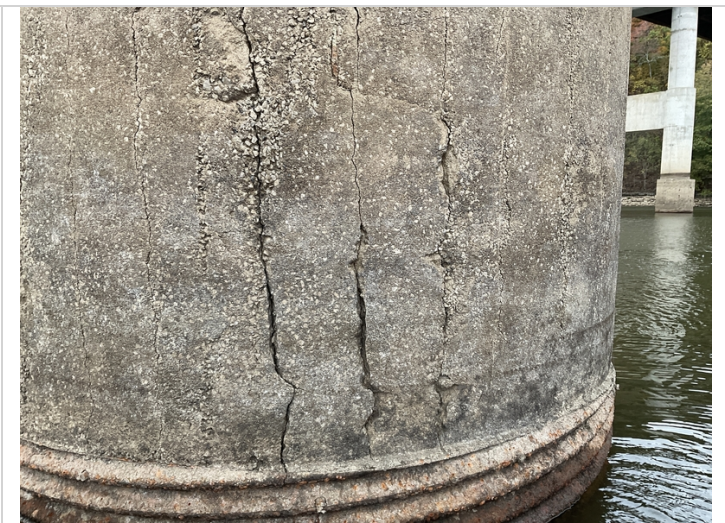
Bent 4, column 2-Concrete deterioration.

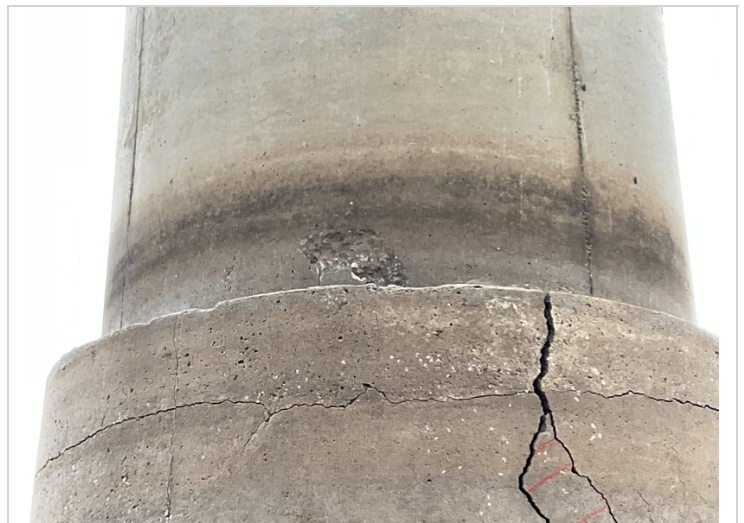
Bent 4, column 1-Wide vertical cracking shallow 10" spall.

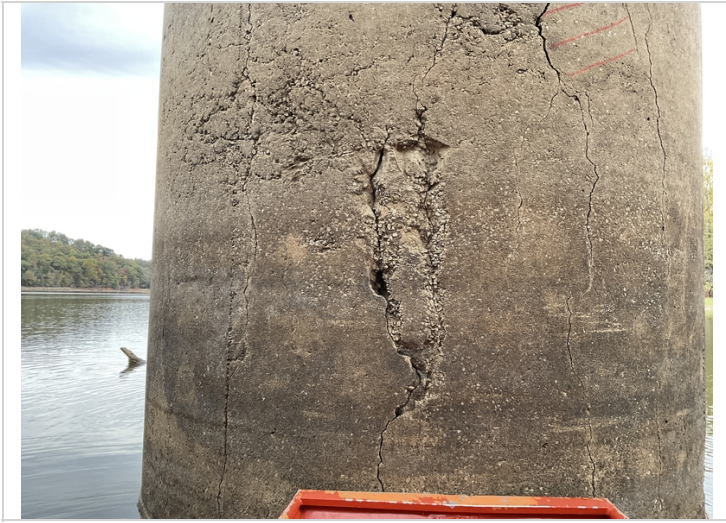
Bent 4, column 1-Concrete deterioration.

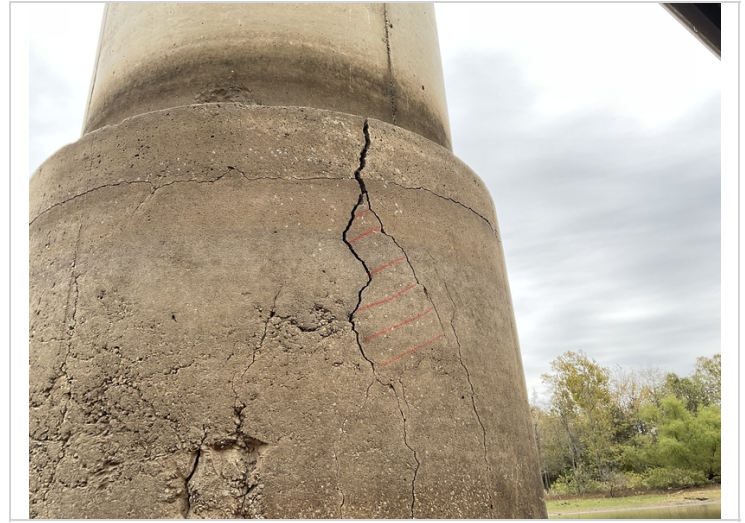
Bent 4, column 1-Wide vertical cracking with delaminated areas.

Most extreme case is Bent # 4, Column # 1 that has a vertical crack approximately 3/4" wide on the face and top of the drilled shaft concrete with the upper portion of the drilled shaft delaminated adjacent to the crack.

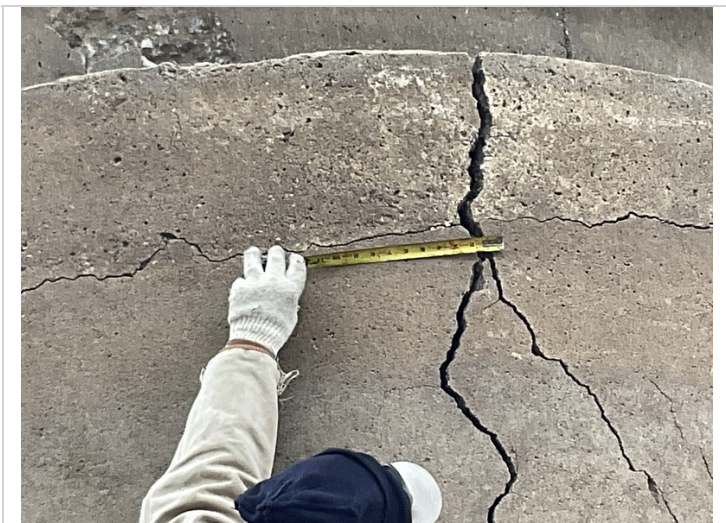
Bent 4, column 1-Wide vertical cracking with delaminated areas.

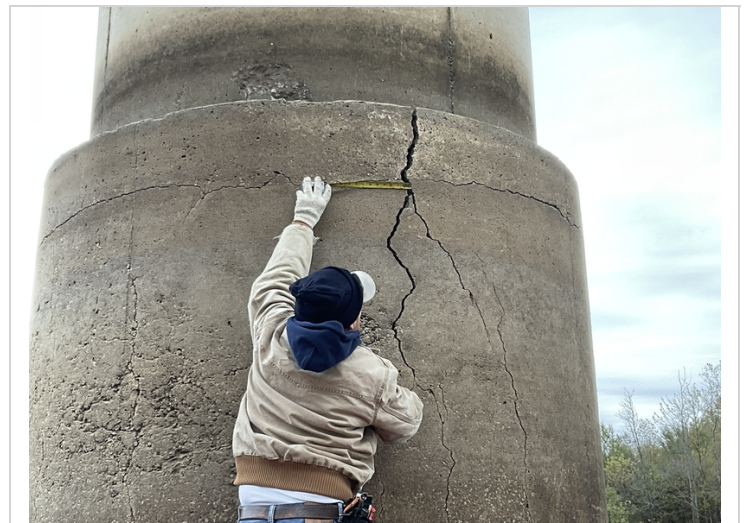
Bent 4, column 1-Wide vertical cracking with delaminated areas.

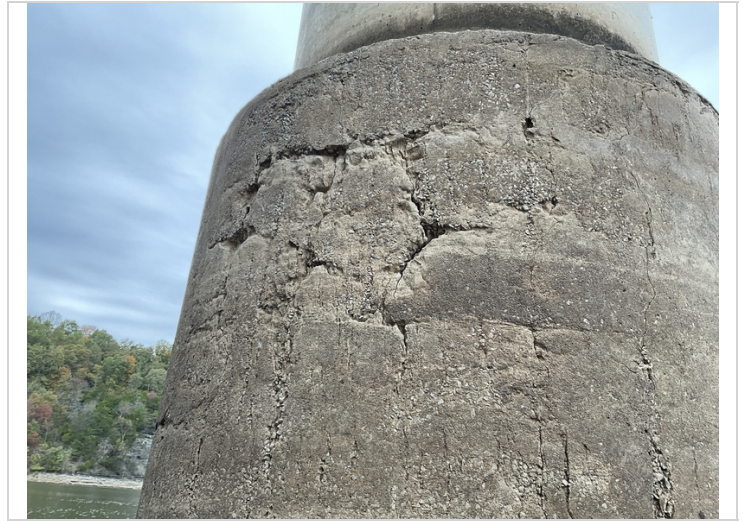
Honeycombing / concrete deterioration in drilled shaft.

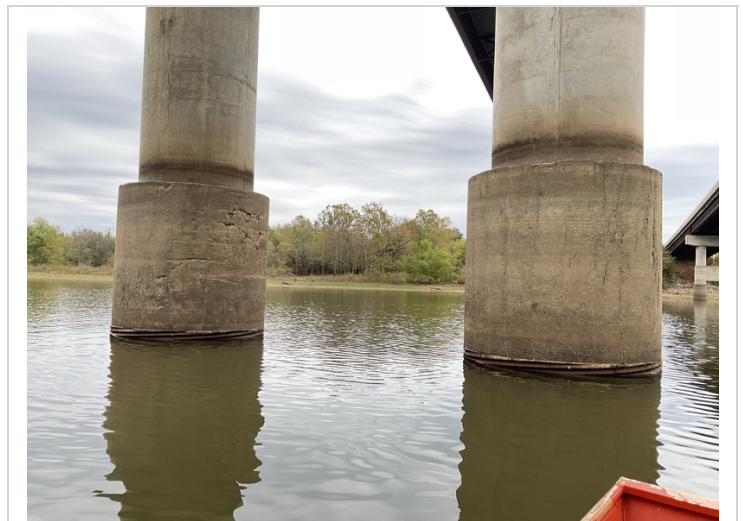
Bent 3 drilled shafts.

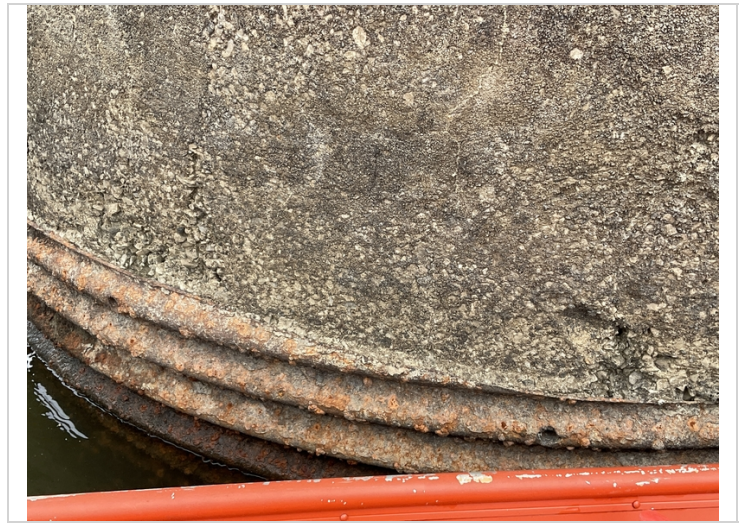
Bent 2, column 1-Concrete deterioration.

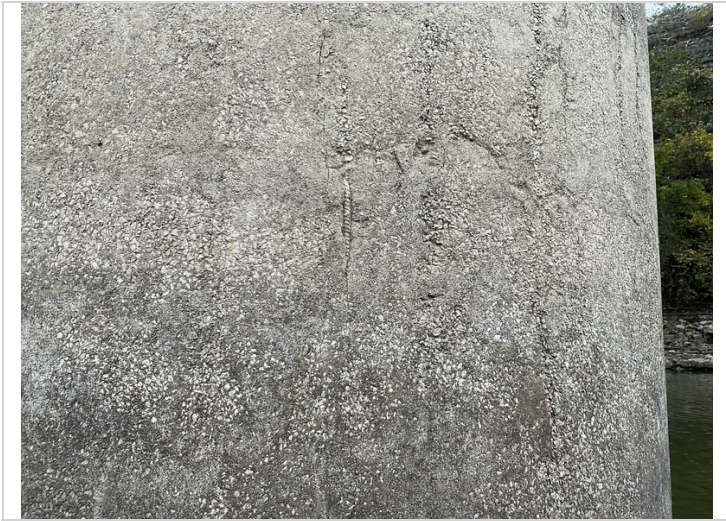
Bent 2, column 1-Exposed steel.

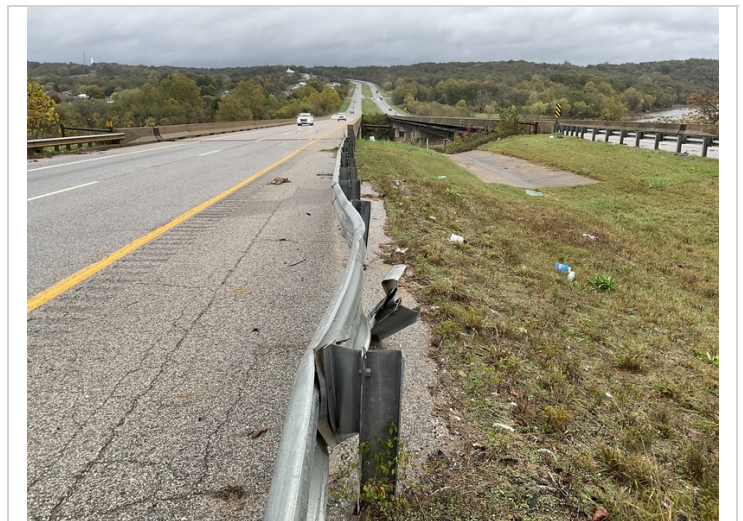
Collision damage to the Southwest approach railing has destroyed approximately 15' of the railing and two railing posts. The collision damage has created a "pocket" in the railing.

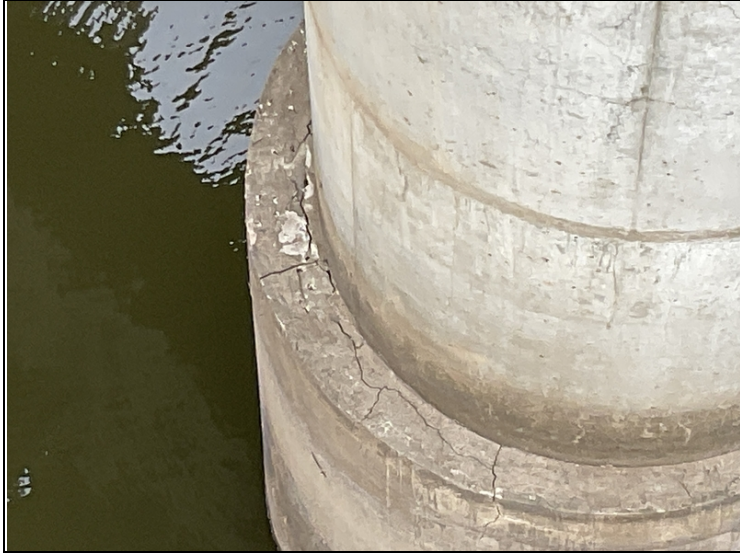
Bent # 5, column # 1-Wide cracking in top of drilled shaft.

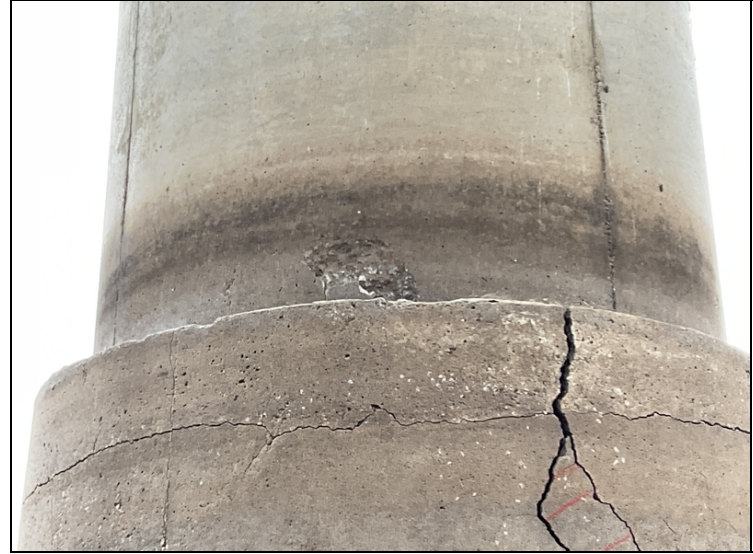
Bent # 4, column # 1-Wide vertical cracking shallow 10" spall.

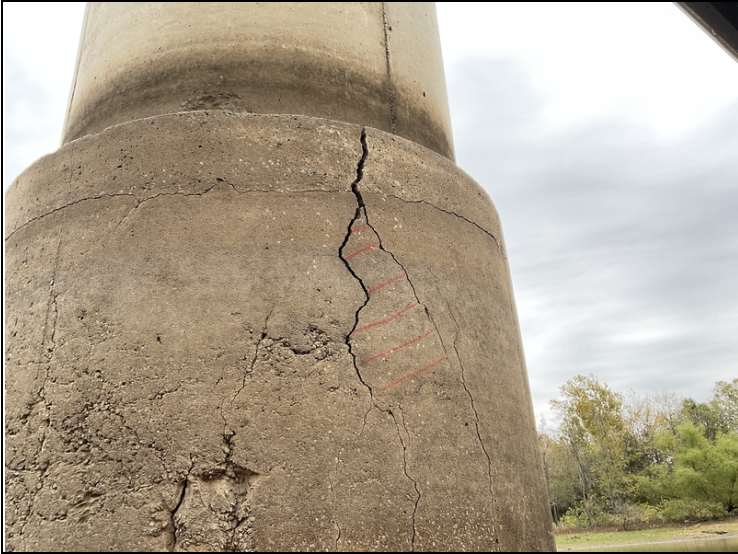
Bent 4, column 1-Wide vertical cracking with delaminated areas.

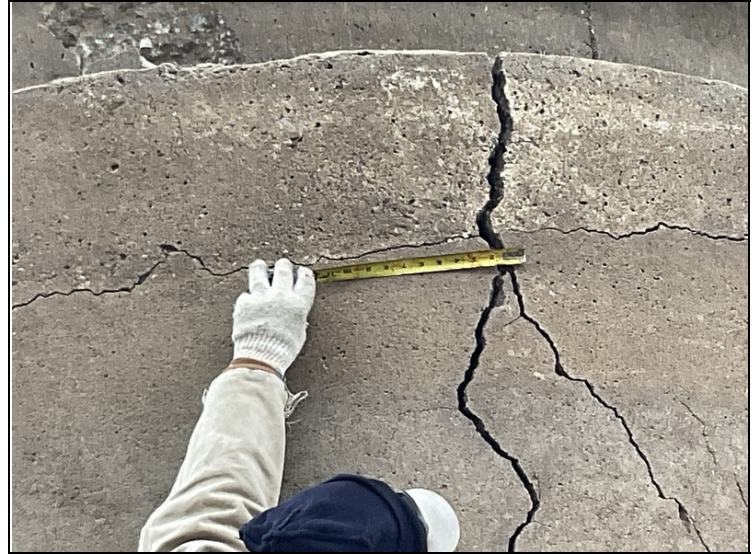
Bent # 4, column # 1-Wide vertical cracking with delaminated areas.

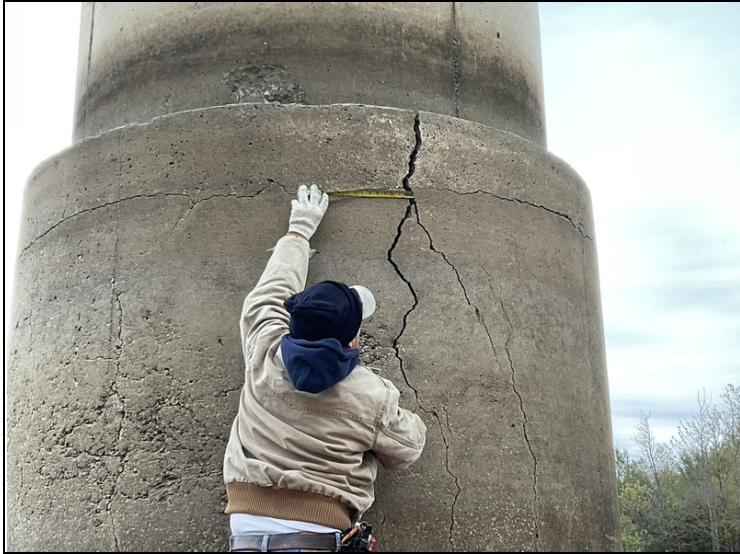
Bent # 4, column # 1-Wide vertical cracking with delaminated areas.

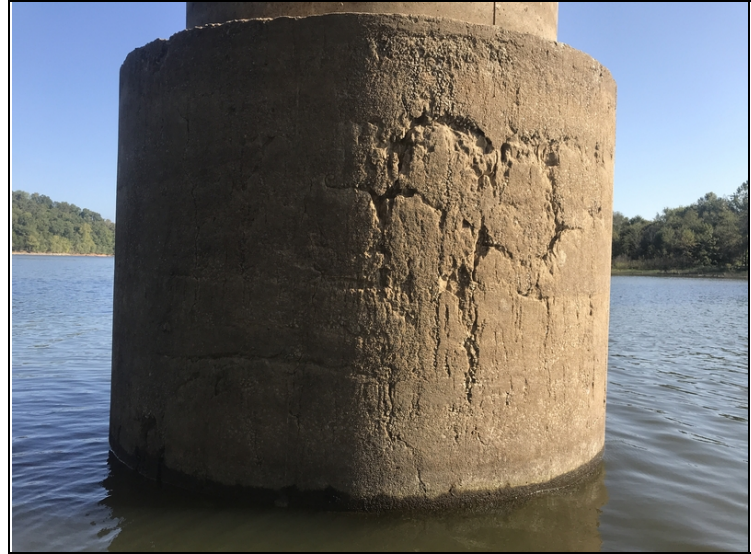
Bent # 3 - Left column has concrete deterioration at the water elevation with a 3' area with exposed reinforcing steel (Hoop) located approximately 1' below the top of the drilled shaft concrete.

Left column of Bent # 3.

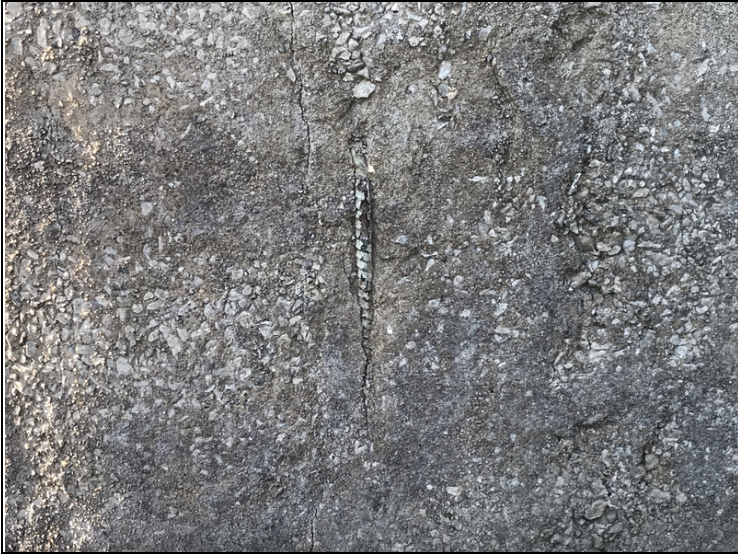
Bent # 2 - Left column has an 8" piece of vertical reinforcing steel visible in the North face of the column. Exposed reinforcing steel appears to be epoxy coated # 4 bar located approximately 4' below the top of the drilled shaft concrete.
Bent # 2 - Right column has an 8" piece of vertical reinforcing steel visible in the West face of the column. Exposed reinforcing steel appears to be epoxy coated # 4 bar.

Bent # 2 Left column. North face of Column.

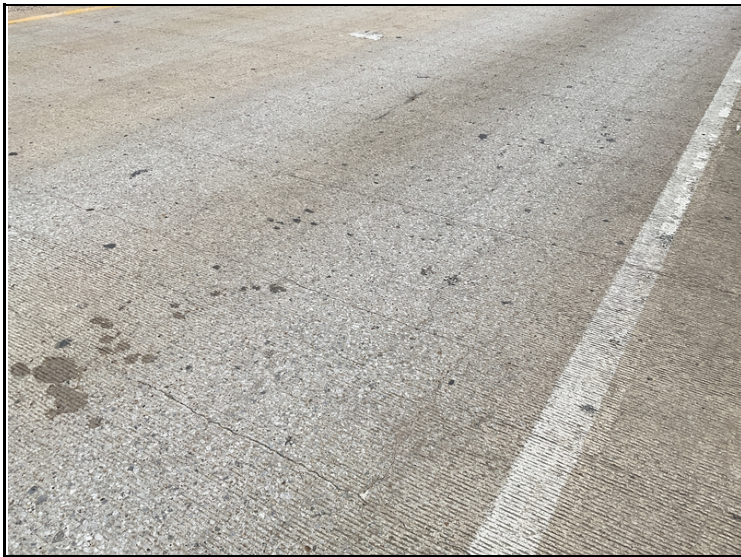
Span 4, left lane-Transverse deck cracking.

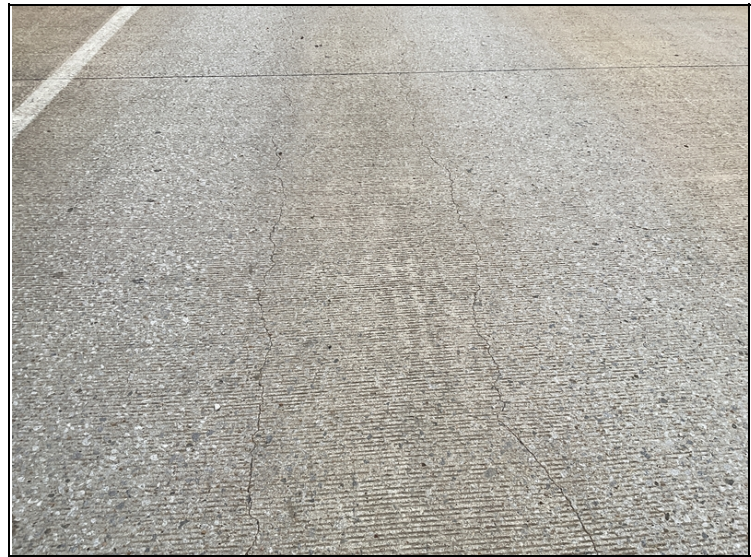
Span 2, left lane-Longitudinal cracking.

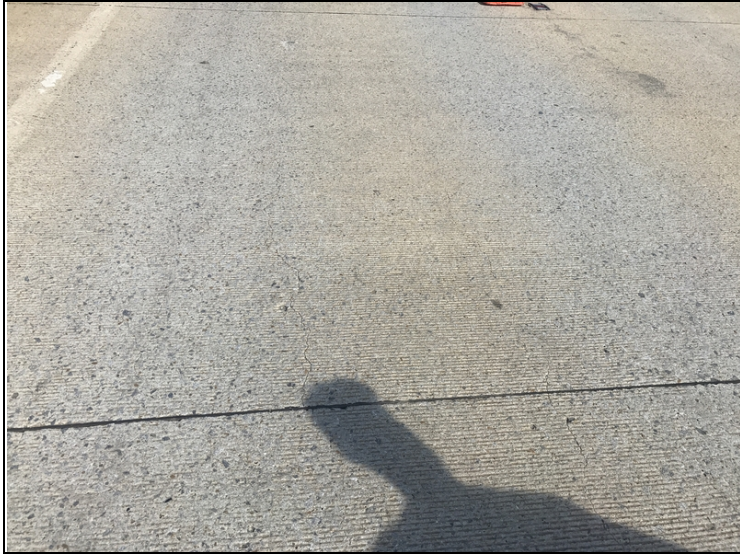
Longitudinal deck cracks.

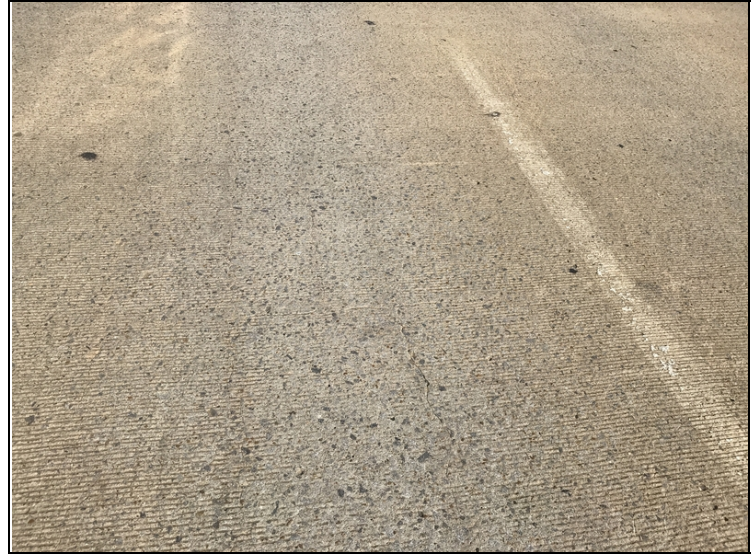
Sealable deck cracks.

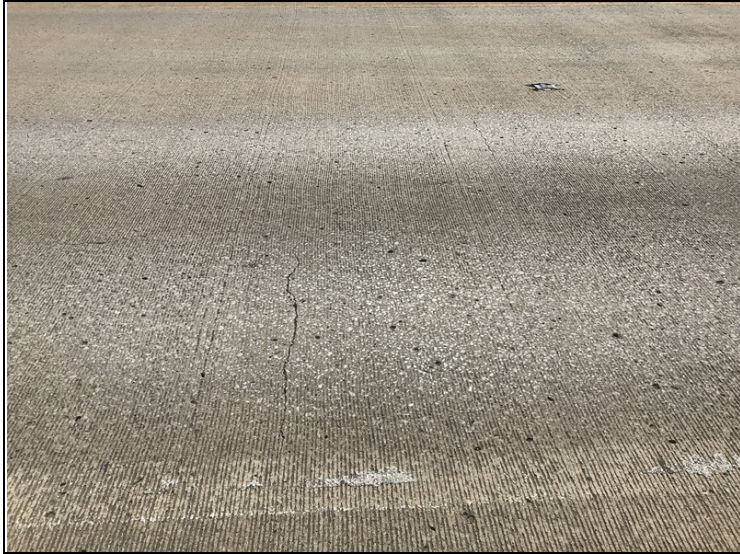
Transverse cracking in the deck.

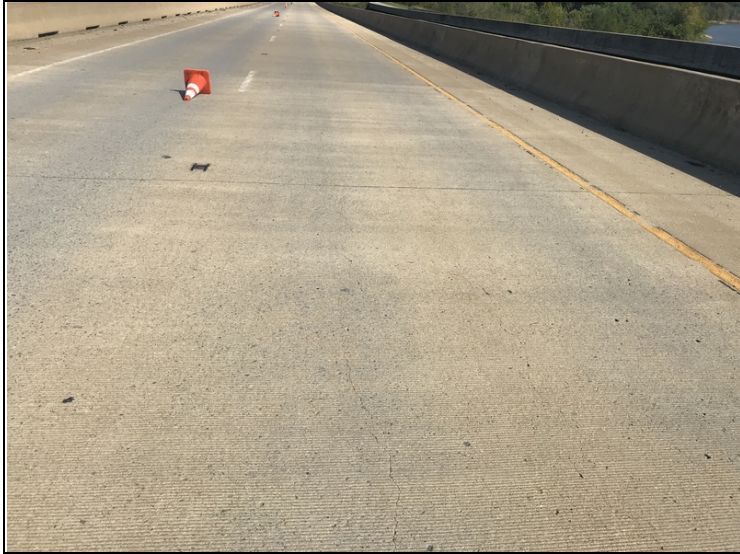
Longitudinal deck cracks.

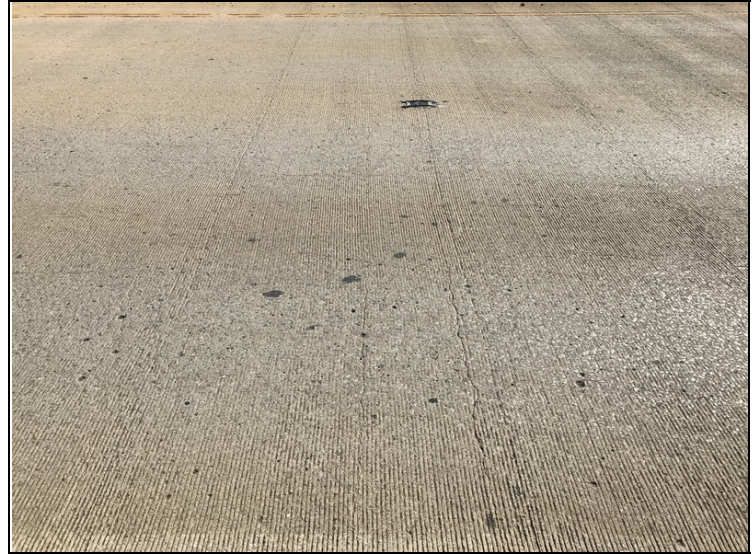
Sealable transverse cracks.

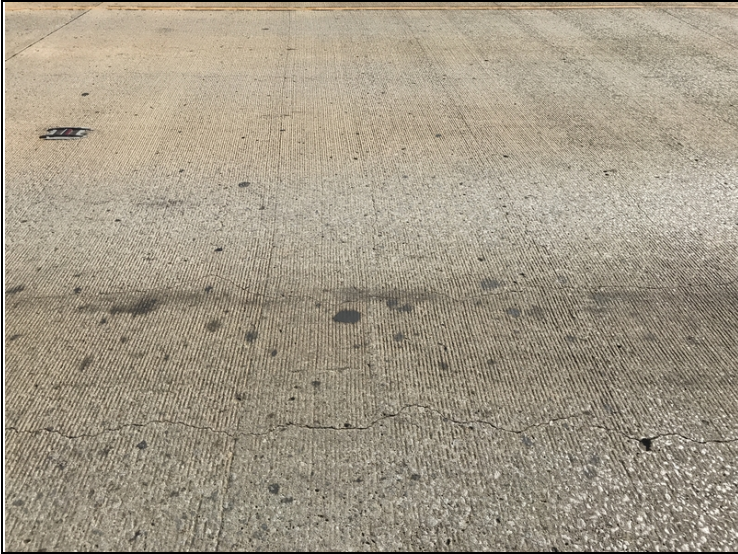
Longitudinal and Transverse cracks.

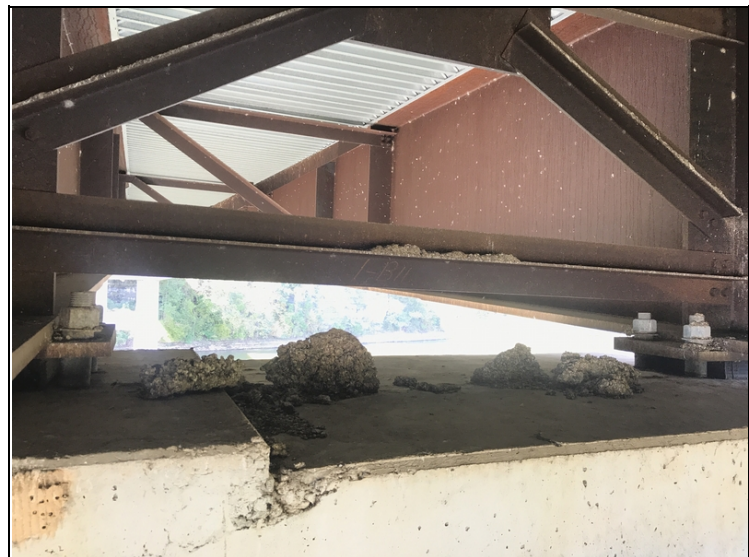
Pigeon droppings. Bent # 4 cap.

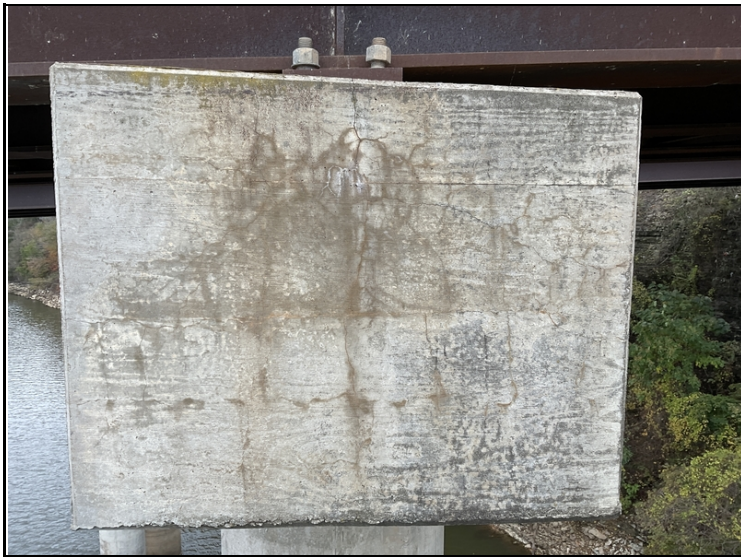
The ends of the intermediate bent caps have map cracking with cracks up to an 1/8" wide in some locations.

Bent # 2 cap, left end-Mapcracking.

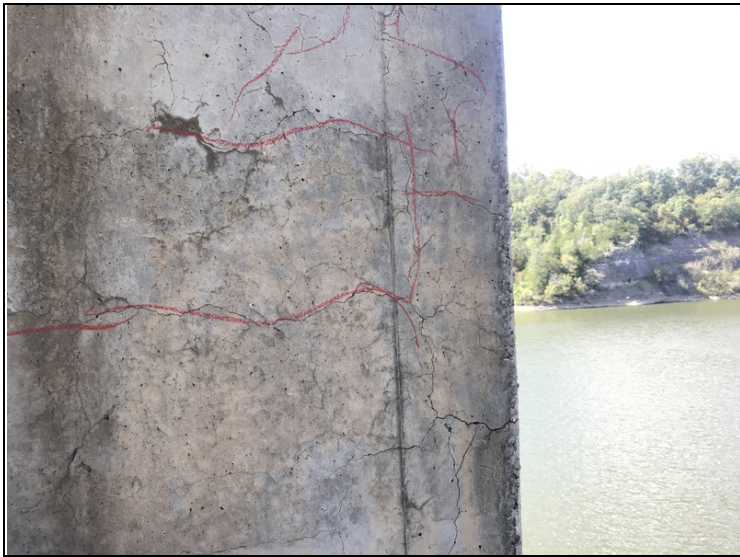
Bent # 4 cap, left side map cracking.

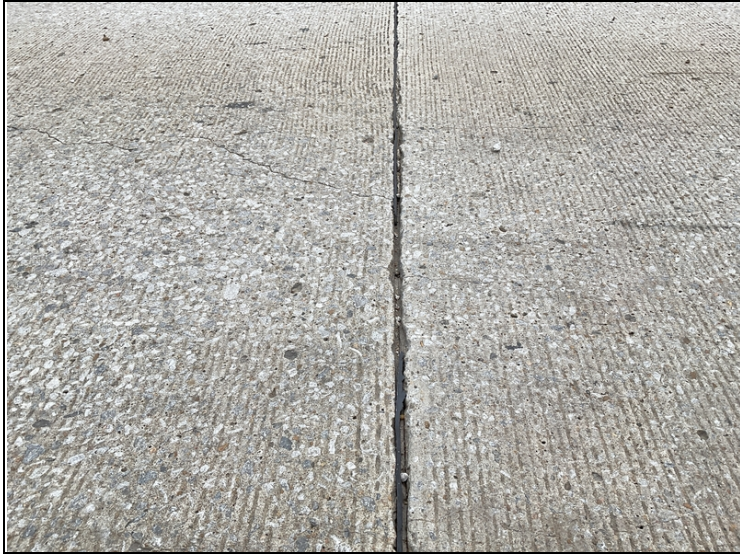
Saw joint material missing.
