Asset #A6686(Routine)

US 412 WB Lanes over Beaver Lake

Location: 7.2 Mi E Jct 71B & 412

Team Lead: Bob McEntyre, Inspection Date: 10/28/2021

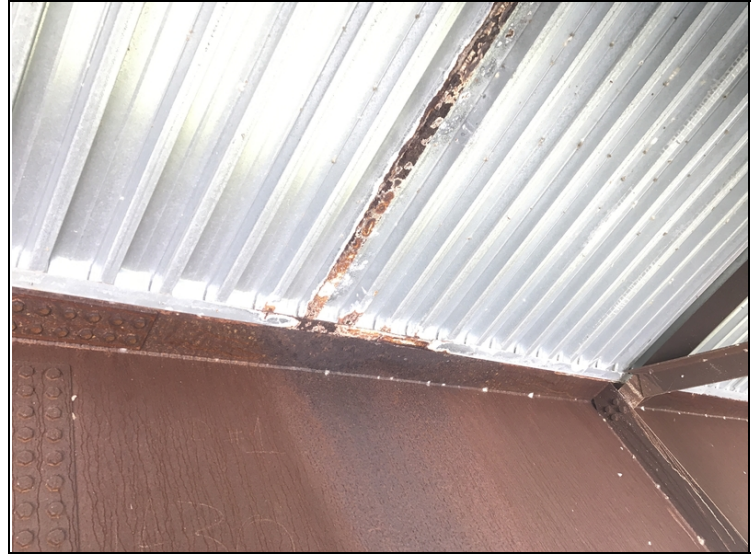
Span # 3. Girder # 3. Splice # 1. Corrosion.

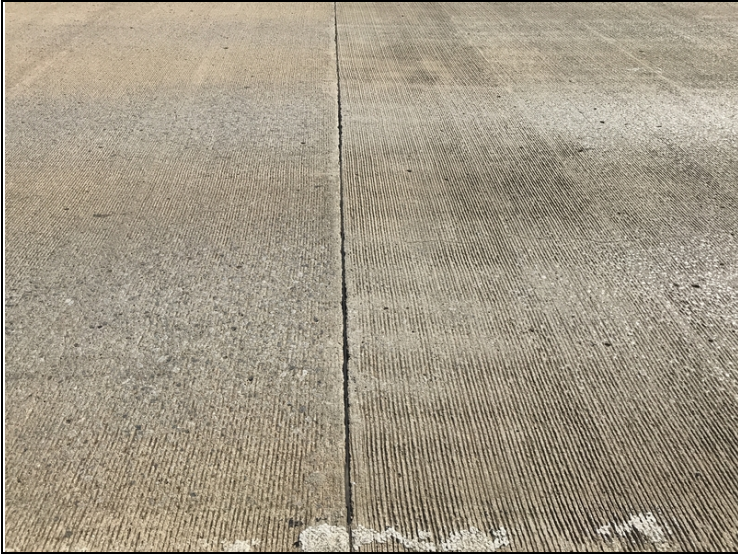
The saw joint sealant is deteriorated and missing in locations and appears to leak water onto the superstructure and metal stay in place forms.

Transverse saw joint sealant.

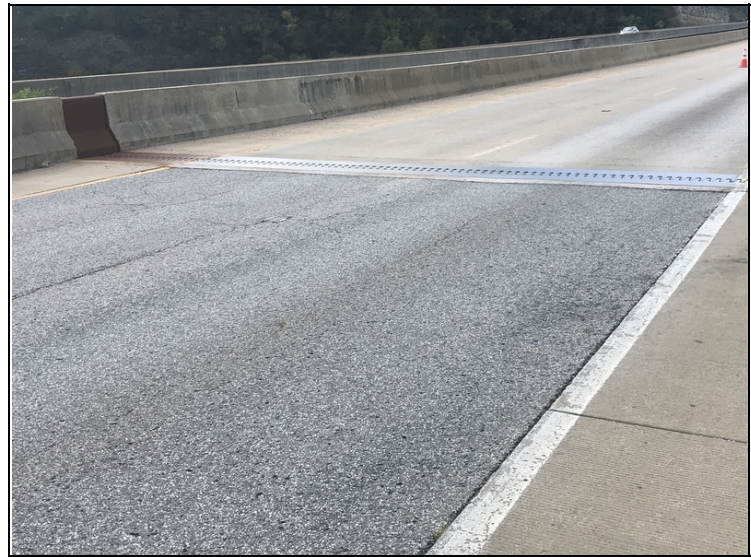
Approach Roadways -
The asphalt at the approaches is beginning to settle.

Asphalt settlement at the East bridge end.

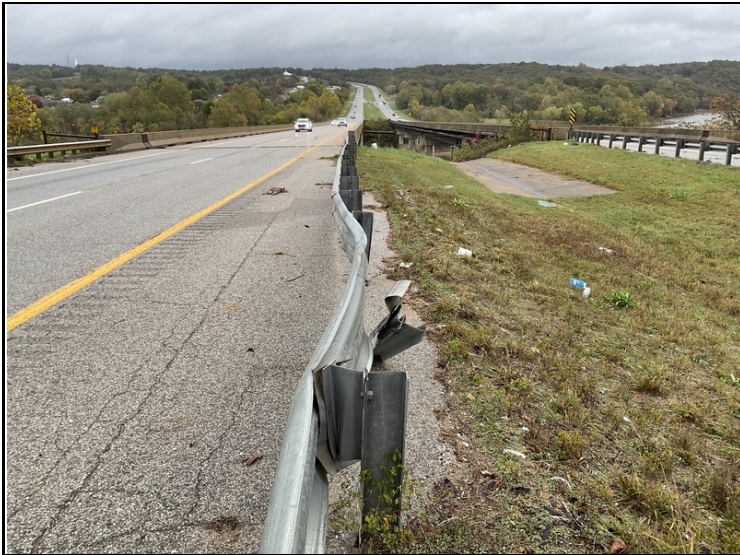
Collision damage to the Southwest approach railing has destroyed approximately 15' of the railing and two railing posts. The collision damage has created a "pocket" in the railing.
