Asset #B6686(Routine)

US 412-East Bound over Beaver Lake

Location: 7.1 Mi E. Jct Hwy US 71B

Team Lead: Bob McEntyre, Inspection Date: 10/28/2021

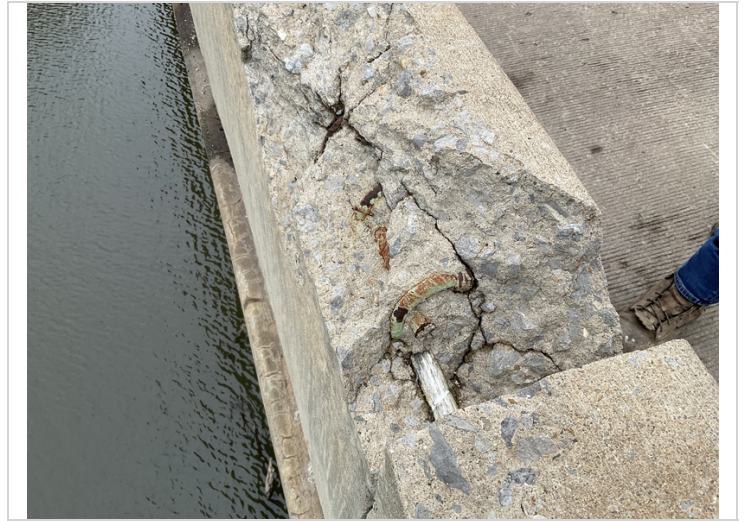
The right parapet in span # 3 has a large spall with exposed epoxy coated and fiberglass reinforcing bar.

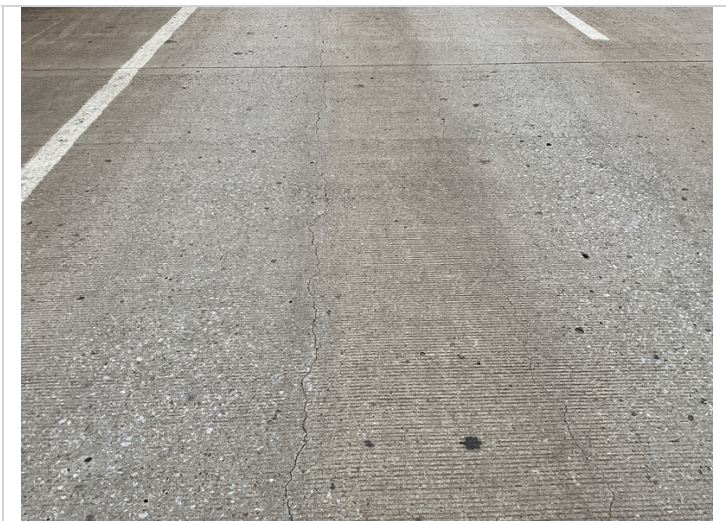
Longitudinal deck cracking.

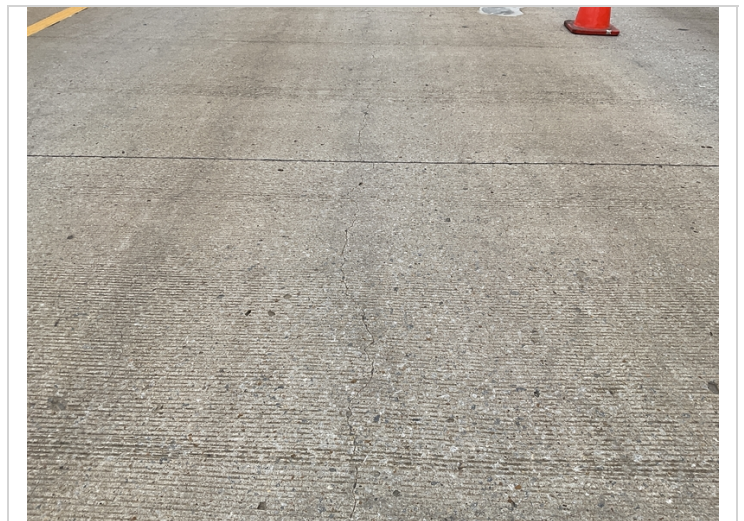
Span 4, left lane-Longitudinal cracking.

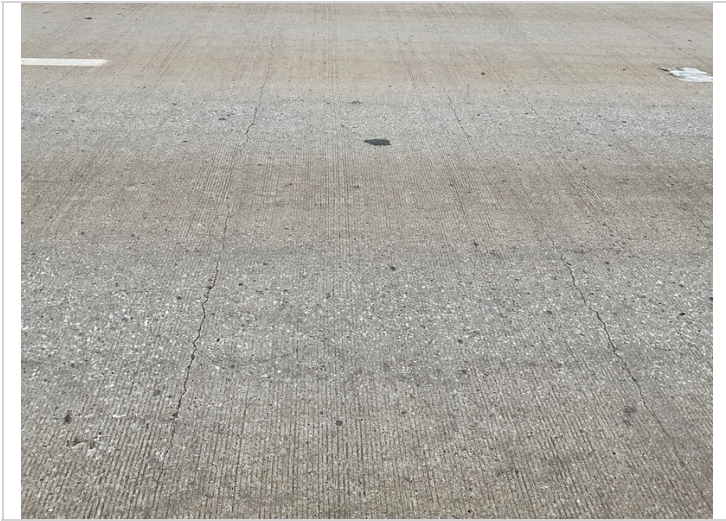
Span 5, right lane-Transverse cracking.

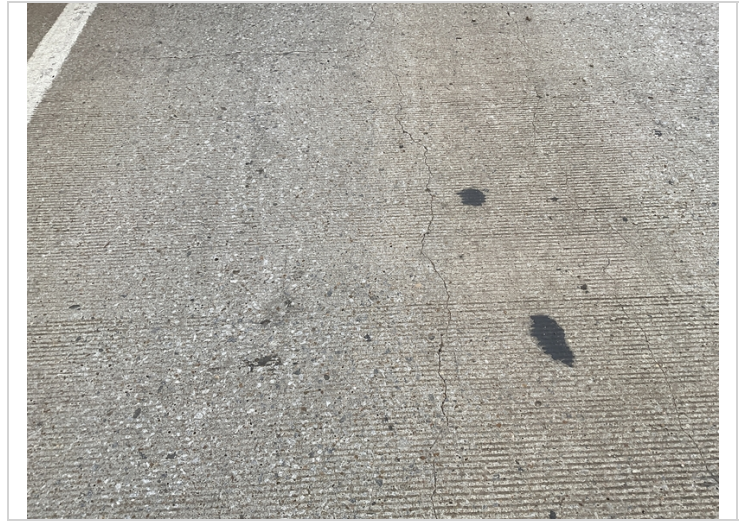
Span 5, right lane-Deck cracking.

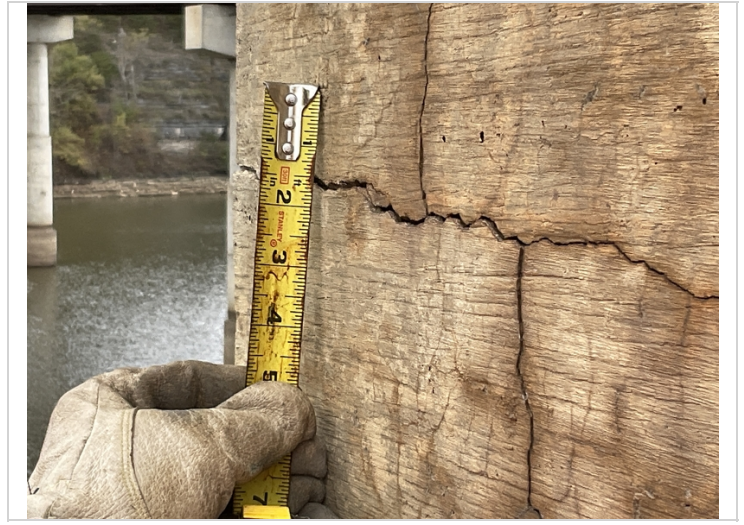
Bent 5 cap, right end-1/8" wide horizontal cracking.

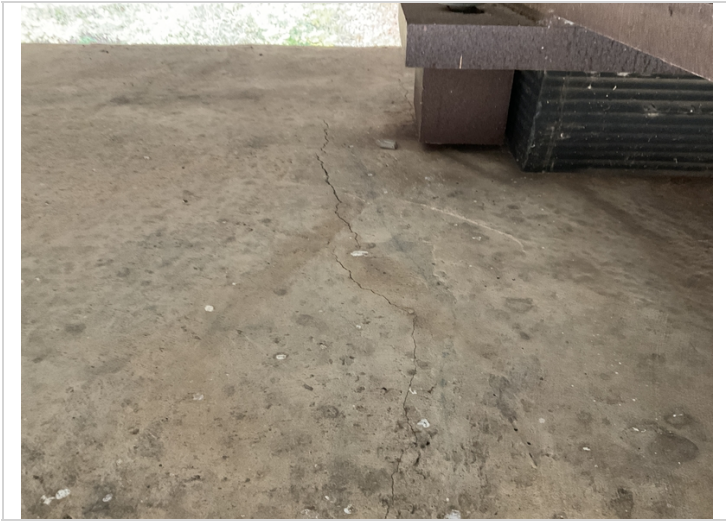
Bent # 5 cap-Transverse crack in top of cap adjacent to beam 2.

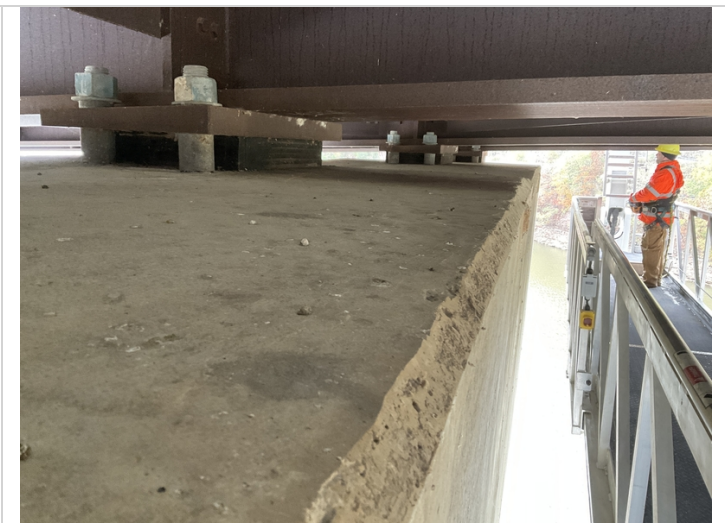
Bent 3 bearing area.

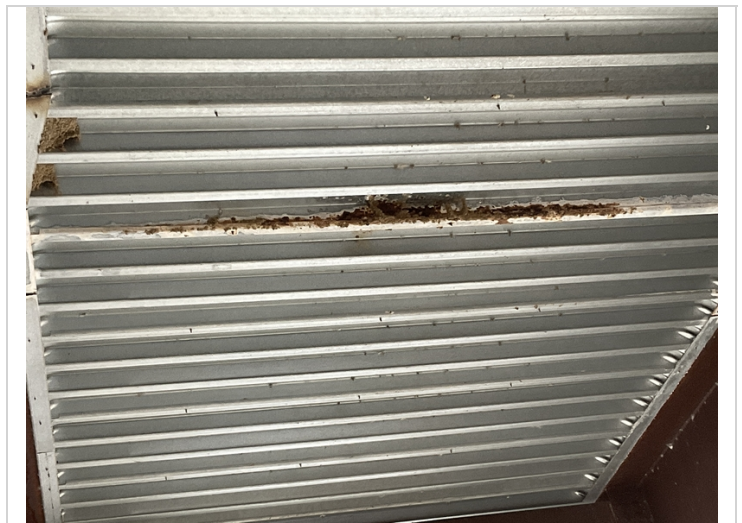
Span 2, bay 3-Corrosion to SIP forms.

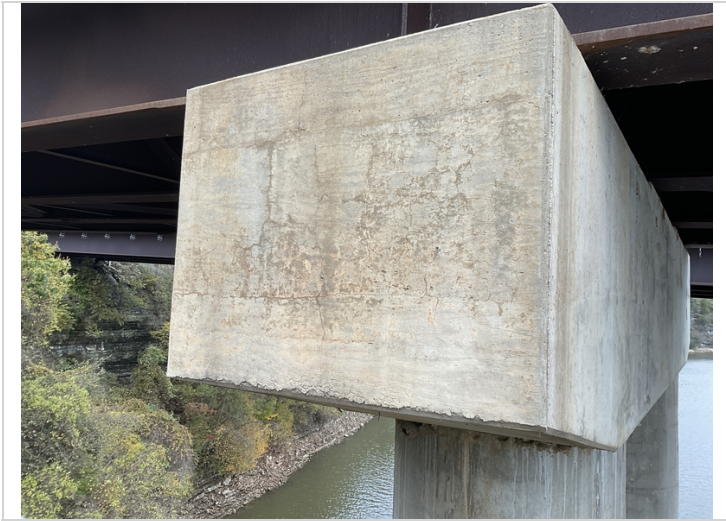
Bent 2 cap, right side-Mapcracking.

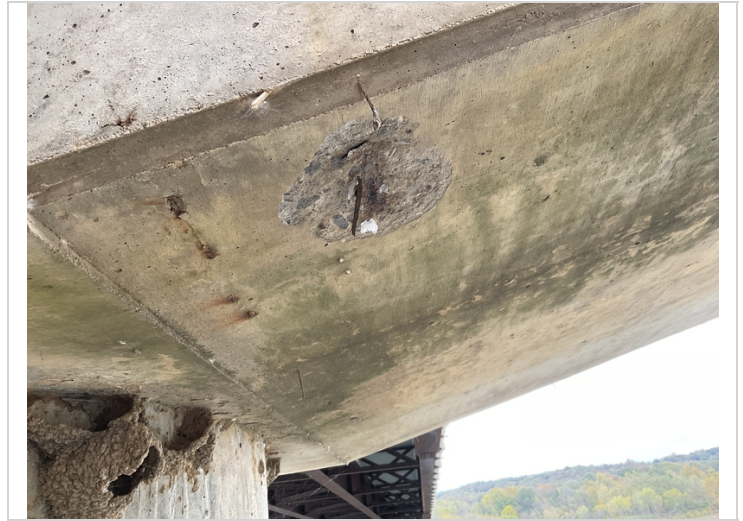
The undersurface on bent # 2 cap has a 6" spall with exposed reinforcing steel on the right side adjacent to column # 2. Exposed steel has initial section loss.

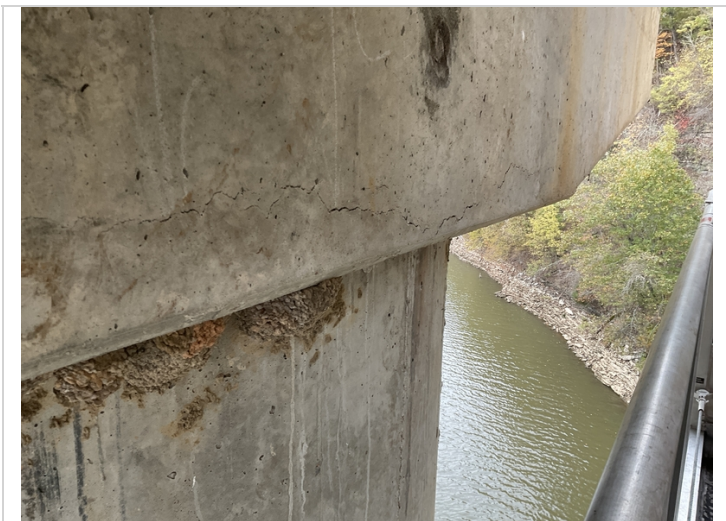
Bent 2 cap backface-Delaminated area over column 2.

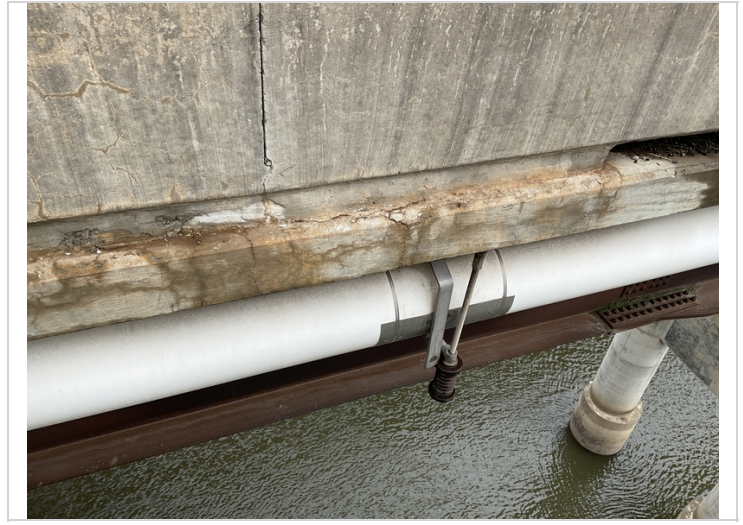
The exterior edges of the deck have mapcracking with areas of scaling and concrete deterioration.

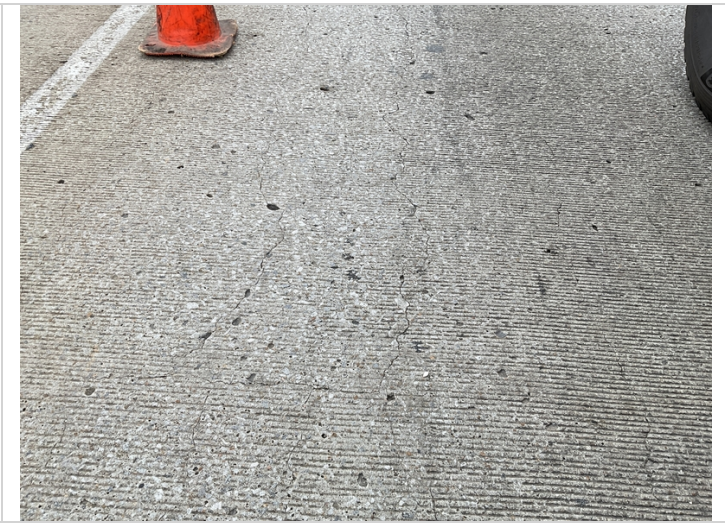
Span 1, right lane-Longitudinal cracking.

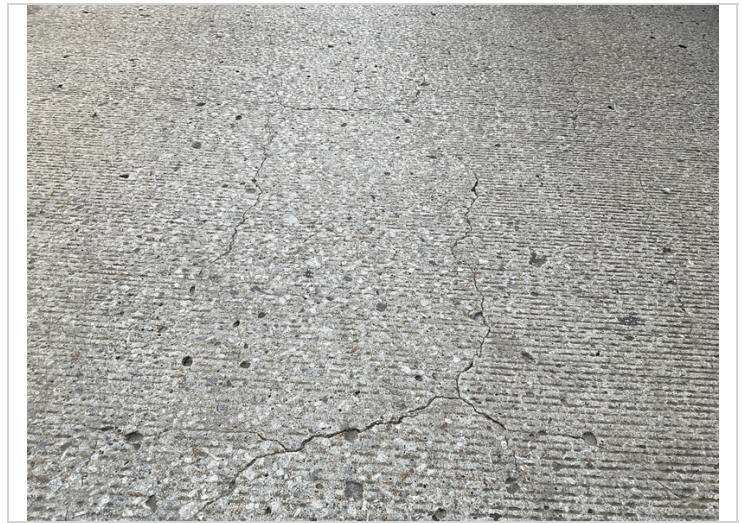
Span 1, right lane-Deck cracking.

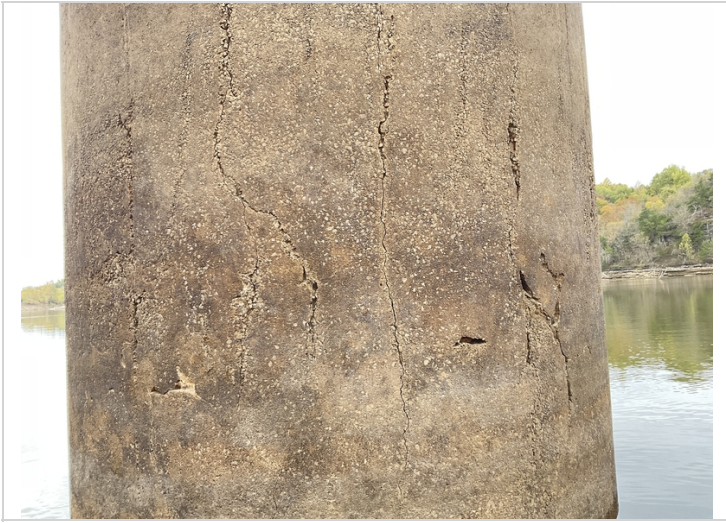
Bent 5, column 2-Vertical cracks.

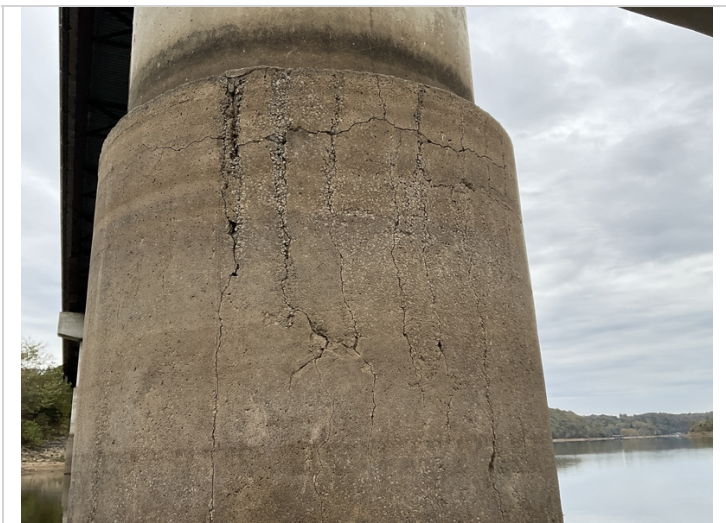
Bent 4, column 1-Wide vertical and horizontal cracking.

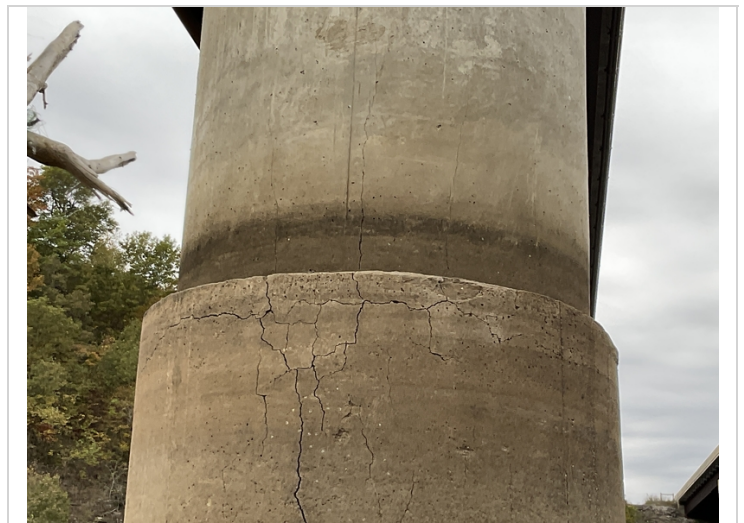
Bent 4, column 1-Mapcracking.

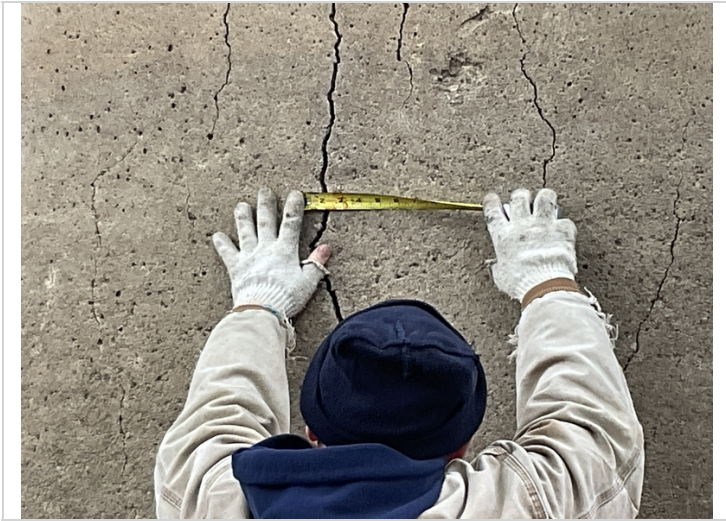
Bent 4, column # 1 has wide vertical cracks in the drilled shaft up to approximately 3/8" wide.

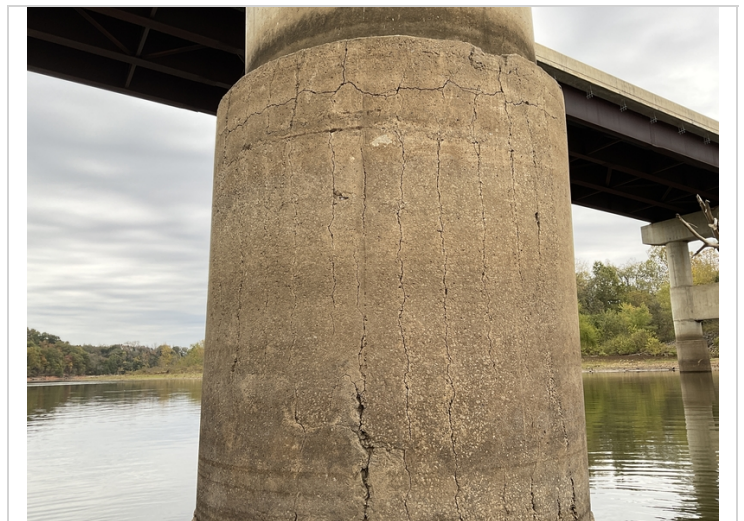
Bent # 4, column 1-Wide vertical cracking.

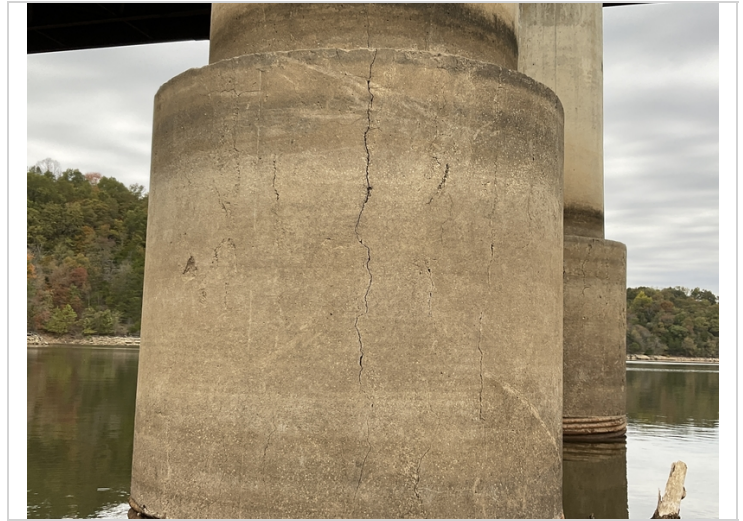
Bent 3, column 2-Wide vertical cracking.

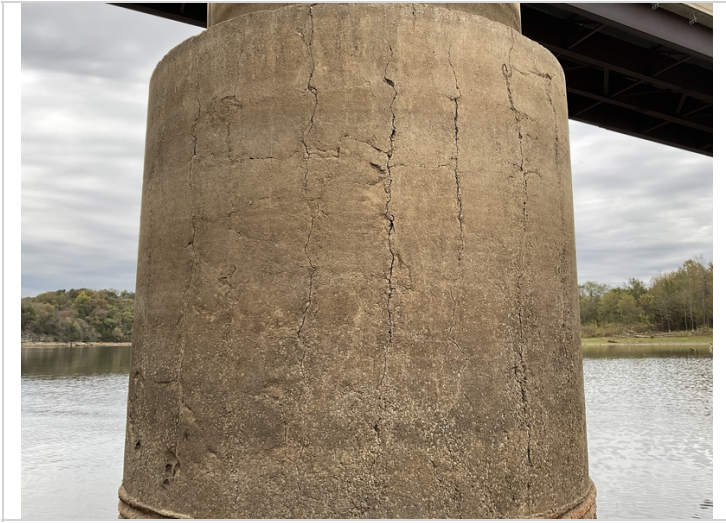
Bent 3, column 1-Wide vertical cracking.

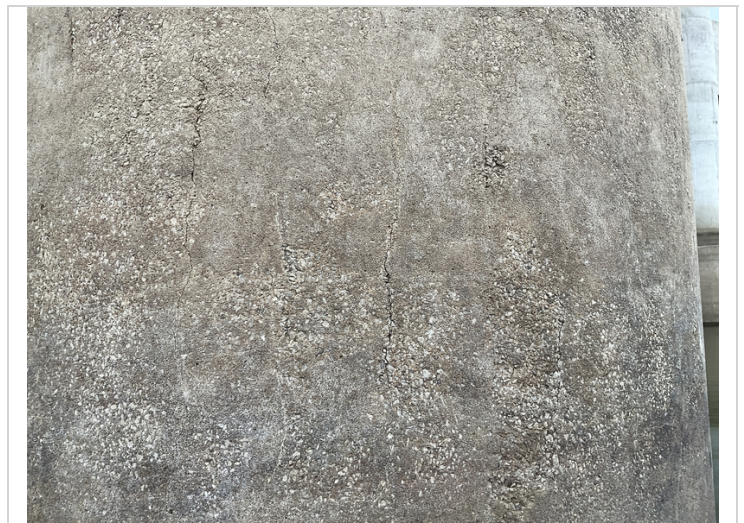
Bent 2, column 1-Vertical cracking.

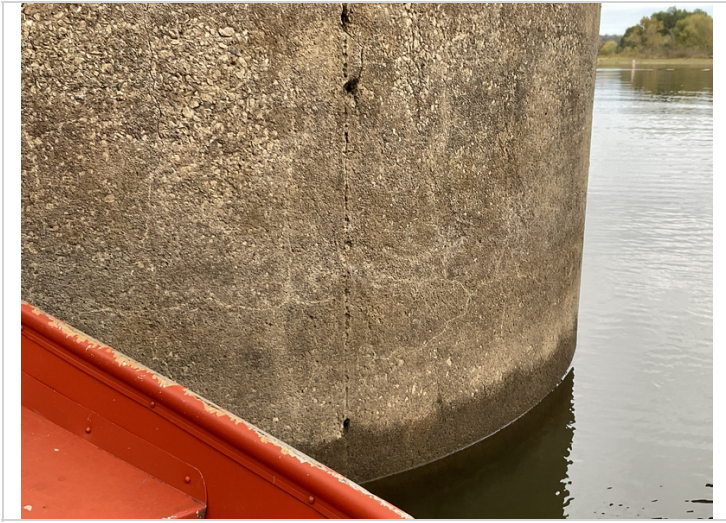
Bent 2, column 1-Light mapcracking.

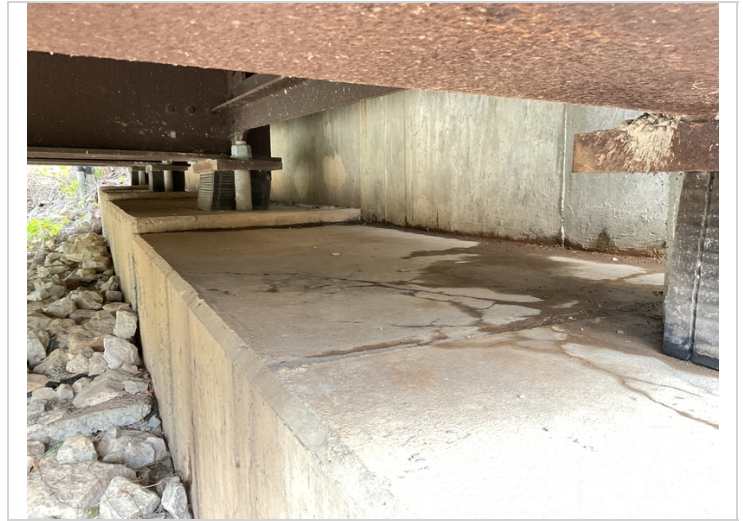
Abutment # 2 has a wide transverse crack that propagates across the bridge seat in bay # 2 located approximately 2' from girder # 3. The crack is 1/8" wide at this inspection.
Photo 1.

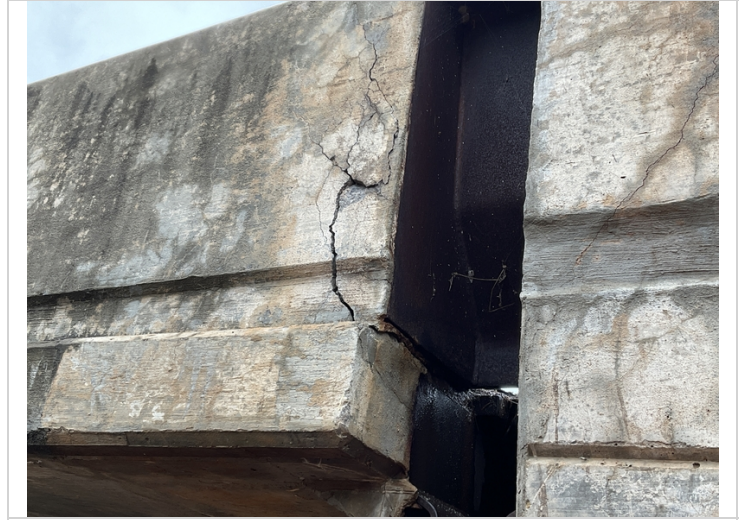
Wide cracking in exterior side of right parapet at abutment #
2

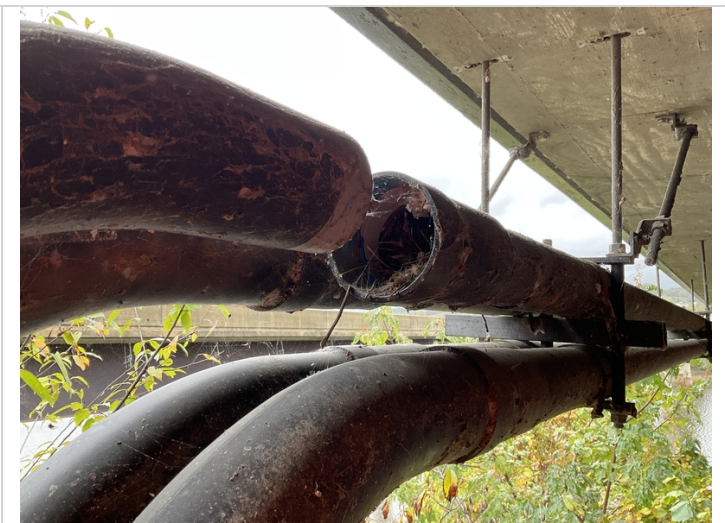
Unused conduit on left side has a failed connection at abutment # 1.

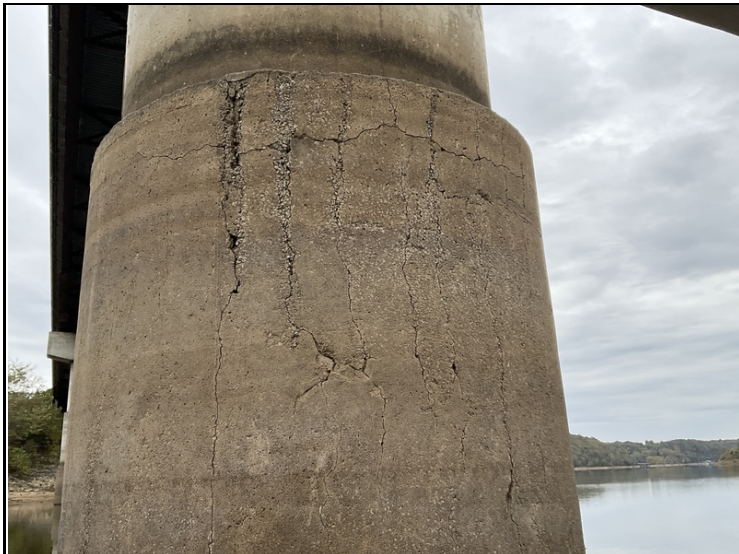
Wide map cracking in the substructure columns with concrete deterioration and exposed reinforcing steel at the water elevation of the columns.

Bent # 4, column # 1-Wide vertical and horizontal cracking.

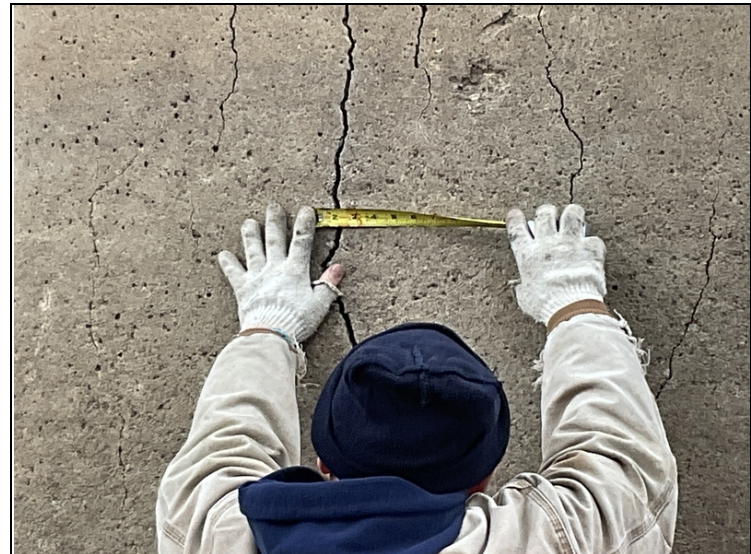
Bent # 4, column # 1 has wide vertical cracks in the drilled shaft up to approximately 3/8" wide.

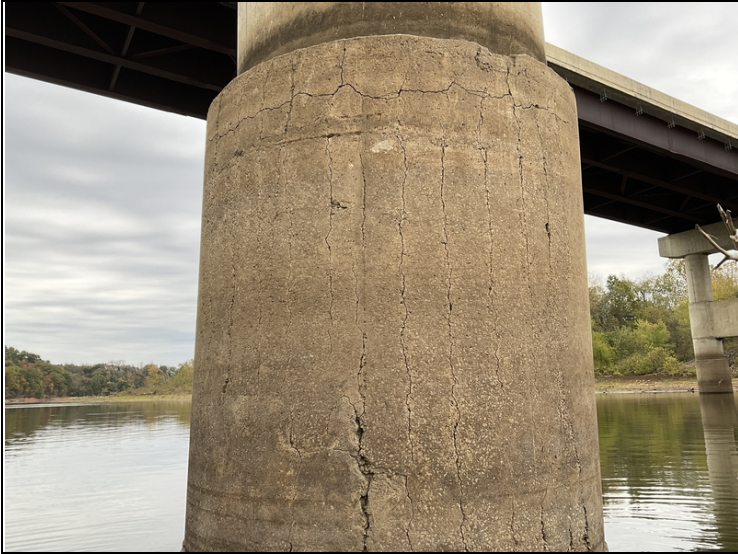
Bent # 4, column 1-Wide vertical cracking.

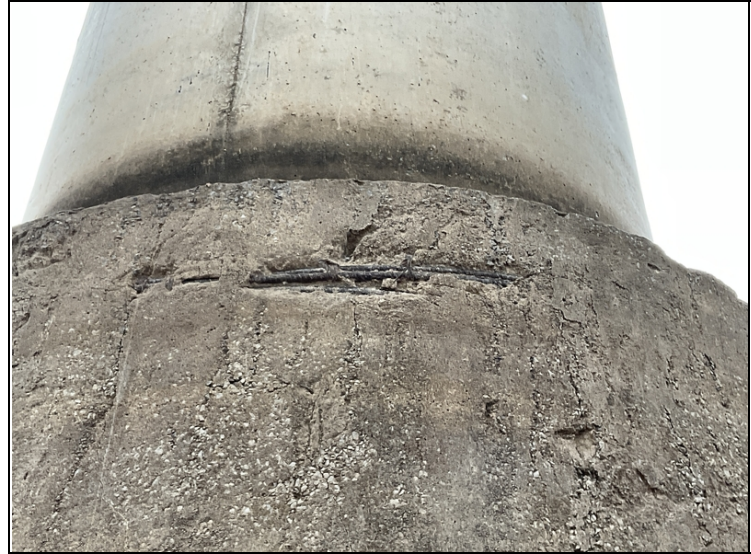
Bent # 3, column 2-Exposed reinforcing steel.

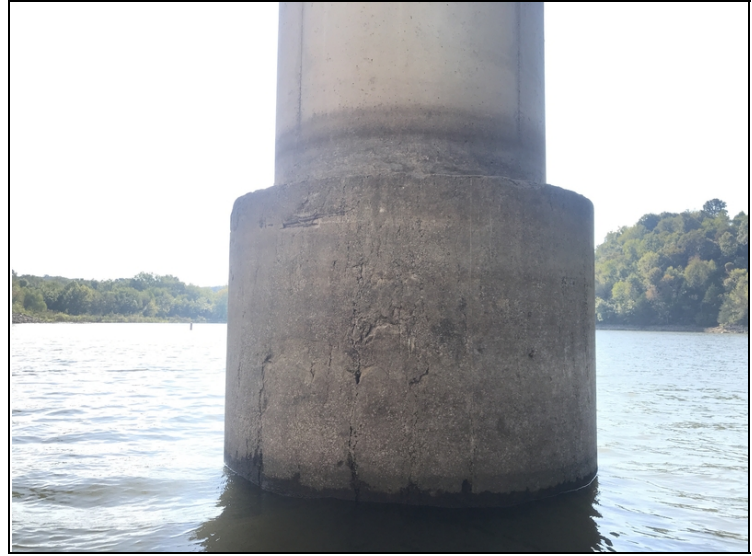
Bent # 3 right column. Exposed reinforcing steel.

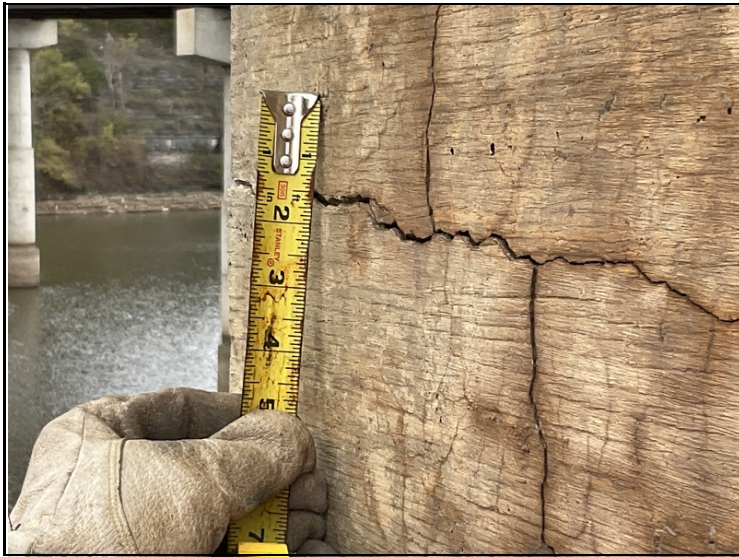
The ends of the intermediate bent caps have heavy wide mapcracking.

Bent # 5 cap, right end-1/8" wide horizontal cracking.

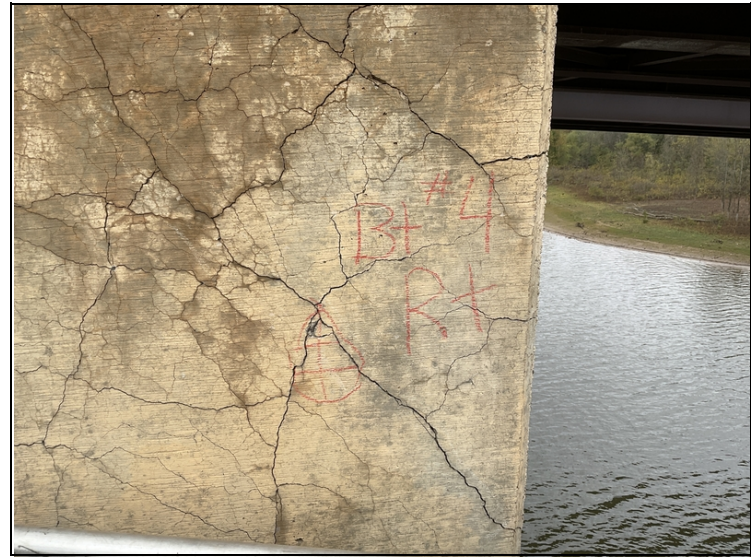
Bent # 4 cap, right end-Delaminated area.

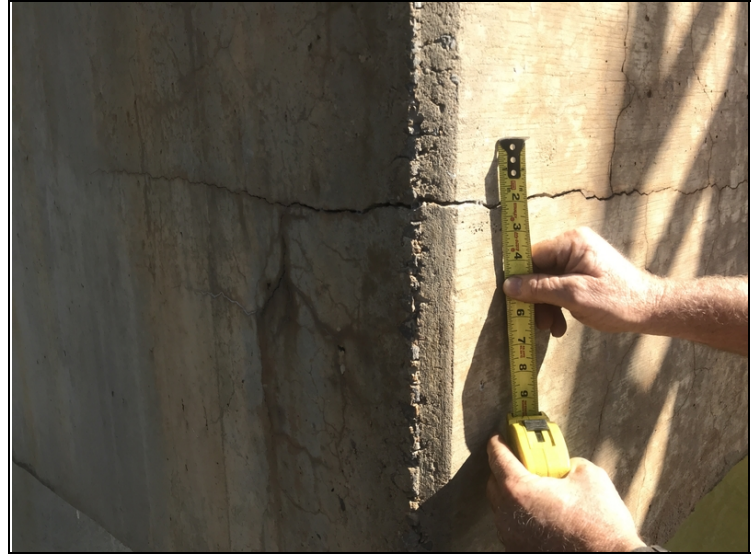
Right end of Bent # 5. 1/8" crack.

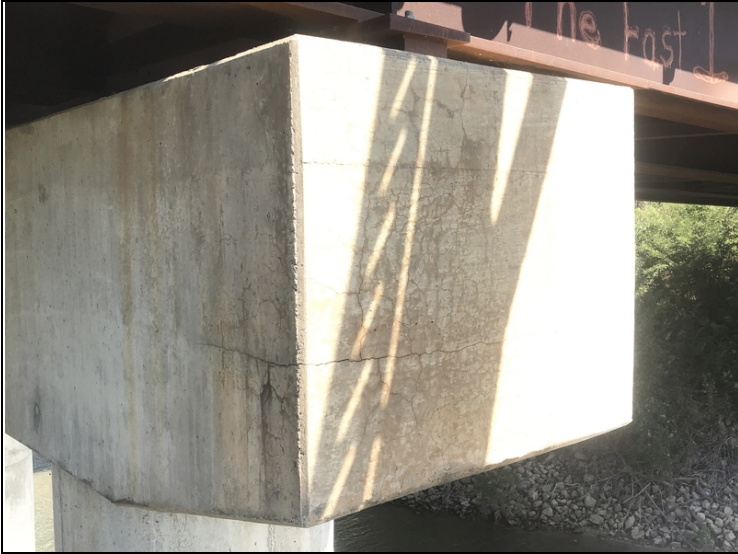
Right end of Bent # 5 Cap. Map cracking.

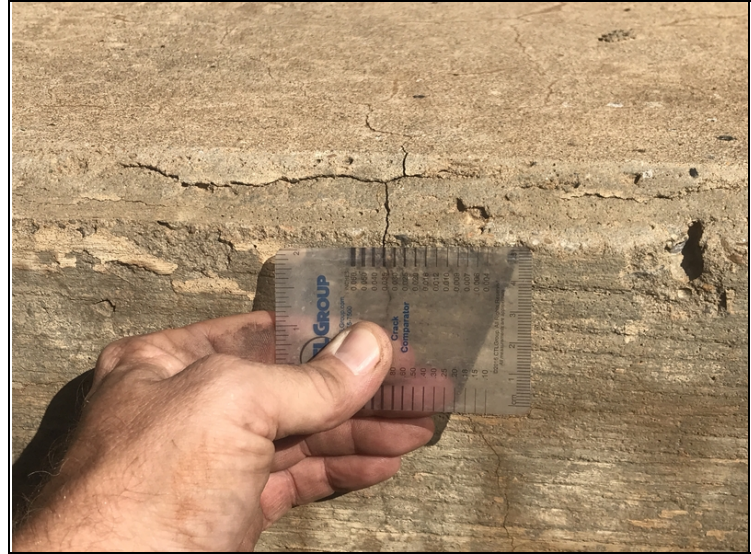
Bent # 3 cap, right side-0.035" cracking.

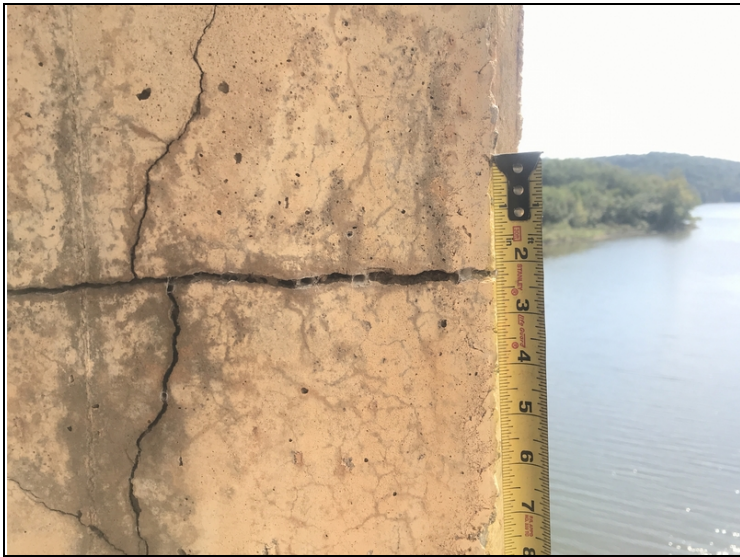
Right end of Bent # 4 cap has 3/8" wide map cracking.

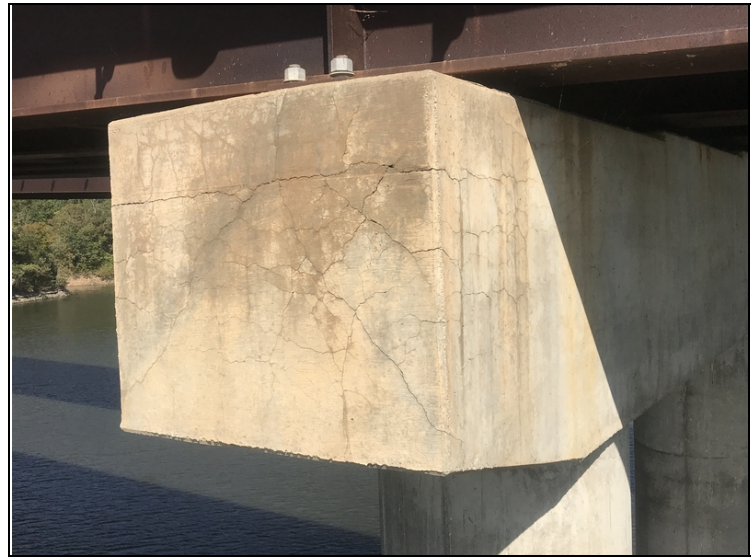
Right end of Bent # 4 cap-Mapcracking.

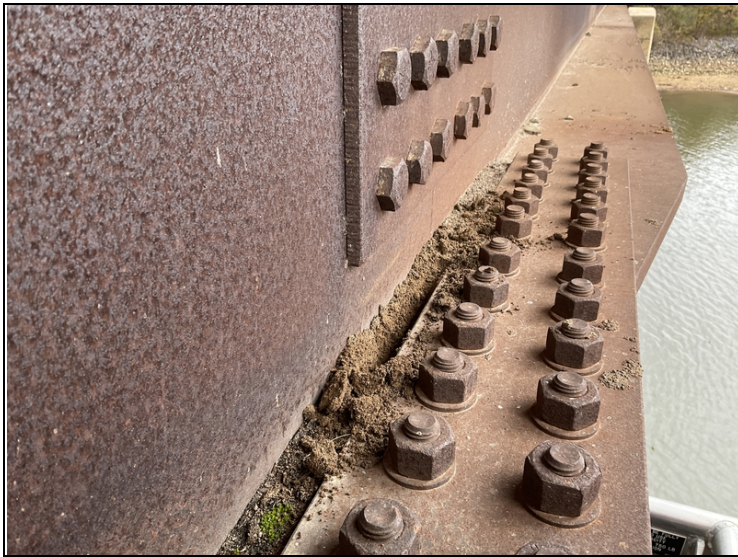
The exterior girders have dirt and debris accumulation adjacent to the splice plate connections that is retaining moisture potentially causing corrosion / abnormal weathering to girders.

The exterior girders have dirt and debris accumulation adjacent to the splice plate connections potentially causing corrosion / abnormal weathering to girders.

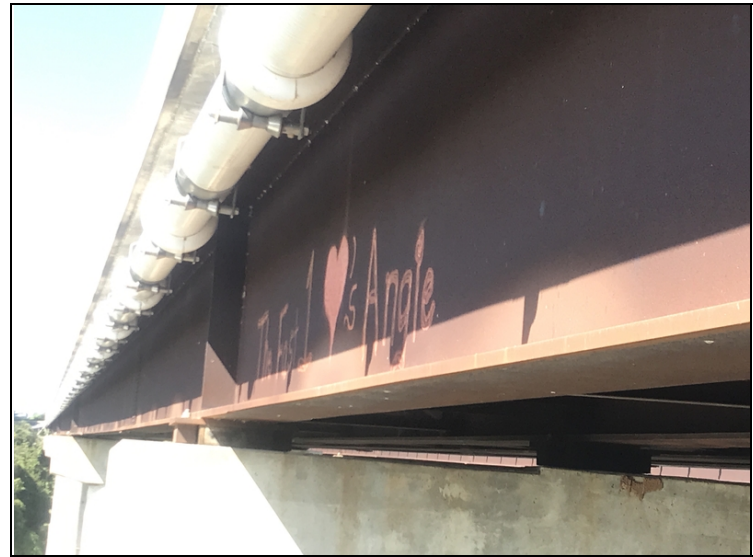
Span # 5, Girder # 4-Graffiti.

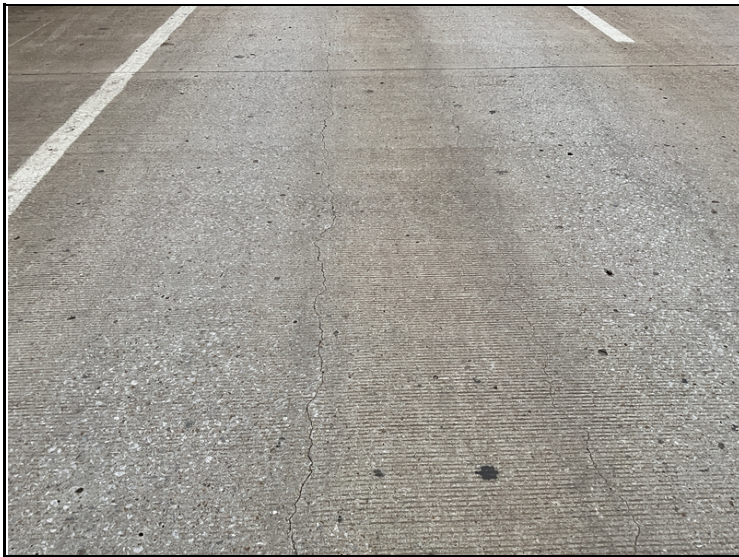
Bridge deck -
The driving surface of the deck has numerous sealable longitudinal and transverse cracks.

Longitudinal deck cracking.

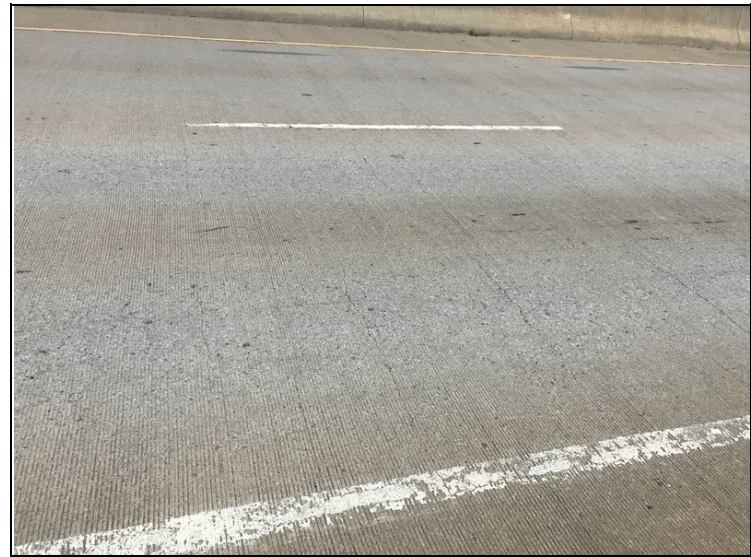
Sealable transverse cracks in the deck.

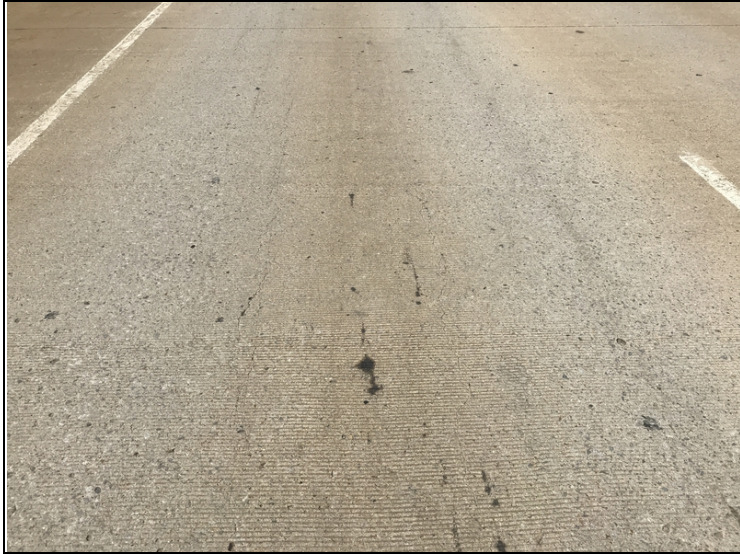
Sealable Longitudinal cracking in the deck.

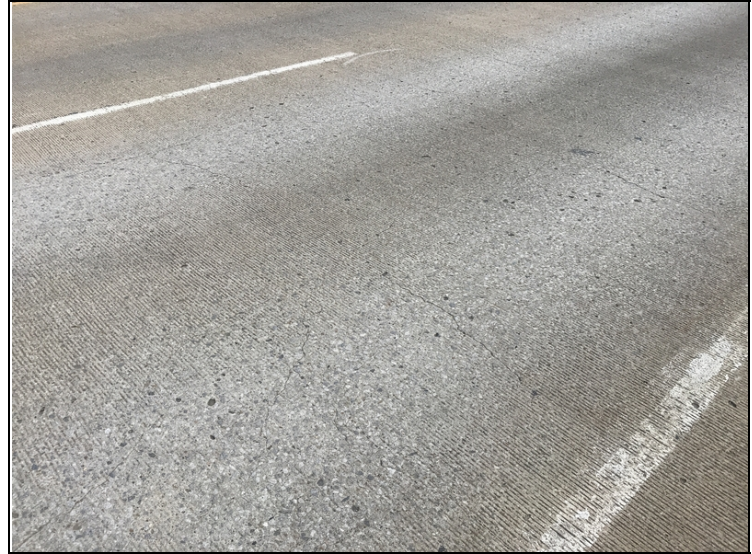
Map cracking.

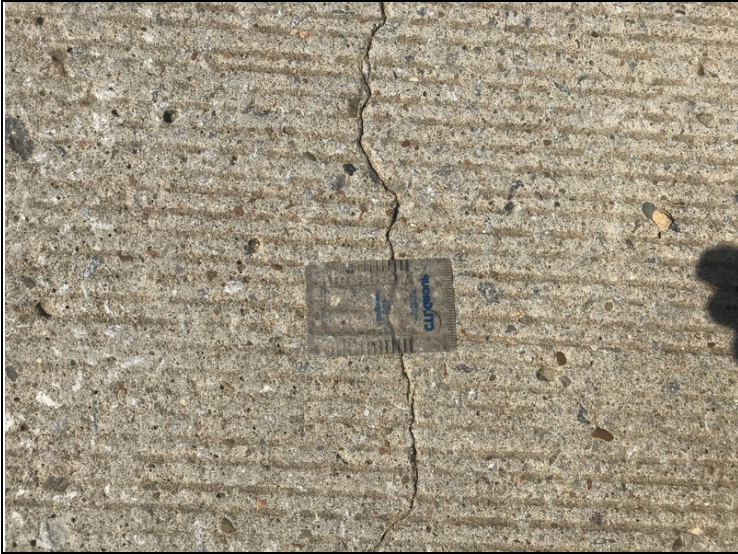
Sealable crack in the deck.

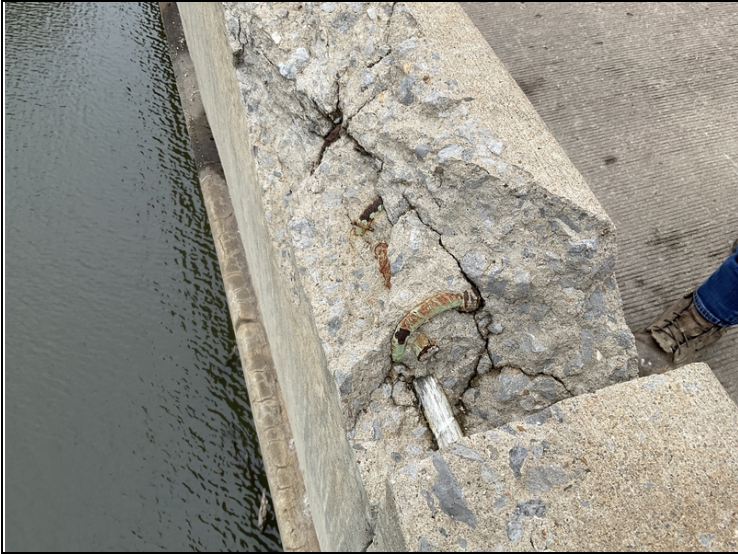
The concrete bridge railing on the right side of Span # 3 has a spall approximately 6' long with exposed reinforcing steel. The parapet walls have map cracking with efflorescence.

The right parapet in span # 3 has a large spall with exposed epoxy reinforcing steel.

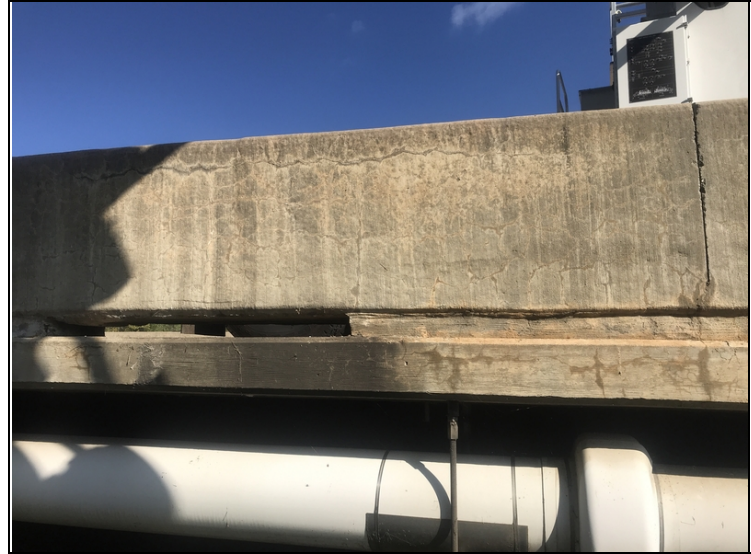
Map cracking with efflorescence in the exterior surface of the Parapet wall.

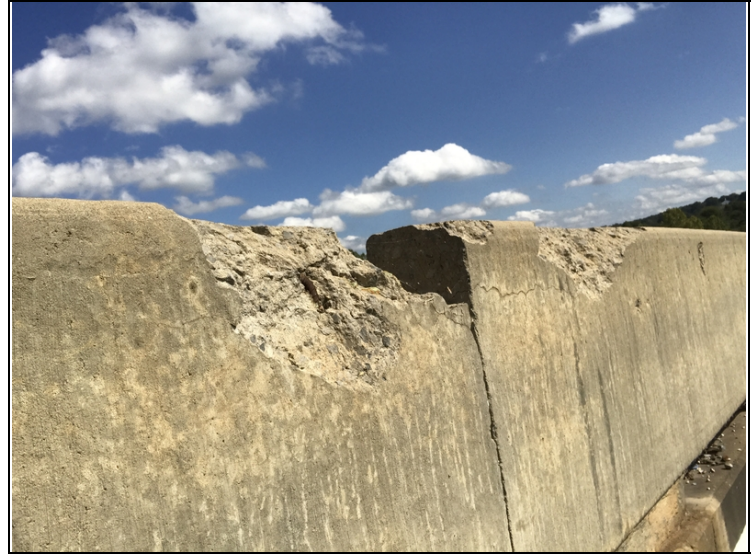
Spall in the Right parapet wall.

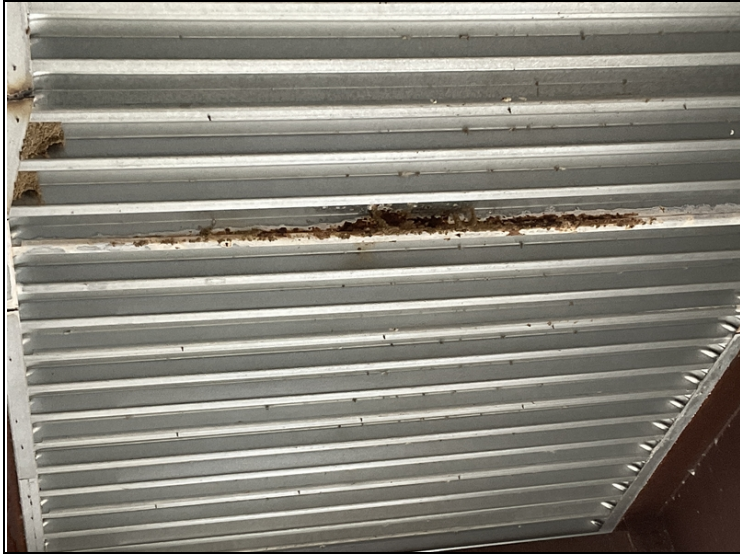
Span # 2, bay # 3-Corrosion to SIP forms.

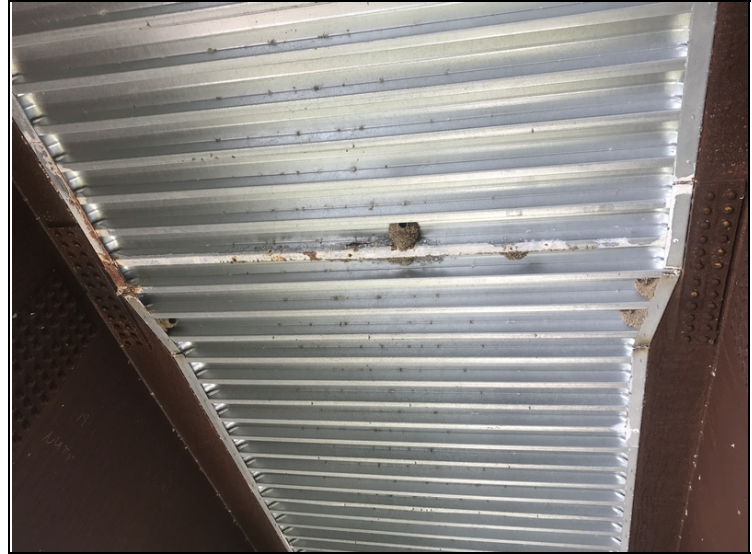
Corrosion in SIP forms.

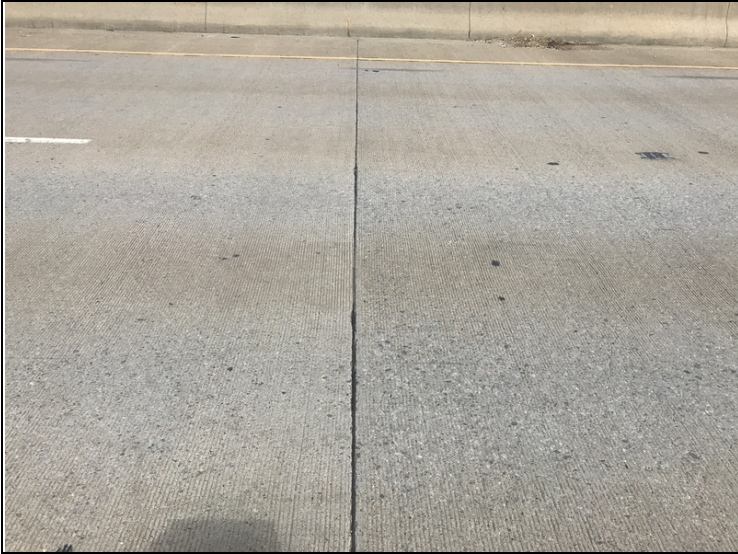
Transverse Saw Joint Sealant in the Deck -
The transverse saw joint sealant in the deck is deteriorated and appears to leak water.

Transverse saw joint sealant is deteriorated.
