Bridge #00329(Routine, Underwater type 2)

US 71B over Mill Creek Sebastian Co.

Location: 0.25 Mi N Jct Phoenix Ave

Team Lead: Jeff Jones Inspection Date: June 02, 2022

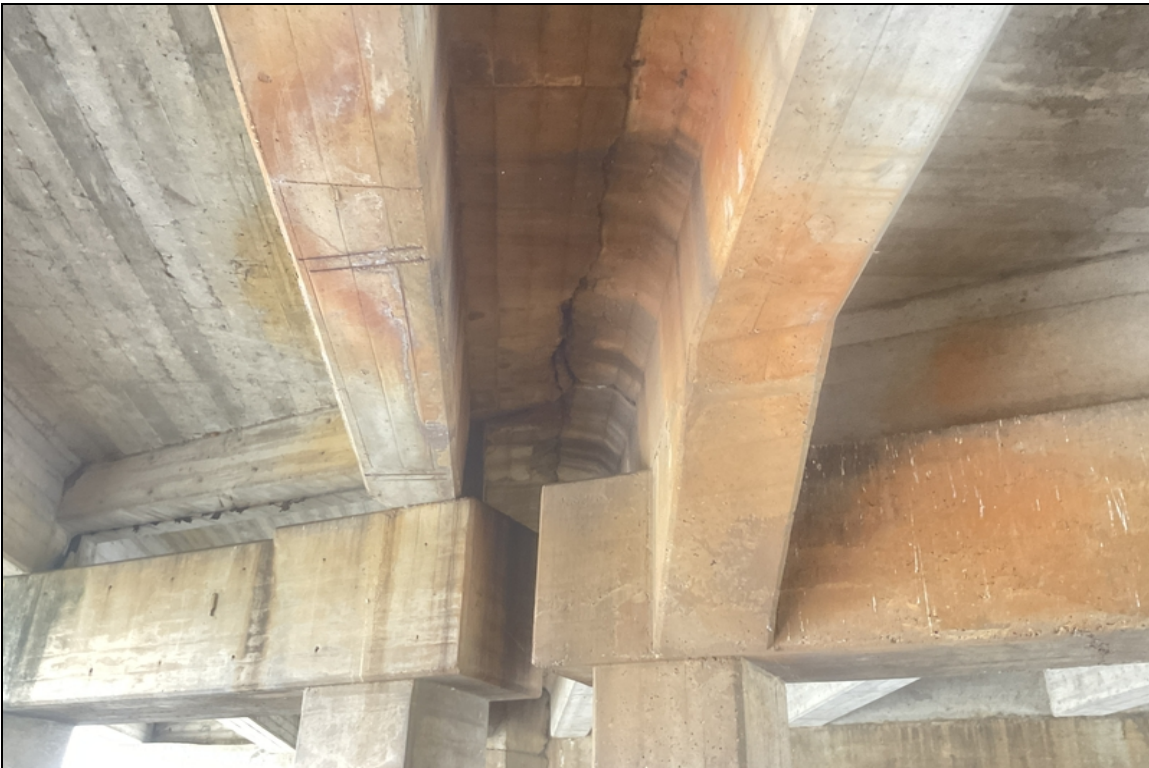
Spalling in the deck soffit over Bent # 2, Bay # 3.

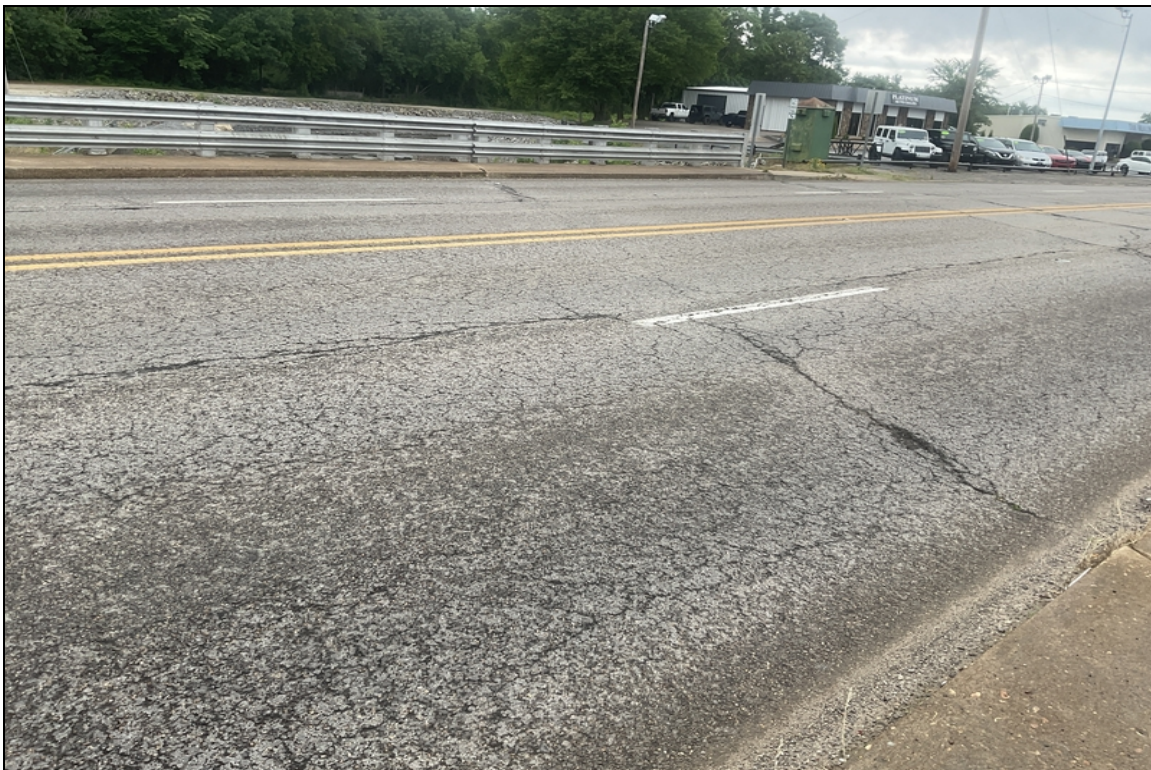
Asphalt breaking apart over the expansion joints.

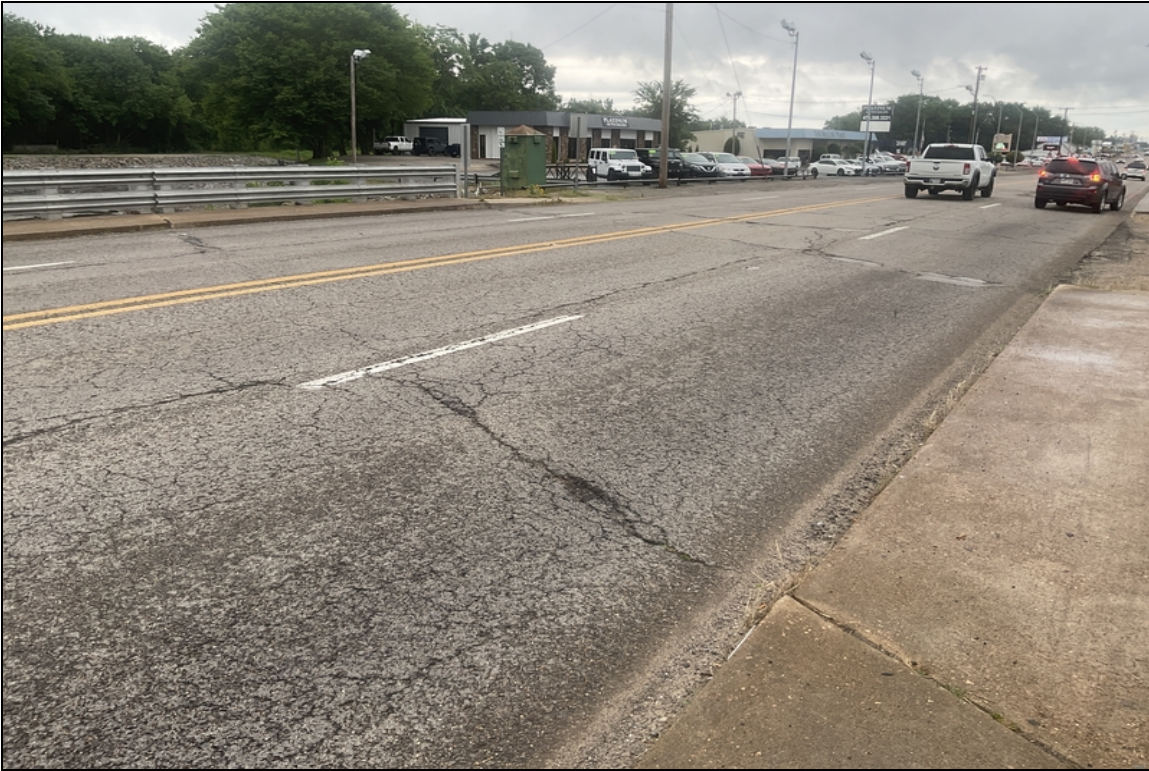
Asphalt breaking apart over the expansion joints with patched areas at the abutments.

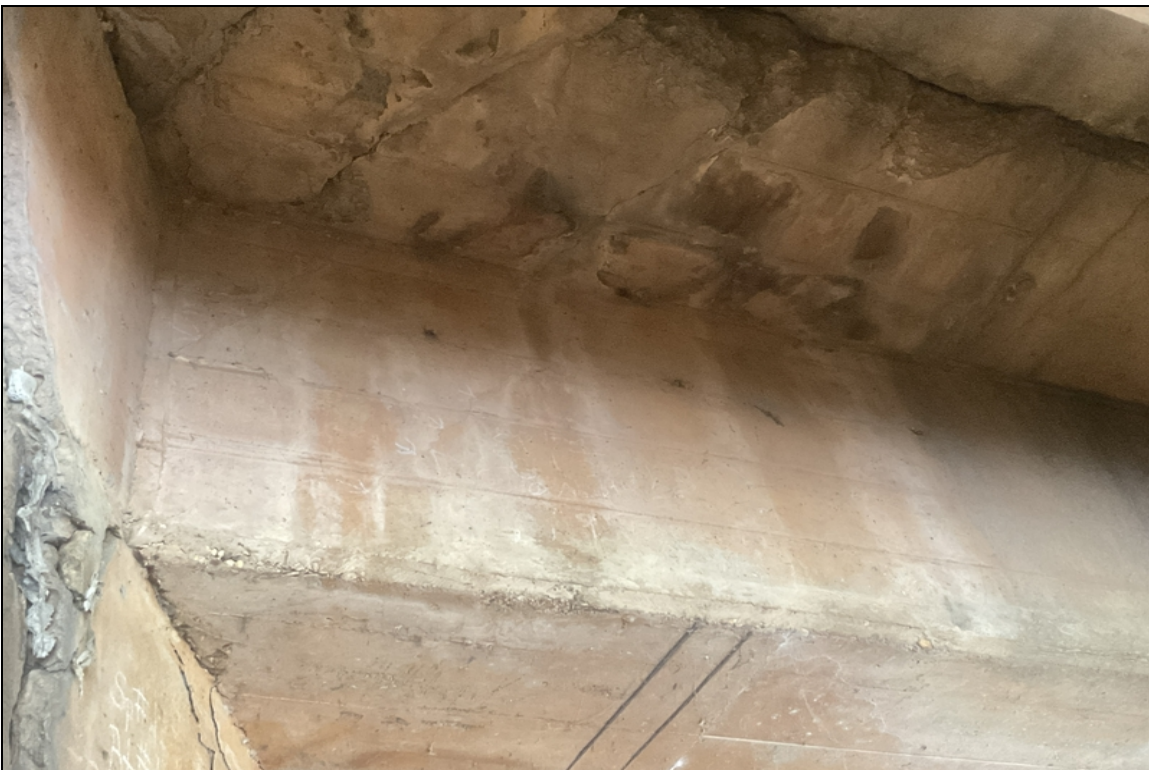
(110)							
-There are no apparent changes in the previously documented shear cracks in the girders. Crack locations are noted below. -There is one hairline shear crack in Girder # 3, Span # 1, adjacent to Abutment # 1. -There are vertical hairline flexure cracks at variable spacing in some of the girders. -There is longitudinal cracking in the base of the stem of Girder # 7, Span # 1, adjacent to Bent # 2. -There are spalls with exposed reinforcing steel in the ends of Girders # 2, 3, and 7 of Span # 1 over Bent # 2. -The spall in Girder # 3 is approximately 18" long. -Span # 2 Girder # 6 has a 8" vertical spall with exposed reinforcing steel adjacent to Bent # 2. -The exterior face of Girder # 9 of Spans # 1 and # 2 have spalling over Bent # 2. -There is a shear crack in Girder # 7 of Span # 2 adjacent to Bent # 3 that is approximately 1/16" wide. The shear crack is visible from both sides of girder. The girder has an additional diagonal crack on the Right side located approximately 2' from Bent # 3. No apparent change since the last inspection. -There is one short duration vertical crack with efflorescence in Girder # 8 of Span # 2 adjacent to Bent # 3.

There is one hairline shear crack in Girder # 3, Span # 1, adjacent to Abutment # 1.

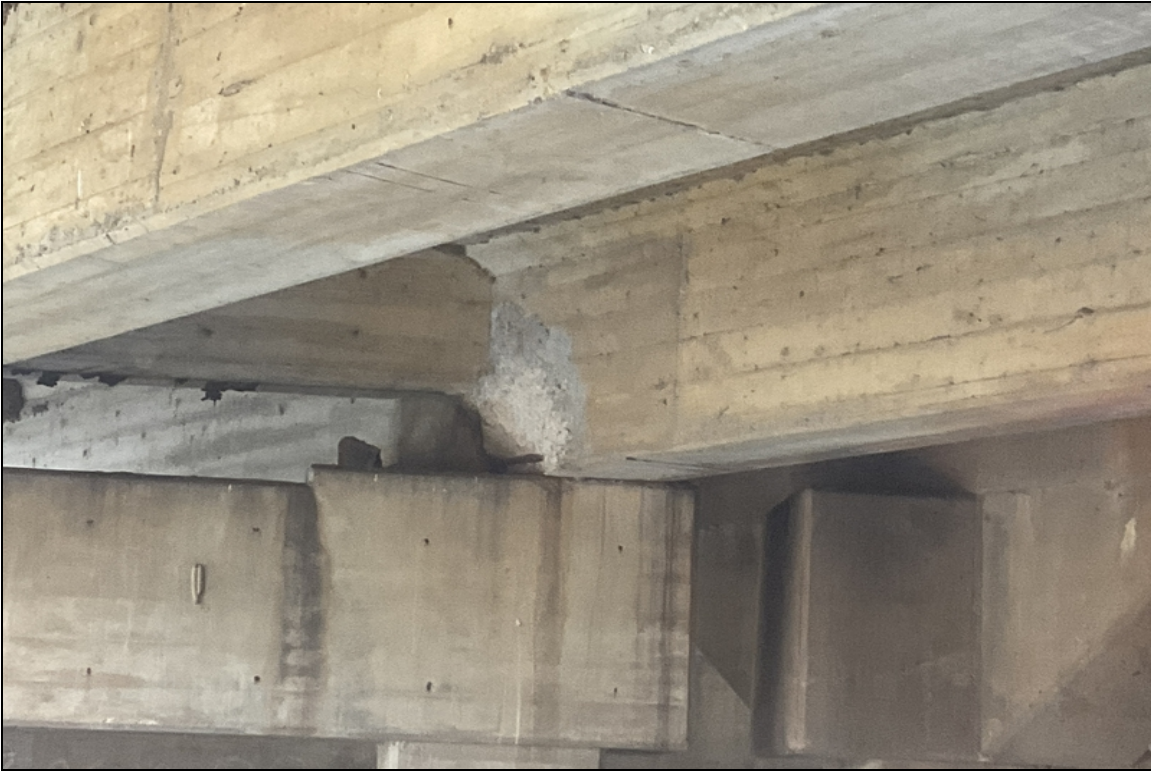
Span # 1 at Bent # 2 - Spall with exposed reinforcing steel in the end of Girder # 3.

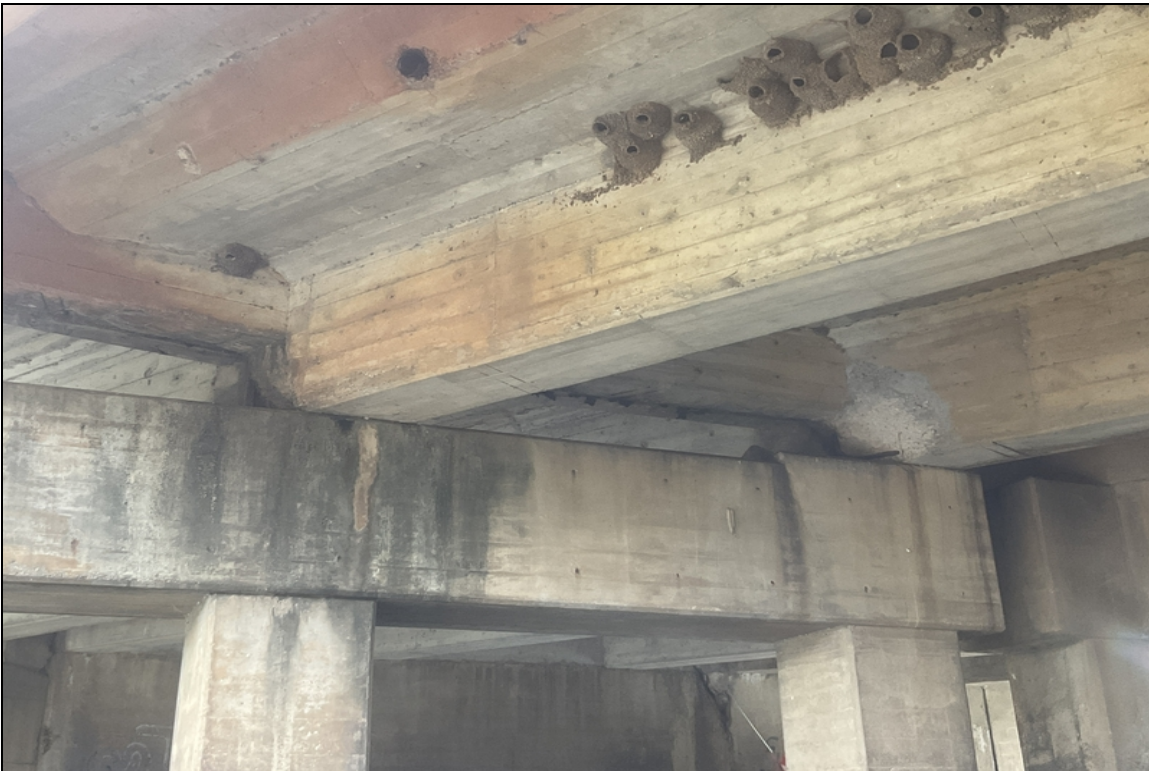
Span # 1, Girders # 2 & 3 at Bent # 2 - Spalls with exposed reinforcing steel.

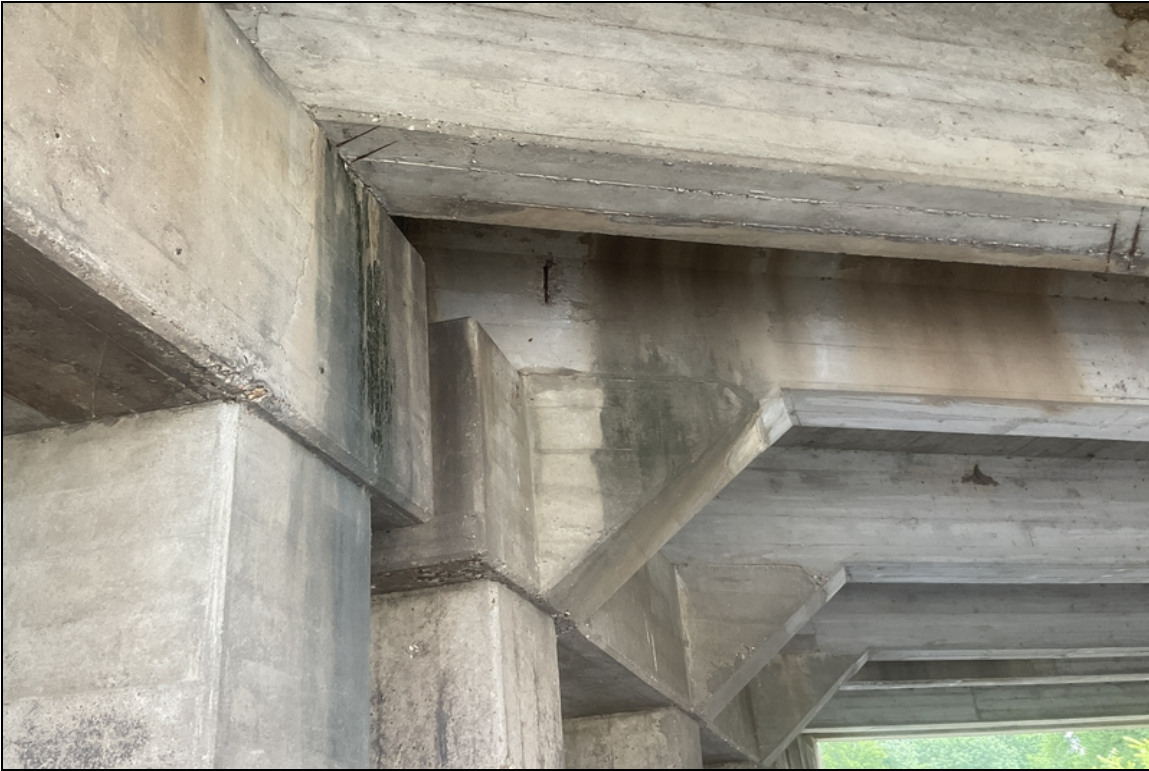
Span # 2 Girder # 6 has a 8" vertical spall with exposed reinforcing steel adjacent to Bent # 2.

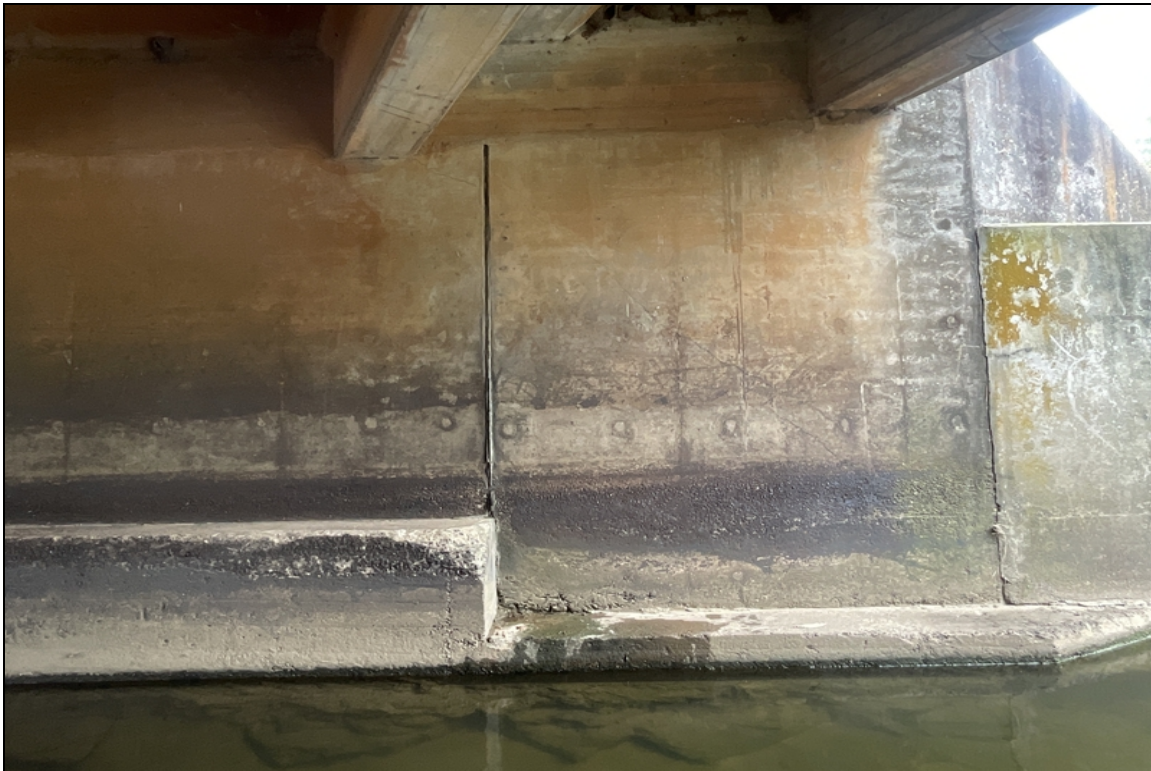
Bent # 1 Left has a 9' long X approximately 1/16" wide diagonal crack under Girder # 2, Bay # 1.

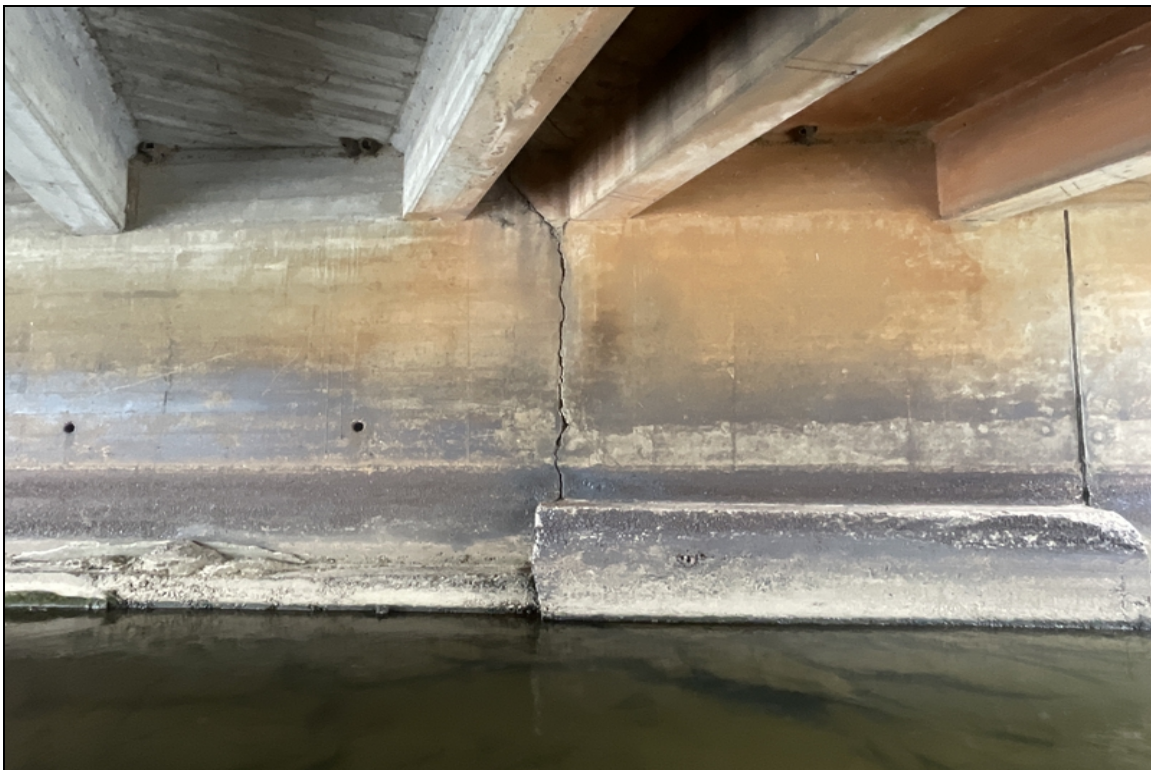
Bent # 1 stem wall appears to have rotated approximately 3/4" toward the channel at the construction joint in Bay # 3 under Girder # 3. The stem wall has a 1/2" wide crack at the construction joint with 3/4" differential offset at the crack.

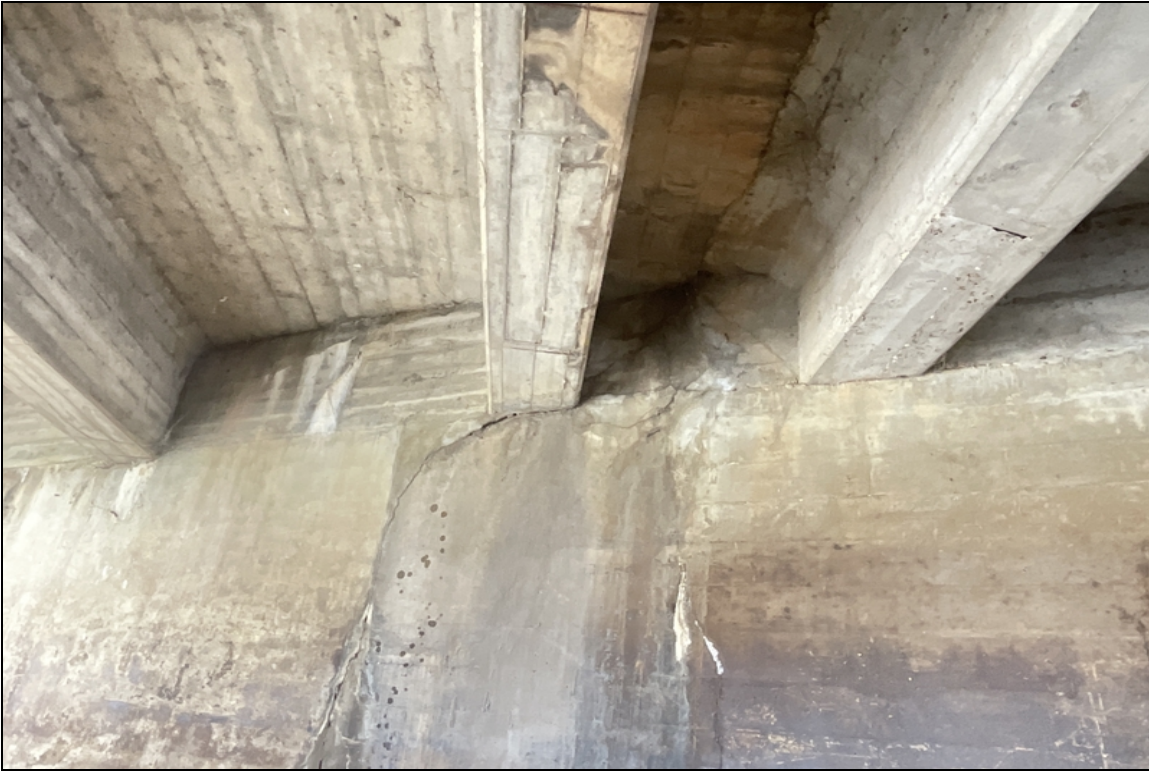
There is one 12" spall in the stem that has been patched between girders # 6 & 7 and adjacent to the Right side of Girder # 7.

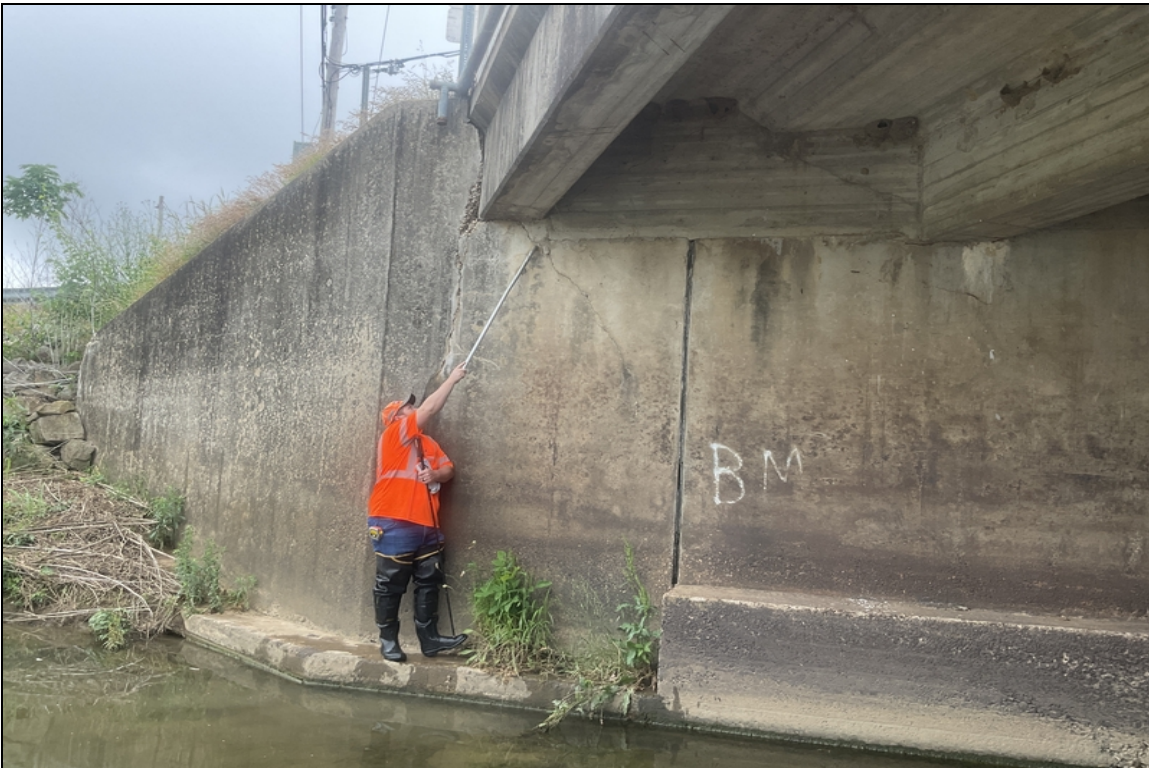
Bent # 1 Right has diagonal cracking under Girder # 9 with a 1/2" offset in the abutment stem (appears to be delaminated).

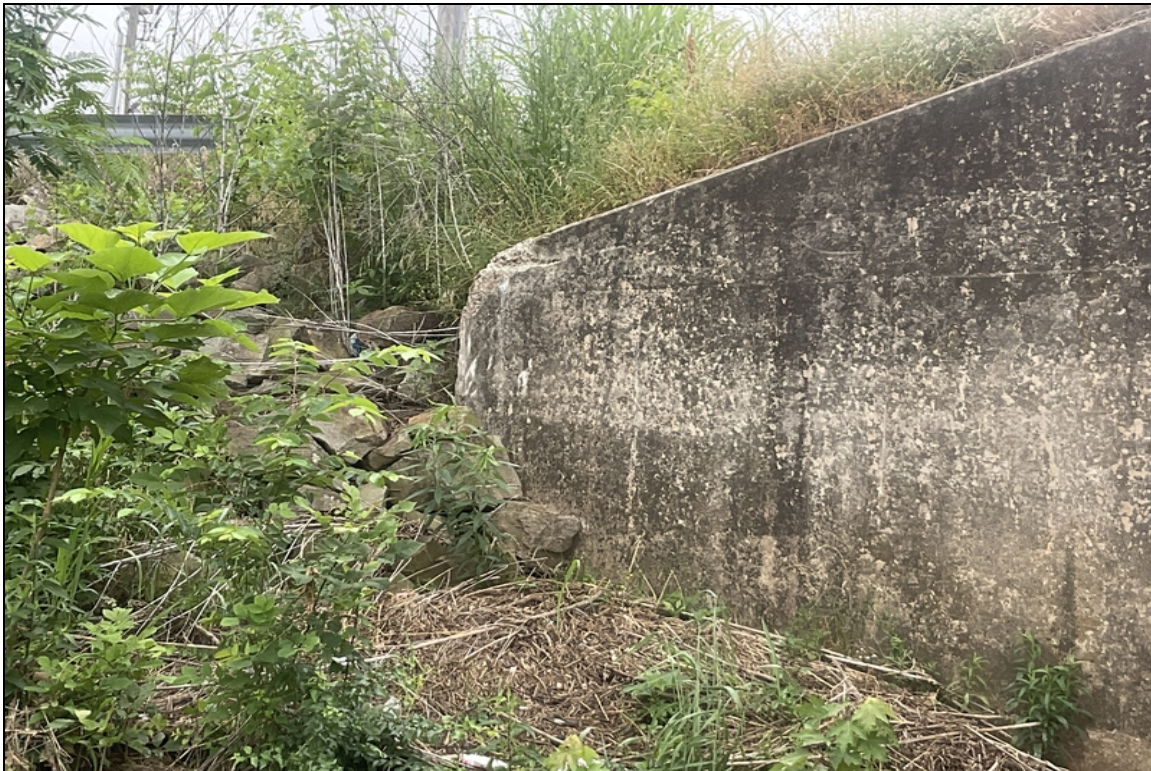
Bent # 1 Right end of the wing wall has concrete section loss and cracking with efflorescence.

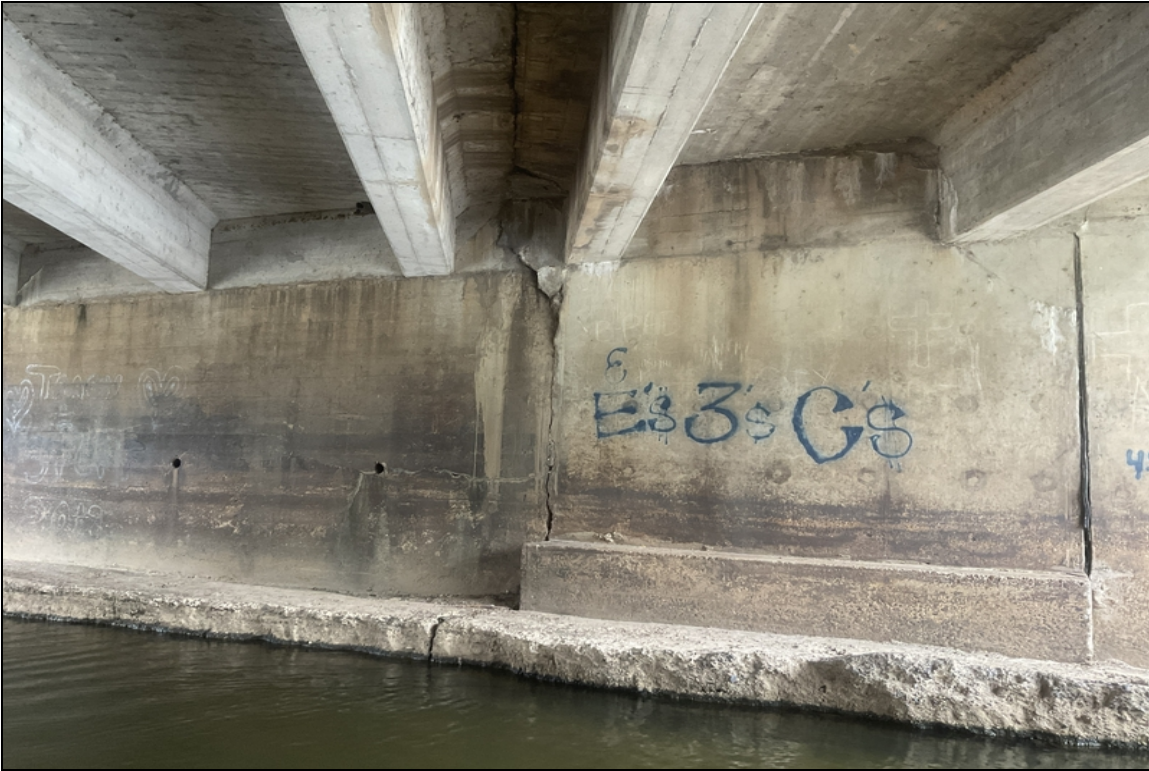
There is a 3' spall with exposed reinforcing steel in the vertical construction joint between Girders # 6 & 7.

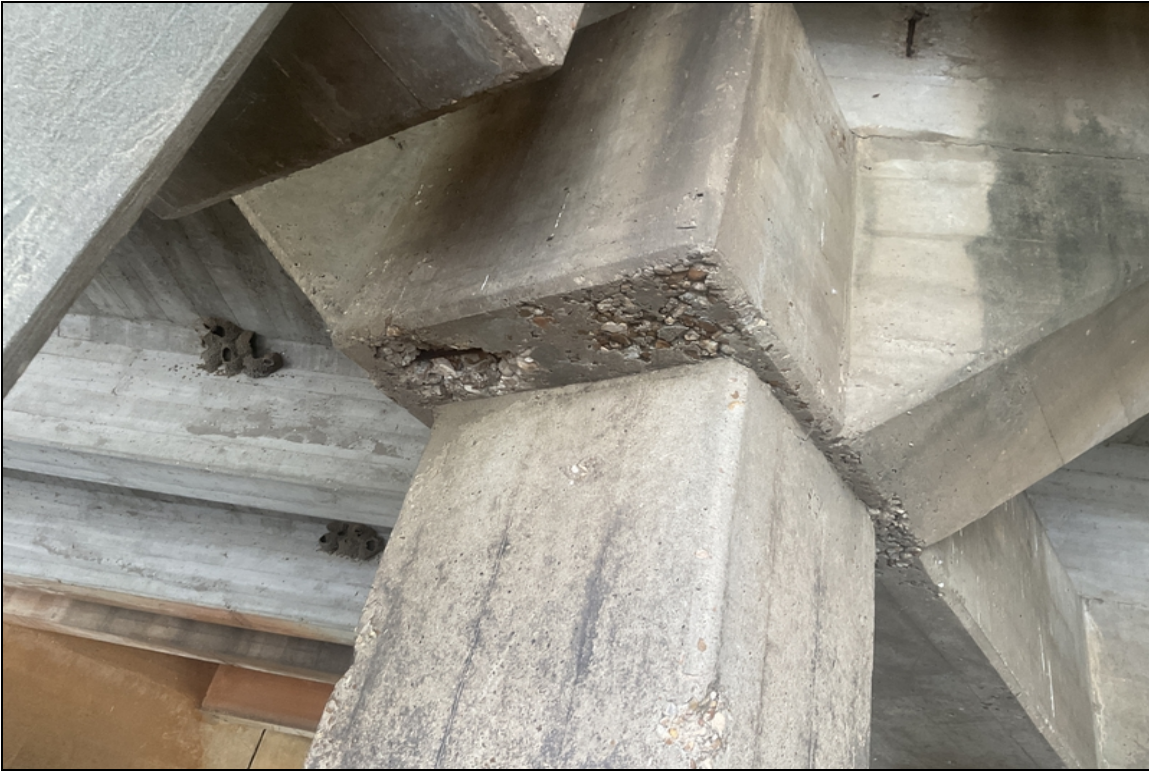
The undersurface of Bent # 2 cap has an 8" spall with exposed reinforcing steel adjacent to Column # 6.

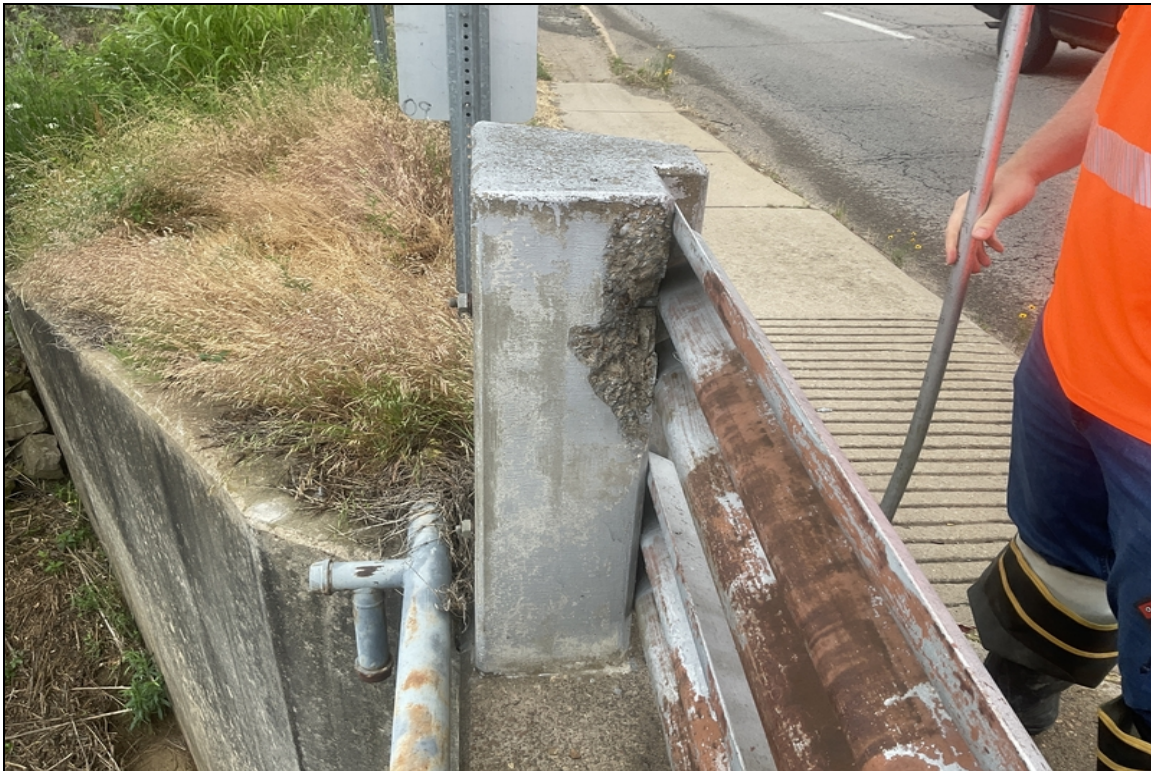
Spall with exposed reinforcing steel in the Southeast end post.

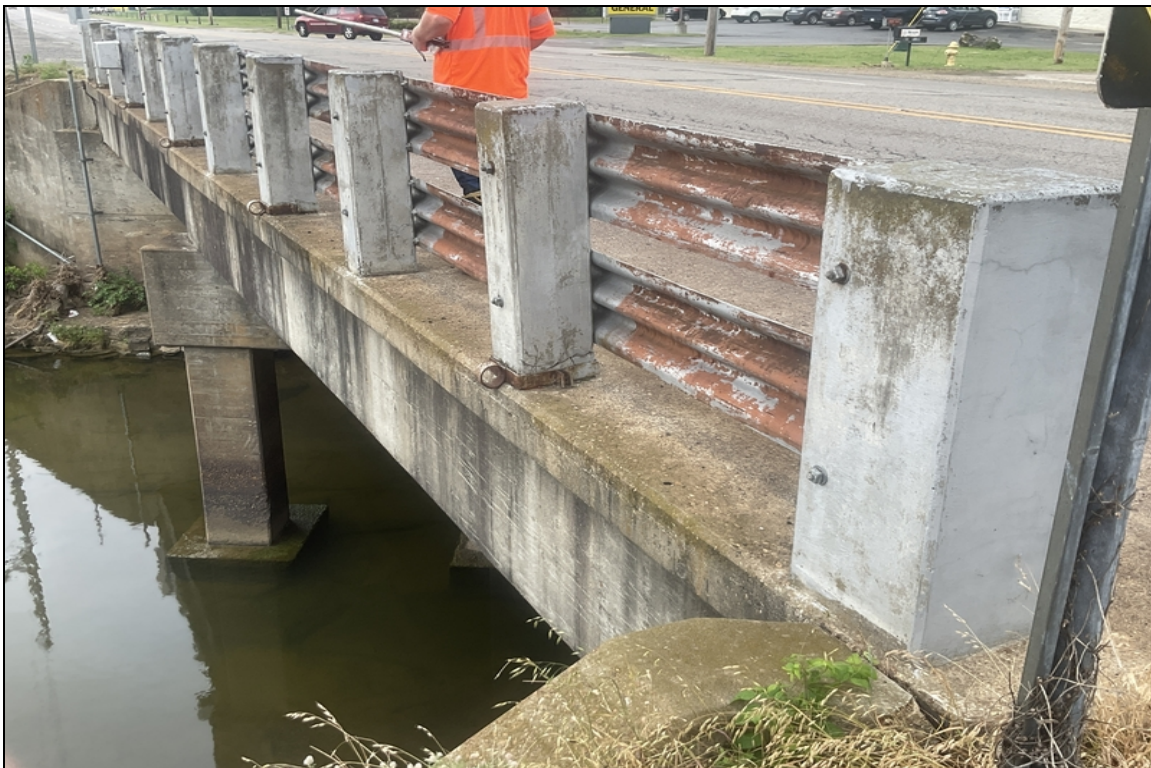
Span # 1 Left side. Fractured concrete bridge railing post.

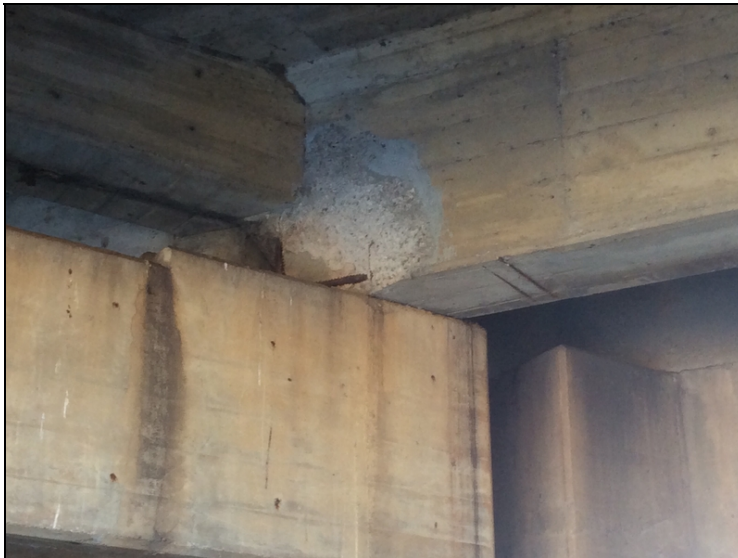
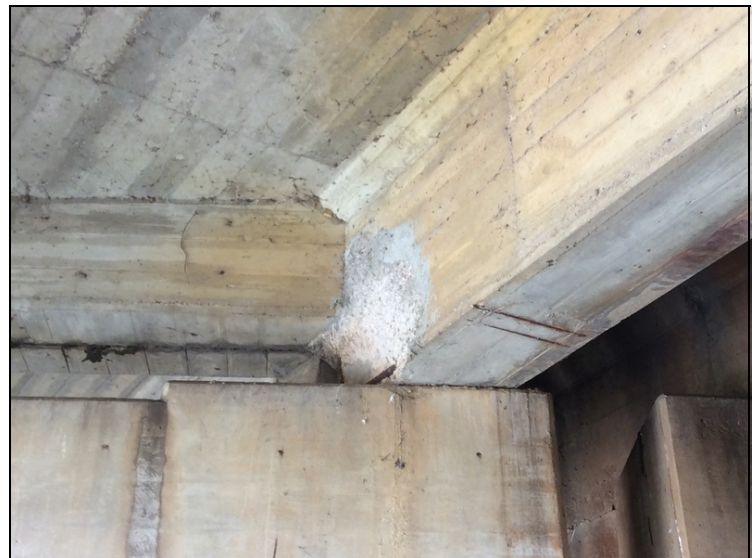
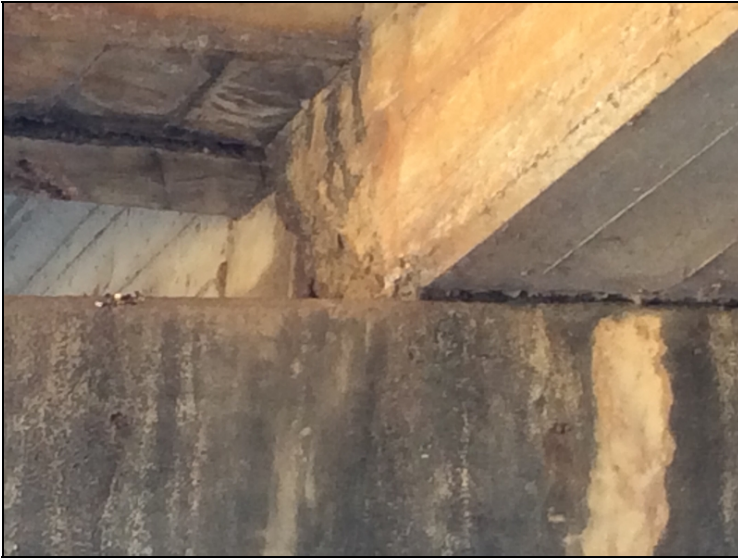
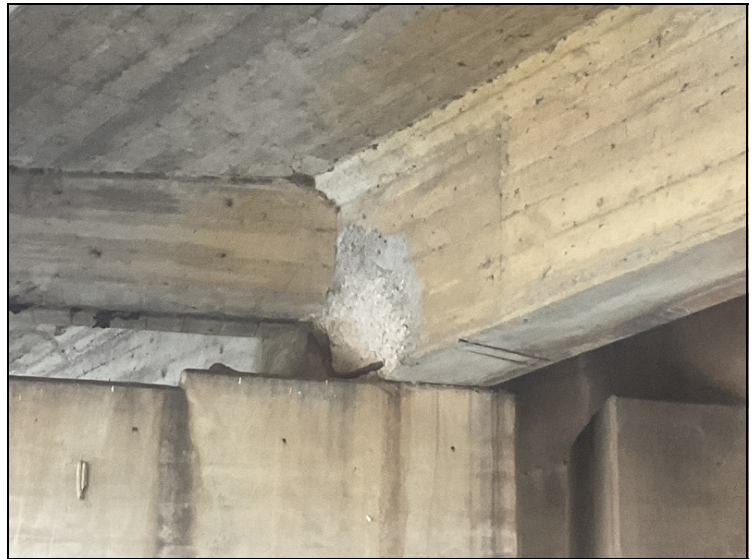
The ends of concrete girders # 2 and # 3 of span # 1 have spalling with exposed reinforcing steel over bent # 2.

Span #1, Girder 3 over Bent 2-Spalling with exposed reinforcing steel.

Spall with exposed reinforcing steel in Span 1. Girder 3. At Bent 2.

Span 1, girder 2 over Bent 2-Spalling.

Span # 1, Girder # 3, at Bent # 2. Spall with exposed reinforcing steel.

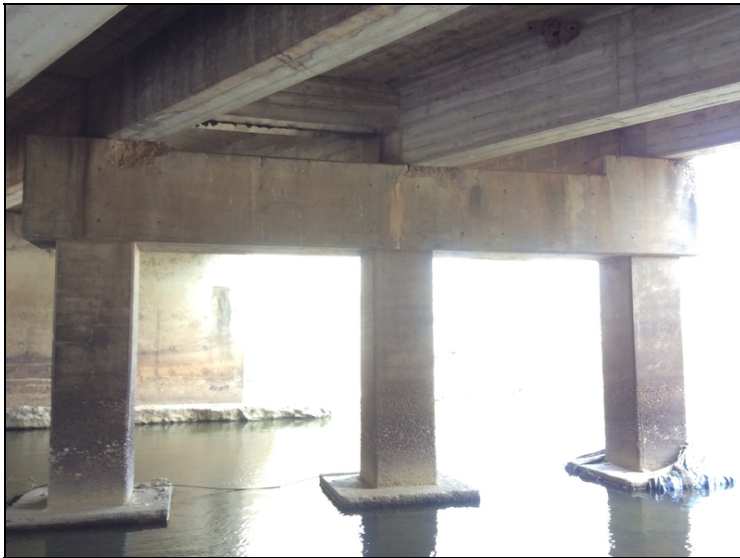
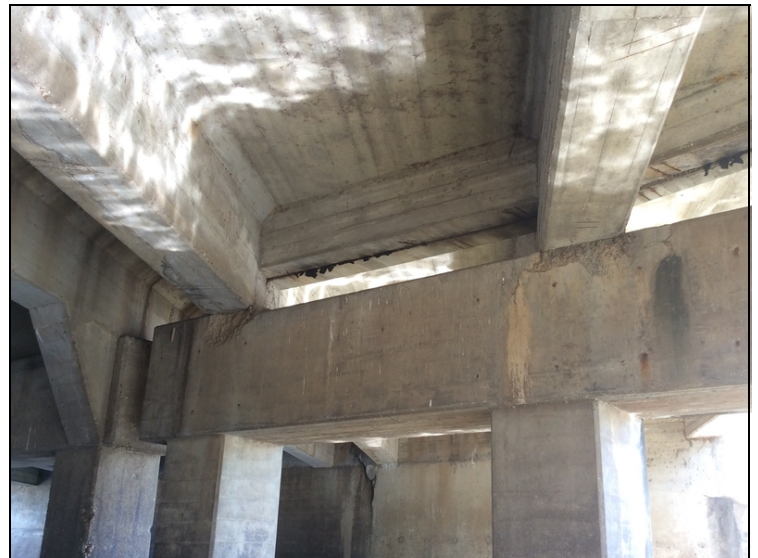
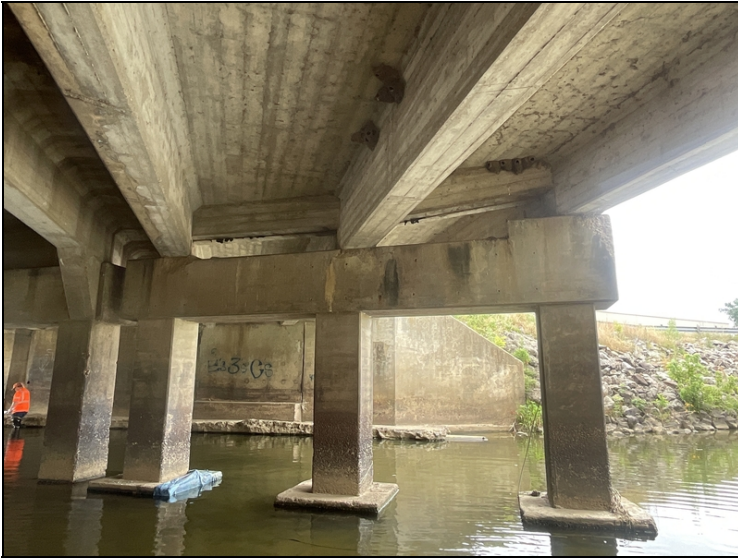
Bent # 2 cap has shallow spalling in the bearing areas of girders # 7, 8, & 9.

The North abutment stem wall has shallow spalling in the bearing area of girder # 1.

Bent #2 cap-Spalling in bearing area of girders #7 and #8.

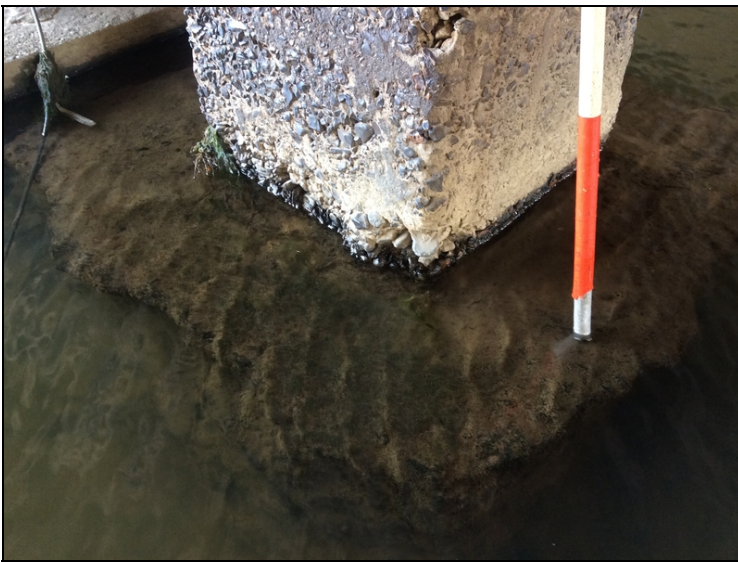
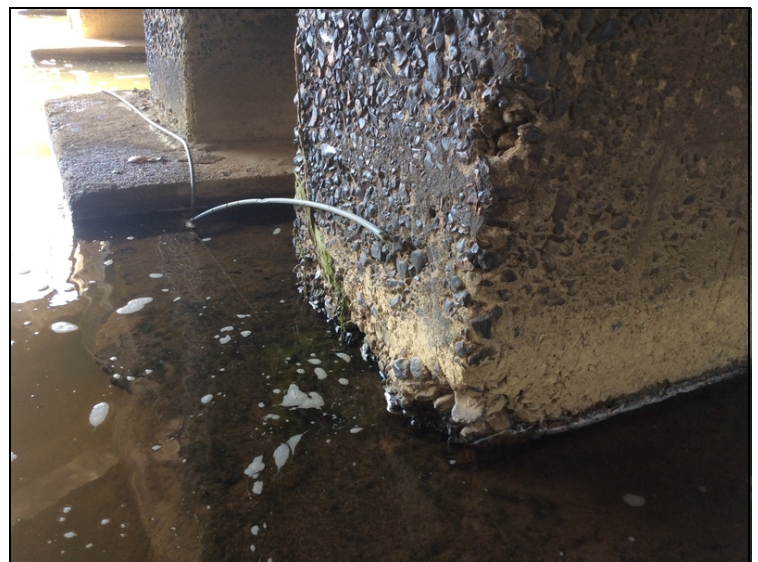
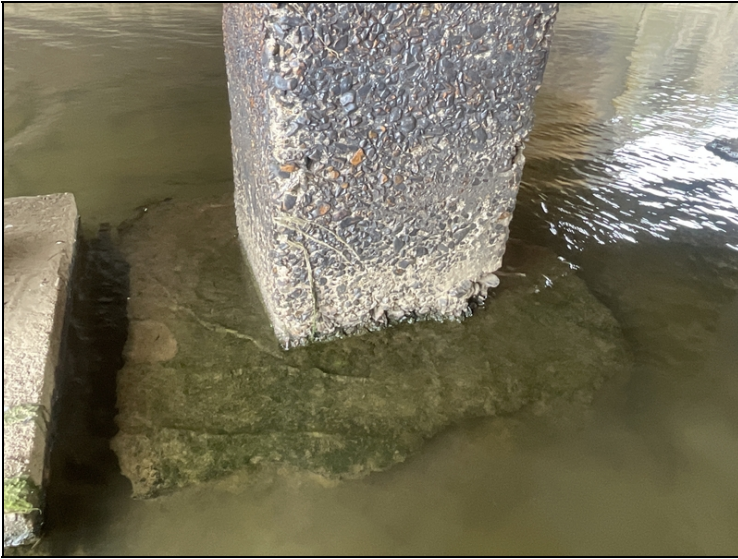
Bent # 2, columns # 5 and # 6 have areas of heavy abrasion with concrete section loss near the bases of the columns.

Concrete deterioration at the base of Bent # 2,
Column # 6.

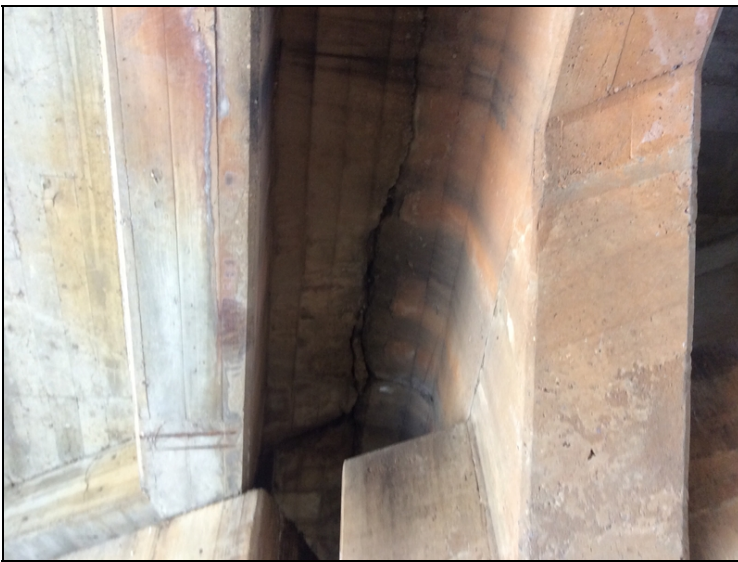
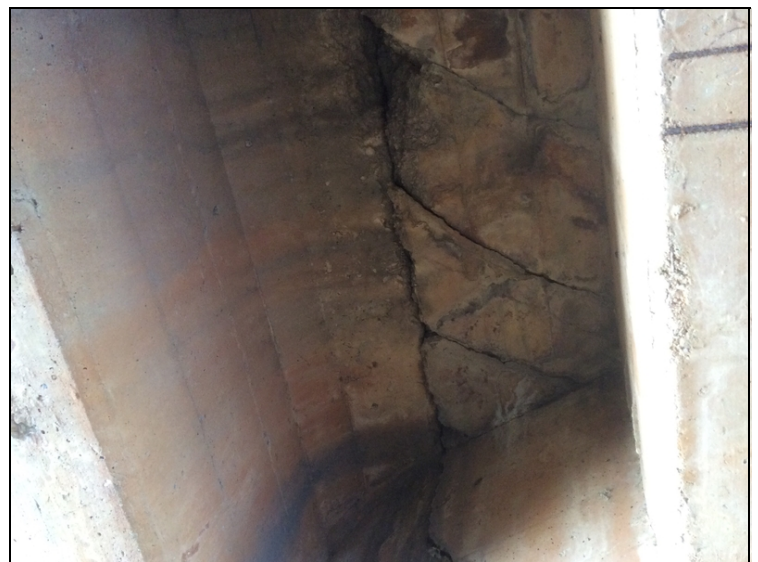
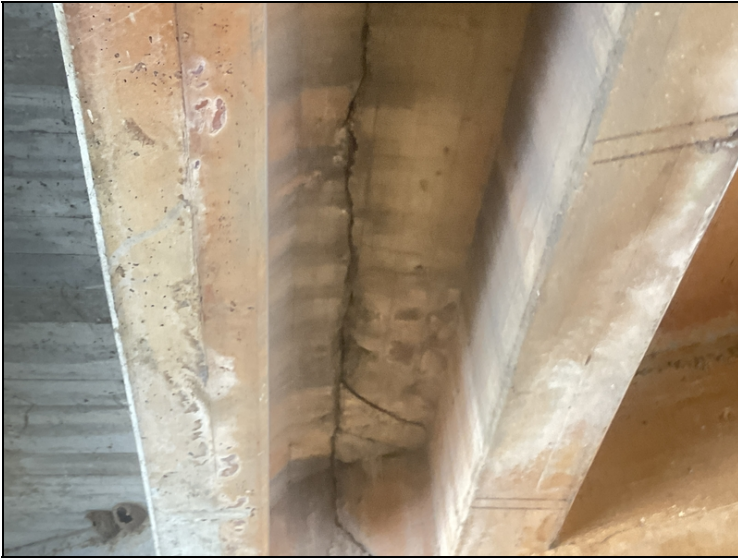
The undersurface of the deck has spalling along the construction joints where the structure has been widened in the past.

Span #1-Delaminated area in deck at construction joint over abutment #1.

Delaminated area at the construction joint under
Span # 1.

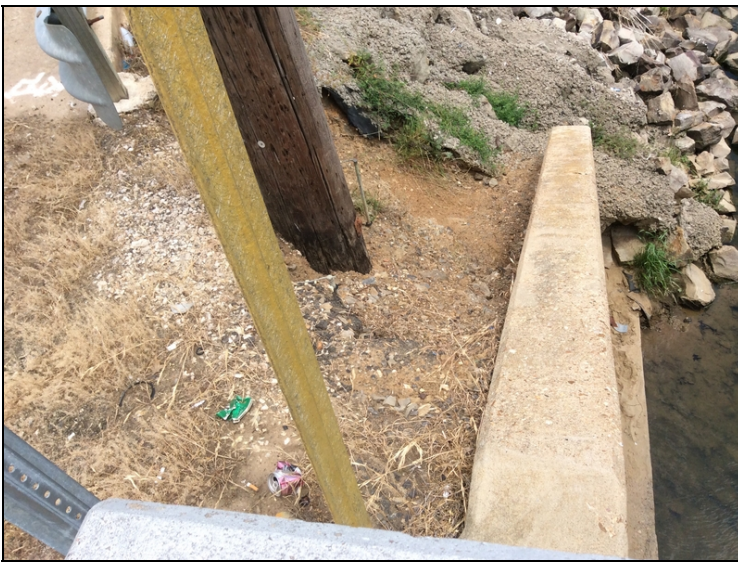
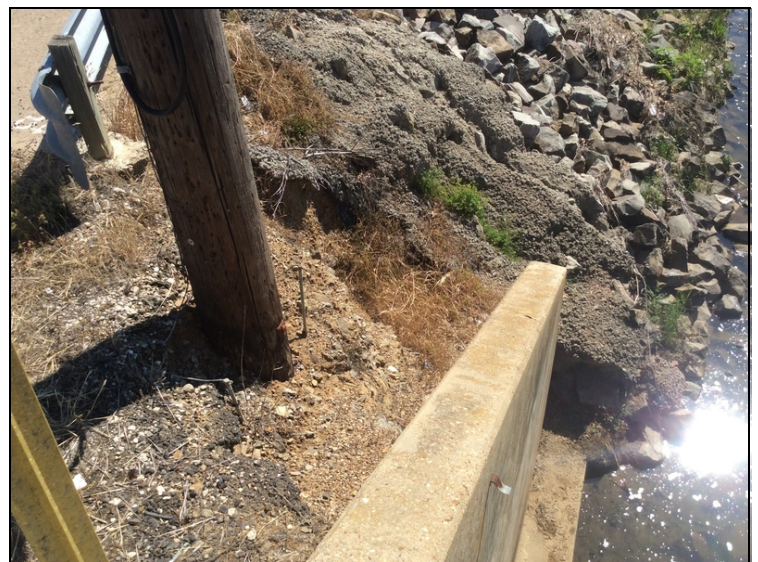
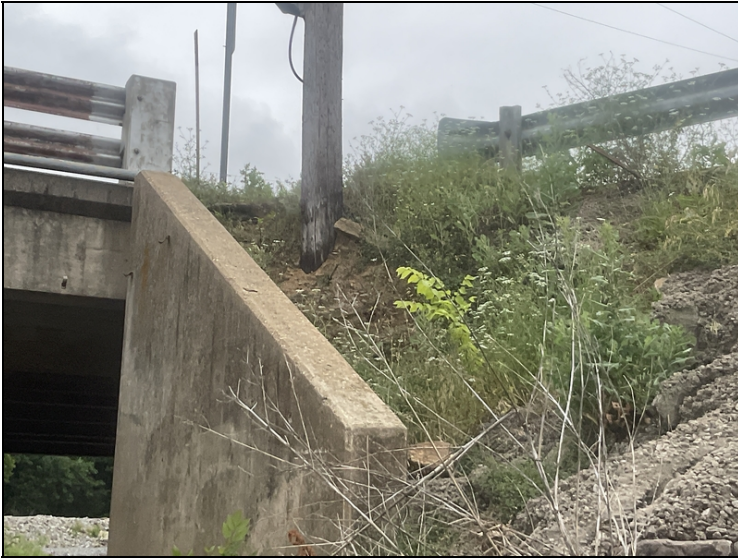
There is minor embankment erosion behind the Northeast wing wall.

Minor erosion behind Northeast wing wall.

Embankment erosion behind the Northeast wing wall.
