Bridge #00329(Routine, Underwater type 2)

US 71B over Mill Creek Sebastian Co.

Location: 0.25 Mi N Jct Phoenix Ave

Team Lead: Jeff Jones Inspection Date: June 02, 2022

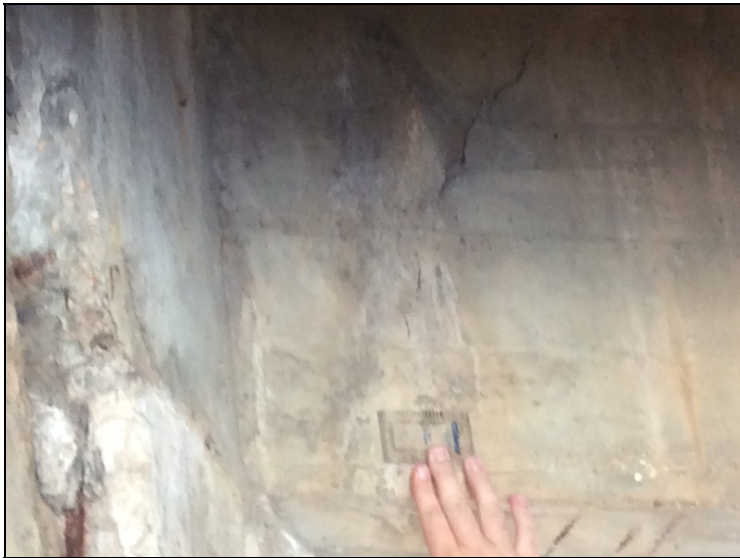
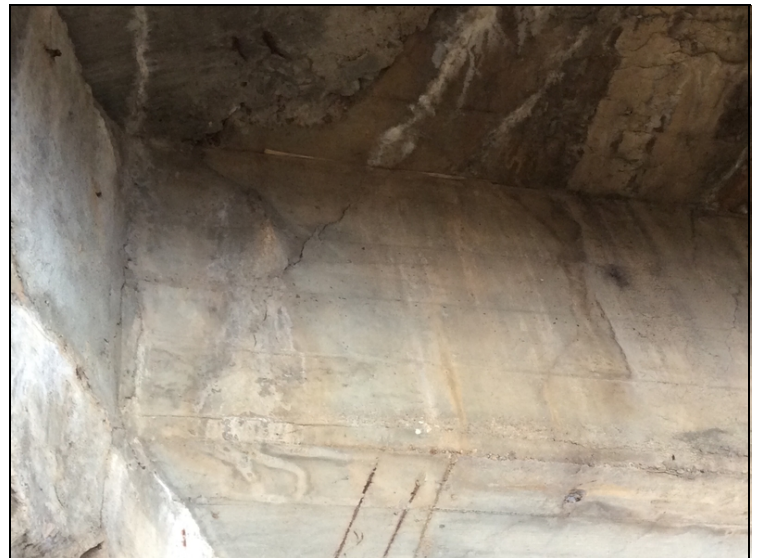
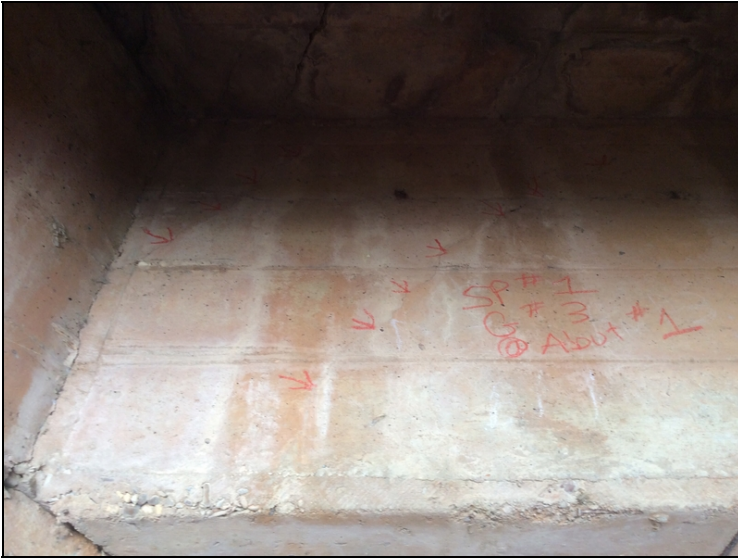
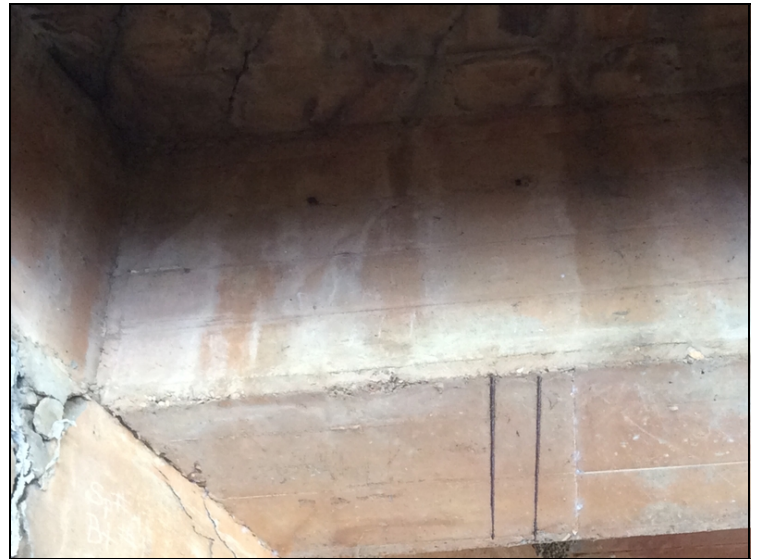
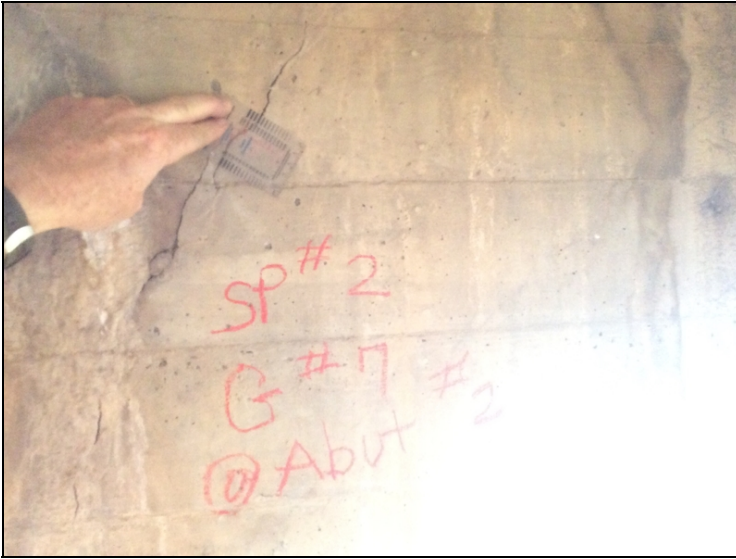
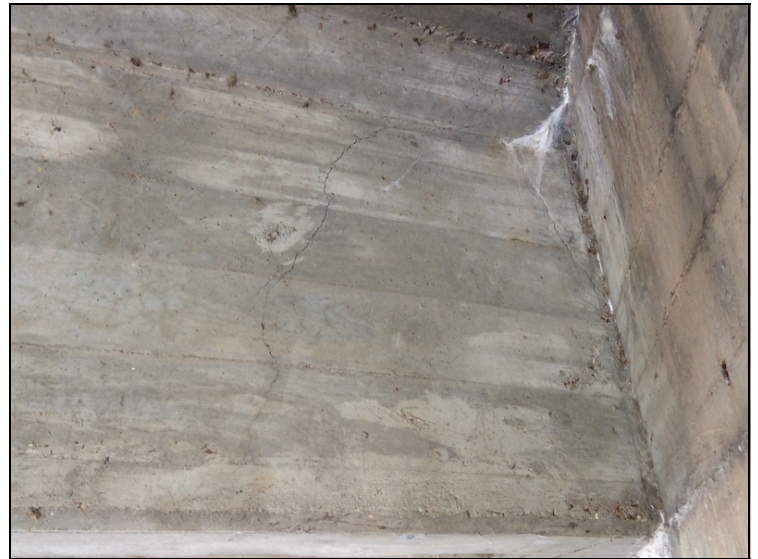
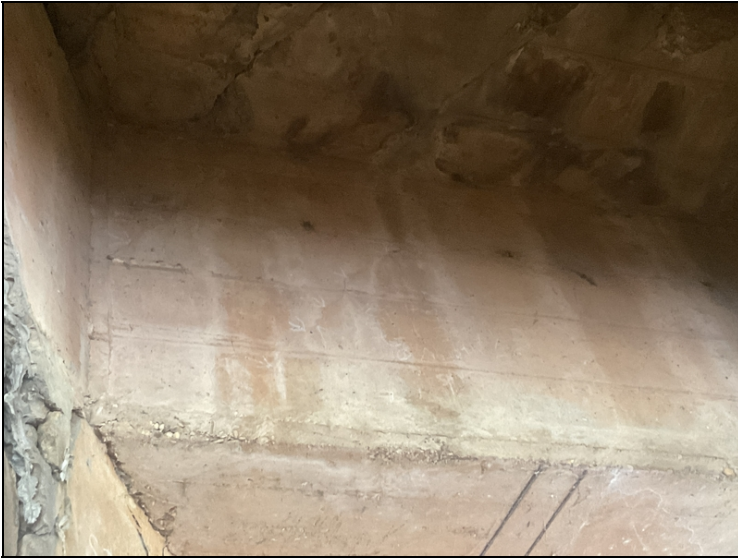
Span # 1, Girder # 3 at abutment # 1, and Span # 2, Girder # 7 at abutment # 2 have shear cracks. No apparent change in crack widths since last inspection.

Shear Crack. Span 2, girder 7. Bent 3. Measures approximately 1/16" at this inspection

Open shear crack. Girder 7. Bent 3.

Span #1, girder #3 at abutment #1-Hairline shear crack.

Hairline shear crack in Span 1. Girder 3. Bent 1.

Span #2, girder #7 at abutment #2-Shear crack.

Span # 1, Bent # 1, Girder # 3, hairline shear crack.

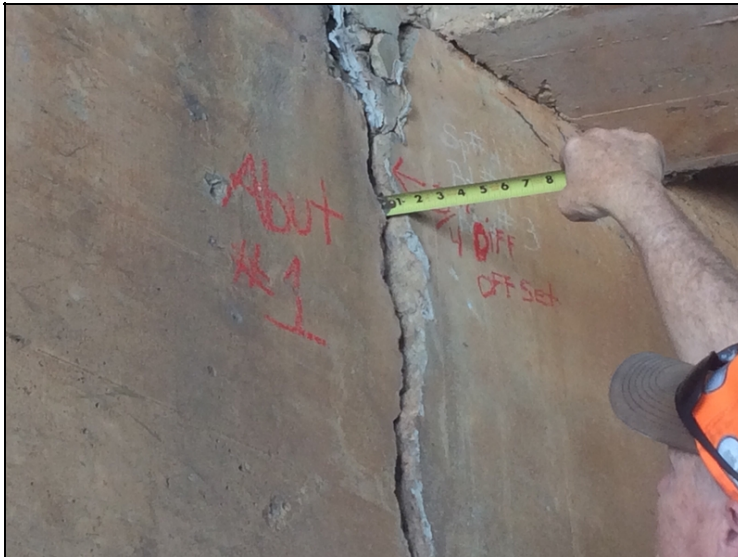
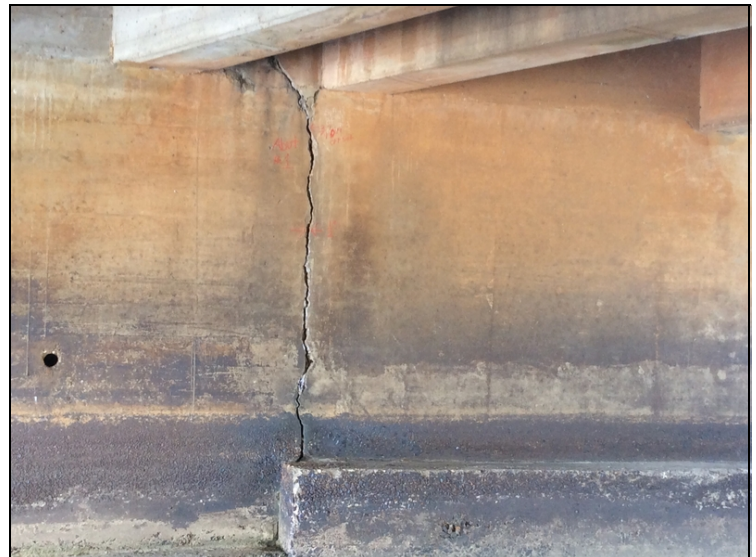
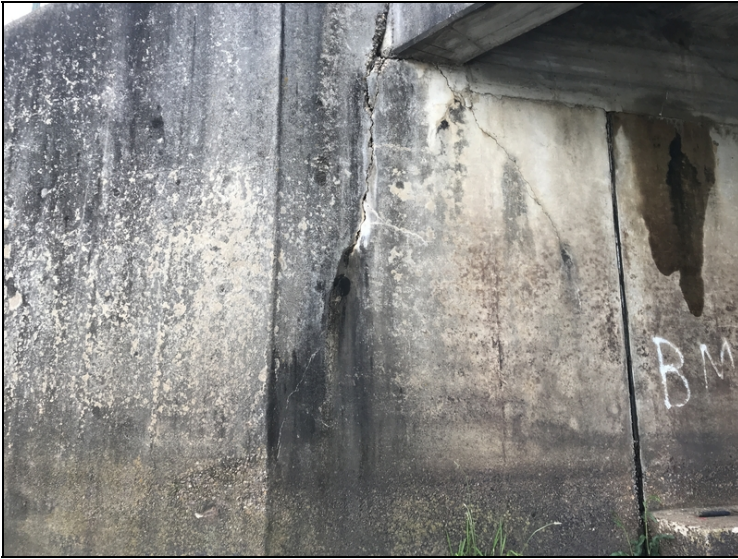
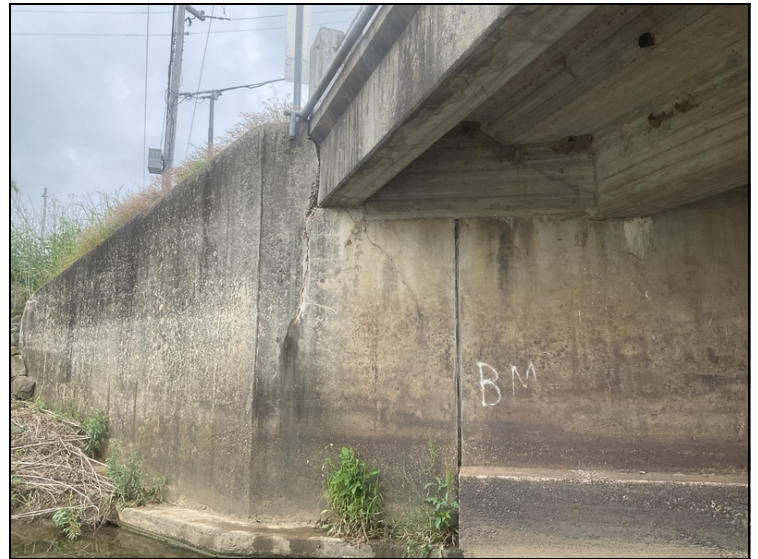
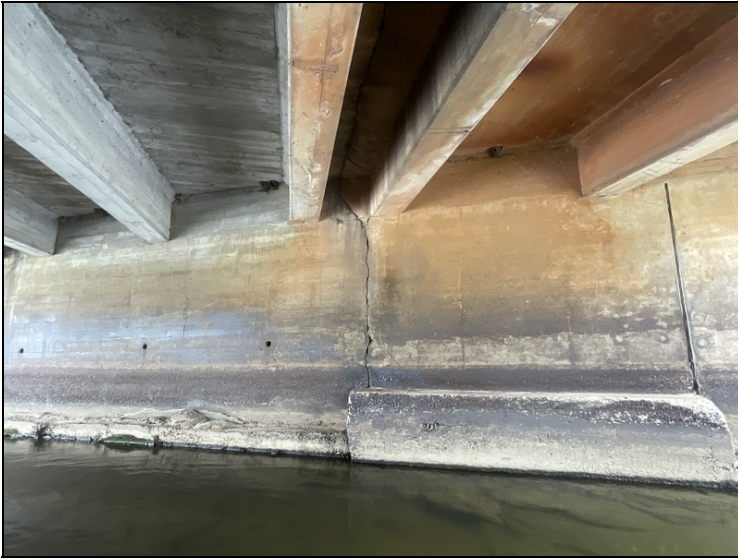
The left side of abutment # 1 stem wall appears to have rotated toward the channel approximately 3/4" at the construction joint creating a wide (1/2") crack at the vertical construction joint with a 3/4" differential offset measured at the top of stem wall.

The Right side of abutment # 1 stem wall has diagonal cracking under girder # 9 with a 1/2" offset in the abutment stem (Appears to be delaminated).

End Bent 1-Differential offset in stem wall.

Abutment #1-Wide racking in breastwall at construction joint.

Bent # 1 Rt diagonal cracking under girder # 9 with a 1/2 offset in the abutment stem.

The Right side of abutment # 1 stem wall has diagonal cracking under girder # 9 with a 1/2 offset in the abutment stem (Appears to be delaminated).

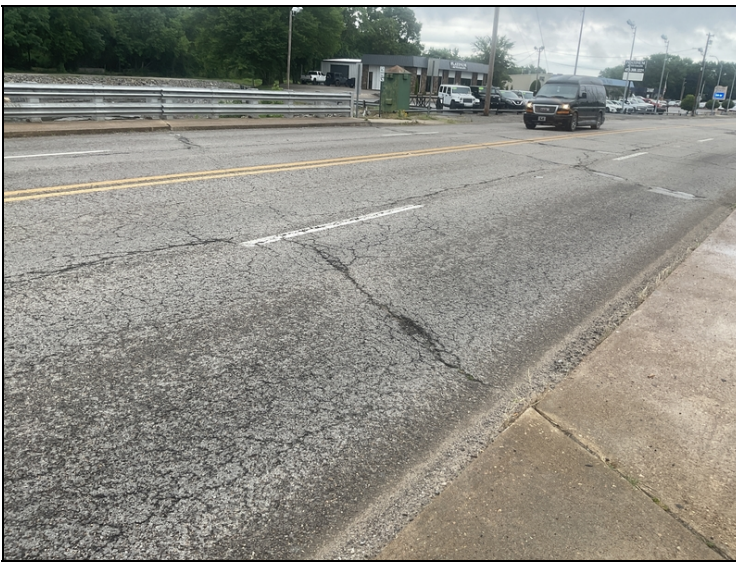
Asphalt breaking apart over the expansion joints with patched areas at the abutments.

Asphalt breaking apart over the expansion joints
with patched areas at the abutments.

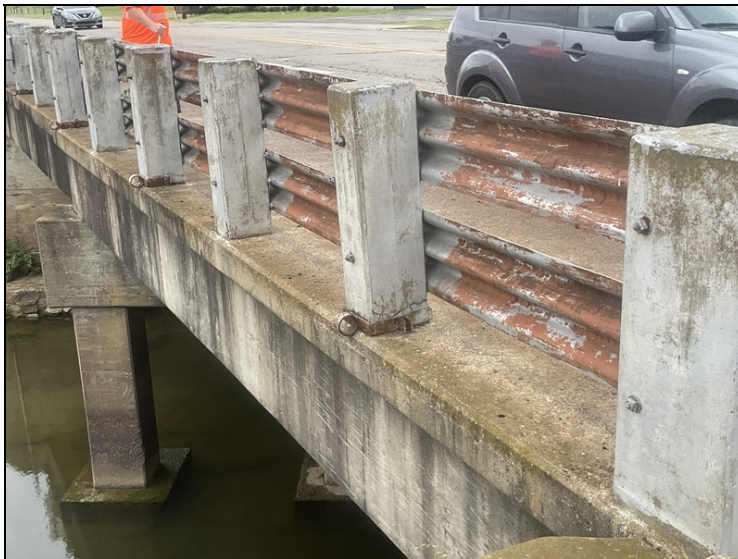
- Both end posts on the Right side of structure have spalling with exposed reinforcing steel in the upper portion of posts adjacent to the railing.
- Post # 2 at Bent # 1 Left is fractured at the base of the rail post.
- Post # 3 at Bent # 1 Left is cracked at the base of the rail post.

- Post # 2 at Bent # 1 Left is fractured at the base of the rail post.
- Post # 3 at Bent # 1 Left is cracked at the base of the rail post.
