Bridge #06901(Routine)
State Highway 255 over Vache Grasse Creek
Location: 1.7 MI N OF 22&255 JCT

Team Lead: Jeff Jones **Inspection Date:** September 19, 2022

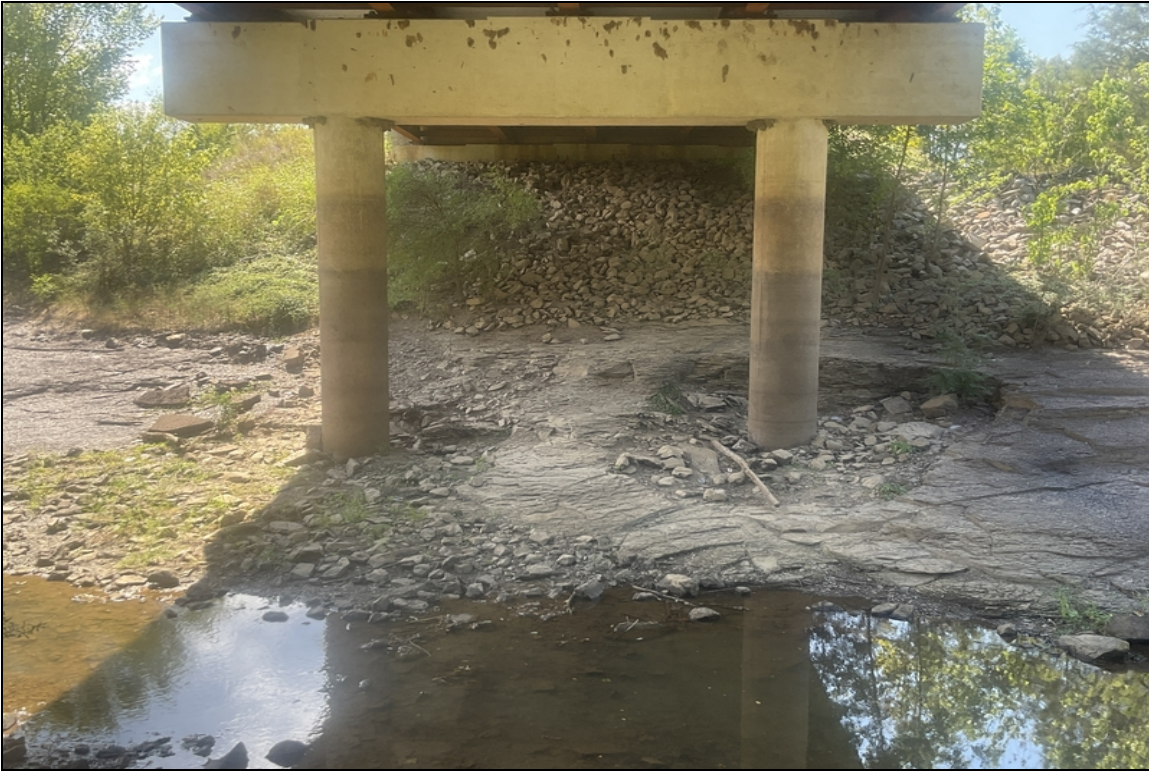
Bent # 3 footings are well keyed into solid shale.

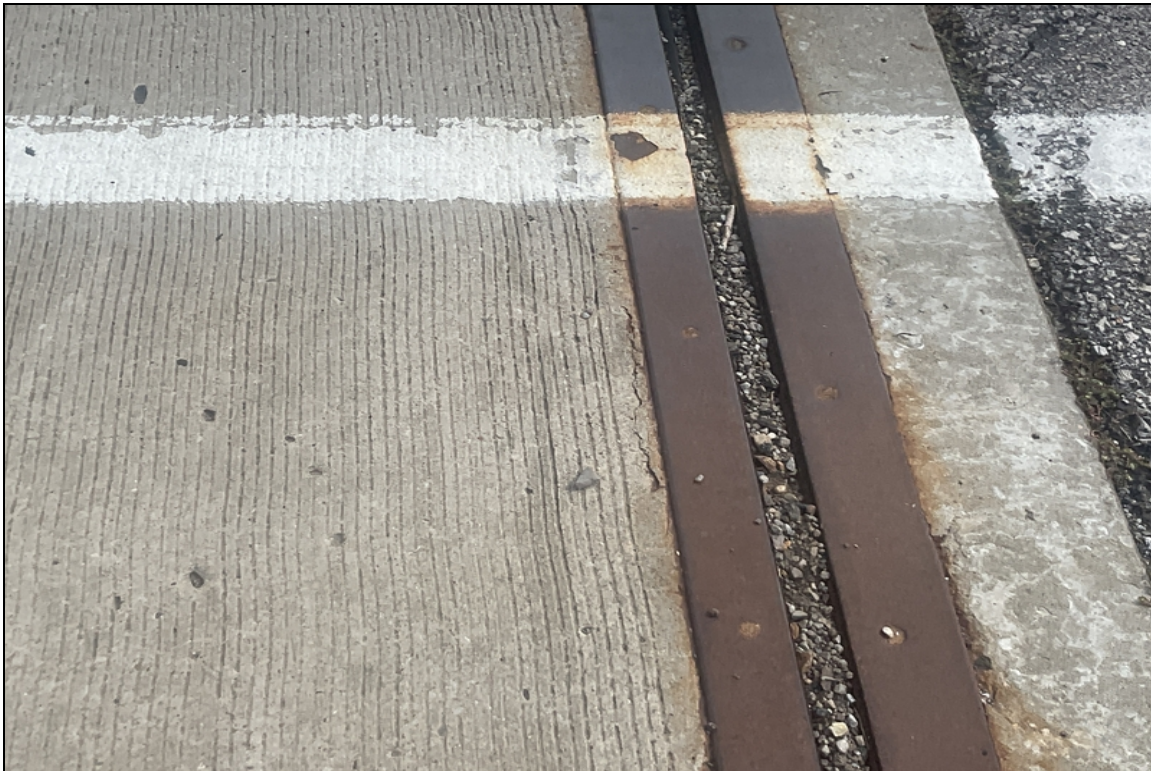
(215)							
-The top of abutment backwalls have several transverse cracks visible from the driving surface. Some of the cracks propagate down the vertical face of backwalls and are visible from the undersurface. -The top of abutment backwalls have a few shallow delaminated areas adjacent to the expansion joint assemblies. -Stains on the abutments indicate that the compression joint seals leak. -The right side of Abutment # 1 has minor earth settlement that has created a void approximately 2' long measured along the length of abutment that penetrates the full width of the bridge seat.

Minor delaminated areas and spalls in the deck adjacent to the expansion joint at the West abutment.

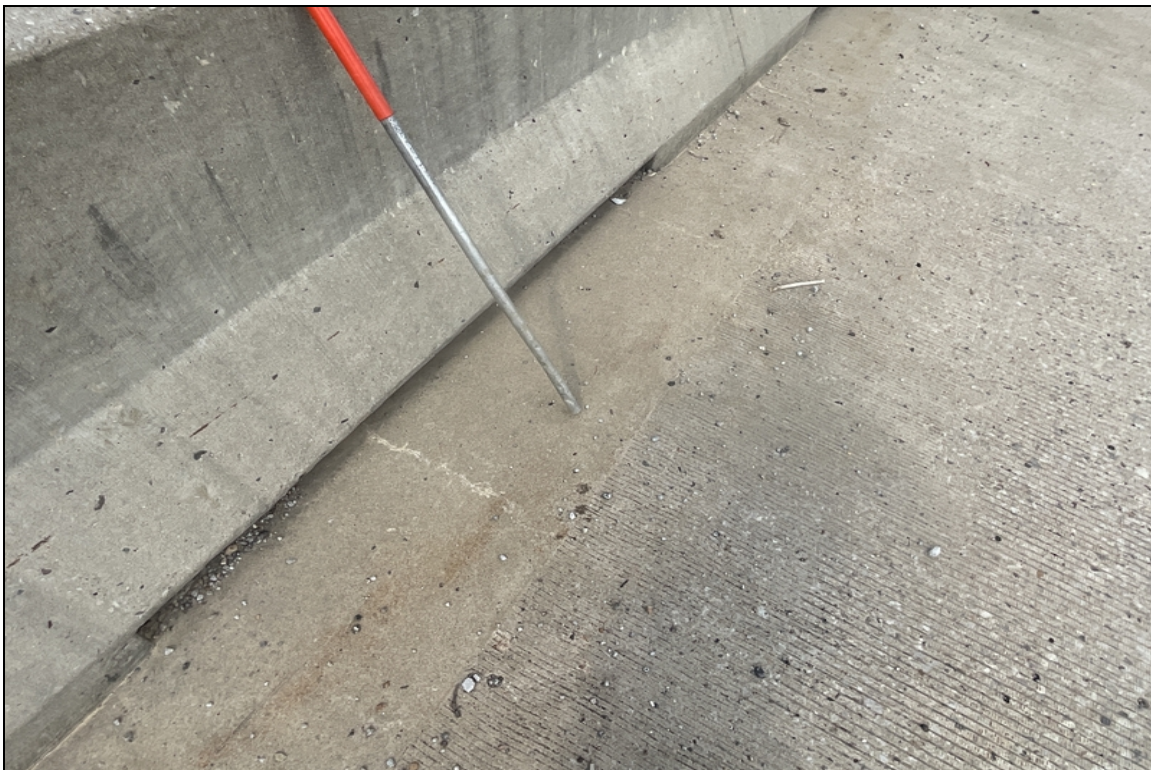
(12)							
-The transverse saw joints have deteriorated sealant in localized areas. -The driving surface of the deck has hairline longitudinal and transverse cracks. The undersurface of the deck overhangs have transverse cracks with light efflorescence that appear to correspond with the joints in the parapet walls. -The driving surface has light abrasion that appears to be from mechanical grinding. -The driving surface has areas of pop outs due to shale inclusions in the concrete from the construction process. -There is minor spalling and delaminated areas in the deck adjacent to the expansion joints. -No significant changes since last inspection.							
107	Steel Open Girder/Beam	LF	1050	1046	4	0	0
1000	Corrosion	LF	4	0	4	0	0
515	Steel Protective Coating	SF	9540	3534	6000	6	0
3430	Oxide Film Degradation Color/Texture Adherence(Steel Protective Coatings)	SF	6006	0	6000	6	0

Transverse cracks in the right gutter.

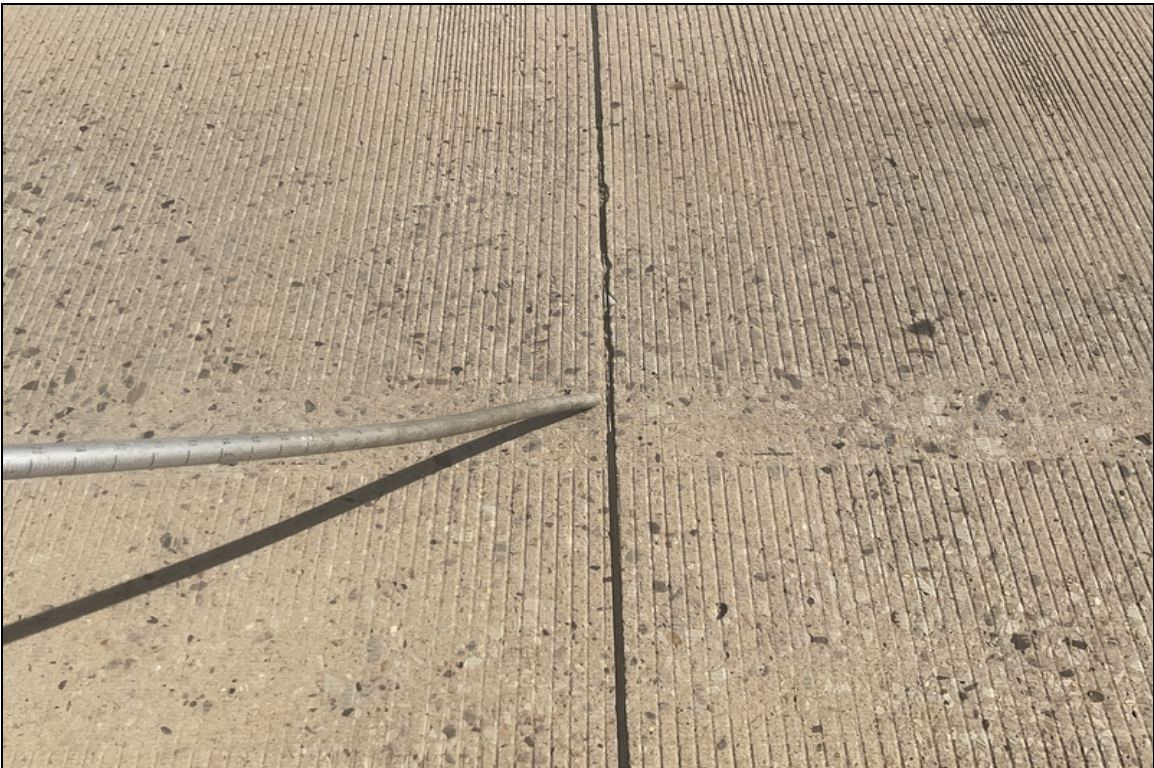
Deteriorated transverse saw joint sealant.

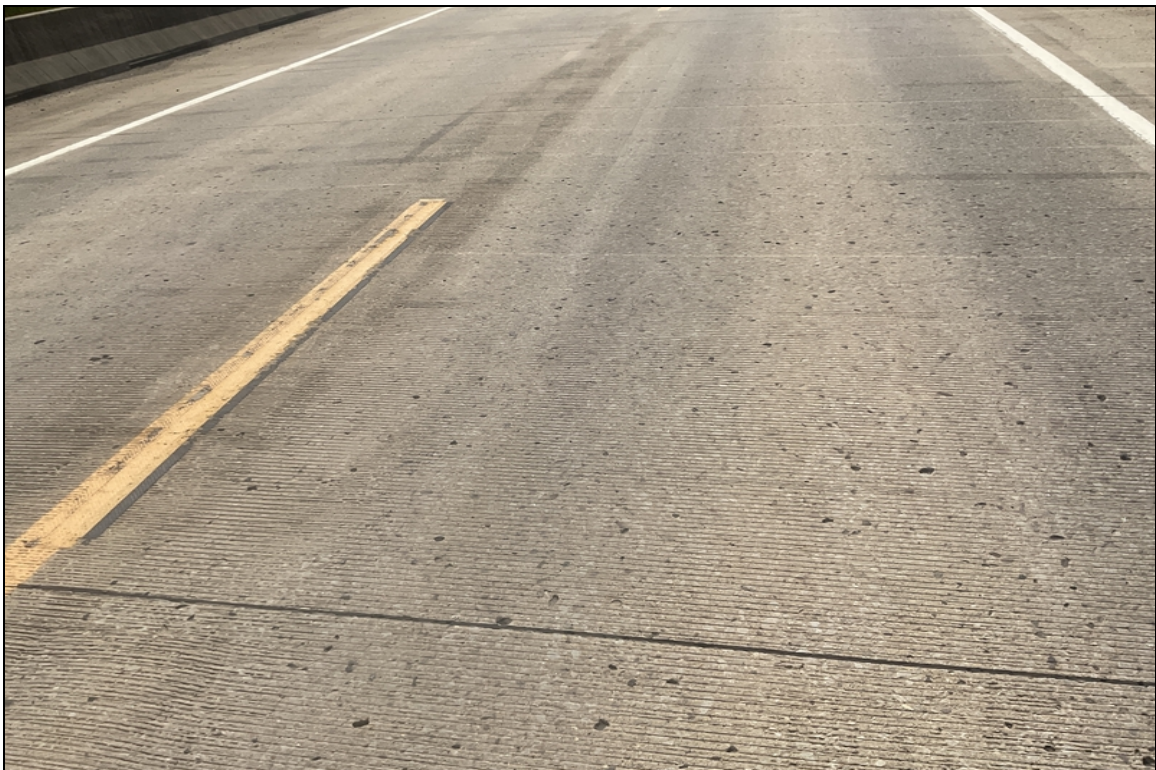
Deck. Pop outs. Typical.

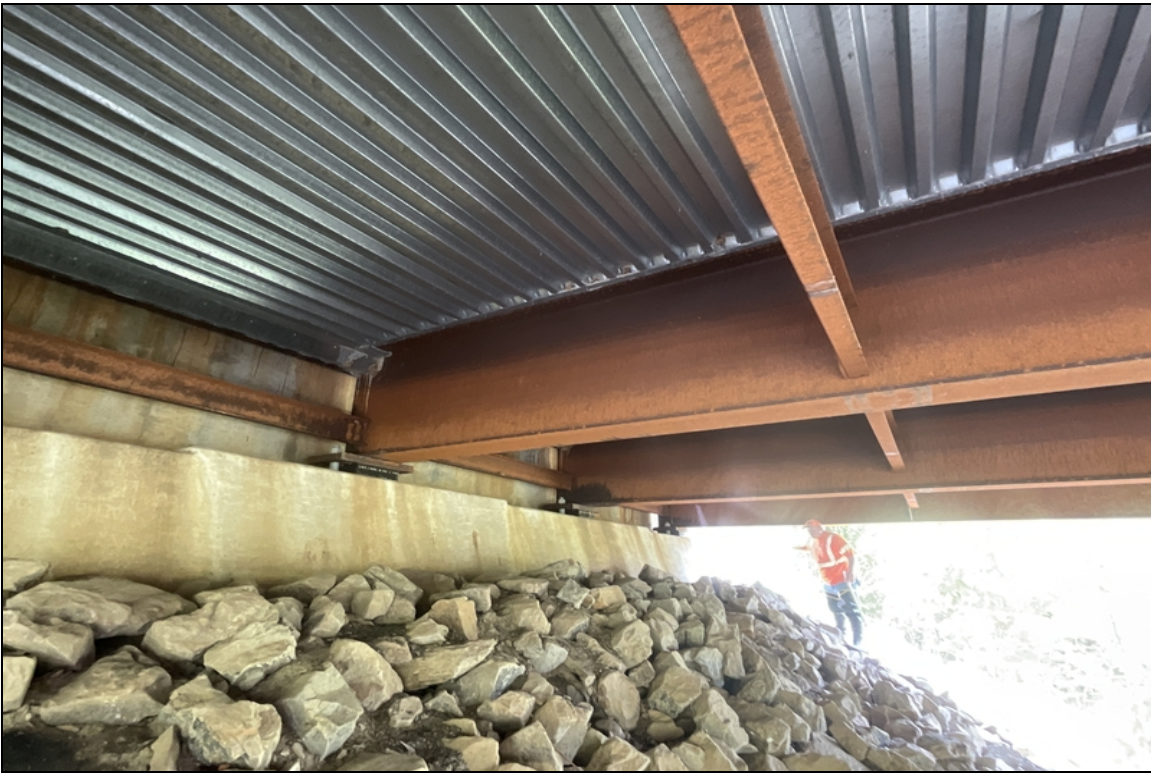
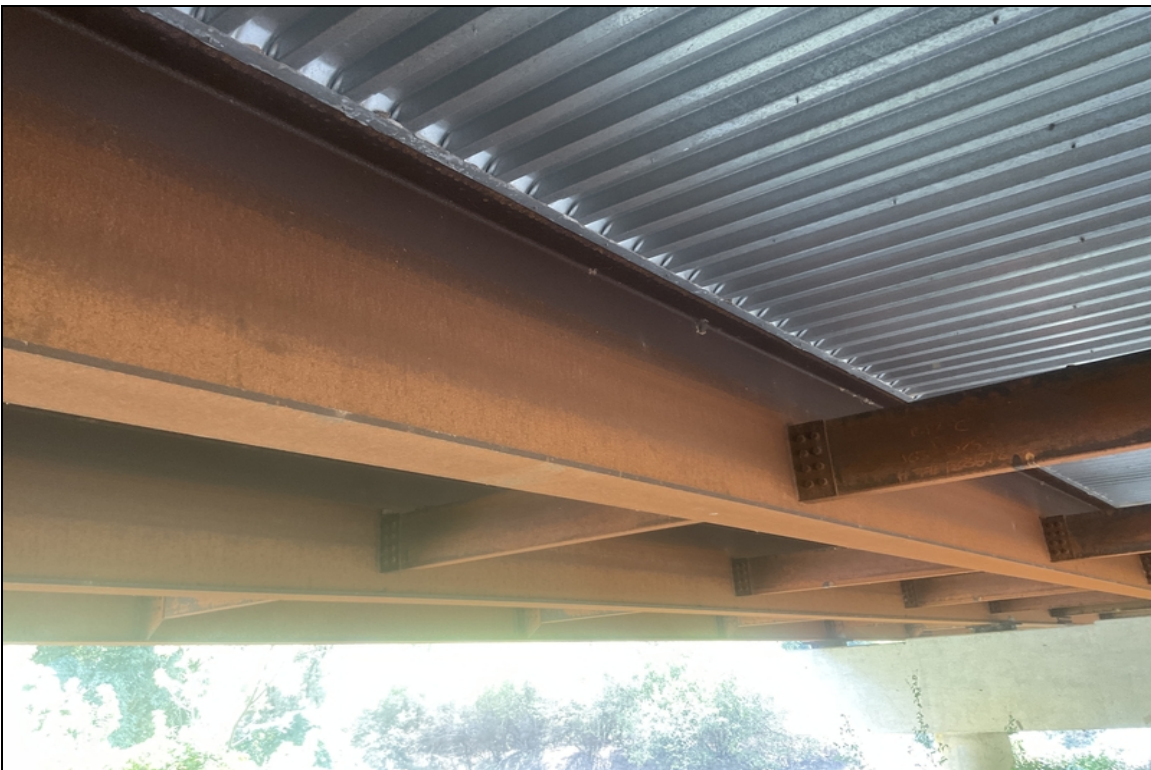
(107)							
09/19/2022 - JCJ & TJL - The weathering steel now has a light reddish color on the bottom flange and web of beams where they were inundated during a high water event.							
-The protective coating on the A588 weathering steel has abnormal weathering over the abutments due to failed expansion joint seals allowing water to leak onto the superstructure. The ends of beams over abutment # 2 are the most notable areas with corrosion starting to initiate on the ends of girders. The weathering steel patina has dark granular flaking.							
205	Reinforced Concrete Column	EA	4	2	2	0	0
1190	Abrasion/Wear (PSC/RC)	EA	2	0	2	0	0

Abnormal weathering (Reddish color) of the protective steel coating.

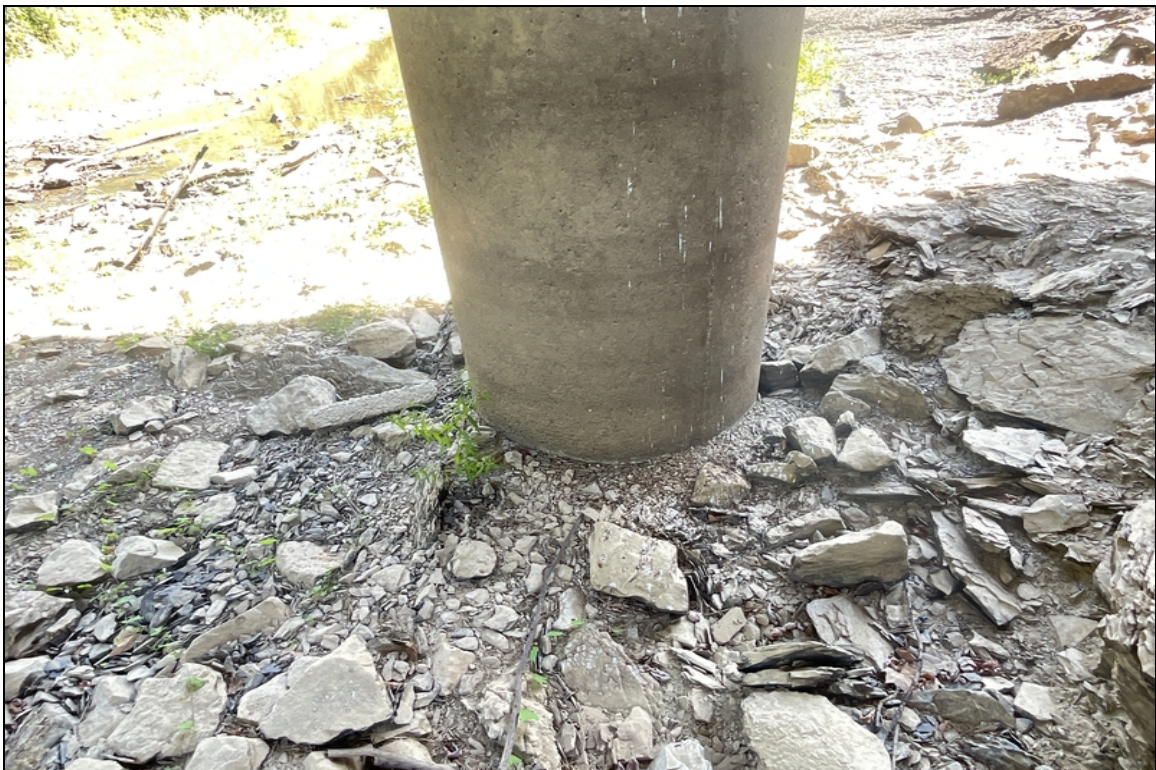
(205)							
-The base of Bent # 3 columns in the channel have light abrasion. -Substructure columns have no other apparent noteworthy deficiencies during this inspection.							
215	Reinforced Concrete Abutment	LF	124	74	50	0	0
1080	Delamination/Spall/Patched Area	LF	9	0	9	0	0
1120	Efflorescence/Rust Staining	LF	2	0	2	0	0
1130	Cracking (RC and Other)	LF	39	0	39	0	0

The base of Bent # 3 columns in the channel have light abrasion.

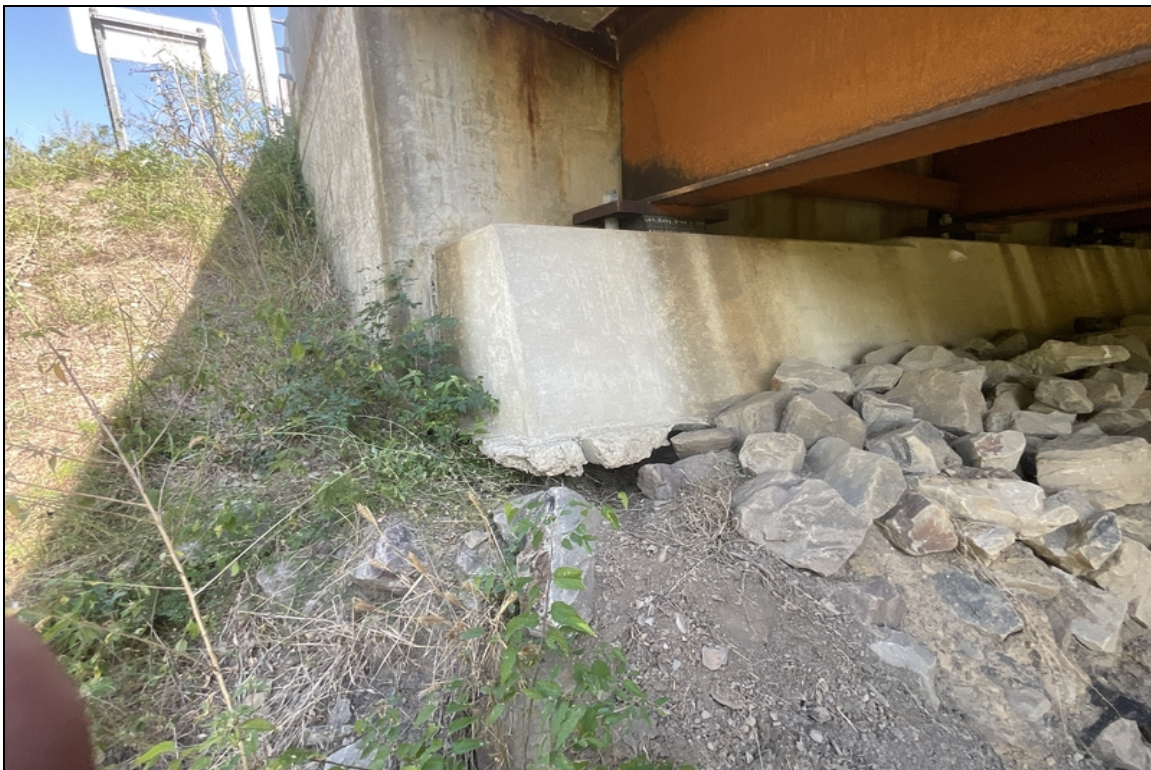
Minor earth settlement under the right side of Bent # 1.

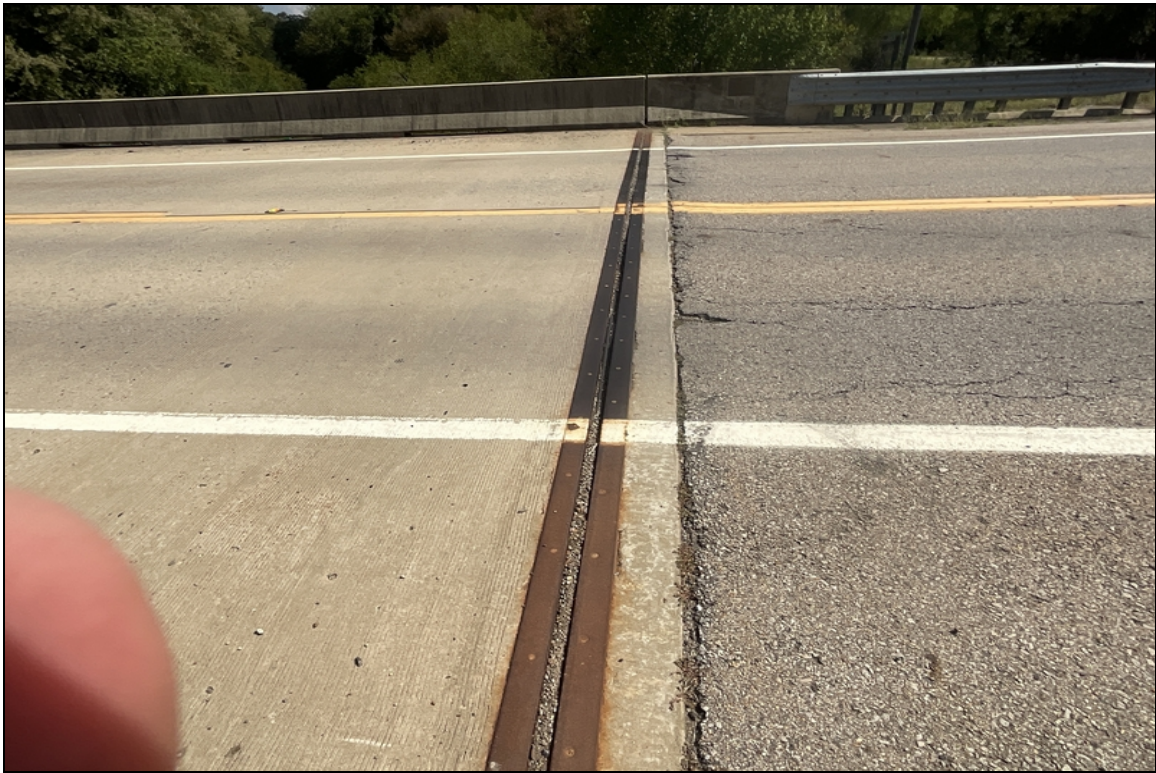
(302)	-Stains on the abutments indicate that the deck joint seals leak. -The compression joint assemblies have pack rust that is contributing to the adhesion failure. -The seal at Abutment # 2 has adhesion failure in areas and has dropped out of its intended position approximately 1" during this inspection. -The assemblies have dirt and debris in the gutters. -There is minor spalling and delaminated areas in the deck adjacent to the expansion joints.						
310	Elastomeric Bearing	EA	20	13	4	3	0
1000	Corrosion	EA	7	0	4	3	0
515	Steel Protective Coating	SF	60	36	6	18	0
3430	Oxide Film Degradation Color/Texture Adherence(Steel Protective Coatings)	SF	24	0	6	18	0

Expansion joint seal at the West abutment.

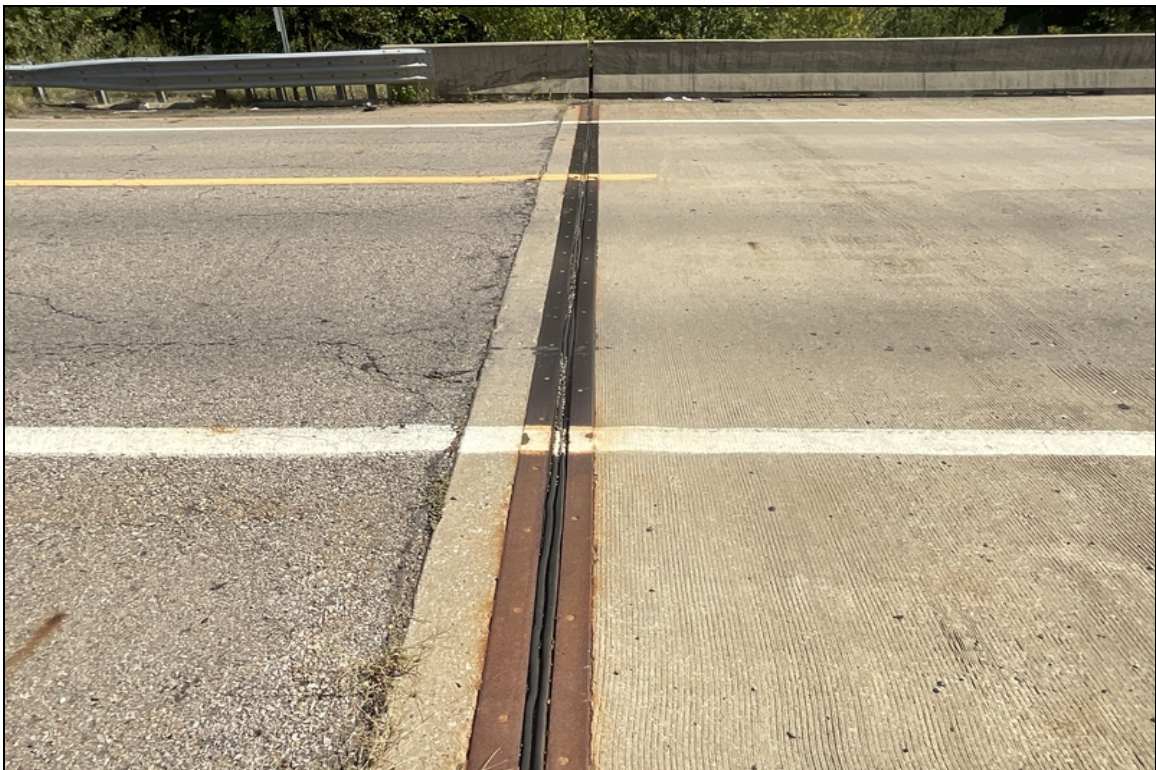
East abutment expansion joint seal.

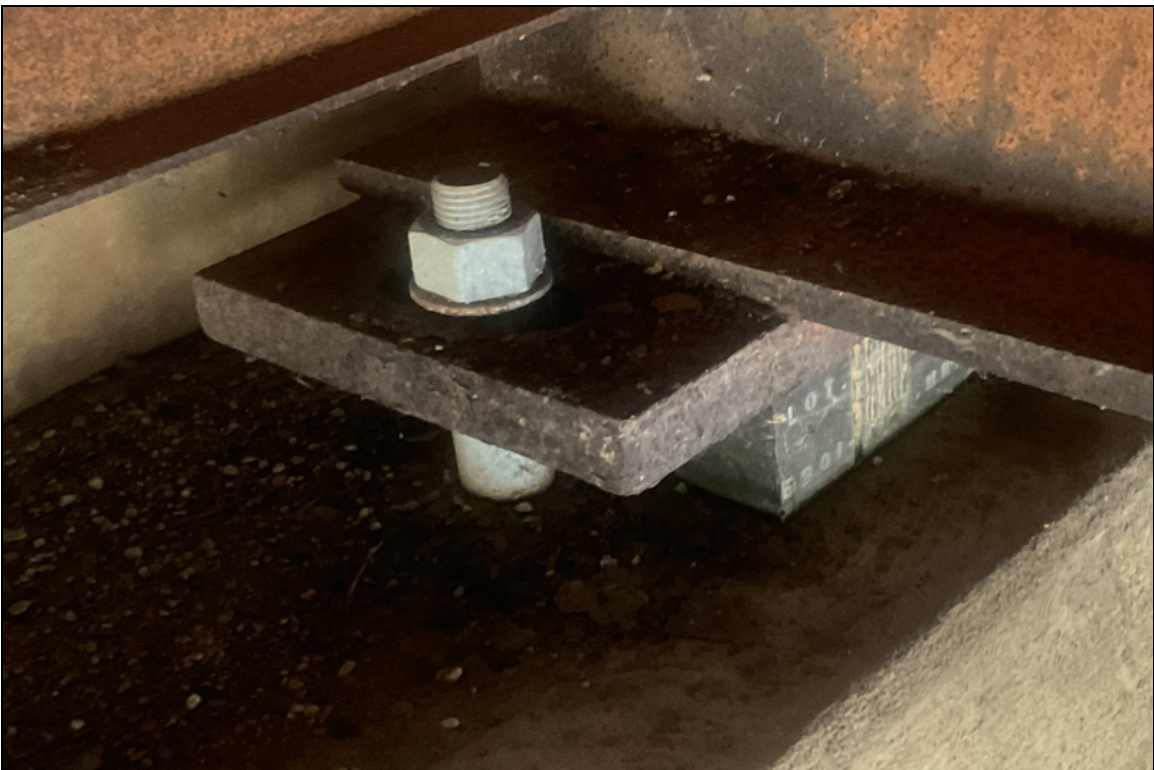
(310)	-The weathering steel patina on the external loading plates have abnormal weathering with dark granular flakes. -Corrosion is beginning to initiate in some locations.						
331	Reinforced Concrete Bridge Railing	LF	424	307	117	0	0
1130	Cracking (RC and Other)	LF	117	0	117	0	0

Beam # 4. Bent # 4. Minor corrosion with flaking rust.

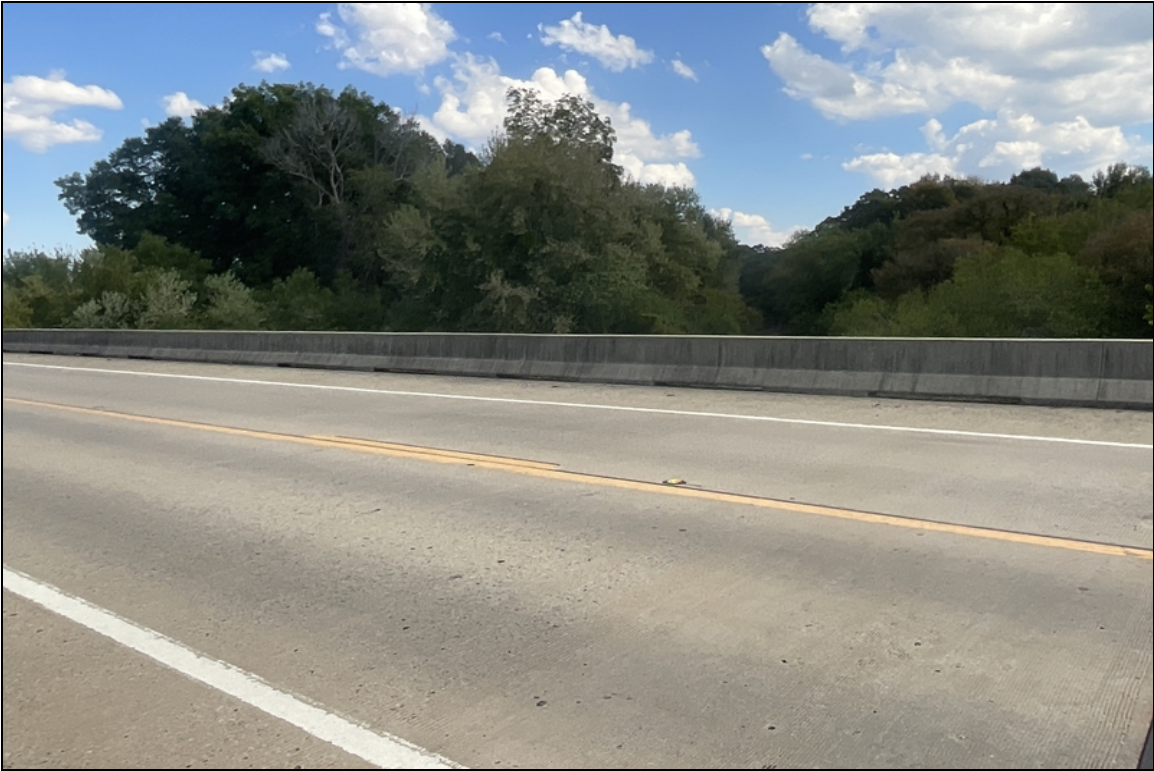
(331)	-The parapet walls have vertical hairline cracks at variable spacing.

Parapet wall. Typical.

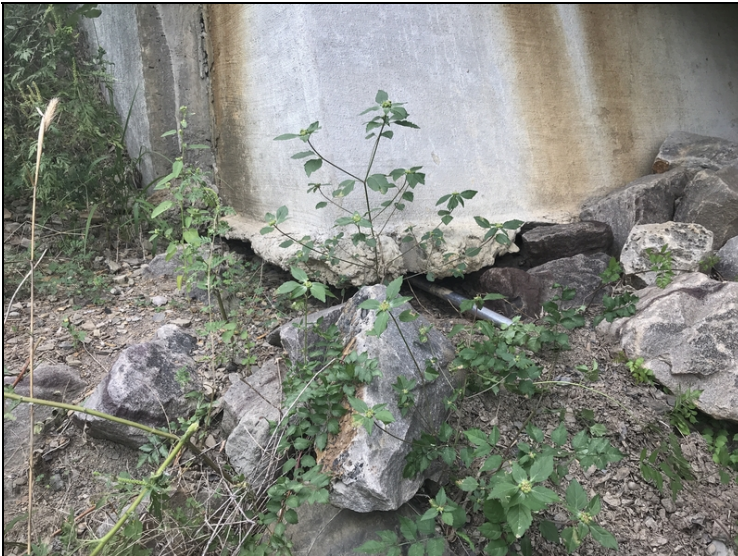
The embankment on the right side of abutment # 1 has minor earth settlement that has created a void approximately 2' long that penetrates the full width of the bridge seat.

The right side of abutment #1 has minor earth settlement that has created a void approximately 2' long that penetrates the full width of the bridge seat.

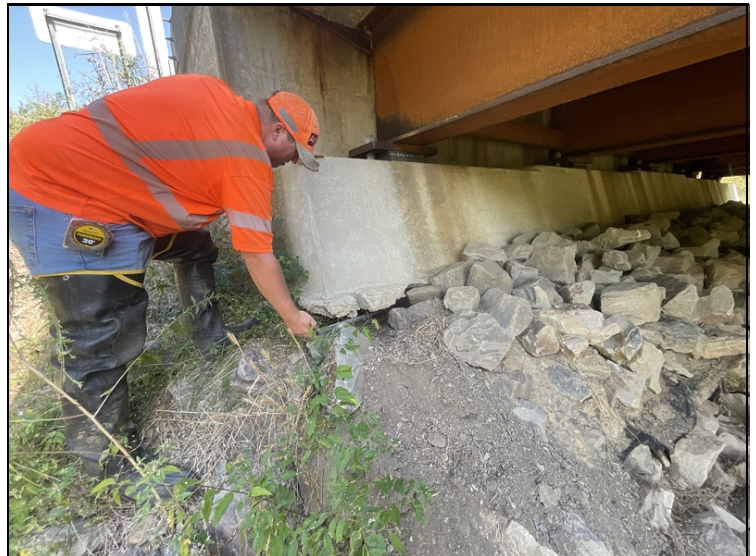
Minor earth settlement under the Right side of Bent # 1.

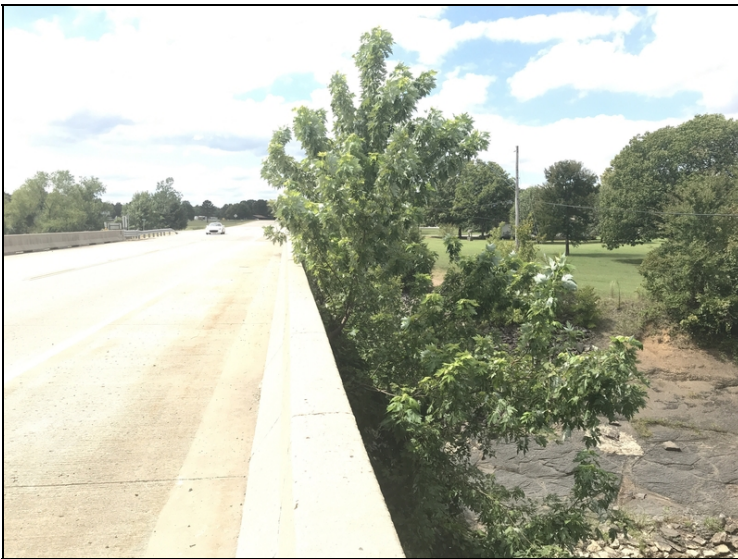
Channel -
The channel has vegetation growing over the parapet on the North side of structure.

The channel has vegetation growing over the parapet on the North side of structure.

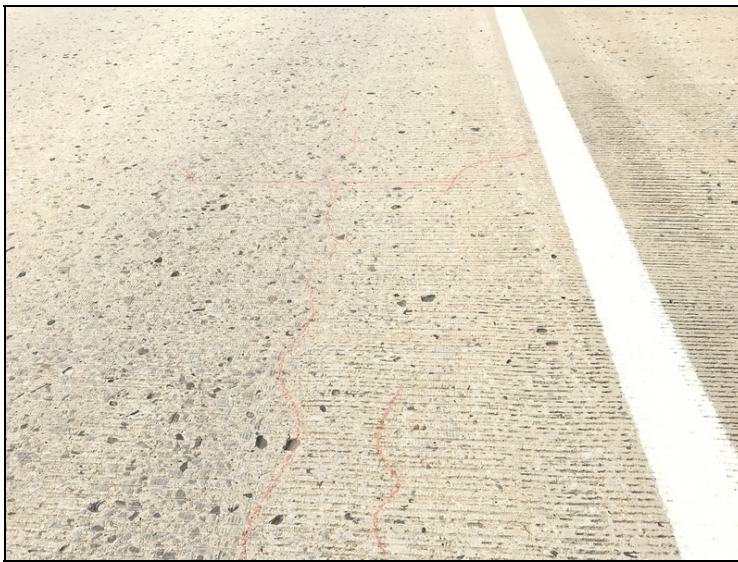
Deck -
The driving surface of the deck has sealable transverse and longitudinal cracking in all spans.

Span #1-Longitudinal and transverse deck cracking.

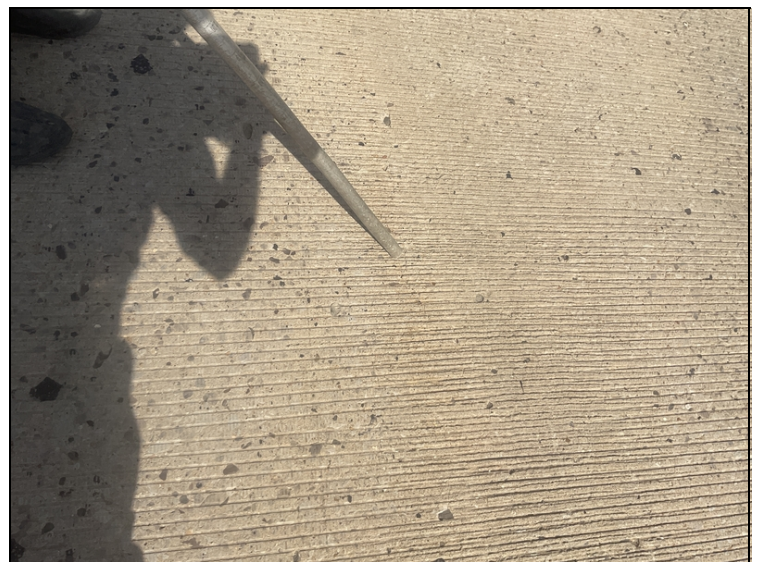
Deck. Sealable Longitudinal crack.

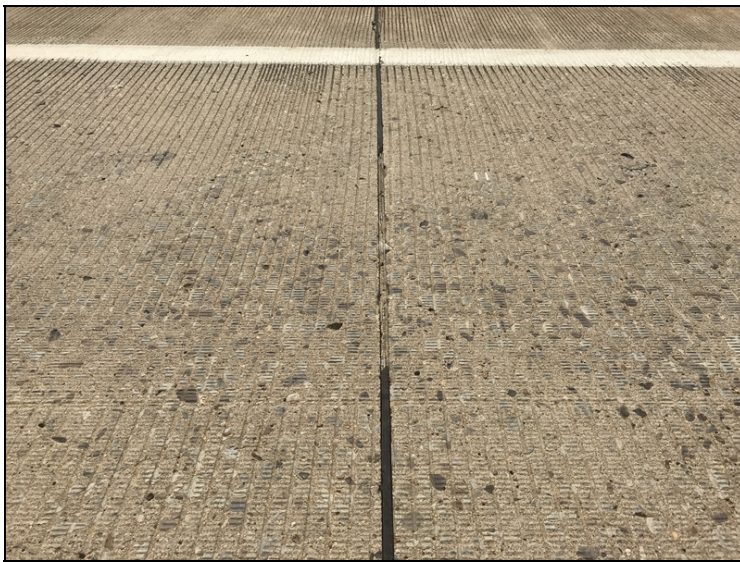
Deck -
The saw joint sealant is deteriorating and missing in areas.

Span #2-Missing sealant in sawn deck joint.

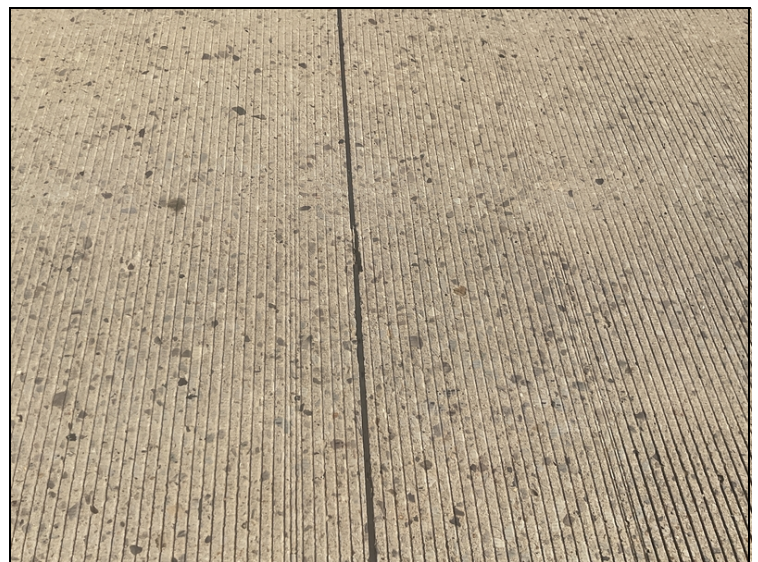
Deteriorated transverse saw joint sealant.

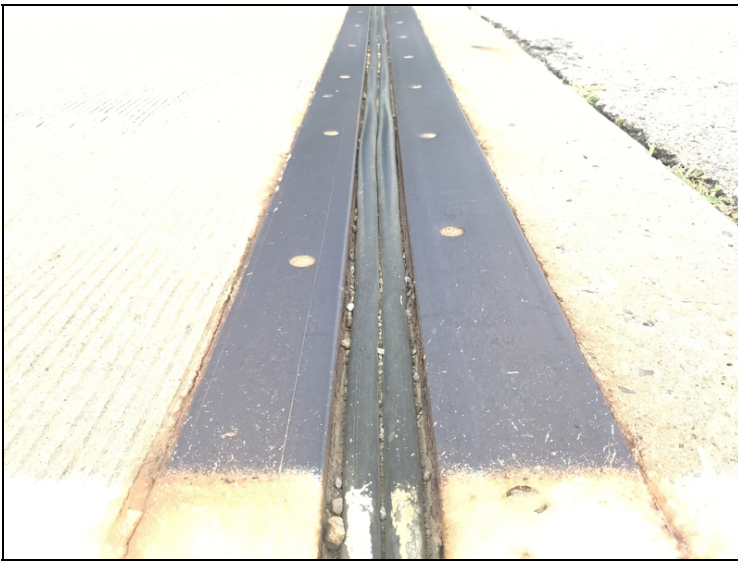
The compression joint seals have adhesion failure and leak water on the substructure. The joint assemblies have pack rust that is contributing to the adhesion failure. The compression joint seal at abutment # 2 has dropped out of its intended position approximately 1".

Abutment #1 compression joint seal-Adhesion failure.

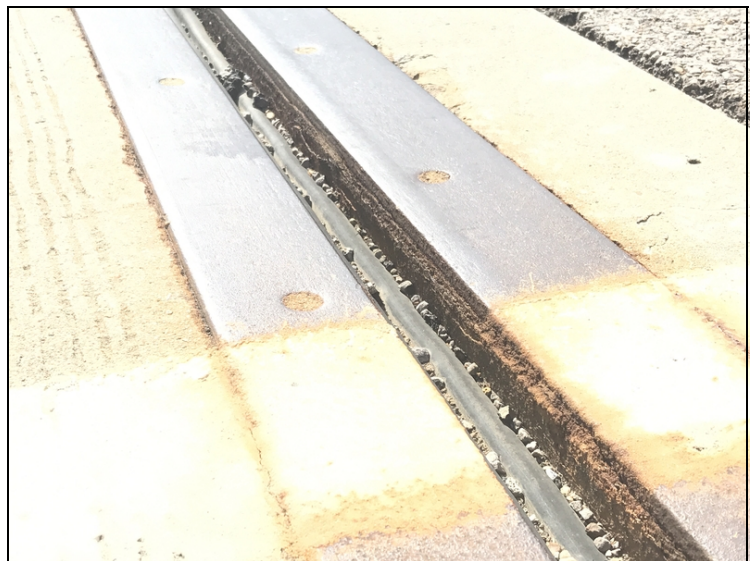
Abutment #2-Pack rust in expansion joint assembly.

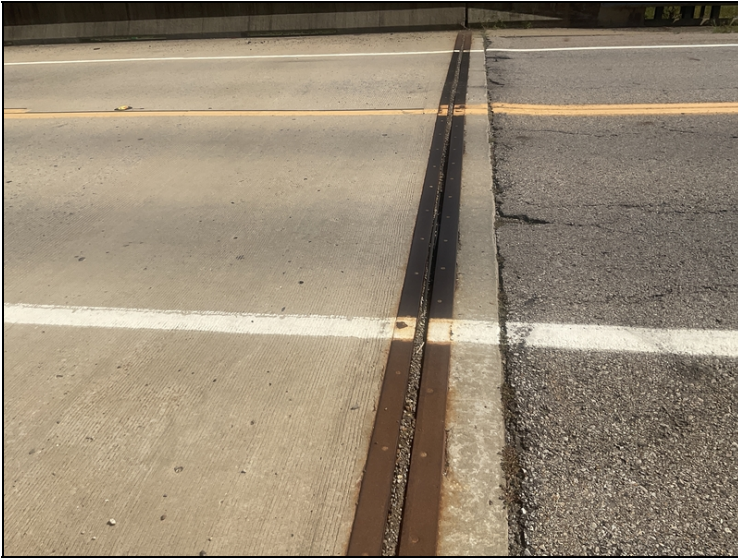
West abutment. Settlement of the expansion joint seal.

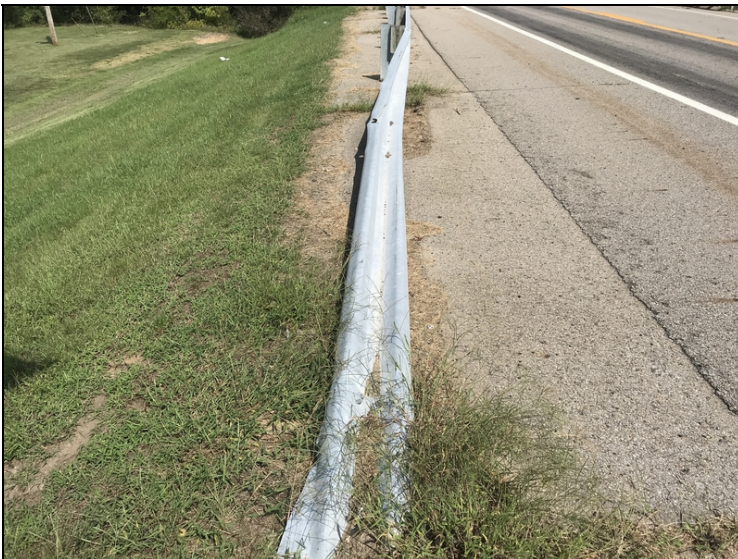
The West approach railing has minor collision damage that has caused out of plane bending to the railing. The Southwest approach railing is missing one of the timber spacing blocks.

Abutment # 2 Rt approach guardrail damage.

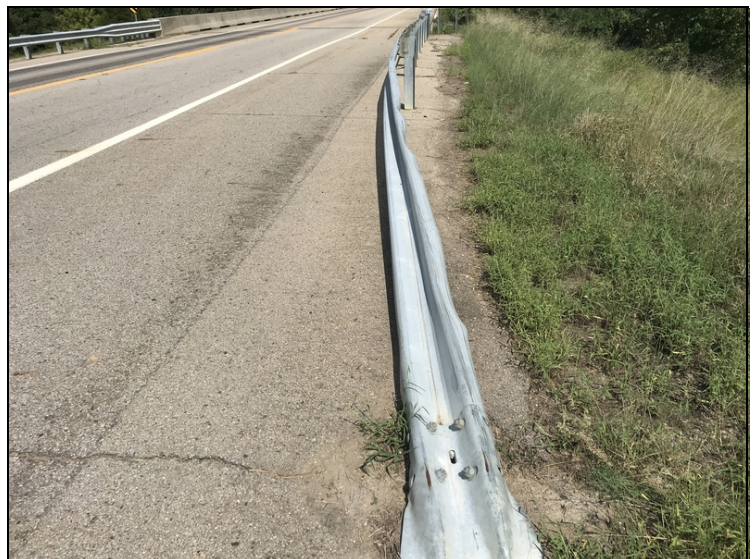
Abutment # 2 Lt approach guardrail damage.

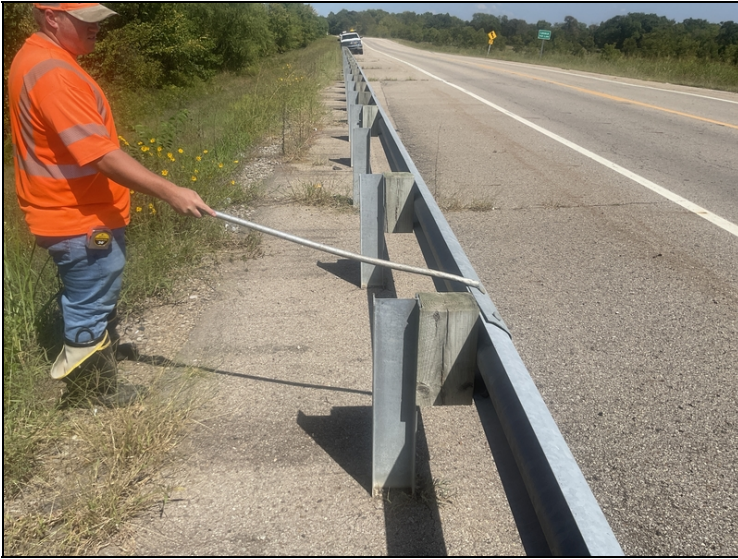
The Northeast approach guardrail is missing one timber spacer block and has a loose bolted connection.

Loose bolted connection pointed out.
Missing spacer block in the background.

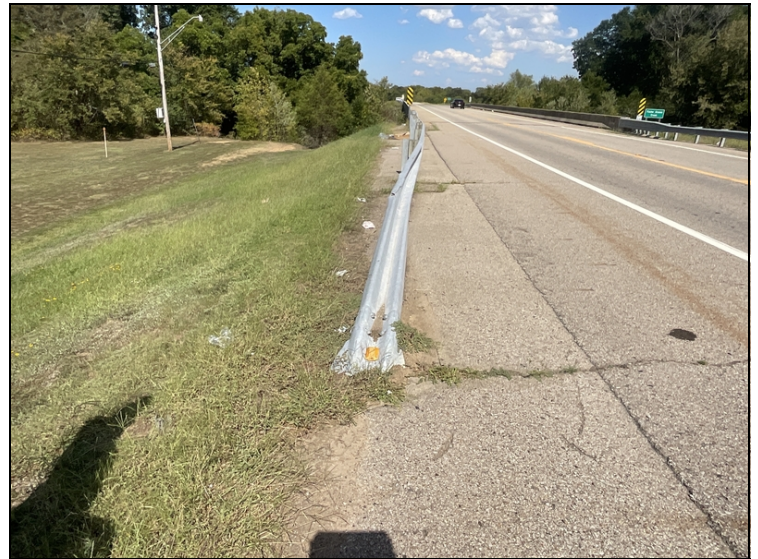
Minor collision damage to the Northwest approach guardrail.

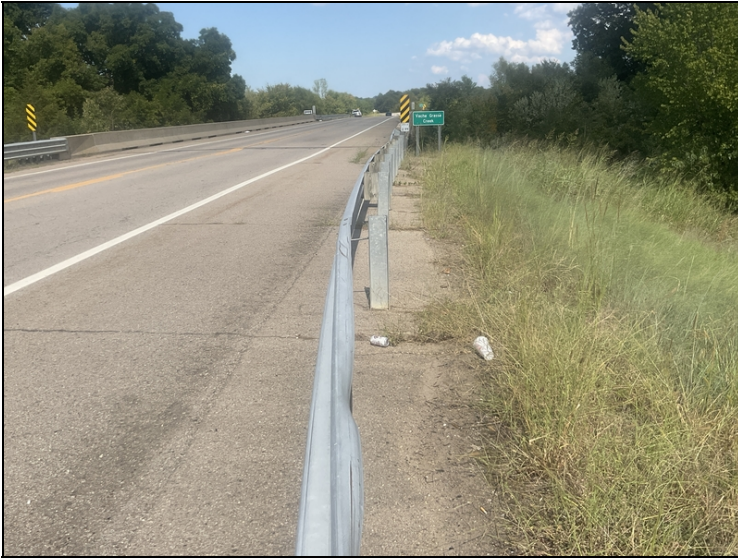
Southwest approach guardrail is missing a timber spacer block.

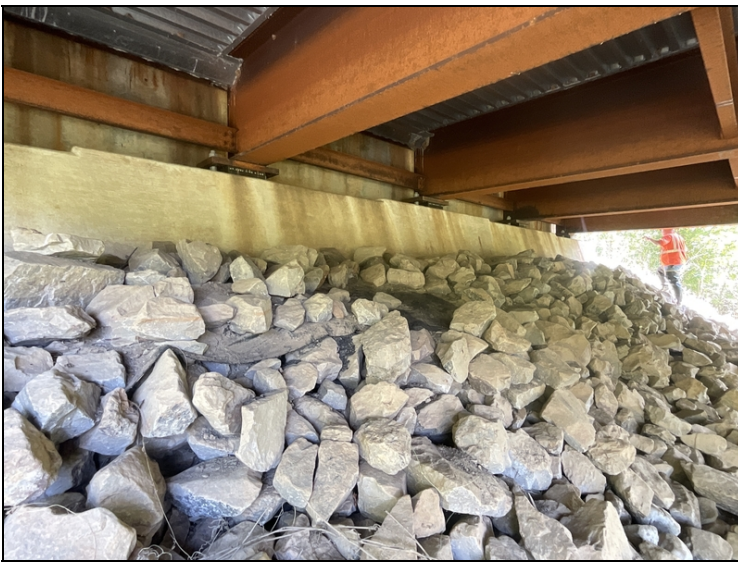
There is minor displacement of the dumped riprap with exposed filter fabric adjacent to the East abutment.

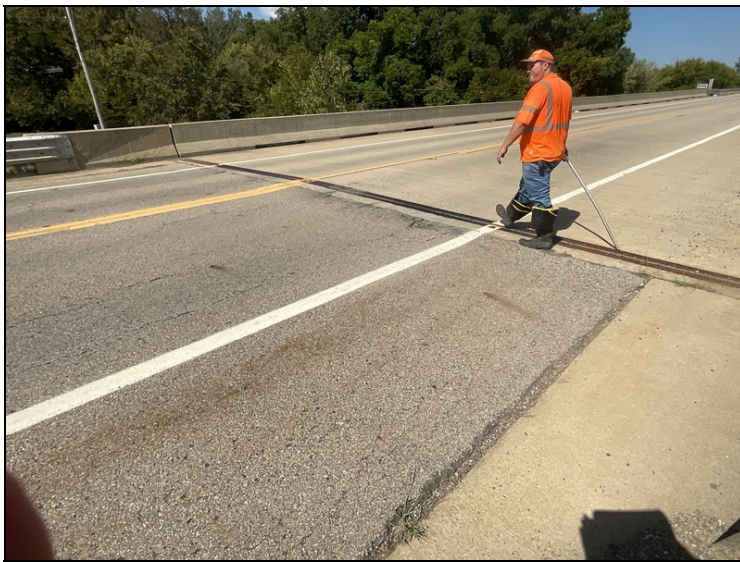
There is settlement in the asphalt at both bridge ends.

Approach roadway at the West bridge end. Asphalt settlement.

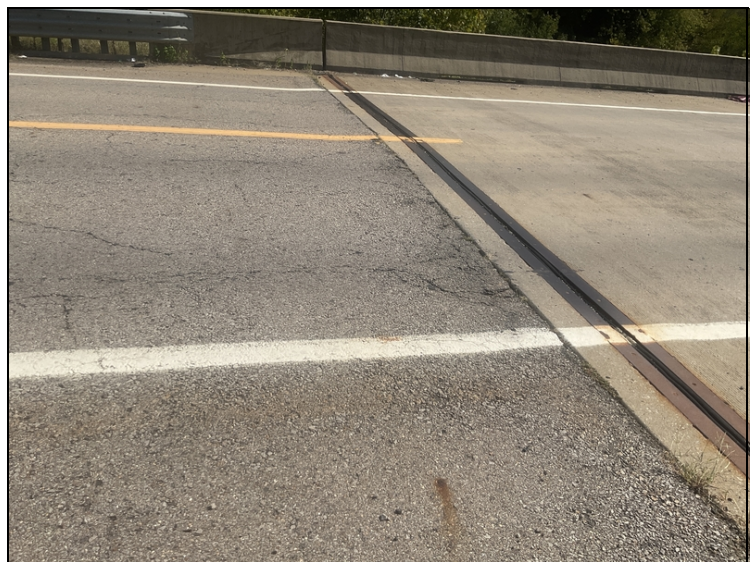
Approach roadway at the East abutment. Asphalt settlement.
