Asset #05175(Routine)

US 64 Seb. Co. over Arkansas River Relief

Location: 0.5 MI S ARK. RIVER

Team Lead: Bob McEntyre Inspection Date: 08/19/2024

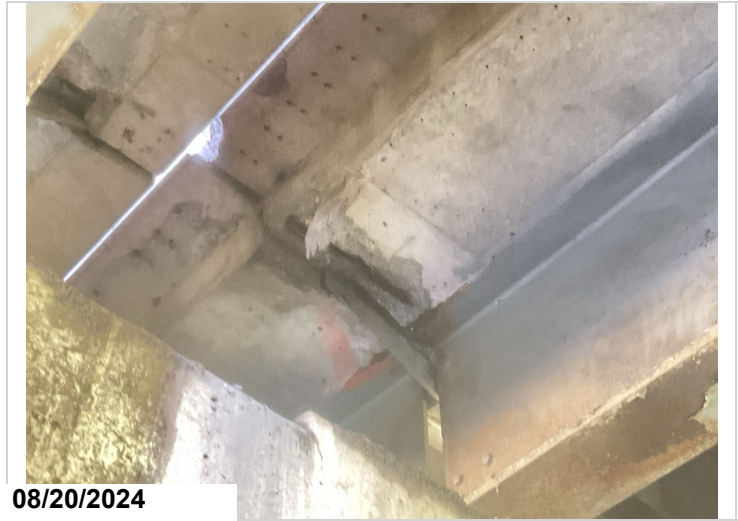
08/19/2024 - RSM & SPC: The bearing areas have heavy dirt and debris that has accumulated against the steel superstructure promoting corrosion. Abutment # 1 pictured.

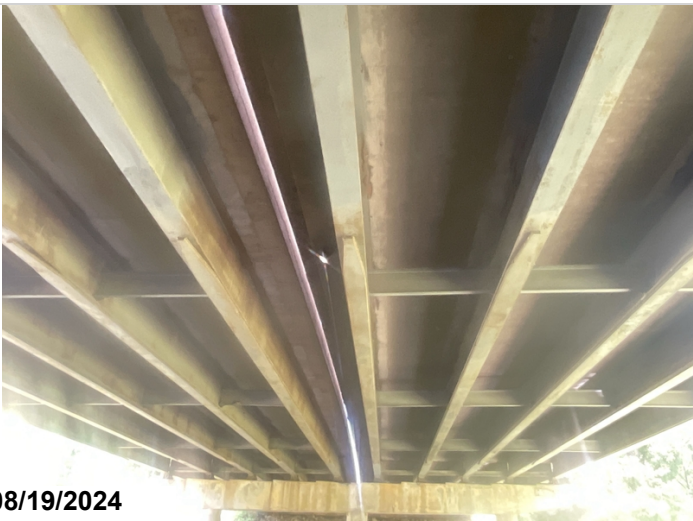
Span # 3 Undersurface, Bent # 4, Bay # 5: Spalling with exposed reinforcing steel. 2SF CS3.

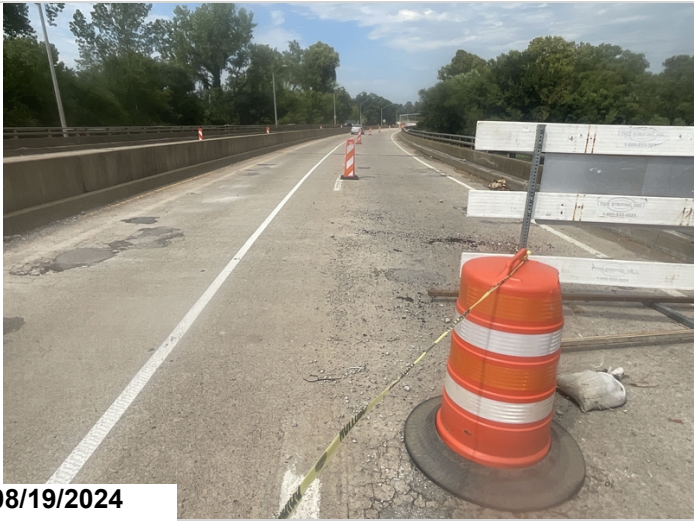
Span # 6, Westbound Outside Lane: Spalling with asphalt repairs.

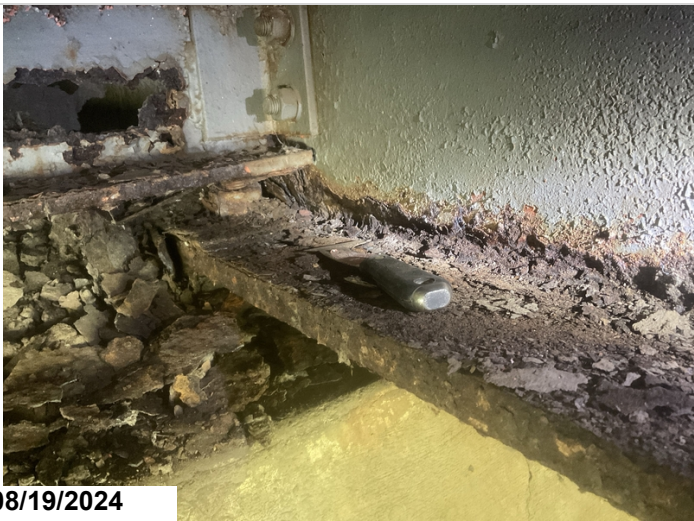
Abutment # 2, Bay # 8: Holes rusted through diaphragm.

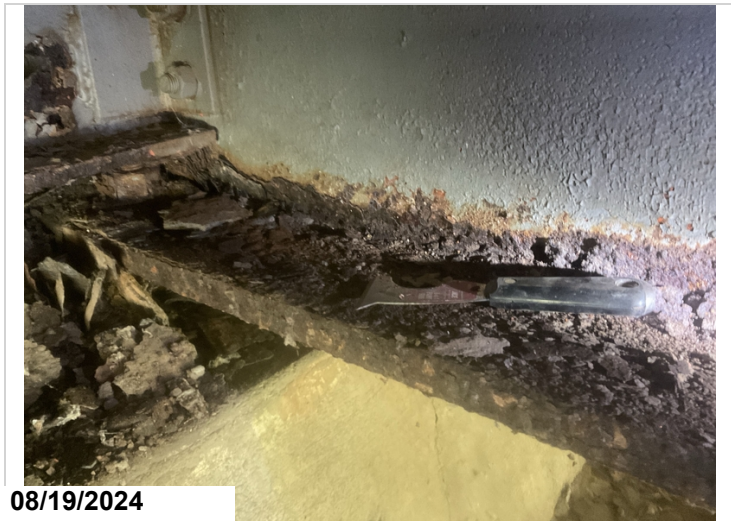
Span # 6, Abutment # 2, Girder # 9: Corrosion / section loss.
3LF CS3.

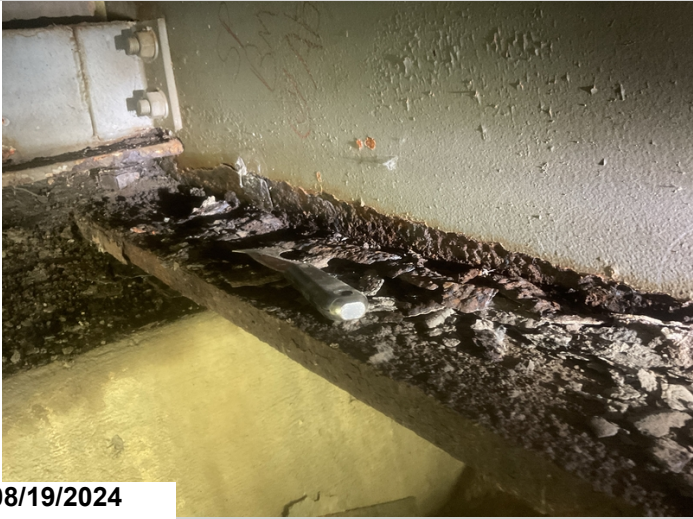
Span # 6, Abutment # 2, Girder # 9: Corrosion / section loss.
3LF CS3.

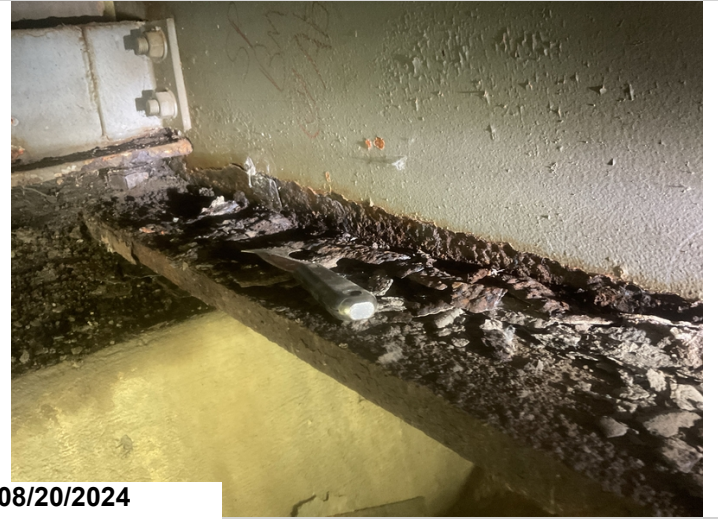
Span # 6, Abutment # 2, Girder # 8: Corrosion / section loss.
4LF CS3.

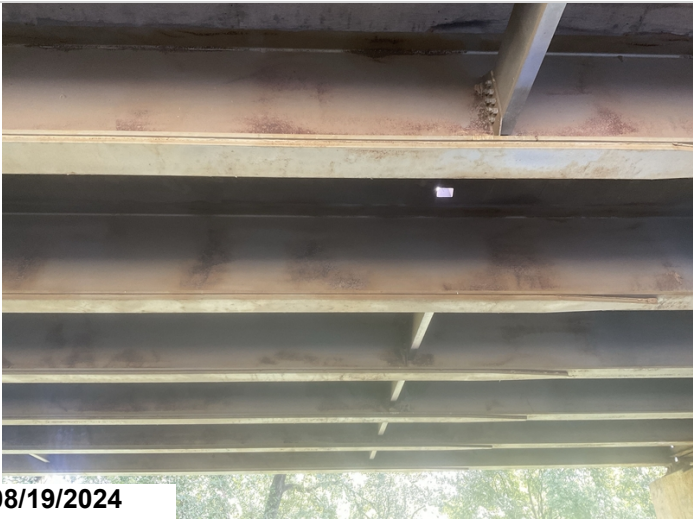
Span # 6, Abutment # 2, Girder # 8: Corrosion / section loss.
4LF CS3.

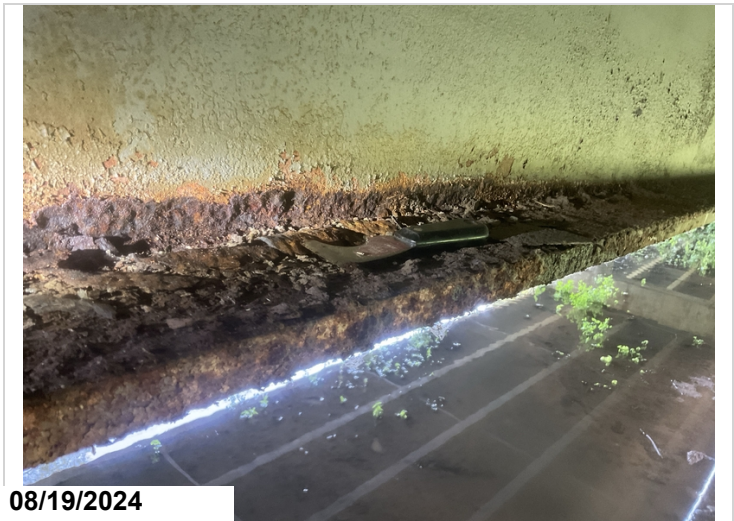
Span # 3, Bent # 3, Girder # 6: Corrosion to web and bottom flange in an area approximately 5' in length. Bottom flange has an estimated 1/16" section loss. Base of web and upper portion of web at expansion dam have an estimated 3/6" section loss. 5LF CS3.

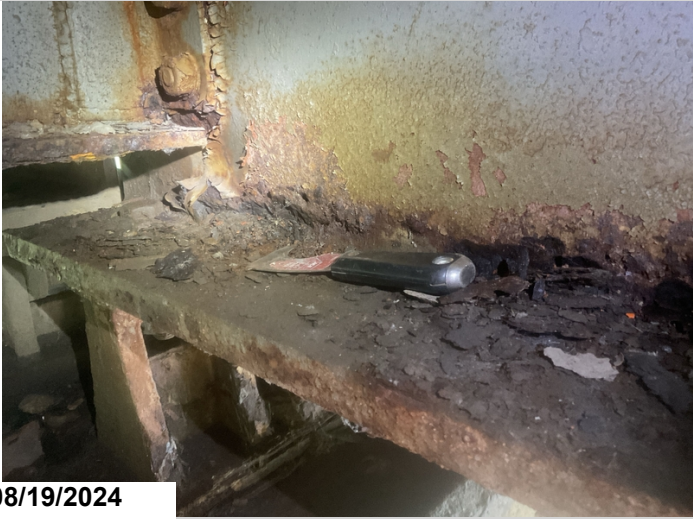
Span # 3, Bent # 3, Girder # 6: Corrosion to web and bottom flange in an area approximately 5' in length. Bottom flange has an estimated 1/16" section loss. Base of web and upper portion of web at expansion dam have an estimated 3/6" section loss. 5LF CS3.

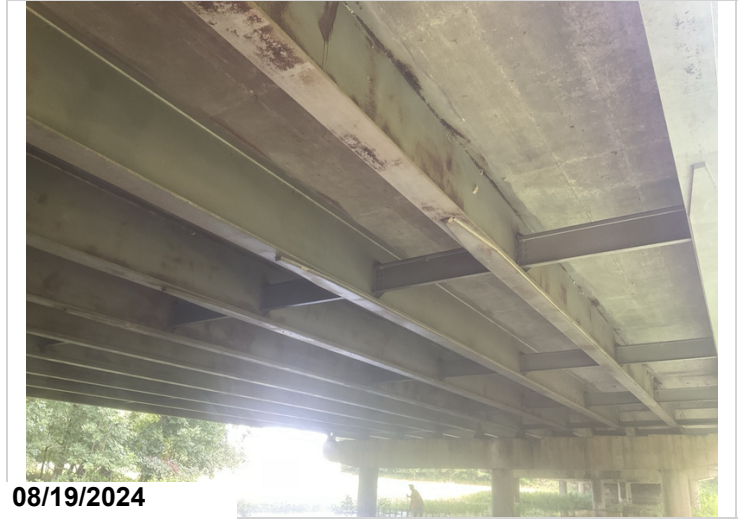
Span # 3, Bent # 3, Girder # 6: Corrosion to web and bottom flange in an area approximately 5' in length. Bottom flange has an estimated 1/16" section loss. Base of web and upper portion of web at expansion dam have an estimated 3/6" section loss. 5LF CS3.

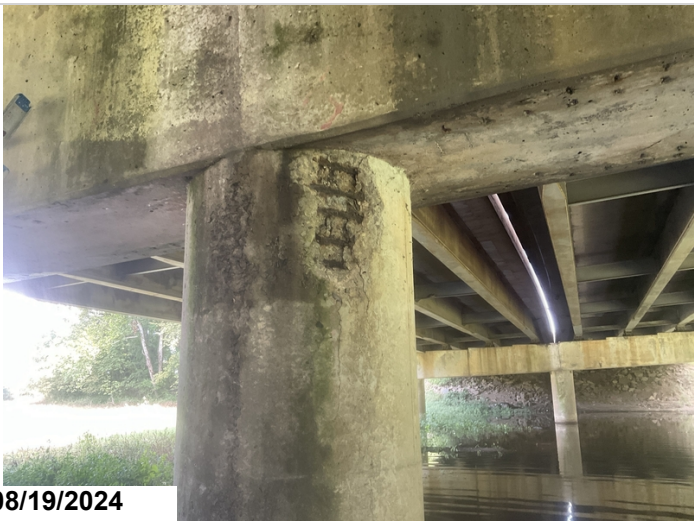
Moderate width vertical cracking in column.

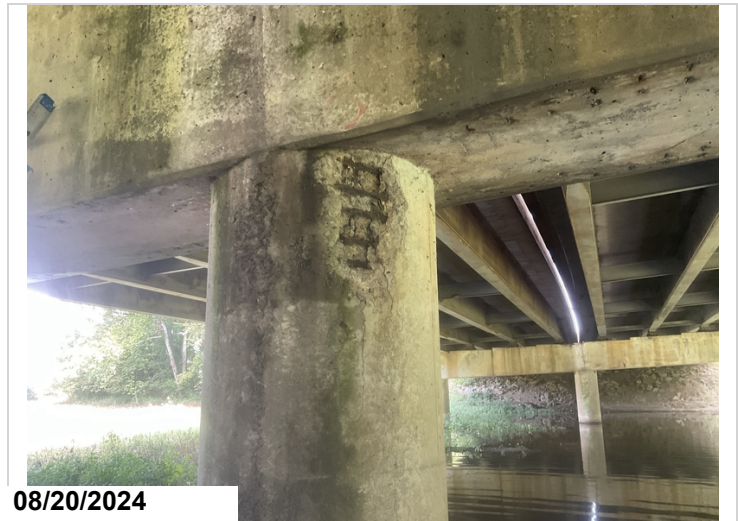
Bent # 5, Column # 2 , Back Side: 21" spall with exposed reinforcing steel with active corrosion / section loss. 1EA CS3.

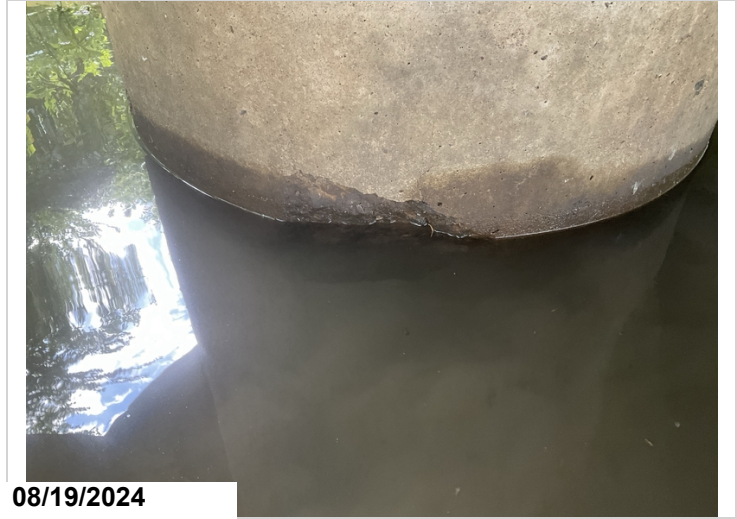
Bent # 3, Column # 3: 12" spall with exposed reinforcing steel in ahead side at the base of the column. Column has delaminated areas and vertical cracking in ahead side and back side. 1EA CS3.

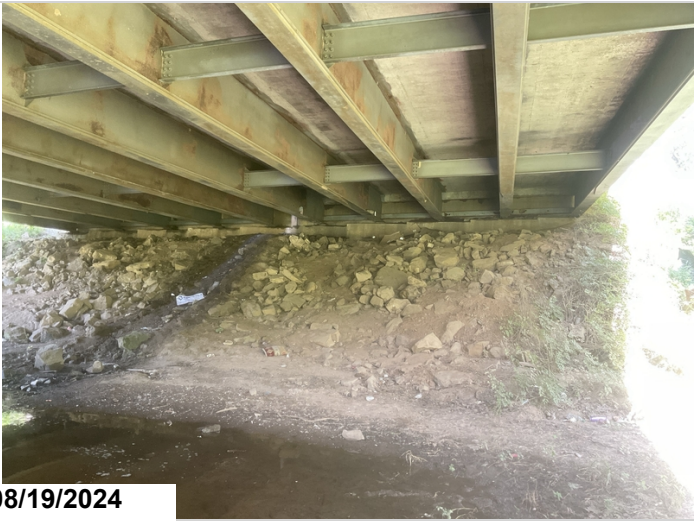
Abutment # 2 Backwall, Bay # 3: Vertical crack with efflorescence. 1LF CS2.

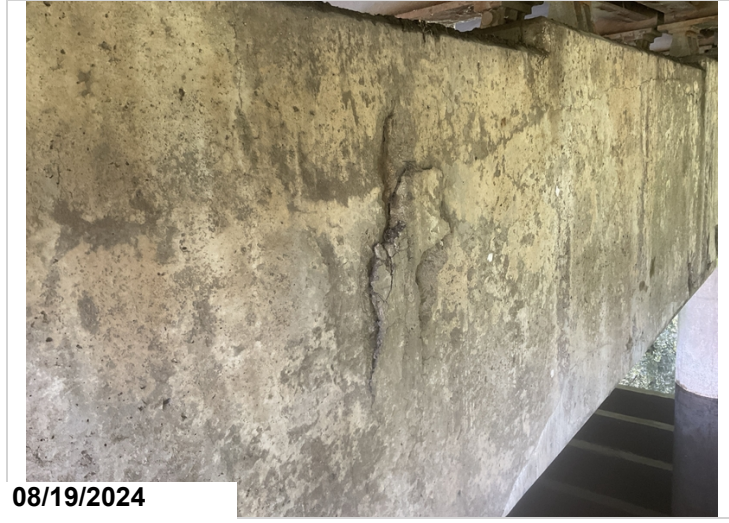
Bent # 5 Cap: Vertical 24" long delaminated area / spall with exposed reinforcing steel and numerous small delaminated areas with three 8" spalls with exposed reinforcing steel on the left side of the back face of cap. 4LF CS3.

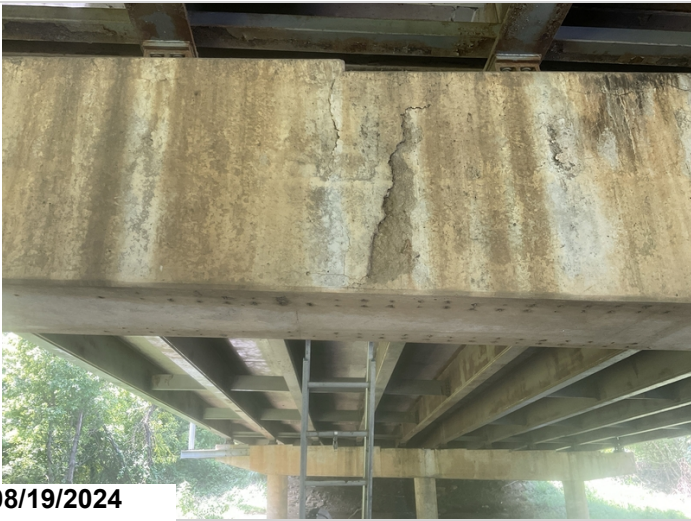
Bent # 5 Cap: Vertical 24" long delaminated area / spall with exposed reinforcing steel and numerous small delaminated areas with three 8" spalls with exposed reinforcing steel on the left side of the back face of cap. 4LF CS3.

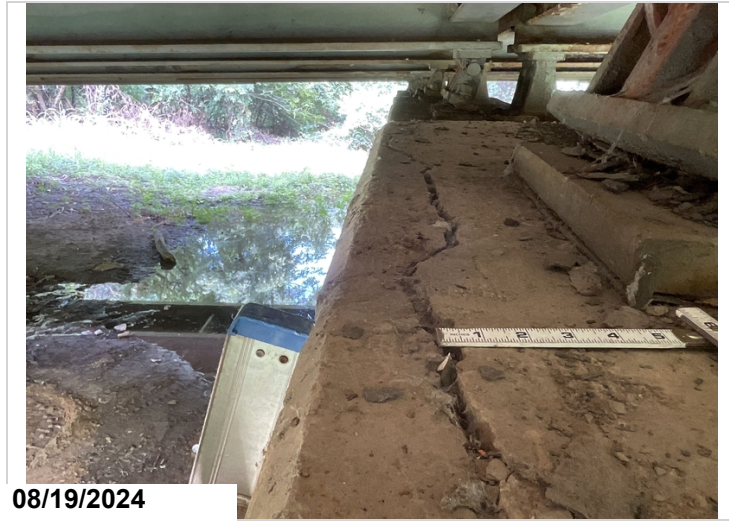
Bent # 3 Cap, Ahead Side, Between Columns # 2 and 3:
Delaminated / spalled area. 1LF CS2. 1LF CS3.

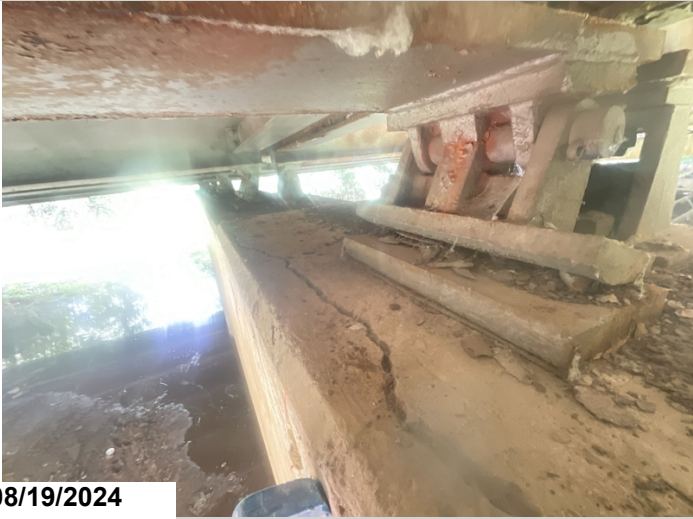
Bent # 2 Cap: Delaminated areas with wide Longitudinal cracking visible in top of cap on right side. 14LF CS2.

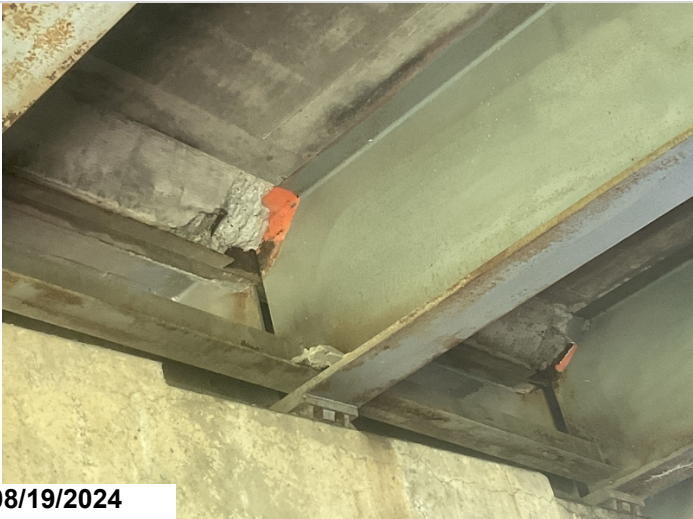
Bent # 2 Cap, Back Right Side: 2 12" spalls with exposed reinforcing steel. Spall, 1LF CS3, Exposed Steel, 1LF CS3.

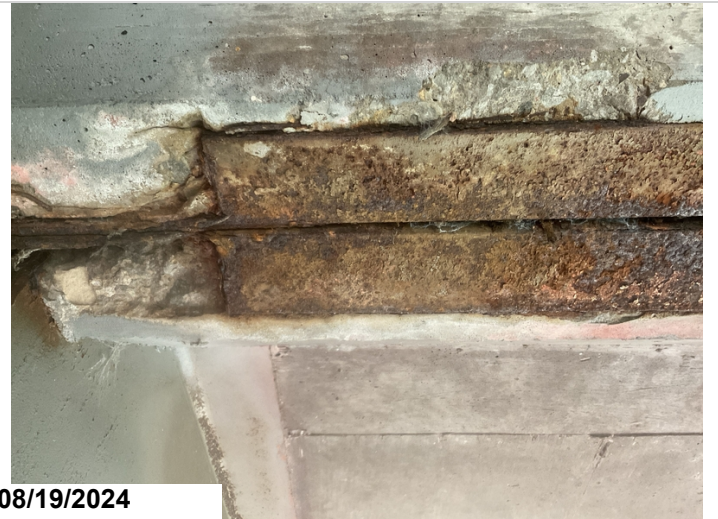
Bent # 5 Expansion Joint Assembly: Assembly is jammed together with distortion visible in assembly from the undersurface. The distortion appears to be spalling the deck expansion dam on the ahead side (Span # 6).

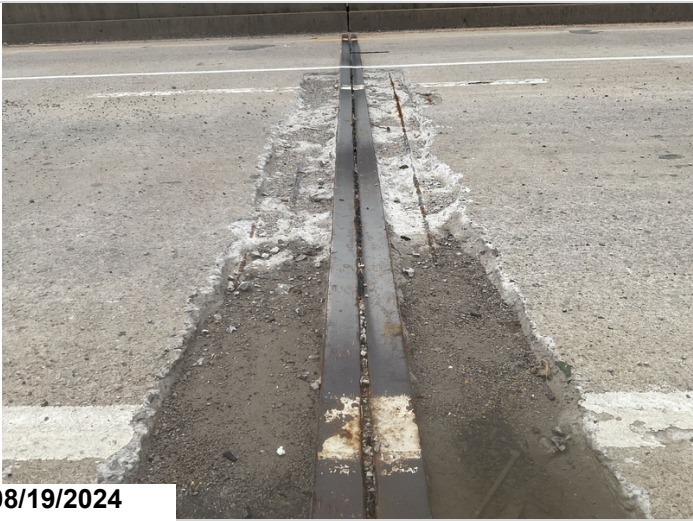
Bent # 2 Expansion Joint Assembly is jammed together in locations.

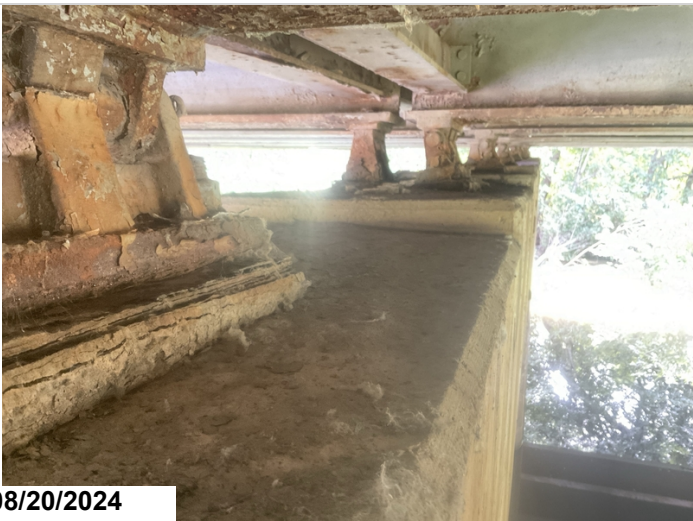
Bent # 3 Bearings: Failing paint system with pack rust between bearing plates.

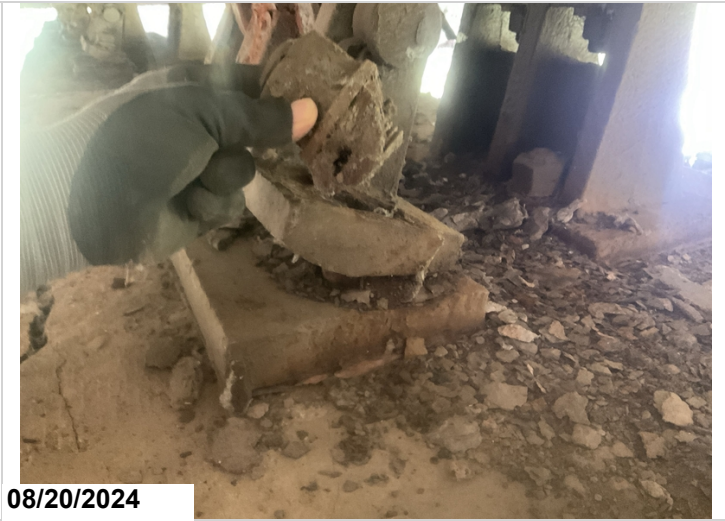
Span # 2, Bent # 3, Bearing # 2: Heavy pack rust between rocker and masonry plate. 1EA CS3.

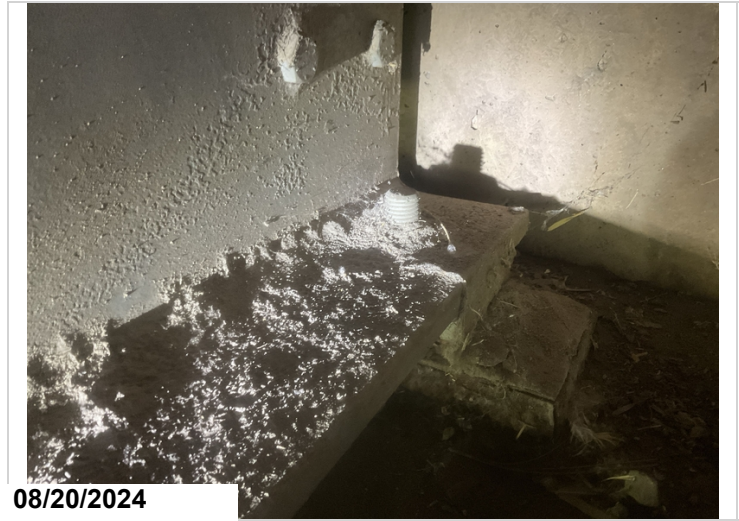
Span # 1, Bent # 2, Bearing # 9: Right anchor bolt sheared off. 1EA CS3.

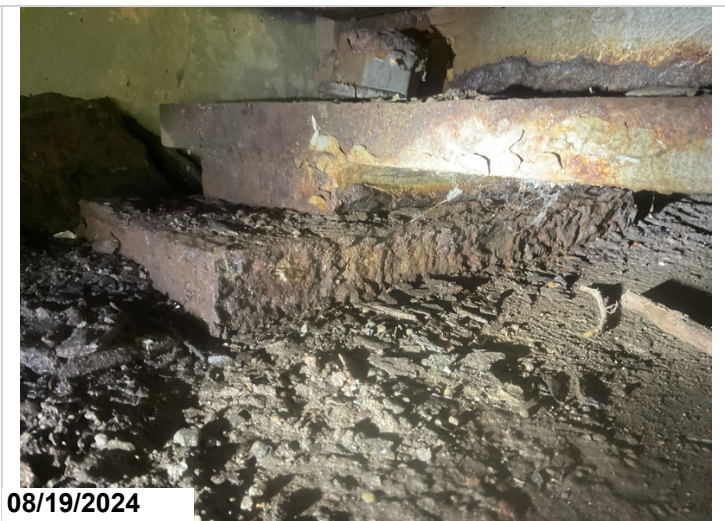
Span # 1, Abutment # 1, Bearing # 6: Missing left anchor bolt nut. 1EA CS2.

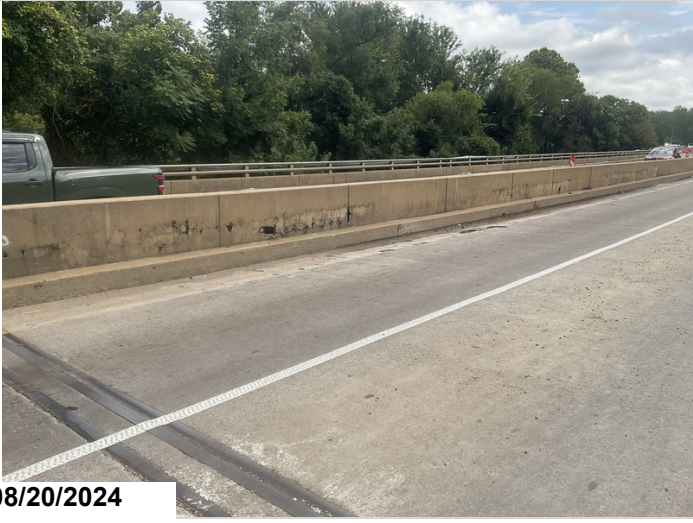
Span # 4, Median Parapet Wall, Adjacent to Bent # 4: Spalls with exposed reinforcing steel. 3LF CS3.

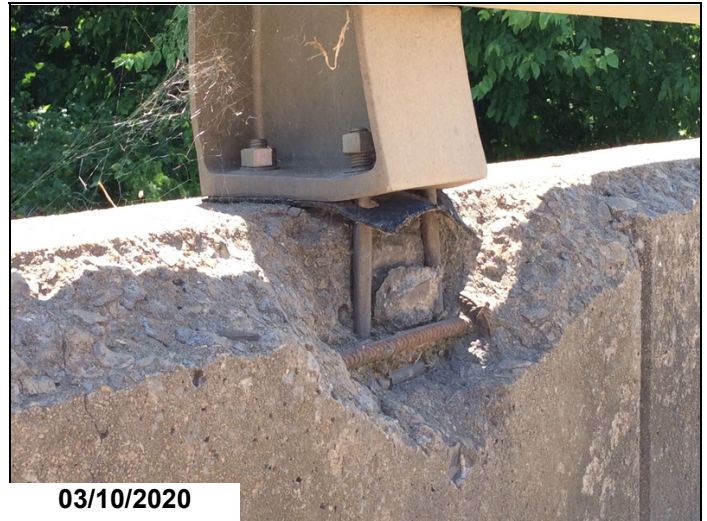
Span # 1: Median Barrier Wall: Concrete deterioration with spalling that exposes reinforcing steel and voids in the wall.

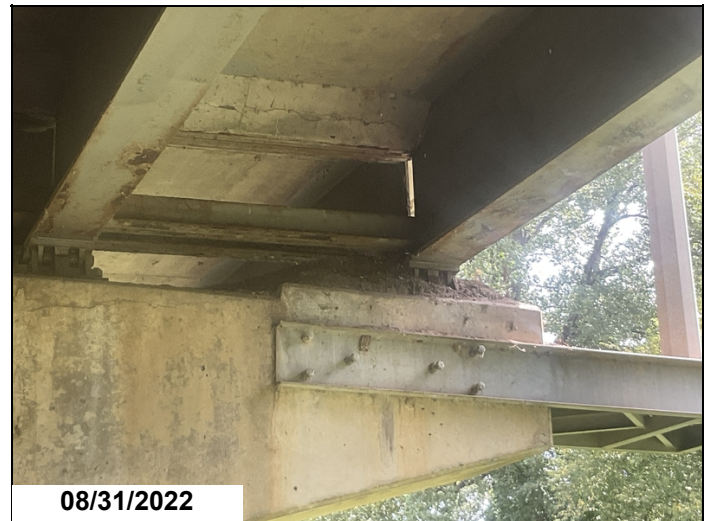
Right end of Bent 4 cap. Bearing is buried in soil.

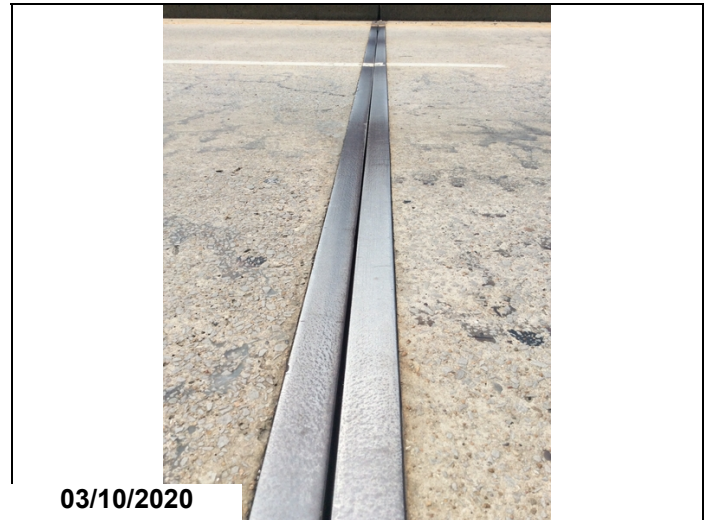
Bent 6. Deck joint seal

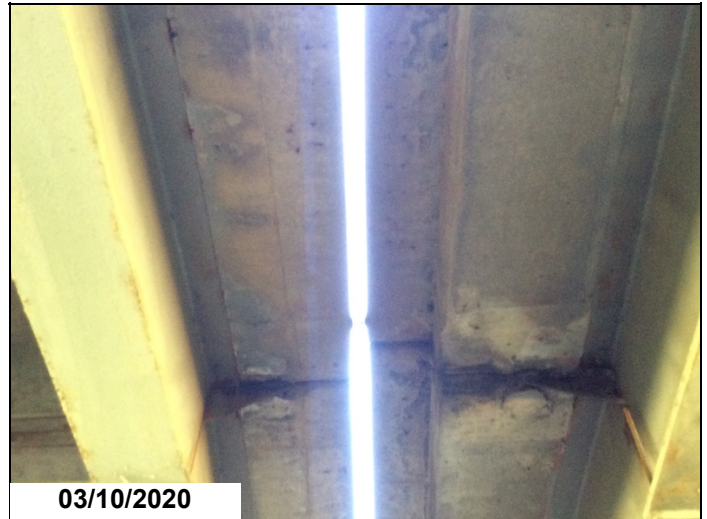
The undersurface of the deck has shallow spalling that exposes reinforcing steel under the median barrier wall and on the left side of the structure over Bents # 4 & 5.
2SF CS3.

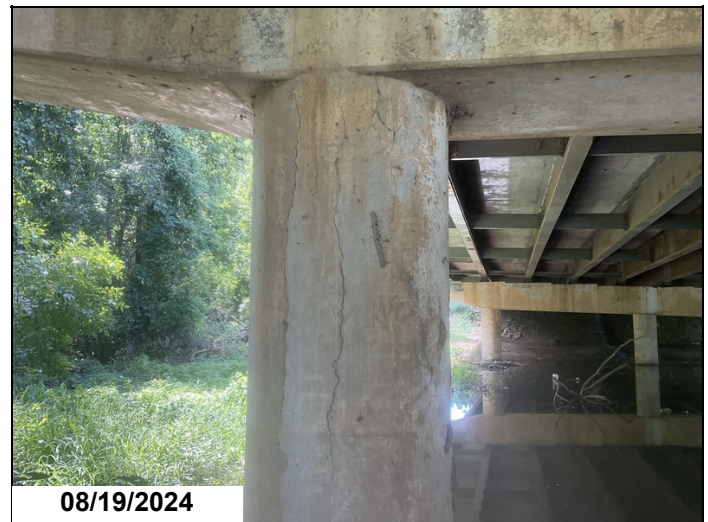
Bent # 3, Column # 3: 12" spall with exposed reinforcing steel in ahead side at the base of the column. Column has delaminated areas and vertical cracking in ahead side and back side. 1EA CS3.

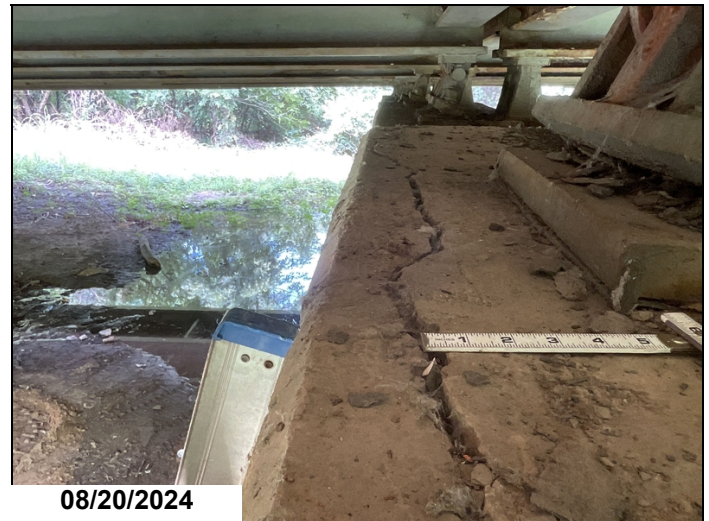
Bent # 2 Cap: Delaminated areas with wide longitudinal cracking visible in top of cap on right side. 14LF CS2.

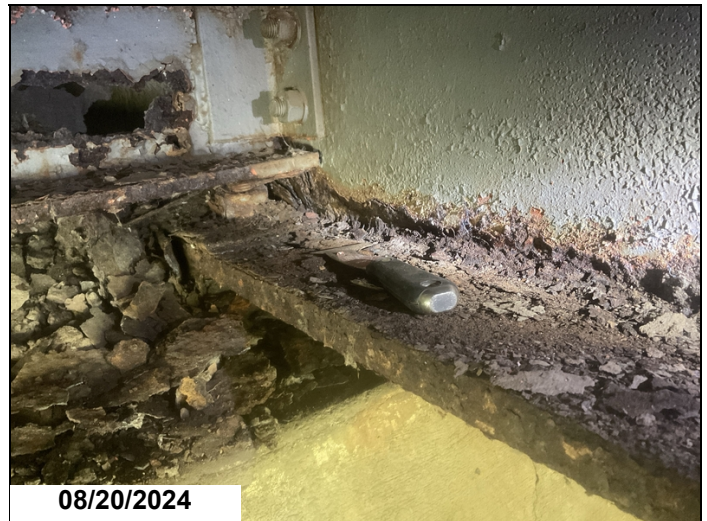
Span # 6, Abutment # 2, Girder # 9: Corrosion / section loss. 3LF CS3.

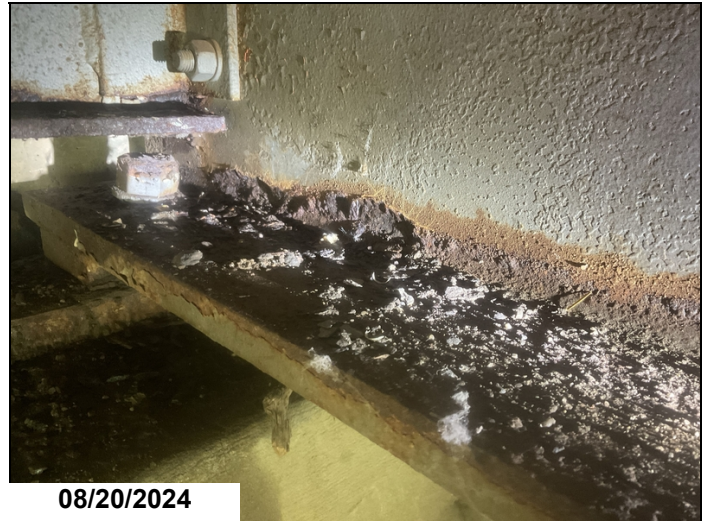
Span # 1, Abutment # 1, Girder # 9: Corrosion with flaking rust/ Section loss. 4LF CS3.

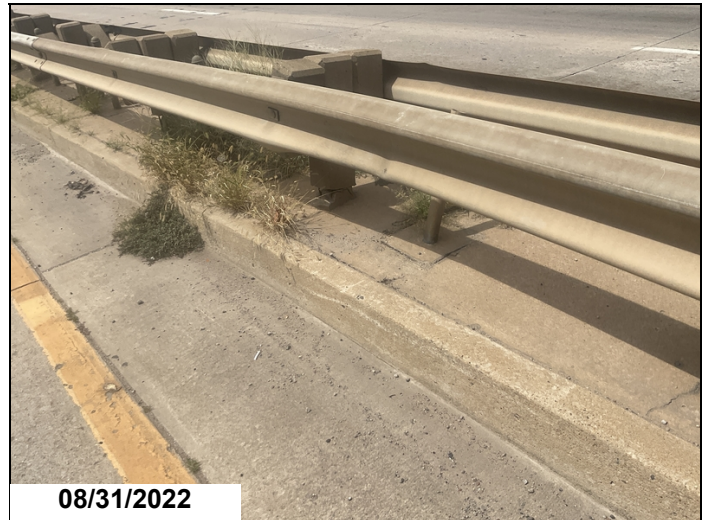
Median Approach Guardrailing of the West approach has several posts that are fractured at the base.

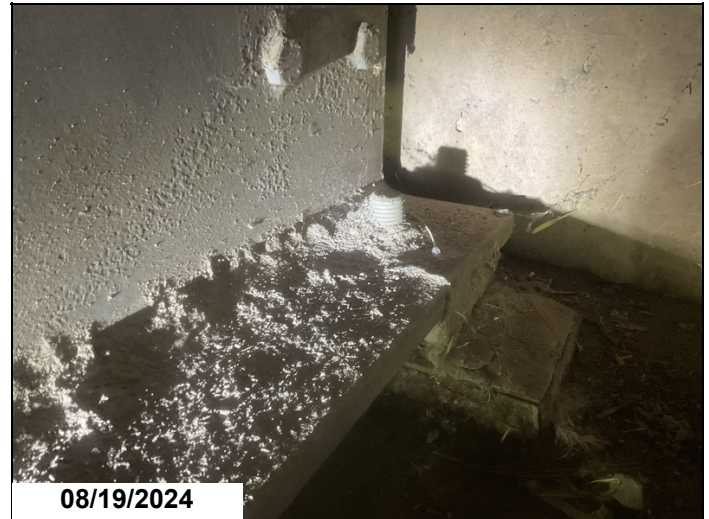
Span # 1, Abutment # 1, Bearing # 6: Missing left anchor bolt nut. 1EA CS2.

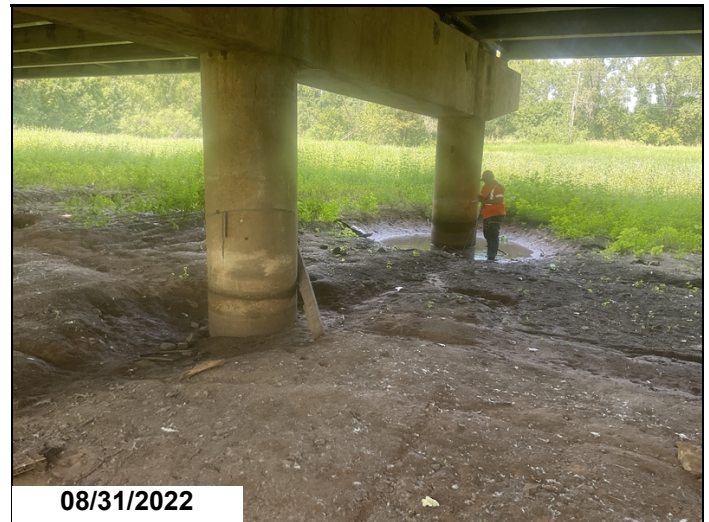
Localized scour around Bent # 6, Column # 1.

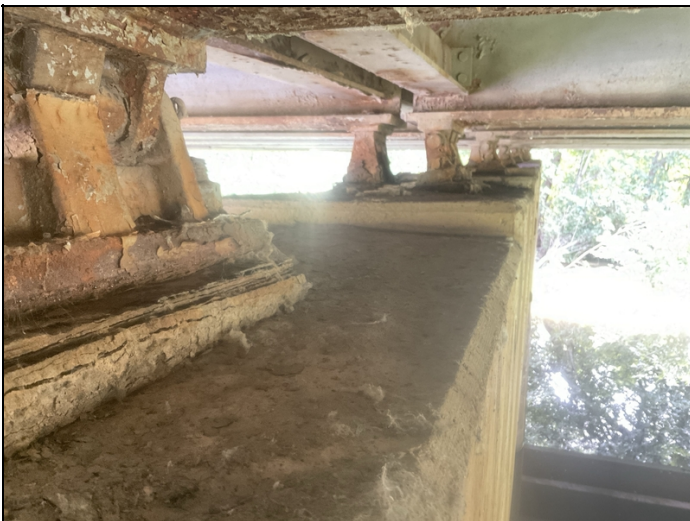
Bent # 3 Bearings: Failing paint system with pack rust between bearing plates.
