Asset #X1025(Routine)

State Highway 253 over Cedar Creek-Seb. Co.

Location: 1.6 MI S OF JCT 271&amp;540

Team Lead: Bob McEntyre Inspection Date: 01/08/2024

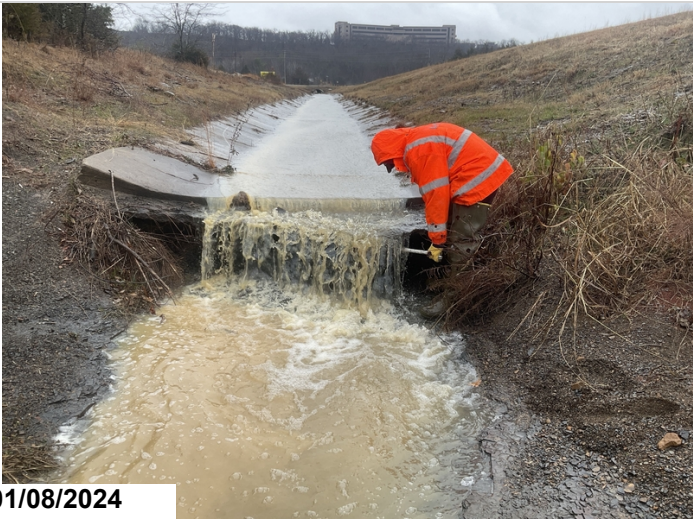
Side drainage ditch paving on Northwest embankment is undermined.

Ditch Paving -  
Ditch paving for side drainage on the Northwest embankment is undermined.

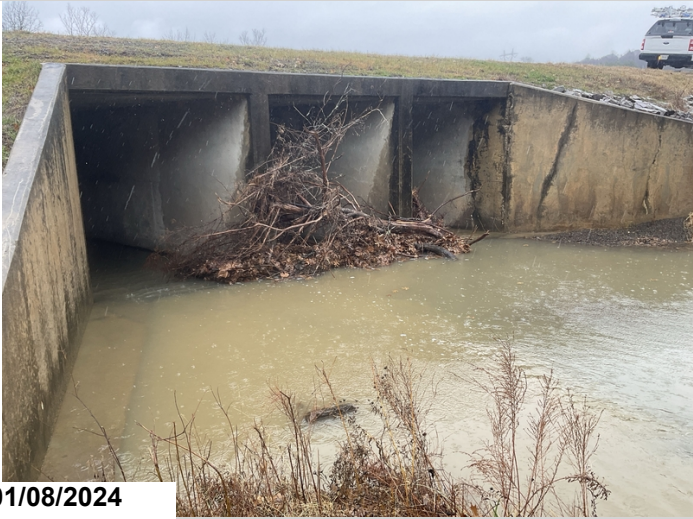
**61 - Channel/Channel Protection** (7 - Bank protection is in need of minor repairs. River control devices and embankment protection have a little minor damage. Banks and/or channel have minor amounts of drift.) Channel has drift accumulation at the inlet end lodged against the culvert that restricts channel flow and promotes additional drift accumulation.

Channel has drift accumulation lodged against the inlet end of culvert that restricts channel flow and promotes additional drift accumulation.

**Type of Work:** Channel Work/Drift Removal

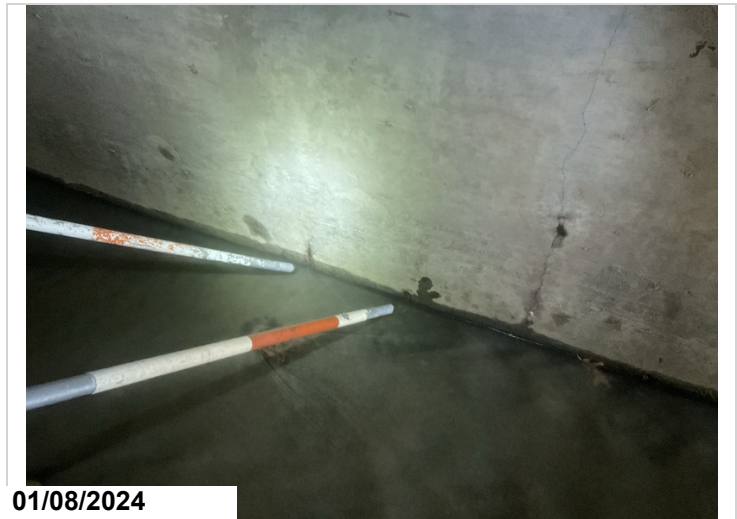
Barrel 3 exterior wall-Shallow spalls with exposed reinforcing steel

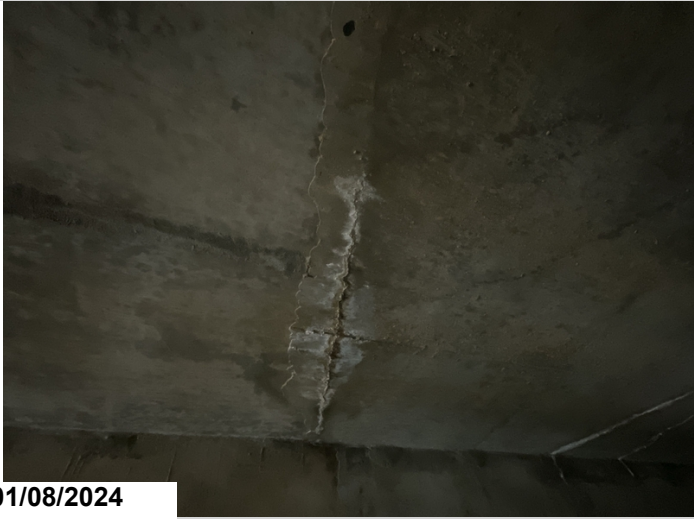
Barrel 2 top slab at construction joint-Staining

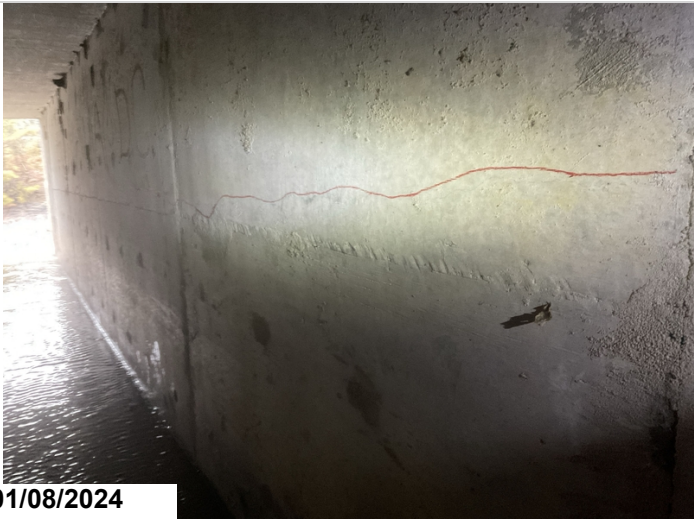
Barrel 1 exterior wall on right side-Hairline horizontal cracking

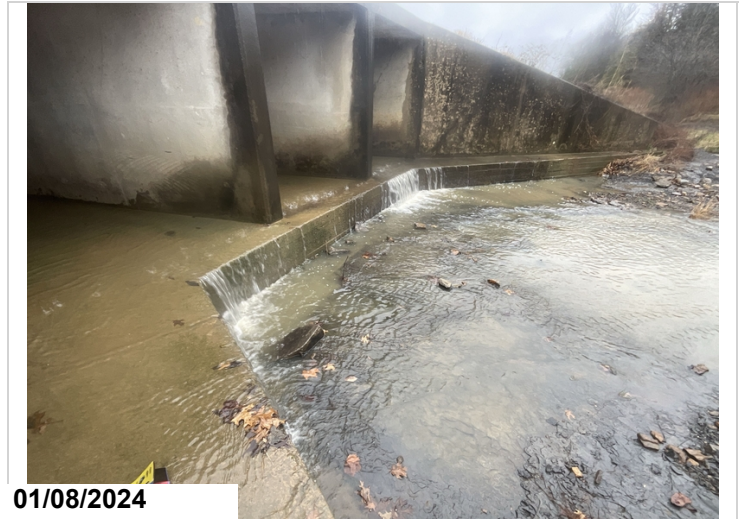
Tow wall exposed on right side

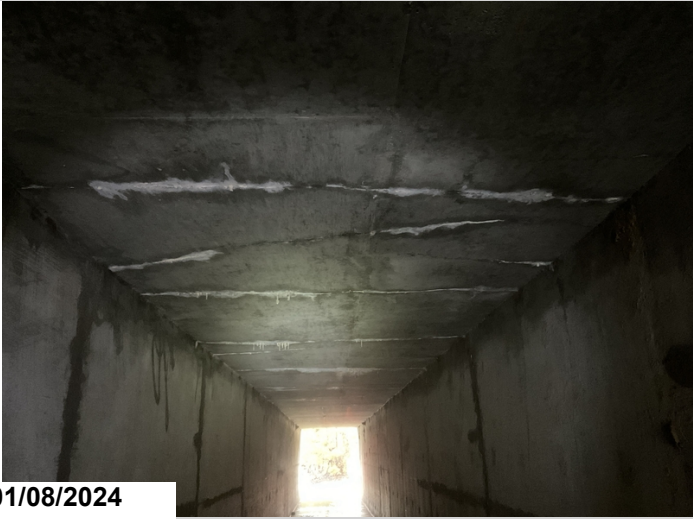
Barrel 1 top slab-Transverse cracks with efflorescence

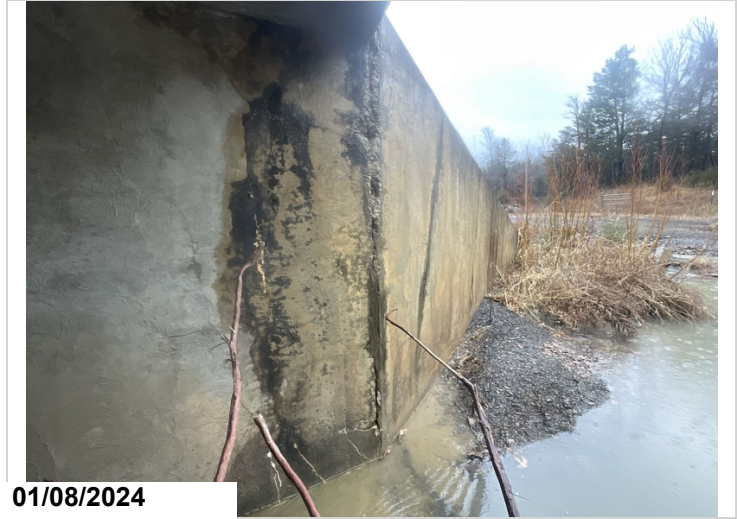
Barrel 1 exterior wall on left side-Spalling with exposed reinforcing steel at wing wall juncture

Barrel # 1 exterior wall on left side at the wing wall juncture has spalling that exposes reinforcing steel in the upper portion of the wing wall. The base of wall has a 12" delaminated/ spalled area.

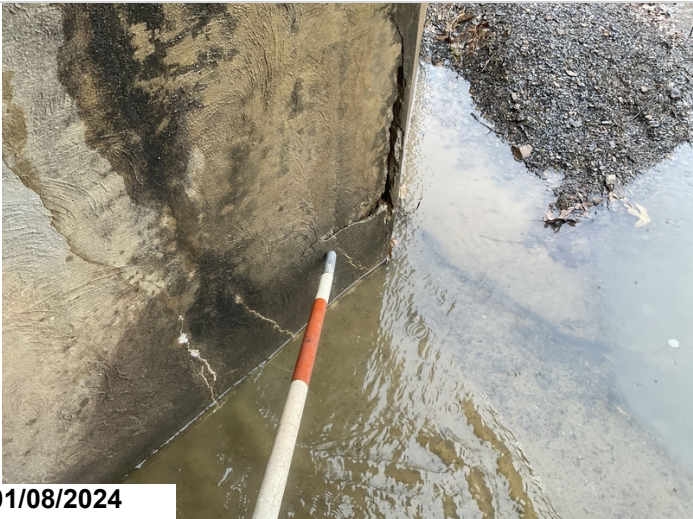
Barrel 1 exterior wall on left side-Delaminated area at wing wall juncture

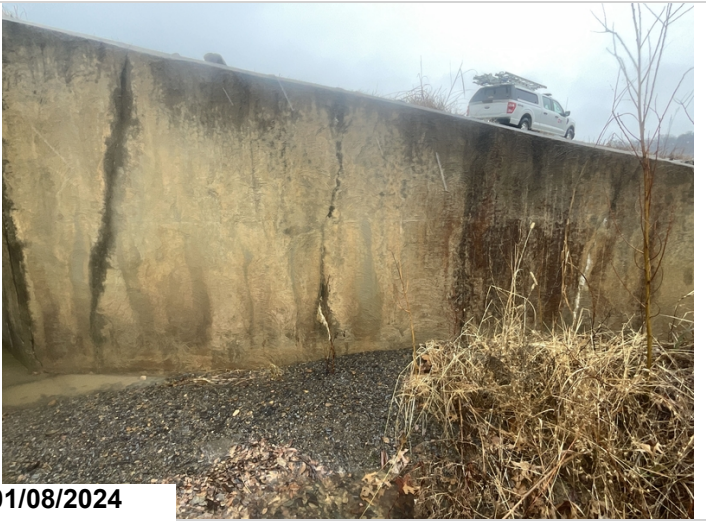
Barrel # 1 left wing wall has three full height vertical cracks and spalling with exposed reinforcing steel at the culvert juncture.

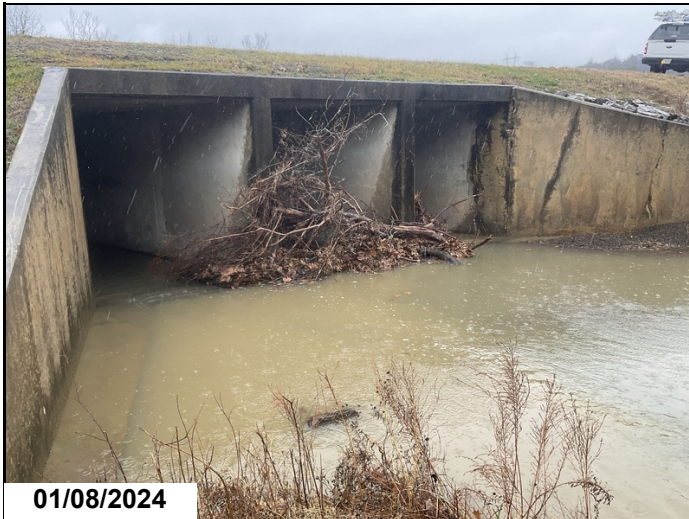
Channel has drift accumulation lodged against the inlet end of culvert that restricts channel flow and promotes additional drift accumulation.

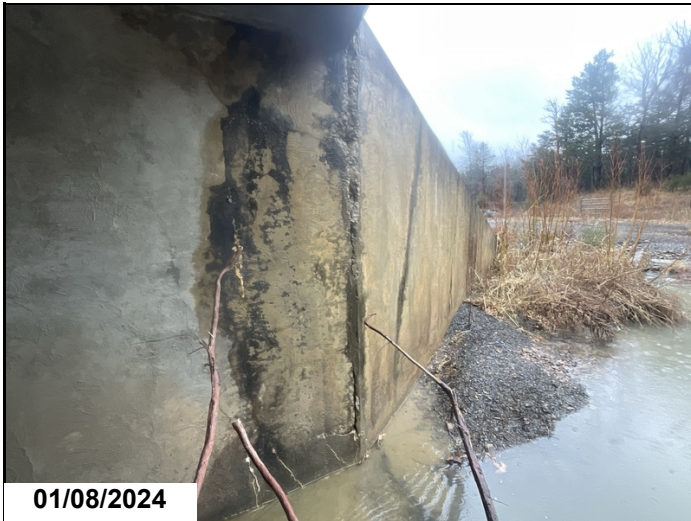
Barrel # 1 exterior wall on left side-Spalling with exposed reinforcing steel at wing wall juncture.

**Type of Work:** Repair (General)

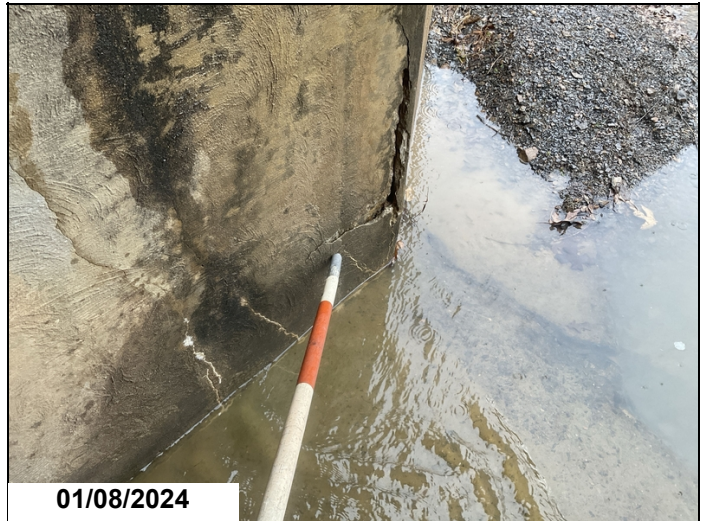
Barrel # 1 exterior wall on left side-Delaminated area at wing wall juncture.

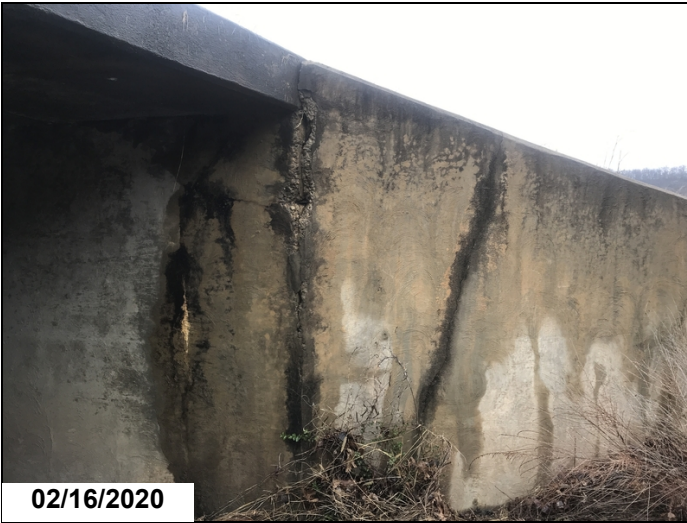
Barrel # 1 exterior wall on left side at the wing wall juncture has spalling that exposes reinforcing steel in the upper portion of the wing wall. The base of wall has a 12" delaminated/ spalled area.

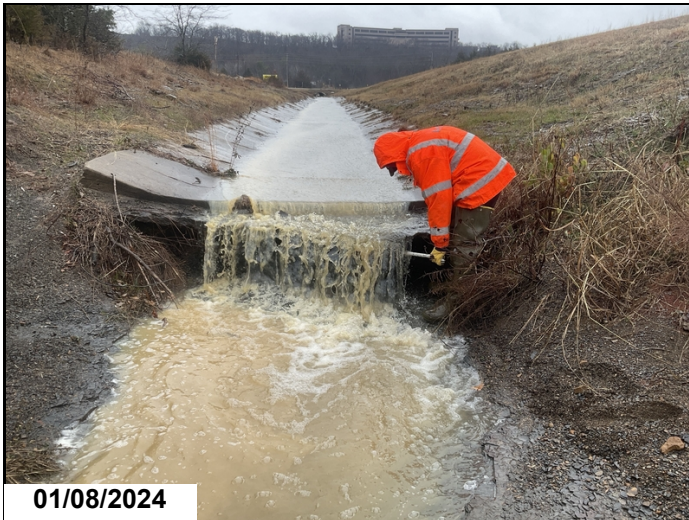
Ditch paving for side drainage on the Northwest embankment is undermined.
