Asset #05909(Routine)

SH 112-Wash Co. over Brush Creek

Location: 0.5 MI SO BENTON CO LN

Team Lead: Eric West Inspection Date: 09/06/2023

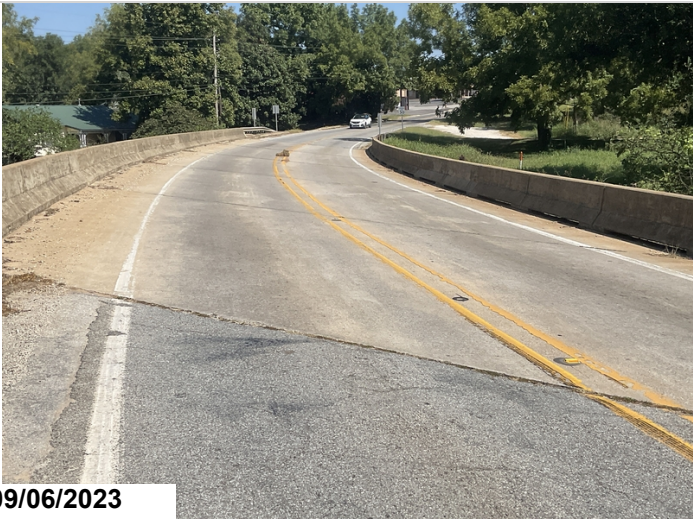
Typical driving surface.

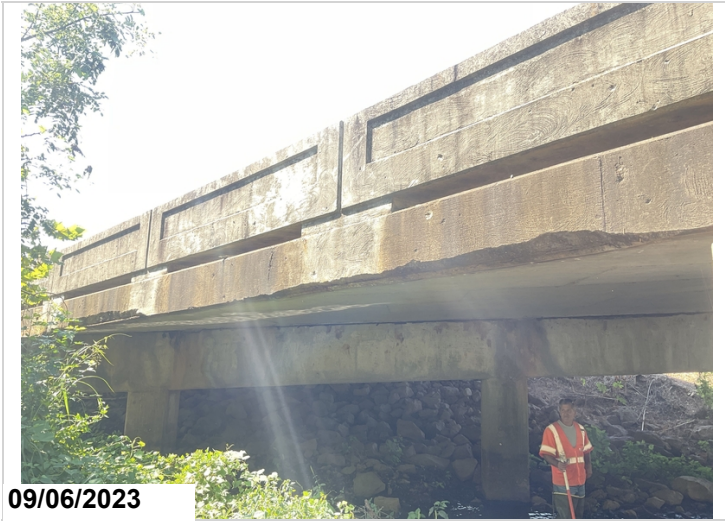
Span # 2 Rt spalling with exposed reinforcing steel.

The undersurface of the slab on the right side of multiple spans have large spalls along the lower edge of the slab that exposed primary reinforcing steel. The exposed reinforcing steel has active corrosion, measurable section loss and has lost bond with the slab in numerous locations.

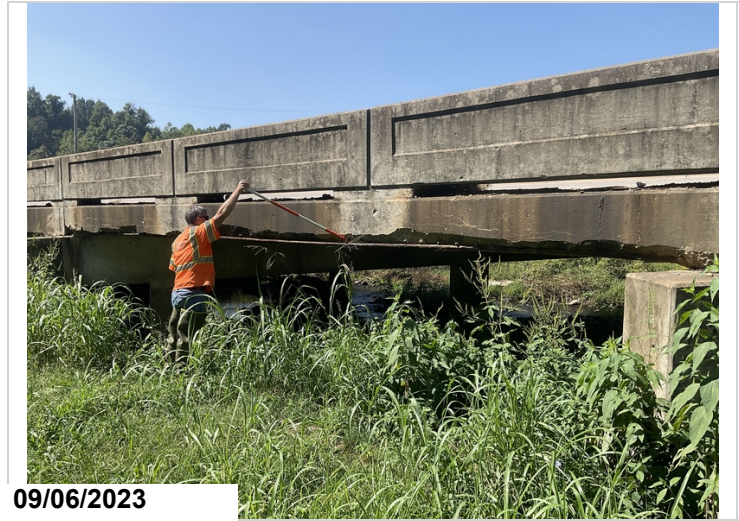
Span # 4 Rt spalling with exposed reinforcing steel.

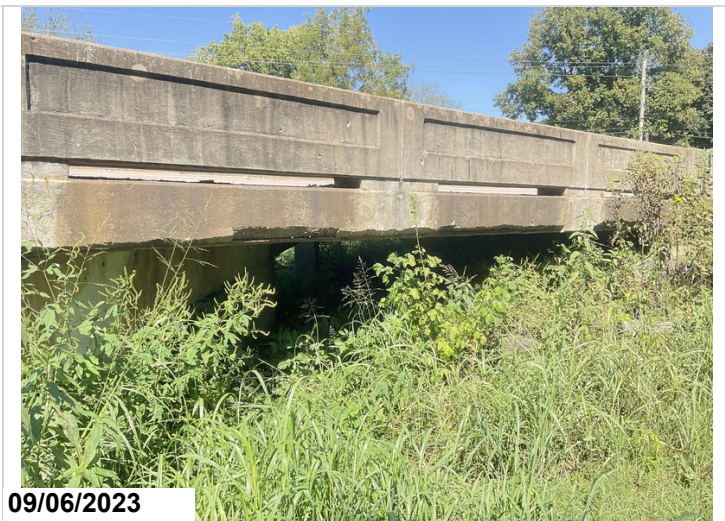
Span # 5 Rt spalling with exposed reinforcing steel.

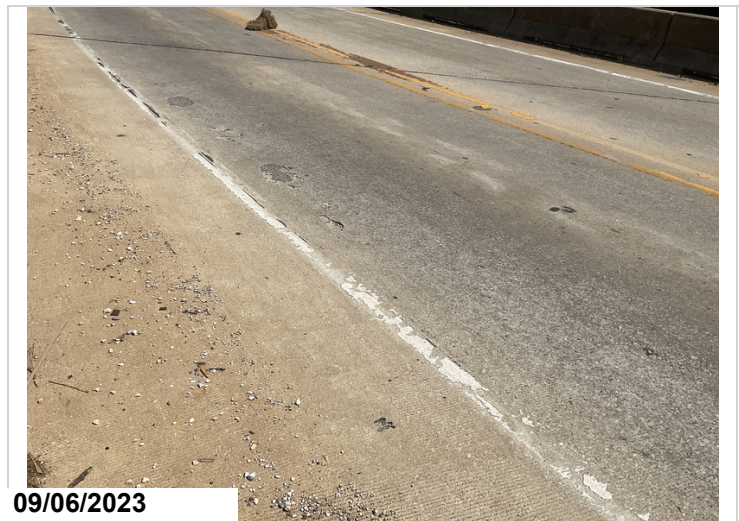
Span # 3 Lt lane spalling and delaminating concrete.

The left lane of span # 3 has delaminated areas in the wheel path with two 15" x 6" spalls that exposed reinforcing steel.

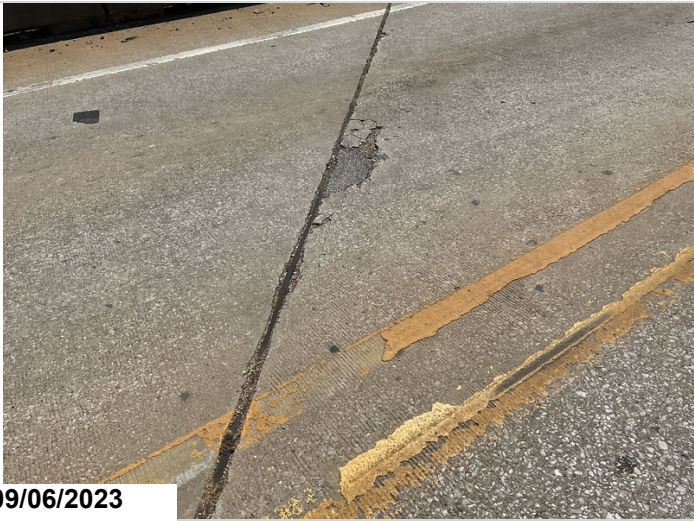
(38) Slab Driving Surface: -Utilizing a chain drag revealed that the left and right shoulder has a few isolated delaminated areas. -The right lane of span # 2 over bent # 3 has a 3' long cracked/delaminated area along the expansion joint that is beginning to spall. -The driving surface of the deck has light abrasion typical. -The left lane of span # 3 has delaminated areas in the wheel path with two 15" x 6" spalls that exposed reinforcing steel.							
Slab Undersurface: -Delaminated areas and concrete spalling with exposed reinforcing steel in the undersurface along the right edge of the slab adjacent to the drip groove. The exposed primary reinforcing steel has up to approximately 25% section loss. The exposed reinforcing steel has numerous areas that have debonded from the slab.							
205	Reinforced Concrete Column	EA	12	5	7	0	0
1190	Abrasion/Wear (PSC/RC)	EA	7	0	7	0	0

Bent # 3 Span # 2 deck spalling.

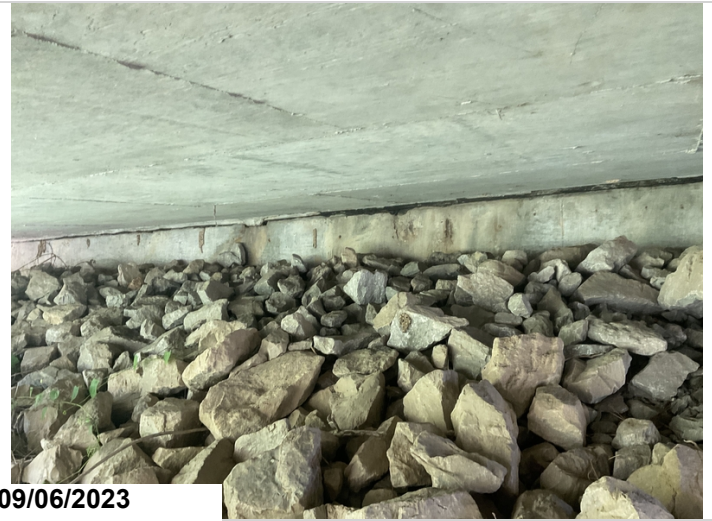
(215) -Abutment # 1 has two 10" areas with shallow spalls that have exposed reinforcing steel near the center of the structure. -Abutment # 2 has a shallow spall at the right key way.							
220	Reinforced Concrete Pile Cap/Footing	LF	5	5	0	0	0

Abutment # 1 spalling with exposed reinforcing steel near the centerline.

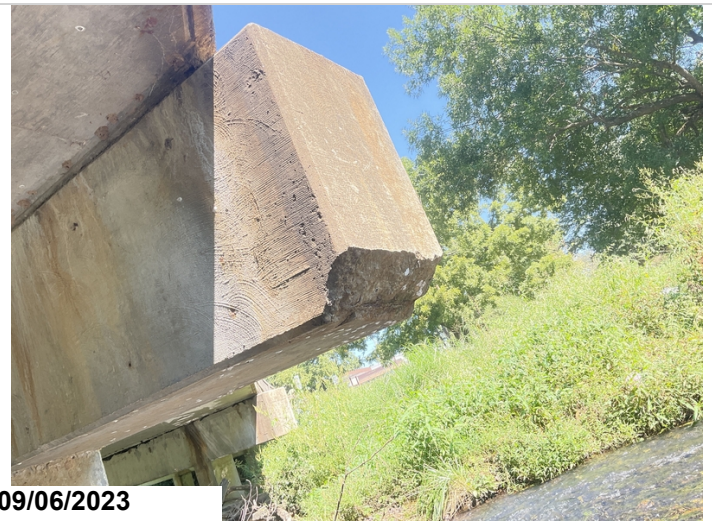
Bent # 3 has a 2' spall with exposed reinforcing steel in the right end of cap.

Substructure -
Spalling with exposed reinforcing steel in the substructure caps.

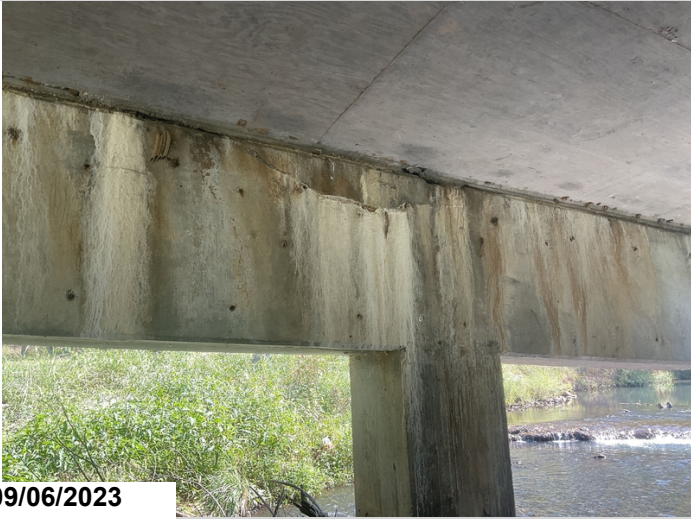
Bent # 3 backface along the top of the cap has a 4' long concrete delamination in bay # 2 adjacent to column # 3 with efflorescence buildup.

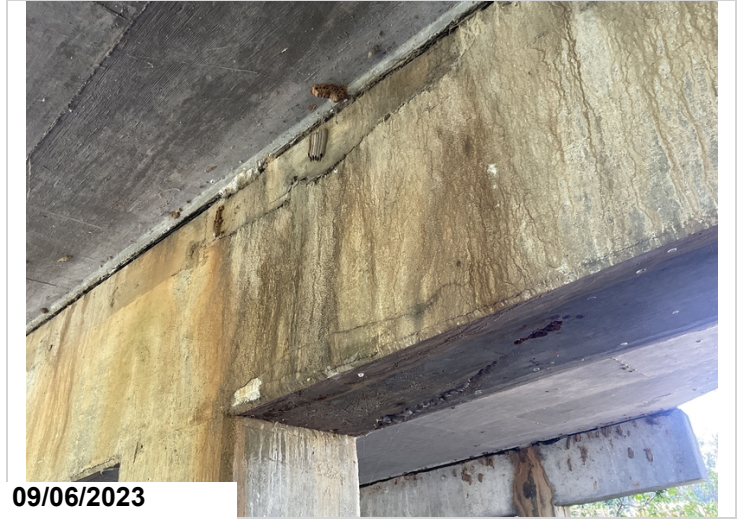
Bent # 3 has a 30" delaminated area / spall with exposed reinforcing steel in the undersurface of the cap adjacent to column # 2 and a 10" delaminated area adjacent to column # 2 in bay # 2.

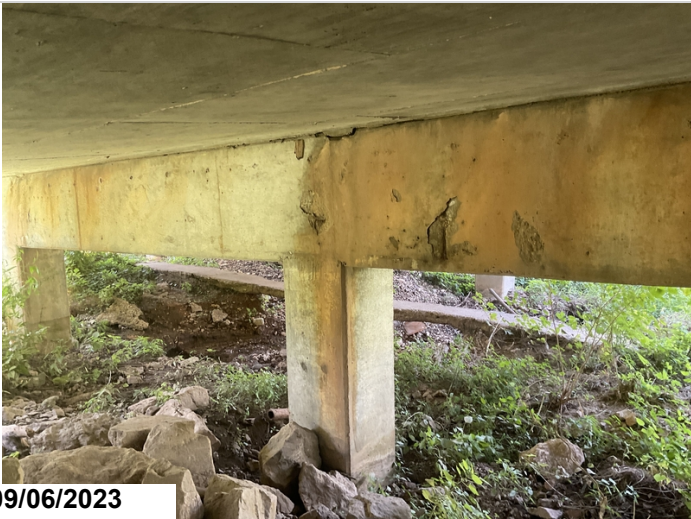
Bent # 5 aheadface spalling with exposed reinforcing steel.

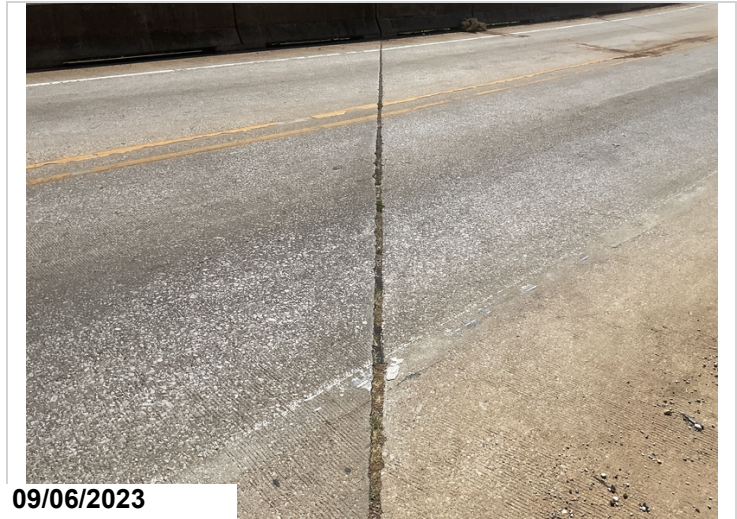
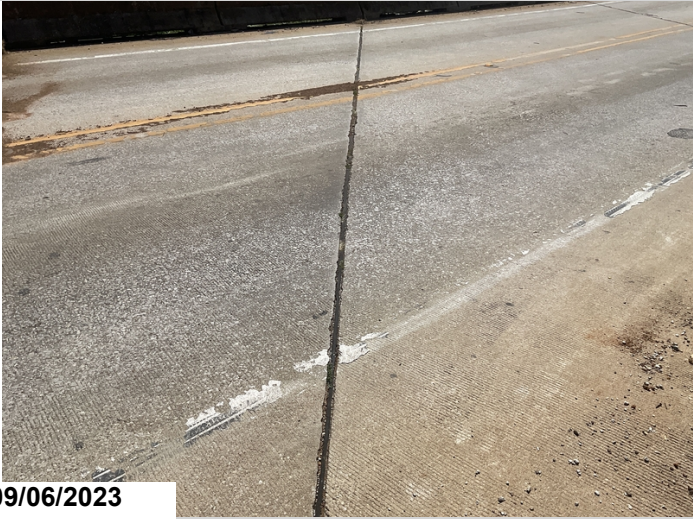
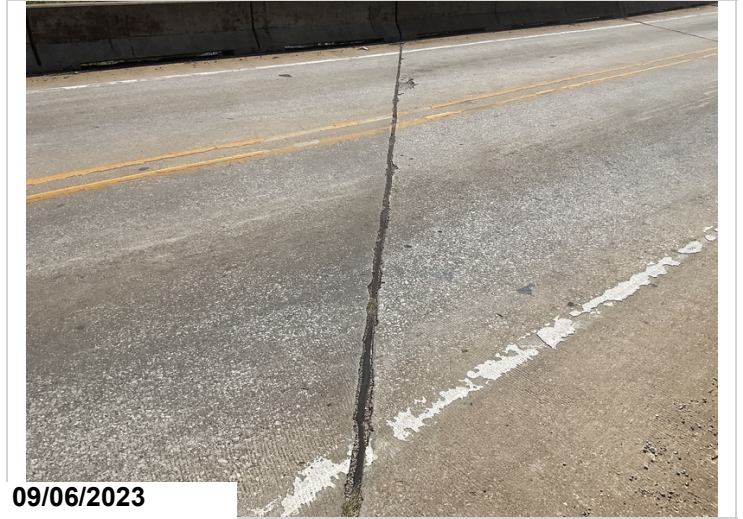
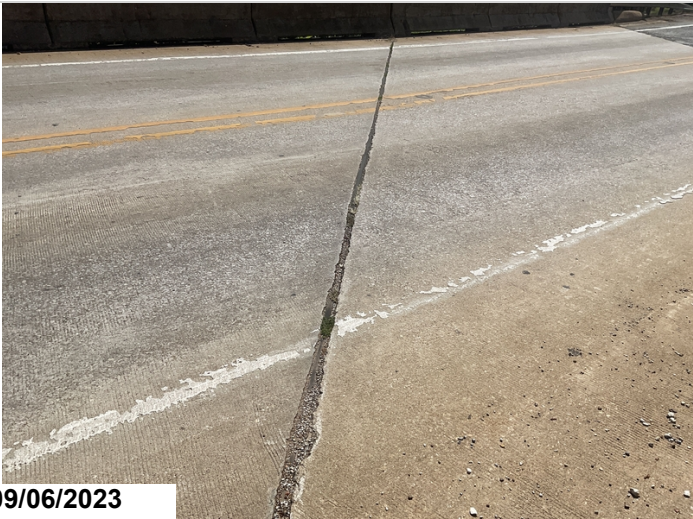
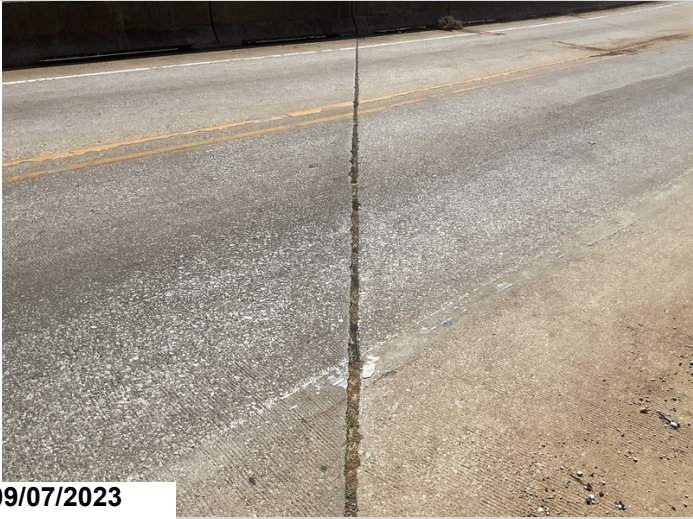
The expansion joints have debris impaction with adhesion failure and deteriorated joint sealant. The joints leak water onto the substructure.

Bent # 5 typical joint seal.

Bent # 4 typical joint seal.

Bent # 3 typical joint seal.

Bent # 2 typical joint seal.

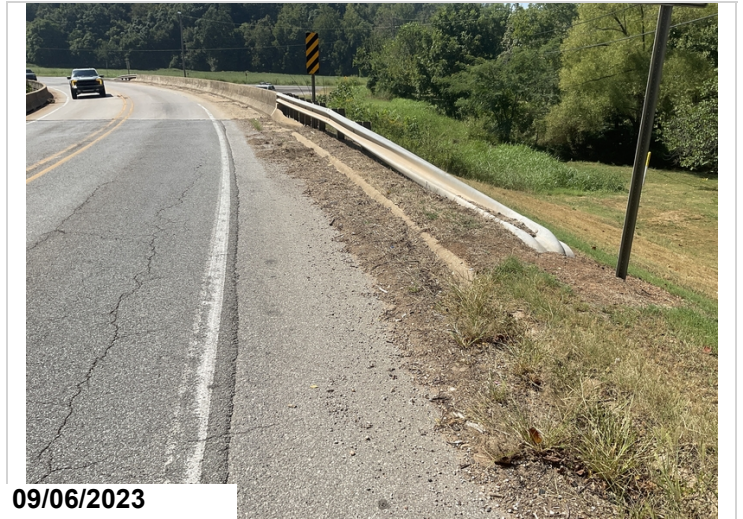
The slab shoulders and the approach roadway shoulders have significant dirt and debris accumulation.

Approach gutters restricted by dirt and debris.

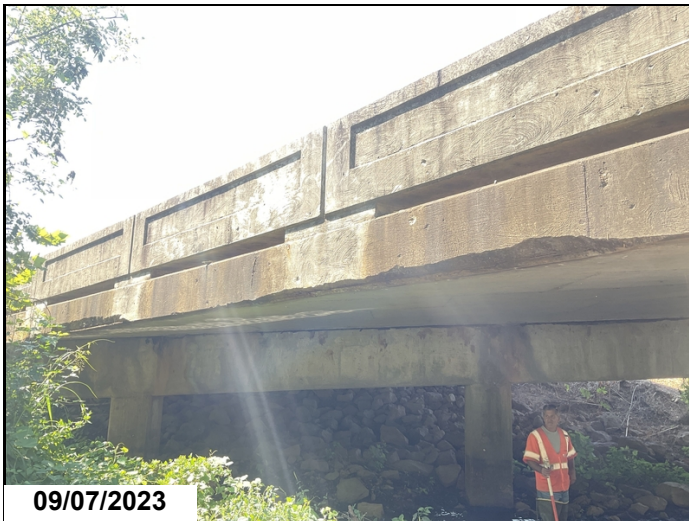
Span # 2 Rt spalling with exposed reinforcing steel.

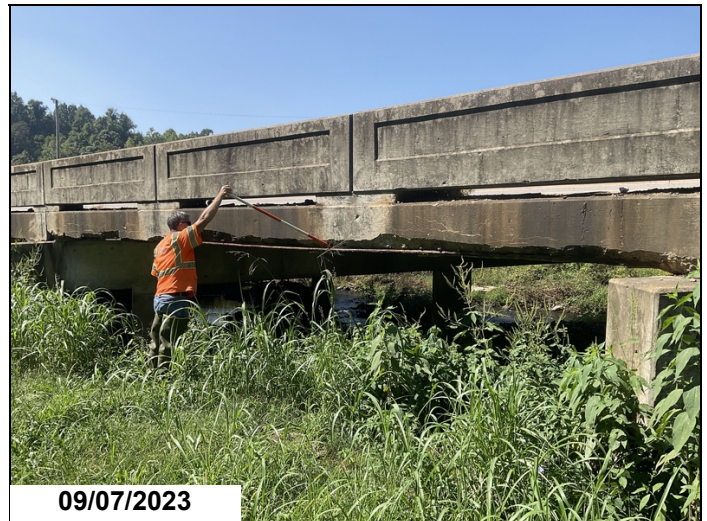
Span # 4 Rt spalling with exposed reinforcing steel.

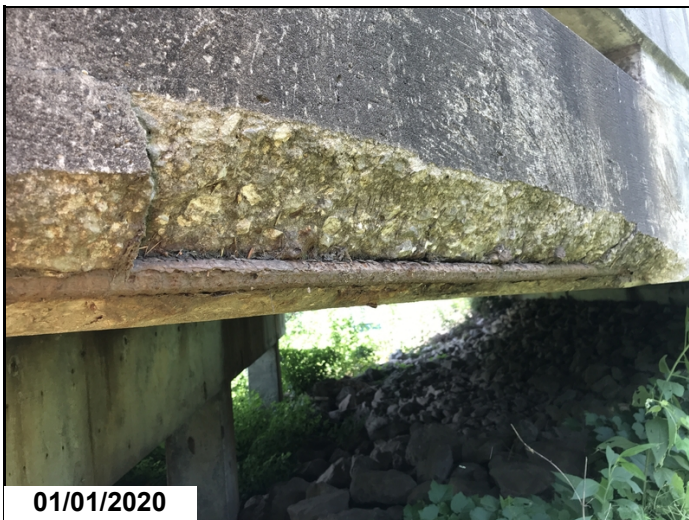
Span # 5-Spalling with exposed reinforcing steel.

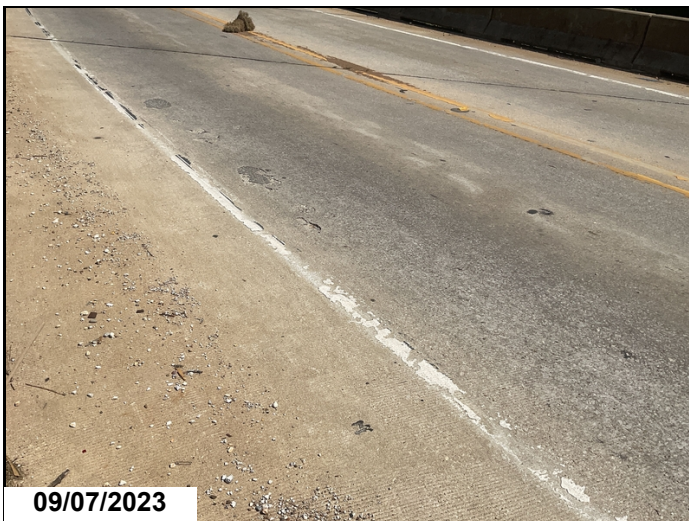
Span # 3 Lt lane spalling and delaminating concrete.

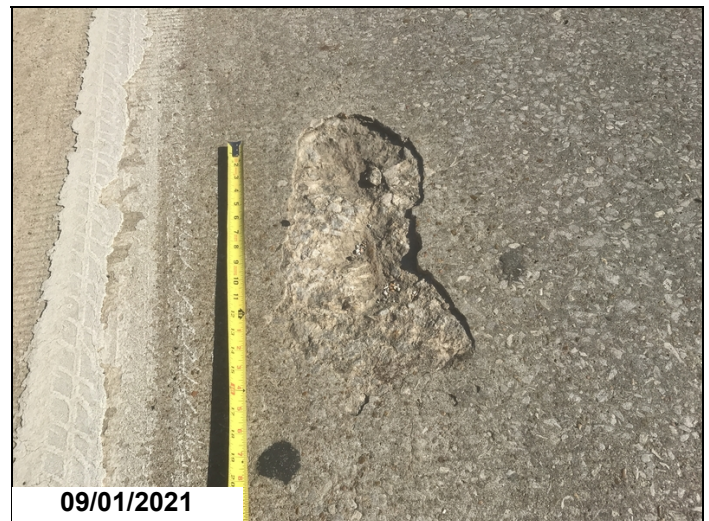
The left lane of span # 3 has delaminated areas in the wheel path with two 15" x 6" spalls that exposed reinforcing steel.

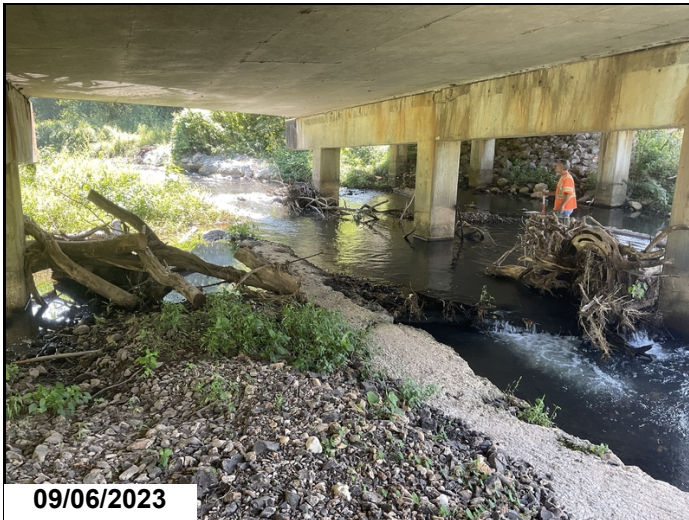
Channel-
Bents # 3 & 4 have minor drift accumulation.

Channel-Bents # 3 & 4 have minor drift accumulation.

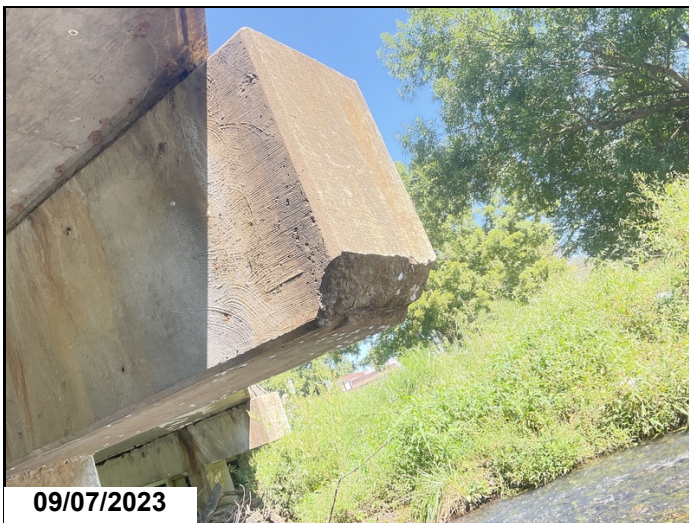
Bent # 3 has a 2' spall with exposed reinforcing steel in the right end of cap.

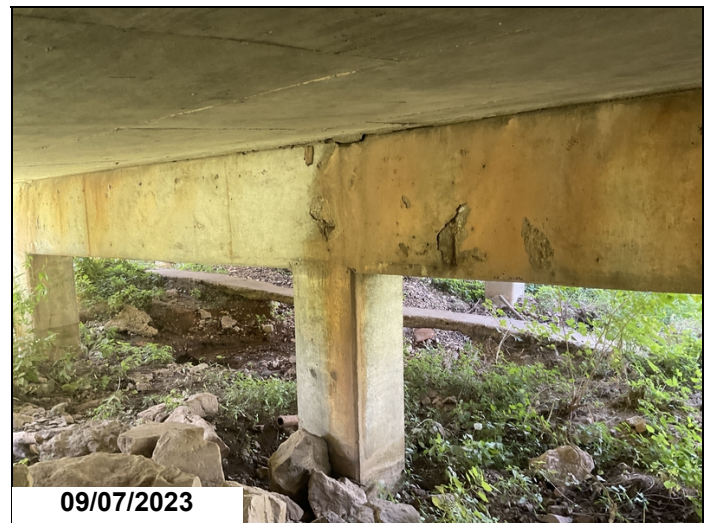
Bent # 5 aheadface spalling with exposed reinforcing steel.

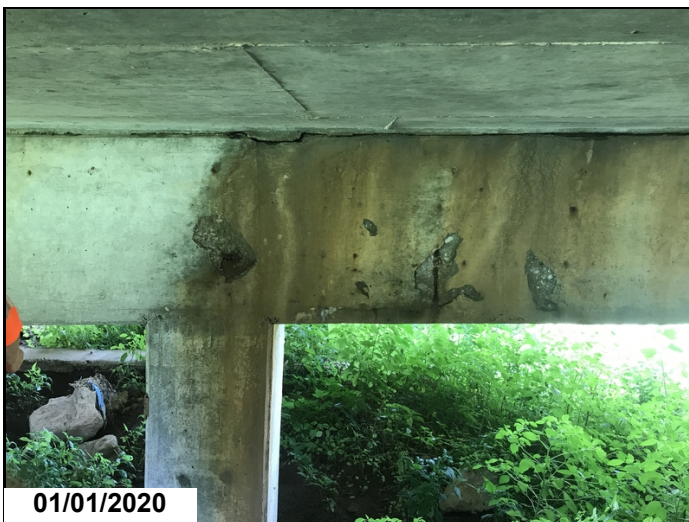
Span # 5 side of Bent # 5-Spalling with exposed reinforcing steel.

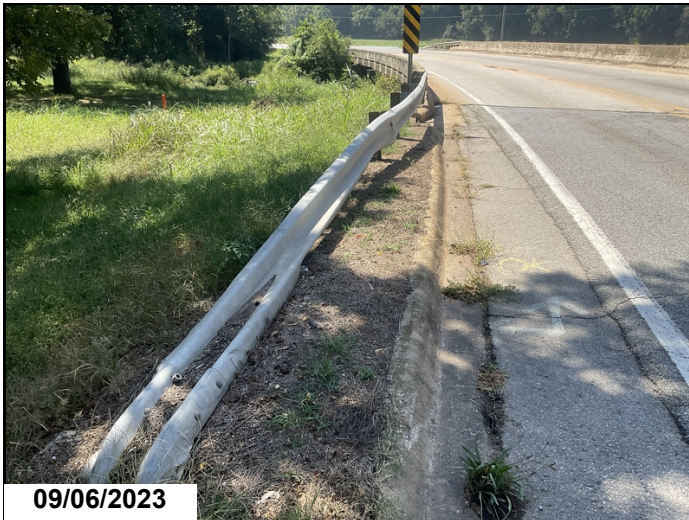
The Northeast approach railing has light collision damage due to traffic impact.

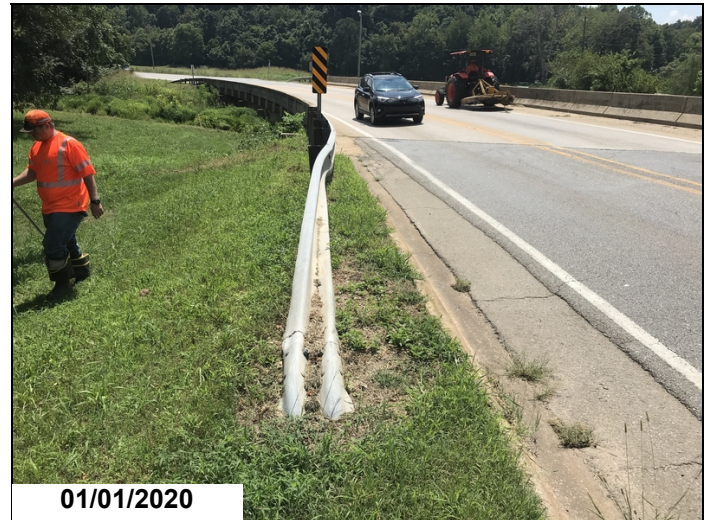
The Northeast approach railing has light collision damage due to traffic impact.

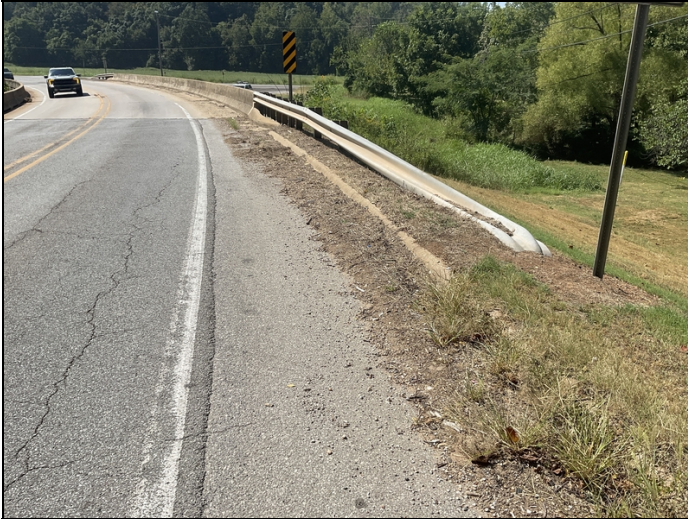
The slab shoulders and the approach roadway shoulders have significant dirt and debris accumulation.

Approach gutters restricted by dirt and debris.

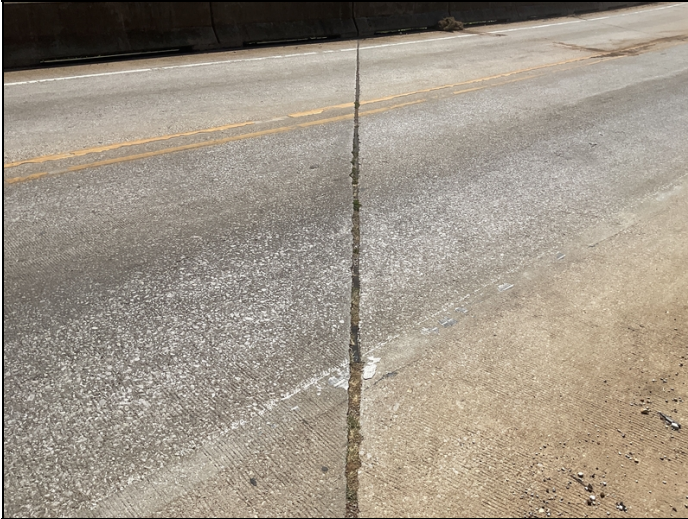
The expansion joints have debris impaction with adhesion failure and deteriorated joint sealant. The joints leak water onto the substructure.

Bent # 5 typical joint seal.
