Asset #05519(Routine)

SH 265 - Wash. Co. over Spring Creek

Location: 8.91 MI N JCT SH 16 & 265

Team Lead: Rhett Franks, Inspection Date: 12/02/2021

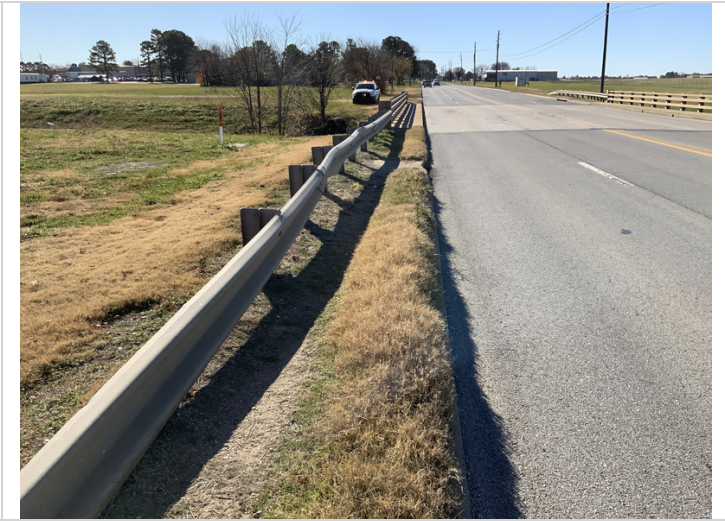
Bent 4 Right minor collision damage to approach bridge railing

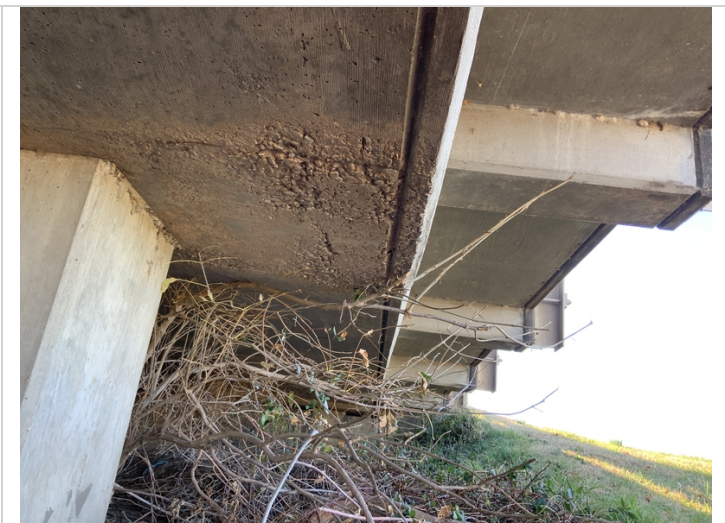
Bent 2 left honeycombing

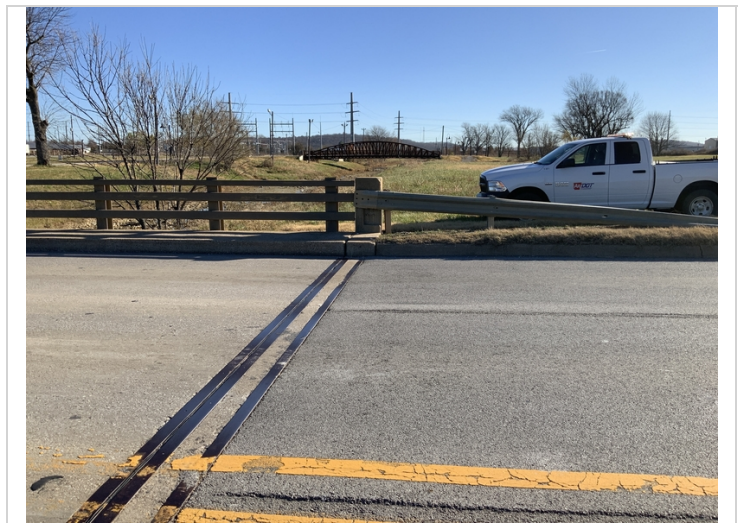
Bent 1 right minor collision damage to approach guardrail

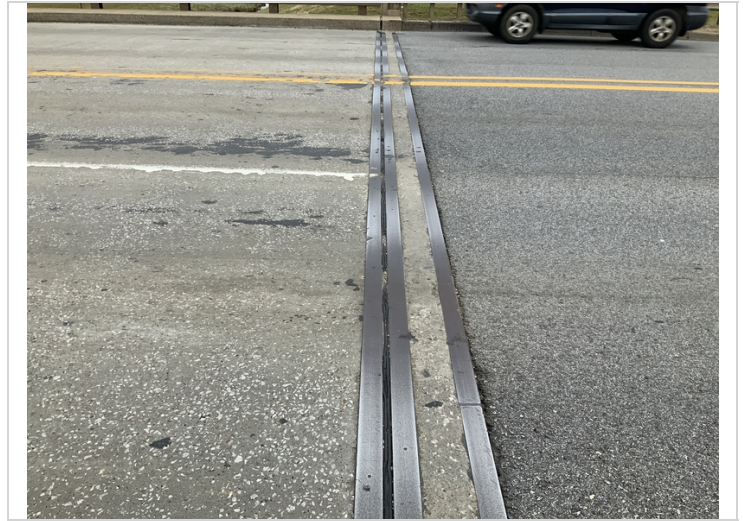
Bent 4 compression joint is cracking and deteriorating. Joints appear to be leaking water on to the abutments.

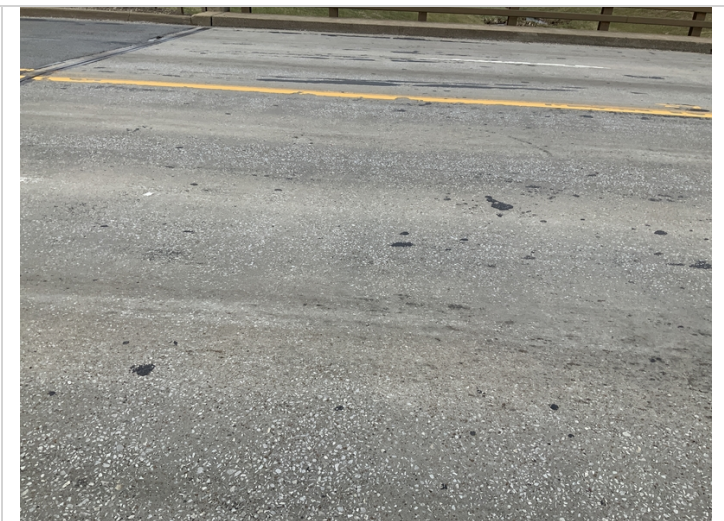
Typical seal-able deck cracking throughout the structure.

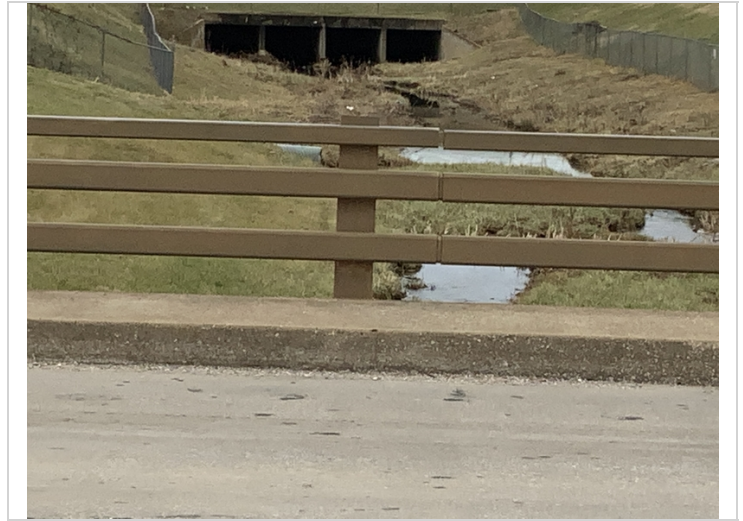
Bent 2 left bridge rail is separated.

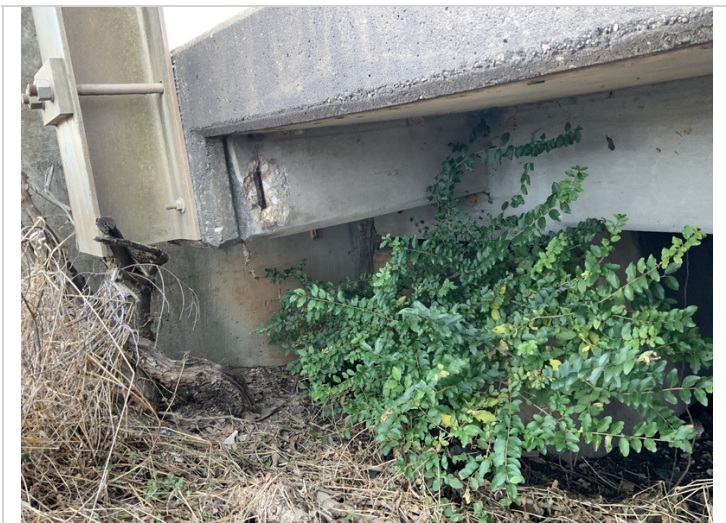
Bent 1 (South Abutment) has spalling with exposed reinforcing steel (Visible from the right side of the structure along the cantilever).

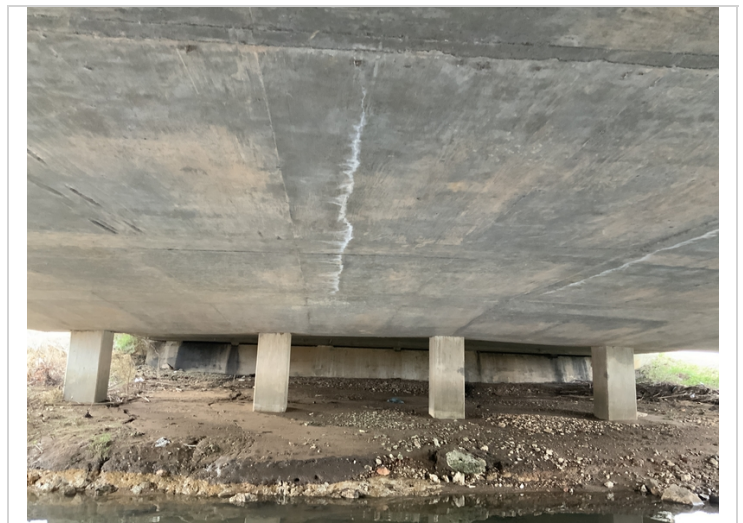
Span 2 has three longitudinal cracking with efflorescence leach through.

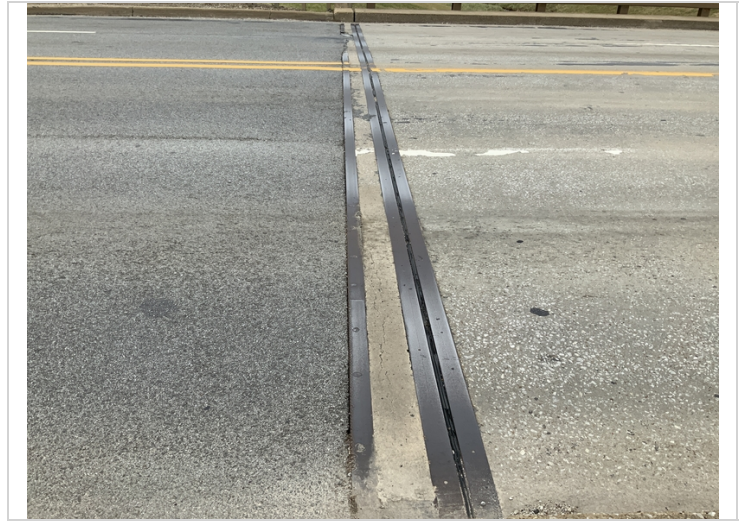
Bent 1 (South Abutment) and Bent 4 (North Abutment) compression joints both have cracking and appear to be leaking.

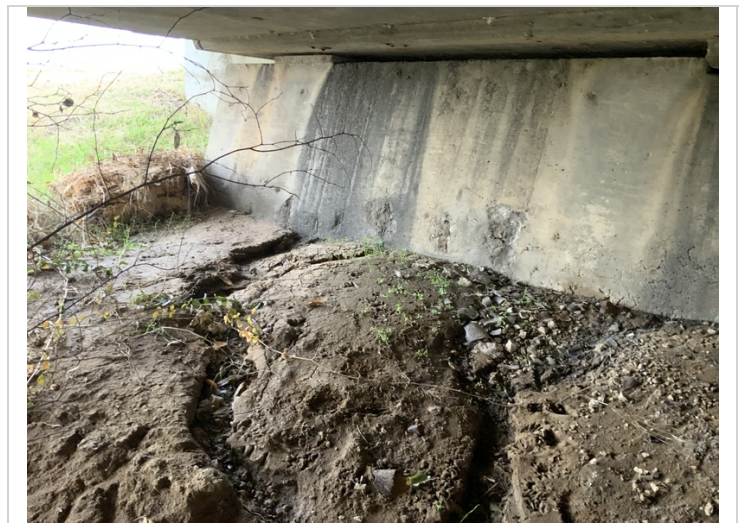
Bent 4 (North Abutment) has 7 spalls with exposed reinforcing steel that has initial section loss at each location.

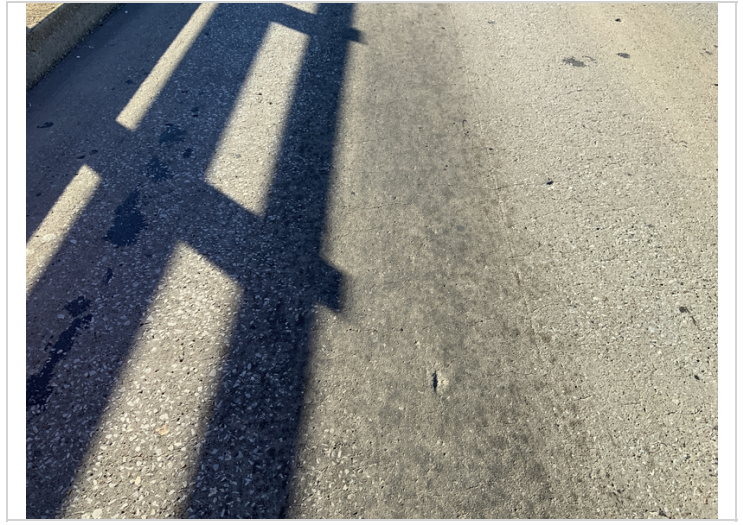
Span right transverse cracking typical

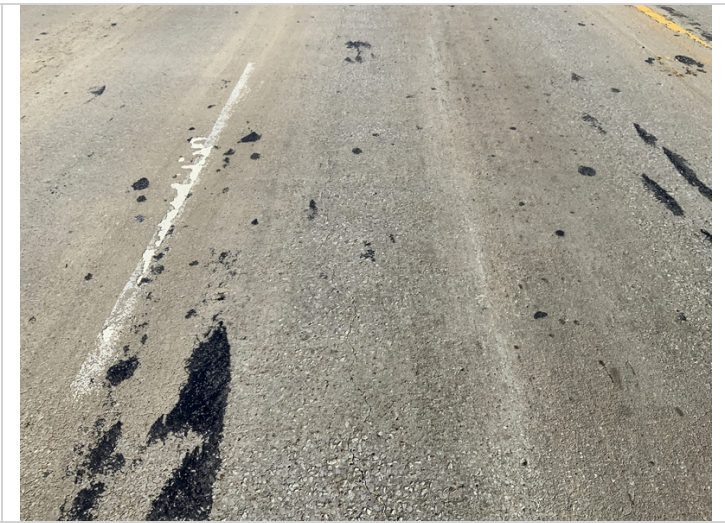
Typical longitudinal cracking

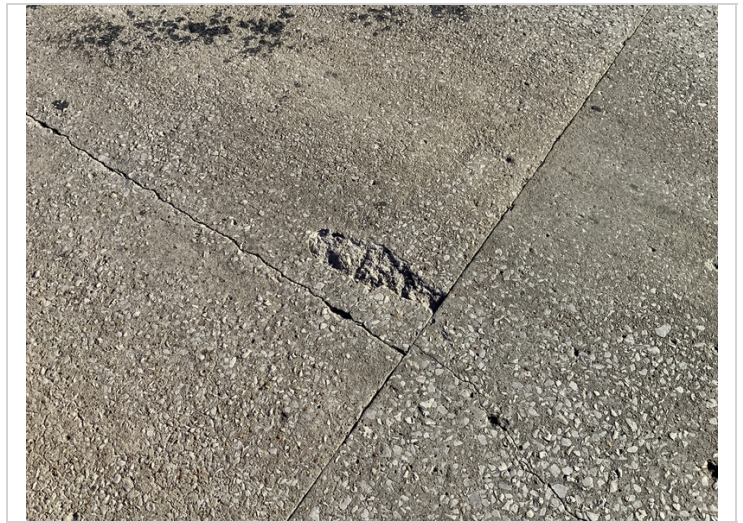
Span 2 Left lane minor Spalling

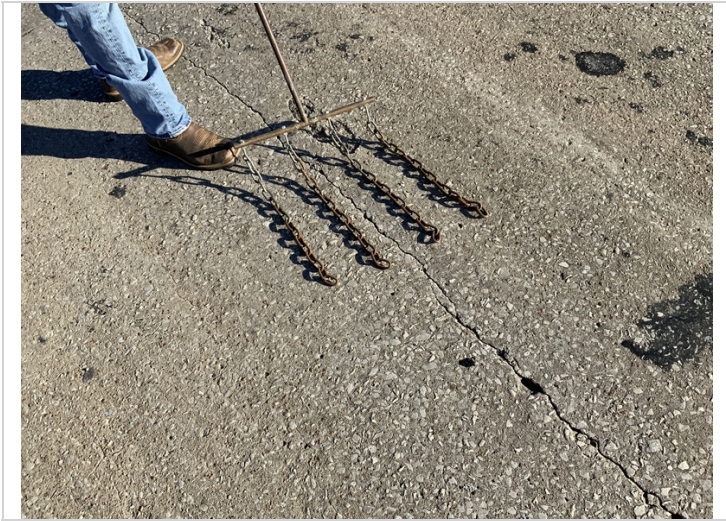
Span 2 Left approx 8ft delaminated area

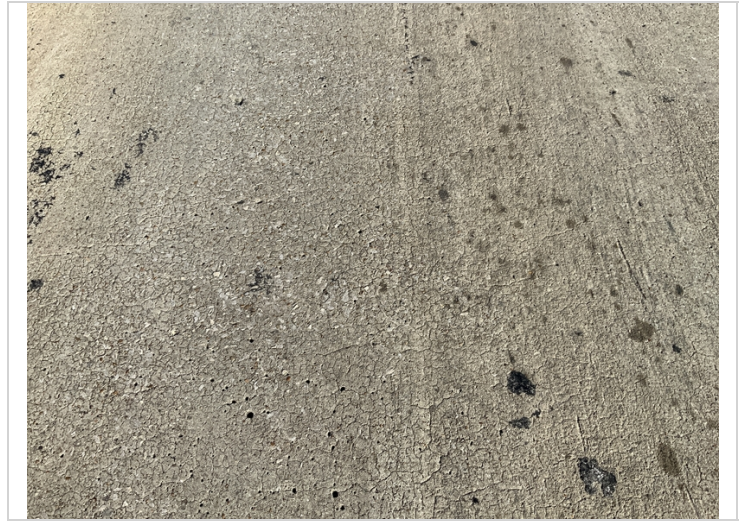
Typical hairline map cracking

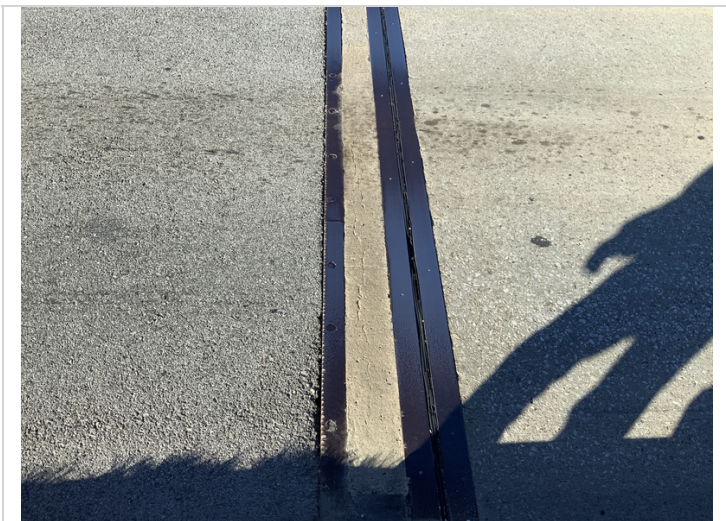
Typical cracking in the back wall

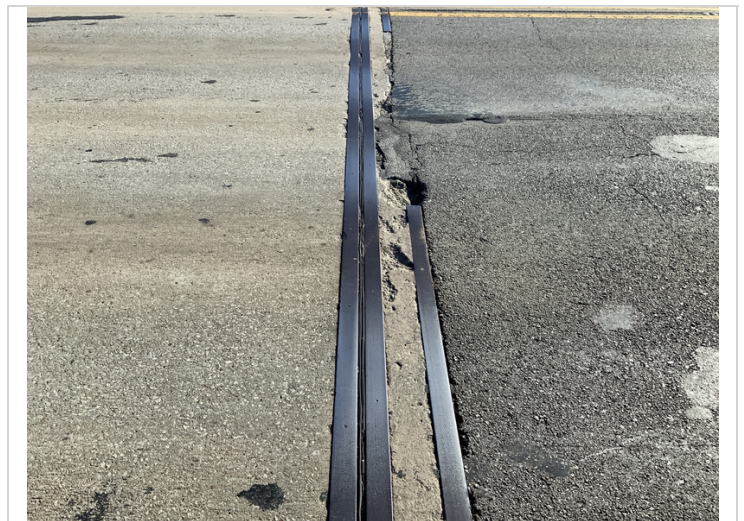
Bent 1 left abut pothole on back wall with approx 12 ft road iron removed

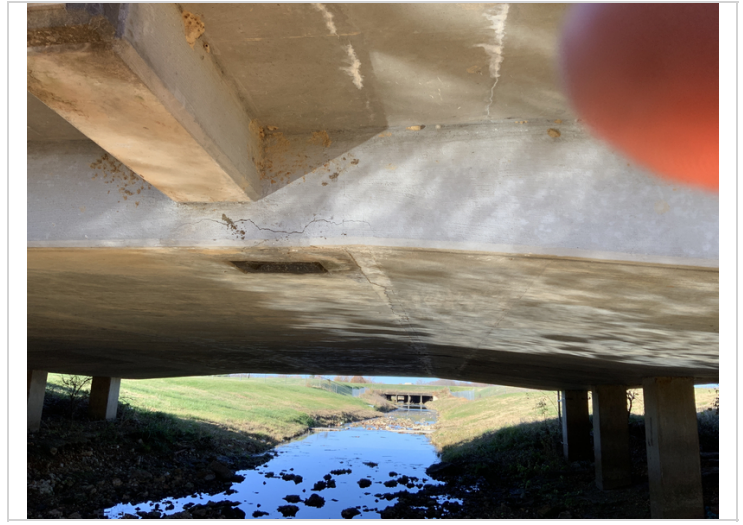
Span 2 Right cracking in edge of deck

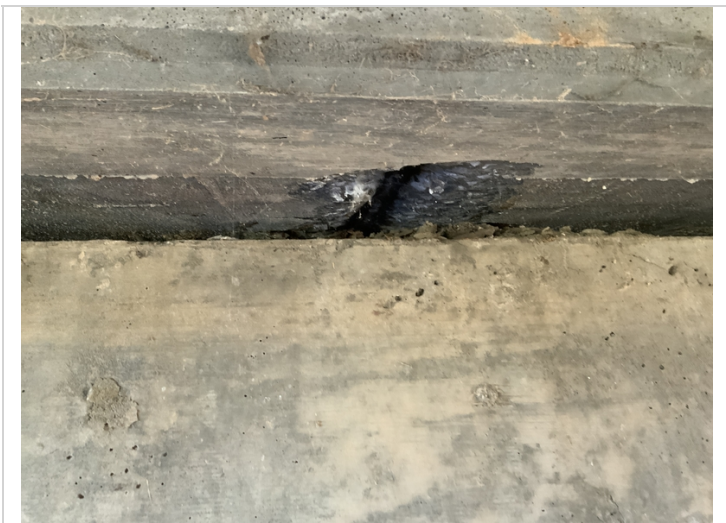
Bent 4 mid span Spalling with exposed reinforcing steel

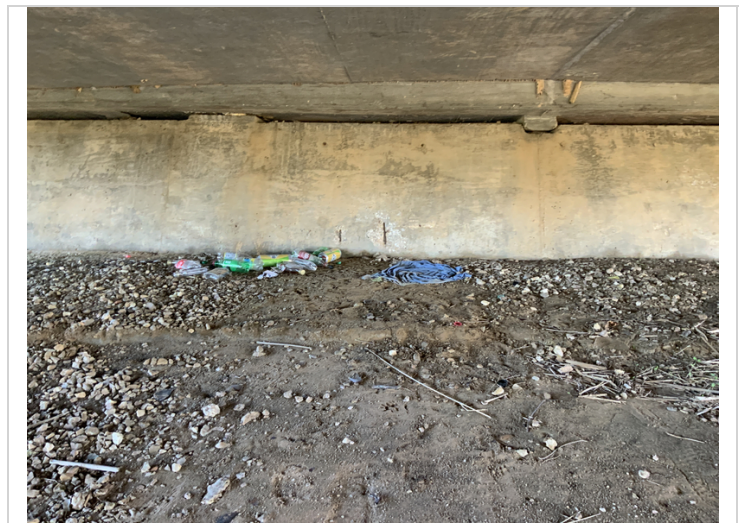
Bent 4 Spalling with exposed reinforcing steel

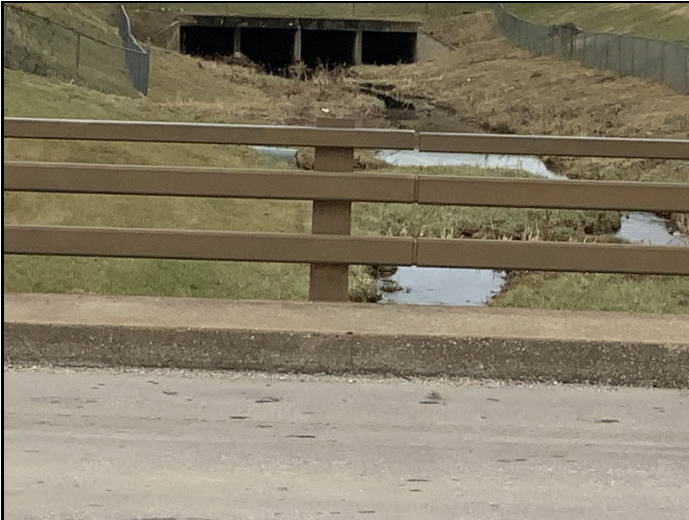
The bridge railing connection joints on the Left and Right sides of the bridge are separated.

Bent 2 left bridge rail is separated.

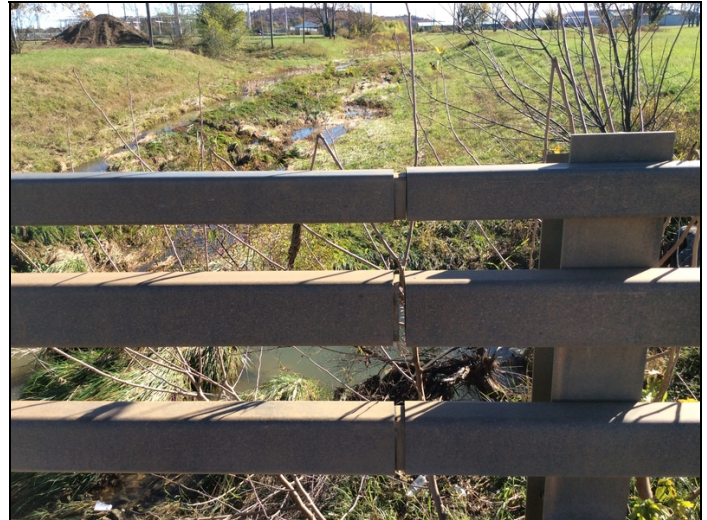
The bridge railing convention joints on the Lt and Rt sides of the bridge are separated.

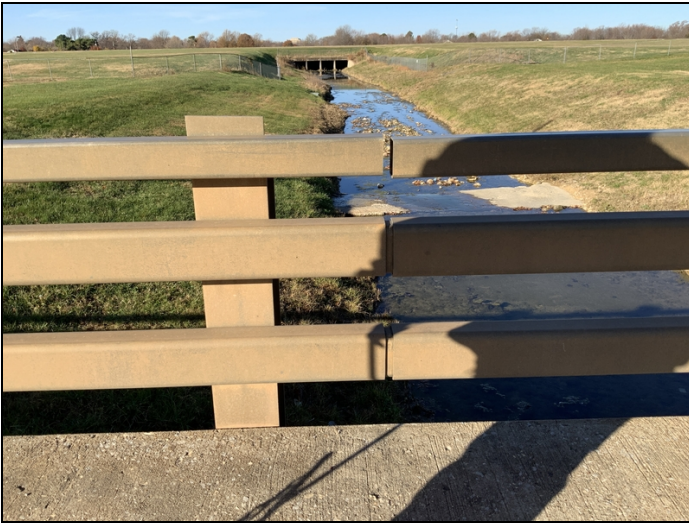
1/2 in misalignment

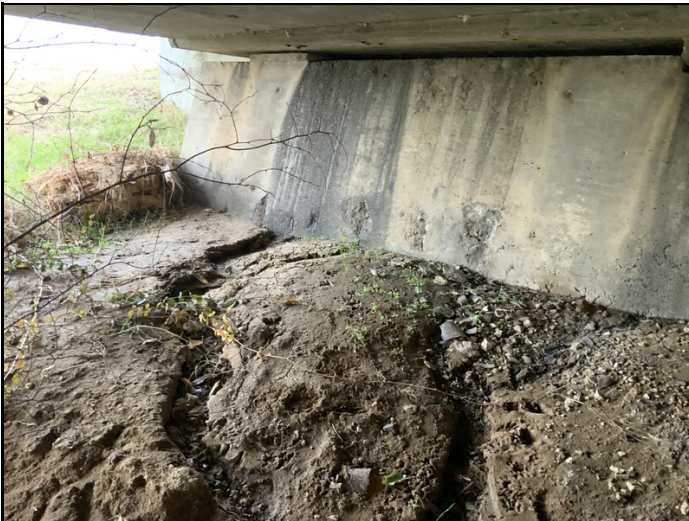
Bent # 4 has spalls with exposed reinforcing steel.

Bent 4 (North Abutment) has 7 spalls with exposed reinforcing steel that has initial section loss at each location.

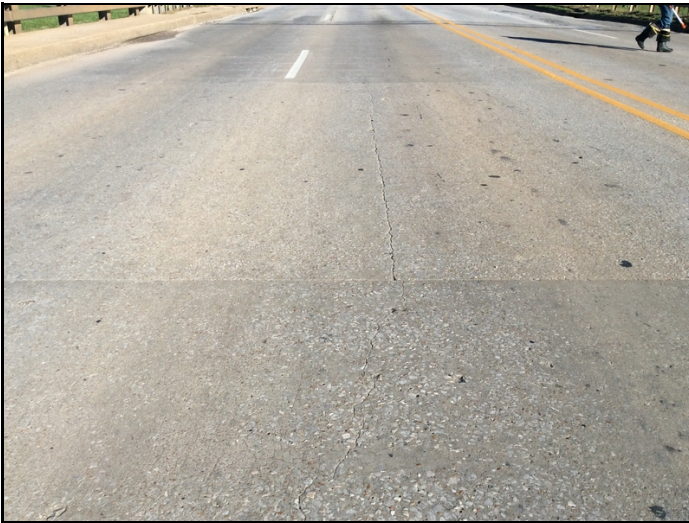
The driving surface of deck has sealable cracking in all spans.

There are sealable map cracks and longitudinal cracks on the driving surface of the deck.

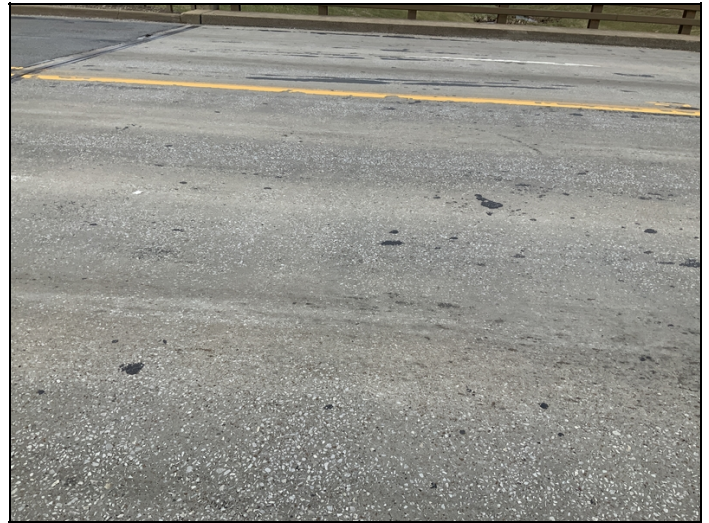
Typical seal-able deck cracking throughout the structure.

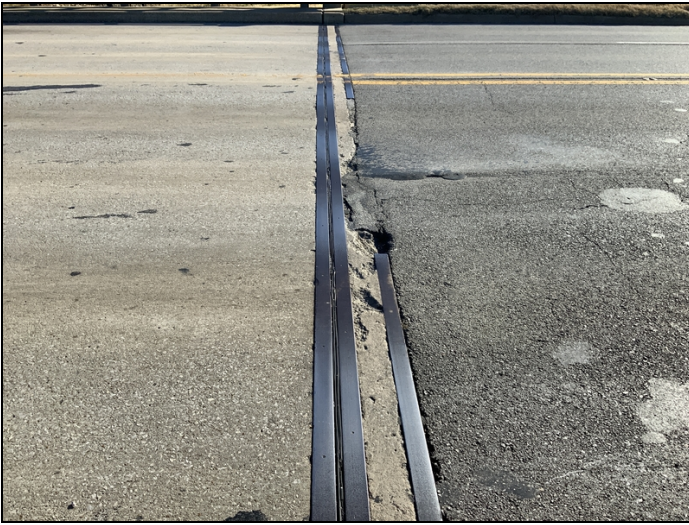
Bent 1 left adhesion failures

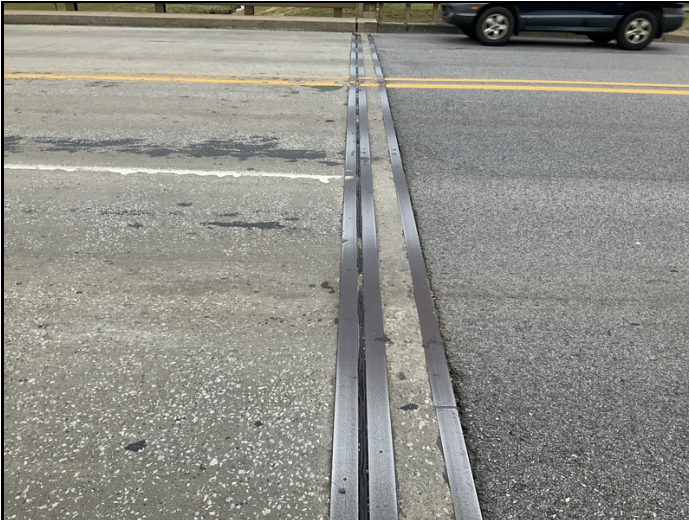
The expansion joint material at the North and South abutments is cracked, deteriorated and leaks in locations.

Typical compression joint seals.

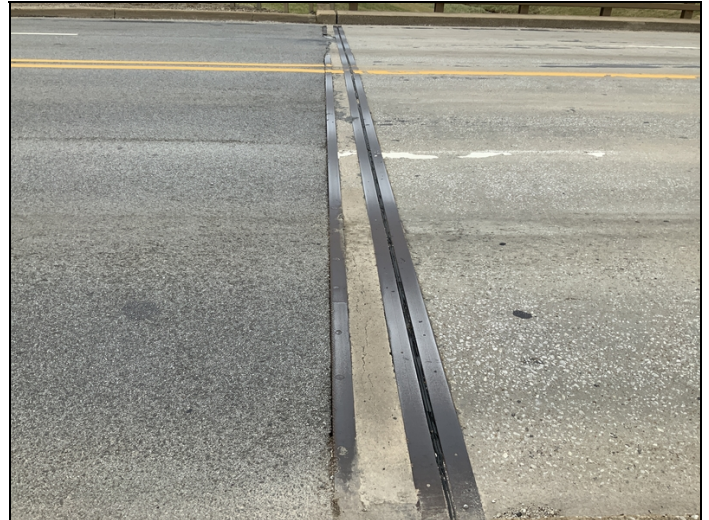
Bent 1 (South Abutment) and Bent 4 (North Abutment) compression joints both have cracking and appear to be leaking.

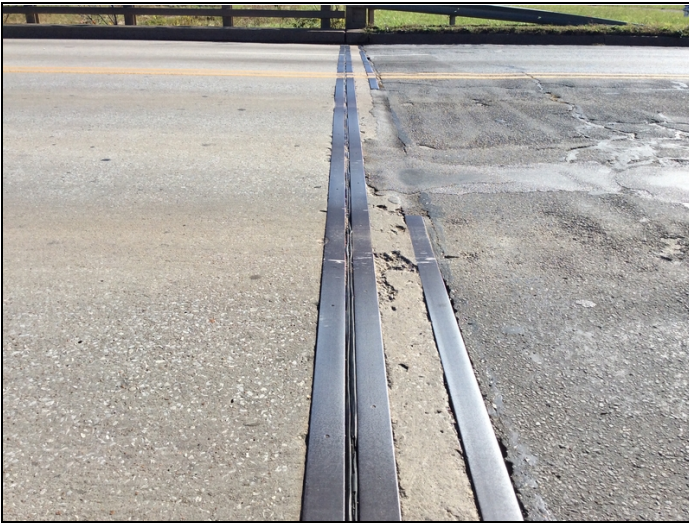
The compression joint seals at the abutments are deteriorated with minor tears on the driving surface and minor adhesion failure that leaks water on the abutments.

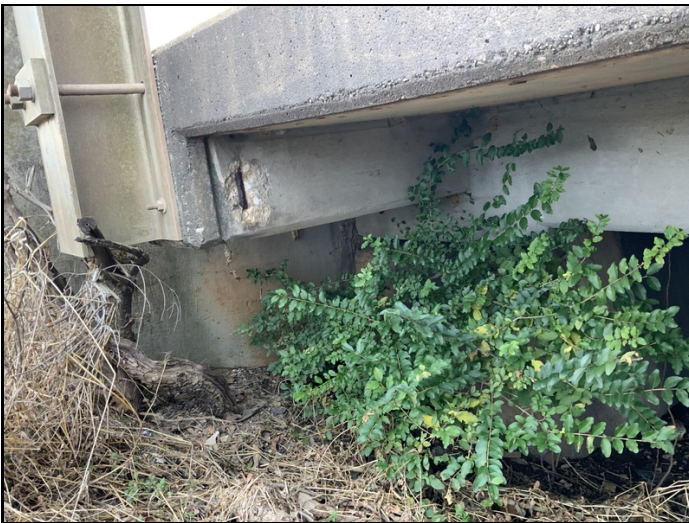
Concrete cantilever sidewalk support on the Northwest and southeast corner of the structure has a softball size spall with exposed reinforcing steel.

Bent 1 (South Abutment) has spalling with exposed reinforcing steel (Visible from the right side of the structure along the cantilever).

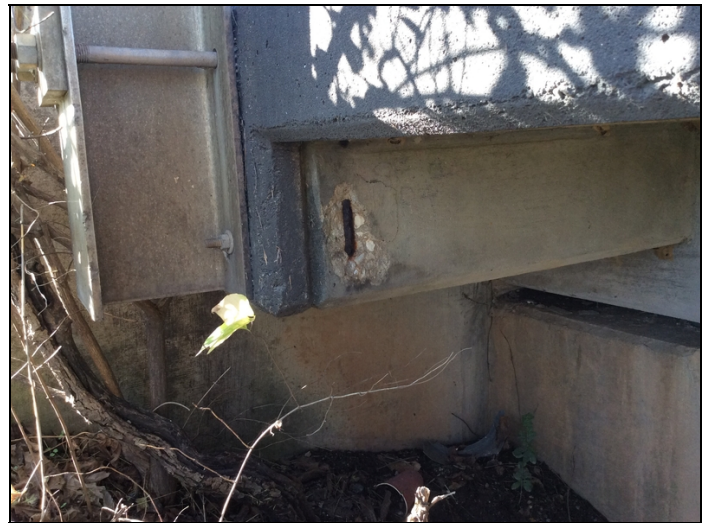
One softball size spall with exposed reinforcing steel at the Southeast edge of deck

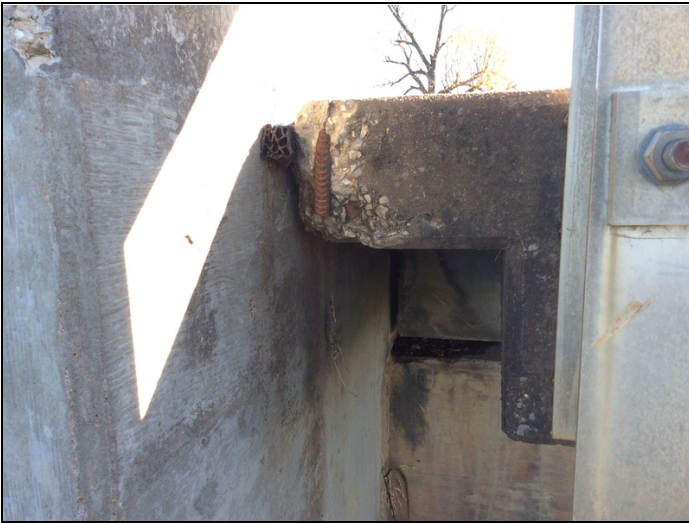
One softball size spall with exposed reinforcing steel at the Northwest edge of deck.

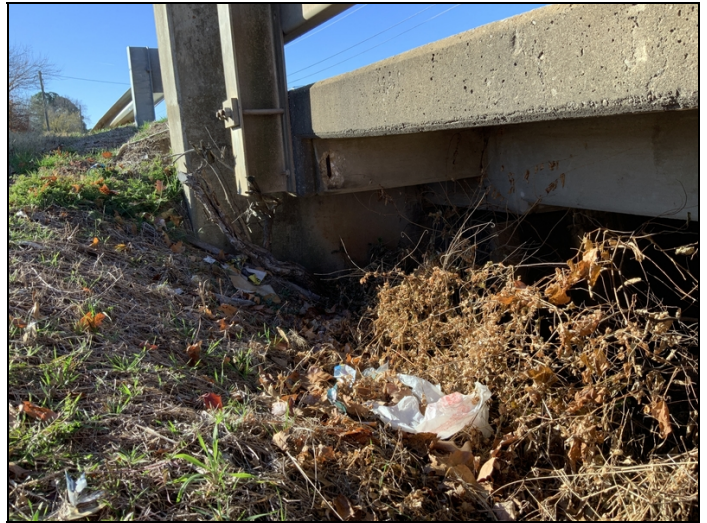
Bent 1 south abutment Spalling with exposed steel
