Asset #000000000007229(Routine, Underwater type 2)

SH 265-Wash Co. over Clear Creek

Location: 6.22 MI N JCT SH 265 & 16

Team Lead: Eric West, Inspection Date: 06/26/2023

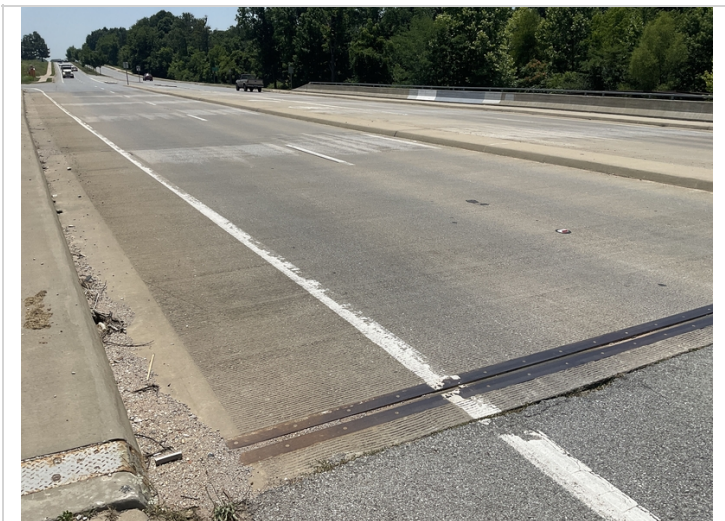
Typical driving surface.

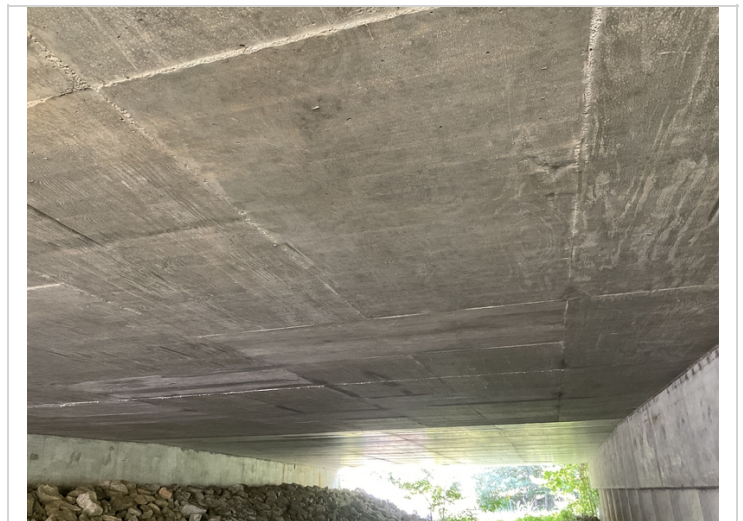
Span # 1 typical undersurface.

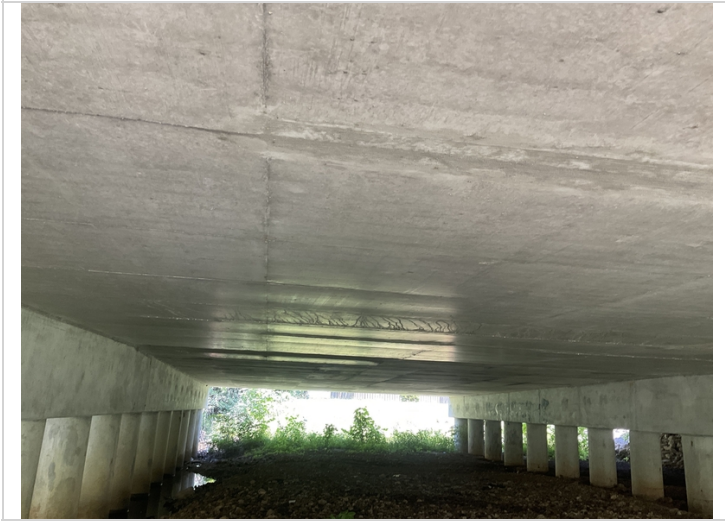
Span # 2 typical undersurface.

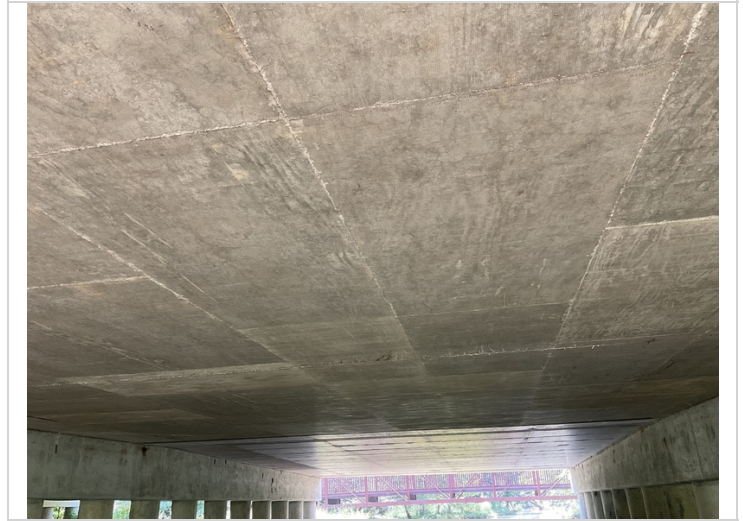
Span # 3 typical undersurface.

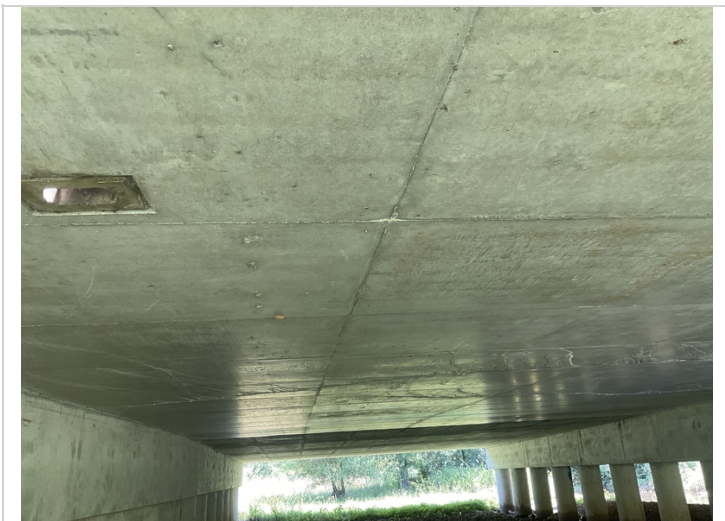
Span # 4 typical undersurface.

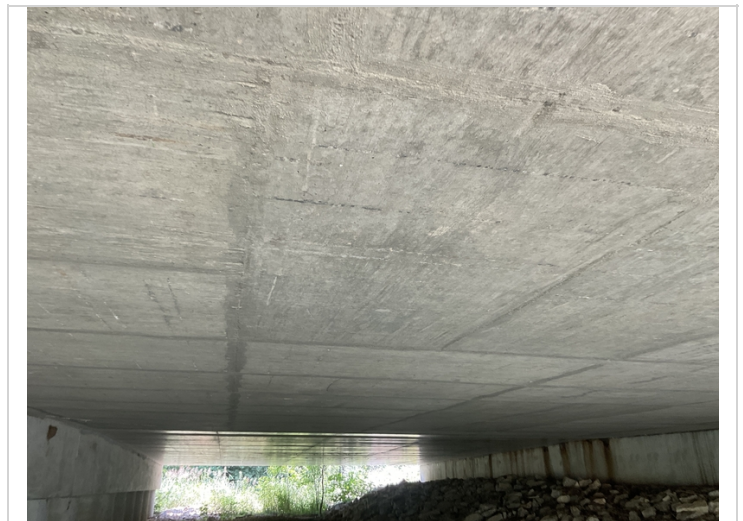
Span # 5 typical undersurface.

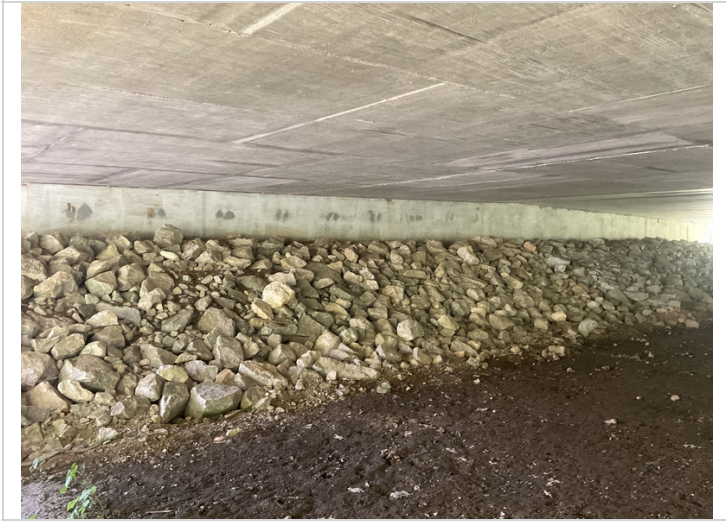
(215) -The tops of the backwalls have numerous transverse cracks. -Abutment # 1 has a couple of shallow spalls with no exposed reinforcing steel adjacent to the key way located approximately 10' left of centerline. -The left end of abutment # 1 has a vertical crack with efflorescence. -Abutment # 2 has efflorescence in the cap and brown staining at the key ways.							
225	Steel Pile	EA	61	61	0	0	0
515	Steel Protective Coating	SF	2714	2702	12	0	0
7000	Damage	EA	12	0	12	0	0

Abutment # 1 typical.

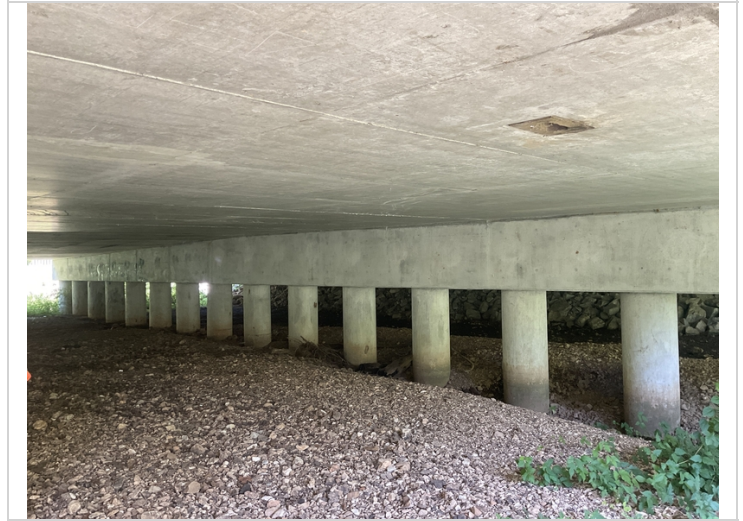
Bent # 2 typical.

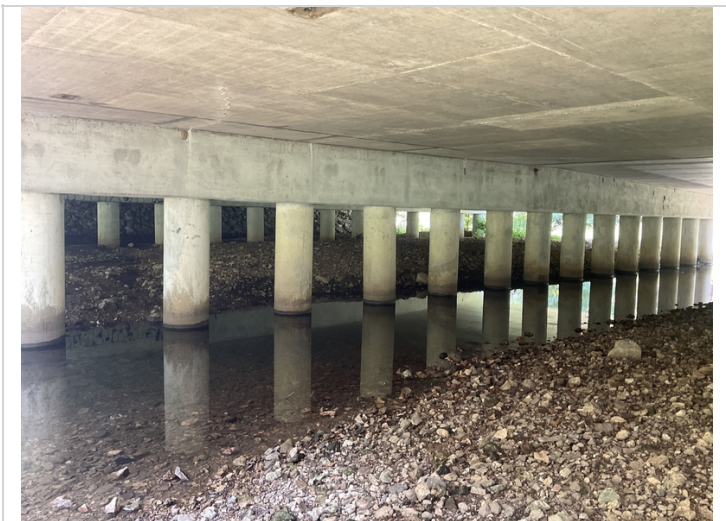
Bent # 3 typical.

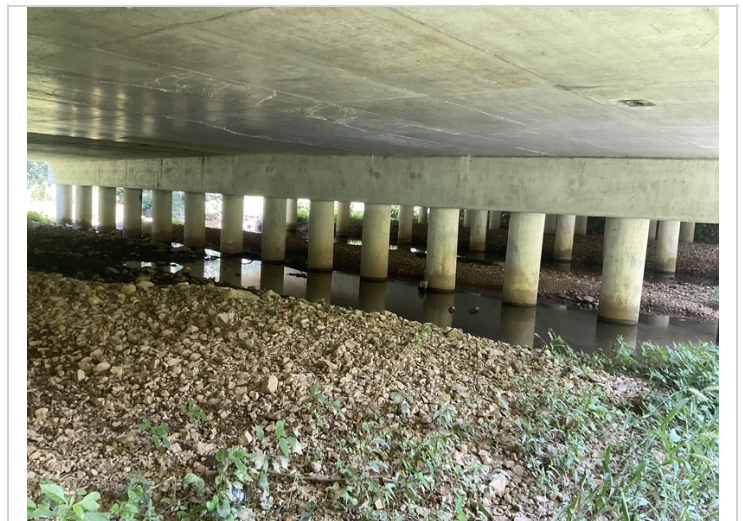
Comment: Columns: Bent # 4 Column # 12 has minor concrete section loss possibly from dirt in the forms during the construction process. Pier Caps: No apparent noteworthy problems at this inspection. Abutments: Transverse cracks typical in the tops of both backwalls.

Bent # 4 typical.

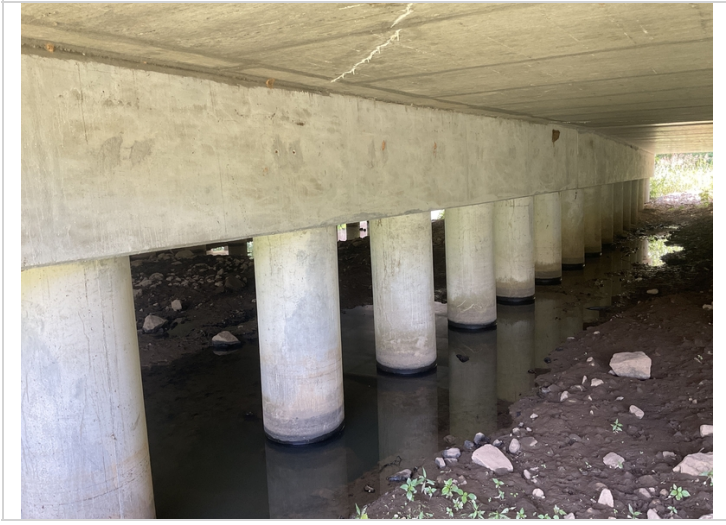
Bent # 5 typical.

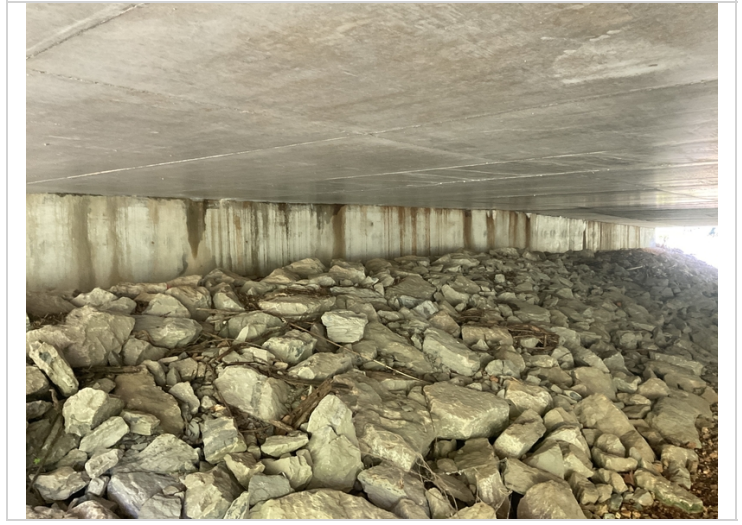
Abutment # 2 typical.

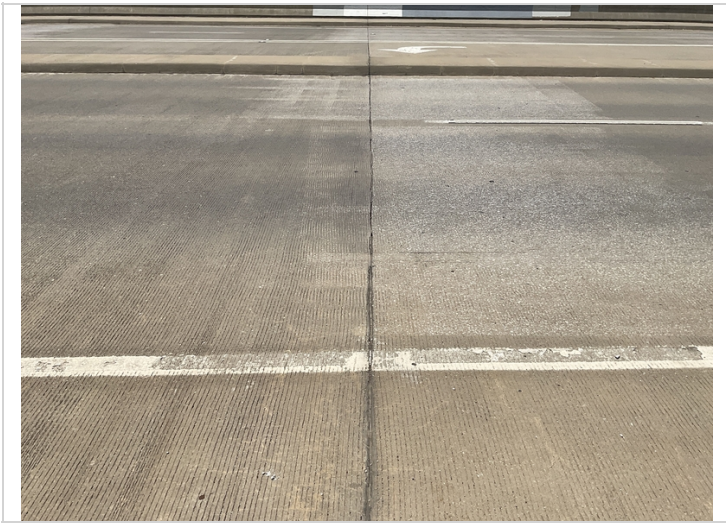
-The poured joint sealant at abutment # 2 expansion joint has a few short duration areas of full depth adhesion failure in the Southbound lanes.

Failing joint sealant.

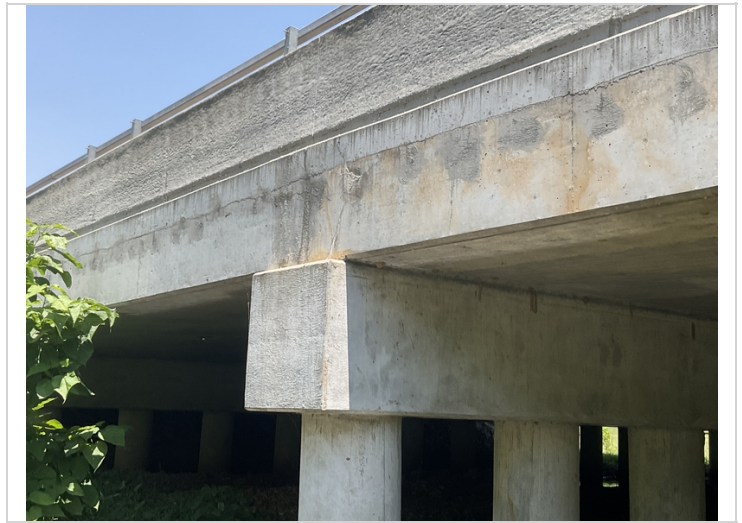
Typical shear type cracking in the edge of the slab over the intermediate bents.

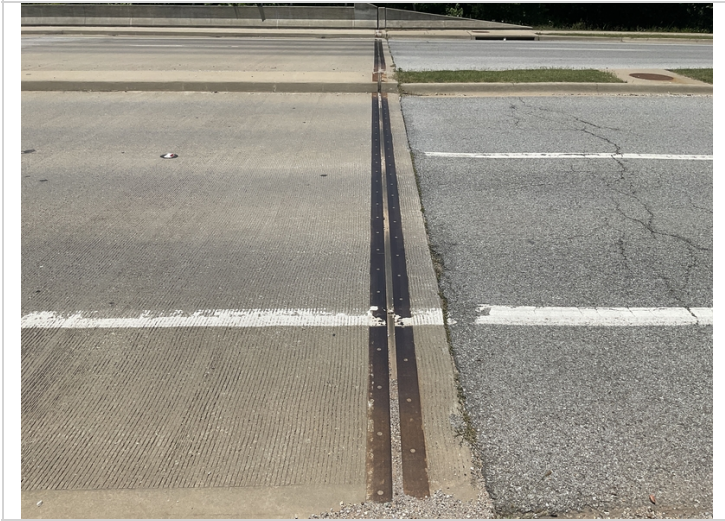
Abutment # 2 typical joint seal.

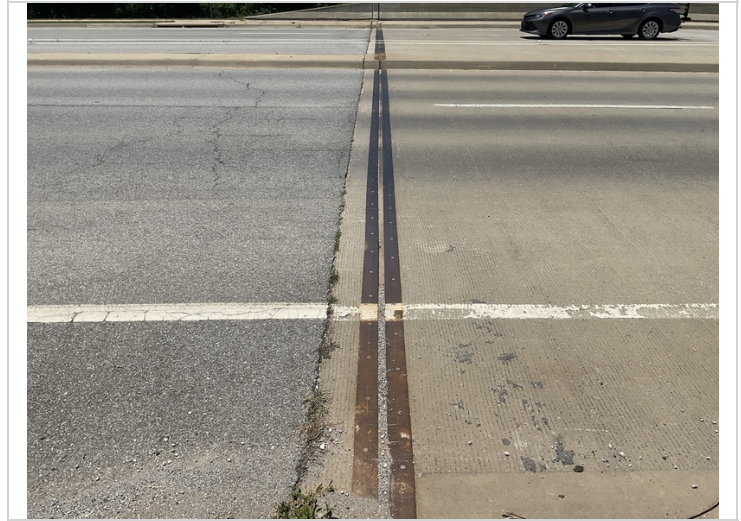
Abutment # 1 joint seal.

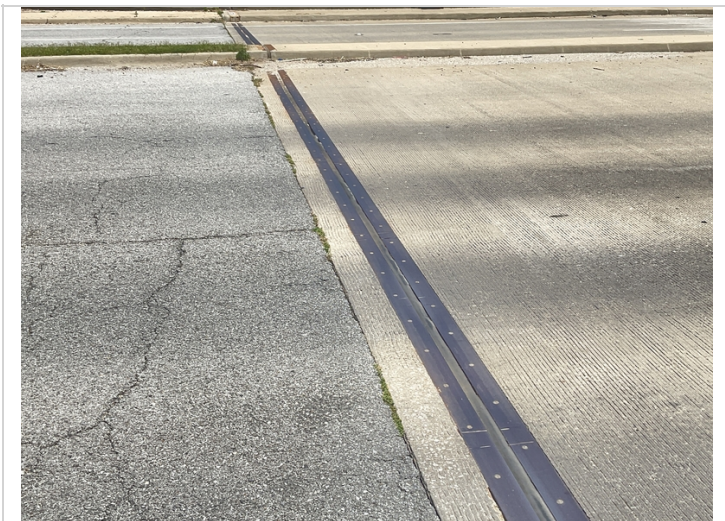
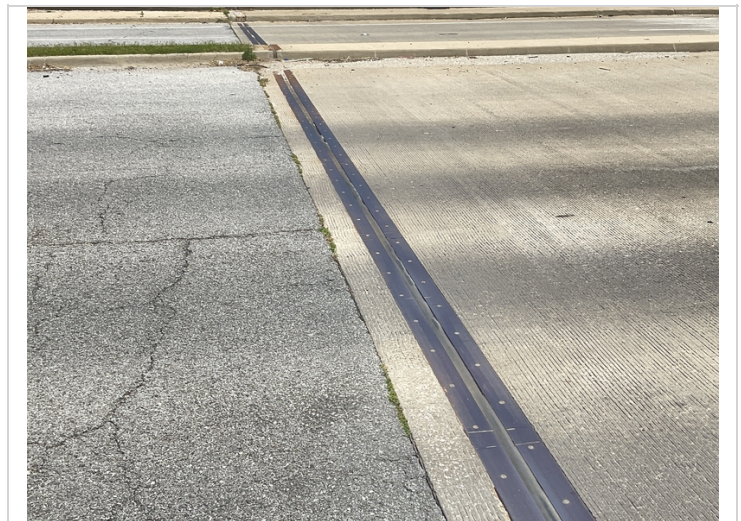
Abutment # 2 joint seal adhesion failure.

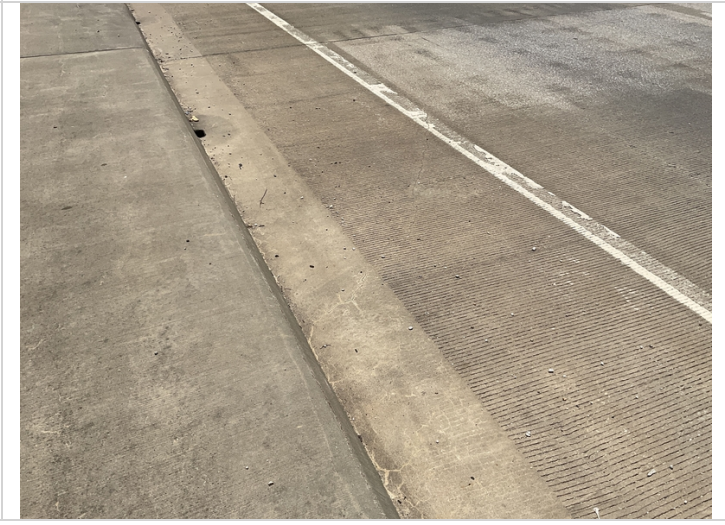
-Driving surface of the deck has numerous sealable transverse, longitudinal, and diagonal cracks. Several of the cracks are visible in the undersurface with light efflorescence. There are several moderate width longitudinal cracks that extend the majority of the length of the structure.

Sealable deck cracking.

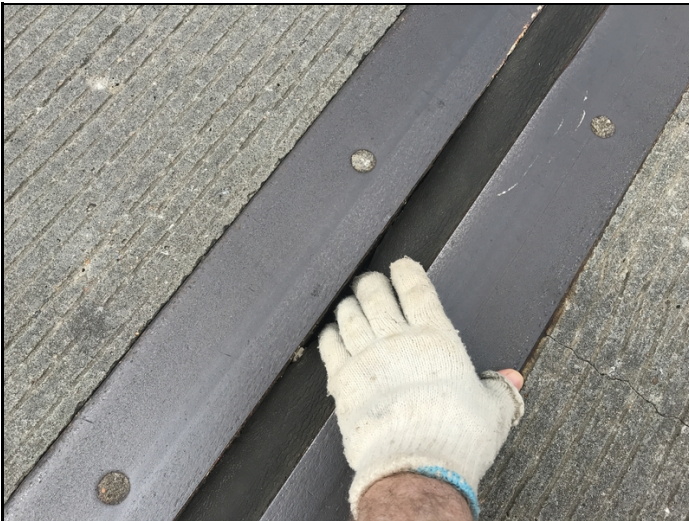
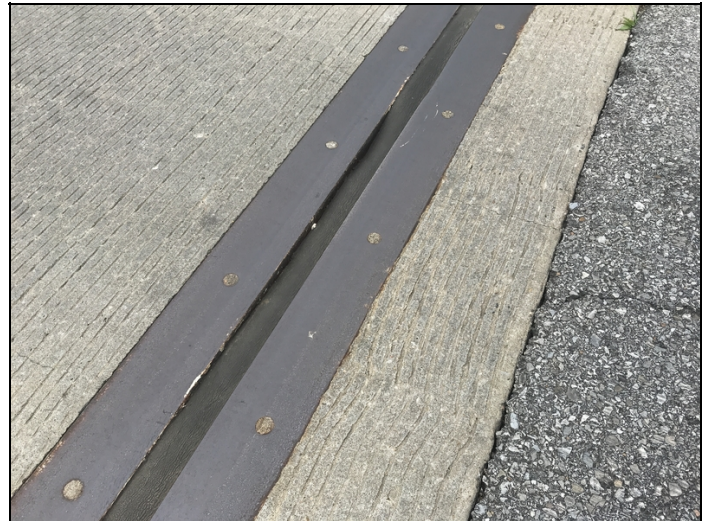
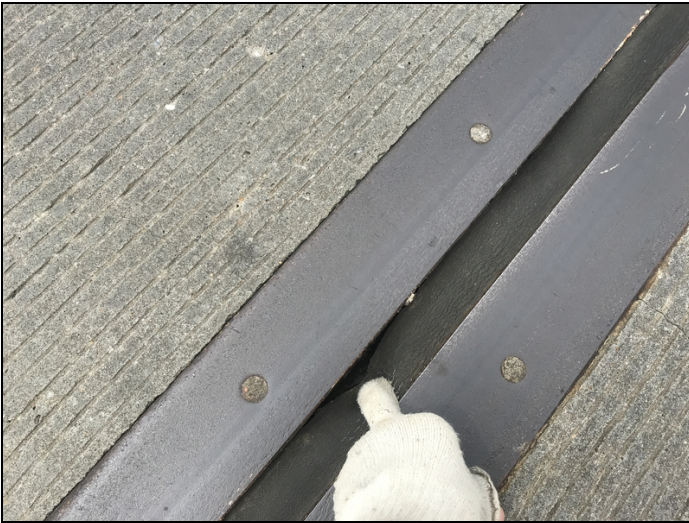
Abutment # 2 Expansion Joint -

The poured joint sealant at abutment # 2 expansion joint has a few short duration areas of full depth adhesion failure in the Southbound lanes

Type of Work: Repair (General)
