Bridge #01649(Routine, Underwater type 2)

SH 59-Washington over Little Branch

Location: 1.80 MI N JCT OF SH 45

Team Lead: Eric West Inspection Date: October 28, 2021

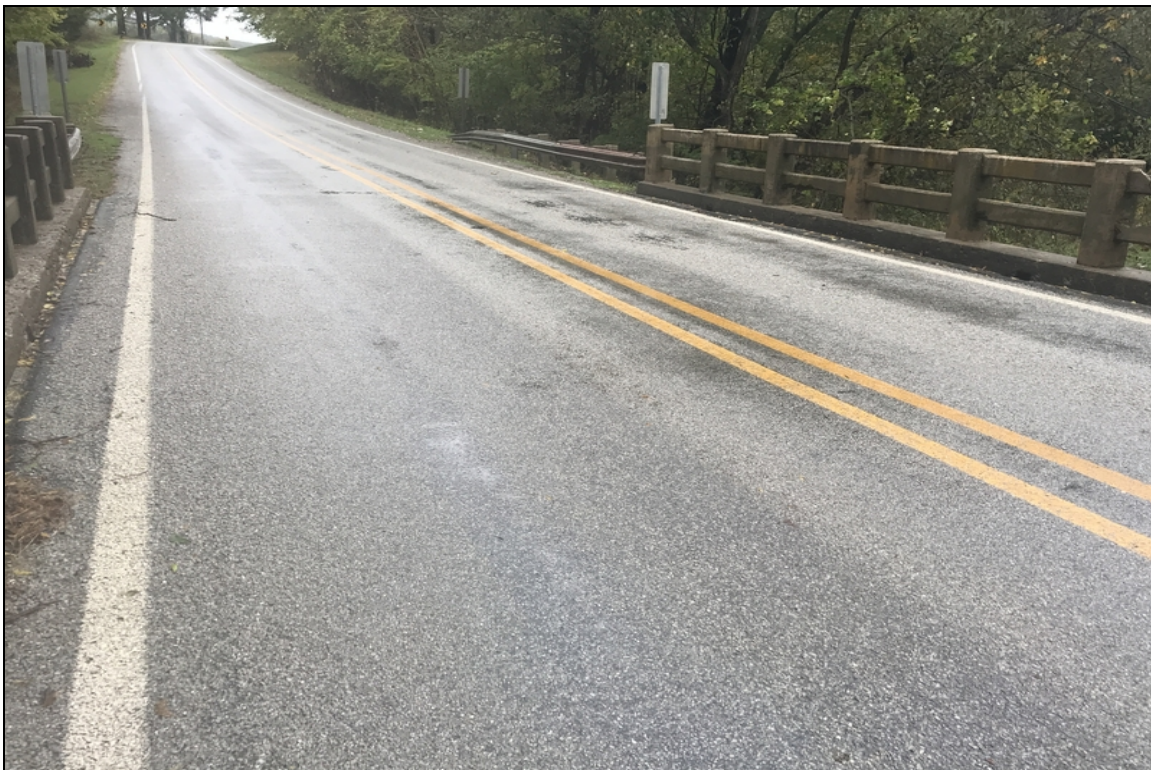
Typical driving surface of the deck.

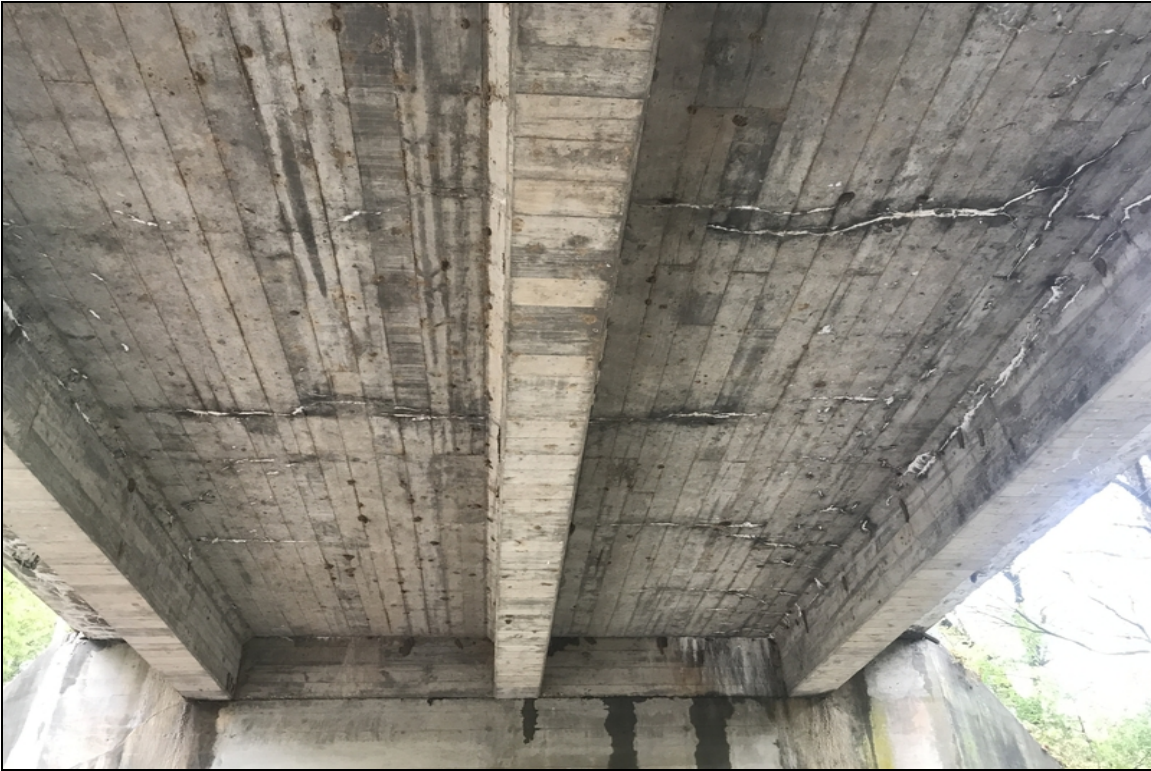
(16)							
-Asphalt driving surface. -The undersurface of the overhangs have map cracking with heavy efflorescence and leaching with soft deteriorated concrete. -There are diagonal cracks with efflorescence in the corners of the deck that are visible from the undersurface of the deck. -There are transverse cracks with efflorescence at variable spacing that are visible from the undersurface of the deck. -There are areas with map cracking with efflorescence visible from the undersurface of the deck. -There is a 2' delaminated area visible from the undersurface of bay # 2 located approximately 5' from bent # 2 and at midspan with a 6" shallow spall with exposed reinforcing steel.							
110	Reinforced Concrete Open Girder/Beam	LF	105	46	59	0	0
1120	Efflorescence/Rust Staining	LF	46	0	46	0	0
1130	Cracking (RC and Other)	LF	13	0	13	0	0

Typical undersurface of the deck.

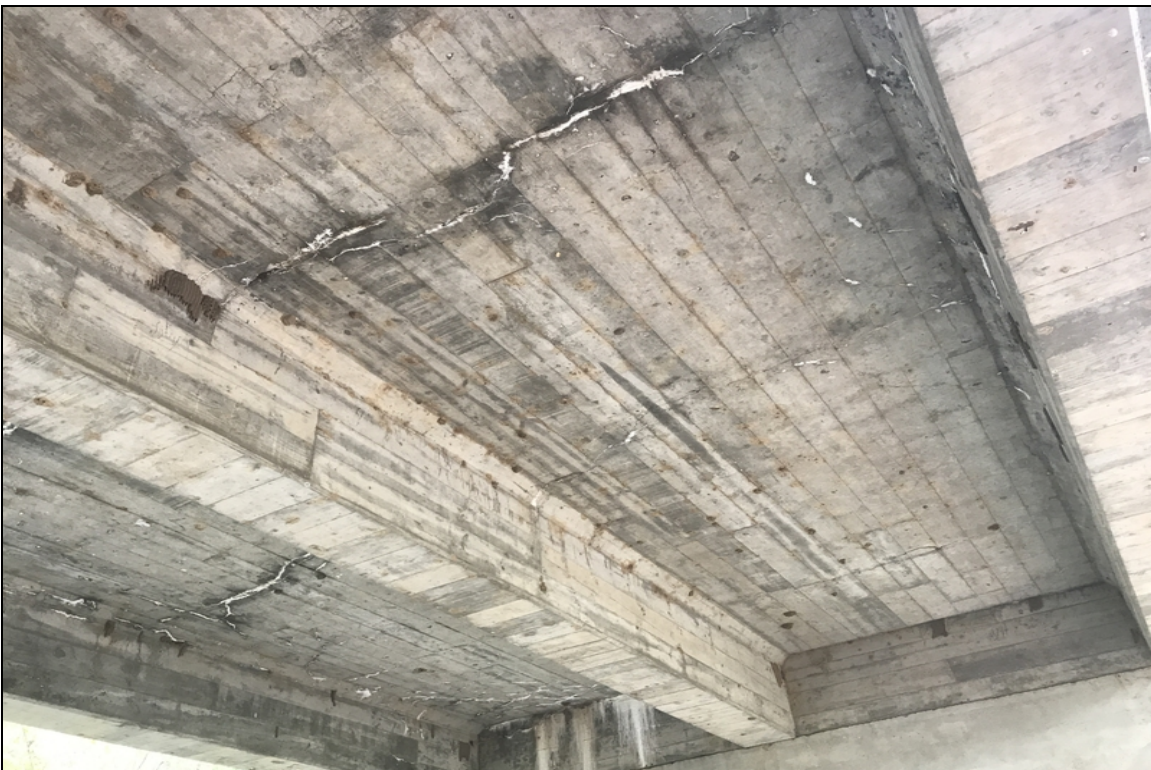
Bay #2 concrete delamination's and spalling with exposed reinforcing steel.

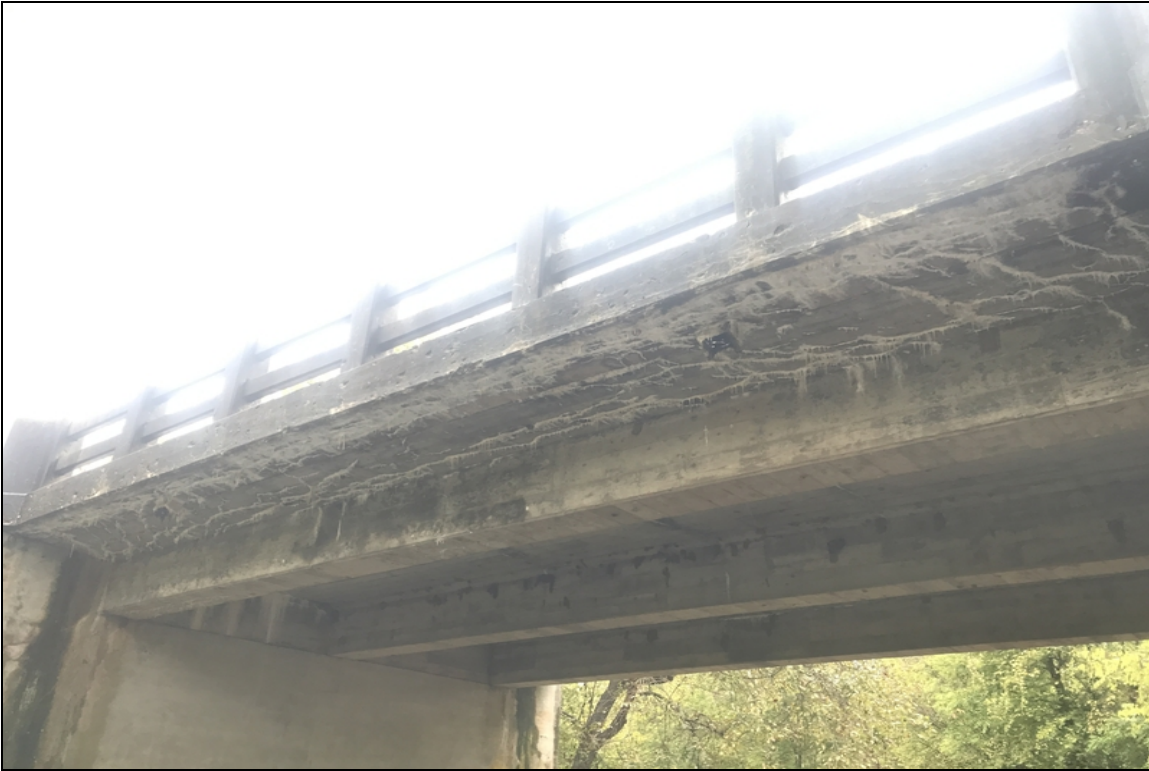
Left overhang and edge of the deck.

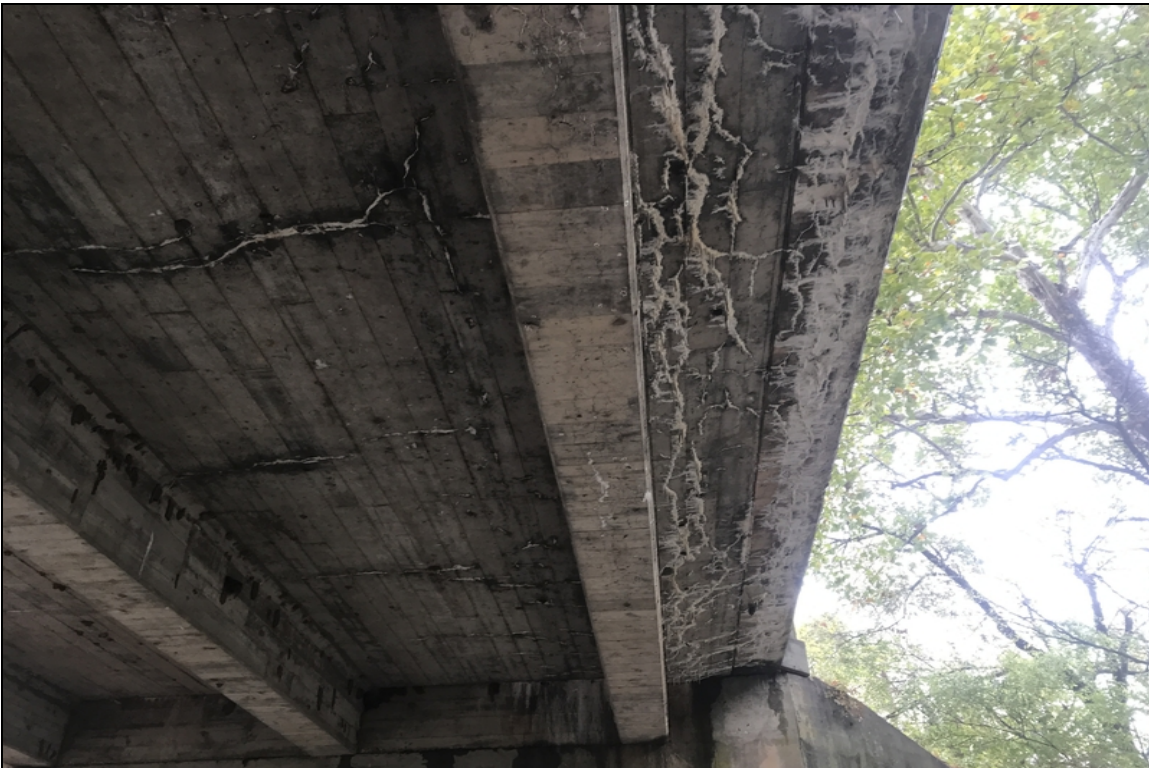
Left overhang and bay #1 cracking with efflorescence buildup.

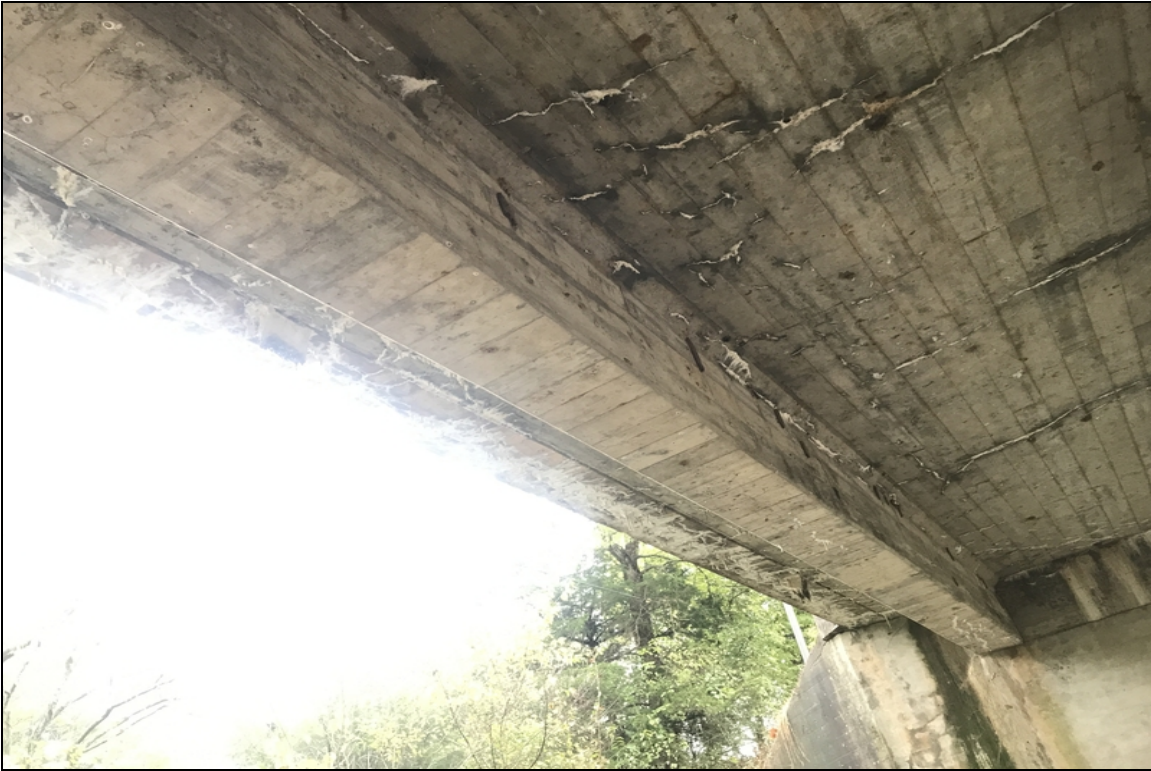
(110)							
-Girder # 1 has an area of map cracking visible in the bottom of girder located near abutment #2 and extending approximately 8' in length toward mid-span and a 3' long section of map cracking near mid-span, both of these areas have efflorescence buildup. The bottom surface has a 2' long section of map cracking adjacent to abutment #1 without efflorescence buildup. The top edge of the girder has longitudinal cracking with efflorescence buildup adjacent to the top flange of the deck.							
215	Reinforced Concrete Abutment	LF	130	80	20	30	0
1080	Delamination/Spall/Patched Area	LF	3	0	1	2	0
1120	Efflorescence/Rust Staining	LF	24	0	6	18	0
1130	Cracking (RC and Other)	LF	23	0	13	10	0

Girder #1 cracking with efflorescence buildup.

Girder # 1 has map cracking with efflorescence in the edges and base of girder.

Map cracking is most prominent adjacent to Bent # 2.

Date Reported: 10/02/2013
Priority: G - General/ Preventive maintenance
Type of Work: Repair
Status: Monitor
Component: 110 - Reinforced Concrete Open Girder/Beam

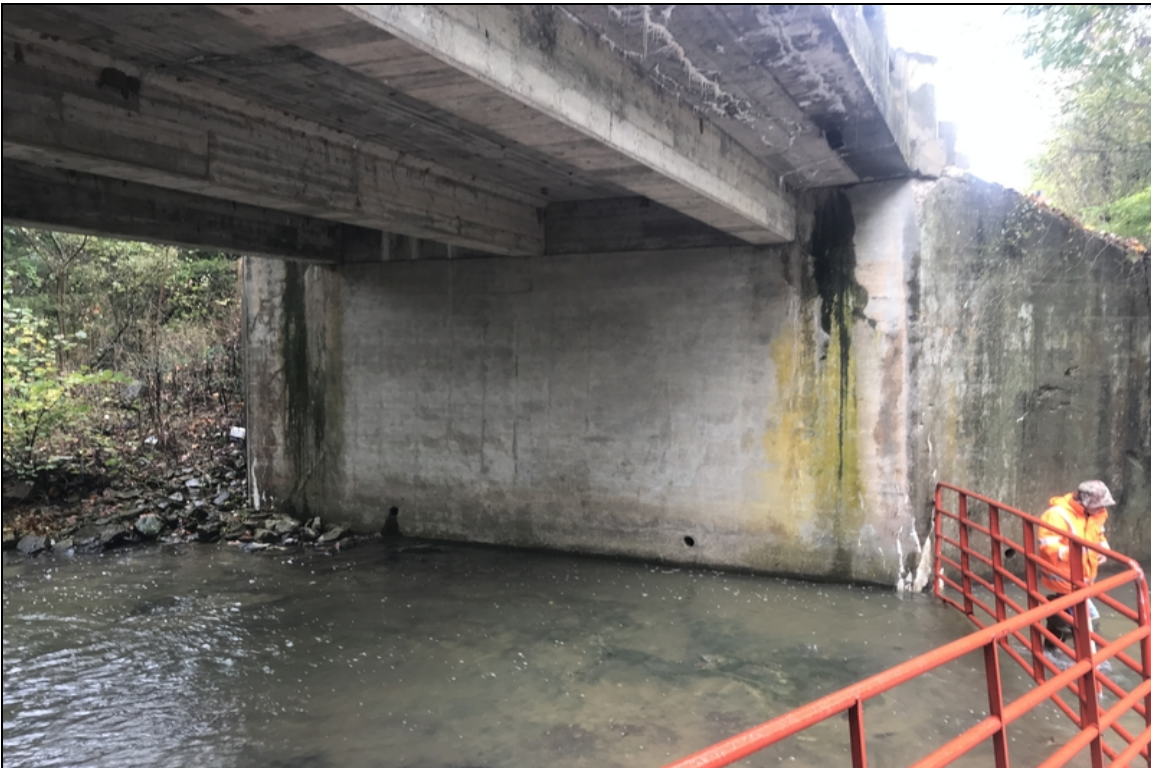
Abutment #2 typical.

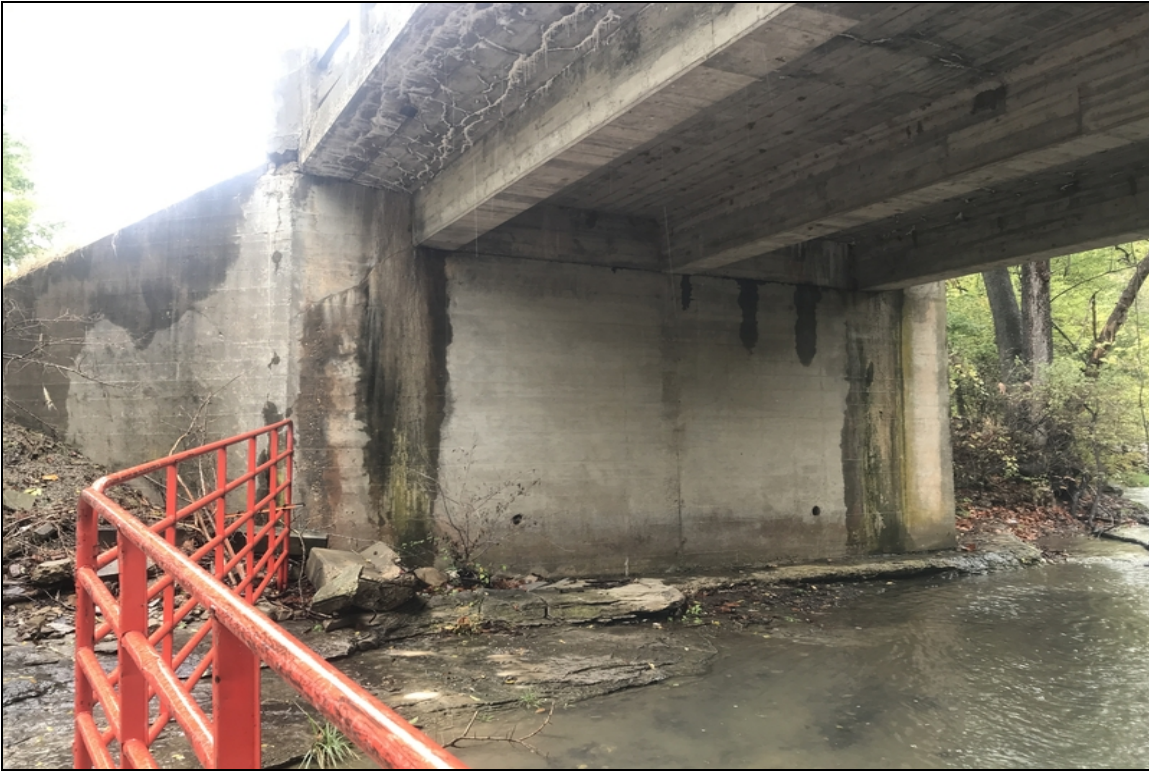
Abutment #1 typical.

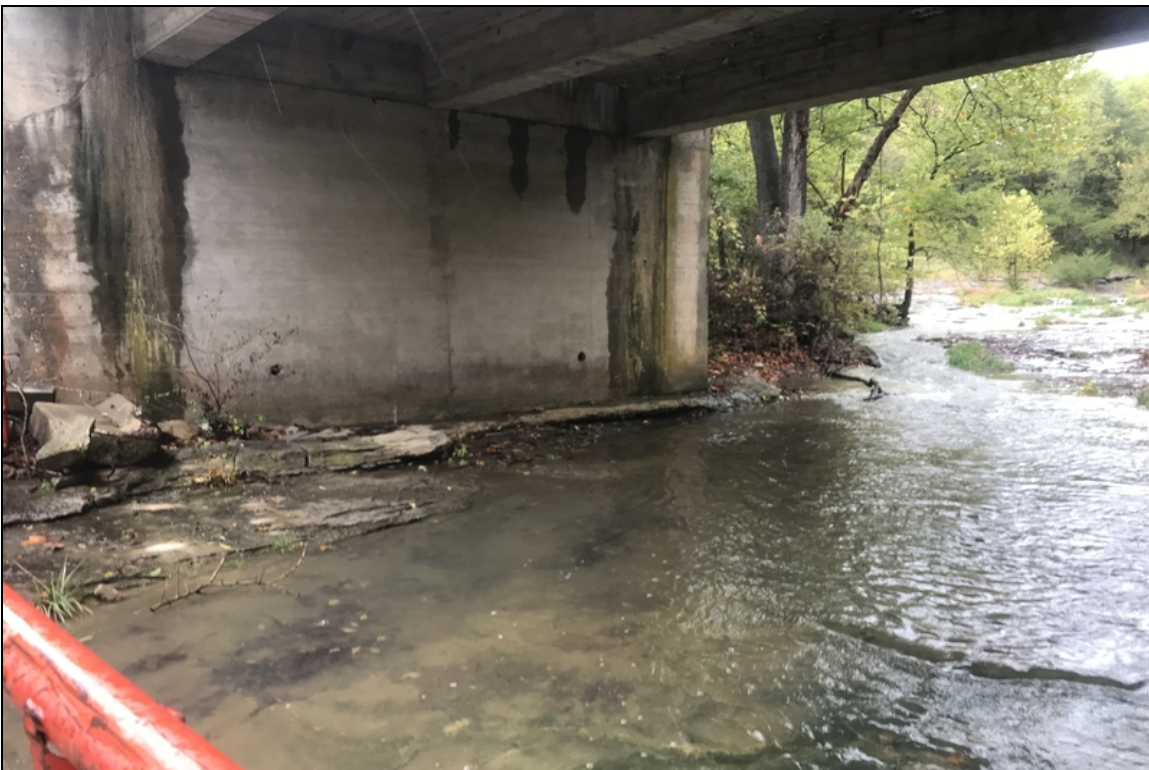
(220)							
-Abutment # 1 footing is partially exposed with minor concrete deterioration with no apparent undermining. -Abutment # 2 top of footing is partly exposed with no apparent undermining.

Abutment #1 Lt exposed footing.

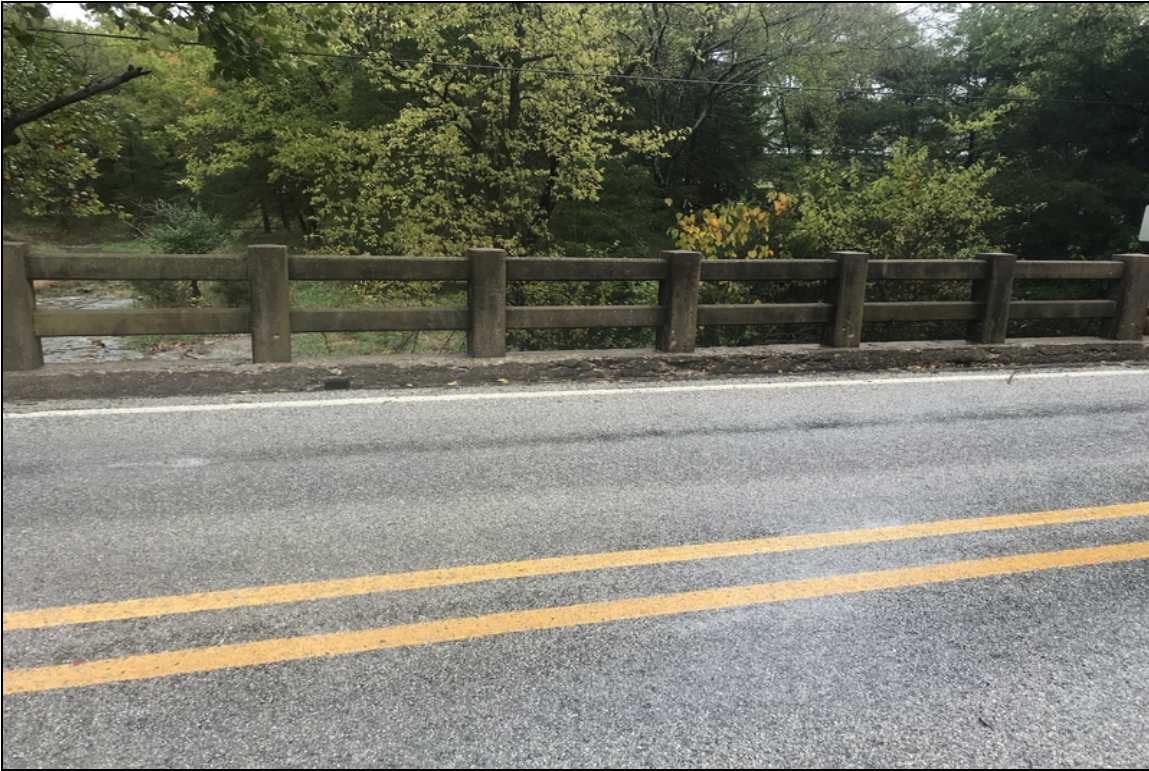
Left curb concrete deterioration.

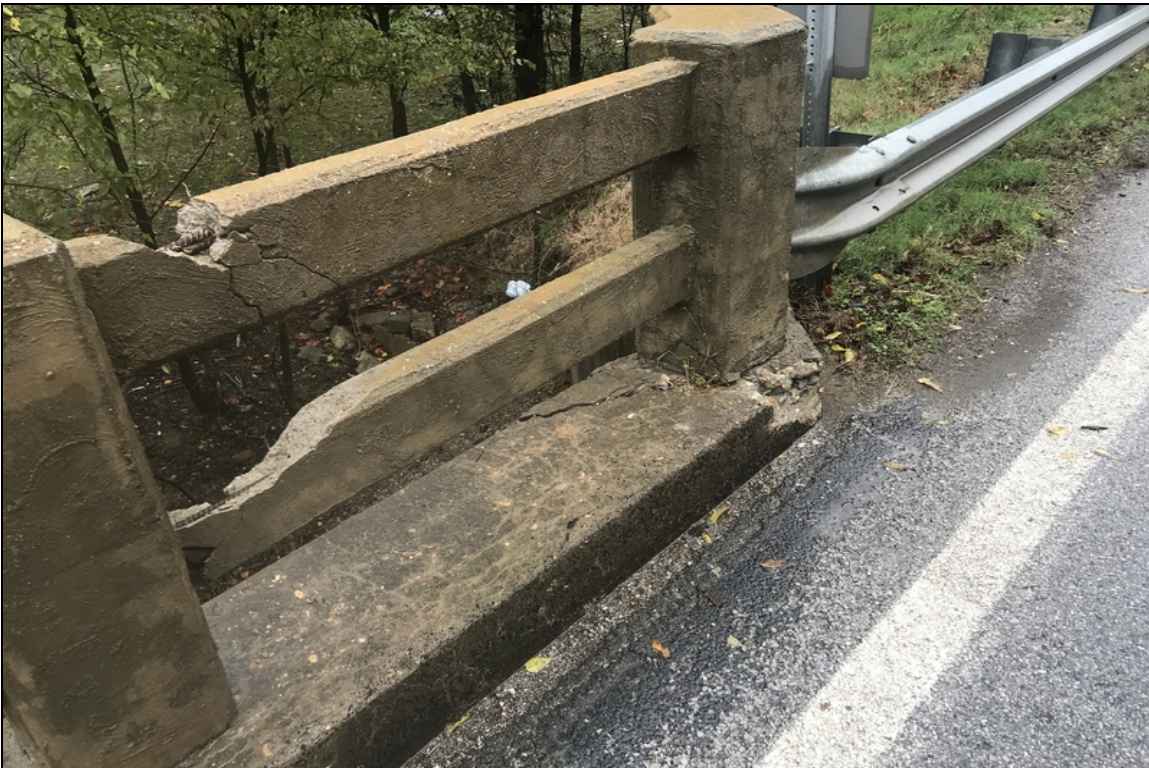
Abutment #1 Rt fractured end post.

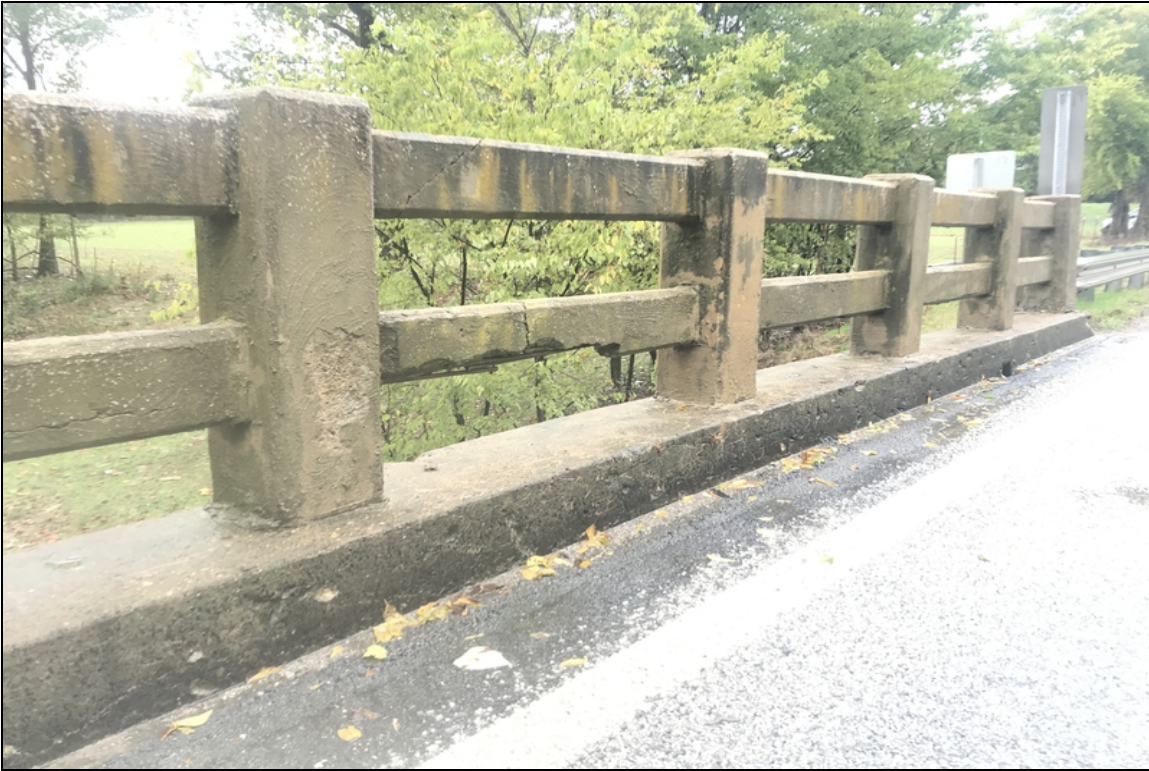
Right bridge rail with exposed reinforcing steel.

R.C. Bridge Railing-
Spalling with exposed reinforcing steel in the horizontal bridge railing.

Date Reported: 10/05/2015
Priority: D- Routine
Type of Work: Repair
Status: Monitor
Component: 331 - Reinforced Concrete Bridge Railing

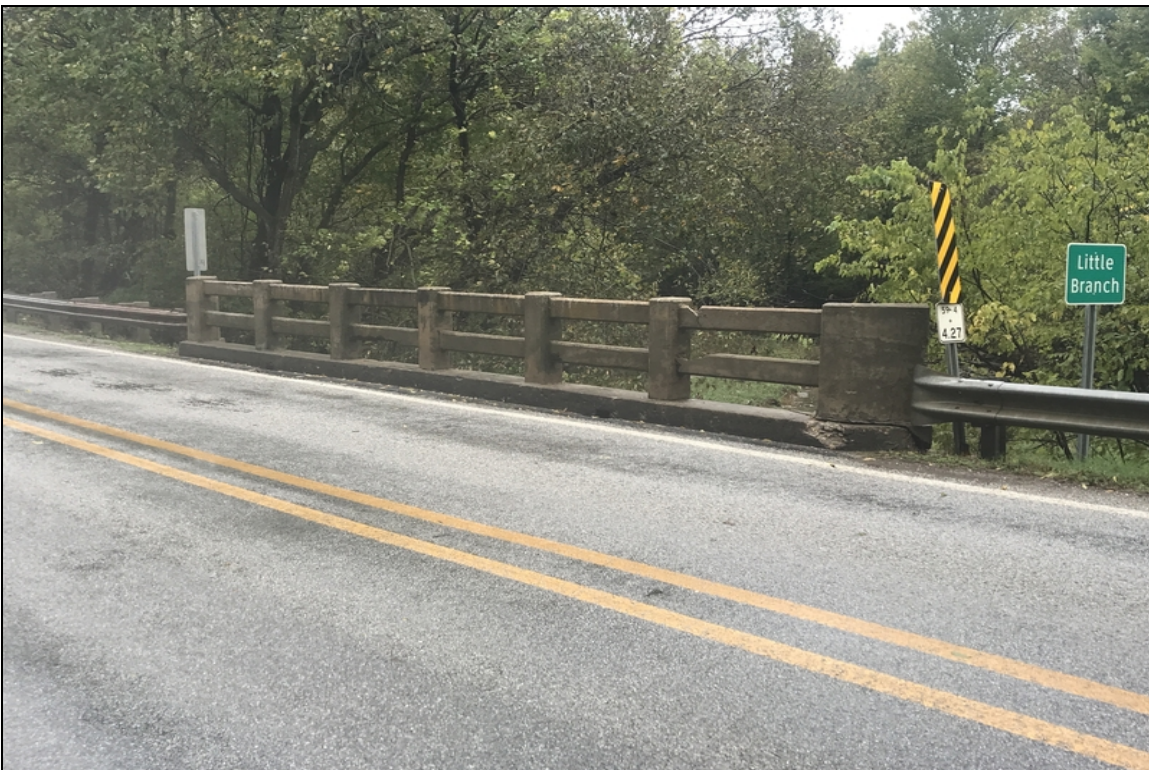
(331)							
-Concrete end post and railing on the right side of structure appears to have been replaced by maintenance forces in the past. -Numerous areas of horizontal map cracking typical in the horizontal concrete railing due to insufficient concrete coverage of reinforcing steel. -Northwest end post has visible cracks and spalls at the curb juncture but is still in place during this inspection. -There are spalled areas on the horizontal bridge rails that have exposed reinforcing steel with no apparent section loss. -The curbs have soft deteriorated concrete with section loss in areas. -The left curb has horizontal cracking with spalling.

Right bridge rail cracking and spalling with exposed reinforcing steel.

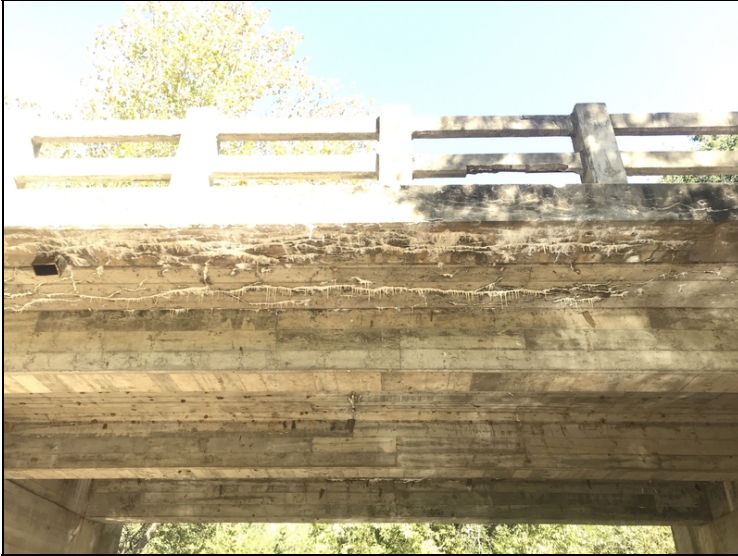
The undersurface of the overhangs have map cracking with efflorescence and leaching with soft deteriorated concrete. The curbs have soft deteriorated concrete. There are diagonal cracks with efflorescence in the corners of the deck that are visible from the undersurface of the deck. There are transverse cracks with efflorescence at variable spacing that are visible from the undersurface of the deck.

Right overhang.

Date Reported: 10/02/2013
Priority: D- Routine
Type of Work: Repair
Status: Open
Component: 16 - Reinforced Concrete Top Flange

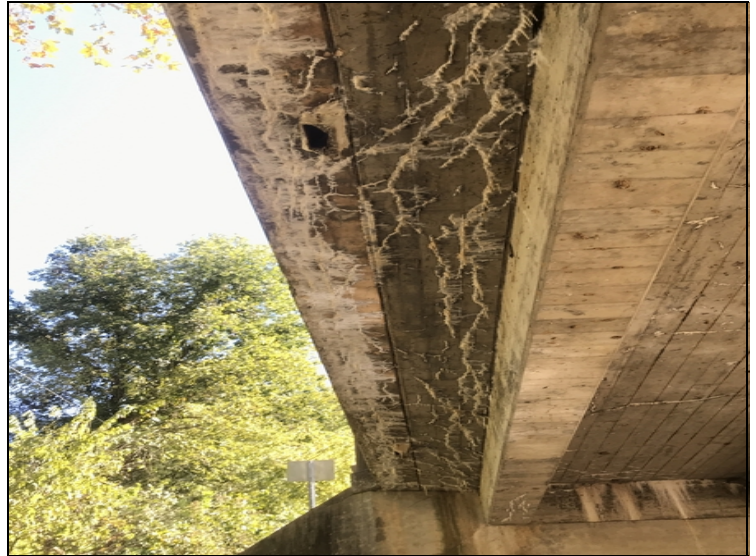
Deck soffit. Left overhang.

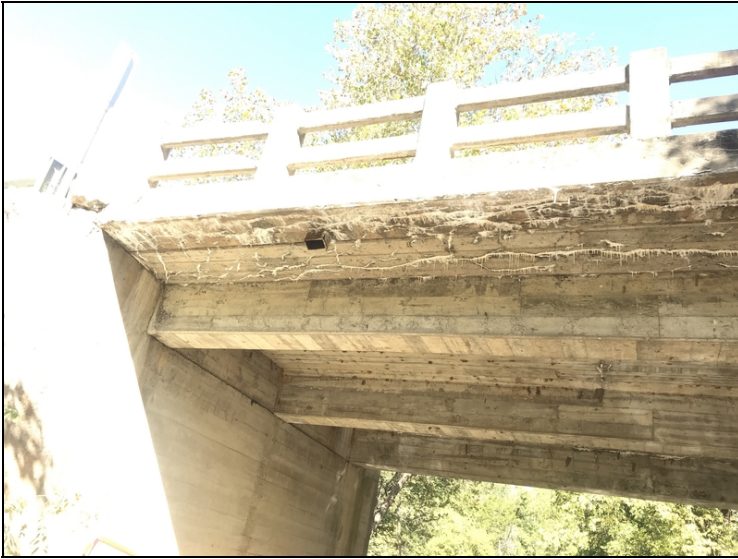
Right overhang.

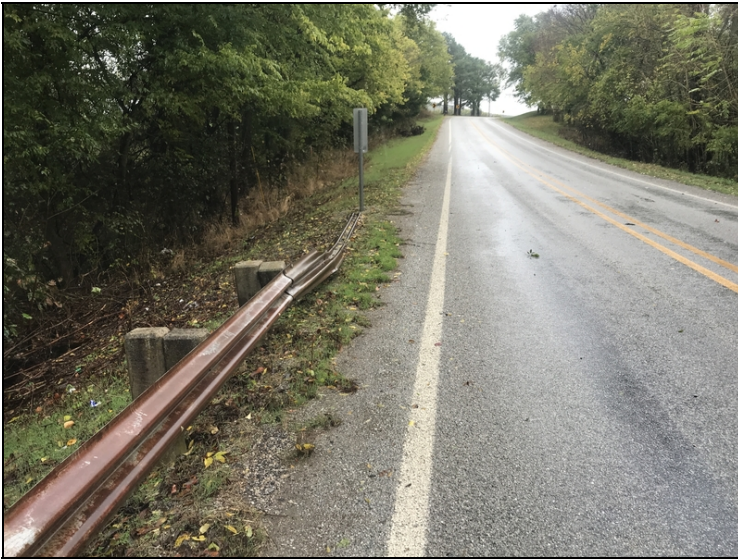
The east approach guardrail has collision damage. The west approach guardrail has minor collision damage.

Abutment #2 Lt approach guardrail damage.

Date Reported: 10/28/2021
Priority: C - Important
Type of Work: Replace
Status: Open
Component: Approach

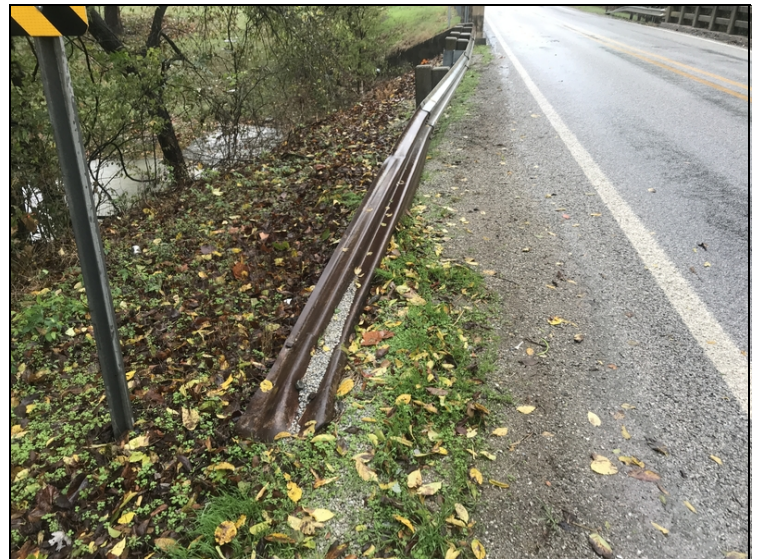
Southwest approach guardrail with minor collision damage.
