Asset #01672(Routine, NSTM)

SH 59-Wash Co. over Baron Fork Creek

Location: 0.05 Mi. S Jct Hwy 45

Team Lead: Eric West, Inspection Date: 06/23/2022

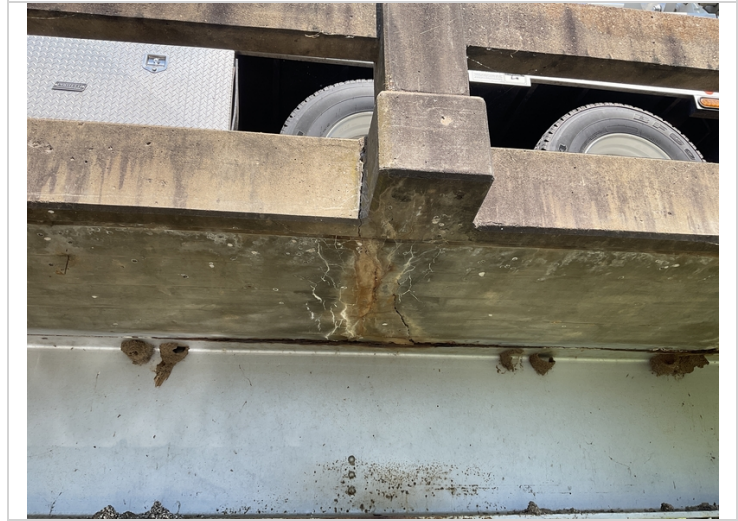
Span #1 Lt transverse cracking under the wheel path over girder #1.

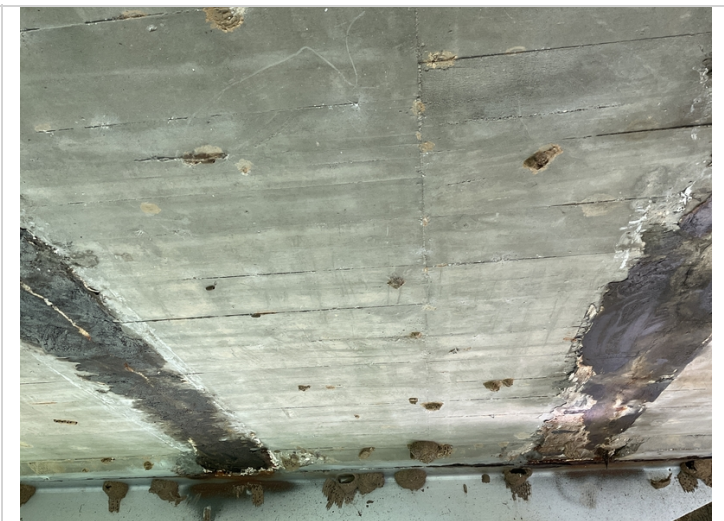
Span #1 transverse cracking repair.

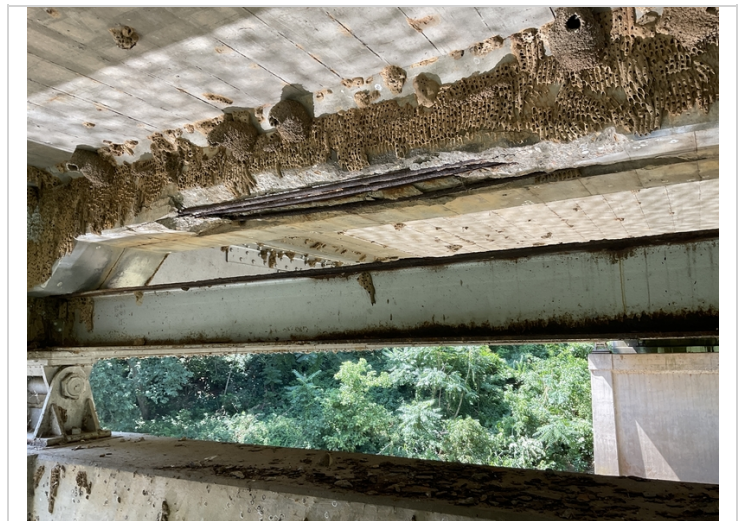
Bent #2 deck haunch spalling with exposed reinforcing steel.

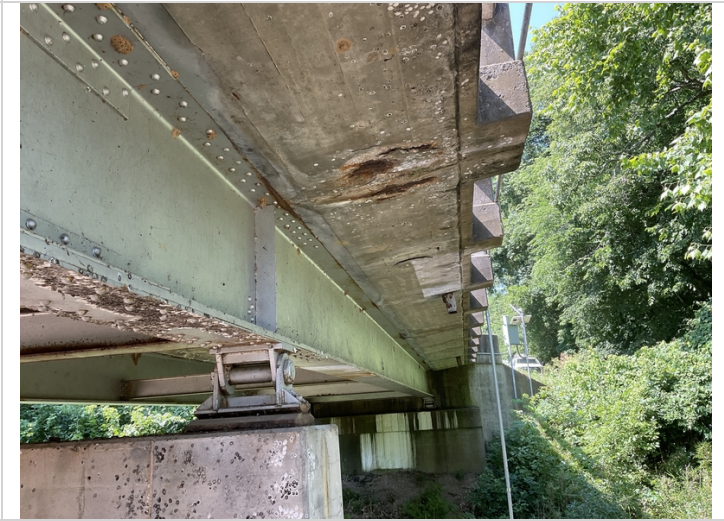
Span #2 & 3 Rt overhang spalling with exposed reinforcing steel.

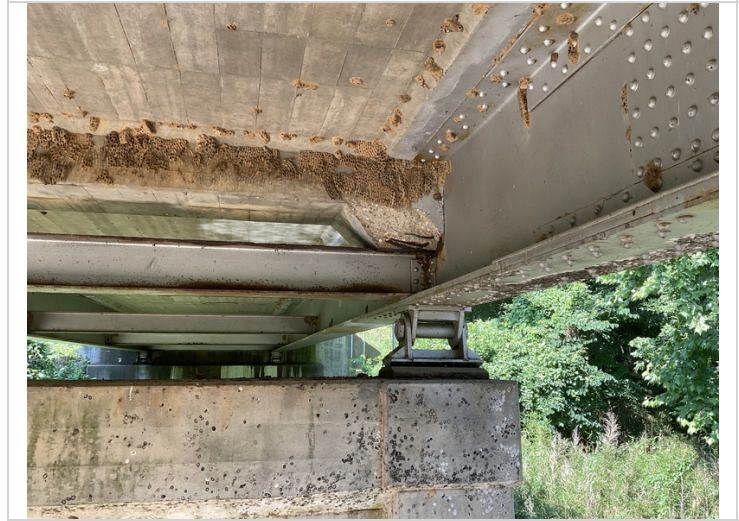
Bent #3 backface spalling with exposed reinforcing steel in the deck haunch.

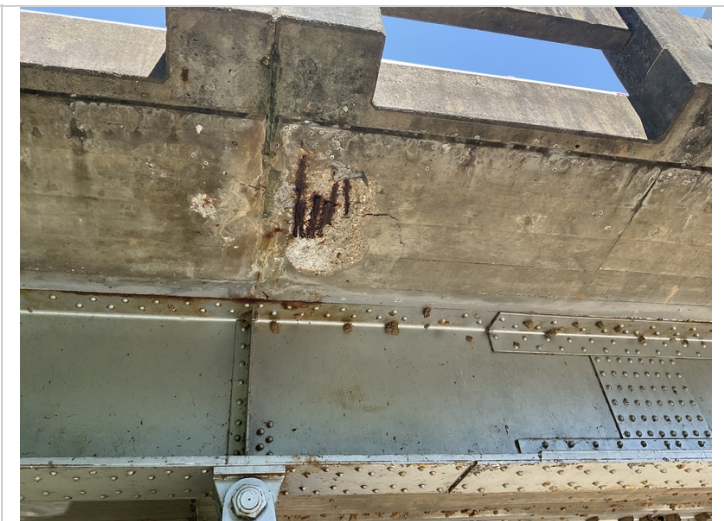
Span #2 Lt spalling with exposed reinforcing steel.

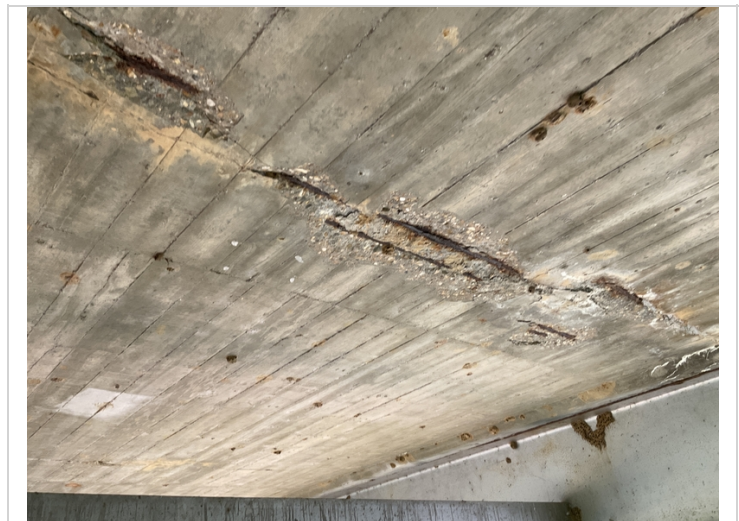
Span #3 undersurface spalling with exposed reinforcing steel.

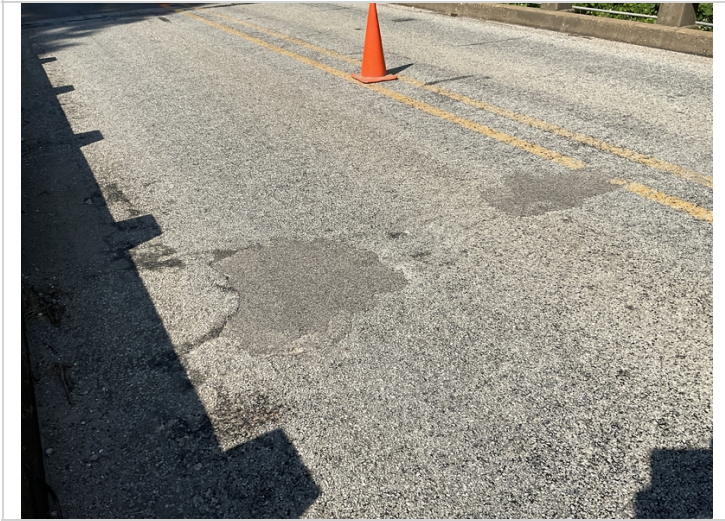
Temporary asphalt patches on the driving surface.

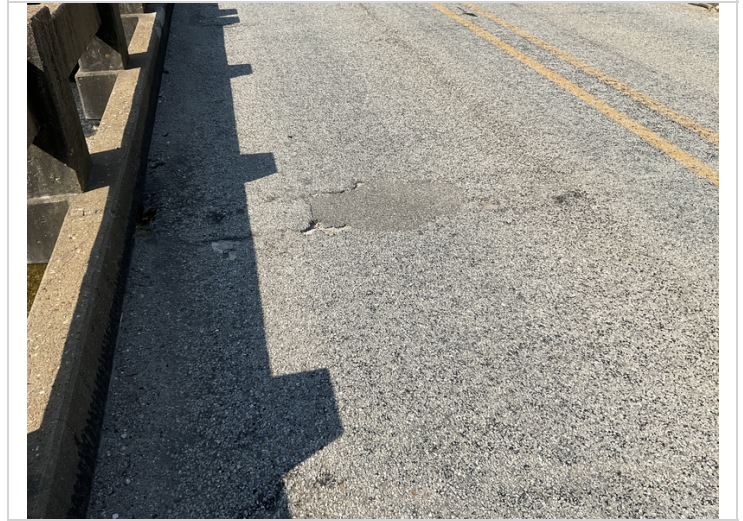
Span #1 temporary asphalt repair.

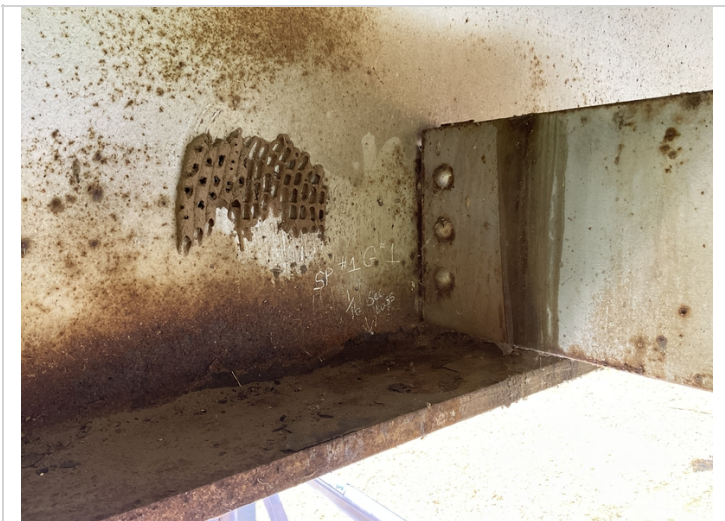
Span #1 girder #1 interior diaphragm connection with 1/16" section loss to the base of the web.

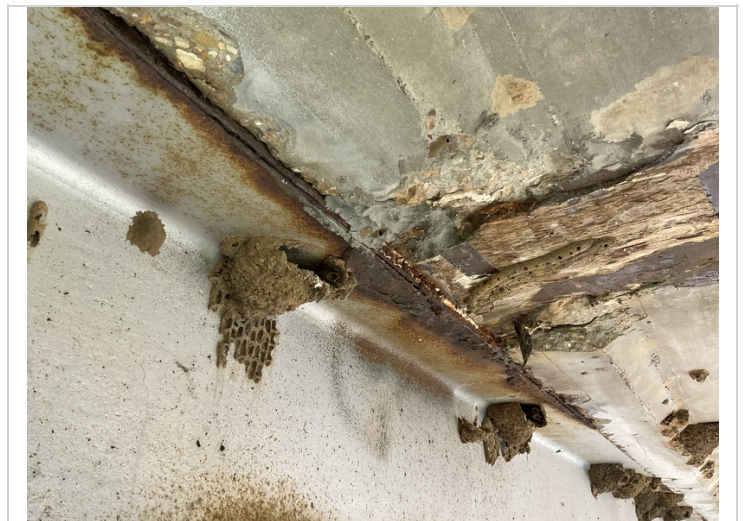
Span #1 Lt top flange active corrosion with pack rust and section loss.

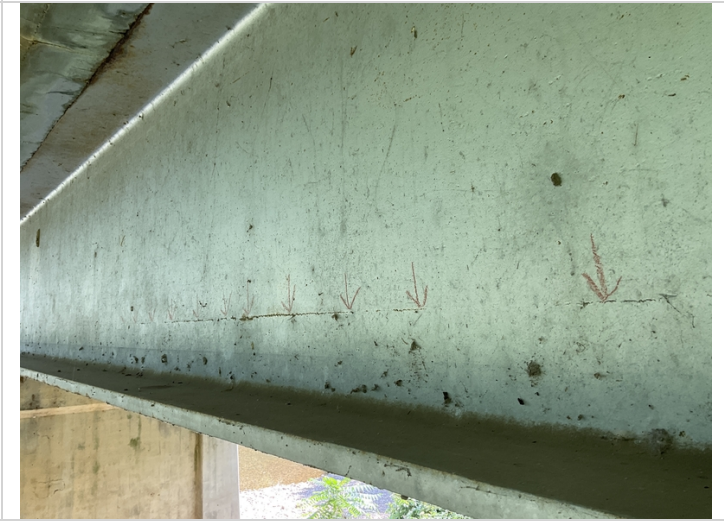
Span 3 girder 2 imperfection.

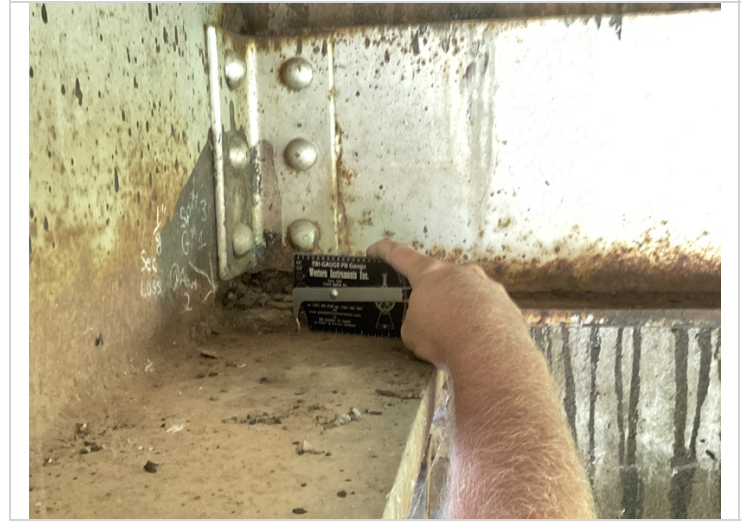
Span 3 girder 1 at abutment 2-Section loss to bottom flange

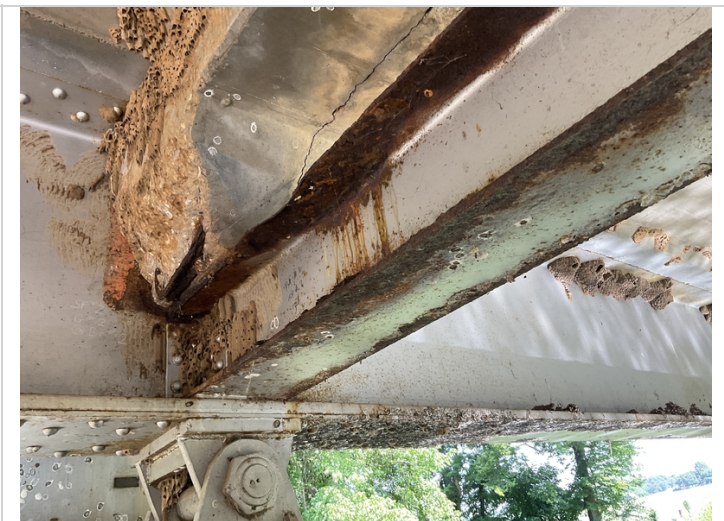
Bent #2 Rt diaphragm holes in the flange.

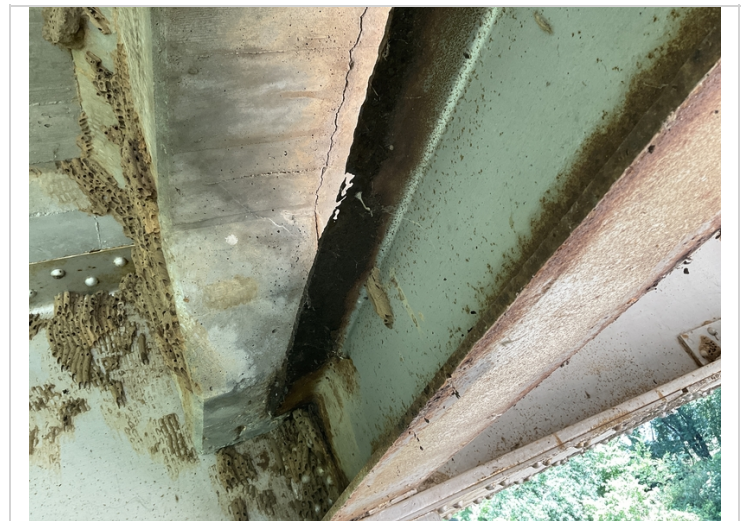
Bent #3 Rt diaphragm with active corrosion and 100% section loss along the top flange.

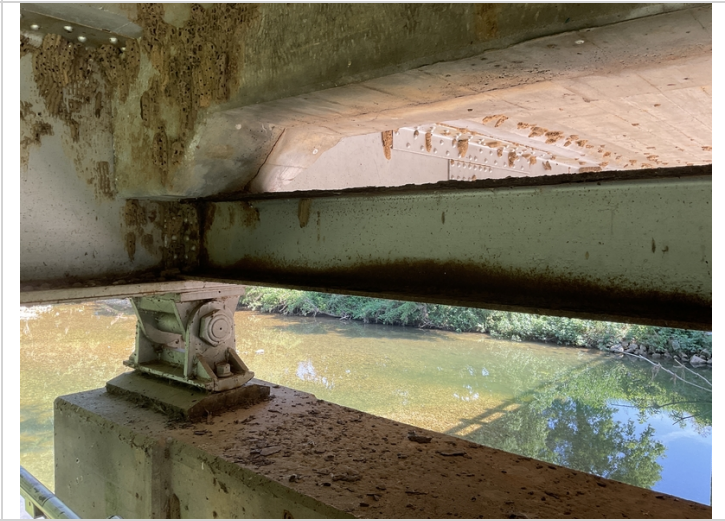
Bent #3 Rt diaphragm with active corrosion and section loss.

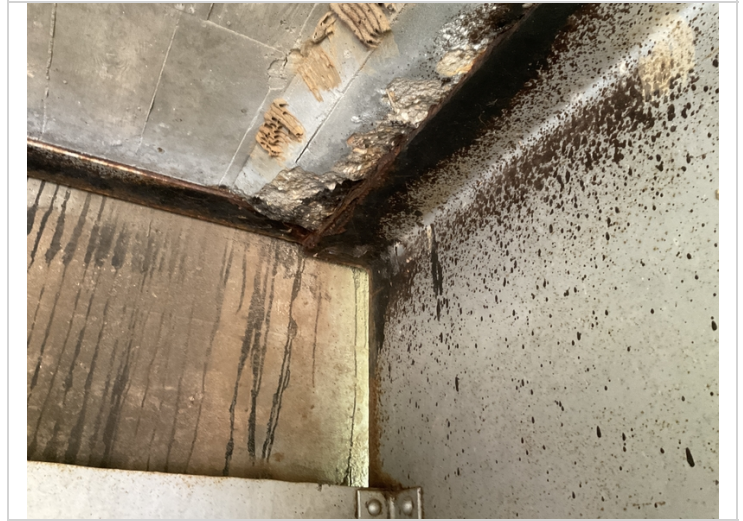
Span #3 Girder #2 @ Abutment #2 active corrosion with pack rust along the top flange.

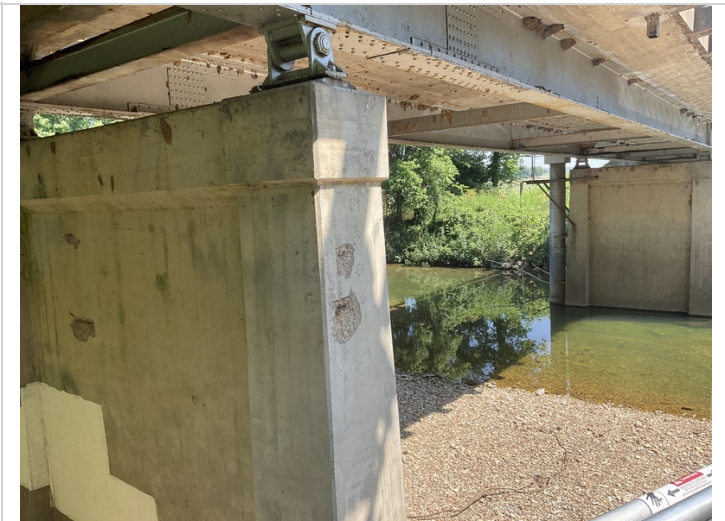
Bent #3 Lt spalling with exposed reinforcing steel.

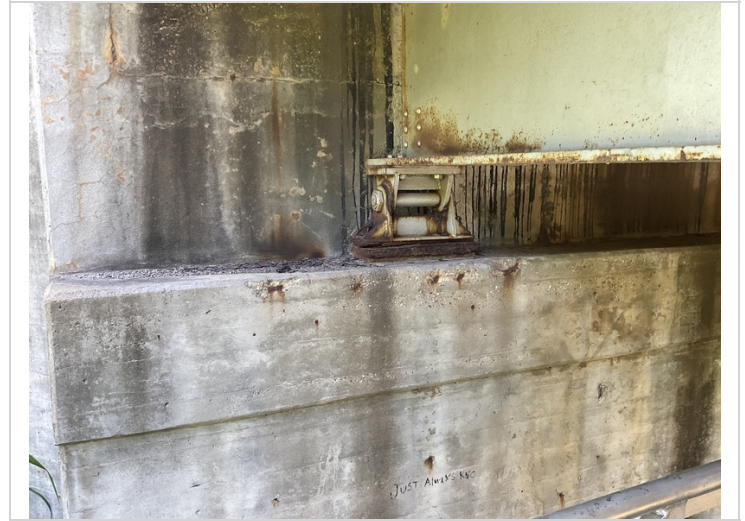
Abutment #1 Rt spalling with exposed reinforcing steel.

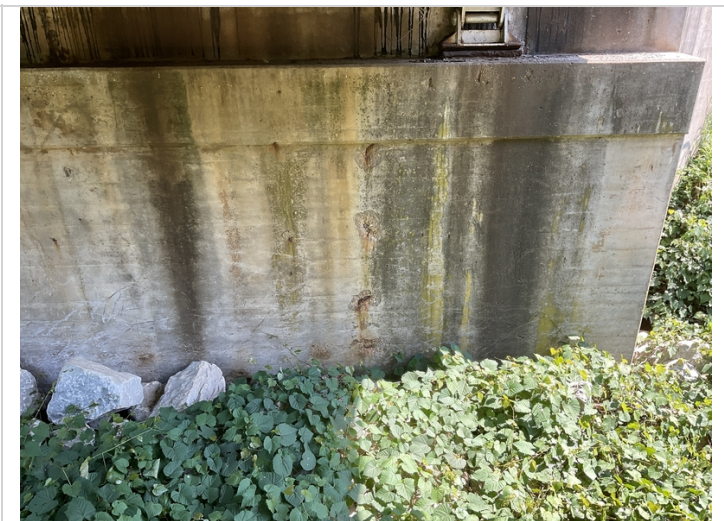
Abutment #1 Lt spalling with exposed reinforcing steel.

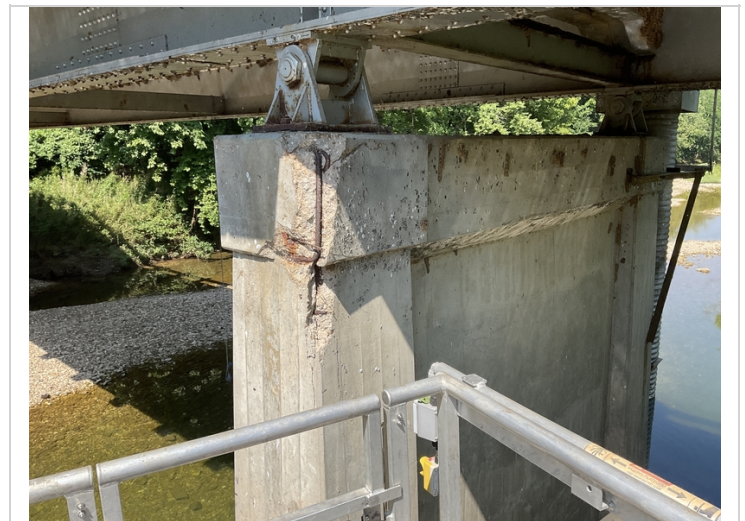
Bent #2 Lt spalling with exposed reinforcing steel.

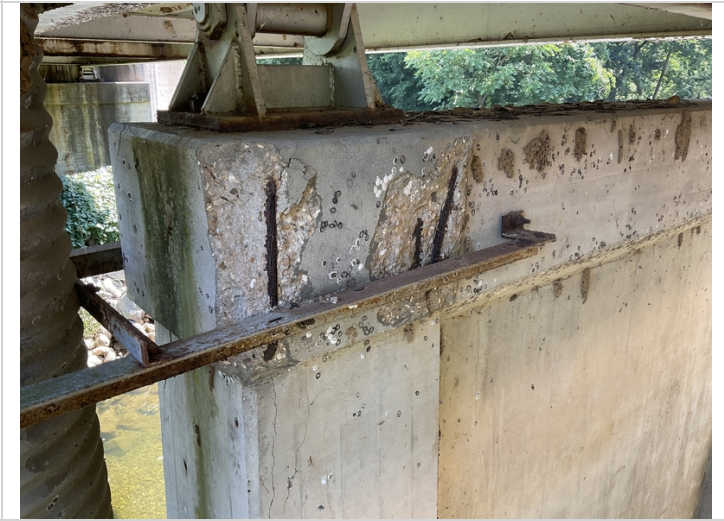
Bent #2 Rt aheadface spalling with exposed reinforcing steel.

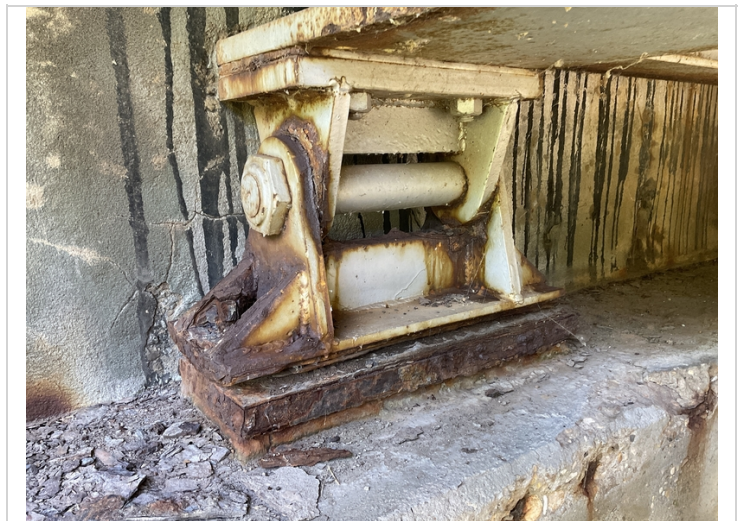
Abutment #1 Rt bearing active corrosion with pack rust.

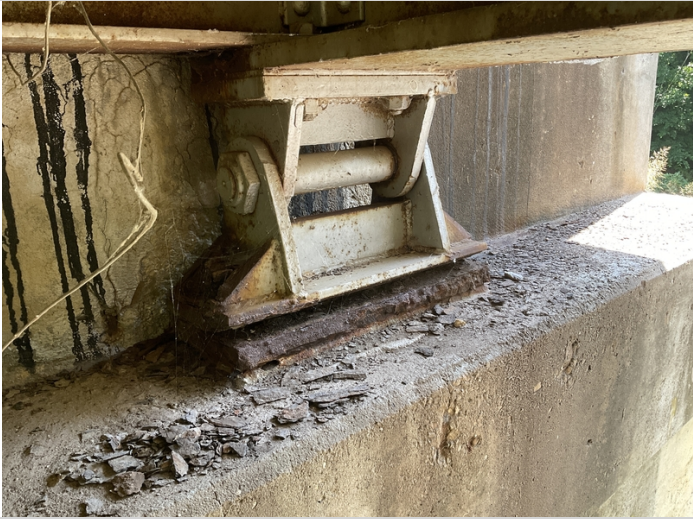
Abutment #1 Lt bearing active corrosion with pack rust.

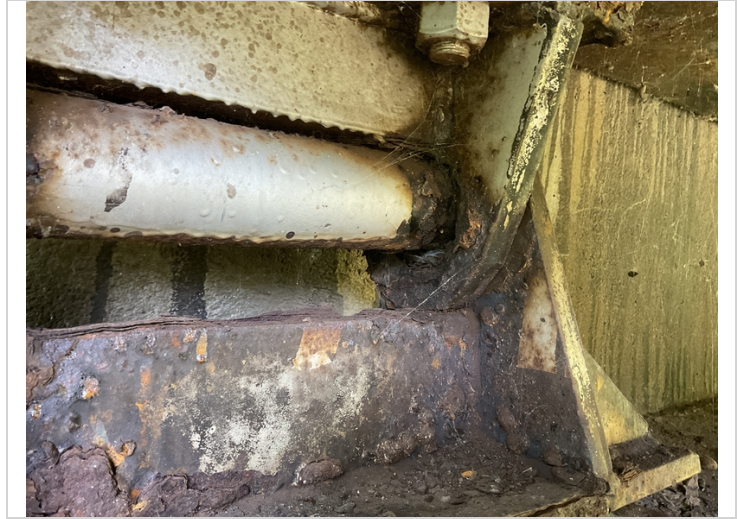
Abutment #2 bearing #1 active corrosion with pack rust and significant section loss to the bearing and pin.

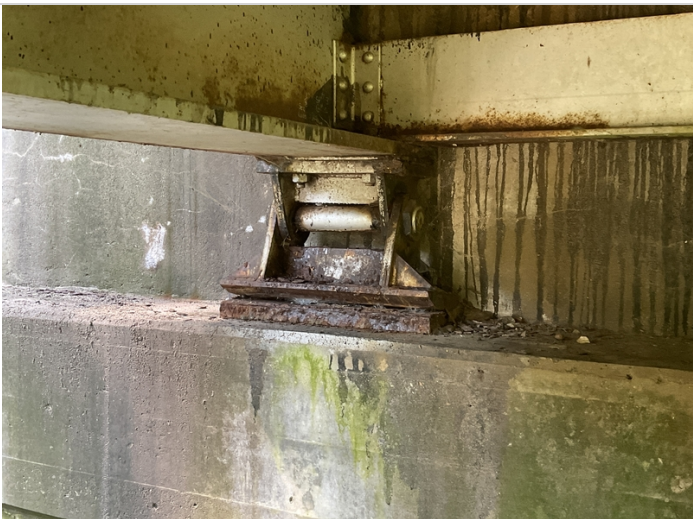
Abutment #2 bearing #1 active corrosion with pack rust.

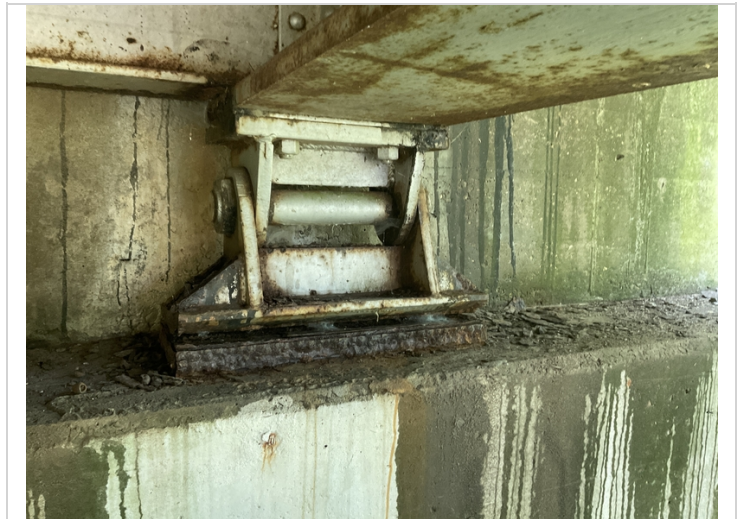
Abutment #2 bearing #2 active corrosion with pack rust.

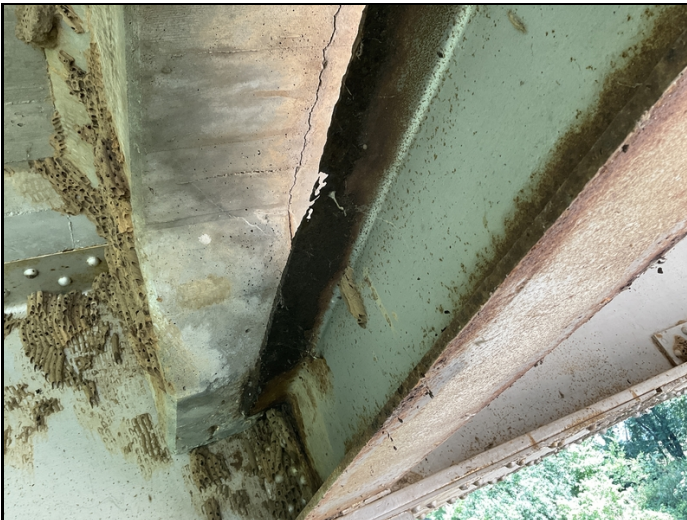
-The diaphragm over Bent #3 Rt has active corrosion and areas of 100% section loss along the top flange.

Bent #3 Rt diaphragm with active corrosion and 100% section loss along the top flange.

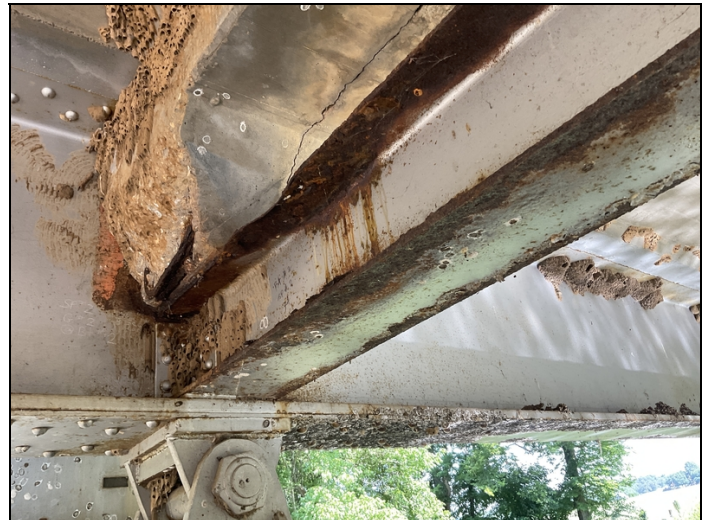
-The diaphragm over bent # 2 adjacent to girder # 2 has knife edge section loss with two dime sized holes rusted through and out of plane bending to top flange.

Bent #2 Rt diaphragm holes in the flange.

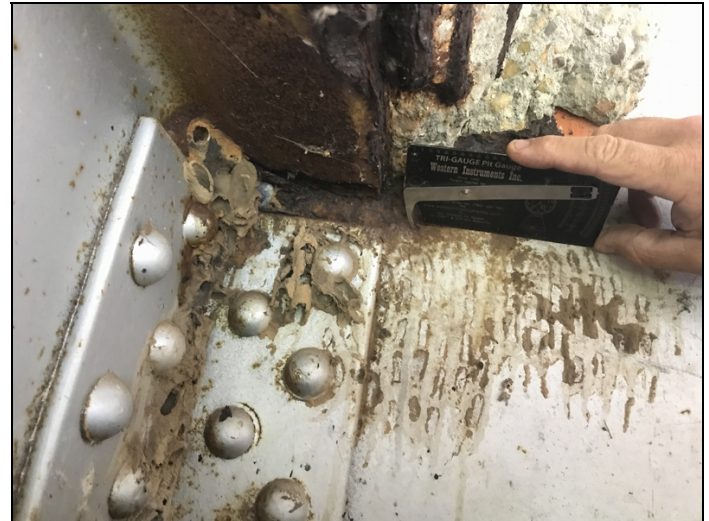
The web of girder # 1 over bent # 3 has up to 5/16" section loss adjacent to the expansion dam.

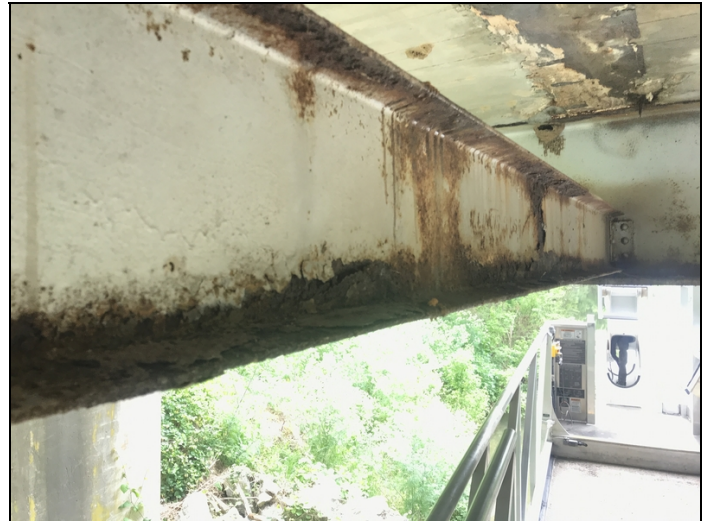
Span 1, diaphragm # 2-Corrosion with section loss.

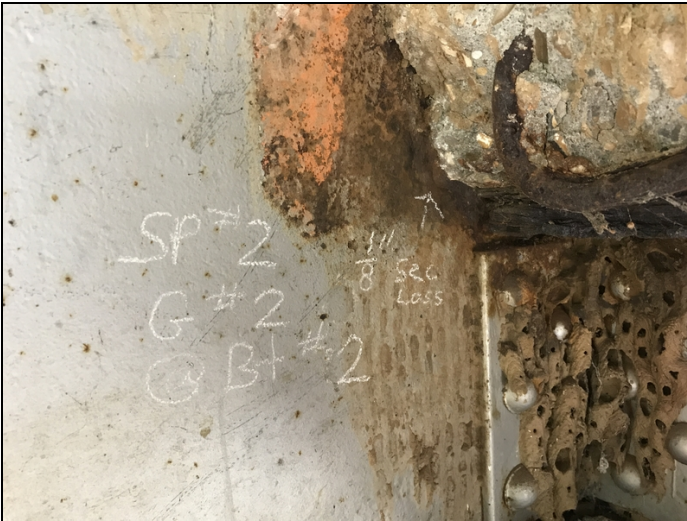
Span 2, girder 2 at bent # 2 has 1/8" section loss to interior side of web at deck haunch juncture.

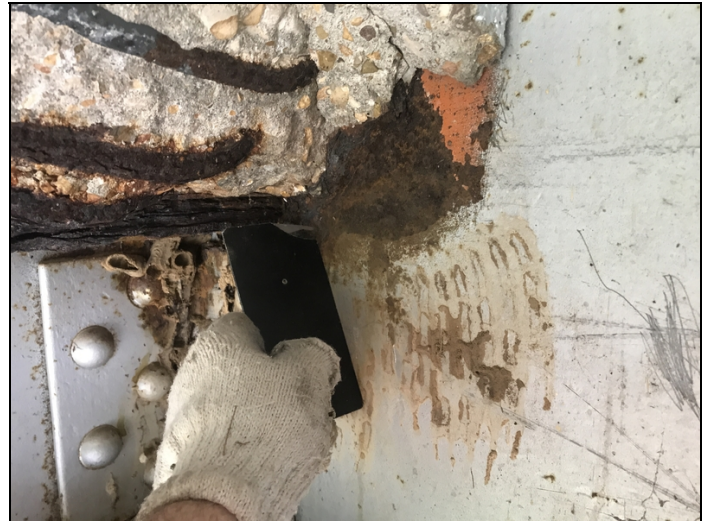
-Span # 2, girder # 2 over bent # 3 has corrosion with up to 5/16" section loss to interior side of web at expansion dam juncture.

Span # 2, girder # 2 over bent # 3 has corrosion with up to 5/16" section loss to interior side of web at expansion dam juncture.

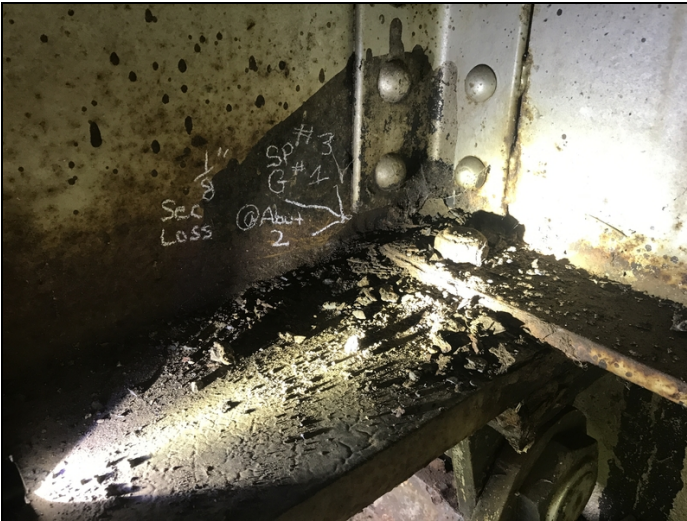
Span # 3, girder # 1 has corrosion to the interior side of web at the diaphragm connection with up to 1/8" section loss. Photo 2.

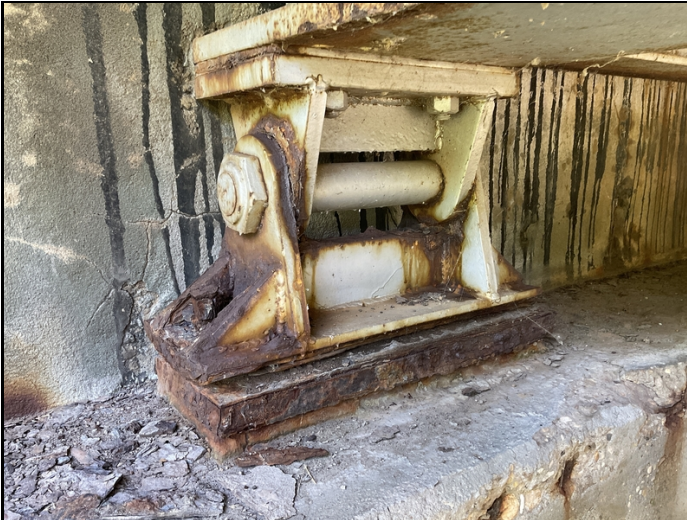
Abutment #1 Rt bearing active corrosion with pack rust.

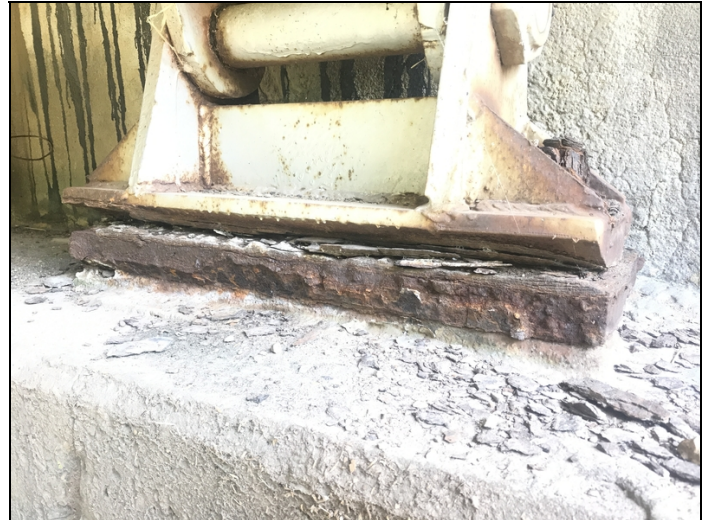
The expansion bearings have active corrosion, layers of rust, and section loss between the masonry plates and the rockers.

The fixed bearings have active corrosion forming on the base of the bearings.

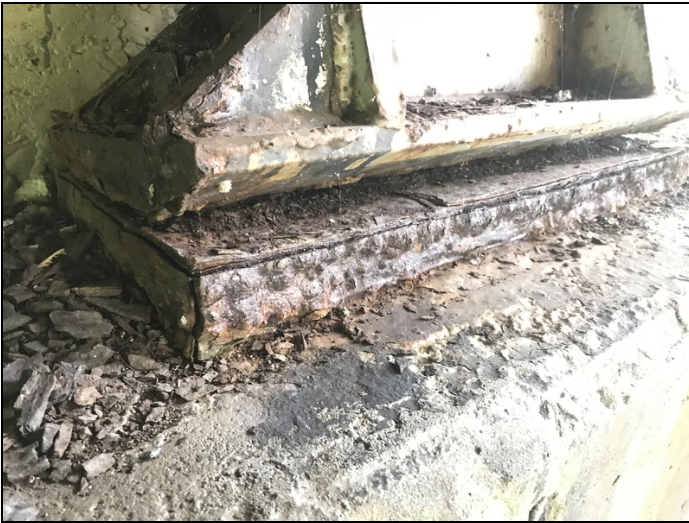
The expansion bearings have active corrosion, layers of rust, and section loss between the masonry plates and the rockers.

The fixed bearings have active corrosion forming on the base of the bearings.

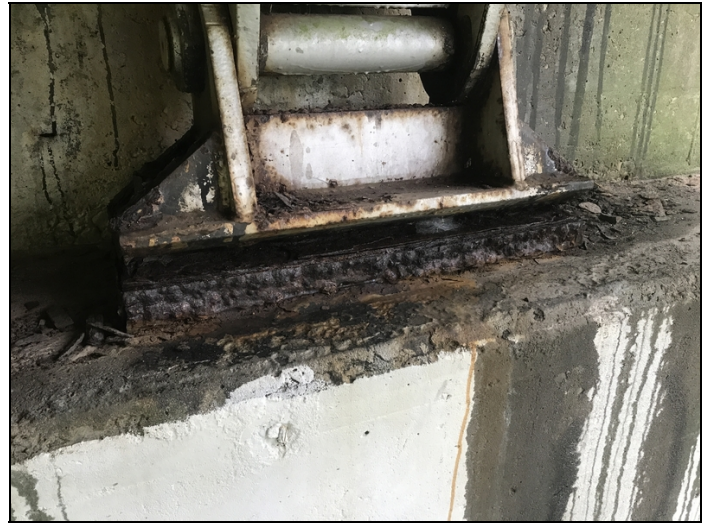
Abutment # 2-Corrosion to bearings.

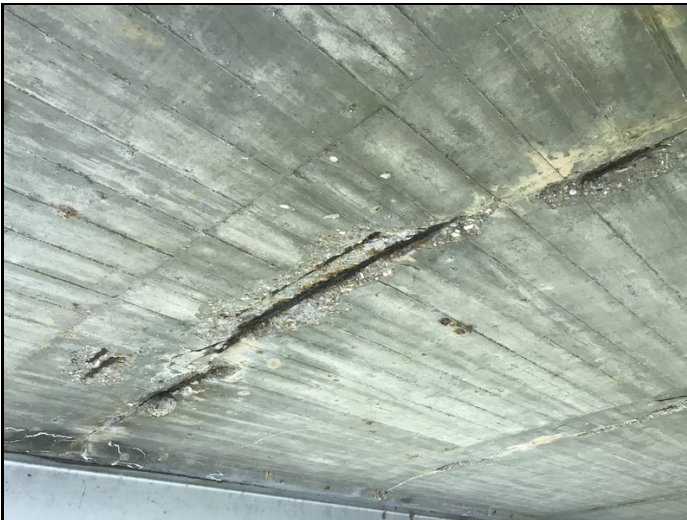
The deck has sealable full depth transverse cracking with areas of spalling with exposed reinforcing steel in the undersurface. The deck haunch / expansion dam over Bent # 2 has spalls with exposed reinforcing steel that are visible from the undersurface of the deck.

Span 3 undersurface-Spalling with exposed reinforcing steel.

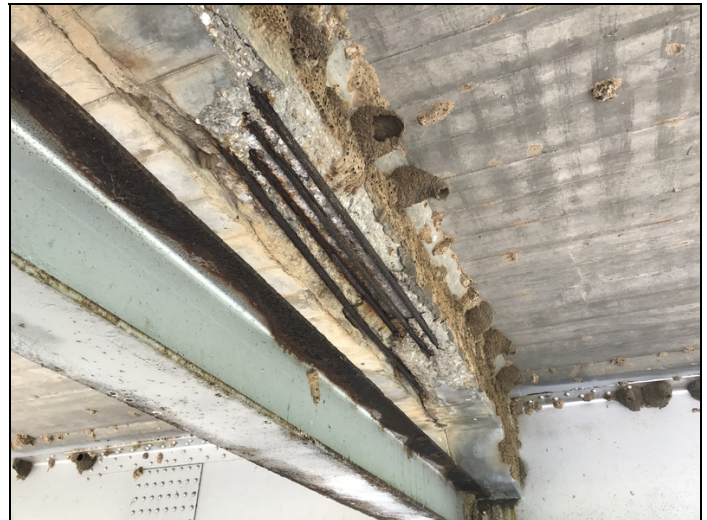
Expansion dam over bent 2-Spalling with exposed reinforcing steel.

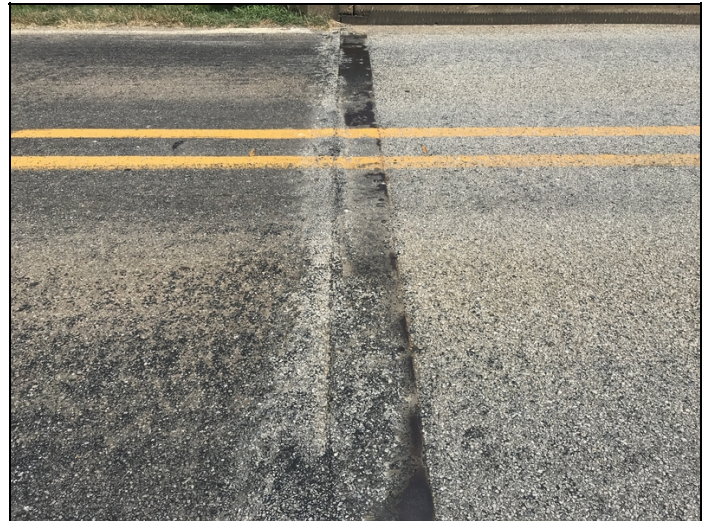
The expansion joint assemblies at the North and South bridge ends appear to be loose in locations. The assemblies are noisy when impacted by traffic.

Abutment 1 sliding plate assembly.

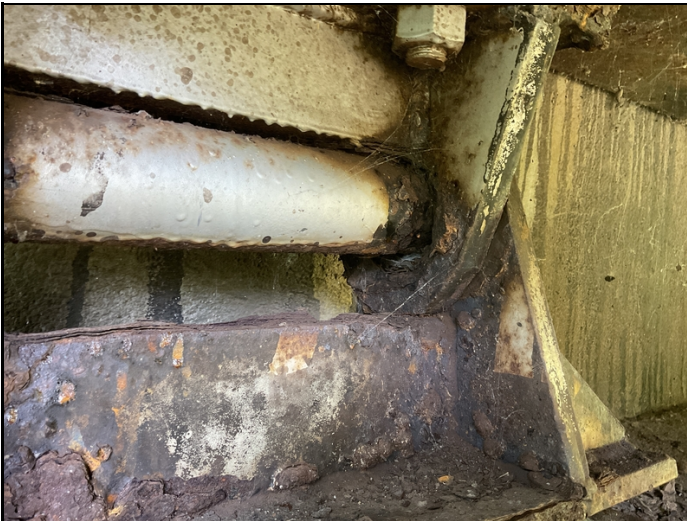
The rocker bearing pins at connections at abutment # 2 have corrosion with significant section loss. The pin at bearing # 1 is the most extreme with up to approximately 1/4" section loss.

Abutment #2 bearing #1 active corrosion with pack rust and significant section loss to the bearing and pin.

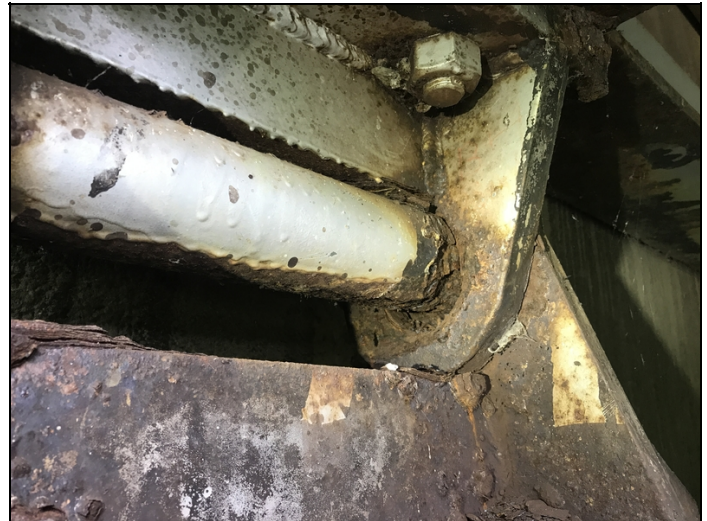
The rocker bearing pins at connections at abutment # 2 have corrosion with significant section loss. The pin at bearing # 1 is the most extreme with up to approximately 1/4" section loss.

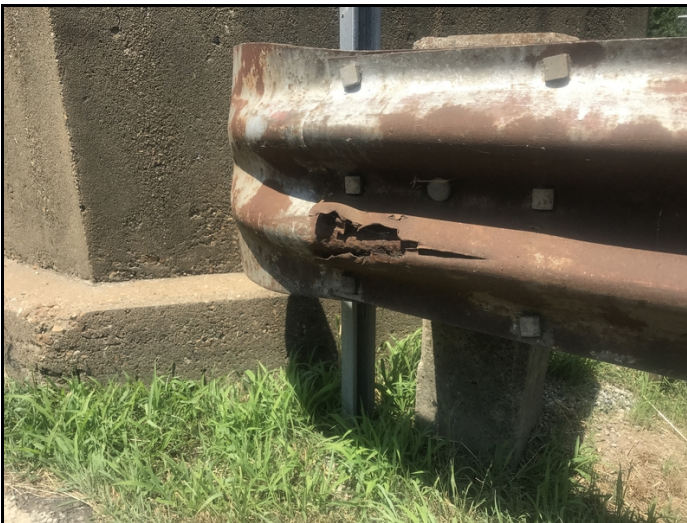
The Northwest approach railing has collision damage that has created sharp jagged edges in the railing near the bridge end.

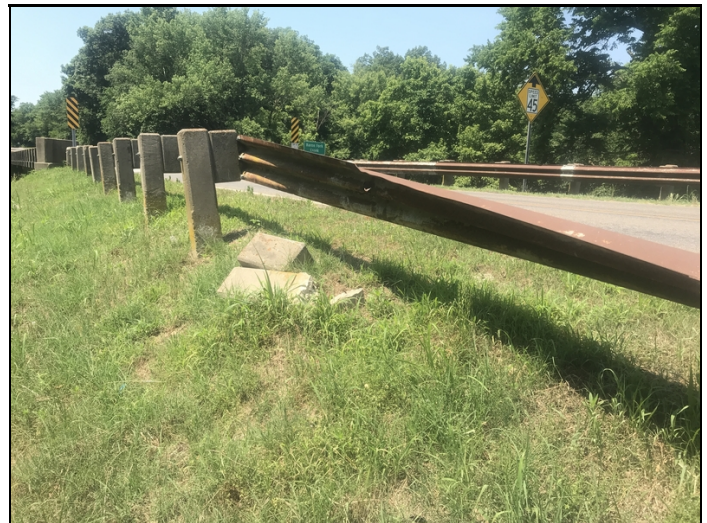
The Northeast approach railing has collision damage that has broken the post that supports the turndown portion of the railing.

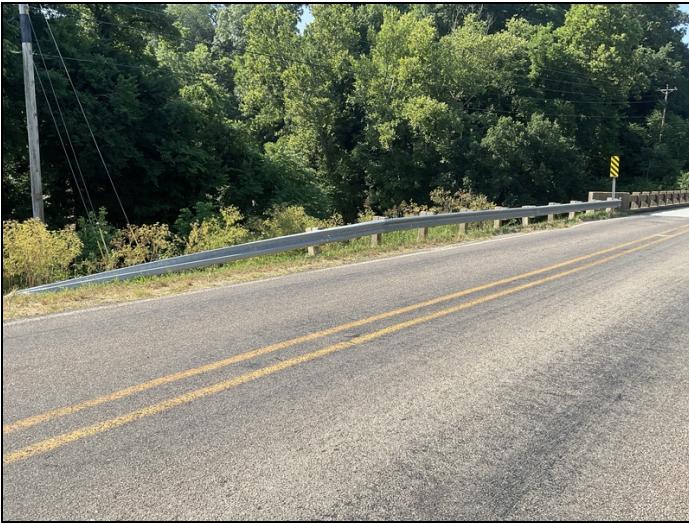
Northeast approach guardrail has been replaced.

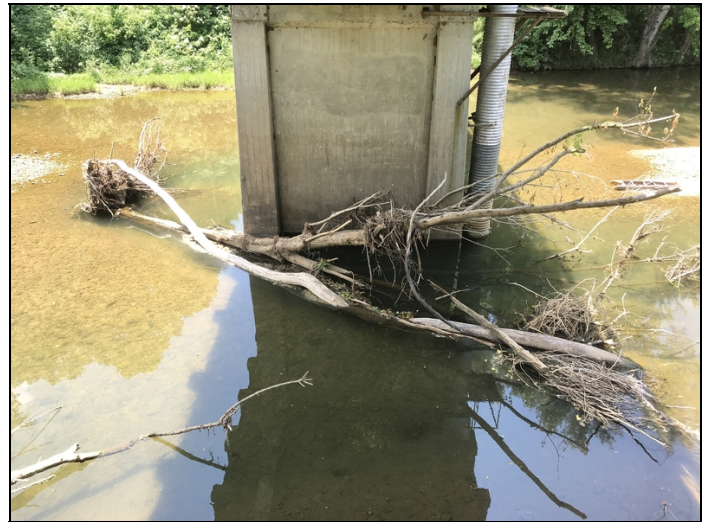
The channel has drift accumulation at bents # 2 and # 3.

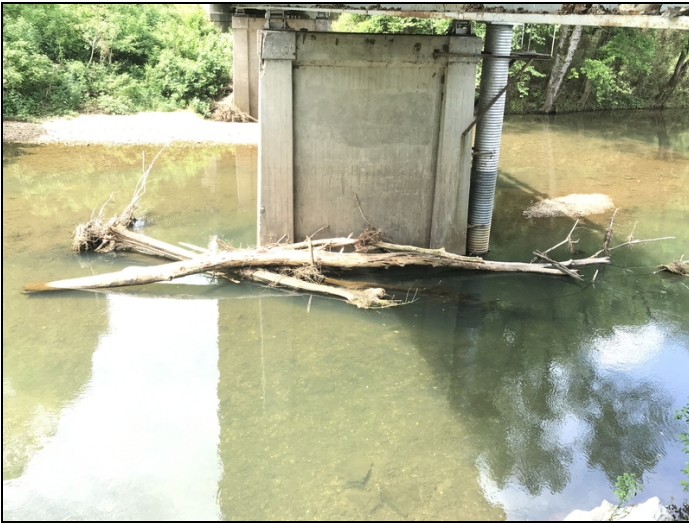
Drift accumulation at bent # 2.

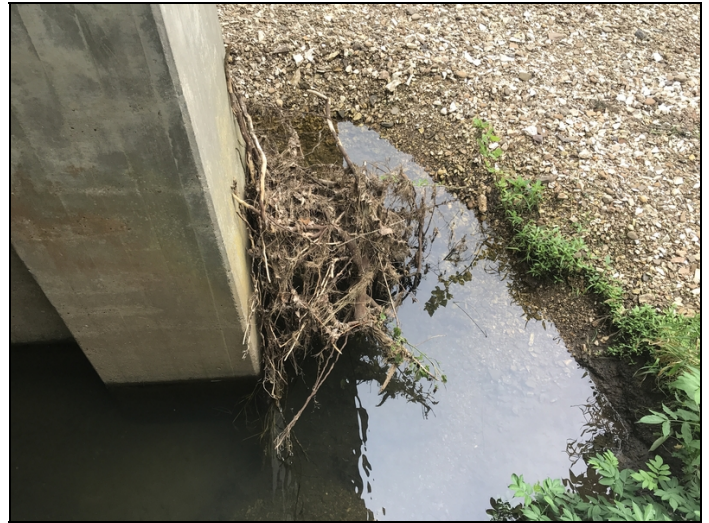
Drift accumulation at bent # 3.

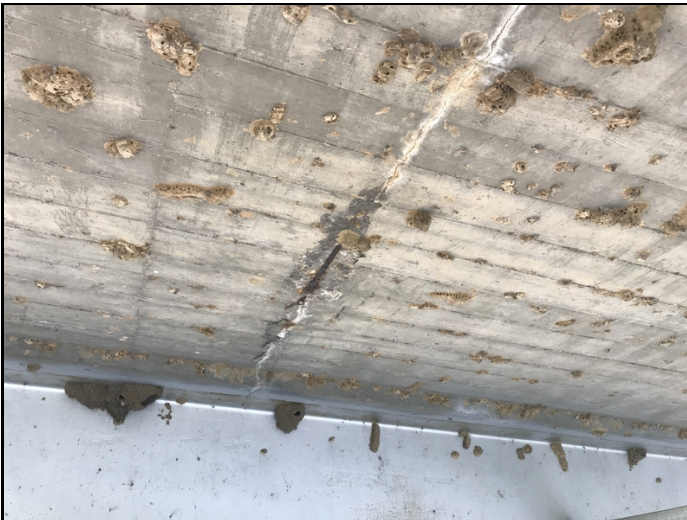
The undersurface of the deck has spalling with exposed reinforcing steel between the girders and in the deck overhangs.

Span 2-Spalling with exposed reinforcing steel.

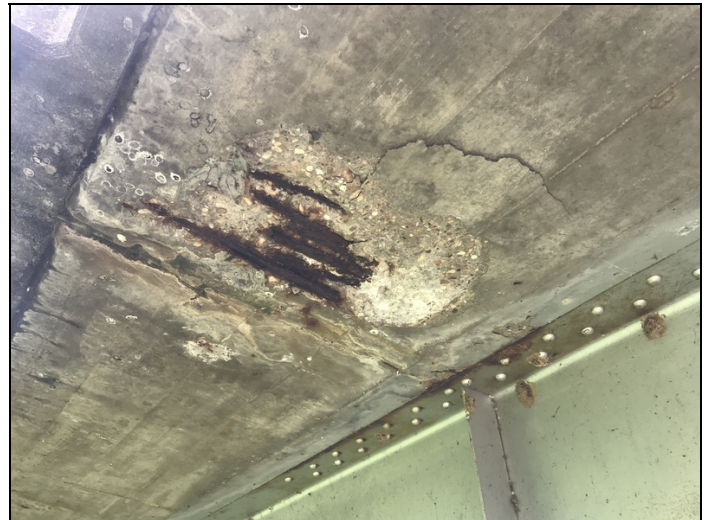
Span 2, left side over bent 3-Spalling with exposed reinforcing steel in deck overhang.

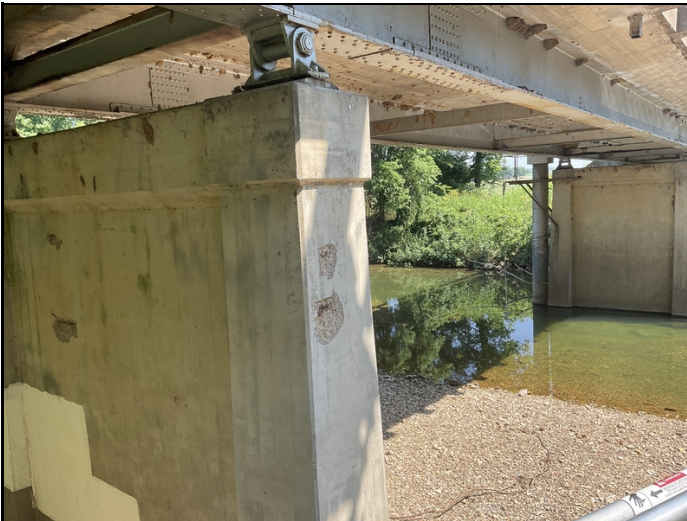
The abutments and the intermediate bents have concrete spalling with exposed reinforcing steel. The exposed reinforcing steel has active corrosion and section loss.

Bent #3 Lt spalling with exposed reinforcing steel.

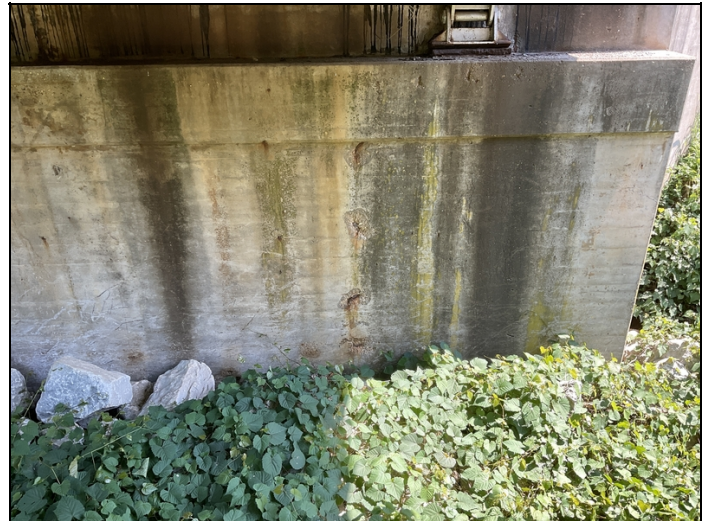
Abutment #1 Lt spalling with exposed reinforcing steel.

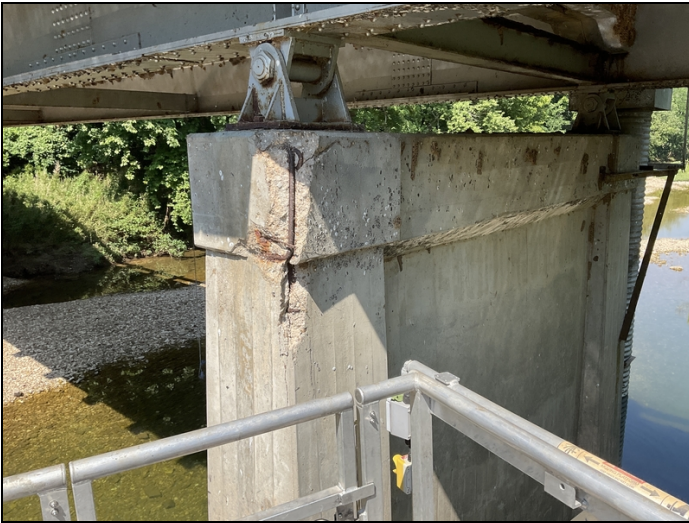
Bent #2 Lt spalling with exposed reinforcing steel.

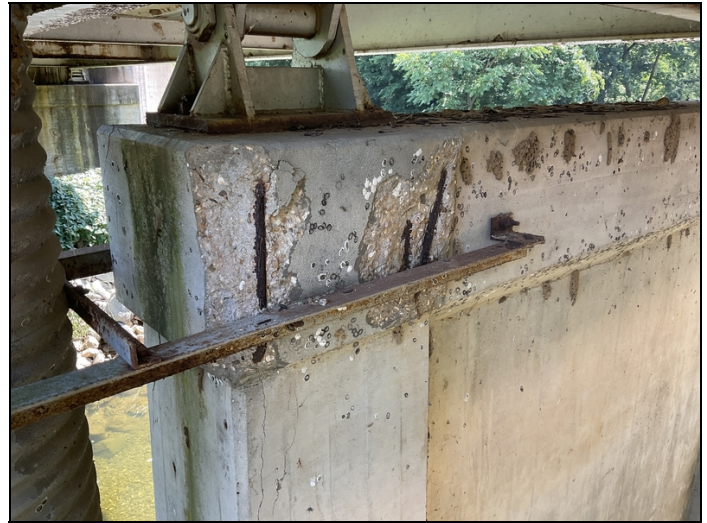
Bent #2 Rt aheadface spalling with exposed reinforcing steel.

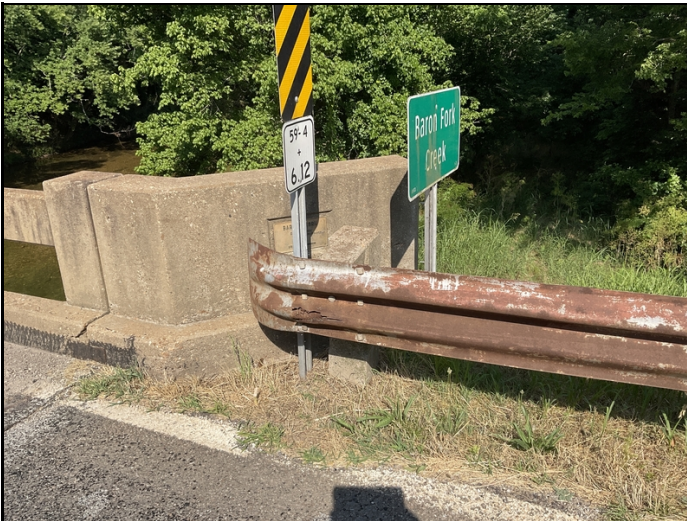
The Northwest approach railing near the bridge end has minor collision damage that has created sharp jagged edges in the railing.

Northwest approach guardrail collision damage.
