Asset #X1298(Routine)

State Highway 59 over Ballard Creek - Wash. Co

Location: 1.2 Mi S Jct Hwy 62

Team Lead: Lee Swan, Inspection Date: 12/07/2022

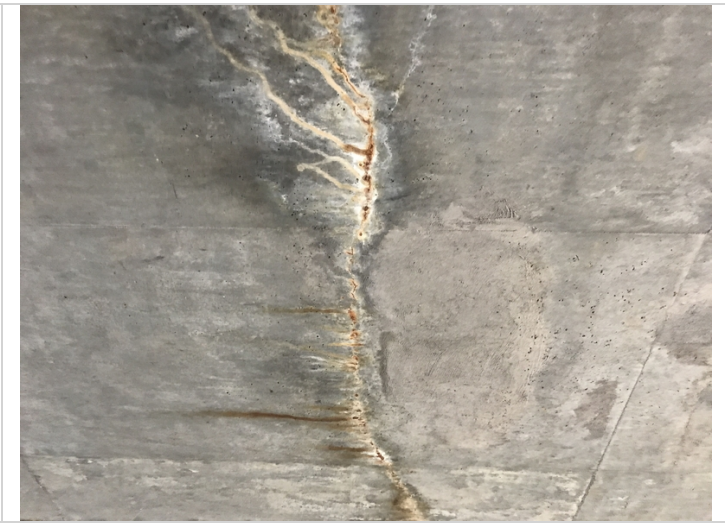
Barrel 1 soffit, rust staining and efflorescence.

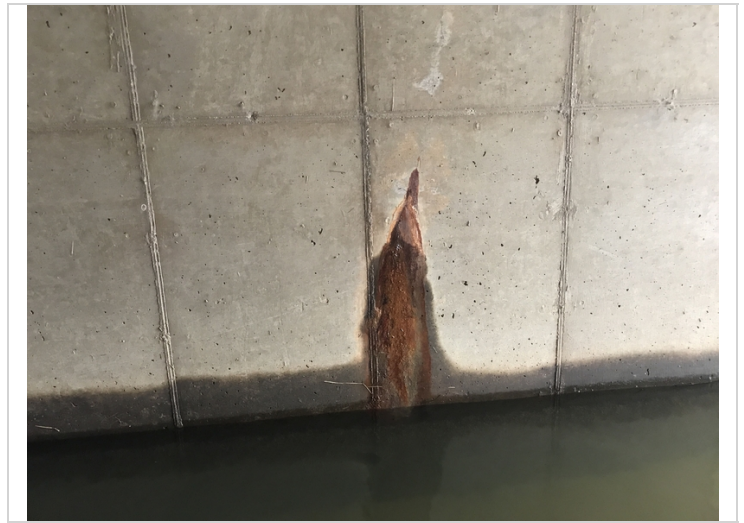
Exterior wall barrel 1, rust staining.

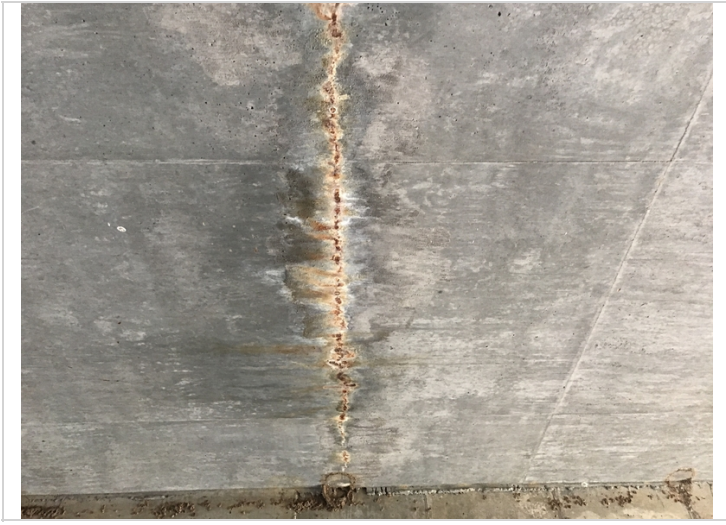
Barrel 4 soffit, rust staining and efflorescence.

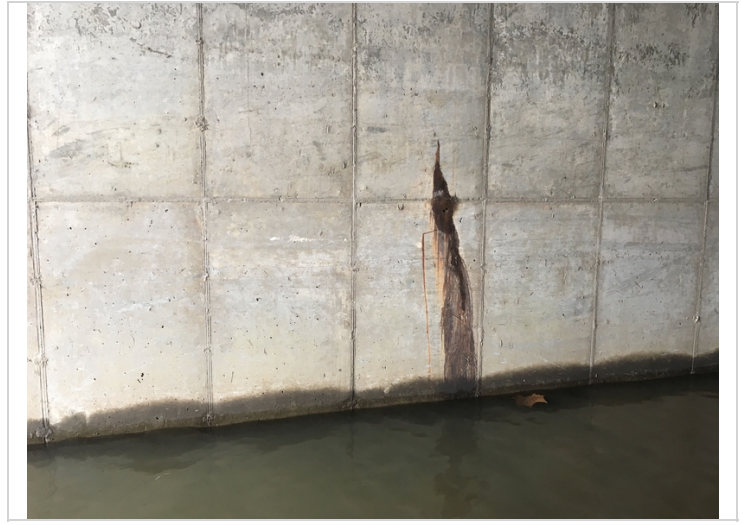
Barrel 5 outside wall.

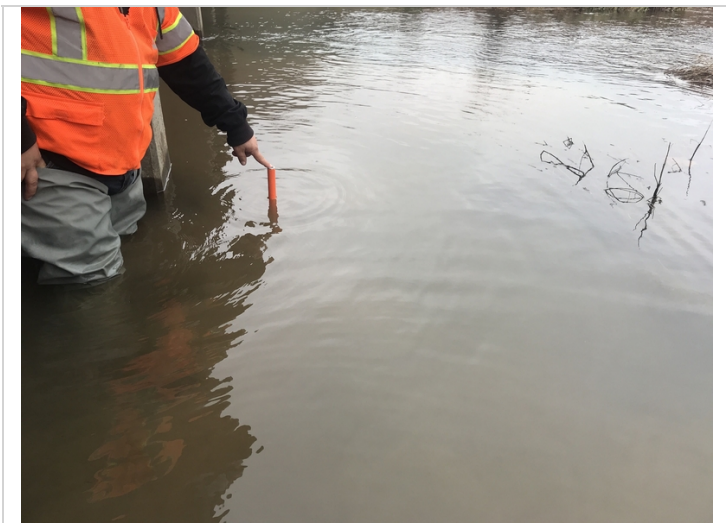
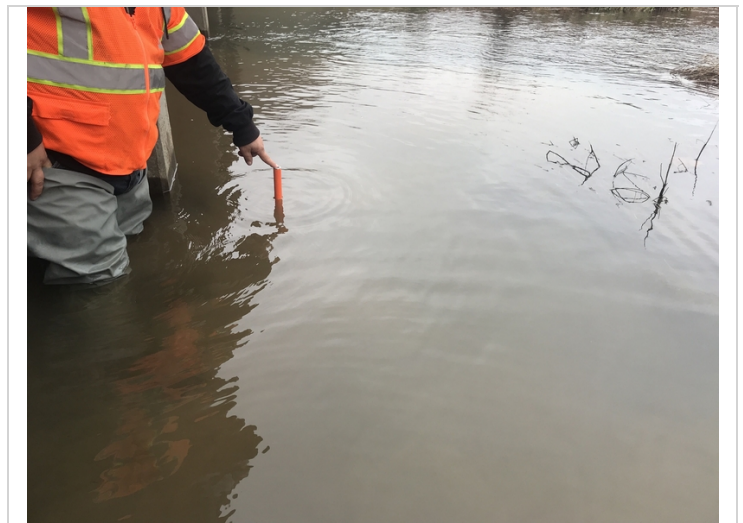
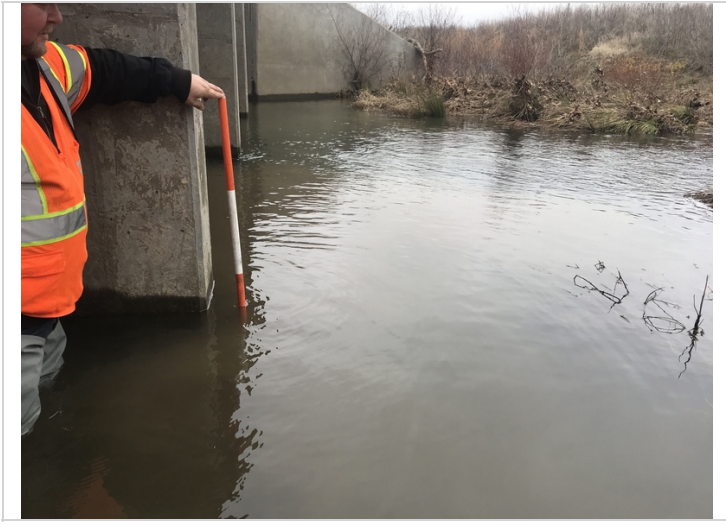
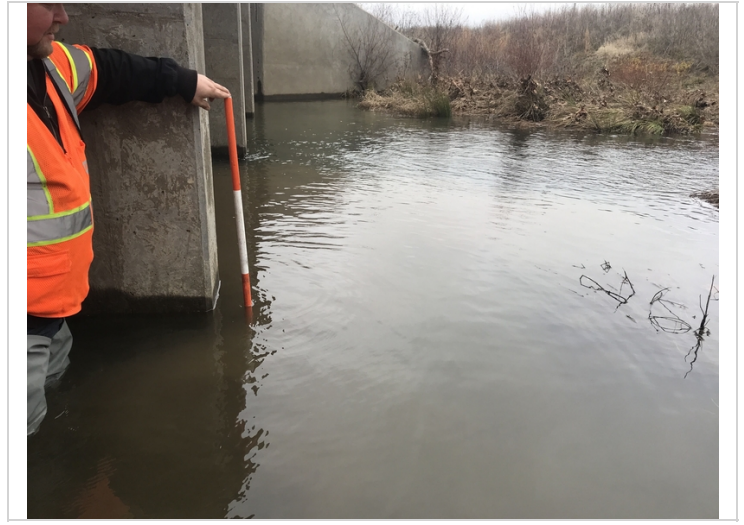
Both inlet and outlet ends hav3 minor scour with up to 2' of scour on the inlet end.

Inlet end at barrel,3, scour

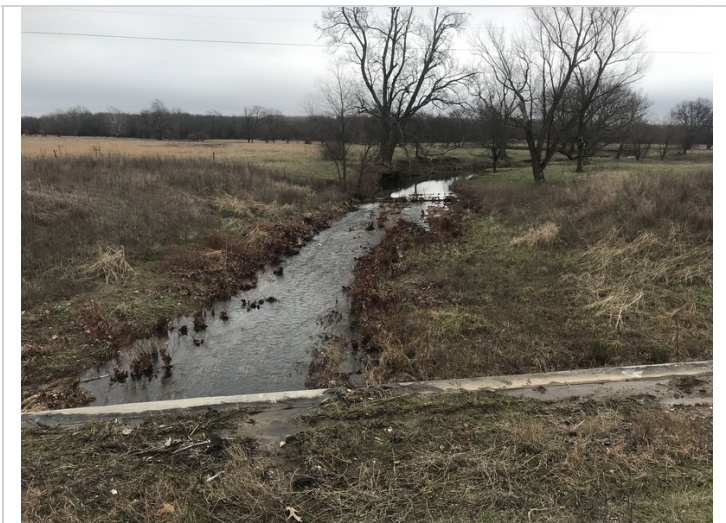
Upstream channel, inlet end of barrels 4 and 5, the channel has silted in.
