Bridge #06557(Routine)

SH 96 Sebastian Co over Vache Grasse Creek

Team Lead: Jeff Jones Inspection Date: October 17, 2022

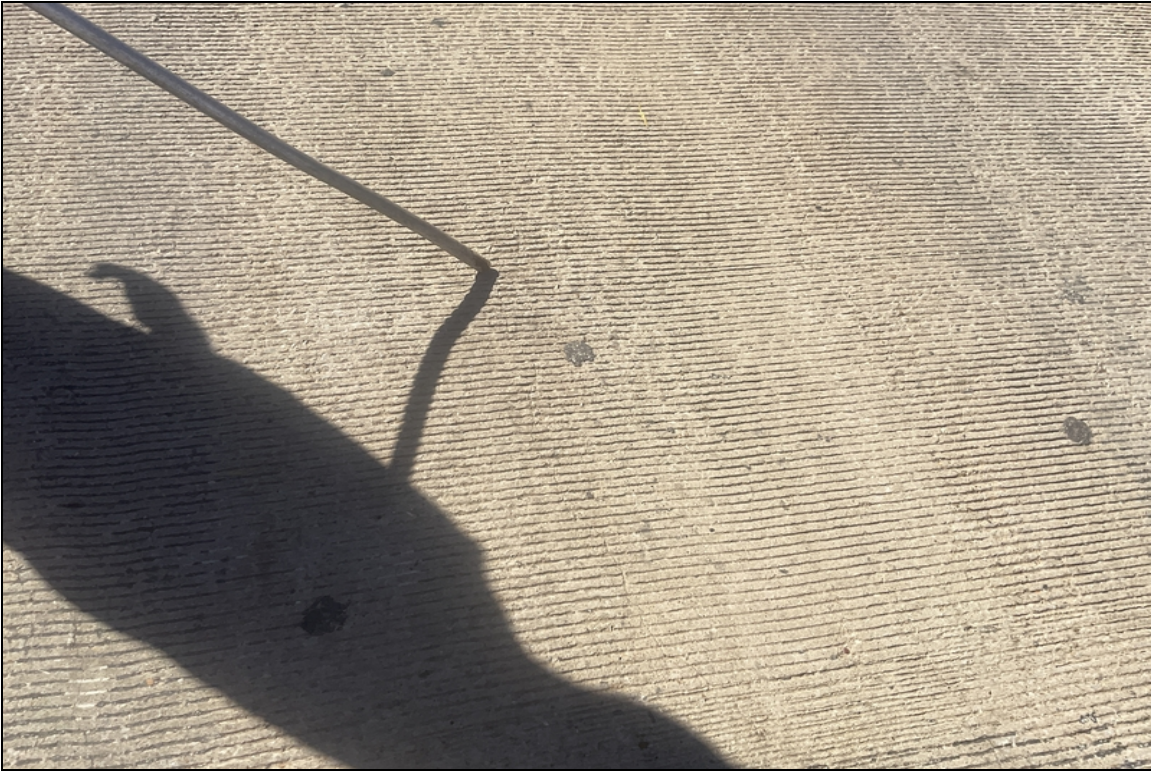
(38)							
-The driving surface of the slab has longitudinal cracks in the wheel paths. -Minor concrete deterioration is visible in the edges of the slab over the intermediate bents. -The driving surface of Span # 3 has minor spalling along expansion joint at Bent # 3. -Slight creep visible in the edge of the slab.							
Undersurface:							
-The undersurface of the slab in Span # 2 has delaminated / spalled areas that expose reinforcing steel along the drip groove on the Right side of the structure. -The Left side has short duration delaminations along the drip groove. -There are vertical hairline flexure cracks at variable spacing visible in the edges of the slab. -The Right side of Span # 3 slab has a baseball sized spall adjacent to the drip groove near mid-span that appears to be from an impact.							
205	Reinforced Concrete Column	EA	4	2	2	0	0
1080	Delamination/Spall/Patched Area	EA	1	0	1	0	0

Longitudinal crack in Span # 3. Typical.

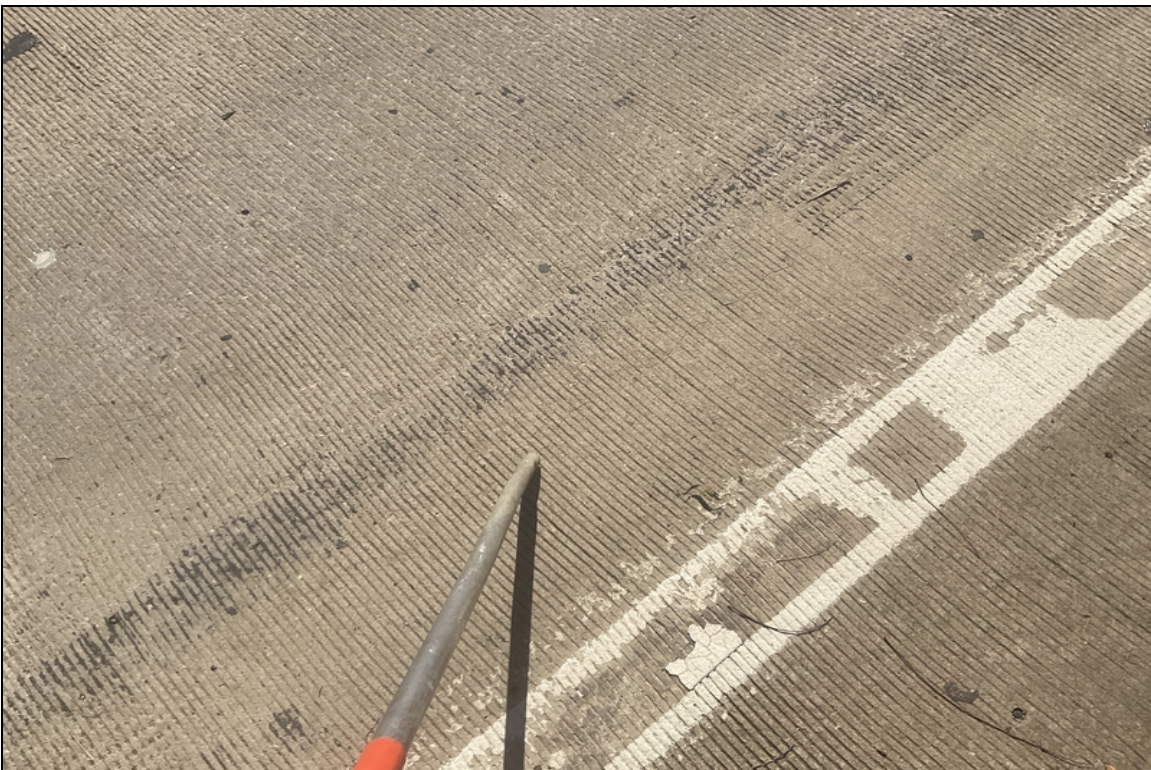
Longitudinal crack in Span # 1. Typical.

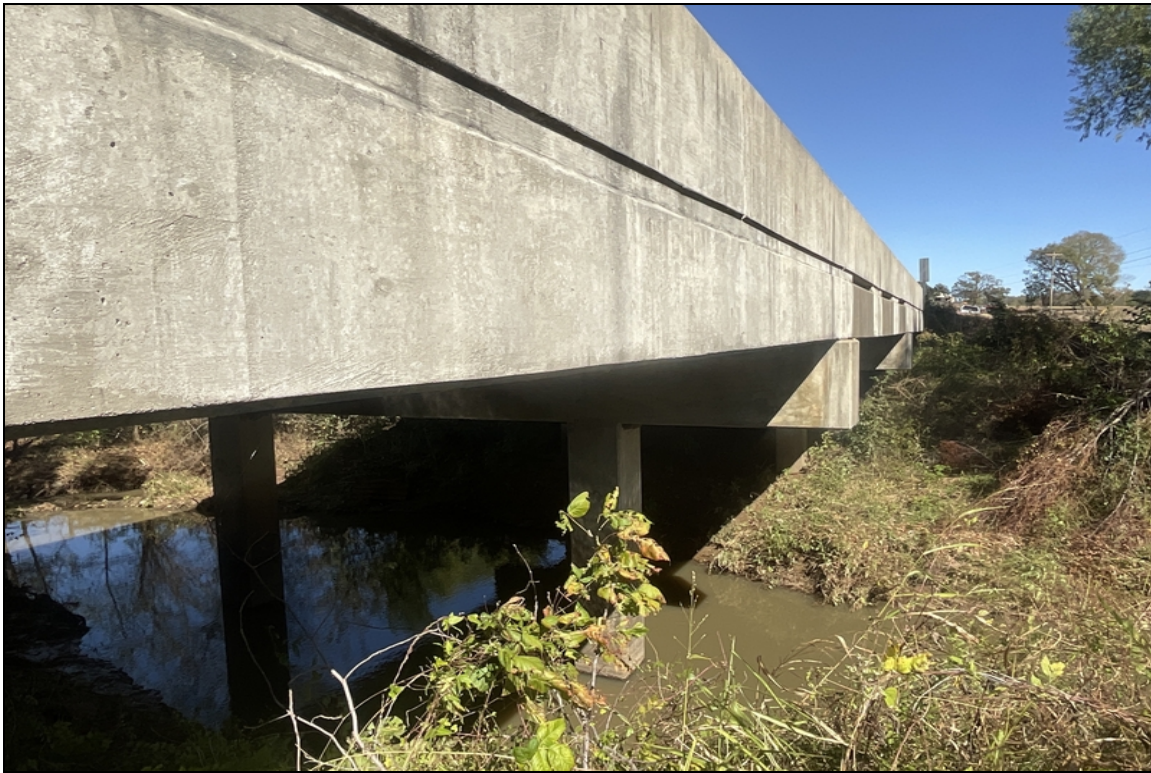
Slight creep visible in the edge of the slab.

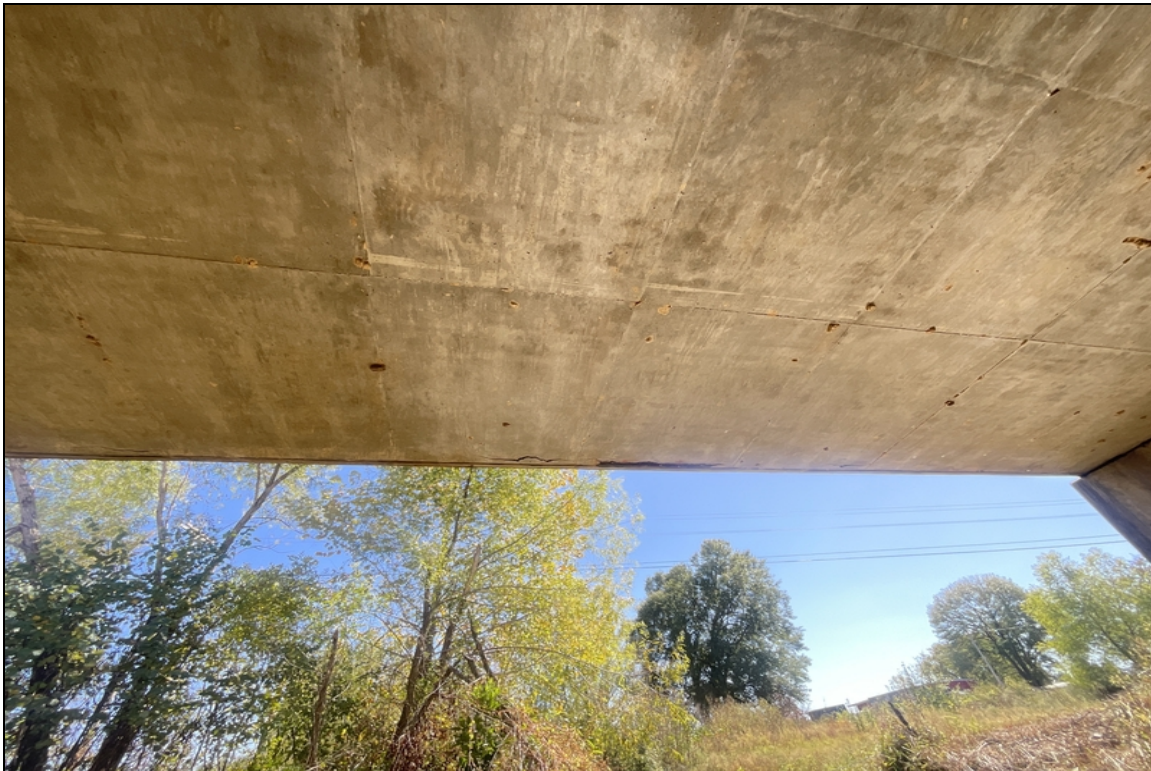
Undersurface of Span # 2 Right. Spalls with exposed reinforcing steel.

The undersurface of the slab on the Right side of Span # 2 has delaminated / spalled areas with exposed reinforcing steel along the drip groove. The exposed reinforcing steel has section loss.

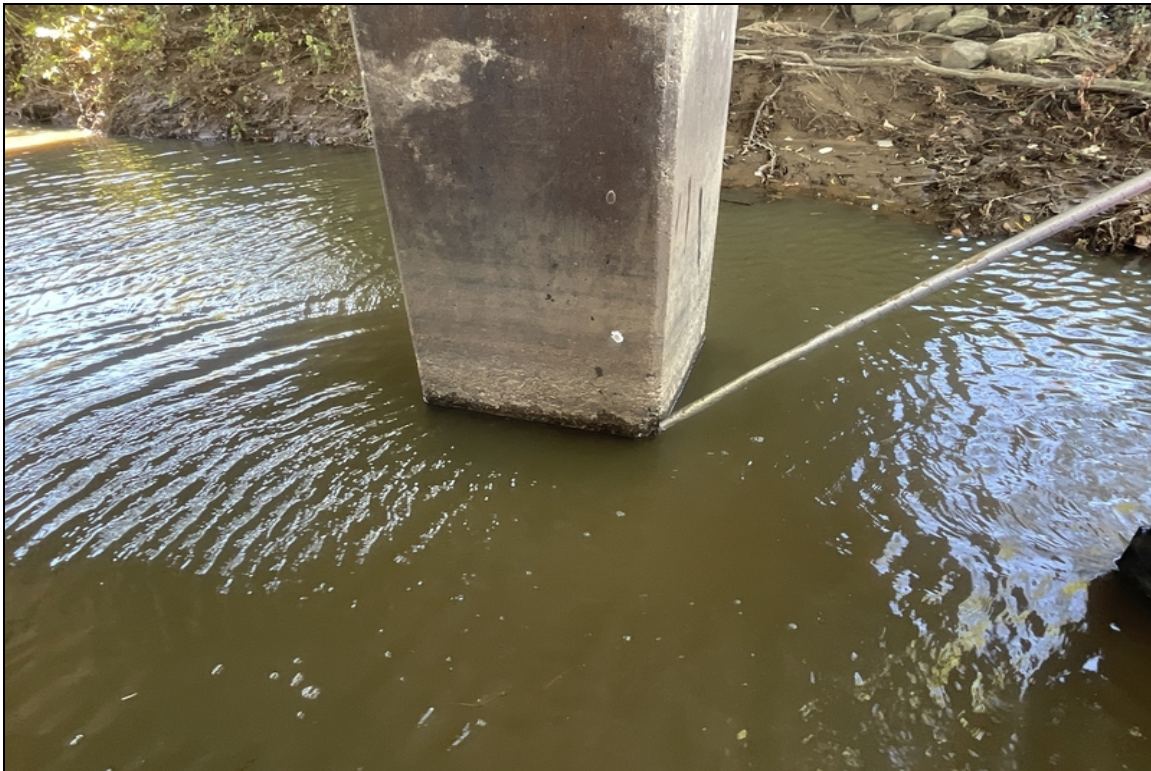
1190	Abrasion/Wear (PSC/RC)	EA	1	0	1	0	0
(205)							
-The base of Bent # 2, Column # 1 has light abrasion with a baseball sized area of concrete deterioration in the exterior edge at the normal water elevation. -The ahead face of Bent # 2, Column # 1 has a 12" tall area of shallow spalling / concrete deterioration with vertical cracks midway up the column. -The base of Bent # 2, Column # 2 has light abrasion. -Bent # 3 columns have no apparent noteworthy deficiencies during this inspection.							
215	Reinforced Concrete Abutment	LF	108	84	0	24	0
1120	Efflorescence/Rust Staining	LF	24	0	0	24	0

Bent # 2. Column # 1. Heavy abrasion at the water elevation.

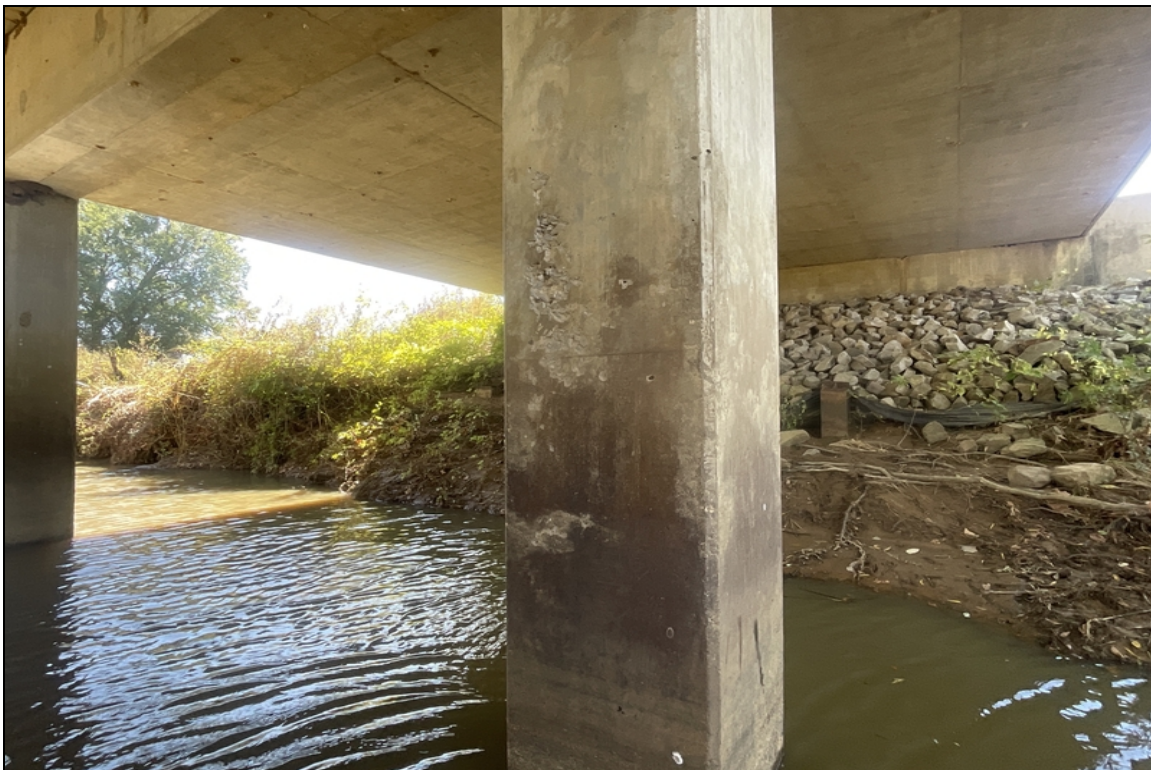
The ahead face of Bent # 2 Column # 1 has a 12" tall area of shallow spalling / concrete deterioration midway up the column.

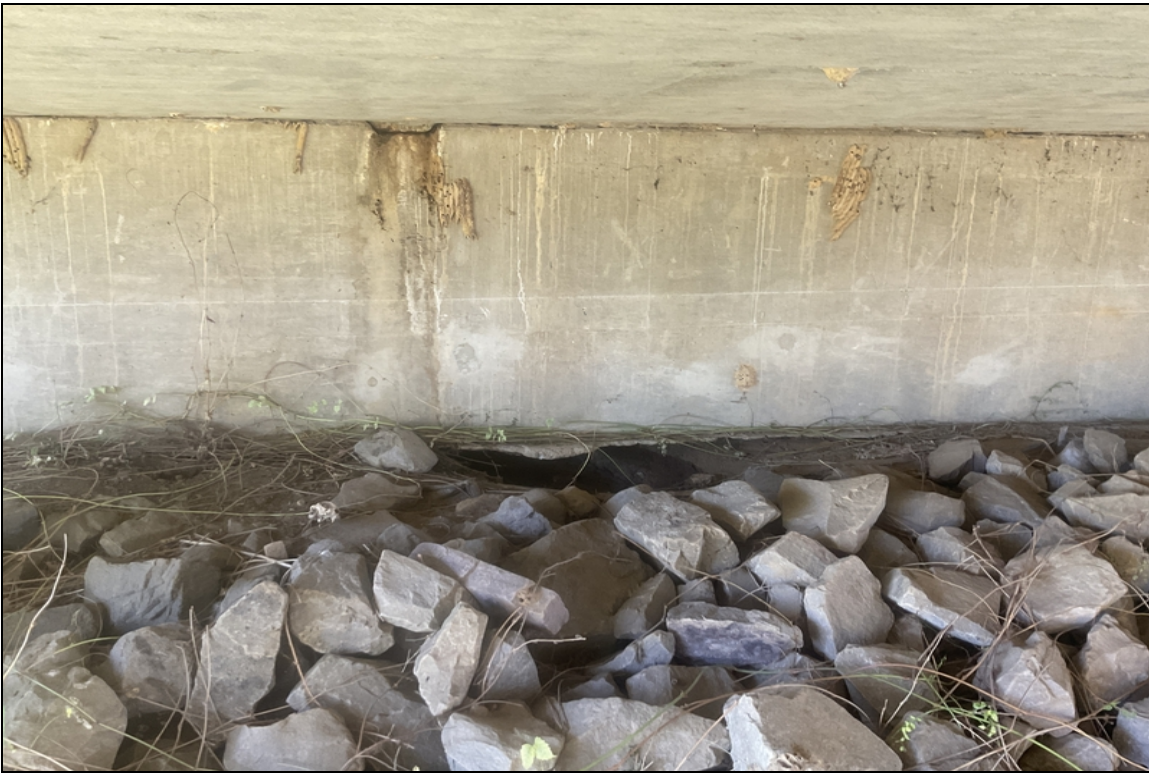
(215)							
-Abutments have water stains with areas that have efflorescence. -The base of Abutment # 1 stem wall has voids due to varmint holes and minor earth settlement under the Left edge of the abutment. -The Left side of Abutment # 2 has minor earth settlement with approximately 2" of air space in an area approximately 5' long. -Abutment # 2 has a hairline vertical crack located approximately 1' Right of centerline with light efflorescence.							
234	Reinforced Concrete Pier Cap	LF	71	46	25	0	0
1080	Delamination/Spall/Patched Area	LF	4	0	4	0	0
1120	Efflorescence/Rust Staining	LF	21	0	21	0	0

Bent # 1 with vermin holes under the abutment cap.

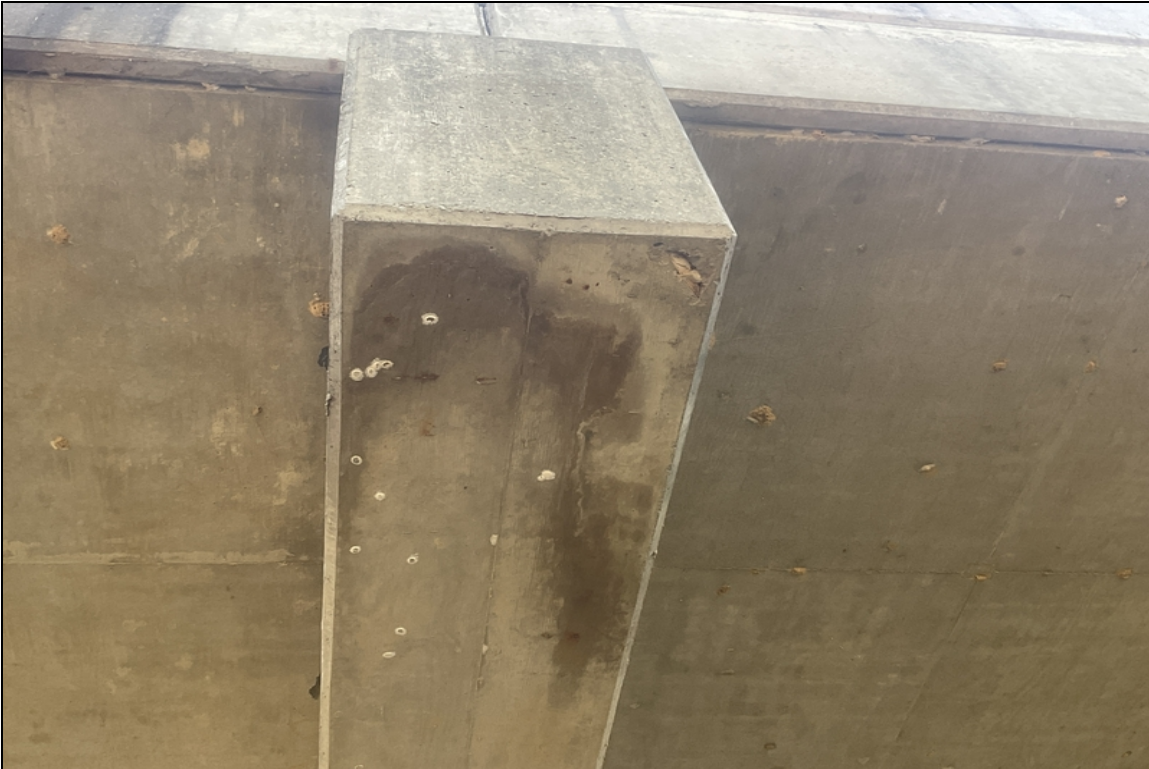
Bent # 2 cap. Left end. Undersurface has a shallow spall with exposed wood that appears to be chamfer cast in the concrete.

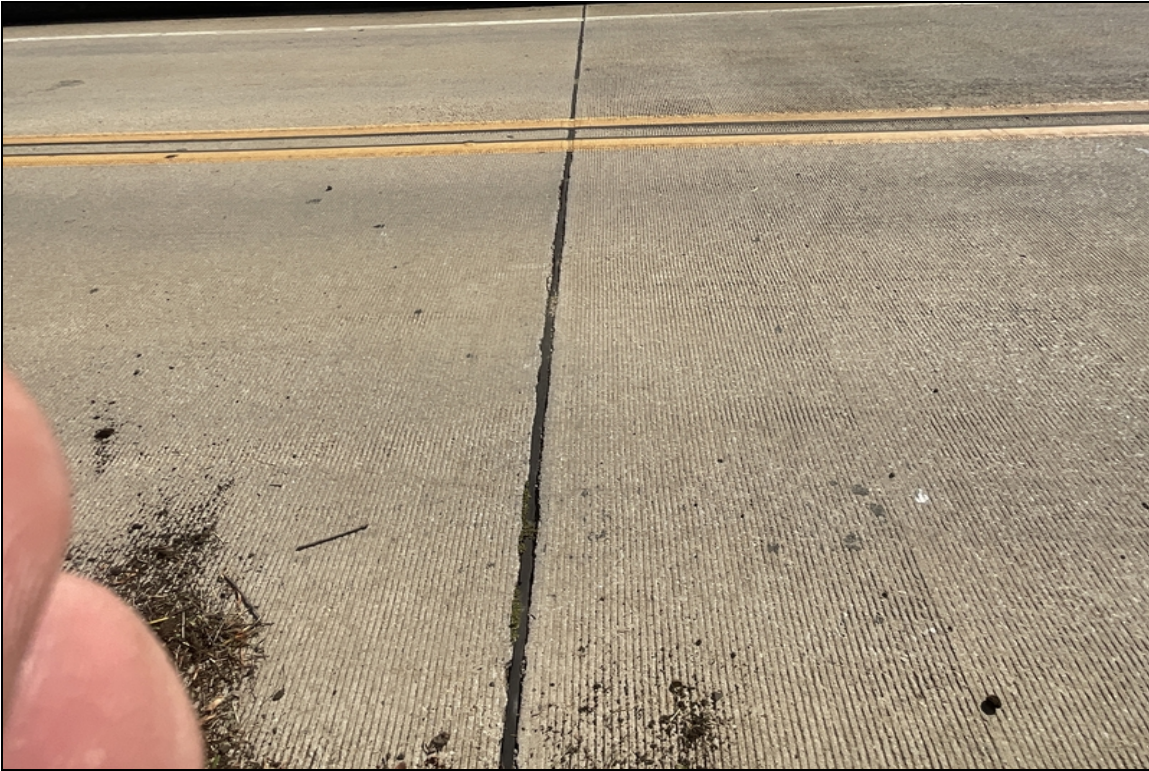
(234)							
-Intermediate bent caps have vertical cracks with light efflorescence over the columns. -Water stains on the caps indicate that the deck joint sealant is leaking.

Expansion joint sealant over Bent # 3. Adhesion failure with leakage.

The expansion joints sealant has adhesion failure the entire length of joints allowing water, dirt, and debris to enter the joints and leak onto the substructure.

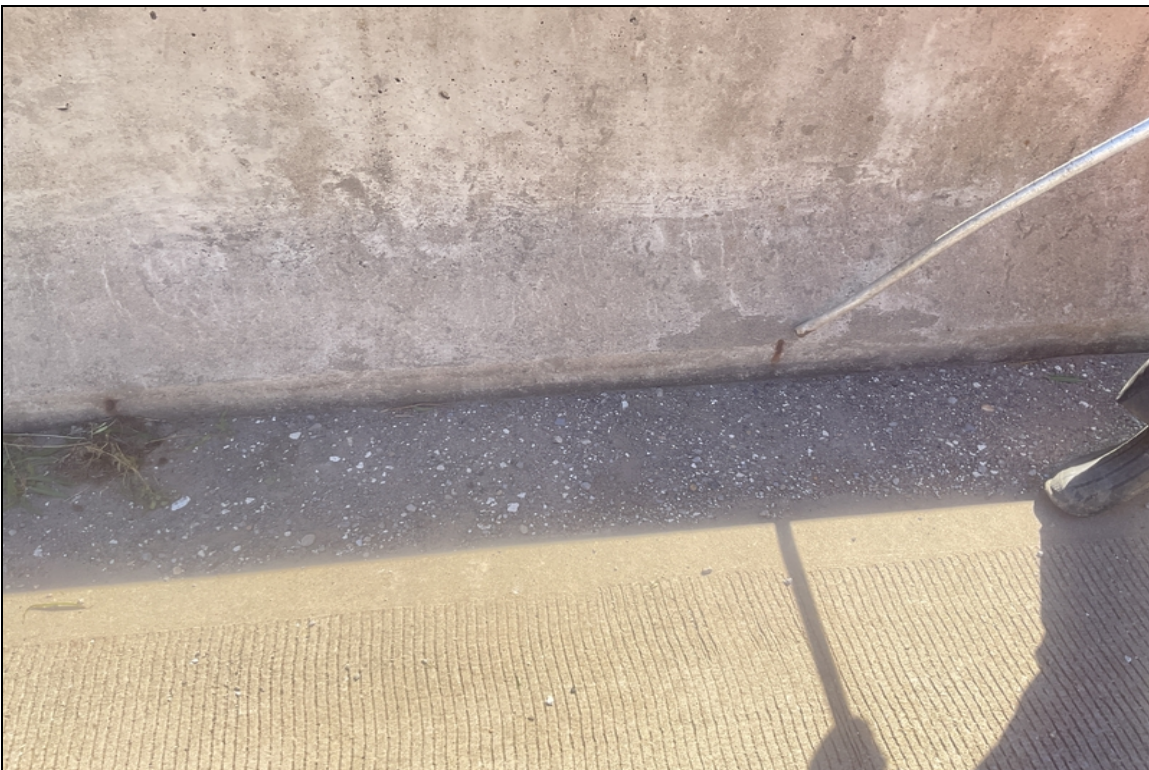
Spall with exposed reinforcing steel in the Right parapet of Span # 3.

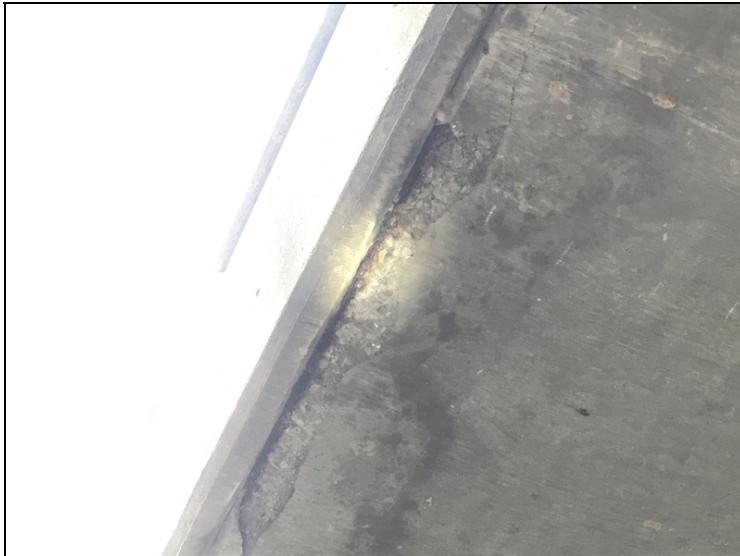
Span #2, right side-Spalling with exposed reinforcing steel along drip groove.

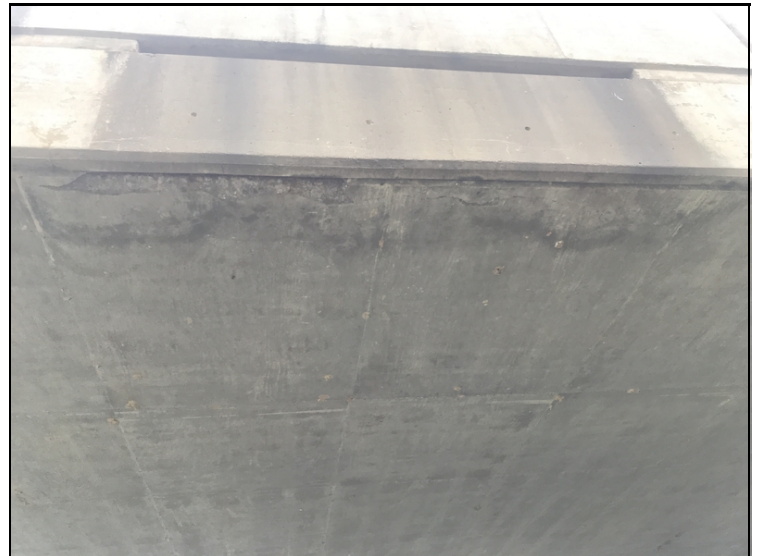
Span #2, right side-Delaminated areas along drip groove.

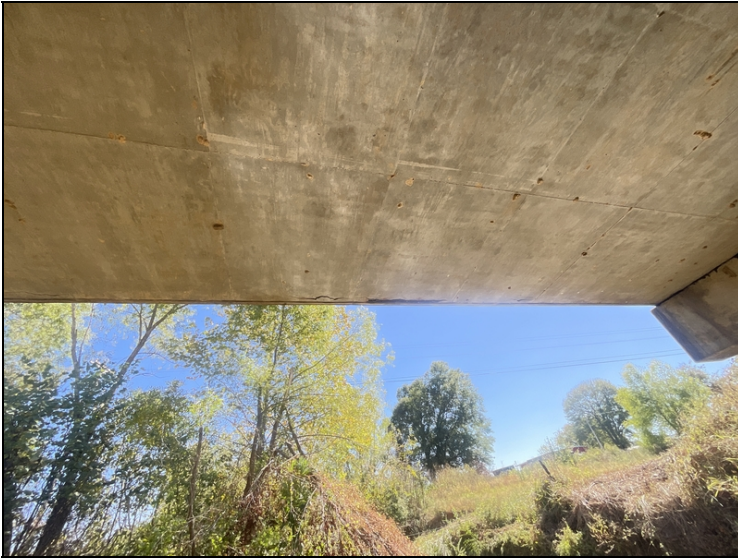
Undersurface of Span # 2 Right. Spalls with exposed reinforcing steel.

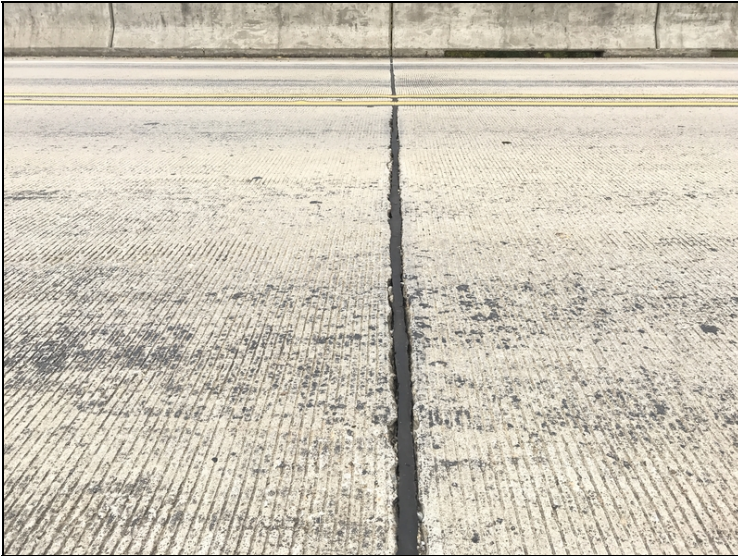
Bent #3 expansion joint adhesion failure.

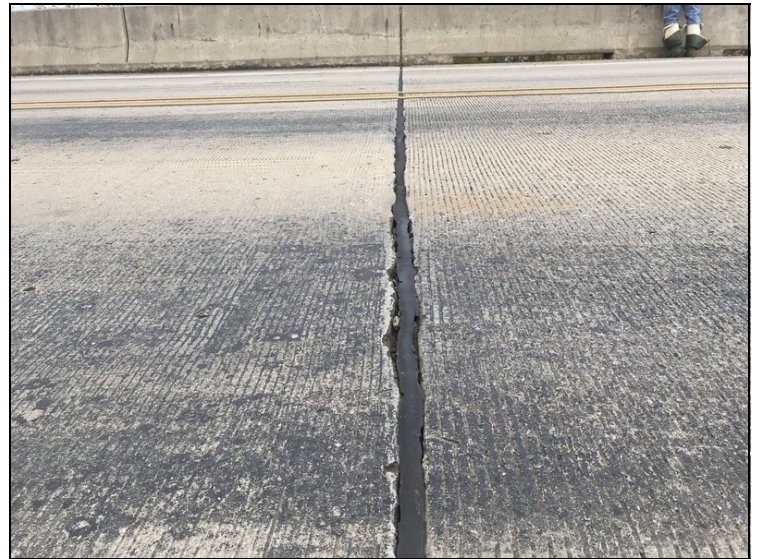
Bent #2 expansion joint-Adhesion failure.

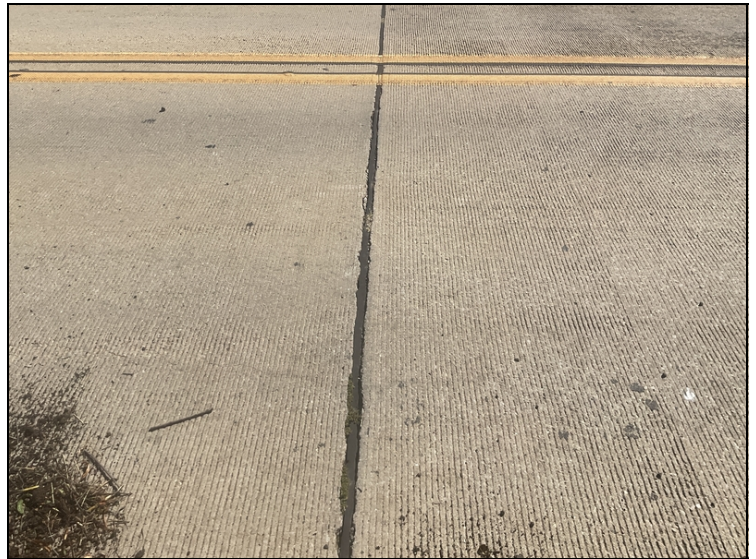
Expansion joint sealant over Bent # 3. Adhesion failure with leakage.
