Bridge #06558(Routine)
State Highway 96 over Vache Grasse Creek
Location: 2.8 MI N SH 10-1

Team Lead: Jeff Jones Inspection Date: October 17, 2022

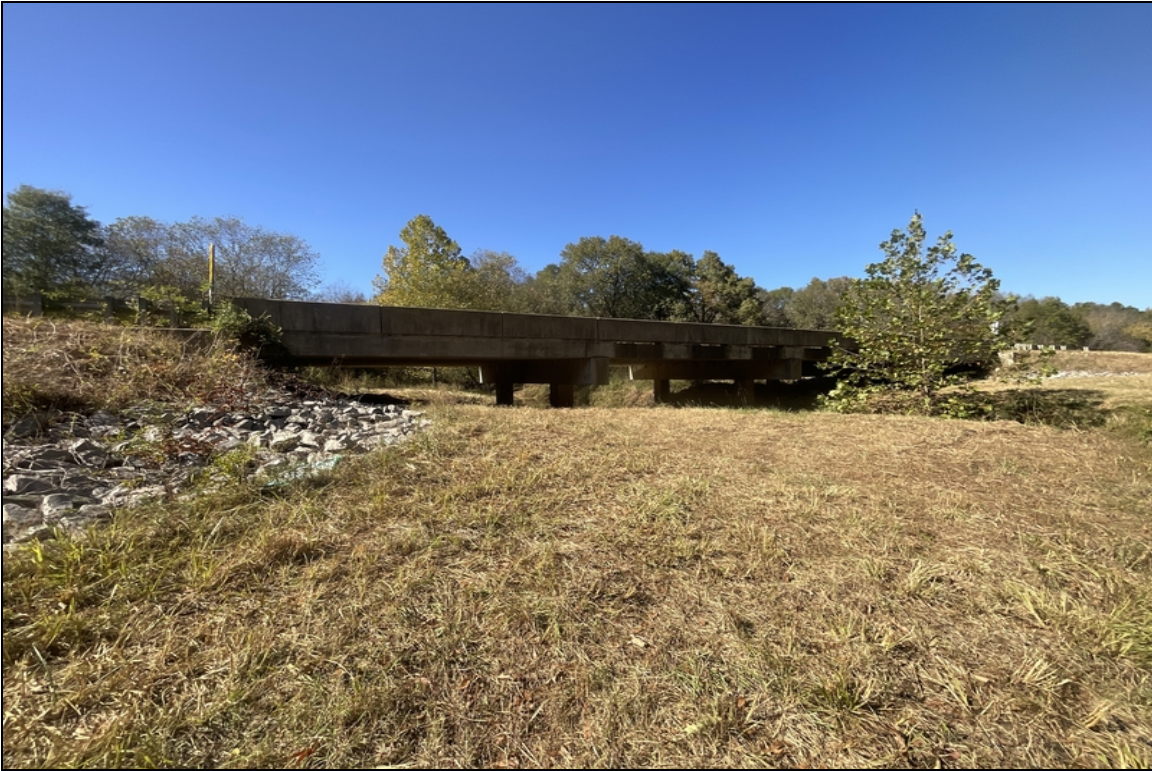
Elevation. Right side of structure.

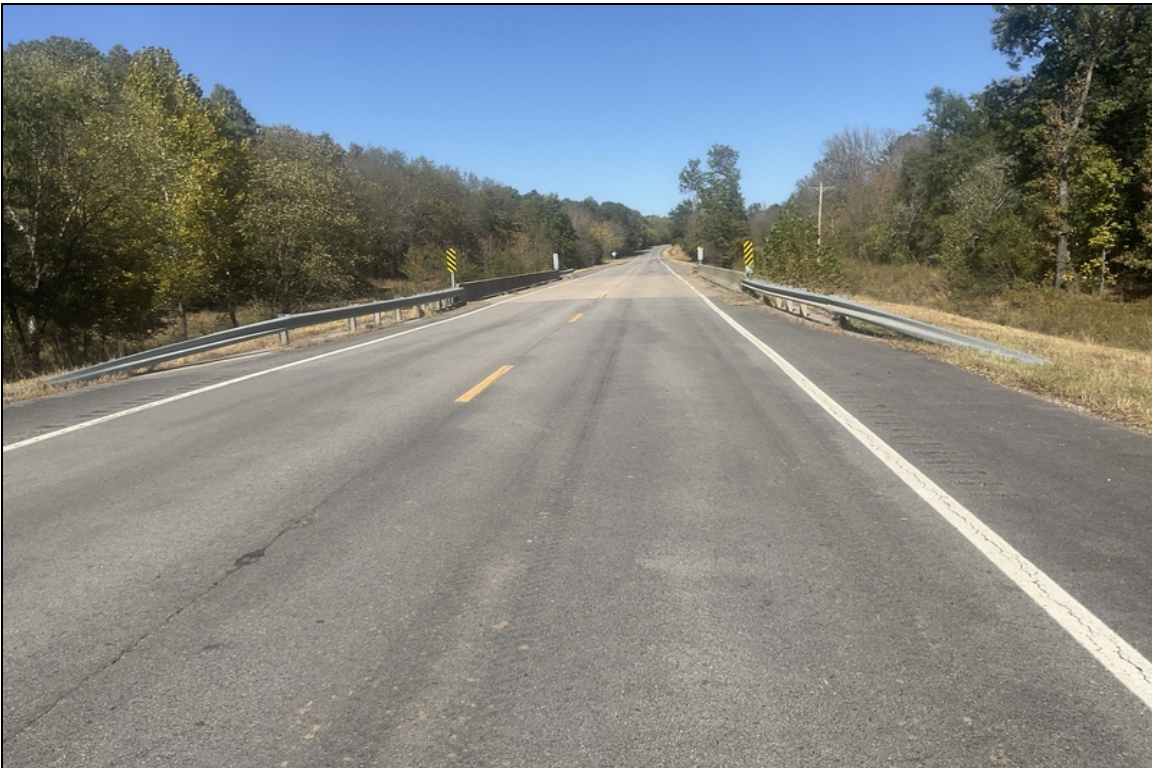
Approach roadway facing North.

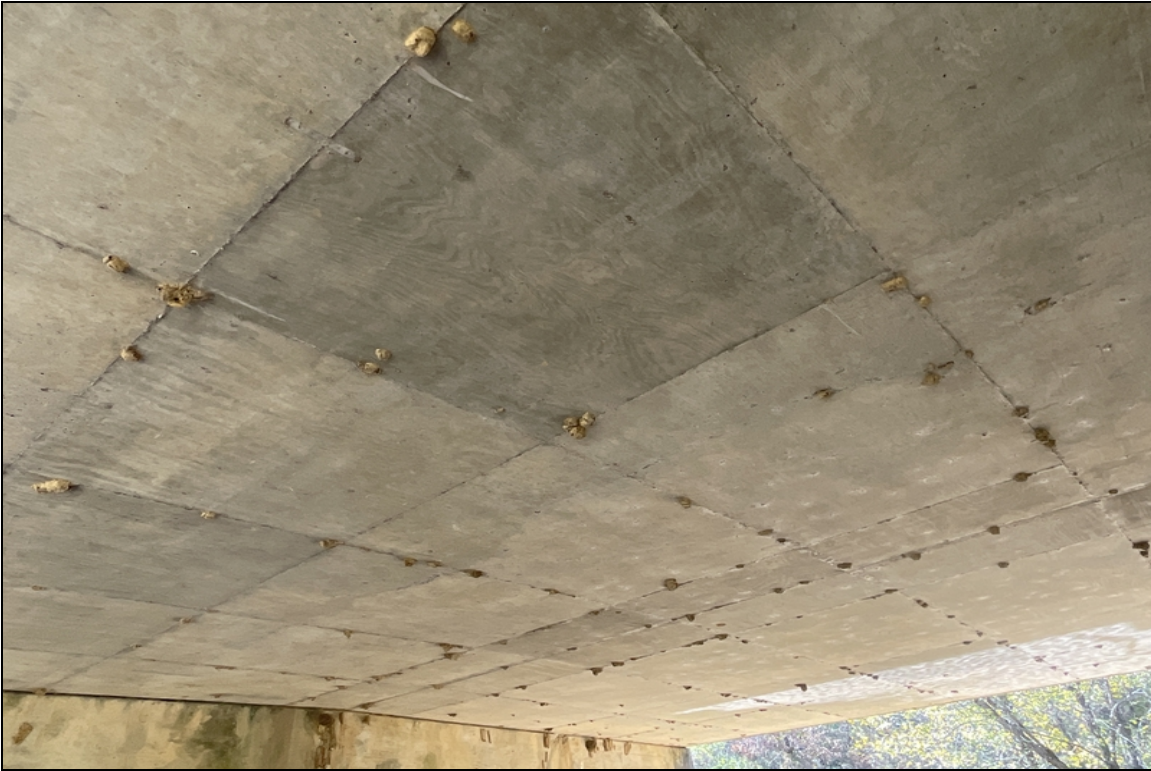
Slab soffit. Typical.

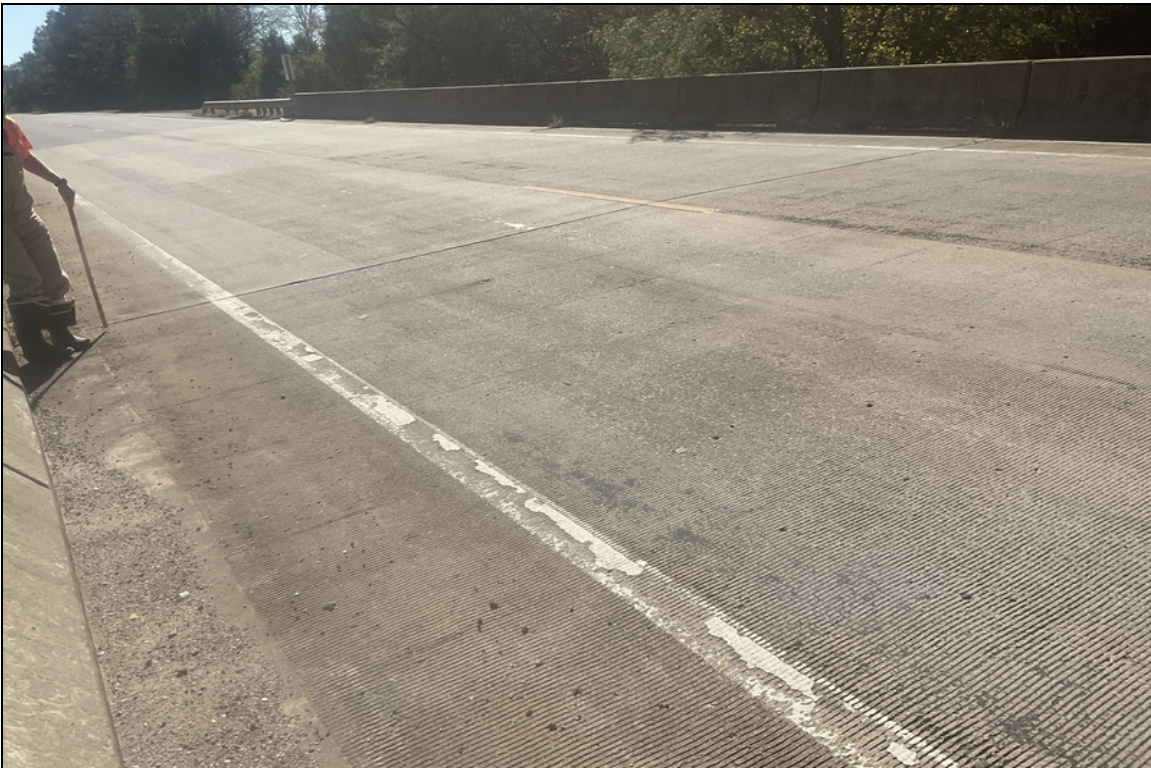
Driving surface of the slab. Typical.

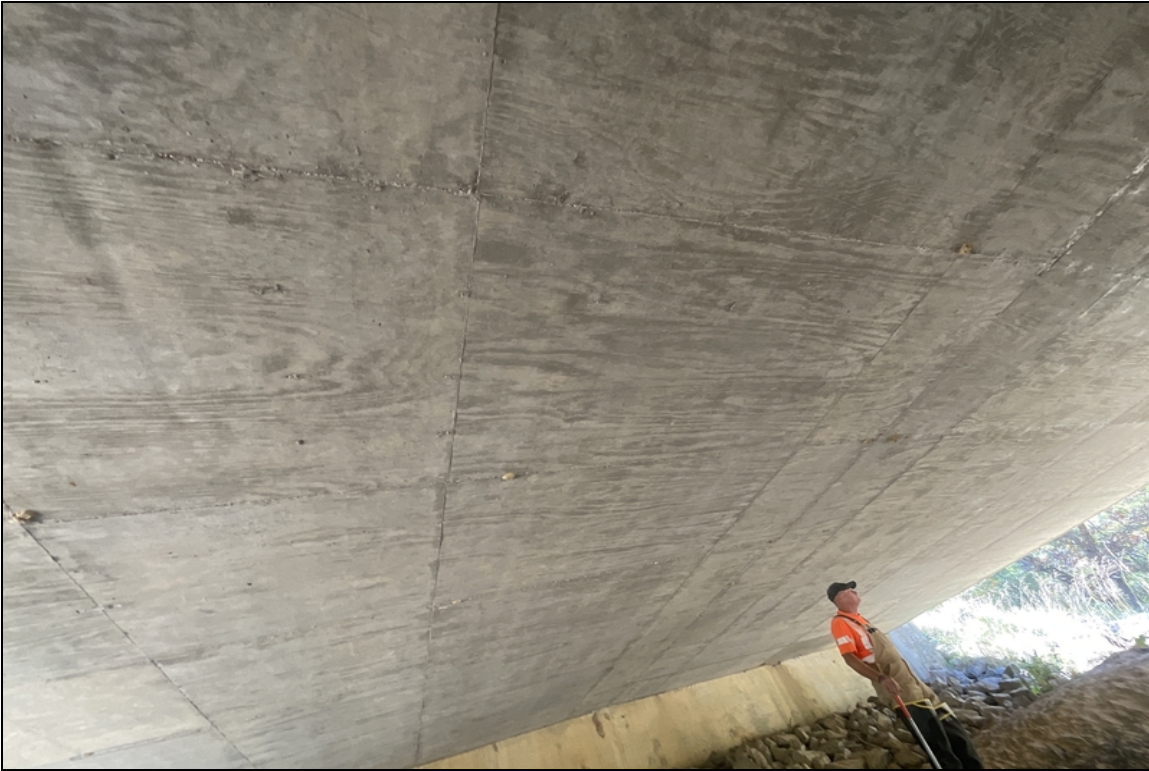
Slab soffit. Span # 1. Typical.

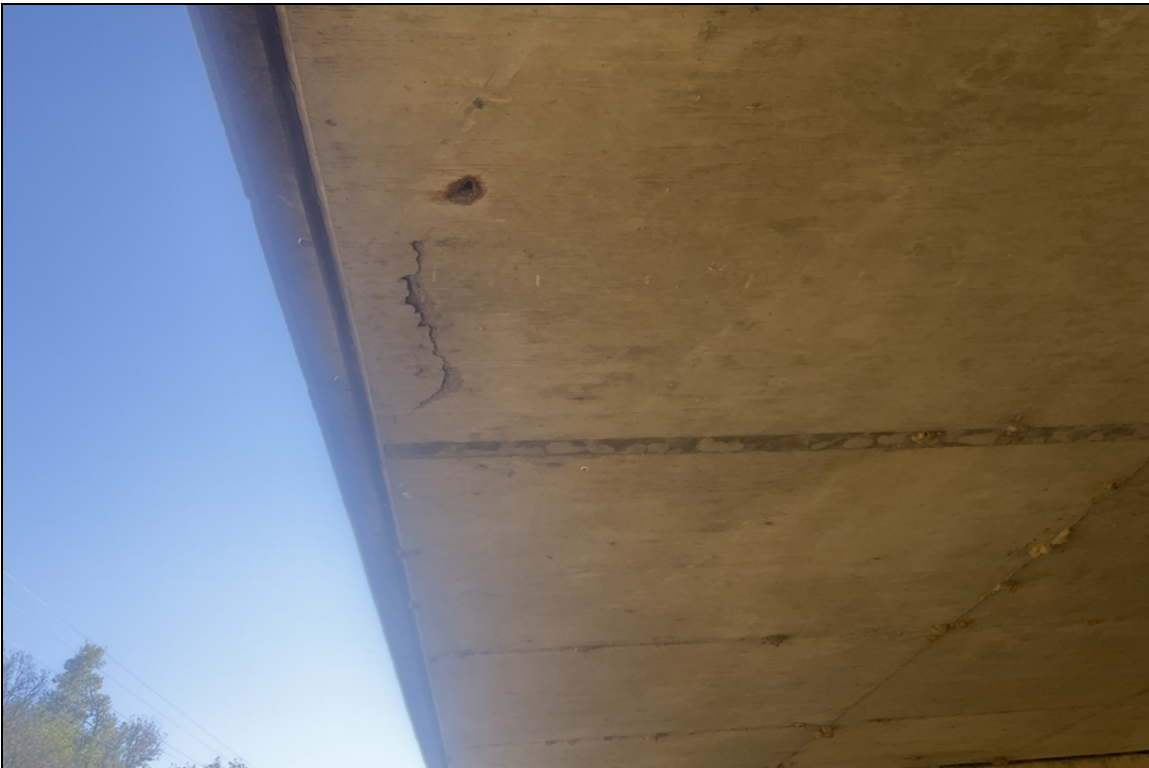
Span # 2. Right. Delaminated area along the drip groove.

The undersurface of the slab on the Right side of Spans # 2 & 3 have delaminated areas along the drip groove.

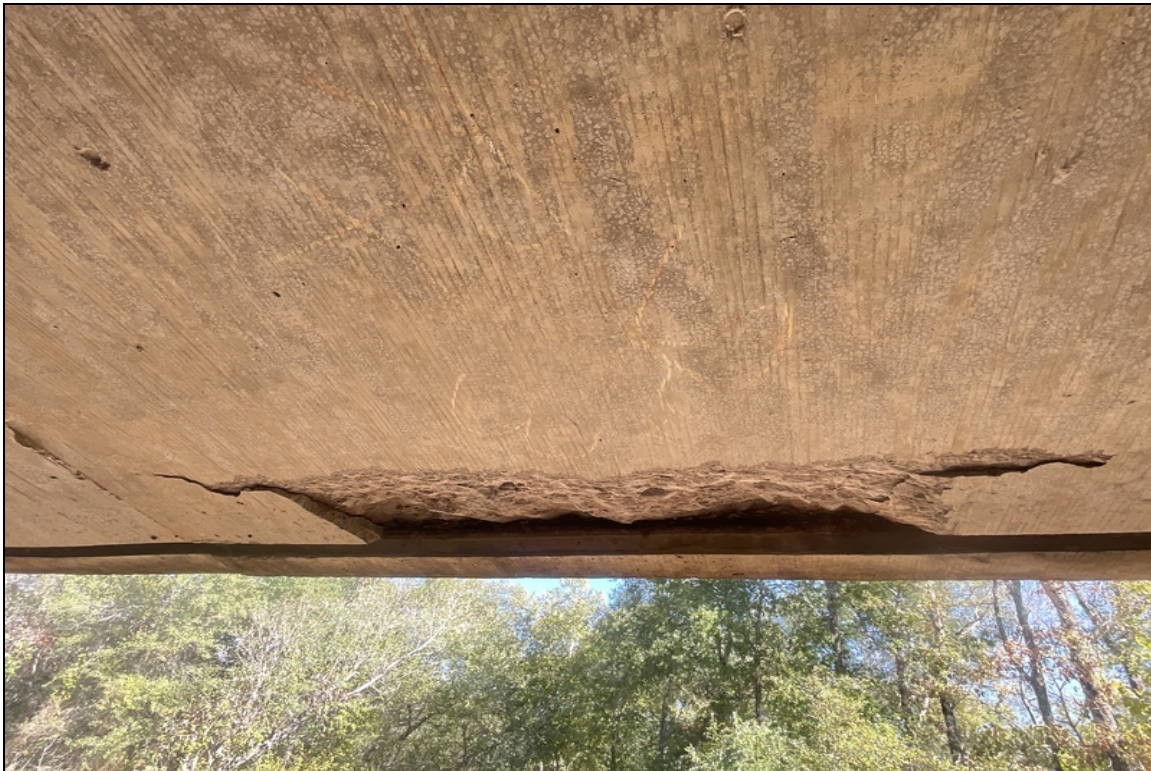
Spall with exposed reinforcing steel in the right drip groove of span # 3.

There is a spall with exposed reinforcing steel in the Right side of Span # 3 along the drip groove.

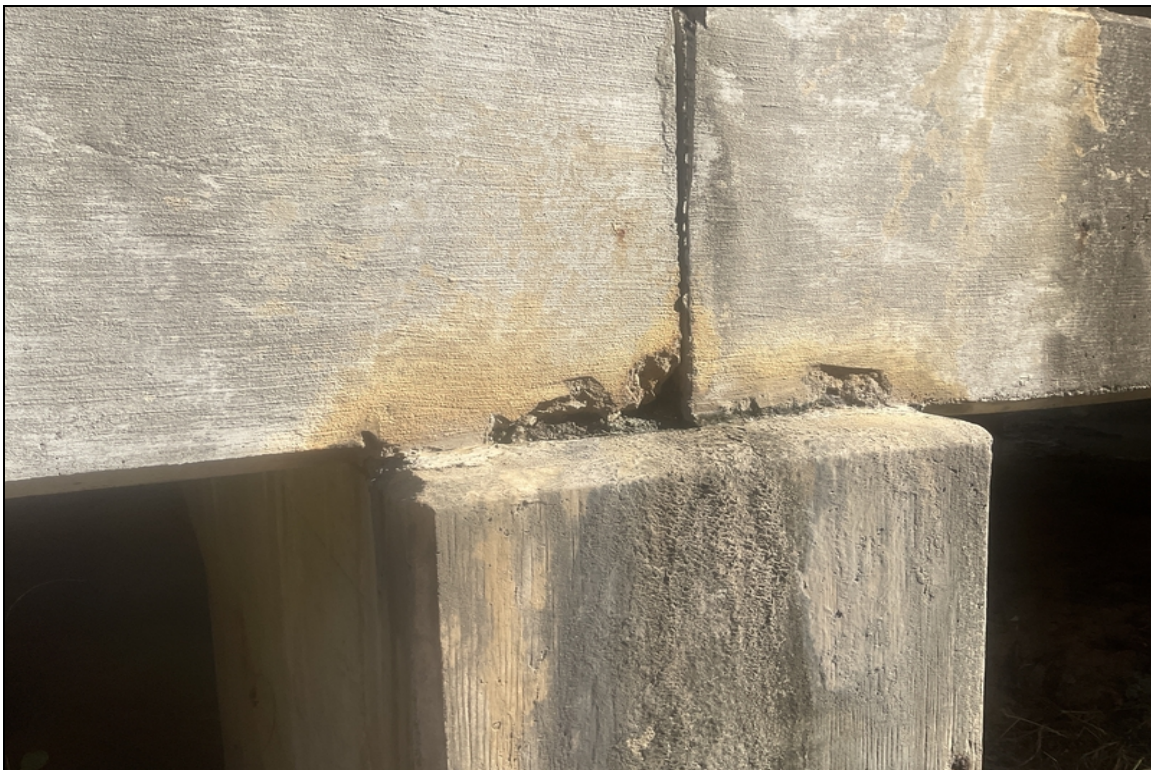
Left edge of spans # 3 & 4 over Bent # 4. Concrete deterioration.

There is minor concrete deterioration and spalling that is visible in the exterior edges of the deck over the intermediate bents.

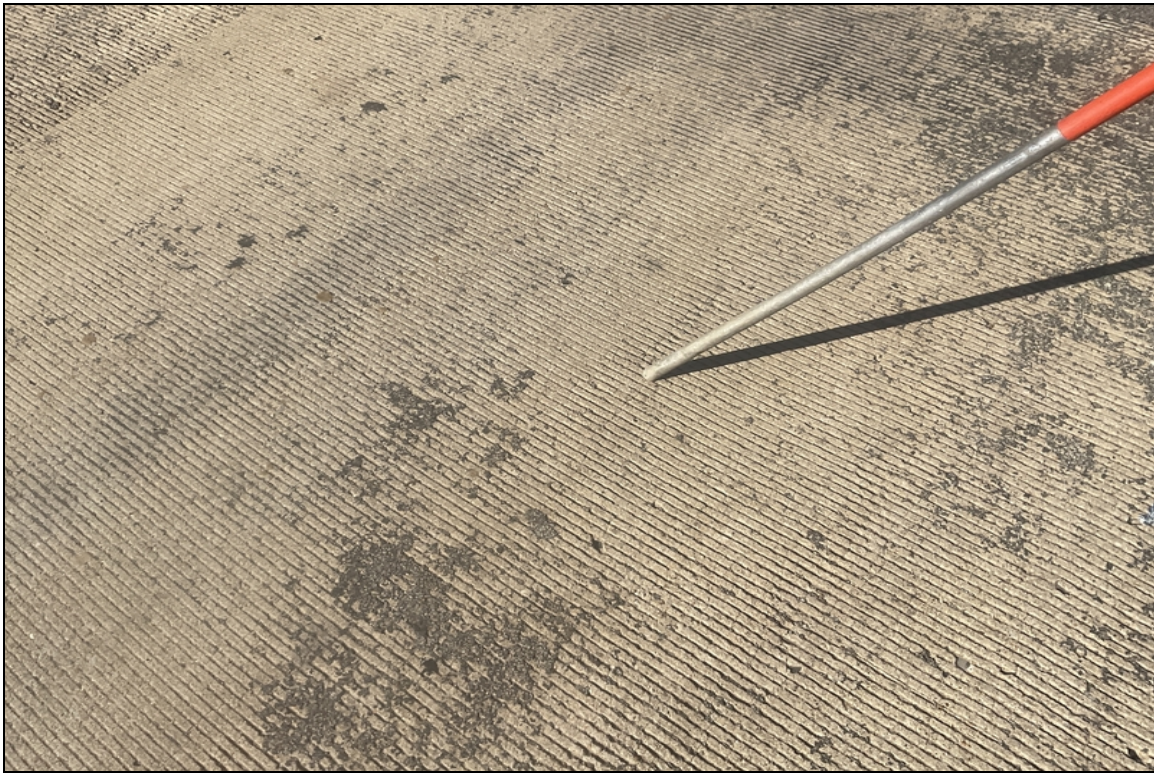
Hairline longitudinal cracks in the driving surface of the slab. Span # 4.

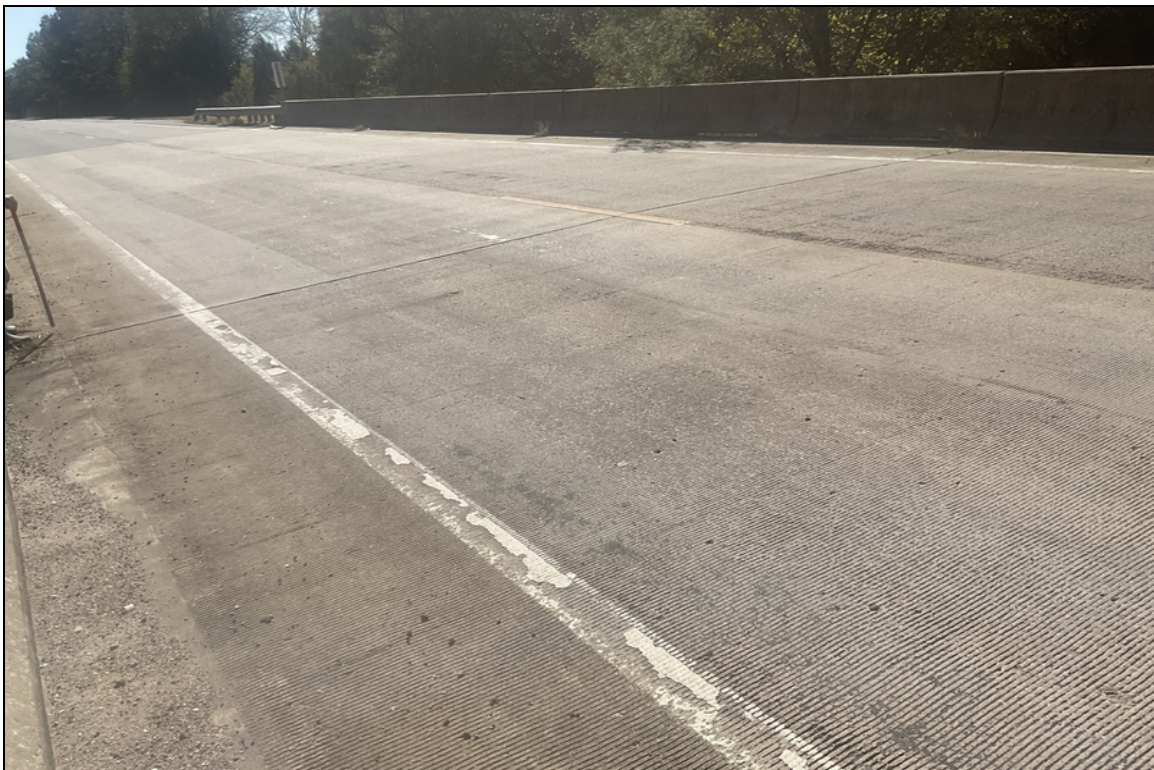
Driving surface of the slab. Typical.

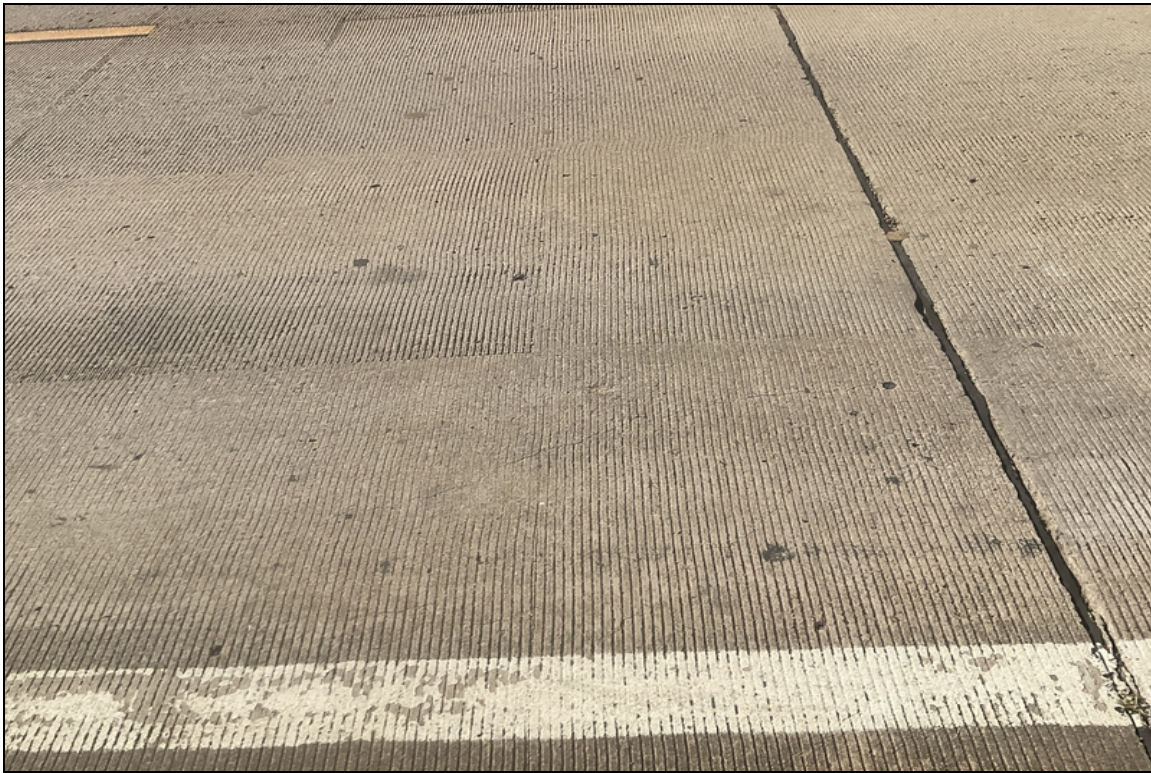
Longitudinal cracking in the driving surface of span # 2.

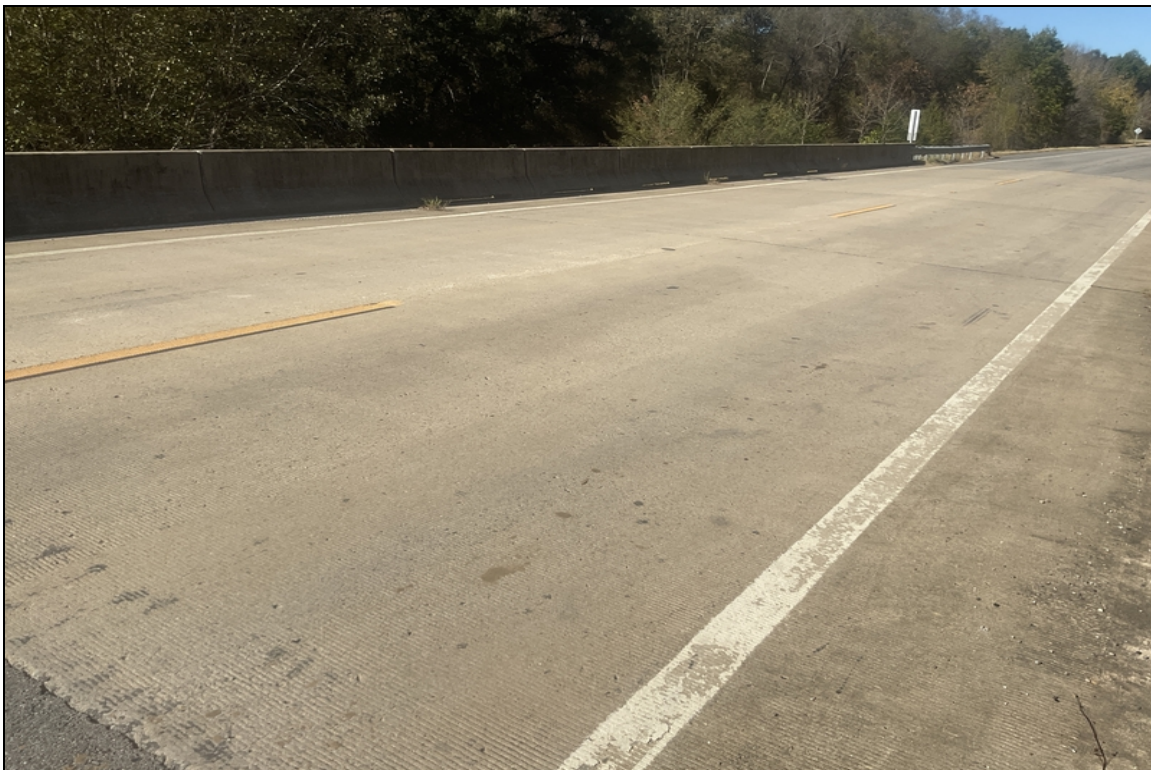
Driving surface of the slab. Typical.

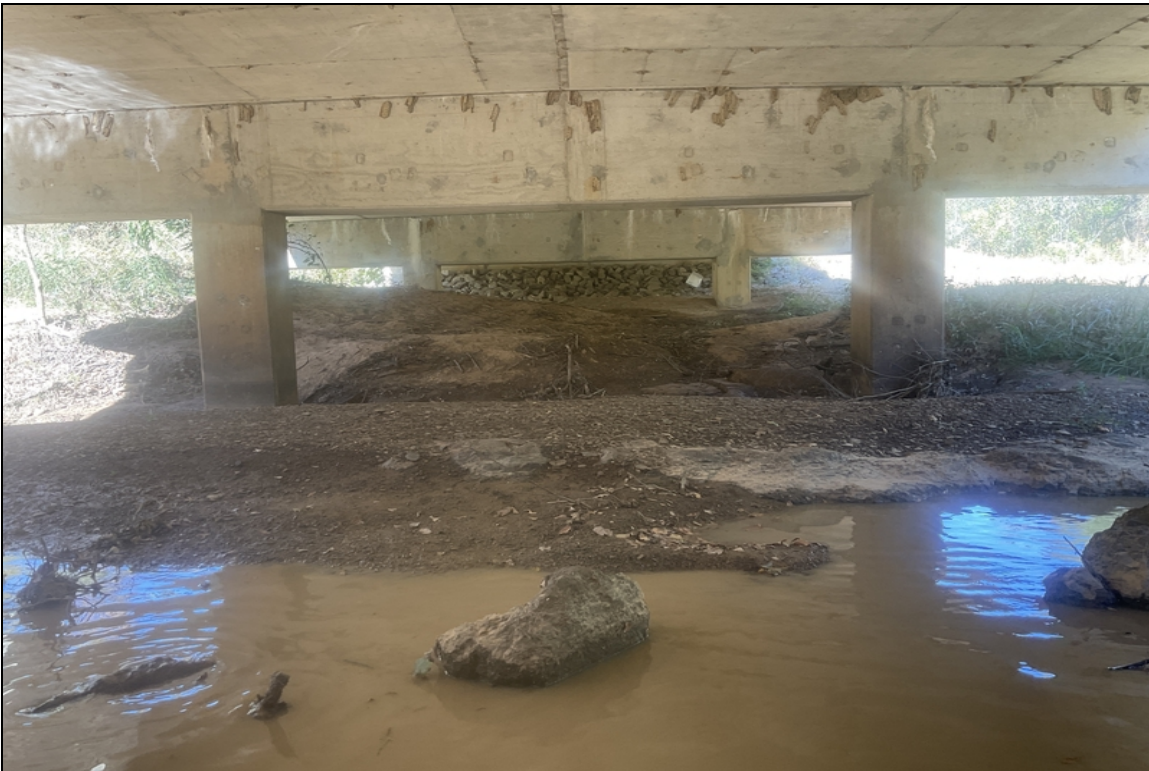
Bent # 3. Columns. Typical.

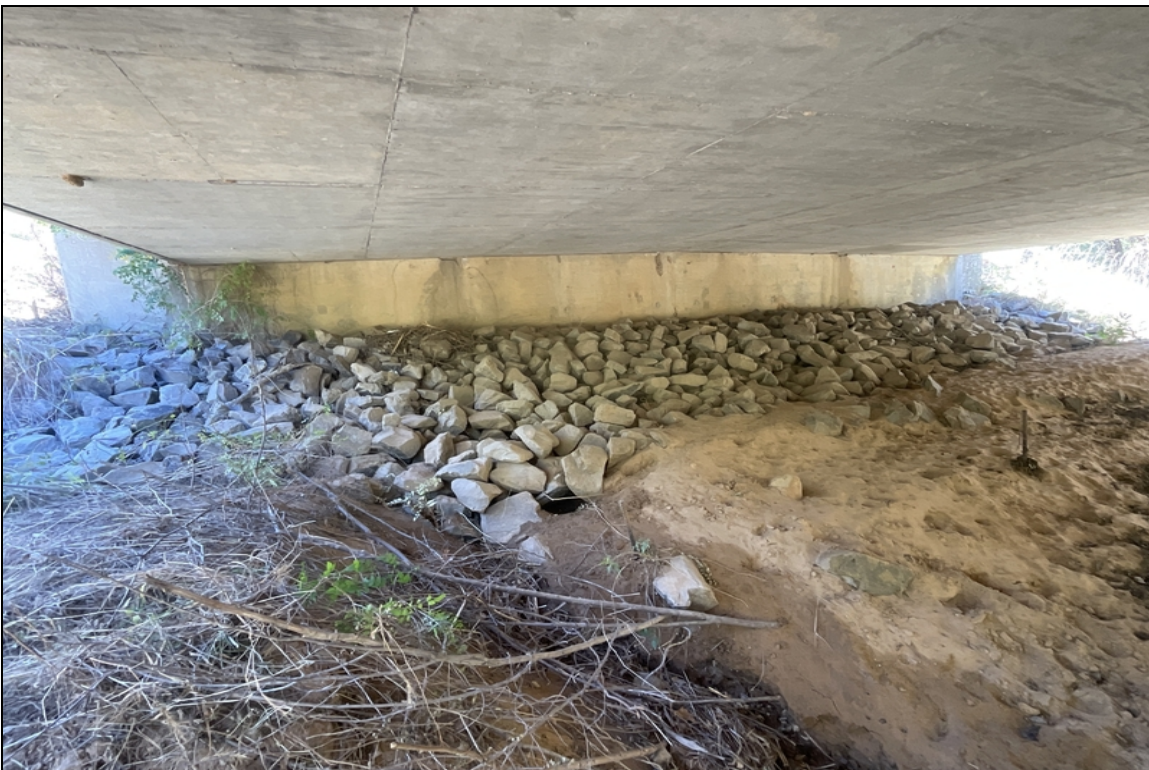
South abutment. Typical.

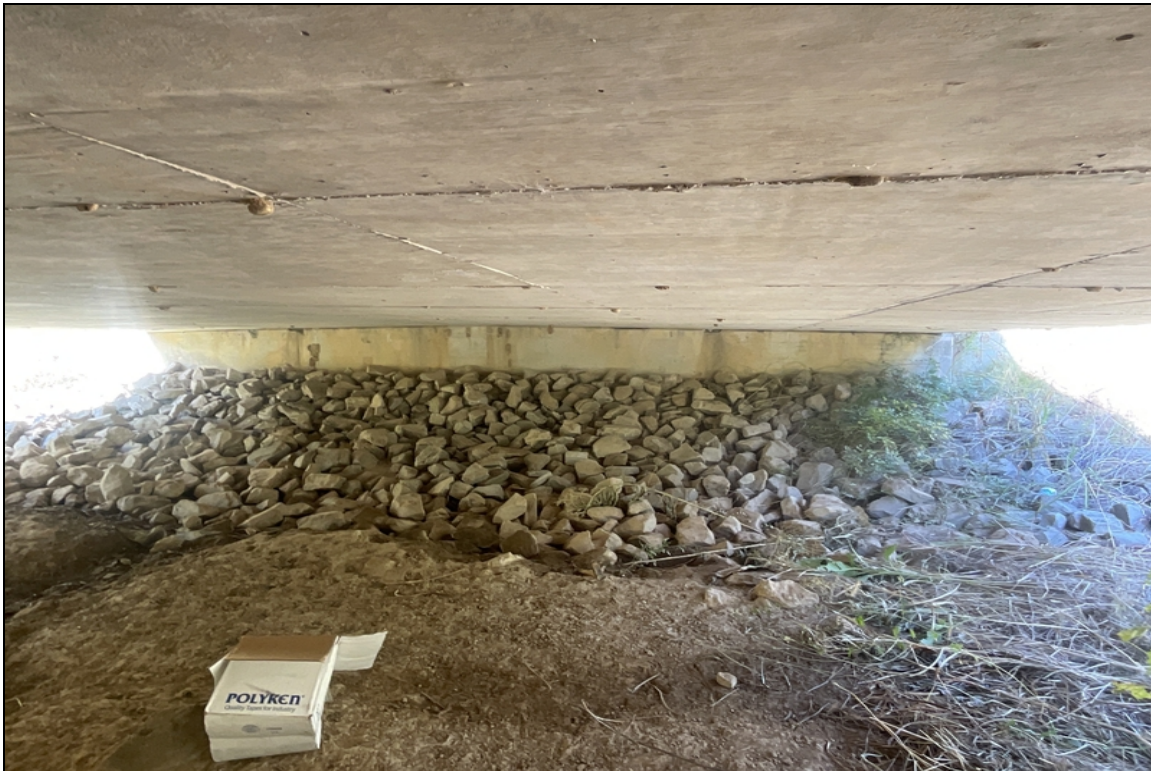
North abutment. Typical.

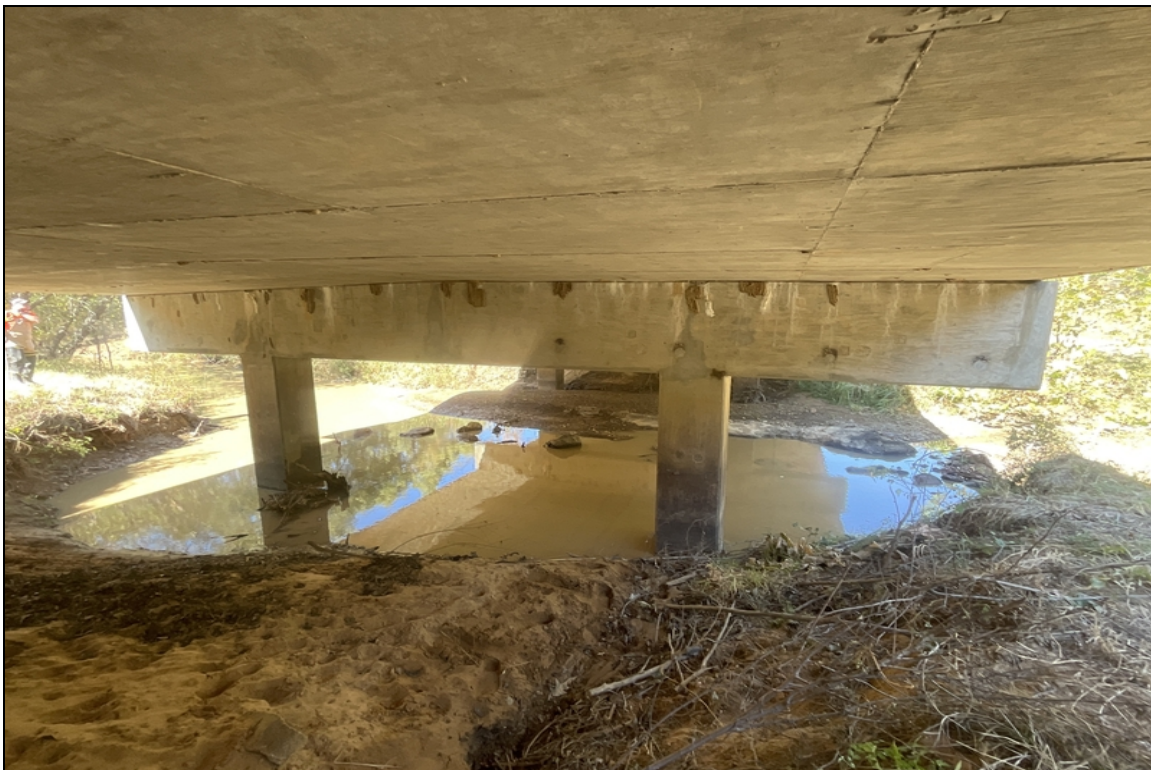
Bent # 2. Typical.

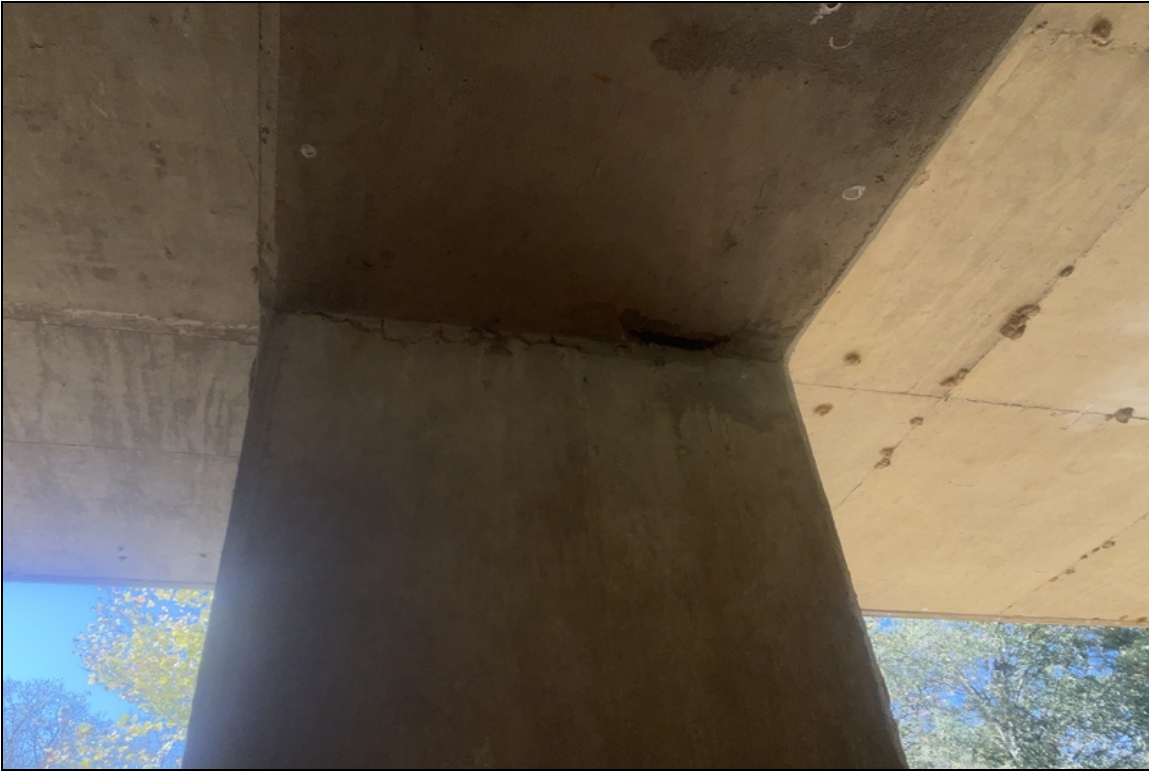
-There is a 6" spall with exposed reinforcing steel in the undersurface of Bent # 2 cap adjacent to Column # 1.

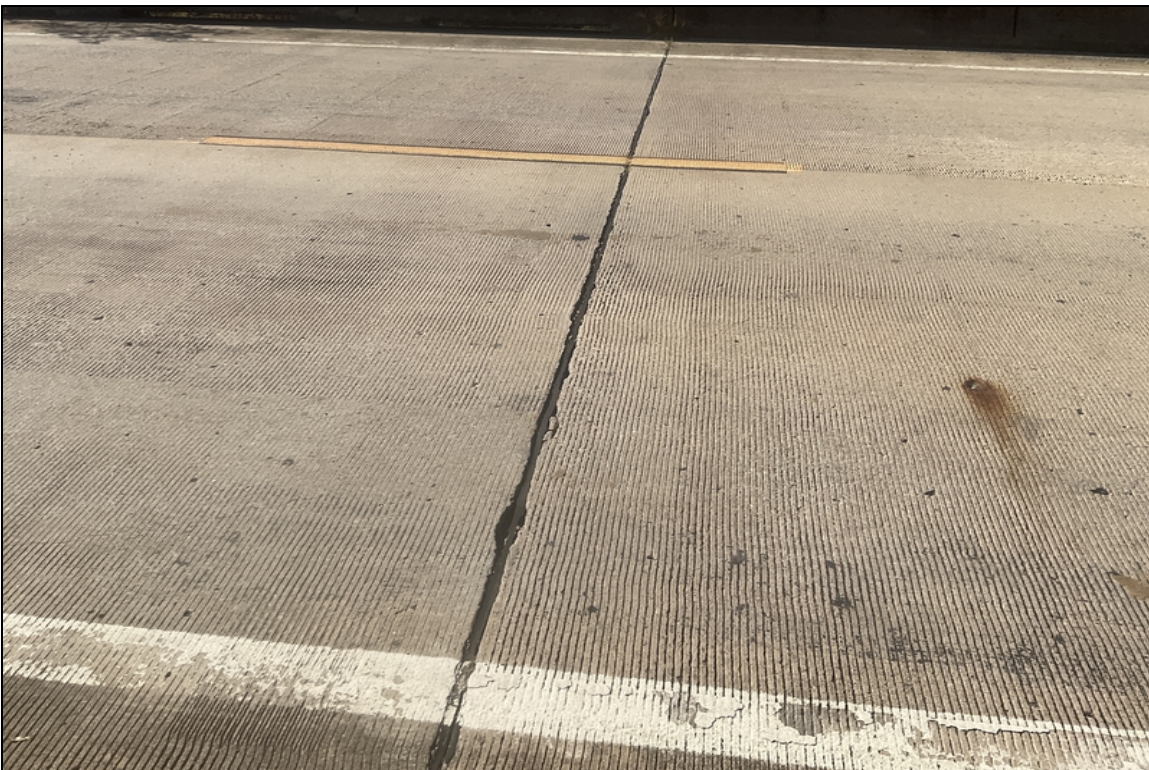
Leaking expansion joint sealant over Bent # 4.

Expansion joint sealant between the concrete slabs have adhesion failure the entire length of joints allowing water, dirt, and debris to enter the joints and leak onto the substructure.

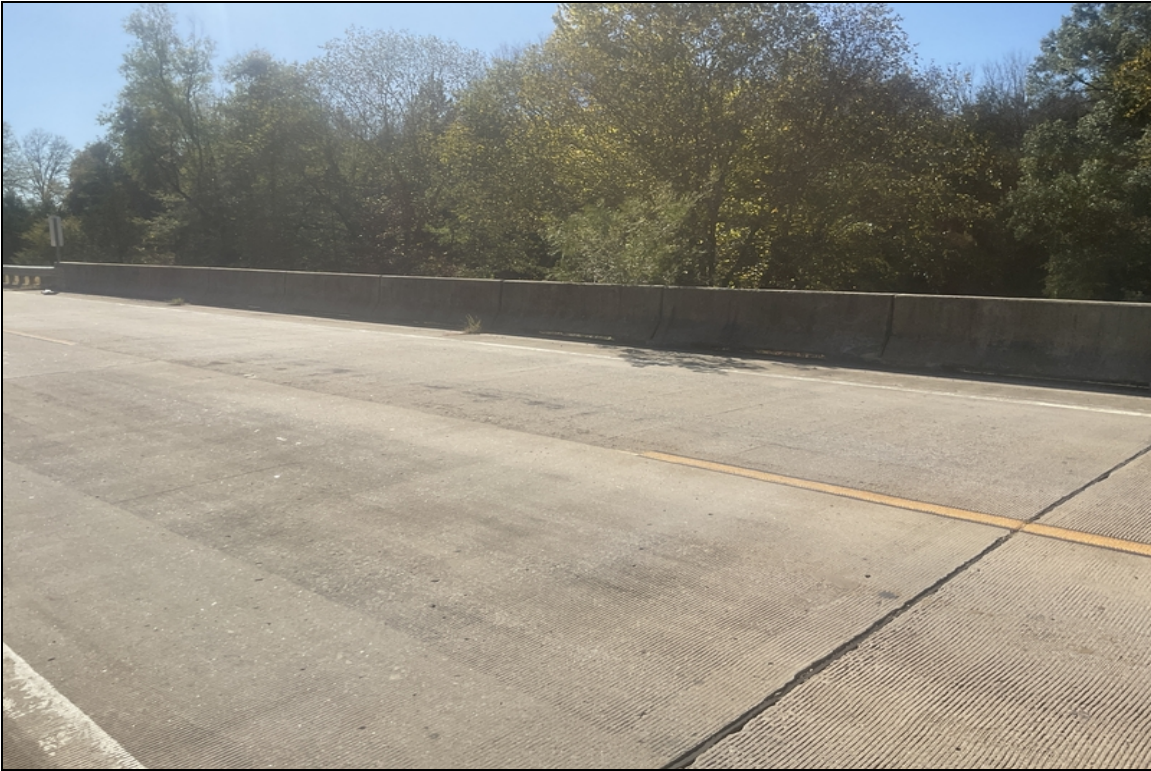
Left concrete bridge railing. Typical.

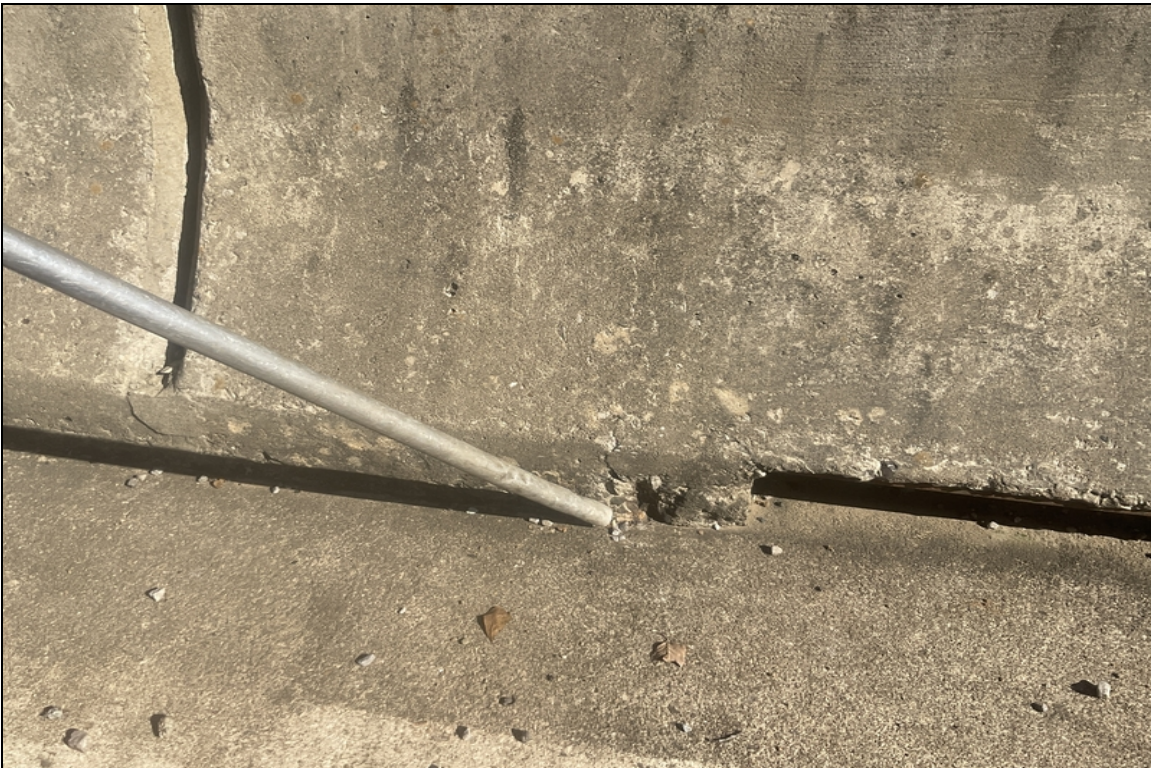
Spalls with exposed reinforcing steel at the base of concrete parapet. Span # 3. Right.

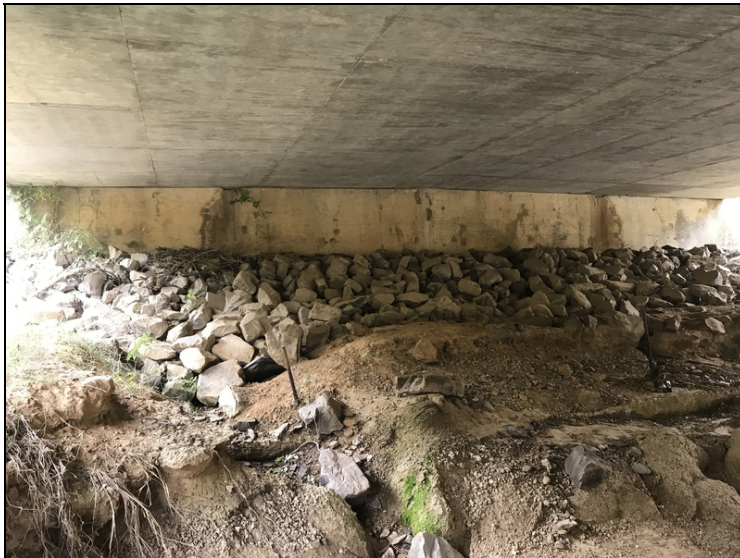
The South embankment has erosion that has displaced a portion of the rip rap.

South embankment-Erosion.

Type of Work: Repair

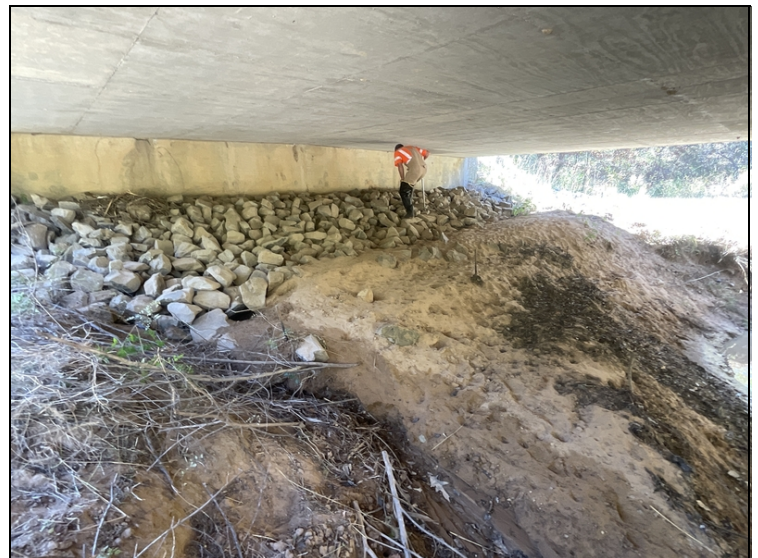
Minor rip rap displacement. South abutment.

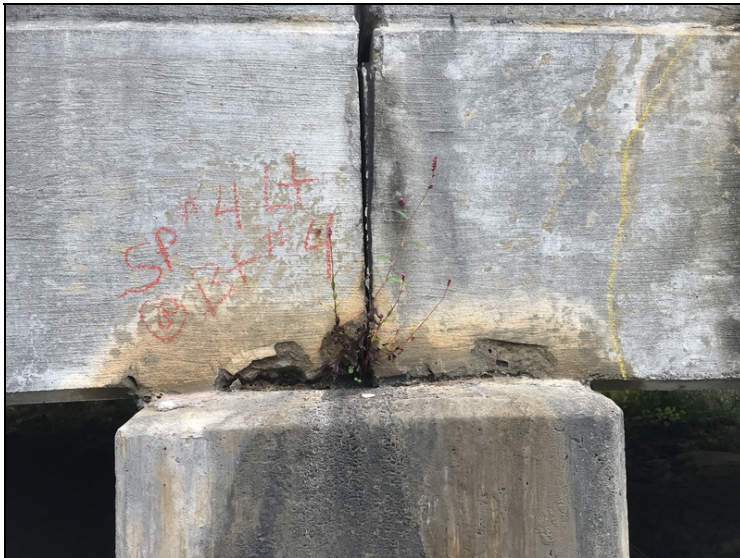
Span # 4, left-Shallow spalls in ends of slab on exterior sides over intermediate bents.

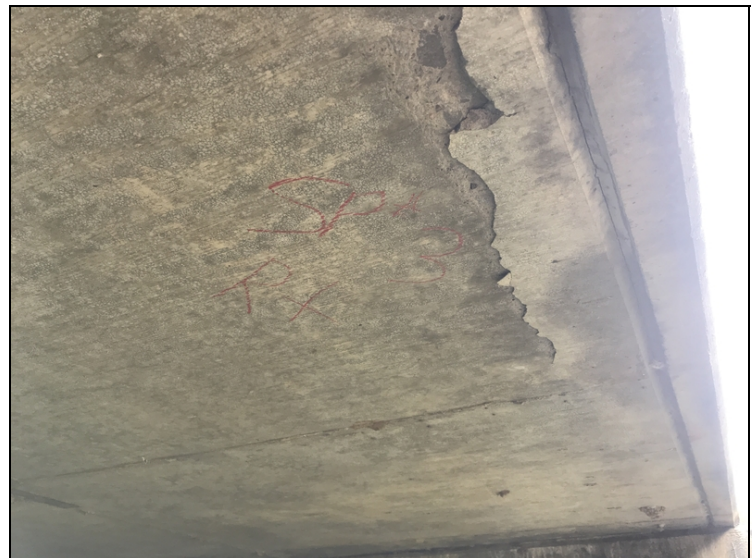
The undersurface of the slab has delaminated areas along the drip groove on the right side in span # 3.

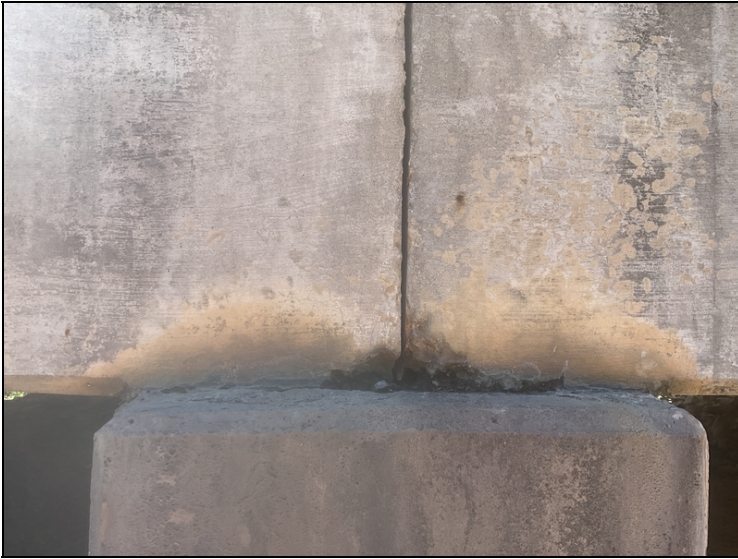
Minor concrete deterioration in edge of slab over Bent # 4 Right.

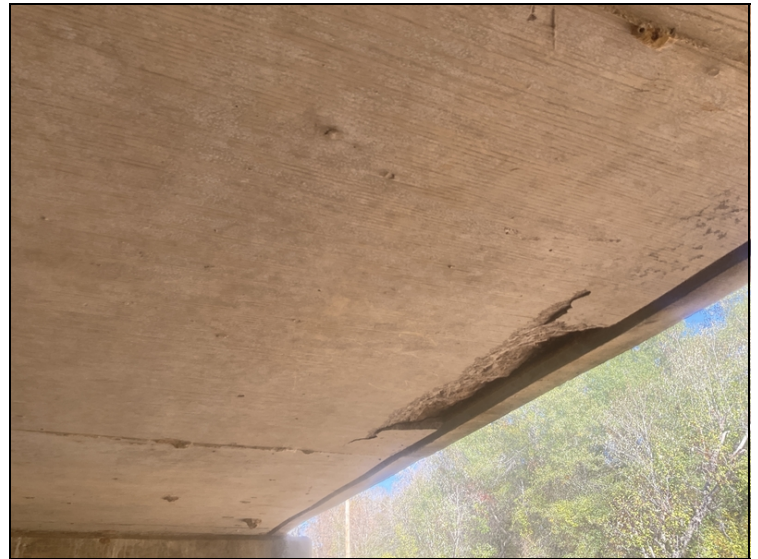
Span # 3. Spall with exposed reinforcing steel in the Right drip groove.

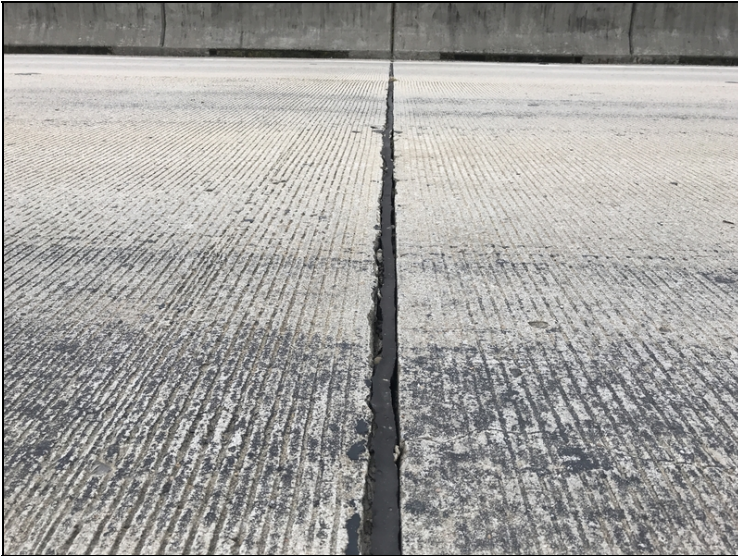
Expansion joint over bent # 3-Adhesion failure.

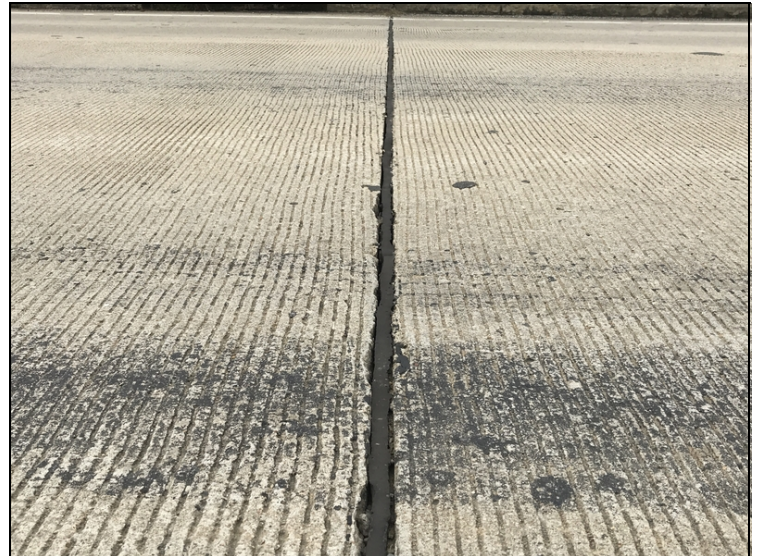
Bent # 2 expansion joint-Adhesion failure.

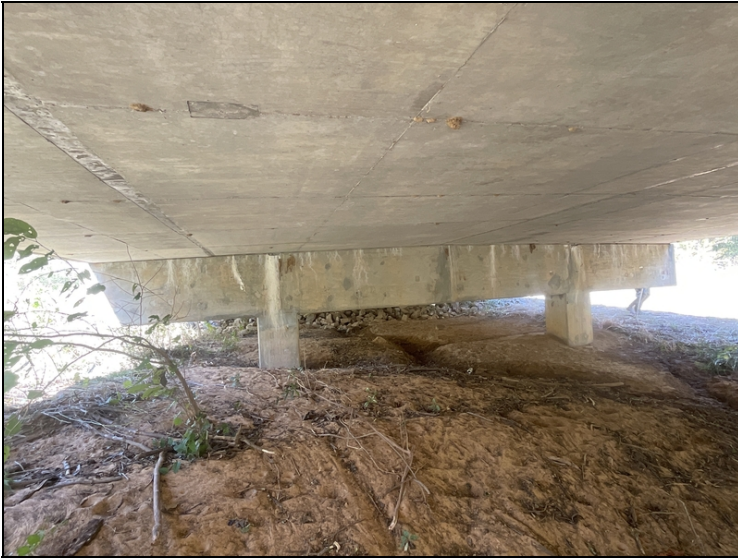
Leakage on bent # 4 cap.

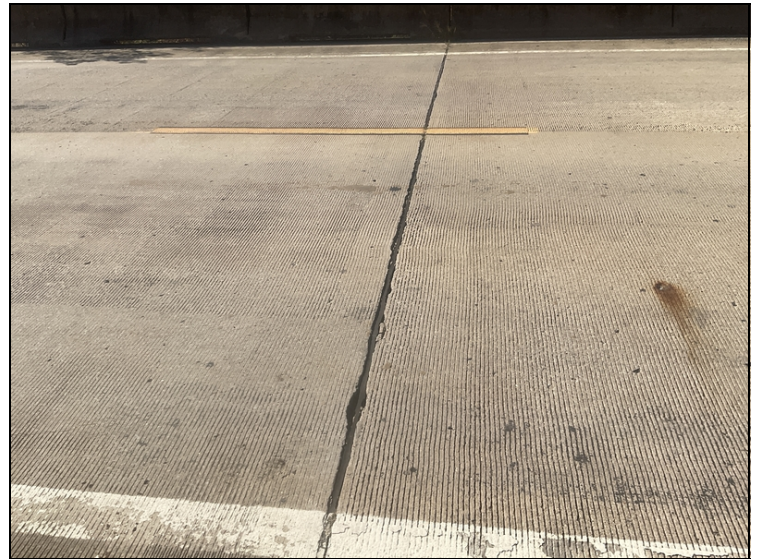
Expansion joint seal over Bent # 4. Leakage.

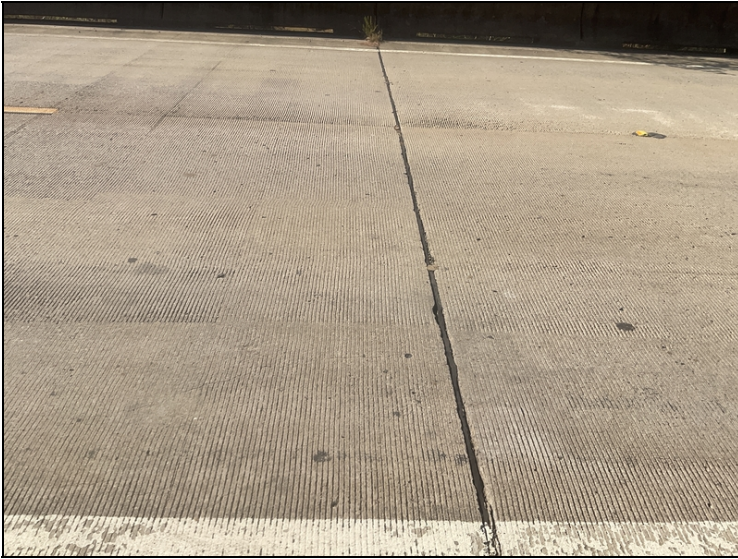
Leaking expansion joint sealant over bent # 3.

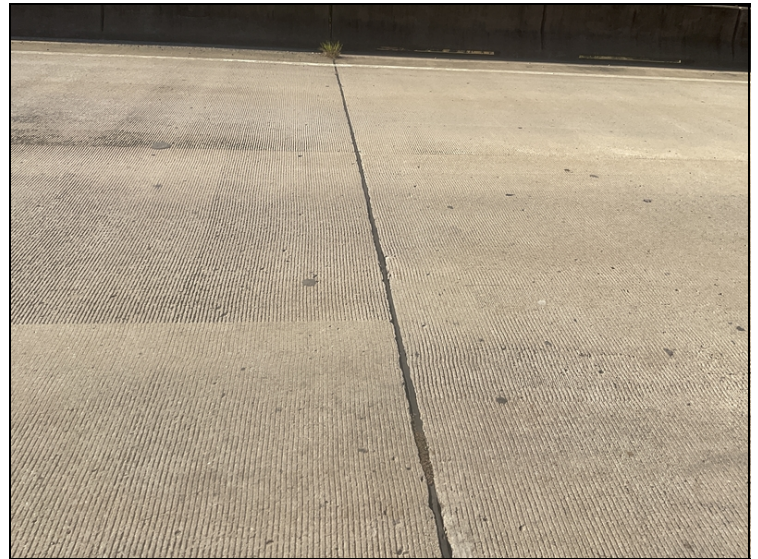
Leaking expansion joint sealant over bent # 2.
