(4) Place Code	0
(6) Features Intersected	Flat Rock Creek Seb. Co.
(7) Facility Carried	State Highway 96
(9) Location	8.10 MI N SH 10-1
(11) Mile Point	7.97 mi

Asset #06559(Routine)

District: 04, County: 131

Team Lead: Jeff Jones, Inspection Date: 12/01/2022

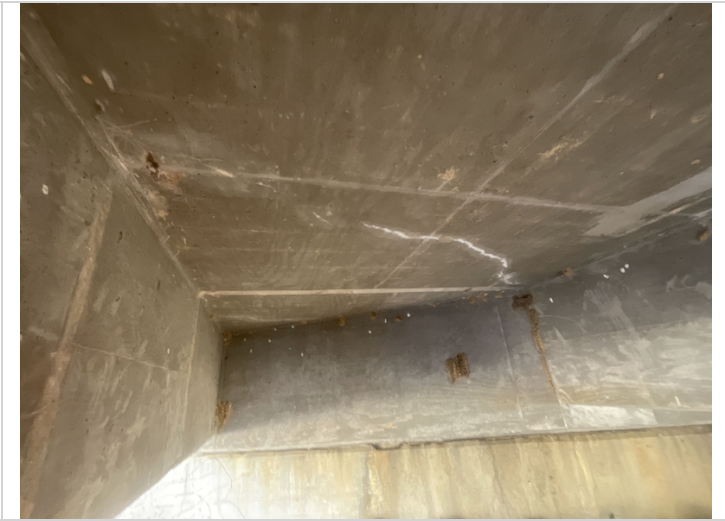
Span # 1. Right. Diagonal crack with efflorescence visible from the undersurface of the top flange.

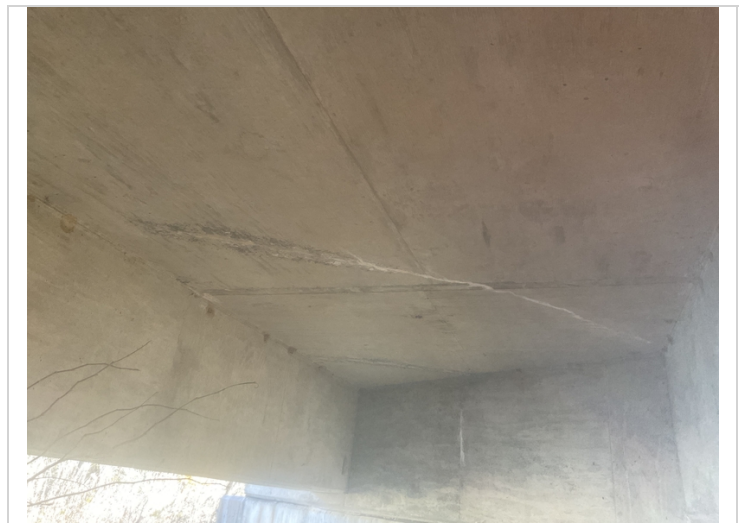
Span # 4. Diagonal cracks with efflorescence in the undersurface.

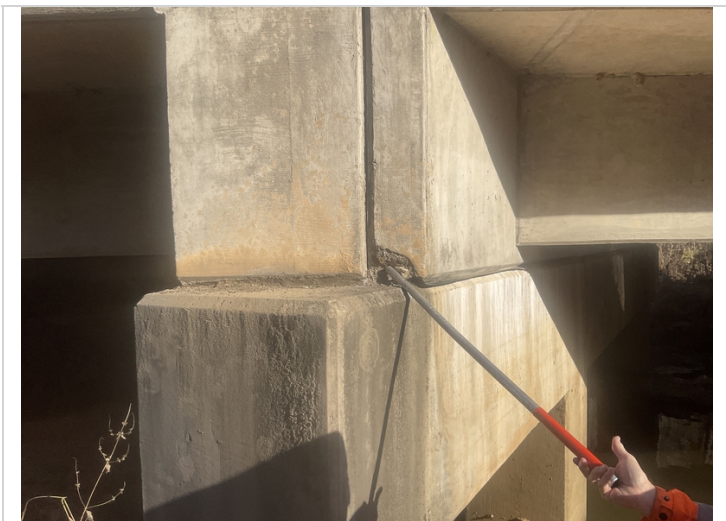
Span # 3. Left end diagram over Bent # 4. Concrete deterioration.

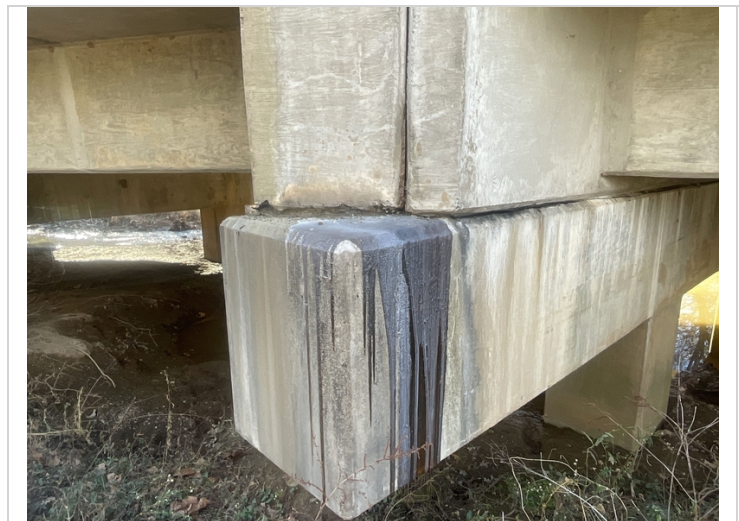
-There is minor concrete deterioration in the exterior edges of the end diaphragms over the intermediate bents.
Epoxy leakage on the cap - Right side of Span # 3 over Bent # 4.

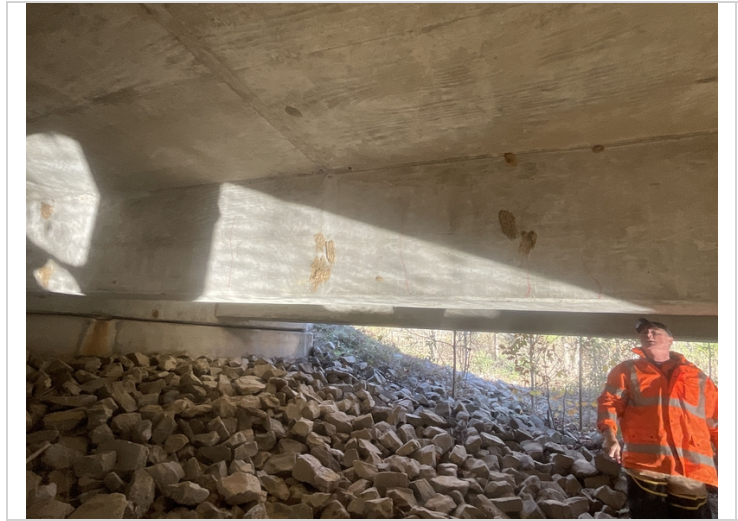
Span 4 - Vertical flexure cracks in the superstructure.
Typical.

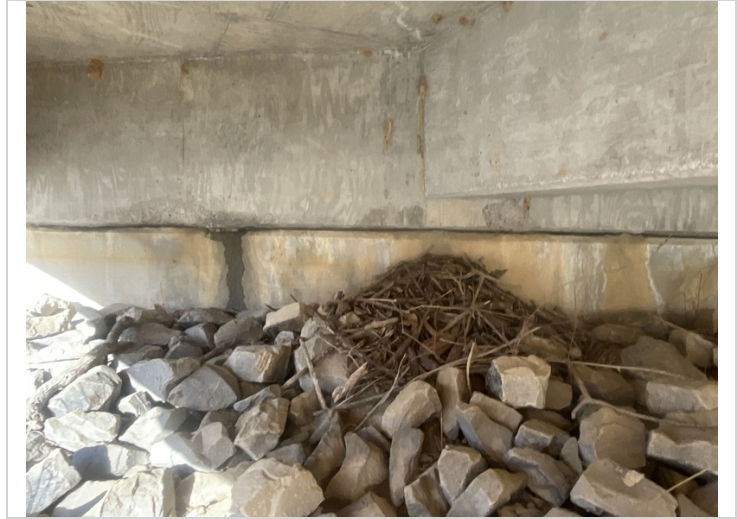
Spalls with no exposed reinforcing steel in the end diaphragm over Bent # 5.

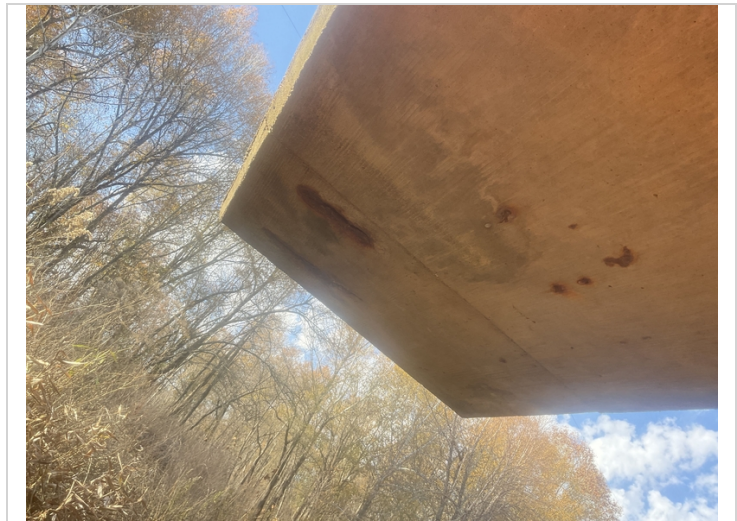
(234) -The intermediate bent caps have vertical hairline cracks at variable spacing. -Bent caps have several vertical hairline cracks between the columns during this inspection. -The Left side of Bent # 2 cap has two 6" long shallow spalls with exposed reinforcing steel visible from the undersurface of the cap. The exposed reinforcing steel has initial section loss during this inspection. -Bent caps have efflorescence where the deck joints leak water onto the caps.

Left overhang of Bent # 2. Spalls with exposed reinforcing.

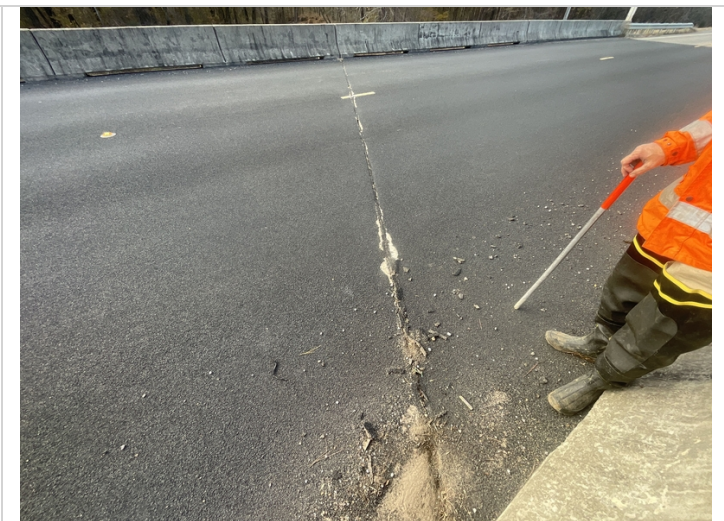
The pourable type expansion joint sealant is deteriorated with adhesion failure the full length of the joints.

The joints leak water onto the substructure.

Expansion joint over Bent # 3. Polymer overlay is peeling off of the joint and adjacent deck.

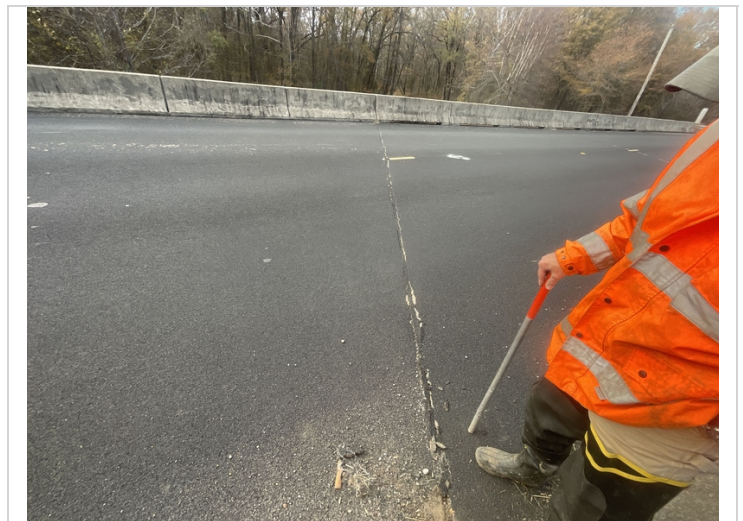
Expansion joint over Bent # 2 polymer overlay is peeling off of the joint and adjacent deck.

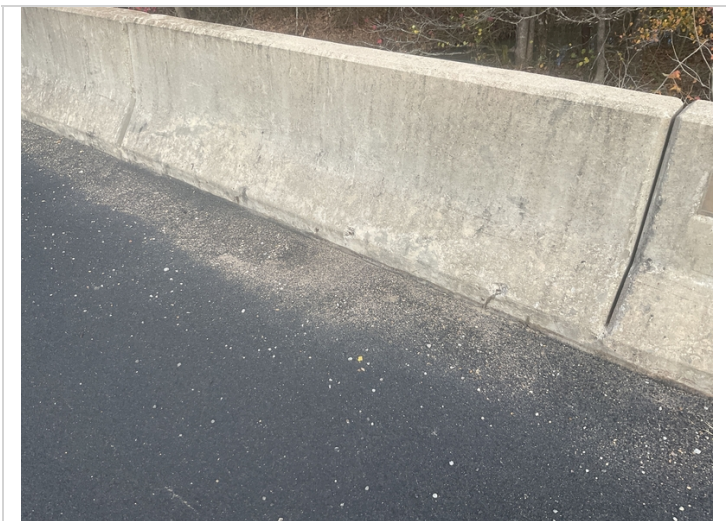
Shallow spalls with exposed reinforcing steel at the base of the parapet.

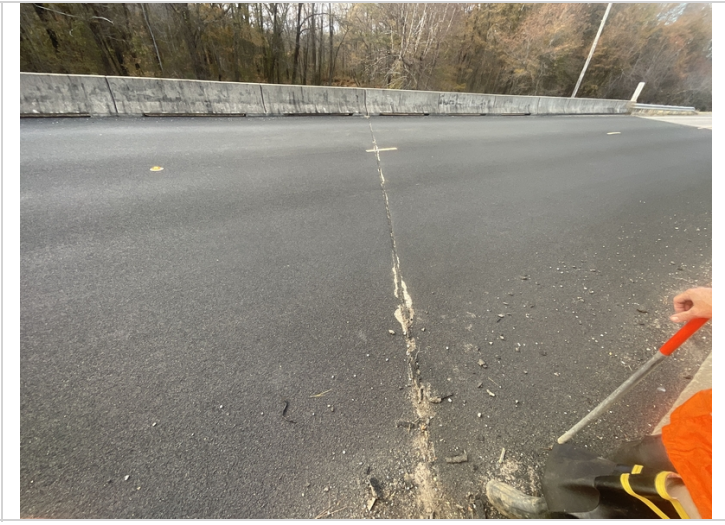
12/01/2022 - JCJ & TJL - The polymer overlay material is peeling off of the joint and adjacent deck.

The pourable type expansion joint sealant is deteriorated with adhesion failure the full length of the joints.

The joints leak water onto the substructure.

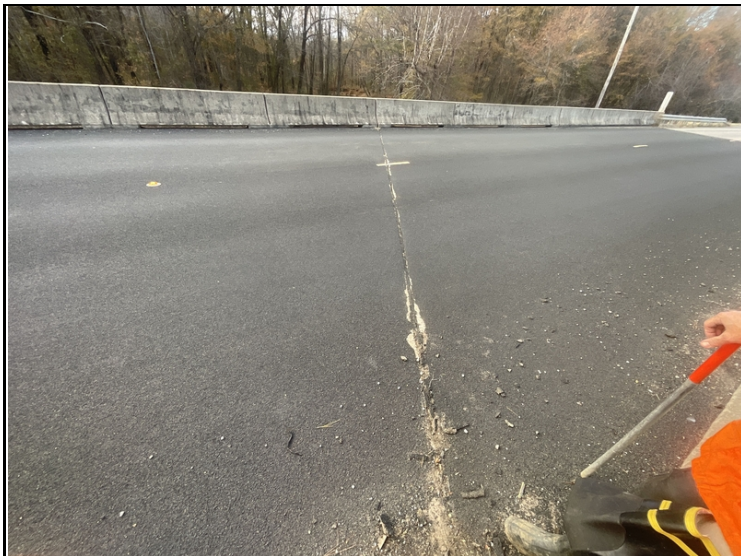
12/01/2022 - JCJ & TJL - The polymer overlay material is peeling off of the joint and adjacent deck.

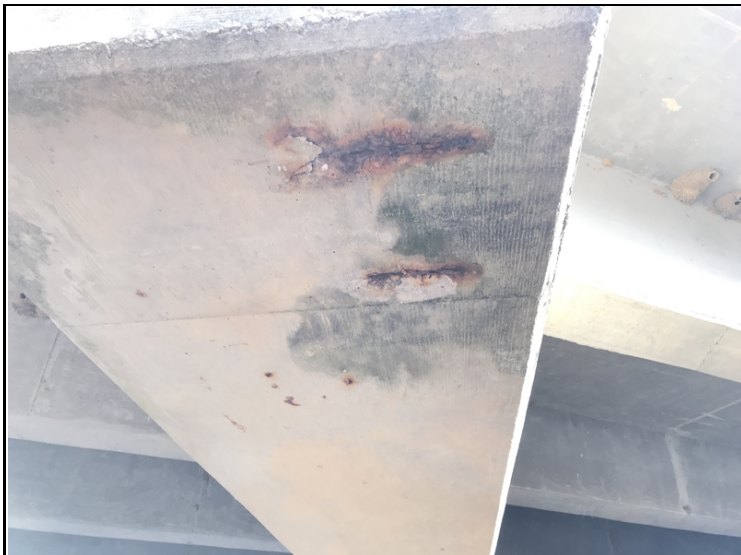
The undersurface of bent # 2 cap has two 6 inch long shallow spalls with exposed reinforcing steel in the left cantilever portion of the cap. The exposed reinforcing steel has initial section loss during this inspection.

The left side of bent # 2 cap has two 6 inch long shallow spalls with exposed reinforcing steel visible from the undersurface of the cap. The exposed reinforcing steel has initial section loss during this inspection.

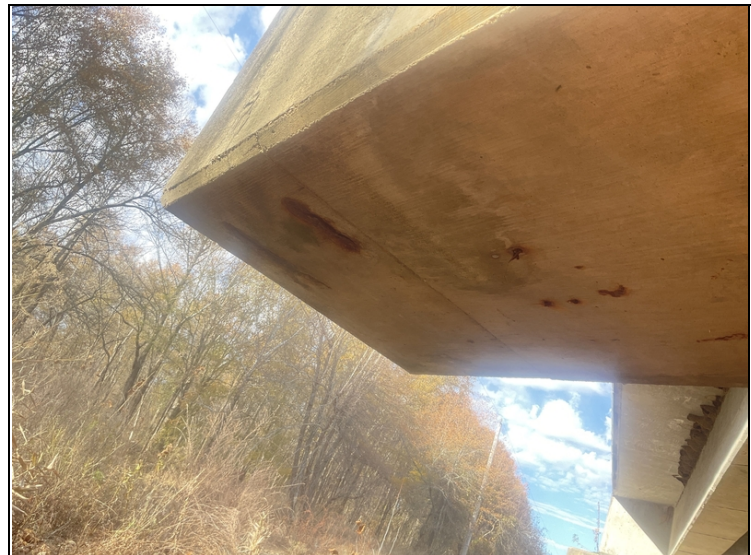
Spalls with exposed reinforcing steel in the Left end of Bent # 2.

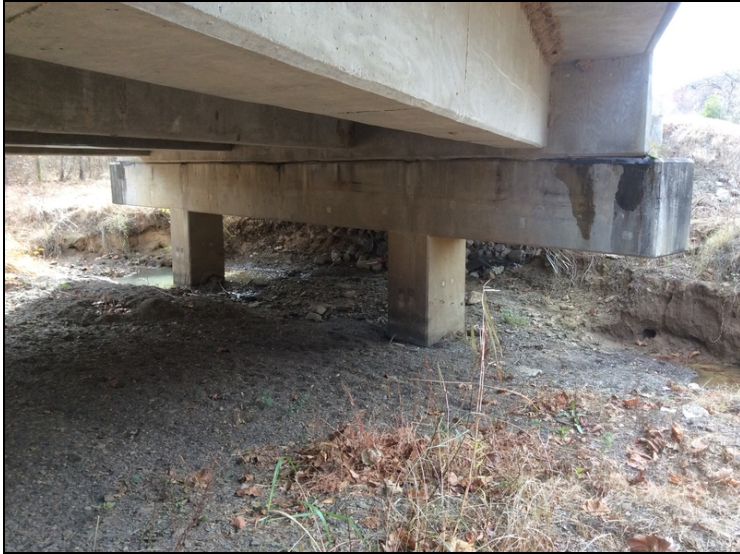
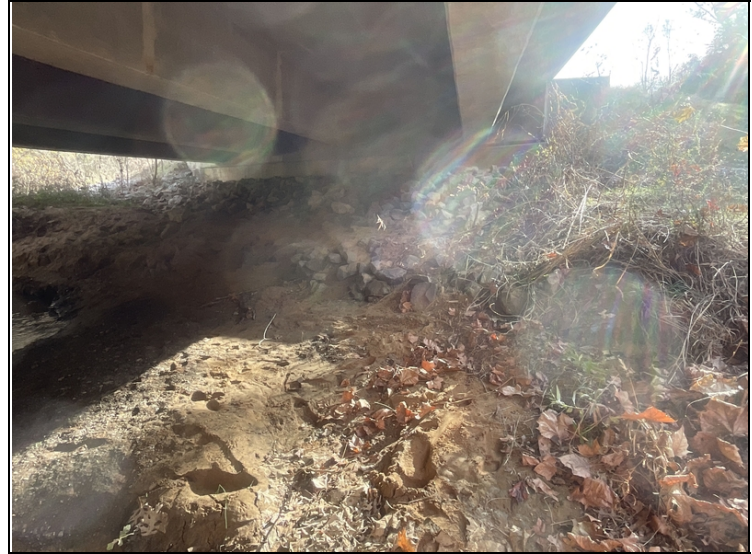
The South embankment has erosion with loss of rip-rap.
The North embankment has minor erosion with exposed filter fabric.

South embankment. Minor erosion.

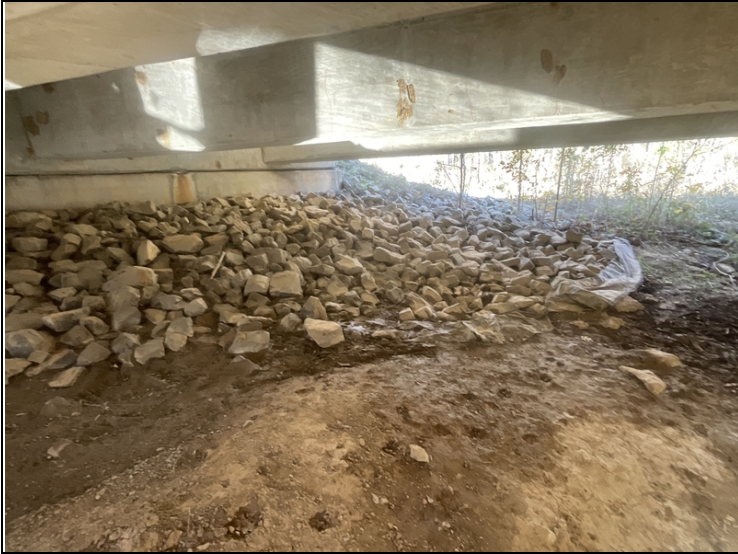
Embankment erosion with exposed filter fabric at the North embankment.
