Asset #03488(Routine)

US 71-Wash Co. over West Fork White River

Location: 0.10 Mi. So. of Greenland

Team Lead: Eric West, Inspection Date: 07/31/2023

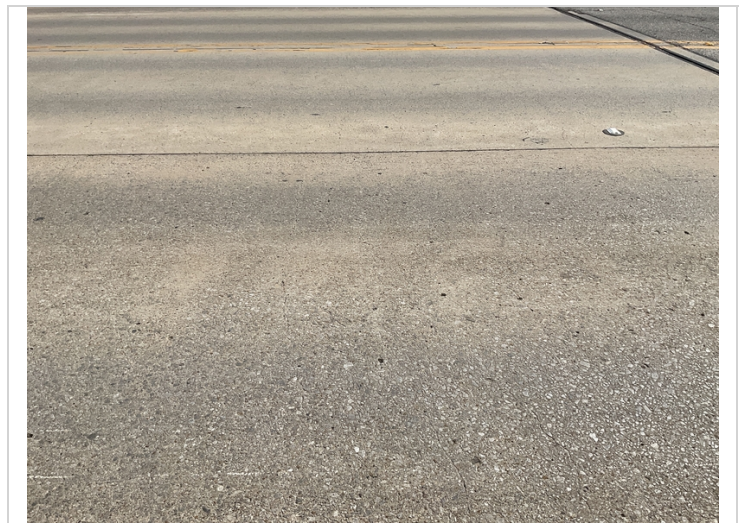
Sealable deck cracking.

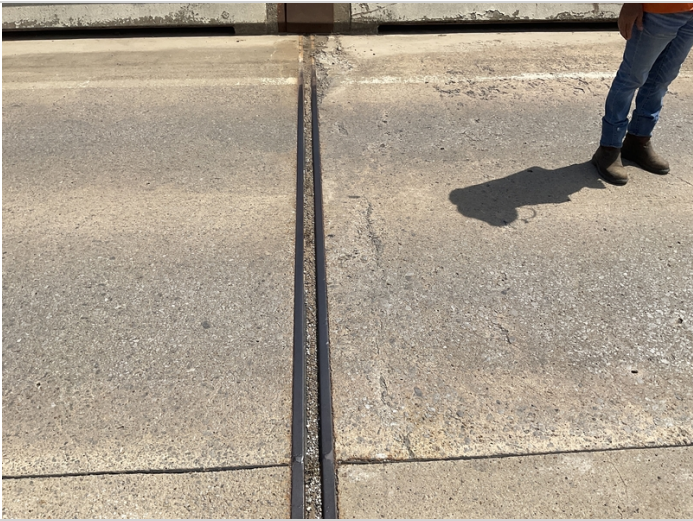
Span # 1 outside lane and shoulder has delaminated concrete and a 5" long area that is breaking apart and extend above the driving surface approximately 1" adjacent to bent # 2.

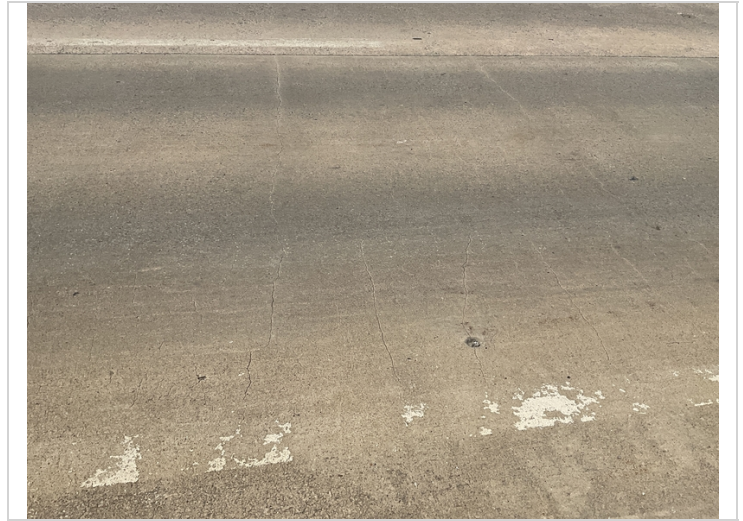
Span # 7 deck cracking.

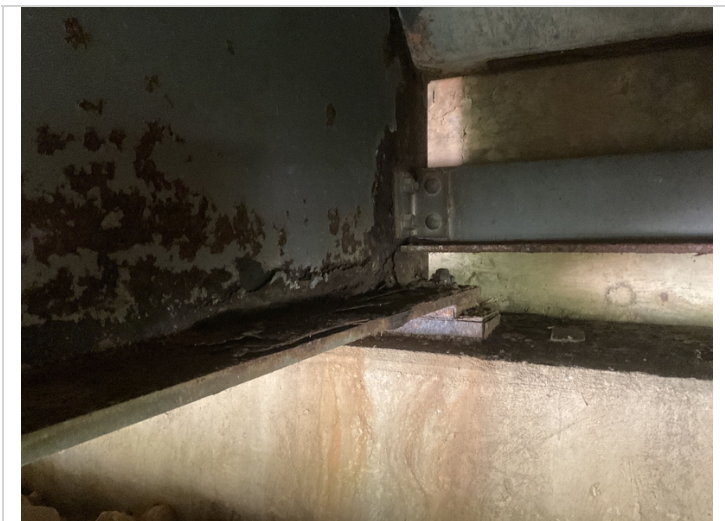
Abutment # 1 beam # 5 active corrosion with pack rust.

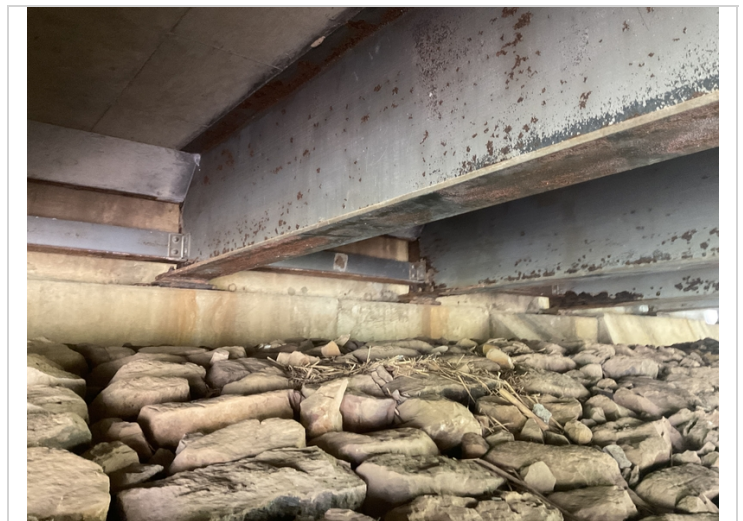
Span # 1, Beams # 3 - 7 have active corrosion, pack rust and up to 1/8" section loss to the webs and bottom flange over Abutment # 1.

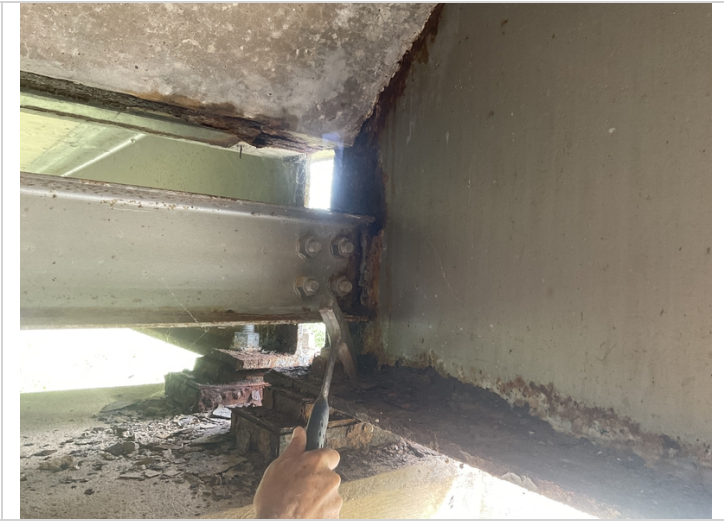
Span # 1, Beam # 9 with up to 3/16" section loss below the expansion dam.

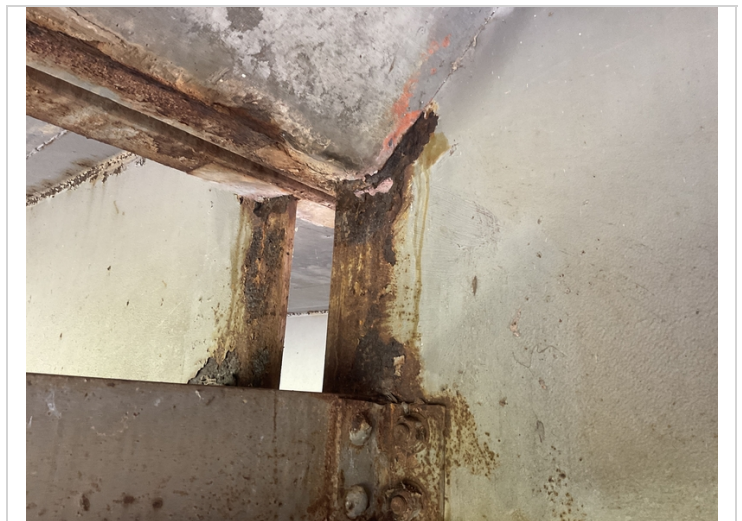
Span # 4, beam # 5 at bent # 5 has a 3" X 1" hole rusted through top of web at the expansion dam juncture.

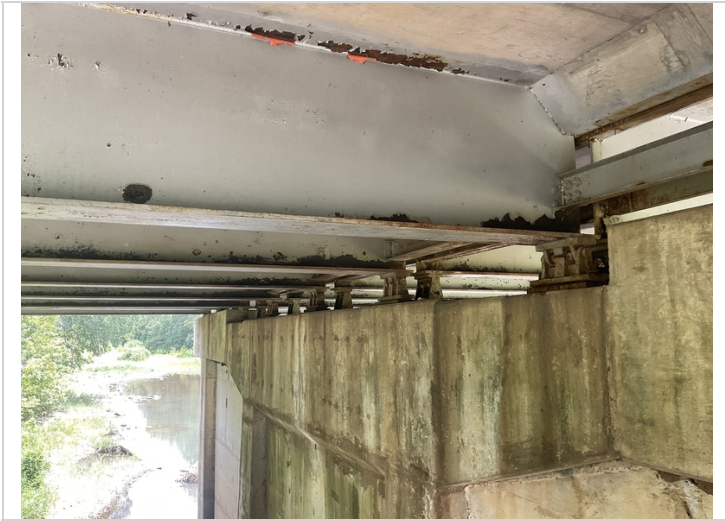
Span # 6 Bent # 6 active corrosion, pack rust and section loss.

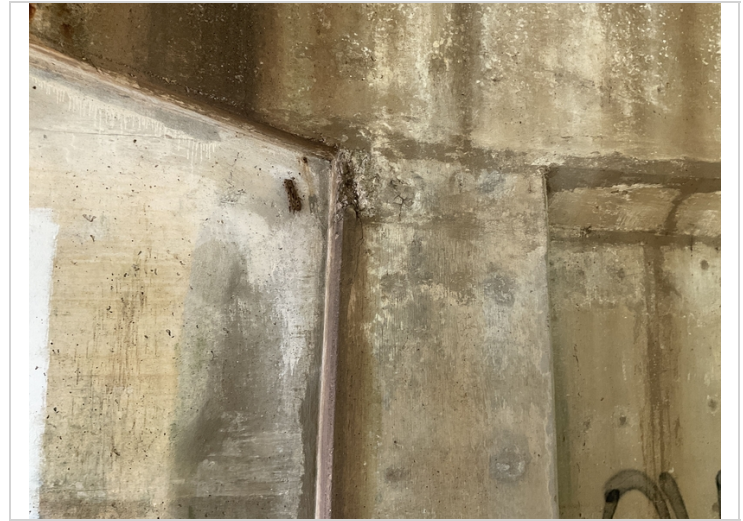
Bent # 3, column # 2 Lt edge of the backface has has concrete deterioration and cracking at the cap juncture.

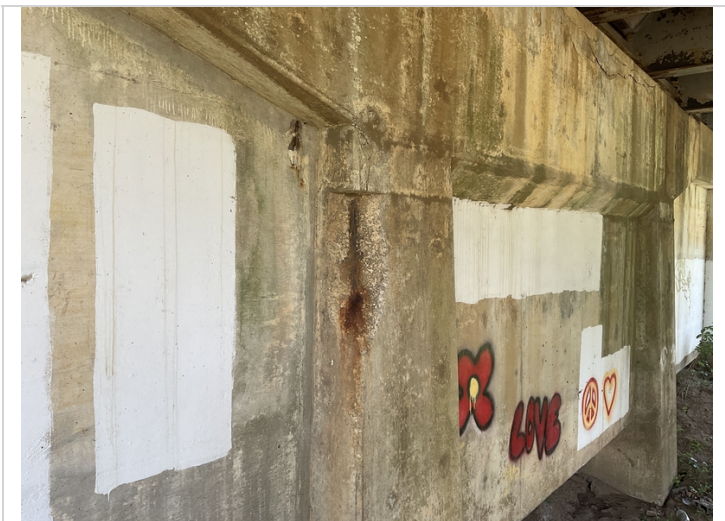
Bent # 3, column # 3 aheadface has a 4.5' tall spall with exposed reinforcing steel. Exposed reinforcing steel has initial section loss.

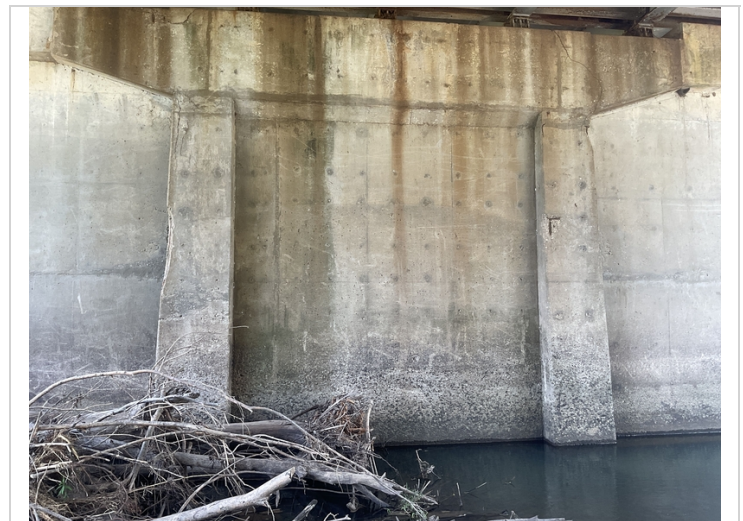
Bent # 5, columns # 2 & 3 backface have multiple spalls with exposed reinforcing steel. Exposed reinforcing steel has active corrosion and pack rust.

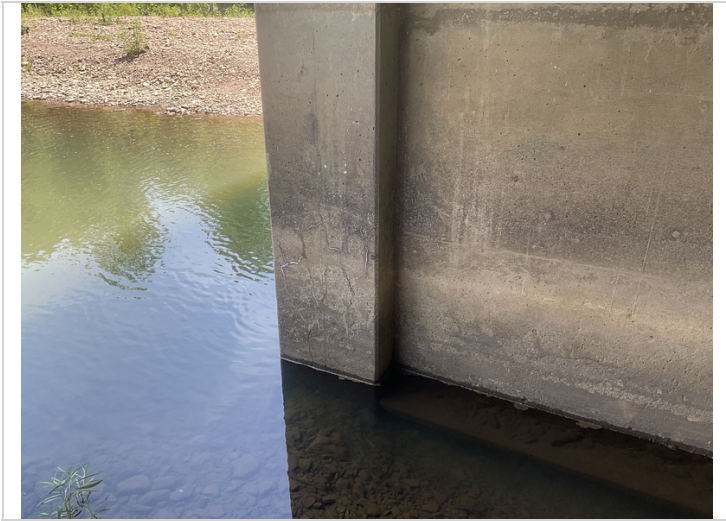
Bent # 5, column # 4 has mapcracking with moderate width vertical cracks and efflorescence buildup in the lower portion of the column.

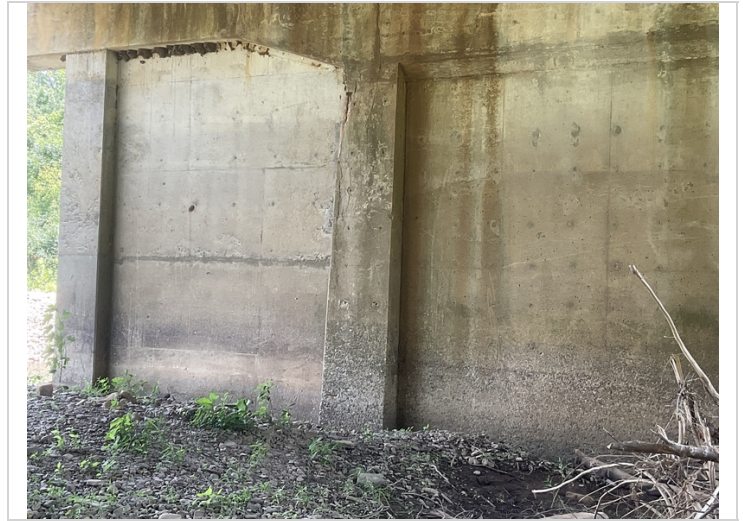
Bent # 6, column # 3 aheadface has an 8' height delaminated/spalled area with exposed reinforcing steel.

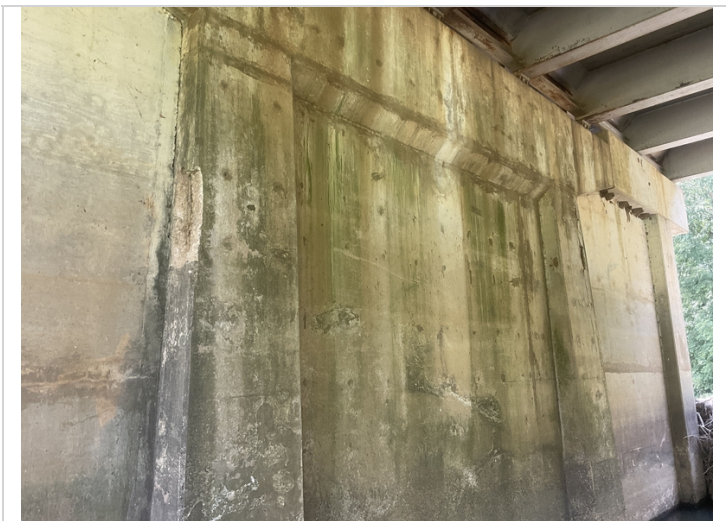
Bent # 6 column # 2 & 3 spalling with exposed reinforcing steel.

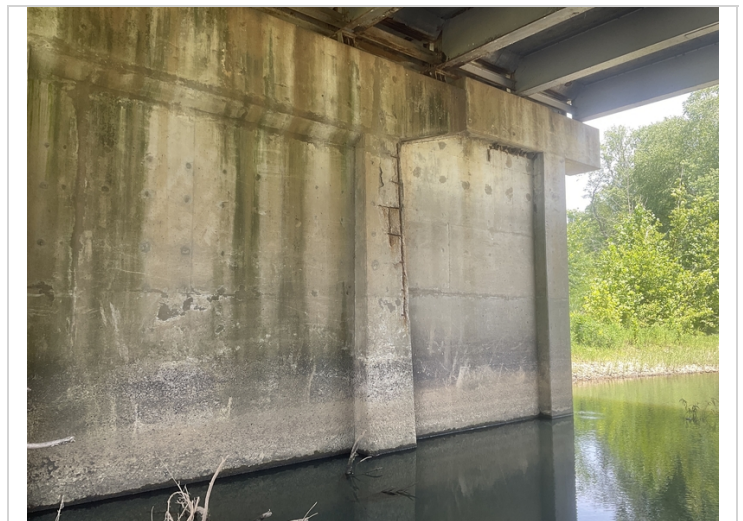
Bent # 6, column # 3 backface has a 10' tall spall with exposed reinforcing steel. The exposed reinforcing steel has active corrosion and pack rust.

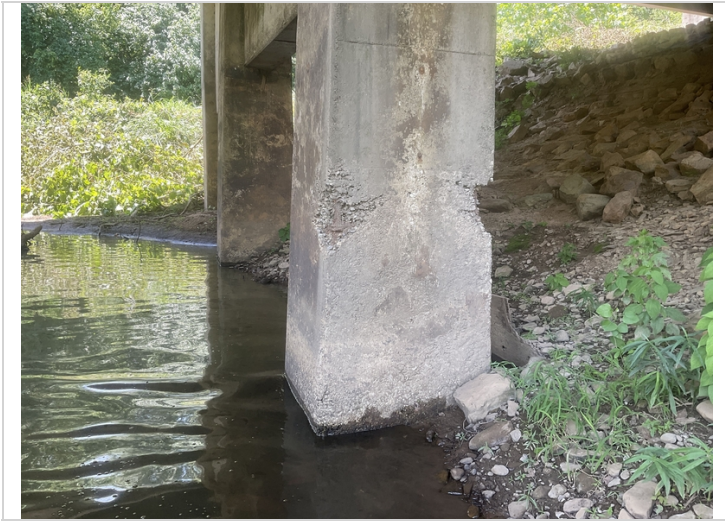
Bent # 7, column # 3 has two 12" tall areas of honeycomb with exposed primary reinforcing steel located 4' above base of column. The exposed steel has corrosion with initial section loss.

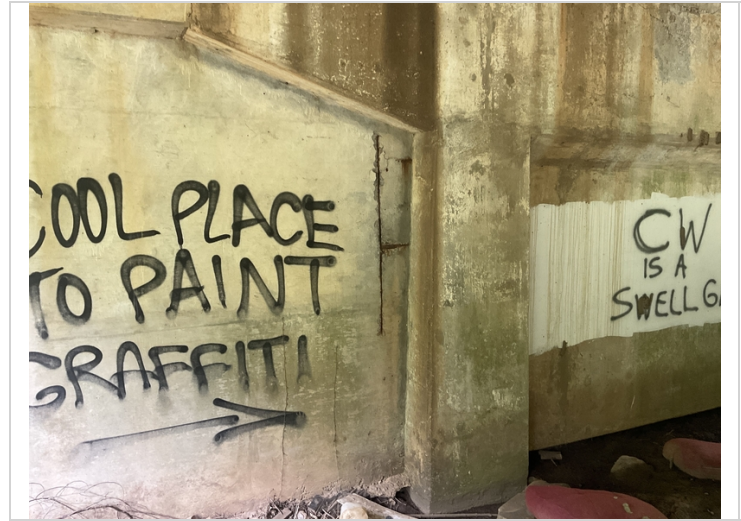
Bent # 2 Lt backface adjacent to column # 2 has a 5' tall X 1' wide area of spalling with exposed reinforcing steel.

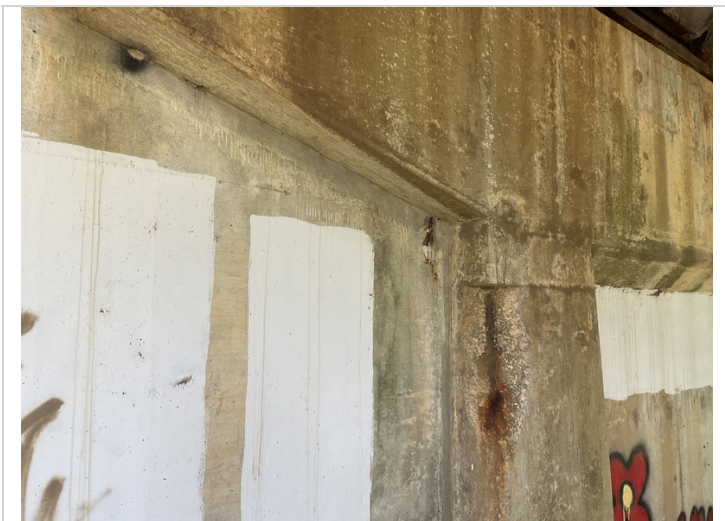
Bent # 3 Rt aheadface has a 6" spall with exposed reinforcing steel adjacent to the top of the Rt edge of column # 3. The exposed reinforcing steel has active corrosion and pack rust.

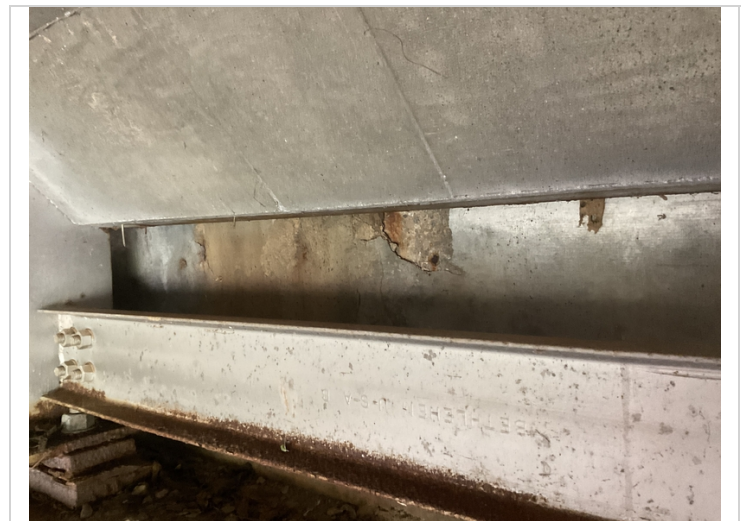
Abutment # 1, bay # 1 spalls with exposed reinforcing steel in the back wall.

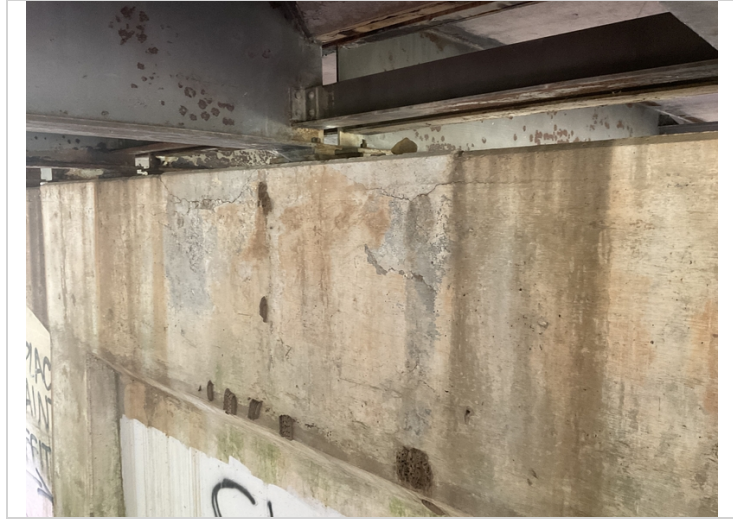
Bent # 2 backface has several moderate sized concrete delaminations and 2 moderate / wide width cracks in the vertical face of the cap located in the original portion of the cap located between beams # 4 - 6.

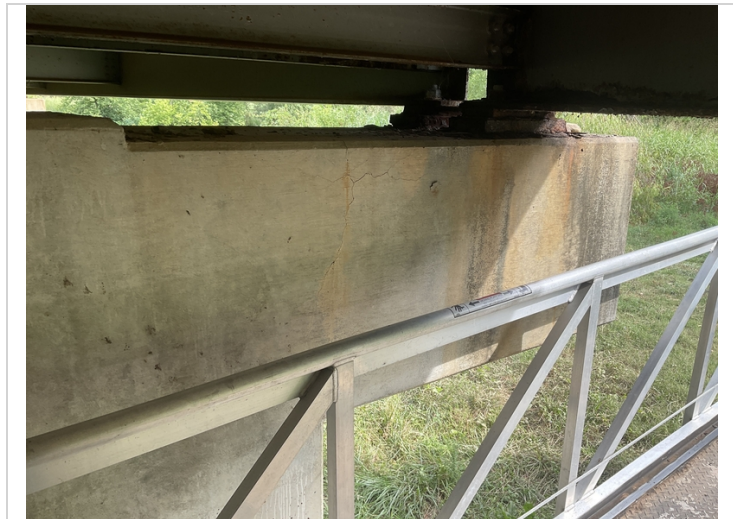
Bent # 2 Rt end of the cap has a semi diagonal crack over the exterior column with horizontal cracks propagating from the diagonal cracking.

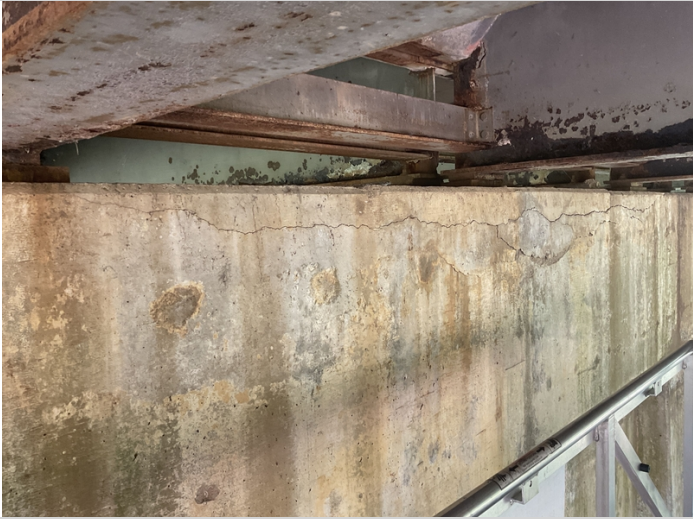
Bent # 3 cap aheadface under beams # 4 - 6 has an approximately 12' long X 13" wide concrete delamination in the vertical face of the cap.

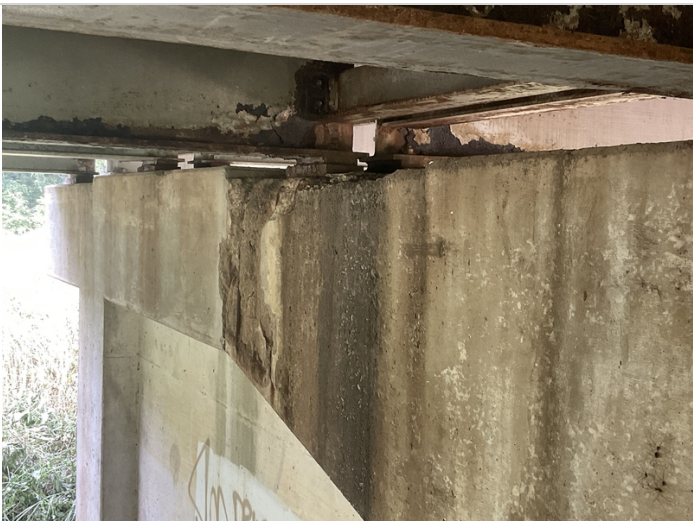
Bent # 3 beam # 3 cap backface spalling with exposed reinforcing steel.

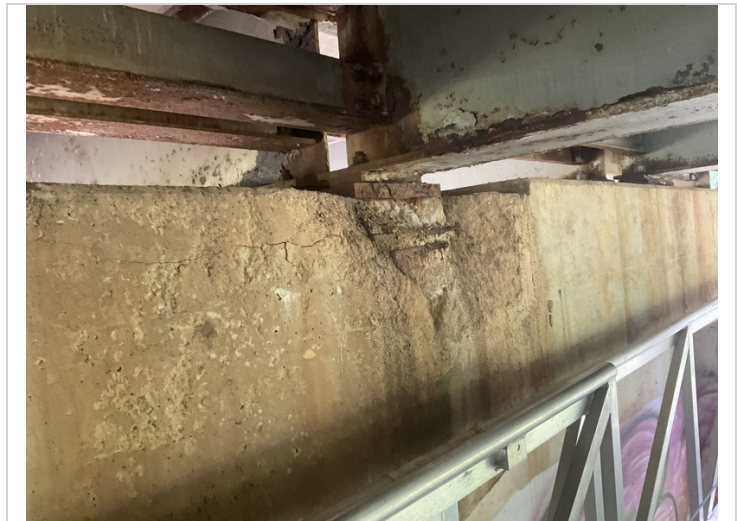
Bent # 3 beam # 7 cap backface spalling with exposed reinforcing steel.

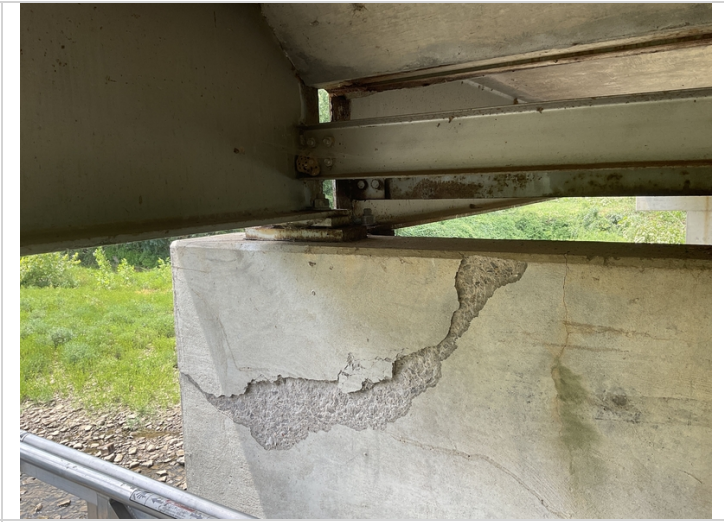
Bent # 4 Lt cap backface with an approximately 4' long X 30" tall concrete delamination that extends from the Lt end of the cap under beam # 1 and appears to extend approximately 2" under the bearing.

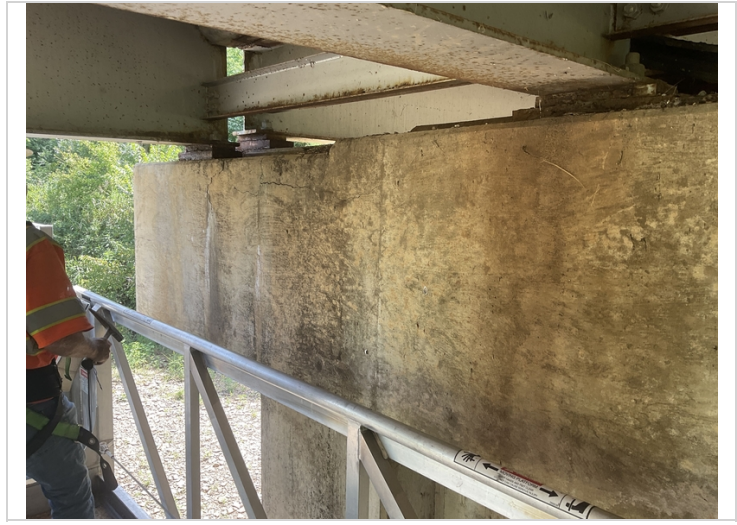
Bent # 4 Rt aheadface end of the cap under bay # 8 has a 5' long area of vertical and horizontal cracks with delaminated concrete and light efflorescence buildup in the vertical face of the cap.

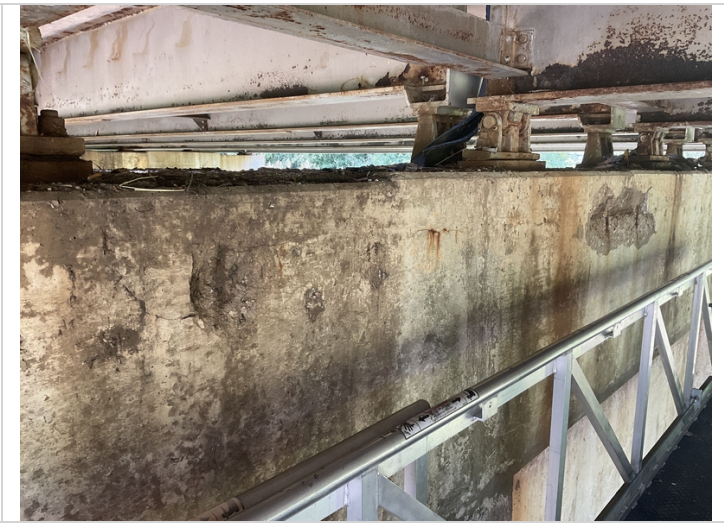
Bent # 4 cap aheadface has a moderate width horizontal crack under beams # 5 - 7 with random delaminations along the crack and a 4' long spall with exposed reinforcing steel under bay # 5 and a 8" spall with exposed reinforcing steel under bay # 6. The exposed reinforcing steel has active corrosion and approximately 20% section loss.

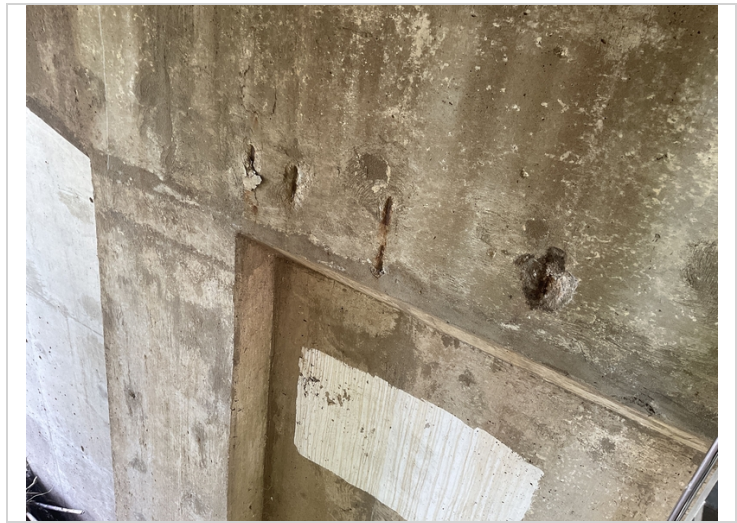
Bent # 4 cap backface has 4 small vertical shallow spalls with exposed reinforcing steel with active corrosion and initial section loss near the bottom edge of the cap adjacent to column # 2.

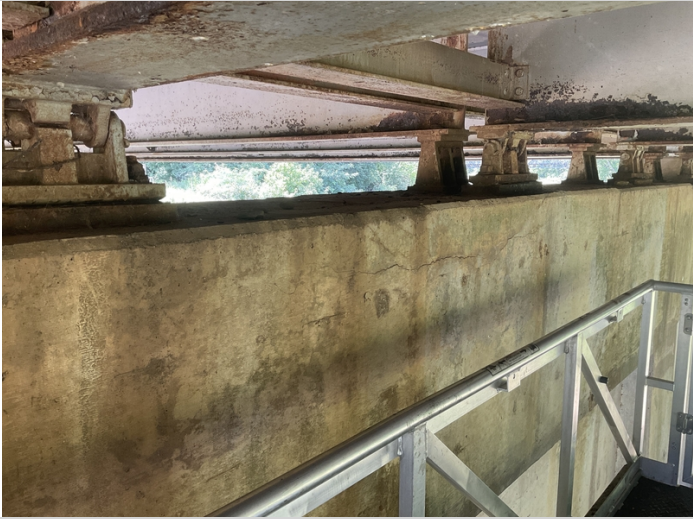
Bent # 5 cap aheadface under bay # 5 has a short duration moderate width horizontal crack with a few small concrete delaminations along the cracking.

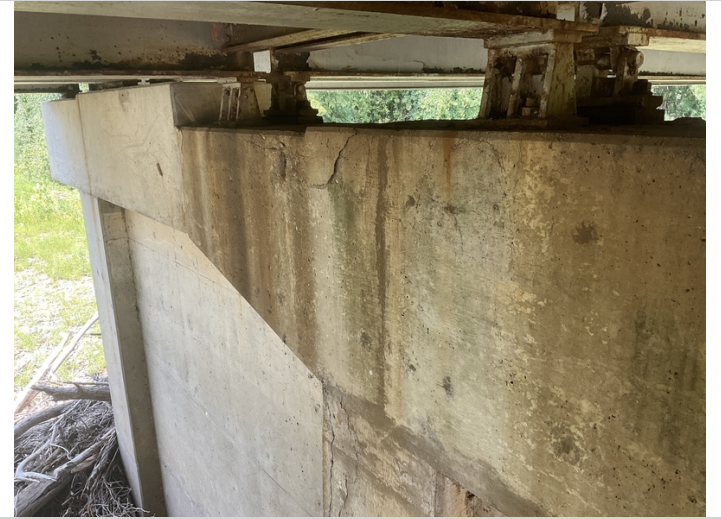
Bent # 5 Lt backface under bay # 3 has a 5' long horizontal crack with a 10" spall with exposed reinforcing steel, the exposed reinforcing steel has active corrosion and initial section loss.

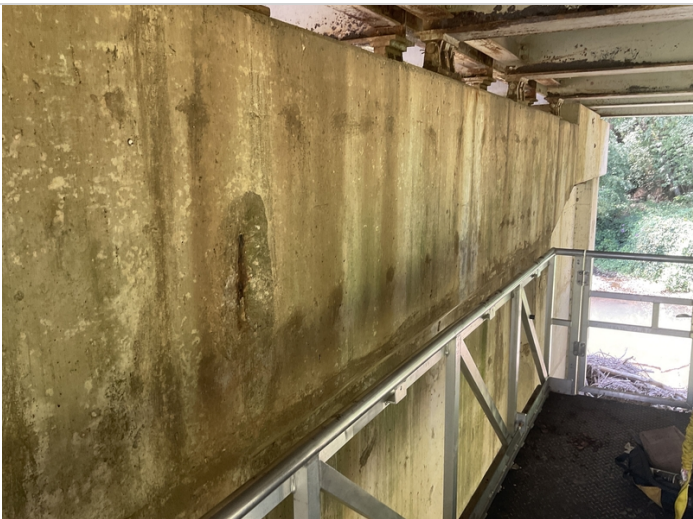
Bent # 6 cap aheadface has a 1' horizontal spall with exposed reinforcing steel over column # 1 and a 2' vertical spall with exposed reinforcing steel located over column # 3.

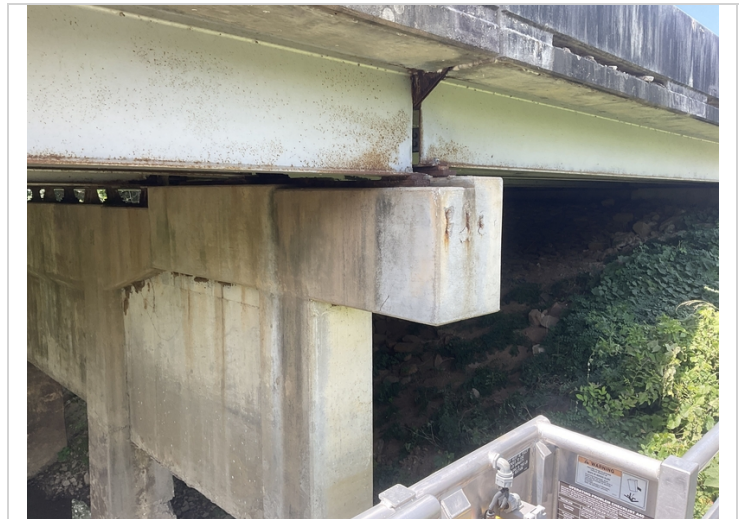
Bent # 7 Rt end of the cap spalling.

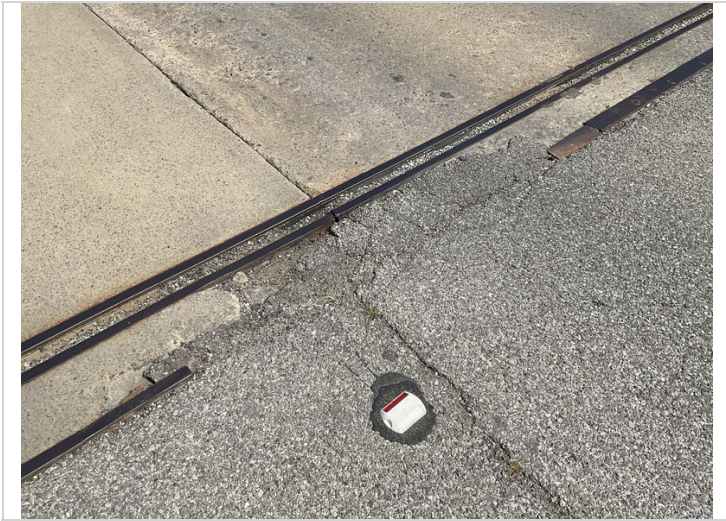
Abutment # 1 Northbound lane cracked welds.

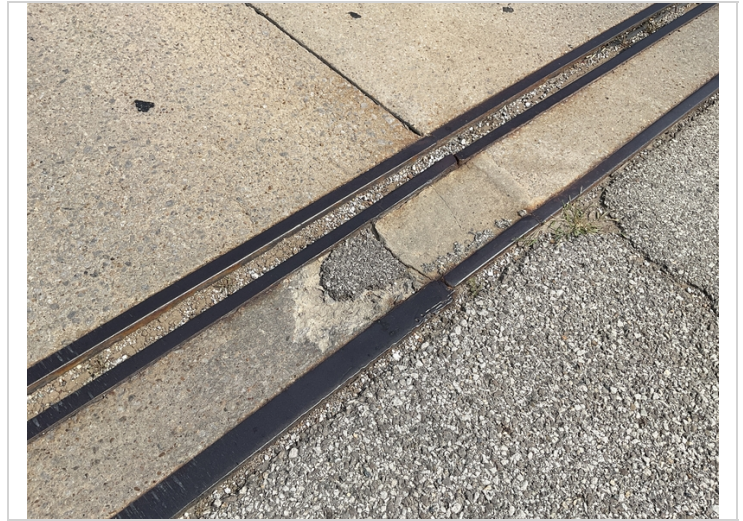
Abutment # 1 Southbound lane cracked weld.

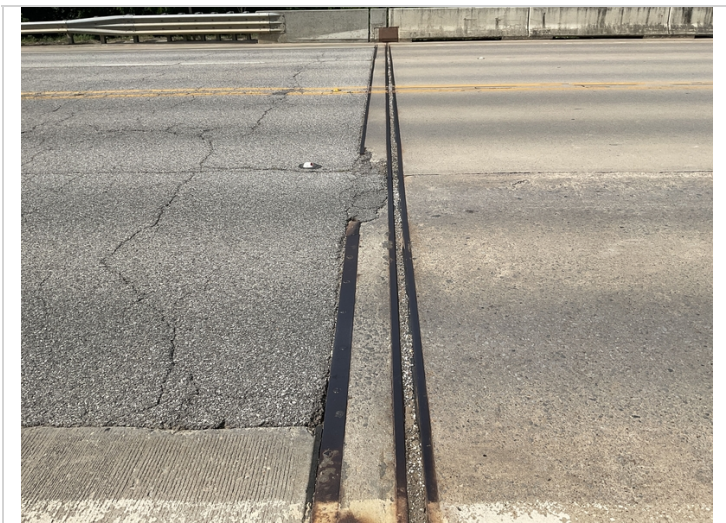
Abutment # 1 strip seal.

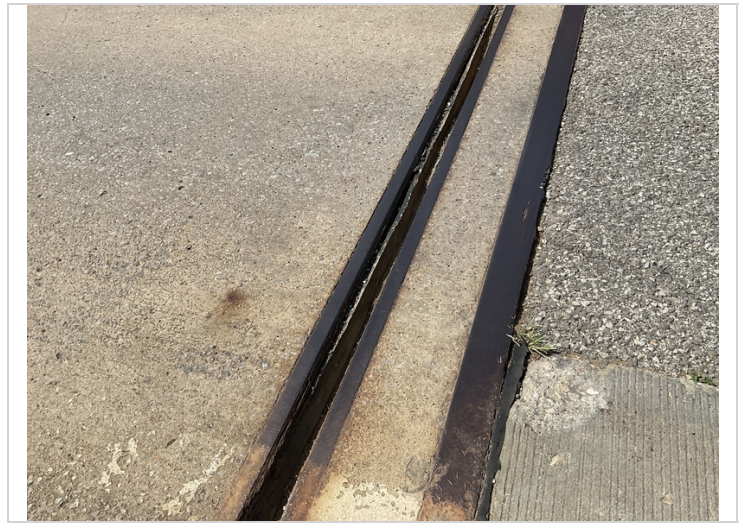
Abutment # 2 strip seals has areas that appear to be pulling out of the extrusion or tearing loose at the extrusion.

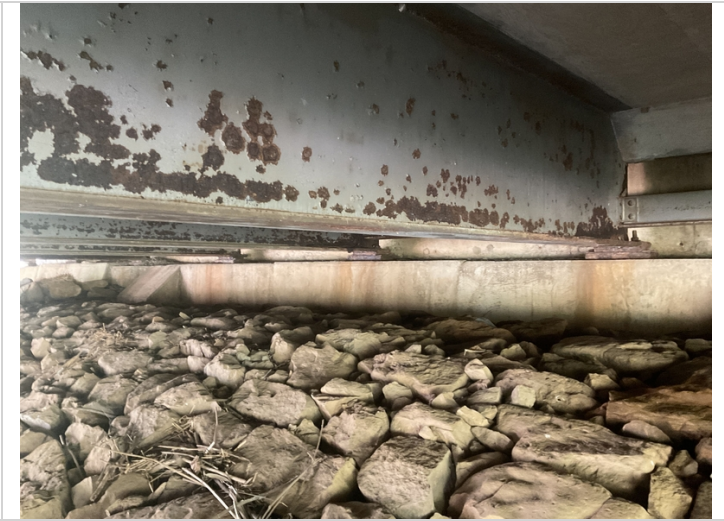
Abutment # 1 bearings typical.

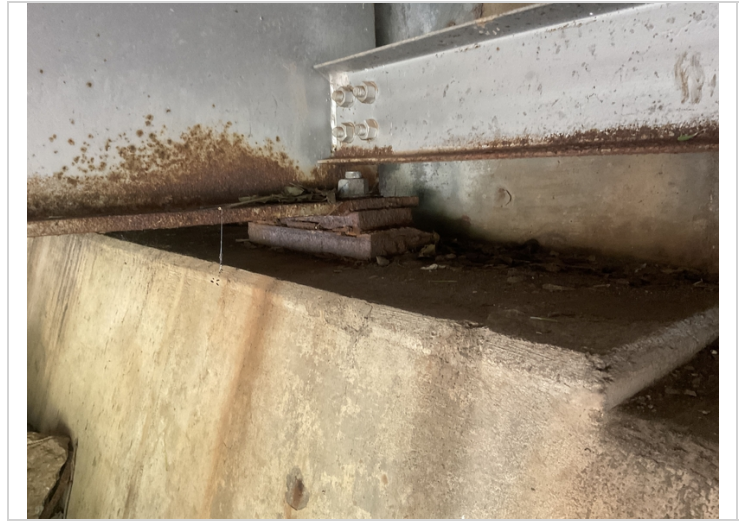
Abutment # 1 bearing # 2 active corrosion with pack rust.

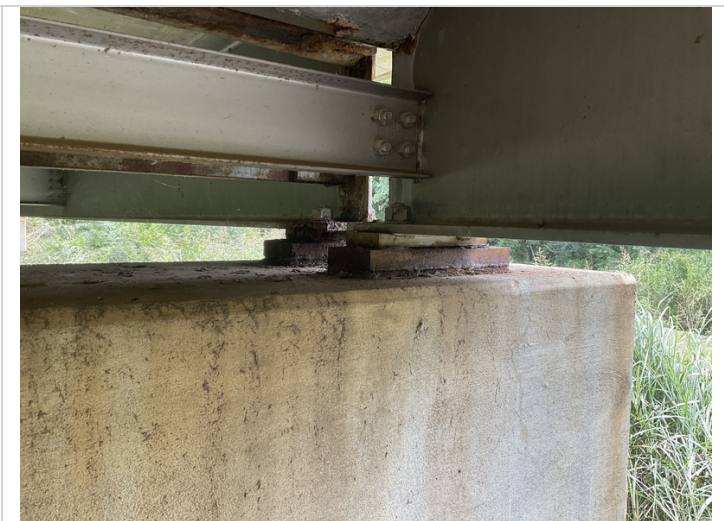
Bent # 3 bearings with active corrosion and pack rust.

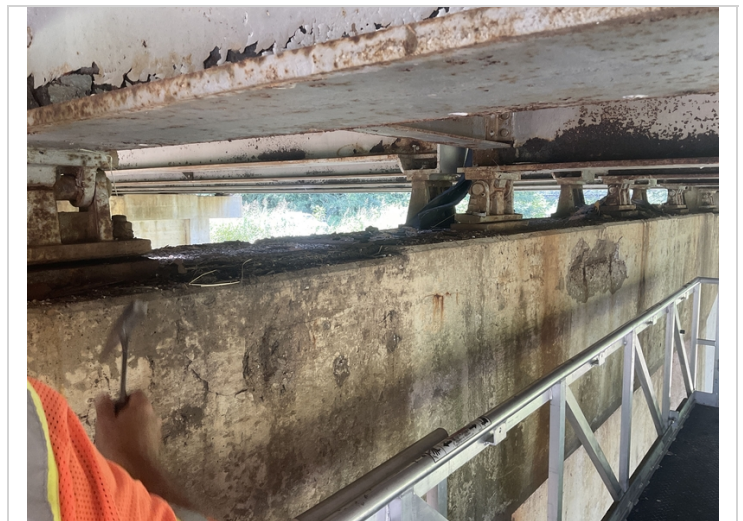
Bent # 4 moveable bearings with active corrosion and minor areas of flaking rust forming.

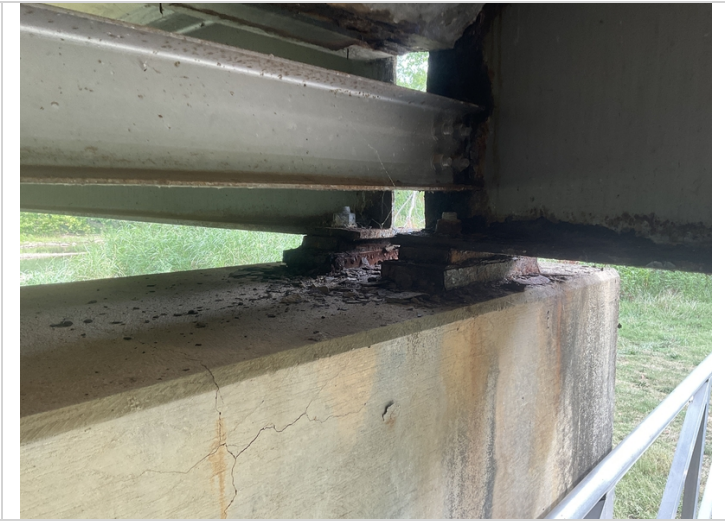
Bent # 2 bearings # 9 active corrosion with pack rust and section loss.

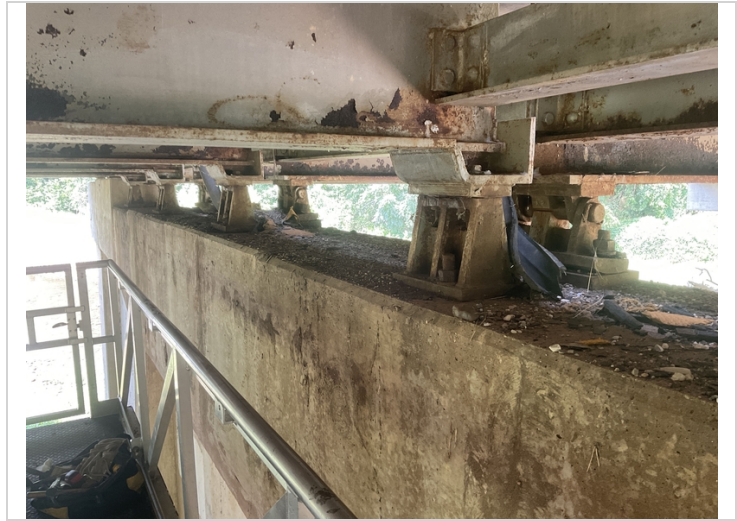
Bent # 4 fixed bearings with active corrosion and pack rust forming.

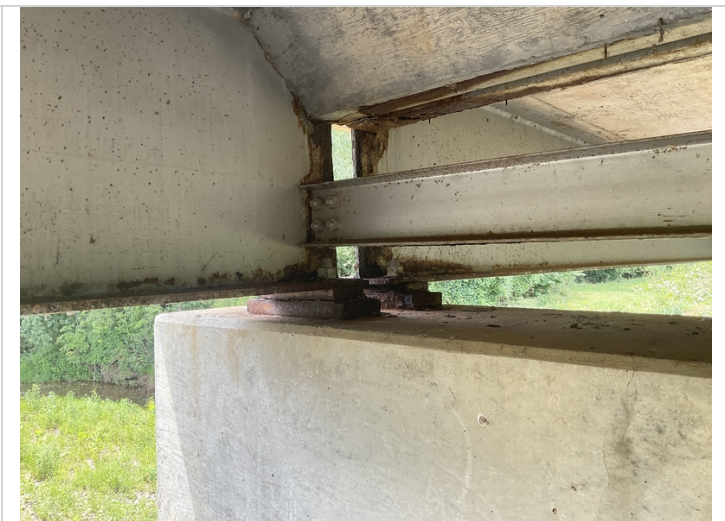
Bent # 5 bearing # 1 active corrosion with pack rust and section loss.

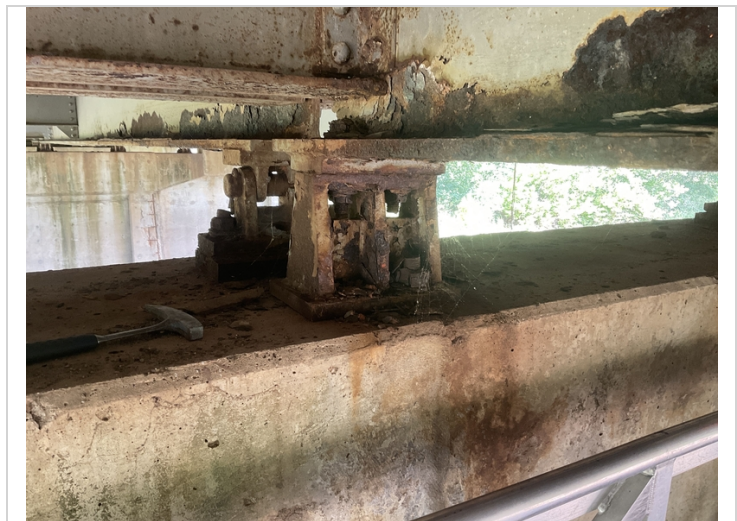
Bent # 5 bearing # 5 active corrosion with pack rust.

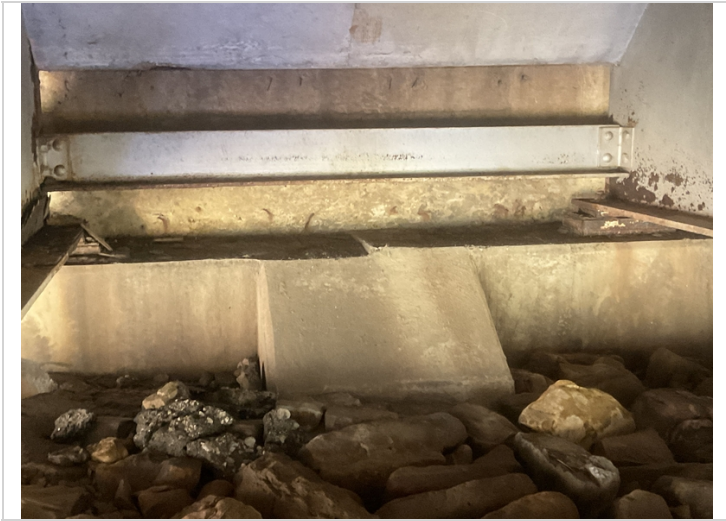
Abutment # 2 fixed bearings with active corrosion and pack rust.

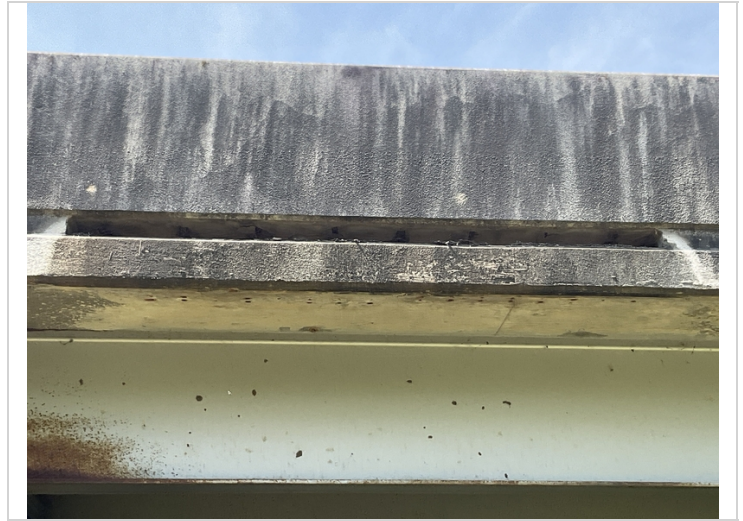
Bridge rail typical spalling with exposed reinforcing steel.

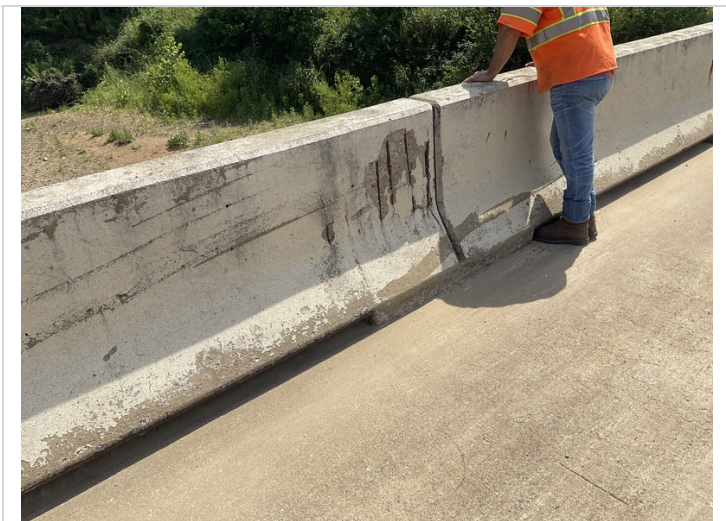
Span # 4 Rt spalling with exposed reinforcing steel in the bridge rail.

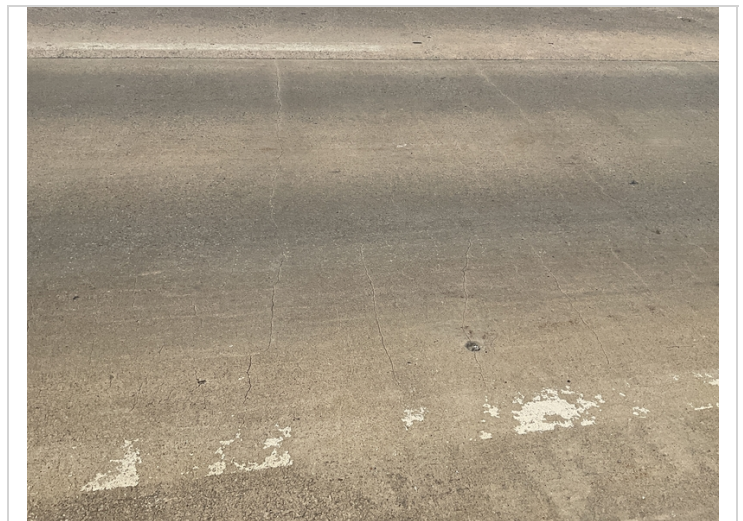
Span # 7 deck cracking.

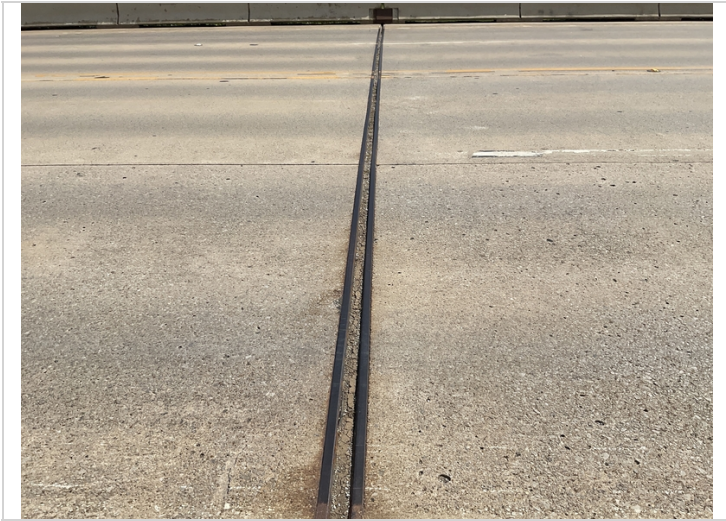
Bent # 6 strip seal typical.

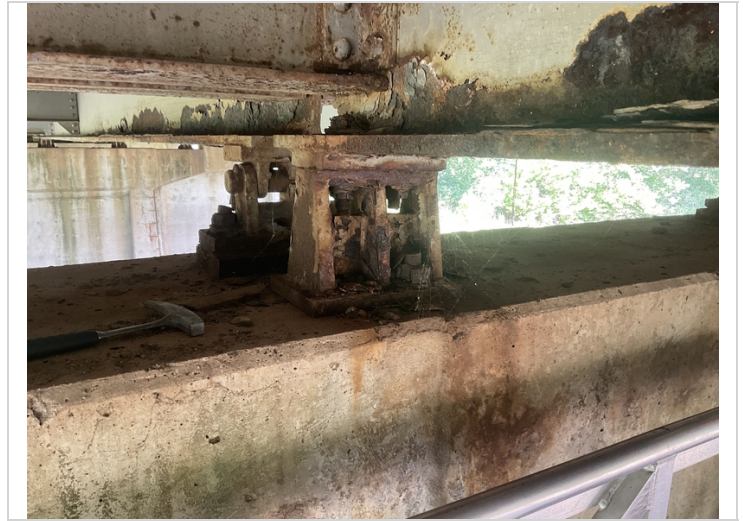
Bent # 5 bearing # 5 active corrosion with pack rust.

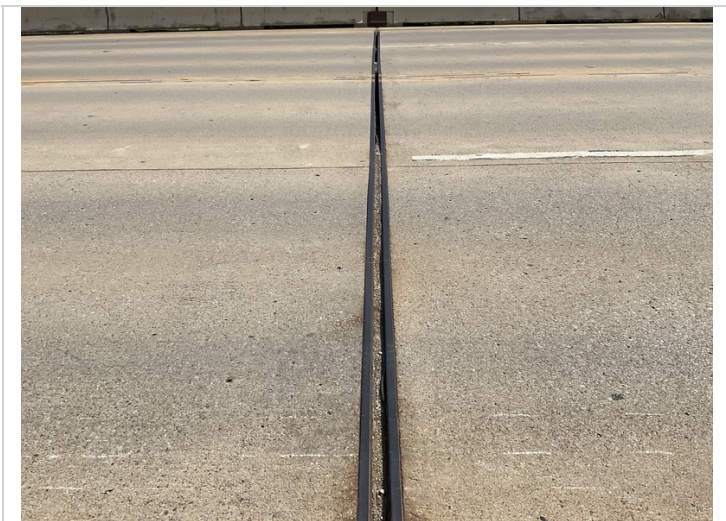
Bent # 4 strip seal typical.

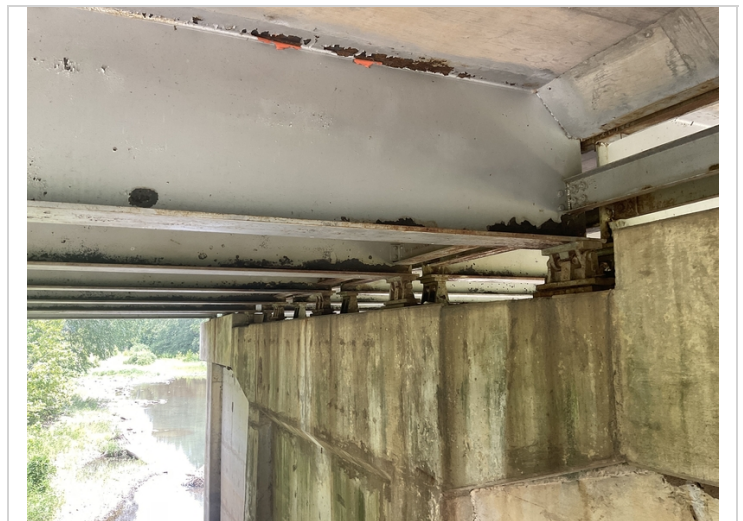
Span # 6 Bent # 6 active corrosion, pack rust and section loss.

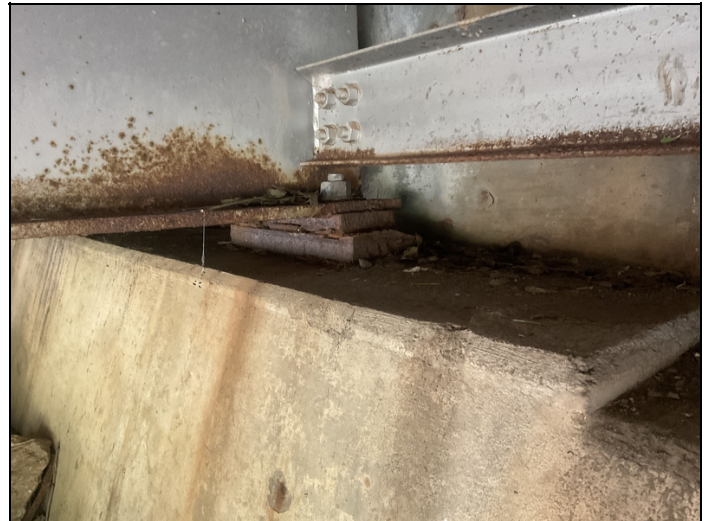
Abutment # 1 bearing # 2 active corrosion with pack rust.

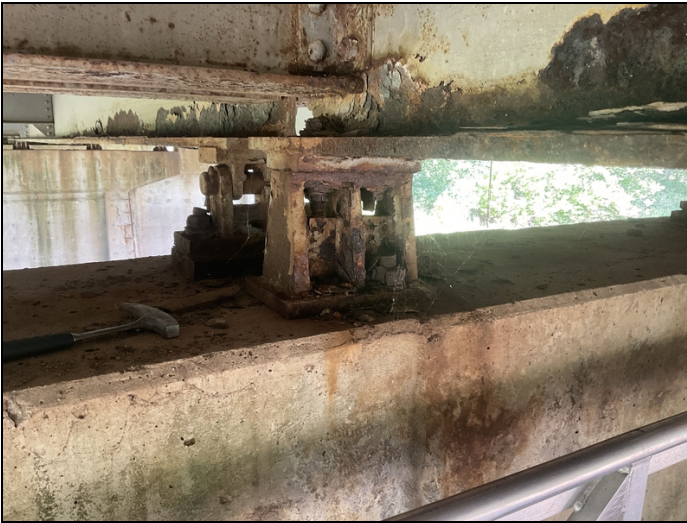
Bent # 5 bearing # 5 active corrosion with pack rust.

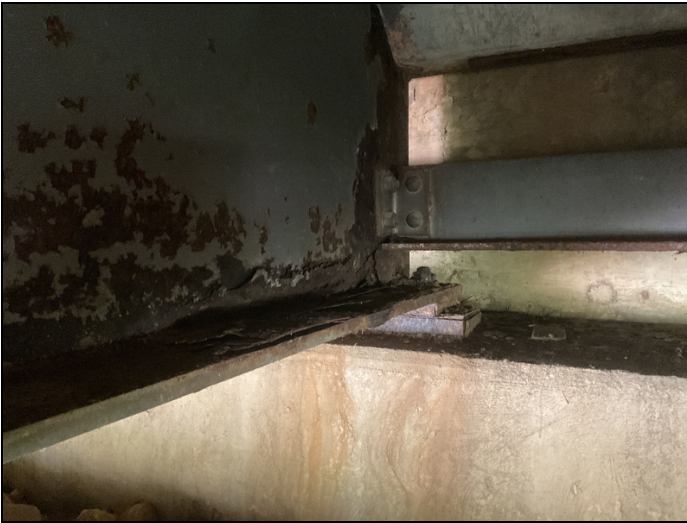
Abutment # 1 beam # 5 active corrosion with pack rust.

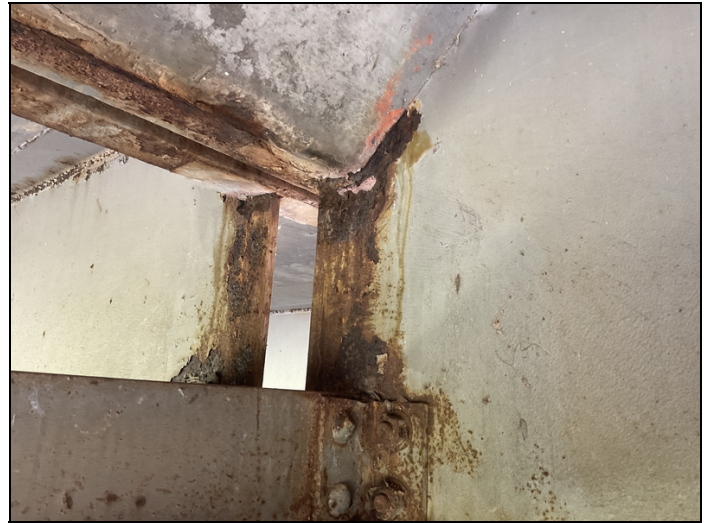
Span # 4, beam # 5 at bent # 5 has a 3" X 1" hole rusted through top of web at the expansion dam juncture.

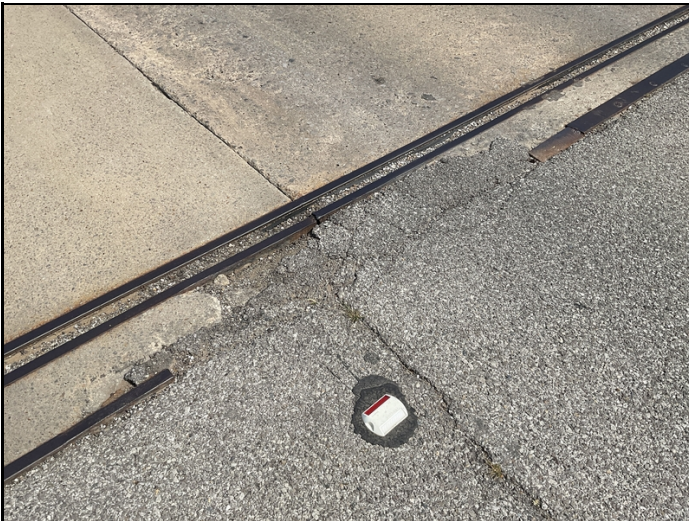
The South abutment road iron and expansion joint assembly has fractures and broken welds in the Northbound and Southbound lanes with a portion of the road iron assembly missing in the Northbound lane.

Abutment # 1 Northbound lane cracked welds.
