Asset #03488(Routine)

US 71-Wash Co. over West Fork White River

Location: 0.10 Mi. So. of Greenland

Team Lead: Eric West, Inspection Date: 07/31/2023

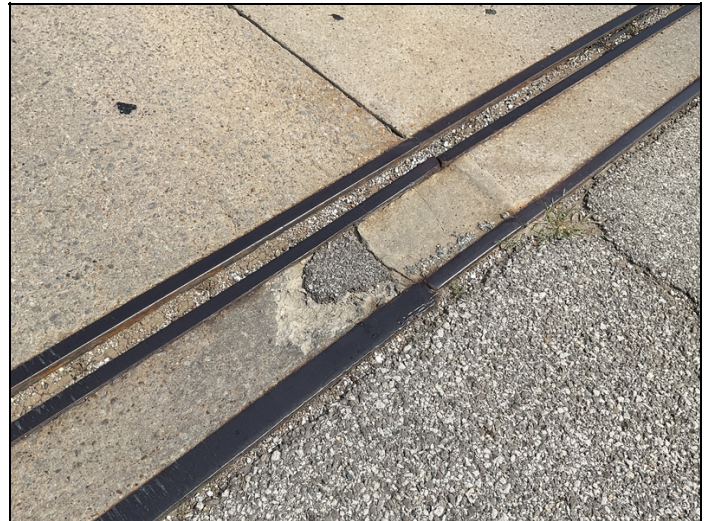
The South abutment road iron and expansion joint assembly has fractures and broken welds in the Northbound and Southbound lanes with a portion of the road iron assembly missing in the Northbound lane.

Abutment # 1 Southbound lane cracked weld.

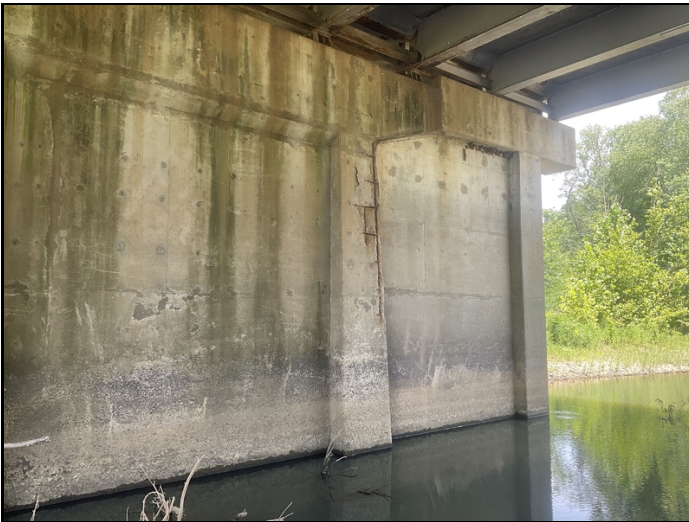
Bent # 6, column # 3 backface has a 10' tall spall with exposed reinforcing steel. The exposed reinforcing steel has active corrosion and pack rust.

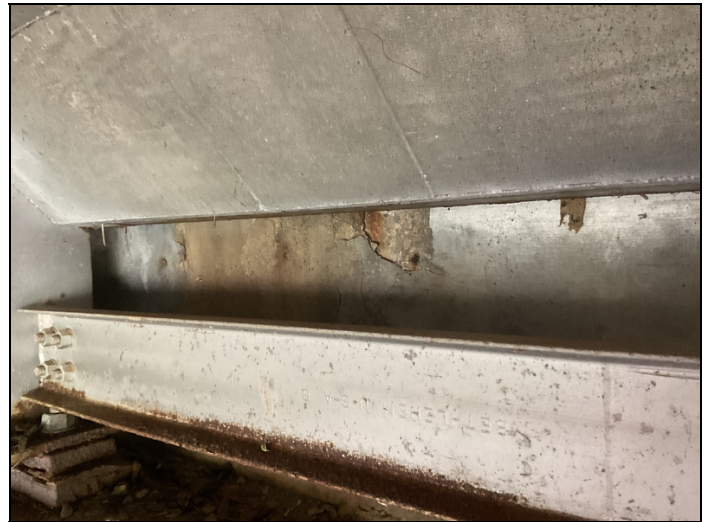
Abutment # 1, bay # 1 spalls with exposed reinforcing steel in the back wall.

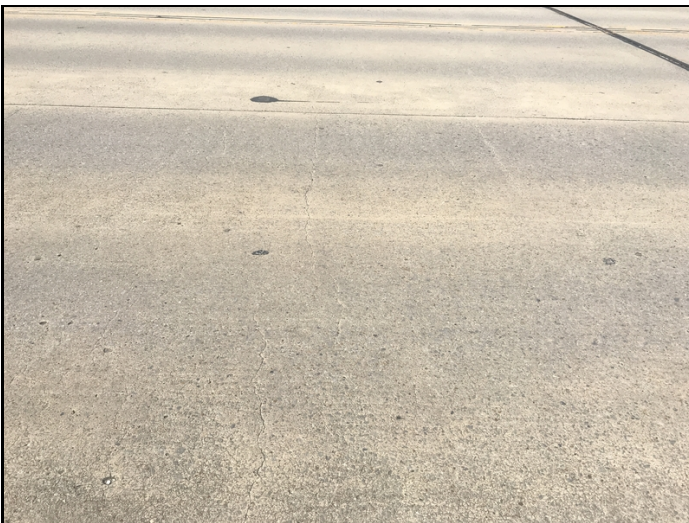
Span 2, right lane-Transverse cracking.

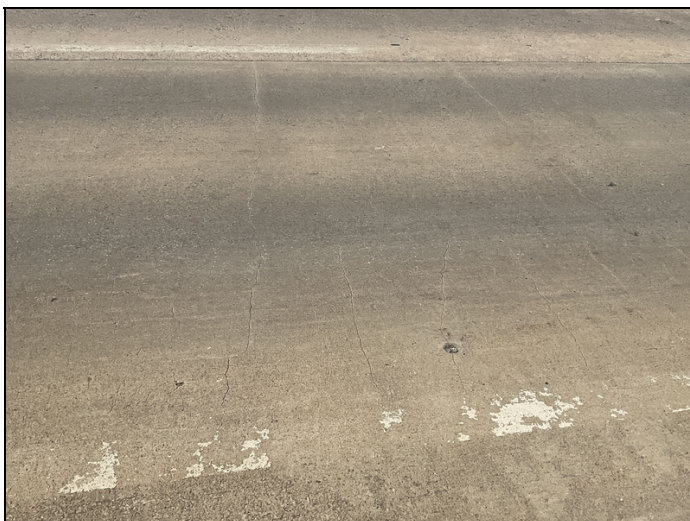
-The shoulders and driving surface of the deck has sealable cracking with numerous delaminated areas in all spans.

Span # 7 deck cracking.

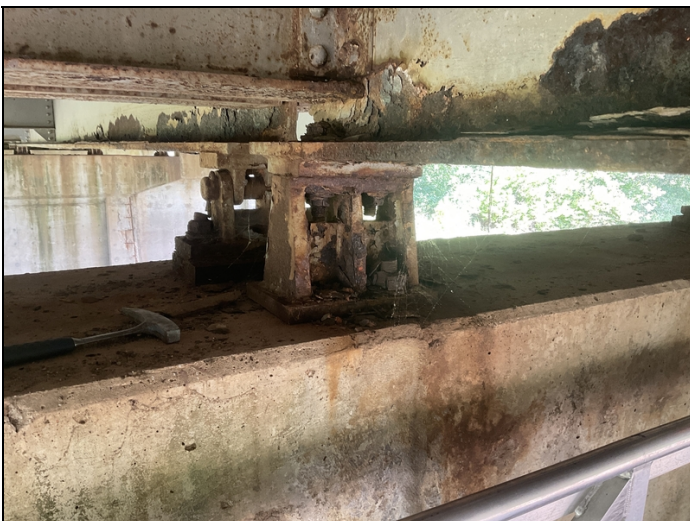
-The beam ends and bearings have active corrosion, pack rust and significant section loss.

Bent # 5 bearing # 5 active corrosion with pack rust.

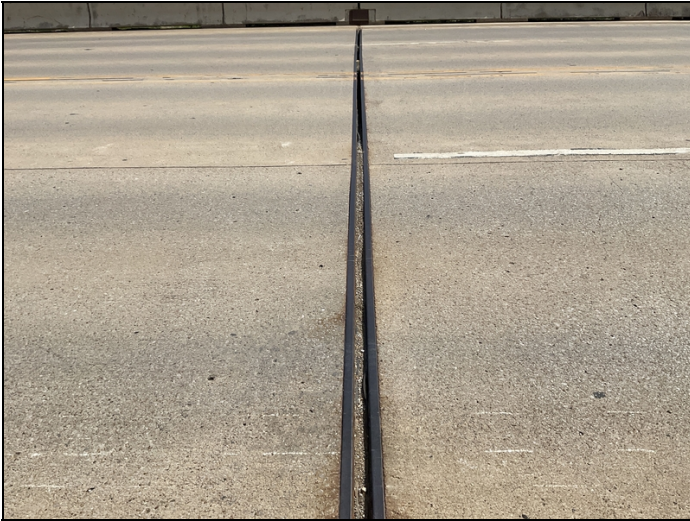
- All expansion joint assemblies have heavy dirt and debris accumulation at this inspection.
- The strip seals appear to be pulling out of the extrusions in numerous locations at all bents.
- Abutment # 1 road iron joint assembly has a cracked weld in the Northbound and Southbound lanes where the structure was widened in the past.
- Bent # 4 has portions of the seal that has fallen out of position and is no longer in the assembly.
- Stains on the substructure caps indicate that the seals leak.

Bent # 4 strip seal typical.
