**Asset #A1424**(Routine, Underwater type 2)

**US 71-Wash Co. over Rock Creek**

**Location: 2.3 MI N JCT SH 170**

**Team Lead: Eric West, Inspection Date: 06/22/2023**

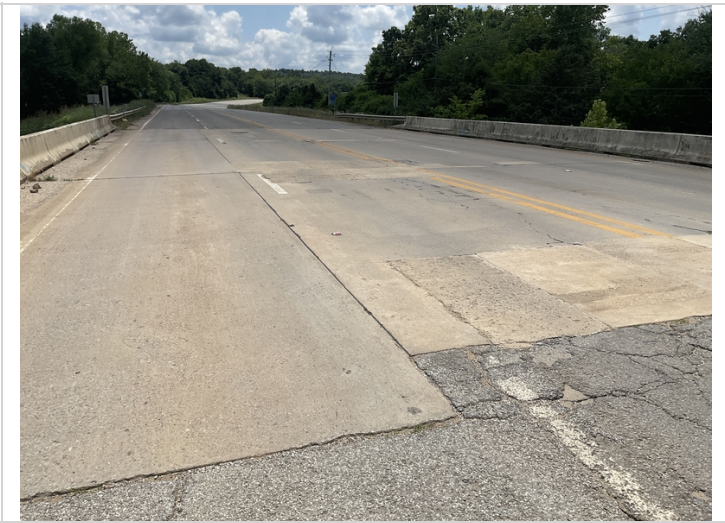
Typical driving surface.

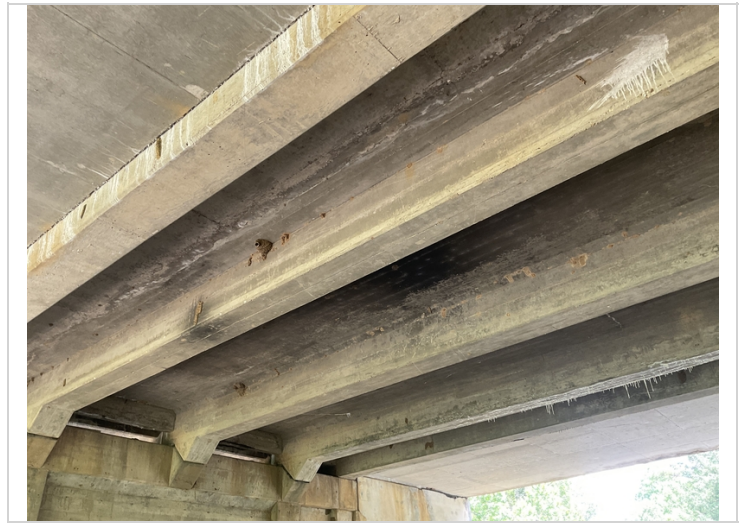
Span # 1 typical undersurface of the deck.

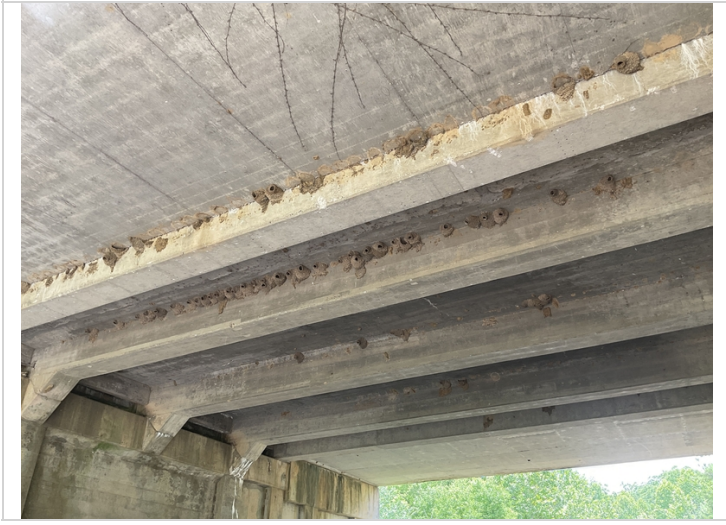
Span # 2 typical undersurface of the deck.

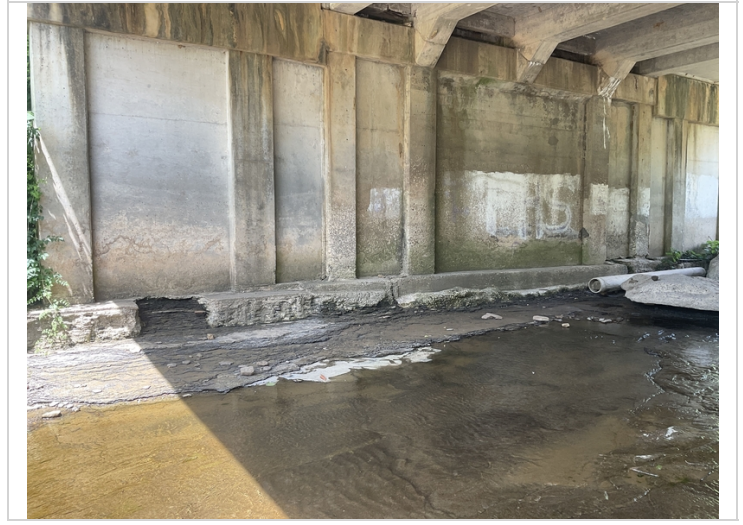
Bent # 3 footings typical.

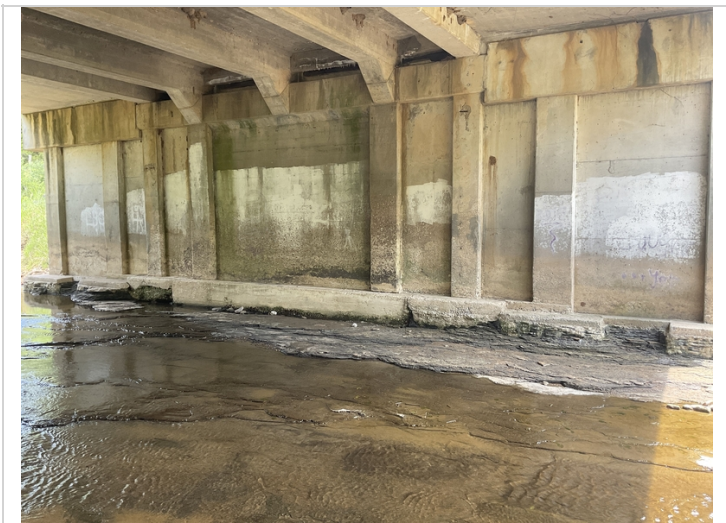
Bent # 2 footings typical.

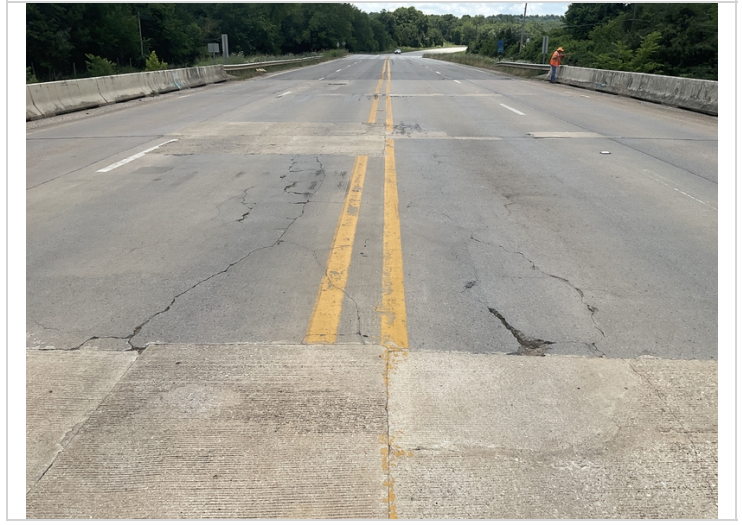
Concrete cracking and spalling on the wearing surface.

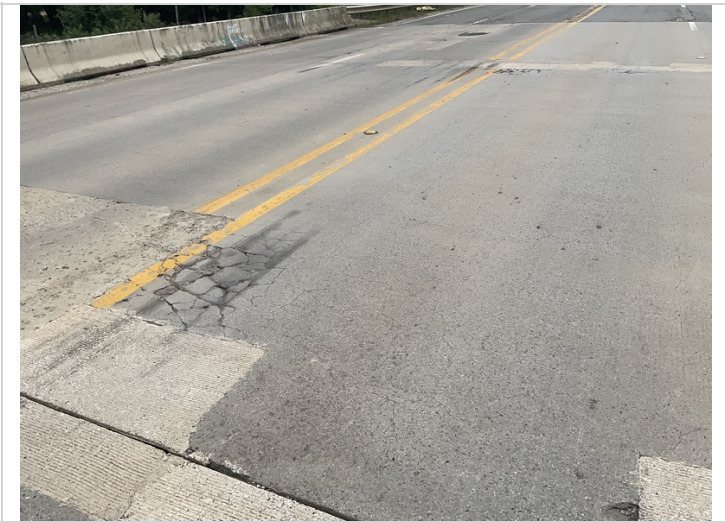
Wearing surface breakup over the intermediate bents.

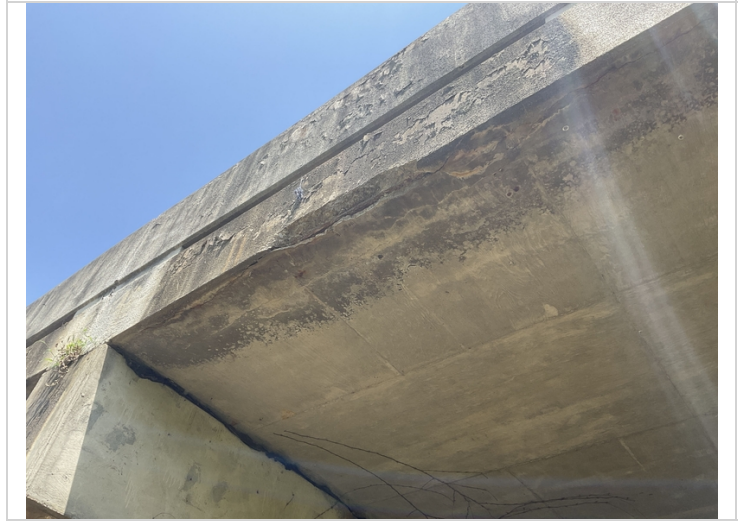
Span # 1 Lt has spalling with exposed reinforcing steel adjacent to bent # 2.

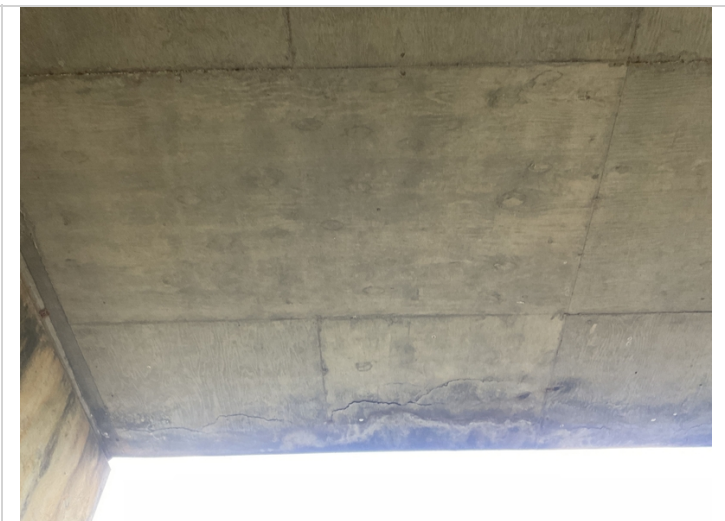
Span # 2 Rt concrete delamination along the edge of the slab.

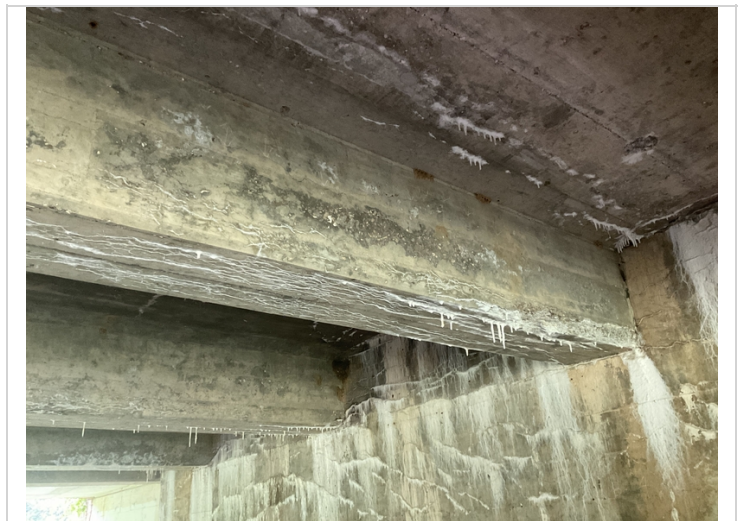
Span # 3 Girder # 4 map cracking with efflorescence buildup and concrete deterioration with section loss adjacent to Abutment # 2.

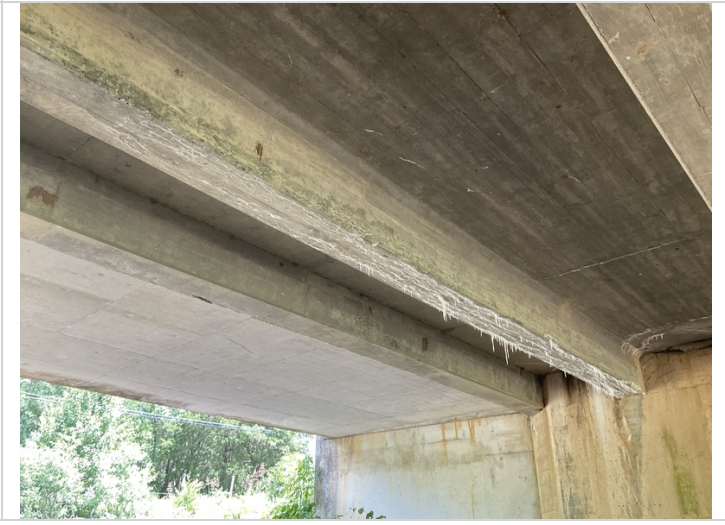
-Span #1 Girder #4 has areas of delaminating concrete adjacent to abutment #1 in the areas of map cracking with efflorescence buildup.

Span # 1 girder # 4 map cracking with efflorescence buildup.

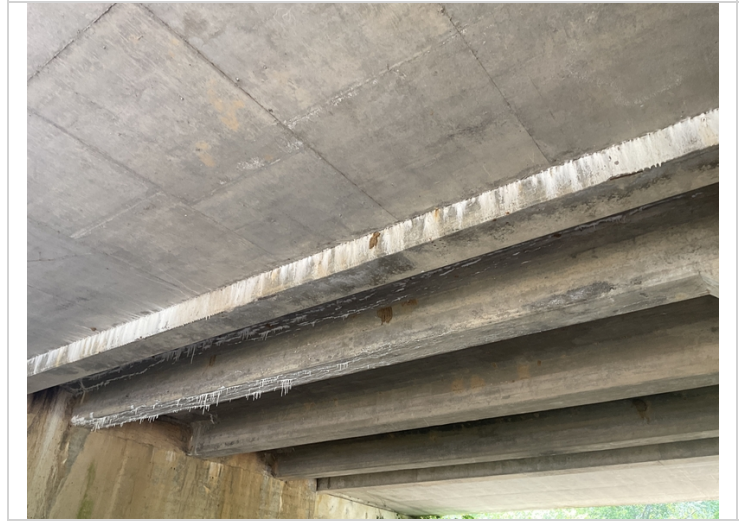
Span # 1 girder # 5 spalling with exposed reinforcing steel.

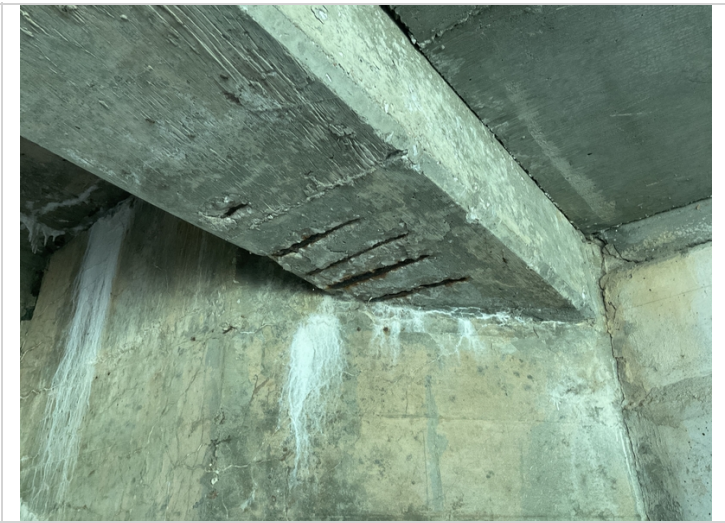
Span # 3 Girder # 5 spalling with exposed reinforcing steel.

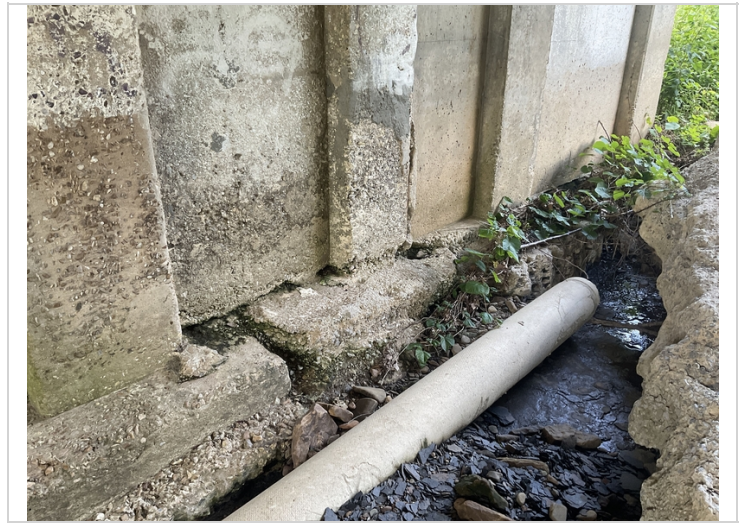
Bent # 3 Column # 6 concrete deterioration along the column base.

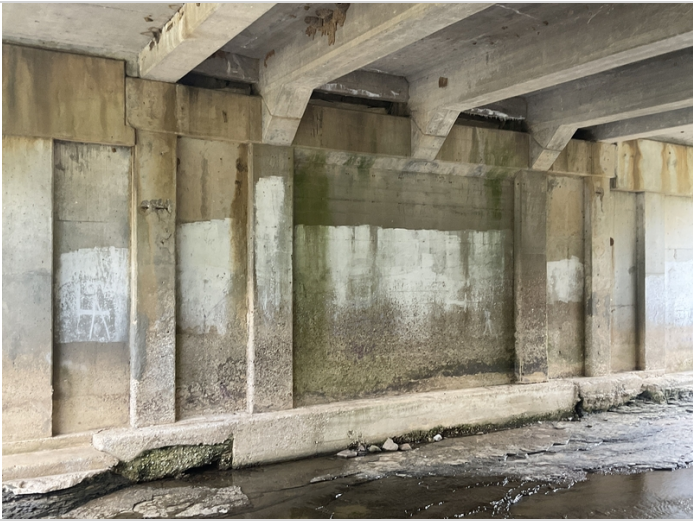
Bent # 2 column # 3 & 6 spalling with exposed reinforcing steel.

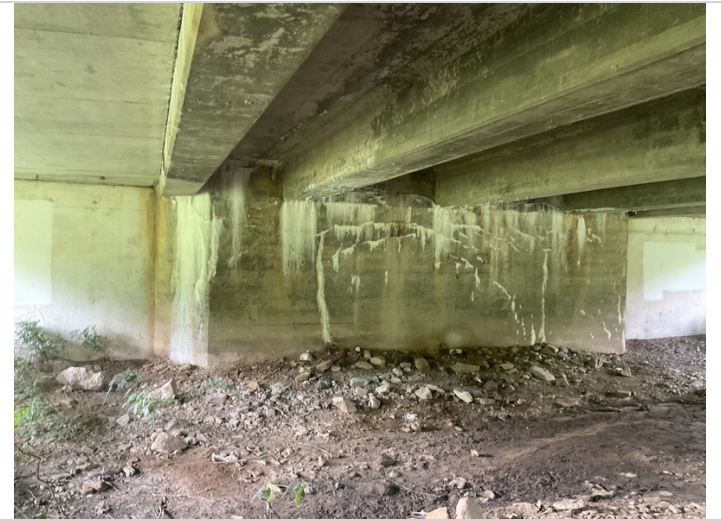
Abutment # 2 cracking with efflorescence buildup.

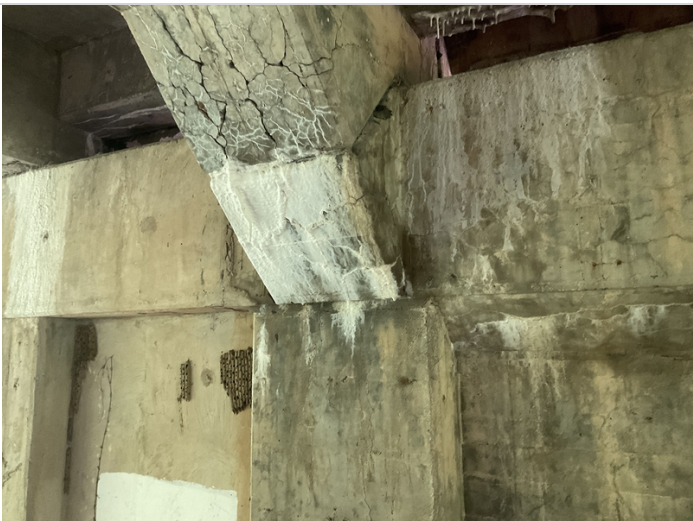
-Span #3, girders #3 & 4 have heavy wide map cracking with efflorescence in the girder haunches at bent # 3. Sounding revealed that the haunch of girder #3 & 4 is delaminated. (The cap haunch in the same location is also delaminated.)

Bent # 3 aheadface wide map cracking with efflorescence buildup under Girder # 4.

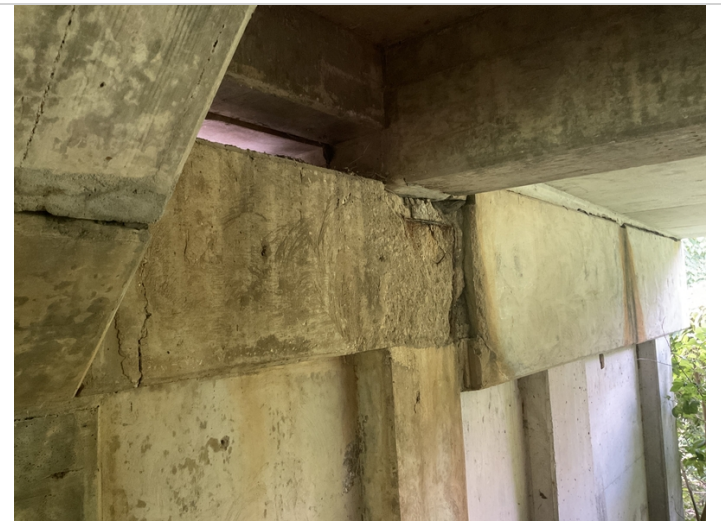
Bent # 3 cap aheadface spalling with exposed reinforcing steel and loss of bearing area.

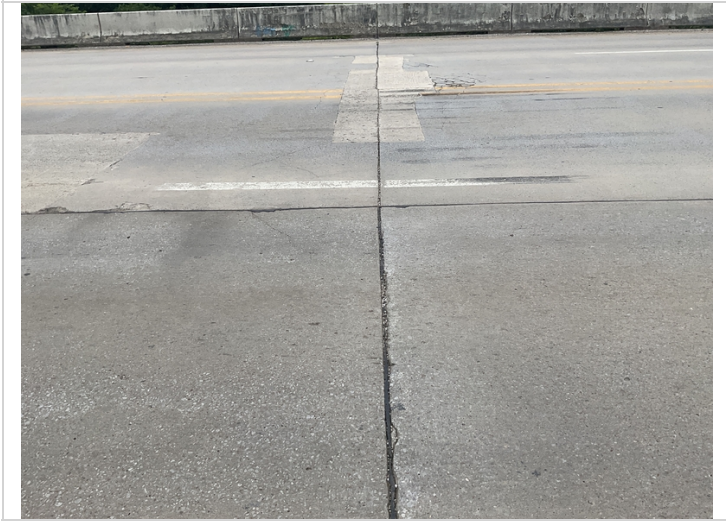
Bent # 2 typical joint seal.

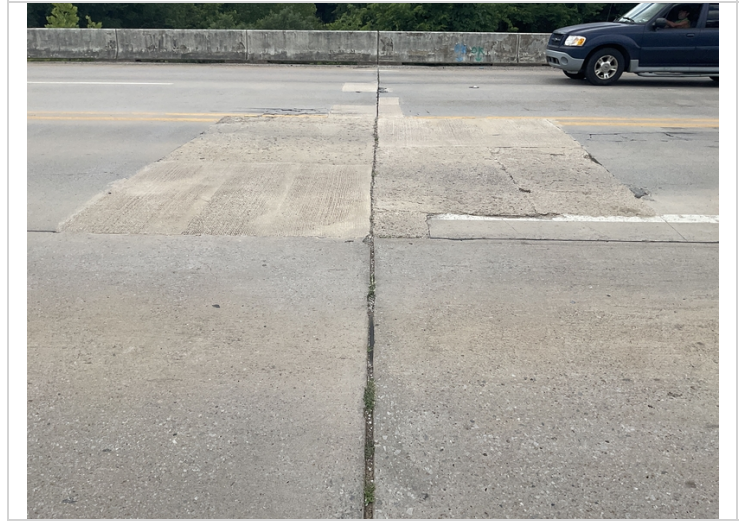
Bent # 3 typical joint seal.

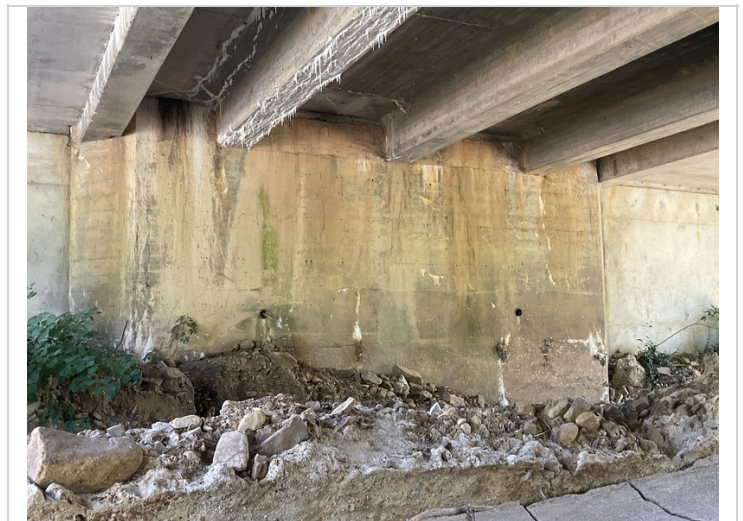
Abutment # 1 cracking with efflorescence buildup.

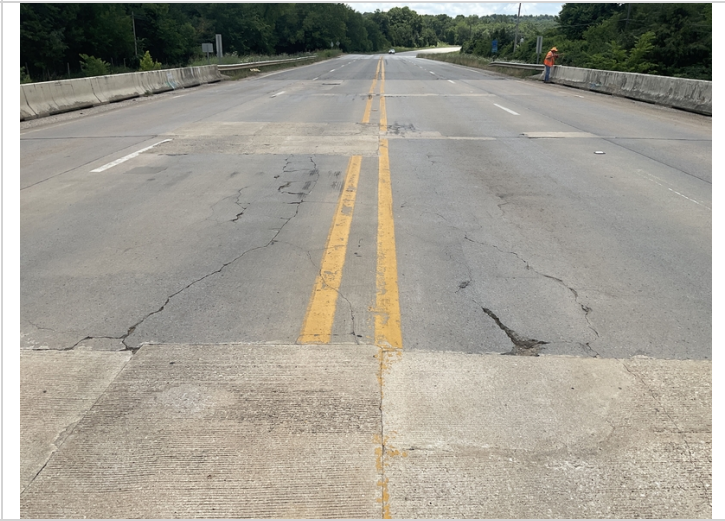
Concrete cracking and spalling on the wearing surface.

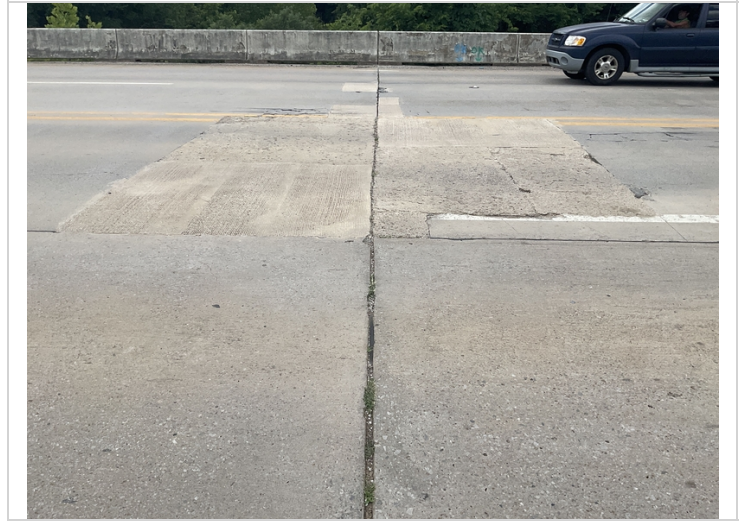
Bent # 3 typical joint seal.

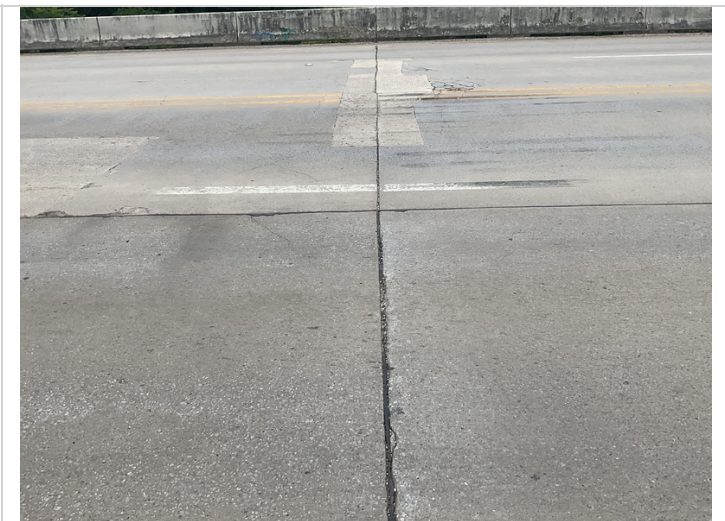
Bent # 2 typical joint seal.

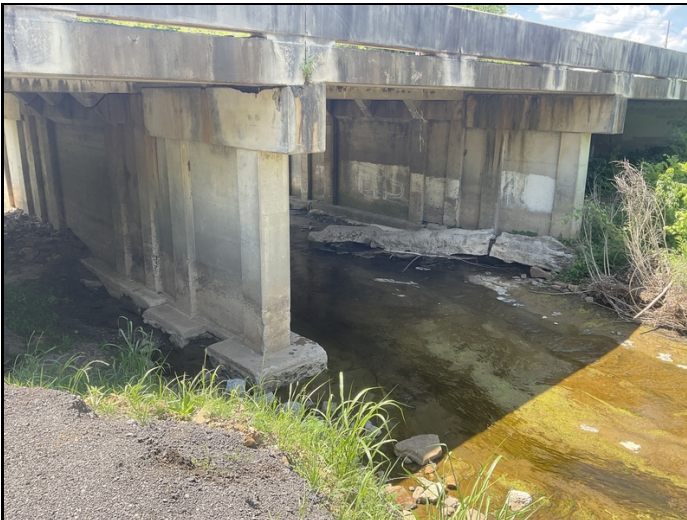
Drift has been removed.

06/22/2023 - EJW - Drift has been removed.

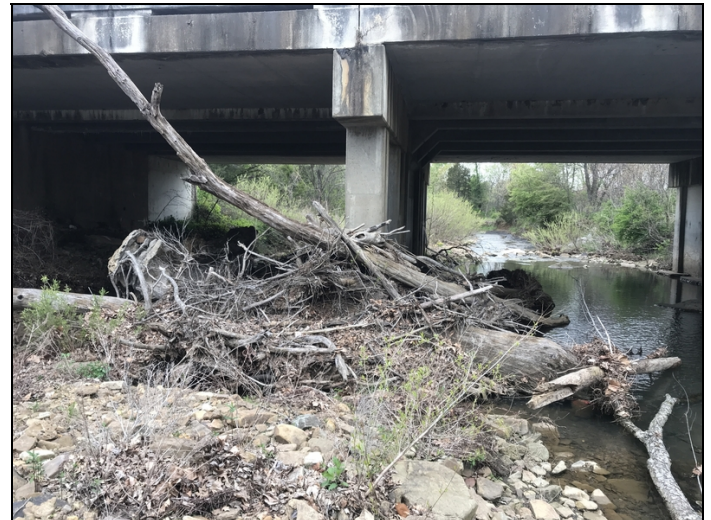
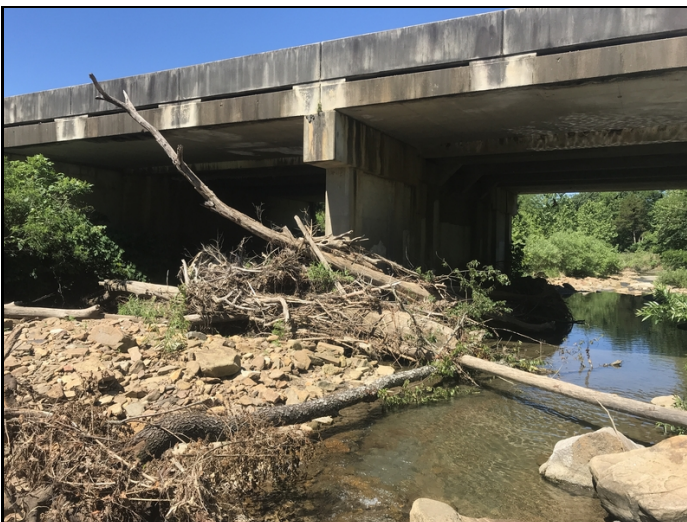
The channel has moderate drift accumulation at bent # 2.

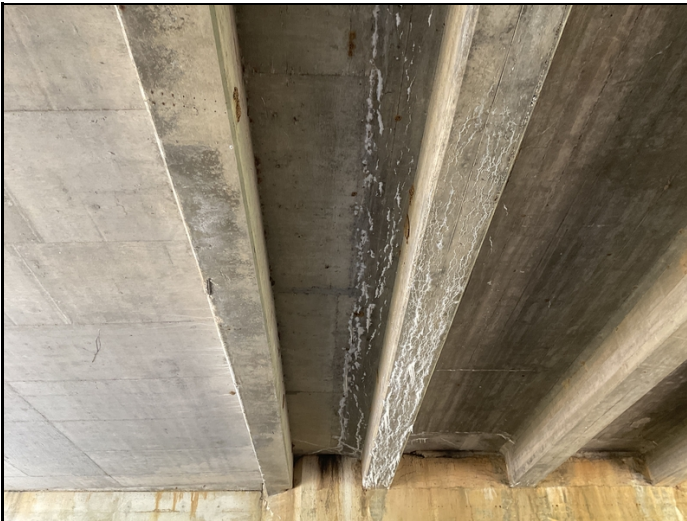
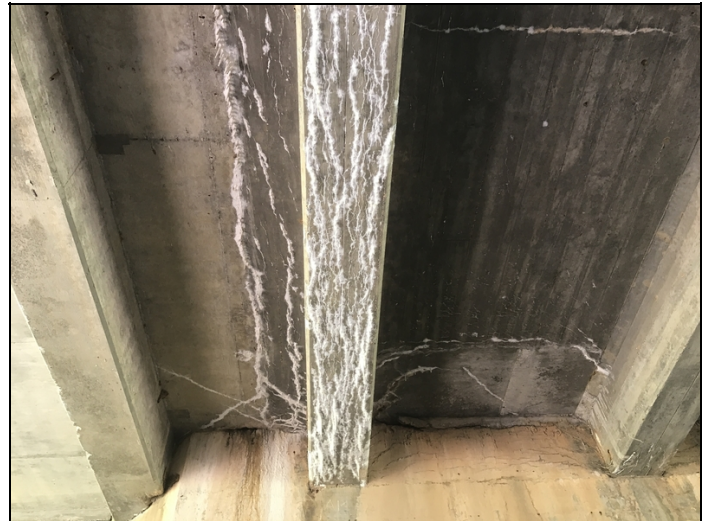
The undersurface of the deck has areas of map cracking with efflorescence adjacent to the bents at the construction joints where the structure was widened.

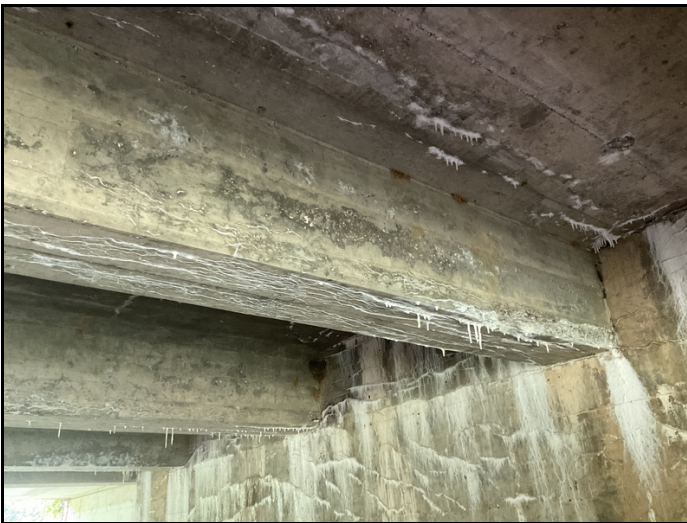
Spans # 1 & 2, Girder # 4 and Span # 3, Girders # 2, 3, & 4 have hairline map cracking with chloride contamination. The majority of the length of girder # 4 in span # 1 has mapcracking with heavy efflorescence. The undersurface and exterior side of the girder is delaminated in an area approximately 4' in length adjacent to abutment # 1. Girders # 3 & 4 in span # 3 have heavy wide map cracking with efflorescence in the girder haunches at bent # 3. Sounding revealed that the haunch of girder # 4 is delaminated. (The cap haunch in the same location is also delaminated.)

Span # 3 Girder # 4 map cracking with efflorescence buildup and concrete deterioration with section loss adjacent to Abutment # 2.

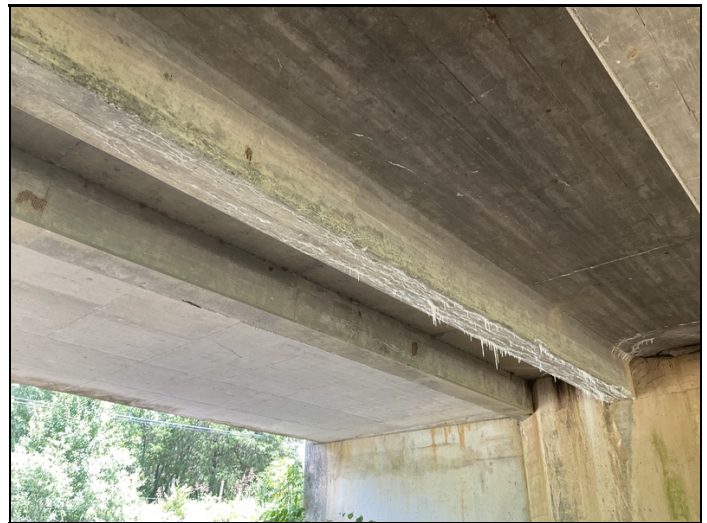
Span # 1 girder # 4 map cracking with efflorescence buildup.

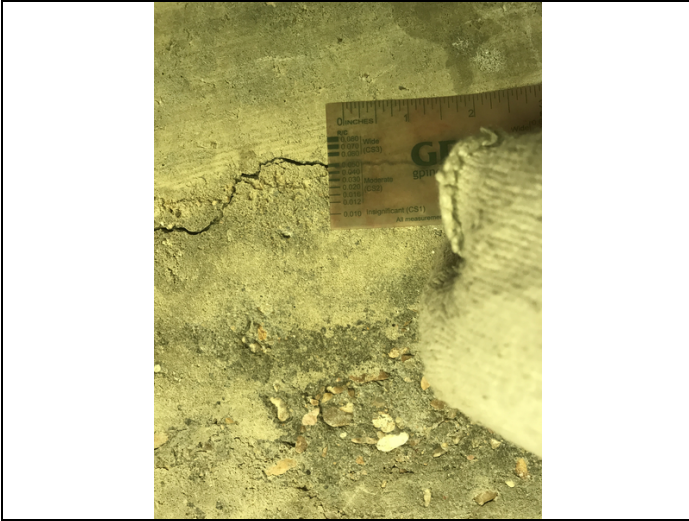
The concrete is soft in the girders and sounds delaminated at the base of girders. There are longitudinal cracks up to 0.050" wide near the neutral axis of the girders adjacent to the bearing area that extend approximately 10' in length.

Span # 3, girder 4-Moderate width longitudinal crack.

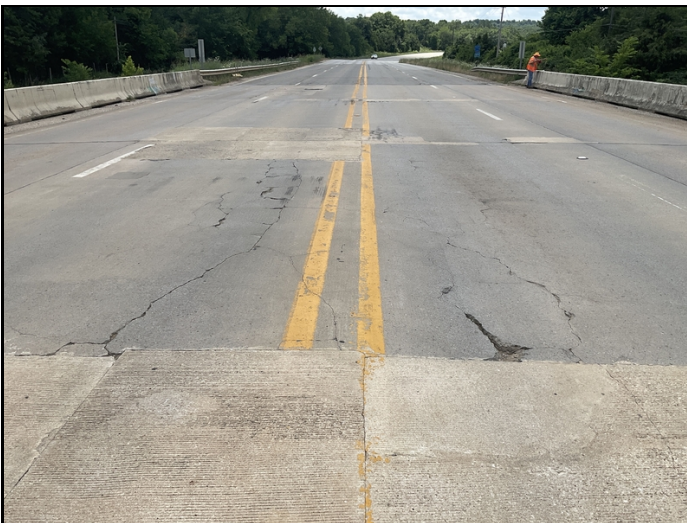
Span # 3 Right inside lane has a longitudinal crack approx. 1/4" wide by 20' long that has approx. 1/8" differential settlement. There is a longitudinal crack with light efflorescence on the undersurface of the deck that appears to correspond with the surface crack but has no differential settlement. There is map cracking in areas where the driving surface of the deck appears to be breaking apart.

Concrete cracking and spalling on the wearing surface.

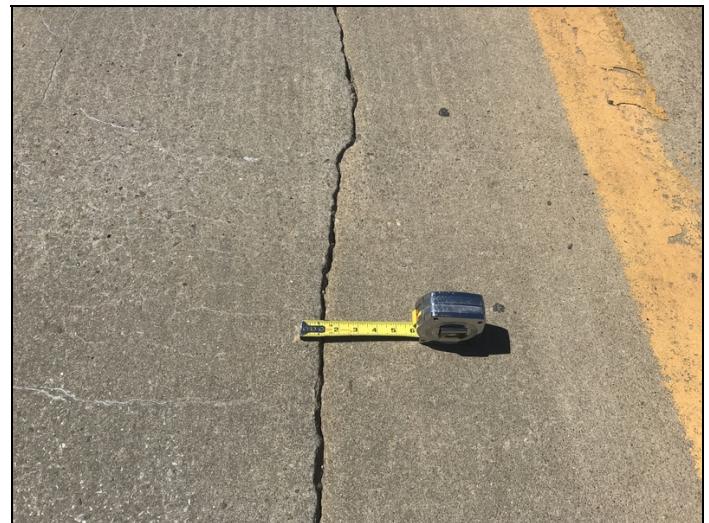
Span # 3, right lane-Wide longitudinal cracking.

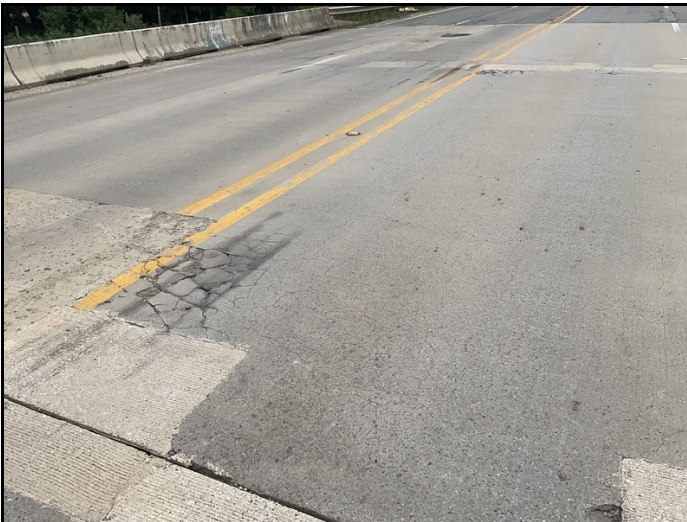
The concrete repaired areas on the driving surface of the deck and the areas surrounding the repairs are delaminated in several locations. Both ends of Span # 2 driving surface adjacent to bents # 2 and # 3 have a 36" x 36" spalled / fractured area near centerline adjacent to previous repairs that is breaking apart with loose concrete. The area surrounding the spalls is delaminated.

Wearing surface breakup over the intermediate bents.

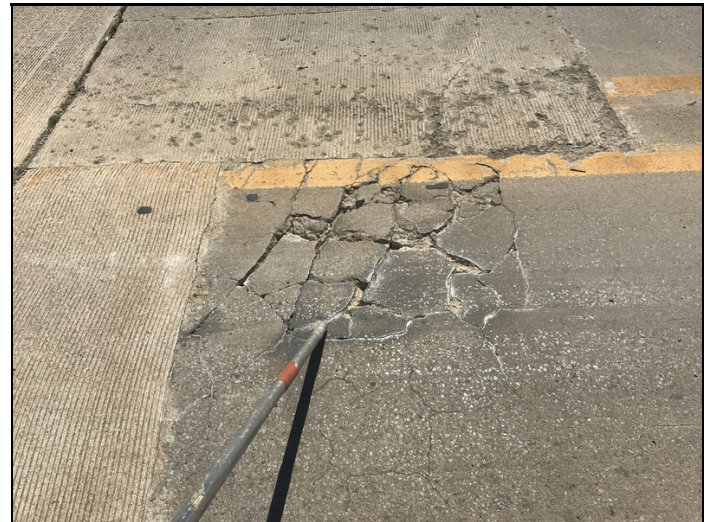
Span # 2 at bent 3-Spalled / delaminated area.

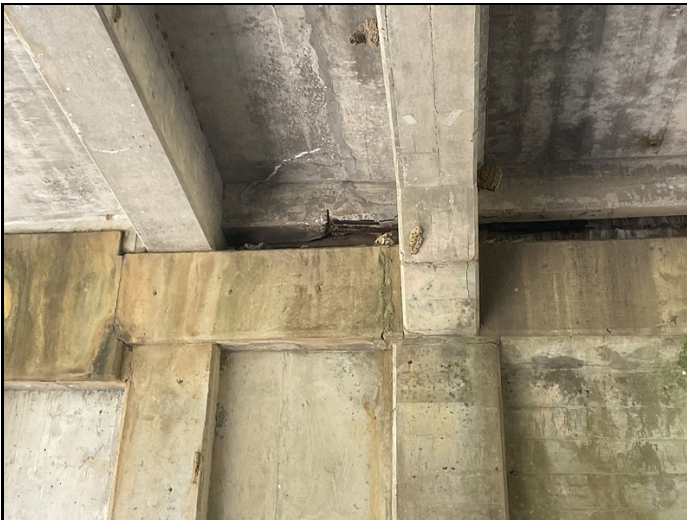
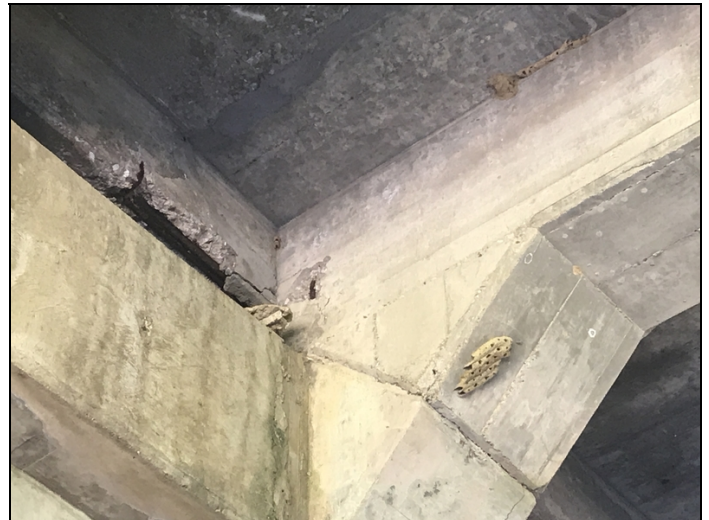
Isolated areas of concrete spalling with exposed reinforcing steel visible in the Expansion joint dams over Bents # 2 & 3.

Isolated areas of concrete spalling with exposed reinforcing steel visible in the Expansion dams over Bents # 2 & 3.

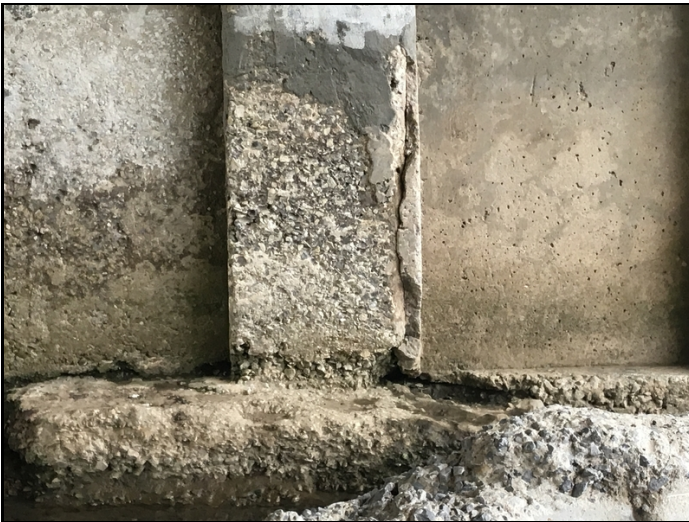
Columns have areas of concrete deterioration and spalling with exposed reinforcing steel.

Bent # 3, column # 6-Concrete deterioration.

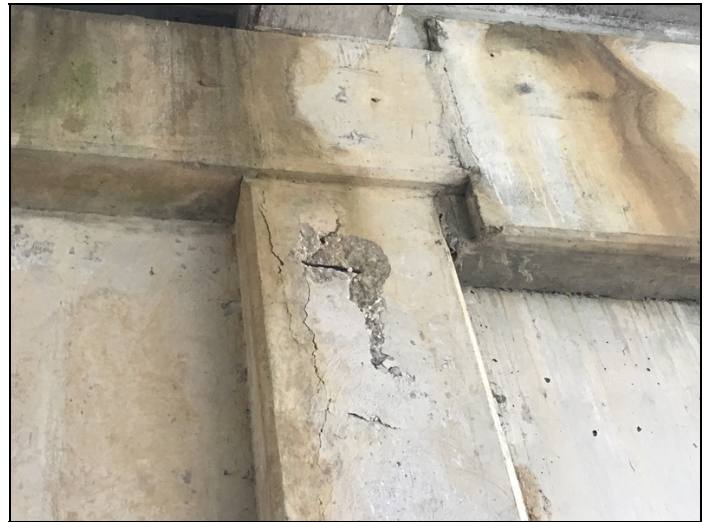
Bent # 2, column # 3-Spalling in ahead face with exposed reinforcing steel.

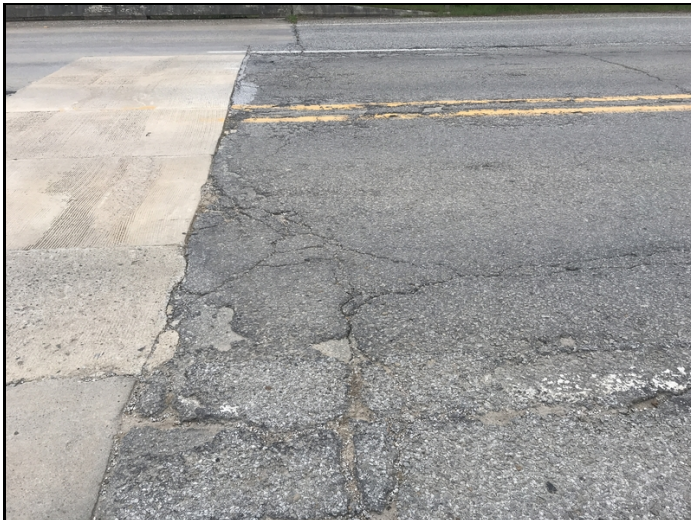
North approach roadway-Mapcracking in asphalt.

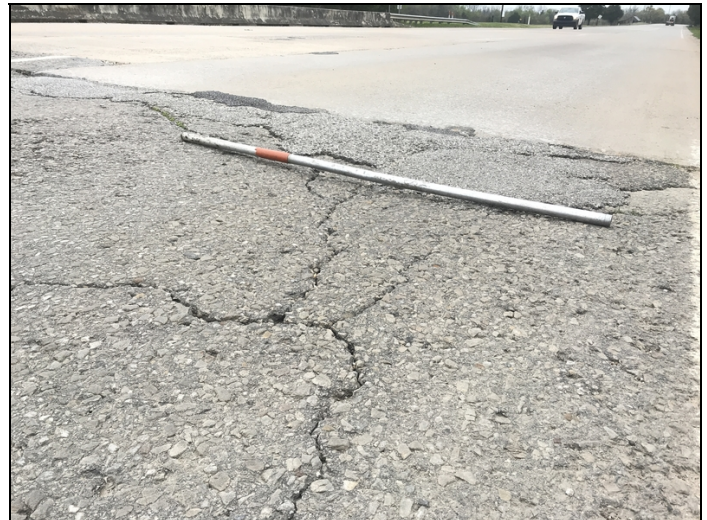
South approach roadway-Settlement in right lane.

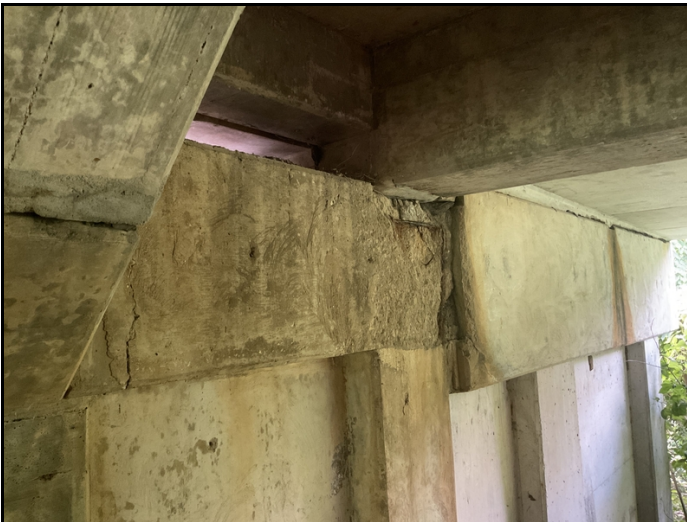
Bent # 3 cap has spalling with exposed reinforcing steel in the ahead face under girder # 1 of span # 3 that has caused approximately 5" of bearing area loss.

Bent # 3 cap aheadface spalling with exposed reinforcing steel and loss of bearing area.

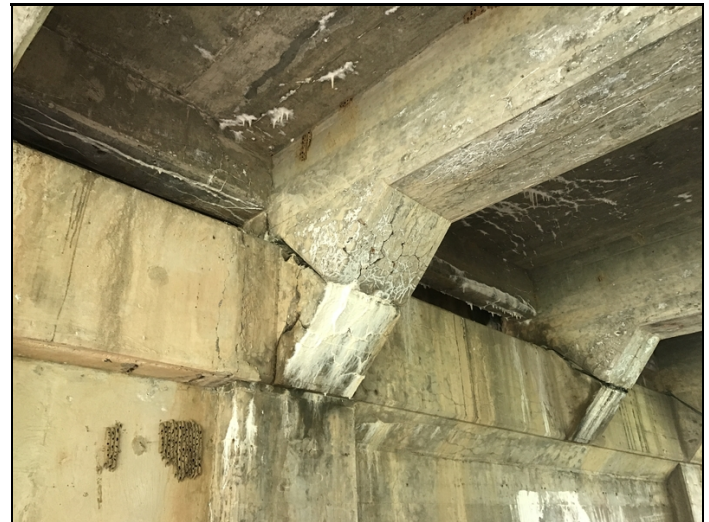
Ahead face of bent # 3 cap under girder # 4 is delaminated.

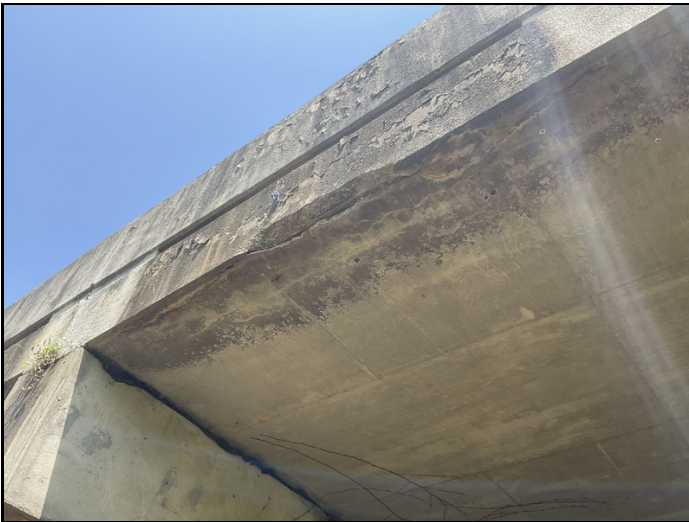
Concrete Slab Span -  
Shallow concrete spalling and delaminated areas along the edges of the slab.

Span # 1 Lt has spalling with exposed reinforcing steel adjacent to bent # 2.

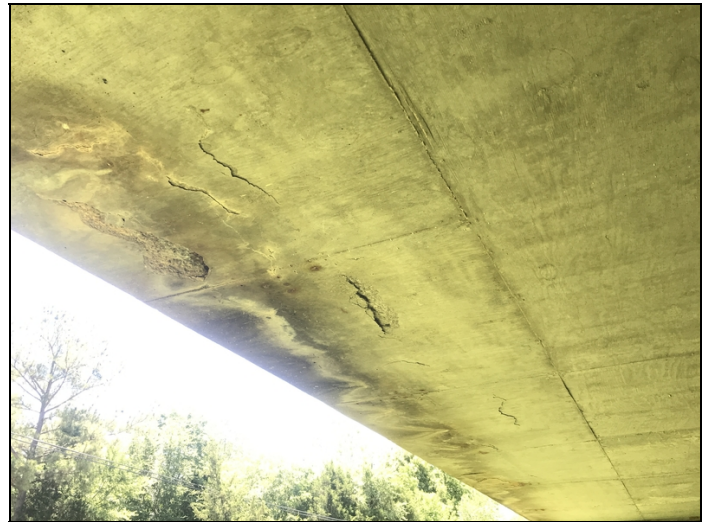
Span # 3, right side-Delaminated areas.

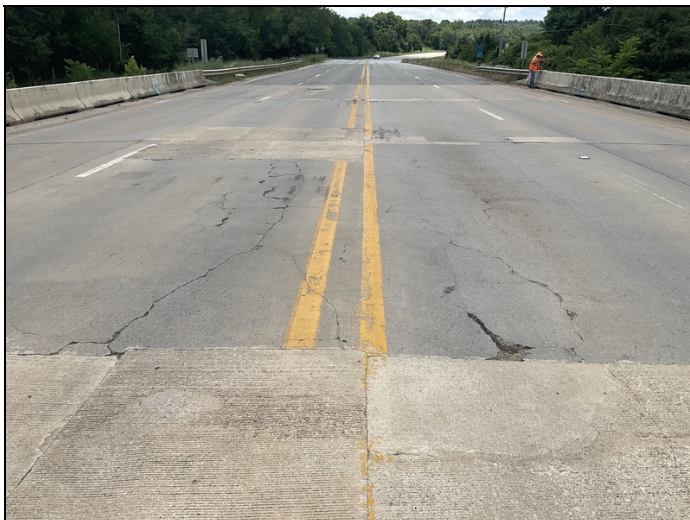
-The driving surface of the deck has sealable cracking.

Concrete cracking and spalling on the wearing surface.

#### **A-54 - Sealable Deck Cracks (Yes)**

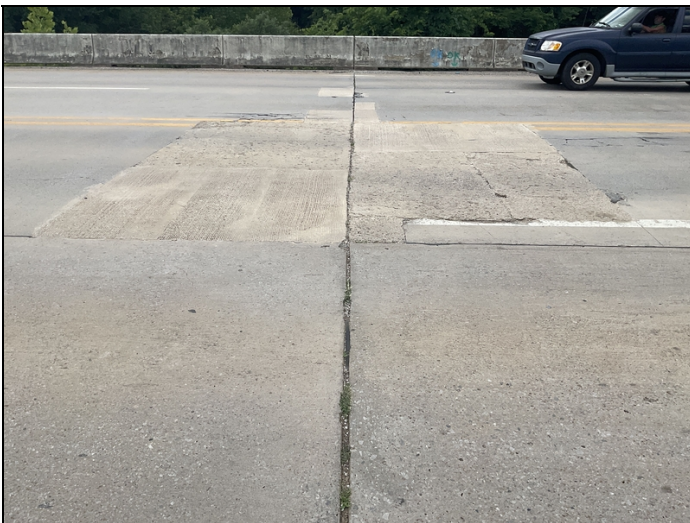
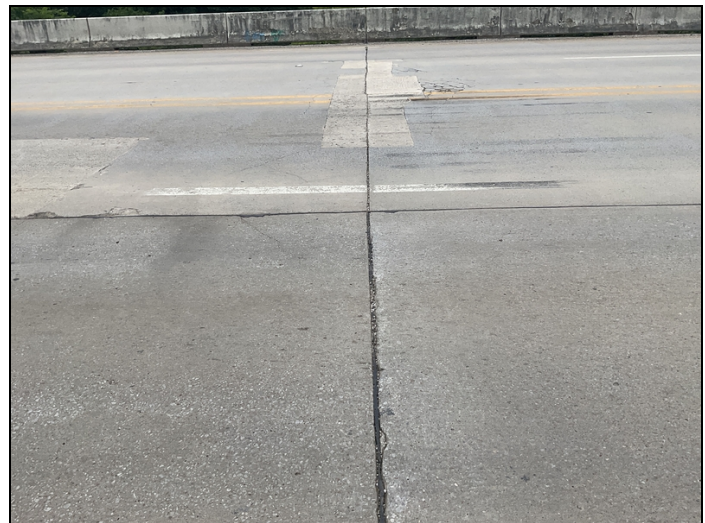
-The joint sealant is deteriorated and leaks water. The joints have dirt and debris impaction.

Bent # 3 typical joint seal.

Bent # 2 typical joint seal.

**A-59 - Joint Repair Needed (Yes)**
