**Asset #A1425**(Routine, Underwater type 2)

**US Highway 71 over Dye Creek - Wash. Co.**

**Location: 0.72 MI N JCT SH 170**

**Team Lead: Eric West, Inspection Date: 12/05/2022**

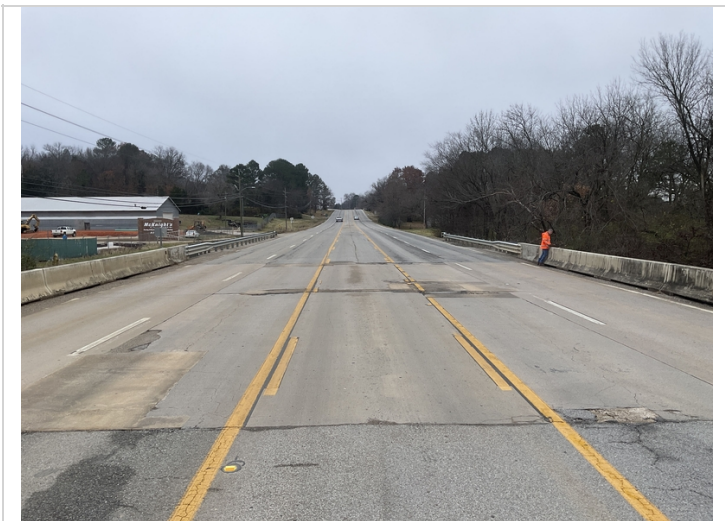
Typical driving surface of the deck.

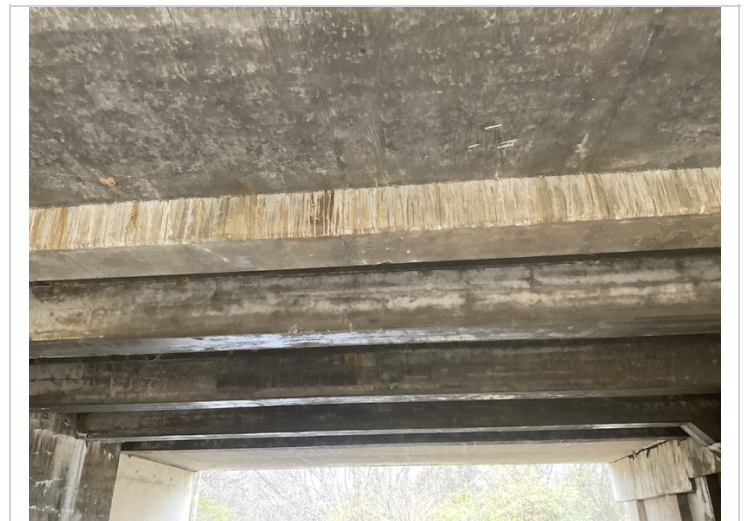
Span #1 typical undersurface of the deck.

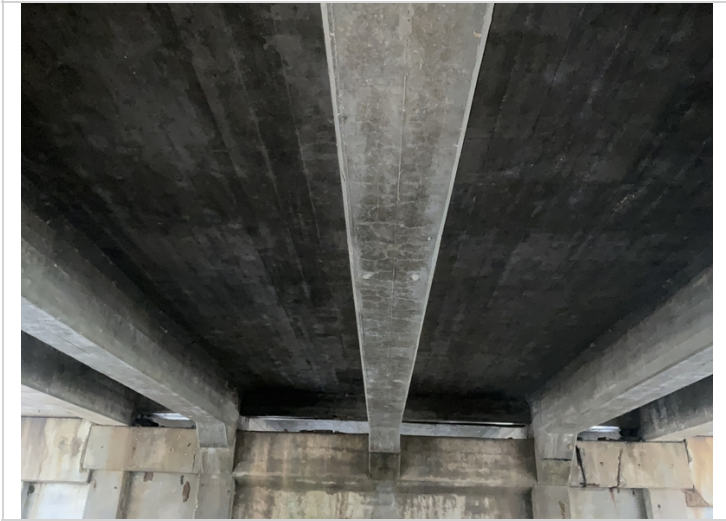
Span #2 typical undersurface of the deck.

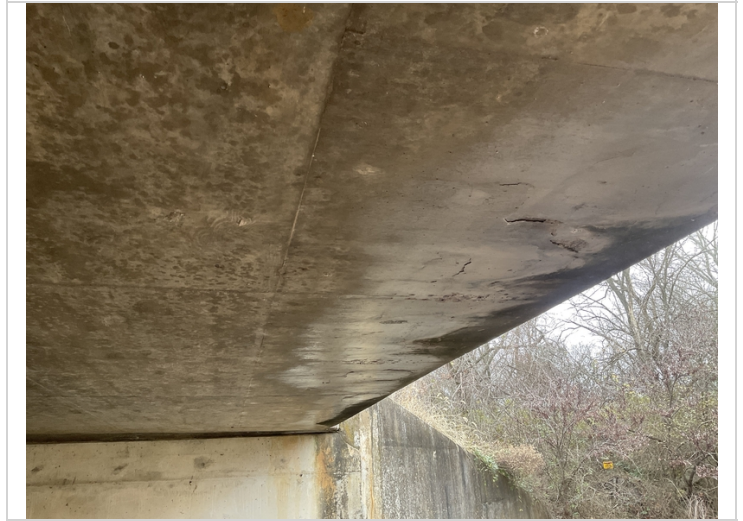
Span #1 Lt concrete delamination along the slab edges.

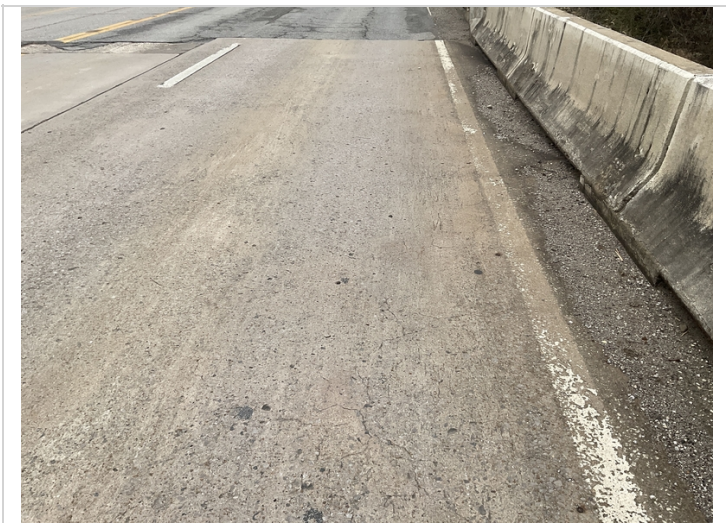
Span #1 Lt map cracking.

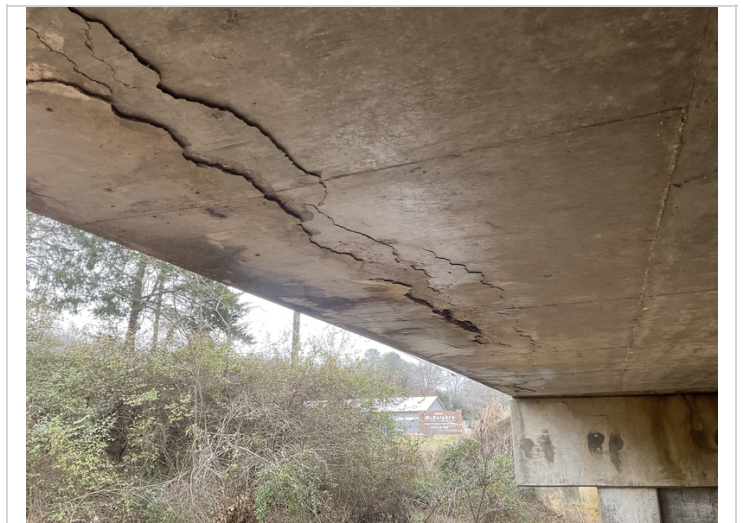
Span #2 Rt concrete delamination and spalling with exposed reinforcing steel.

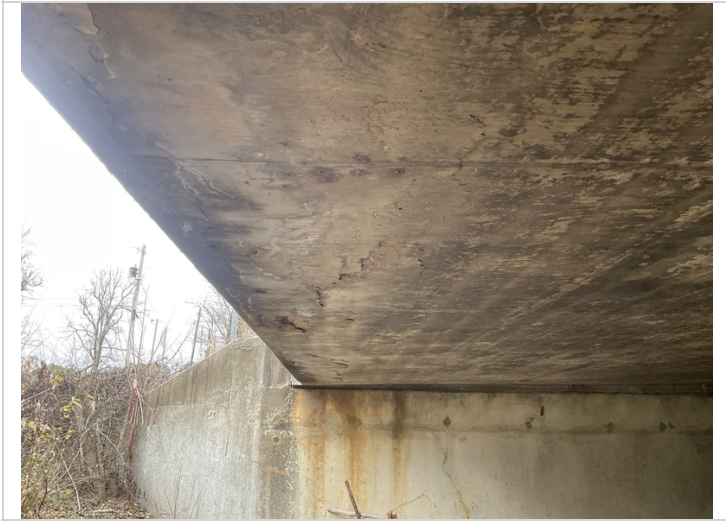
Span #2 Lt concrete delamination and spalling with exposed reinforcing steel.

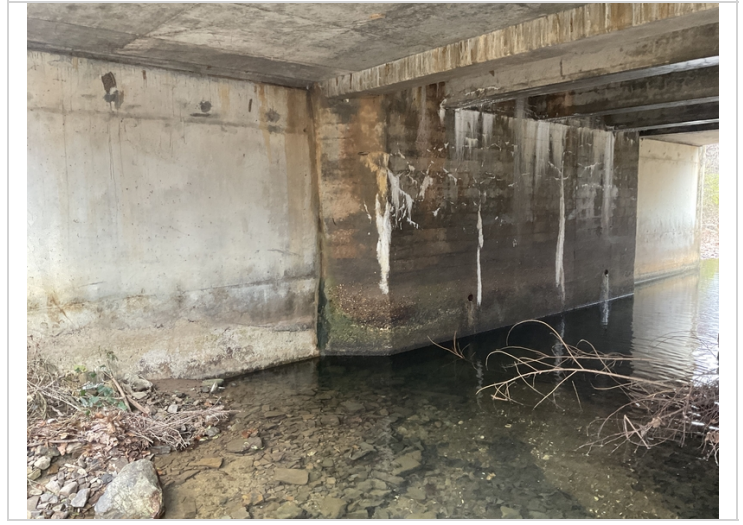
Abutment #1 typical.

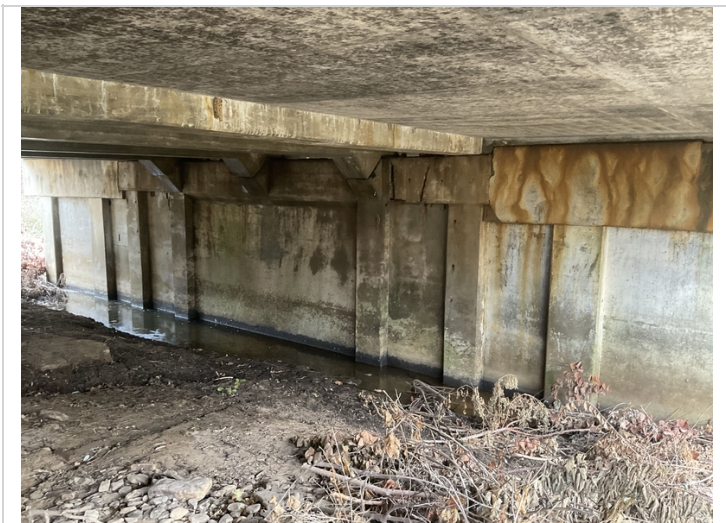
Bent #2 typical.

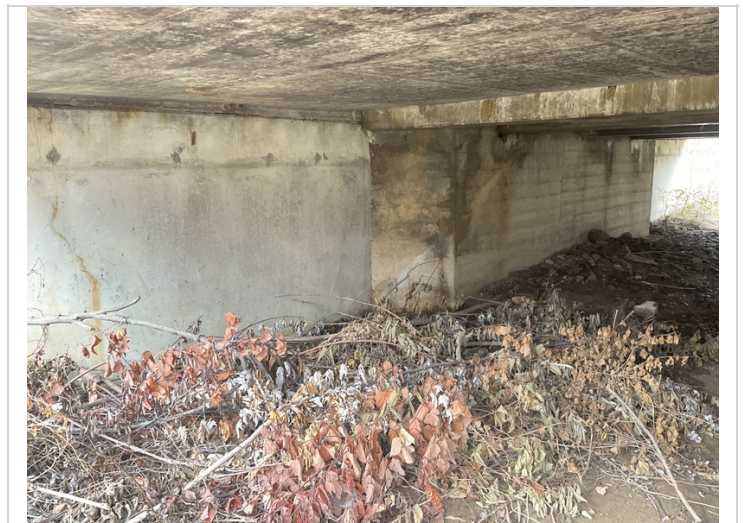
Abutment #2 typical.

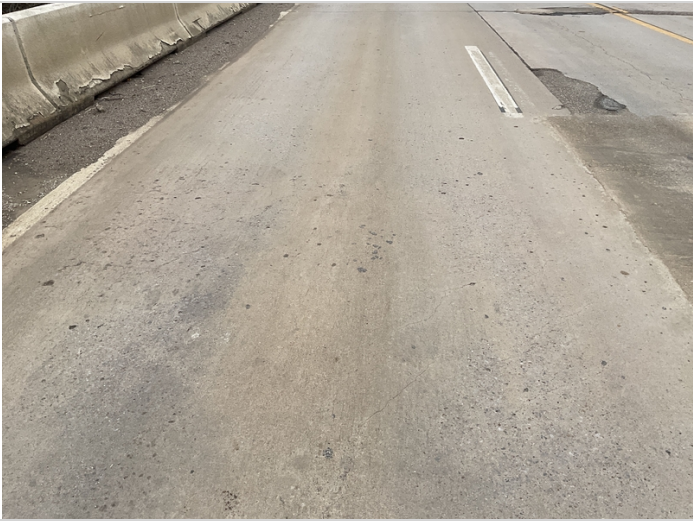
Span #2 Rt slab span cracking.

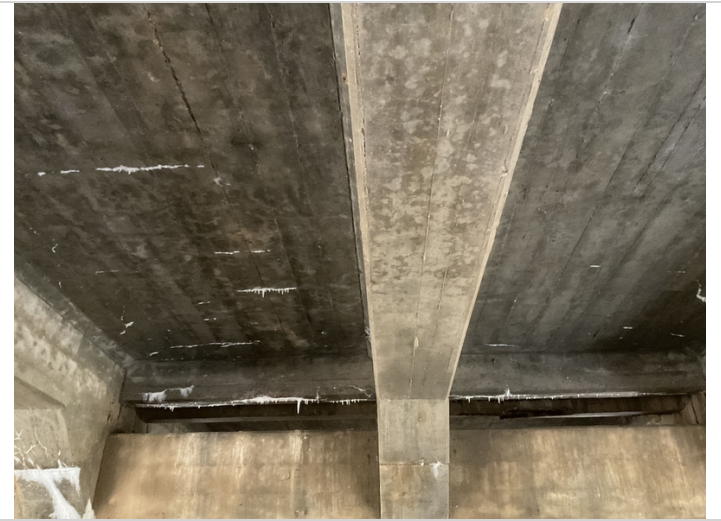
Span #1 adjacent to bent #2 transverse cracking with efflorescence buildup.

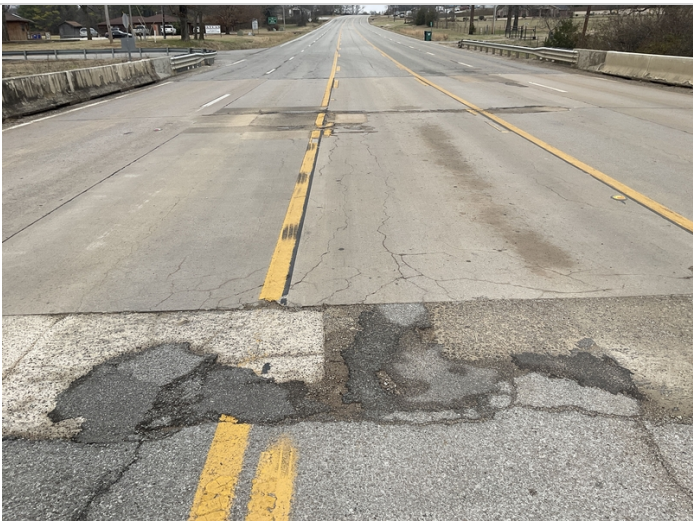
Span #1 cracking on the wearing surface.

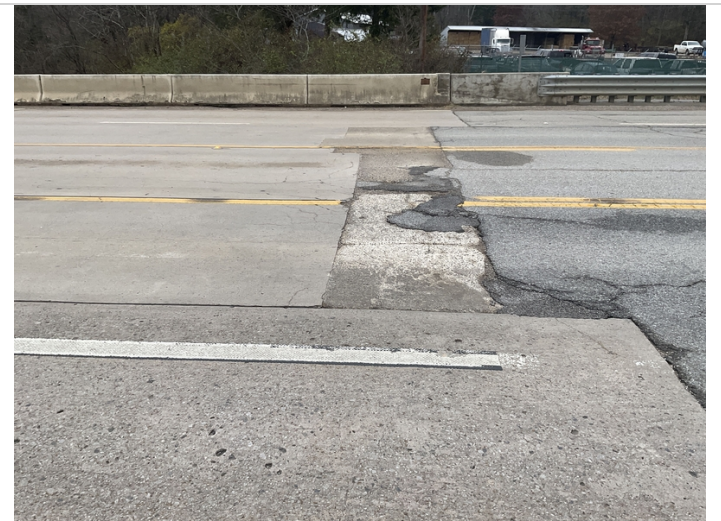
Span #1 wearing surface cracking and failing repairs.

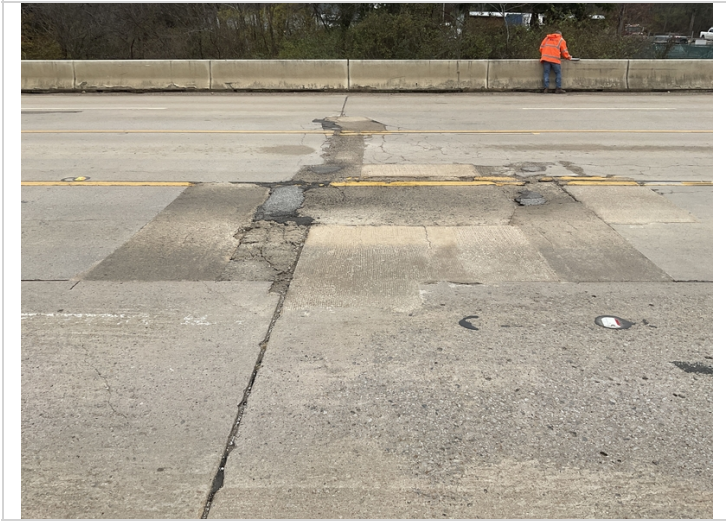
Wearing surface failed repairs over Bent #2.

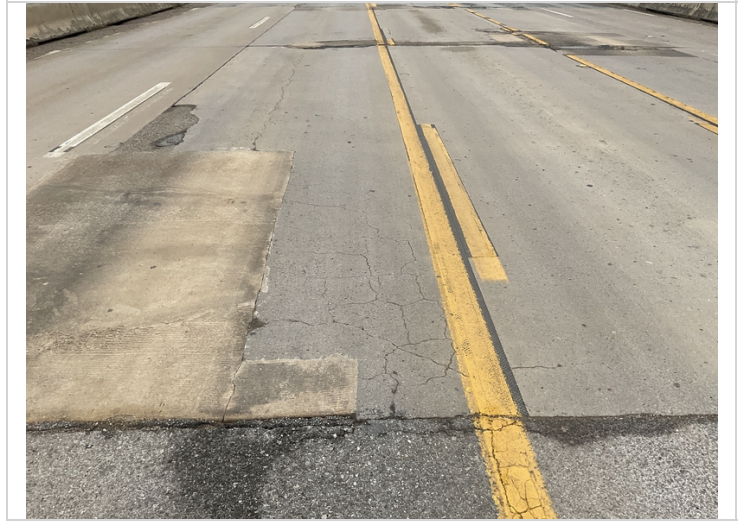
Span # 2 wearing surface cracking.

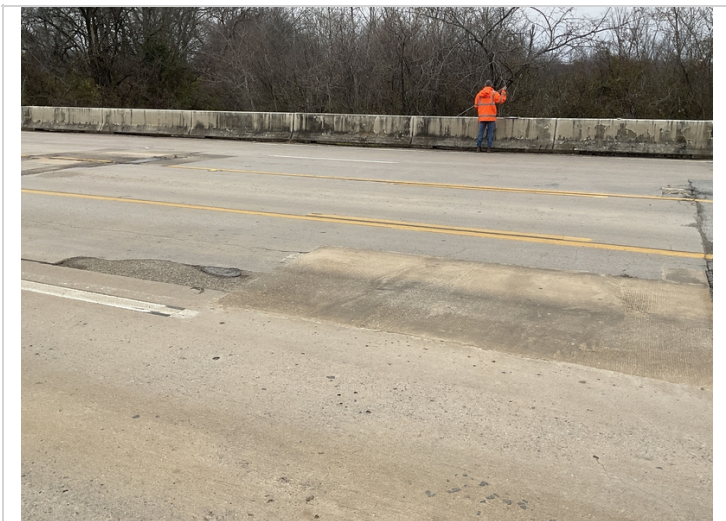
Span #2 failing repairs.

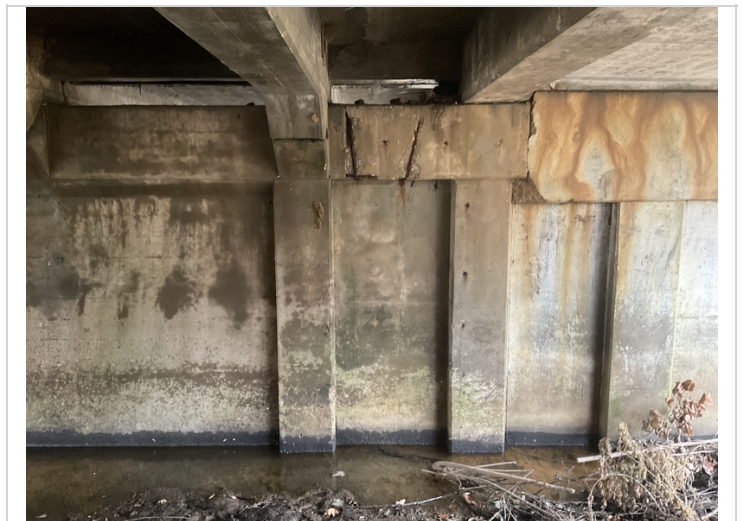
Bent #2 aheadface spalling with exposed reinforcing steel.

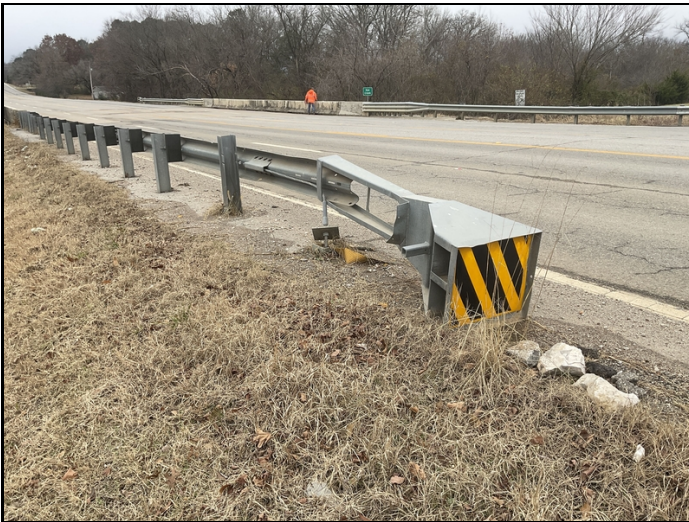
The Northeast approach guardrail end terminal has collision damage with a missing wood post.

Northeast approach guardrail collision damage.

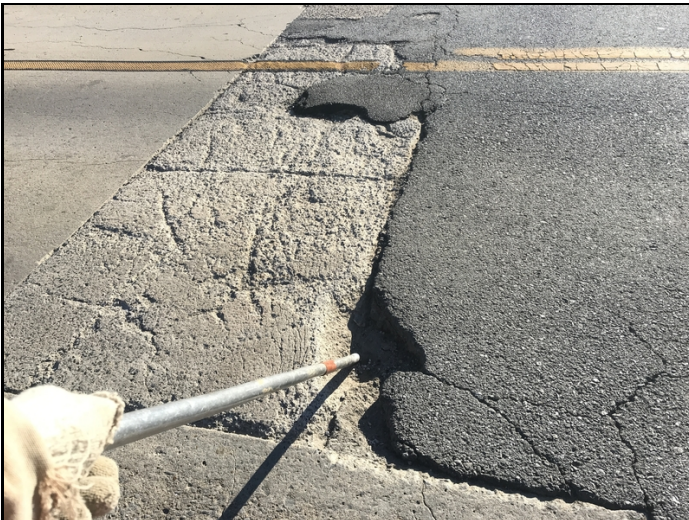
The left lane of the South approach roadway has large potholes at the bridge end.

12/05/2022 - EJW - Maintenance forces have placed asphalt in the potholes as a temporary repair. Deficiencies still exist at this inspection.

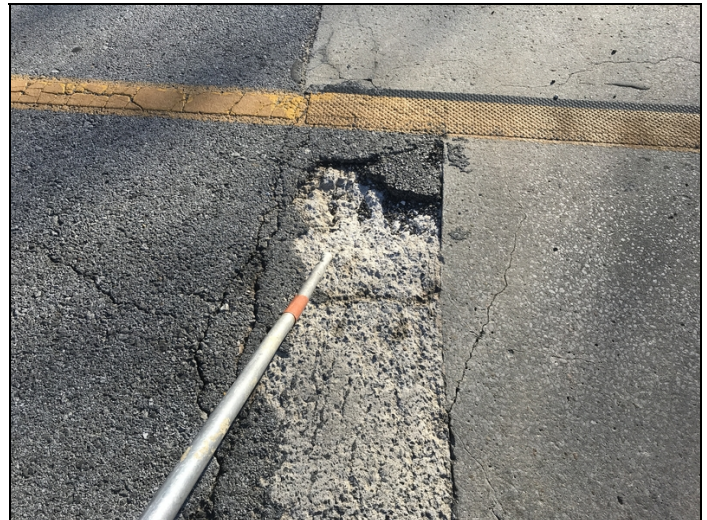
The concrete repairs are breaking apart with potholes on the driving surface of the deck. The repairs appear delaminated when sounded.

Failing repair over abutment 2.

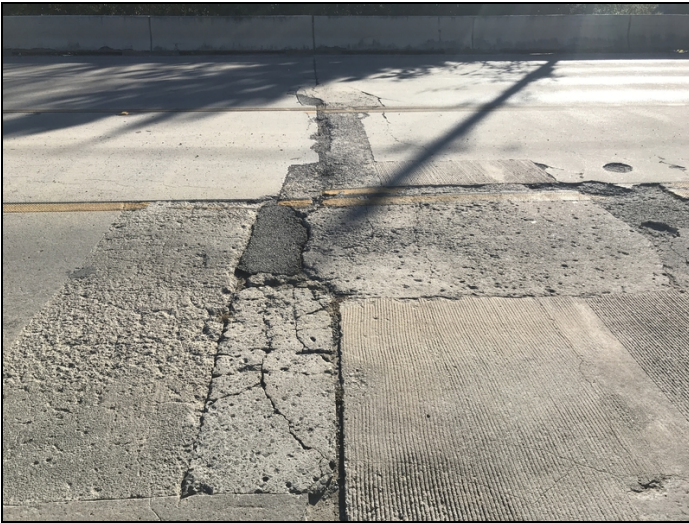
Repairs over bent 2.

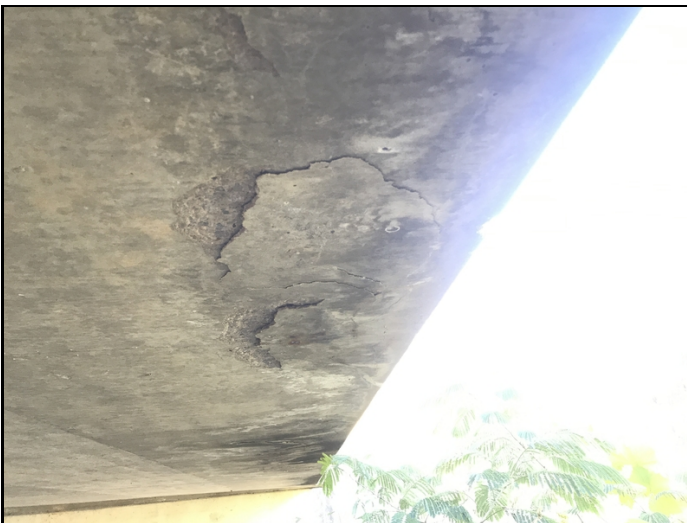
The undersurface of the concrete slab portion of the deck has 3' wide areas that are delaminated along both exterior edges.

Span 1, left side-Delaminated areas along slab edge.

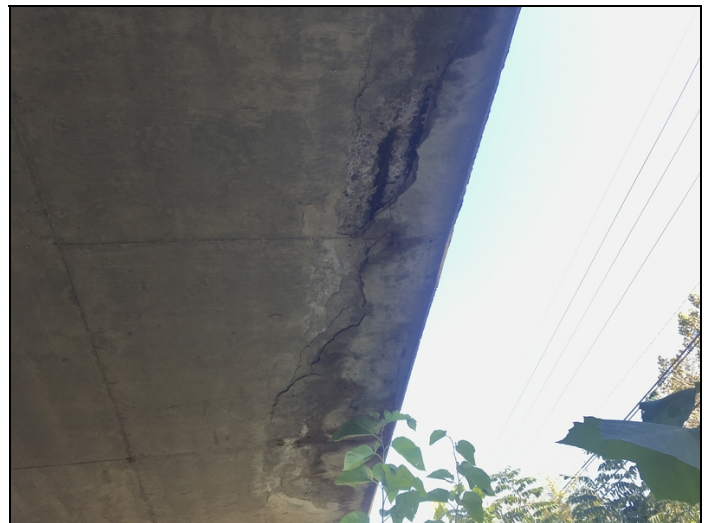
Span # 2 has spalling with exposed reinforcing steel on the undersurface along both exterior edges of the concrete slabs. The exposed reinforcing steel has active corrosion with initial section loss.

Span 2 slab, right side-Spalling / delaminated areas with exposed reinforcing steel.

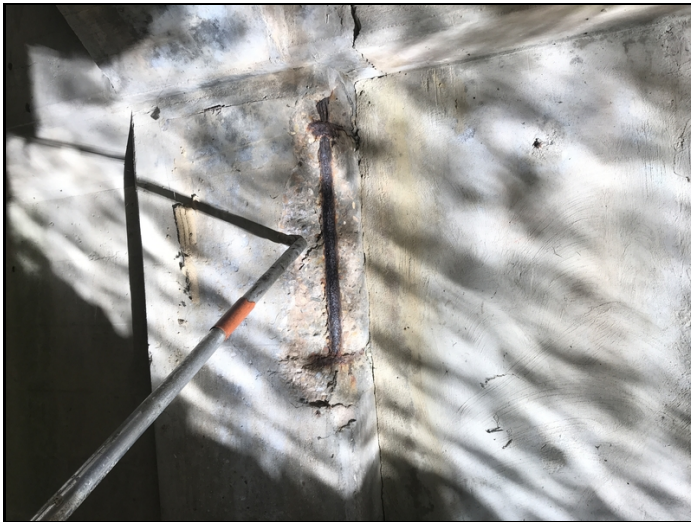
Concrete spalls with exposed reinforcing steel in Bent # 2 cap and Column # 5.

Bent # 2, column # 5-Spalling with exposed reinforcing steel.

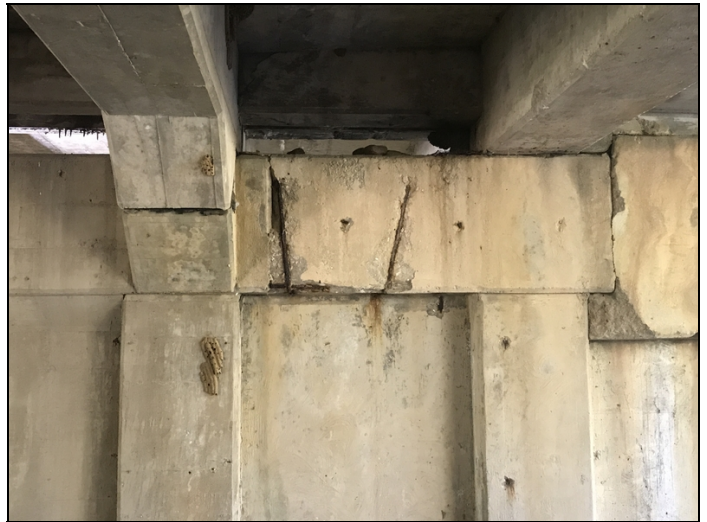
Bent # 2 cap-Spalling with exposed reinforcing in bay 1.

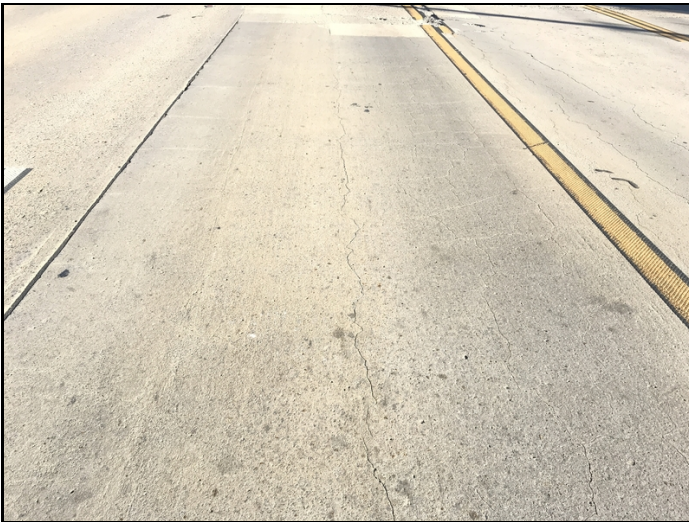
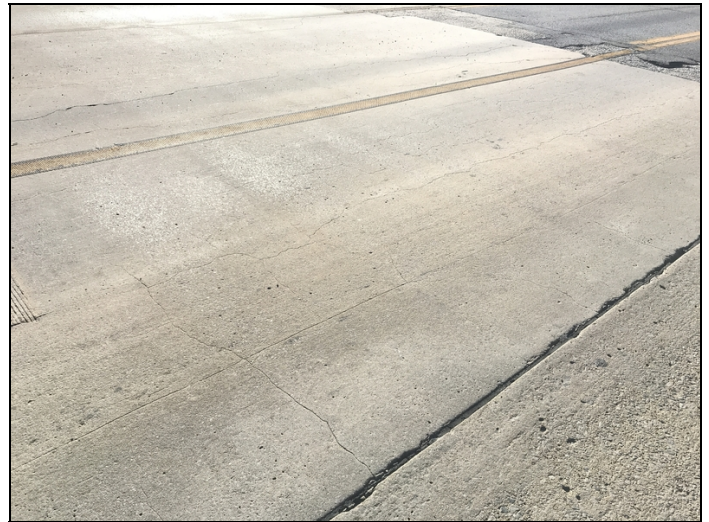
The driving surface of the deck has sealable longitudinal and map cracking.

Longitudinal and mapcracking in driving surface.

Longitudinal and mapcracking in driving surface of original portion of deck.

**A-54 - Sealable Deck Cracks (Yes)**

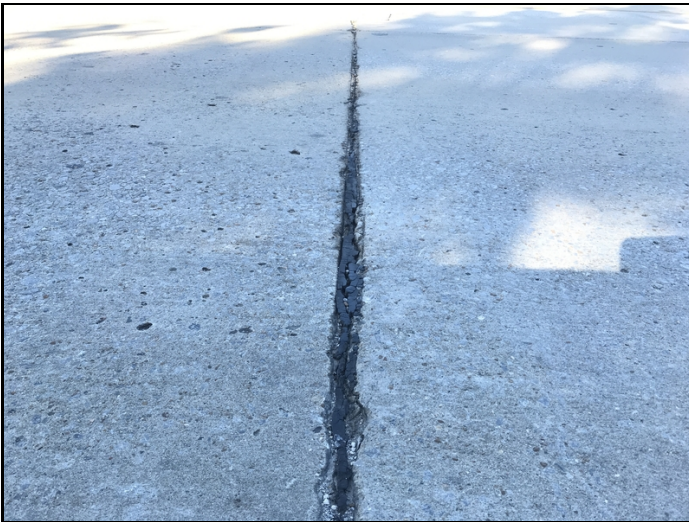
The compression deck joint seals are deteriorating and appear to leak water.

**A-59 - Joint Repair Needed (Yes)**
