Asset #B1423(Routine, Underwater type 2)

US 71 - Wash. Co. over Barnett Creek

Location: 4.31 MI SE OF US 62

Team Lead: Eric West, Inspection Date: 08/22/2023

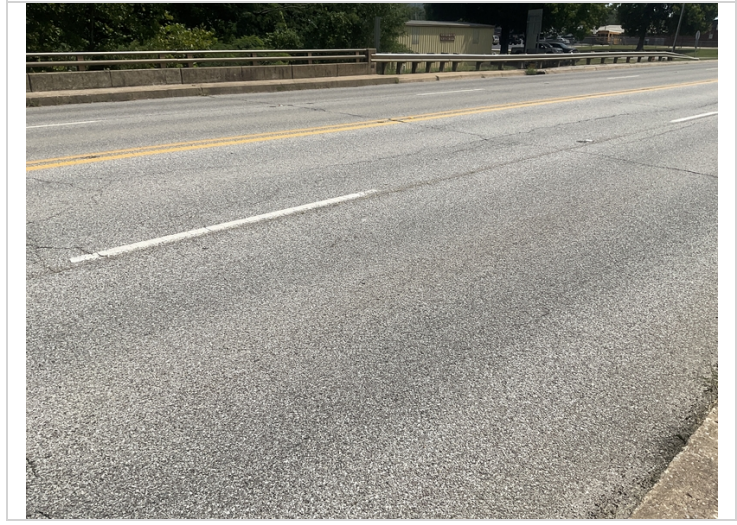
Typical driving surface.

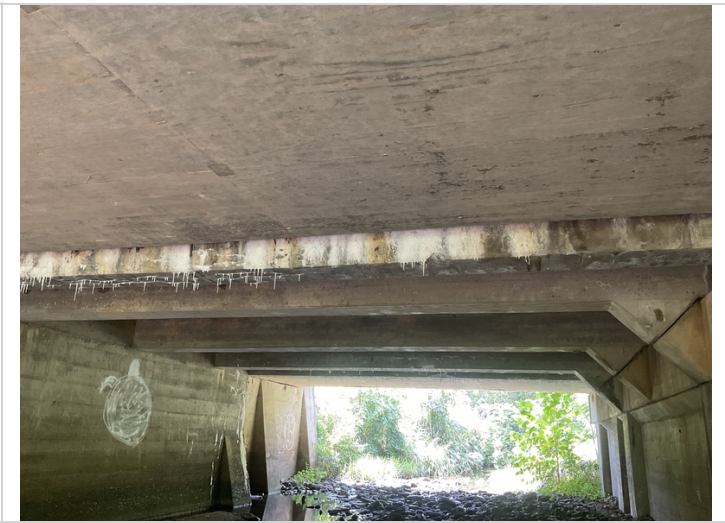
Span # 1 typical undersurface.

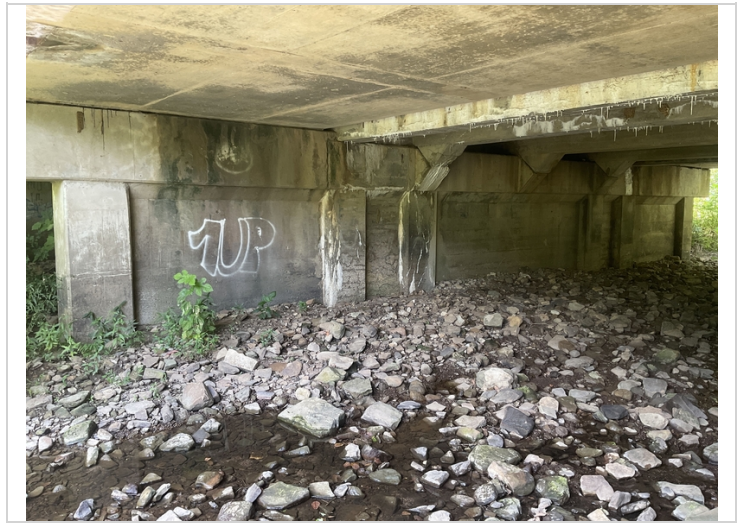
Bent # 2 typical.

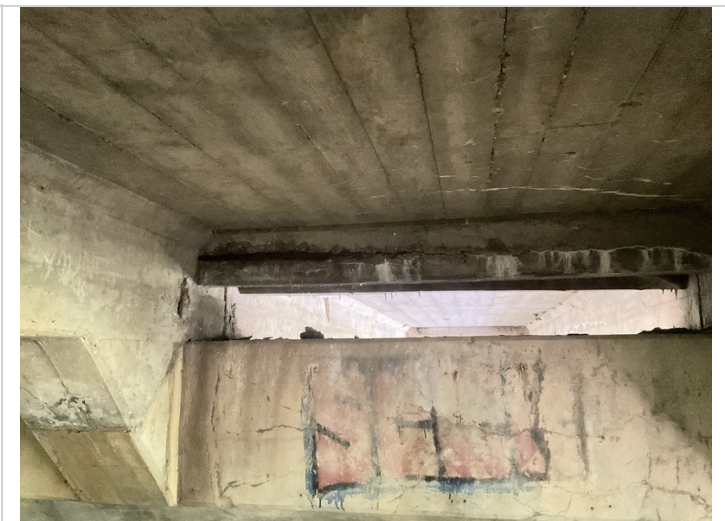
Span # 2 bay # 1 deck haunch over Bent # 2 spalling with exposed reinforcing steel.

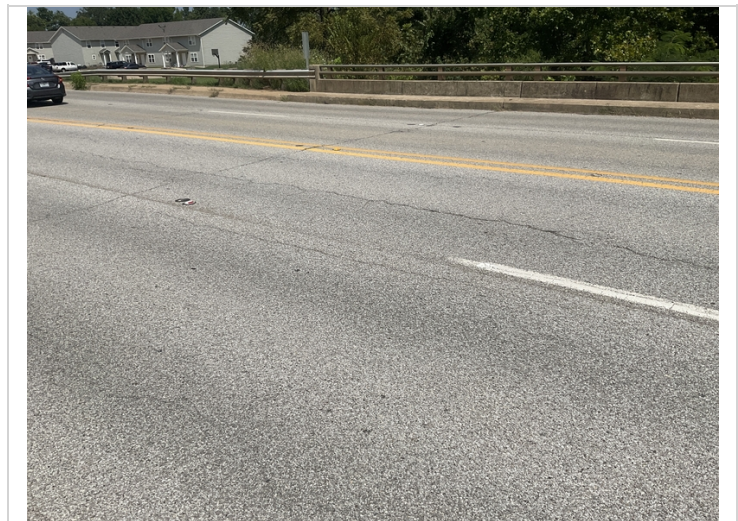
| ELEMENTS | DESCRIPTION | UNITS | TOTAL | CS1 | CS2 | CS3 | CS4 |
|---|---|---|---|---|---|---|---|
| (16) -The ACHM wearing surface has transverse reflective cracking over bent # 2 and longitudinal reflective cracking over the construction joints where the structure was widened. -The undersurface of the deck has areas of longitudinal and transverse cracking with light efflorescence at variable spacing. -The undersurface has areas with map cracking with light efflorescence adjacent to the abutments. (510-16) -The wearing surface has cracking in the wheel paths and over the joints. | | | | | | | |

Cracking in the asphalt wearing surface.

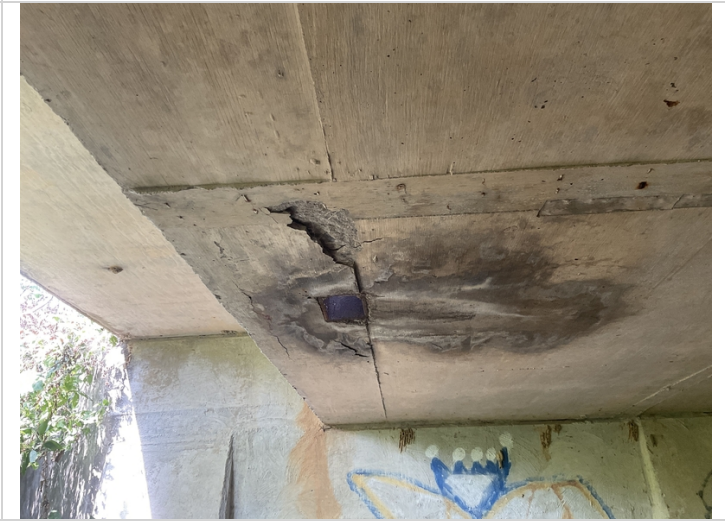
| ELEMENTS | DESCRIPTION | UNITS | TOTAL | CS1 | CS2 | CS3 | CS4 |
|---|---|---|---|---|---|---|---|
| (38) -The structure was widened on both sides in the past with concrete slab spans. -Delaminated areas and shallow spalling in the undersurface of the slab along both edges adjacent to the deck drains in both spans. | | | | | | | |

Span # 2 Lt concrete spalling and delaminating adjacent to the deck drains.

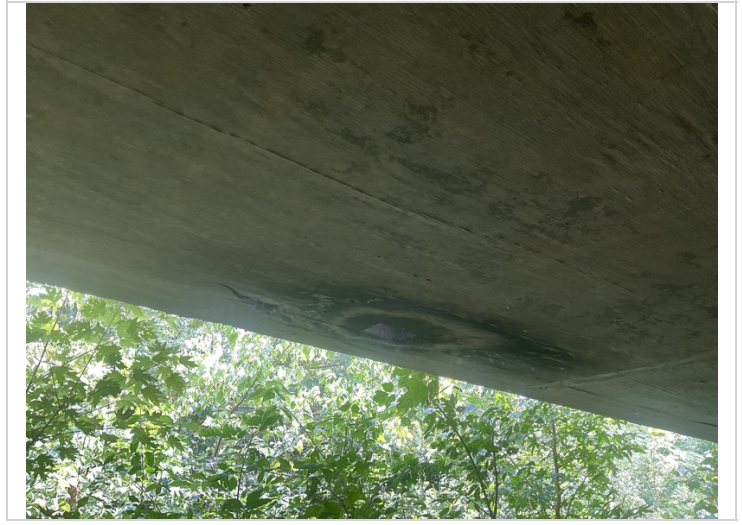
Span # 2 Rt concrete delamination adjacent to the deck drains.

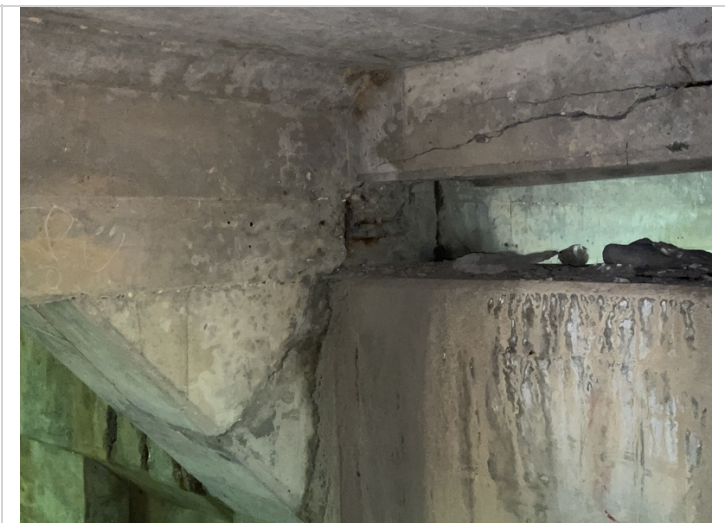
Span # 2 girder # 4 spalling with exposed reinforcing steel over Bent # 2.

The end of Girders # 3 & 4 in Span # 2 over Bent # 2 have a shallow spall that exposes reinforcing steel that has active corrosion with initial section loss.

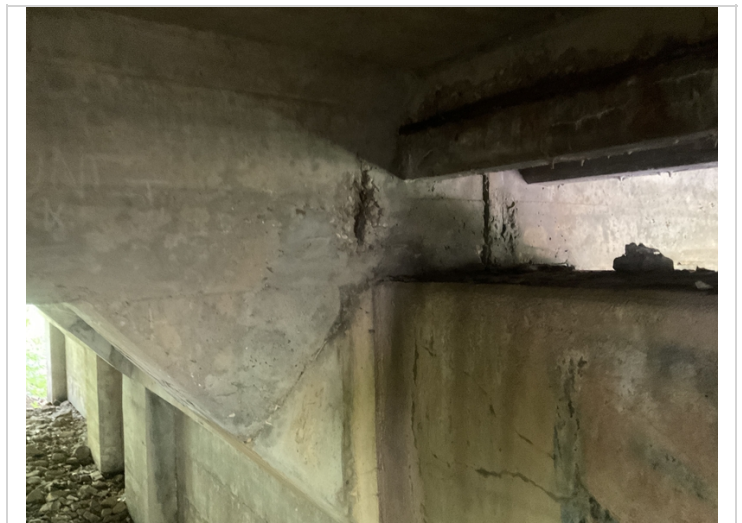
Span # 1 & 2 Girder # 3 spalling with exposed reinforcing steel.

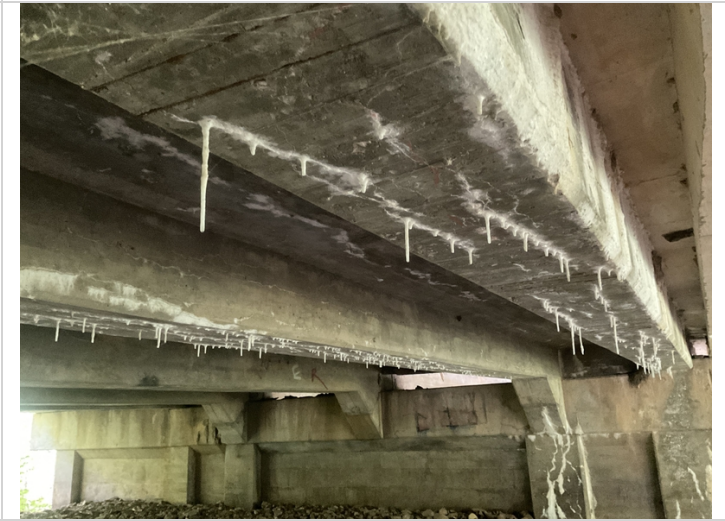
Span # 2 girders # 1 & 2 efflorescence buildup.

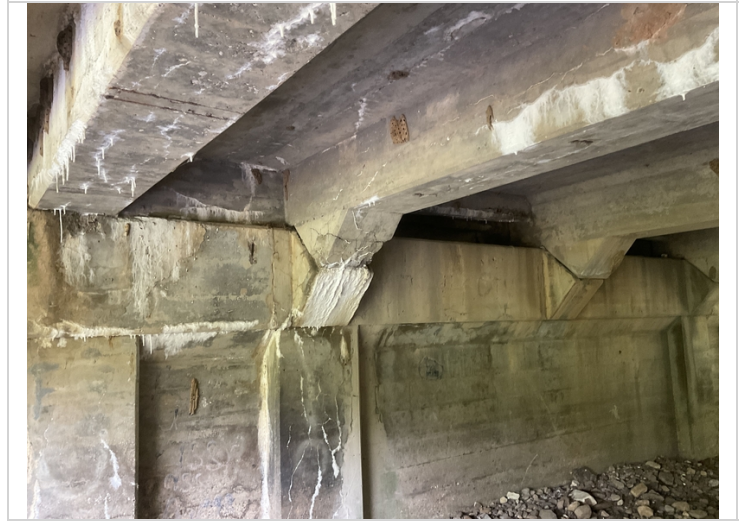
Span # 1 girder # 2 haunch cracking.

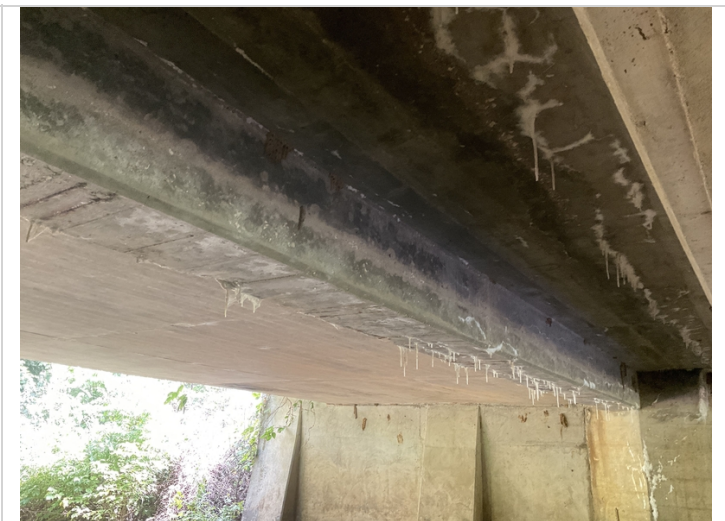
Span # 1 beam # 5 efflorescence buildup.

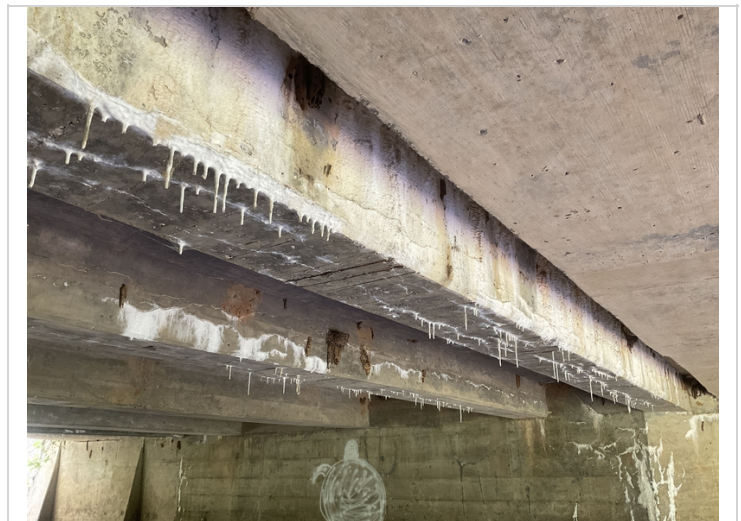
| ELEMENTS | DESCRIPTION | UNITS | TOTAL | CS1 | CS2 | CS3 | CS4 |
|---|---|---|---|---|---|---|---|
| (110) -Beams # 1, 2, & 5 in span # 1, and beams # 1 and # 2 of span # 2 have heavy longitudinal and map cracking with heavy efflorescence. -Span # 1, girder # 2 has shallow spalling with exposed reinforcing steel along the bottom of the girder. Exposed reinforcing steel appears to be transverse secondary reinforcement. -The beam haunches at bent # 2 have map cracking, some with efflorescence. Span # 1, girder # 2 haunch at bent # 2 has wide mapcracking with spalling. -Span # 1, girder # 5 has two 6" shallow spalls near abutment # 1 and one 6" spall approximately 7' from bent # 2. -Span # 2, girder # 1 has a 4" shallow spall with exposed reinforcing steel located 2' from bent # 2. Exposed steel has initial section loss. The undersurface of the girder has a 5' long delaminated area adjacent to abutment # 2. -Span # 2, girders # 3 & 4 have a spall with exposed reinforcing steel with active corrosion and initial section loss at the end of the girder over bent # 2. | | | | | | | |

Span # 1 beams # 1 & 2 efflorescence buildup.

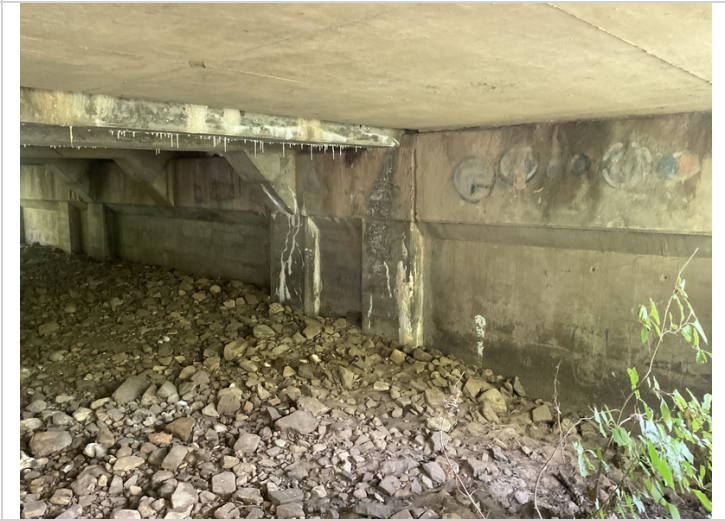
| ELEMENTS | DESCRIPTION | UNITS | TOTAL | CS1 | CS2 | CS3 | CS4 |
|---|---|---|---|---|---|---|---|
| (205) -Bent # 2, columns # 2 & 3 have map cracking with efflorescence. -Light scale and minor abrasion at the base of the columns. | | | | | | | |

Bent # 2, columns # 2 & 3 have map cracking with efflorescence.

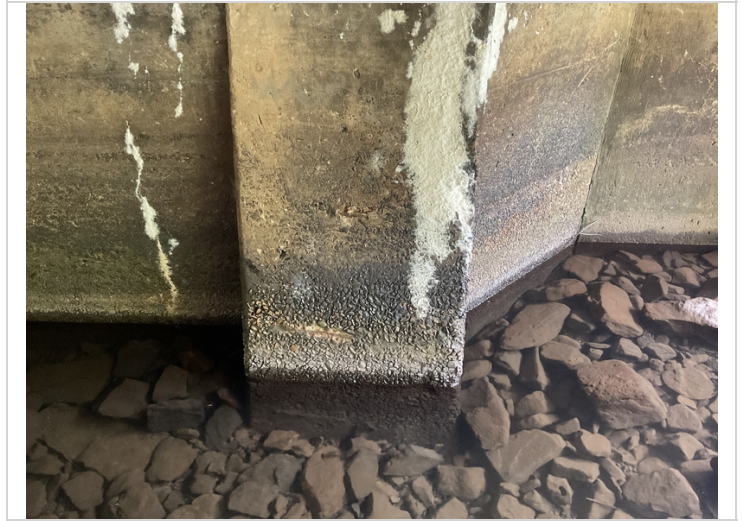
Abutment # 1 column # 3 exposed reinforcing steel.

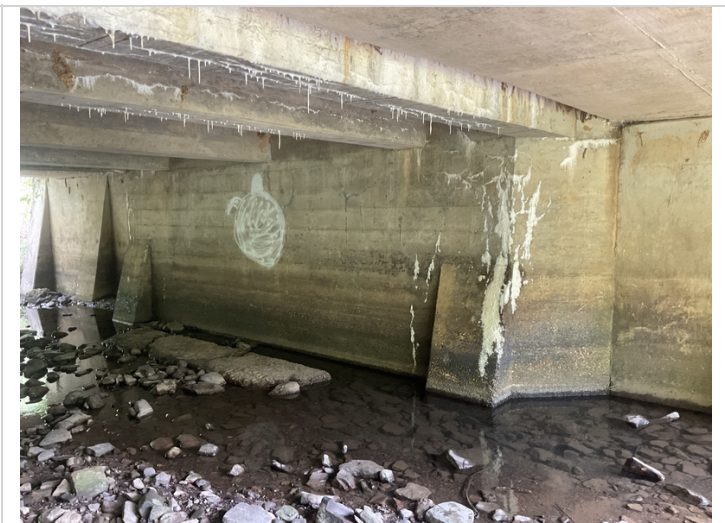
| ELEMENTS | DESCRIPTION | UNITS | TOTAL | CS1 | CS2 | CS3 | CS4 |
|---|---|---|---|---|---|---|---|
| (215) -Light map cracking with efflorescence and light abrasion on the edges of the abutments adjacent to the wing wall junctures in the original section of the structure. -Abutment # 1 column # 3 has 2 horizontal sections of exposed reinforcing steel. | | | | | | | |

Abutment # 1 cracking with efflorescence buildup.

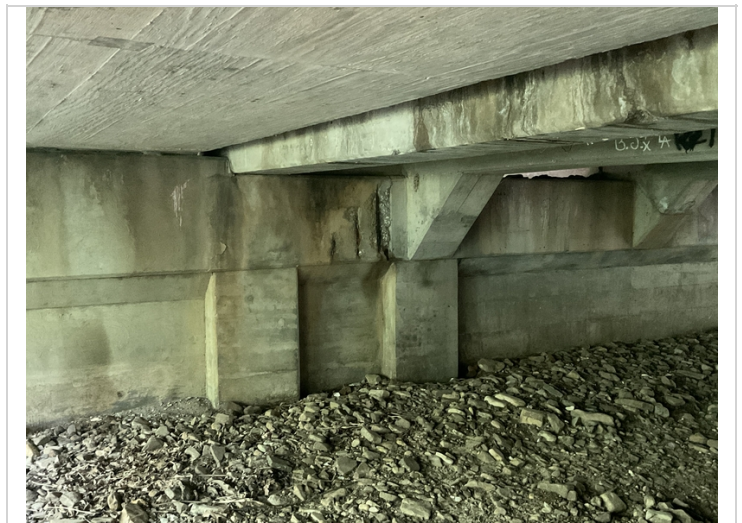
| ELEMENTS | DESCRIPTION | UNITS | TOTAL | CS1 | CS2 | CS3 | CS4 |
|--|---|---|---|---|---|---|---|
| (331) -Concrete portions of the bridge railing have spalls with exposed reinforcing steel. -The right bridge railing in span # 2 has hairline map cracking and 1 minor spall. -There are spalls with exposed reinforcing steel visible from the undersurface of the side walk on the right side of span # 2. | | | | | | | |

Span # 2 Rt spalling with exposed reinforcing steel.

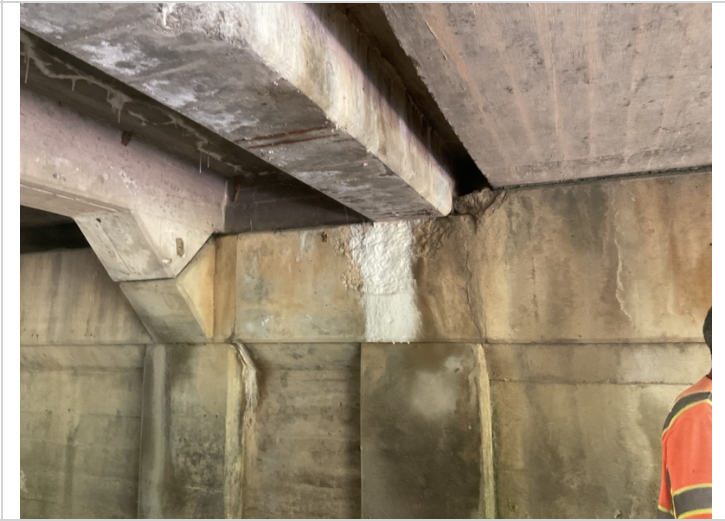
Span # 1 girder # 5 spalling in the bearing area.

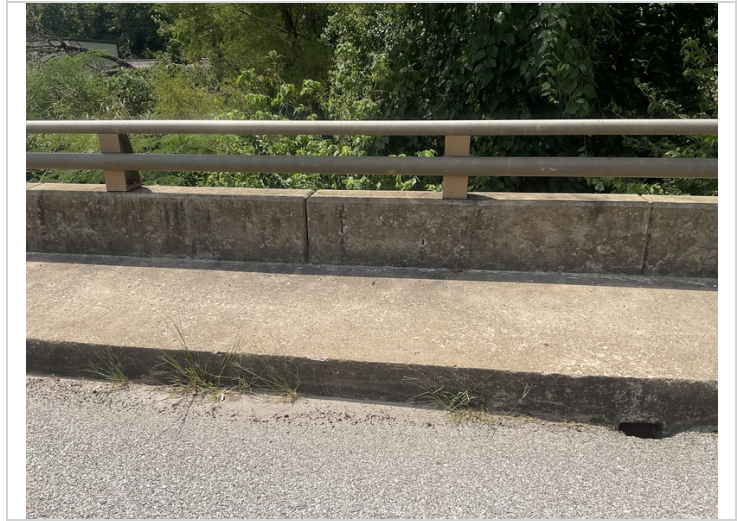
Span # 2 Lt exposed reinforcing steel.

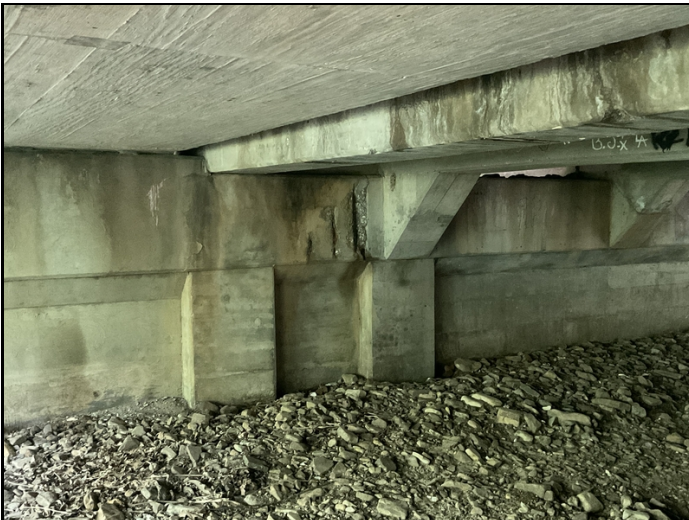
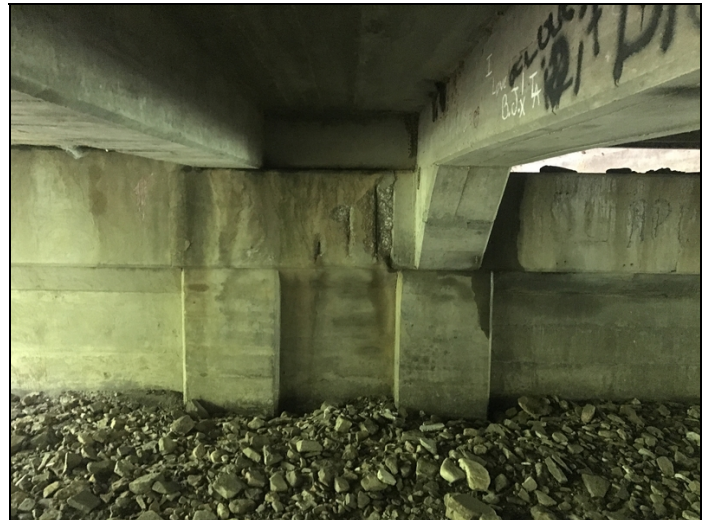
The ahead face of Bent # 2 cap has spalling with exposed reinforcing steel adjacent to girder # 4.

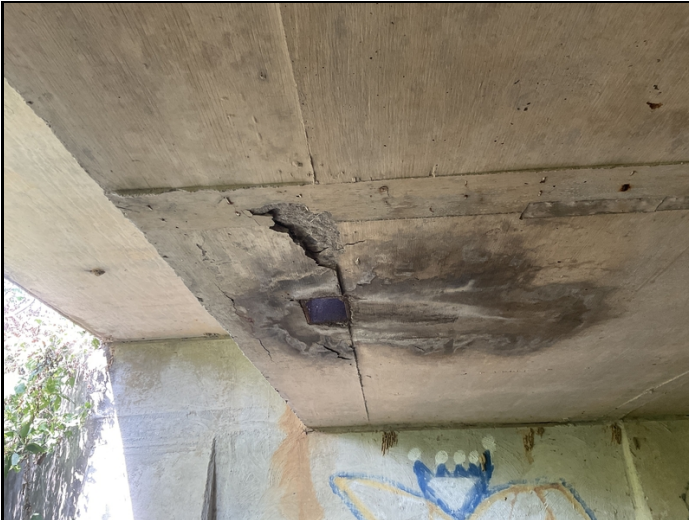
Delaminated/Spalled areas with exposed reinforcing steel along the edges of the slab undersurface adjacent to the deck drains in both spans.

Span # 2 Lt concrete spalling and delaminating adjacent to the deck drains.

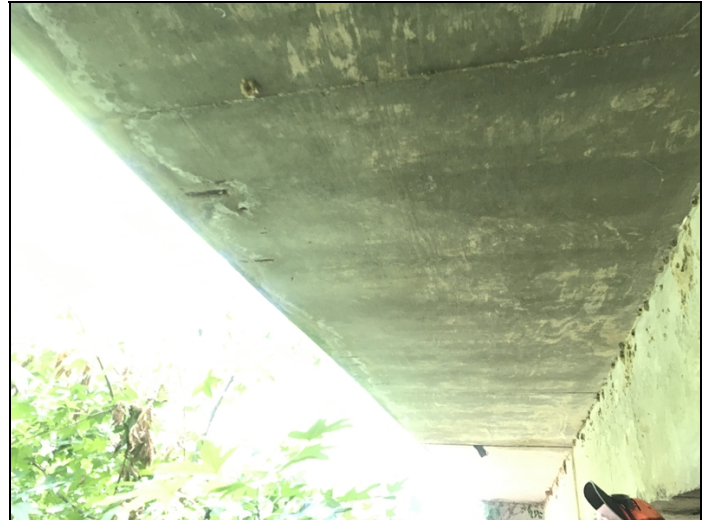
The undersurface of the pedestrian sidewalk on the right side has areas of spalling with exposed reinforcing steel.

Span # 2. Right overhang. Exposed reinforcing steel.

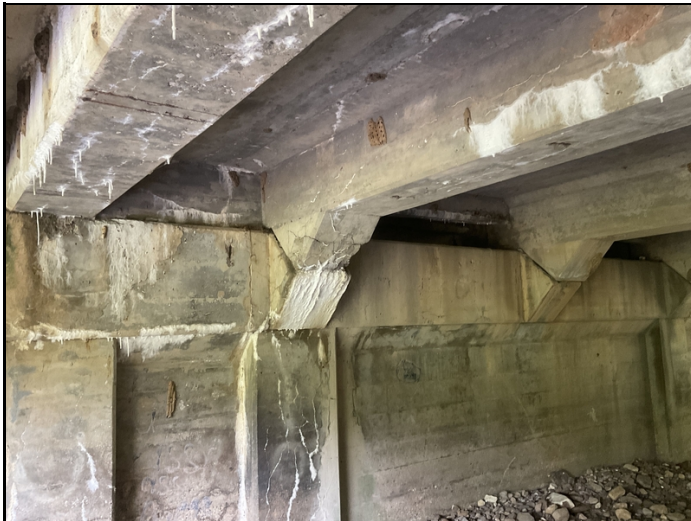
The cap and beam haunches have map cracking with efflorescence. The expansion material between the girder haunch and cap haunch is missing at span # 1, girder # 4 at bent # 2.

Span # 1 girder # 2 haunch cracking.

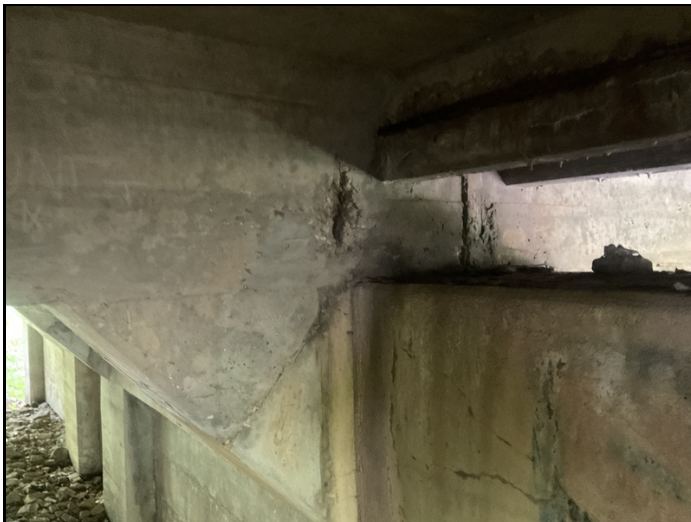
Span # 1 & 2 Girder # 3 spalling with exposed reinforcing steel.

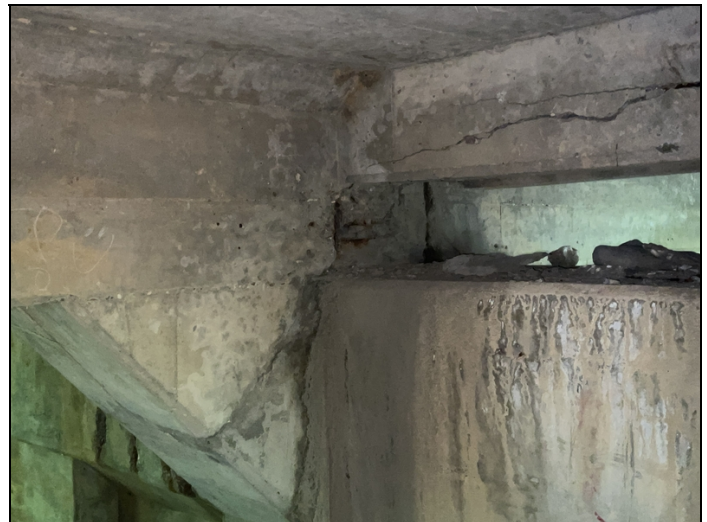
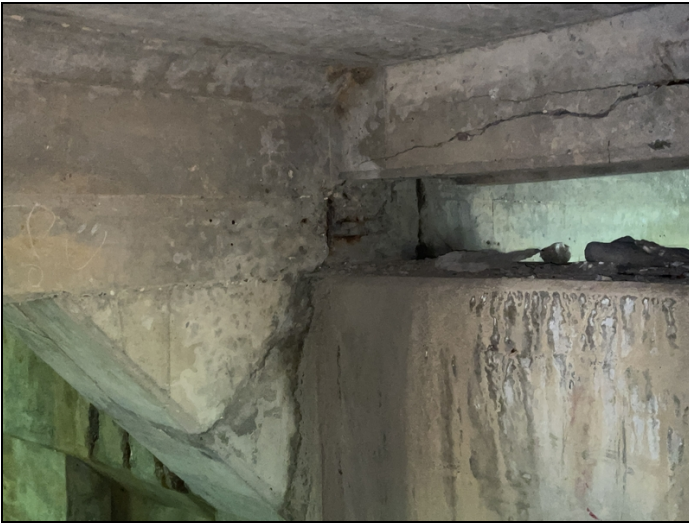
Span # 2 girder # 4 spalling with exposed reinforcing steel over Bent # 2.

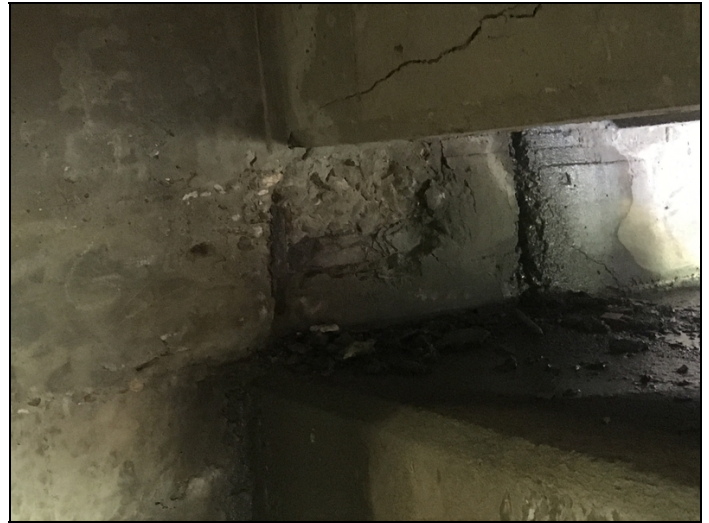
Exposed reinforcing steel in the end of Girder # 4 over Bent # 2.

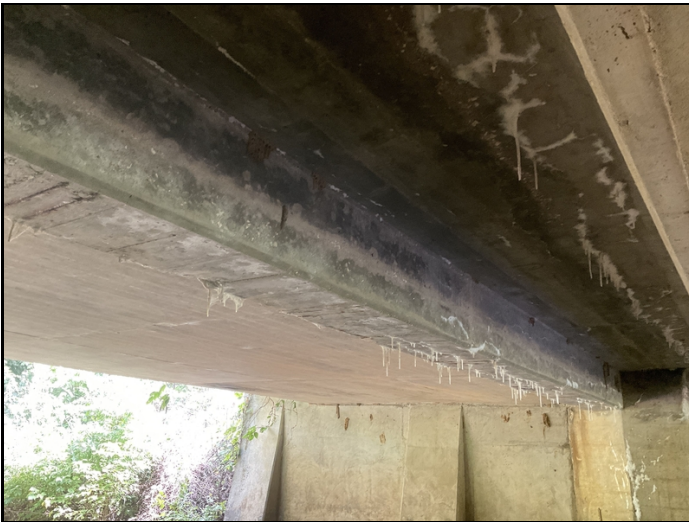
The concrete Tee beams in both spans have longitudinal and map cracking with heavy efflorescence.

Span # 1 beam # 5 efflorescence buildup.

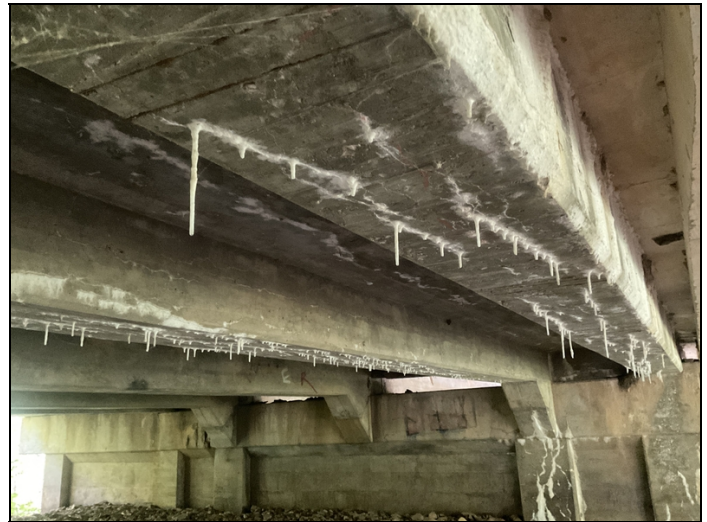
Span # 2 girders # 1 & 2 efflorescence buildup.

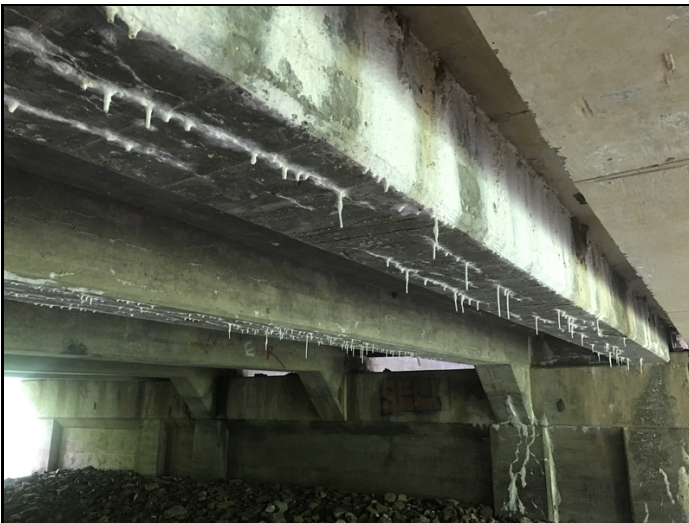
Girders # 1 & 2 in Span # 2-Mapcracking with efflorescence.

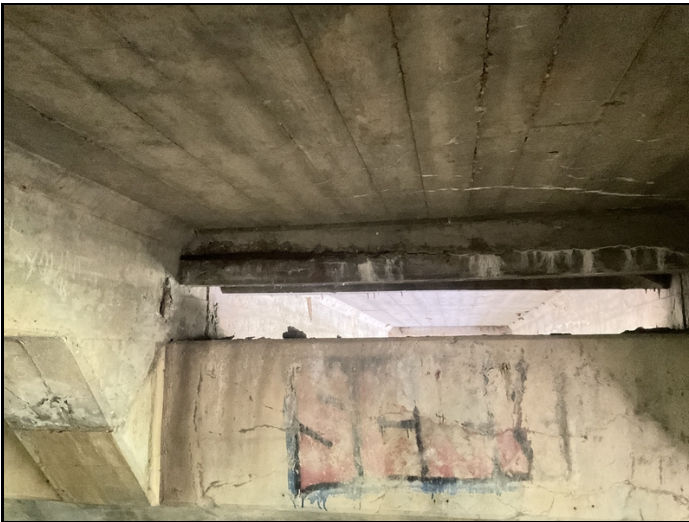
The undersurface of the deck has areas of map cracking with efflorescence adjacent to the bents and between the girders.

Span # 2 bay # 1 deck haunch over Bent # 2 spalling with exposed reinforcing steel.

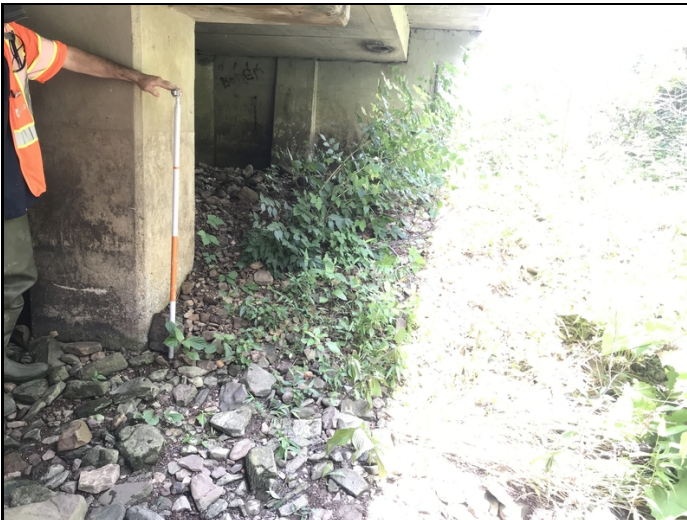
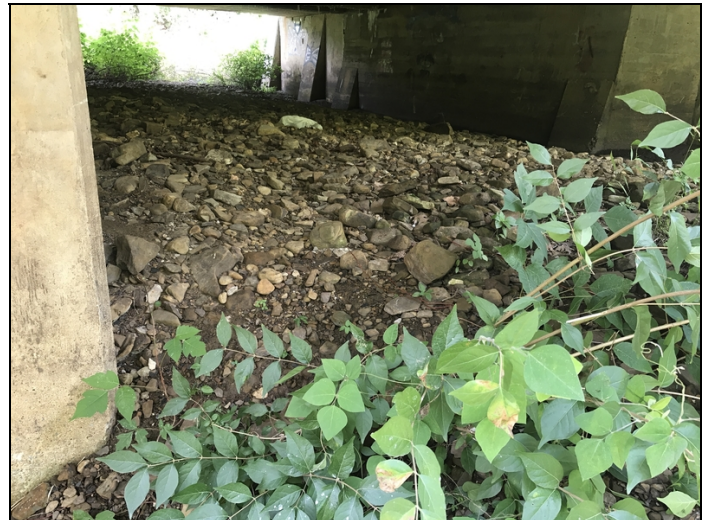
Span # 2 is restricted by approximately 3' of streambed material accumulation.

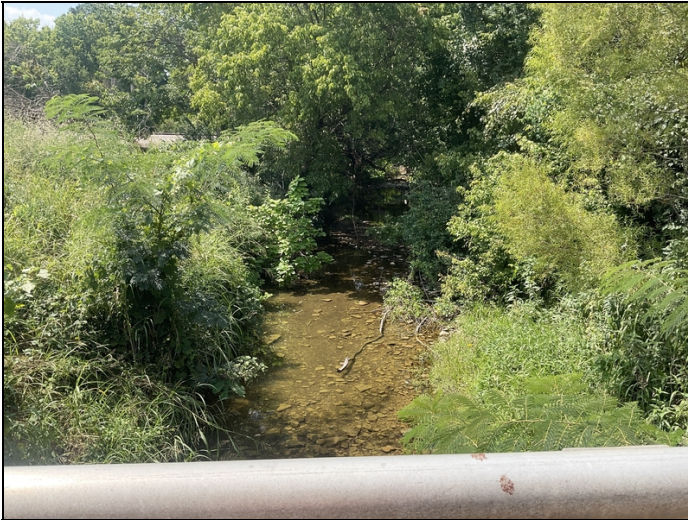
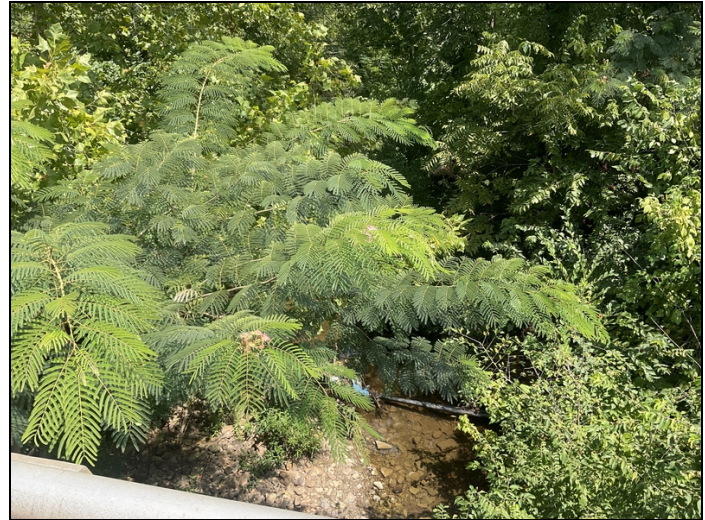
The channel is partially restricted by trees and vegetation.
