Asset #M1383(Routine)

US 71 - Washington over Ditch

Location: 11.25 MI NE OF SH 74

Team Lead: Eric West, Inspection Date: 07/24/2023

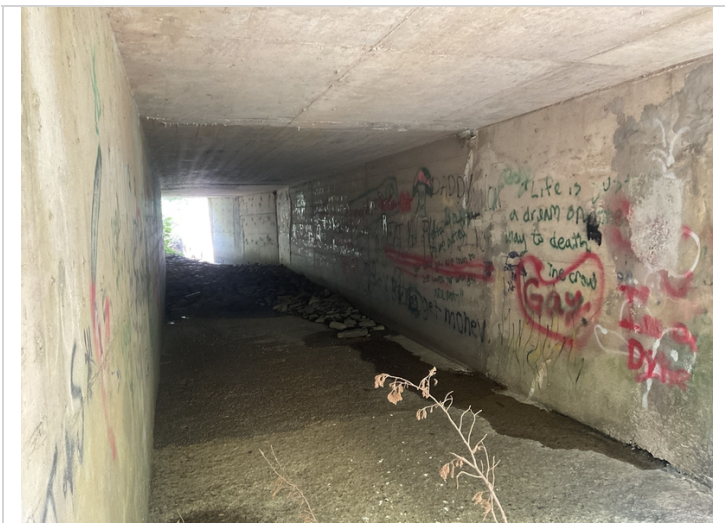
Barrel # 2 typical.

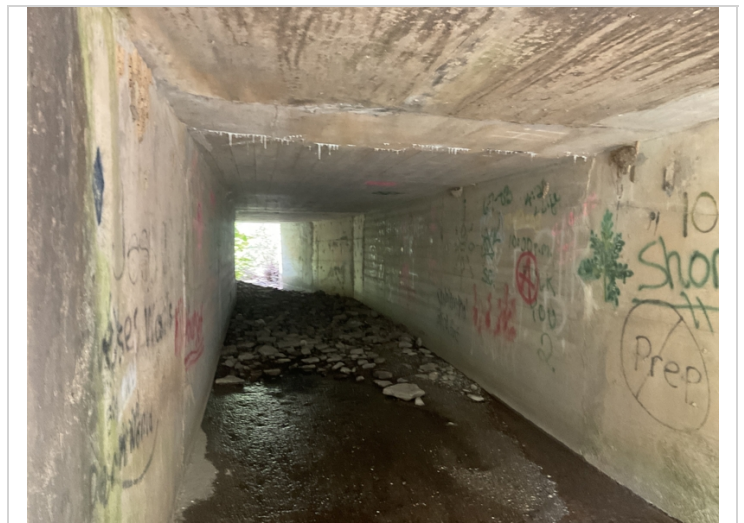
Barrel # 1 typical.

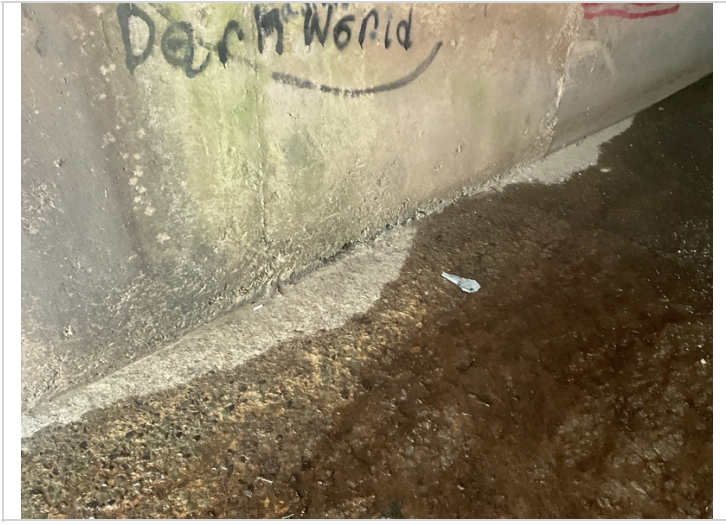
Barrel # 1 Rt concrete deterioration and section loss.

The base of the culvert walls have areas of abrasion/concrete deterioration. The worst areas are the base of the exterior wall of barrel # 1 which has concrete deterioration up to 4" deep located approximately 11' from the inlet end of the structure. The base of the exterior wall of barrel # 2 has a small area of honeycombing/concrete deterioration with up to 2-1/2" of concrete section loss at the outlet end of the structure.

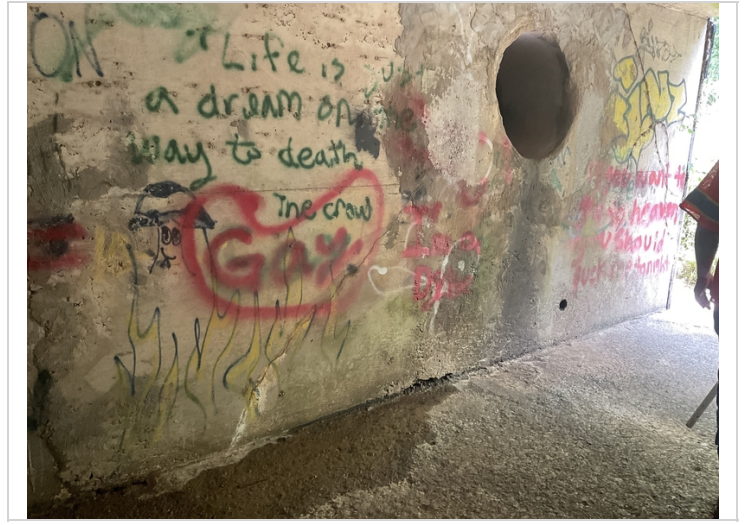
(241) -Transverse cracks in the top slab with efflorescence at the construction joints.  
-Medium scale/abrasion on the bottom slab and base of the walls.  
-Minor concrete deterioration/spalling in the left end of the center wall.  
-There are shallow spalls with no exposed reinforcing steel in both head walls.  
-Barrel # 1 exterior has a 3” shallow spall with exposed reinforcing steel on the right side located near the top slab juncture adjacent to drop inlet approximately 10’ from the wing wall juncture.  
-Barrel # 1 base of the exterior wall has concrete deterioration up to 4” deep located approximately 11’ from the inlet end of the structure.  
-Barrel # 2 base of the exterior wall has a small area of honeycombing with deteriorated concrete up to 2 1/2” deep located at the outlet end of the structure.  
-Barrel # 2 exterior wall has a 6’ long diagonal crack on the right side at the drainage pipe that's incorporated into the wall that measures up to 0.050” in width, the crack has efflorescence buildup. Additionally, the Rt widen section has a full width horizontal cracking located approximately half way up the wall and a narrow width diagonal crack that extends to the base of the wall at the wing wall juncture.

Barrel # 2 Rt diagonal cracking with efflorescence buildup.

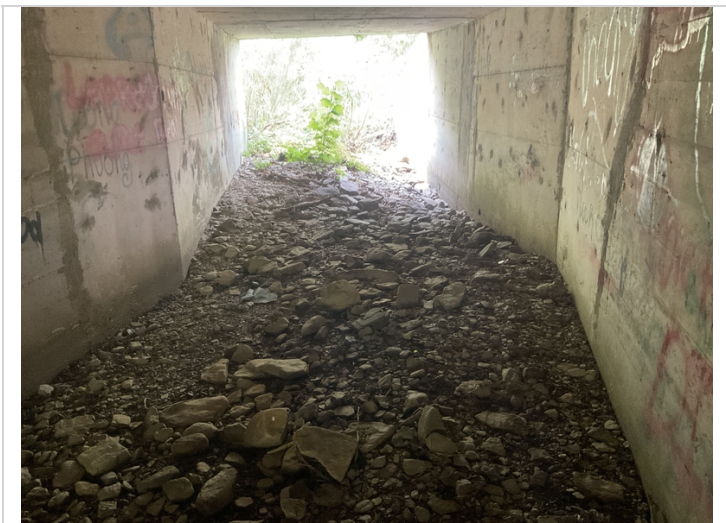
-Barrel # 2 has up to 24” of streambed material accumulation at the outlet end (left side).

Barrel # 2 Lt stream bed material accumulation.

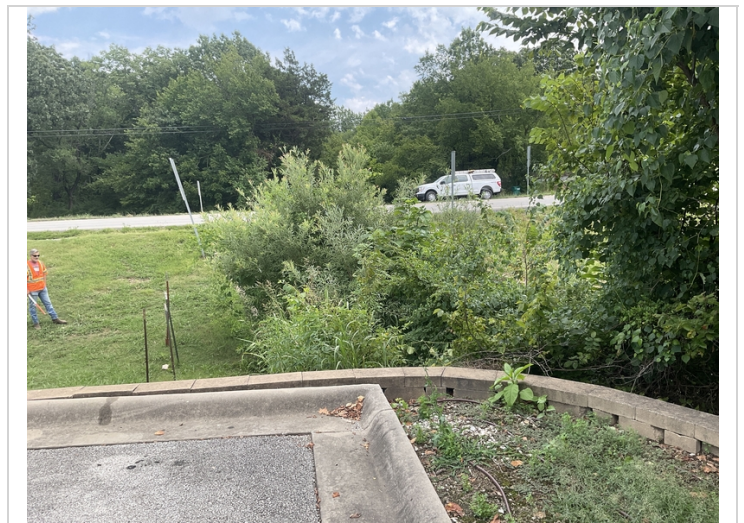
**61 - Channel/Channel Protection** (5 - Bank protection is being eroded. River control devices and/or embankment have major damage. Trees and brush restrict the channel.)

-The outlet end of channel is restricted by trees and heavy vegetation.

Channel restricted by trees and vegetation.

#### **A-64 - Vegetation Removal Requested** (Y)

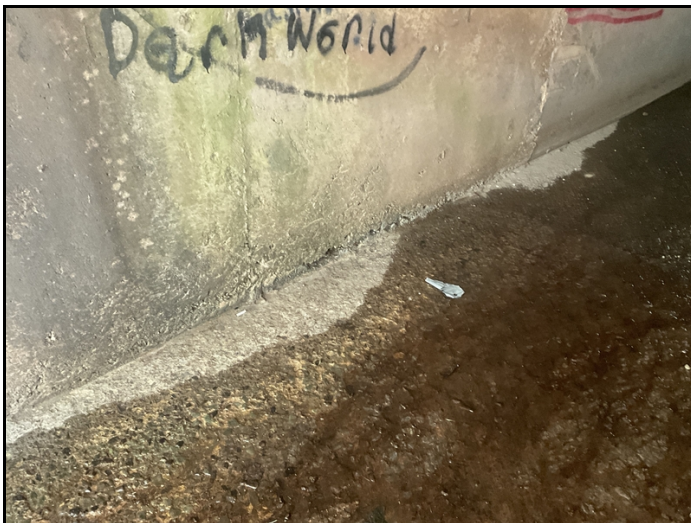
Barrel # 1 Rt concrete deterioration and section loss.

**Type of Work:** Repair (General)

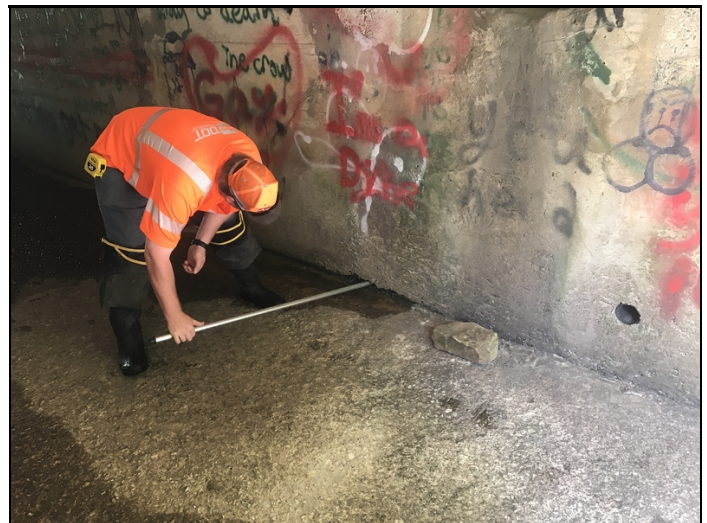
North wall of Barrel # 2. Concrete deterioration.

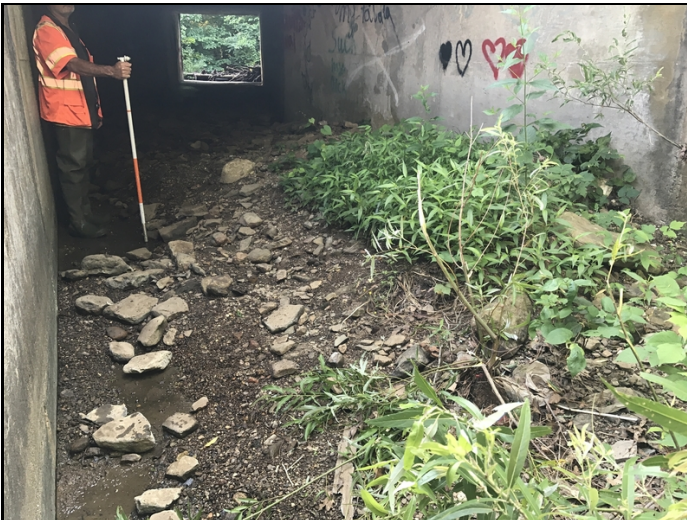
The interior of both barrels have up to 24" of streambed material in the left side near outlet end.

The interior of Barrel # 2 has up to 24" of streambed material in the left side near outlet end.

**Type of Work:** Channel Work/Drift Removal

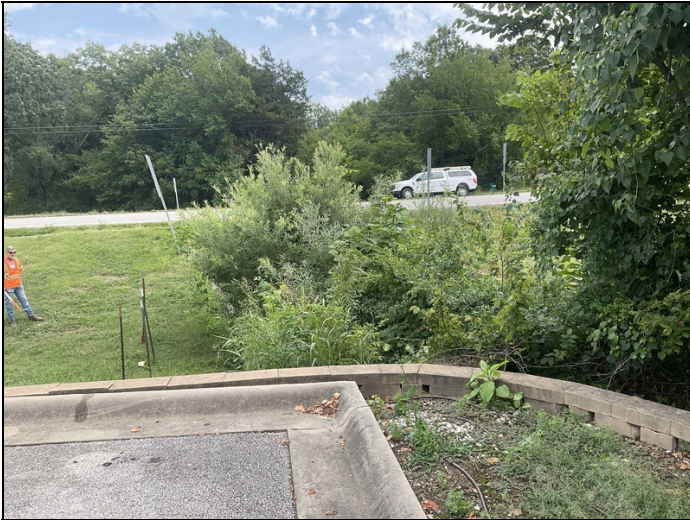
The channel is restricted by trees and vegetation.

Channel restricted by trees and vegetation.

**A-64 - Vegetation Removal Requested (Yes)**
