Asset #M1384(Routine)

US 71 - Washington over Ditch

Team Lead: Eric West, Inspection Date: 07/24/2023

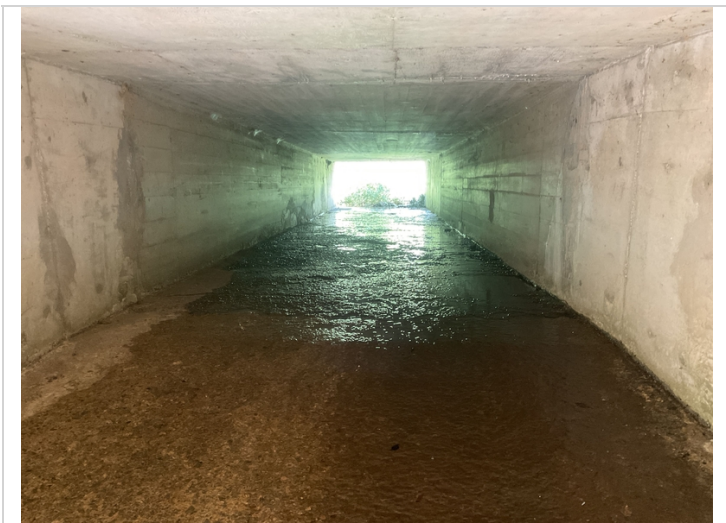
Barrel # 2 typical.

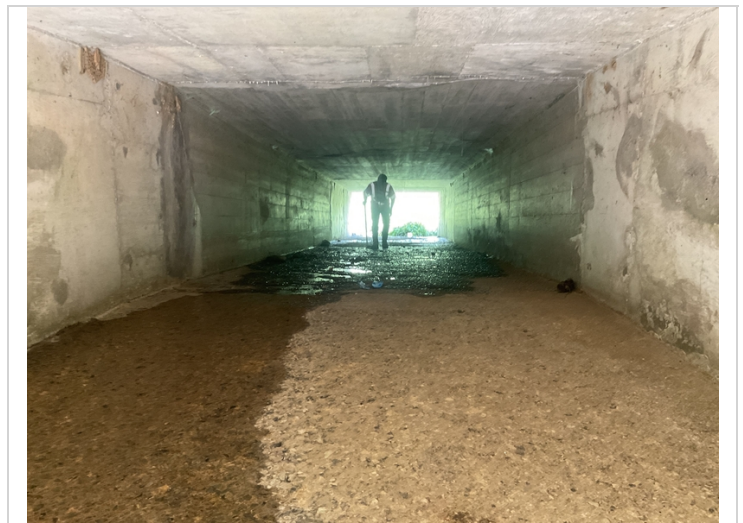
Barrel # 1 typical.

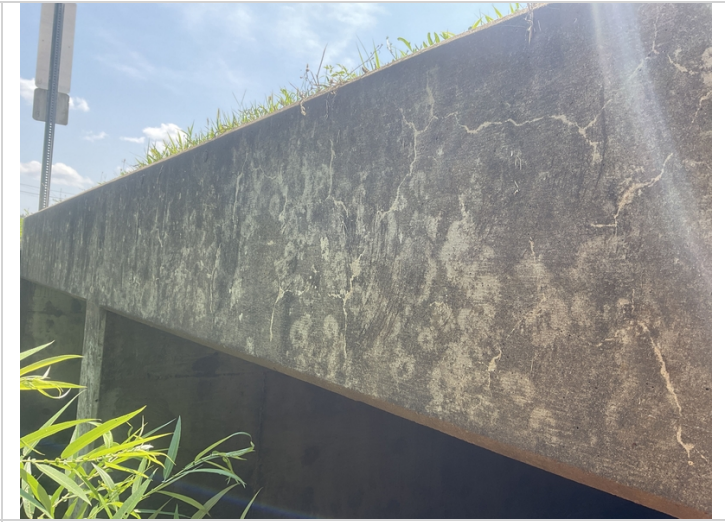
Right head wall map cracking with light staining.

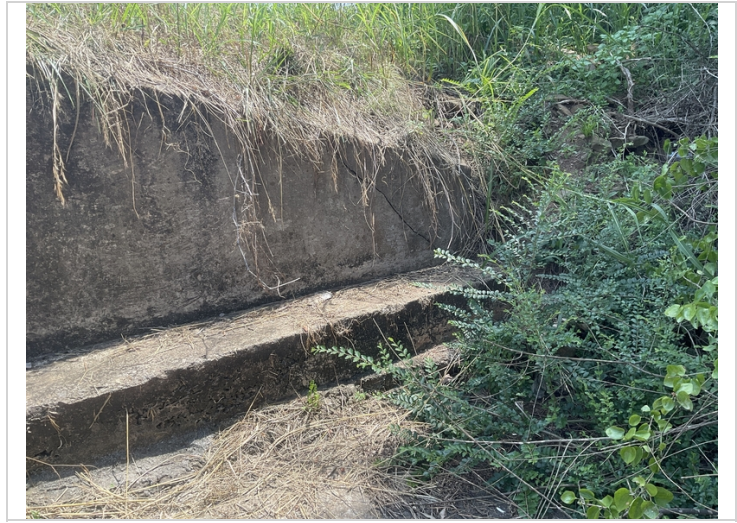
Barrel # 1 Lt end of the Southwest wing wall has a wide diagonal crack.

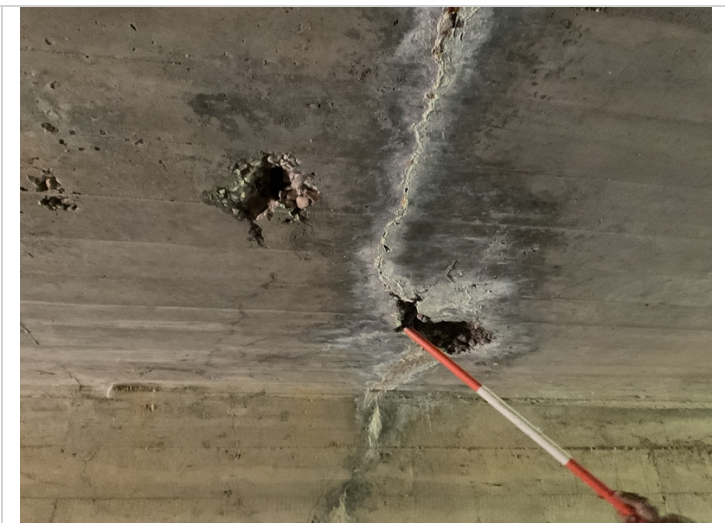
Barrel # 1 top slab has a 2' area and an 8" area with concrete deterioration/spalling with exposed reinforcing steel. Exposed reinforcing steel has active corrosion and measures 5/8" remaining section at this inspection. Concrete section loss up to 4" deep in the larger area of deterioration.

The top slab of barrel # 1 has a 2' area and an 8" area with concrete deterioration/spalling with exposed reinforcing steel. Exposed reinforcing steel has active corrosion and measures 5/8" remaining section at this inspection. Concrete section loss up to 3" deep in the larger area of deterioration.

**Type of Work:** Repair (General)

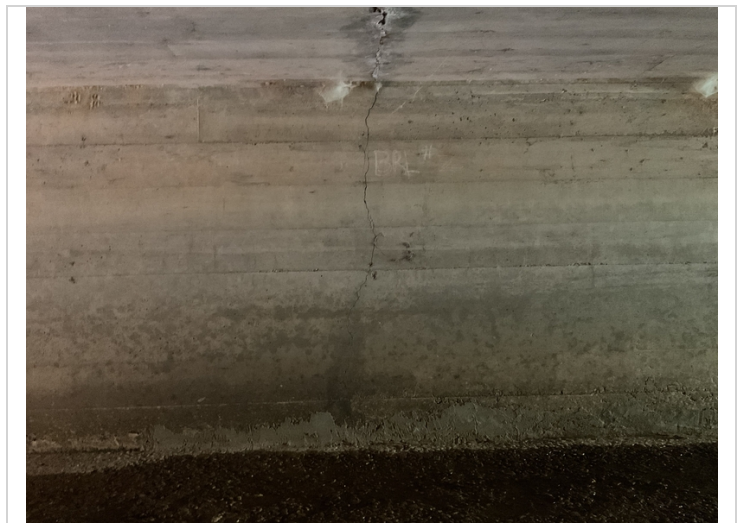
Barrel # 2 wide cracking near the centerline.

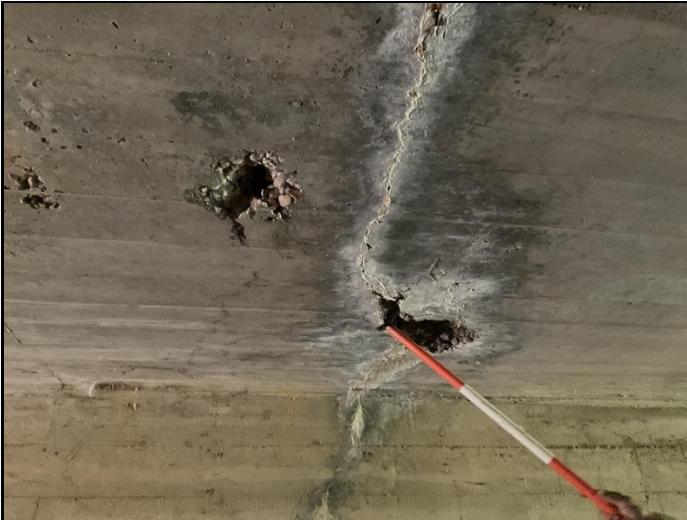
Barrel # 1 top slab has a 2' area and an 8" area with concrete deterioration/spalling with exposed reinforcing steel. Exposed reinforcing steel has active corrosion and measures 5/8" remaining section at this inspection. Concrete section loss up to 4" deep in the larger area of deterioration.
