**Bridge #07057**(Routine, Underwater type 2)

**US 71 Sec 16 over West Fork of White River**

**Location: 4.36 Mi N Crawford Co Lin**

**Team Lead:** Eric West **Inspection Date:** June 01, 2022

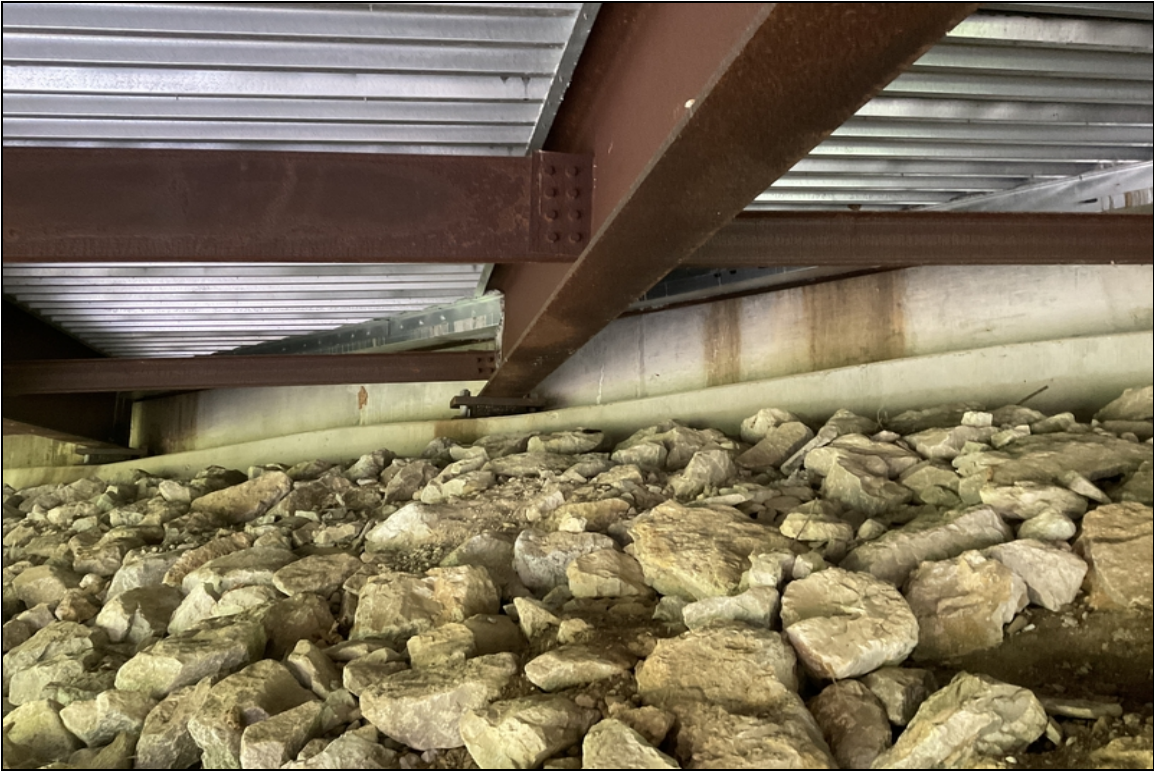
Abutment #2 vertical crack with efflorescence buildup.

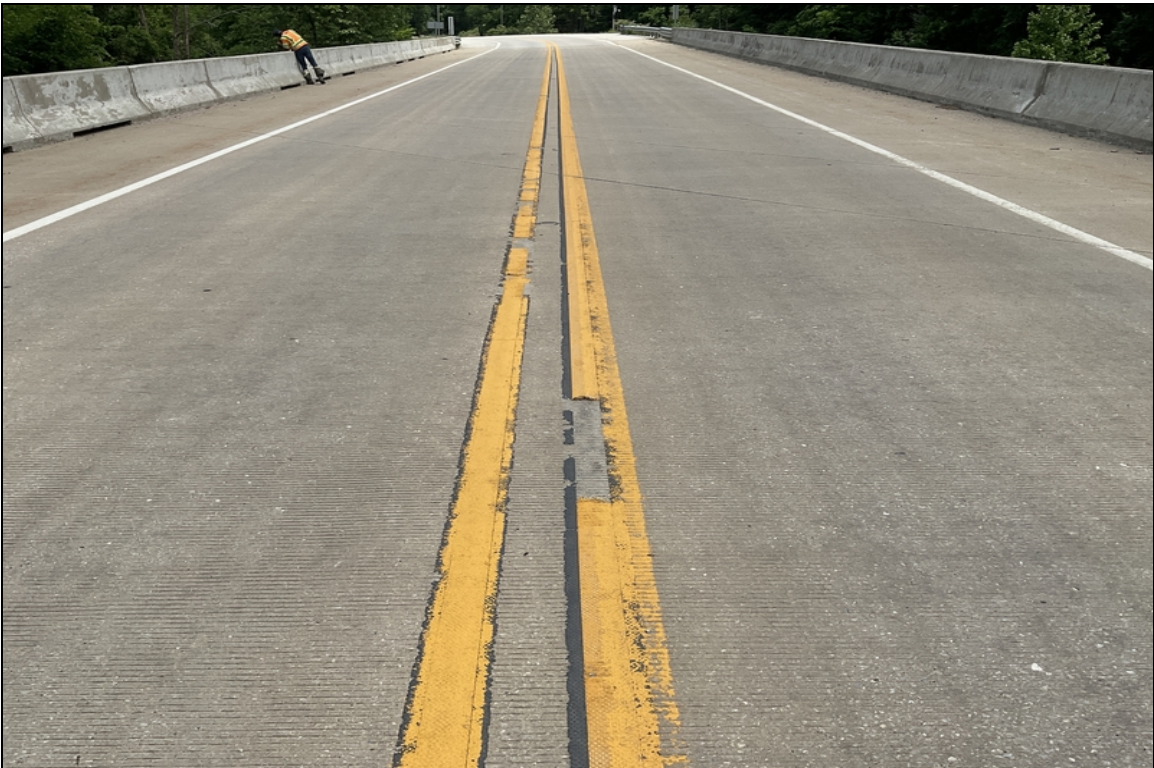
Typical driving surface of the deck.

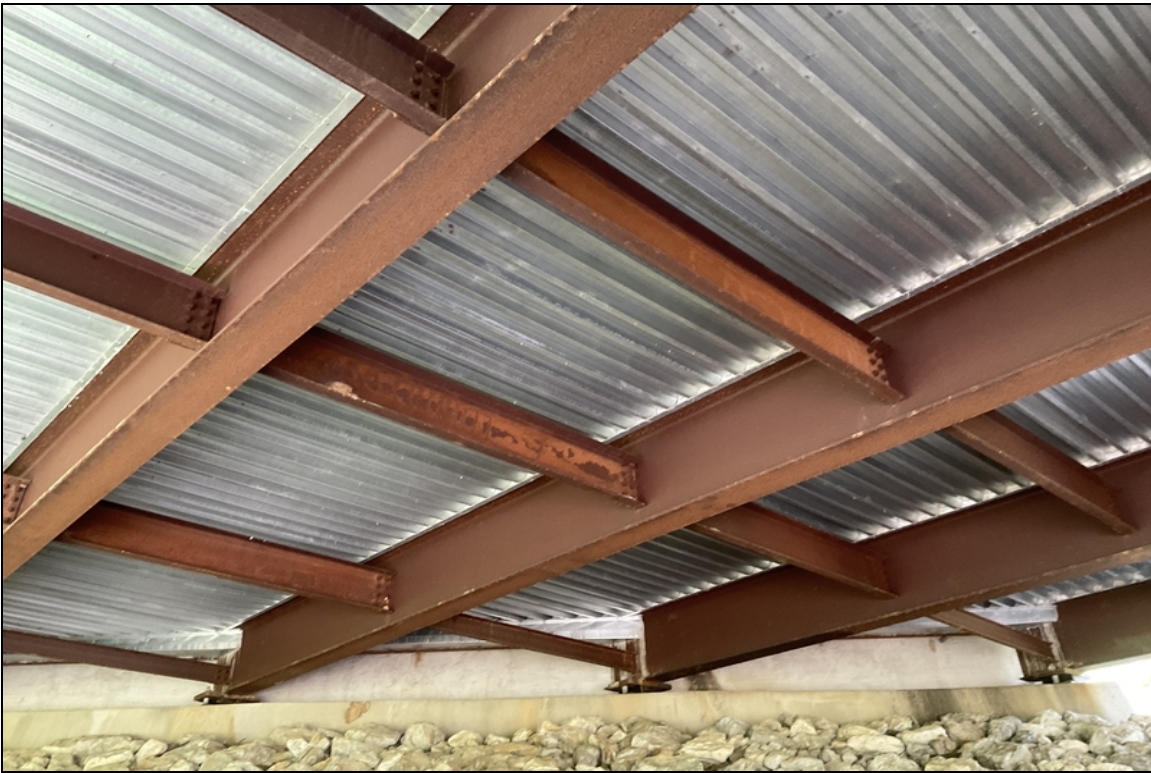
Span #1 typical undersurface of the deck.

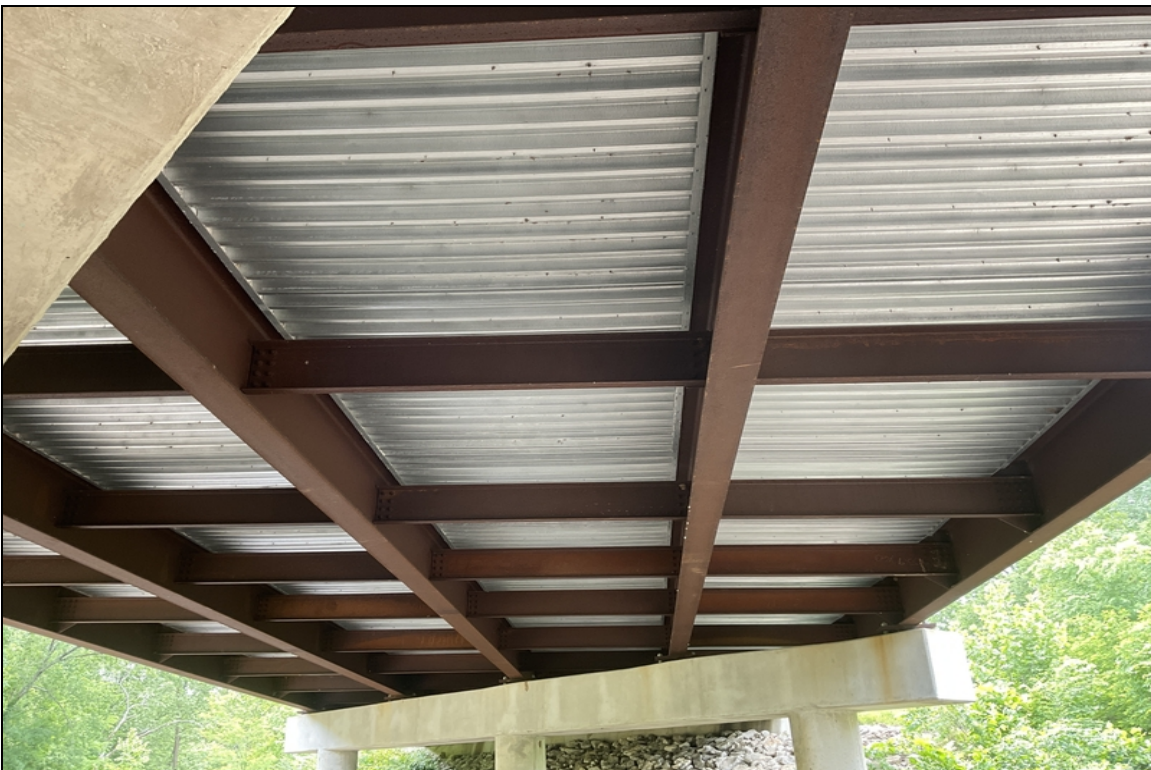
Span #2 typical undersurface of the deck.

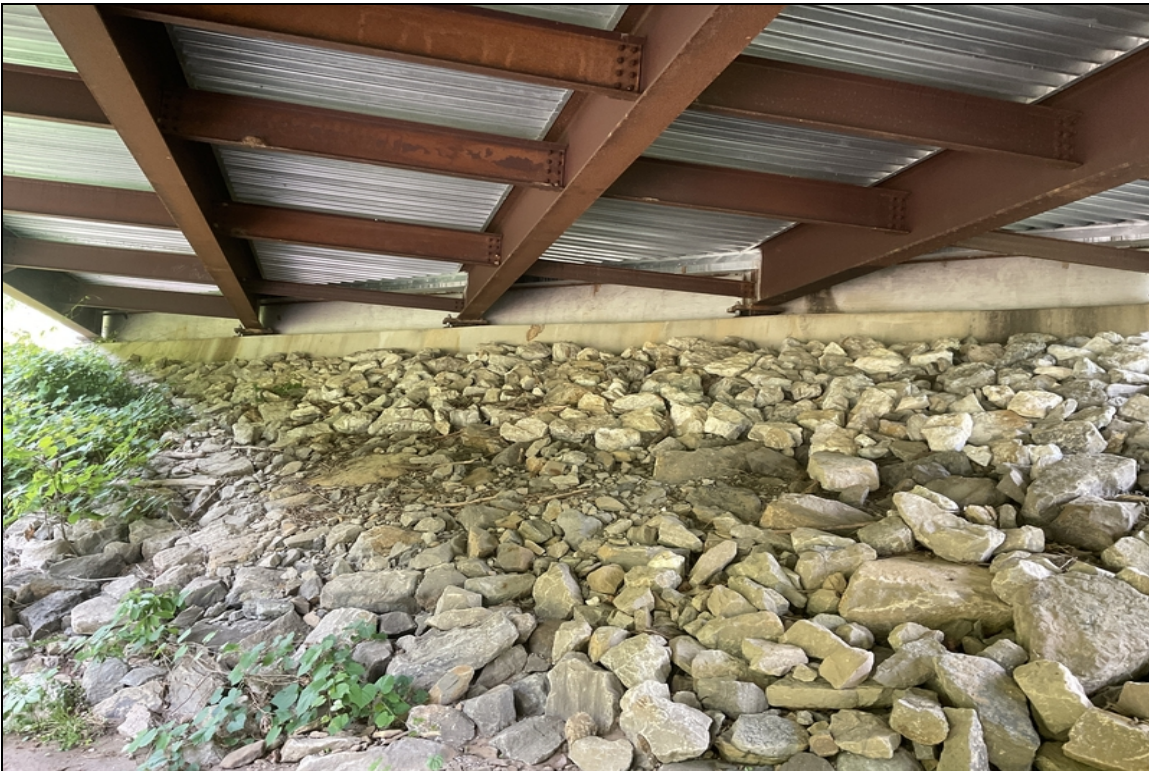
Abutment #1 typical.

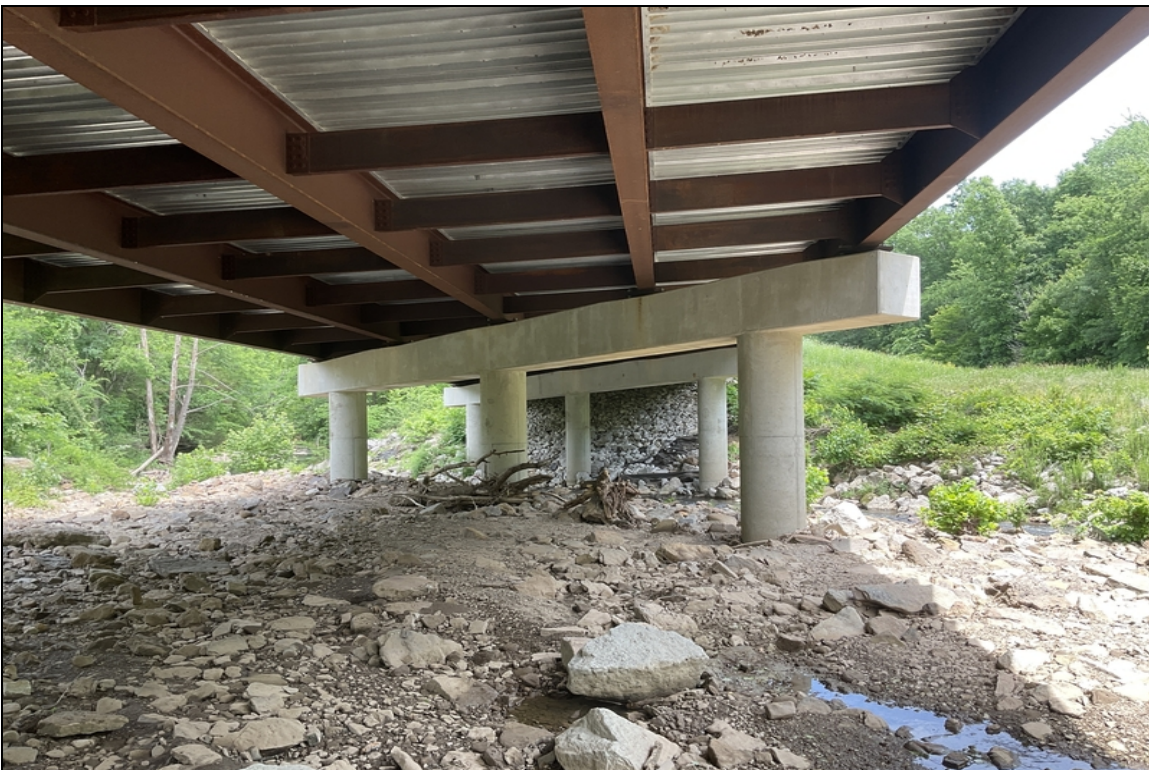
Typical intermediate bent.

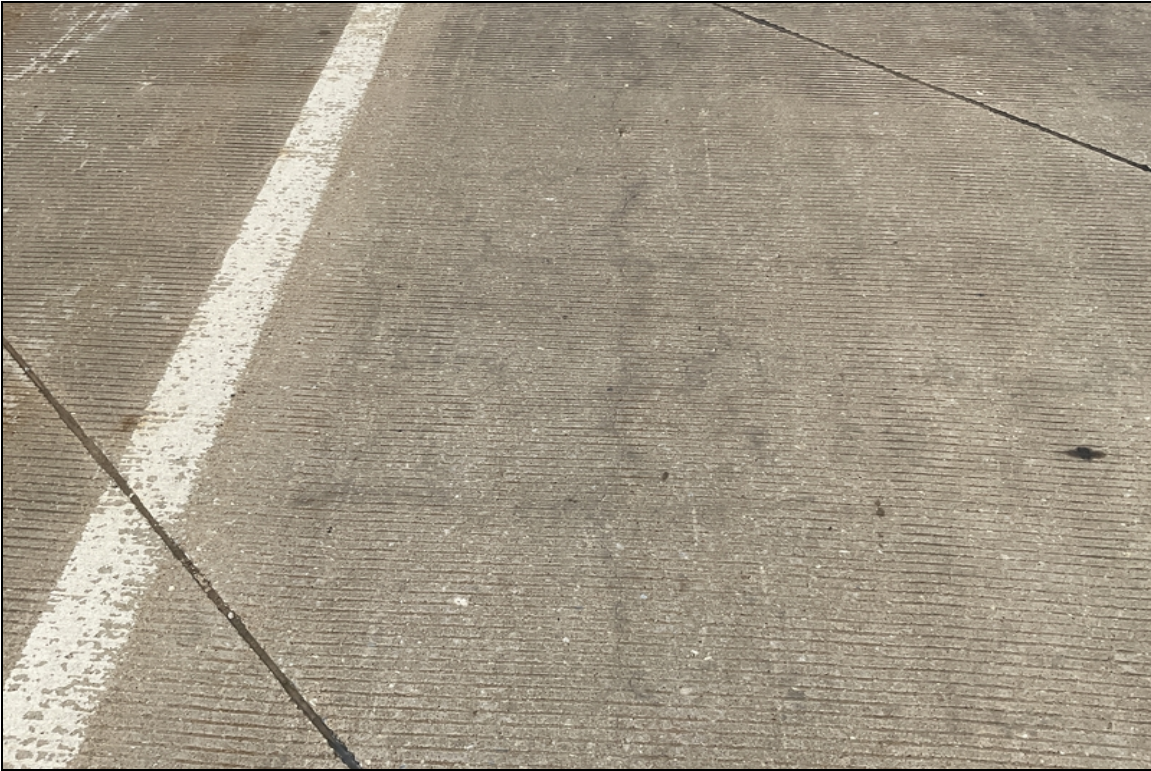
(12)							
-The Left lane of Spans # 1, 2, and 3 have a full length longitudinal hairline crack located approximately 12" from the white line. -The Left lane of Span # 2 has an area of staining. Stains are approximately 12" long and are spaced approximately 8" to 14" apart with no apparent change since the last inspection. -The overhangs of the deck have transverse cracking with efflorescence visible in the undersurface that correspond with the joints in the parapet wall. -Bent # 2 has a random saw joint from the construction process. Contractor has sealed random saw joint.							
107	Steel Open Girder/Beam	LF	1000	1000	0	0	0
515	Steel Protective Coating	SF	9243	1030	8213	0	0
3430	Oxide Film Degradation Color/Texture Adherence(Steel Protective Coatings)	SF	9138	925	8213	0	0

Sealable deck cracking.

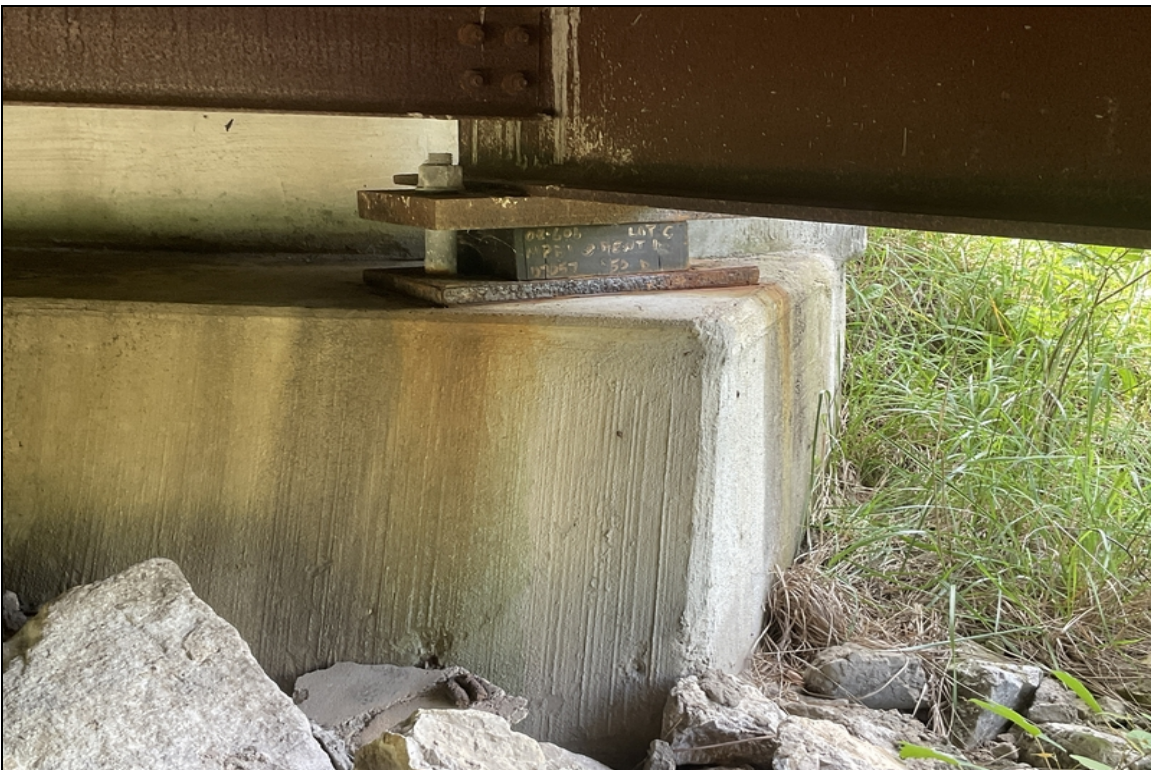
(310)							
-External load plates and masonry plates have active corrosion with light pack rust in areas.							
Previous Inspection Notes -							
A portion of the anchor bolt sleeve appears to have been removed in order to accommodate the sleeve. The masonry plate is making contact with the anchor bolt at this inspection. Temperature is approximately 95 degrees.							
331	Reinforced Concrete Bridge Railing	LF	400	369	31	0	0
1130	Cracking (RC and Other)	LF	31	0	31	0	0

Abutment #1 bearing #1 active corrosion with pack rust.

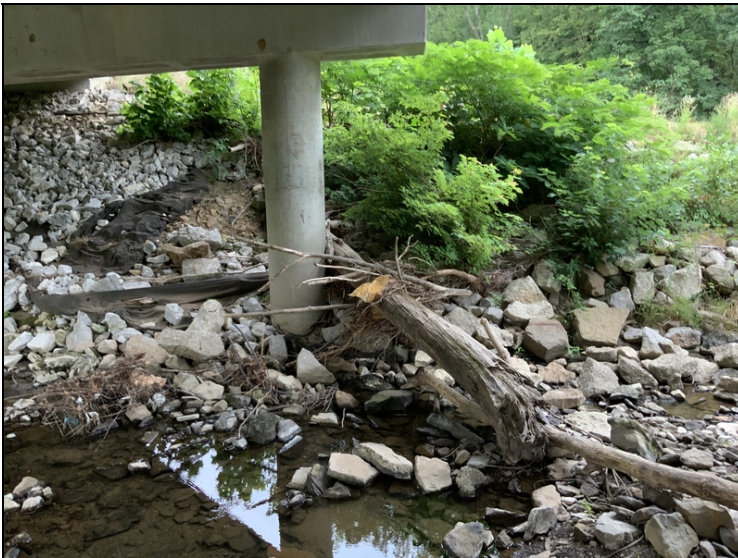
North embankment adjacent to Bent # 4 has rip rap displacement that exposes the filter fabric.  
Large drift accumulation at Bent 4.

Bent 4 Column 3 Large drift

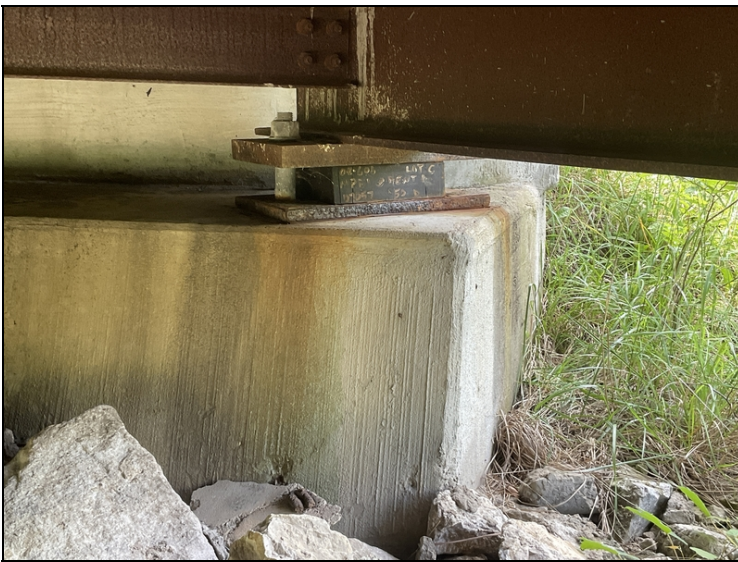
The external load plates and the masonry plates have active corrosion with pack rust in areas.

Abutment #1 bearing #1 active corrosion with pack rust.
