**Bridge #07058(Routine)**  
**US 71 - Washington over Hutchins Creek**  
**Location: 6.83 Mi N Crawford Co Lin**

**Team Lead: Eric West Inspection Date: June 01, 2022**

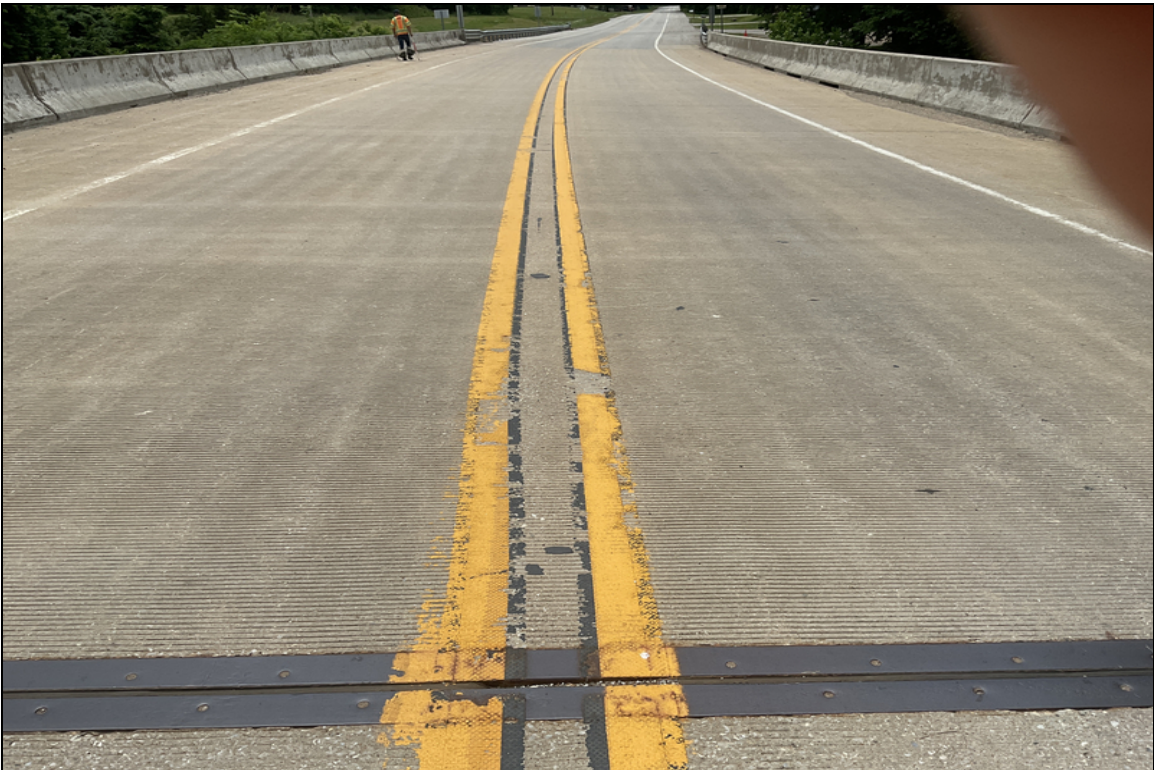
Typical driving surface of the deck.

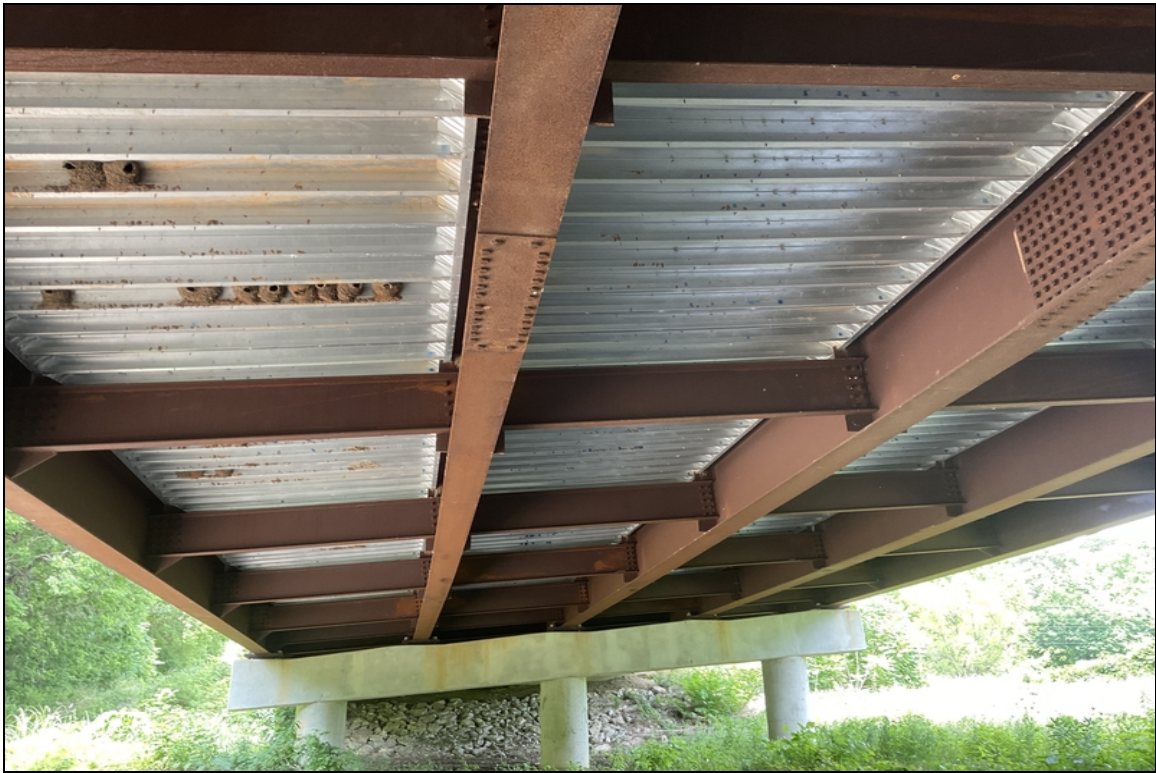
Typical undersurface of the deck.

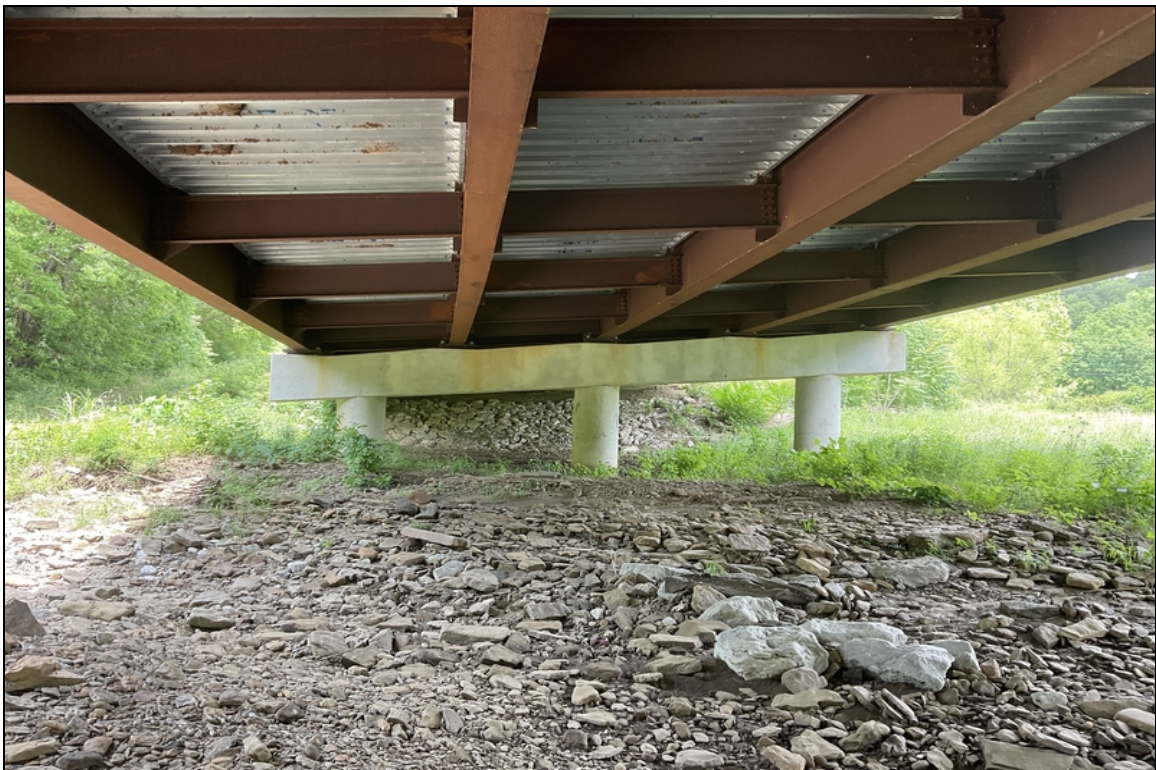
Intermediate bent typical.

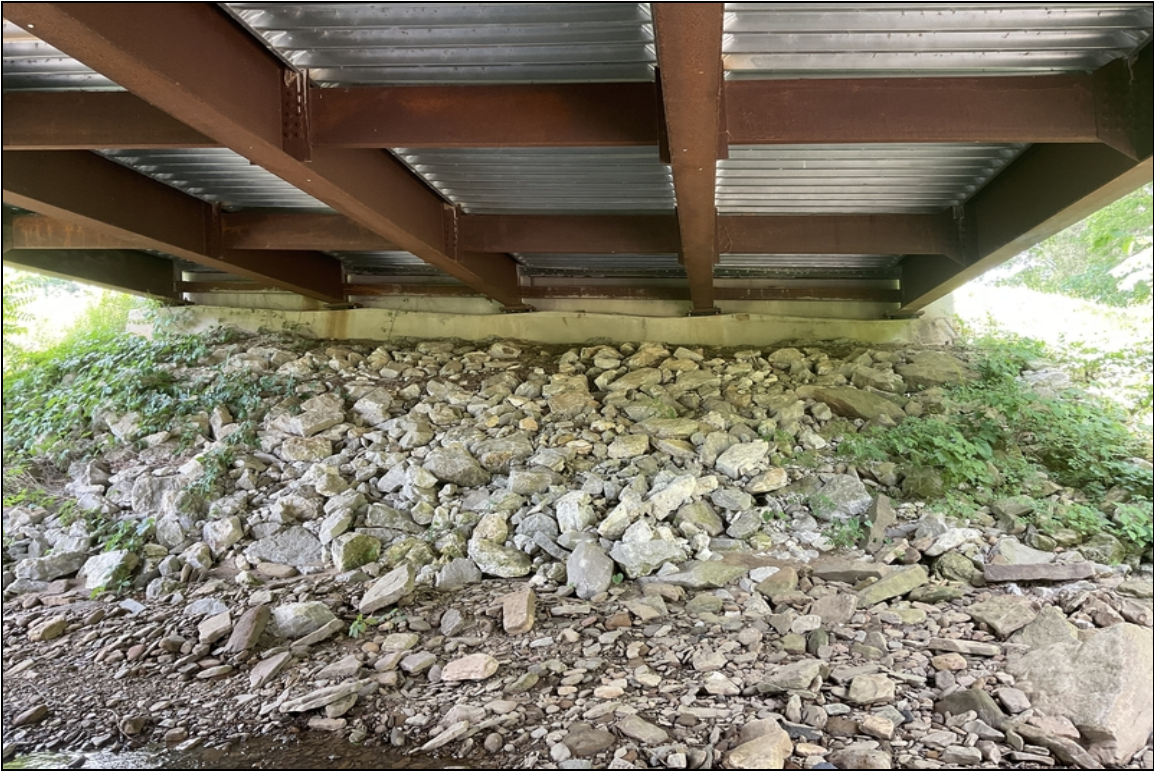
Abutment #1 typical.

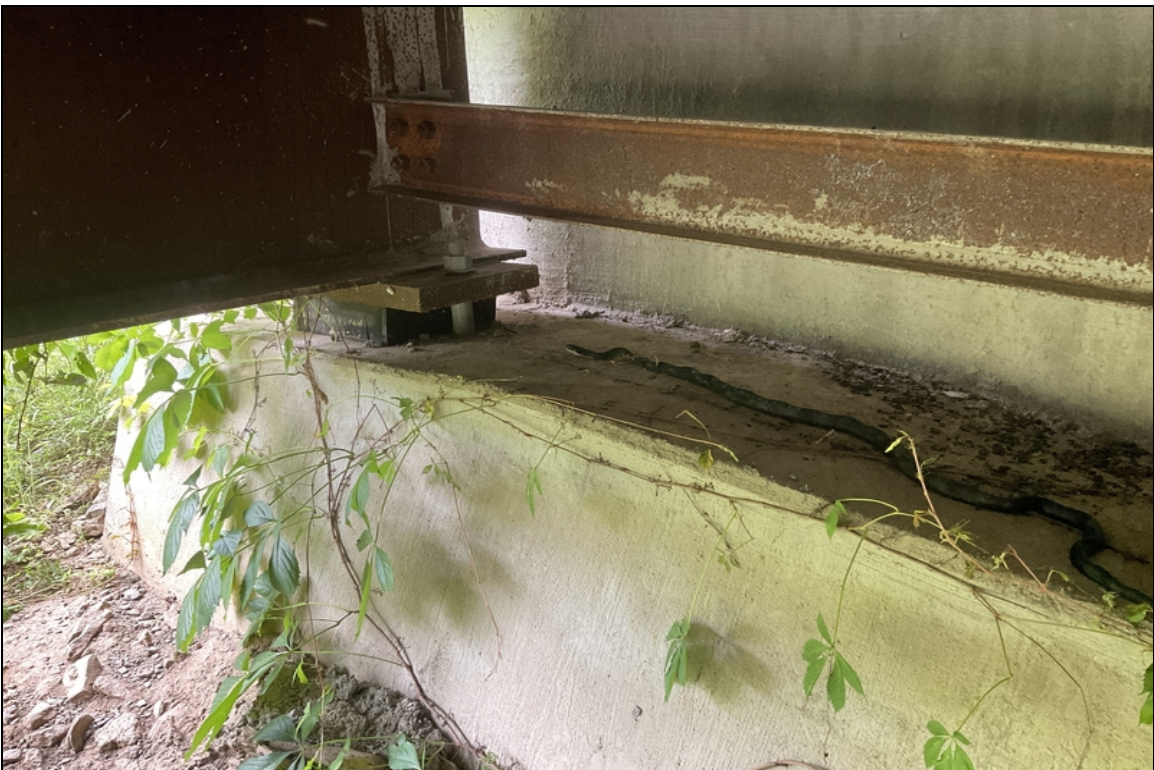
Abutment #1 typical bearings.

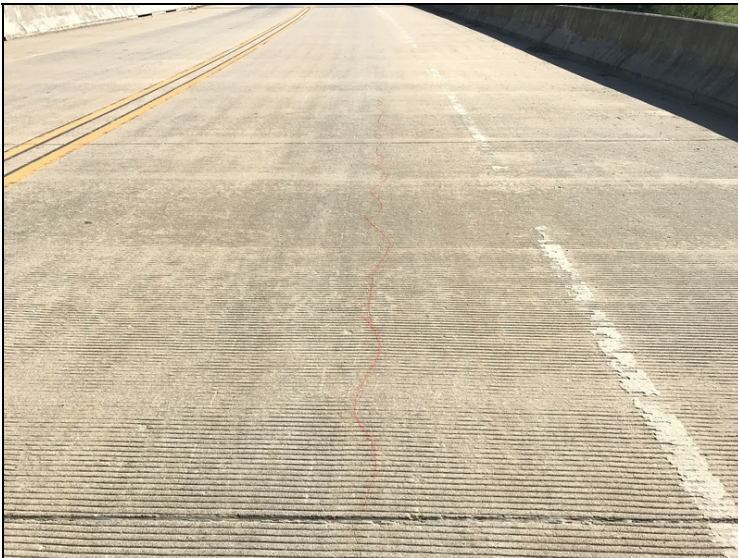
Deck -  
The driving surface of the deck has sealable longitudinal cracks in all spans.

The driving surface of the deck has sealable longitudinal cracks in all spans.

**Date Reported:** 06/02/2020  
**Priority:** G - General/ Preventive maintenance  
**Type of Work:** Repair  
**Status:** Monitor  
**Inspection Direction** S to N  
**Component:** Deck

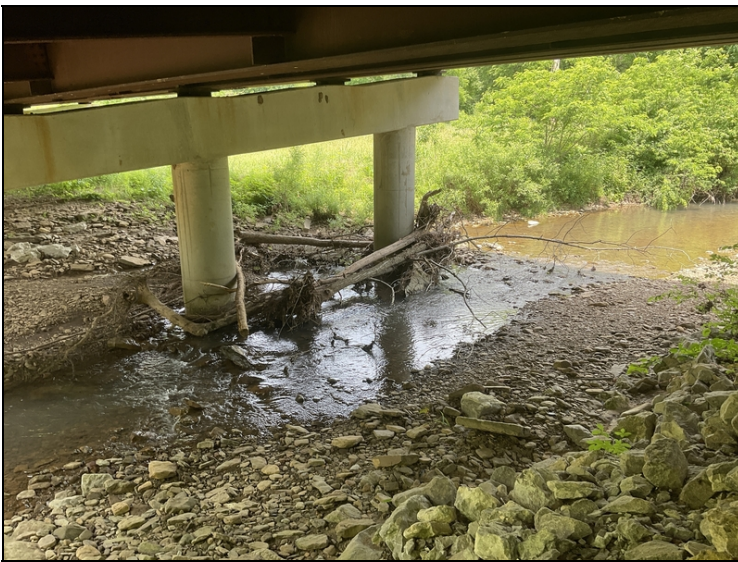
Channel-  
Light drift accumulation at Bent # 2.

Bent #2 light drift accumulation.

05/19/2020 - RSM & SPC: Routine and Underwater Type II inspections conducted this date. See element notes for documentation. Channel sounded / profiled this inspection. See Microstation sketch linked in "Files" tab for sounding measurements. NBIS Condition Rating for item "61" lowered from "8" to "7" due to drift accumulation at bent # 2.

Date Reported: 06/06/2022  
Priority: D- Routine  
Type of Work: Clean  
Status: Open  
Inspection Direction S to N  
Component: Channel
