Asset #00879(Routine, Underwater type 2)

State Highway 45 over Cedar Creek - Seb. Co.

Location: 0.7 Mi S Jct Hwy 253

Team Lead: Bob McEntyre Inspection Date: 09/25/2024

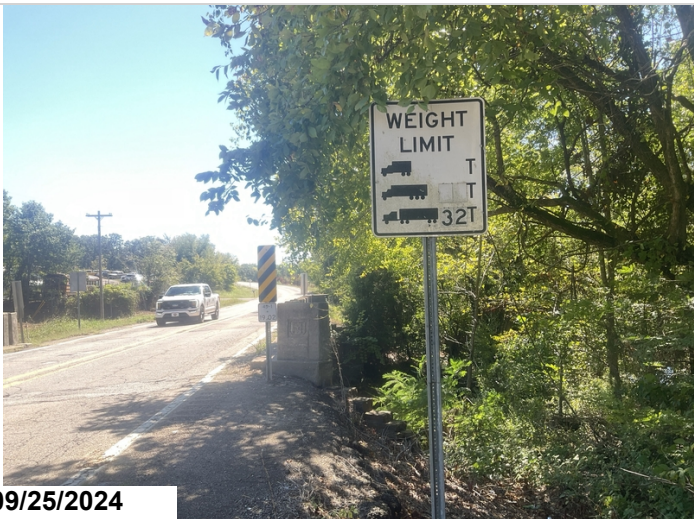
North approach load posting.

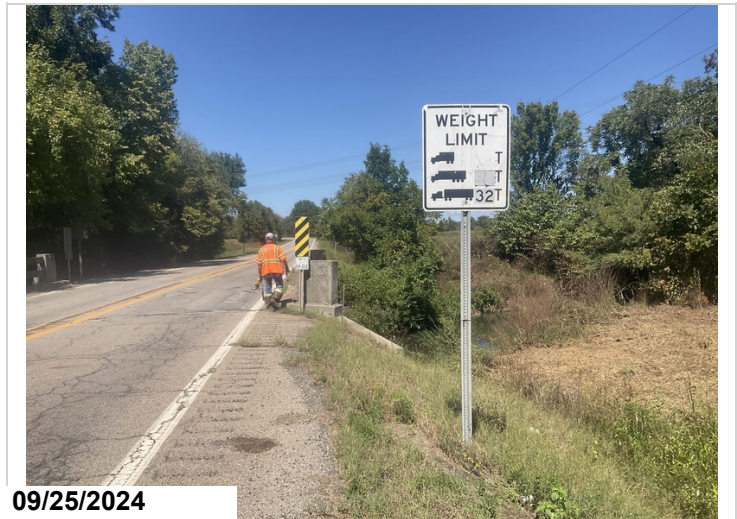
South approach load posting.

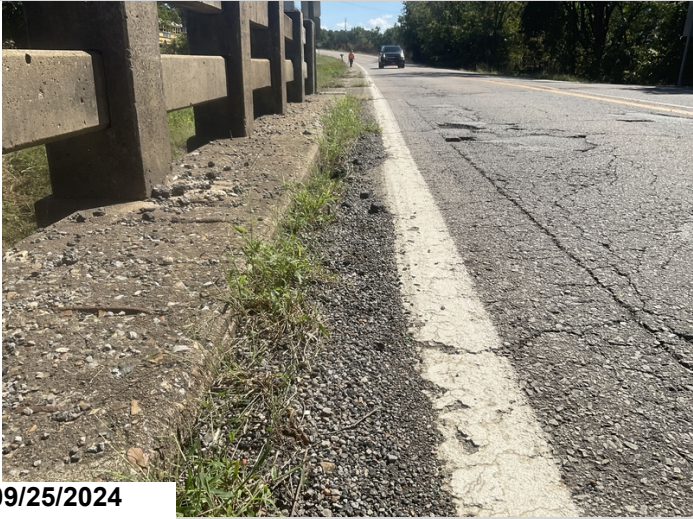
Gutters have heavy dirt and debris accumulation that restricts the deck drains.

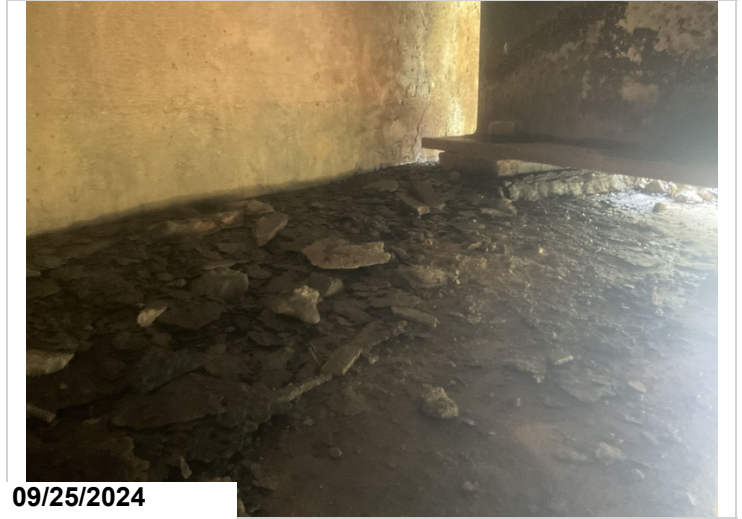
Abutment # 1: Dirt and debris accumulation in bearing area.

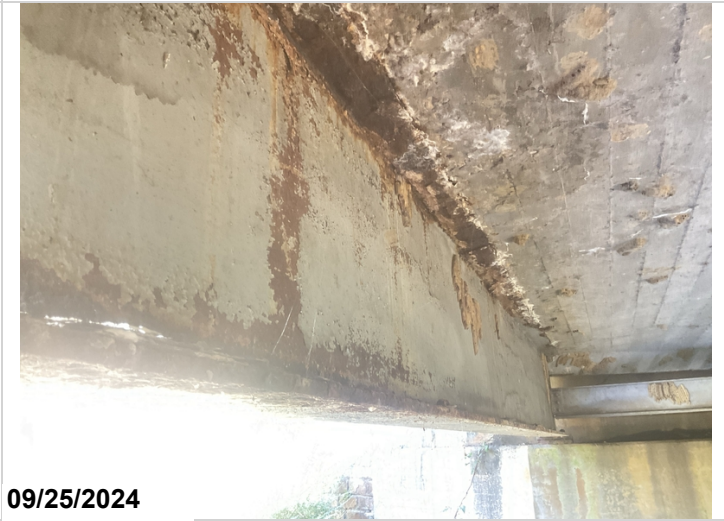
09/25/2024 - RSM & SPC: Superstructure is in fair overall condition with paint failures on several girders with areas of corrosion, flaking rust and section loss. Bearing devices have heavy corrosion with pack rust between the bearing plates.

Right exterior girder: Corrosion with flaking rust / section loss.

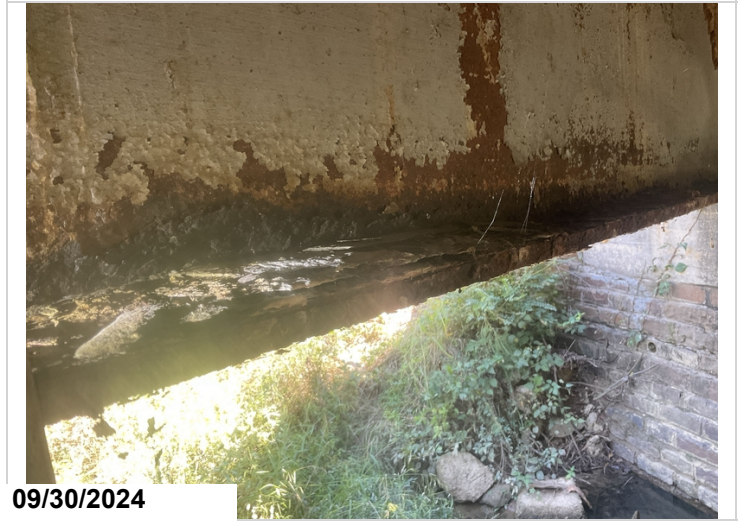
Right exterior girder: Corrosion with flaking rust / section loss.

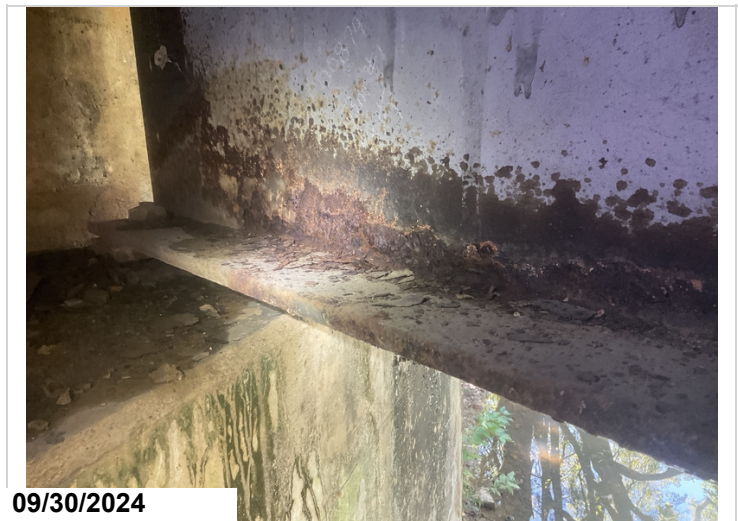
Girder # 1, Abutment # 1: Corrosion with flaking rust. 5LF CS3.

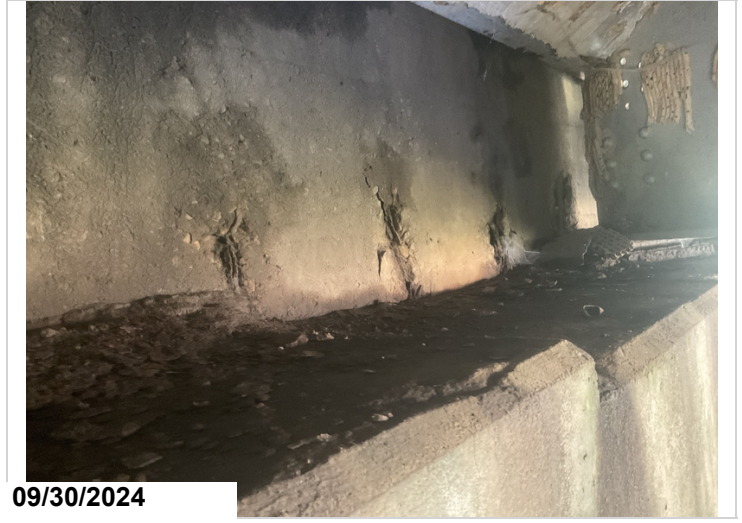
Abutment # 2 Backwall: Spalls with exposed reinforcing steel. 8LF CS3.

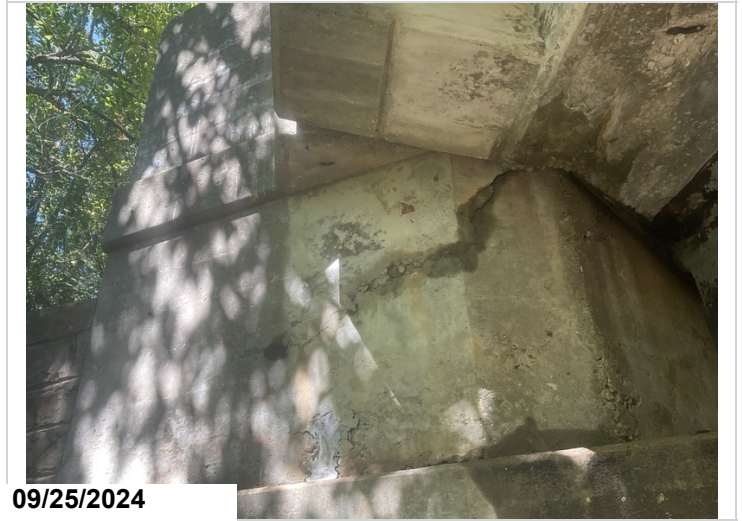
09/25/2024 - RSM & SPC: Substructure is in fair overall condition. The left and right sides of stone masonry abutment # 1 has settlement cracks that follow the masonry joints and propagate into the Southwest and Southeast wing walls. The crack in the Southwest wall propagates from base of abutment diagonally up the masonry joints extending approximately 9' in length to the top of the wing wall. The crack is up to 1/2" wide in locations. The concrete backwalls have some shallow spalling with exposed reinforcing steel. Stone Masonry stem walls have minor grout deterioration along the base. Abutment # 2 Backwall on the left side is fractured under the end post from apparent traffic impact.

Abutment # 2 Backwall, Left Side: Fractured under the end post from apparent traffic impact. 4LF CS3.

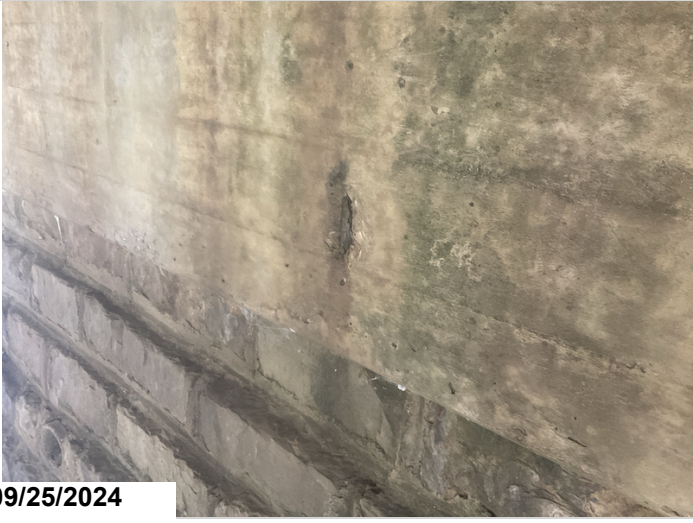
Abutment # 1 Cap, Bay # 1: Shallow spall with exposed reinforcing steel. 1LF CS3.

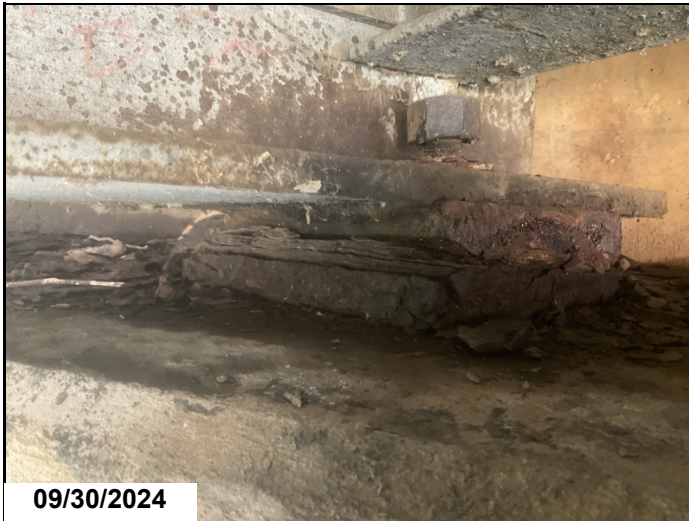
The bearings have heavy corrosion with thick pack rust between sole plates and rocker devices that appear to be restricting movement.

Abutment # 2: Bearing # 2: Corrosion with flaking rust / section loss. 1EA CS3.

Type of Work: Bearing Repair/Replacement

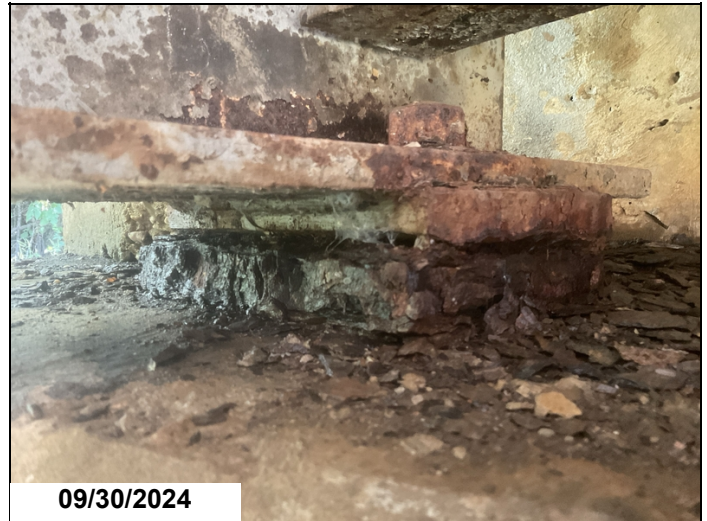
Abutment # 2: Bearing # 1: Corrosion with flaking rust / section loss. 1EA CS3.

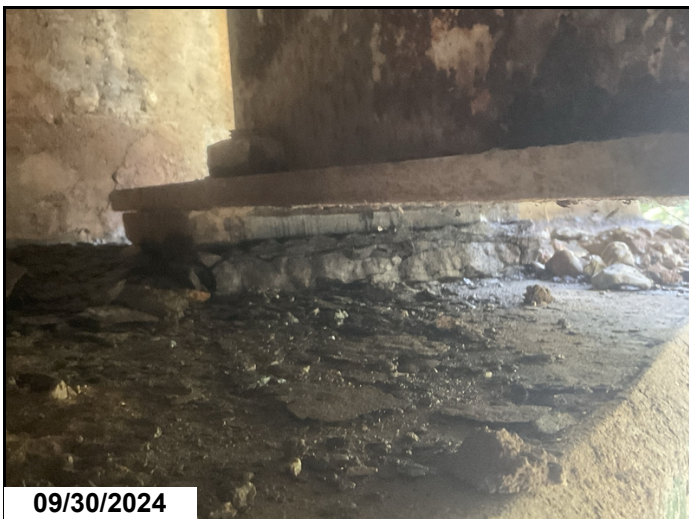
Abutment # 1, Bearing # 1: Corrosion with flaking rust / section loss. 1EA CS3.

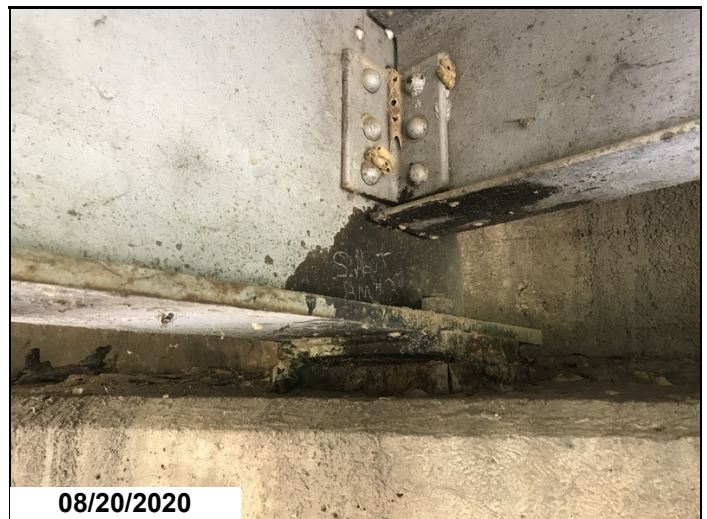
Abutment # 1 bearing #2 active corrosion.

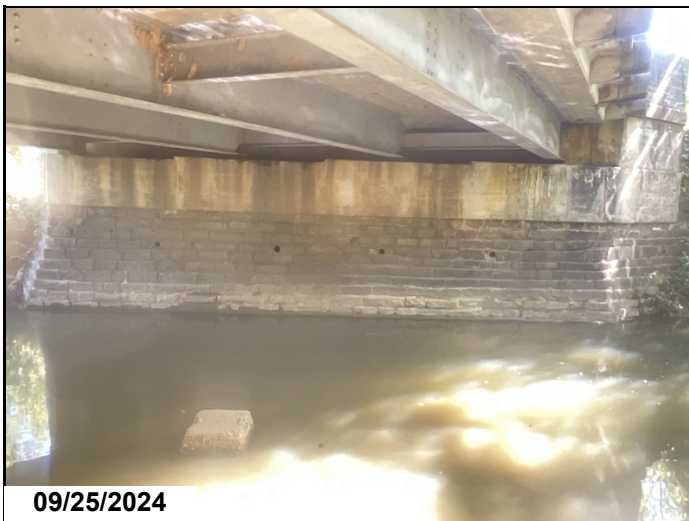
09/25/2024 - RSM - Settlement cracks still exists with no change.

08/20/2020 - EJW & JPW - Maintenance forces have made some minor grouted repairs along the Left wing wall cracking. The grout repairs are cracked.

The left and right sides of stone masonry abutment # 1 have settlement cracks that follow the masonry joints and propagate into the Southwest and Southeast wing walls. The crack in the Southwest wall propagates from base of abutment diagonally up the masonry joints extending approximately 9' in length to the top of the wing wall. The crack is up to 1/2" wide in locations.

Type of Work: Substructure Repair

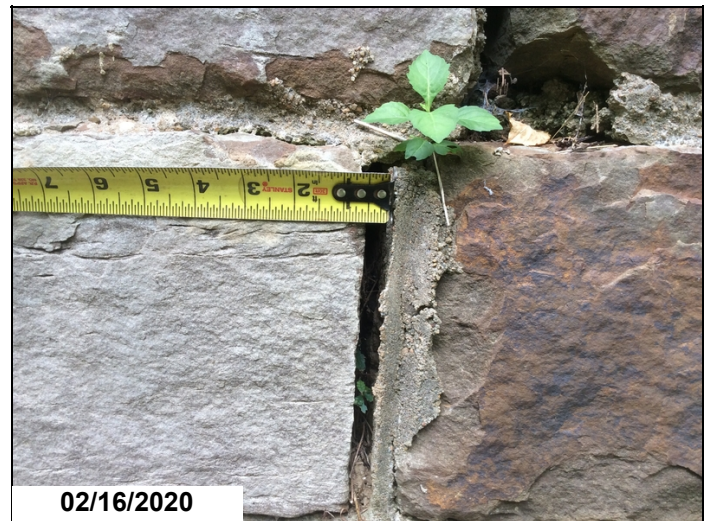
Southwest wing wall-Settlement crack up to 1/2" wide.

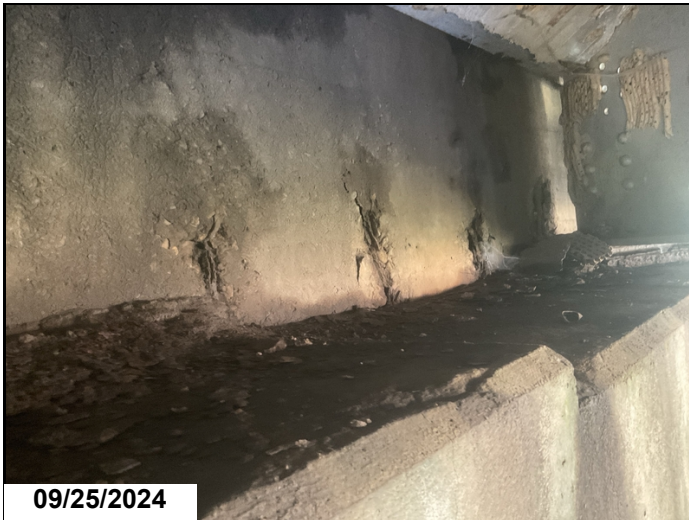
Substructure Back Walls -
Substructure backwalls have areas of spalling with exposed reinforcing steel.

Abutment # 2 Backwall: Spalls with exposed reinforcing steel. 8LF CS3.

Type of Work: Substructure Repair

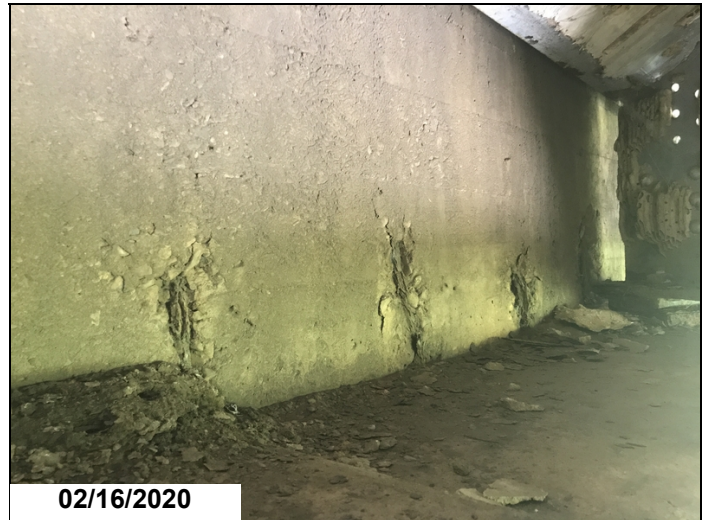
Spalling in abutment # 2 backwall. Photo between girders # 2 and # 3.

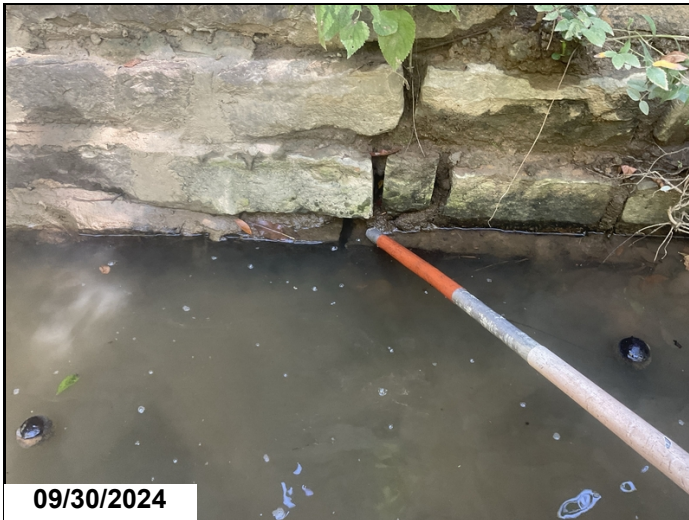
The base of the South abutment (abutment # 1) has grout deterioration between the stones at the water elevation.

Abutment # 1: Grout deterioration at the water elevation.
23LF CS3.

Type of Work: Substructure Repair

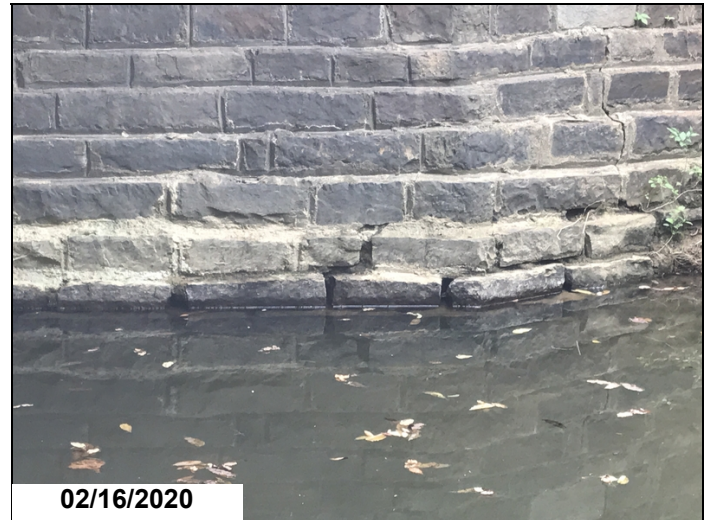
Abutment #1-Grout deterioration between stones.

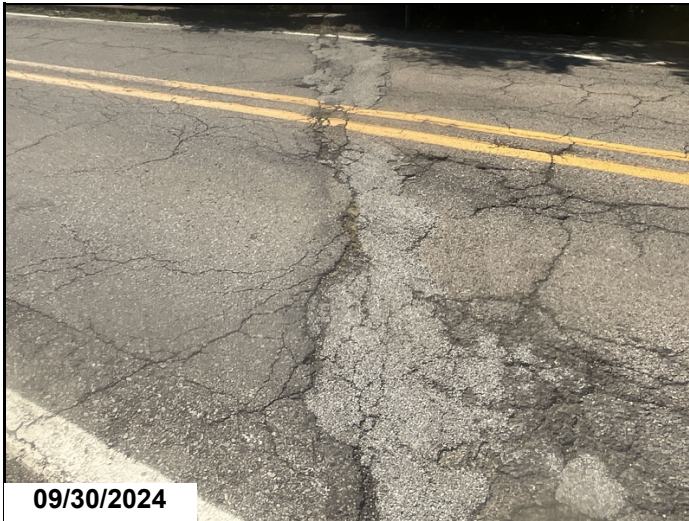
The asphalt driving surface of the deck has map cracking, minor rutting in the travel lanes, and is breaking up over the deck joints at the abutments creating potholes at the bridge ends.

Asphalt breaking apart over abutment # 2.

Type of Work: Deck Repair

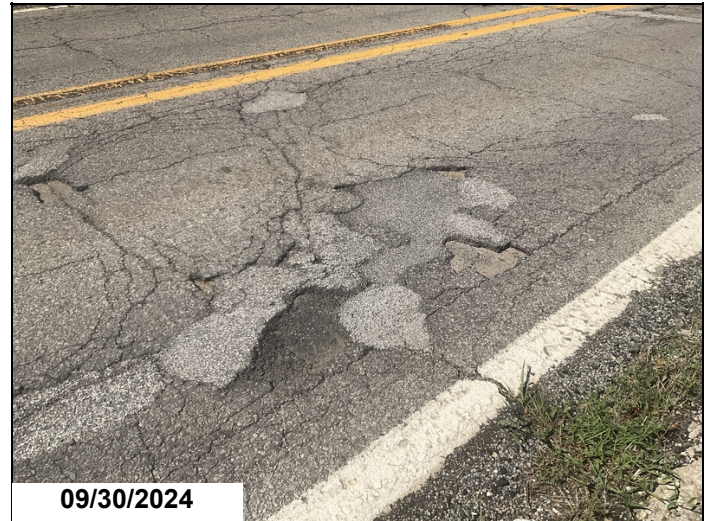
Left Lane: Potholes in asphalt driving surface.

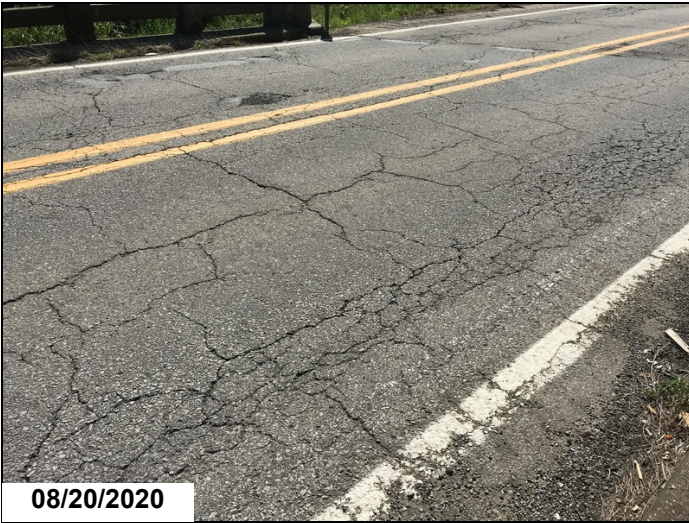
The asphalt driving surface of the deck has map cracking, minor rutting in the travel lanes, and is breaking up over the deck joints at the abutments creating potholes at the bridge ends.

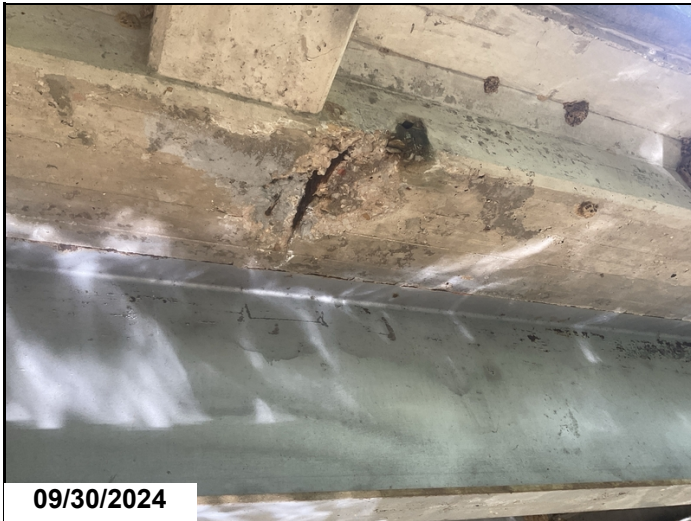
The undersurface of the overhang portion of the deck has areas of spalling with exposed reinforcing steel on the right and left sides of the structure.

Left Deck Overhang, 8' From Abutment # 2: 16" spall with exposed reinforcing steel. 2SF CS3.

Type of Work: Deck Repair

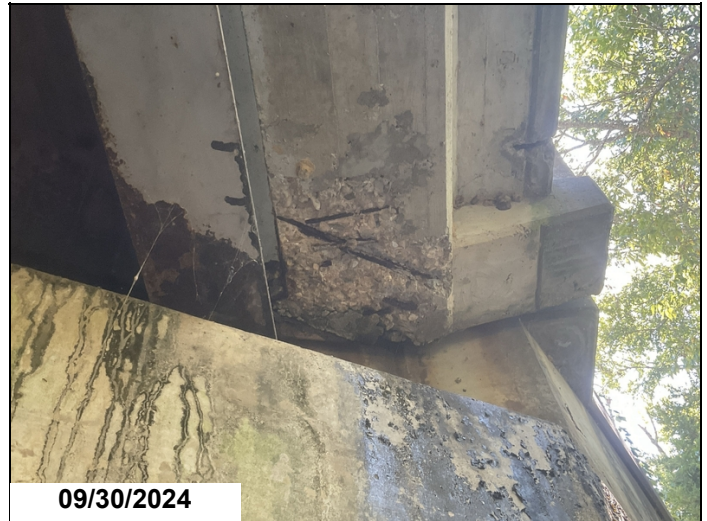
Left Deck Overhang, At Abutment # 1: 4SF CS3.

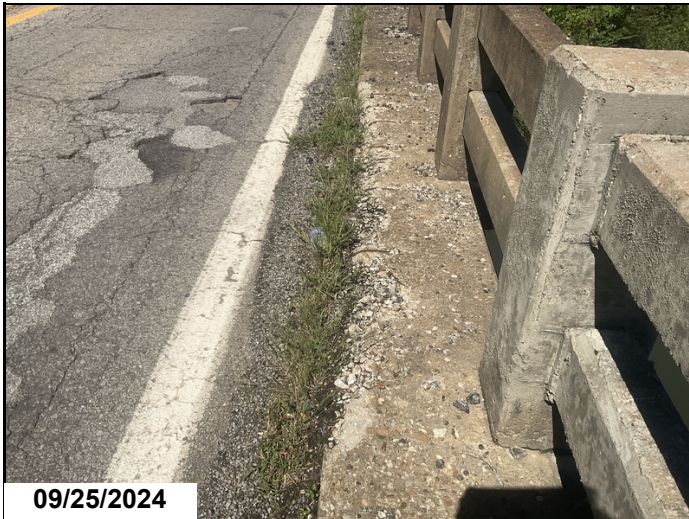
The concrete curb on the right side of structure has concrete deterioration with shallow spalling that exposes reinforcing steel.

Right Curb: Areas of soft and deteriorating concrete with exposed reinforcing steel throughout. 22LF CS3.

Type of Work: Repair (General)

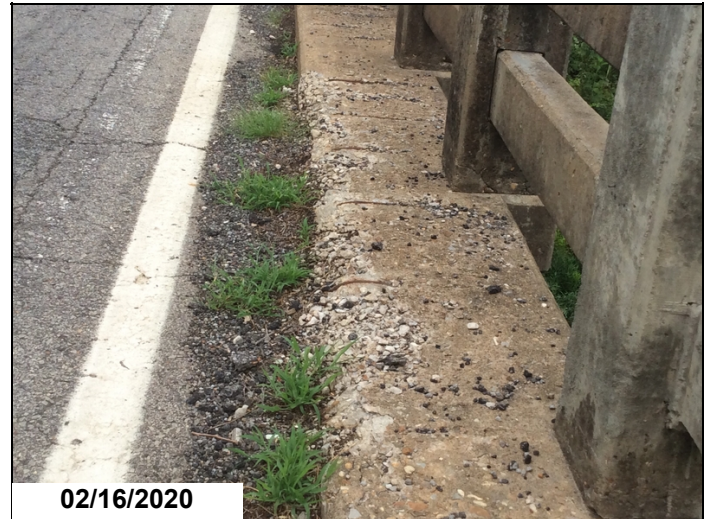
Right curb-Concrete deterioration with spalling that exposes reinforcing steel.

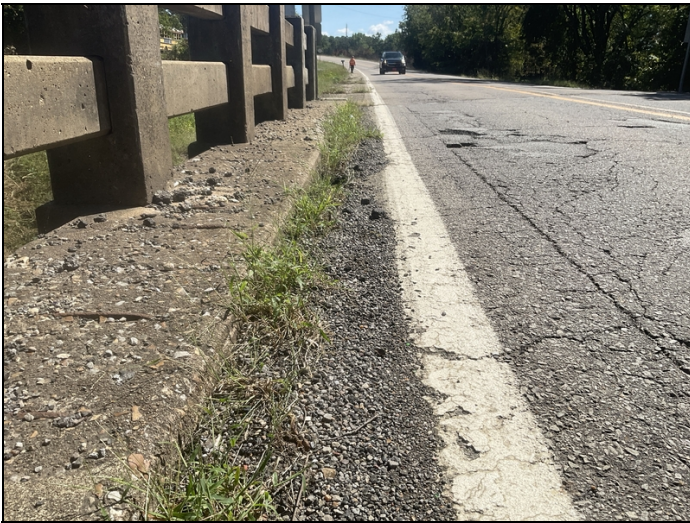
Gutters have heavy dirt and debris accumulation that restricts the deck drains.

A-55 - Deck Washing Needed (Yes)

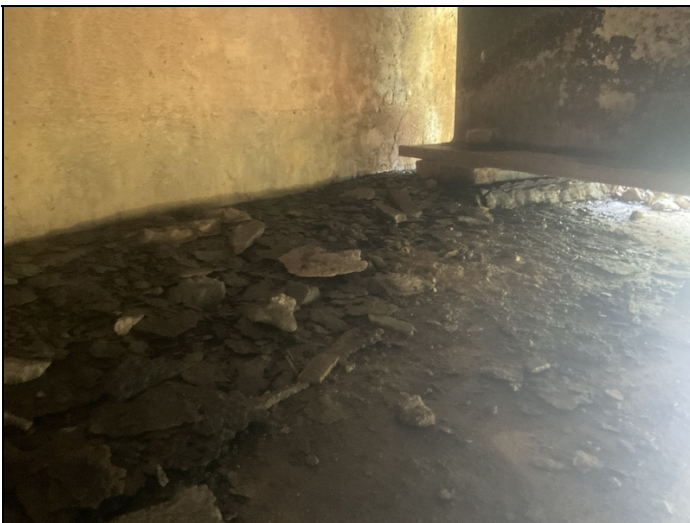
Abutment # 1: Dirt and debris accumulation in bearing area.

A-58 - Cap Cleaning/Flushing Needed (Yes)

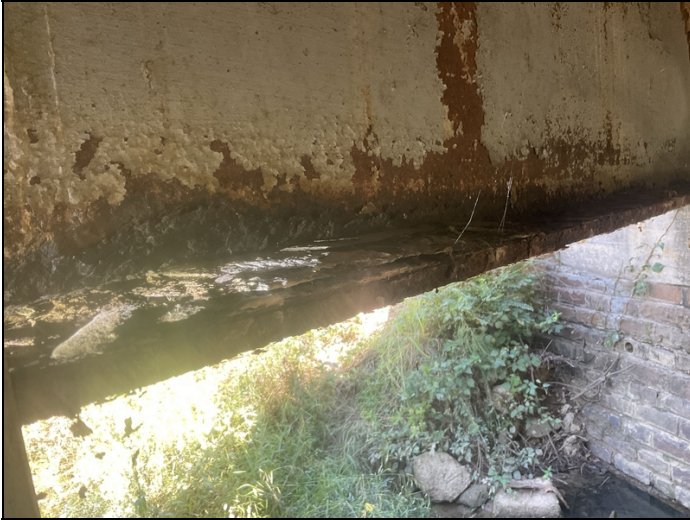
09/25/2024 - RSM & SPC: The superstructure has a failing paint system with areas of active corrosion to the top flanges and girder ends.

Right exterior girder: Corrosion with flaking rust / section loss.

A-60 - Full Girder Painting Needed (Yes)

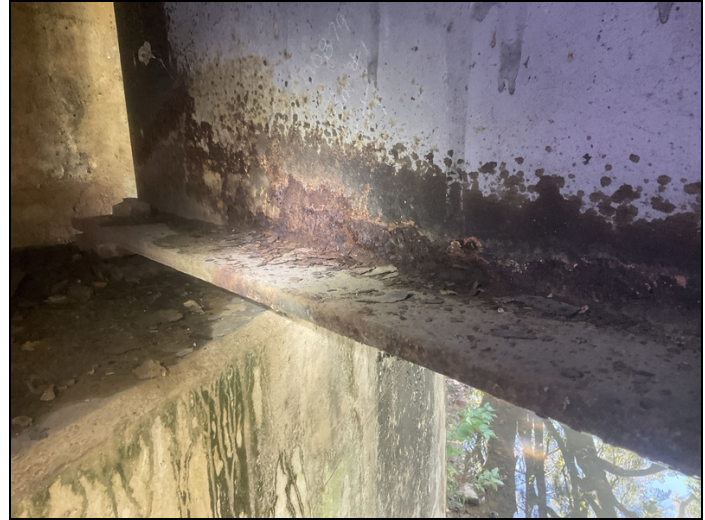
Girder # 1, Abutment # 1: Corrosion with flaking rust. 5LF CS3.
