Asset #07176(Routine)

S.H. 45 - Sec. 2 over I-540 Sebastian Co.

Location: 3.74 Mi. N. of US 71

Team Lead: Bob McEntyre Inspection Date: 11/25/2024

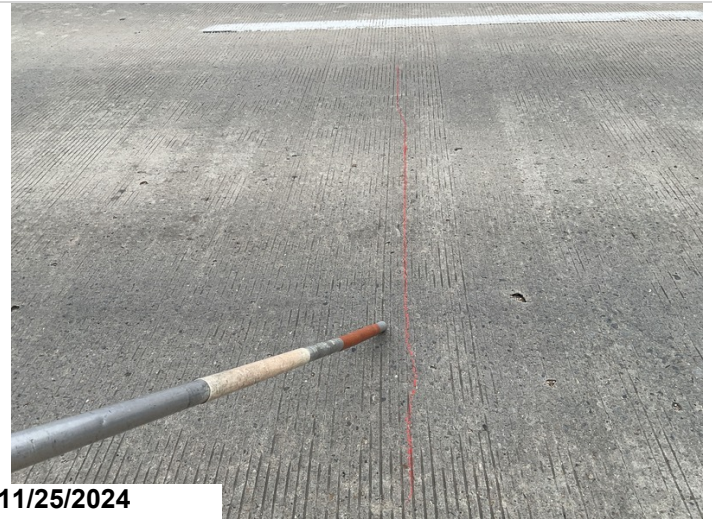
Span # 1, Right Lane: Transverse cracks.

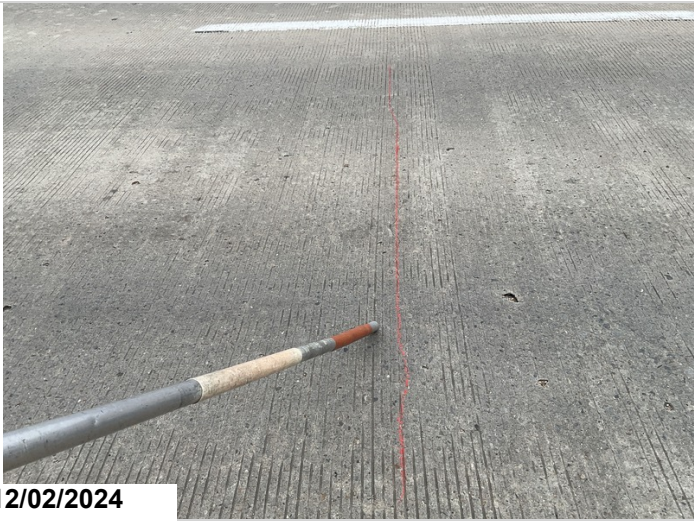
Span # 1, Right Lane: Transverse cracks.

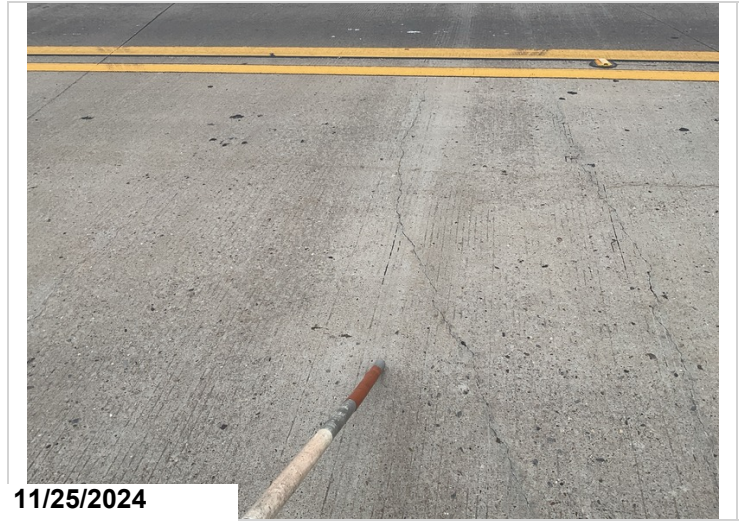
Span # 2, Over Bent # 2: Transverse crack.

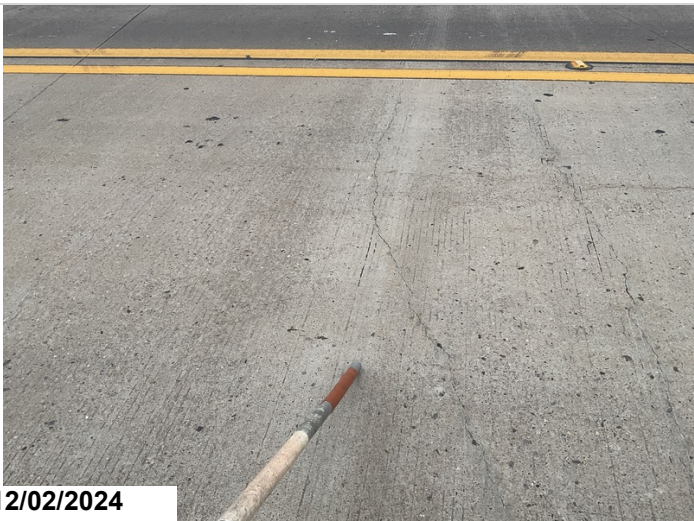
Span # 2, Over Bent # 2: Transverse crack.

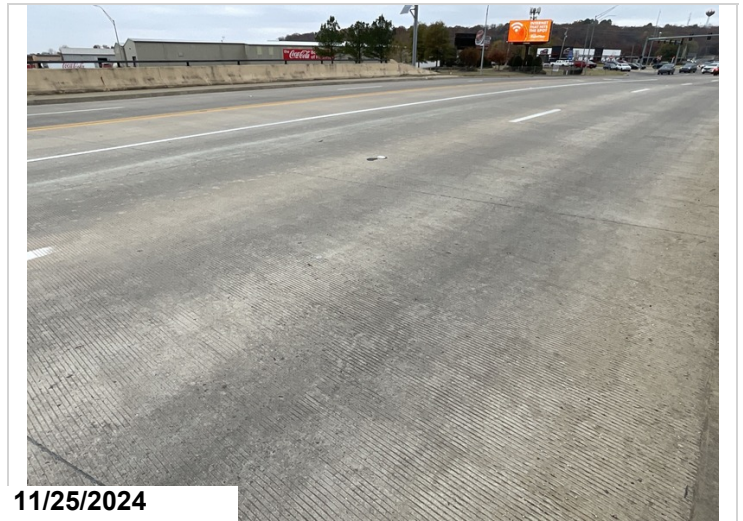
The driving surface of the deck has sealable cracking and appears to be a good candidate for a polymer wearing surface based on the condition of the deck at time of inspection.

The driving surface of the deck has sealable cracking and appears to be a good candidate for a polymer wearing surface based on the condition of the deck at time of inspection.

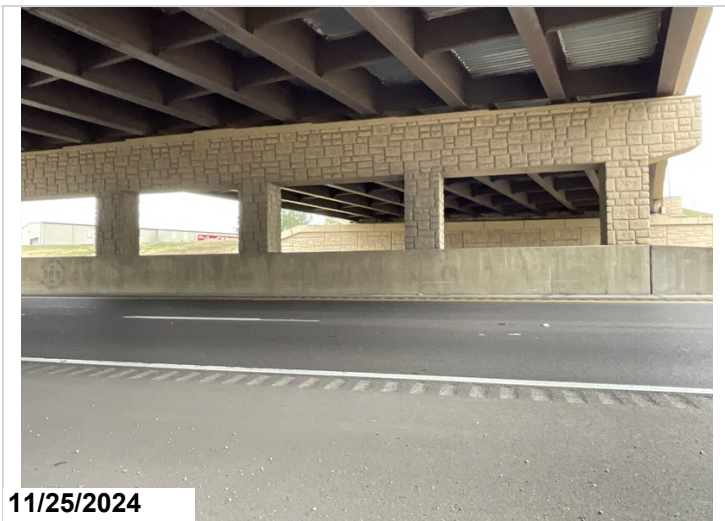
Bent # 2 Columns: No apparent noteworthy deficiencies.

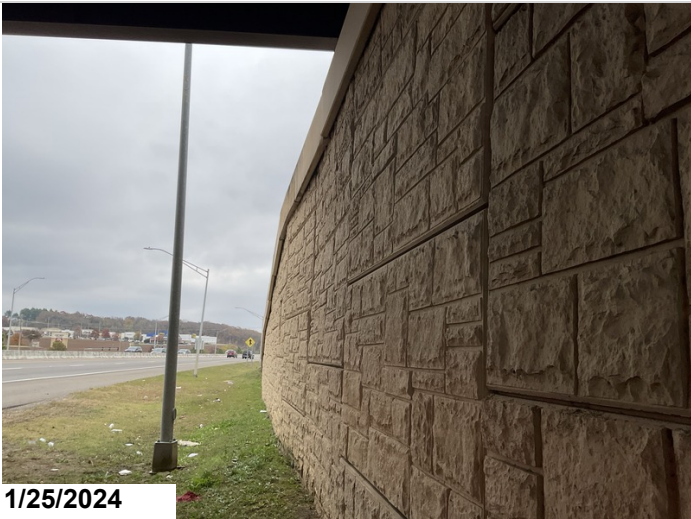
11/01/2022 - JCJ & TJL - Bent # 1, South Mechanically Stabilized Earth Wall (MSE) still appears misaligned and bulging. Bent # 3 MSE wall with the settled bottom panel under Beam # 7 has had the gap filled with backer rod and covered with a silicone type product as a type of repair. No evidence of further settlement to this panel. There are no apparent changes or leakage of fill material since the last inspection.

Abutment # 1 MSE wall still appears misaligned and bulging on the right side under girder # 10.

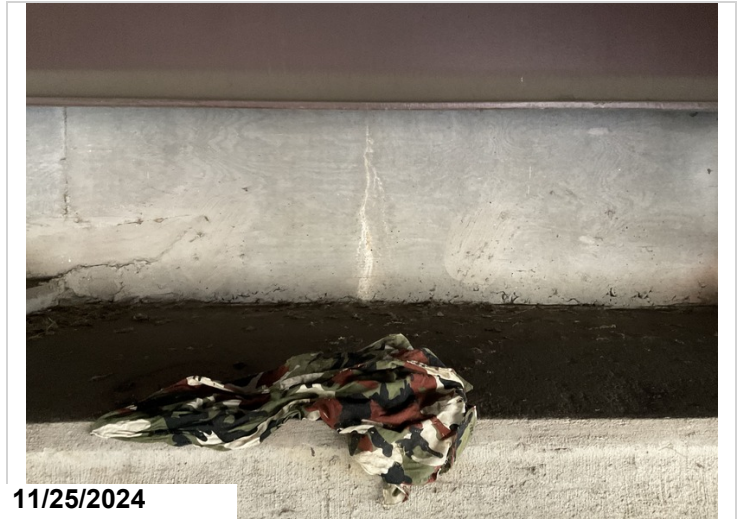
Abutment # 1 Backwall, Bay # 2: Verticrack with efflorescence. 1LF CS2.

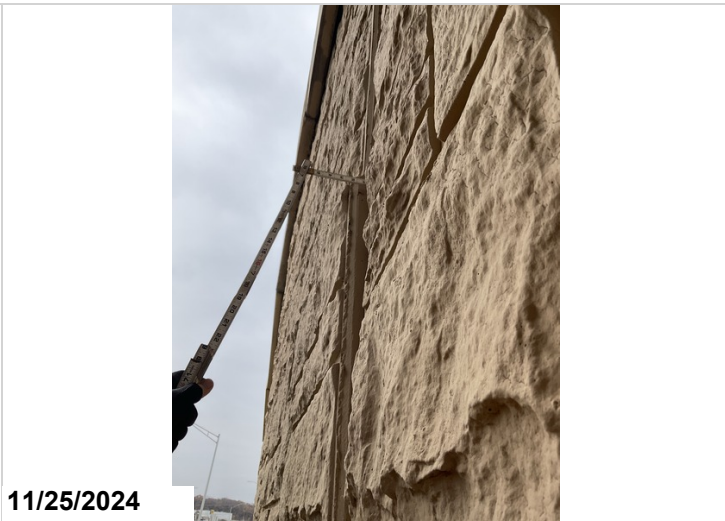
Abutment # 1 MSE wall still appears misaligned and bulging.

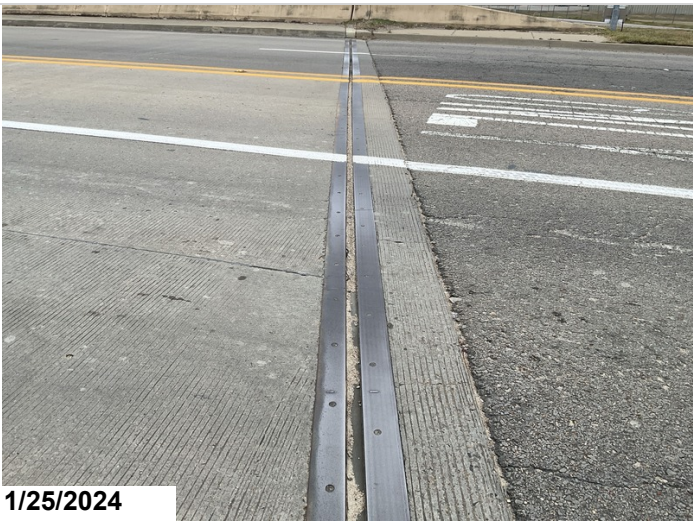
Abutment # 2 Expansion Joint: Dirt and debris in assembly.

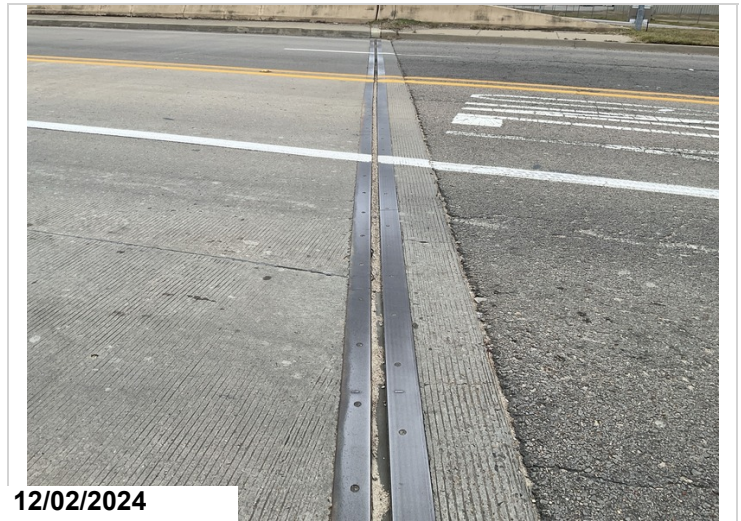
Abutment # 2 Expansion Joint: Dirt and debris in assembly.

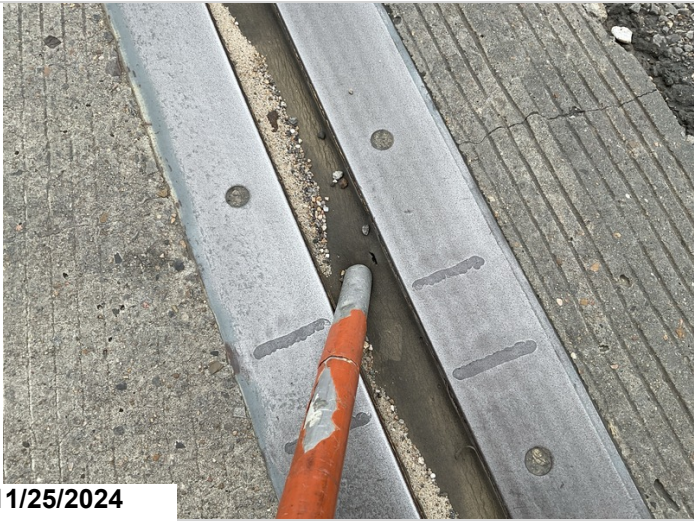
Abutment # 2 Expansion Joint, Right Lane: Full depth rip/puncture. 1LF CS4.

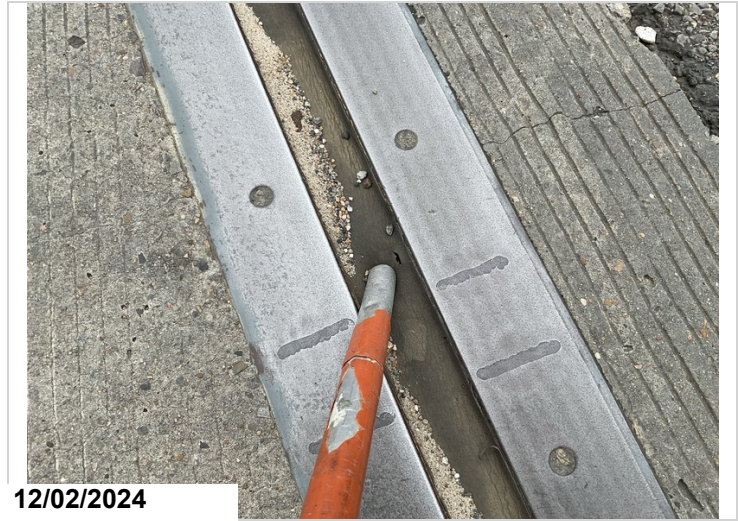
Few isolated areas of tears/ rips in the sealant allowing water to leak onto the substructure and superstructure.

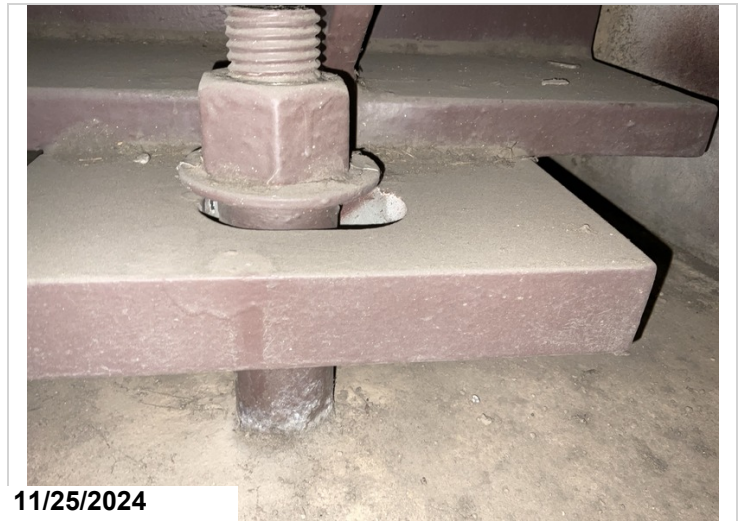
(310) The bearings have minor expansion of the elastomeric bearings visible at both abutments. Elastomeric bearings over Abutment # 2 are expanded more than the bearings over Abutment # 1.							
330	Metal Bridge Railing	LF	558	558	0	0	0
515	Steel Protective Coating	SF	188	188	0	0	0

Elastomeric bearings over Abutment # 2 are expanded more than the bearings over Abutment # 1.

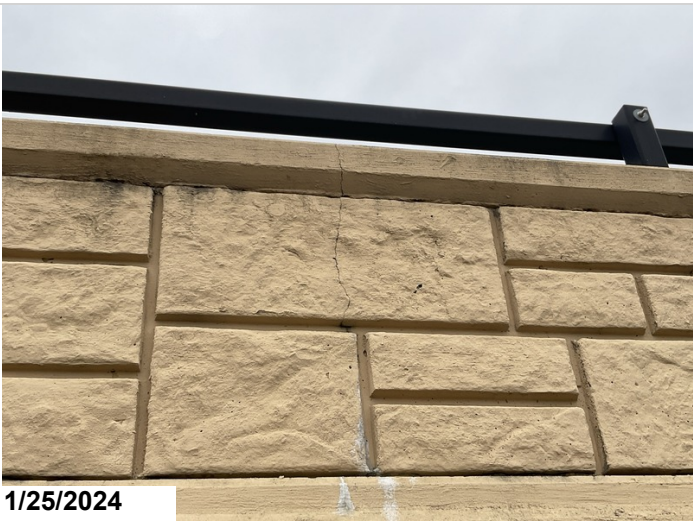
(331) Right Bridge Railing: Top of concrete bridge railing has transverse cracks at random locations. Left bridge Railing, Span # 2: Insignificant scrape marks near abutment # 2 that appear to be from traffic impact. Left bridge railing has numerous vertical cracks that correspond with the sawn joints and other random locations.

Span # 2, Left Railing: Vertical crack. 1LF CS2.

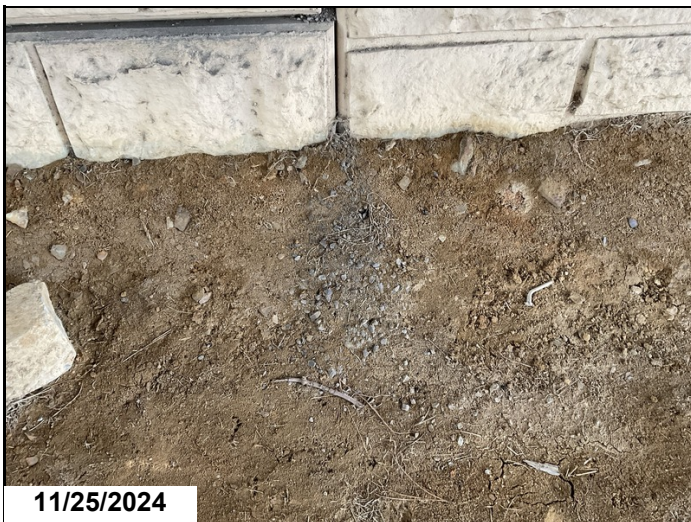
The MSE walls have minor fill material leakage through the vertical construction joint near the base of the wall. Abutment # 1 MSE Wall has minor leakage of granular material at base of wall under Girder # 7. This leakage at MSE wall at abutment # 2 is near centerline of abutment and adjacent to the panel (West Side) that had fill material leakage in the past, the previous leaking joint was filled with backer rod and covered with silicone as a repair, the repair is still holding.

North MSE wall under Girder # 6 has minor leakage of granular fill visible at the base of the wall.

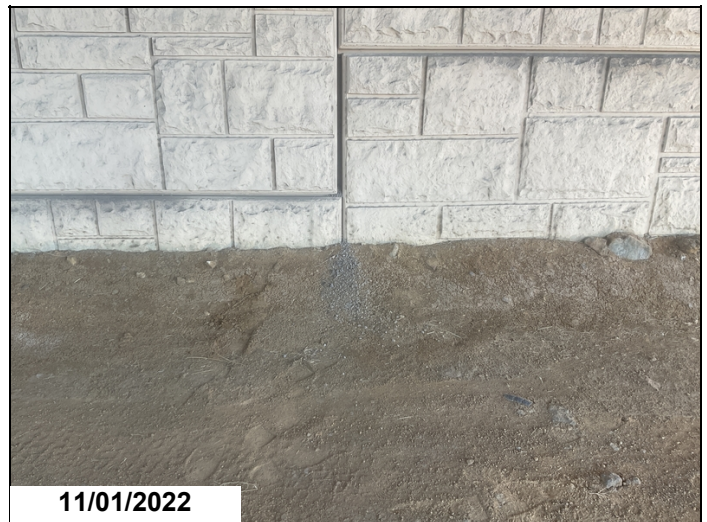
North MSE wall under Beam # 6 has minor leakage of granular fill visible at the base of the wall.

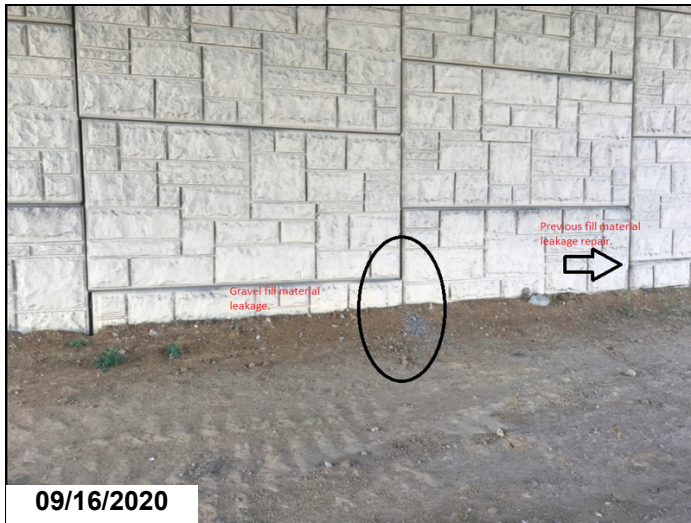
Abutment # 2 MSE wall with minor gravel leakage through the joint.

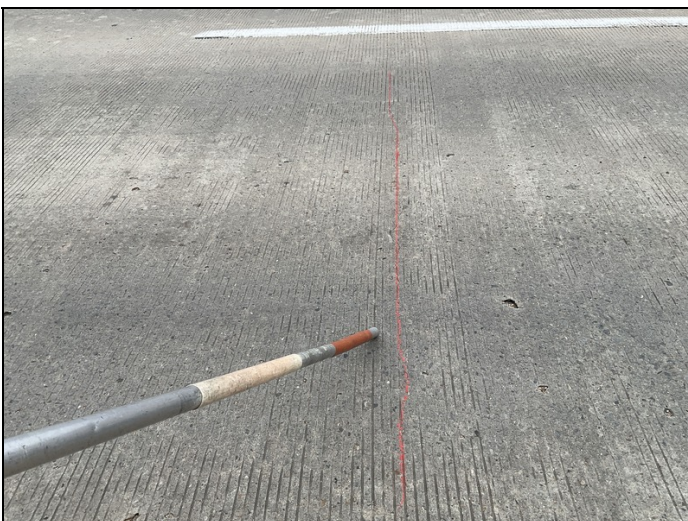
The driving surface of the deck has sealable transverse and longitudinal cracking. The epoxy based sealant previously used to seal the transverse cracks has failed in most locations.

Span # 1, Right Lane: Transverse cracks.

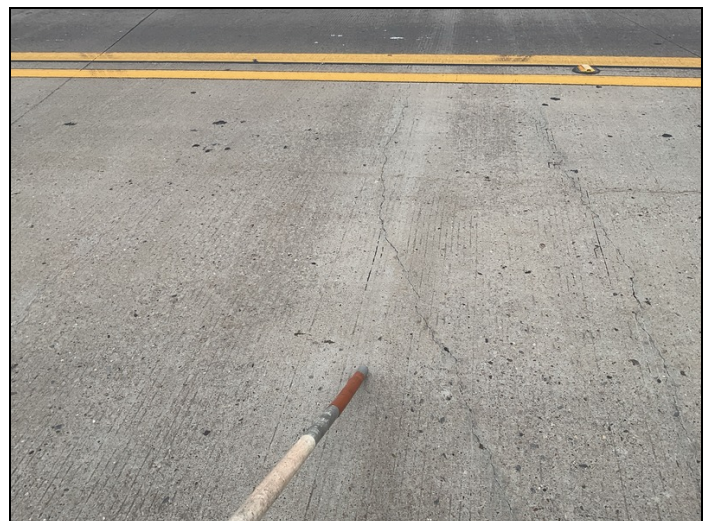
Span # 2, Over Bent # 2: Transverse crack.

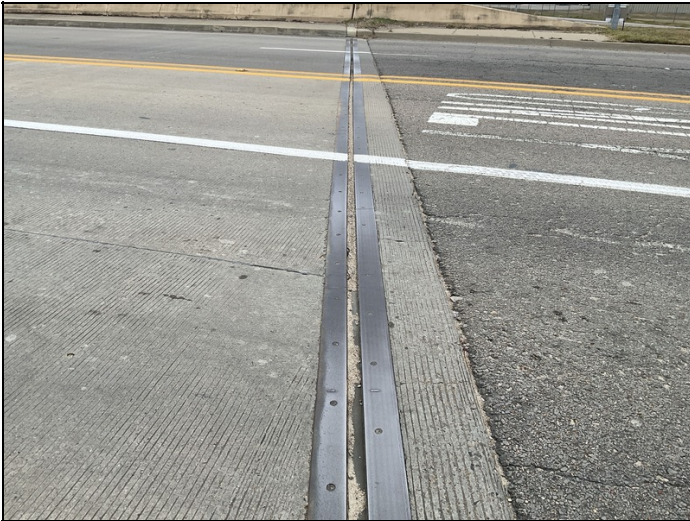
Expansion joint assemblies have dirt and debris accumulation.

Abutment # 2 Expansion Joint: Dirt and debris in assembly.

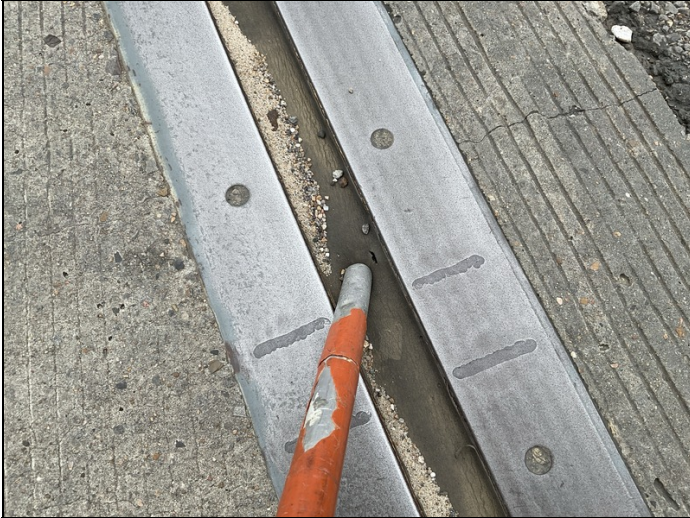
Few isolated areas of tears/ rips in the sealant allowing water to leak onto the substructure and superstructure.

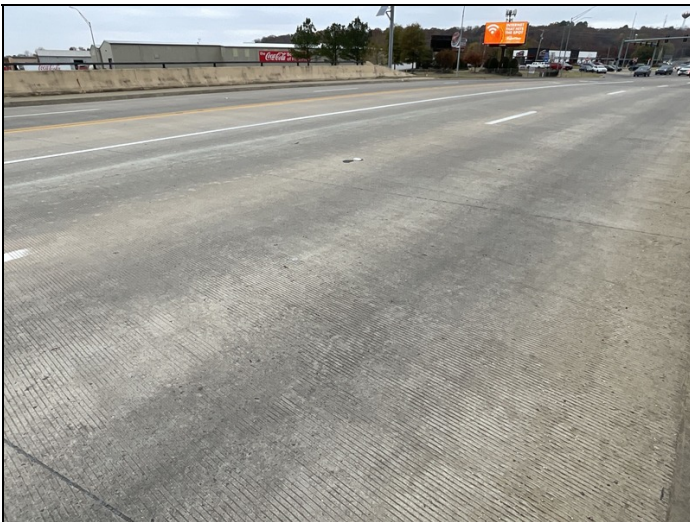
The driving surface of the deck has sealable cracking and appears to be a good candidate for a polymer wearing surface based on the condition of the deck at time of inspection.
