Asset #X0252(Routine)
SH 45 over Wells Creek Seb. Co.
Location: 5.21 MI SW JCT US 71

Team Lead: Bob McEntyre Inspection Date: 07/11/2024

IDENTIFICATION	
(1) State Names	5 - Arkansas
(8) Structure Number	X0252
(5) Inventory Route	1
(2) Highway Agency District	04 - District 04
(3) County Code	131 - Sebastian County

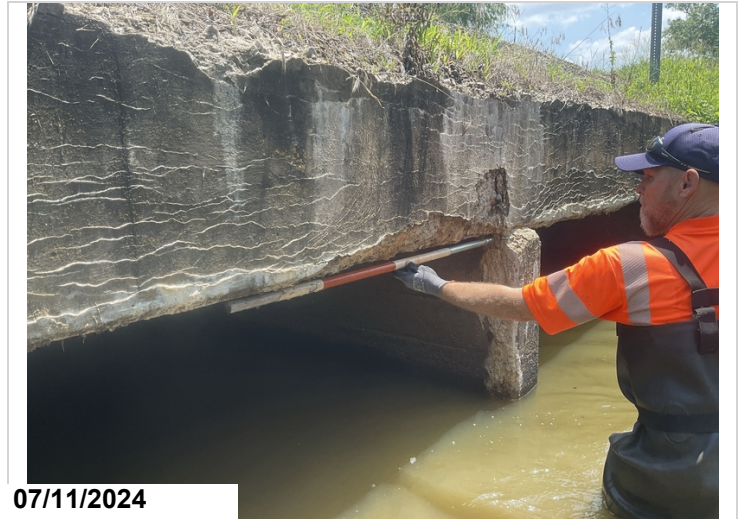
Barrels # 1 and 2 Top Slab, Left Exterior Edge: Undersurface has a 3' spalled area and concrete deterioration with efflorescence along the Left exterior edge. 1LF Spalling CS3

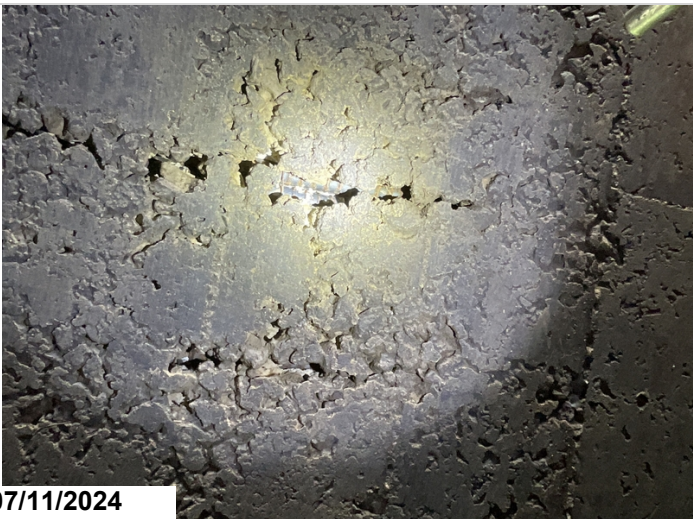
Top Slab Undersurface: Areas of honeycombing that exposes reinforcing steel from the construction process. 1LF Exposed Steel CS2

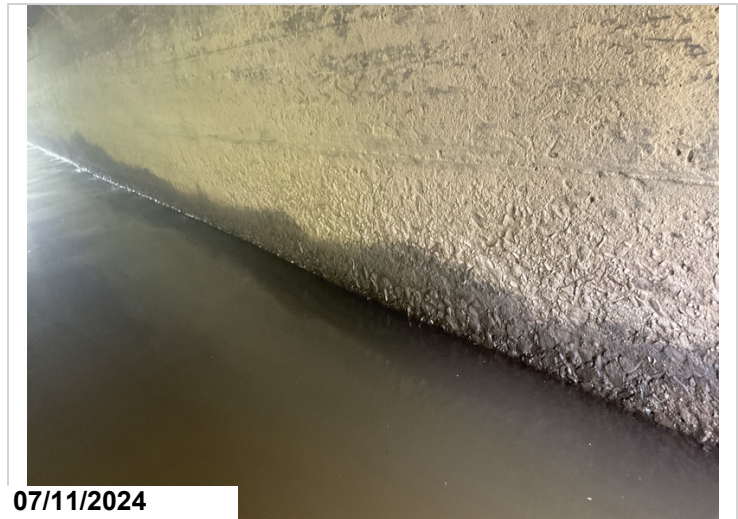
Walls: Light abrasion to the walls at the water elevation.

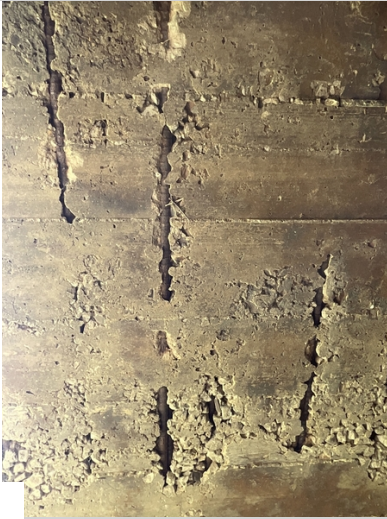
Top Slab Undersurface: Areas of honeycombing that exposes reinforcing steel from the construction process. The most extensive area with honeycombing is in Barrel # 2 at the inlet end of structure. Exposed steel 2LF CS3.

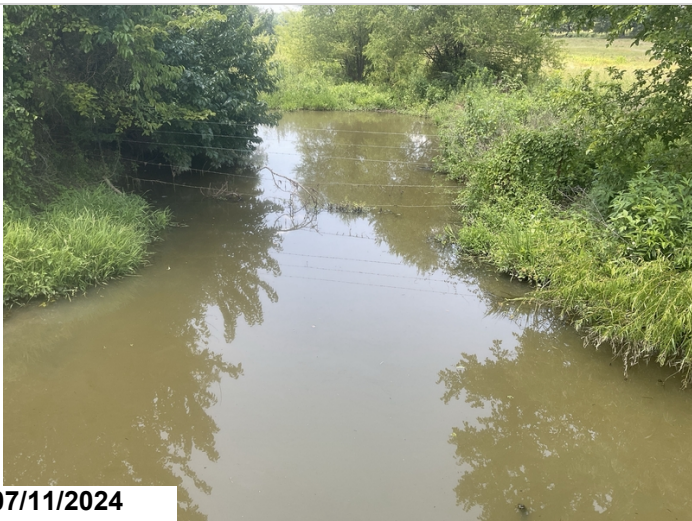
07/11/2024 - RSM & SPC: The downstream channel (West Side) has streambed material accumulation (possible beaver dam) preventing flow and causing standing water under the culvert. Water is approximately 2' deep at time of inspection.

Downstream Channel looking West.

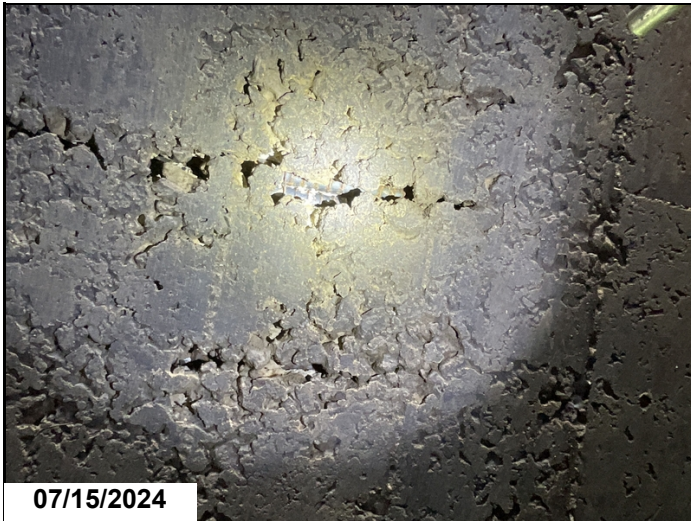
The undersurface of the top slab has areas of honeycombing that exposes reinforcing steel. Exposed reinforcing steel has a light rust coating with isolated areas of initial section loss.

Top Slab Undersurface: Areas of honeycombing that exposes reinforcing steel from the construction process.
1LF Exposed Steel CS2

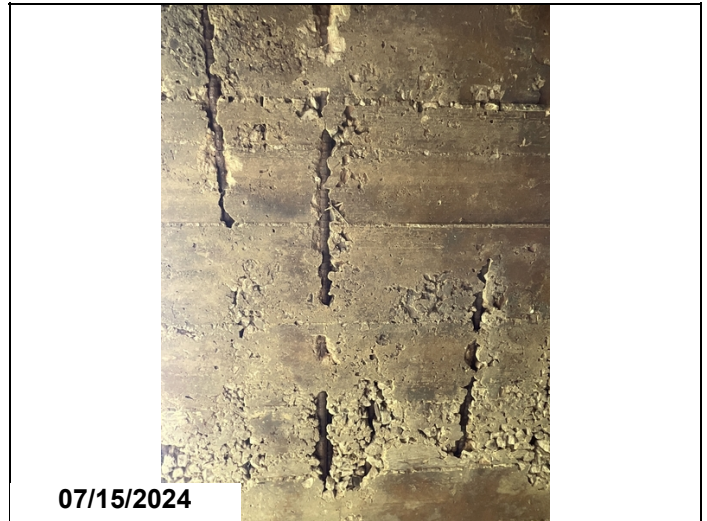
Top Slab Undersurface: Areas of honeycombing from the construction process that exposes reinforcing steel. The most extensive area with honeycombing is in Barrel # 2 at the inlet end of structure. Exposed steel 2LF CS3.

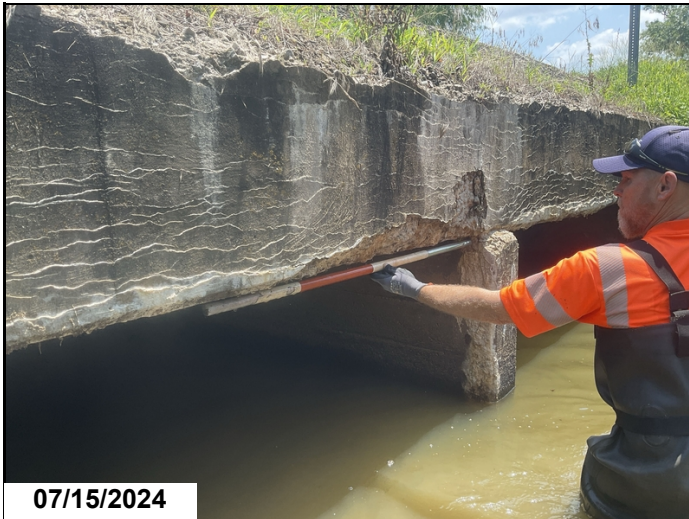
The Left headwall and vertical face of top slab has soft and deteriorating concrete over Barrels # 1 and 2 with mapcracking and efflorescence. The concrete is beginning to spall along the undersurface edges.

07/15/2024
Barrels # 1 and 2 Top Slab, Left Exterior Edge:
Undersurface has a 3' spalled area and concrete
deterioration with efflorescence along the Left exterior
edge. 1LF Spalling CS3

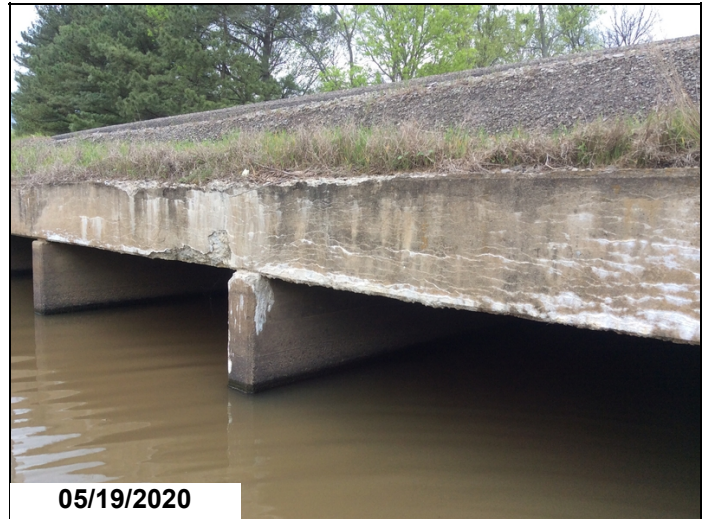
05/19/2020
The Left headwall and vertical face of top slab has soft
and deteriorating concrete over Barrels # 1 and 2 with
mapcracking and efflorescence. The concrete is
beginning to spall along the undersurface edges.
