Asset #A0667(Other Special Recurring)

US 62 - Wash Co. over Ballard Creek

Location: 2.01 MI E OKLAHOMA STATE

Team Lead: Jeff Jones Inspection Date: 07/18/2024

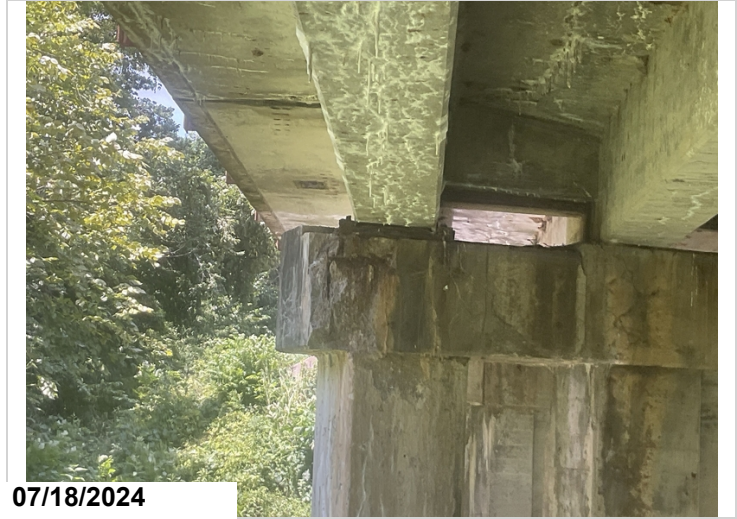
(234) -Bent # 2 cap, Rt side has concrete deterioration, delaminated areas with heavy map cracking and efflorescence. Sounding the cap revealed that the delaminated area extends under the bearing of girder # 5 of span # 1. The affected area has concrete section loss with exposed reinforcing steel with approximately 2" of bearing area loss to the exterior side of bearing device. -Bent # 2 cap, Lt side has a baseball sized spall with exposed reinforcing steel with approximately 1/8" section loss visible from the undersurface of the cap between columns # 1 and 2. The ahead face of cap has a shallow 5" long shallow spall with exposed reinforcing steel under girder # 1. -Bent #2 ahead face of cap has a horizontal crack located approximately 6" below the top of cap between girders # 2 & 3. -Bent # 3, left and right sides of cap have concrete deterioration with map cracking and heavy efflorescence. -Bent # 3 cap, concrete deterioration in the top of cap with 1" deep x 12" long area of section loss adjacent to span # 3, girder # 2. -Bent # 3 cap ahead face has map cracking in bays # 1, 2 and 4 with delaminated areas under girders # 1, 2 and 5 of span # 3. -Bent # 3 cap Lt side in the widened portion is delaminated with soft deteriorated concrete with concrete section loss / spalling that exposes the reinforcing steel and has caused approximately 2" of bearing area loss to girder # 1 of span # 3. The delaminated area appears to extend under approximately 50% of the bearing device at this inspection. -Bent # 3 cap Rt ahead face has concrete deterioration with spalling with exposed reinforcing steel that has caused approximately 2" of bearing area loss to girder # 5 of span # 3. The delaminated areas extend under the bearing device. Bent # 3 Rt aheadface of the widened portion is delaminated when sounded.

Bent 3. Ahead face, Right side of cap has concrete deterioration.

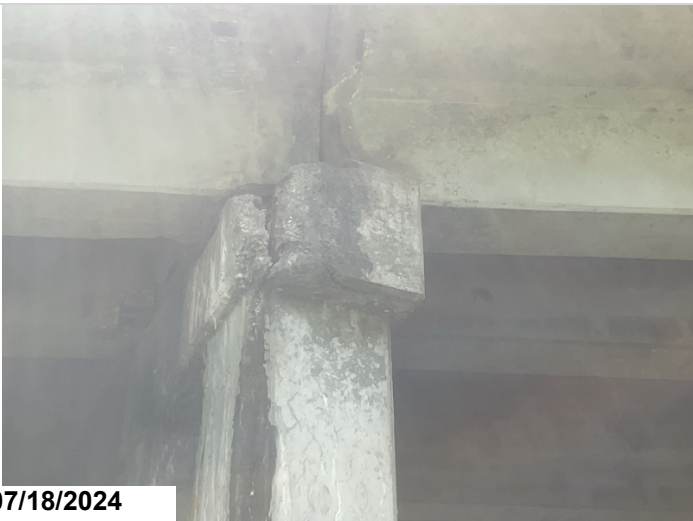
Bent 3. Left side of cap has concrete deterioration.

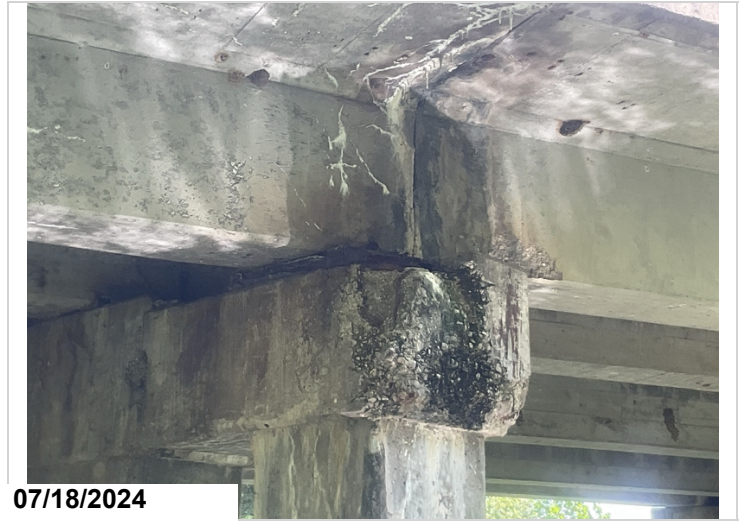
Bent 2 cap. Right end. Concrete deterioration.

The right side of bent 2 cap has concrete deterioration, delaminated areas with heavy map cracking, and efflorescence. Sounding the cap revealed that the delaminated area extends under the bearing of girder 5 of span 1. The affected area has concrete section loss with exposed reinforcing steel with approximately 2" of bearing area loss to the exterior side of bearing device.

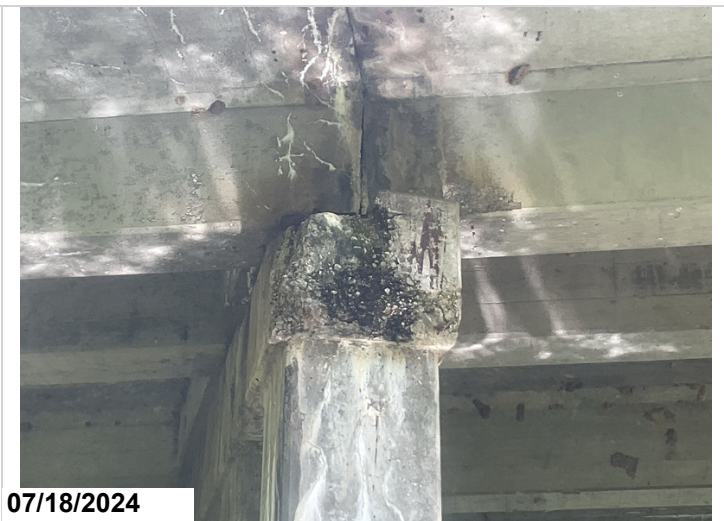
Bent 2 cap. Right end. Concrete deterioration.

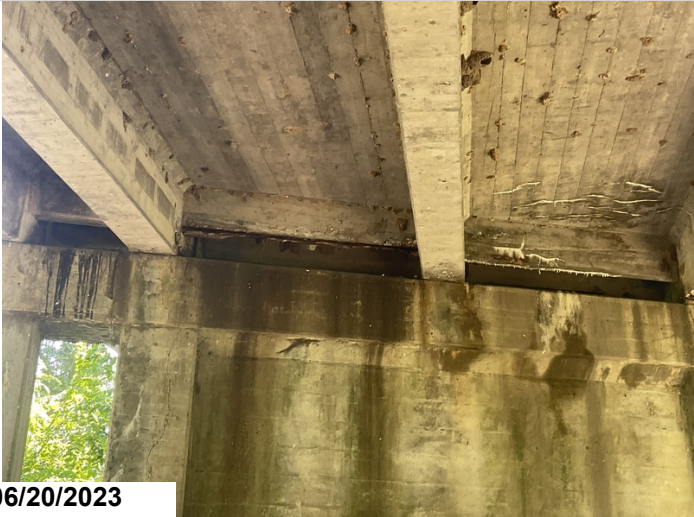
Span # 2 bay # 2 spalling with exposed reinforcing steel in the expansion dam.

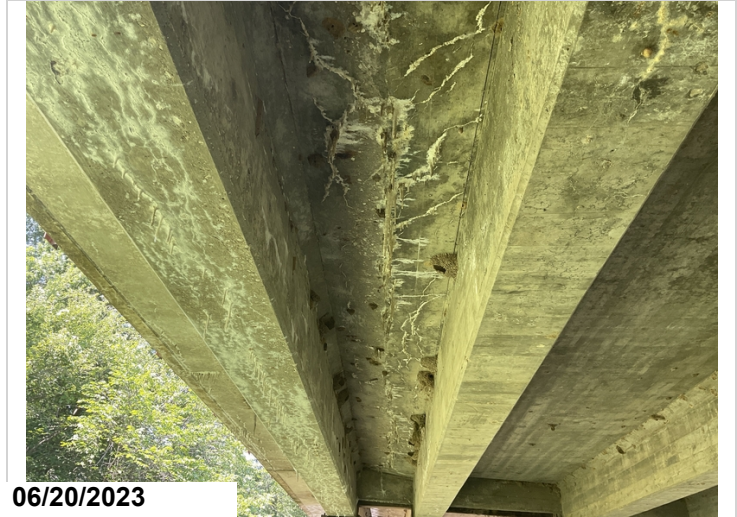
Span # 3 bay # 4 efflorescence buildup.

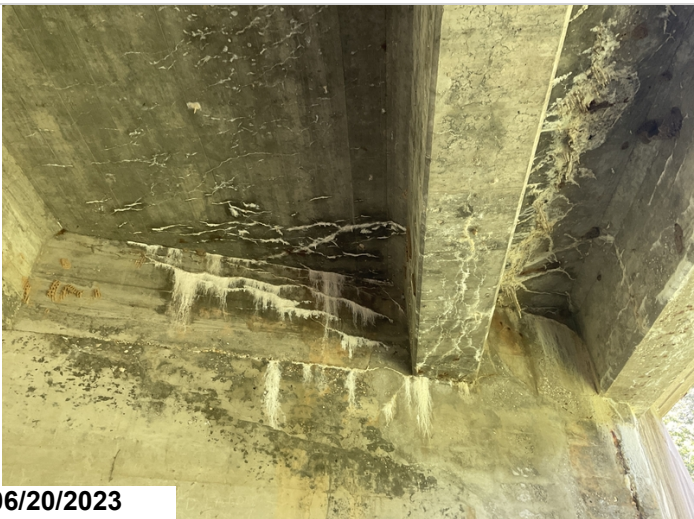
Span # 3 undersurface cracking with efflorescence buildup.

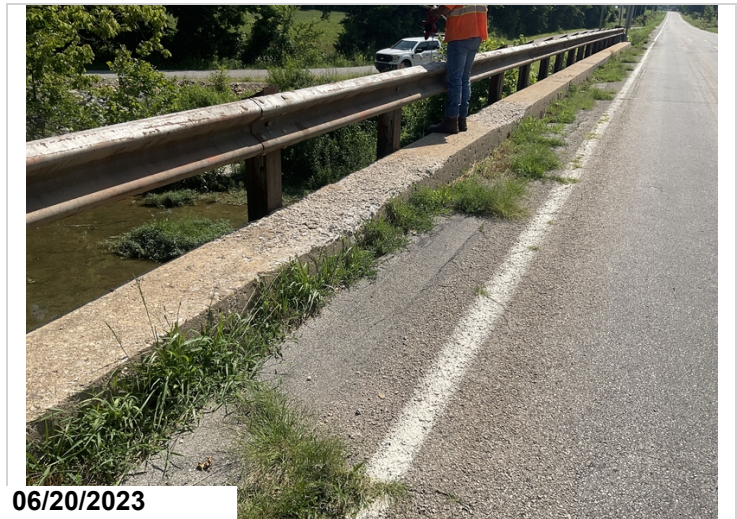
Left curb concrete deterioration.

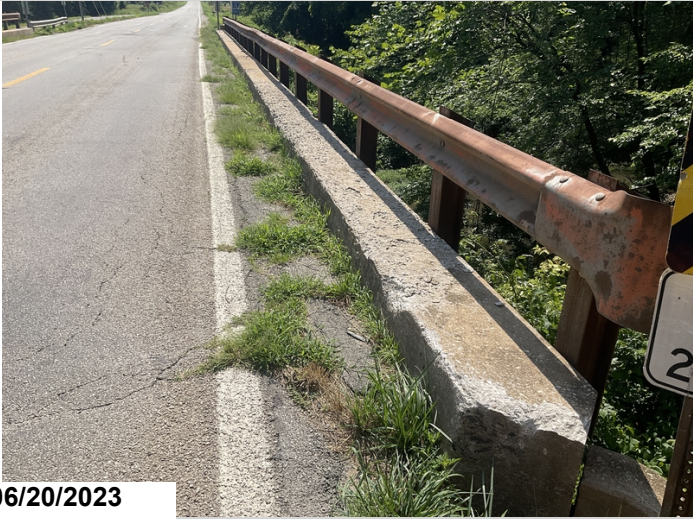
Right curb concrete deterioration.

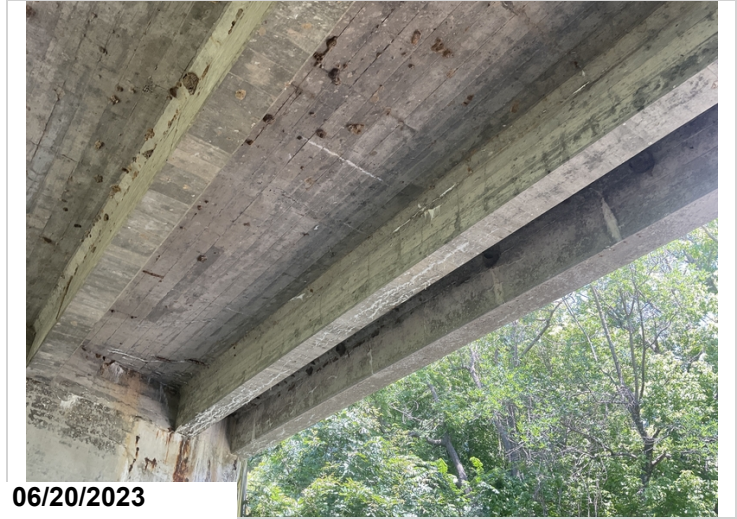
Span # 1 girders # 1 & 2 cracking with efflorescence buildup.

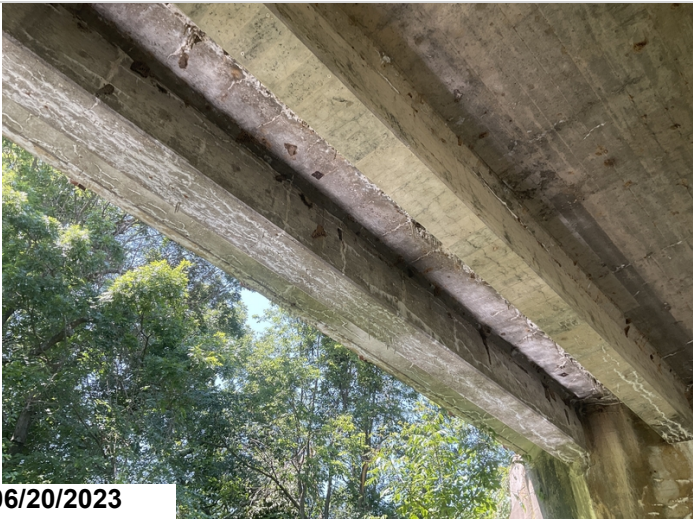
Span # 1 girders # 4 & 5 cracking with efflorescence buildup.

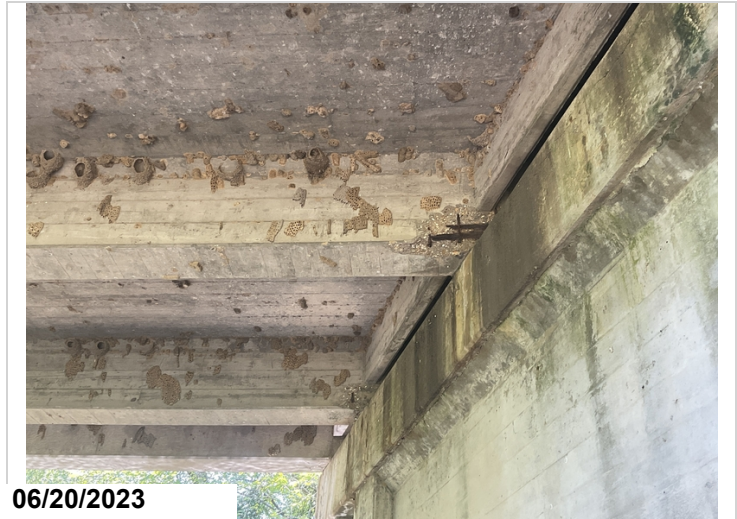
Span # 2 girders # 3 & 4 spalling with exposed reinforcing steel.

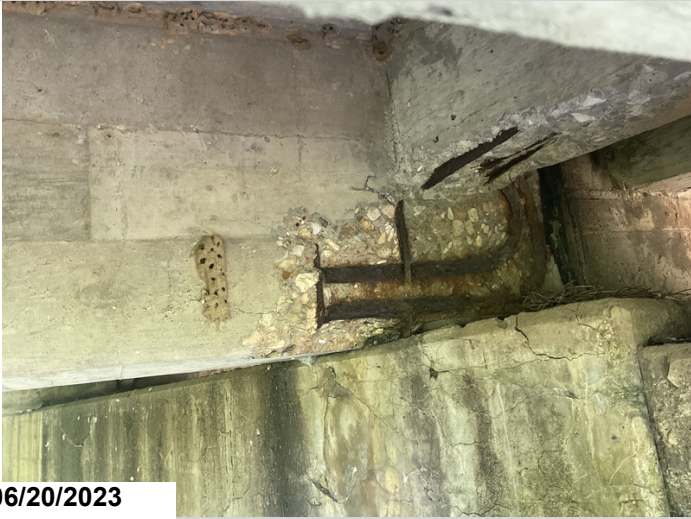
Span # 3 Bent # 3 Girder # 2 spalling with exposed reinforcing steel.

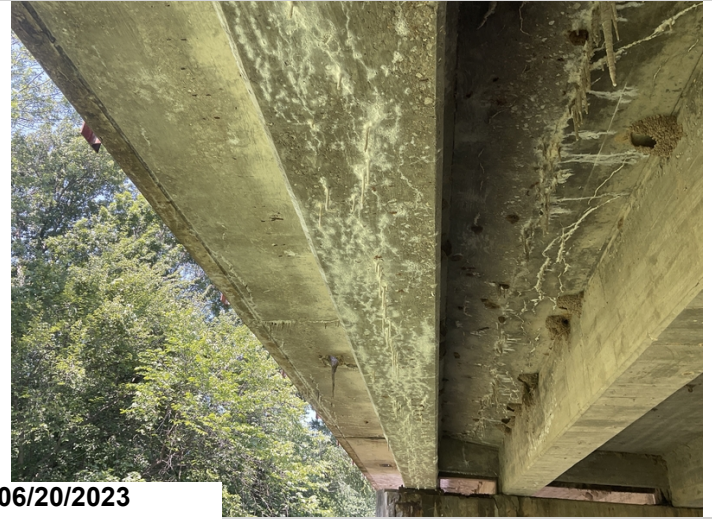
Span # 3 Girder # 5 cracking with efflorescence buildup.

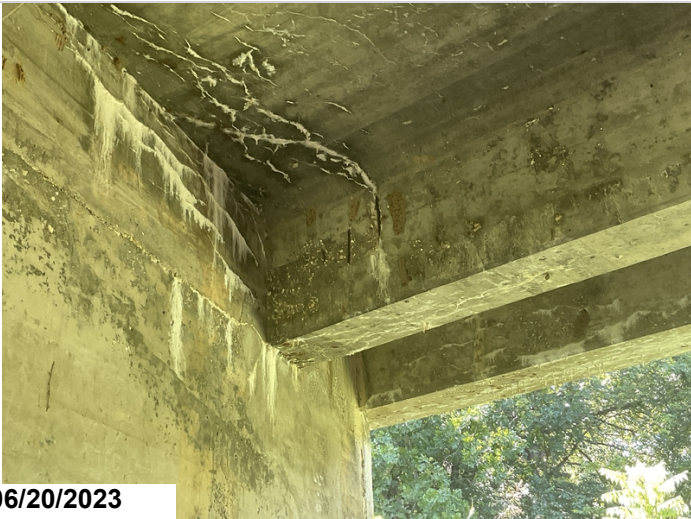
Abutment # 2 Girder # 4 spalling with exposed reinforcing steel.

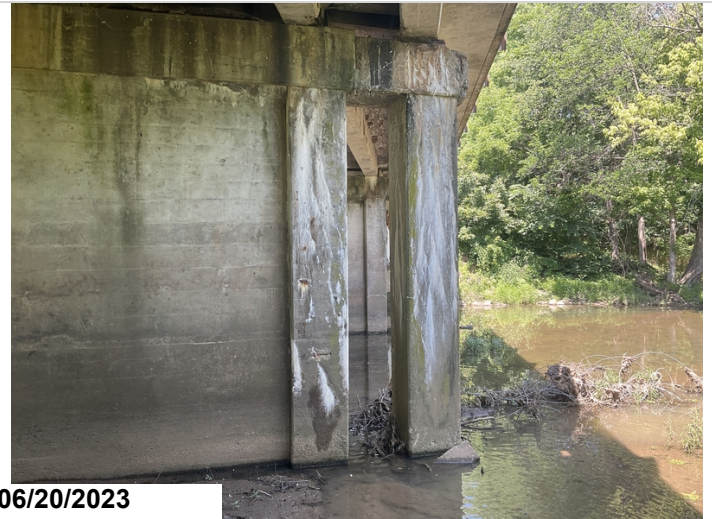
Bent # 3 columns # 1 & 2 cracking with efflorescence buildup.

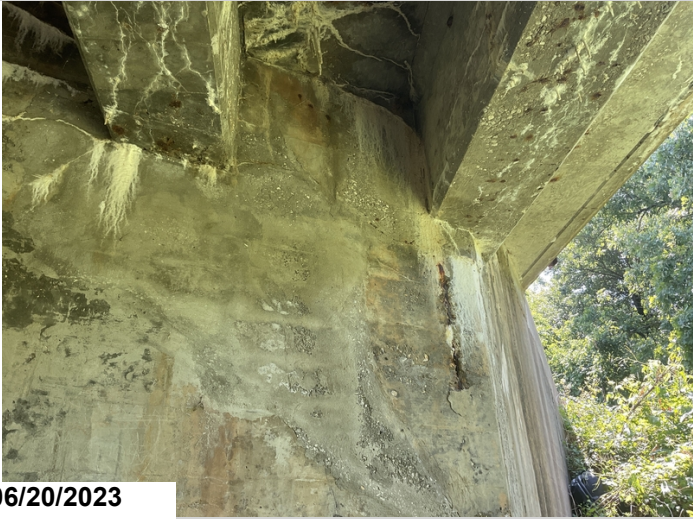
Abutment # 2 Rt spalling with exposed reinforcing steel.

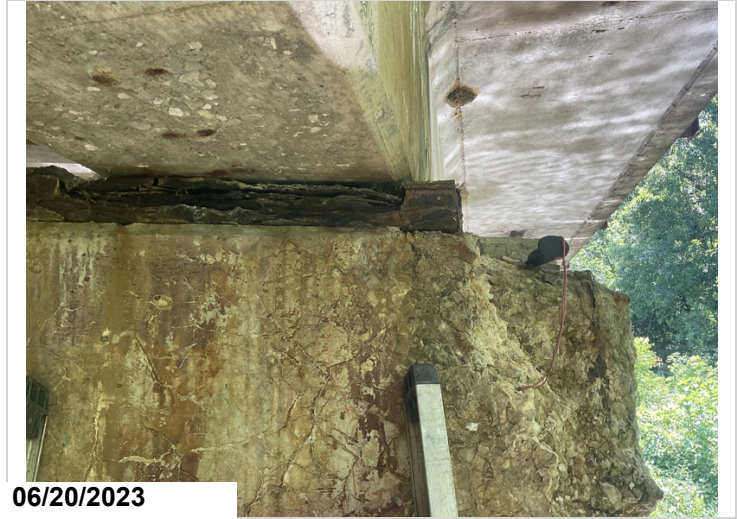
Bent # 2 Rt spalling with exposed reinforcing steel and loss of bearing area.

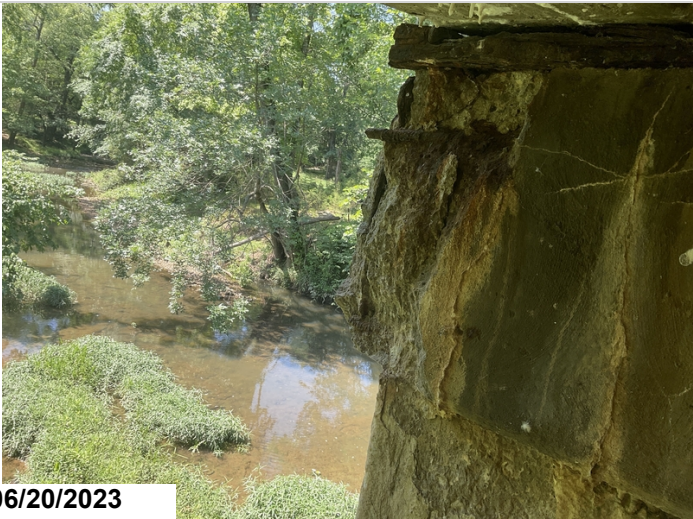
Bent # 3 cap Rt ahead face has concrete deterioration with spalling with exposed reinforcing steel that has caused approximately 2" of bearing area loss to girder # 5 of span # 3. The delaminated areas extend under the bearing device.

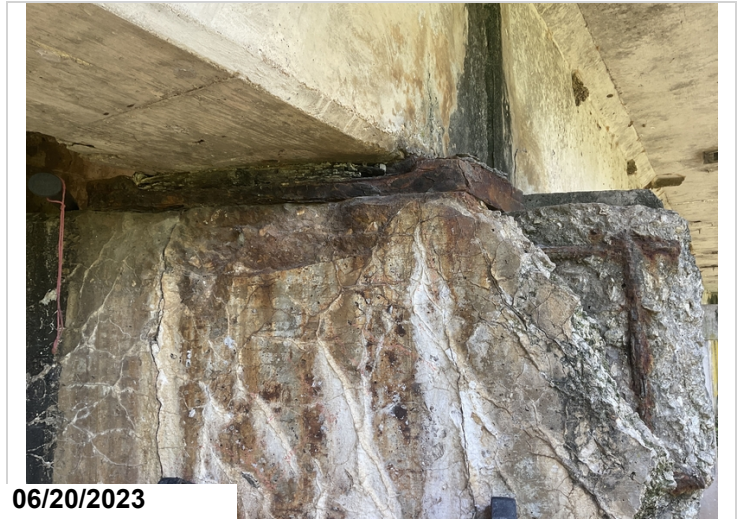
Bent # 3 Lt concrete delamination with bearing area loss under girder # 1.

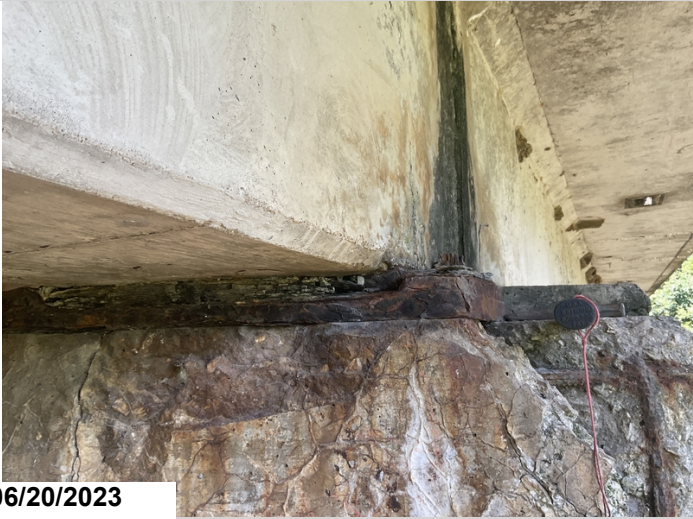
Bent # 3 Girder # 1 bearing with active corrosion and pack rust.

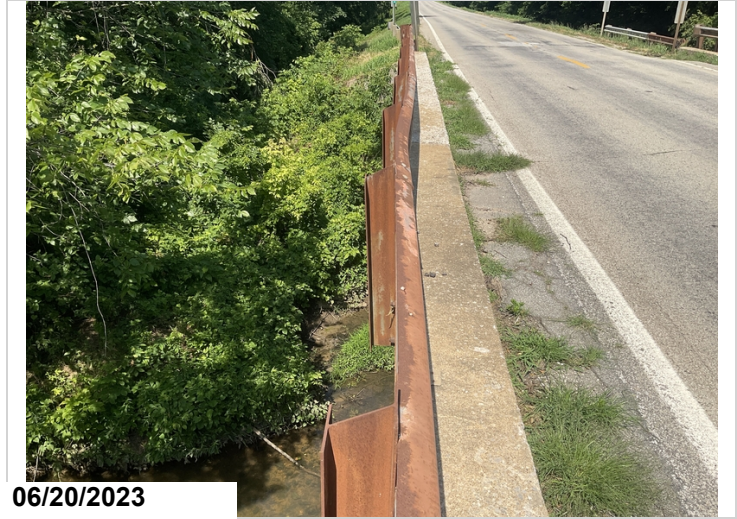
Span # 2 Rt collision damage.

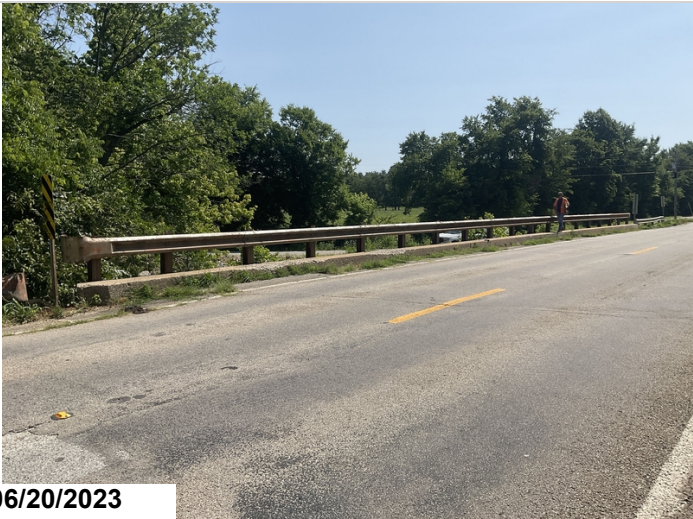
Left bridge rail failing paint system.

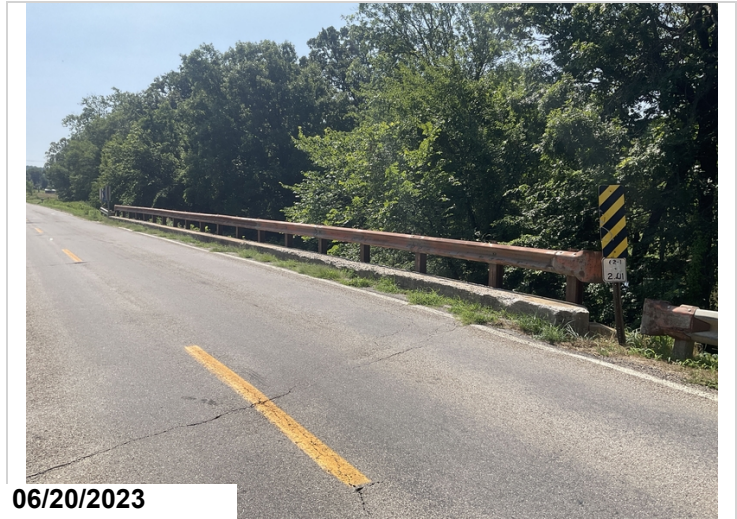
Right bridge rail failing paint system.

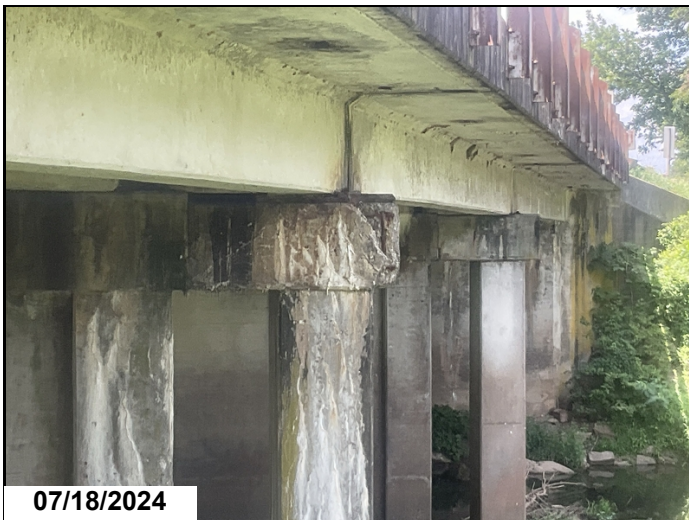
The left side of bent 3 cap is delaminated with soft deteriorated concrete with concrete section loss / spalling that exposes the reinforcing steel and has caused approximately 2" of bearing area loss to girder 1 of span 3. The delaminated area appears to extend under approximately 50% of the bearing device during this inspection.

Bent 3 cap, Ahead face, Left end has concrete deterioration with loss of bearing area.

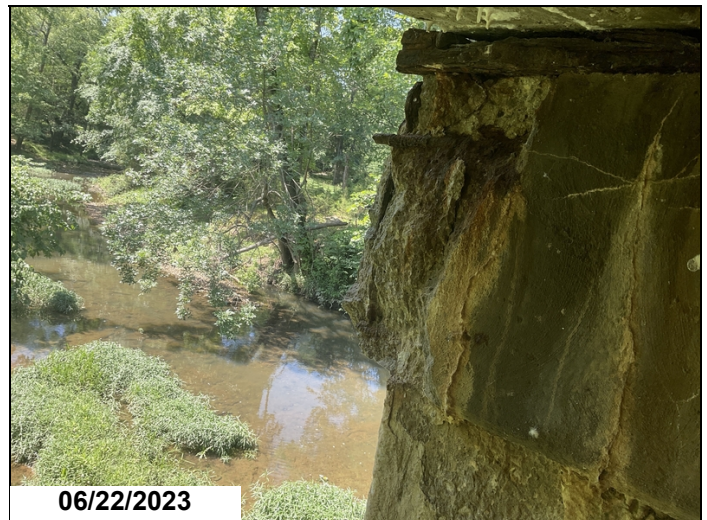
The right end of bent 3 cap has concrete deterioration and spalling with exposed reinforcing steel that has caused approximately 2" of bearing area loss to girder 5 of span 3. The delaminated areas extend under the bearing device.

Bent 3 cap Rt ahead face has concrete deterioration with spalling with exposed reinforcing steel that has caused approximately 2" of bearing area loss to girder 5 of span 3. The delaminated areas extend under the bearing device.

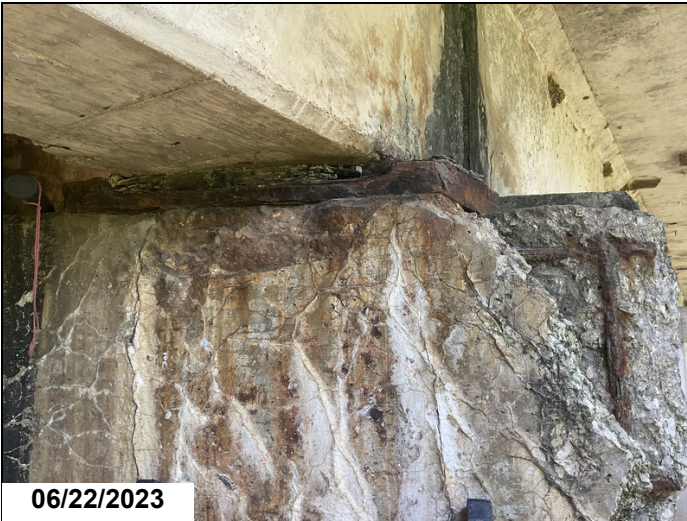
Bent 3 Lt concrete delamination with bearing area loss under girder 1.

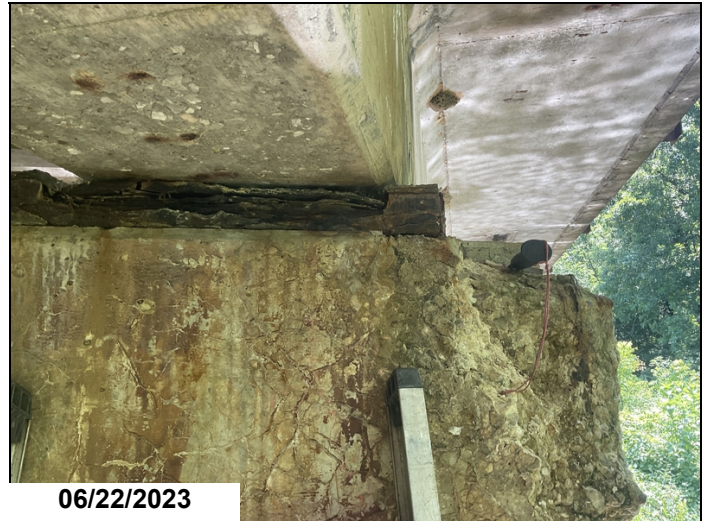
Bent 2 Rt spalling with exposed reinforcing steel and loss of bearing area.

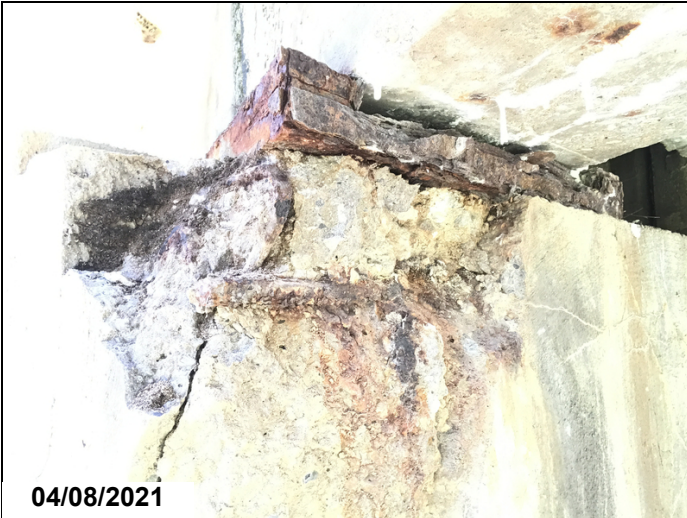
The right end of bent 3 cap has concrete deterioration with spalling that has caused approximately 2" of bearing area loss to girder 5 of span 3. The delaminated areas extend under the bearing device.

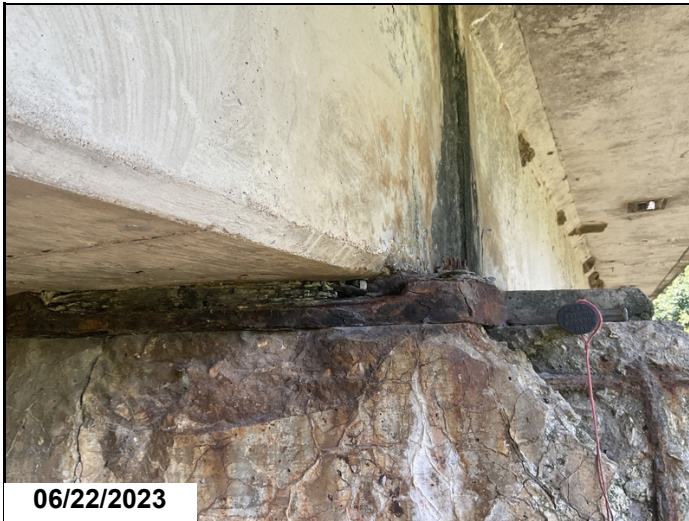
Expansion Bearings under Girders 1 & 5 have heavy active corrosion with thick flaking rust and are beginning to come apart.

Bent 3 Girder 1 bearing with active corrosion and pack rust.

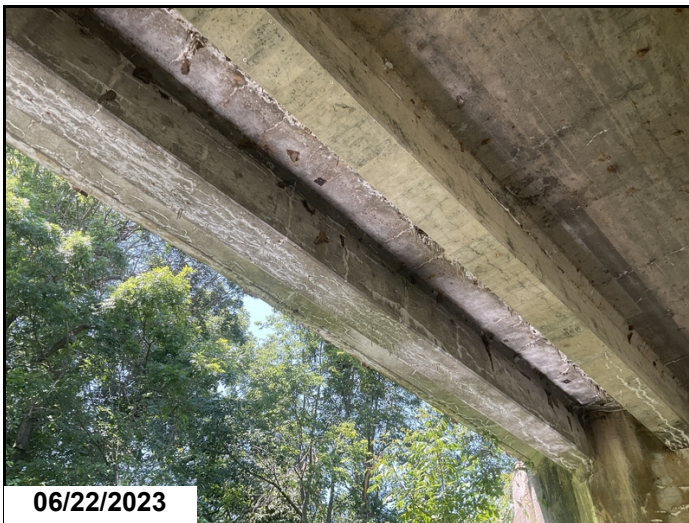
Span 1, Girder 5 has longitudinal and vertical cracking with efflorescence at approximately 2' centers. Girder 2 has spalling with exposed reinforcing steel over Bent 2.

Span 1 girders 4 & 5 cracking with efflorescence buildup.

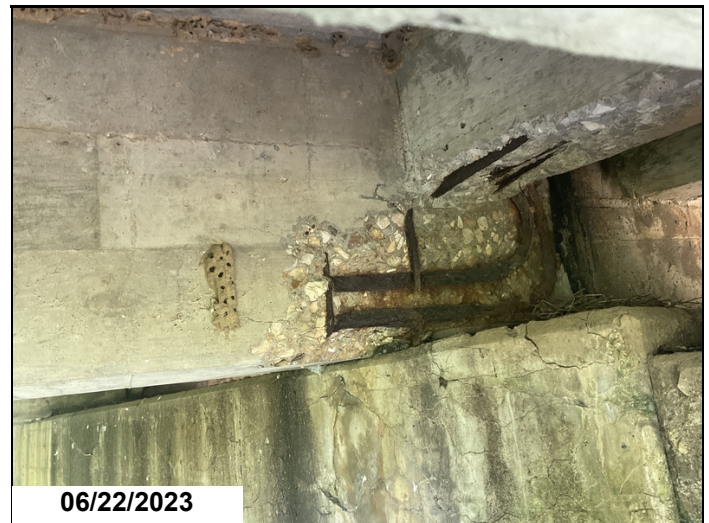
Span 3, Girder 2 has a 24" spall with exposed reinforcing steel over Bent 3. Girder 4 has a 10" spalled area over Bent 3 and shallow vertical spalls with exposed rebar adjacent to Bent 4. Girder 5 has map cracking with efflorescence.

Span 3 Bent 3 Girder 2 spalling with exposed reinforcing steel.

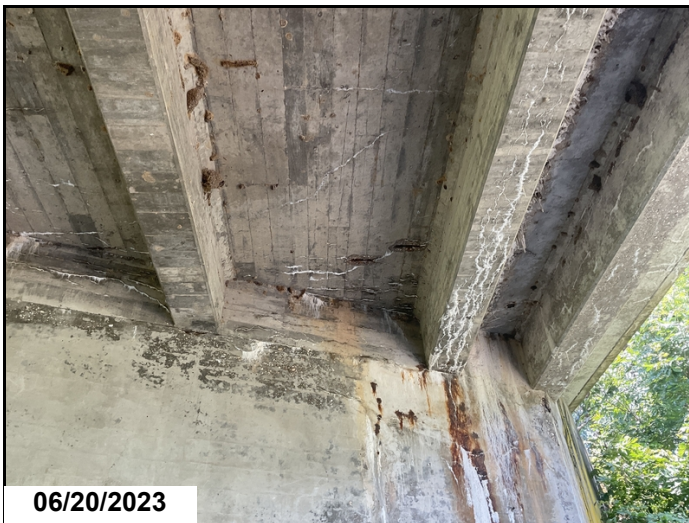
Span 1, Undersurface of the deck has 2 basketball sized spalls with exposed reinforcing steel in Bay 2 located approximately 2' from abutment 1. Bay 3 has one 10" spall adjacent to abutment 1. Longitudinal and map cracking with heavy efflorescence in Bays 1 and 4 where deck was widened at a later date.

Span 1 bay 2 spalling with exposed reinforcing steel.

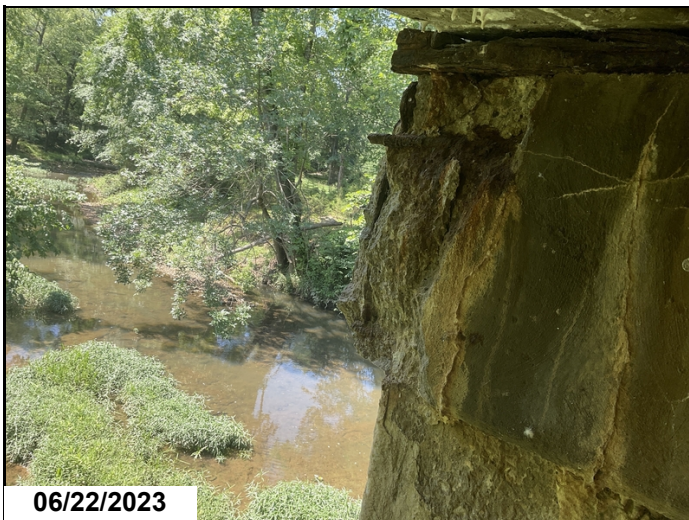
Bent 3 cap Rt ahead face has concrete deterioration with spalling with exposed reinforcing steel that has caused approximately 2" of bearing area loss to girder 5 of span 3. The delaminated areas extend under the bearing device.

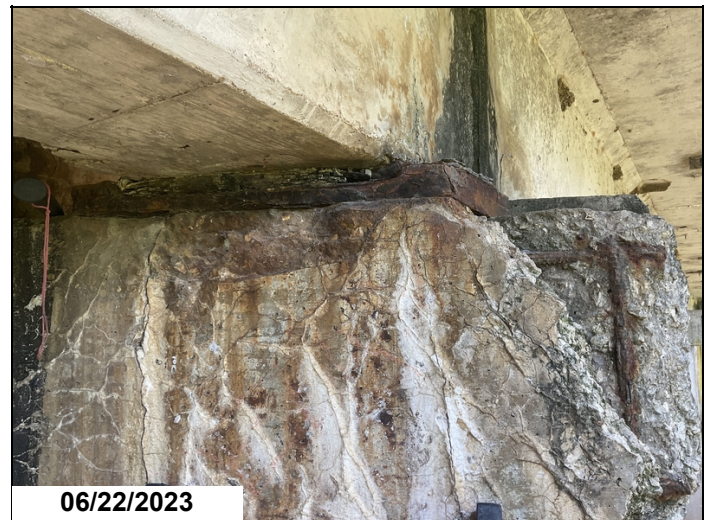
Bent 3 Lt concrete delamination with bearing area loss under girder 1.

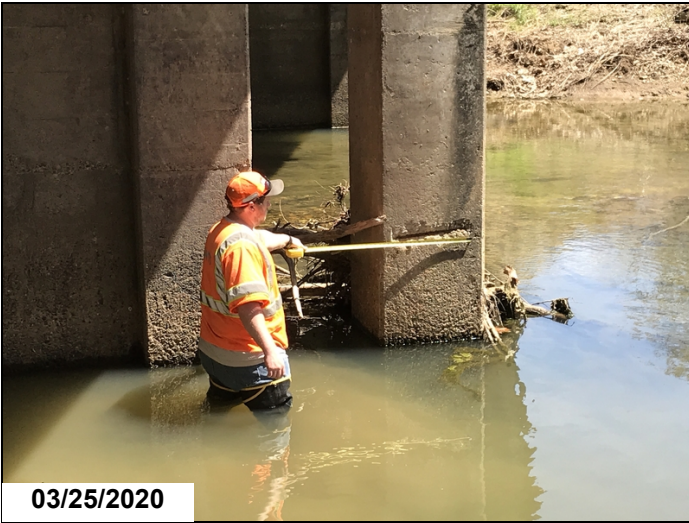
Bent 2, Column 4.

Bent 2, Column 2 has a 10" spall with exposed reinforcing steel located 4' below the cap on the Left side of column. Column 4 has a shallow spall with exposed reinforcing steel above the water elevation. Column 3 has a 3' area of map cracking located approximately 8' below the cap and a 12" X 2" area of concrete section loss with no exposed reinforcing steel at the water elevation. The top of Column 3 has vertical cracks with heavy efflorescence. Column 3 has a softball sized spall with exposed reinforcing steel visible in the Right side of column. Column 4 has 4' tall longitudinal cracks with efflorescence that begin at the cap.

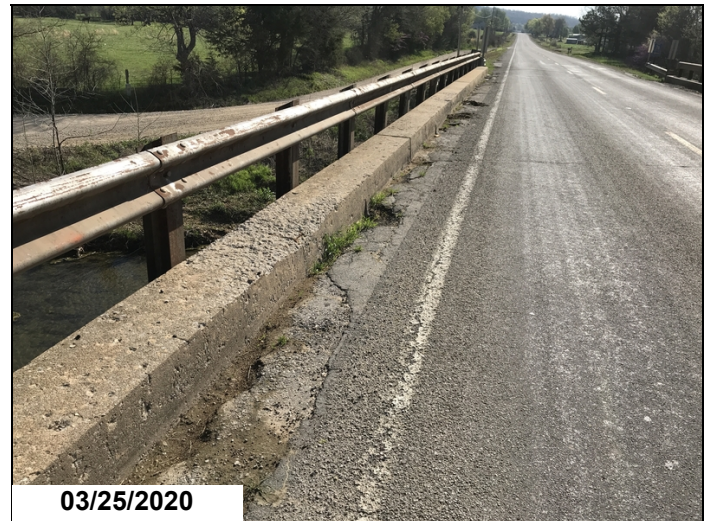
Asphalt driving surface of the deck sounds hollow when sounded along the gutters and over the widened sections of the deck. Concrete is rotten and deteriorated at the deck drains with exposed reinforcing steel typical. Concrete curbs have up to 1/2" section loss with isolated areas with exposed reinforcing steel.

Left curb of Deck. Gutter.
