Asset #M1090(Routine)

US Highway 62 over Ditch - Wash. Co.

Location: 0.93 M E OF OKLAHOMA SL

Team Lead: Eric West, Inspection Date: 05/18/2023

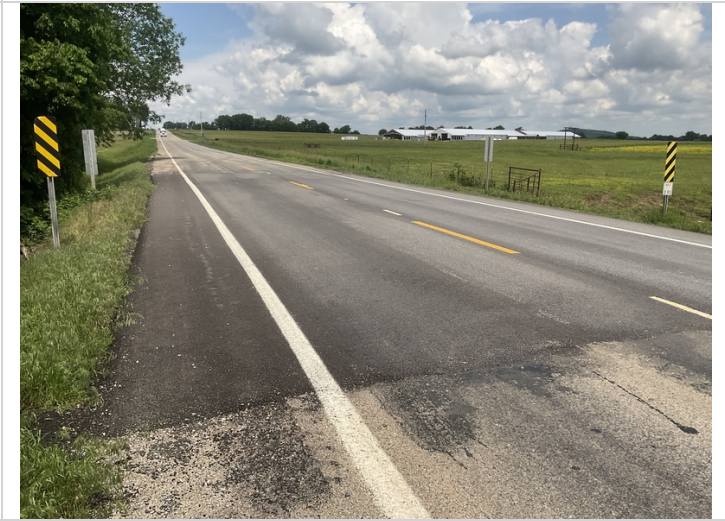
Typical driving surface.

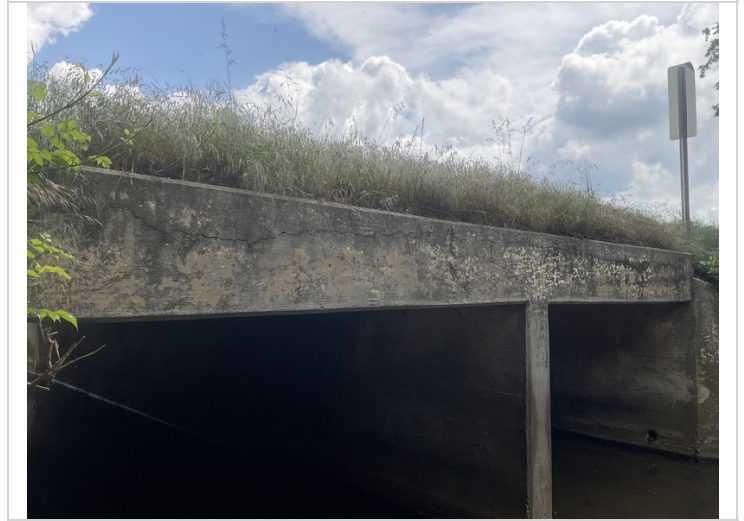
Right head wall horizontal wide cracking.

The headwall on the right side of the structure has wide horizontal cracking.

Type of Work: Repair (General)

Status: Monitor

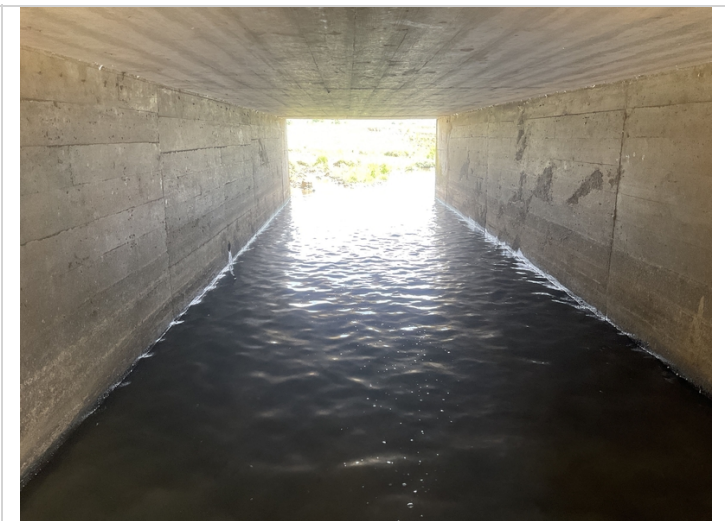
Barrel # 1 typical.

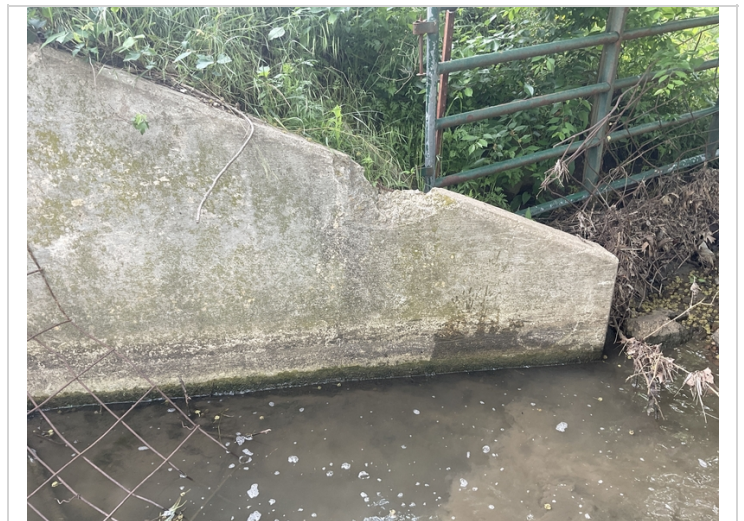
Barrel # 2 Rt wing wall spalling with exposed reinforcing steel.

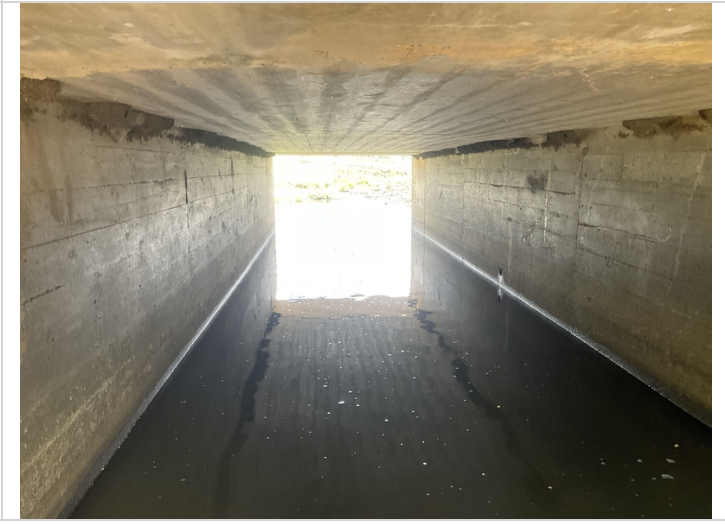
Barrel # 2 typical.

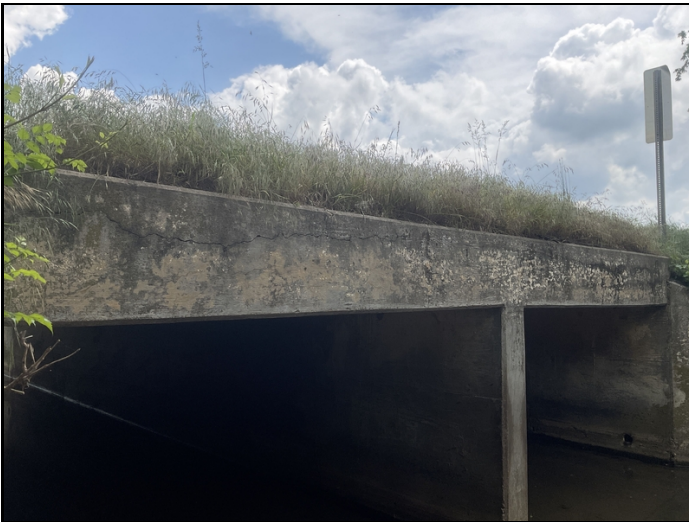
Right head wall with wide horizontal cracking.

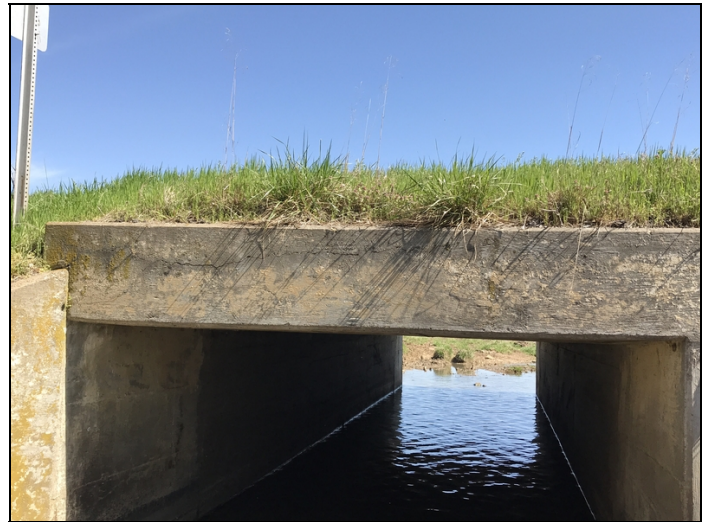
Horizontal cracking. Inlet end of Barrel # 1 headwall.

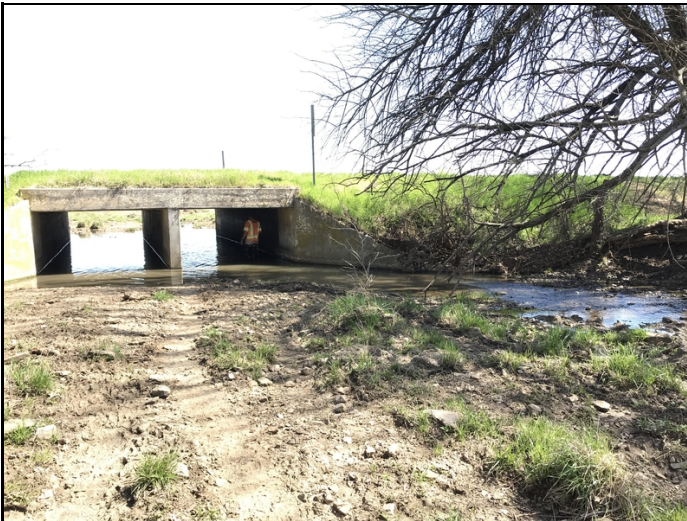
The upstream channel has streambed material accumulation that is directing stream flow into the Southeast wing wall causing minor erosion behind the wing wall.

Channel. Inlet end of structure.

Type of Work: (Inactive) (Inactive) 1 - Clean

Status: Monitor

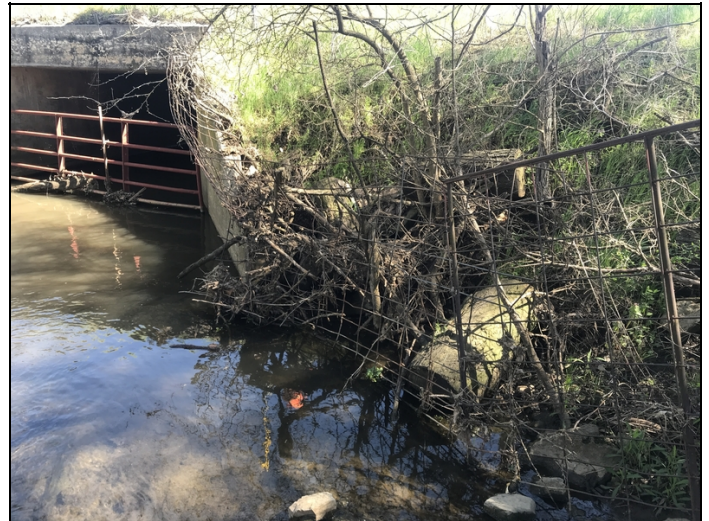
61 - Channel/Channel Protection (6 - Bank is beginning to slump. River control devices and embankment protection have widespread minor damage. There is minor stream bed movement evident. Debris is restricting the channel slightly.)
-The upstream channel has streambed material accumulation that is directing stream flow into the Southeast wing wall causing minor erosion behind the wing wall.

The upstream channel has streambed material accumulation that is directing stream flow into the Southeast wing wall causing minor erosion behind the wing wall.
