Asset #A3959(Routine)

US 64-SEC 2, WB LN over I 540-SEC 2-Crawford Co.

Location: JCT. HWY 64,71 & 540

Team Lead: Bob McEntyre Inspection Date: 09/13/2023

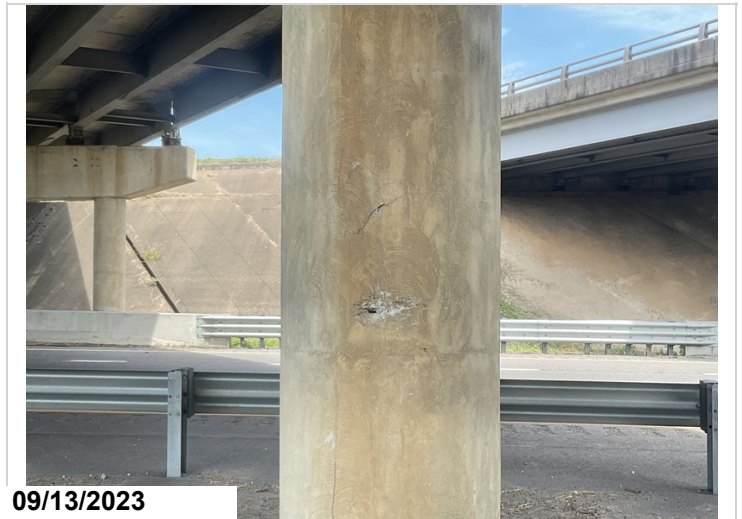
(205) -Bent # 3, column # 2 has random cracking at the base. -Bent # 4, column # 2, backface, has a softball sized spall with exposed reinforcing steel and an 8" delaminated area just above the spall. -Bent # 5, column # 3 has vertical cracking near the base of the column.							
215	Reinforced Concrete Abutment	LF	126	54	70	2	0
1080	Delamination/Spall/Patched Area	LF	1	0	1	0	0
1090	Exposed Rebar	LF	3	0	1	2	0
1120	Efflorescence/Rust Staining	LF	3	0	3	0	0
1130	Cracking (RC and Other)	LF	65	0	65	0	0

Bent # 4, Column # 2 has a softball sized spall with exposed reinforcing steel and an 8" delaminated area just above the spall.

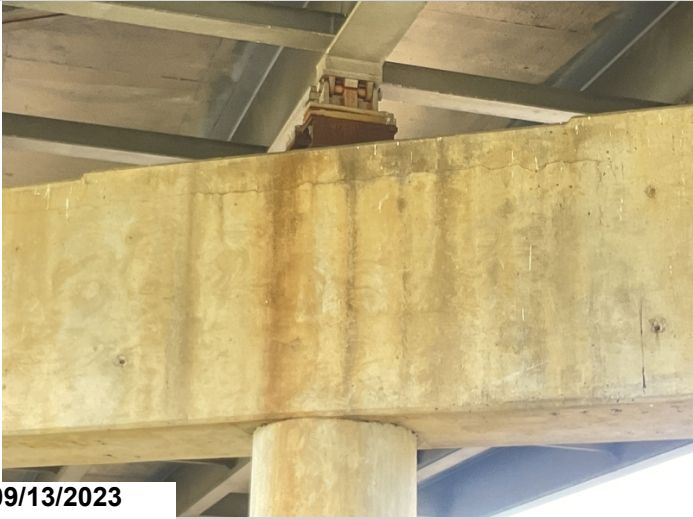
Bent # 4 has a horizontal crack located approximately 6" below the top of the cap.

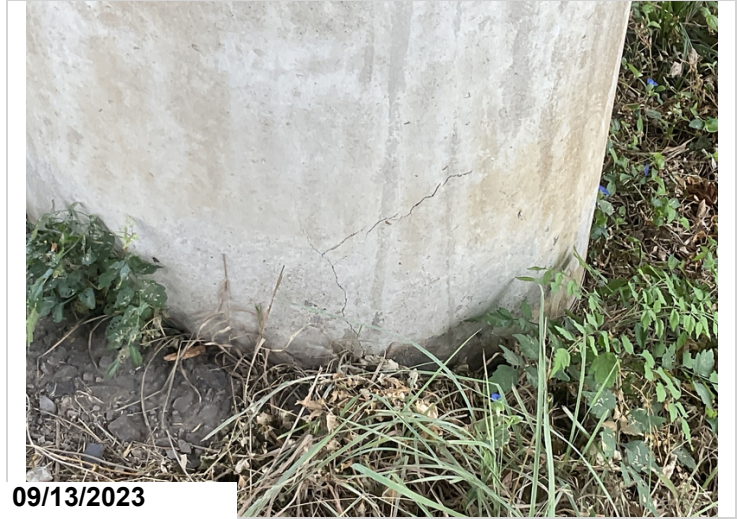
Bent # 3 column # 2 has random cracking at the base.

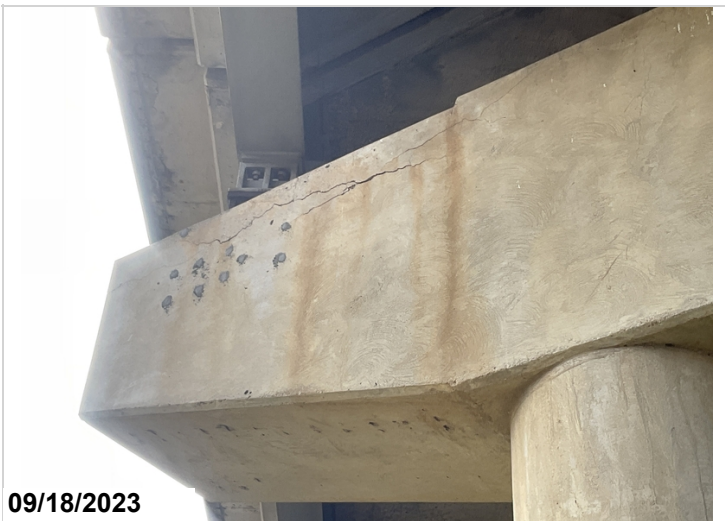
Bent # 3 has horizontal / map cracks located approximately 8" below top of cap in Bays # 1, 4, 5, & 6.

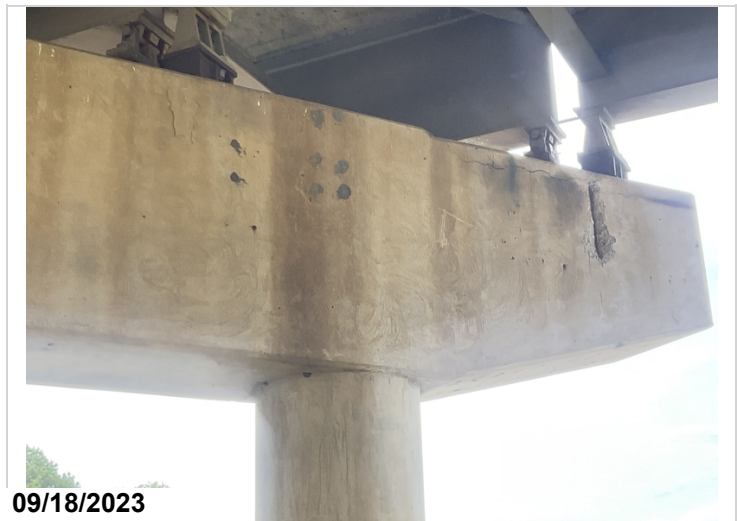
Bent # 3 Span # 3 has an 18" spall with exposed reinforcing steel in the Left side of cap and several smaller vertical delaminated areas in Bay # 2.

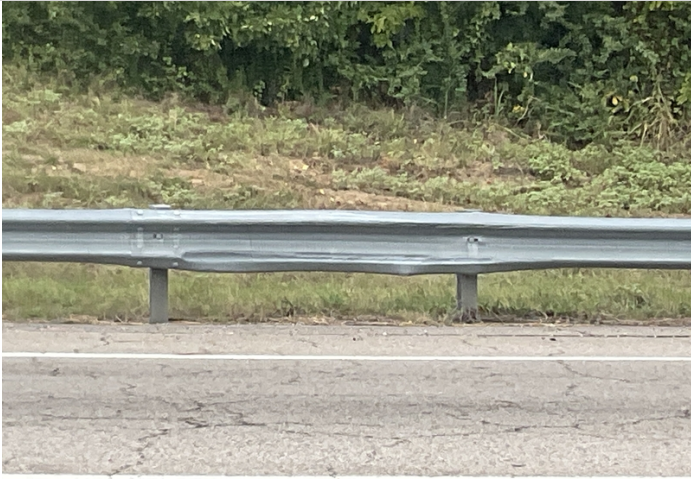
Minor collision damage, left east rail

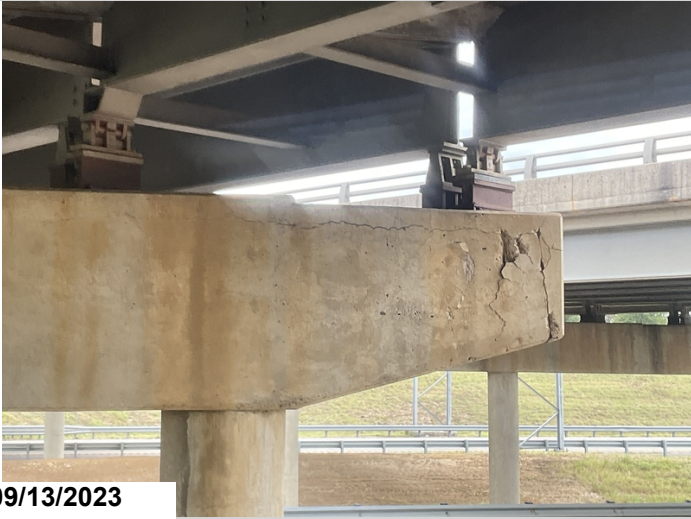
(234) -Bents # 2, 3, & 4 have hairline vertical cracks over and adjacent to columns # 1 & 3 on both left and right sides. -Bent # 2, Right side of cap has a 2' area with delaminated areas, map cracking, and spalls with exposed reinforcing steel with initial section loss. -Bent # 2 has vertical delaminated areas on the West face between columns # 1 & 2. -Bent # 2 has a horizontal crack located approximately 6" below the top of cap in locations on both faces of the cap and a diagonal crack that starts at column # 1 and extends to the exterior cap face. -Bent # 3 cap ahead face on left side has an 18" spall with exposed reinforcing steel and several smaller vertical delaminated areas in bay # 2. -Bent # 3 has horizontal / map cracks located approximately 8" below top of cap in bays # 1, 4, 5, & 6. -Bent # 4 has a horizontal crack located approximately 6" below the top of the cap that runs from the left end to approximately 3' past column # 2 and 2 random vertical delaminated areas. Span # 4 side has two vertical delaminated areas under bay # 5. -Bent # 5 has several 3' long vertical spalls with exposed reinforcing steel with initial section loss in the left side of cap. -Bent # 5, cap backface has horizontal cracking below bays # 5 & 6.

Bent # 2, Right side of cap has a 2' area with delaminated areas, map cracking, and spalls with exposed reinforcing steel with initial section loss.

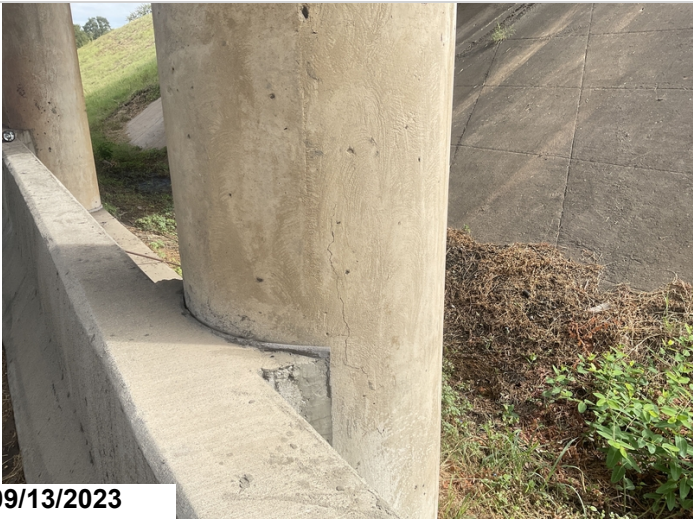
Bent # 5, Column # 3 has vertical cracking near the base of the column

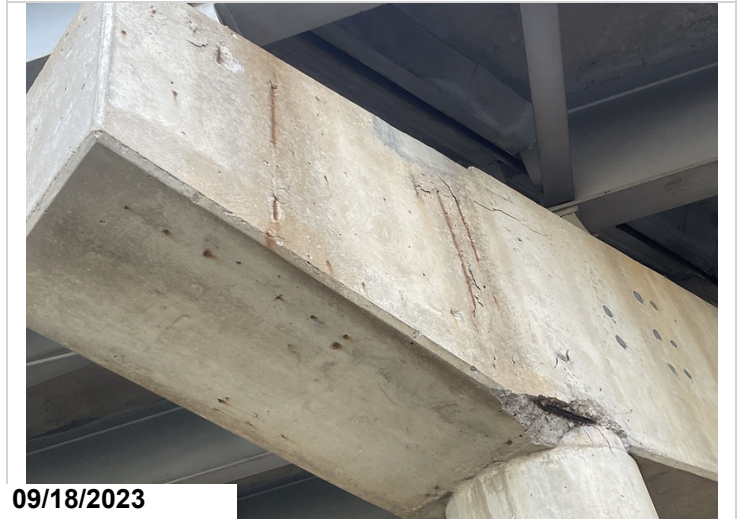
Bent # 5 has several 3' long vertical spalls with exposed reinforcing steel with initial section loss in the Left side of cap.

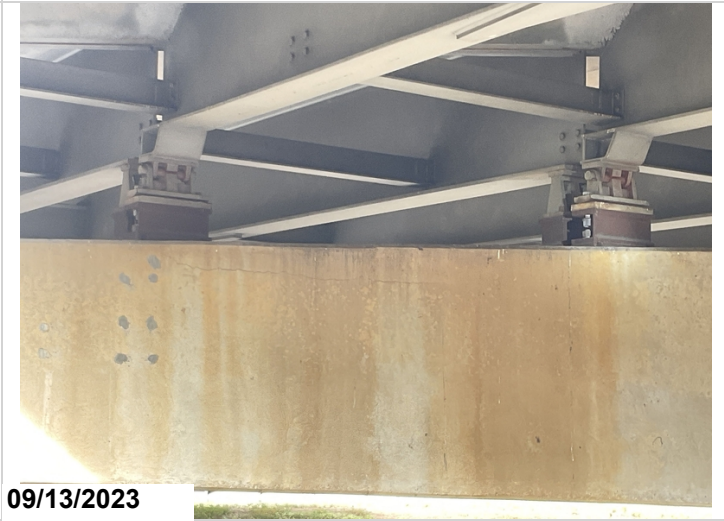
Bent # 5 Span # 4 side of cap has horizontal cracking below Bays # 5 & 6

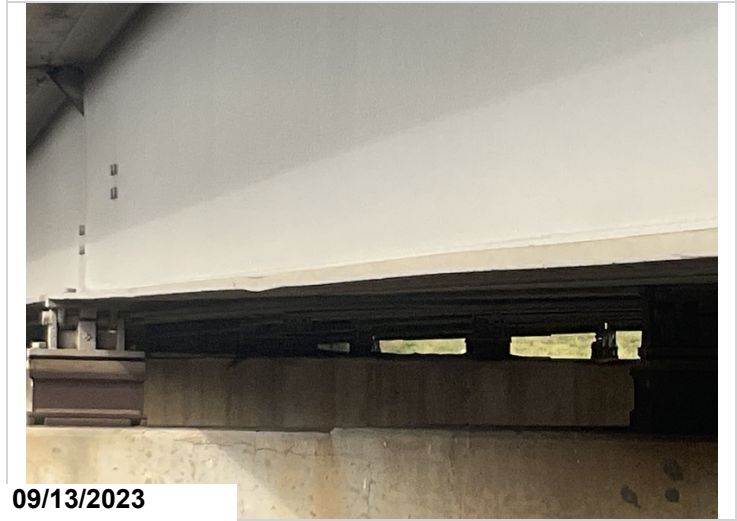
Span 5 beam 7 exterior edge imperfection

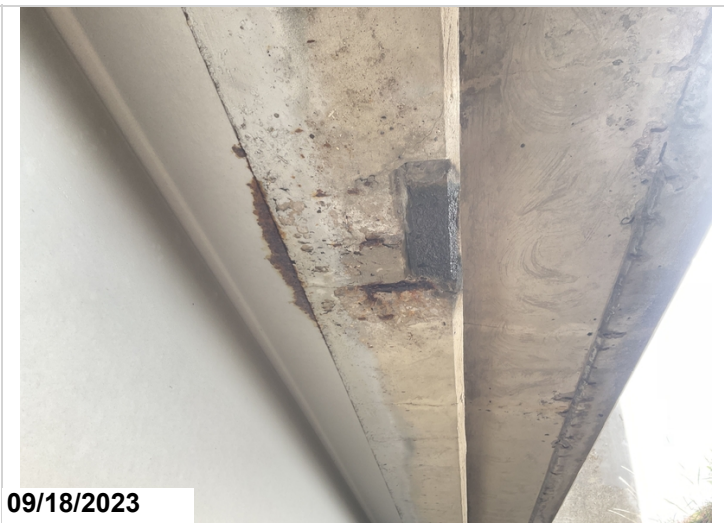
Spalling with exposed reinforcing steel around deck drain.

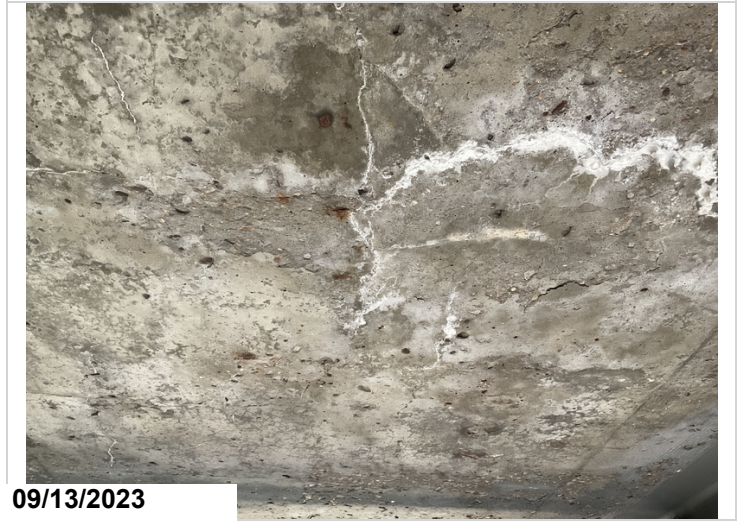
Span 5, bay 1, undersurface scaling and cracking with efflorescence.

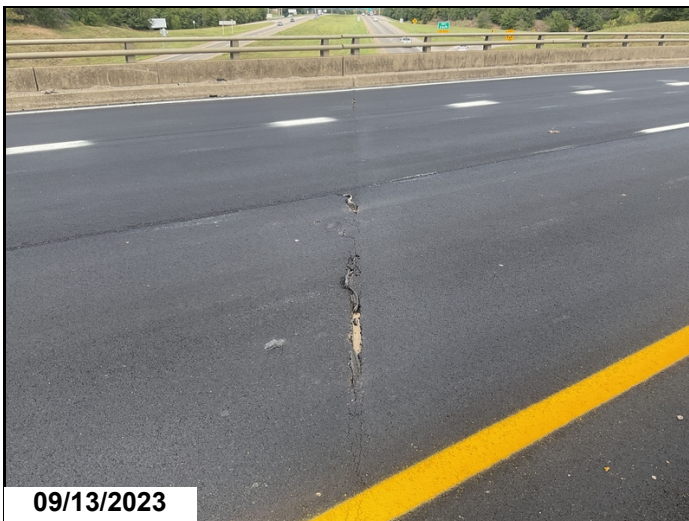
09/13/2023 - RSM - Deficiencies in driving surface of deck still exists but are not visible due to ACHM overlay constructed by State Maintenance Forces since last inspection.

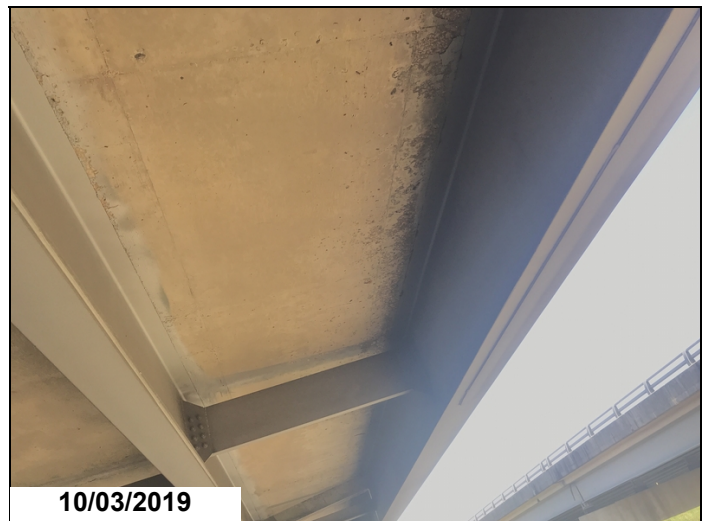
Span # 1, bay # 6 scaling.

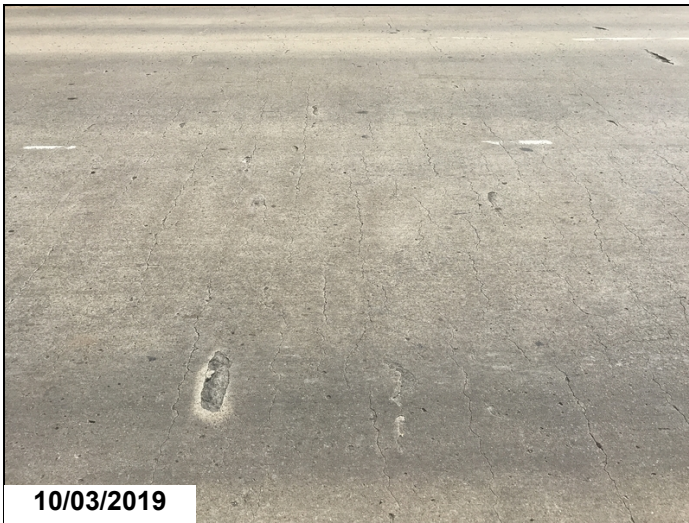
Span # 3 cracking.

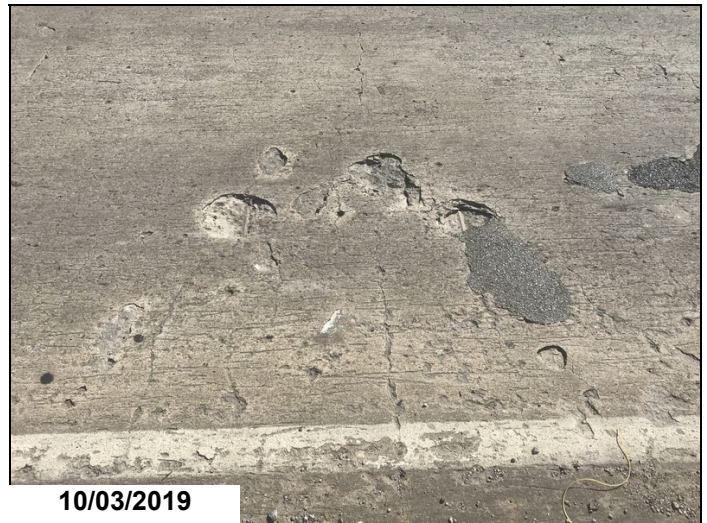
Span # 4 spalling with exposed reinforcing steel.

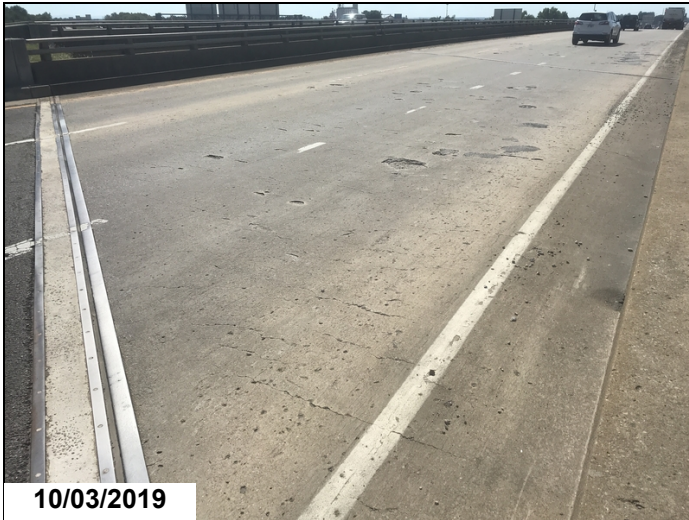
The driving surface of the deck has sealable cracking, large delaminated areas and numerous spalls with exposed reinforcing steel. The temporary asphalt patches have failed in several locations.

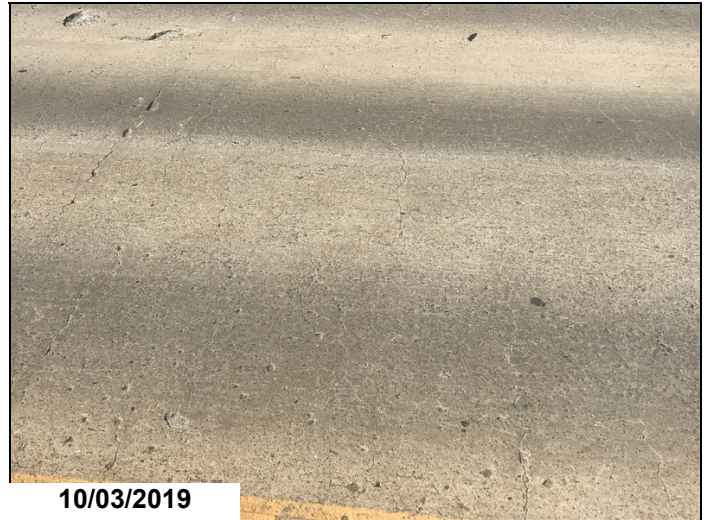
Span # 5 transverse cracking.

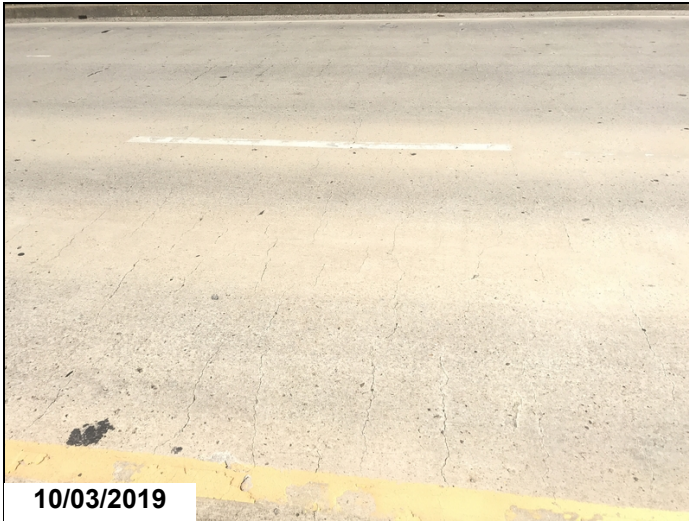
Span # 3 transverse cracking.

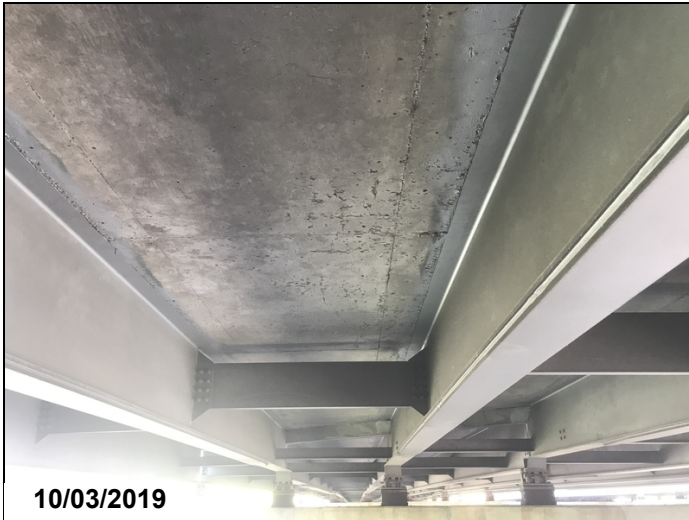
Span # 1 Bay # 2 map cracking and concrete scale on the undersurface of the deck.

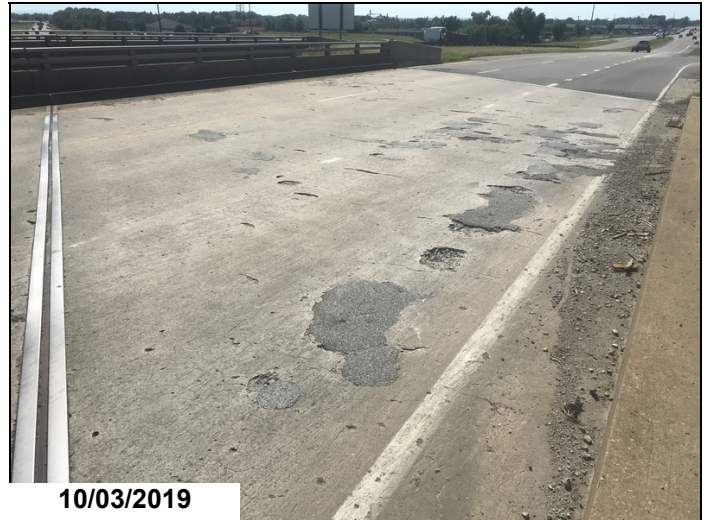
The driving surface of the deck has sealable cracking, large delaminated areas and numerous spalls with exposed reinforcing steel. The temporary asphalt patches have failed in several locations. Span # 1 pictured.

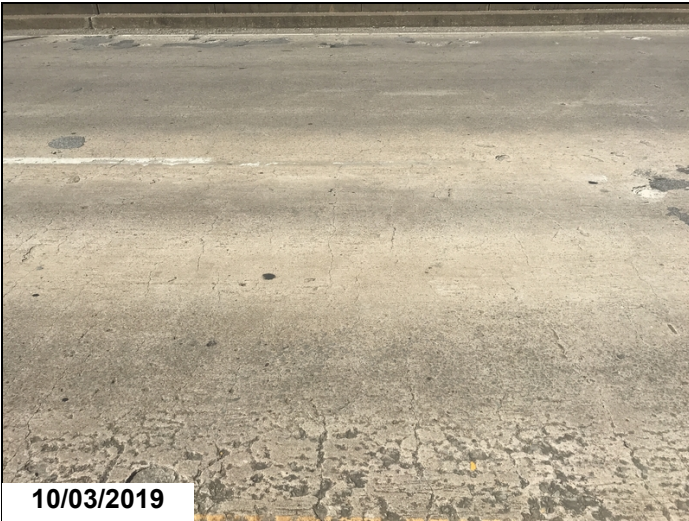
Span # 4 transverse cracking.

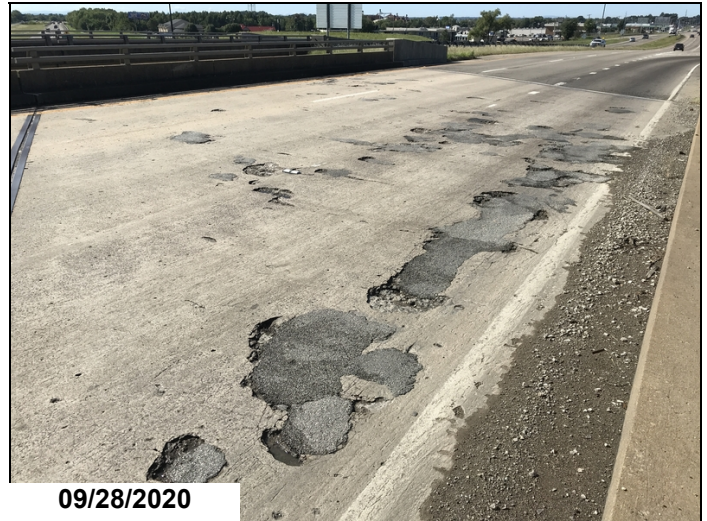
The driving surface of the deck has sealable cracking, large delaminated areas and numerous spalls with exposed reinforcing steel. The temporary asphalt patches have failed in several locations. Span # 5 pictured.

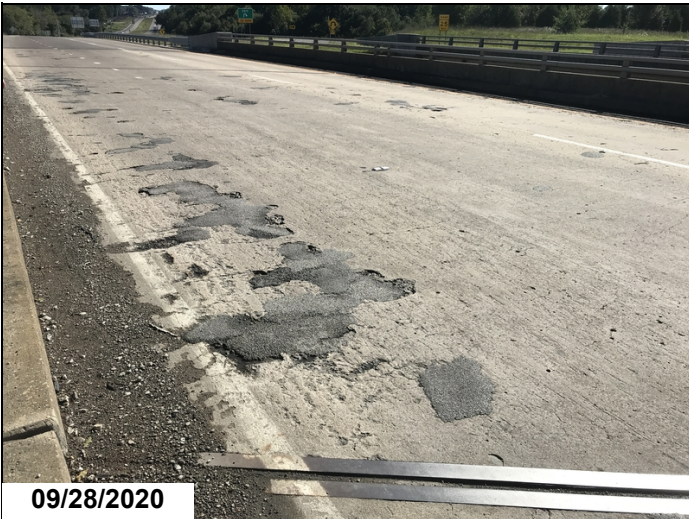
The driving surface of the deck has sealable cracking, large delaminated areas and numerous spalls with exposed reinforcing steel. The temporary asphalt patches have failed in several locations. Span # 2 pictured.

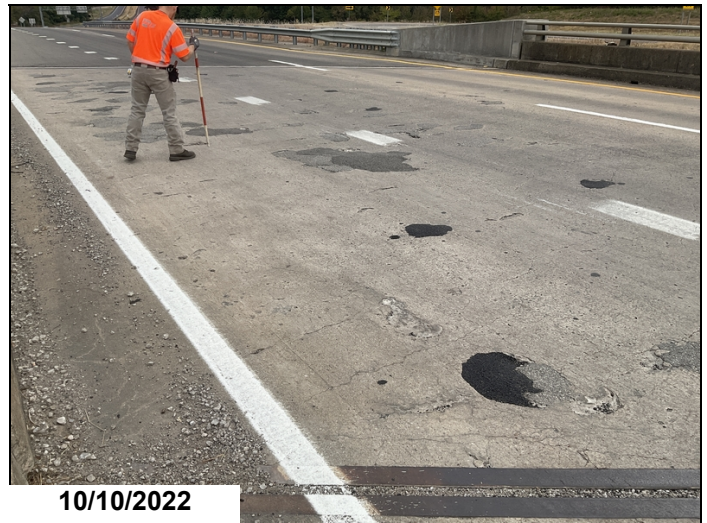
The driving surface of the deck has sealable cracking, large delaminated areas and numerous spalls with exposed reinforcing steel. The temporary asphalt patches have failed in several locations. Span # 5 pictured.

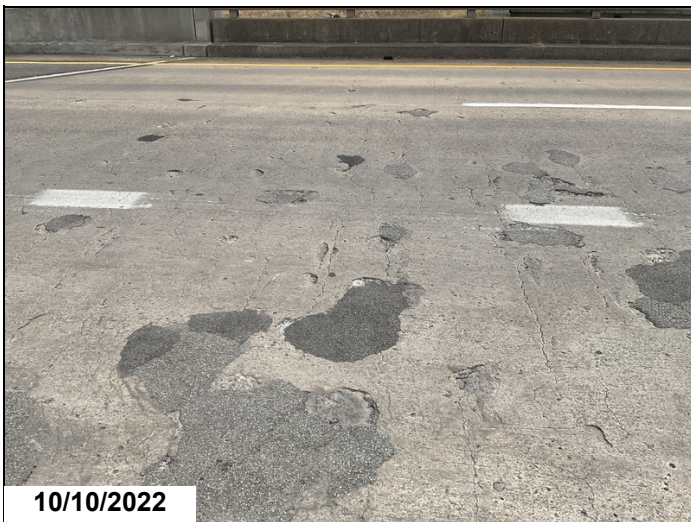
The driving surface of the deck has sealable cracking, large delaminated areas and numerous spalls with exposed reinforcing steel. The temporary asphalt patches have failed in several locations. Span # 5 pictured.

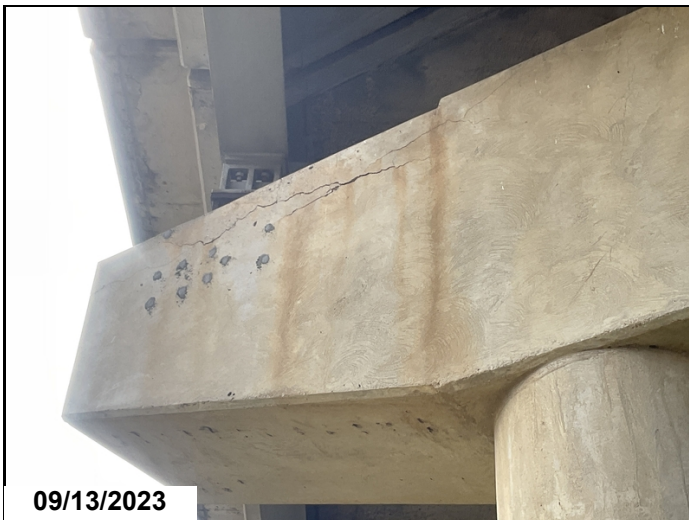
Bent # 3 has horizontal / map cracks located approximately 8" below top of cap in Bays # 1, 4, 5, & 6.

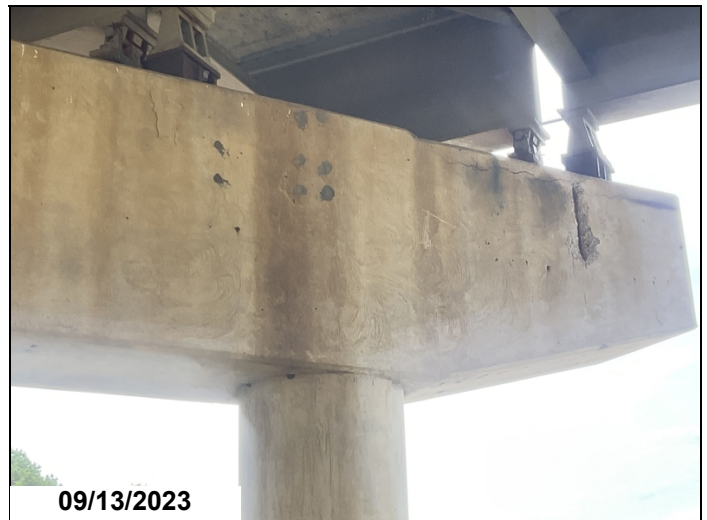
Bent # 3 Span # 3 has an 18" spall with exposed reinforcing steel in the Left side of cap and several smaller vertical delaminated areas in bay # 2.

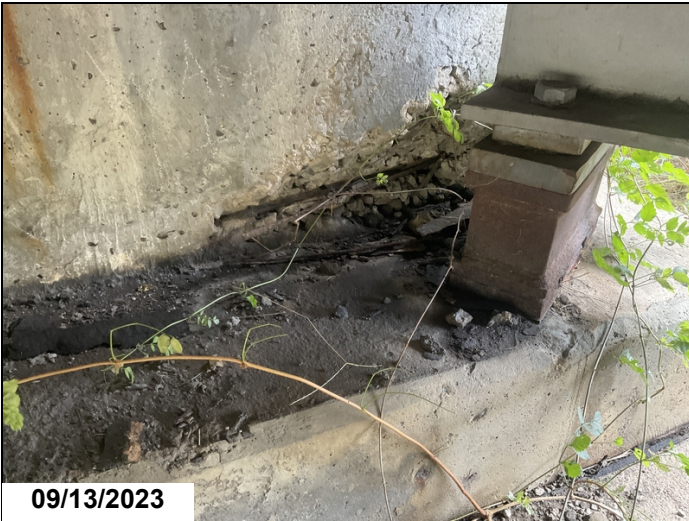
Abutment # 1 has a 2' spall with exposed reinforcing steel with approximately 1/8" section loss to the reinforcing steel located in the left end of the abutment.

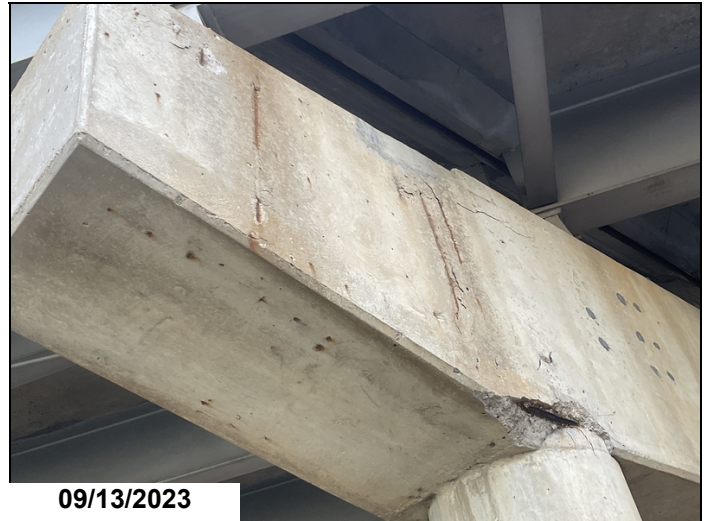
Bent # 5 has several 3' long vertical spalls with exposed reinforcing steel with initial section loss in the Left side of cap.

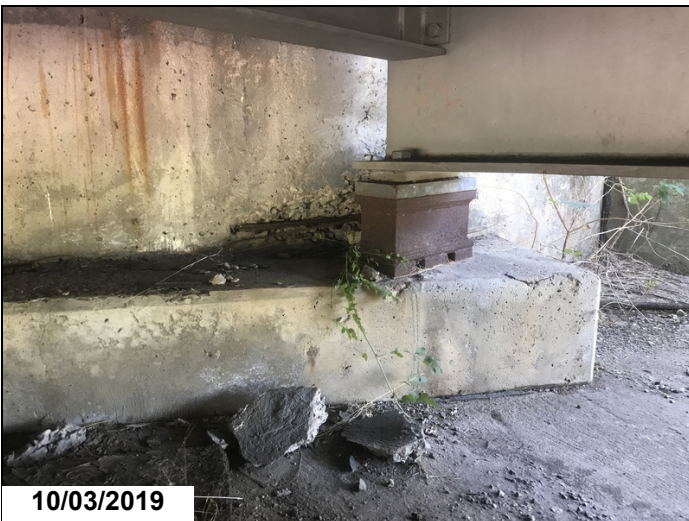
Abutment # 1 backwall on left side has spalling with exposed reinforcing steel with active corrosion.

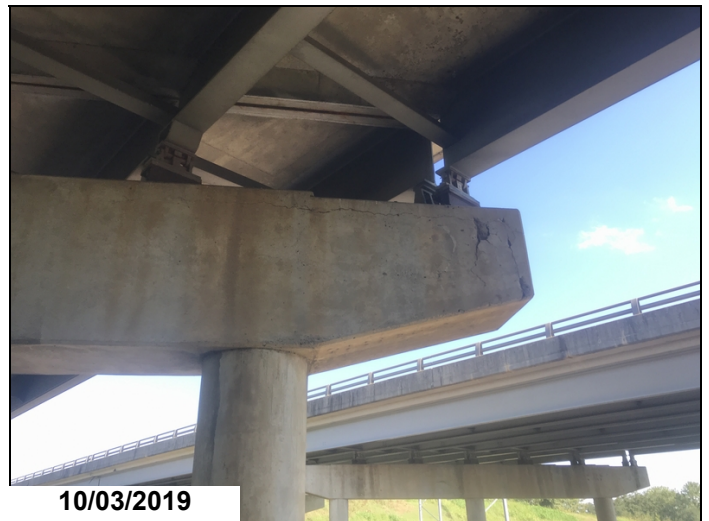
Bent # 2 backface of cap on right side has spalling and cracking from past leakage through the deck joints.

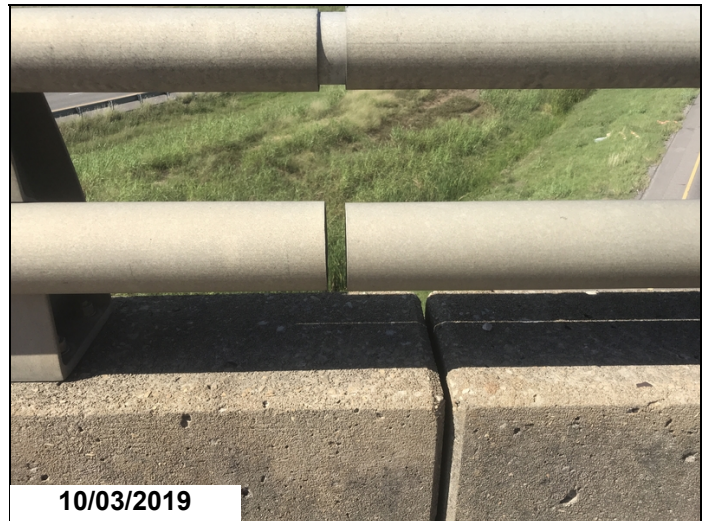
Bridge railings have several loose tube connections that have vibrated out of position.

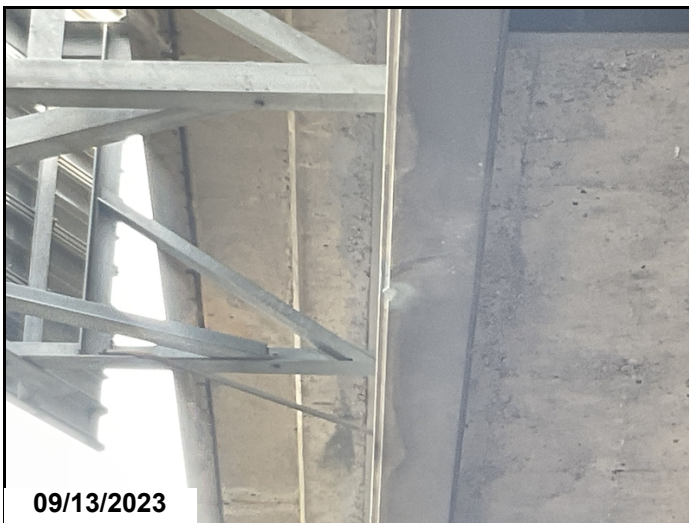
09/13/2023 - RSM - Maintenance forces have painted the area of collision damage to beam # 1 bottom flange cover plate in span # 2 since last inspection.

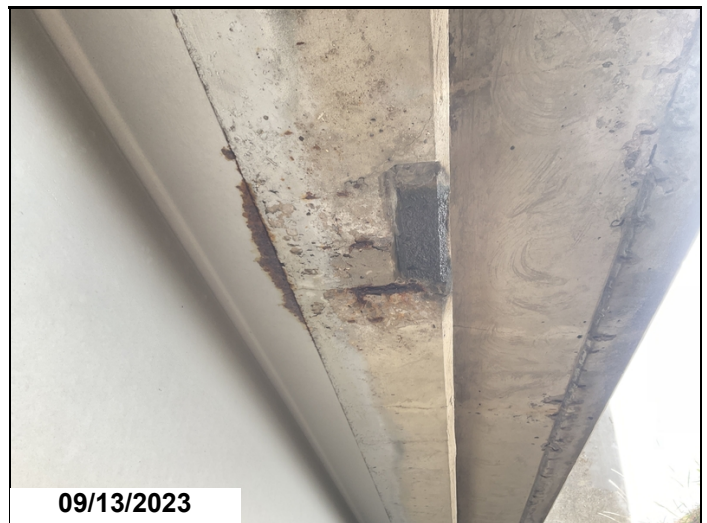
Corrosion to top flange of beam # 1.

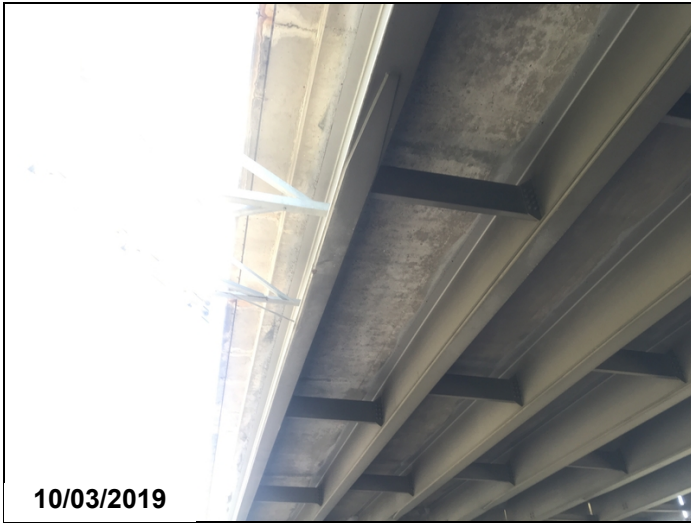
Span # 2 Beam # 1 old traffic impact scar.

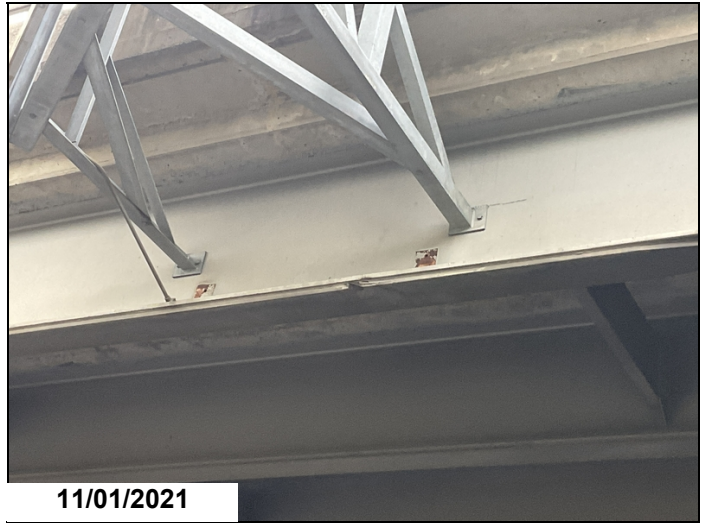
Span # 2, beam # 1 has a 2" X 2" x 1/2" notch in the bottom cover plate due to traffic impact locate above the Rt lane.

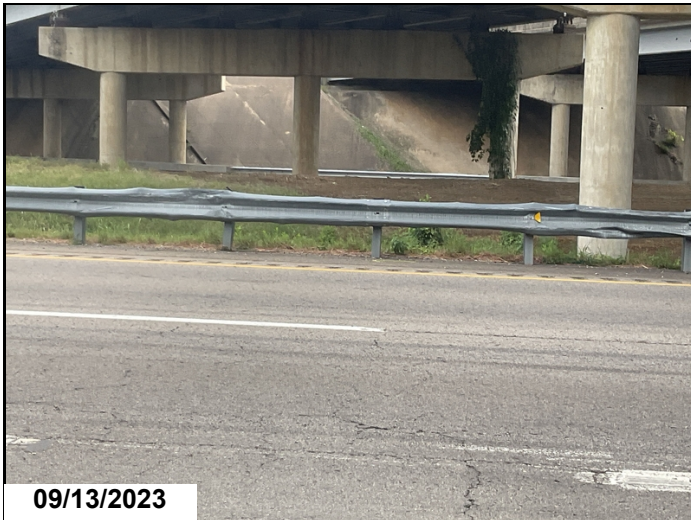
The inside guard railing for I-540 Southbound lanes has collision damage.
