Bridge 05464 Inspection Report

Route:16 Section:02 Log:3.929

INSPECTIONS *			
(90) Inspection Date			07/16/2024
(91) Frequency			24
(92) Critical Feature Inspection	Done	Freq. (Mon)	Date
A: Fracture Critical Detail	No		
B: Underwater Inspection	No		
C: Other Special Inspection	No		
* The inspection date and frequency information in this box contains the current NBI date and frequency information. Please refer to the report header for the date this inspection was conducted.

Team Lead: Jeff Jones, Inspection Date: 07/16/2024

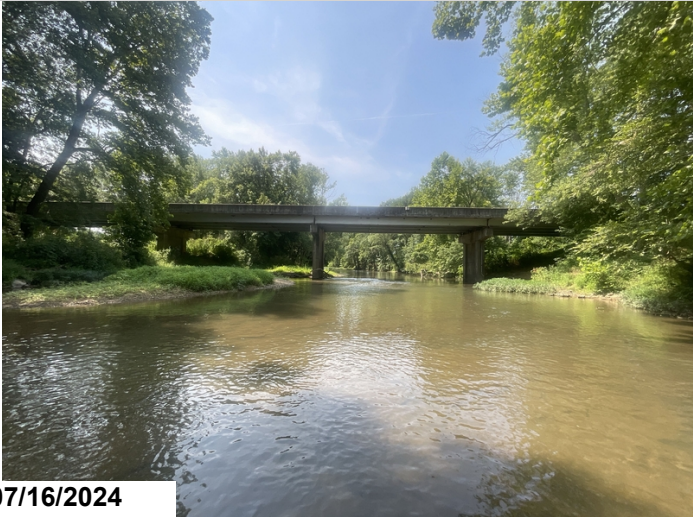
Elevation. Left side of structure.

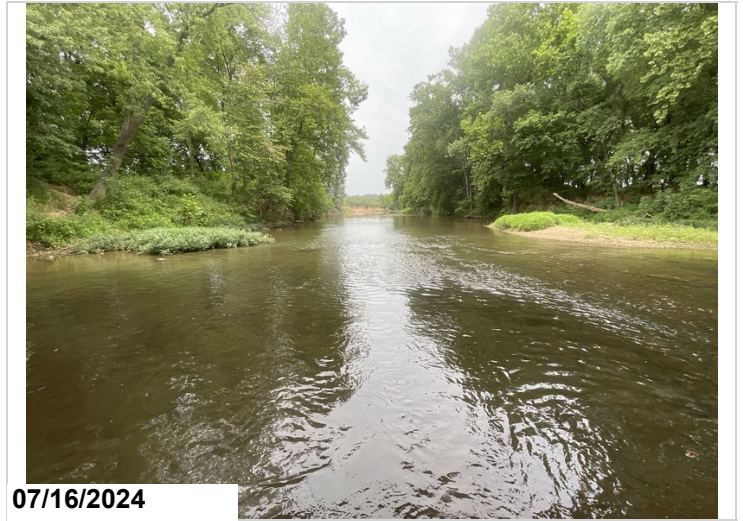
Channel. Left side of structure.

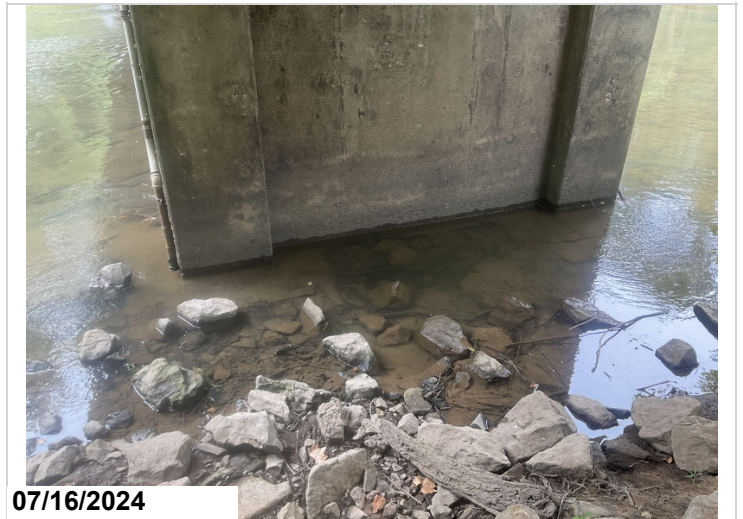
Wading and probing along with visual observations during low and clear water conditions indicate that the top of Bent 2 & 3 footings are exposed. Top of footings appear to be well keyed into the solid rock channel. Top of footings appear to be reasonably close to the same elevation as the adjacent channel floor with no apparent scour problems during this inspection.

Top of Bent 2 footing exposed.

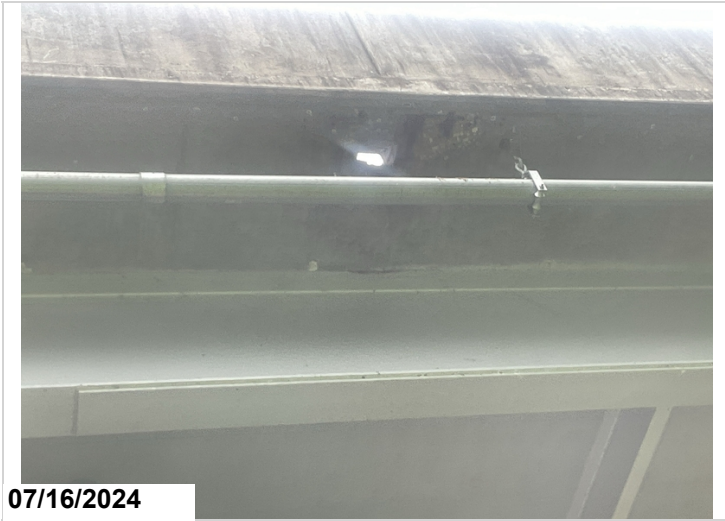
The deck is over all in good condition with isolated areas with concrete deterioration around the deck drains that is visible from the undersurface of the deck.

Span 3, Right side, Deck undersurface has Spalls with exposed reinforcing steel adjacent to the deck drains.

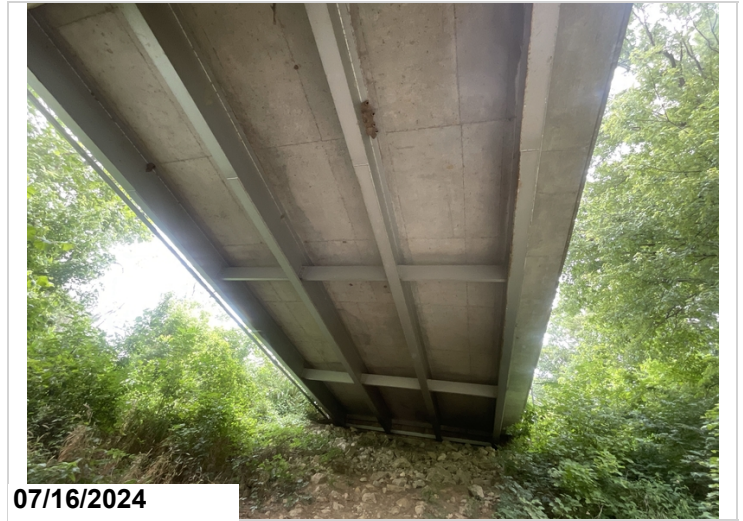
Deck undersurface. Span 1. Typical.

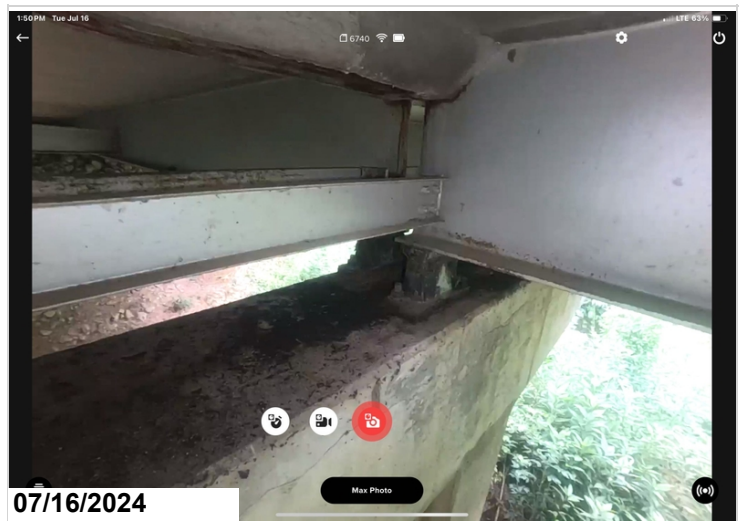
Bent 5 cap, Right side, Girder 3.

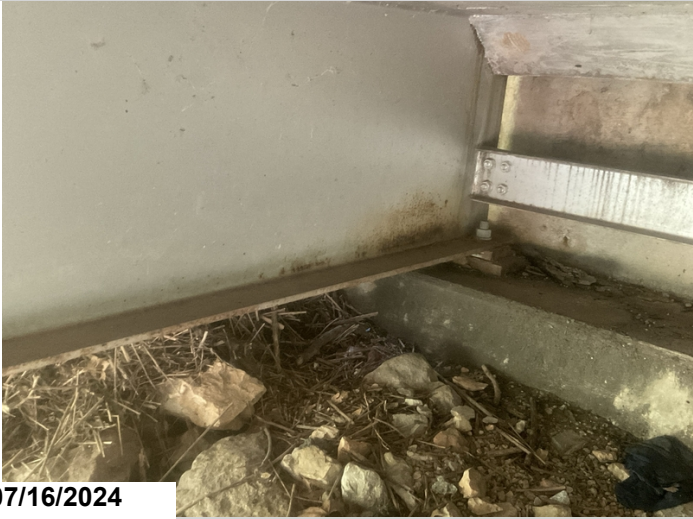
Abutment 1, Girder 4 has areas of corrosion showing through the paint system.

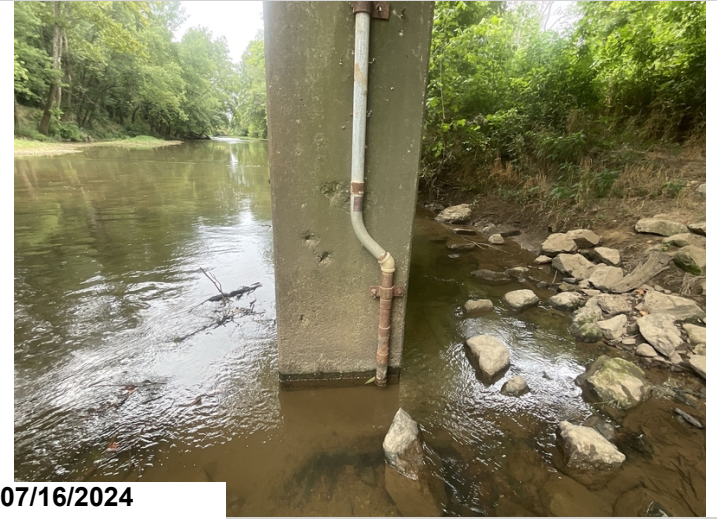
Bent 2, Column 1 has minor shallow spalls adjacent to the water quality testing brackets.

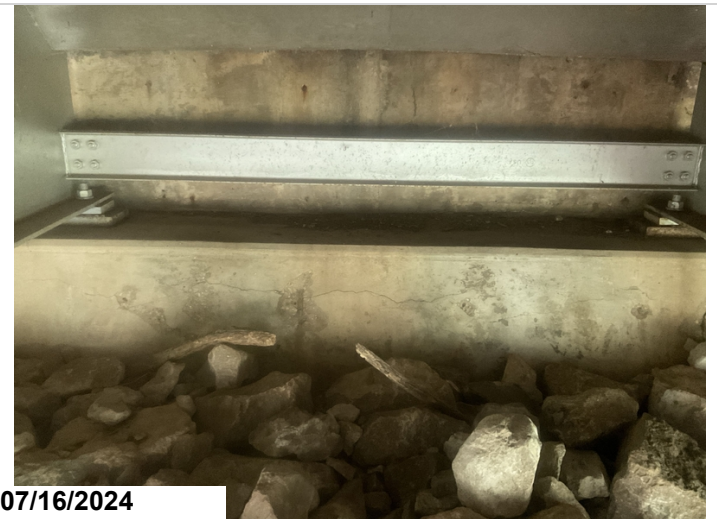
Abutment 2 cap, Horizontal crack approximately 1/16" wide.

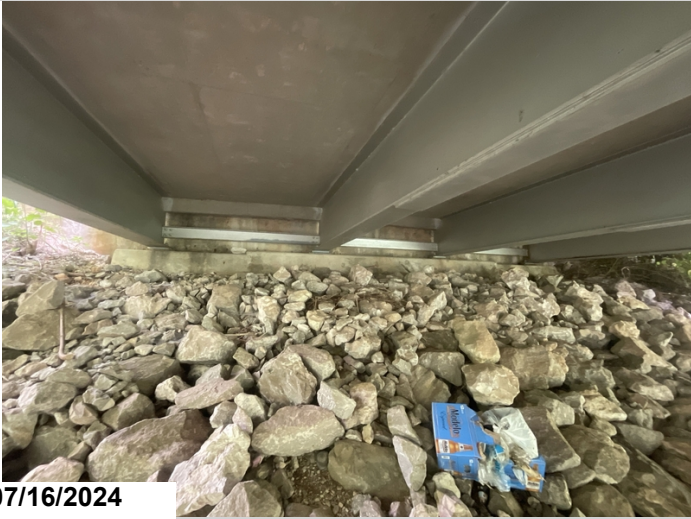
Abutment 2. Typical.

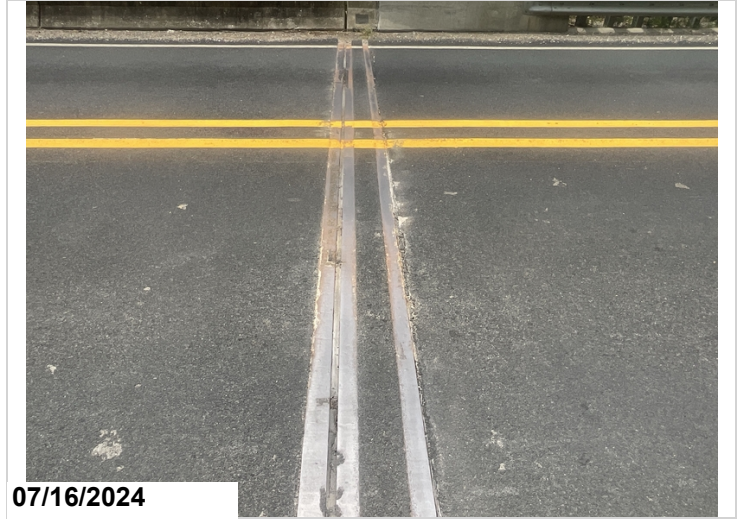
Top of Abutment 1 backwall. Polymer wearing surface.

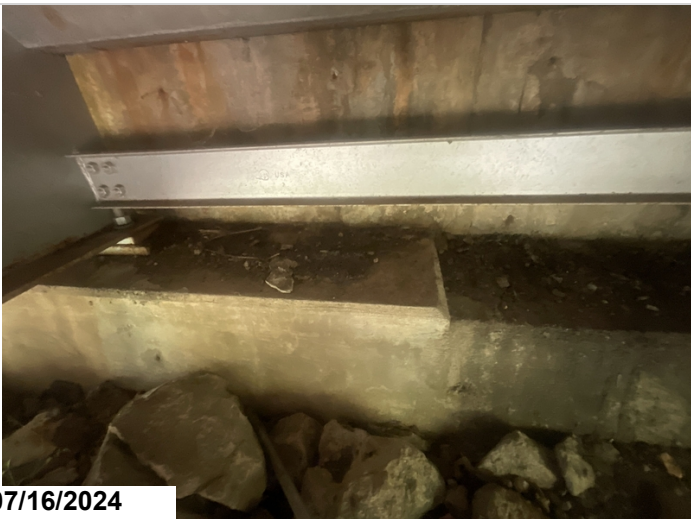
Abutment 1. Debris on cap.

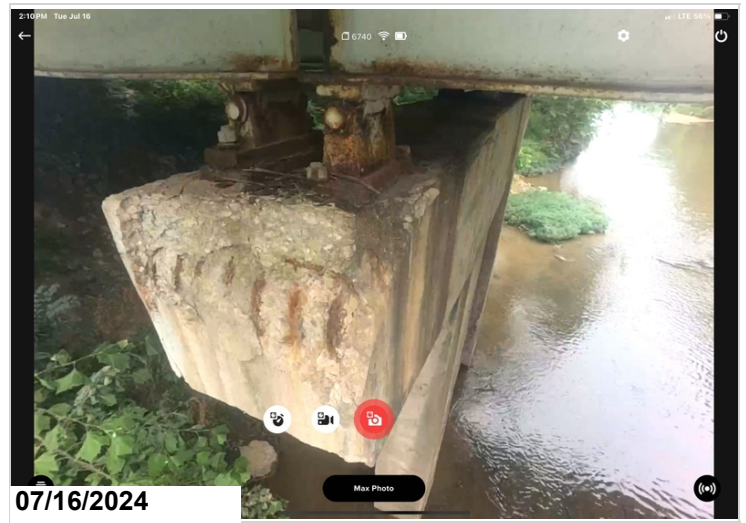
Bent 2 cap Right end.

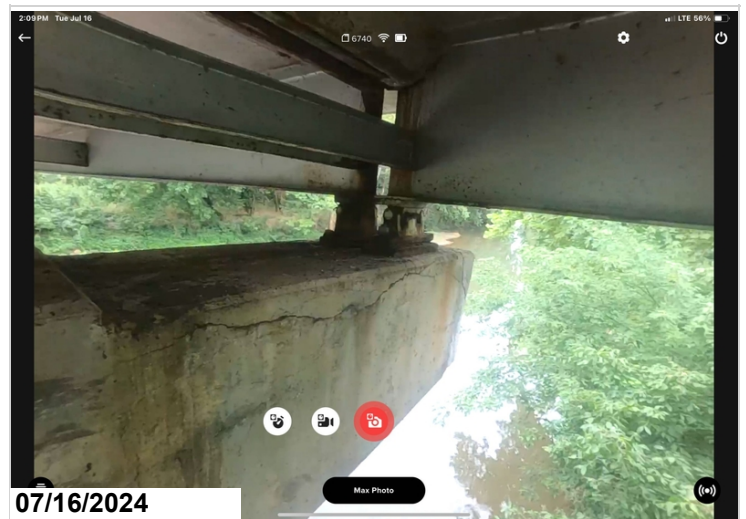
Bent 2 cap, back face, Right side.

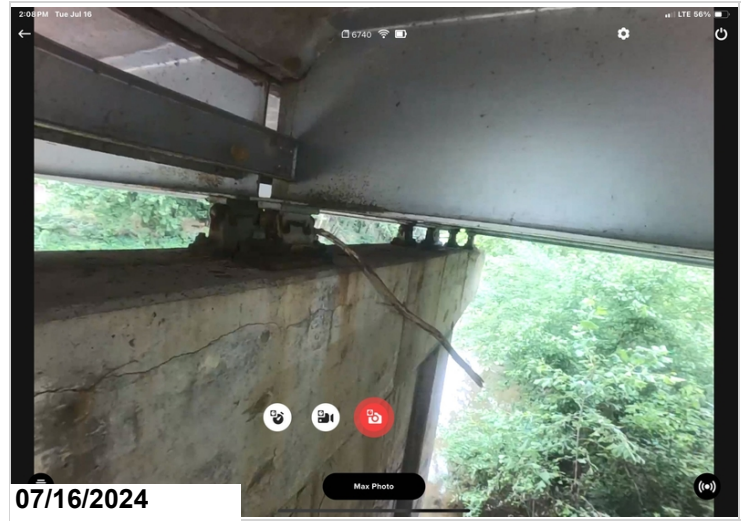
(234) The intermediate bent caps have bat guano accumulation that contributes to the accelerated deterioration of the concrete. The intermediate bent caps have 1/8" wide horizontal cracking located approximately 4 to 6 inches below the top of the cap indicating active corrosion in the primary longitudinal reinforcing steel. 64LF CS3 Cracking Efflorescence - Bt3=3LF CS2, Bt4=7LF CS2, Bt5=2LF CS2 Bent 2, Right end of cap has map cracking and shallow spalls and one 24 inch spall visible from the undersurface of the cap with exposed reinforcing steel. Top of the cap appears to be delaminated above the horizontal crack. 2LF CS3 Exposed Reinforcing Steel Bent 3 cap has several delaminated areas and multiple shallow spalls with exposed reinforcing steel. 6LF CS3 Exposed Reinforcing Steel, 7LF CS2 Delamination/Spall Bent 4, Previous inspector documented sounding with a hammer indicates the top of the cap is delaminated above the horizontal cracking. Right end of the cap has cracking that extends to the anchor bolts. 2LF CS3 Exposed Reinforcing Steel, 2LF CS2 Delamination/Spall

Bent 2 cap, Back Face, Open horizontal cracks indicating corrosion in the primary longitudinal reinforcing steel.

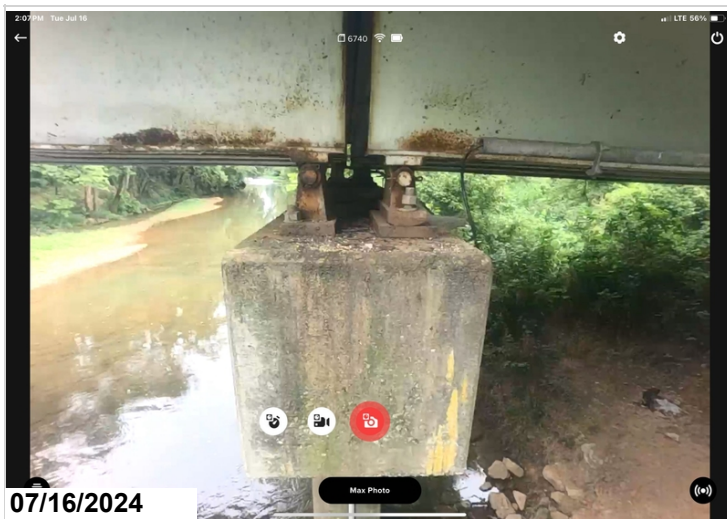
Bent 2 cap, Left end, Wire for monitoring water gauge.

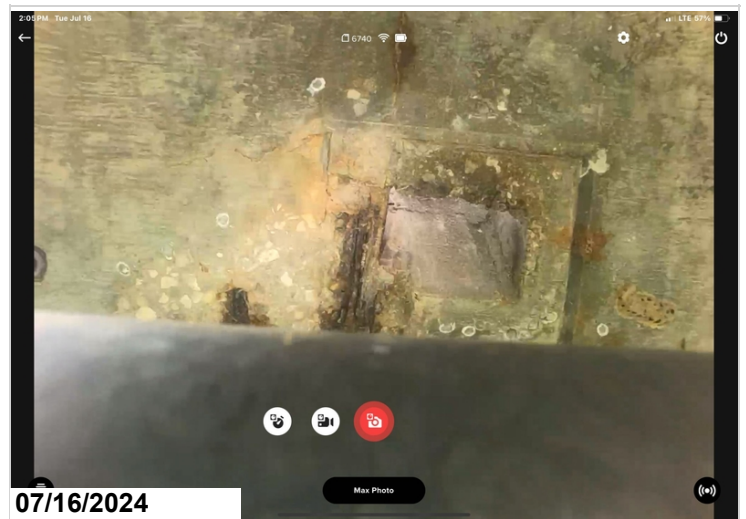
Span 3, Undersurface of the deck, Right overhang has spalling with exposed reinforcing steel adjacent to the deck drains.

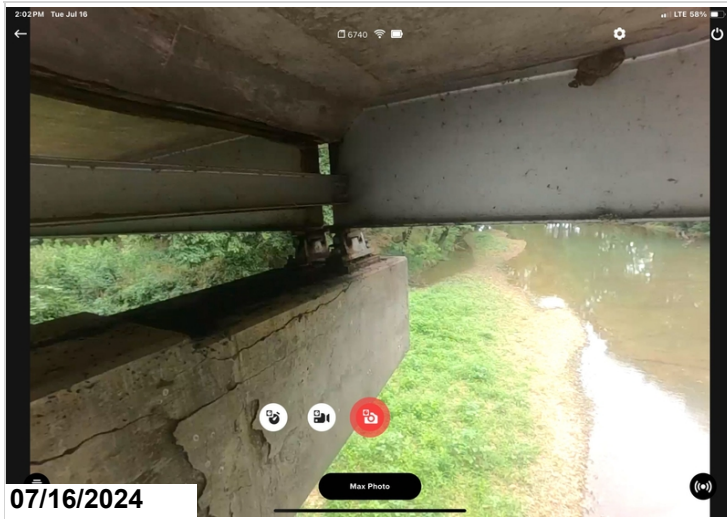
Bent 3 cap, Right end, Bearings for Girder 4.

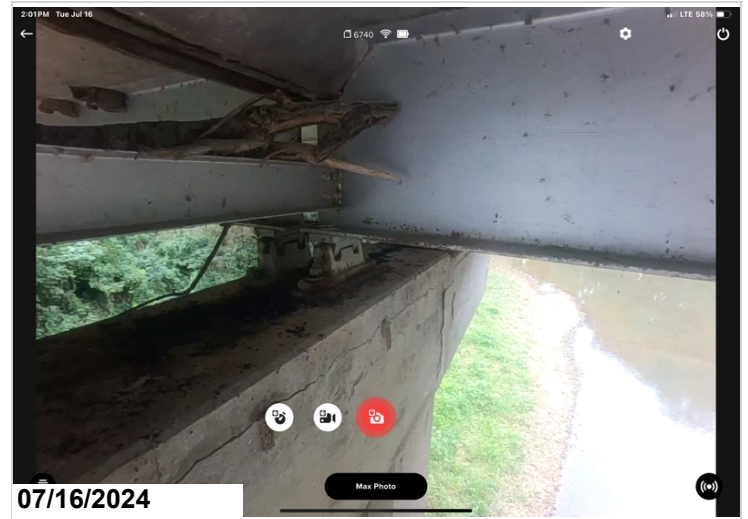
Bent 3 cap, Bearings for Girder 3, Open horizontal cracks indicating corrosion in the primary longitudinal reinforcing steel.

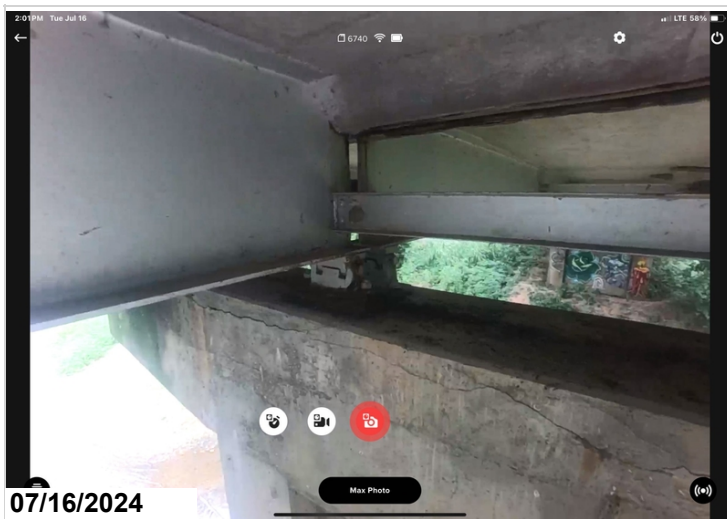
Bent 3 cap, Looking Left Open horizontal cracks indicating corrosion in the primary longitudinal reinforcing steel.

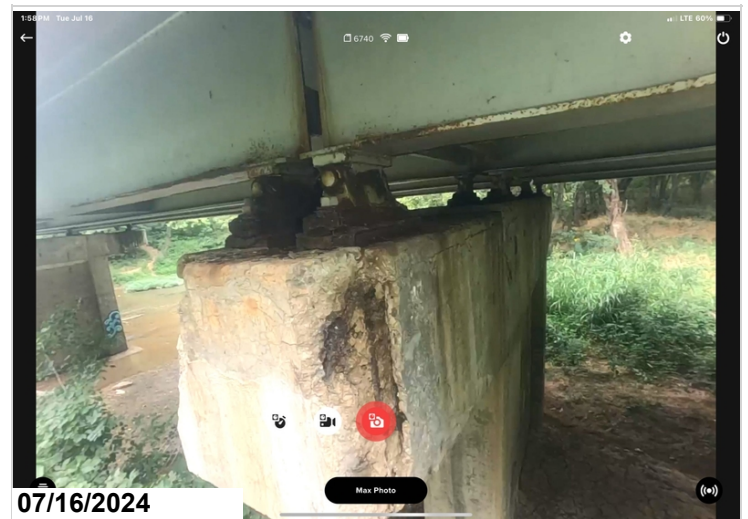
Bent 4 Right end of cap, concrete deterioration with exposed reinforcing steel.

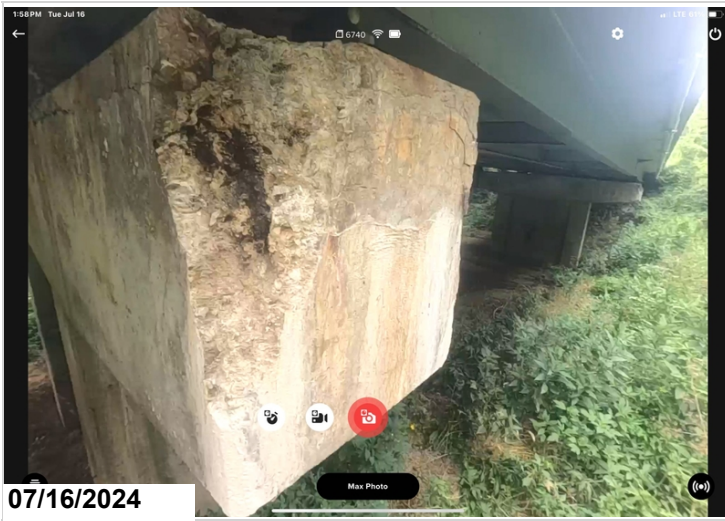
Bent 4 Right end of cap.

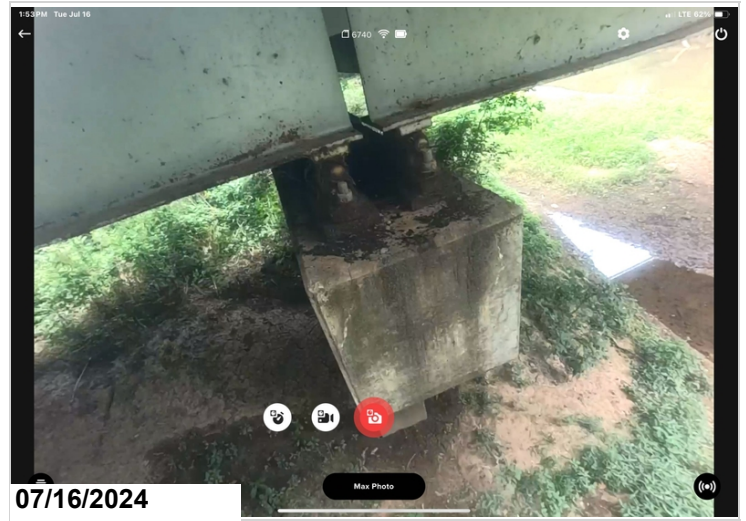
Bent 4 cap Left.

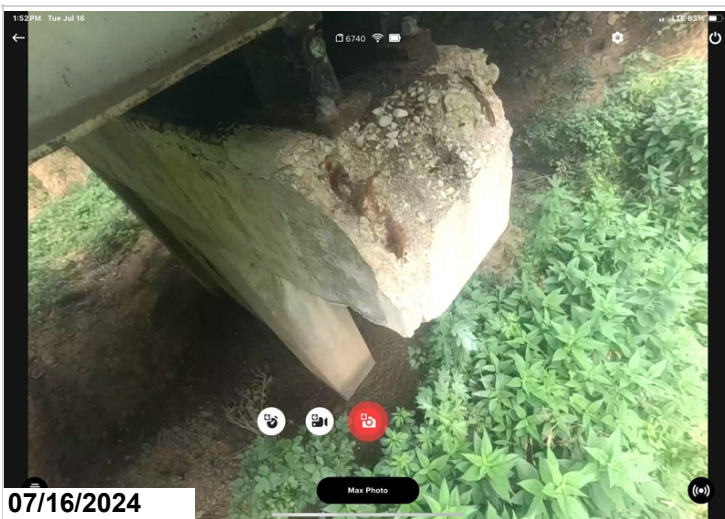
Bent 5 cap, Right side, Concrete deterioration.

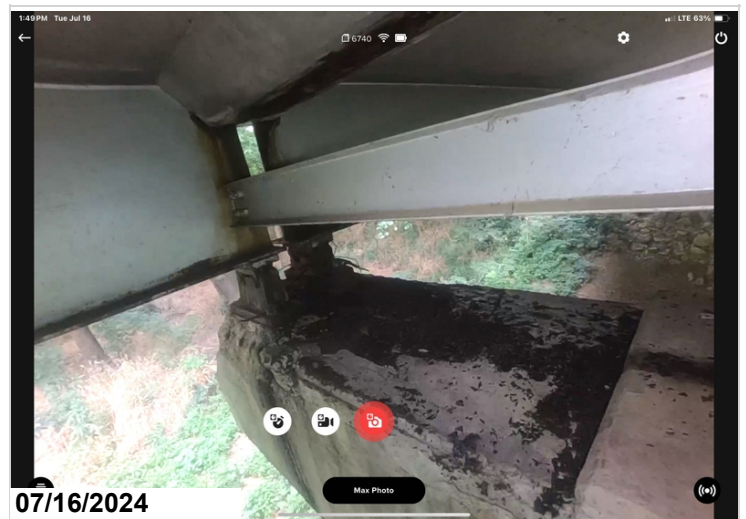
Bent 5 cap, Left side, Concrete deterioration, Bat droppings.

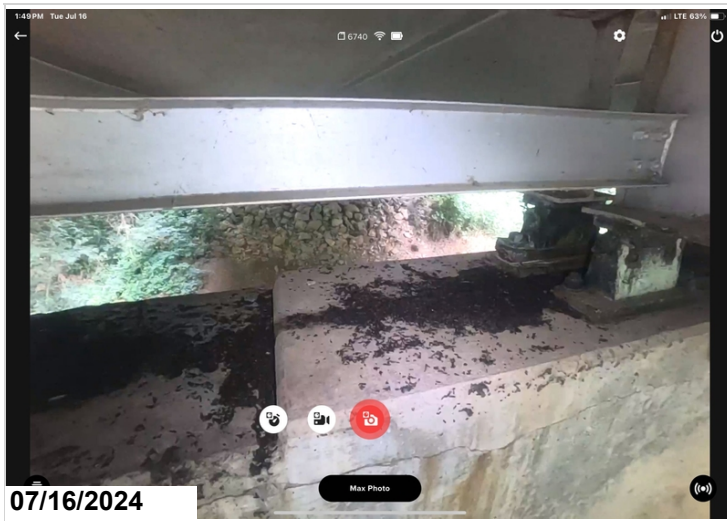
Bent 5 cap, Left side, Bat droppings.

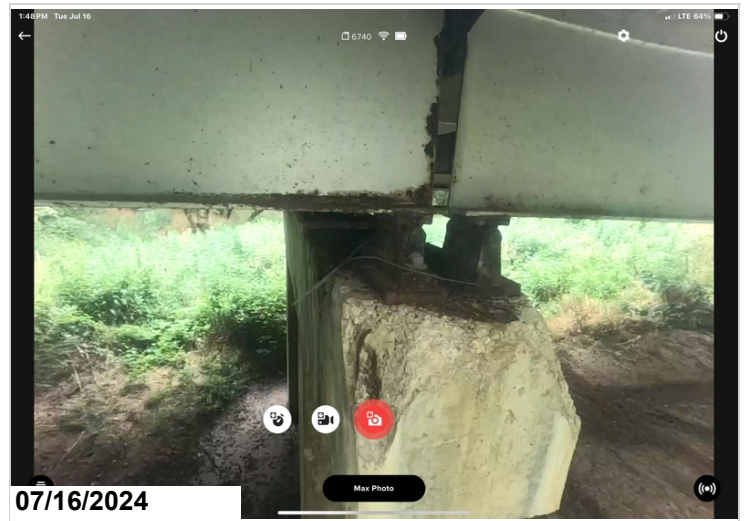
Bent 5 cap, Left side, Concrete deterioration.

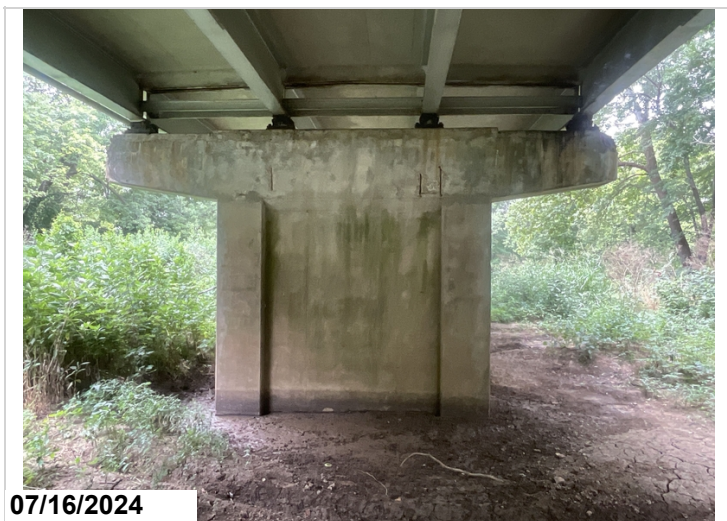
Bent 5 ahead face. Typical.

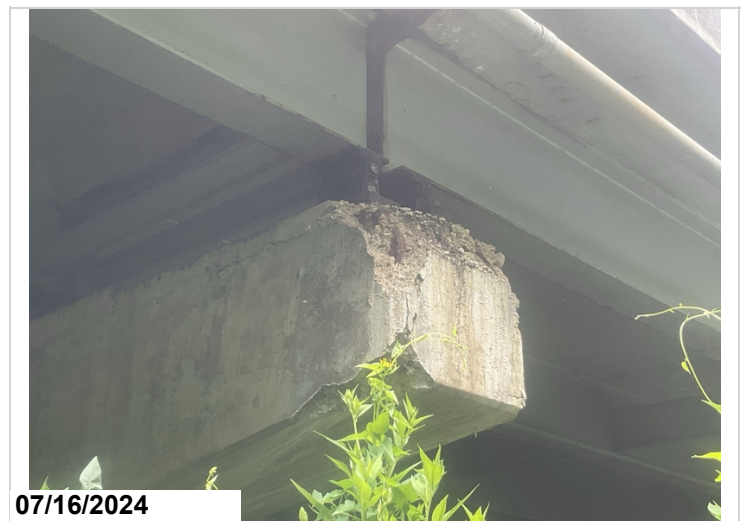
Bent 5. Right end of cap. Soft deteriorated concrete with exposed reinforcing steel.

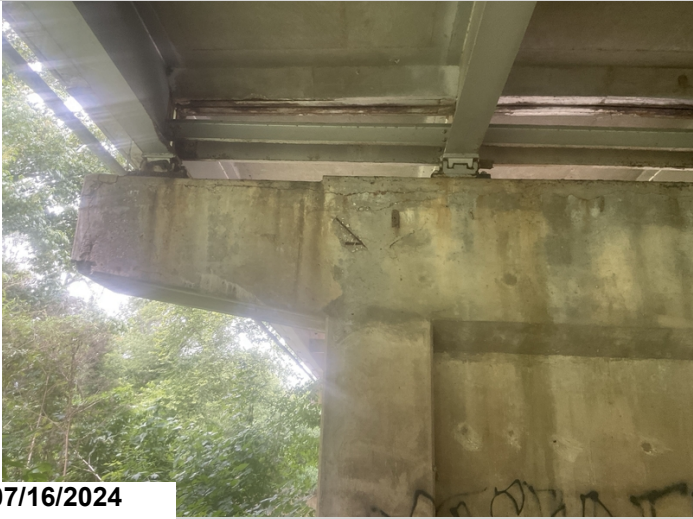
Bent 4 cap, Ahead face, Right side.

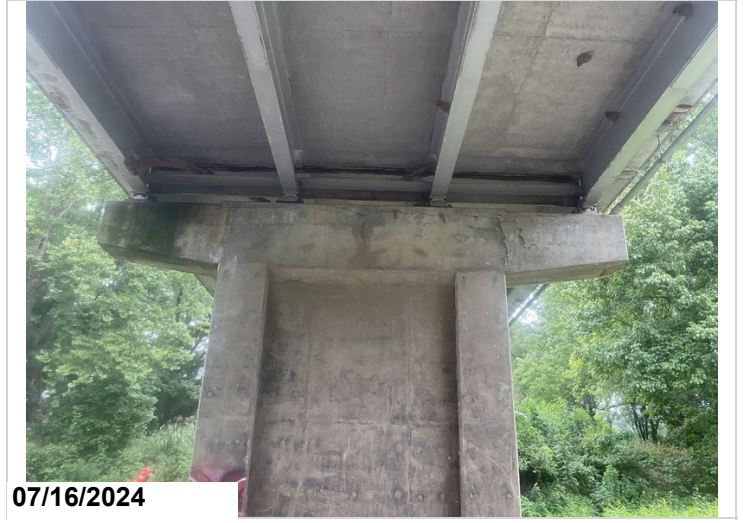
Bent 3. Back face.

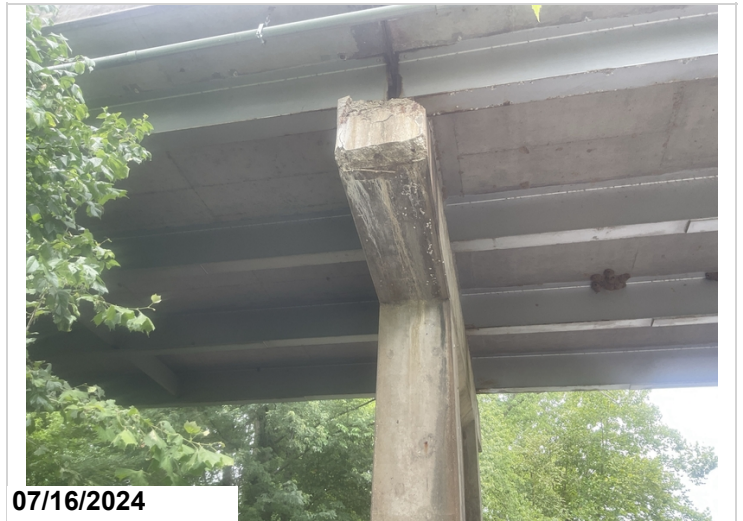
Right end of Bent 2 cap. Concrete deterioration with exposed reinforcing steel.

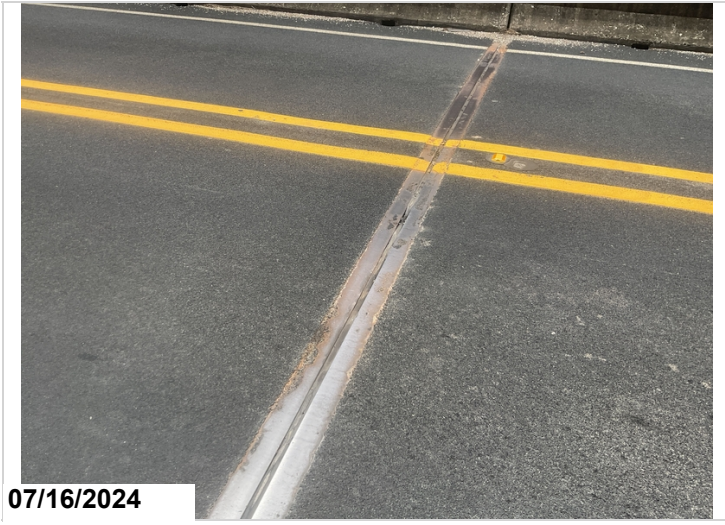
Expansion joint seal over Bent 4. Typical.

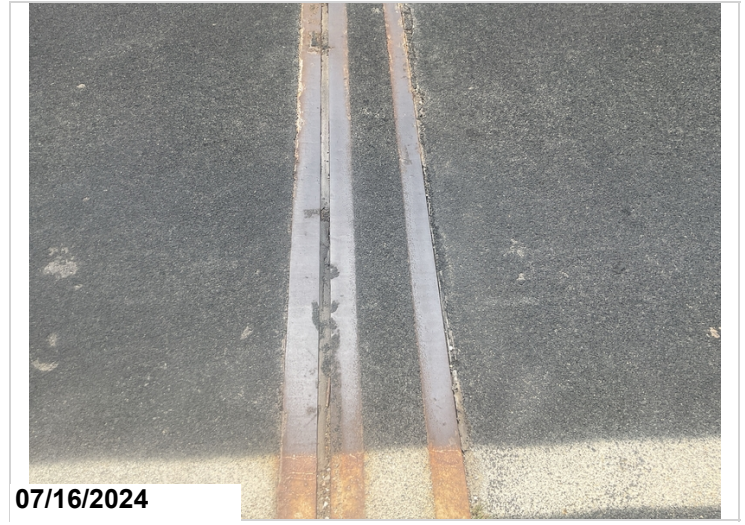
Abutment 1 expansion joint seal.

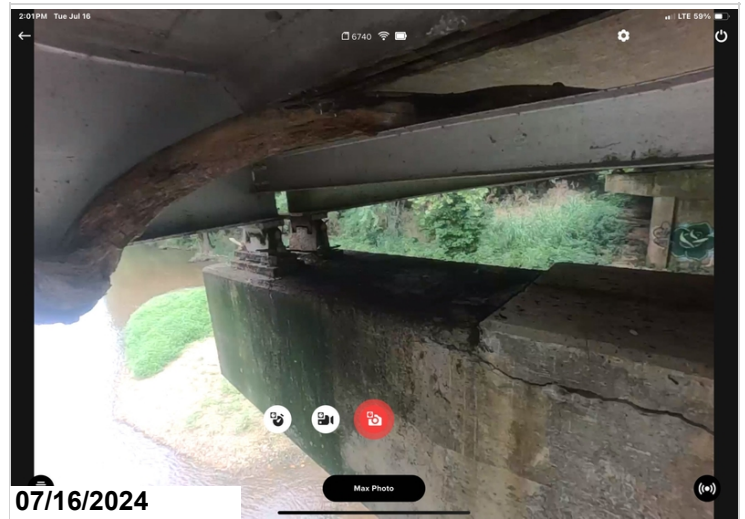
Bent 3 cap. Left Bearings for Girder 1.

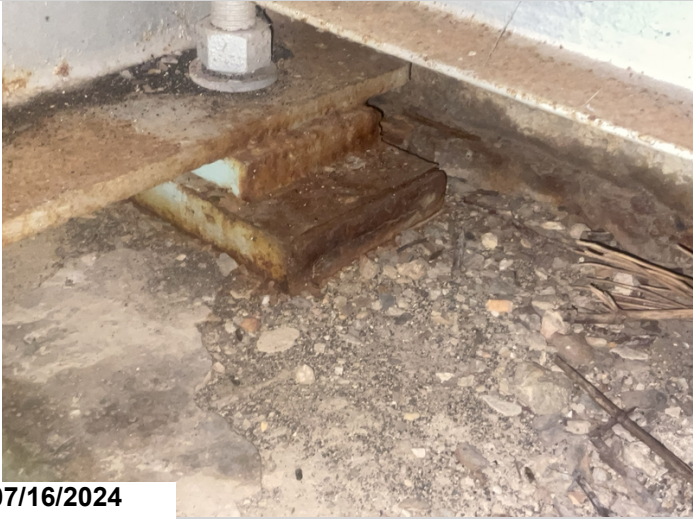
Abutment 1 Girder 2, fixed bearings have active corrosion with flaking rust.

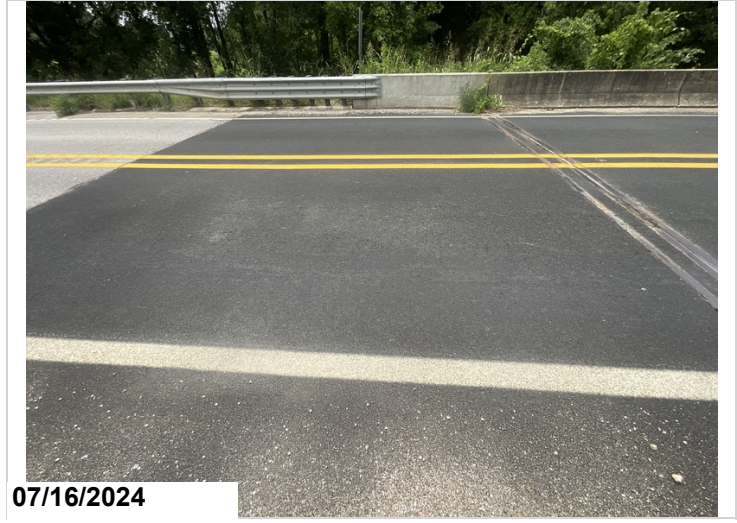
East approach slab. Typical.

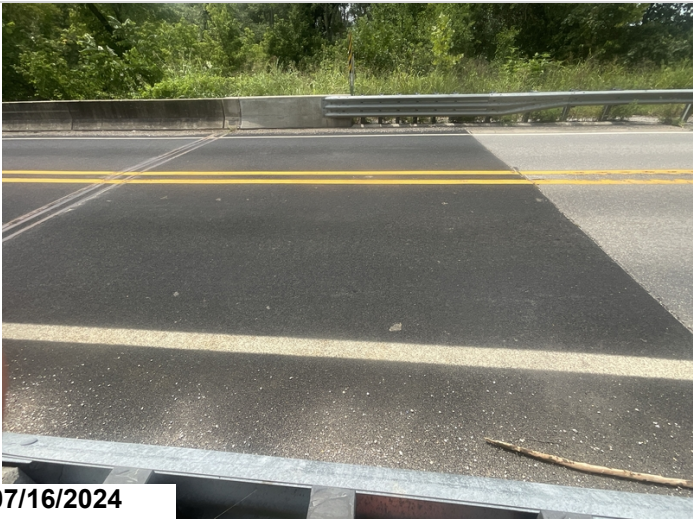
West approach slab. New polymer wearing surface.

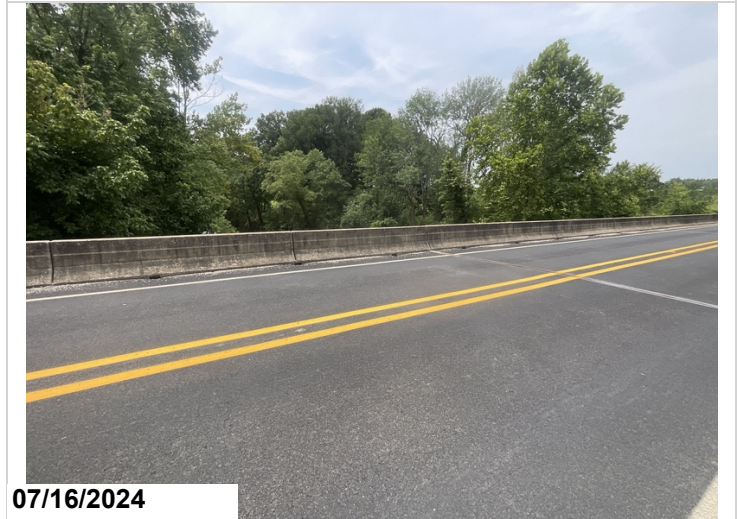
Right parapet. Typical.

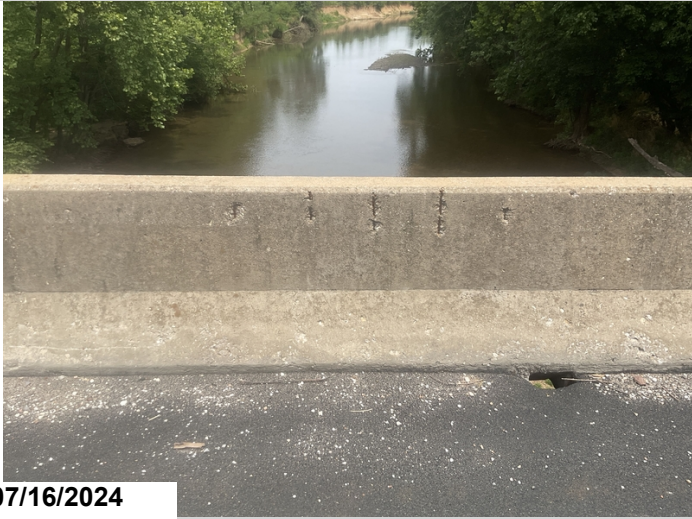
1080	Delamination/Spall/Patched Area	LF	12	0	12	0	0
1090	Exposed Rebar	LF	62	0	62	0	0
(331) Numerous delaminated areas and shallow spalls with exposed reinforcing steel where steel has very little concrete cover from

Left Parapet. Spalls with exposed reinforcing steel.

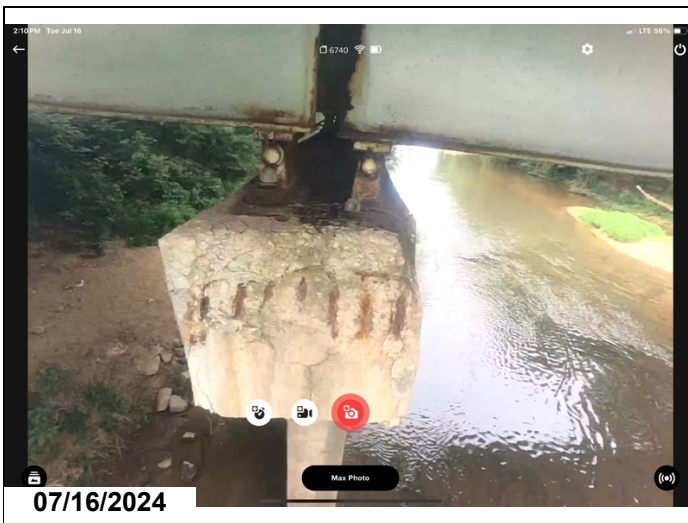
The intermediate bent caps have wide horizontal cracks, delaminated concrete, concrete deterioration with significant section loss, map cracking, and spalling with exposed reinforcing steel.

Bent 2 cap Right end.

Type of Work: Substructure Repair

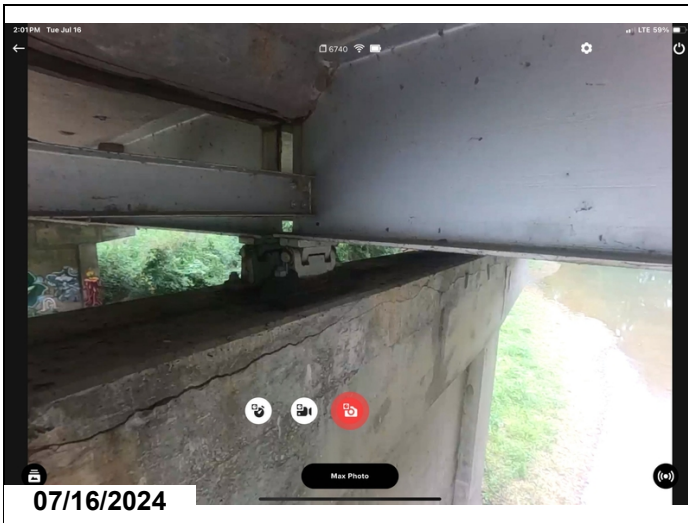
Bent 3 cap, Looking Right Open horizontal cracks indicating corrosion in the primary longitudinal reinforcing steel.

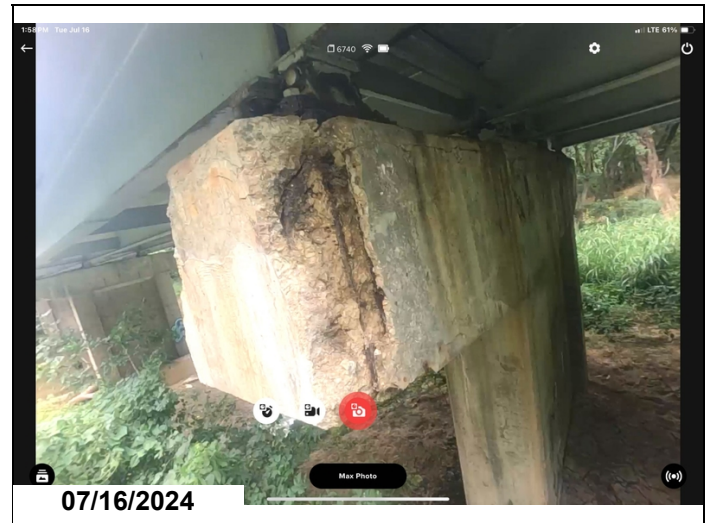
Bent 4 Right end of cap, concrete deterioration with exposed reinforcing steel.

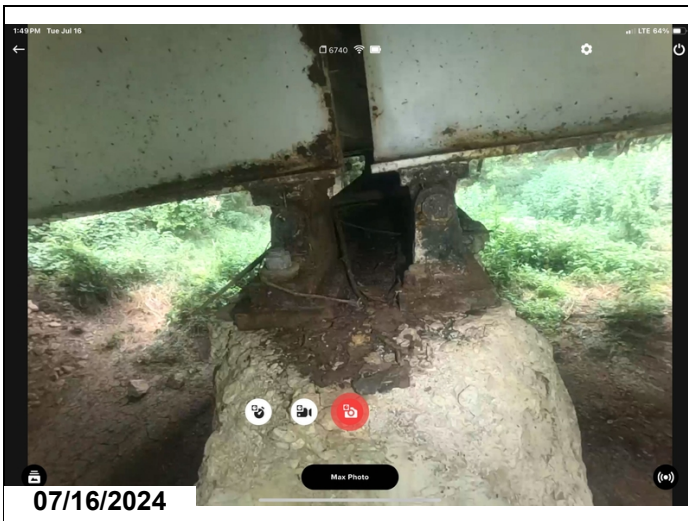
Bent 5 cap, Left side, Concrete deterioration.

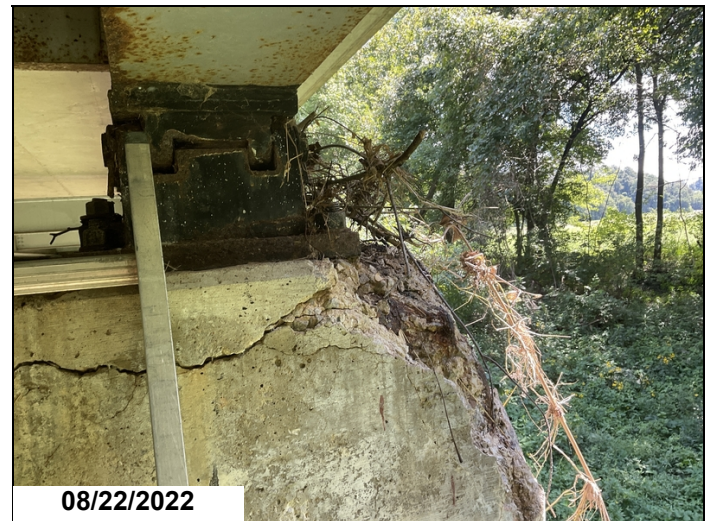
Bent 5 Rt top of the cap delaminating with loss of bearing area and exposed reinforcing steel.

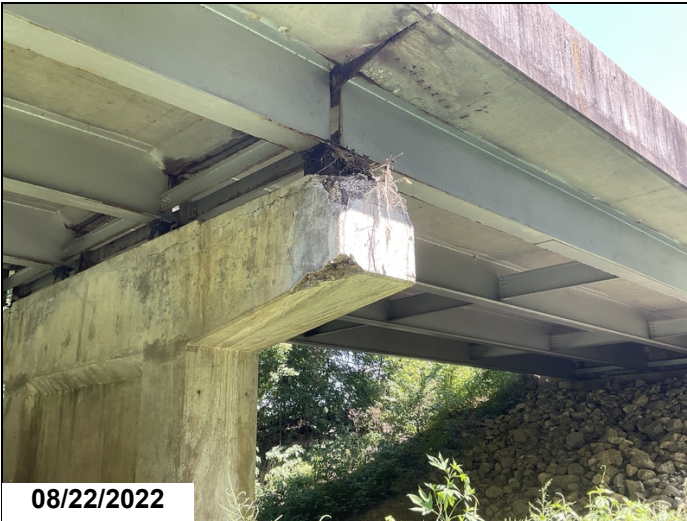
Bent 5 Rt concrete deterioration with exposed reinforcing steel.

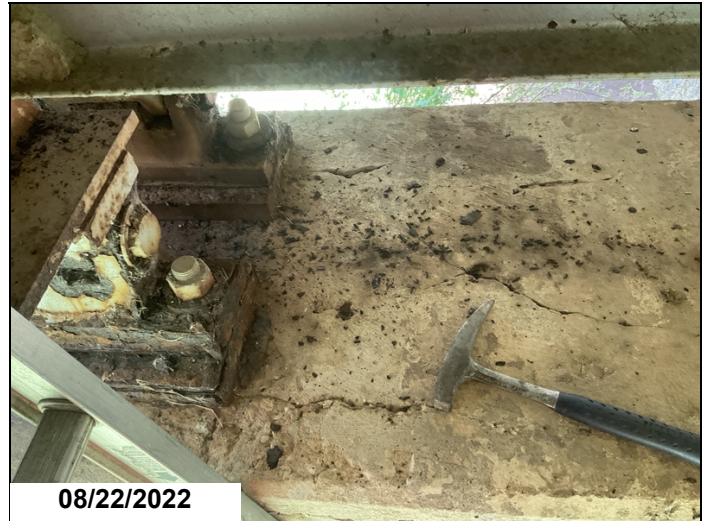
Bent 4 Rt cracking and delaminating concrete in the top of the cap.

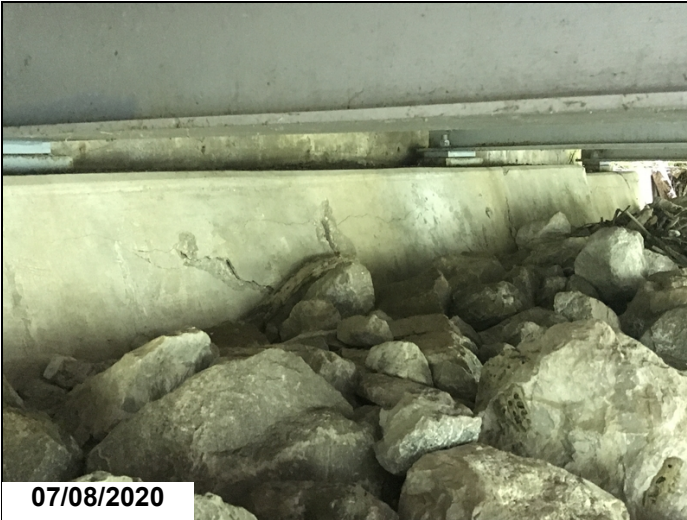
Abutment 2 cap has delaminated areas and spalls with exposed reinforcing steel.

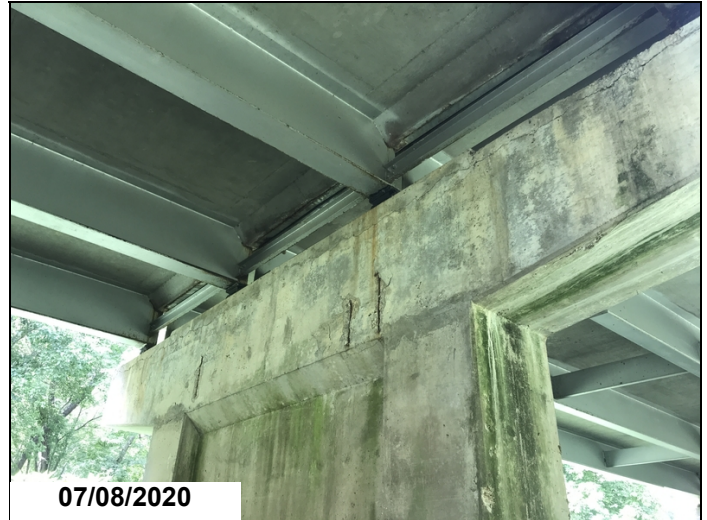
The intermediate bent caps have moderate width horizontal cracking, concrete deterioration with map cracking, and spalling with exposed reinforcing steel.

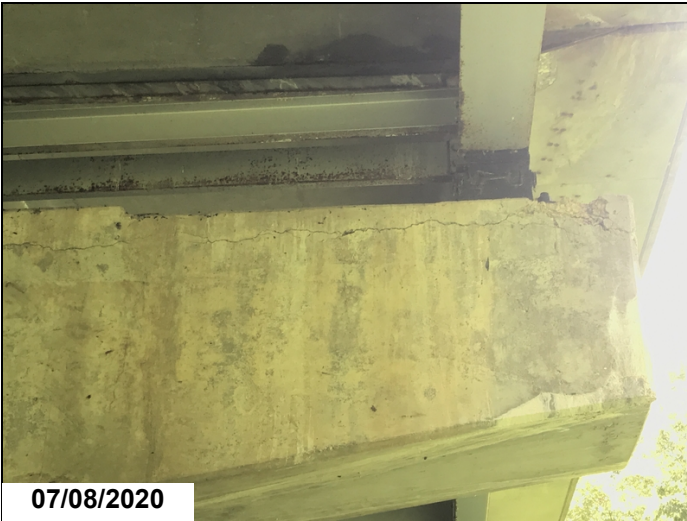
The intermediate bent caps have moderate width horizontal cracking, concrete deterioration with map cracking, and spalling with exposed reinforcing steel.

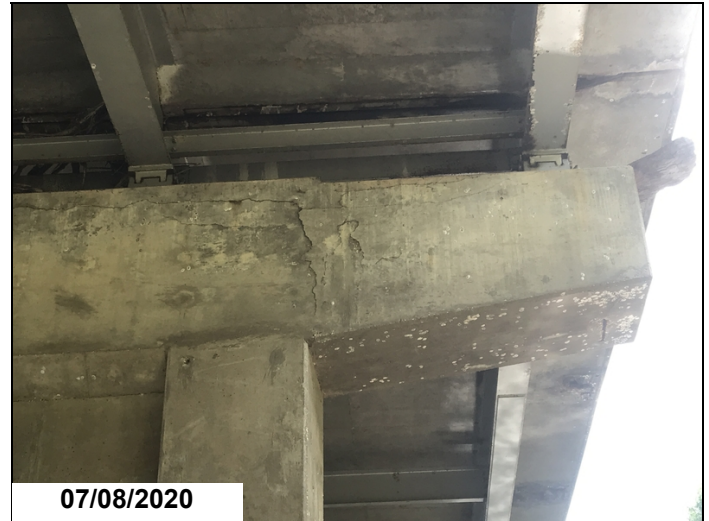
The intermediate bent caps have moderate width horizontal cracking, concrete deterioration with map cracking, and spalling with exposed reinforcing steel.

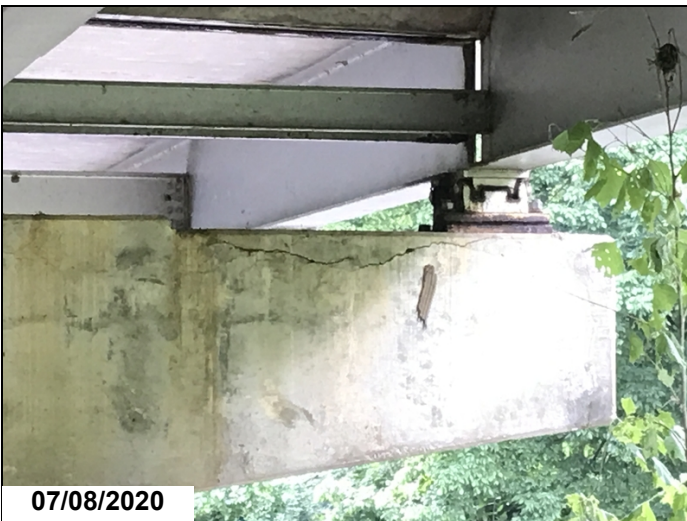
Bent 2 cap-Wide horizontal cracking.

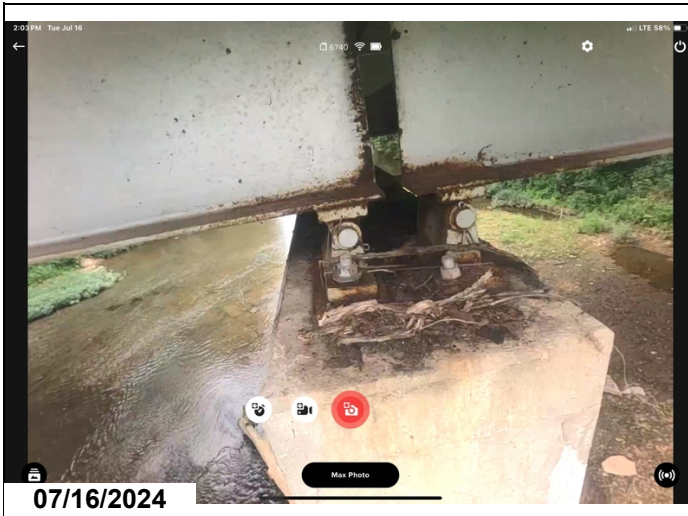
The bearings have active corrosion and pack rust. The pack rust appears to be causing a height differential in the deck between the spans over the intermediate bents.

Bent 3 cap, Right end, Bearings for Girder 4.

Type of Work: Bearing Repair/Replacement

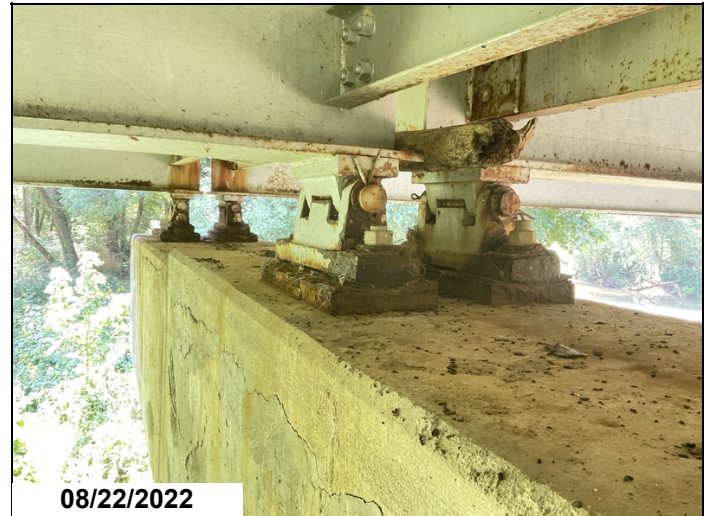
Bent 4 bearings with active corrosion and pack rust.

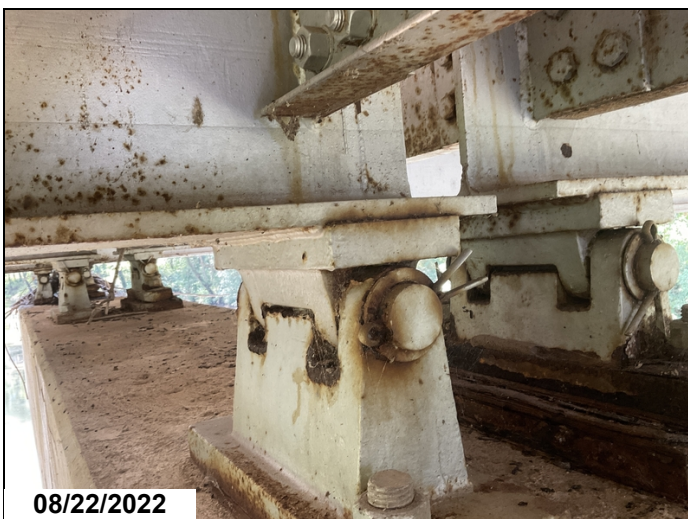
Bent 3 bottom flange misalignment from active corrosion between the masonry plate and the expansion bearings.

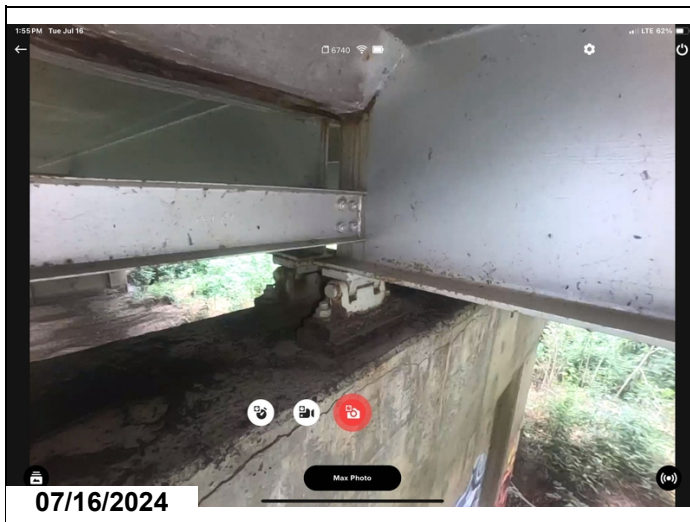
Bent 4 cap, horizontal open crack in the cap. Girder 2
Bearing corrosion.

Type of Work: Superstructure Repair

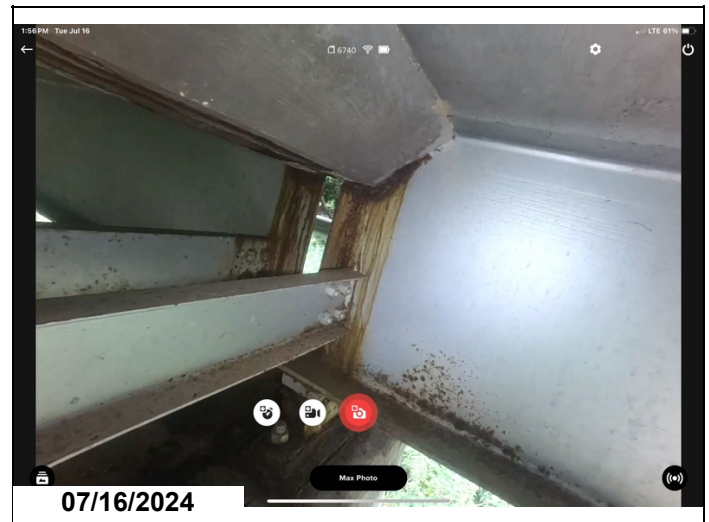
The girder ends have areas of active corrosion where failing expansion joint seals have allowed water to leak onto the Superstructure in the past. The girder ends have flaking rust with initial section loss in the upper portion of the webs at the expansion dam juncture in some locations.

Bent 4 cap, Girder 2 corrosion in the web at the
expansion dam juncture.
