Bridge 05464 Inspection Report

Route:16 Section:02 Log:3.929

INSPECTIONS *			
(90) Inspection Date			07/16/2024
(91) Frequency			24
(92) Critical Feature Inspection	Done	Freq. (Mon)	Date
A: Fracture Critical Detail	No		
B: Underwater Inspection	No		
C: Other Special Inspection	No		
* The inspection date and frequency information in this box contains the current NBI date and frequency information. Please refer to the report header for the date this inspection was conducted.

Team Lead: Jeff Jones, Inspection Date: 07/16/2024

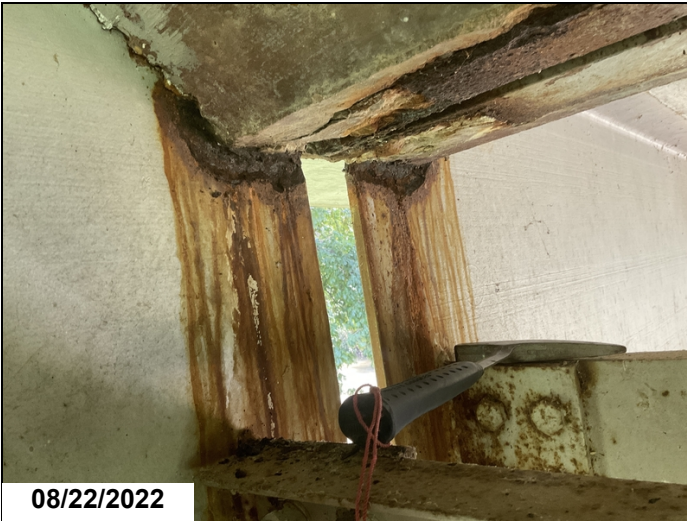
Bent 4 beam 4 active corrosion with approximately 3/16" section loss at the expansion dam juncture.

Type of Work: Superstructure Repair

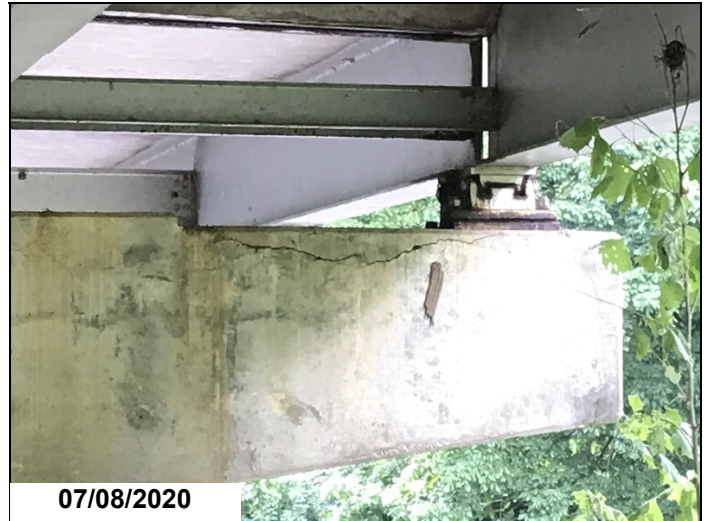
The bearings have areas with active corrosion. The most notable areas are over bents 4 and 5 which have areas of corrosion with thick flaking rust.

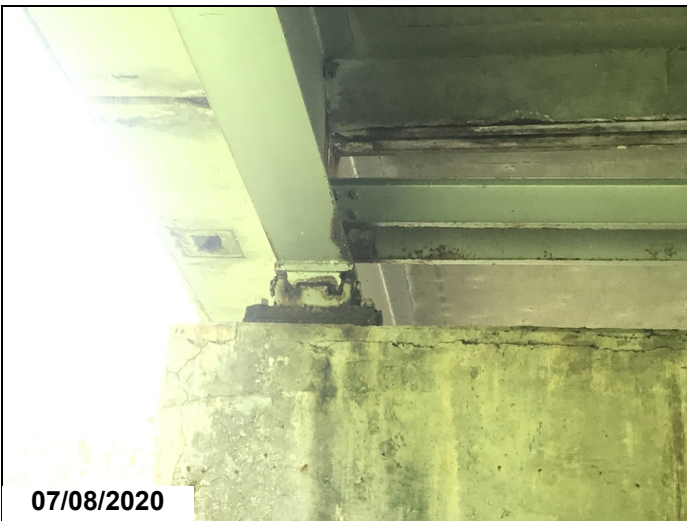
The bearings have areas with active corrosion. The most notable areas are over bents 4 and 5 which have areas of corrosion with thick flaking rust.

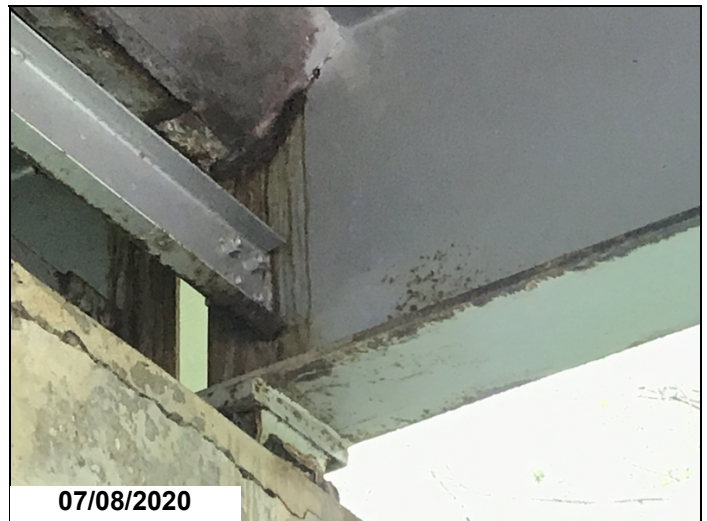
The ends of beams have areas of active corrosion where failing expansion joint seals have allowed water to leak onto the Superstructure in the past. The beam ends have flaking rust with initial section loss in the upper portion of the webs at the expansion dam juncture in some locations.

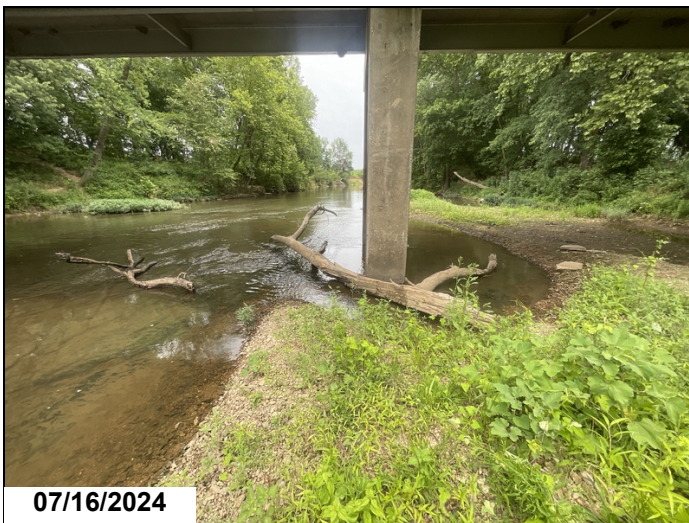
Bent 3. Drift accumulation.

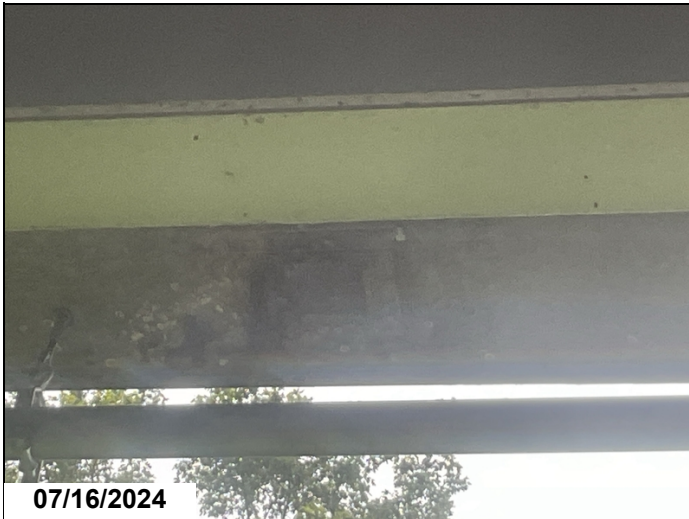
The undersurface of the deck has delaminated and spalled areas with exposed reinforcing steel adjacent to the deck drains in several locations.

Spalls with exposed reinforcing steel next to the drains.
Span 3 Right.

Type of Work: Deck Repair

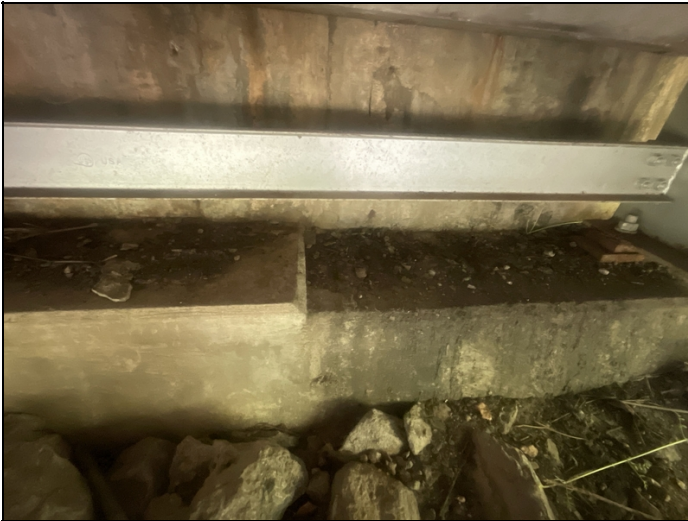
Abutment 1. Debris on cap.

A-58 - Cap Cleaning/Flushing Needed (Yes)
Debris on the caps.
