Bridge 02728 Inspection Report

Asset #02728(Posting Sign Verification)

SH 23-Franklin Co. over Gar Creek

Team Lead: Jeff Jones Inspection Date: 03/11/2025

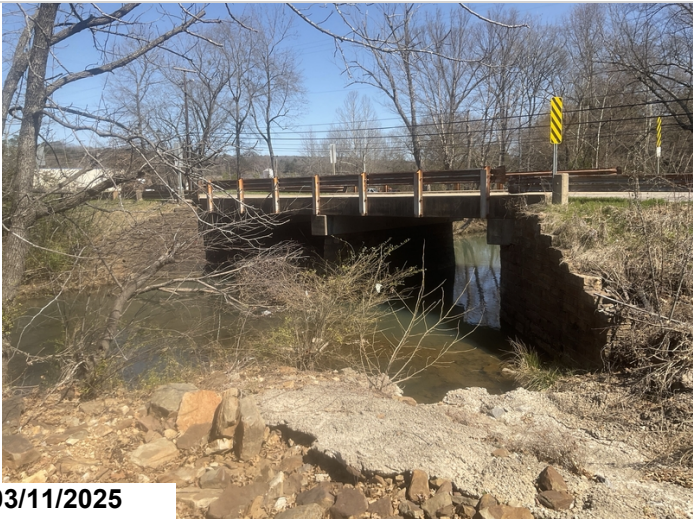
03/11/2025 - JCJ & TJL - Posting Sign Verification Inspection conducted this date.
Elevation, Right side of structure.

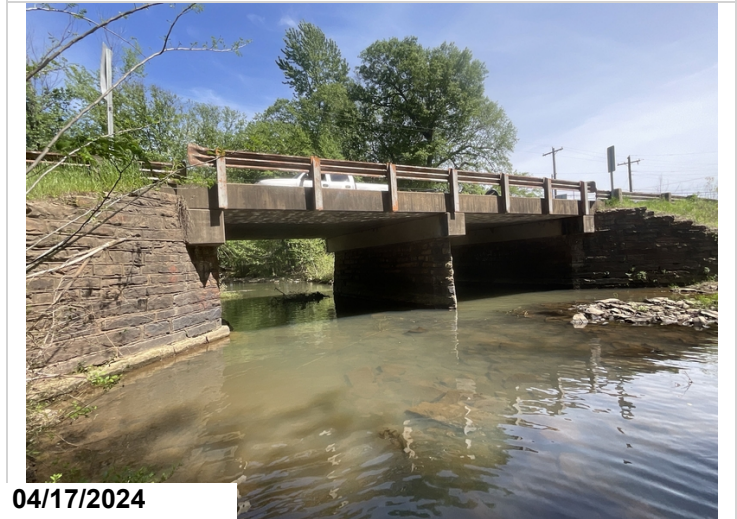
04/17/2024

Elevation. Left side of structure.

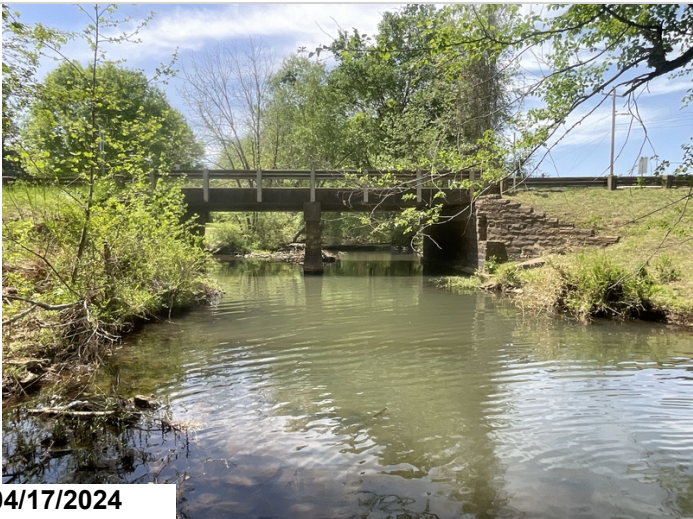
04/17/2024

Elevation. Right side of structure.

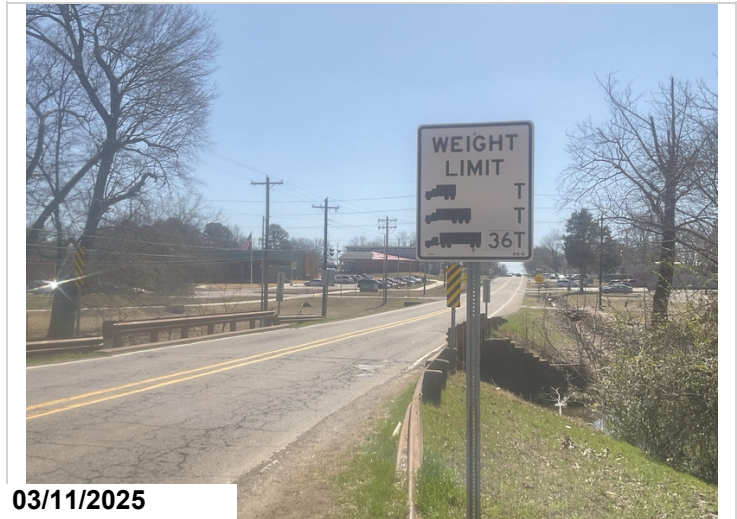
03/11/2025 - JCJ & TJL - Posting Sign Verification Inspection conducted this date.
Weight Limit Sign at the North end of structure.

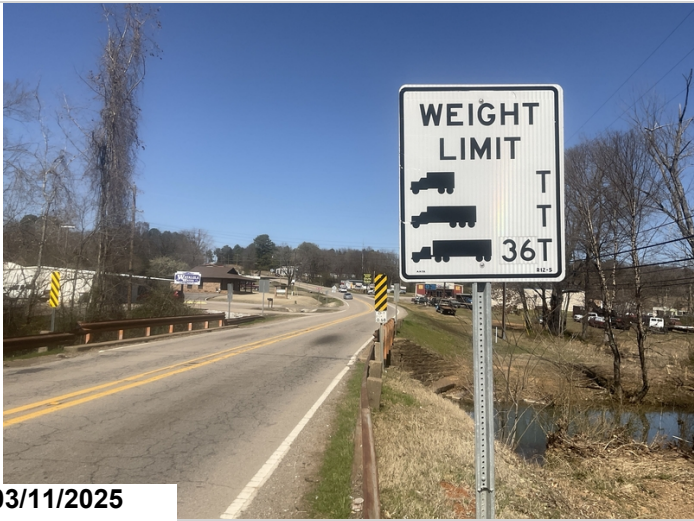
03/11/2025 - JCJ & TJL - Posting Sign Verification Inspection conducted this date.
Weight Limit Sign at the South end of structure.

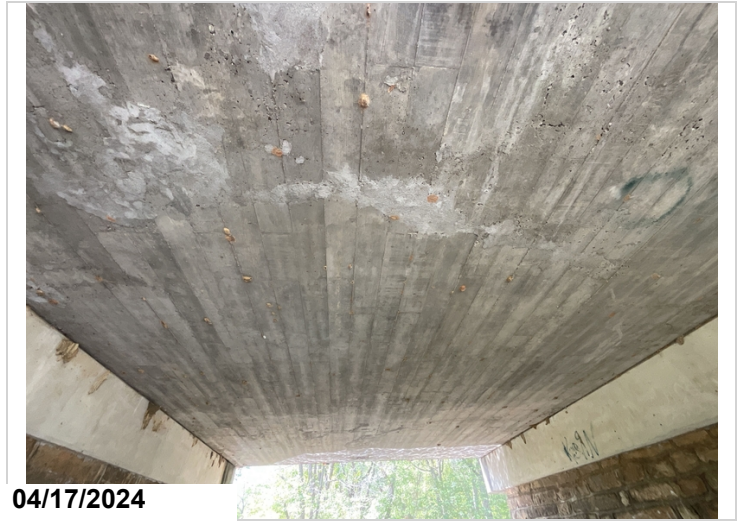
04/17/2024

Delaminated areas and one spall with exposed reinforcing steel.

Slab undersurface. Typical.

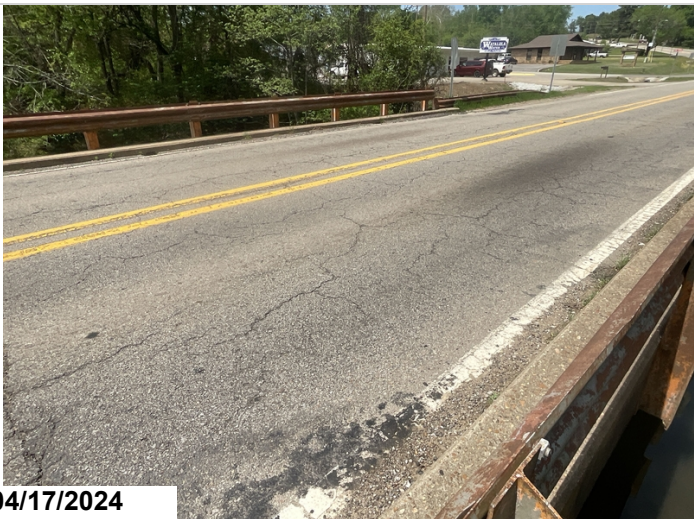
04/17/2024

Asphalt Wearing Surface has minor deterioration with map cracking.

Driving surface of deck. Typical.

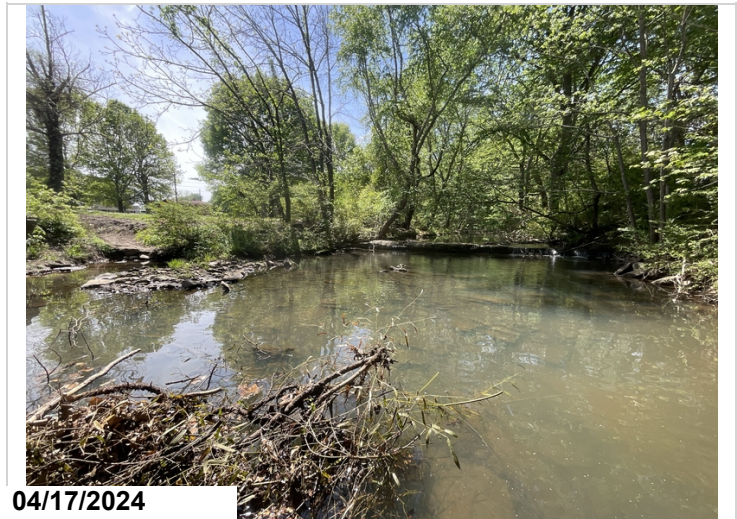
04/17/2024

The banks of the channel are well vegetated with some minor insignificant embankment erosion observed on the Left and Right ends of the structure.

Channel. Left side of structure.

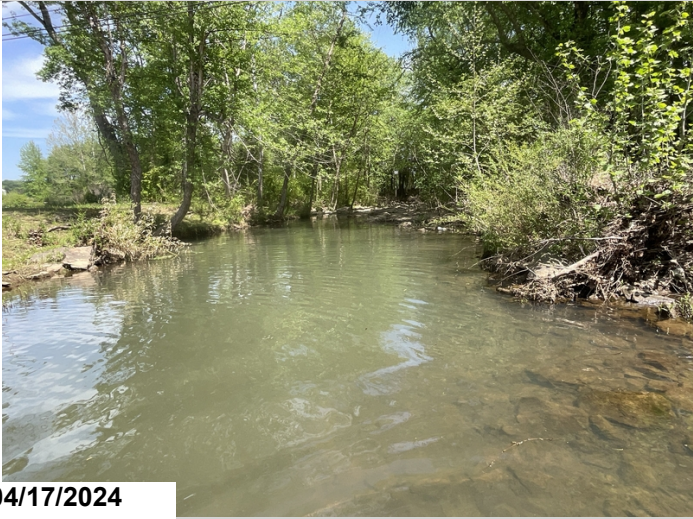
Channel. Right side of structure.

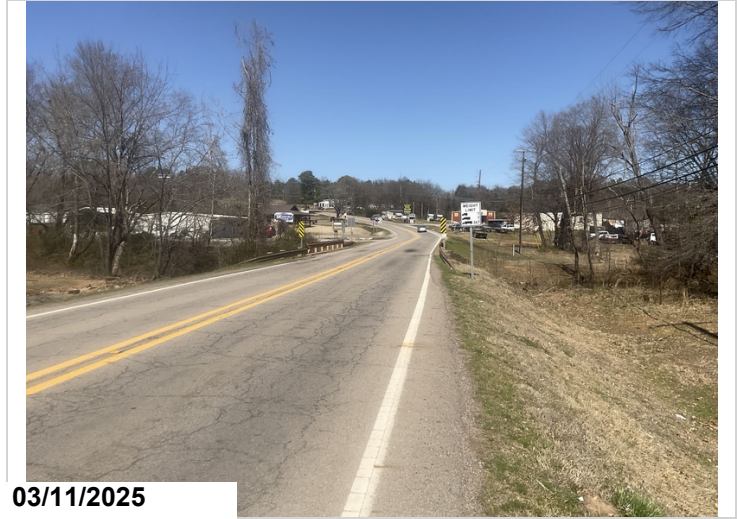
03/11/2025 - JCJ & TJL - Posting Sign Verification Inspection conducted this date.
Approach roadway facing North.

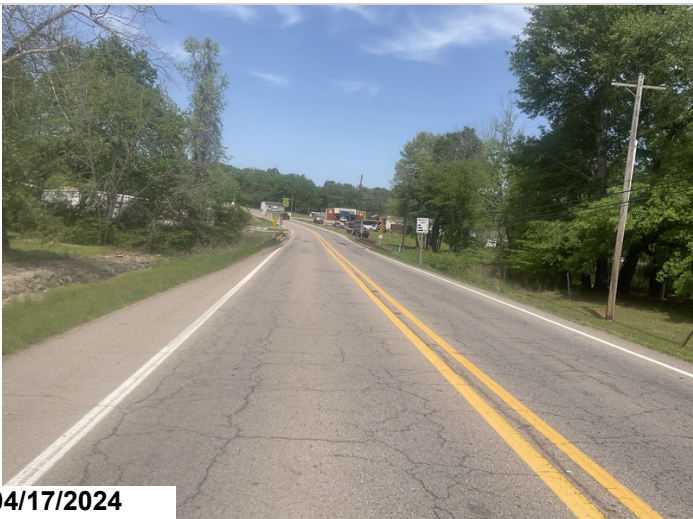
Approach roadway facing North.

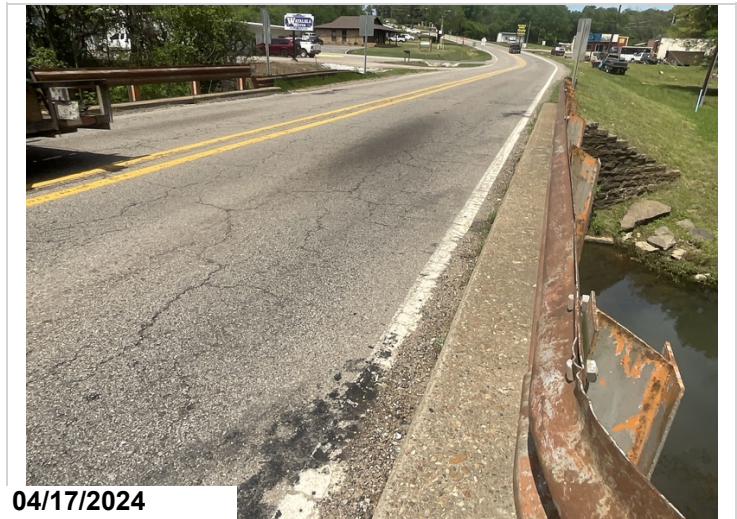
There is minor debris and vegetation in the gutters.

Minor debris and vegetation in the gutters.

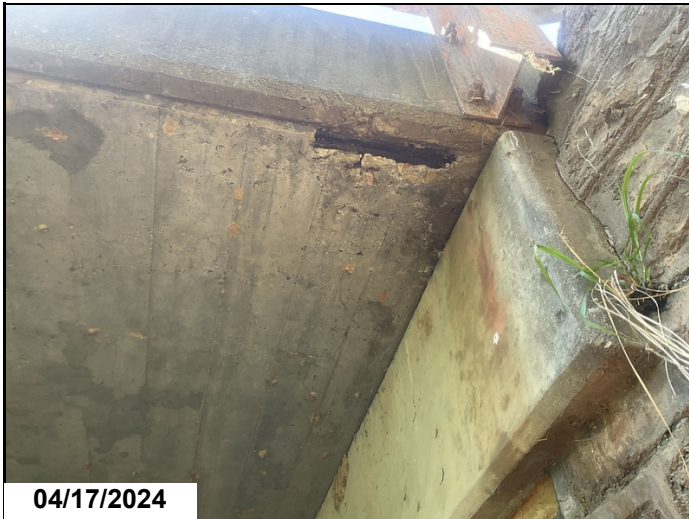
The undersurface of Span # 2 on the right side adjacent to abutment # 2 cap has an area of spalling with exposed primary longitudinal reinforcing steel. The exposed reinforcing steel has active corrosion and layers of flaking rust.

Span # 2, Right edge, Undersurface of slab has one 12" spall with exposed reinforcing steel with approximately 1/8" section loss located adjacent to Abutment # 2.

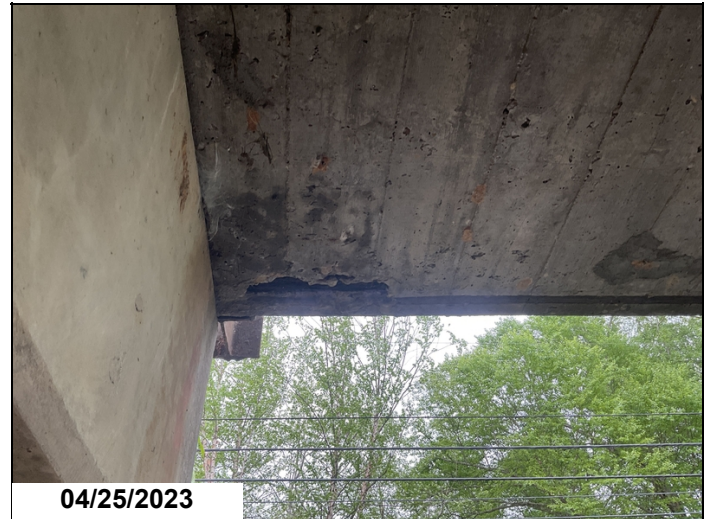
Span # 2 Rt spalling with exposed reinforcing steel.

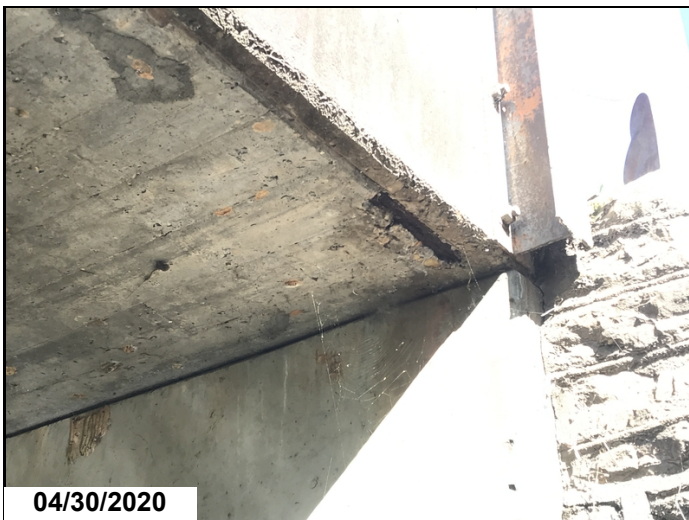
Span # 2, right side-Spall with exposed reinforcing steel adjacent to abutment # 2.

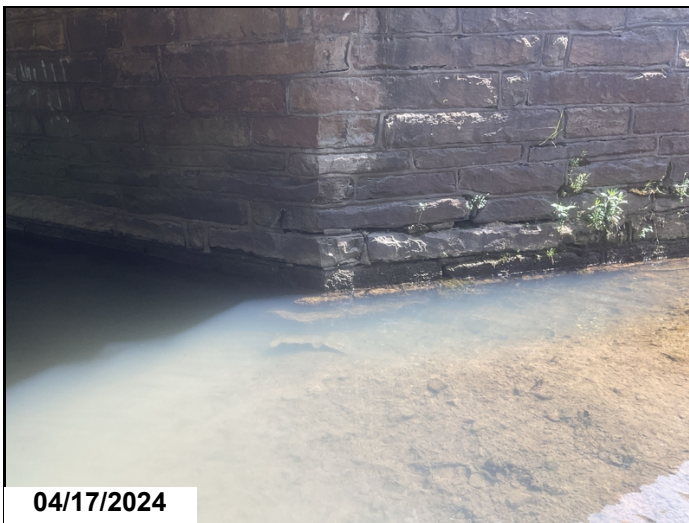
04/17/2024

The base of the bents have minor grout deterioration between the stone.

Abutment # 1, Left side has Grout deterioration between the stone.

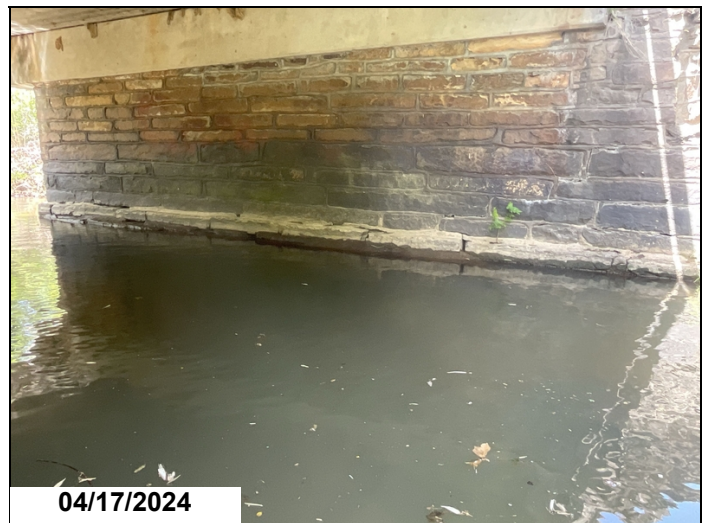
04/17/2024

Abutment # 2, Base of abutment has grout deterioration between the stone.

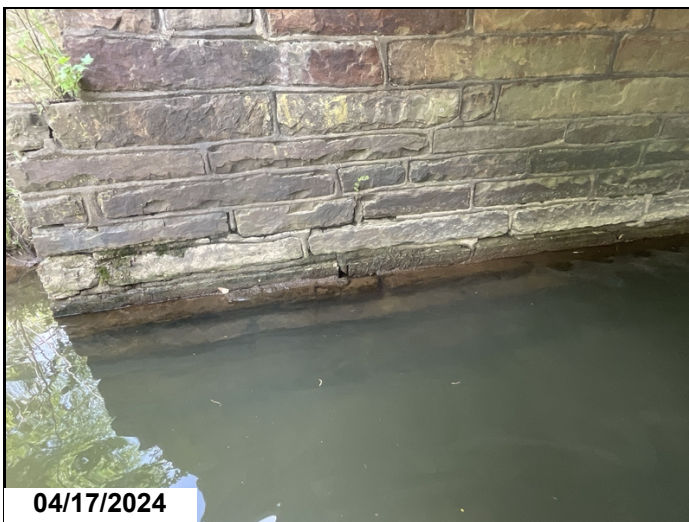
04/17/2024

Abutment # 1, Right side has Grout deterioration between the stone.

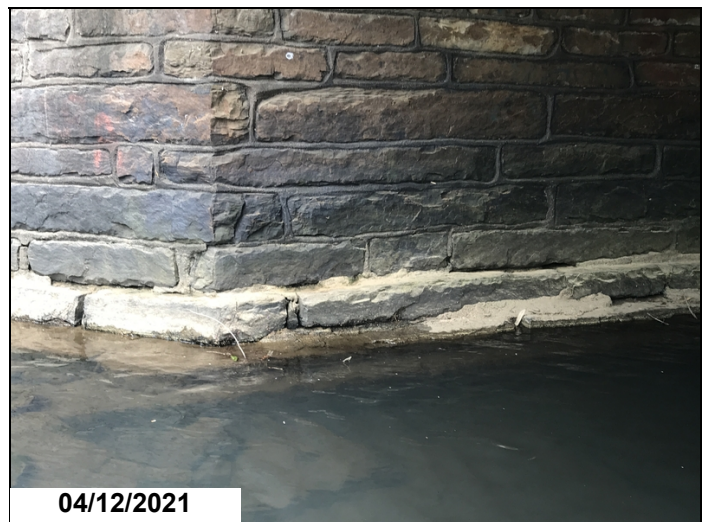
04/12/2021

Abutment # 2, left side-Grout deterioration.

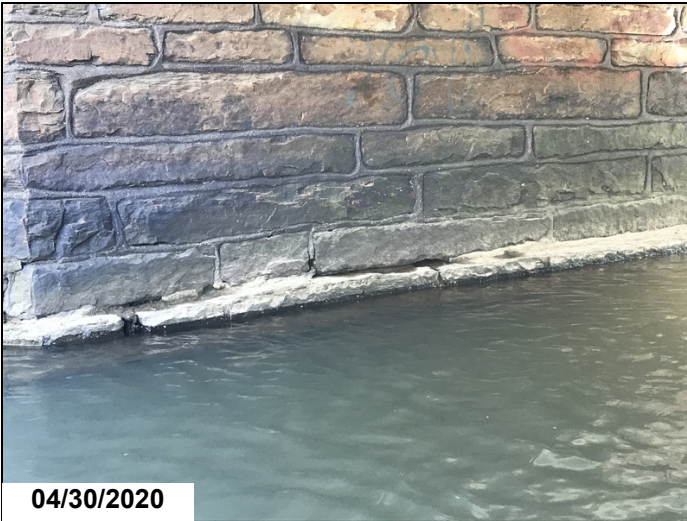
Abutment # 2-Minor grout deterioration.

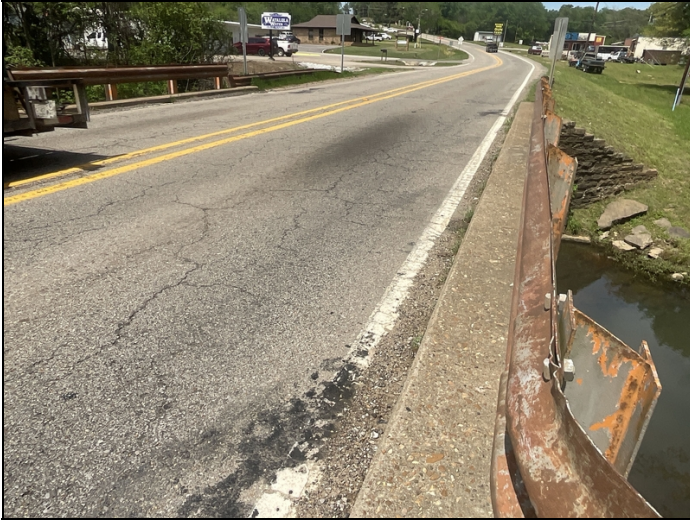
There is minor debris and vegetation in the gutters.

Minor debris and vegetation in the gutters.

A-55 - Deck Washing Needed (Yes)
