## Bridge 05259 Inspection Report

| IDENTIFICATION | |
|---|---|
| (6) Features Intersected | White Oak Creek |
| (7) Facility Carried | SH 23-Franklin Co. |

Team Lead: Jeff Jones, Inspection Date: 10/01/2025

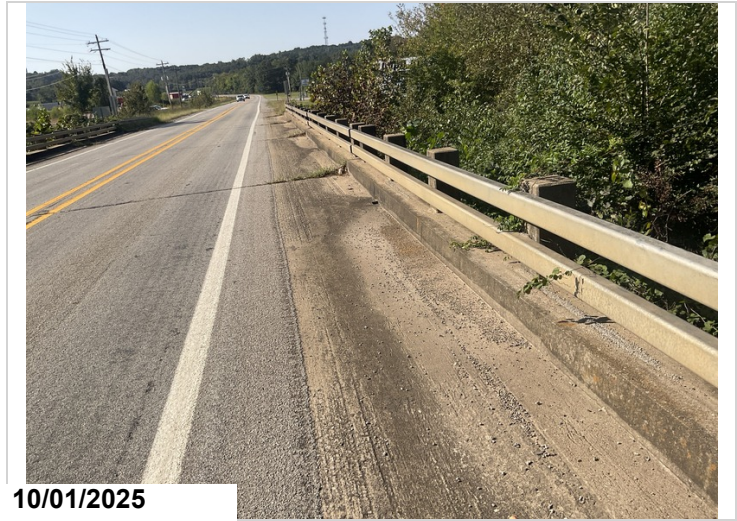
Deck shoulders have minor debris and gravel.

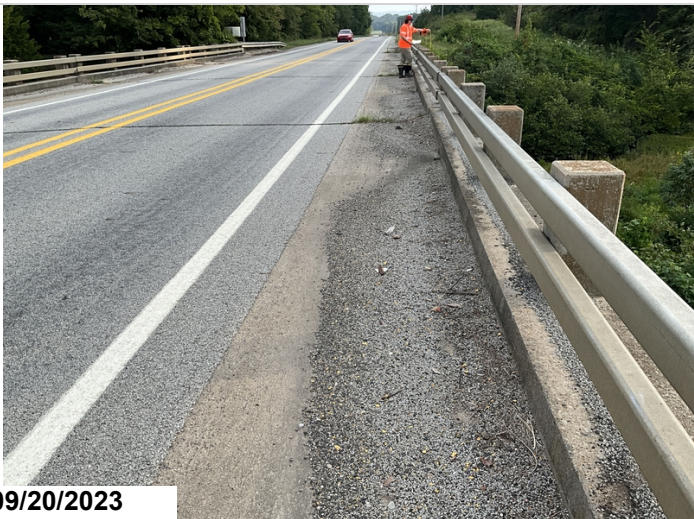
Deck shoulders have debris and gravel.

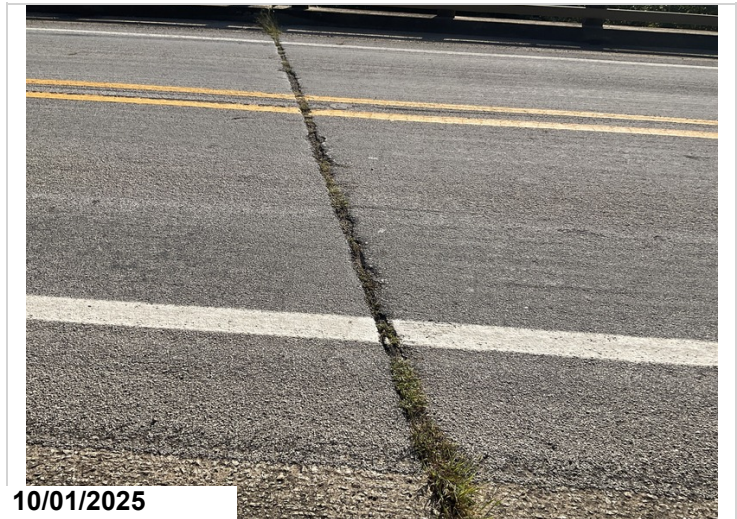
Expansion joint over Bent 4, Debris accumulation

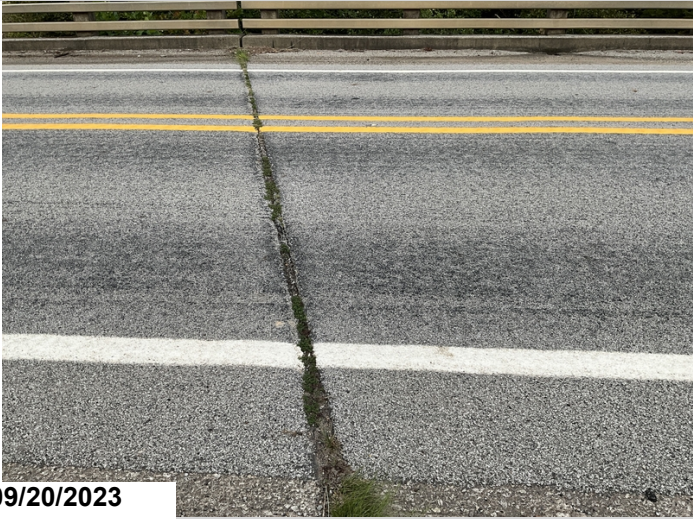
Bent 1, 2, and 3 has debris impaction with vegetation growth in joints.

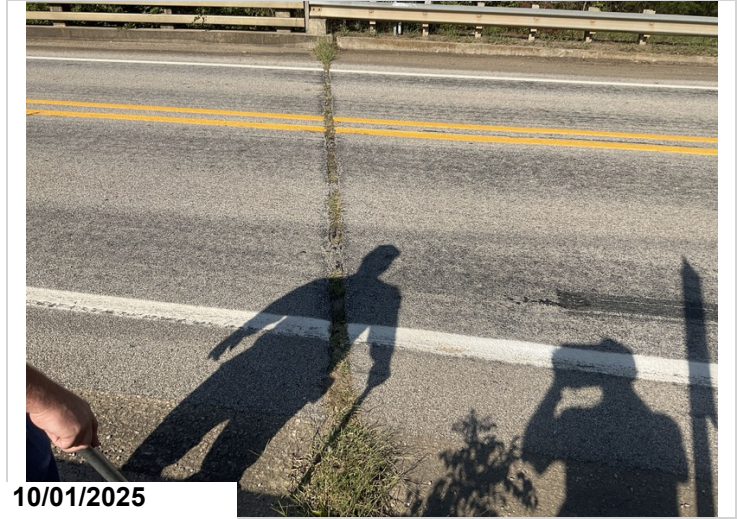
Abutment 2: expansion joint: debris accumulation.

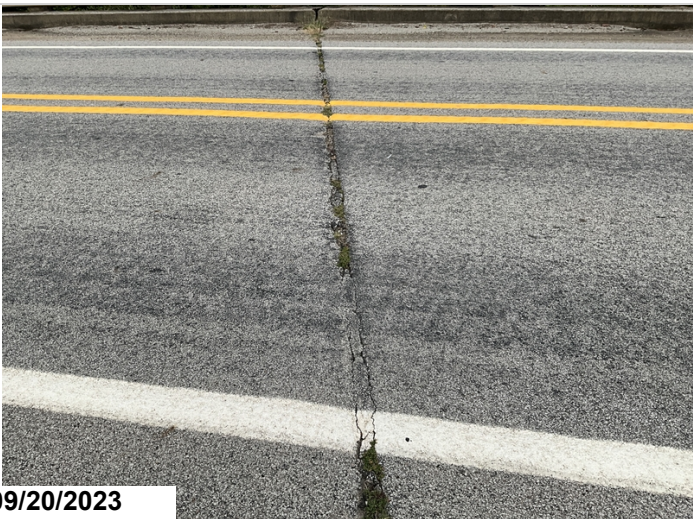
All joints have asphalt in joint that needs to be removed.

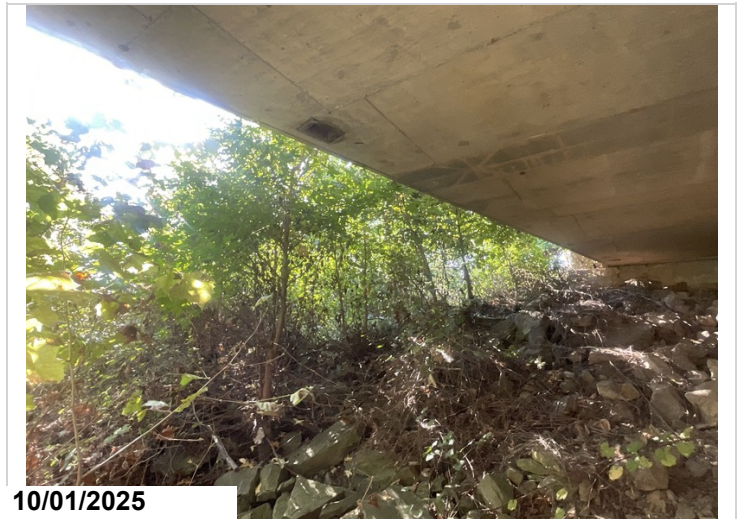
Vegetation. Span 1, Right.

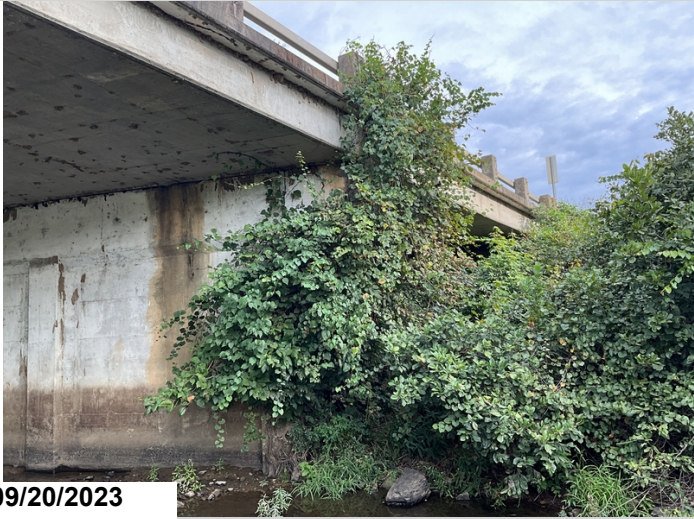
Bent 4 right side has vegetation growth.

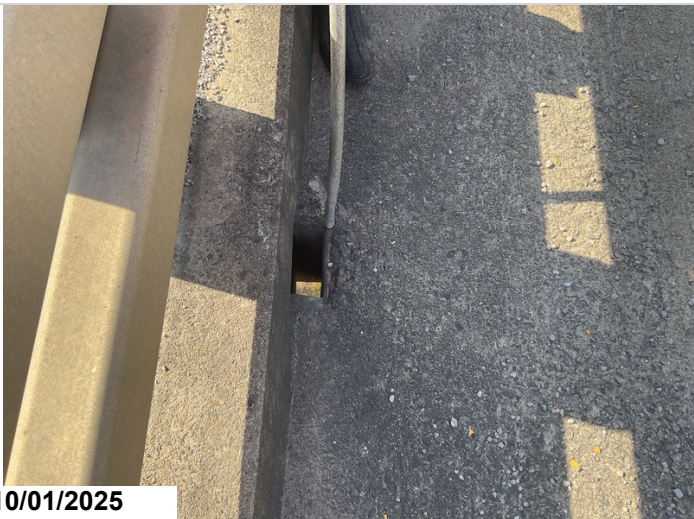
Deck drain, Span 2, Right: Exposed reinforcing steel. 1SF  
CS2

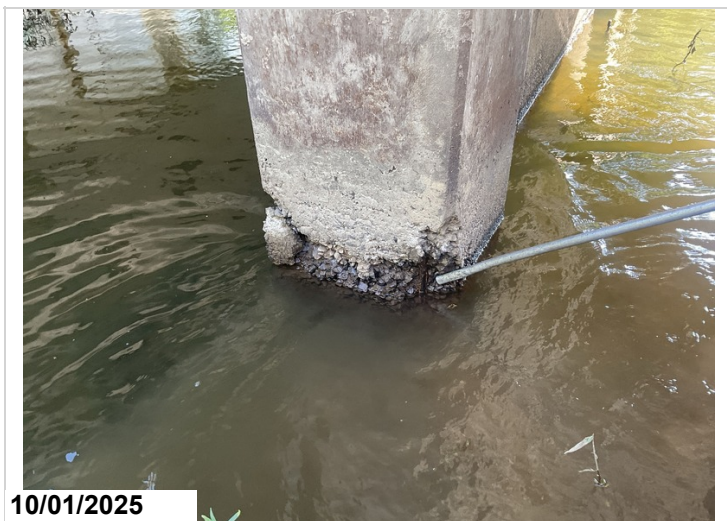
| ELEMENTS | DESCRIPTION | UNITS | TOTAL | CS1 | CS2 | CS3 | CS4 |
|--|---|---|---|---|---|---|---|
| <p>(205) Total Quantities:<br/> Spall 2EA CS2, 1EA CS3<br/> Exposed Reinforcing steel 1EA CS3<br/> Abrasion 5EA CS2<br/> Bent 3, Column 1, Base at water elevation: Concrete deterioration up to 5" deep with exposed reinforcing steel. 1EA CS3<br/> Bent 3, Columns 2 &amp; 3, Base: Concrete deterioration with no exposed reinforcing steel. 1EA CS2, 1EA CS3</p> | | | | | | | |

Bent 3, Column 1, Base at water elevation: Concrete deterioration up to 5" deep with exposed reinforcing steel.  
1EA CS3

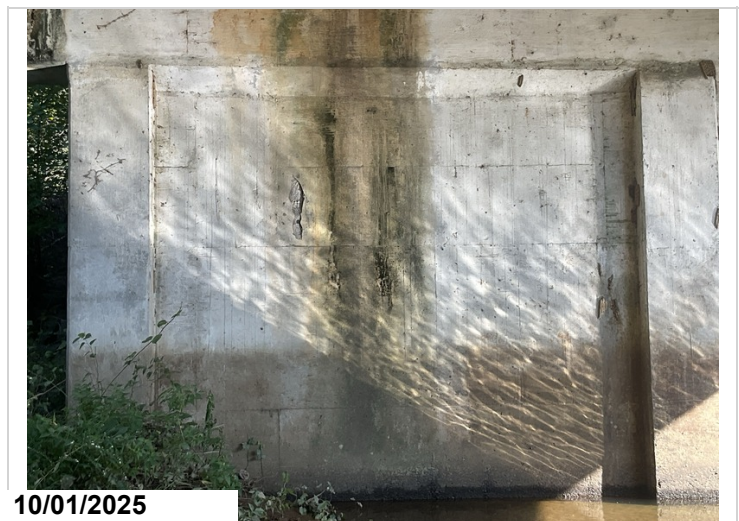
| ELEMENTS | DESCRIPTION | UNITS | TOTAL | CS1 | CS2 | CS3 | CS4 |
|--|---|---|---|---|---|---|---|
| <p>(210) Bent 2, Back face, Adjacent to column 2: Two 10" spalls with exposed reinforcing steel. 2LF CS3<br/> Bent 4, Back face, Left: 1'-8" vertical spall with no exposed reinforcing steel. 1LF CS3<br/> Vertical cracks. 10LF CS2, 1LF CS3<br/> Base of walls: Abrasion. 52LF CS2, 3LF CS3</p> | | | | | | | |

Bent 4, Back face, Left: 1'-8" vertical spall with no exposed reinforcing steel. 1LF CS3

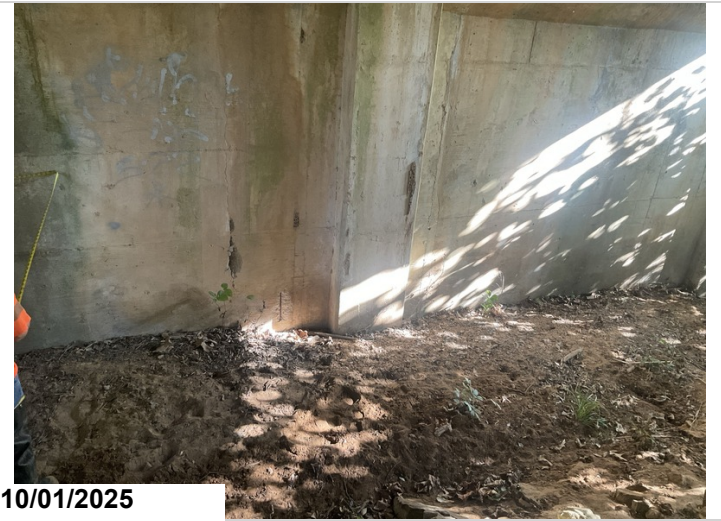
Bent 2, Backface, Adjacent to column 2: Two 10" spalls with exposed reinforcing steel. 2LF CS3

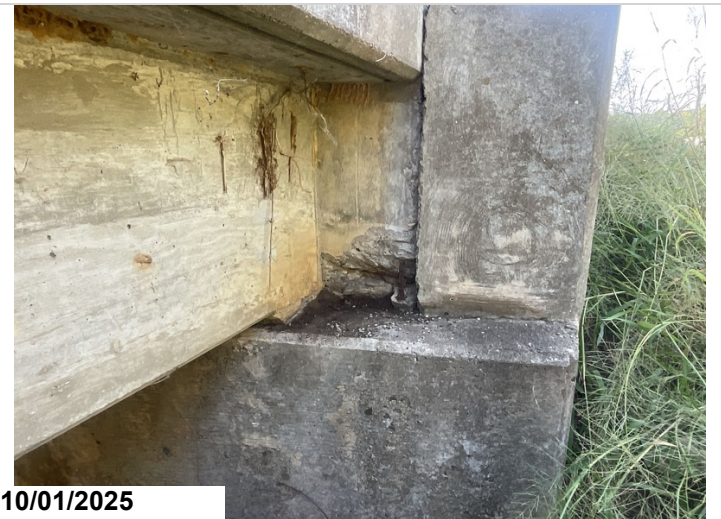
| ELEMENTS | DESCRIPTION | UNITS | TOTAL | CS1 | CS2 | CS3 | CS4 |
|--|---|---|---|---|---|---|---|
| (215) Total spalls. 2LF CS2<br>Abutments: Minor stains.<br>Abutment 1, Left: One 4" spall with exposed reinforcing steel. 1LF CS3<br>Abutment 2, Right: One 3" shallow spall with no exposed reinforcing steel. 1LF CS2 | | | | | | | |

Abutment 1, Left: One 4" spall with exposed reinforcing steel. 1LF CS3

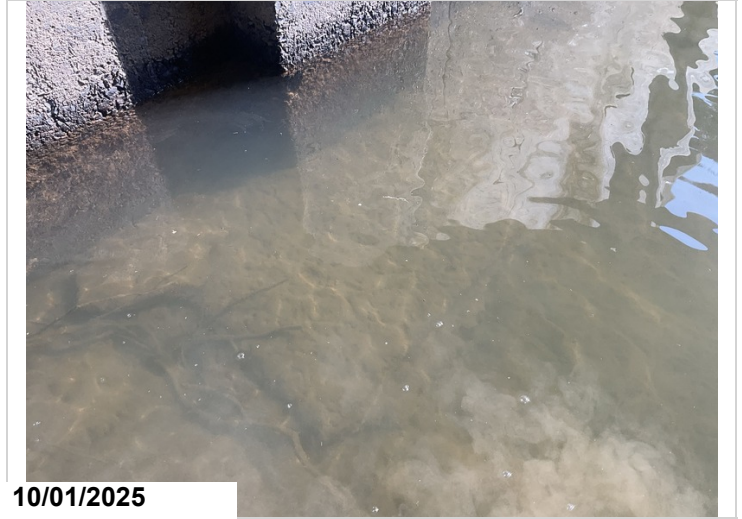
09/11/2019 - JCJ & TJL - Type 2 Underwater Inspection - Wading and probing during low and clear water conditions indicate that the top of Bent # 3 footing is exposed during this inspection. The footing appears to be well keyed into hard shale with no apparent scour problems during this inspection. Review of ArDOT Plan Drawing # 16716 & 16717 shows that the structure has concrete spread footings keyed into solid rock.

Bent 3, Column 2, Footing: Top is exposed. Well keyed into solid rock channel

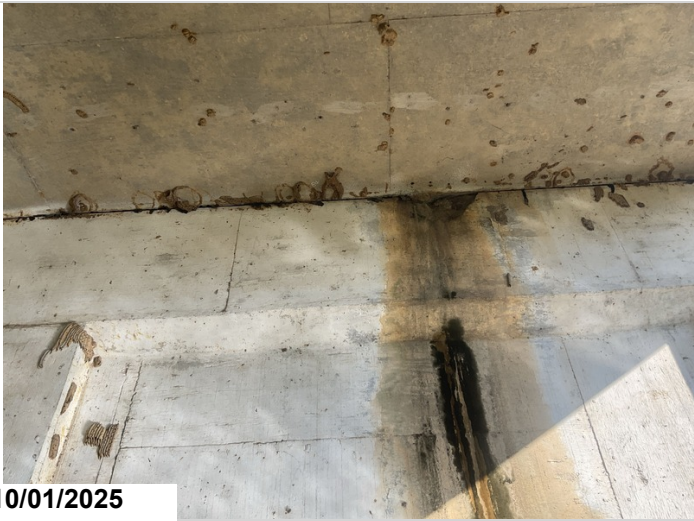
Bent 3, Back face, Right: 1'-6" spall.

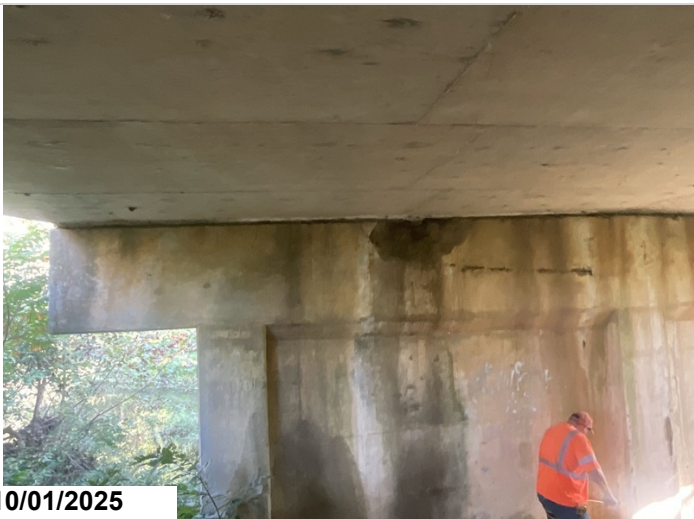
| ELEMENTS | DESCRIPTION | UNITS | TOTAL | CS1 | CS2 | CS3 | CS4 |
|--|---|---|---|---|---|---|---|
| (234) Total exposed reinforcing steel 10LF CS3<br>Efflorescence/Rust Staining 2LF CS2<br>Cracking 8LF CS2<br>Keyways: Shallow spalling/delaminated areas typical.<br>Bent 2: Spalling/delaminated areas. 12LF CS2<br>Bent 2 back: Large spalls (Up to 6') with exposed reinforcing steel exposed with section loss. Reinforcing steel 6LF CS3, Spalling 3LF CS3<br>Bent 2, Right side: Large delaminated areas.<br>Bent 2, Cap, Ahead: Large areas of delaminated areas.<br>Bent 3, Cap: Spalling. 6LF CS3<br>Bent 4, Cap: Spalling. 3LF CS3 | | | | | | | |

Bent 2 cap, Back face, Left: Spalls with exposed reinforcing steel and delaminated areas.

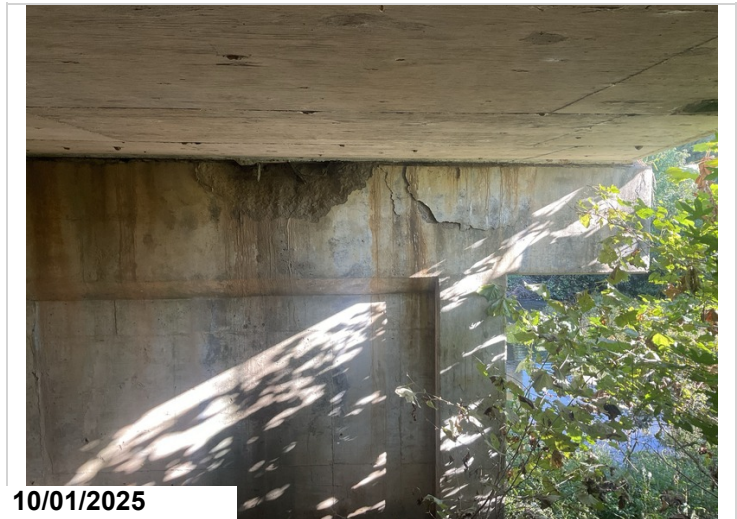
Bent 2 cap, Back face, Right: Spalls with exposed reinforcing steel and delaminated areas.

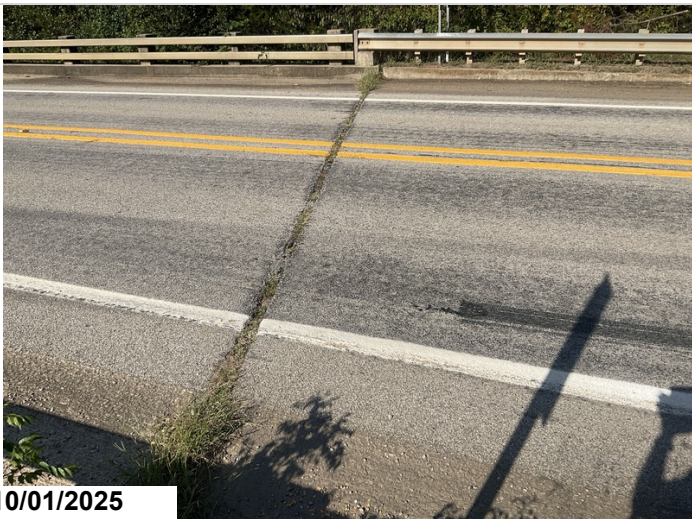
Abutment 2, Expansion joint: Debris accumulation.

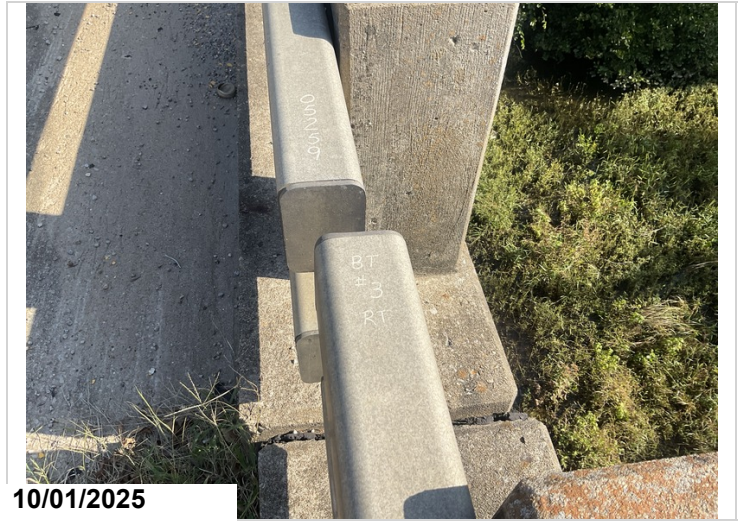
Minor offset in edge of slab over the intermediate bents:  
Typical for slab span structures on a skew.

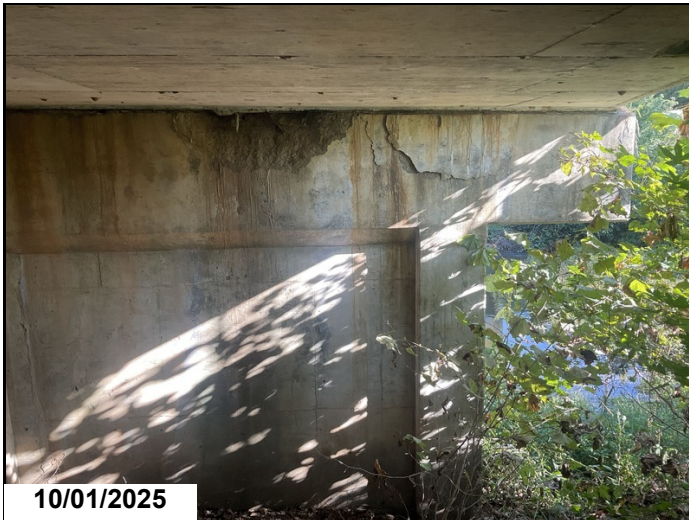
Bent 2 cap, Keyways: Large spalls with exposed reinforcing steel.

Bent 2 cap, Back face: Spalls with exposed reinforcing steel and delaminated areas.

Type of Work: Repair (General)

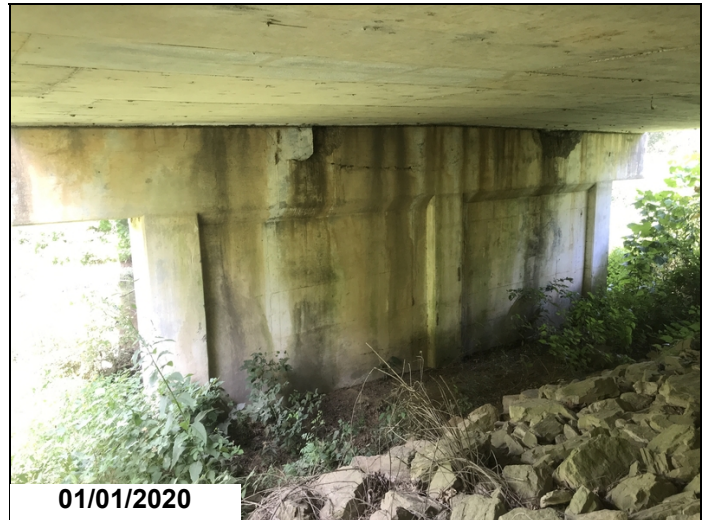
Bent 2 cap has large spalls with exposed reinforcing steel at the keyways.

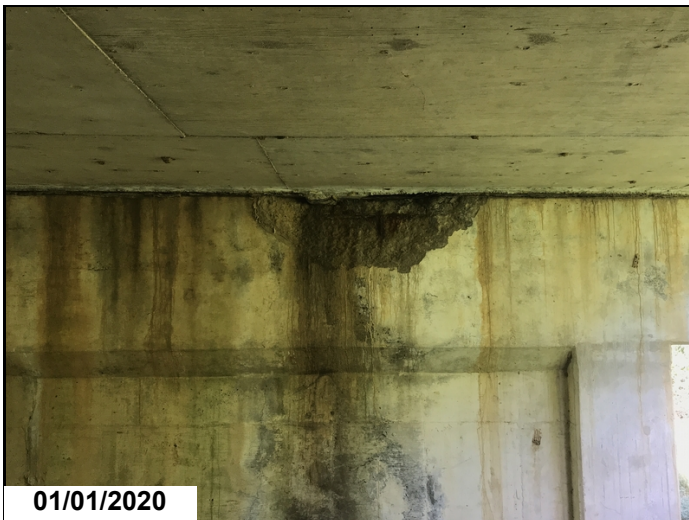
Bent 2 cap has large spalls with exposed reinforcing steel at the keyways.

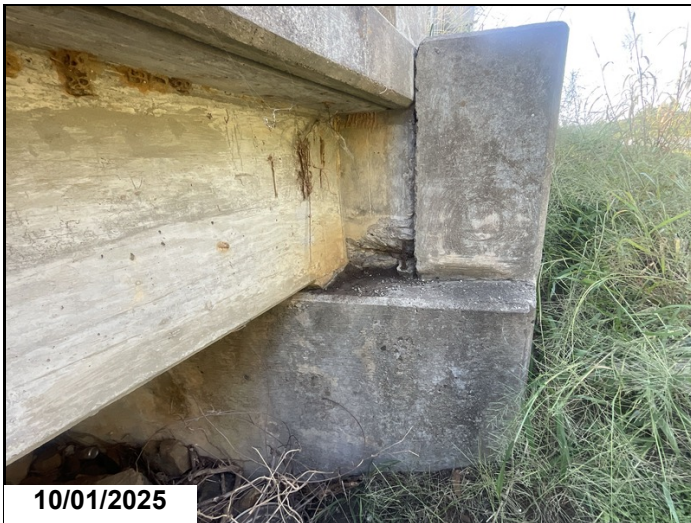
Abutment 1, Backwall, Left side: Spall with exposed reinforcing steel.

Type of Work: Repair (General)

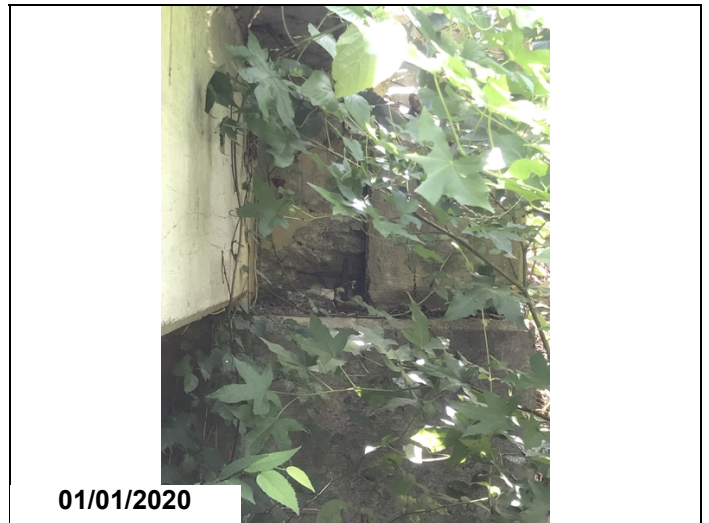
Abutment 1, Backwall, Left side: Spall with exposed reinforcing steel.

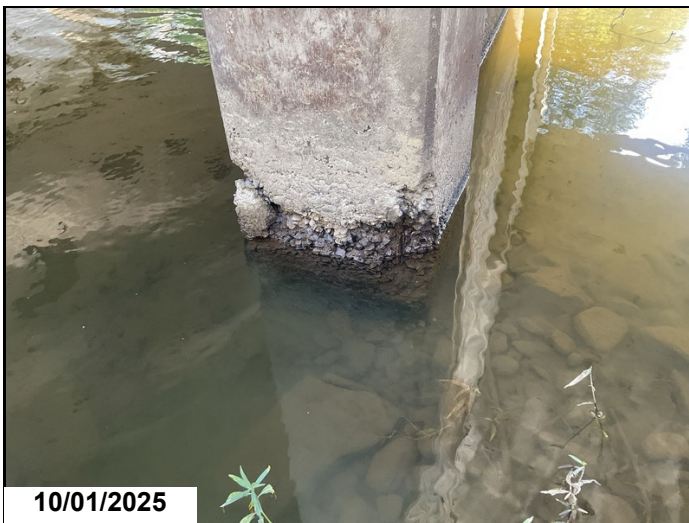
Bents 2 & 3, Column bases: Areas of concrete deterioration and deteriorated repairs.  
Bent 2, Column 1 base: Two 10" spalls with up to 5" of concrete section loss.

Bent 3, Column 1, Base at water elevation: Concrete deterioration up to 5" deep with exposed reinforcing steel.  
1EA CS3

Type of Work: Substructure Repair

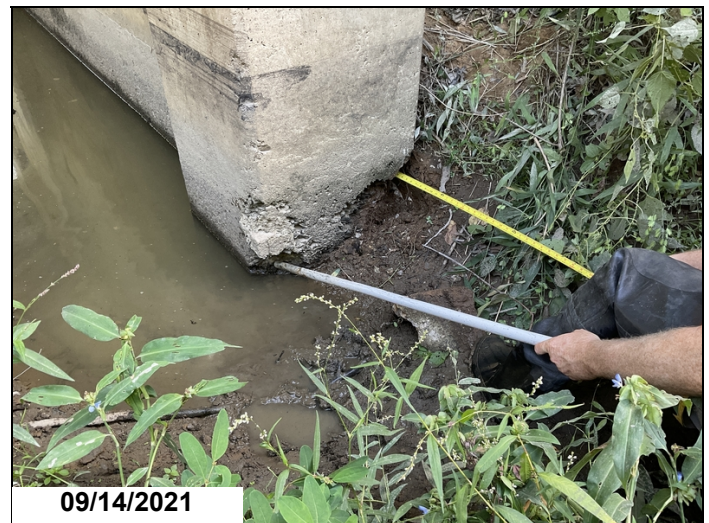
There are two 10" spalls at the base of bent # 2, column # 1 with up to 5" of concrete section loss.

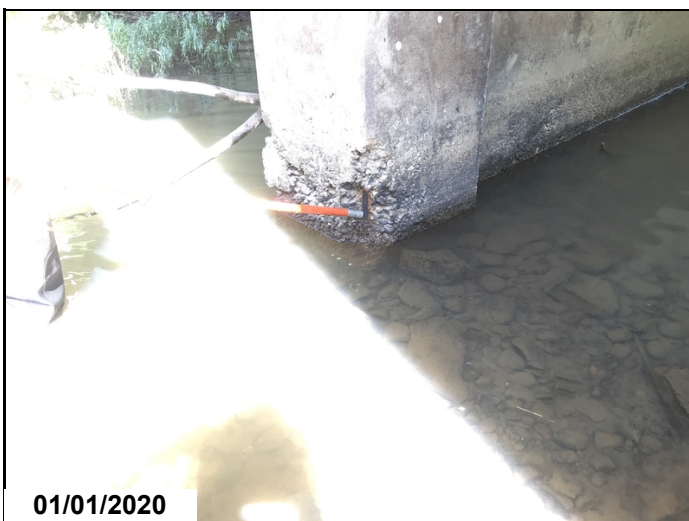
Bent # 3. Column # 1. Spall with exposed reinforcing steel with 1/8" section loss.

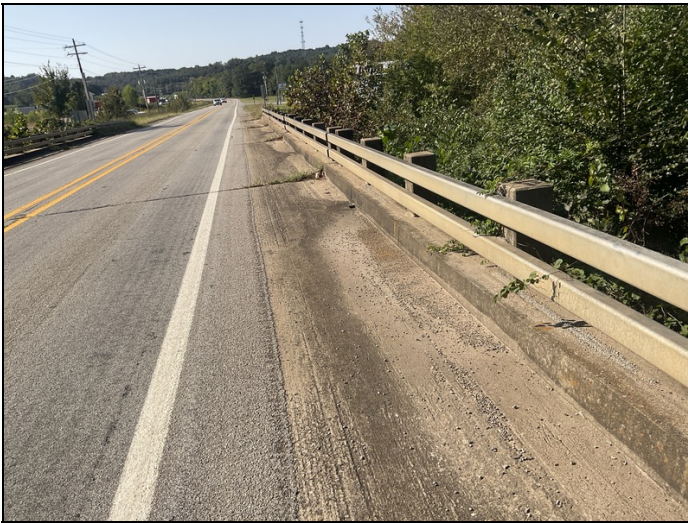
Deck shoulders have minor debris and gravel.

**A-55 - Deck Washing Needed (Yes)**

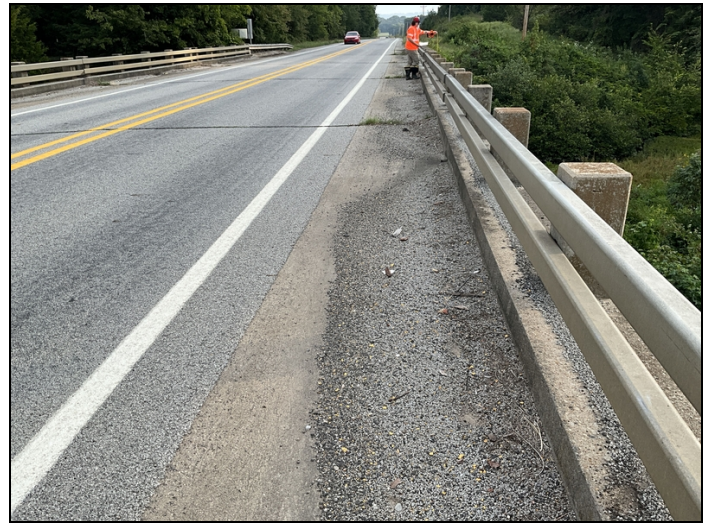
Deck shoulders have debris and gravel.

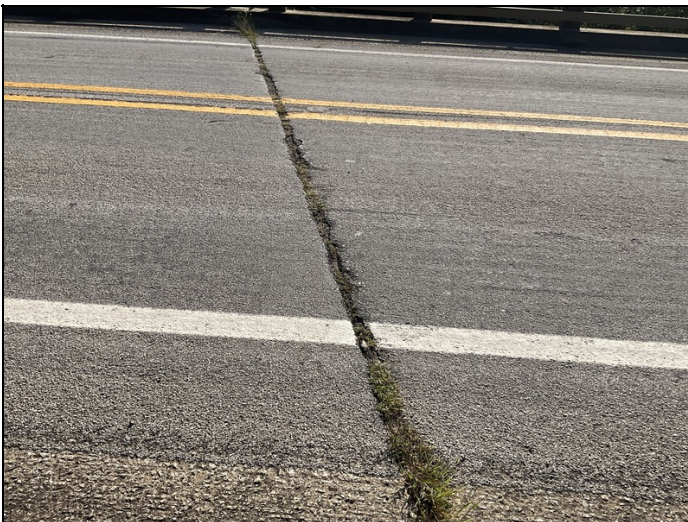
Expansion joint over Bent 4, Debris accumulation

**A-56 - Joint Cleaning/Flushing Needed (Yes)**

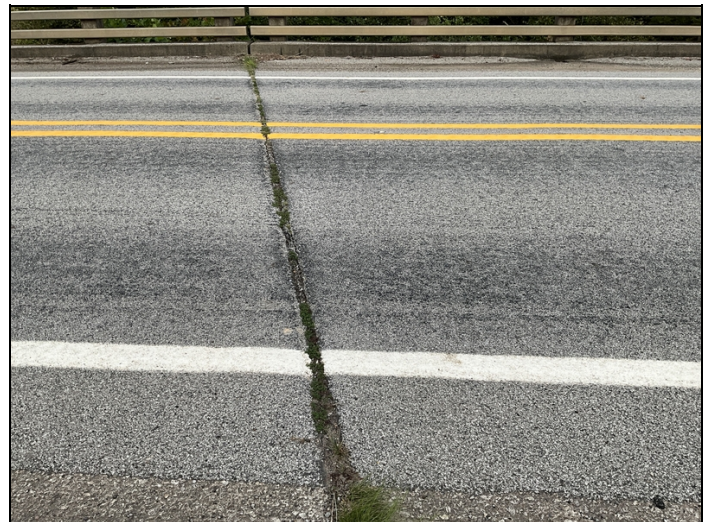
Bent 1, 2, and 3 has debris impactation with vegetation growth in joints.

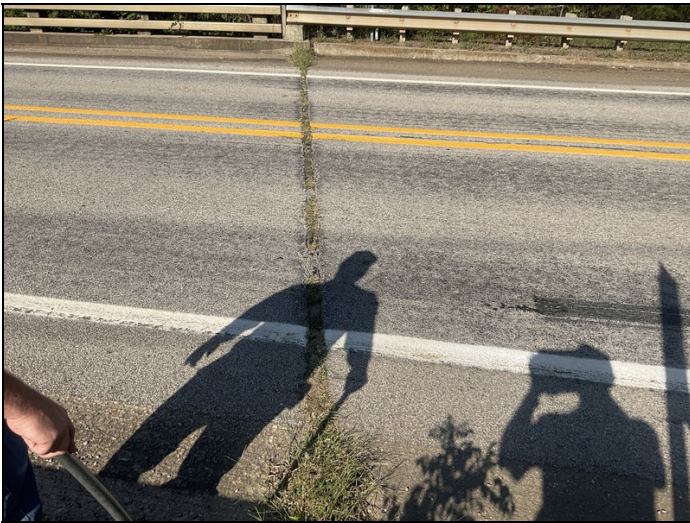
Abutment 2: expansion joint: debris accumulation.

**A-59 - Joint Repair Needed (Yes)**

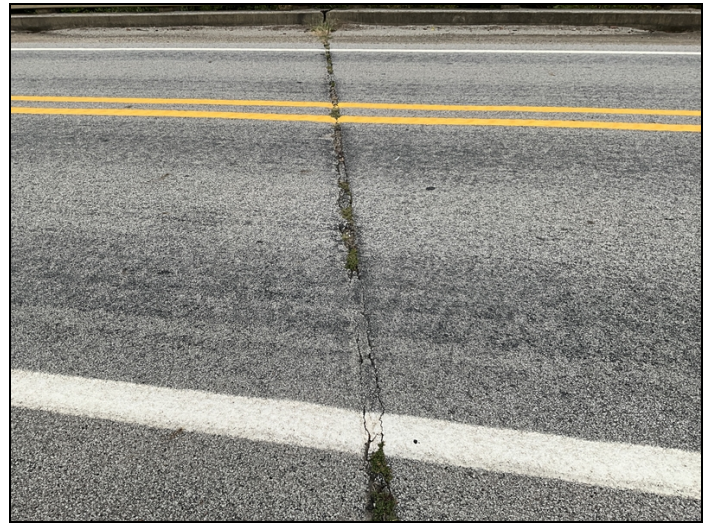
All joints have asphalt in joint that needs to be removed.

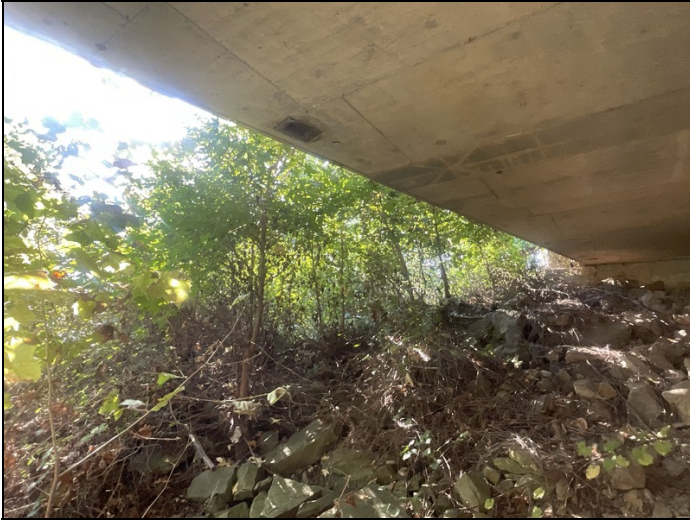
Vegetation. Span 1, Right.

**A-64 - Vegetation Removal Requested (Yes)**

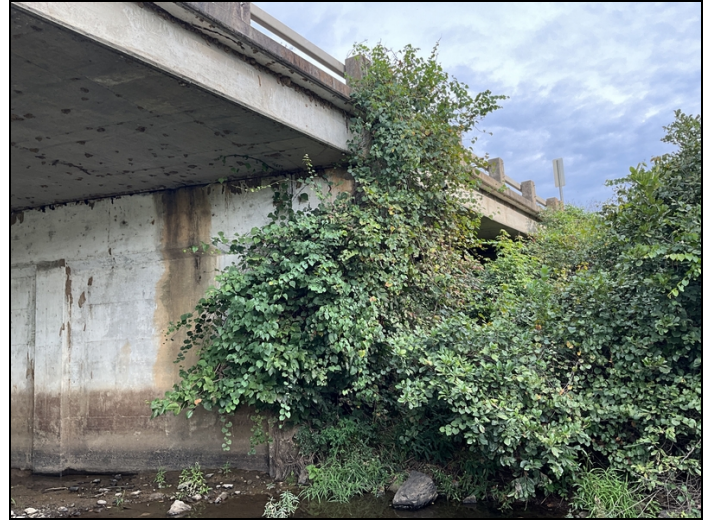
Bent 4 right side has vegetation growth.
