Bridge A3557 Inspection Report

Team Lead: Jeff Jones, Inspection Date: 07/08/2024

Asset #A3557(Routine, Underwater type 2)
State Highway 219 over Gar Branch-Franklin Co.
Location: 0.21 NO JCT 219 & 64
Team Lead: Jeff Jones Inspection Date: 07/08/2024

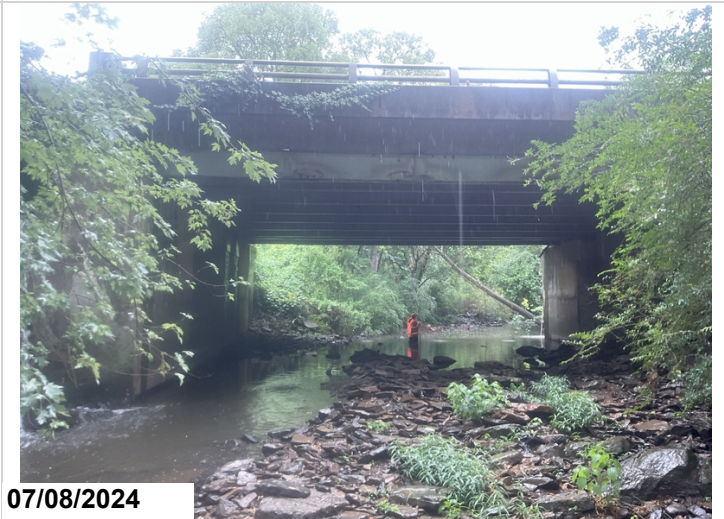
Elevation. Right side of structure.

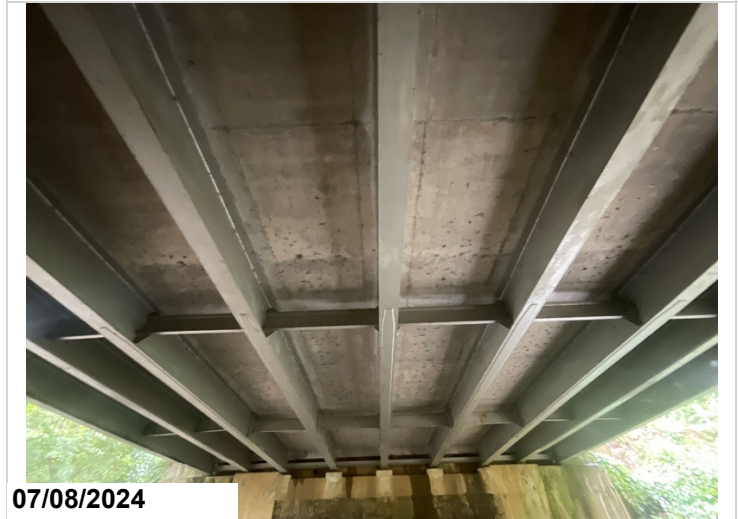
Undersurface of the deck. Typical.

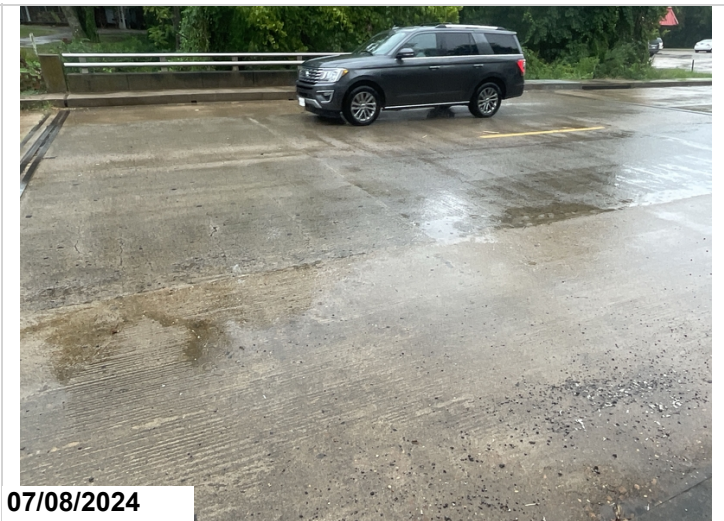
Deck. Typical.

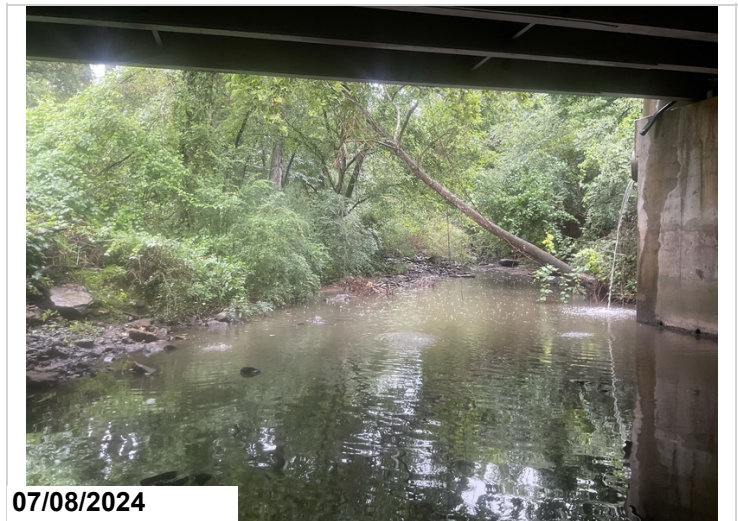
Channel left side of structure.

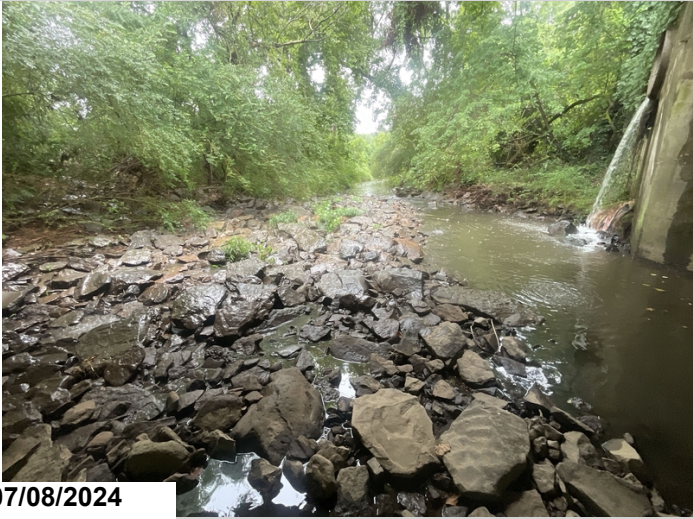
Channel. Right side of structure.

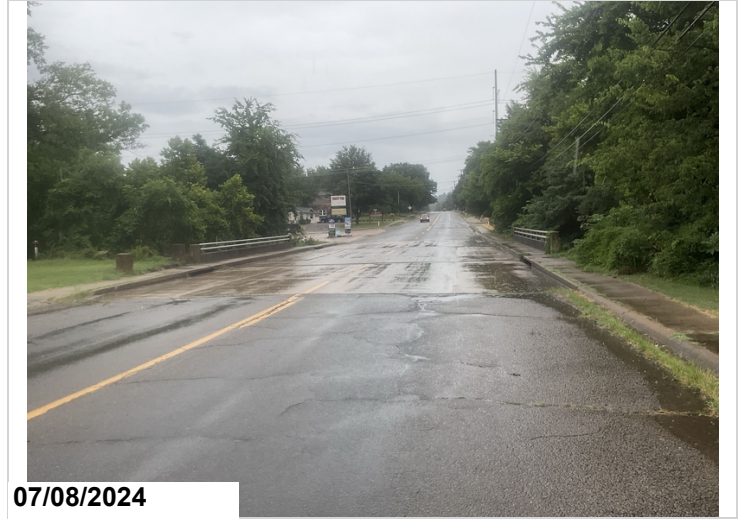
Approach roadway facing North.

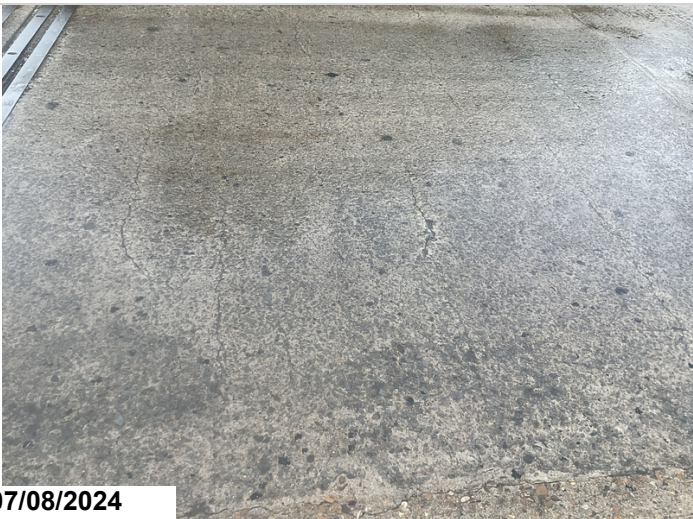
The driving surface of the deck has numerous areas of sealable transverse and map cracking.

Sealable map cracking in the deck.

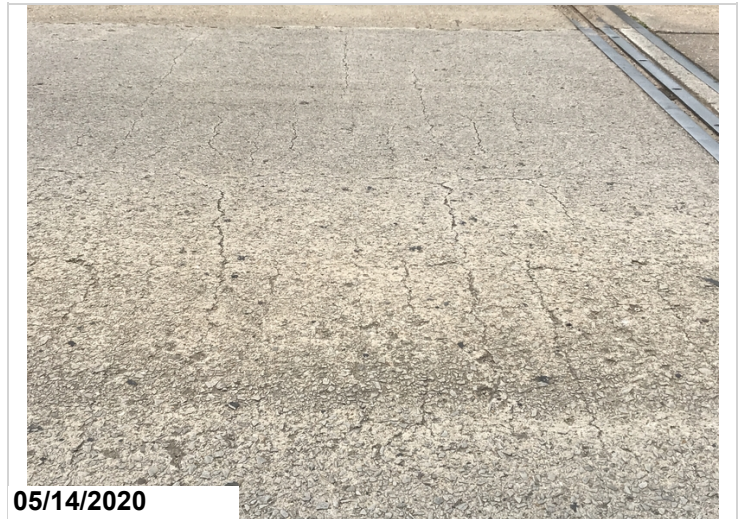
Right lane at abutment 2-Mapcracking.

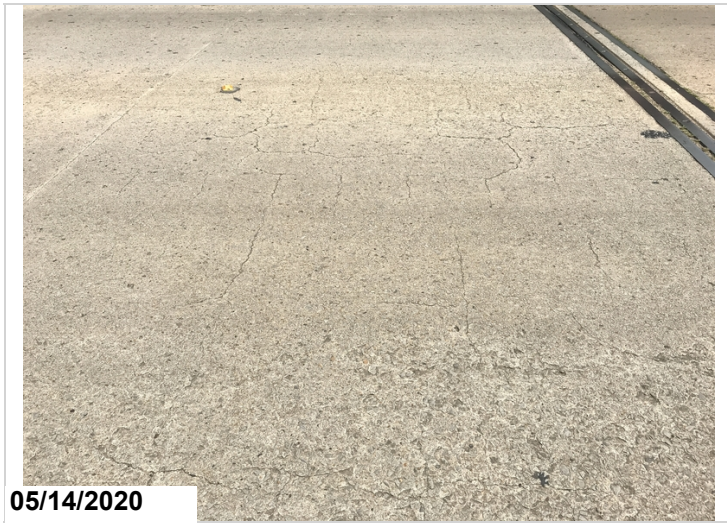
Mapcracking.

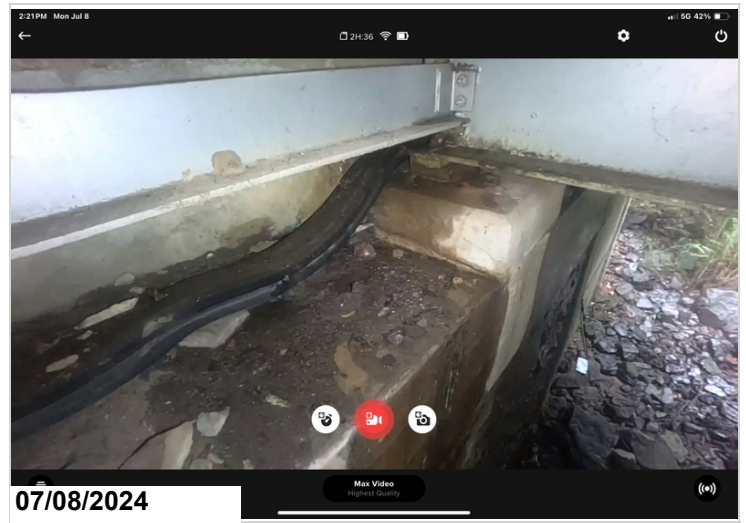
Abutment 2, Debris on cap.

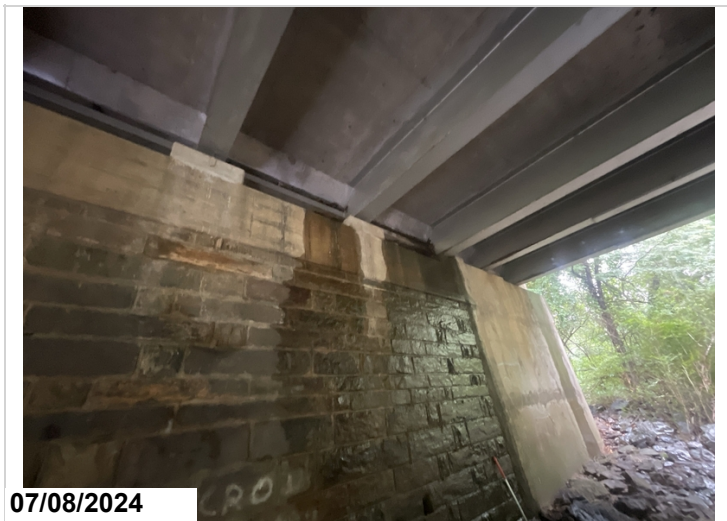
Abutment 2. Expansion joint seal leaking.

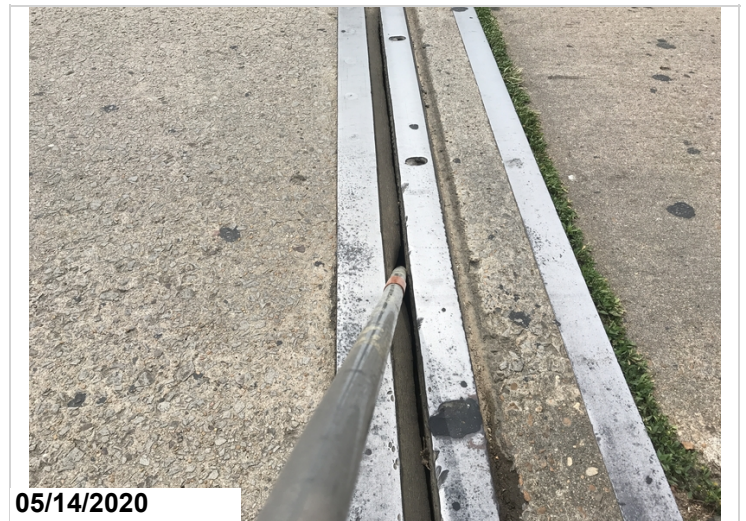
The pourable type expansion joint sealant at abutment # 2 (North abutment) has adhesion failure in the driving lane allowing water, dirt and debris to leak onto the substructure.

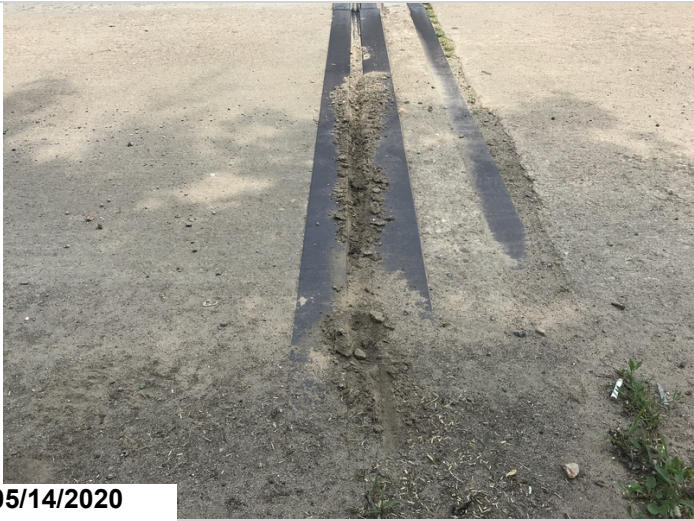
The pre-formed compression joint seal at abutment # 1 has dirt and debris causing adhesion failure.

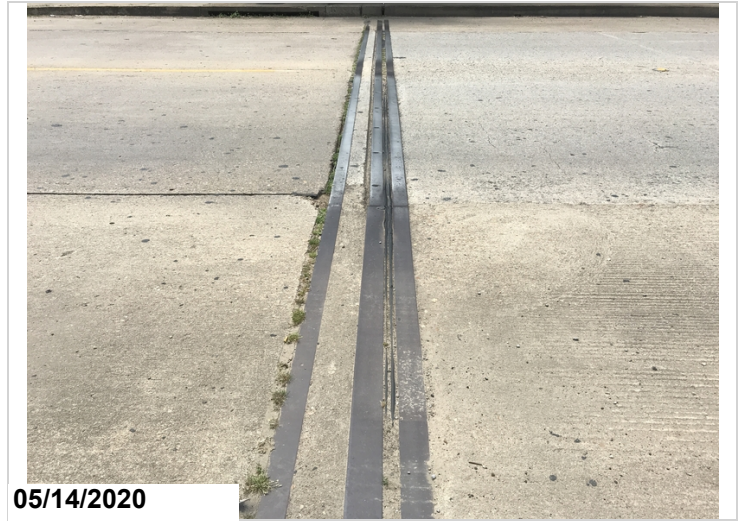
The pre-formed compression joint seal at abutment # 1 has dirt and debris causing adhesion failure.

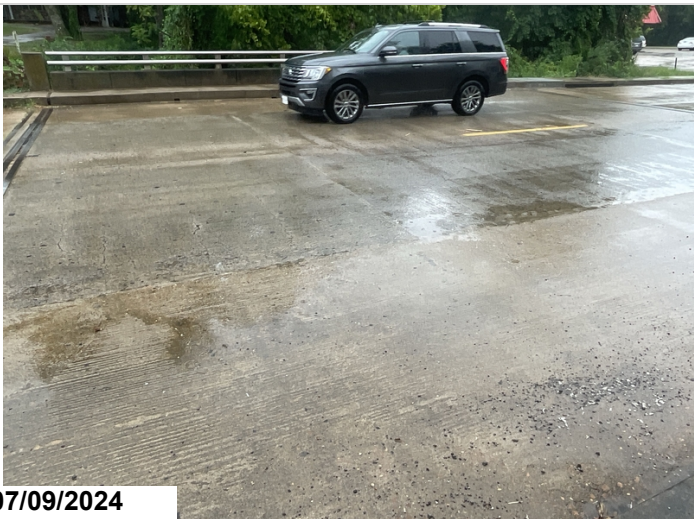
Deck. Typical.

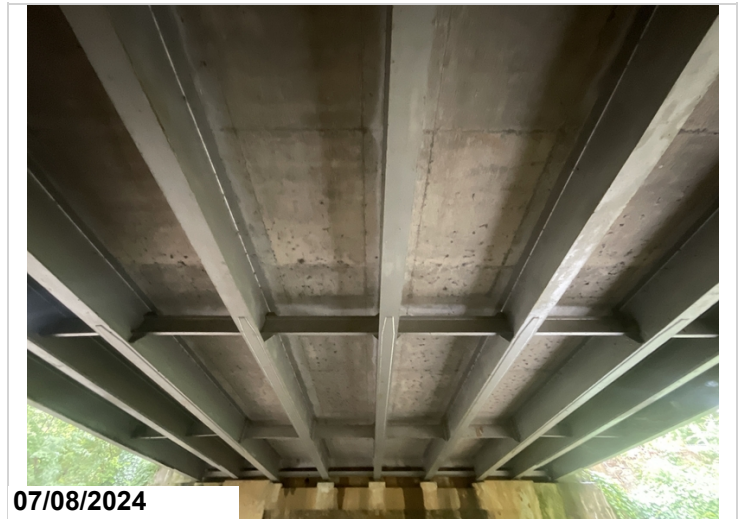
Undersurface of the deck. Typical.

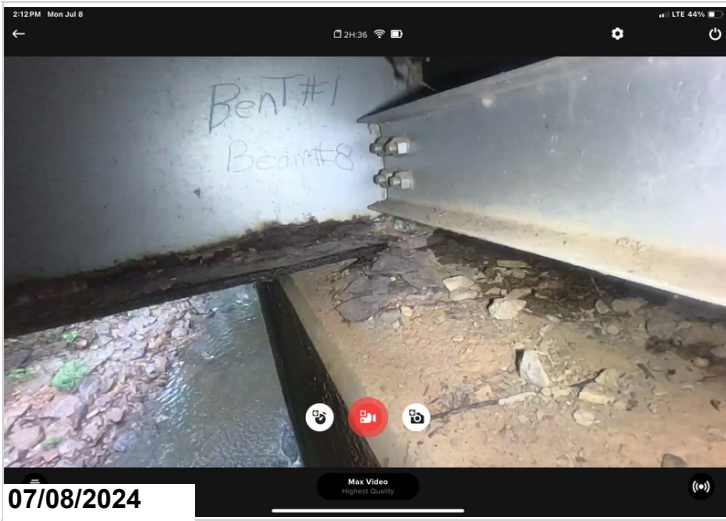
The superstructure has active corrosion with thick flaking rust to the ends of the beams with up to 1/16" section loss to base of webs and 1/8" section loss to the bottom flanges.

Abutment 1, Girder 8, Corrosion.

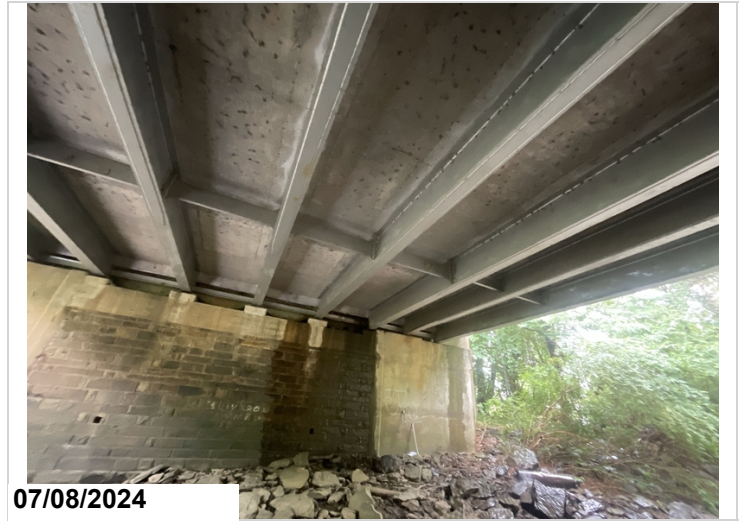
Superstructure. Typical.

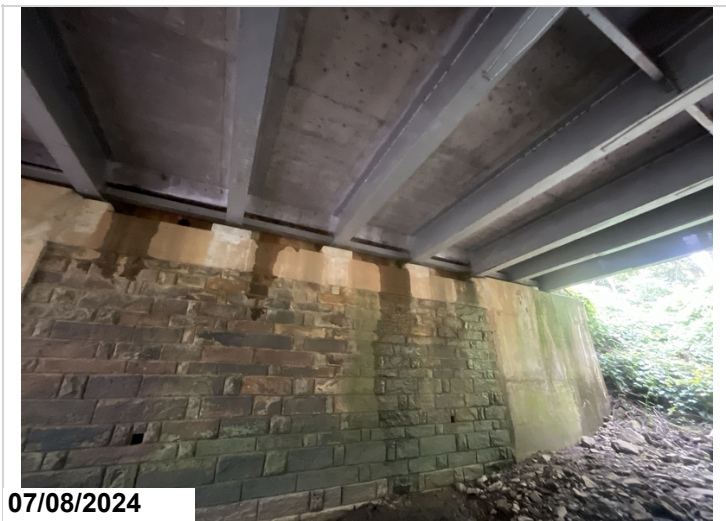
Superstructure. Typical.

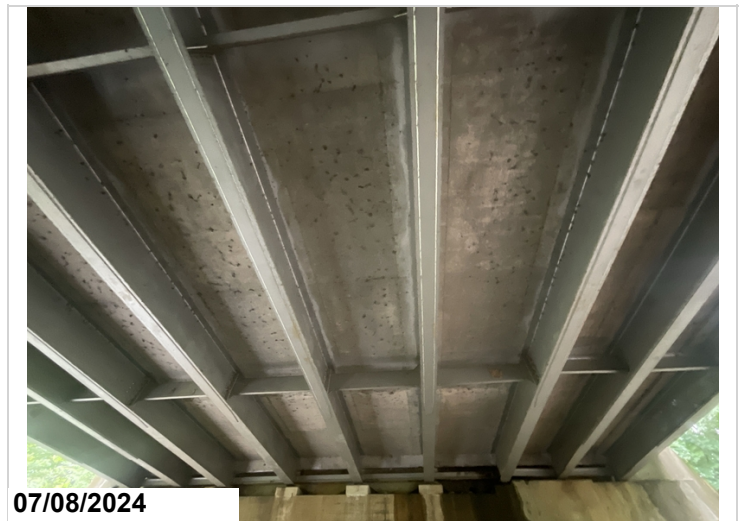
Superstructure. Typical.

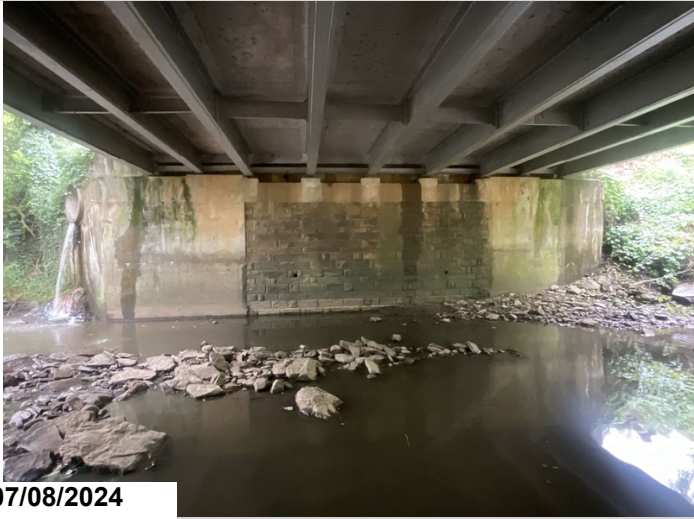
Abutment 1. Typical.

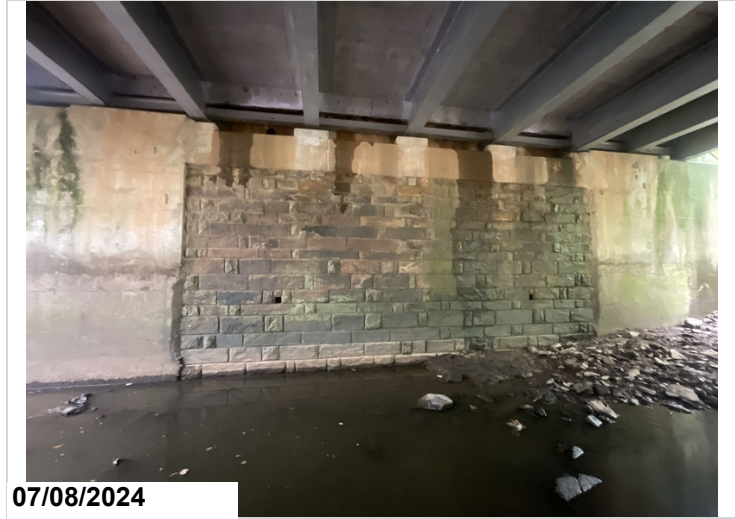
Abutment 1. Typical.

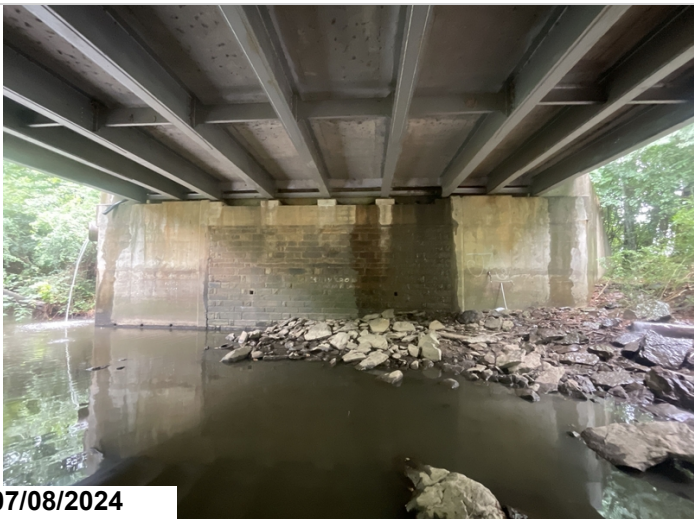
Abutment 2. Typical.

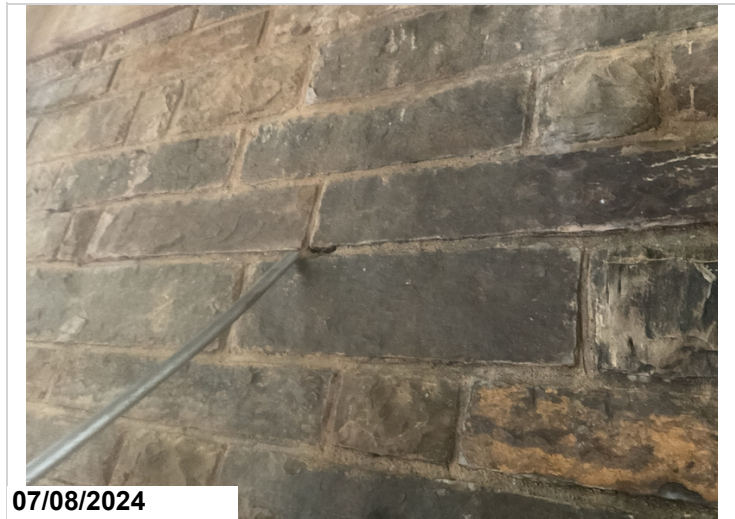
Abutment 2 has one small area of mortar deterioration between the stone. 1 LF CS2

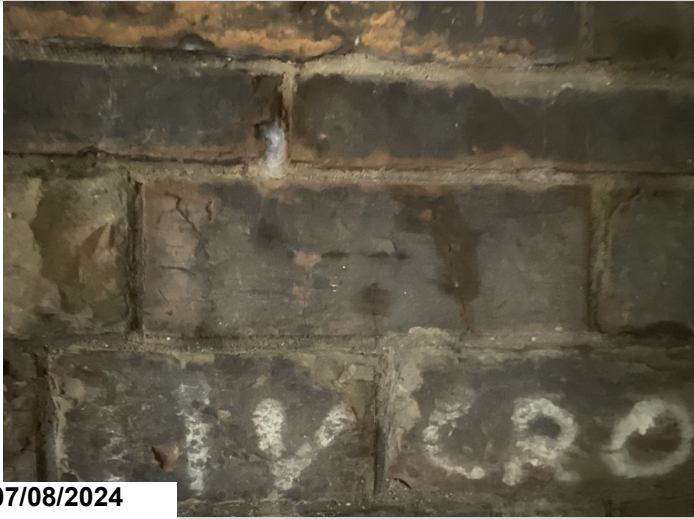
Abutment 2. Vertical crack in a stone.

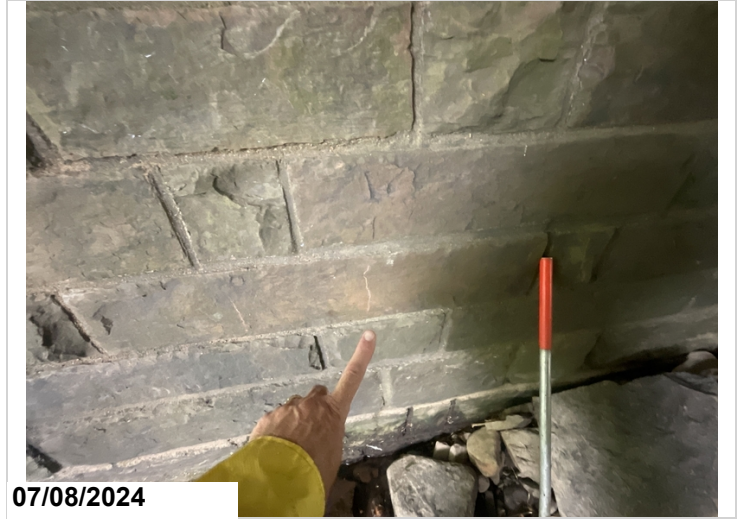
Abutment 2. Vertical crack in a stone.

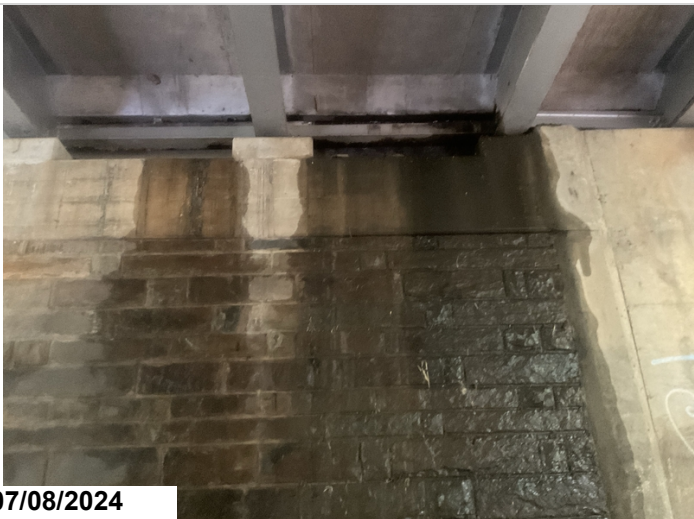
Abutment 2, Joint leakage.

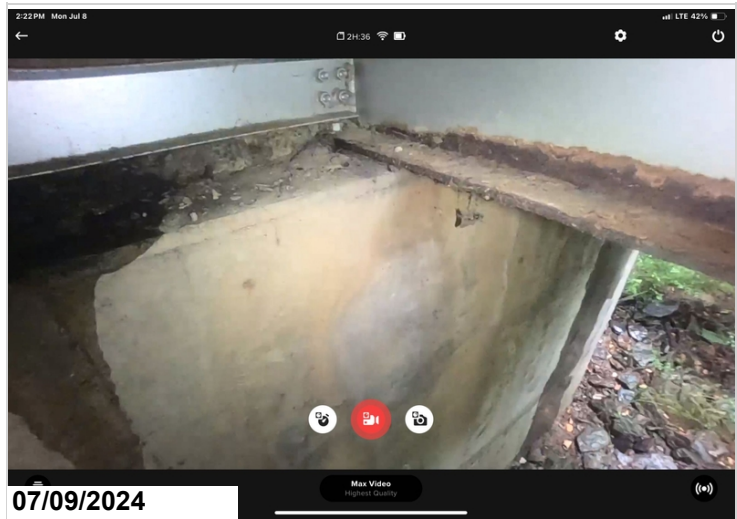
Abutment 2, Girder 8 Bearing corrosion.

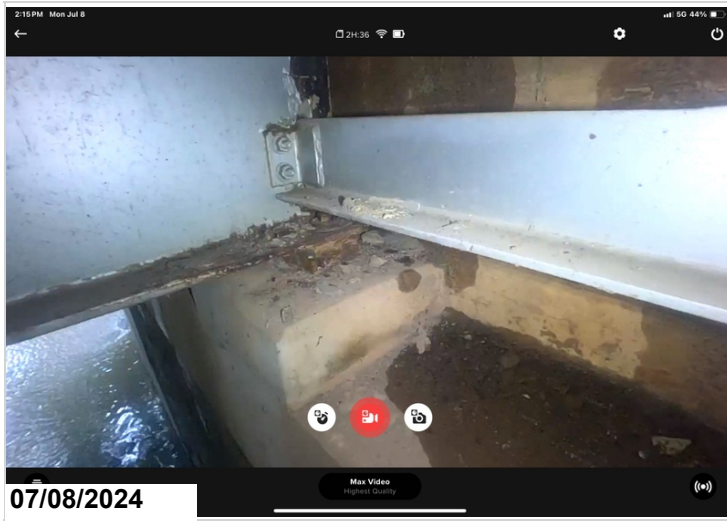
Abutment 1, Girder 5, Bearing Corrosion.

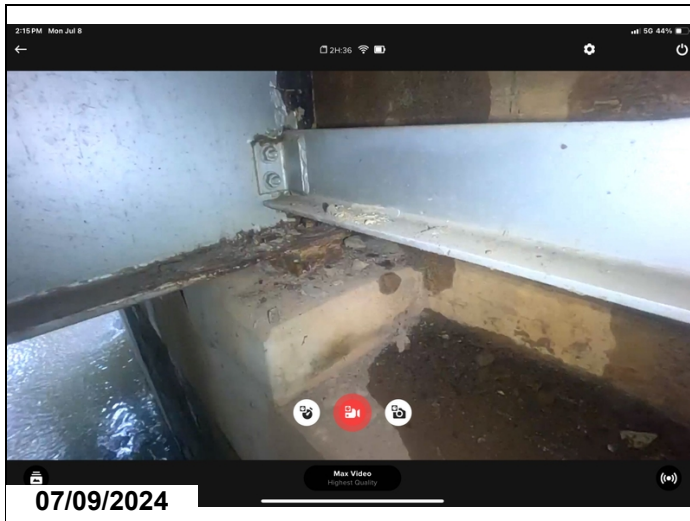
Abutment 1, Girder 5, Bearing Corrosion.

Type of Work: Bearing Repair/Replacement

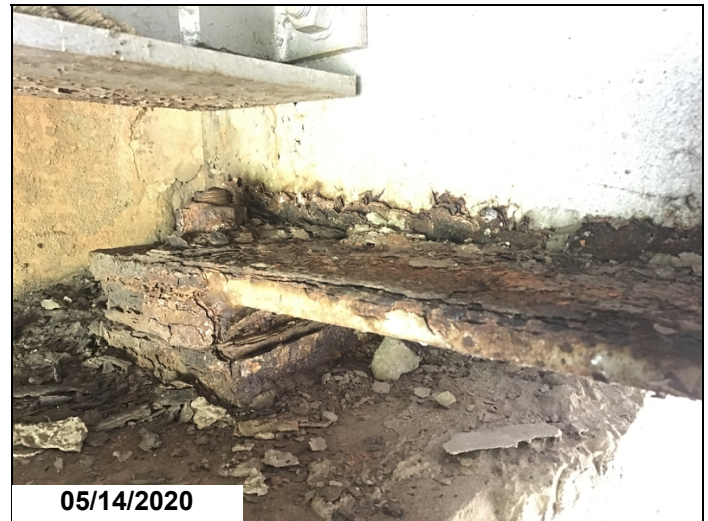
The bearings have areas of heavy corrosion with thick flaking rust and section loss. The bearings in some locations have heavy pack rust between the bearing plates.

A few of the bearings at both abutments have fretting visible with vertical movement under live load.

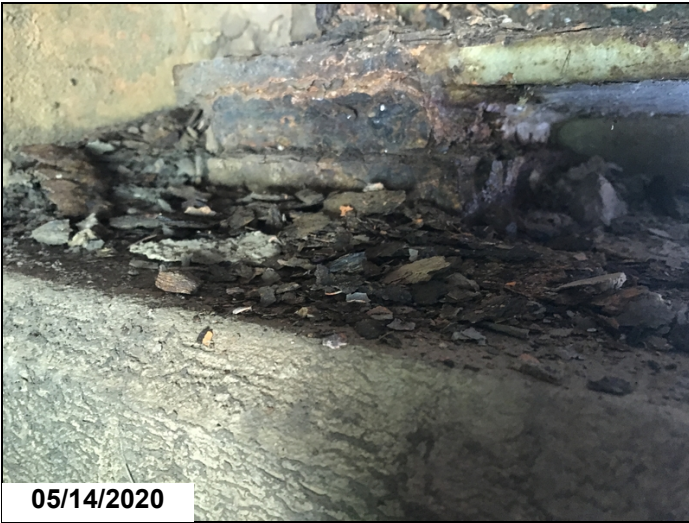
05/14/2020

The bearings have areas of heavy corrosion with thick flaking rust and section loss. The bearings in some locations have heavy pack rust between the bearing plates.

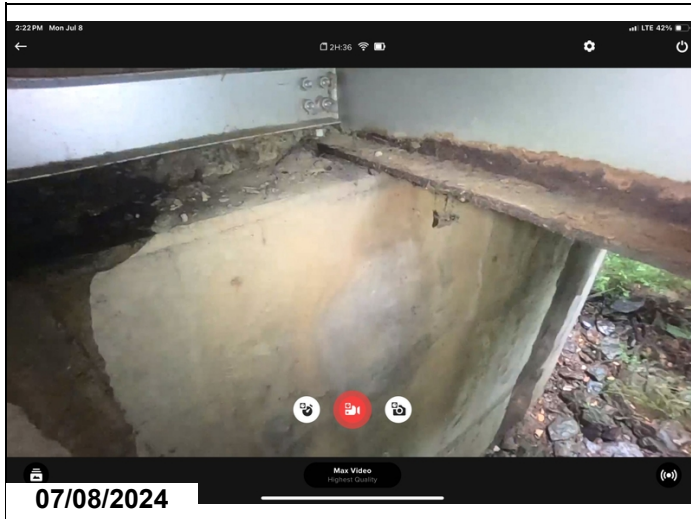
Abutment 2, Girder 8 corrosion.

Type of Work: Superstructure Repair

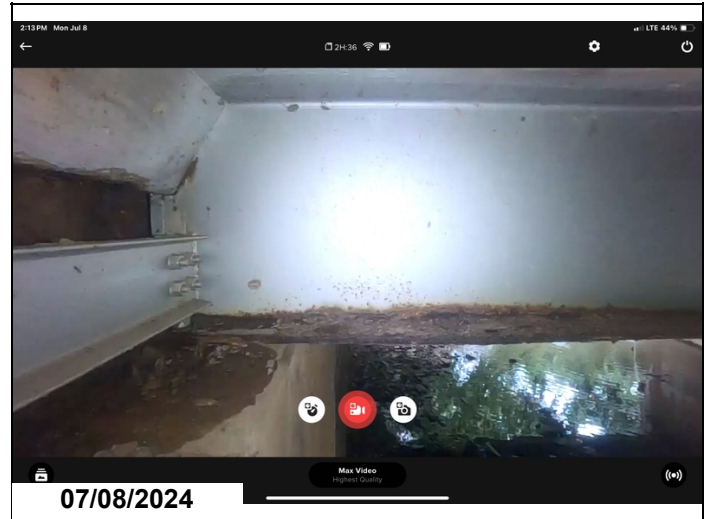
Abutment 1, Girder 8, Corrosion.

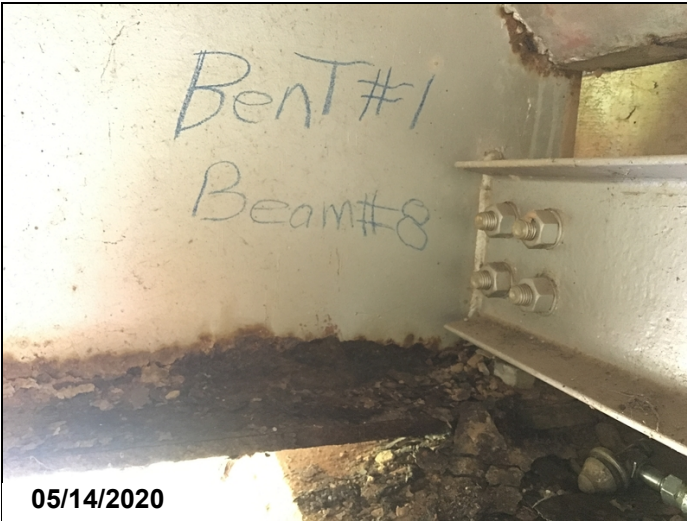
The superstructure has active corrosion with thick flaking rust to the ends of the beams with up to 1/16" section loss to base of webs and 1/8" section loss to the bottom flanges.

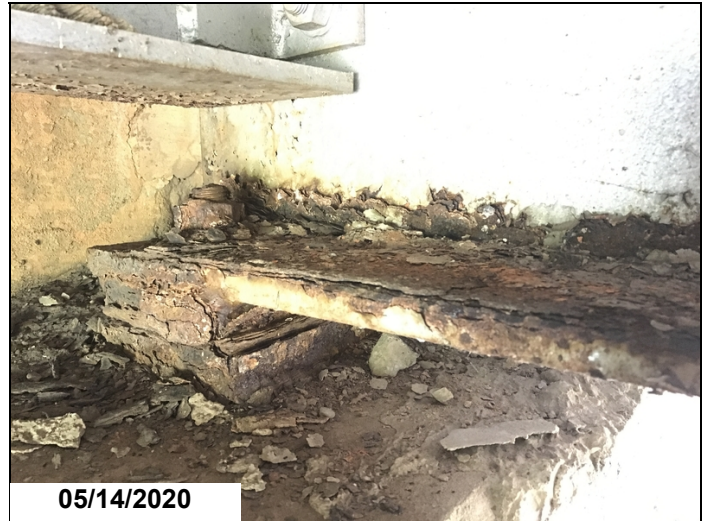
The superstructure has active corrosion with thick flaking rust to the ends of the beams with up to 1/16" section loss to base of webs and 1/8" section loss to the bottom flanges.

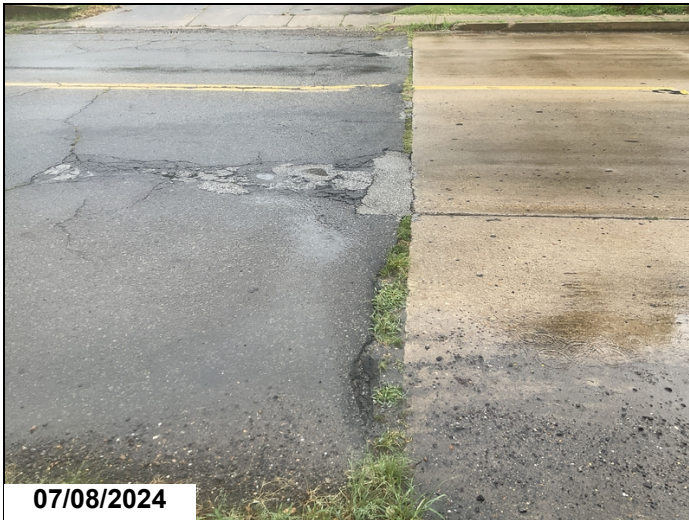
South approach Pot hole. Maintenance Forces have filled the pot hole with an asphalt patch.

07/08/2024 - JCJ & TJL - Maintenance Forces have filled the pot hole with an asphalt patch. Priority Code reduced to a "C" Priority during this inspection.

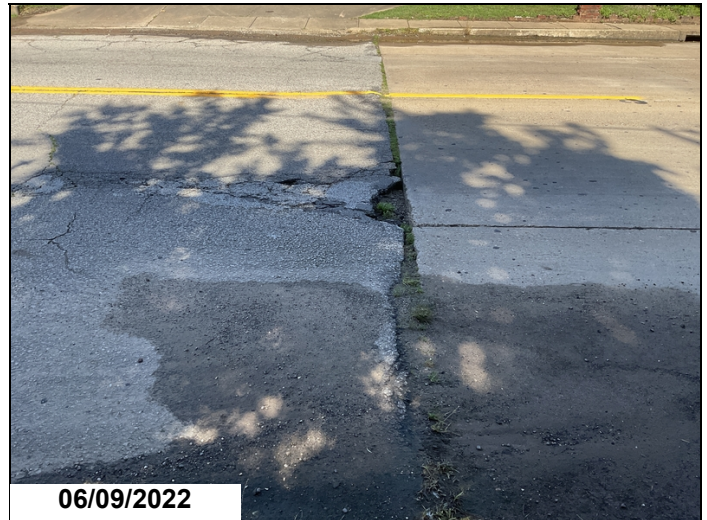
South approach roadway potholes at the end of the approach slab.

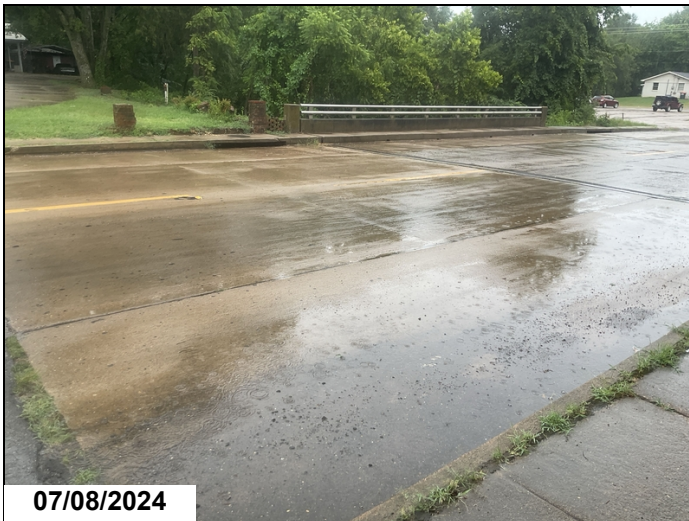
South approach Slab.

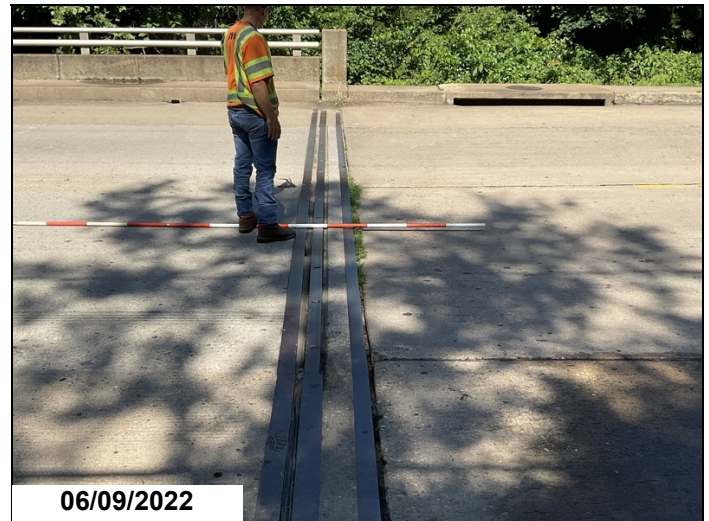
North approach slab settlement.

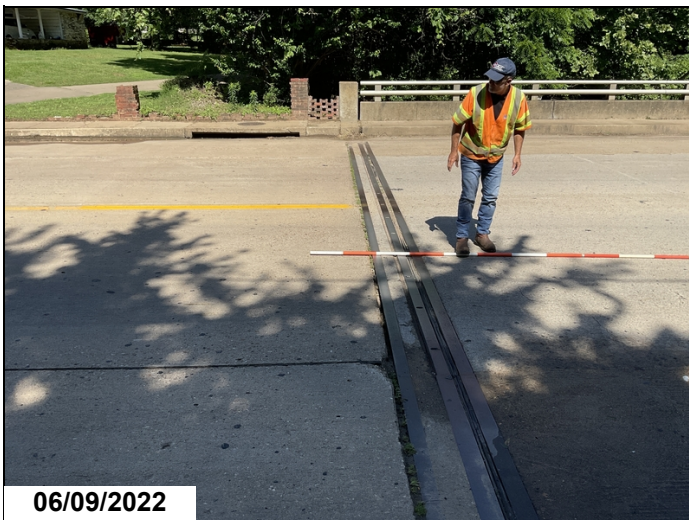
South approach slab settlement.

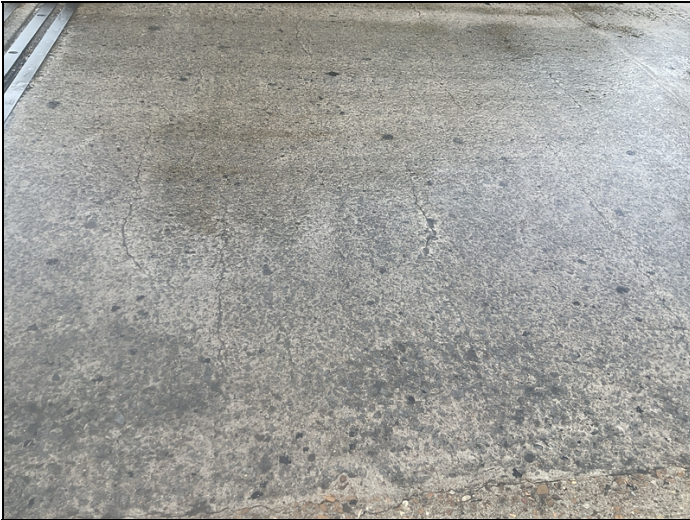
Sealable map cracking in the deck.

A-54 - Sealable Deck Cracks (Yes)

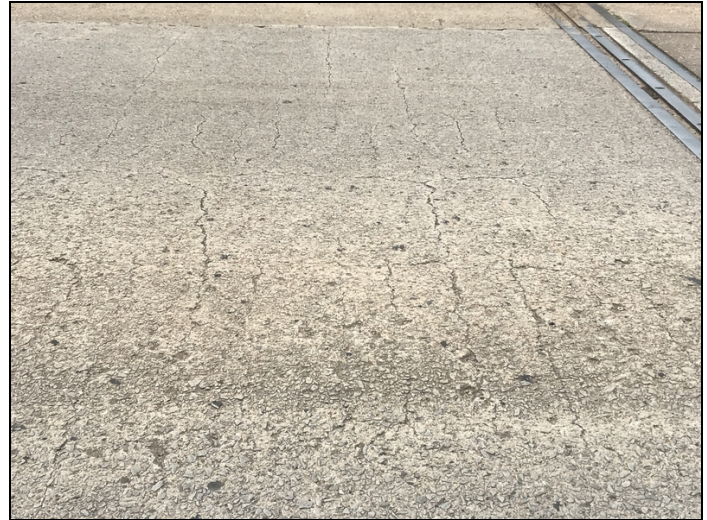
Right lane at abutment 2-Mapcracking.

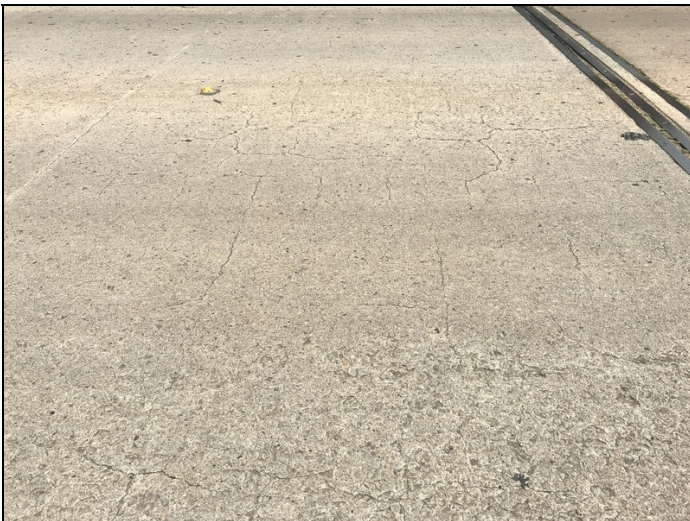
Mapcracking.

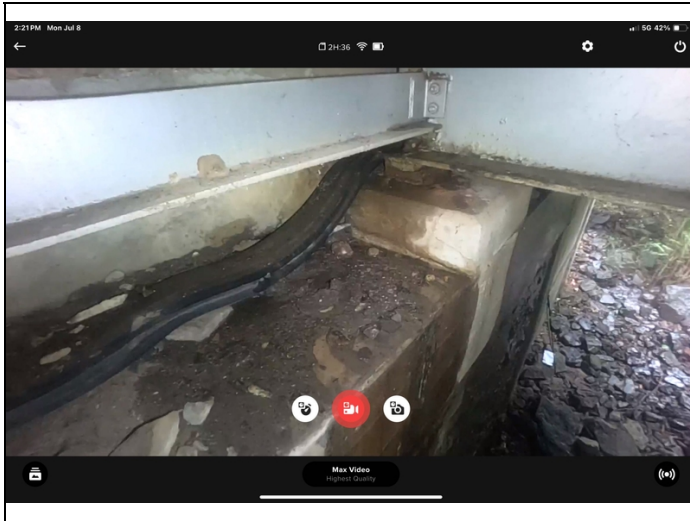
Abutment 2, Debris on cap.

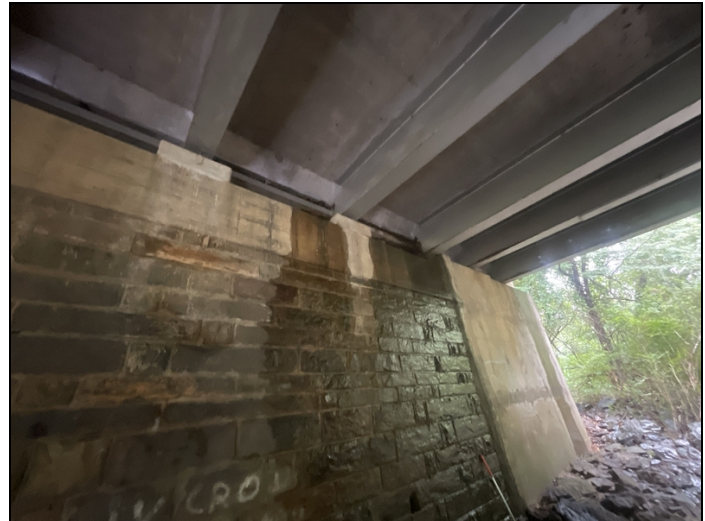
Abutment 2. Expansion joint seal leaking.

A-59 - Joint Repair Needed (Yes)

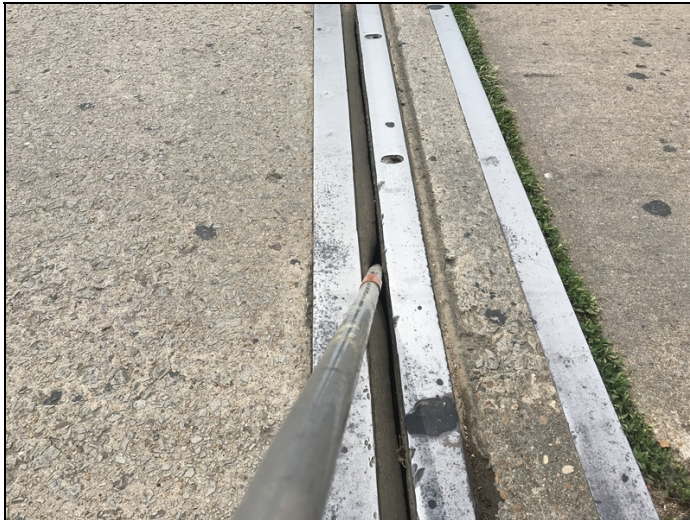
The pourable type expansion joint sealant at abutment # 2 (North abutment) has adhesion failure in the driving lane allowing water, dirt and debris to leak onto the substructure.

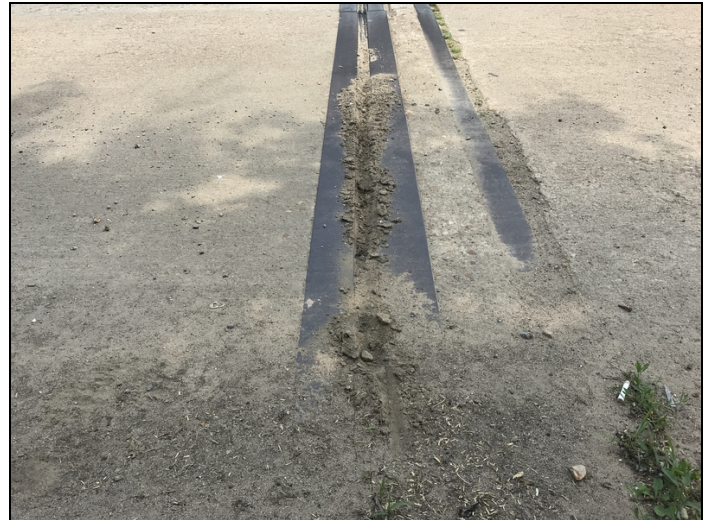
The pre-formed compression joint seal at abutment # 1 has dirt and debris causing adhesion failure.

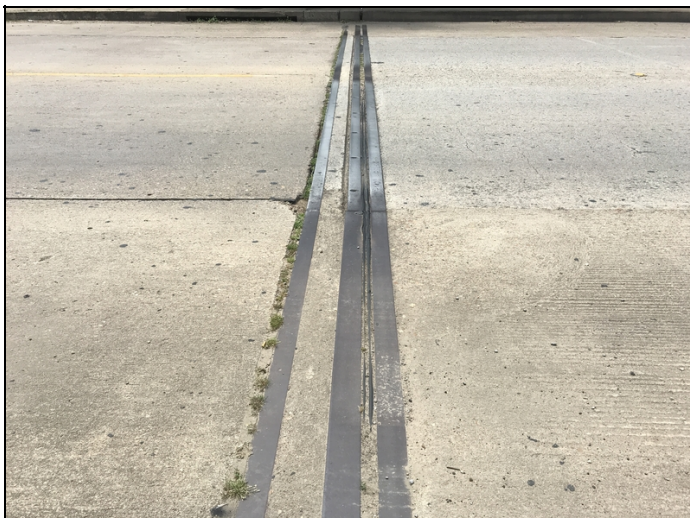
The pre-formed compression joint seal at abutment # 1 has dirt and debris causing adhesion failure.

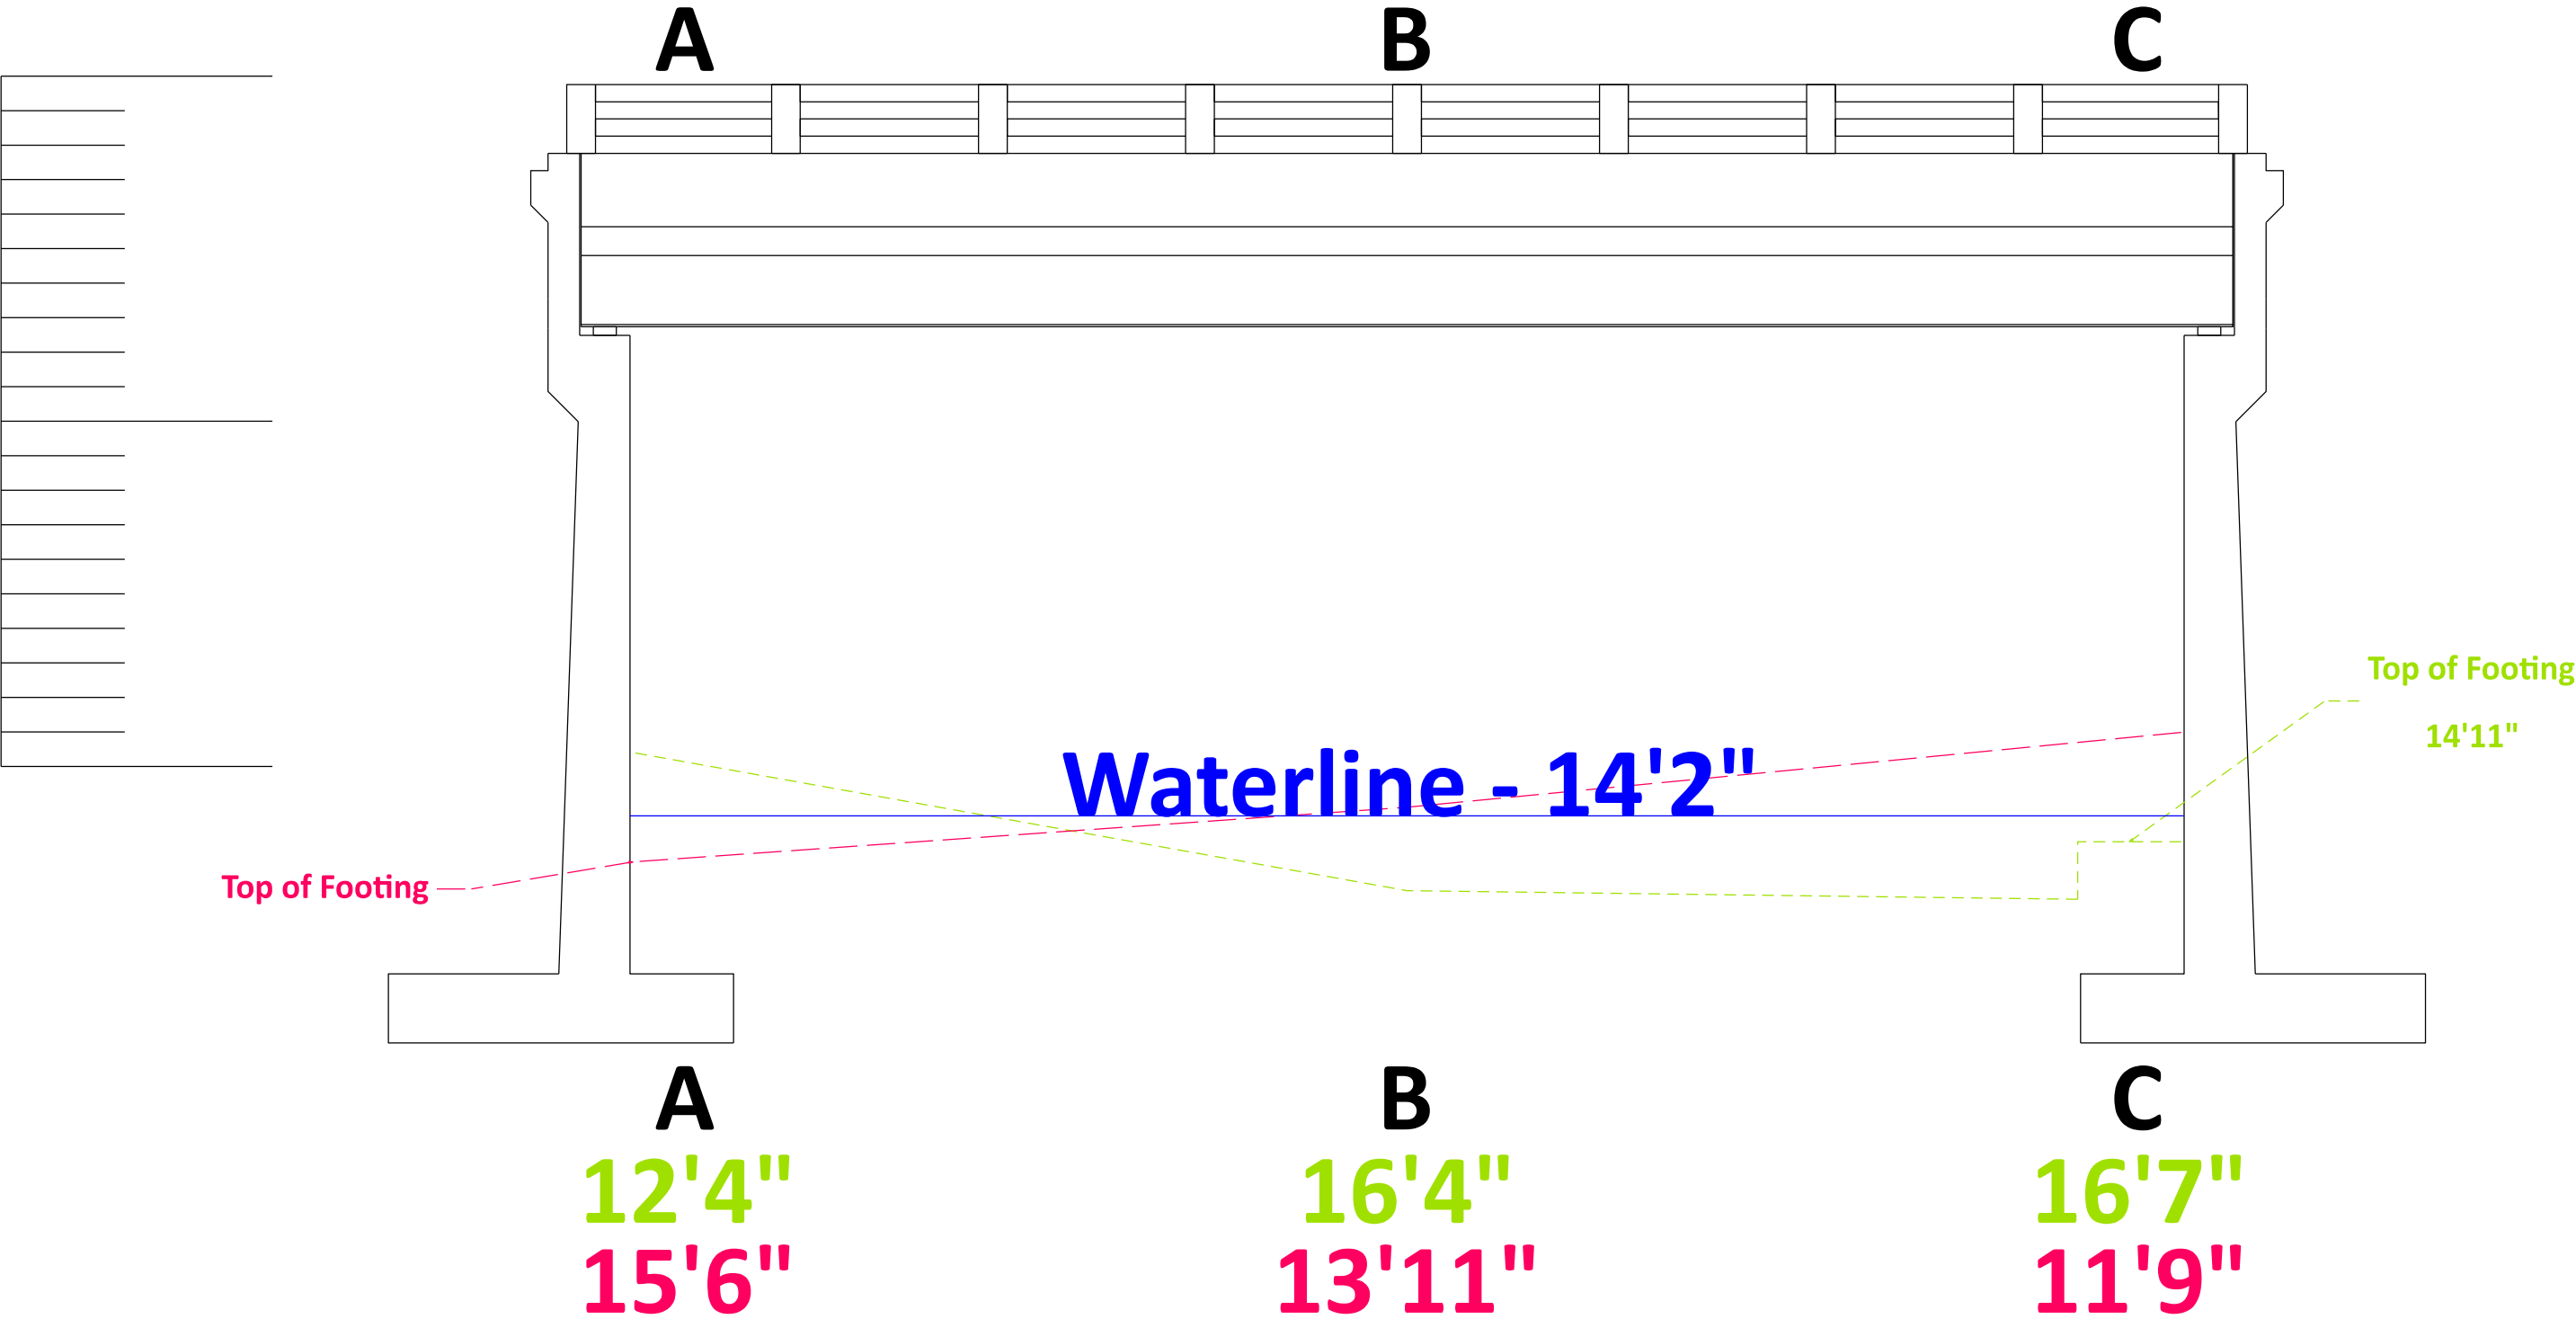
10' Scale

Measurements taken under exterior girders
