Bridge M1146 Inspection Report

National Bridge Inventory Data Sheet

Team Lead: Jeff Jones, Inspection Date: 04/09/2024

Asset #M1146(Routine)
US Highway 64 over Ditch - Franklin Co.

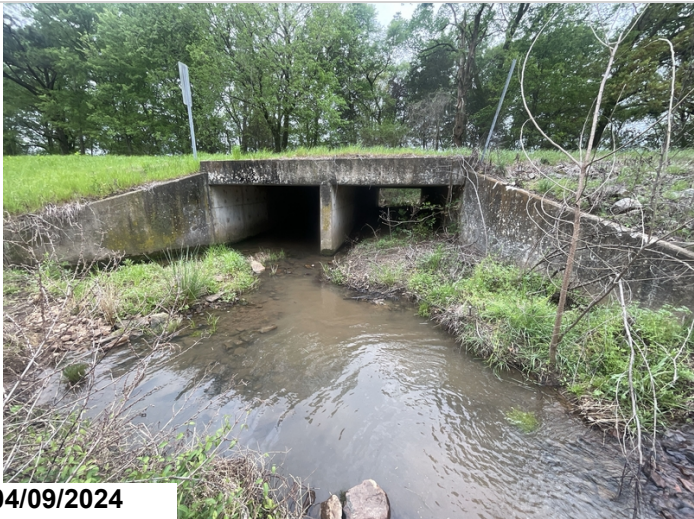
Elevation. Left side of structure.

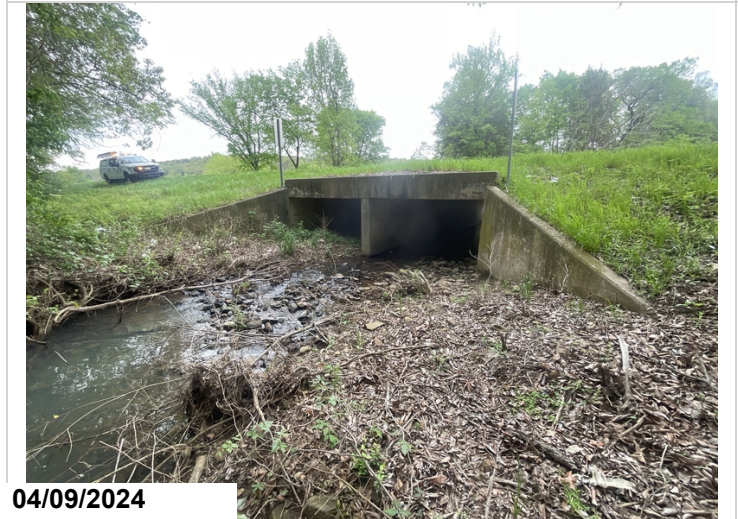
Elevation. Right side of structure.

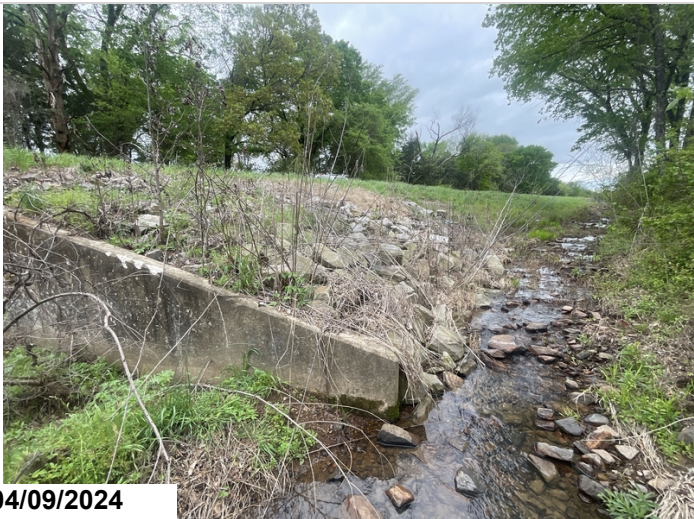
Maintenance forces have placed rip rap in the eroded area behind the Northwest wing wall in the past, repair is still holding.

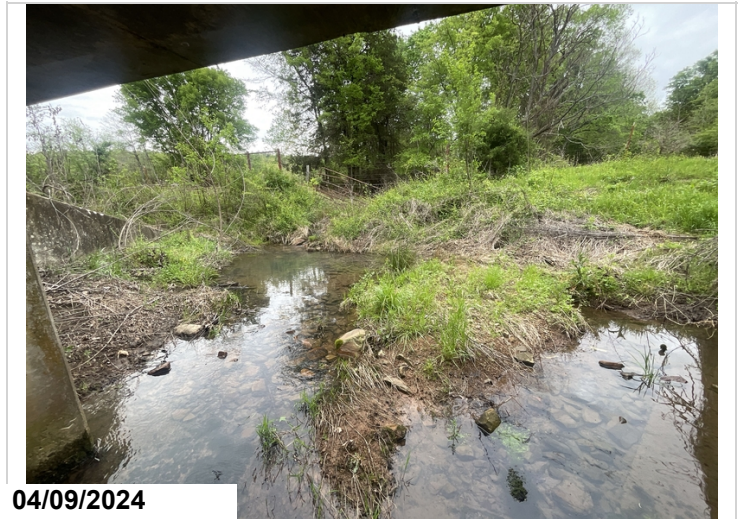
Channel. Left side of structure.

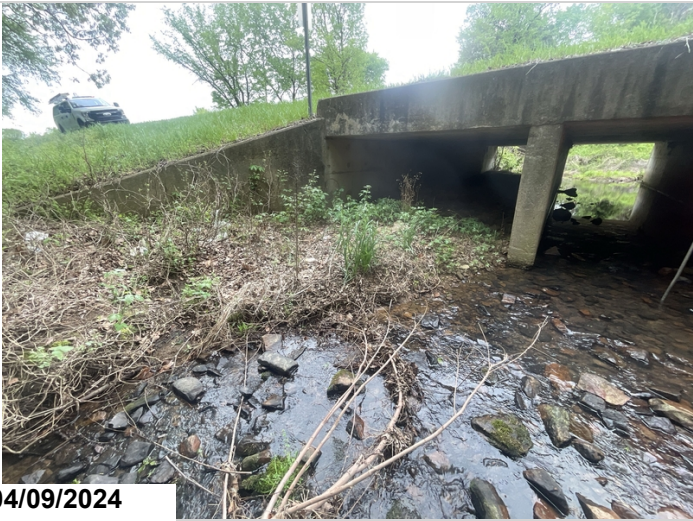
61 - Channel/Channel Protection (6 - Bank is beginning to slump. River control devices and embankment protection have widespread minor damage. There is minor stream bed movement evident. Debris is restricting the channel slightly.) Maintenance forces have placed rip rap in the eroded area behind the Northwest wing wall in the past, repair is still holding during this inspection.
Channel on the right side of structure has embankment erosion.
There is gravel accumulation in the channel that restricts the opening of Barrel # 1.
There is approximately 20" of rock accumulation in Barrel # 1.

RC Box Culvert -
There is approximately 20" of rock accumulation in Barrel # 1.

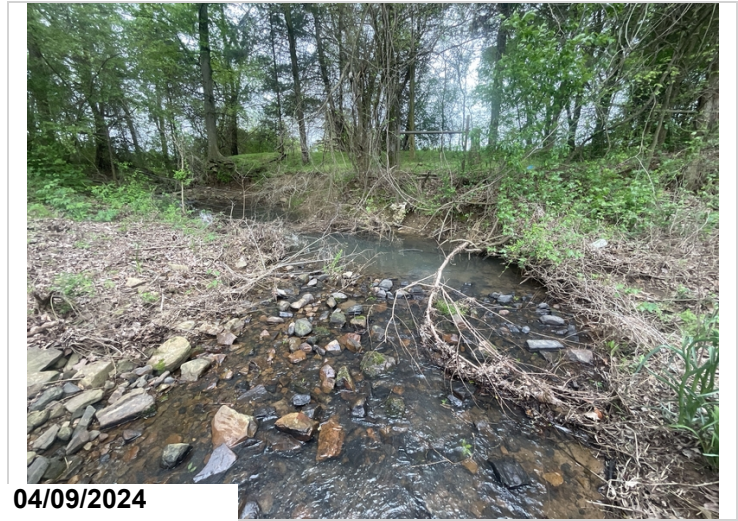
Channel. Right side of structure.

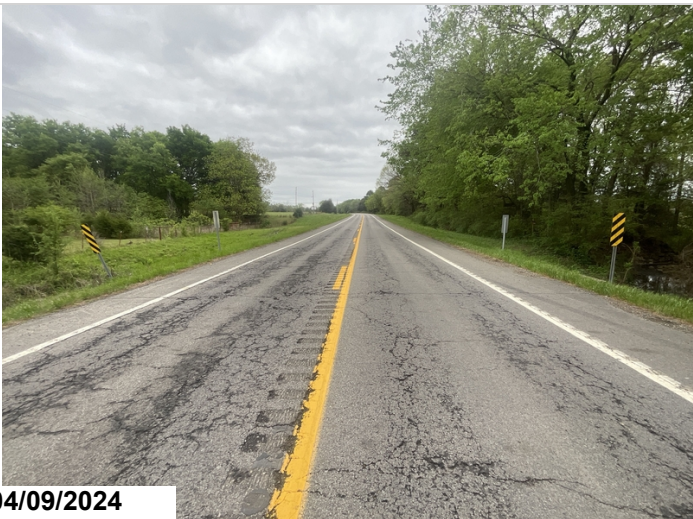
Approach roadway facing East.

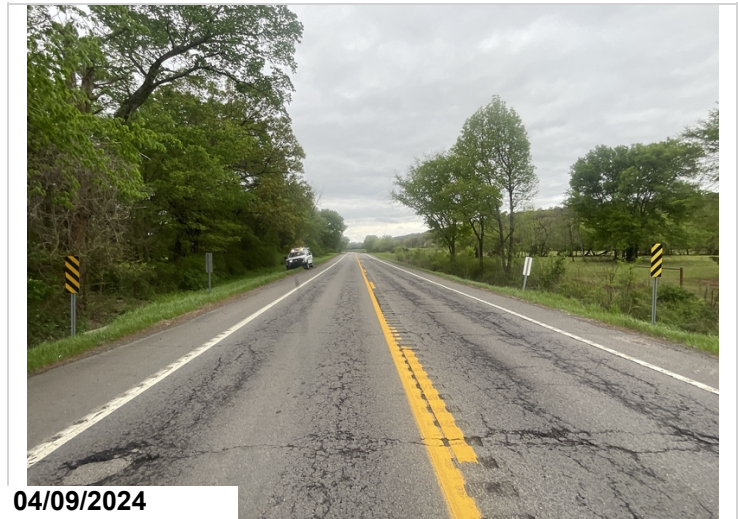
Approach roadway facing West.

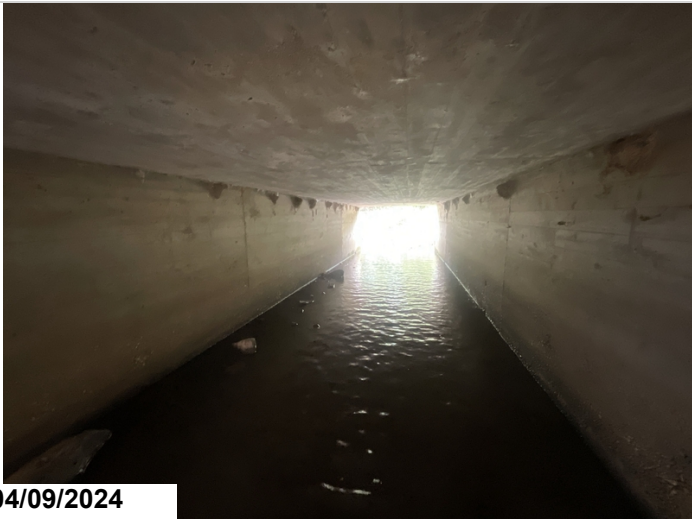
Barrel # 2. Typical.

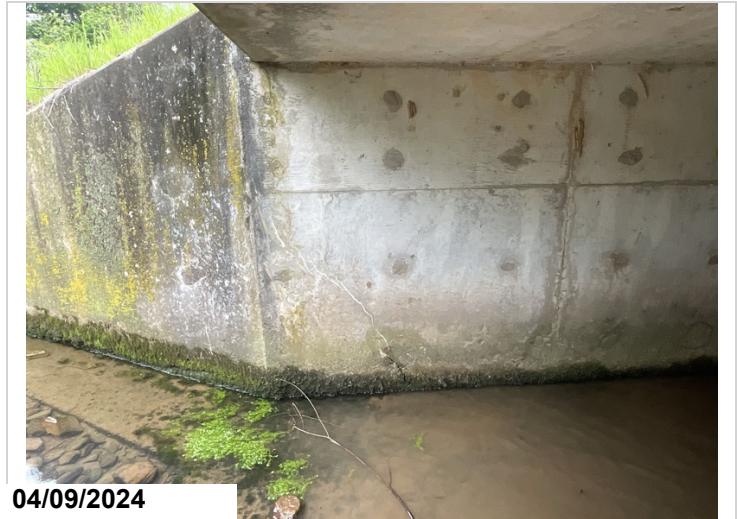
Barrel # 2 Exterior wall, left end has a diagonal crack with efflorescence adjacent to the wing wall juncture. 3LF CS2

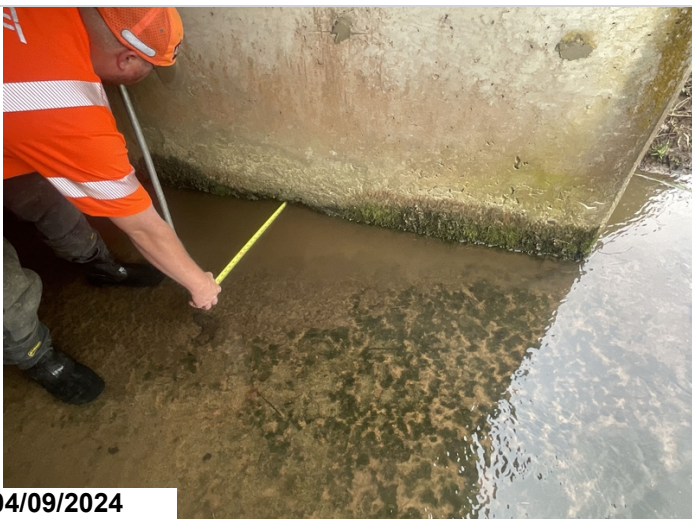
The base of Wall # 2 Ahead face, Right side has minor concrete deterioration up to 2" deep. 1' long x 3 1/2" tall x 3" deep concrete section loss. 1LF CS3

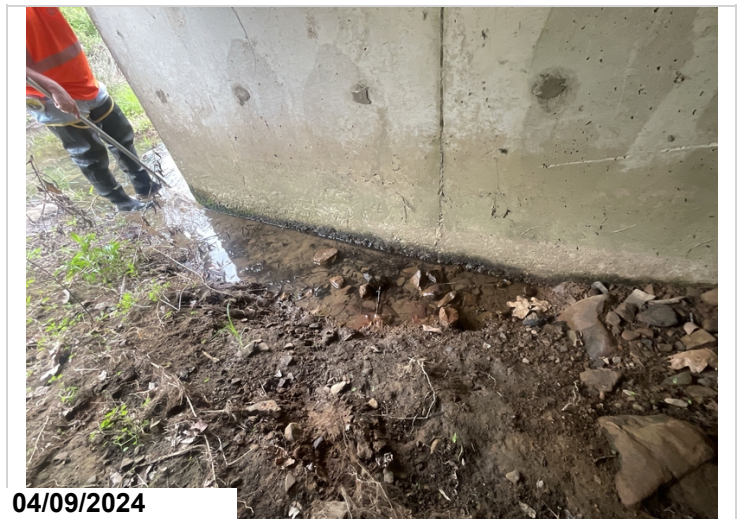
Wall # 2. Abrasion. 7LF CS3

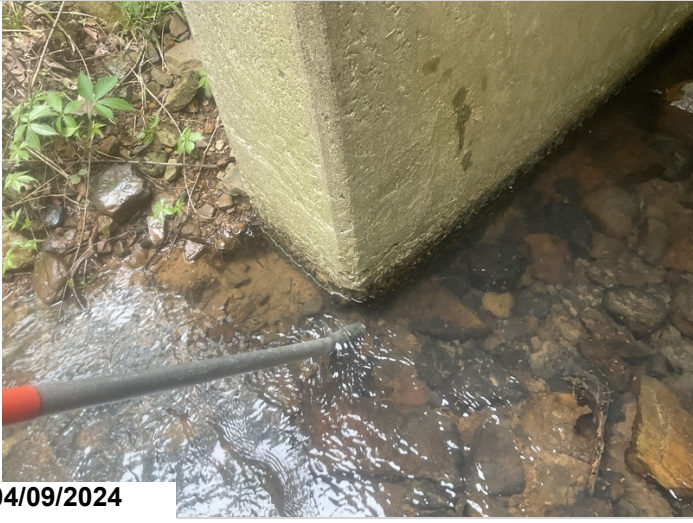
The base of Wall # 2 Right has minor concrete deterioration
1LF CS3

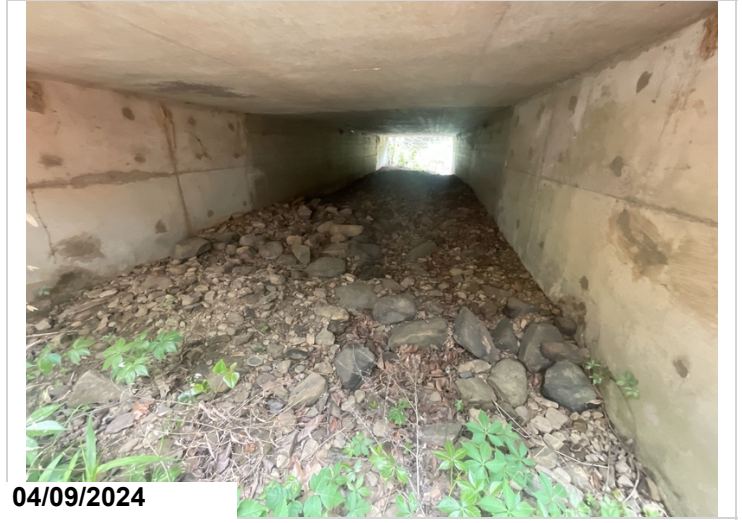
Barrel # 1. Typical.

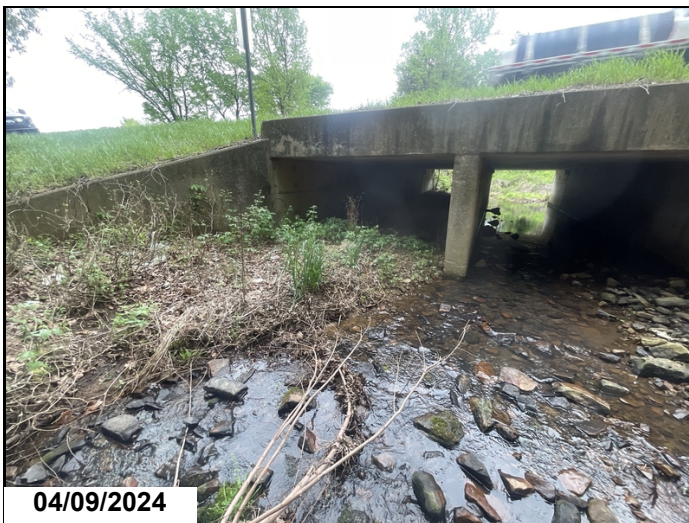
There is approximately 20" of rock accumulation in Barrel # 1.

RC Box Culvert -
There is approximately 20" of rock accumulation in Barrel # 1.

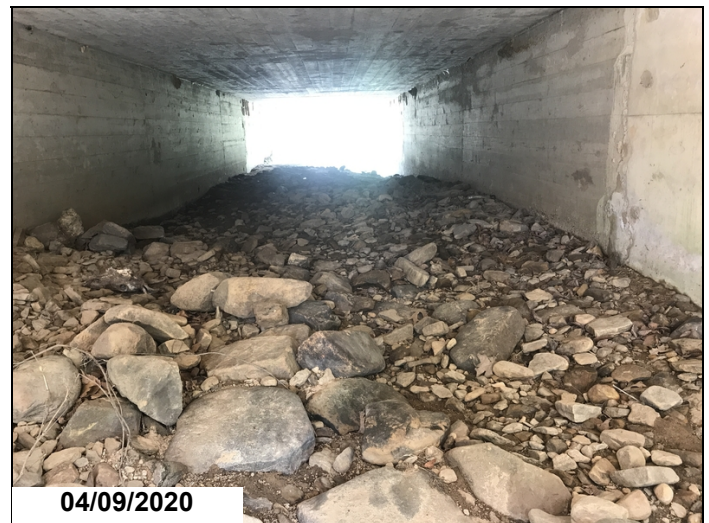
Barrel # 1-Streambed material accumulation.
